# **Definite Plan for the Lower Klamath Project**

## **Appendix E – Reservoir Rim Stability Evaluation**

June 2018

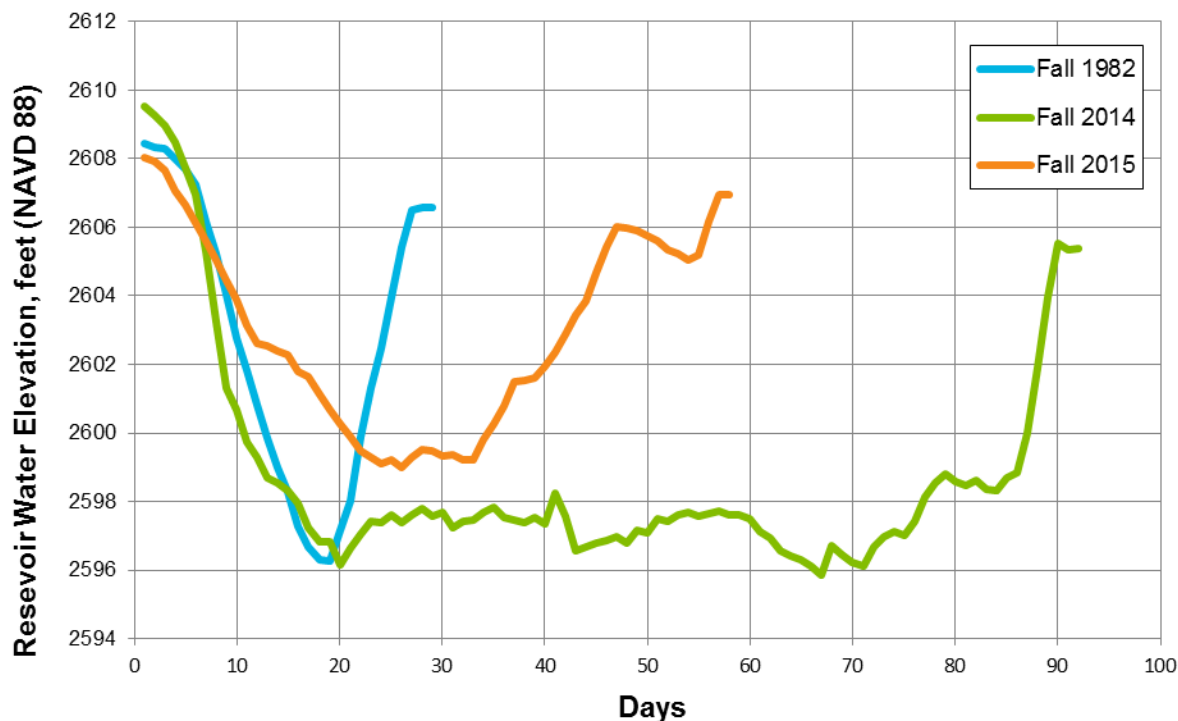
Figure 3-1 Copco Lake Maximum Historical Drawdown Events (1978 to 2016)

The maximum daily drawdown rate of 2 feet per day occurred in 2014 when the reservoir was drawn down nearly 14 feet. Based on inquiries made to PacifiCorp, slope failures were not observed in connection with the three reservoir drawdown events, although there was no specific effort made to determine whether slope failures occurred (email with Demian Ebert August 2, 2017).

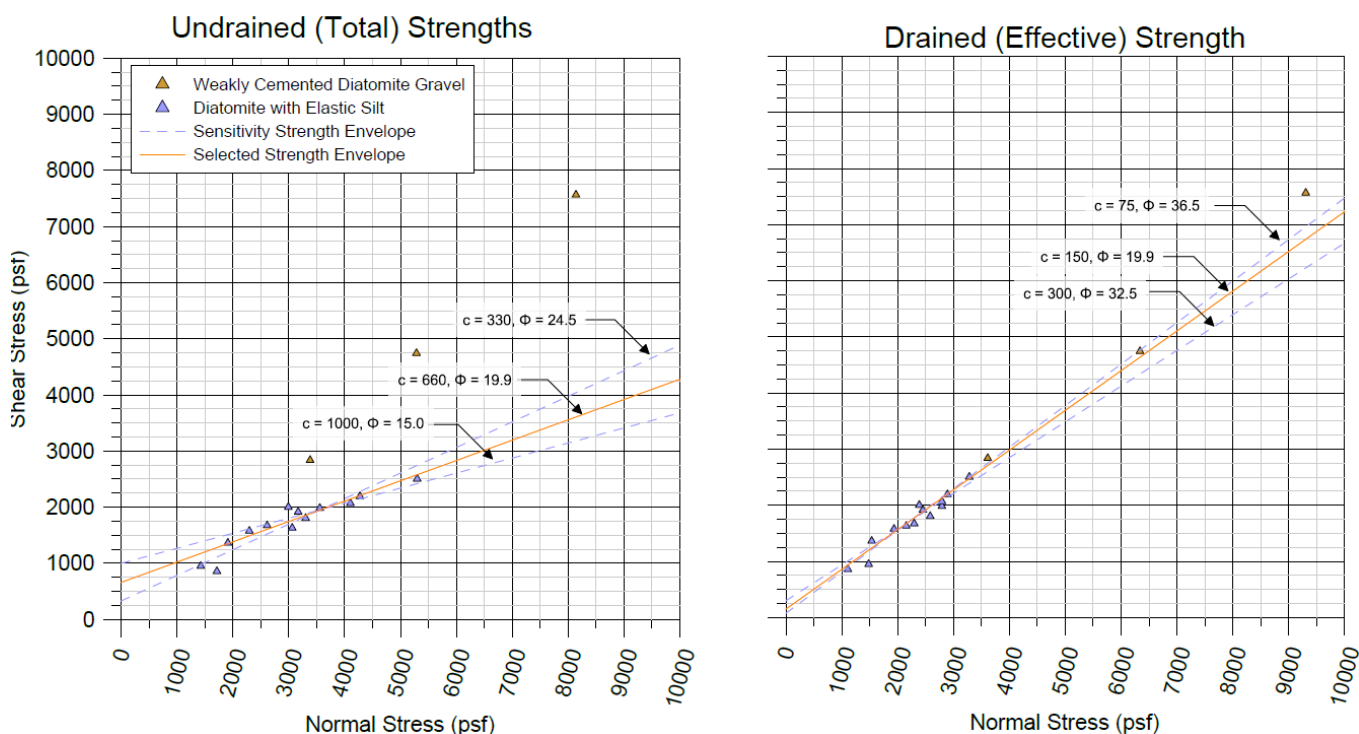
**Figure 3-3 Selected Strength Envelopes**

The diatomite consists of a low density material that is significantly weaker than the underlying bedrock materials. In addition, the material has a low permeability (about  $1 \times 10^{-6}$  cm/s) and will behave as an undrained material during reservoir drawdown, regardless of the drawdown rate. Several different types of diatomite were observed including a rock like diatomite (referred to as diatomite in the boring logs), diatomite that had more of an elastic silt like behavior (referred to as diatomite with elastic silt in the boring logs), and a weakly cemented diatomite. Properties of the diatomite with elastic silt were chosen to represent all the types of diatomite since it was the most common type observed. Table 3-2 and Figure 3-3 summarize strength testing of the diatomite.

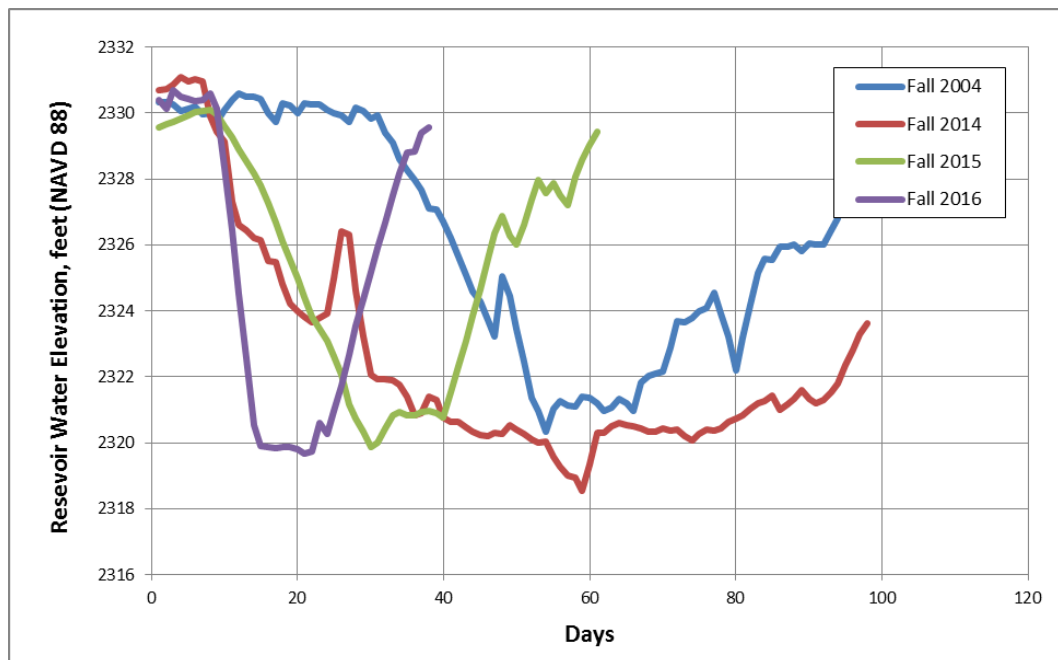
**Figure 4-1 Iron Gate Reservoir Maximum Historical Drawdown Events (1979 to 2016)**

The magnitude of the drawdowns ranged from about 9 feet to 14.5 feet. The maximum daily drawdown rate of 2 feet per day occurred in 2014. Based on inquiries made to PacifiCorp, there were no reported slope failures resulting from these drawdowns (email with Demian Ebert August 2, 2017).

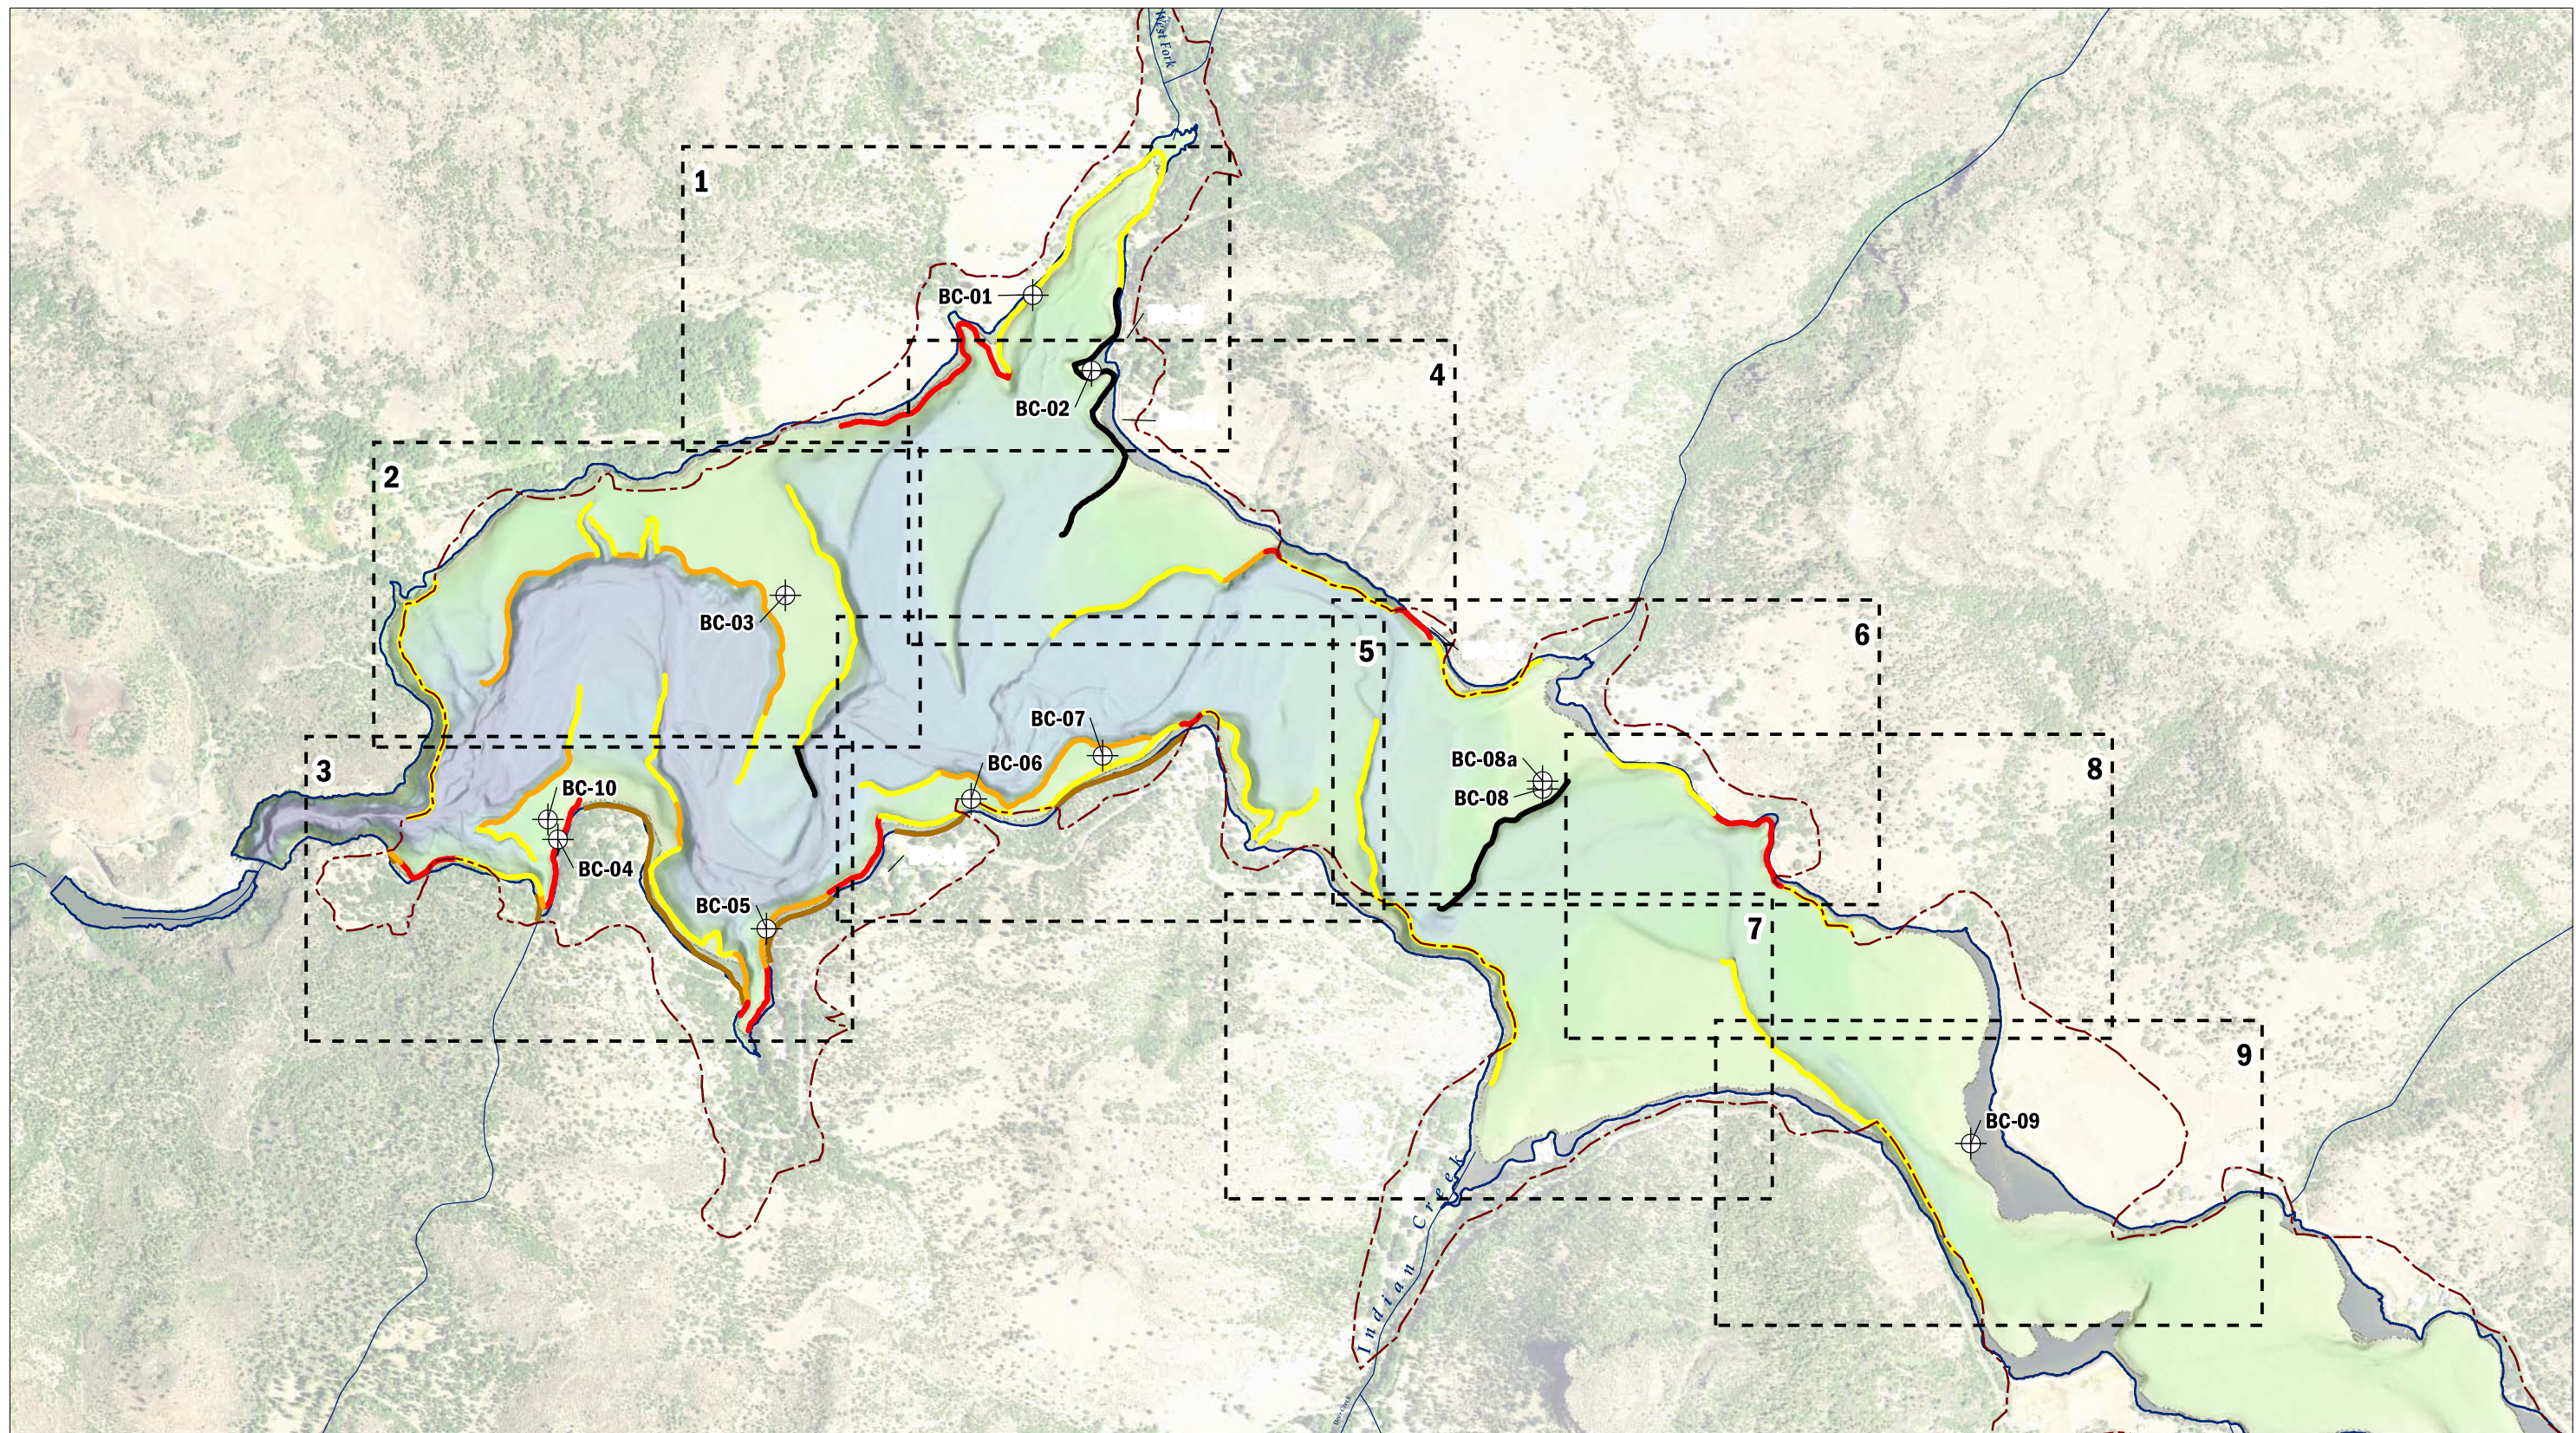
**FIGURE 3-4**

The geologic assessment and slope stability analysis summarized above indicate that certain segments along the Copco No. 1 reservoir rim have a potential for slope failure that could impact existing roads and/or private property. In some areas, the impact could be relatively minor, while in other areas the impact could be greater. Based on the referenced analysis, approximately 3,700 linear feet of slopes along Copco Road (north shore segments S4, S9, S11 and S15), and approximately 2,800 linear feet of slope adjacent to

Additional field geologic data is required to confirm the potential for slope failure along the referenced reservoir rim segments. KRRC will complete the additional field investigation in July and August of 2018, followed by completion of a series of material property laboratory tests. KRRC will use results from the field investigation and laboratory testing to update stability assessments in the rim segments of concern in fall 2018. Should additional study determine that there is a high probability of slope failure in any of these areas, KRRC will consider the following actions to offset potential impacts:

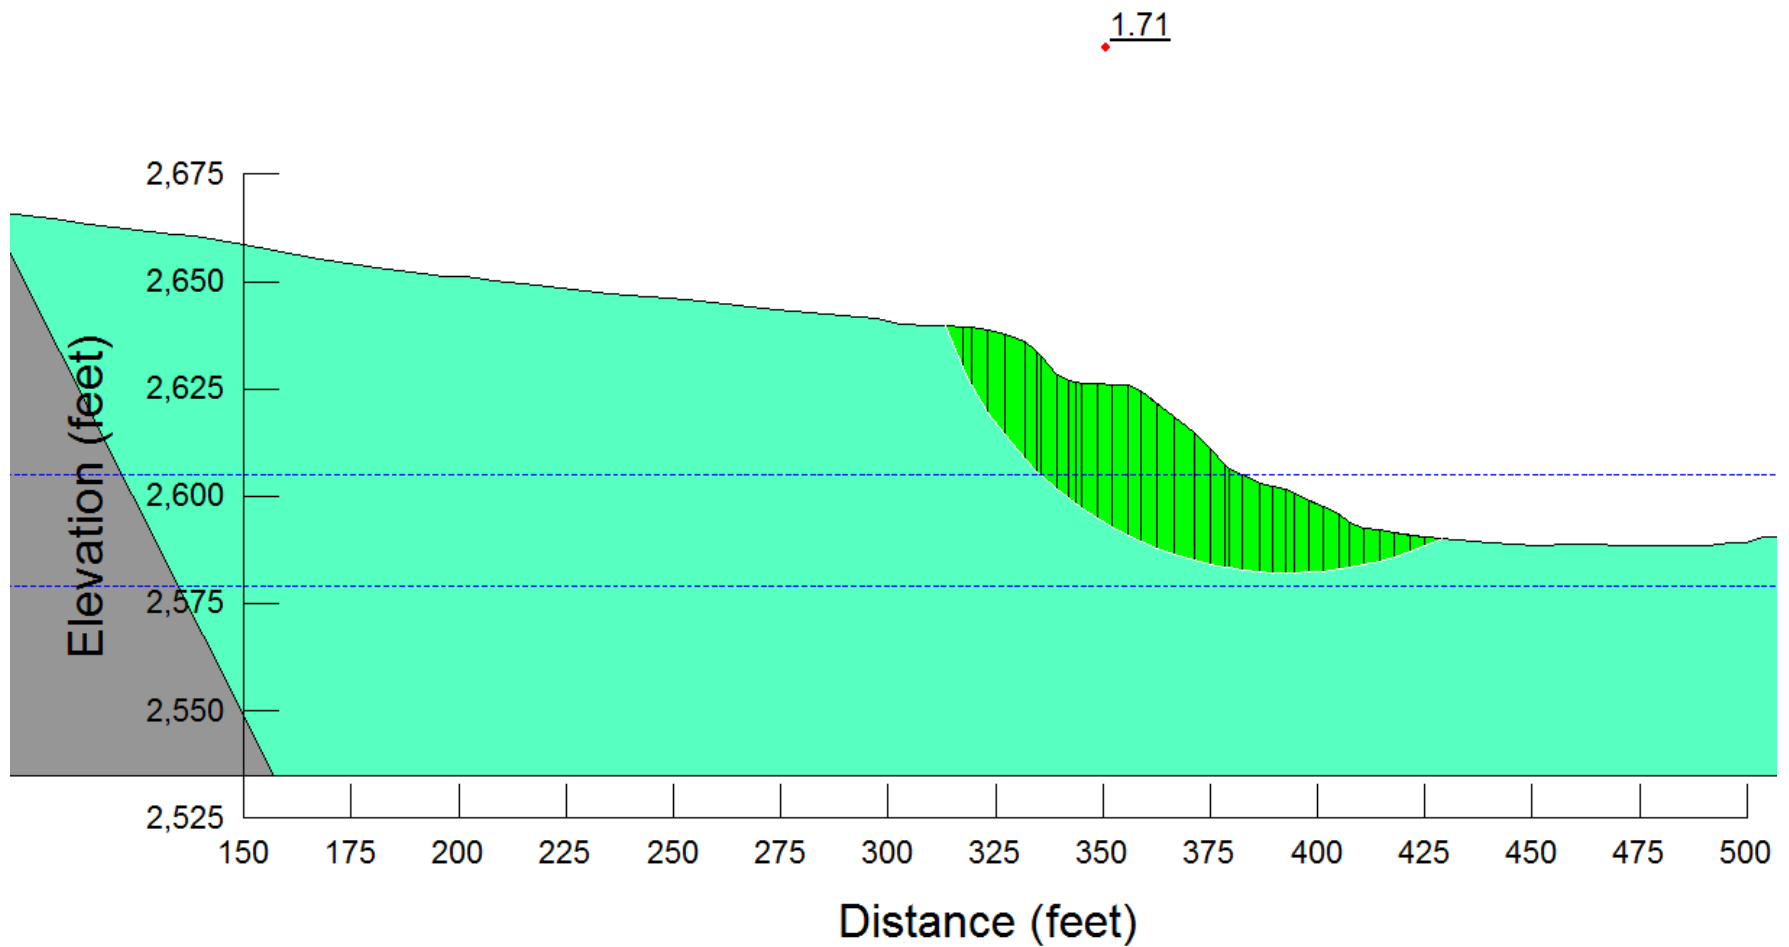
Klamath River Renewal Corporation	Copco Reservoir Slope Stability Segment N11, Section 1 Rapid Drawdown Analysis	Figure 3-5b
<b>AECOM</b>

A summary of the results of the slope stability analyses are presented below. KRRC used a factor of safety of 1.15 as the pass/fail criteria due to the critical nature of some areas and the lack of specific data at most of these locations. Figure 3-4 shows a plan view of the current analysis results, and Figure 3-5 shows cross section results for the rapid drawdown analyses.

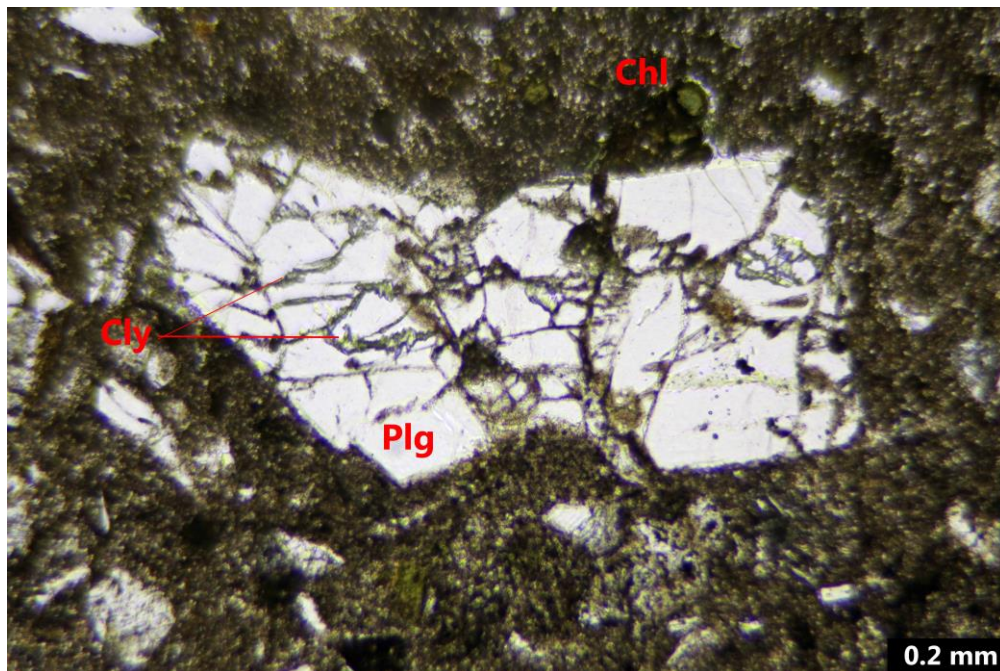
**Fig. 4** - Plane polarized light. Field of view = 1.7 mm wide (magnification 10X). A detail of a Plagioclase grain, crossed by many fractures, all filled with Clay Minerals (Cly). Some Chlorite individuals (Chl) may be identified in the upper part of the picture.

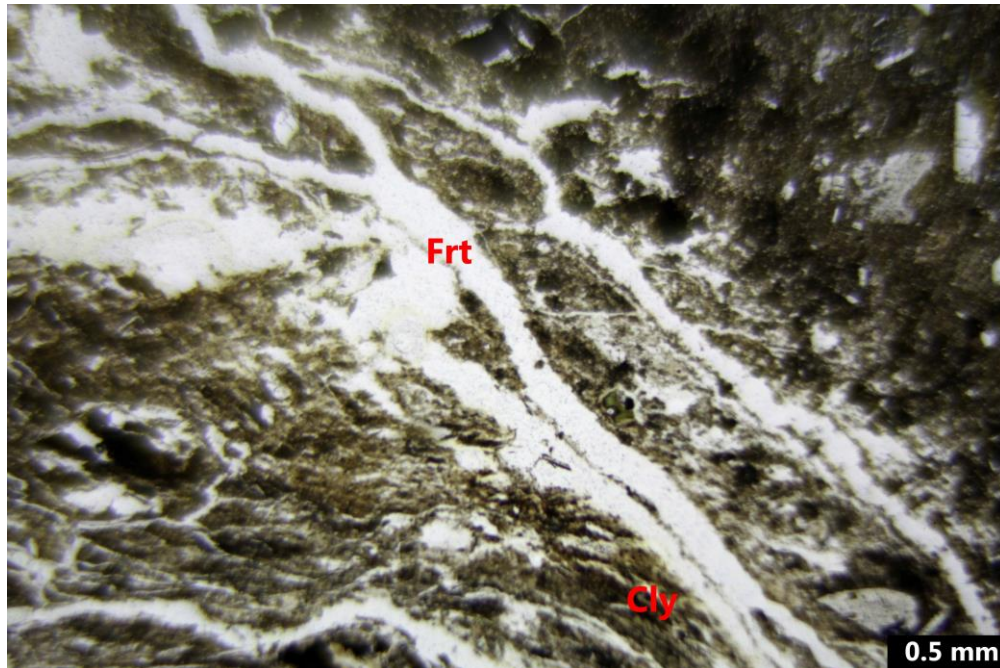
**Fig. 6** - Plane polarized light. Field of view = 4 mm wide (magnification 4X). A selected area of the section with a well-developed fracture system (Frt).

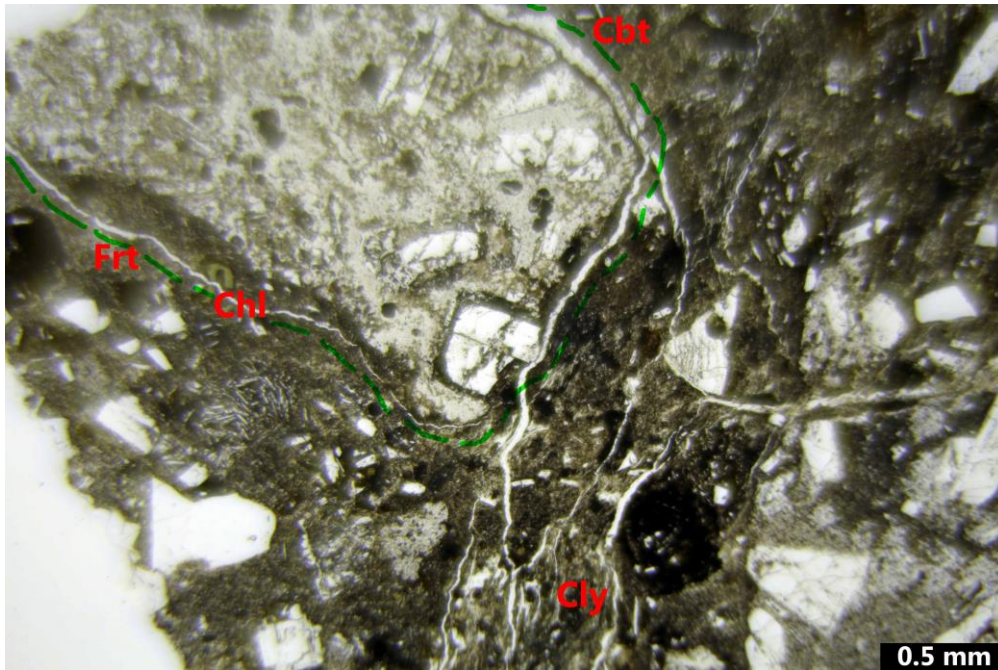
**Fig. 4** - Plane polarized light. Field of view = 4 mm wide (magnification 4X). A view of a volcanic clast. A common feature of all the clasts in this thin section is the presence of fractures surrounding clast boundaries (follow the green dashed line). In this case the fracture is filled with secondary Carbonates (Cbt).

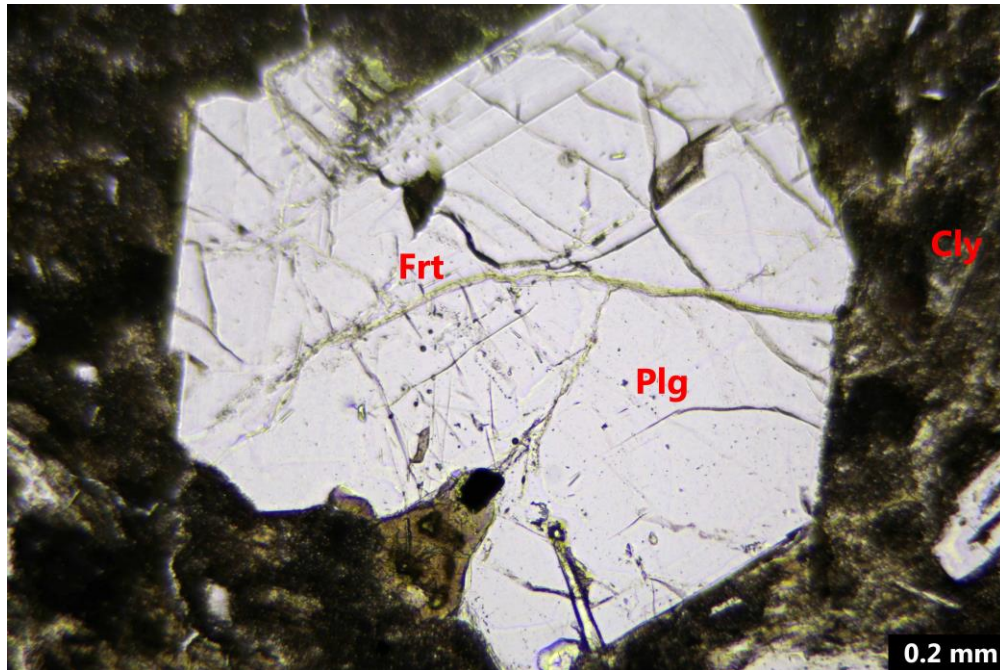
**Fig. 6** - Plane polarized light. Field of view = 1.7 mm wide (magnification 10X). A detail of a Plagioclase crystal, showing grain alteration and suturing features: fractures cross the crystal and are also filled with Clay Minerals.
