**UNITED STATES OF AMERICA
BEFORE THE
FEDERAL ENERGY REGULATORY COMMISSION**

**Project Nos. 14803-001;
2082-063**

**EXHIBIT N (1 of 2)
Waste Disposal and Hazardous Materials Management Plan**

**Waste Disposal and
Hazardous Materials
Management Plan**

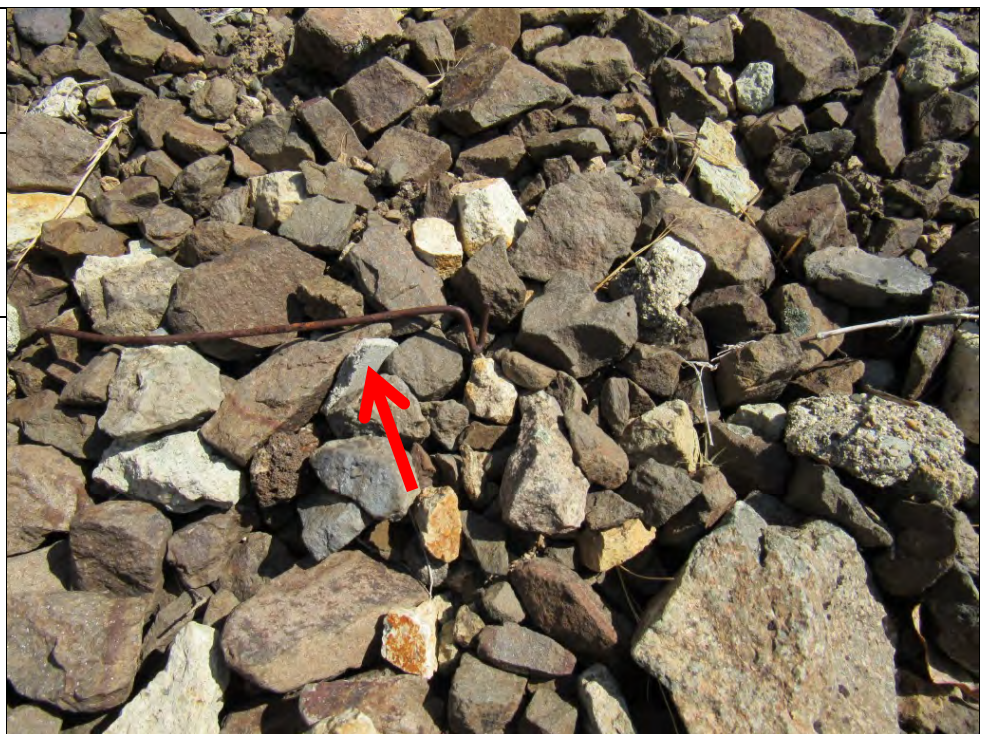
Photo No./ Material ID: CC2FBH - 13	Date: 9/11/2018 to 9/13/2018
Structure/Material Location: Copco No. 2 Former Bunkhouse/ Scattered throughout exterior in landscaping rock cover	
*Description (by layer): 1: Cement asbestos board (CAB) debris (M)

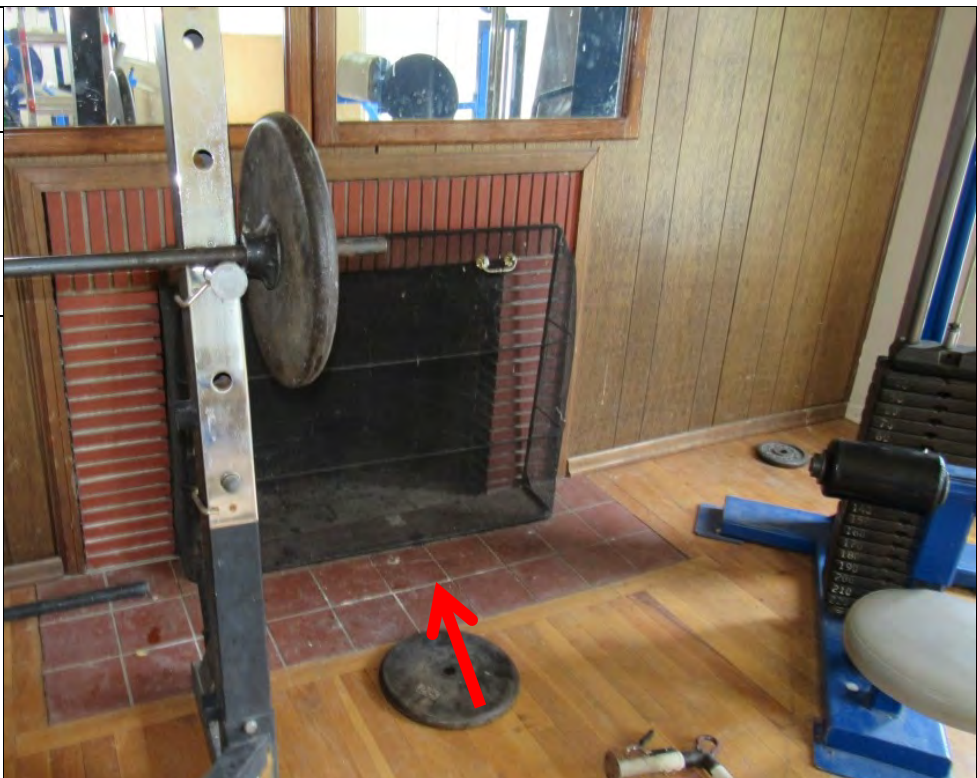
Photo No./ Material ID: CC2R5 - 11	Date: 9/11/2018 to 9/13/2018

Structure/Material Location: Copco No. 2 Residence 5/ Floor in living room		
*Description (by layer): 1: Gray grout associated with fireplace (M)
