**Klamath River Renewal Corporation  
PacifiCorp**

**AMENDED APPLICATION FOR SURRENDER OF LICENSE  
FOR MAJOR PROJECT AND REMOVAL OF PROJECT WORKS**

**EXHIBIT N (1 of 2)  
Waste Disposal and Hazardous Materials Management Plan  
(Amended December 15, 2021)**

**Waste Disposal and  
Hazardous Materials  
Management Plan**

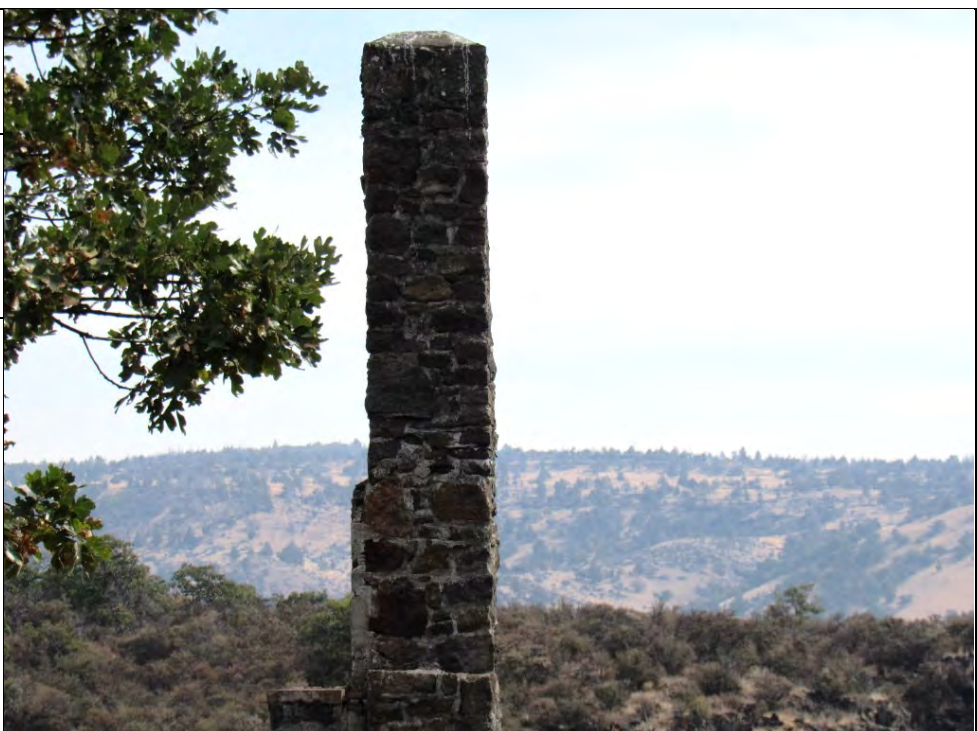
<b>Photo No./ Material ID:</b>  CC1FFR - 01	<b>Date:</b>  9/10/2018 to 9/11/2018

<b>Structure/Material Location:</b>  <b>Copco No. 1 Emergency Spill Equipment Shed/ Throughout roof</b>		
<b>*Description (by layer):</b>  <b>Assumed gray grout associated with river rock chimney (M)</b>

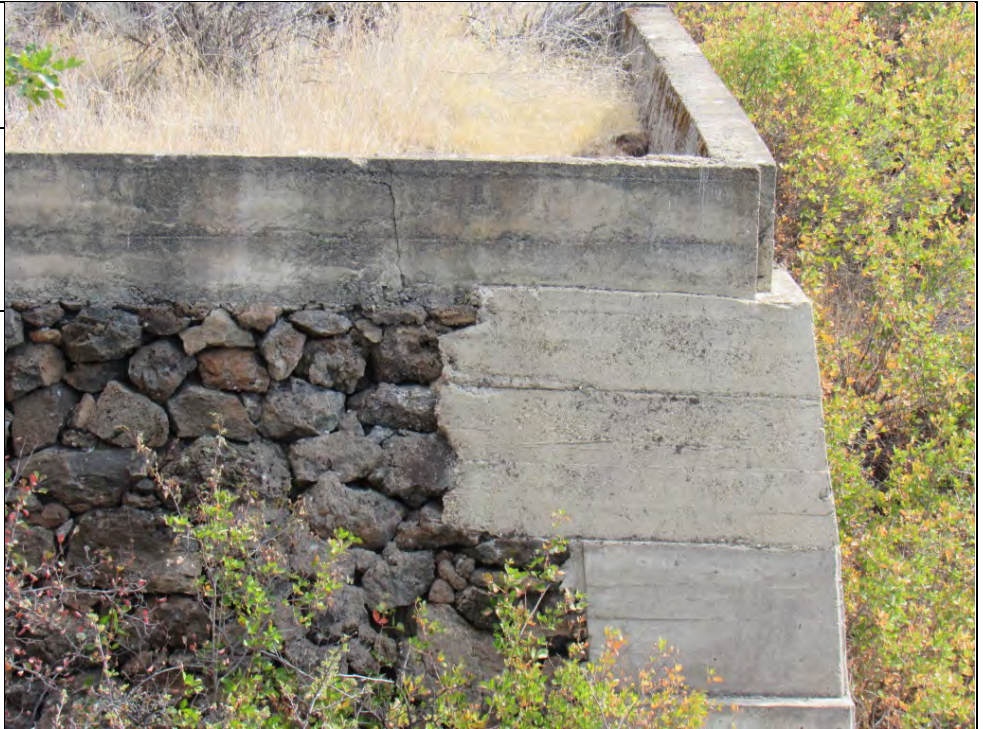
**Assumed gray grout  
associated with foundation  
(M)**

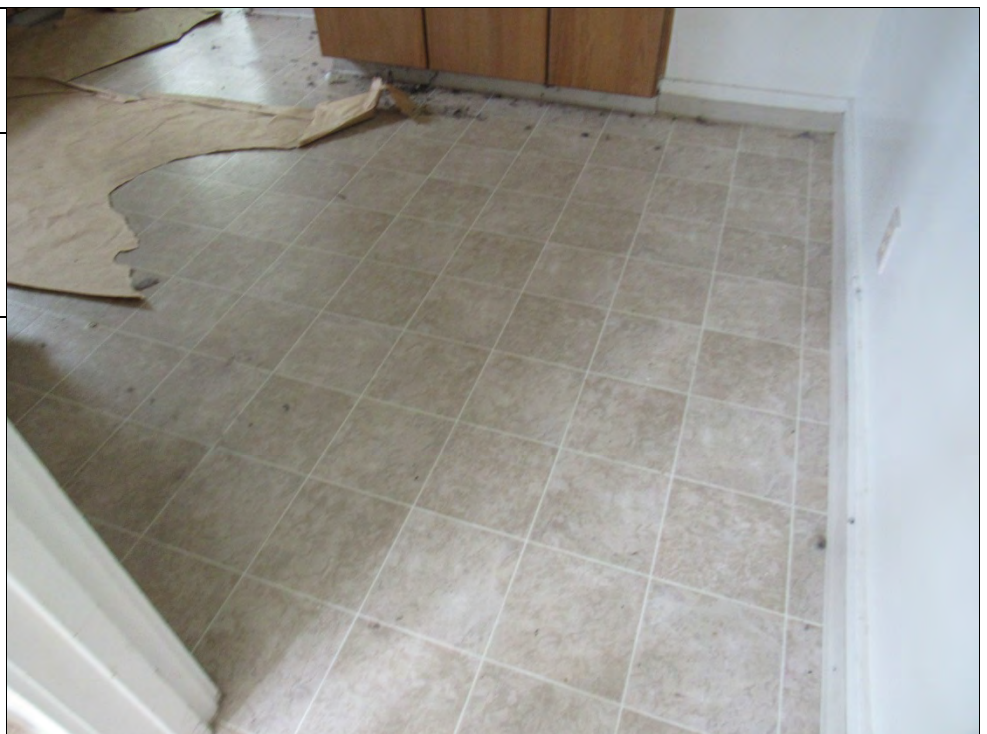
<b>Photo No./ Material ID:</b>  CC1R2 - 03	<b>Date:</b>  9/10/2018 to 9/11/2018
<b>Structure/Material Location:</b>  Copco No. 1 Residence 2/ Walls in kitchen, mud room, and bathroom	
<b>*Description (by layer):</b> 1: Light gray vinyl floor sheeting with swirl and square pattern (M) 2: White paper backing with tan mastic (M)

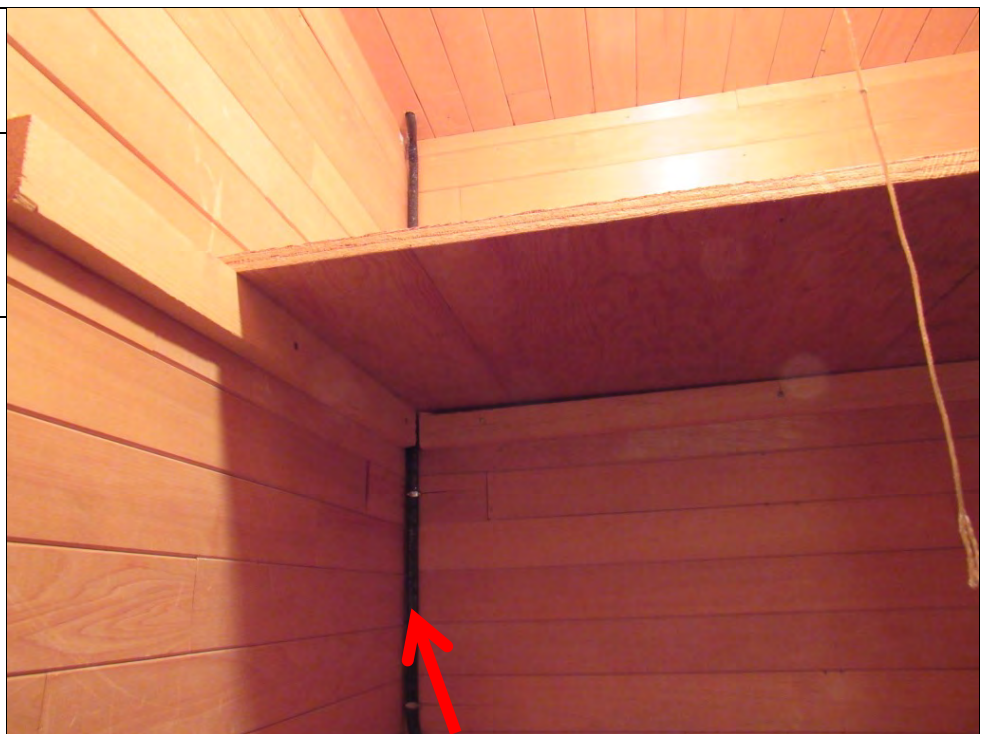
<b>Photo No./ Material ID:</b>  CC1R2 - 05	<b>Date:</b>  9/10/2018 to 9/11/2018
<b>Structure/Material Location:</b>  Copco No. 1 Residence 2/ Throughout interior wall spaces and attic	
<b>*Description (by layer):</b>  <b>Assumed asbestos-containing asphaltic woven electrical wire insulation (M)</b>

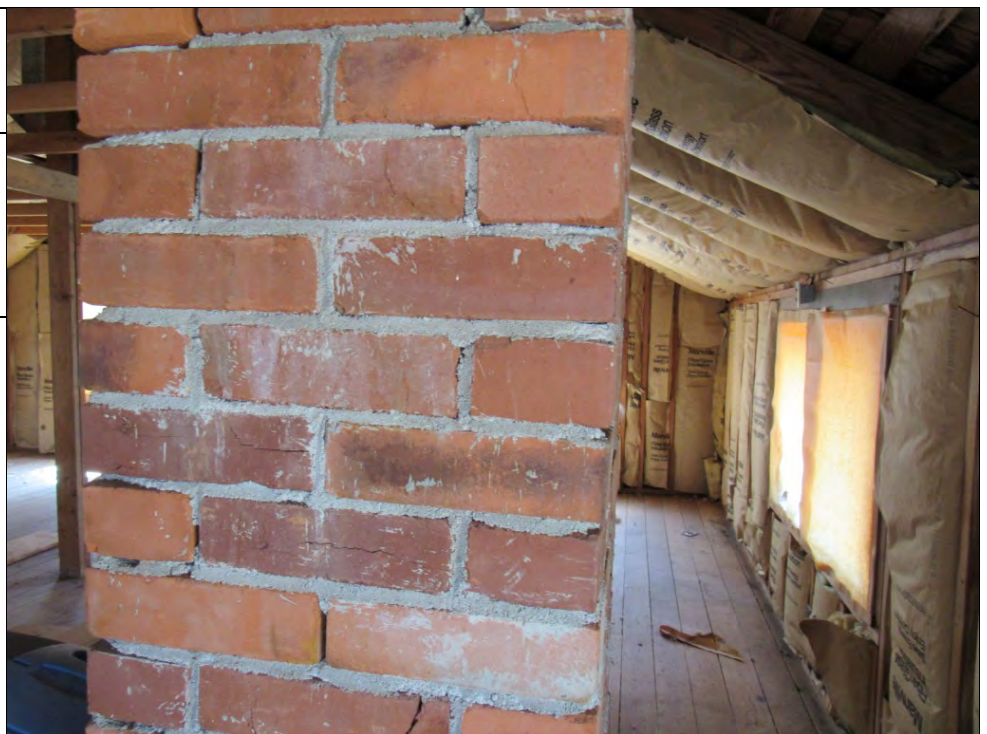
<b>Photo No./ Material ID:</b>  CC2FCH - 03	<b>Date:</b>  9/11/2018 to 9/13/2018
<b>Structure/Material Location:</b>  Copco No. 2 Former Cookhouse/ Second floor attic space	
<b>*Description (by layer):</b>  1: Gray grout (M)

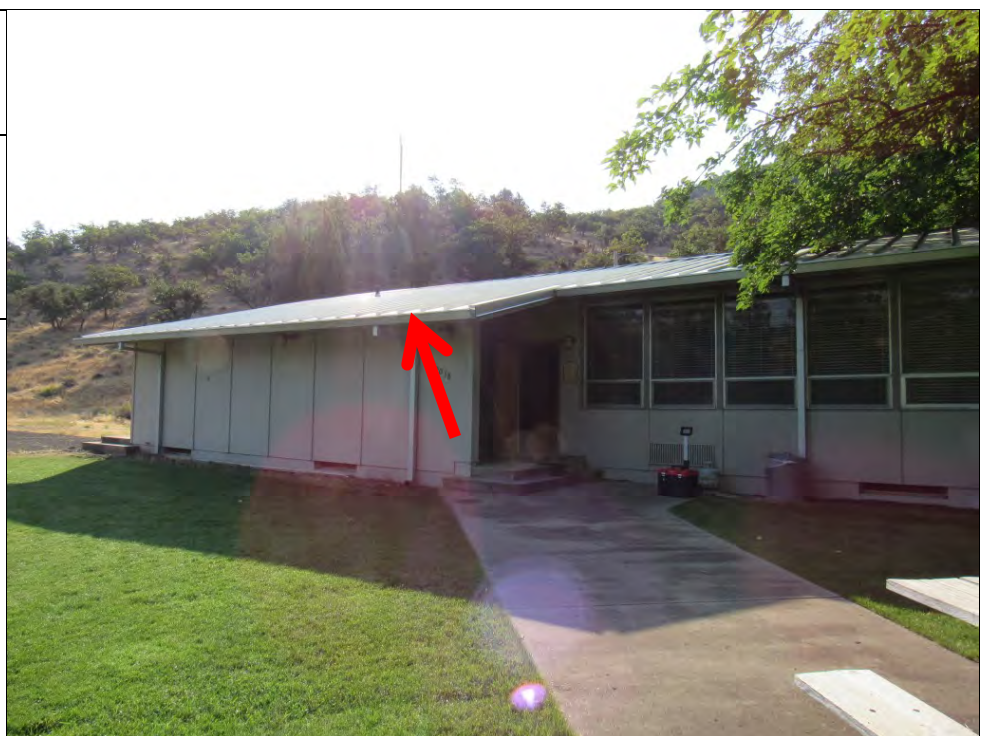
**Assumed asbestos-containing  
roofing paper (M)**

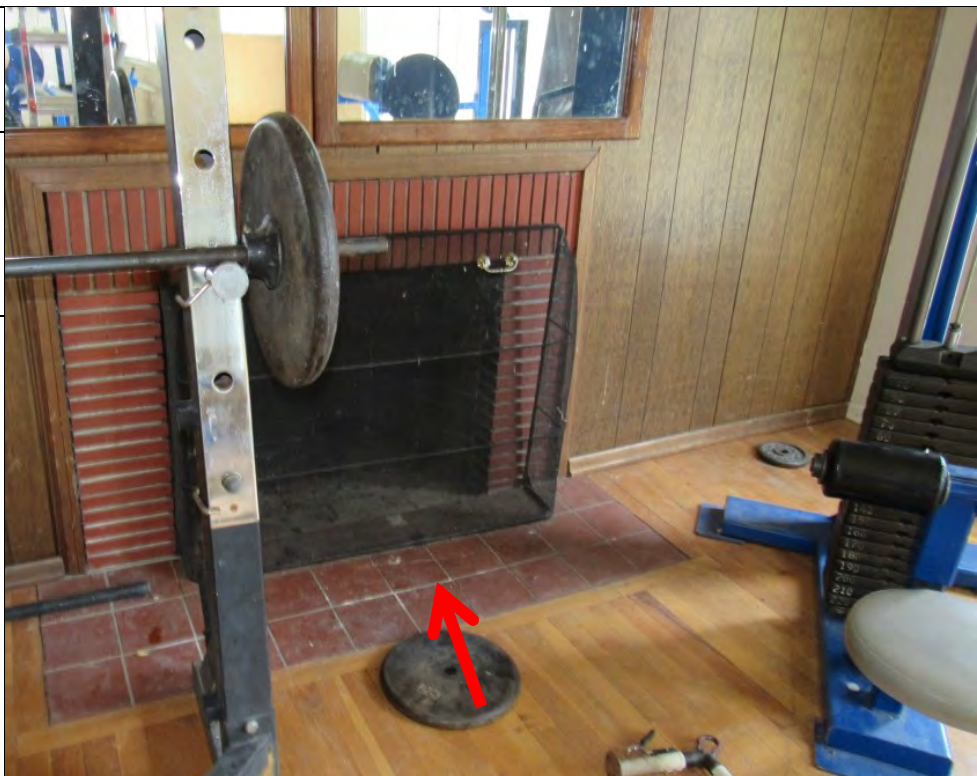
<b>Photo No./ Material ID:</b>  CC2R5 - 11	<b>Date:</b>  9/11/2018 to 9/13/2018

<b>Structure/Material Location:</b>  Copco No. 2 Residence 5/ Floor in living room		
<b>*Description (by layer):</b>  1: Gray grout associated with fireplace (M)
