**UNITED STATES OF AMERICA
BEFORE THE
FEDERAL ENERGY REGULATORY COMMISSION**

**AMENDED APPLICATION FOR SURRENDER OF LICENSE
FOR MAJOR PROJECT AND REMOVAL OF PROJECT WORKS**

**EXHIBIT N (2 of 2)
Waste Disposal and Hazardous Materials Management Plan
(Amended December 15, 2021)**

**HAZARDOUS MATERIALS SURVEY
FINAL REPORT**

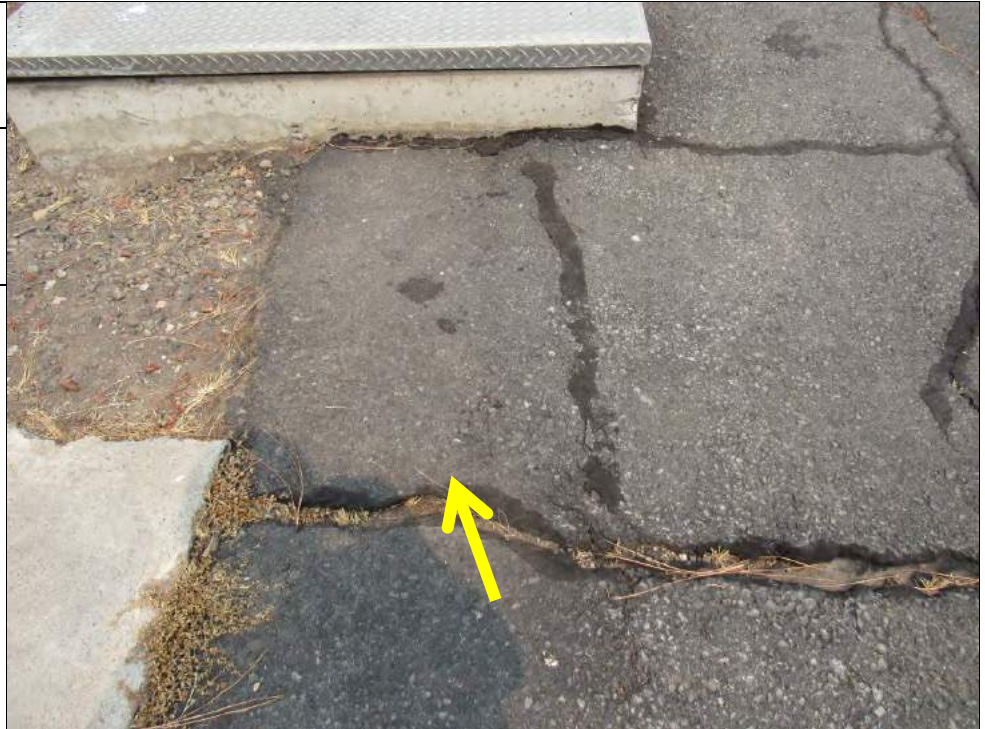
Photo No./ Material ID: JCIS - 03	Date: 8/20/2018 to 8/23/2018
Structure/Material Location: JC Boyle Dam Intake Structure/ Intake structure walkway	
*Description (by layer): 1: Textured cementitious coating on walkway (M)
