APPENDIX E

Preliminary Services Diversion Tunnel Inspection

RE: Klamath River Renewal Project – Iron Gate and Copco No. 1 Diversion Tunnel Geotechnical Inspection

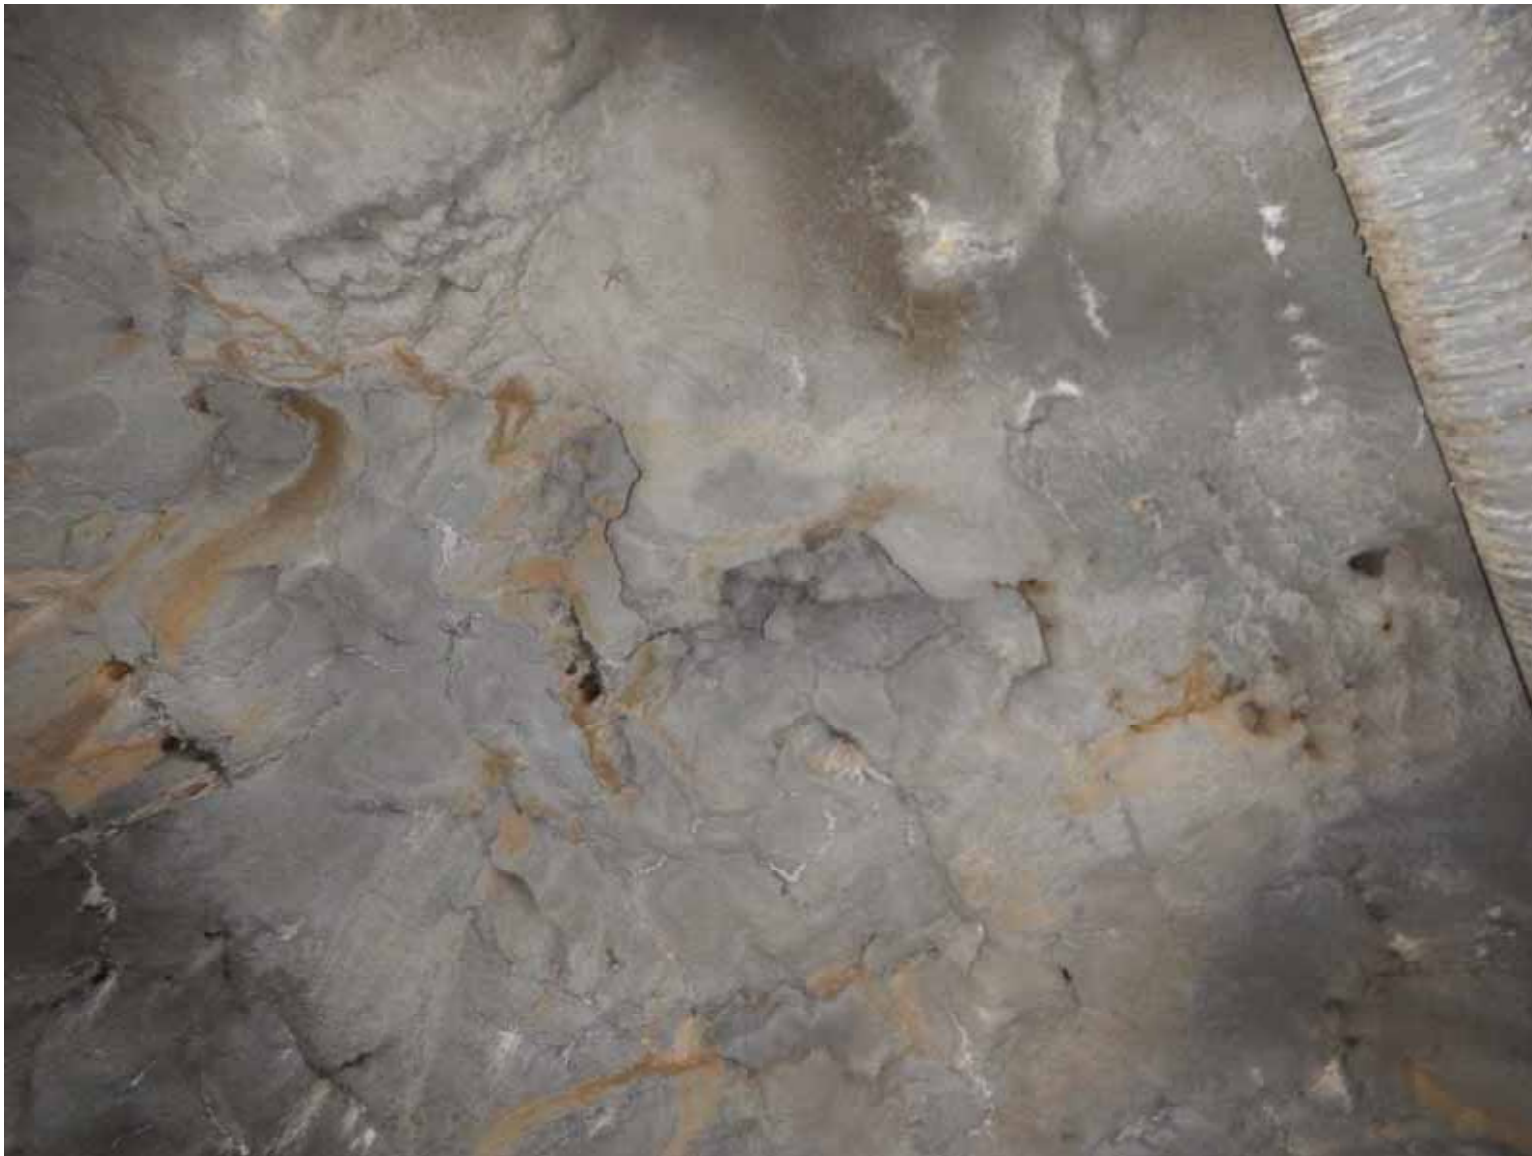
Profile of the tunnel crown in the shotcreted section is locally highly irregular suggesting the presence of a 'loose' closely jointed rock mass with previous crown instability

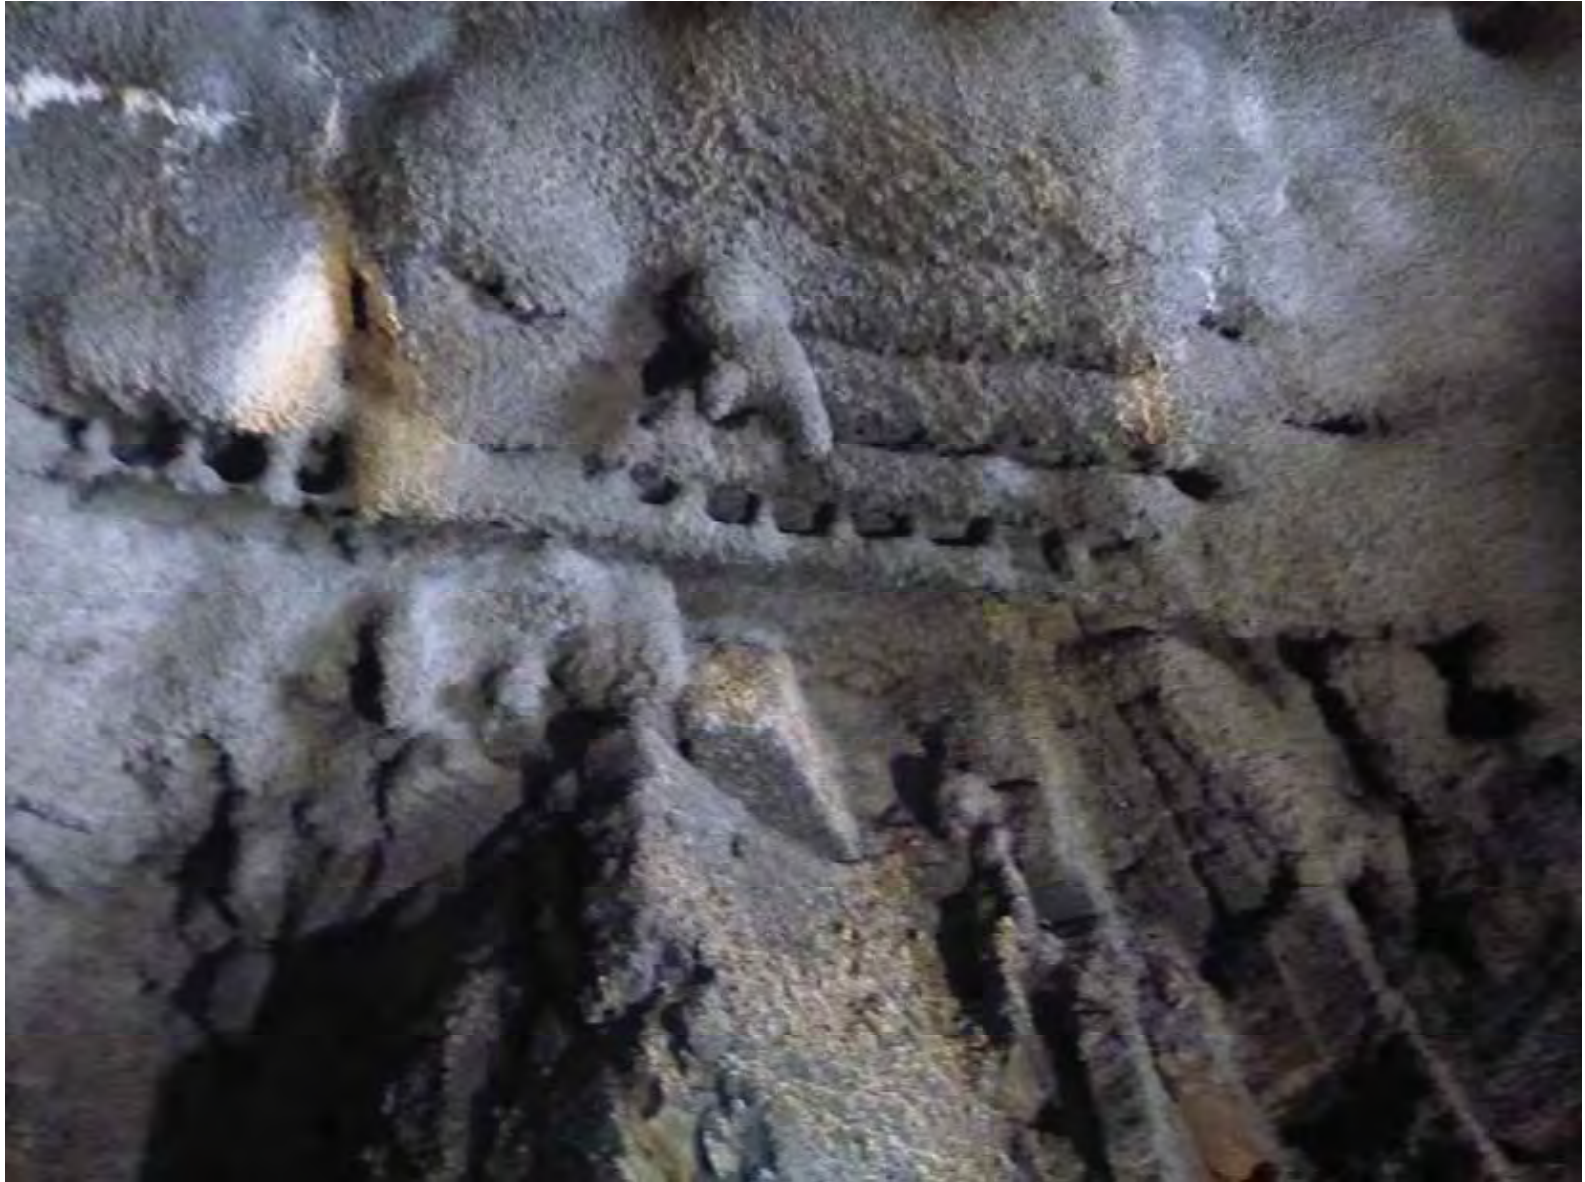
Shotcreted section with welded wire mesh and possible spot bolts

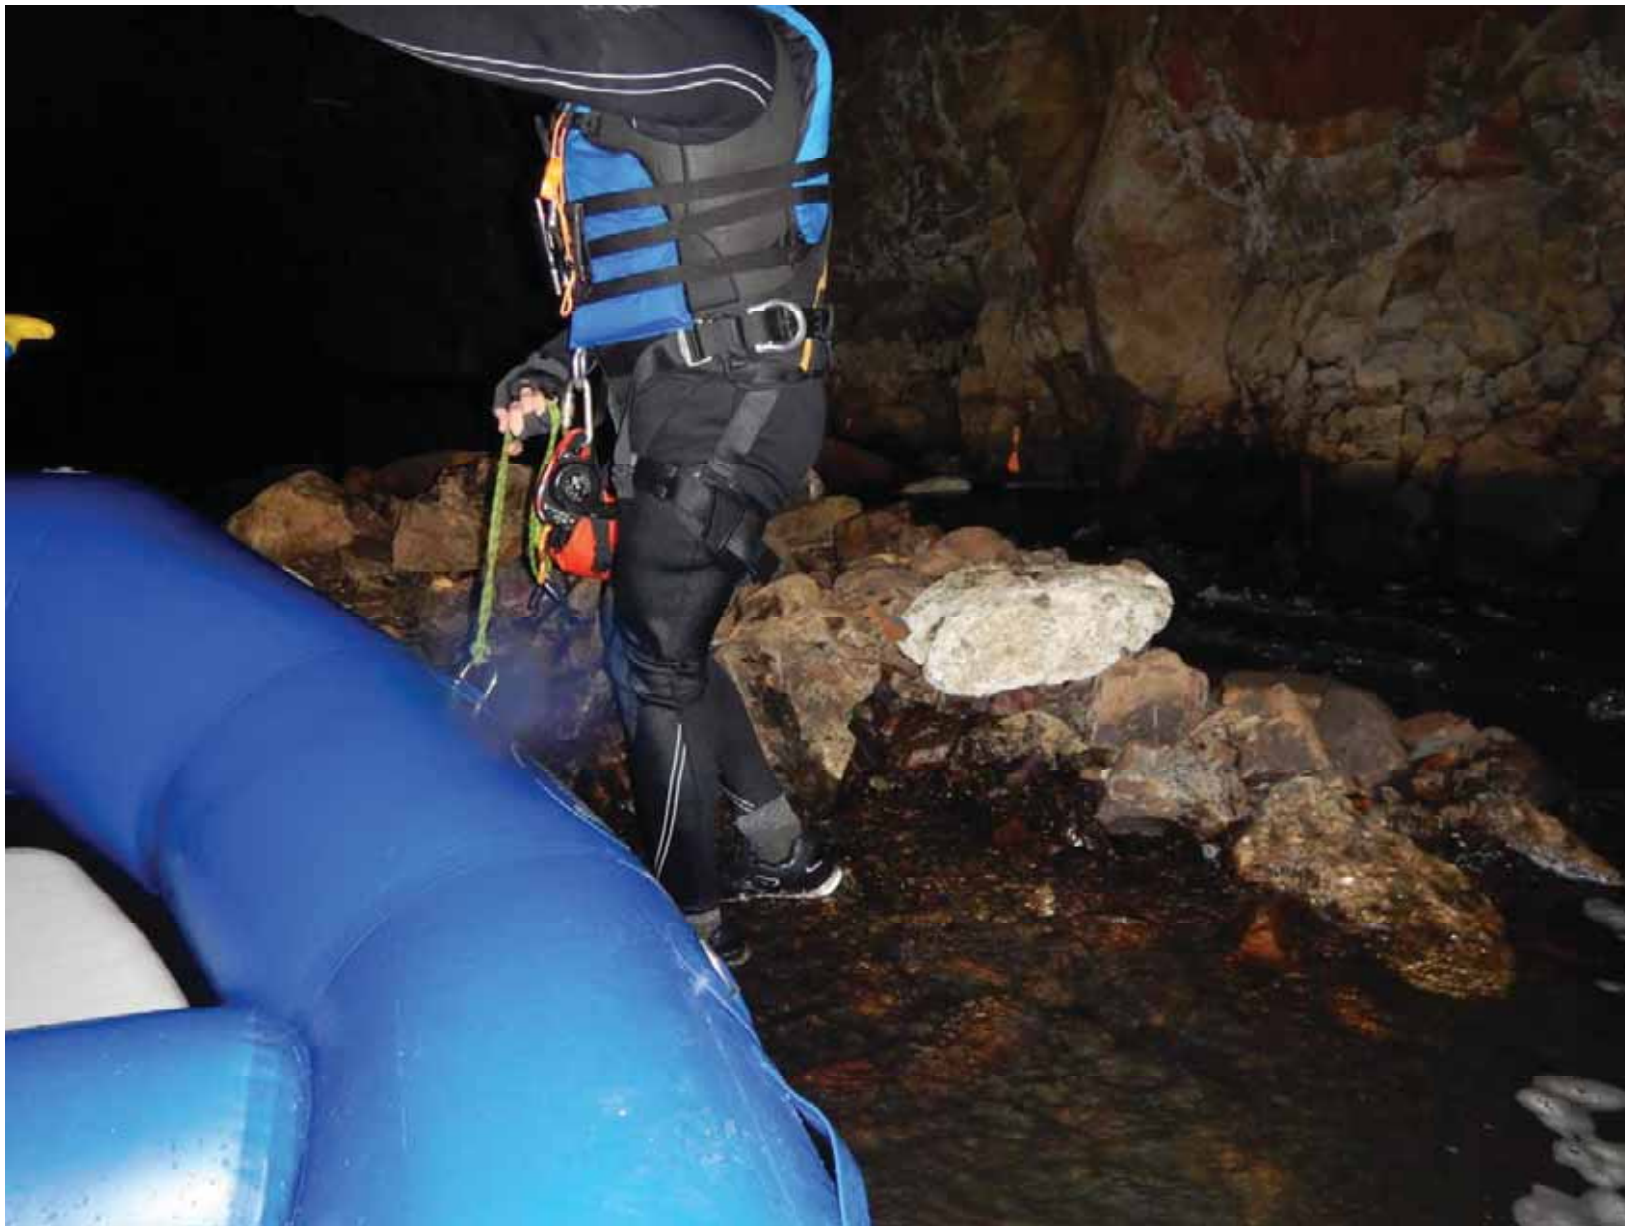
A rubble pile was observed in the centre portion of the tunnel invert at STA 286.4 ft (Photo 9, Appendix B). There is no obvious source zone for a wedge failure in the tunnel crown above the rubble pile. However, an approximately 3-ft sized rock block has detached from the left wall at this location. The rubble pile predominantly comprises bedrock blocks but also includes some blocks of concrete.

STA. 286.4 ft - 'Rubble Pile' includes concrete as well as rock fragments. No obvious evidence of a rock fall from the tunnel crown at this location

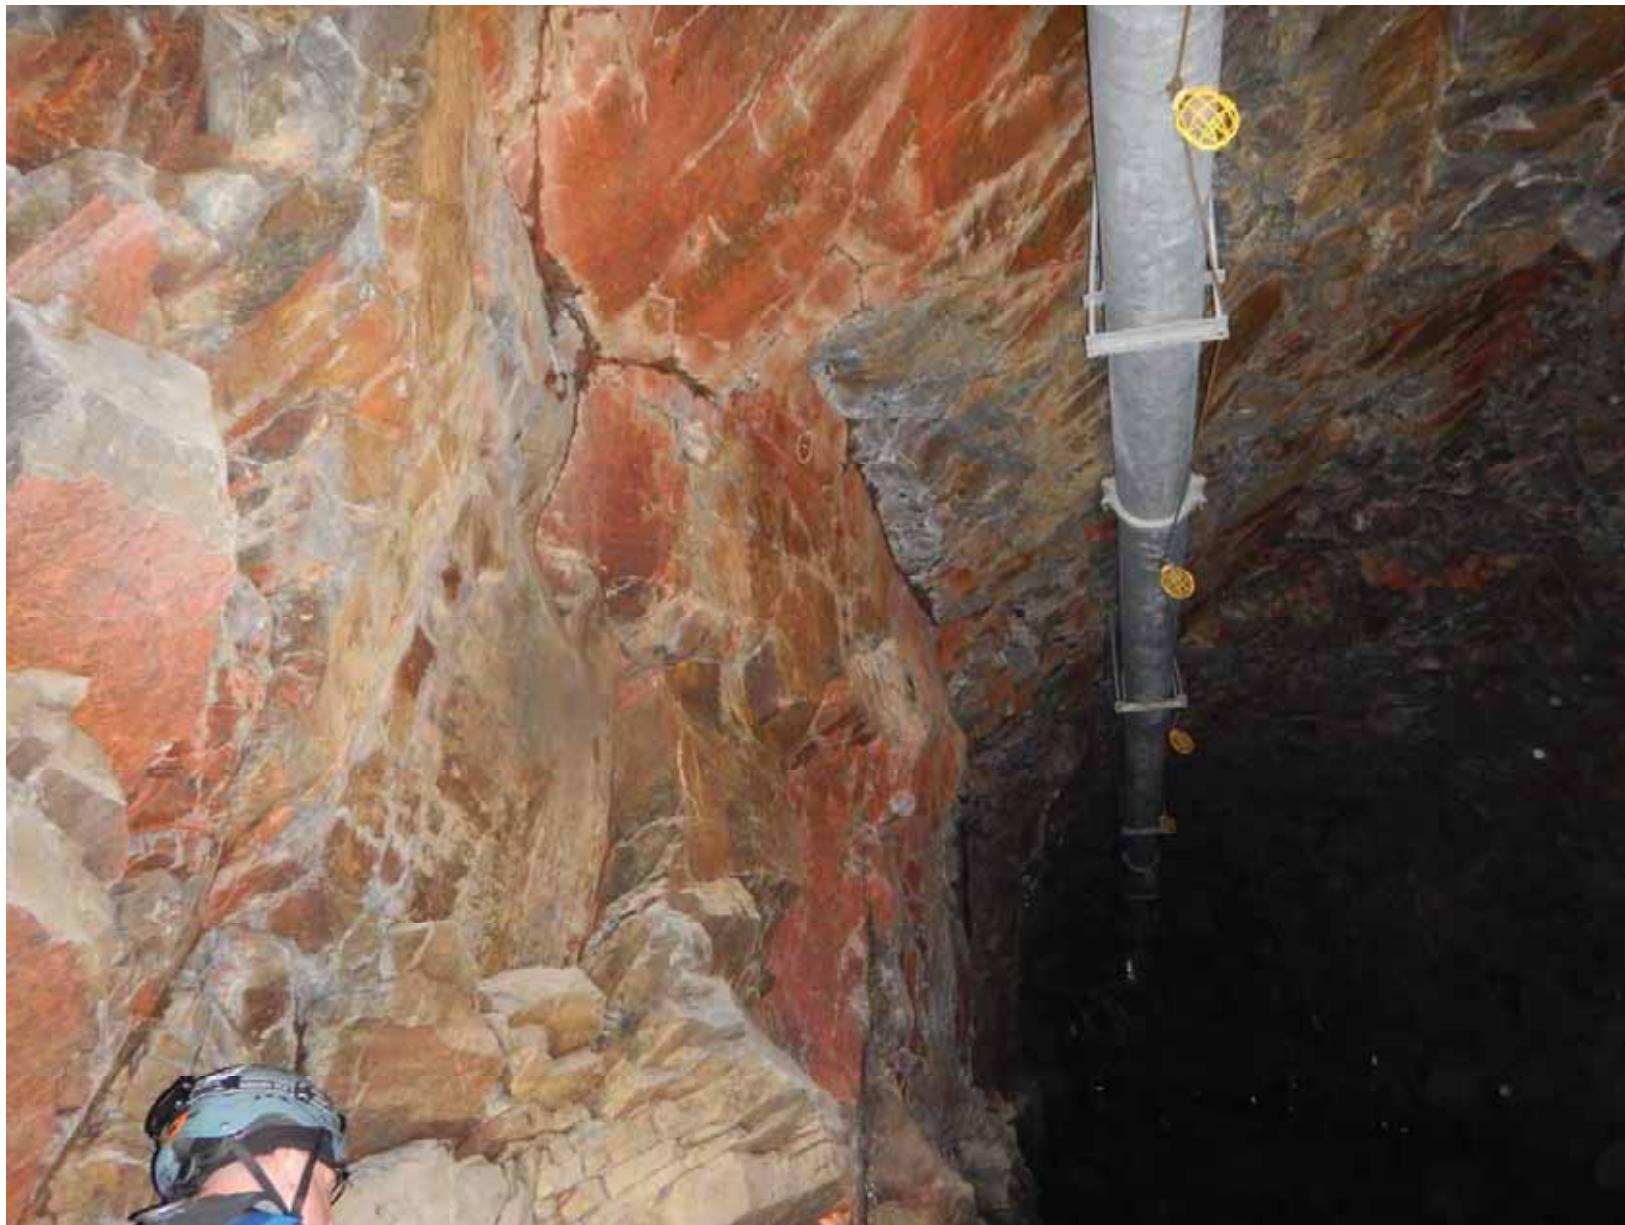
STA. 252.6 ft - Tunnel wall is developed along sub-vertical Set 1 Joint

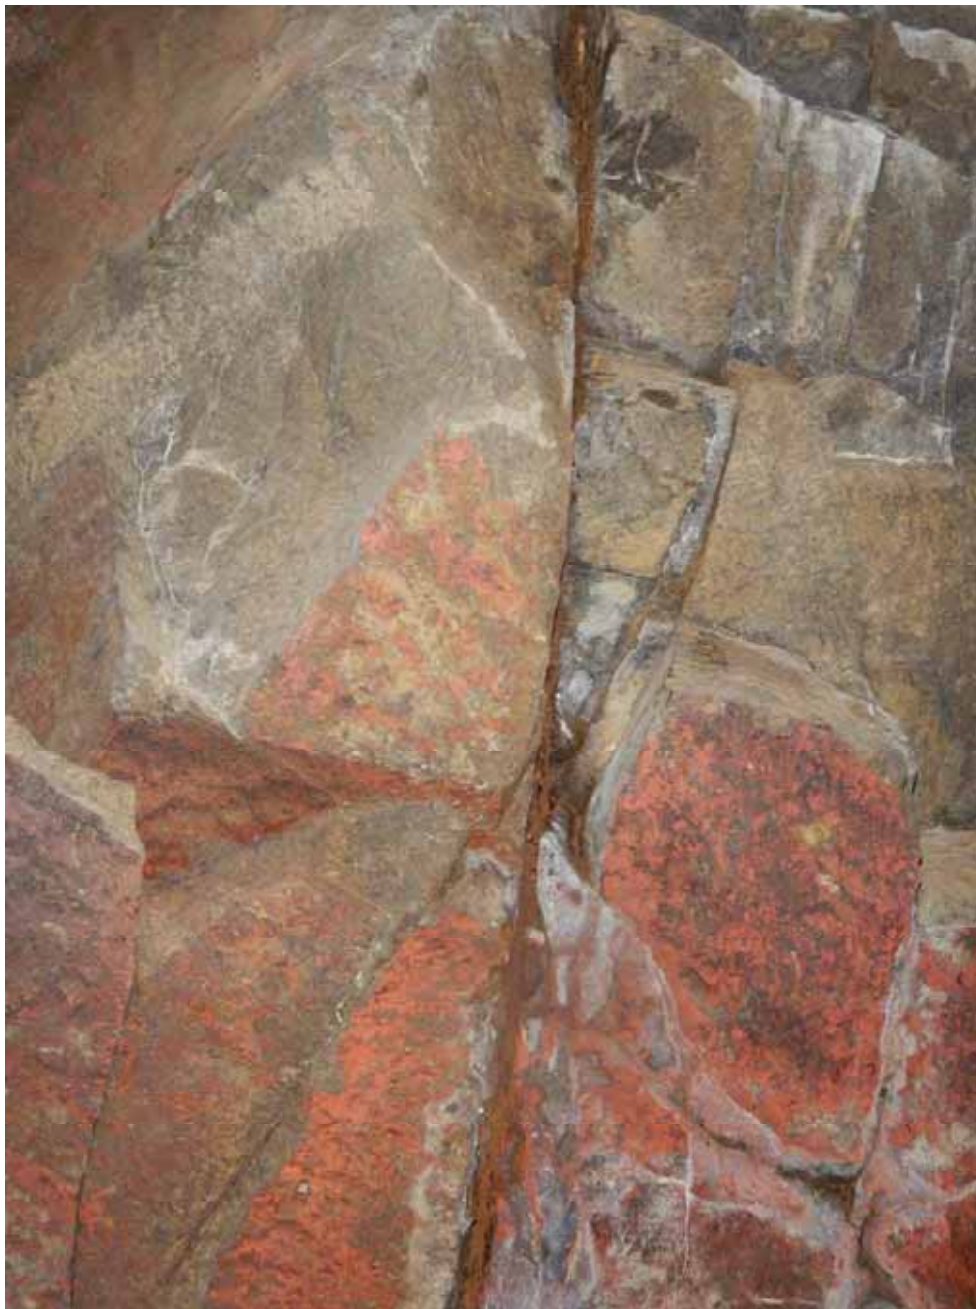
STA. 253.6 ft – Very Steep Set 2 Joint with 1/16 to 1/4-inch of sandy clay infill

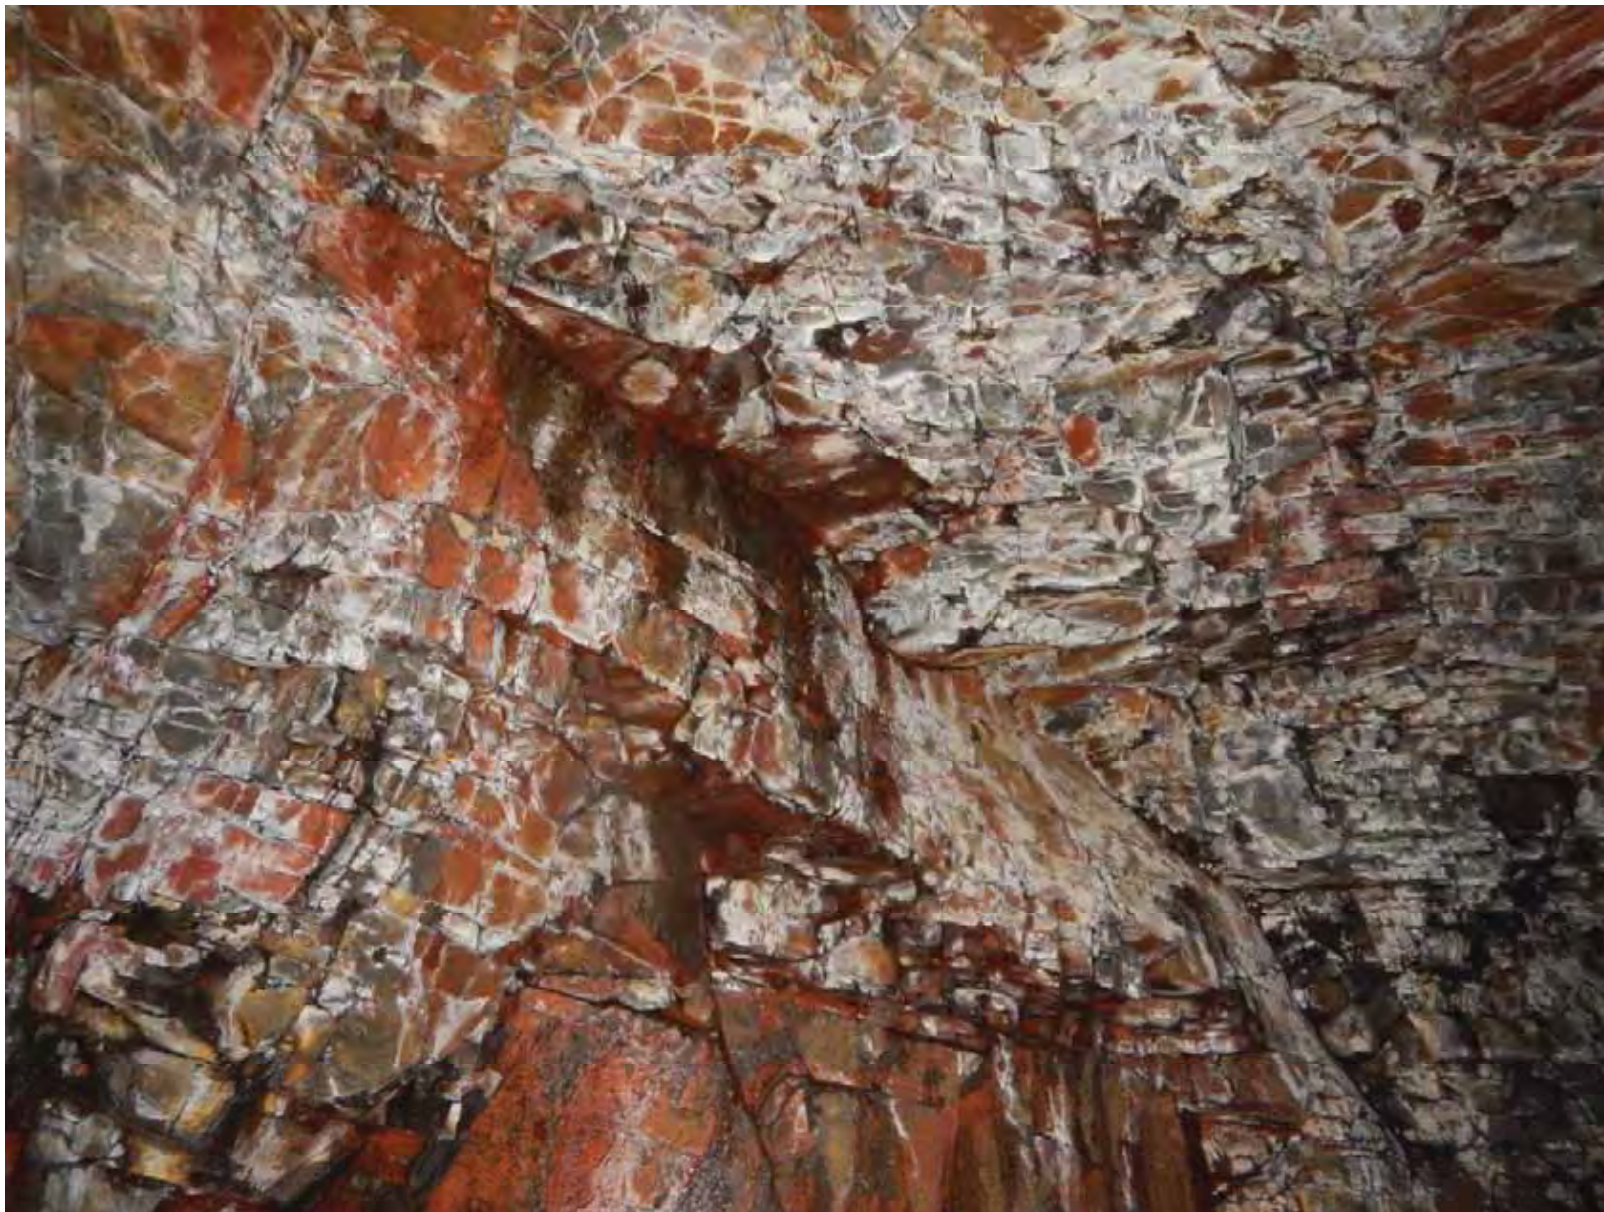
Slight seepage (approximately 1 drop every 2 seconds) was observed in the tunnel crown at STA. 453.7 ft (Photo 12, Appendix B) and STA. 509.5 ft (Photo 13, Appendix B). Seepage was also observed around the upstream concrete liner (Photo 14, Appendix B).

STA 453.7 ft – 9.8 ft long triangular wedge failure at crown/wall interface formed by intersection of Set 1 and Set 3 Joint.
Note water seepage.

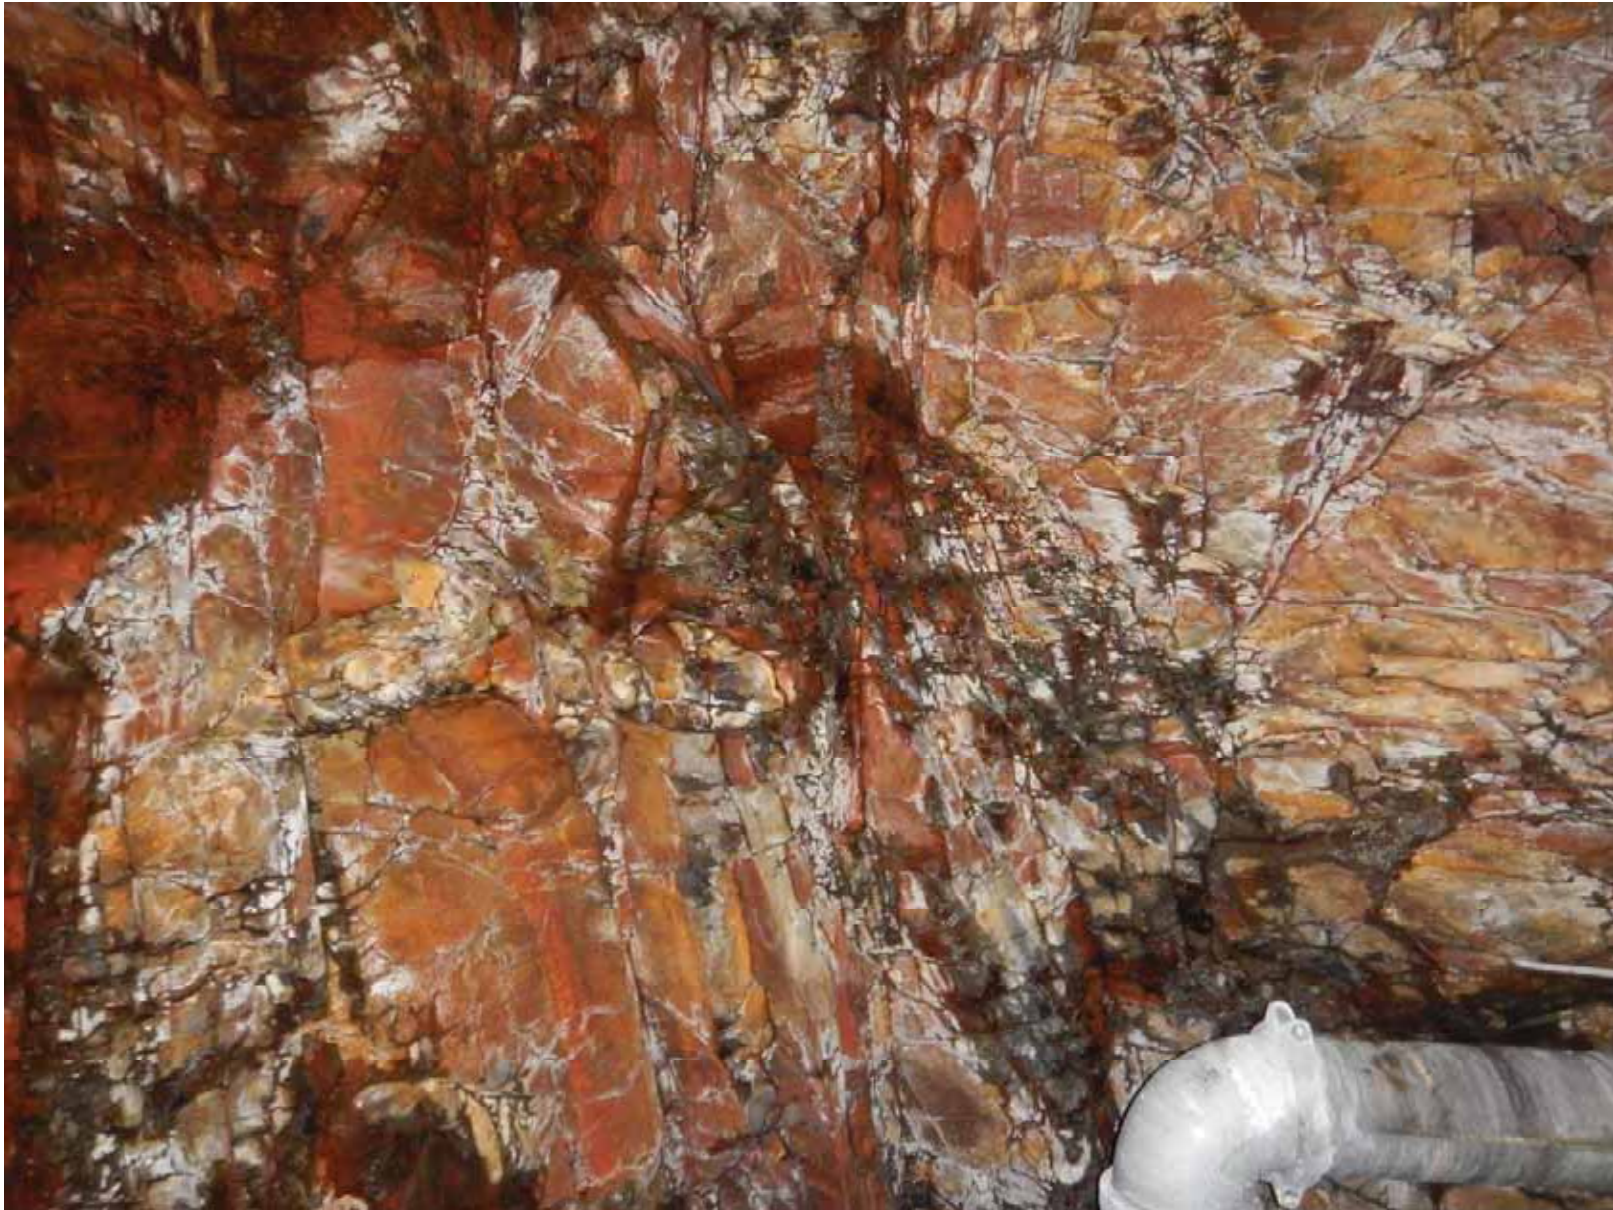
STA 509.5 ft – Seepage in Tunnel Crown

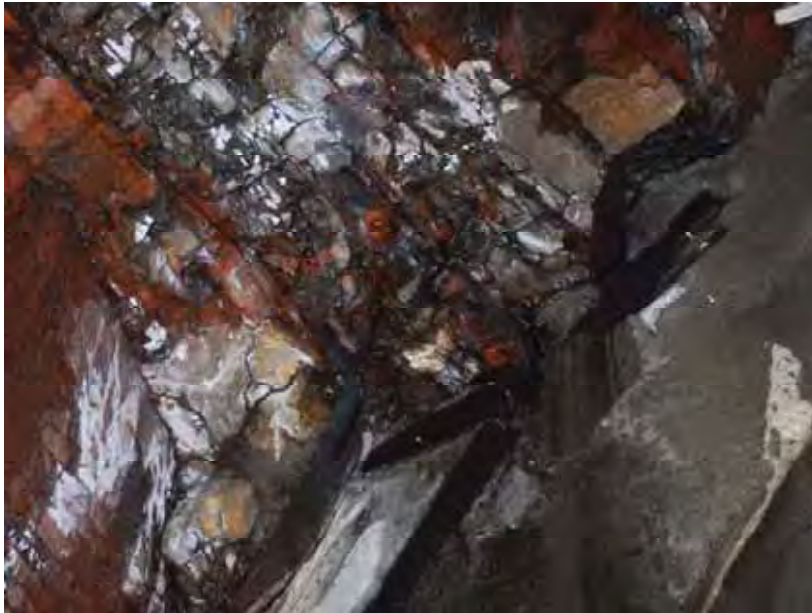
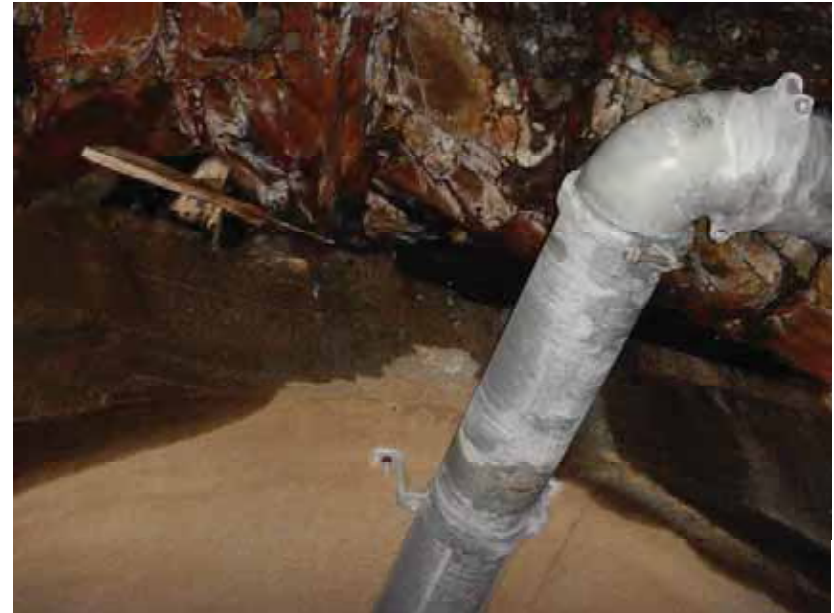
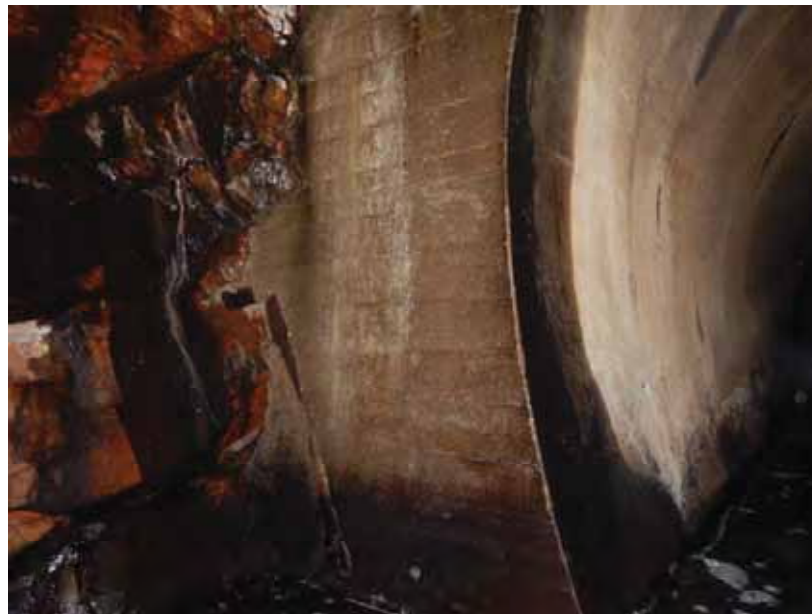
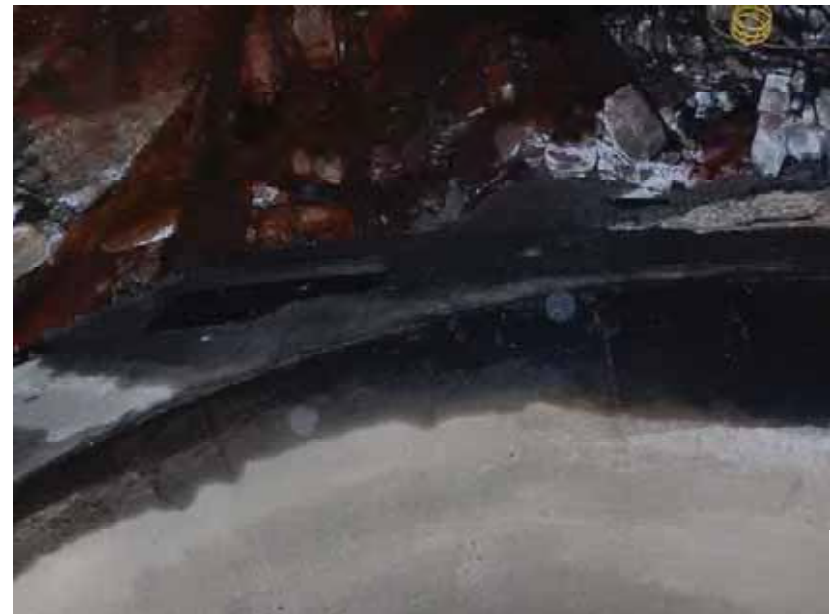
STA. 516.7 ft – Seepage observed around Upstream Concrete Liner

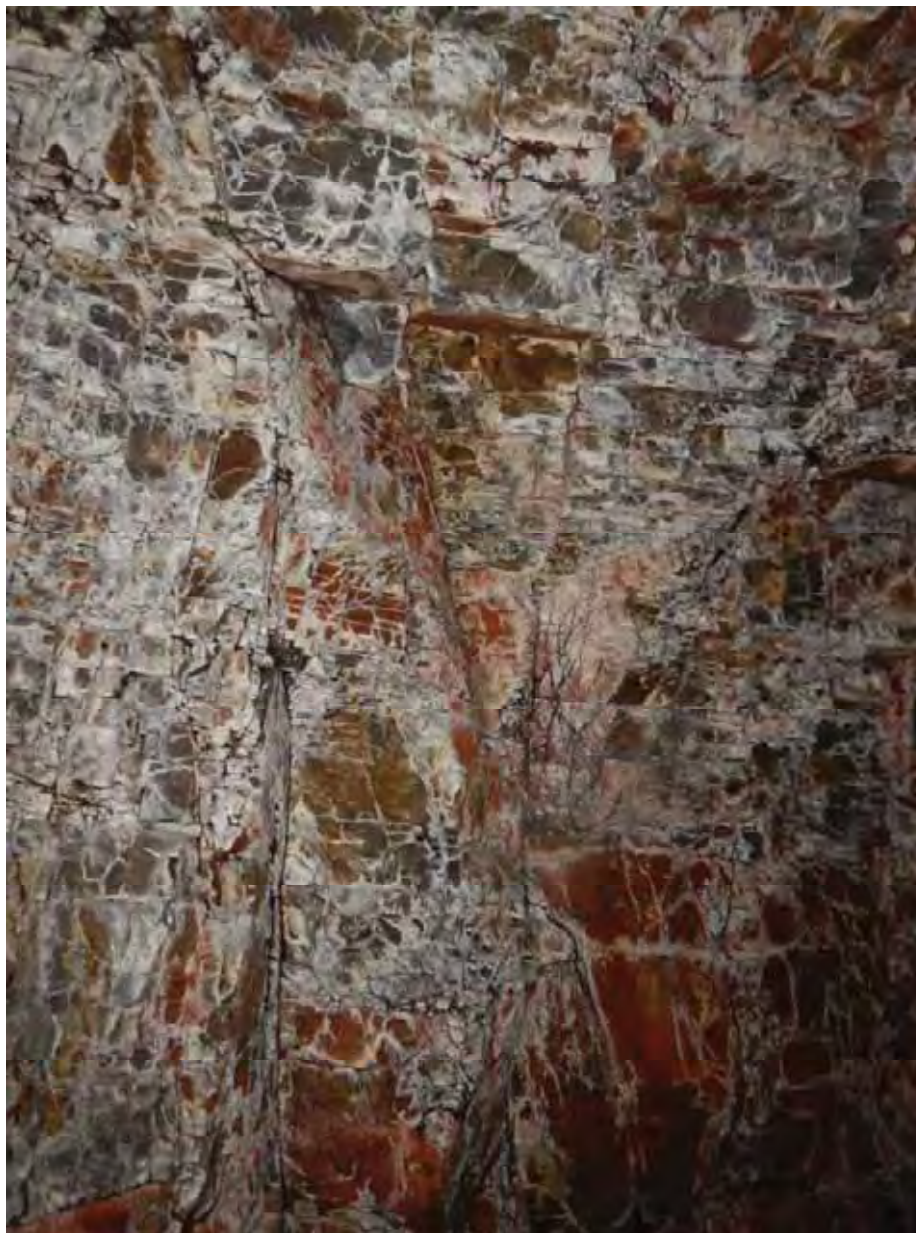
Wedge failures were observed in the tunnel crown at STA. 30.5 ft (6.5 ft x 6.5 ft x 2.3 ft), STA. 104.3 ft (approximately 35 ft³), STA 380.6 ft (approximately 53 ft³) (Photo 15, Appendix B), STA. 421.6 ft (10 foot-long wedge failure in crown with water seepage), and STA 454.4 ft (approximately 53 ft³). The wedge failures generally occurred in the area of intersection between the tunnel walls and the crown and resulted from the intersection of the low angle Set 3 joints with the very steep Set 1 and Set 2 joints. An approximately 3-ft sized rock block has detached from the left wall at STA 286.4 ft.

STA 380.6 ft - Triangular 53 ft³ wedge failure at crown/wall interface in area with very closely to closely spaced joints. The wedge was formed by the intersection of low angle Set 3 Joint with steep joints

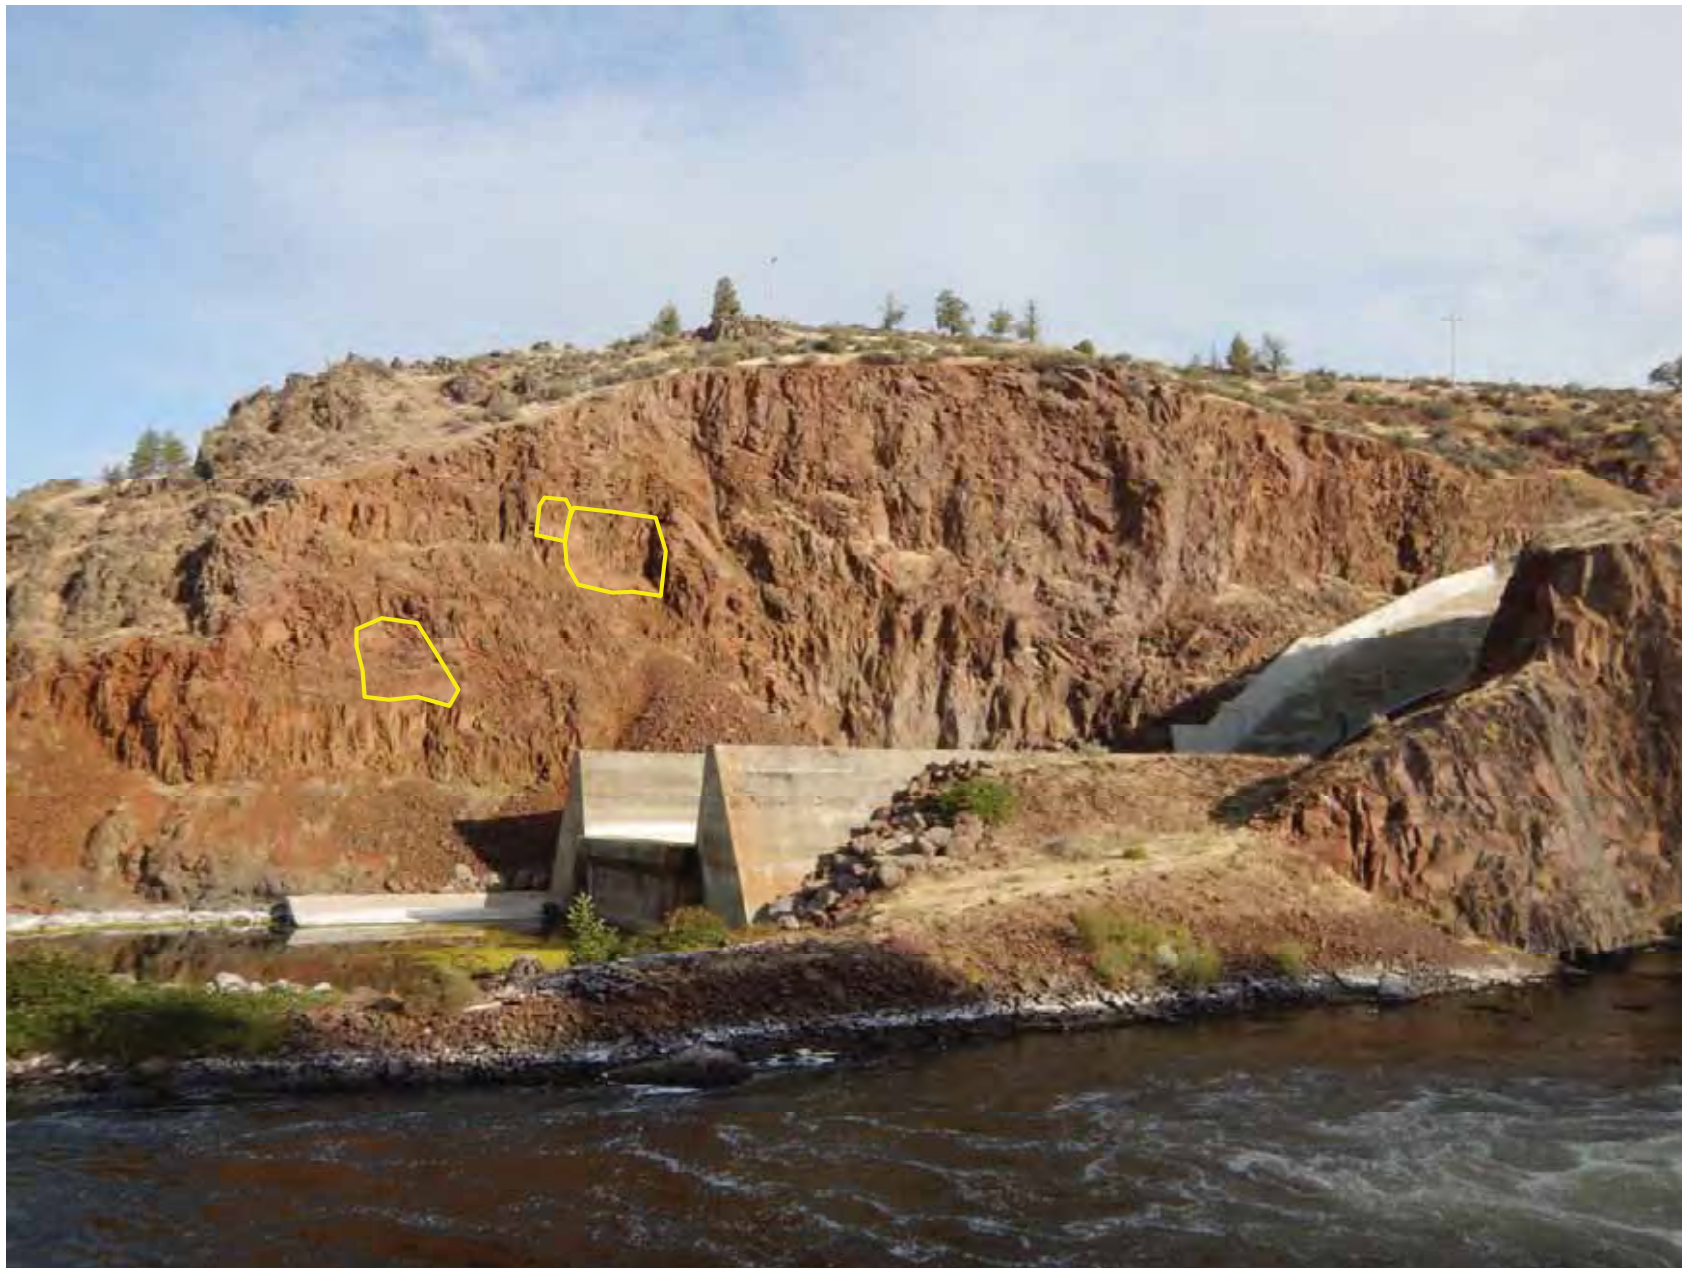
Set 4 joints have formed the failure surface for at least two relatively small-scale (less than 1,750 ft³) rockslides in the rock cut outside of the tunnel and adjacent to the spillway (Photo 16, Appendix B). Joints belonging to this set may have acted as a failure surface for the previous rockslide that covered the channel immediately downstream of the portal and was removed in 2007 as part of the rehabilitation project. The draped rock slope netting that has been installed on the rock cut in this area (Photo 17, Appendix B) will be effective in controlling the fall of rock blocks with a volume in the order of 35 ft³.

Rock Slides have occurred in the Rock Cut above the Spillway

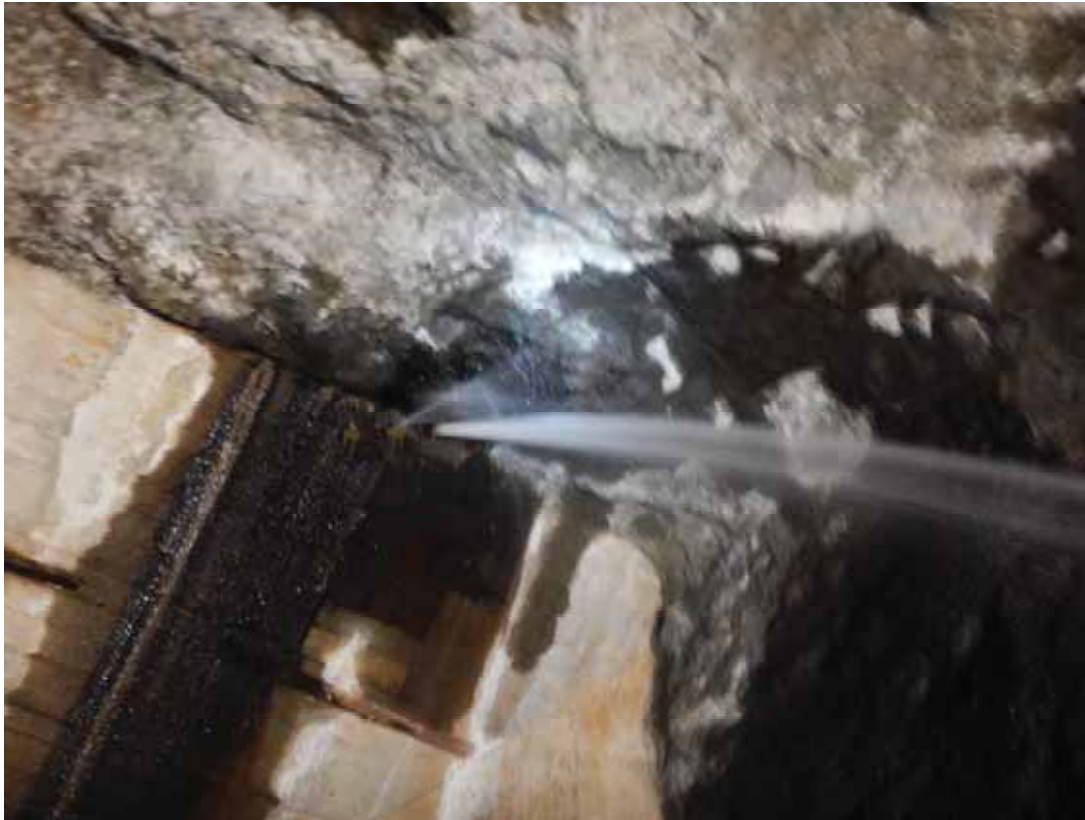
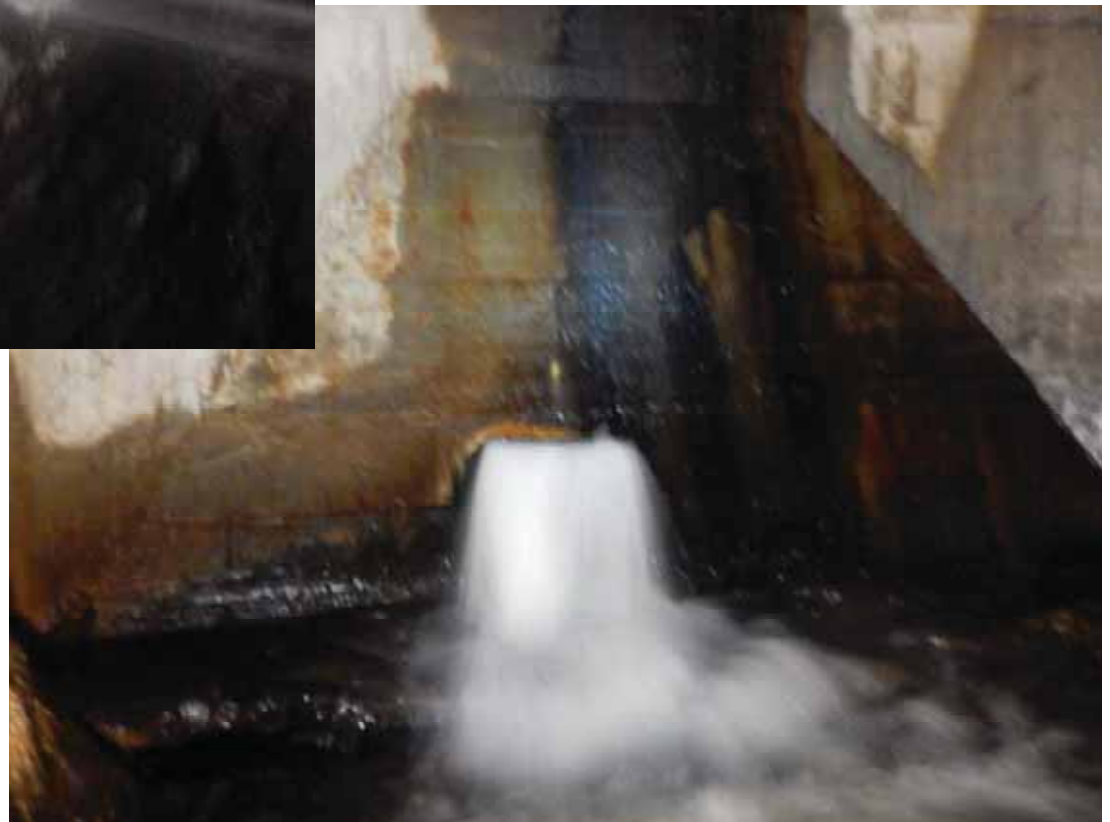
STA 176.5 ft - Tunnel Plug - Water flow at tunnel crown and from valve

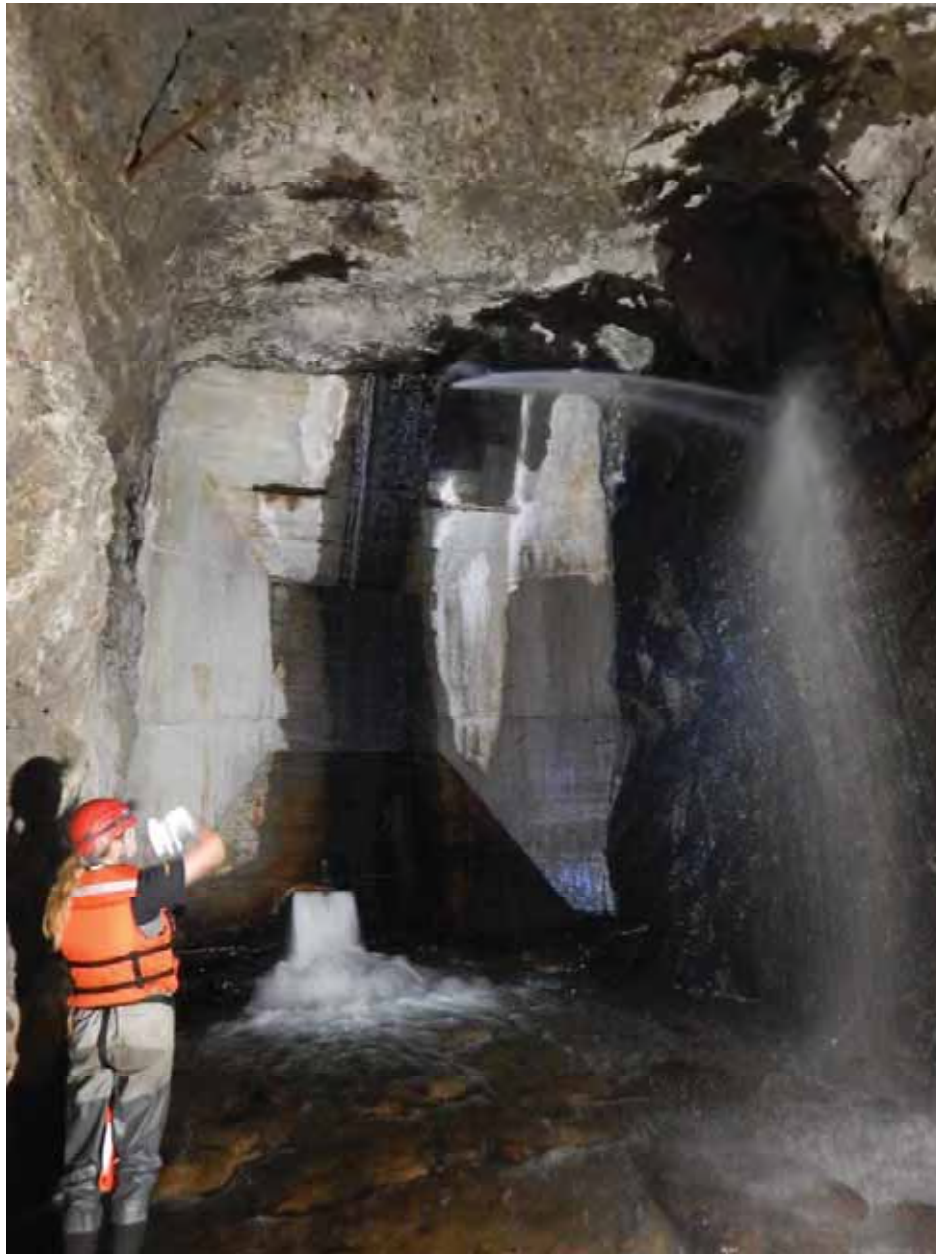
STA 176.5 ft - Tunnel Plug - Water flow at tunnel crown and seepage from top of recessed area of concrete

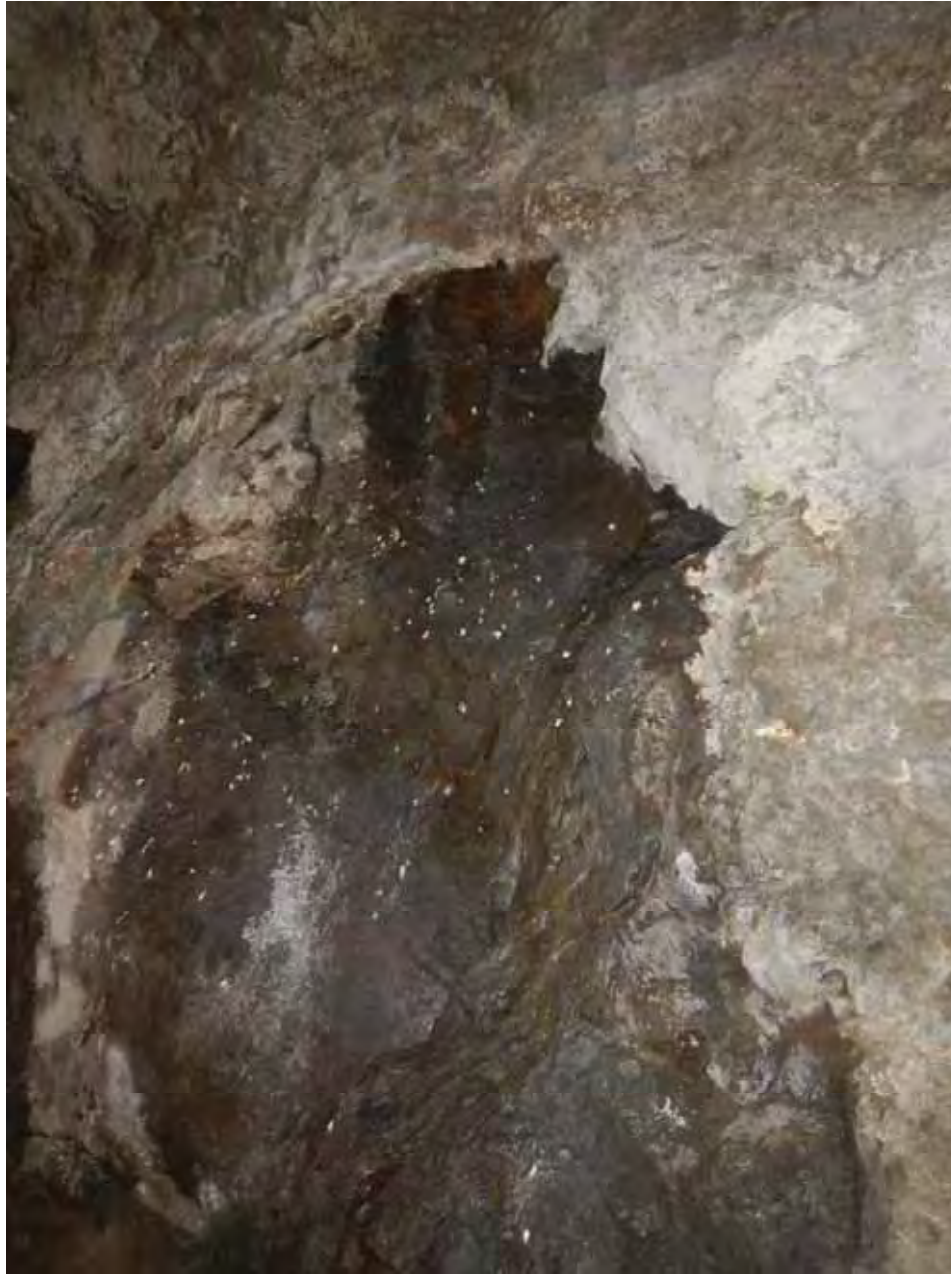
STA. 108.3 ft – Seepage from Low angle Set 3 Discontinuity
