APPENDIX E

Preliminary Services Diversion Tunnel Inspection

RE: Klamath River Renewal Project – Iron Gate and Copco No. 1 Diversion Tunnel Geotechnical Inspection

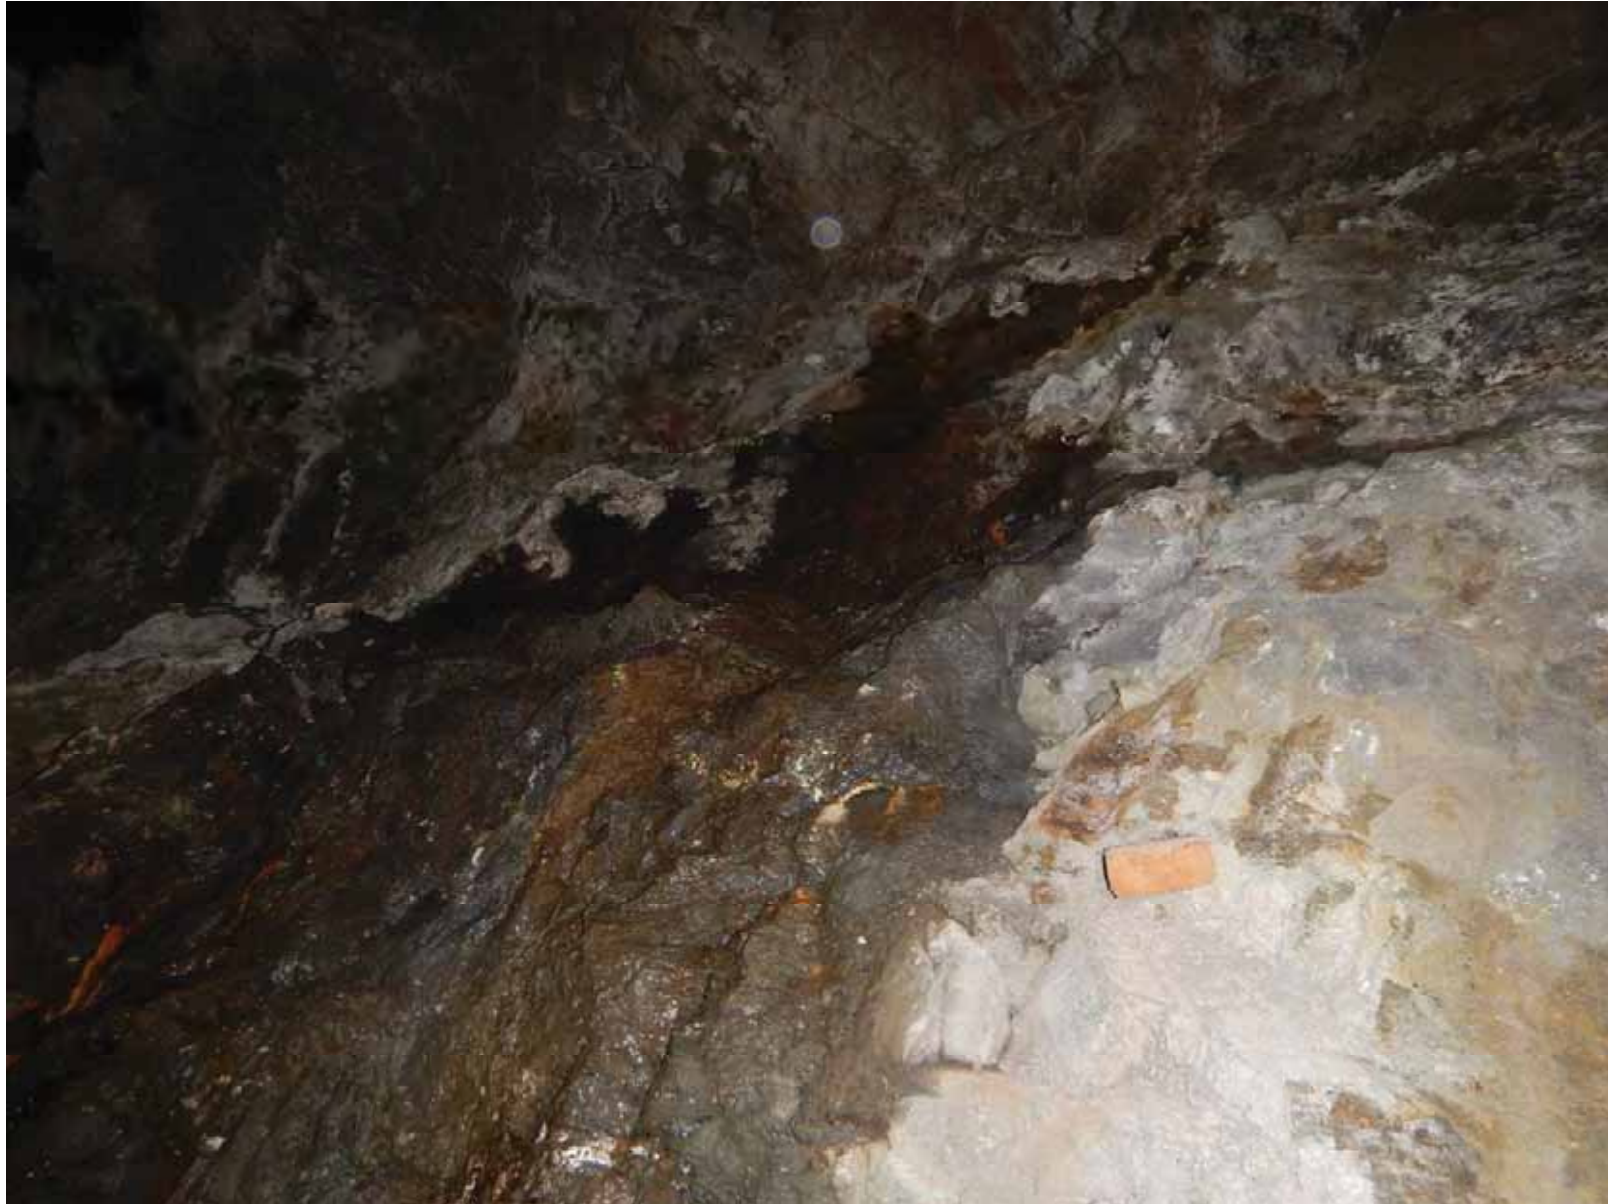
STA. 144.4 ft – Seepage from Set 1 Joint

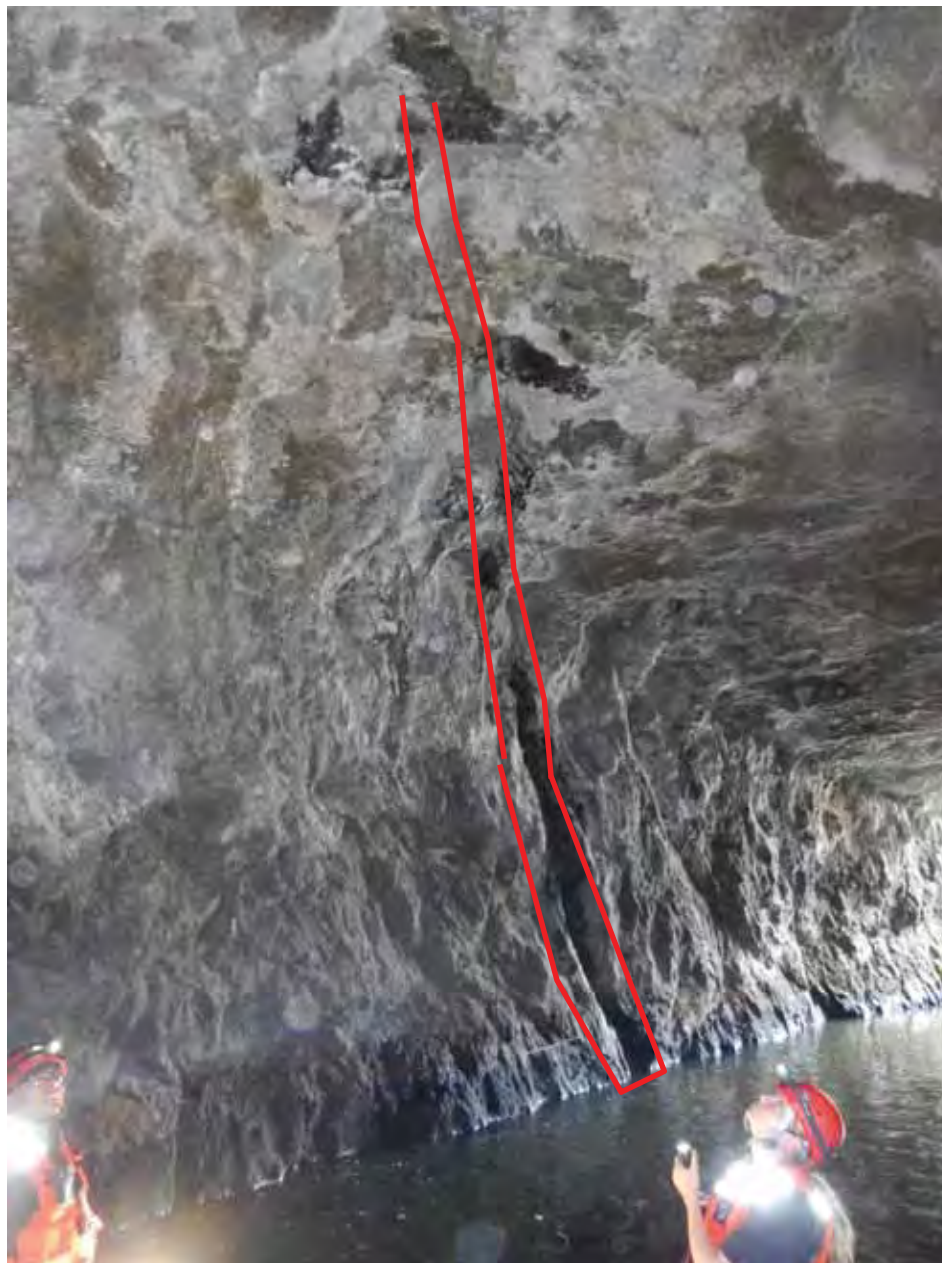
STA 44.6 to STA 49.2 ft - Highly persistent (up to 65 ft Set 1 Joint slightly oblique to tunnel alignment showing seepage. This joint possibly extends to the ground surface.

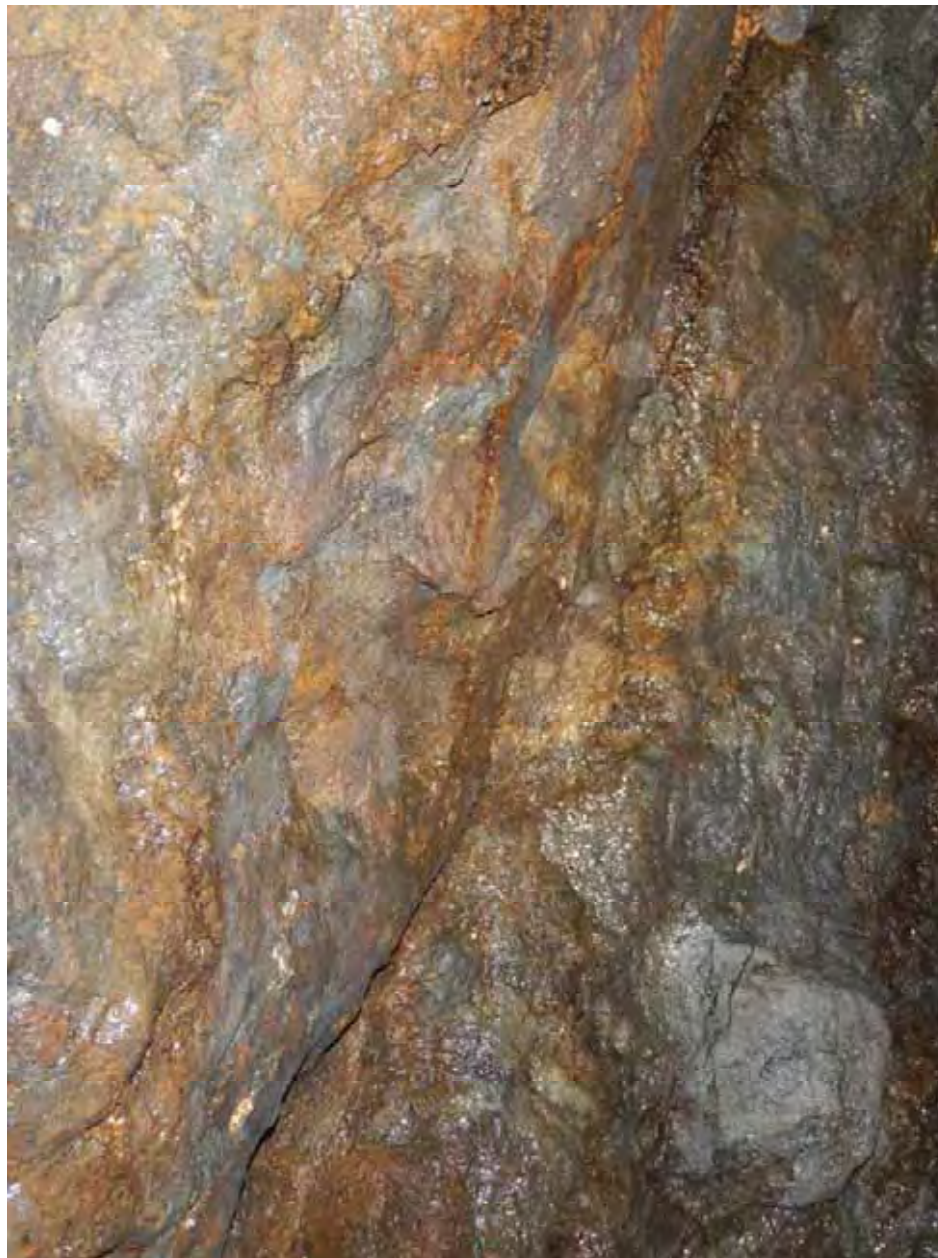
STA. 124.7 to 145.0 ft - Highly persistent Set 1 Joint, 1-inch wide with soil infill comprising weak to medium strong gravel size rock fragments with trace to some sand and trace clay

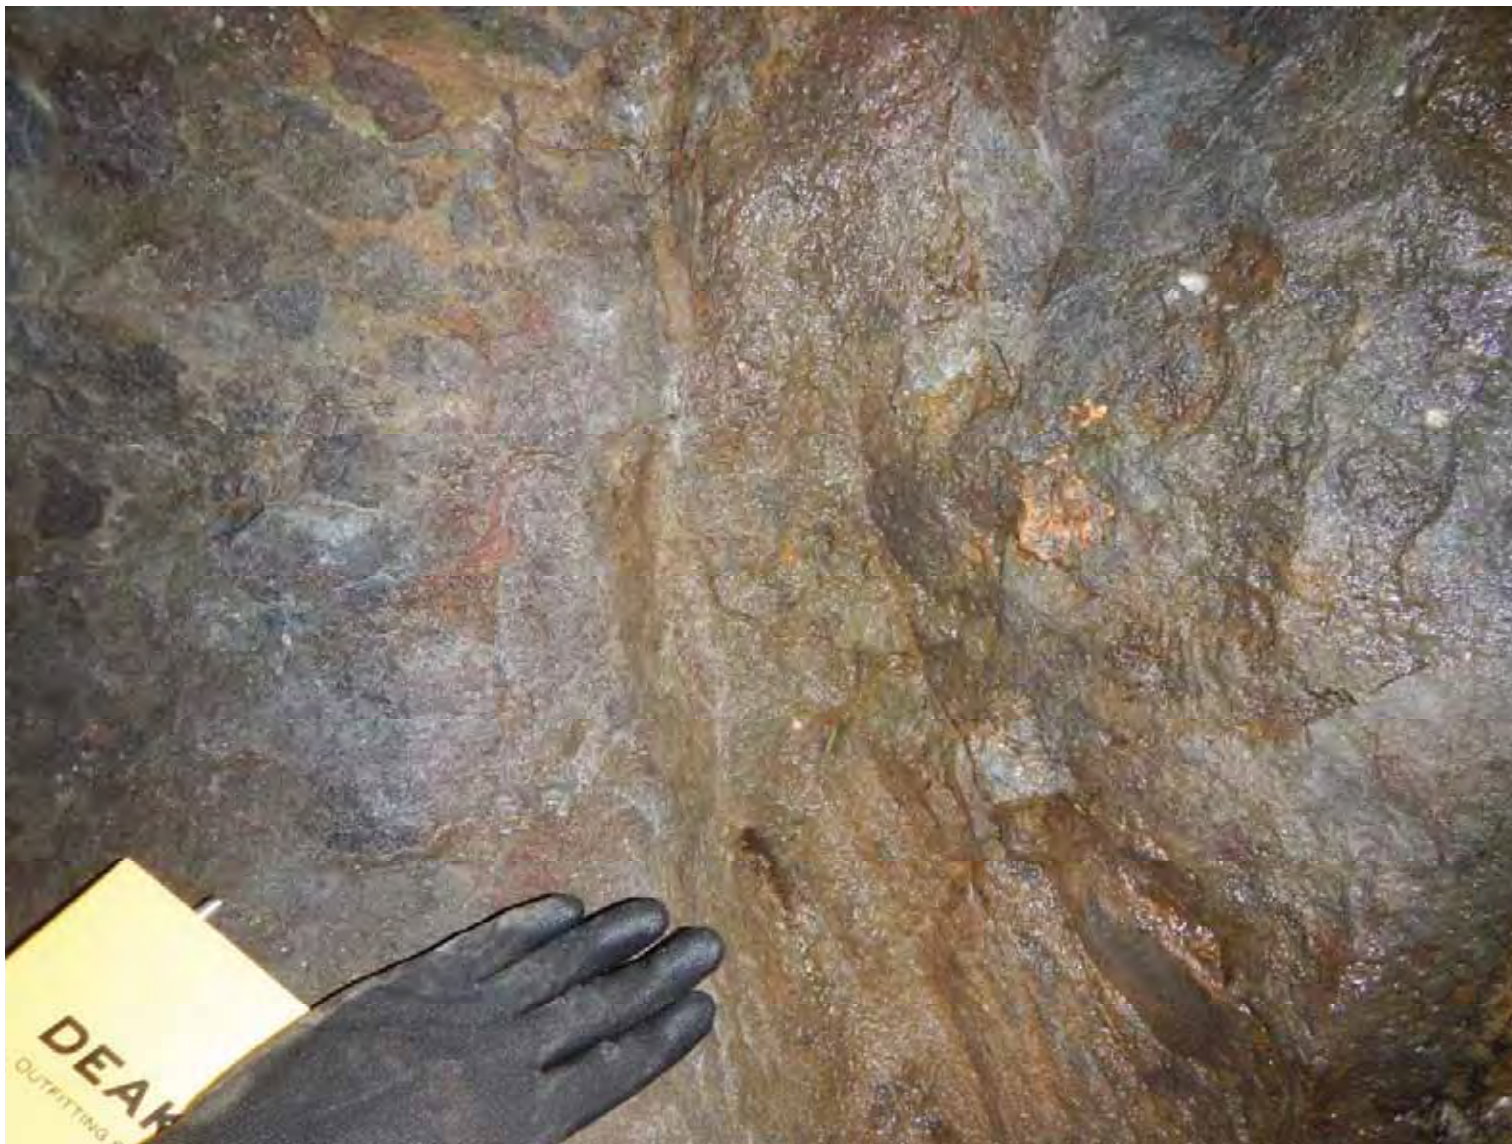
STA.105 ft Set 2 Joint, 1/16 to 1/4-inch wide with soil infill (weak to medium strong gravel size rock fragments with some soft clay), see page. Differentially weathered zone is 8 to 12 inch-wide and comprises weak to medium strong material.

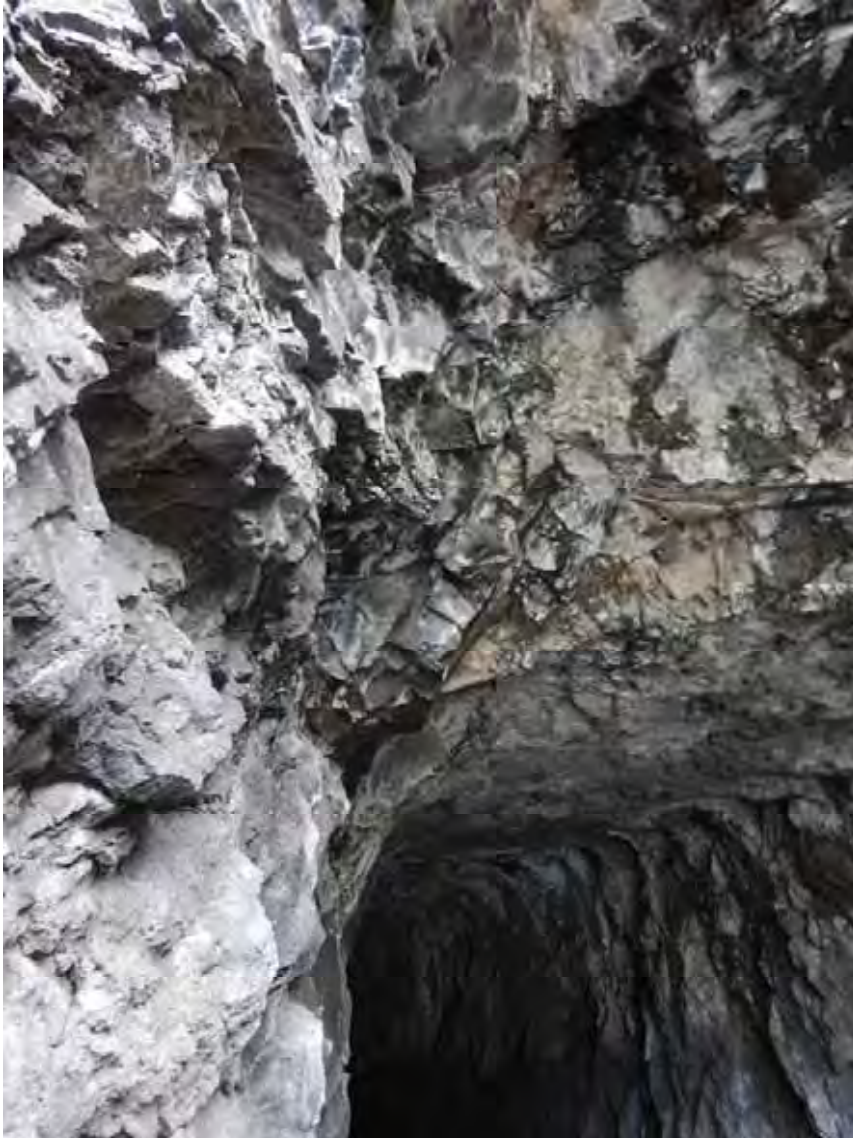
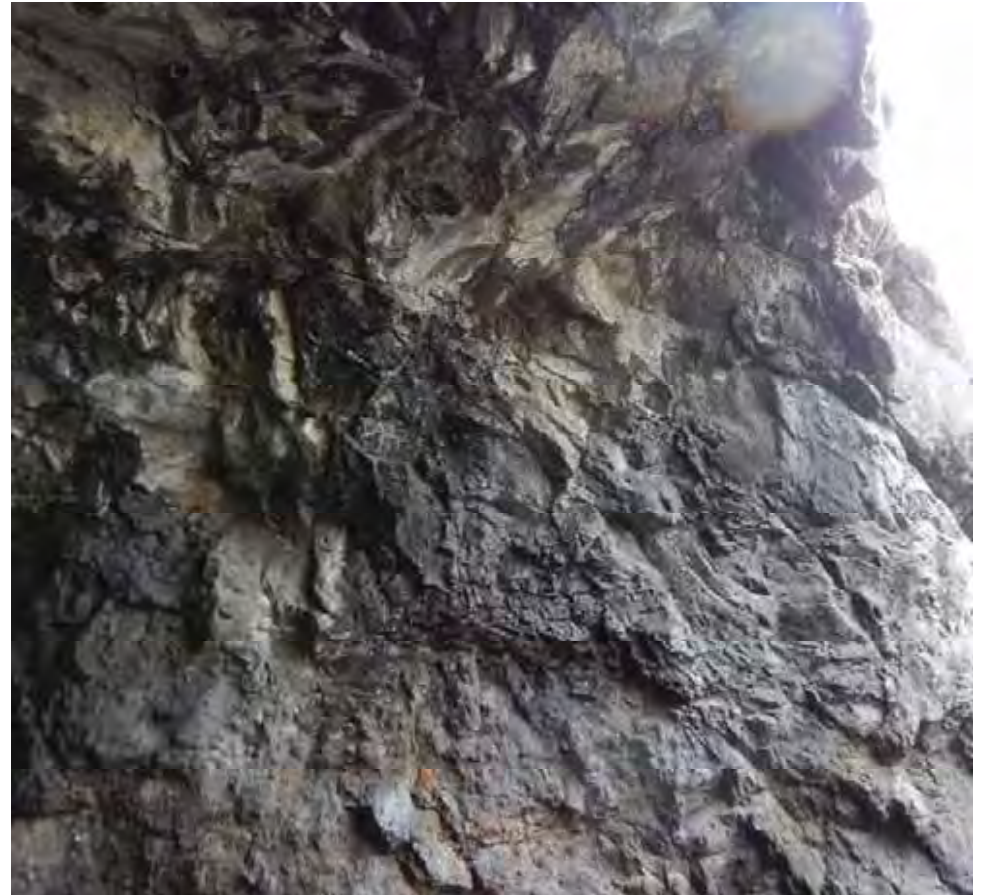
Overbreak observed in the first 15 ft of the Tunnel Crown from the Portal.
