Klamath River Renewal Corporation

Project No. 14803-001

**LICENSE SURRENDER ORDER
LOWER KLAMATH PROJECT**

Waste Disposal and Hazardous Materials Management Plan

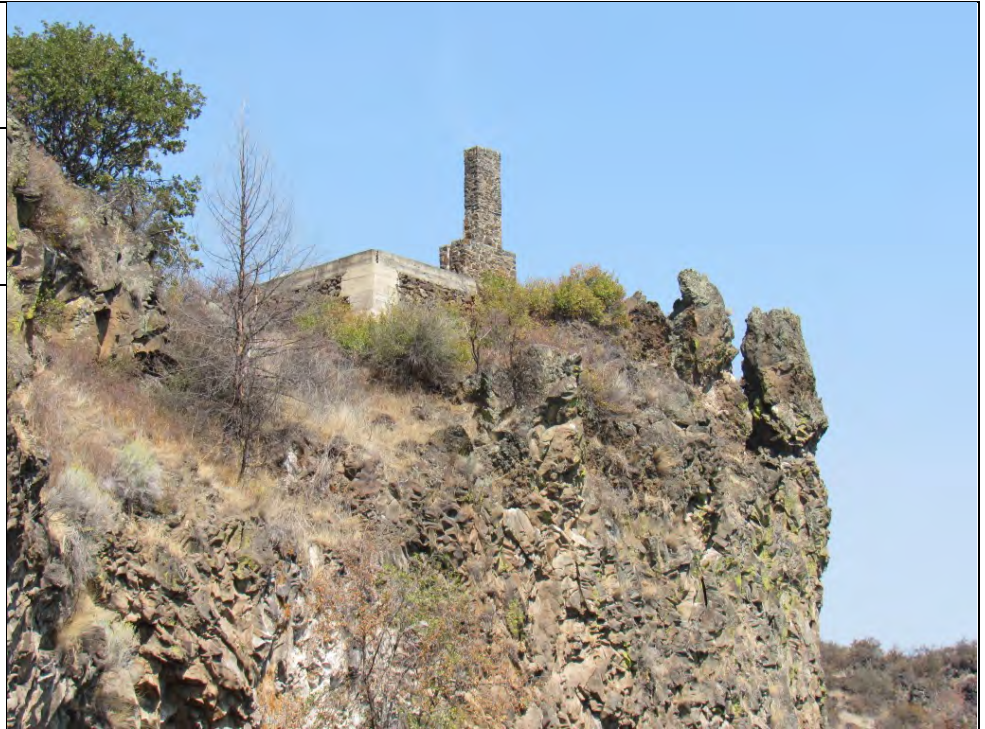
CC1FFR - 01

**Assumed gray grout
associated with river rock
chimney (M)**

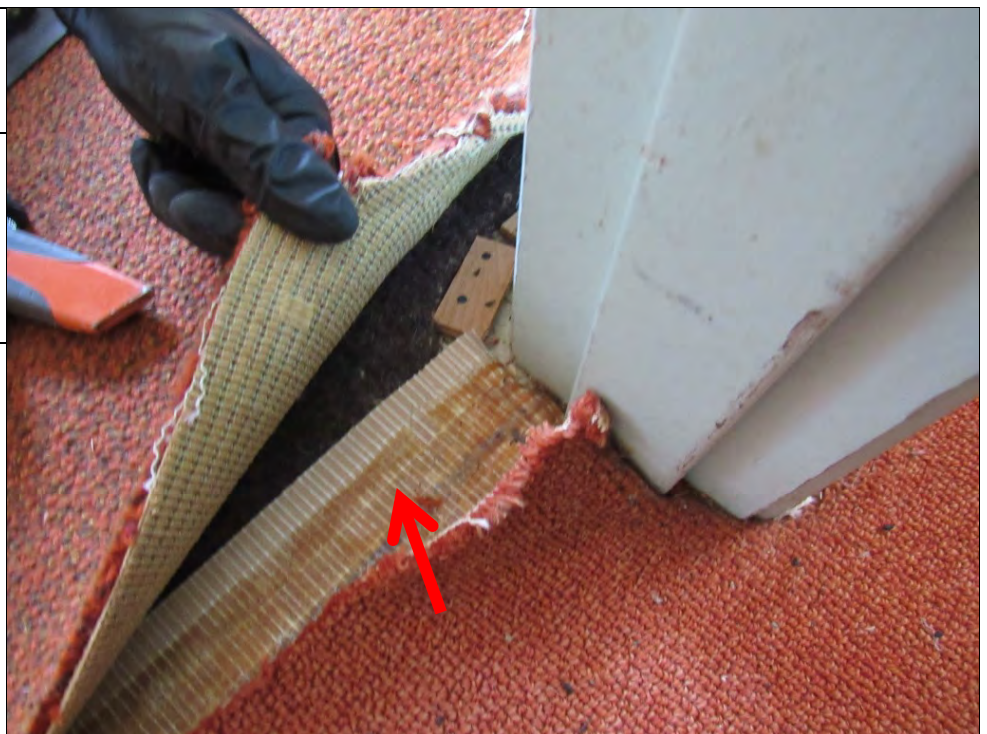
Photo No./ Material ID: CC2FBH - 05	Date: 9/11/2018 to 9/13/2018
Structure/Material Location: Copco No. 2 Former Bunkhouse/ Carpet seam at tack down wood strips at base of doors throughout	
*Description (by layer): 1: Orange carpet mastic (M)

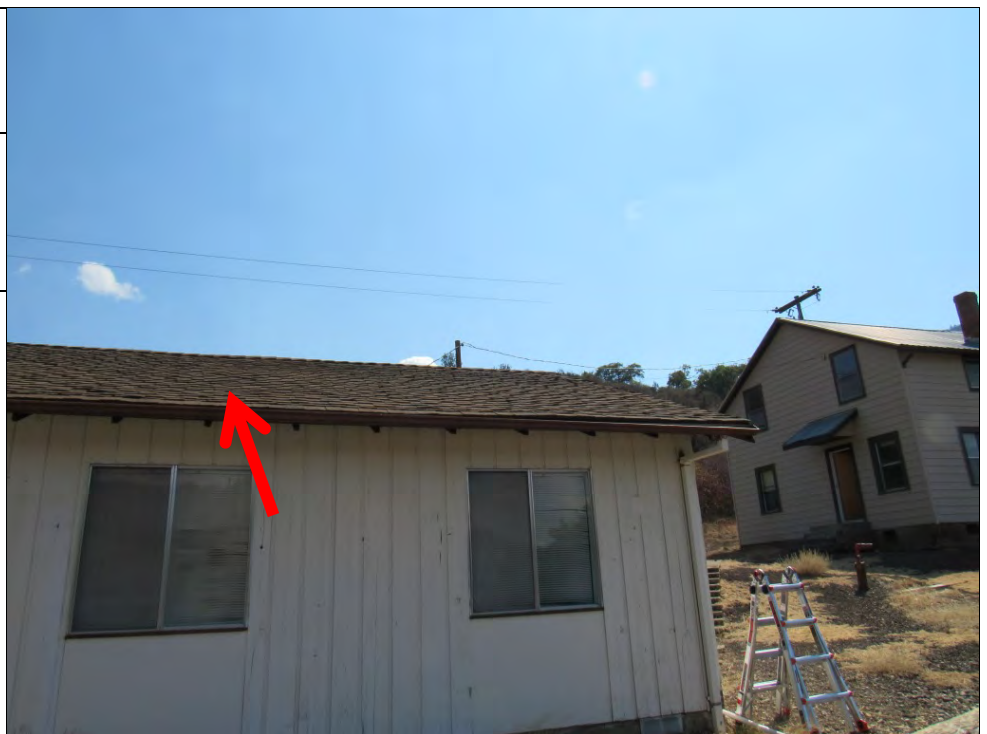
Photo No./ Material ID: CC2FBH - 11	Date: 9/11/2018 to 9/13/2018
Structure/Material Location: Copco No. 2 Former Bunkhouse/ Throughout roof	
*Description (by layer): 1: Asphaltic roof shingles with granules (M) 2: Black asphaltic material (M) 3: Asphaltic roof shingles with granules (M) 4: Black asphaltic material (M)

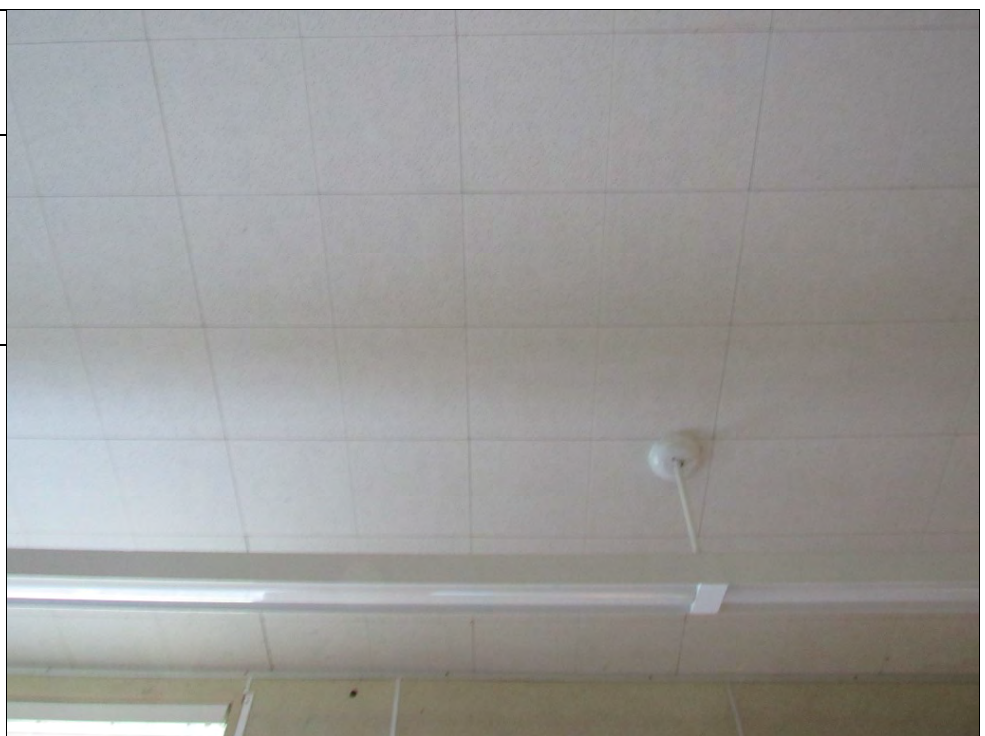
**1: 12"x12" white tongue and
groove nailed-on ceiling tiles (M)**
