BULK ASBESTOS MATERIAL *Analysis Request*

ENTEK CONSULTING GROUP, INC.

Site Address: Iron Gate Dam

Iron Gate Development
Hazardous Building Materials Survey

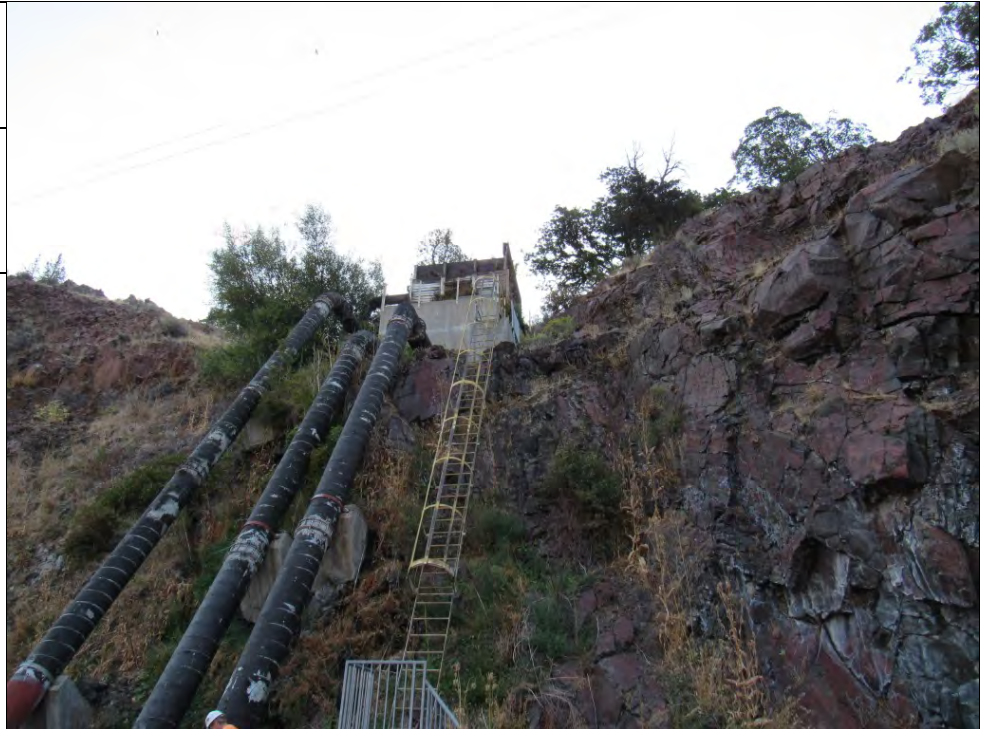
Photo No./ Material ID: IGDAE - 01	Date: 9/12/2018
Structure/Material Location: Iron Gate Dam Aerator/ Aerator piping, hatchery water supply	
*Description (by layer): 1: Black asphaltic pipe wrap (M)

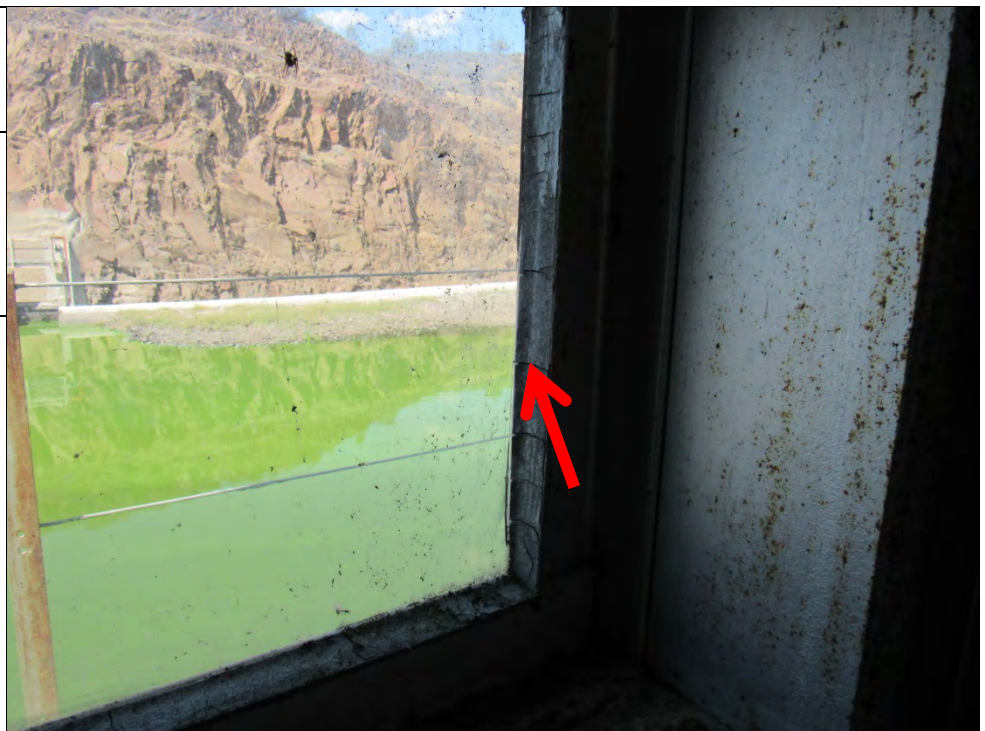
- 1: Silver paint (M)
- 2: **Gray window putty (M)**

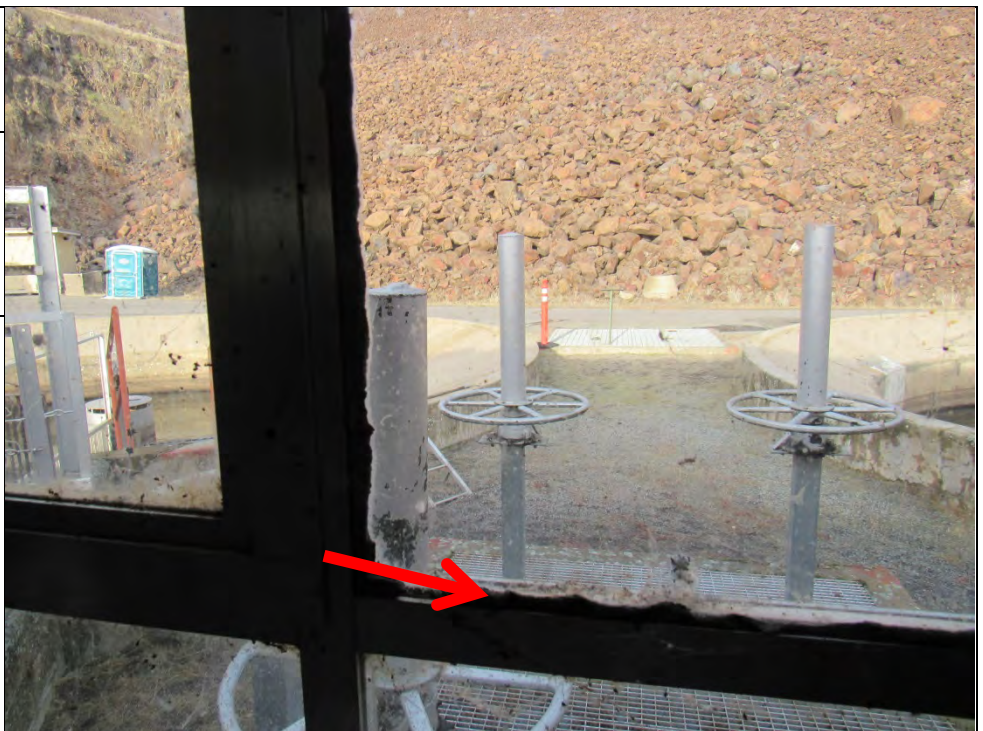
**1: Gray brittle window putty
(M)**

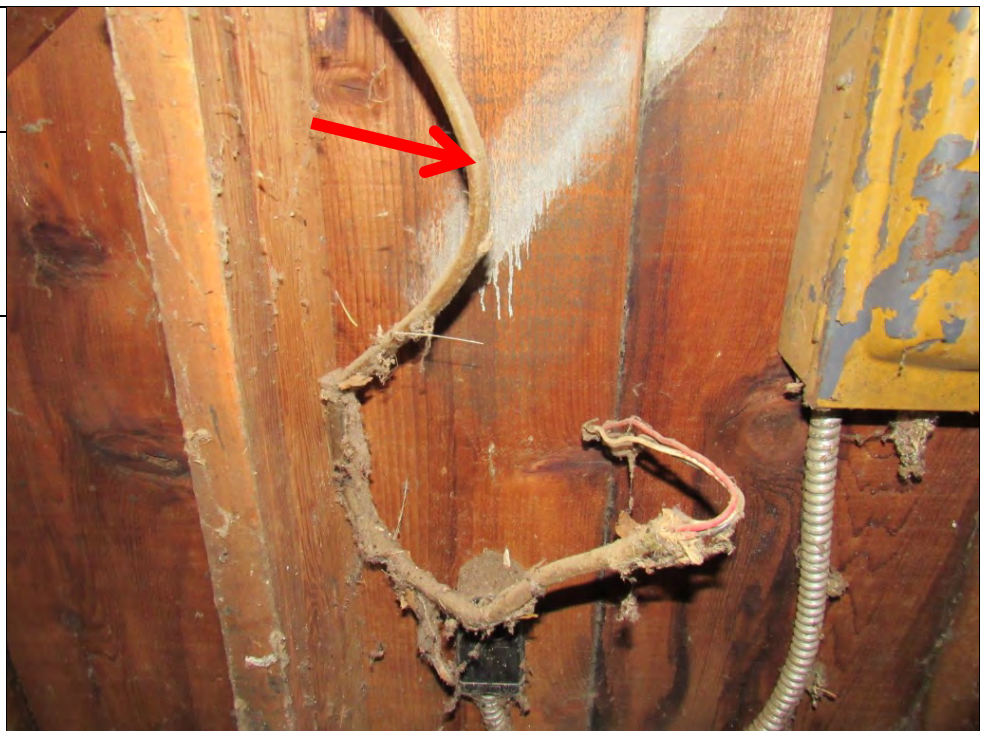
**Assumed asbestos-containing
silver woven electrical wire
insulation**

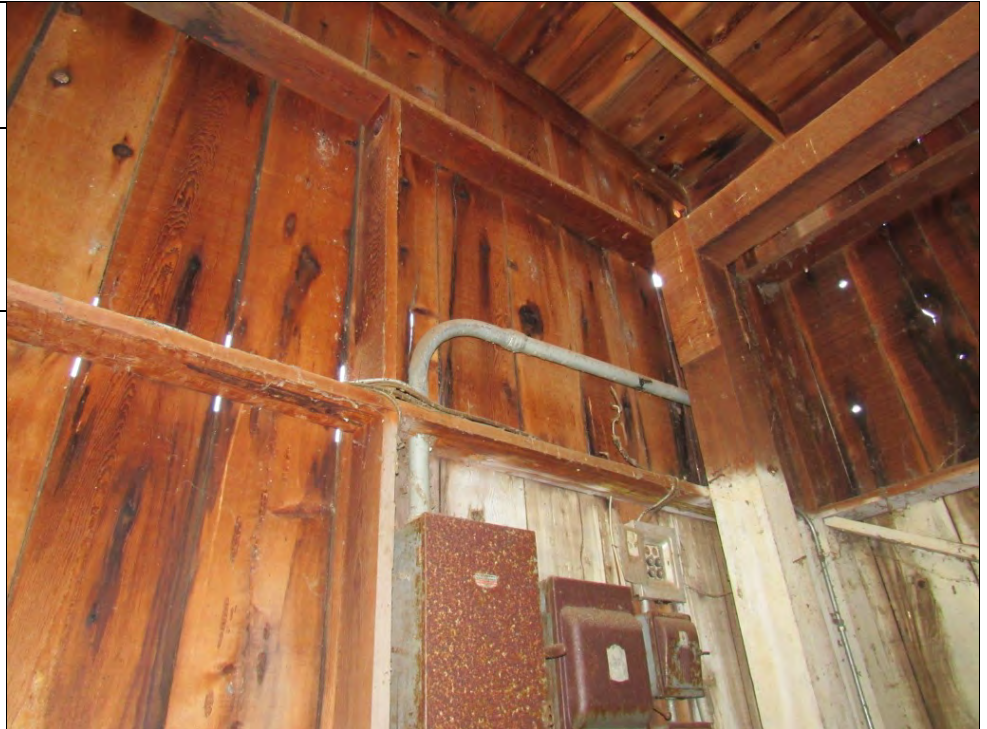
Photo No./ Material ID:	Date:
IGDMS - 02	9/14/2018
Structure/Material Location: Iron Gate Dam Maintenance Shed/ Throughout Maintenance Shed	
*Description (by layer): Assumed asbestos-containing electrical panel backing in older electrical panels

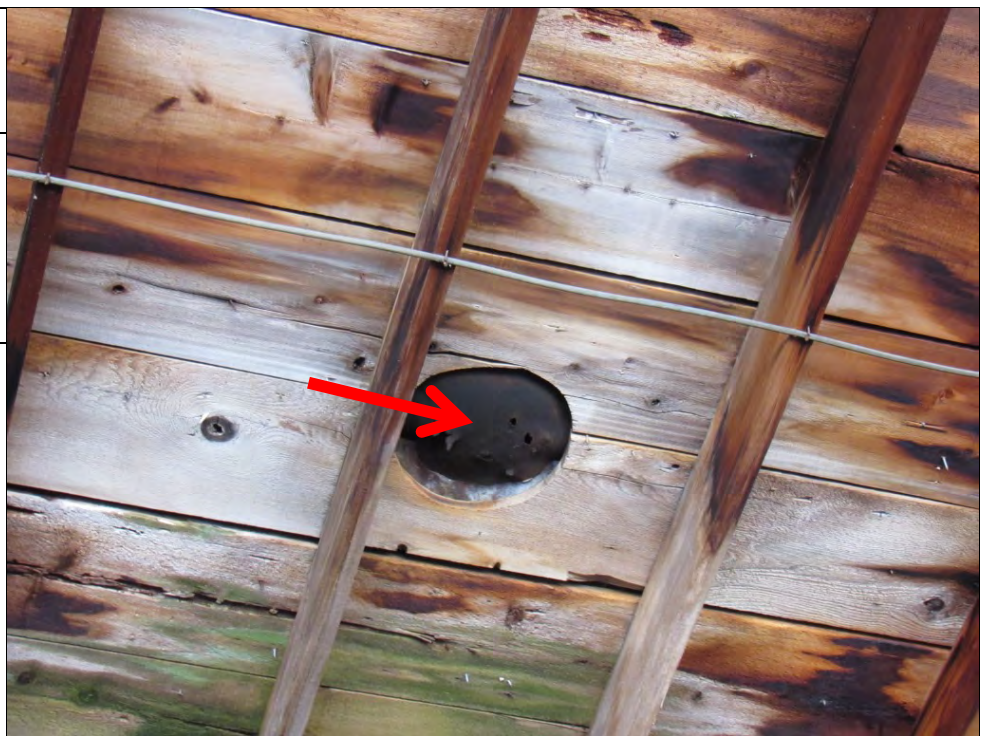
Photo No./ Material ID:	Date:
IGDMS - 03	9/14/2018
Structure/Material Location: Iron Gate Dam Maintenance Shed/ Throughout Maintenance Shed roof, underneath corrugated metal roofing	
*Description (by layer): Assumed asbestos-containing roofing paper

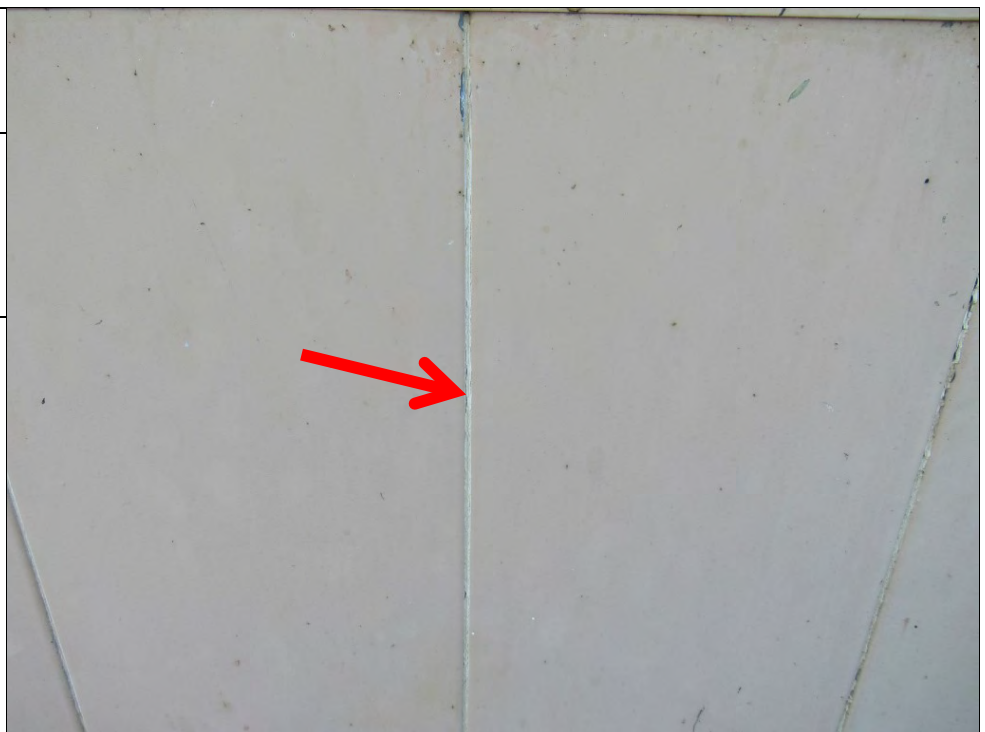
Photo No./ Material ID: IGDPIS - 03	Date: 9/14/2018
Structure/Material Location: Iron Gate Dam Penstock Intake Structure/ Exterior metal siding seams	
*Description (by layer): 1: White caulking (M) 2: Beige soft material with paint (M)

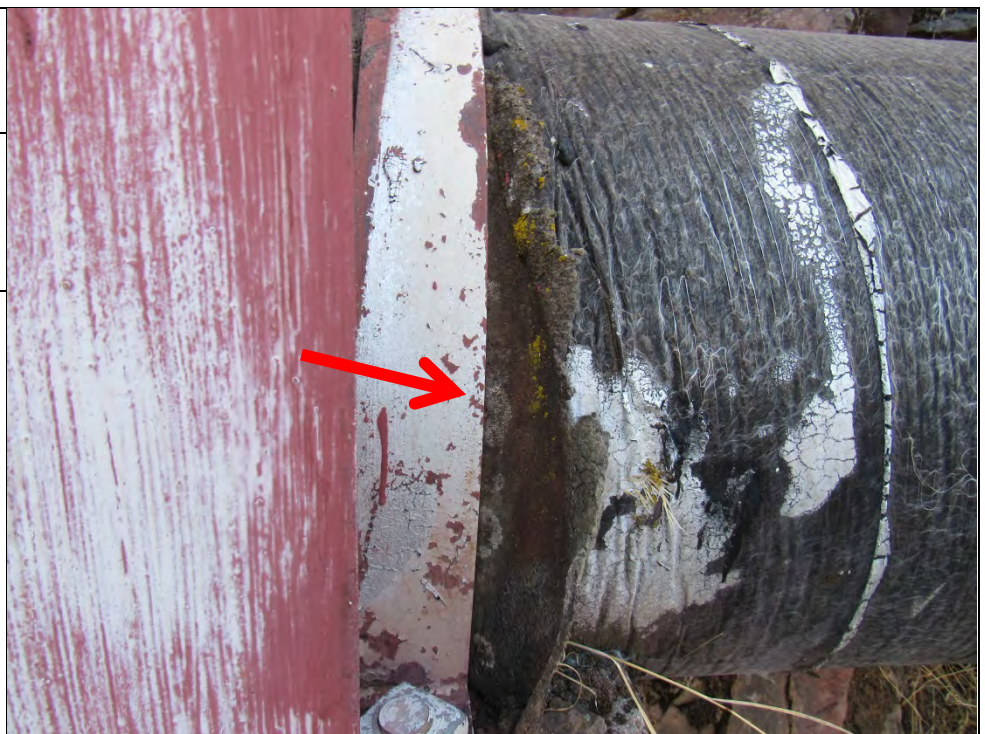
Photo No./ Material ID: IGDPS - 03	Date: 9/14/2018
Structure/Material Location: Iron Gate Dam Penstock/ Hatchery water supply piping	
*Description (by layer): 1: Brown fibrous gasket at pipe line saddles (M)

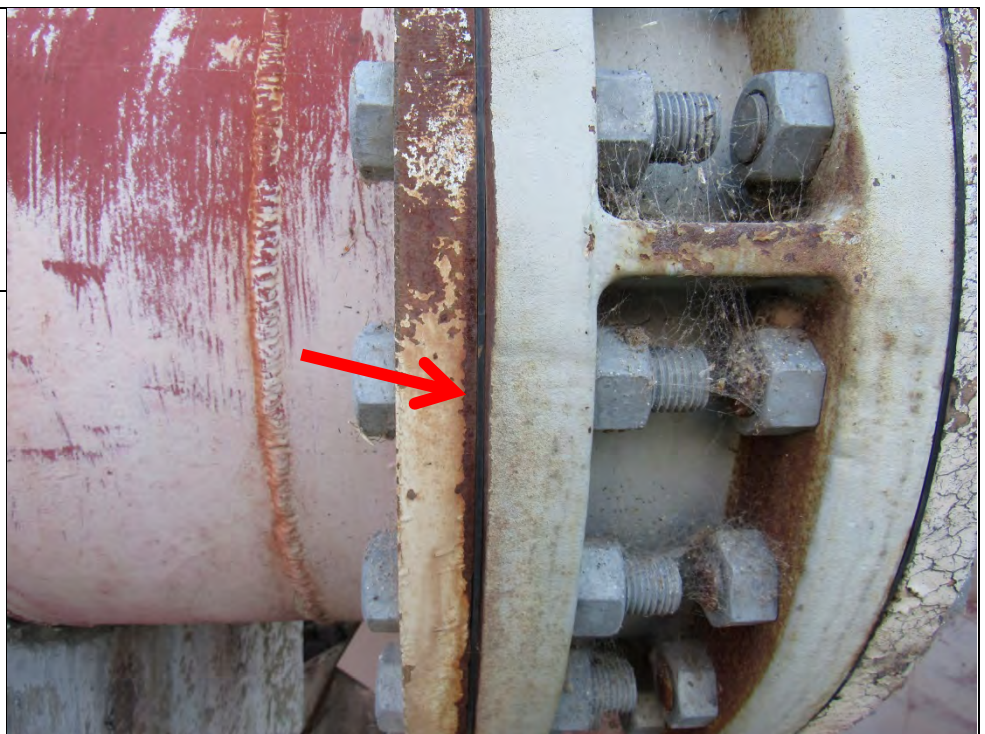
Photo No./ Material ID: IGDPS - 05	Date: 9/14/2018
Structure/Material Location: Iron Gate Dam Penstock/ Hatchery water supply piping	
*Description (by layer): 1: Black gasket (M)
