APPENDIX A FIGURES

JC Boyle Dam
 Keno, OR

APPENDIX B HSA PHOTOLOGS

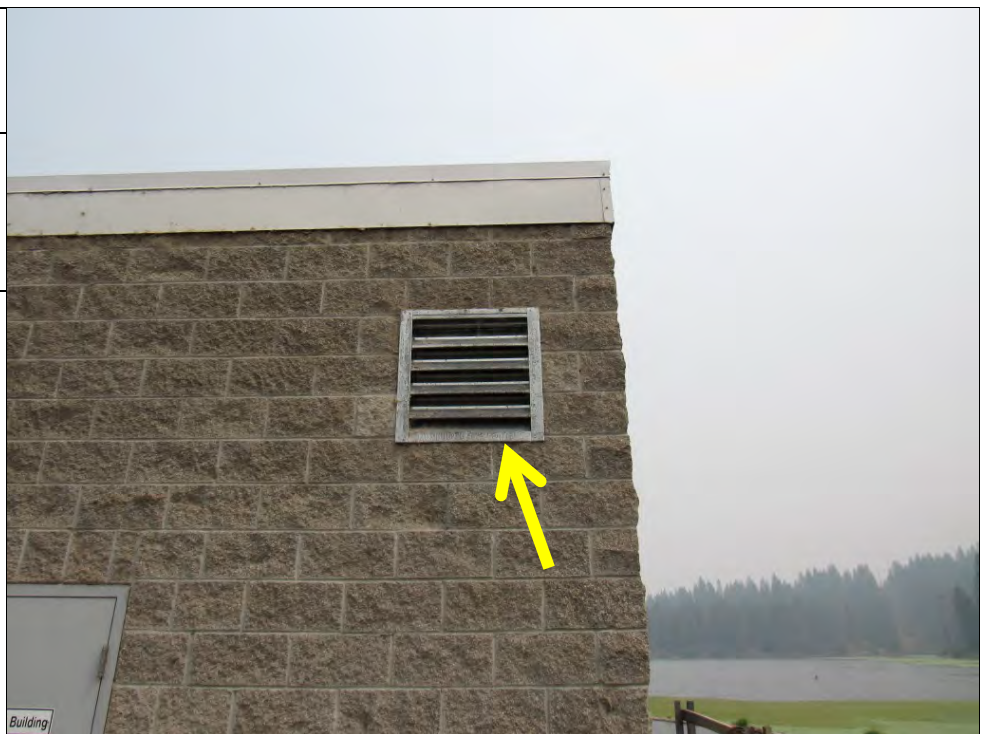
Photo No./ Material ID:	Date:
JCFP - 05	8/20/2018 to 8/23/2018
Structure/Material Location:	
JC Boyle Dam Fire Protection Building/ Around exterior vents	
*Description (by layer):	
1: Off-white sealant (M)

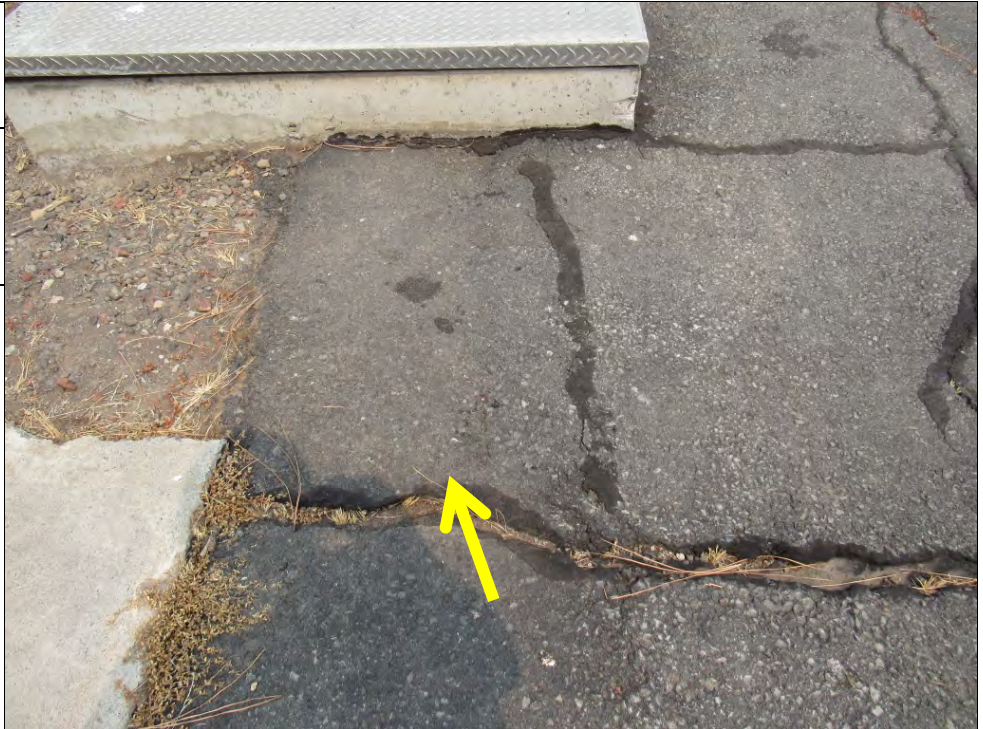
Photo No./ Material ID: JCIS - 02	Date: 8/20/2018 to 8/23/2018
Structure/Material Location: JC Boyle Dam Intake Structure/ Driveway area of intake structure	
*Description (by layer): 1: Asphaltic concrete crack sealant (M)

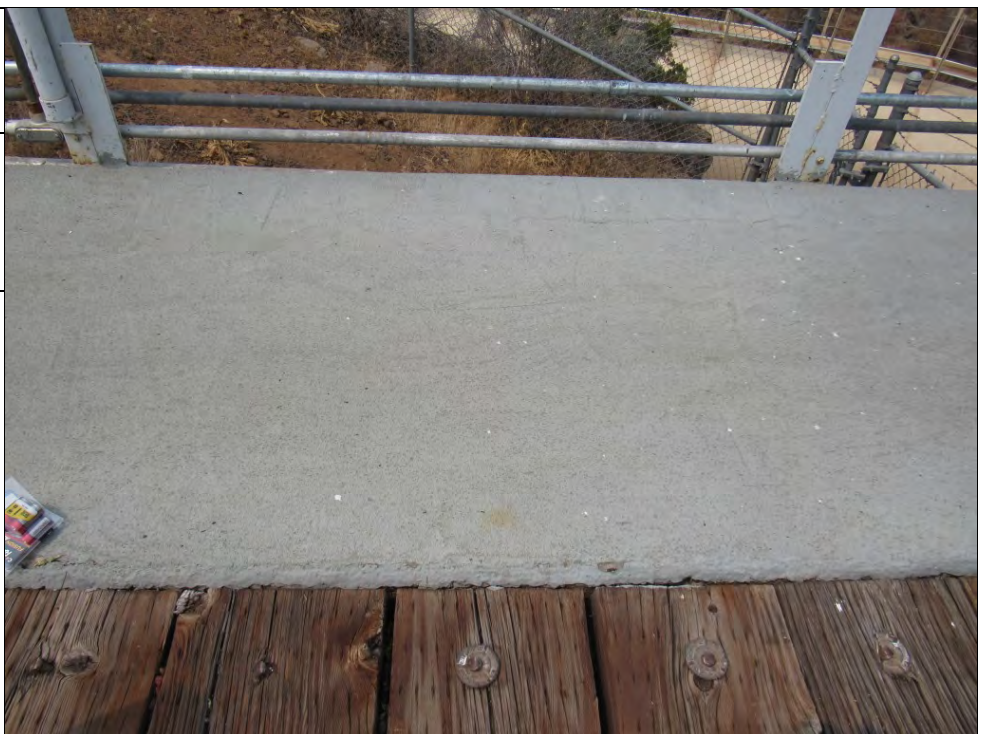
Photo No./ Material ID: JCIS - 03	Date: 8/20/2018 to 8/23/2018
Structure/Material Location: JC Boyle Dam Intake Structure/ Intake structure walkway	
*Description (by layer): 1: Textured cementitious coating on walkway (M)

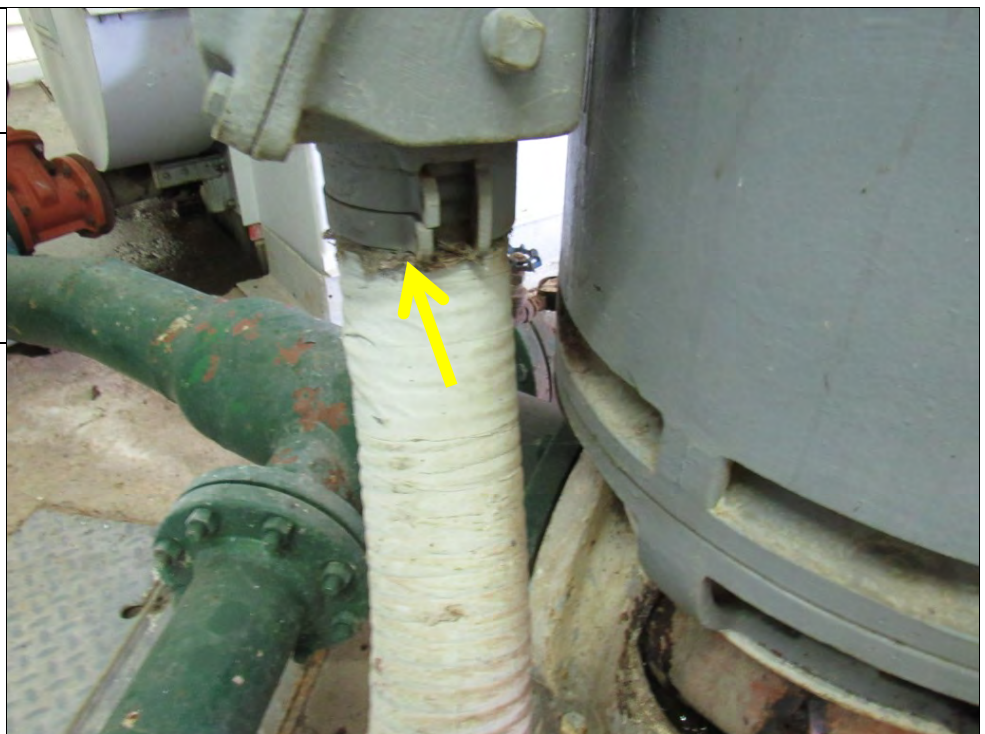
Photo No./ Material ID: JCIS - 05	Date: 8/20/2018 to 8/23/2018
Structure/Material Location: JC Boyle Dam Intake Structure/ Flex pipe connection associated with pump inside Fish Screen Building	
*Description (by layer): 1: Brown woven gasket (M)

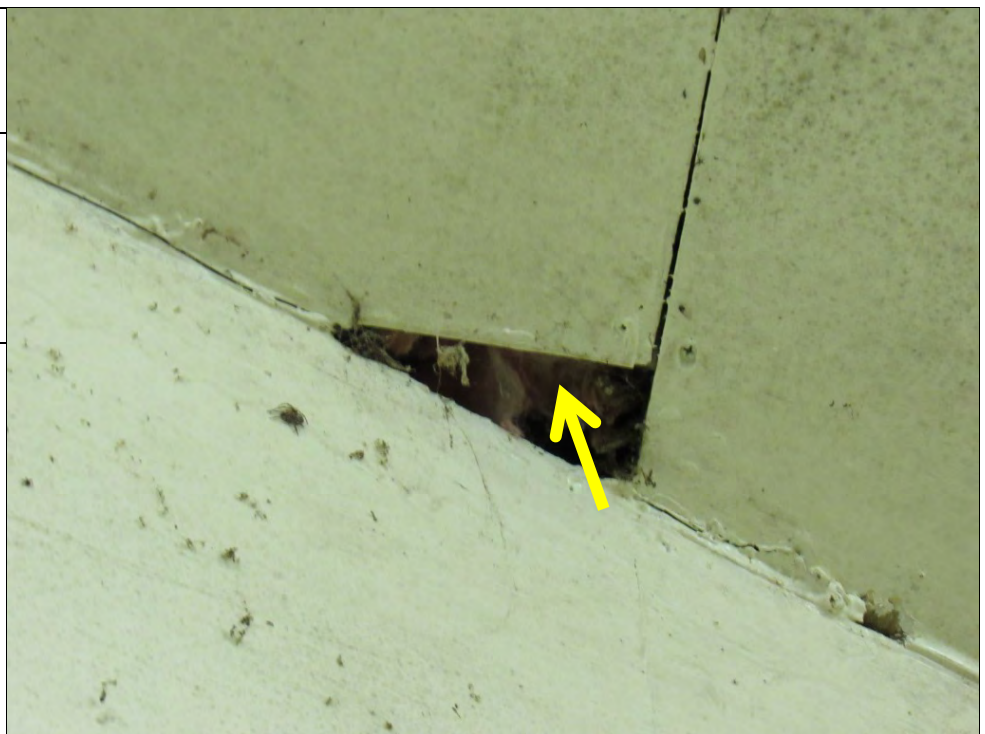
Photo No./ Material ID: JCIS - 07	Date: 8/20/2018 to 8/23/2018
Structure/Material Location: JC Boyle Dam Intake Structure/ At concrete wall/wood ceiling interface inside Fish Screen Building	
*Description (by layer): 1: White caulking (M) 2: Brown caulking (M)

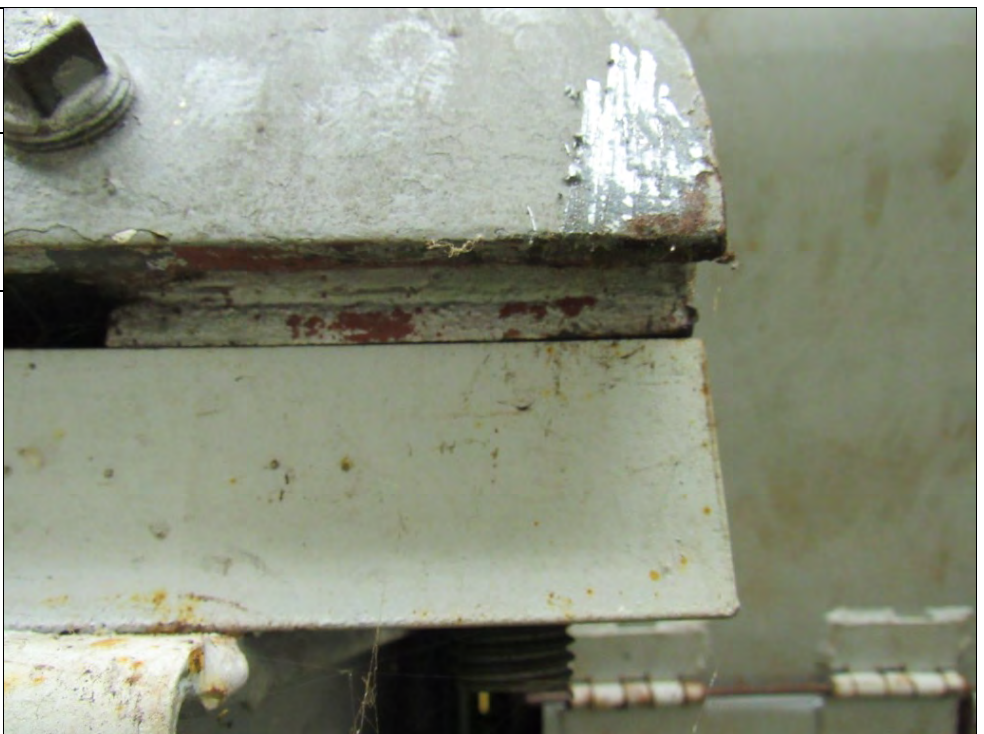
Photo No./ Material ID: JCIS - 09	Date: 8/20/2018 to 8/23/2018
Structure/Material Location: JC Boyle Dam Intake Structure/ Around exterior vents	
*Description (by layer): 1: Thick silver paint (M) 2: Paint on piping (M)

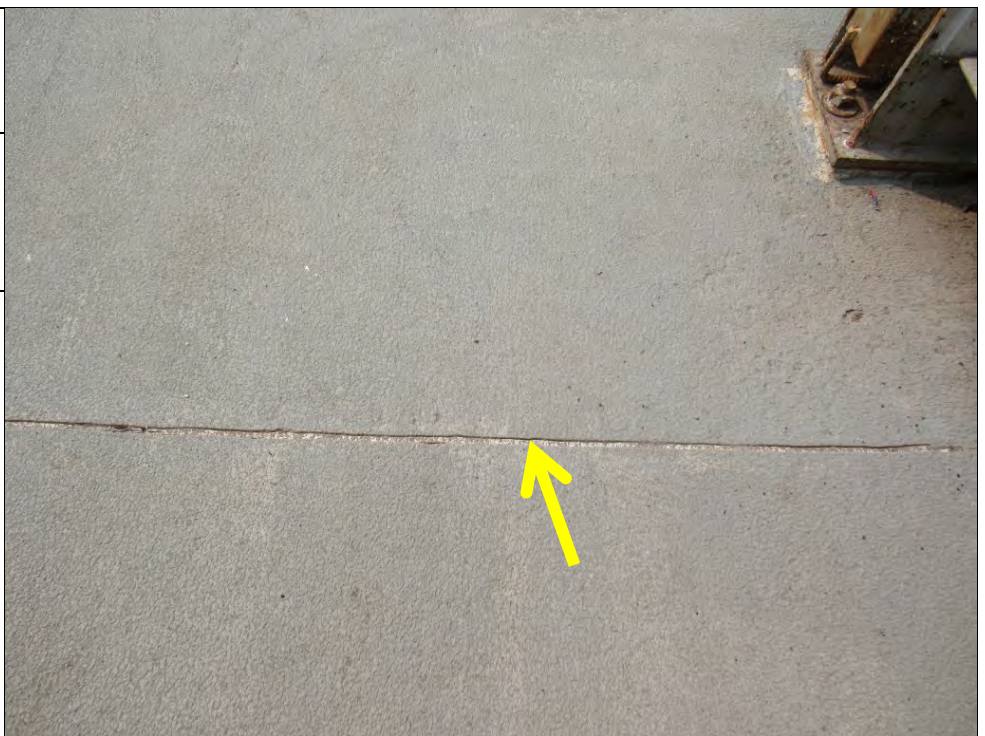
Photo No./ Material ID:	Date:
JCIS - 11	8/20/2018 to 8/23/2018
Structure/Material Location:	
JC Boyle Dam Intake Structure/ At walkway expansion joints	
*Description (by layer):	
1: White sealant (M)

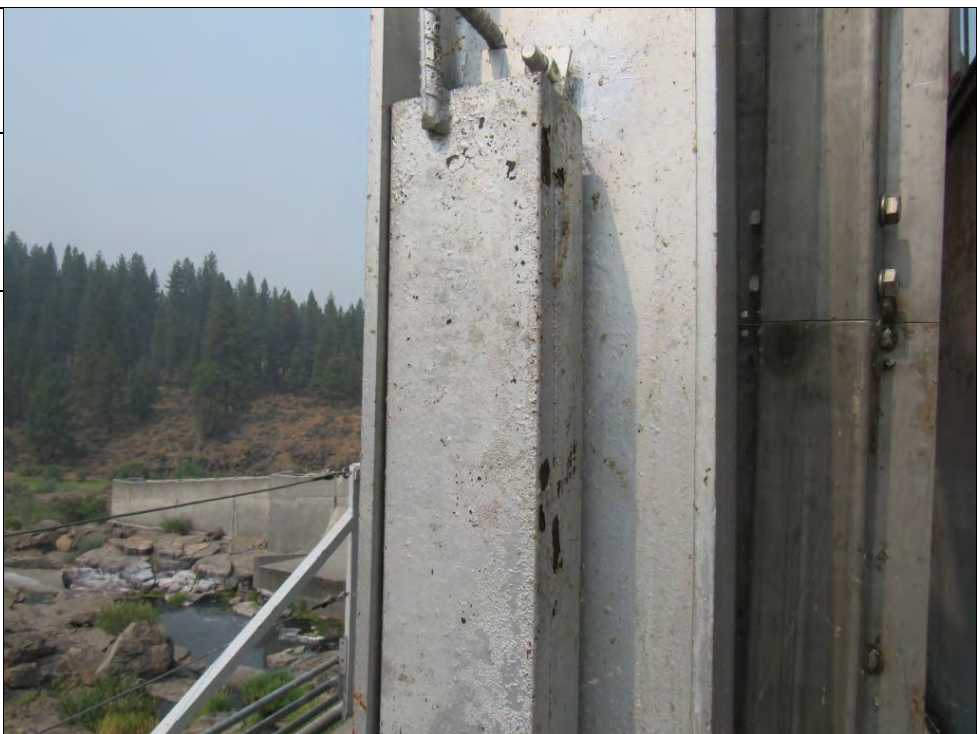
Photo No./ Material ID: JCIS - 13	Date: 8/20/2018 to 8/23/2018

Structure/Material Location: JC Boyle Dam Intake Structure/ Stop log structural cage frame		
*Description (by layer): 1: Thick silver paint (M) 2: Residual corroded metal (M)

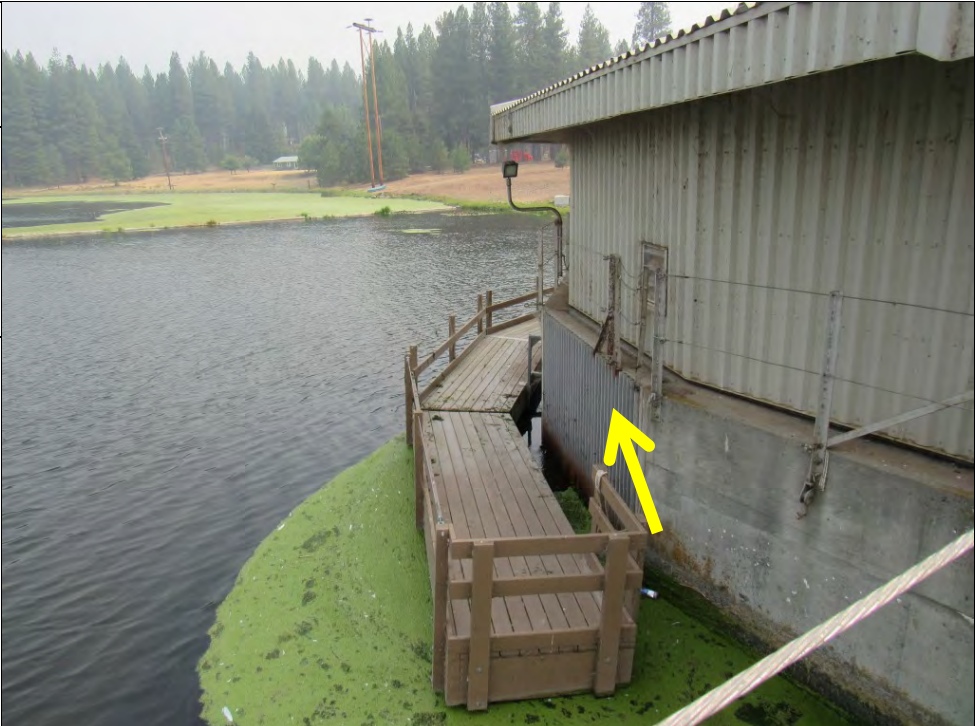
Photo No./ Material ID: JCIS - 15	Date: 8/20/2018 to 8/23/2018

Structure/Material Location: JC Boyle Dam Intake Structure/ Exterior of intake structure, below fish screen house lower section		
*Description (by layer): 1: Thick silver paint (M) 2: Residual corroded metal (M)

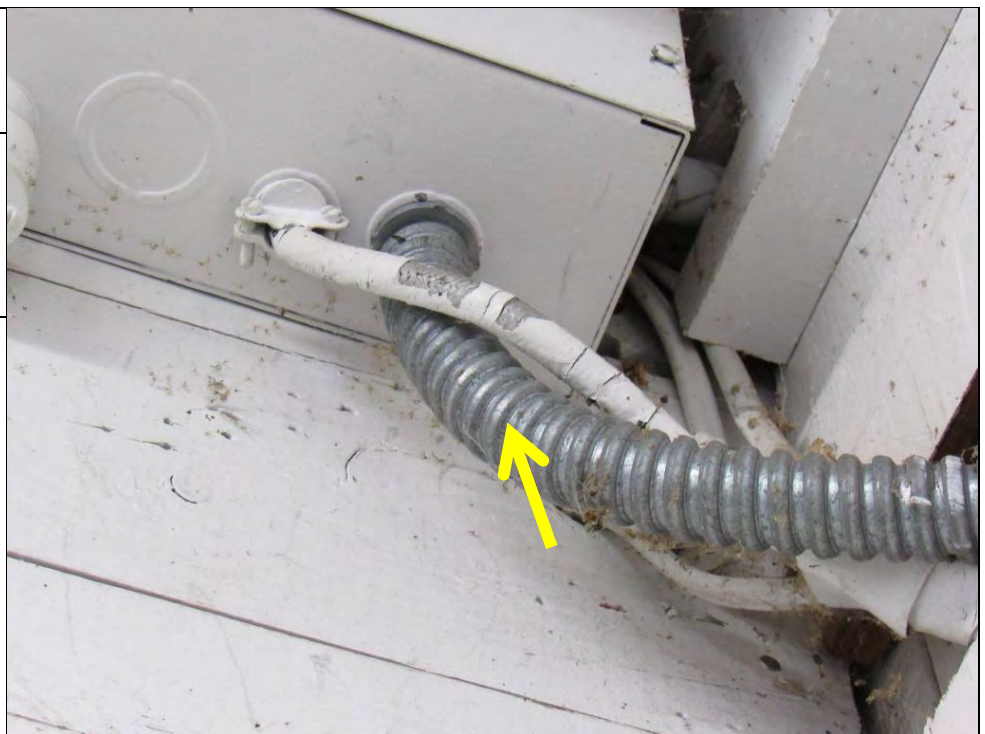
Photo No./ Material ID: JCOW - 09	Date: 8/20/2018 to 8/23/2018
Structure/Material Location: JC Boyle Dam Office and Warehouse/ Throughout Office and Warehouse	
*Description (by layer): Assumed electrical wire insulation inside conduit (M)

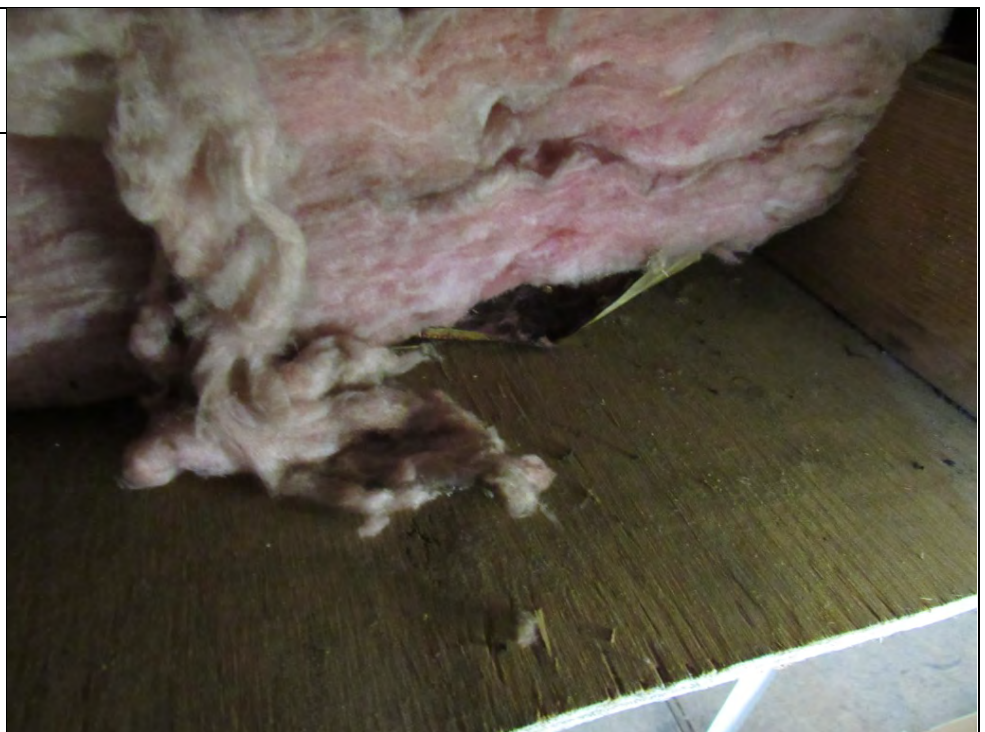
Photo No./ Material ID: JCOW - 11	Date: 8/20/2018 to 8/23/2018
Structure/Material Location: JC Boyle Dam Office and Warehouse/ Above ceiling in attic of Warehouse	
*Description (by layer): 1: Black asphaltic mastic with paper (M) 2: Pink fiberglass batt insulation (T)

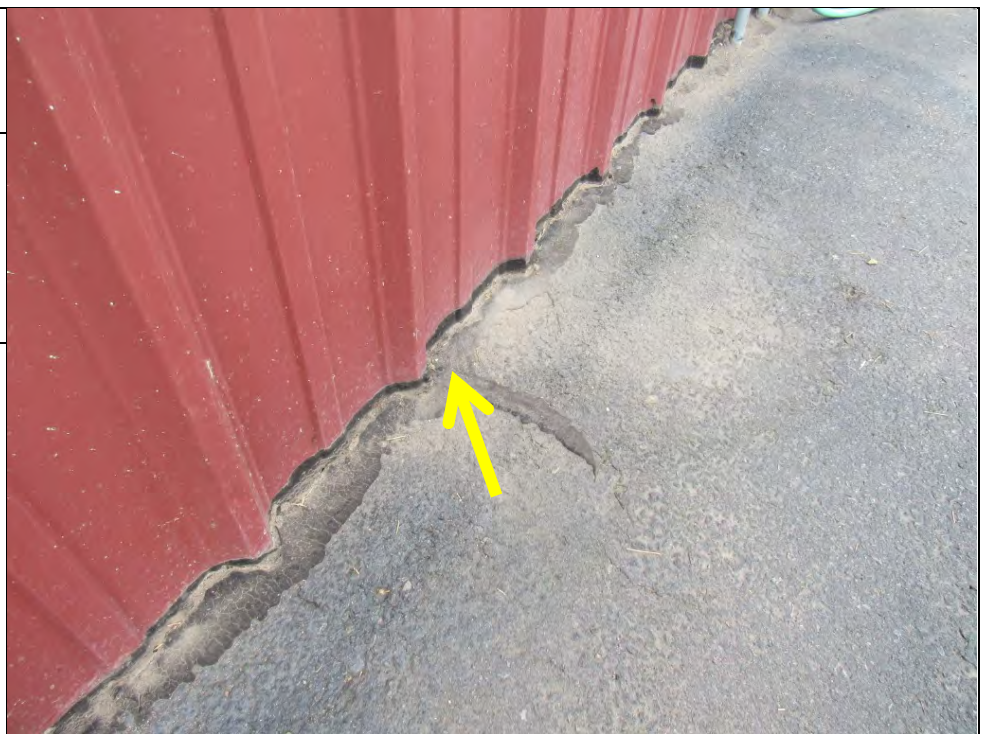
Photo No./ Material ID: JCOW - 13	Date: 8/20/2018 to 8/23/2018
Structure/Material Location: JC Boyle Dam Office and Warehouse/ At base of exterior metal walls, at wall/concrete interface	
*Description (by layer): 1: Black caulking (M)

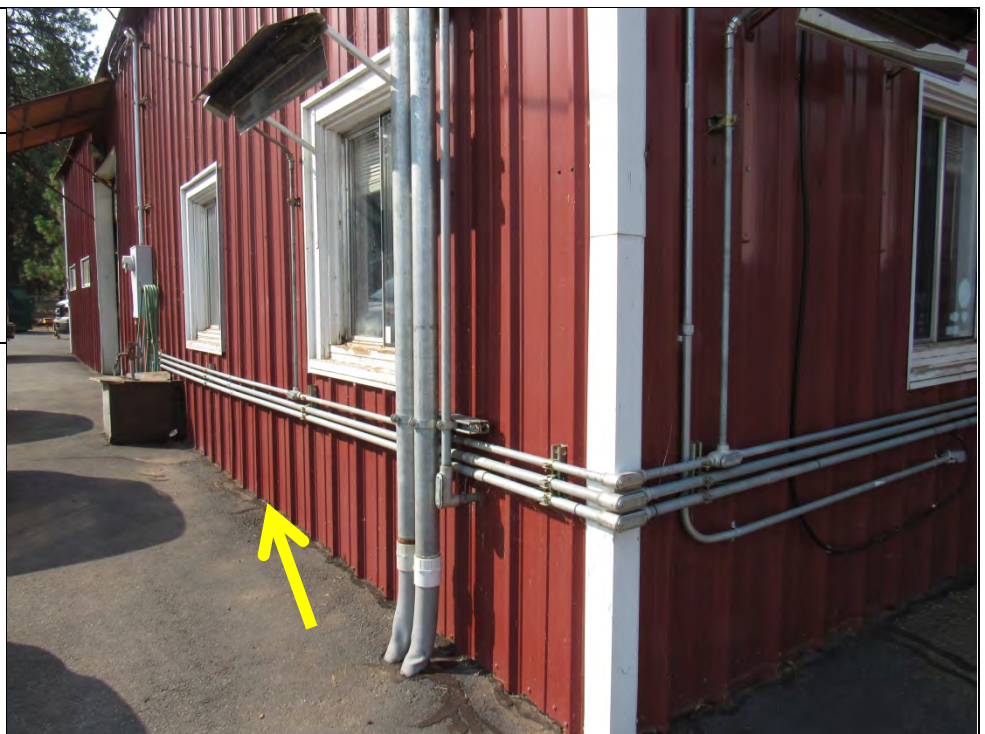
Photo No./ Material ID: JCOW - 17	Date: 8/20/2018 to 8/23/2018
Structure/Material Location: JC Boyle Dam Office and Warehouse/ Underneath corrugated metal siding throughout Office Warehouse	
*Description (by layer): 1: Brown asphaltic vapor barrier paper (M)

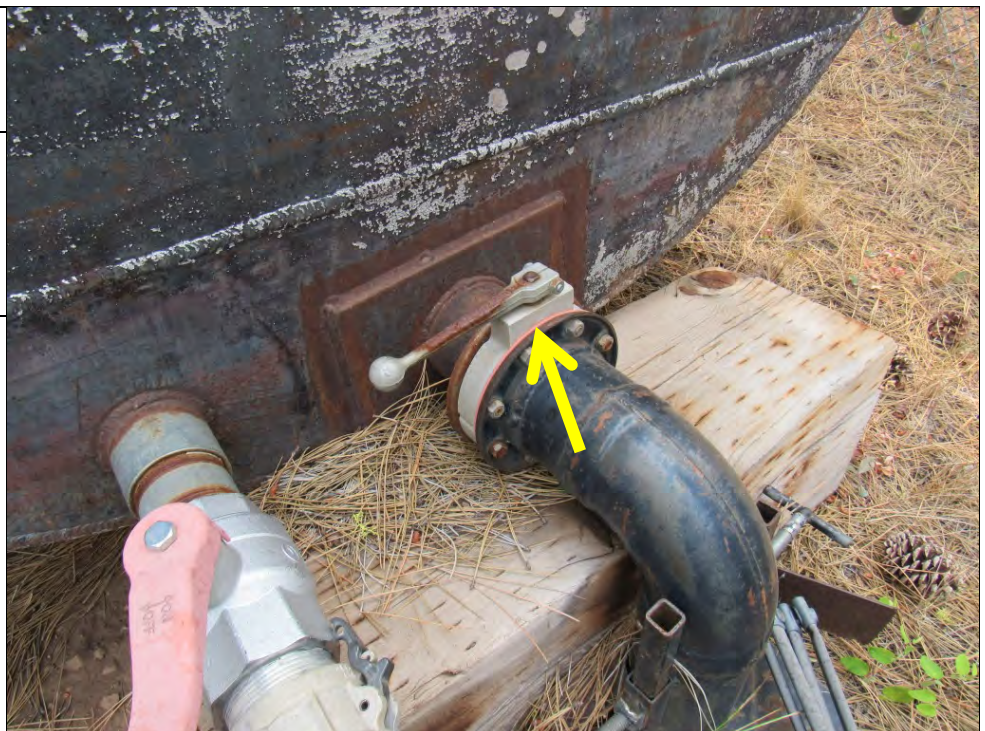
Photo No./ Material ID: JCBY - 01	Date: 9/17/2018
Structure/Material Location: JC Boyle Dam Outdoor Storage Area/ Out of service storage tank in Outdoor Storage Area	
*Description (by layer): 1: Red gasket (M) 2: Yellow mastic (M)

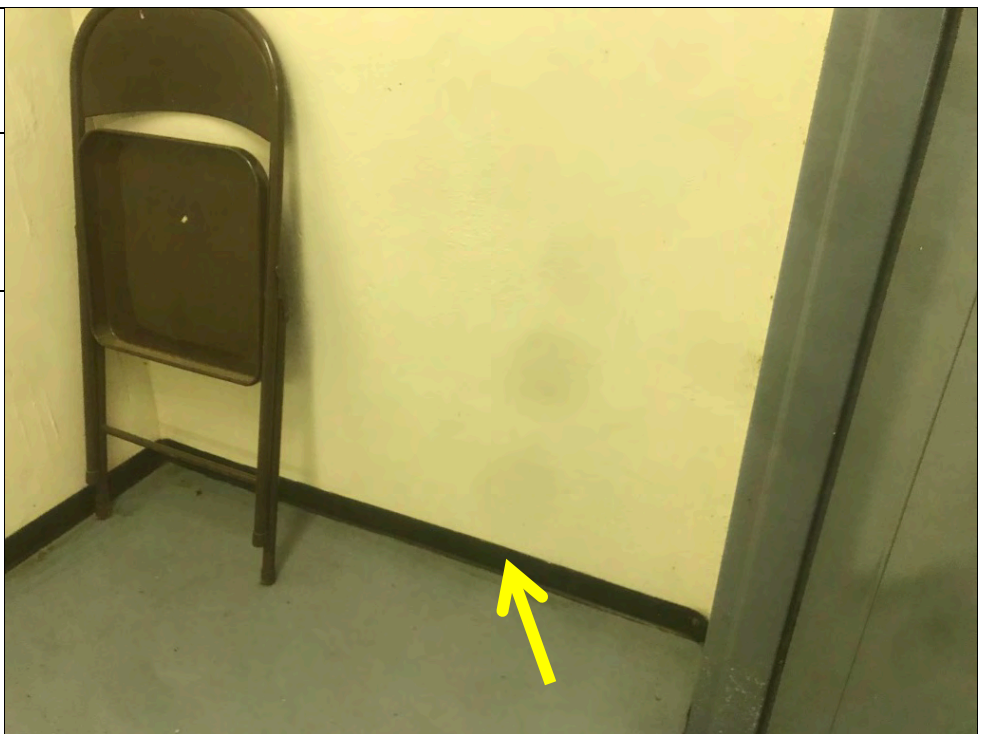
Photo No./ Material ID: JCPH - 03	Date: 8/20/2018 to 8/23/2018
Structure/Material Location: JC Boyle Dam Powerhouse/ Restroom walls	
*Description (by layer): 1: 2" black rubber cove base (M) 2: Yellow mastic (M)

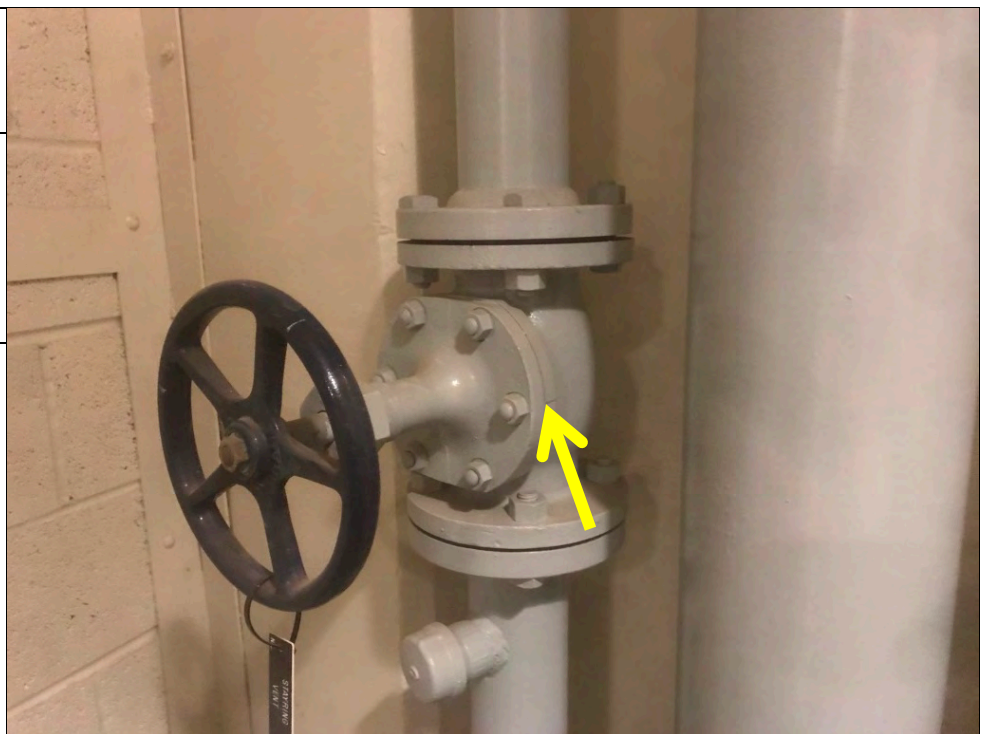
Photo No./ Material ID: JCPH - 05	Date: 08/20/18 to 08/23/2018
Structure/Material Location: JC Boyle Dam Powerhouse/ Piping and mechanical equipment throughout Pumphouse	
*Description (by layer): Assumed asbestos-containing gaskets

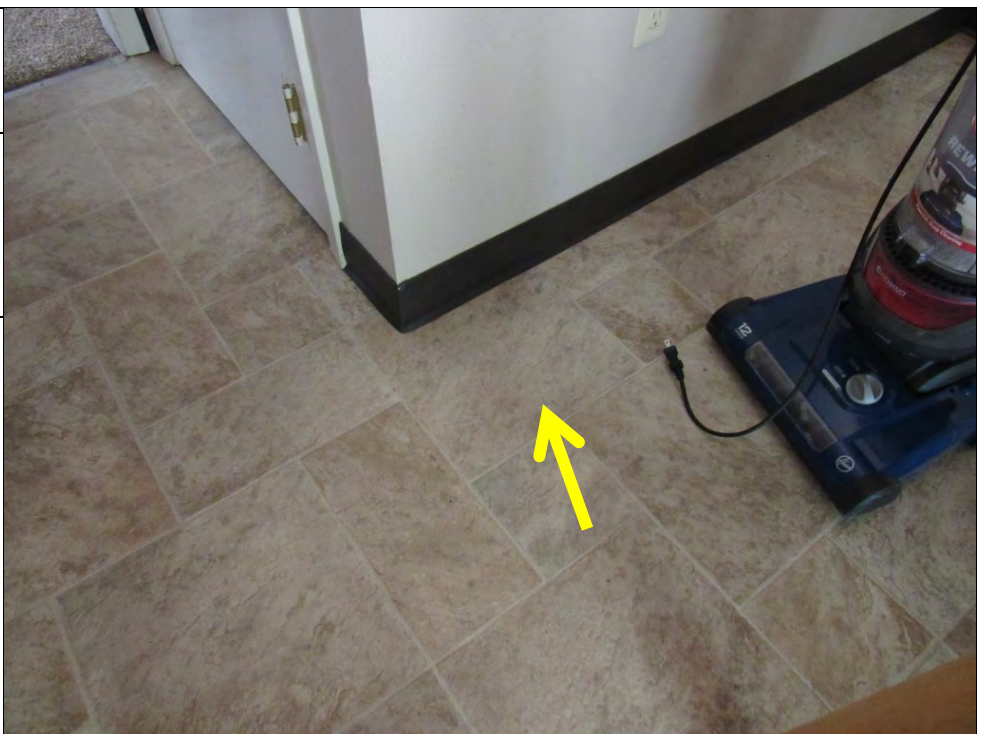
Photo No./ Material ID:	Date:
JCR1 - 05	08/20/18 to 08/23/2018
Structure/Material Location: JC Boyle Dam Residence 1/ Flooring in dining room and kitchen	
*Description (by layer): 1: Gray vinyl floor sheeting with marble and cobblestone pattern (M) 2: Yellow mastic (M)
