APPENDIX E

Preliminary Services Diversion Tunnel Inspection

RE: Klamath River Renewal Project – Iron Gate and Copco No. 1 Diversion Tunnel Geotechnical Inspection

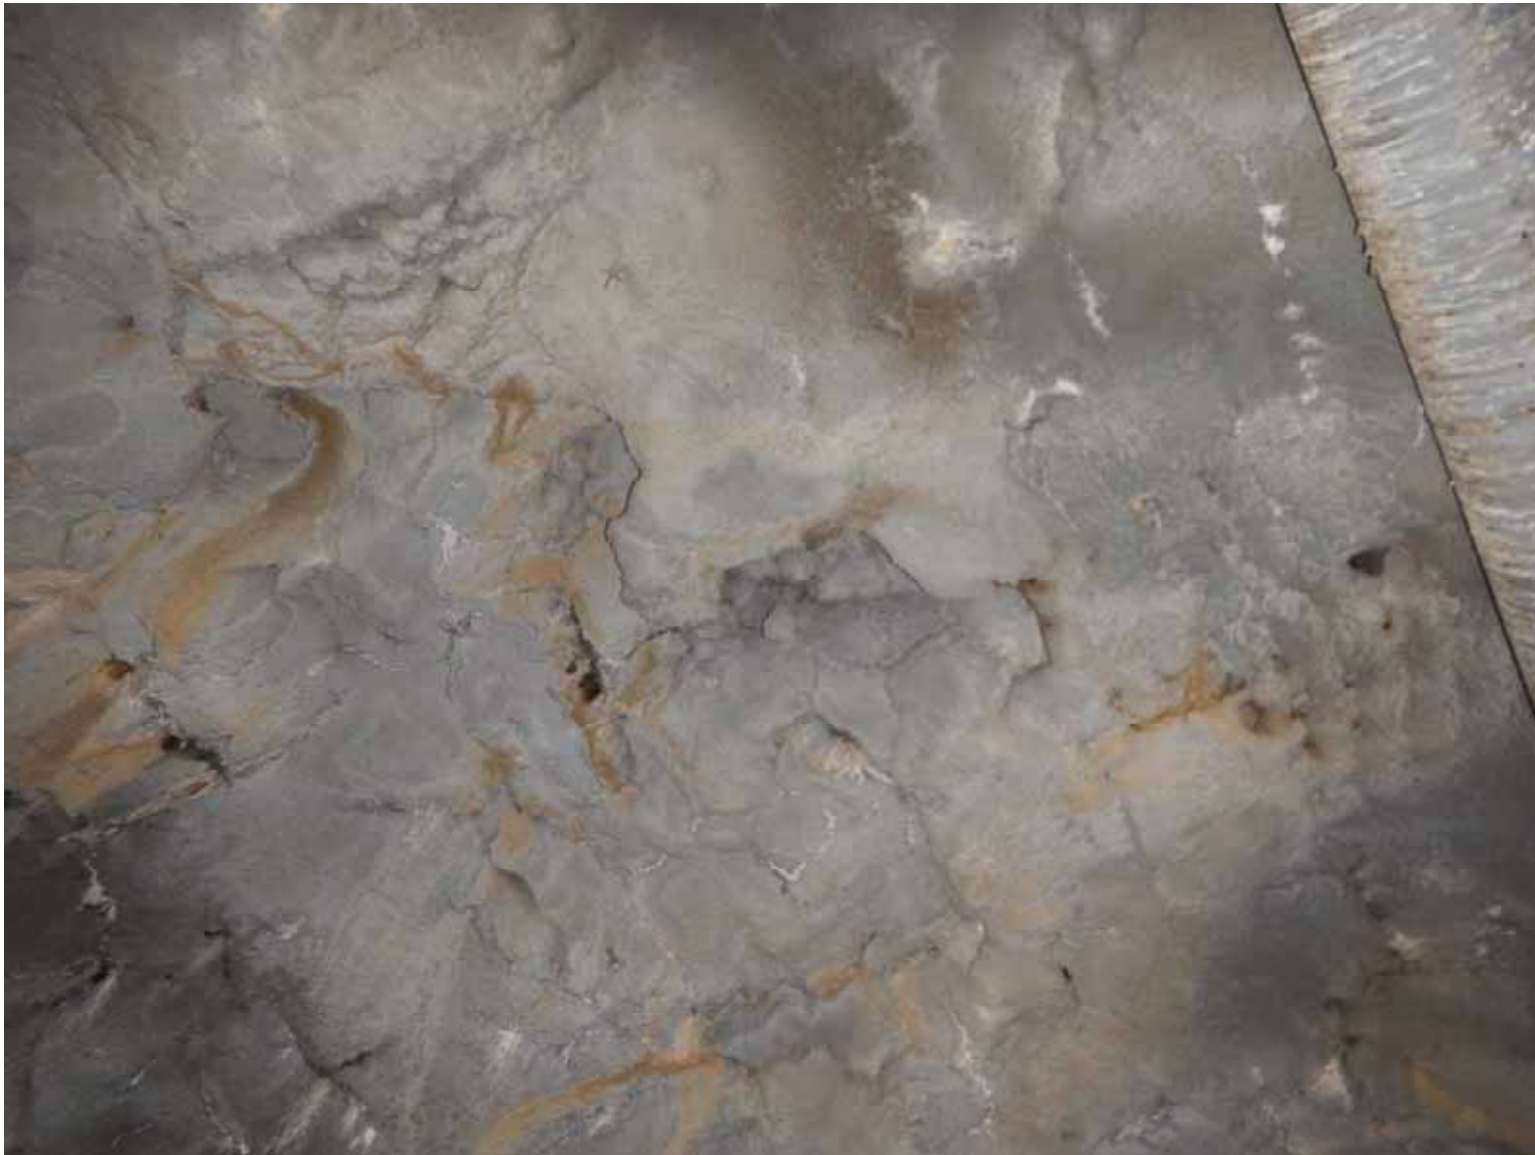
Profile of the tunnel crown in the shotcreted section is locally highly irregular suggesting the presence of a 'loose' closely jointed rock mass with previous crown instability

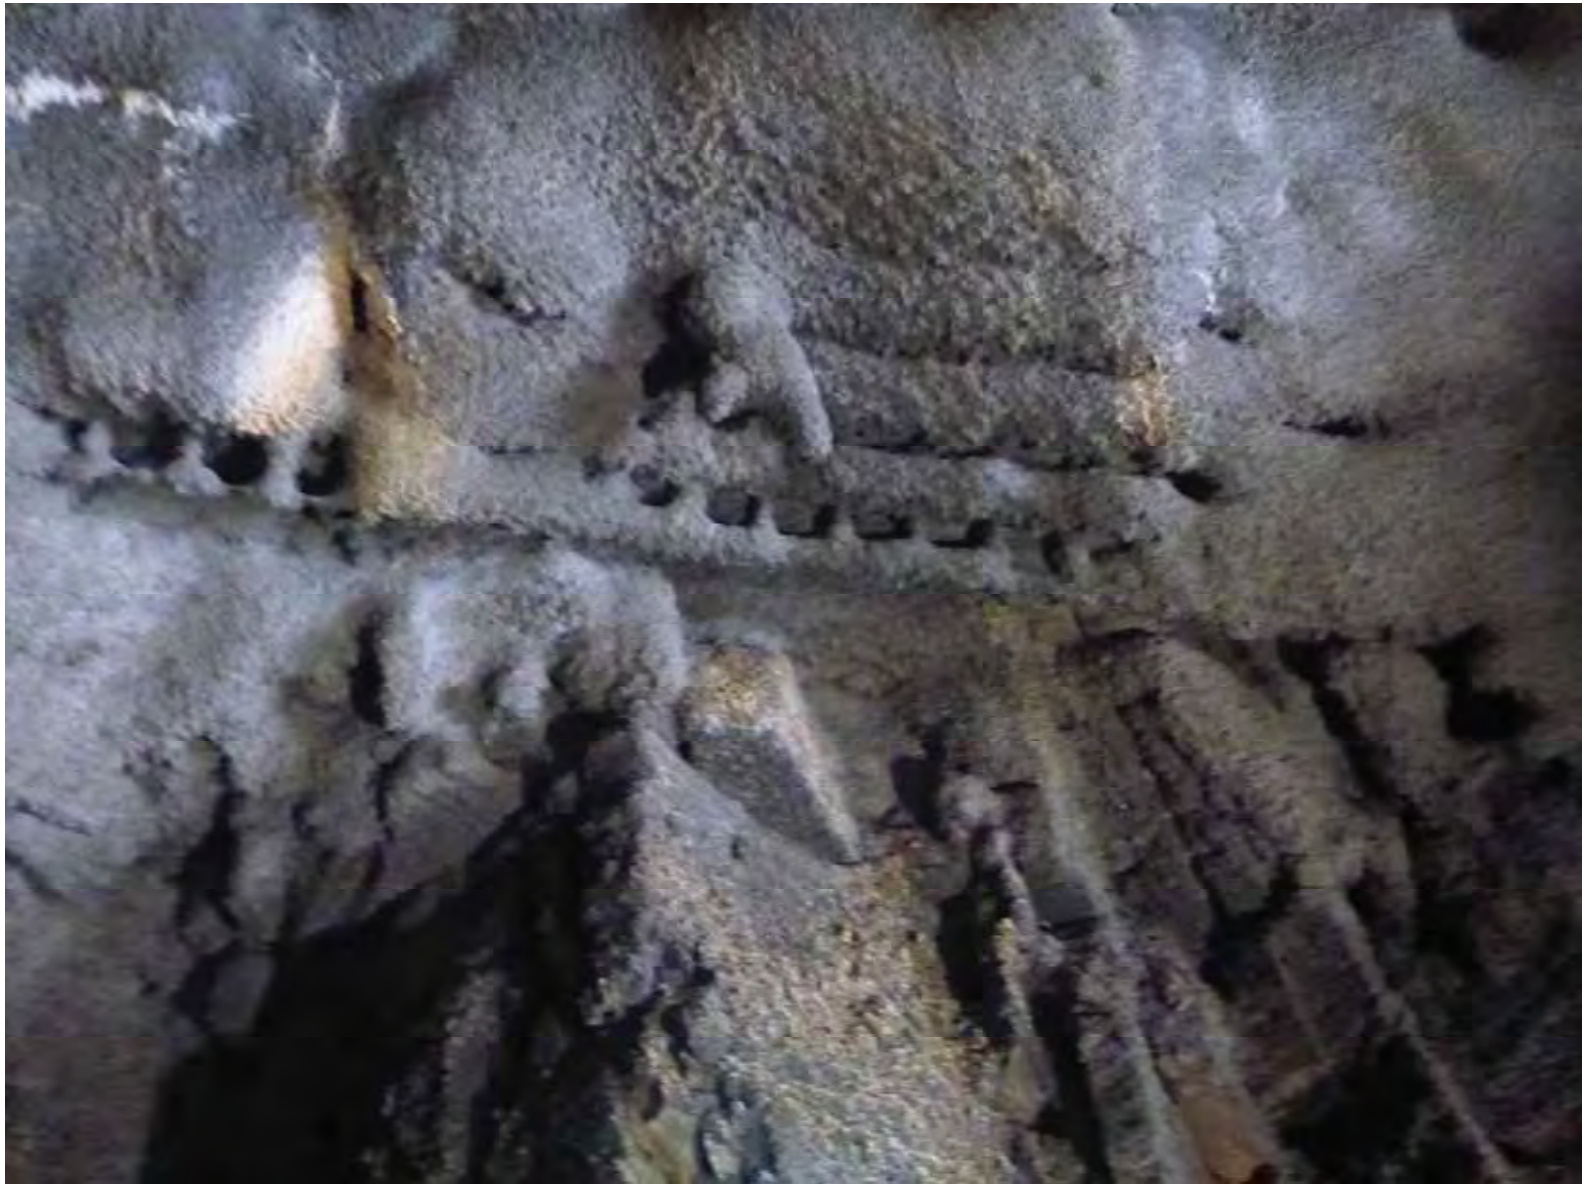
Shotcreted section with welded wire mesh and possible spot bolts

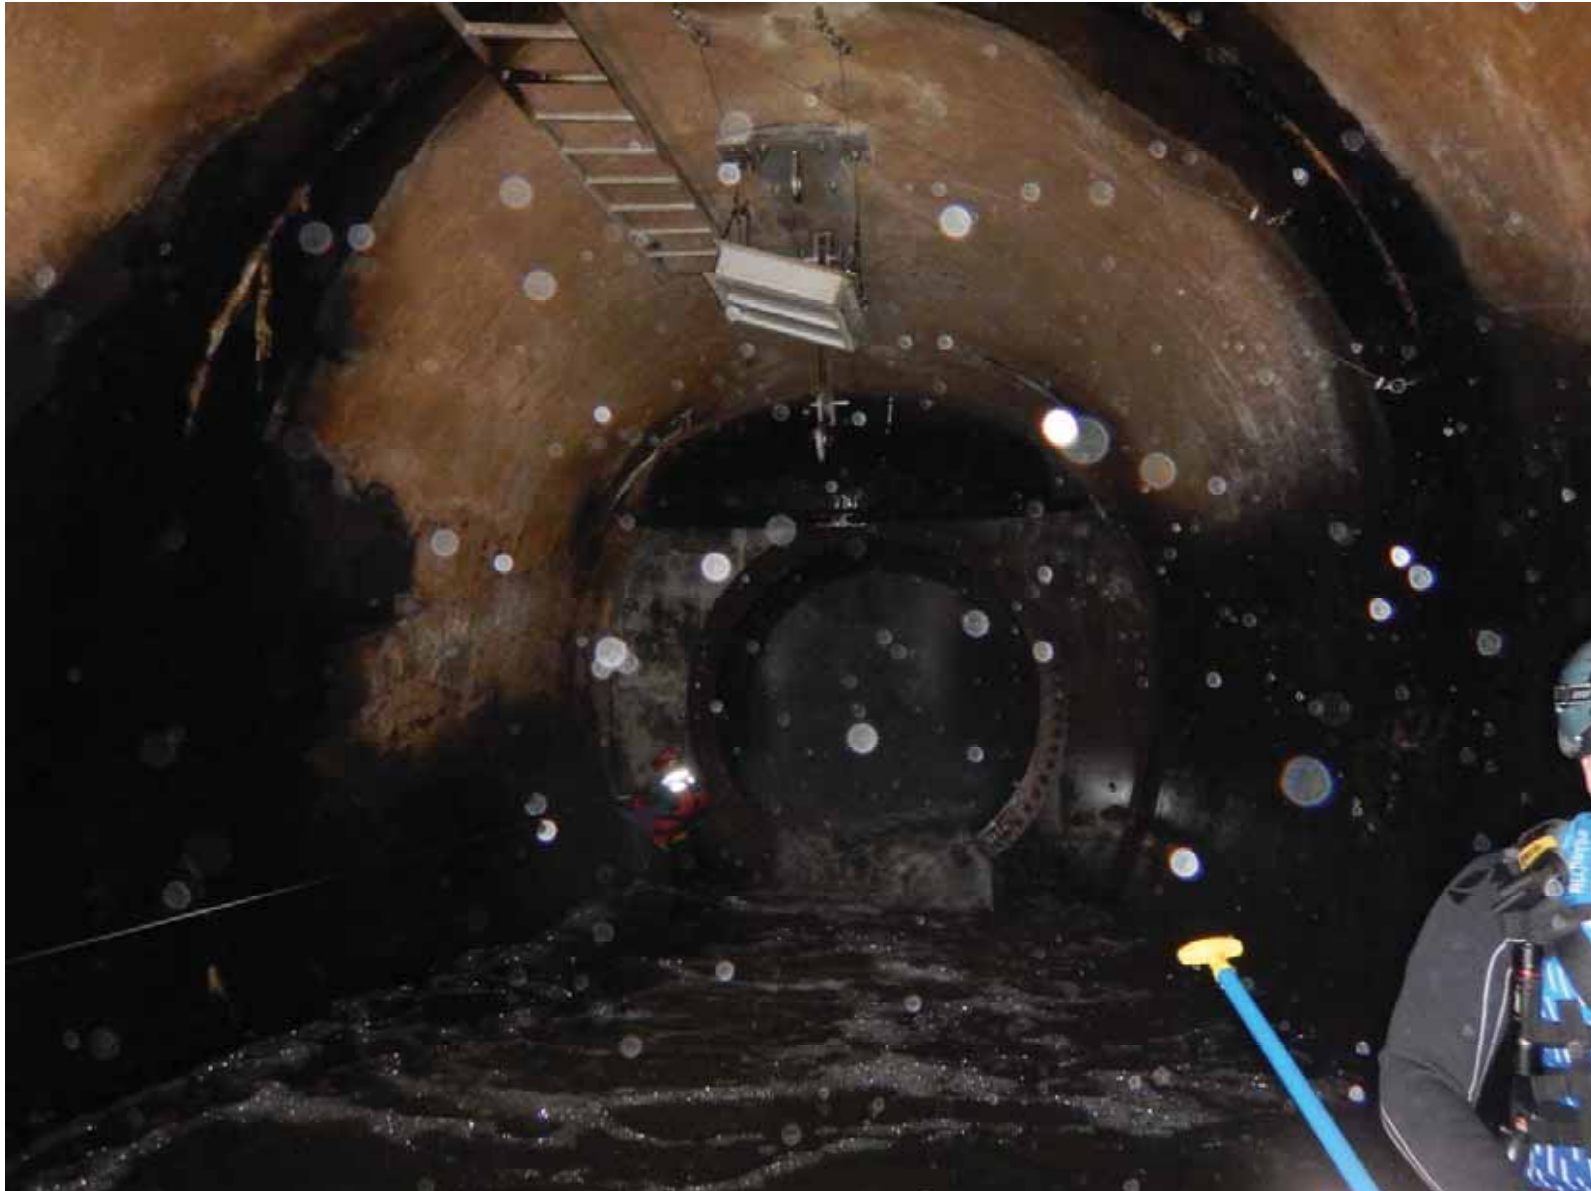
STA. 577.6 ft - Concrete Ring and Blind Flange

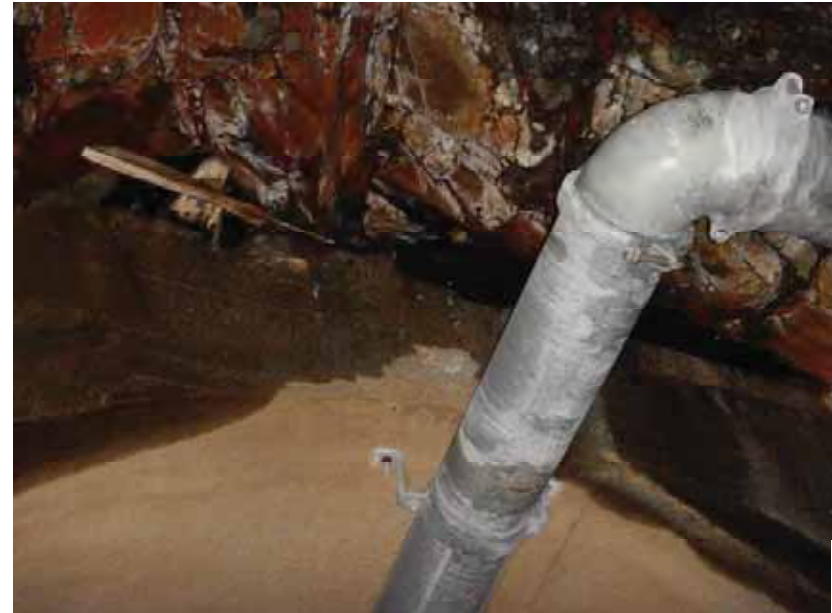
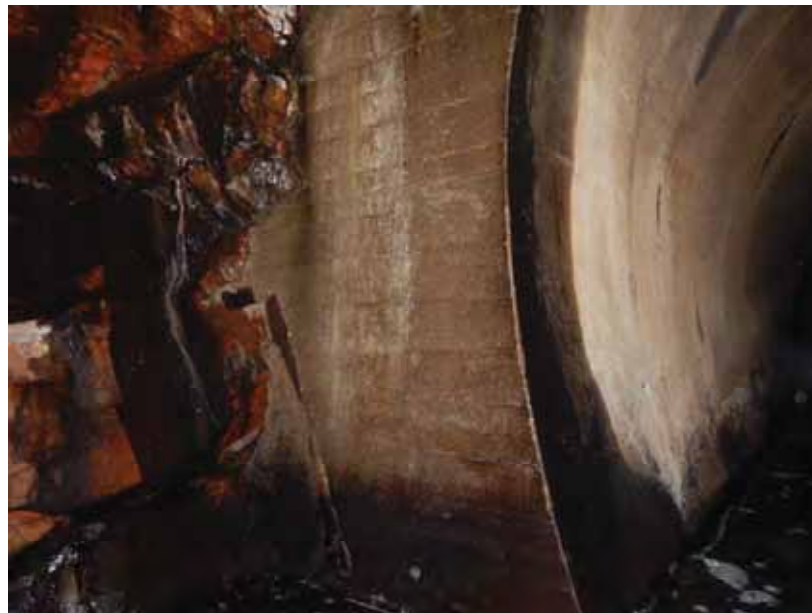
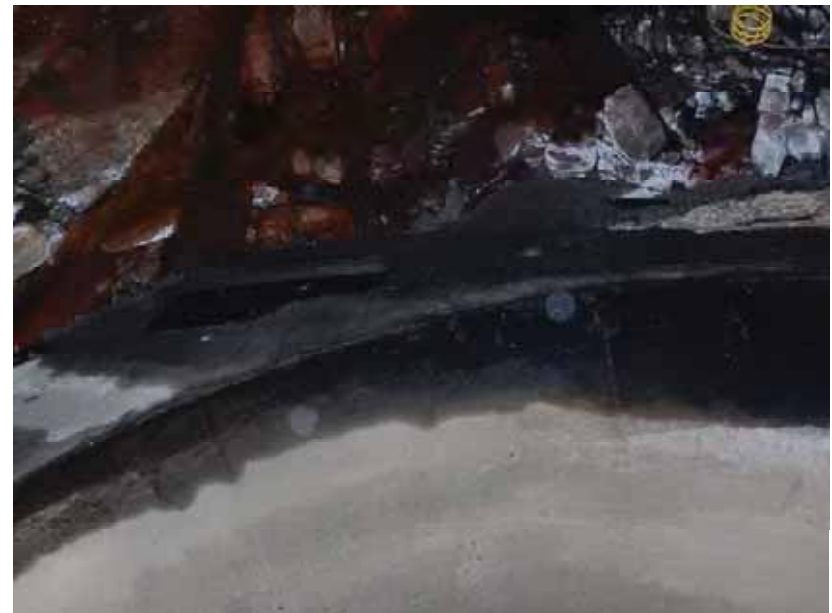
STA. 516.7 ft – Seepage observed around Upstream Concrete Liner

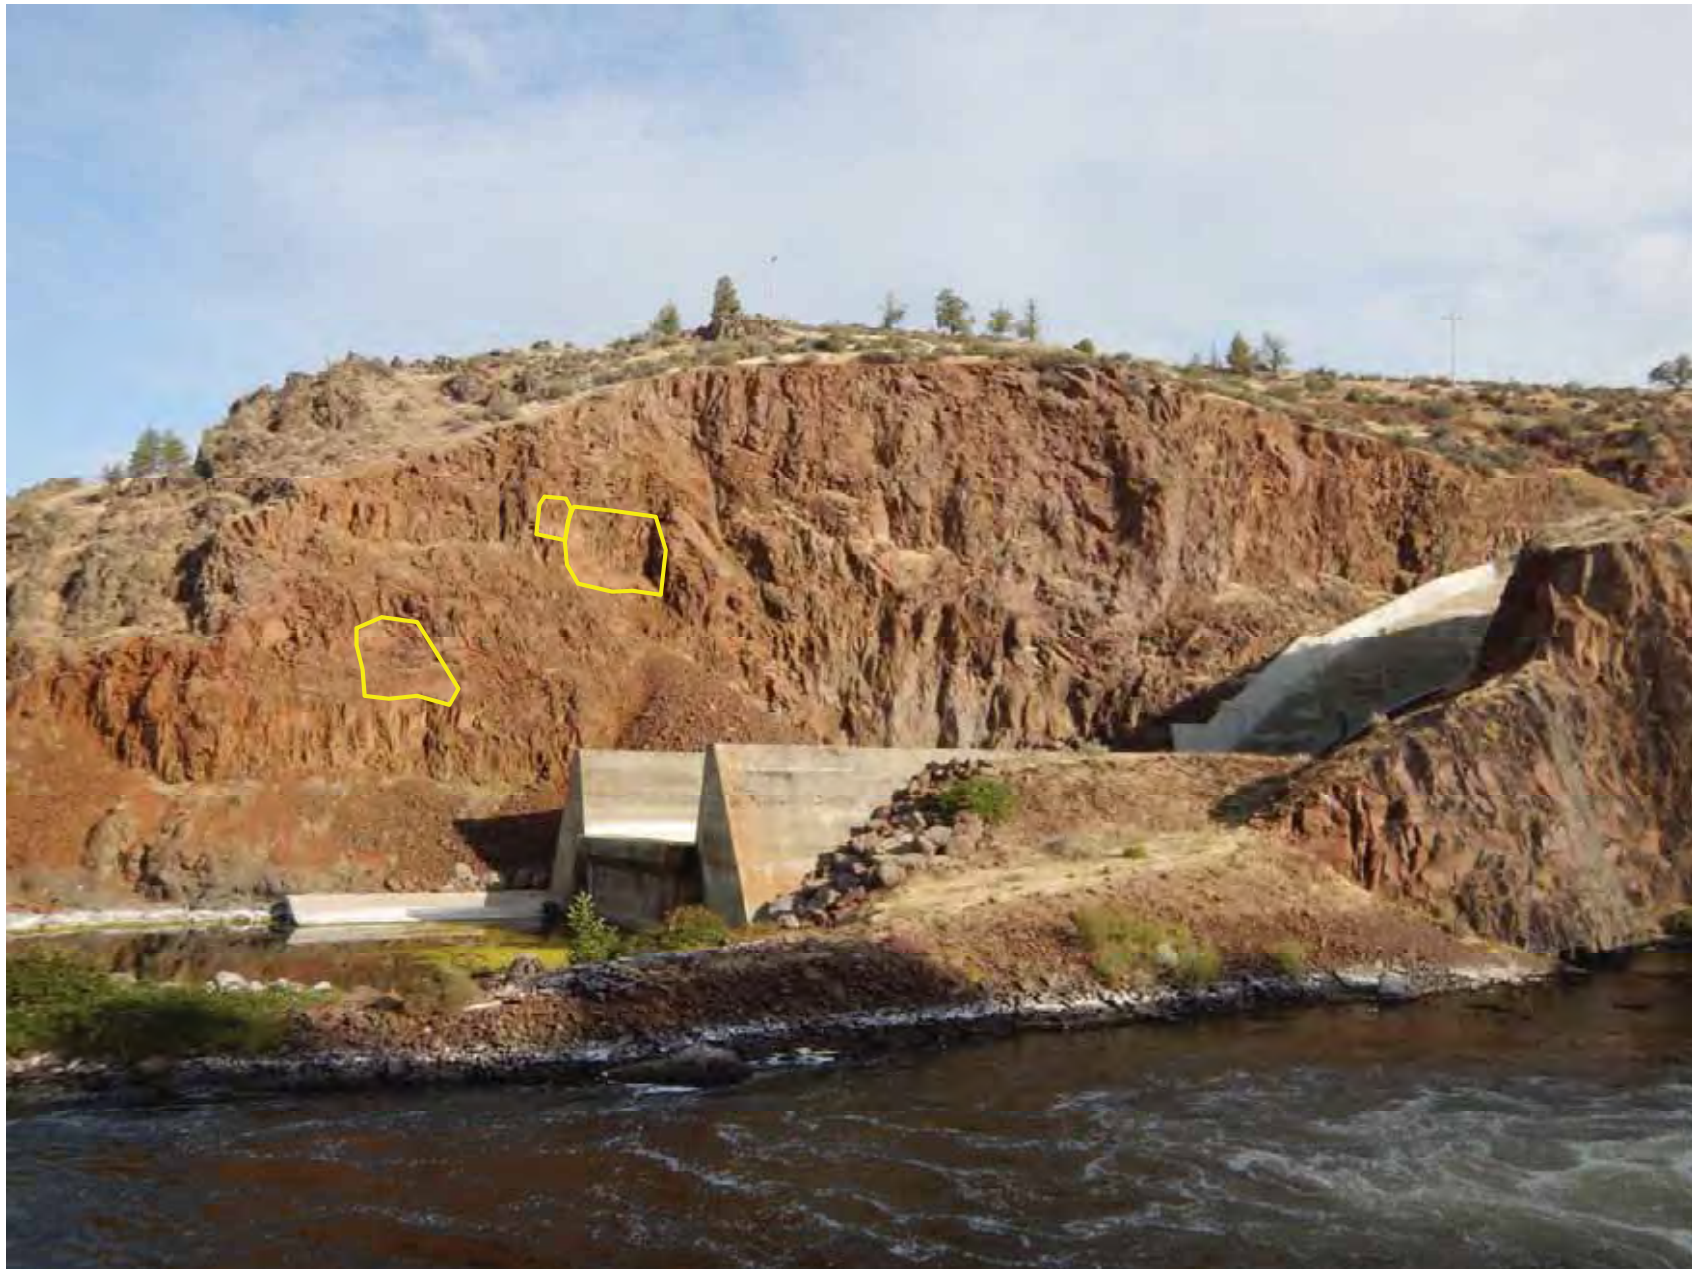
Set 4 joints have formed the failure surface for at least two relatively small-scale (less than 1,750 ft³) rockslides in the rock cut outside of the tunnel and adjacent to the spillway (Photo 16, Appendix B). Joints belonging to this set may have acted as a failure surface for the previous rockslide that covered the channel immediately downstream of the portal and was removed in 2007 as part of the rehabilitation project. The draped rock slope netting that has been installed on the rock cut in this area (Photo 17, Appendix B) will be effective in controlling the fall of rock blocks with a volume in the order of 35 ft³.

Rock Slides have occurred in the Rock Cut above the Spillway

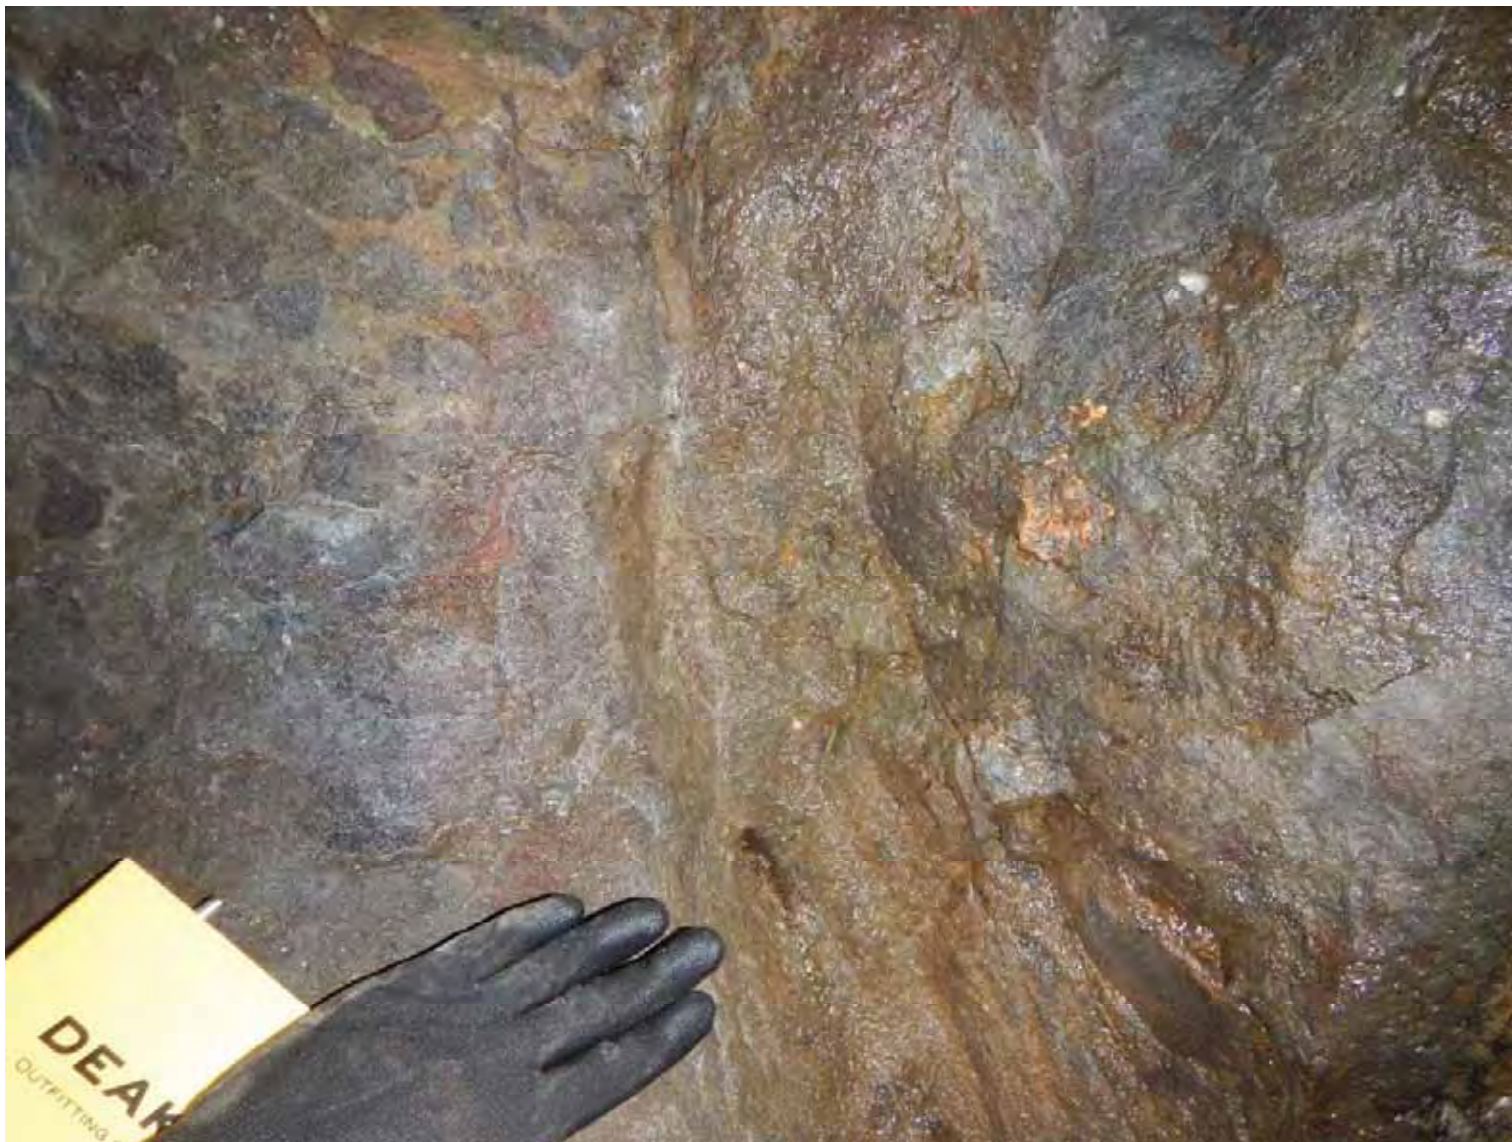
STA.105 ft Set 2 Joint, 1/16 to 1/4-inch wide with soil infill (weak to medium strong gravel size rock fragments with some soft clay), see page. Differentially weathered zone is 8 to 12 inch-wide and comprises weak to medium strong material.
