APPENDIX G4

Test Pit Photographs

ROCK SLOPE HAZARDS

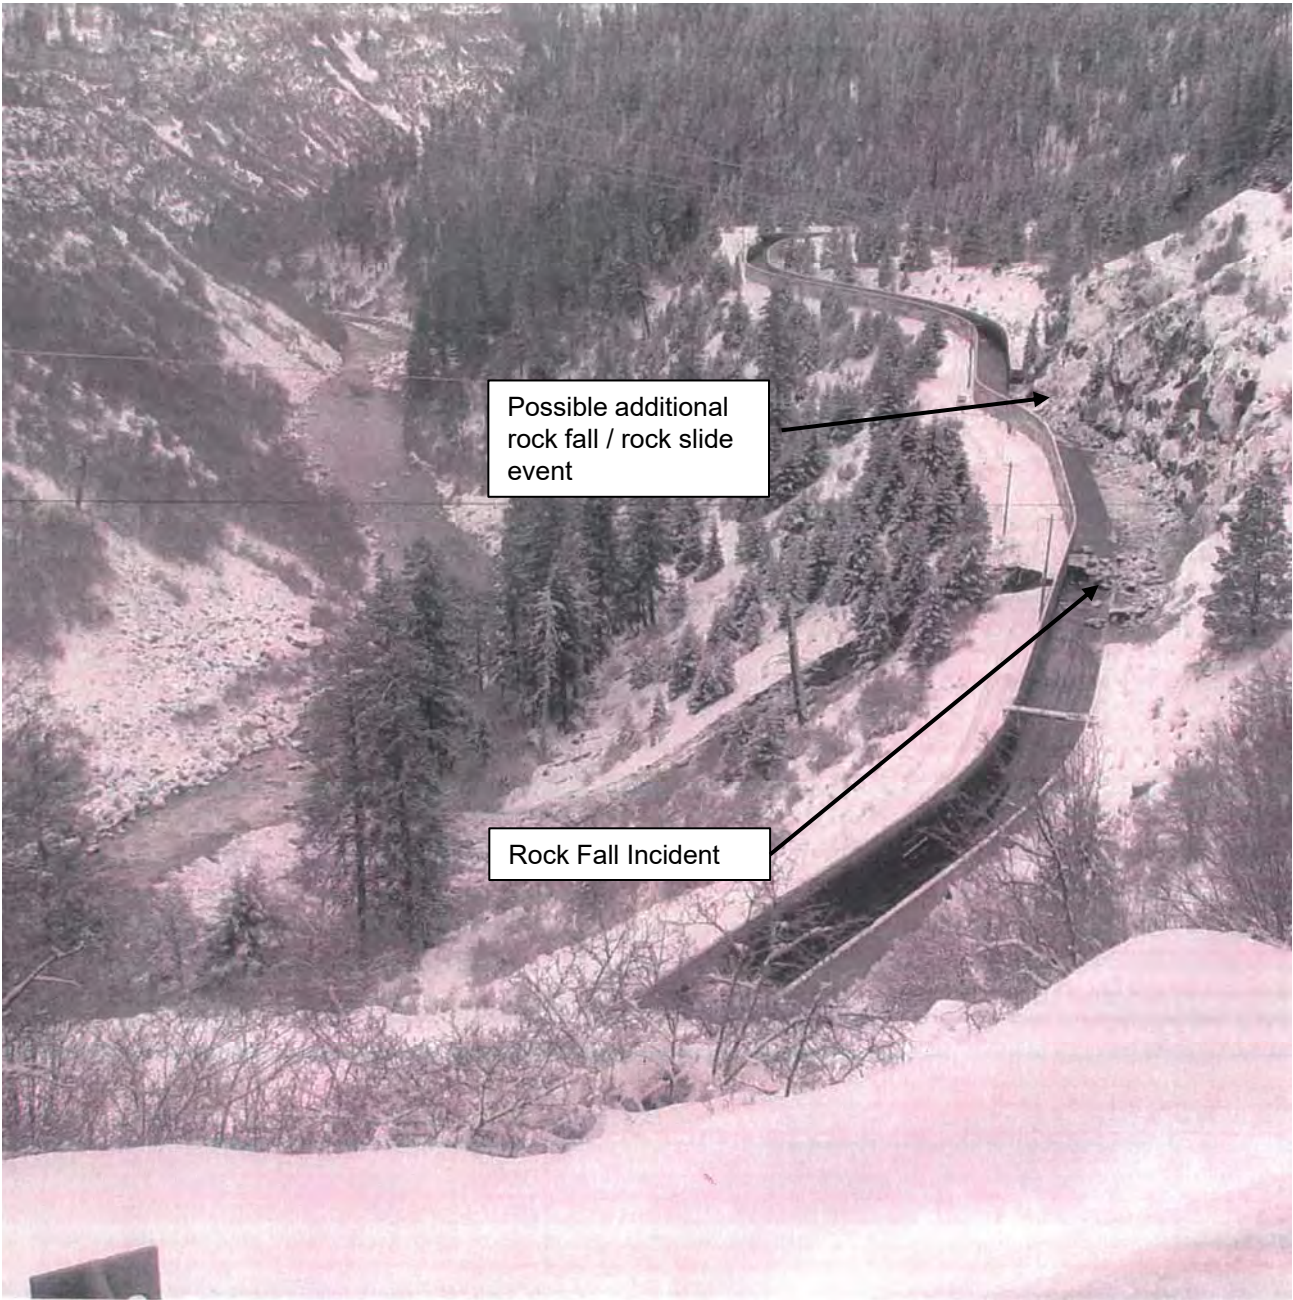
KIEWIT INFRASTRUCTURE WEST CO.	
KLAMATH RIVER RENEWAL PROJECT	
JC BOYLE POWER CANAL PHOTO OF ROCK FALL INCIDENT SUPPLIED BY PACIFIC CORP.

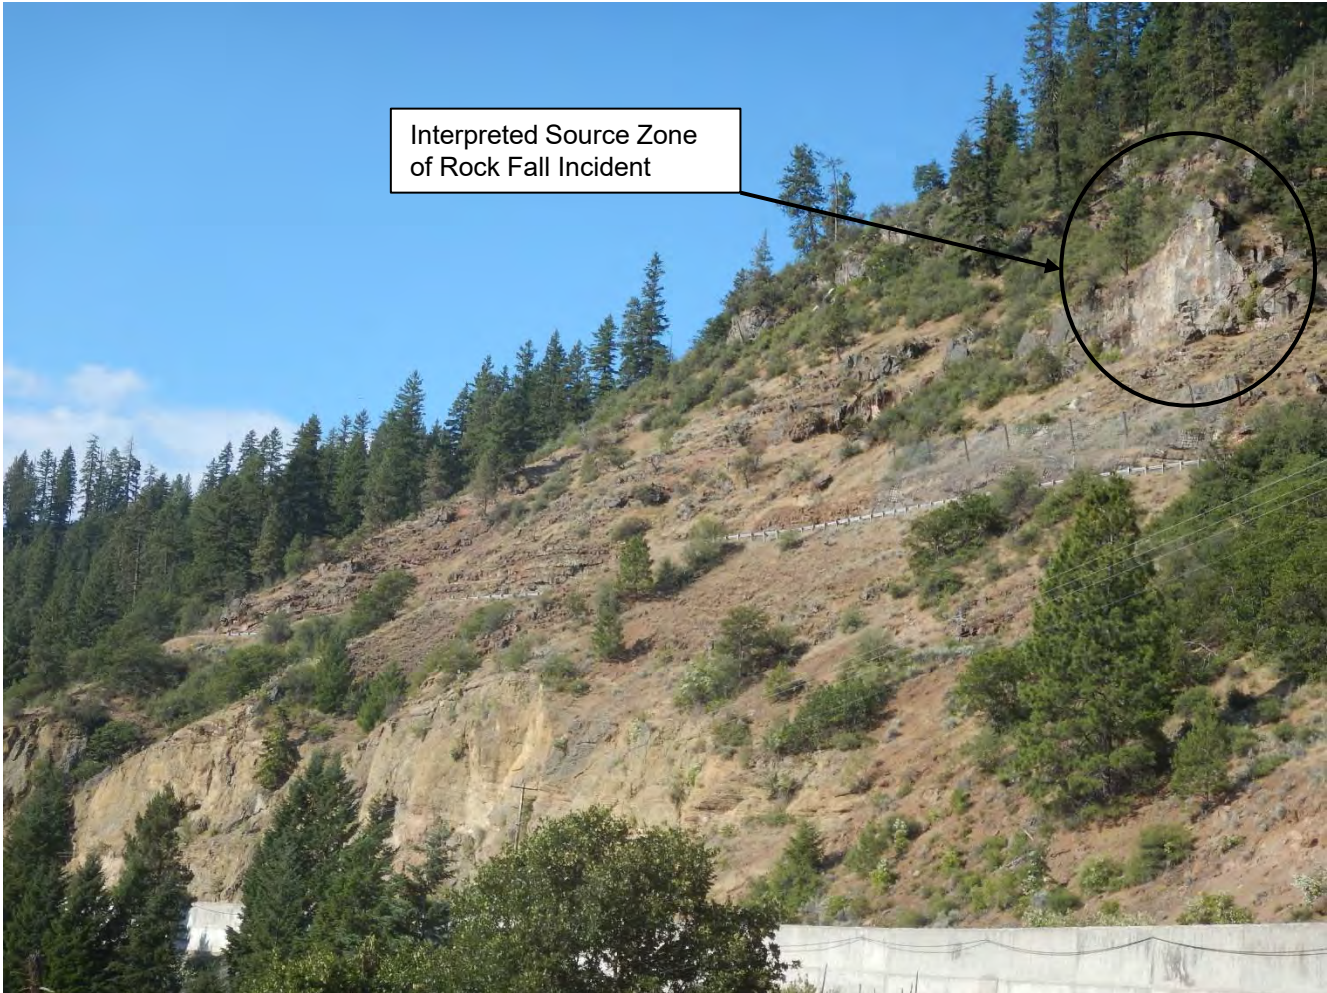
KIEWIT INFRASTRUCTURE WEST CO.			
					KLAMATH RIVER RENEWAL PROJECT			
					JC BOYLE POWER CANAL INTERPRETED SOURCE ZONE OF ROCK FALL INCIDENT			
					<div>

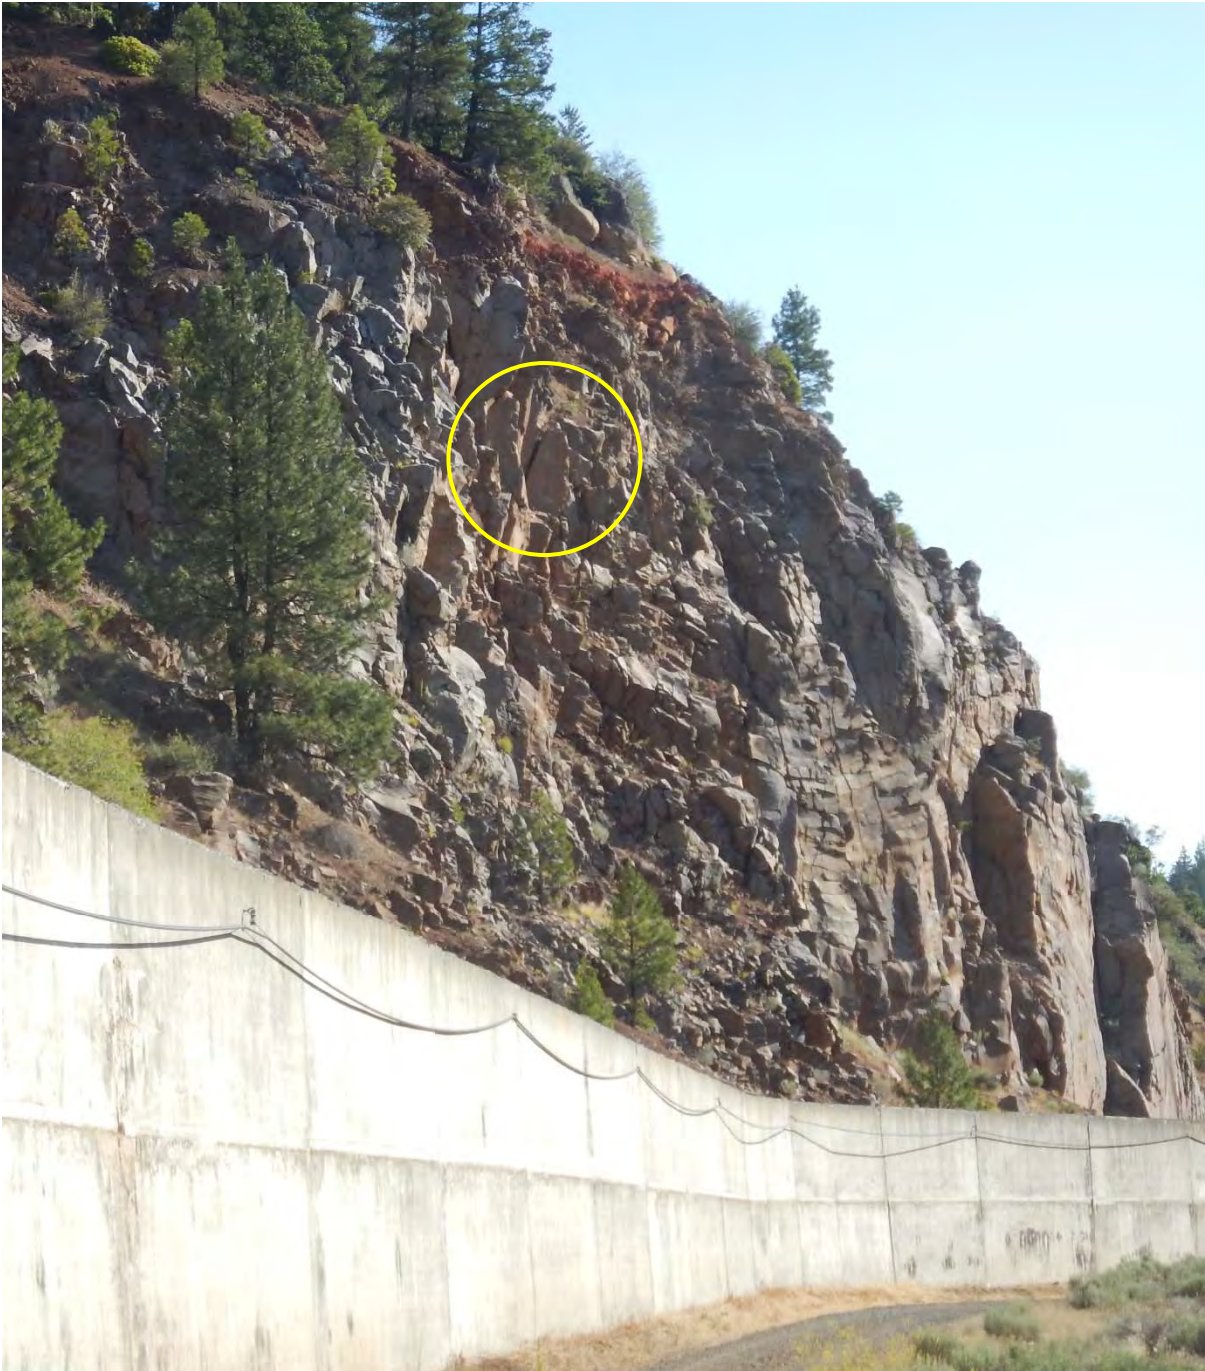
KIEWIT INFRASTRUCTURE WEST CO.	
KLAMATH RIVER RENEWAL PROJECT	
JC BOYLE POWER CANAL SUB-VERTICAL JOINTS GIVE RISE TO POTENTIAL FOR TOPPLING FAILURE

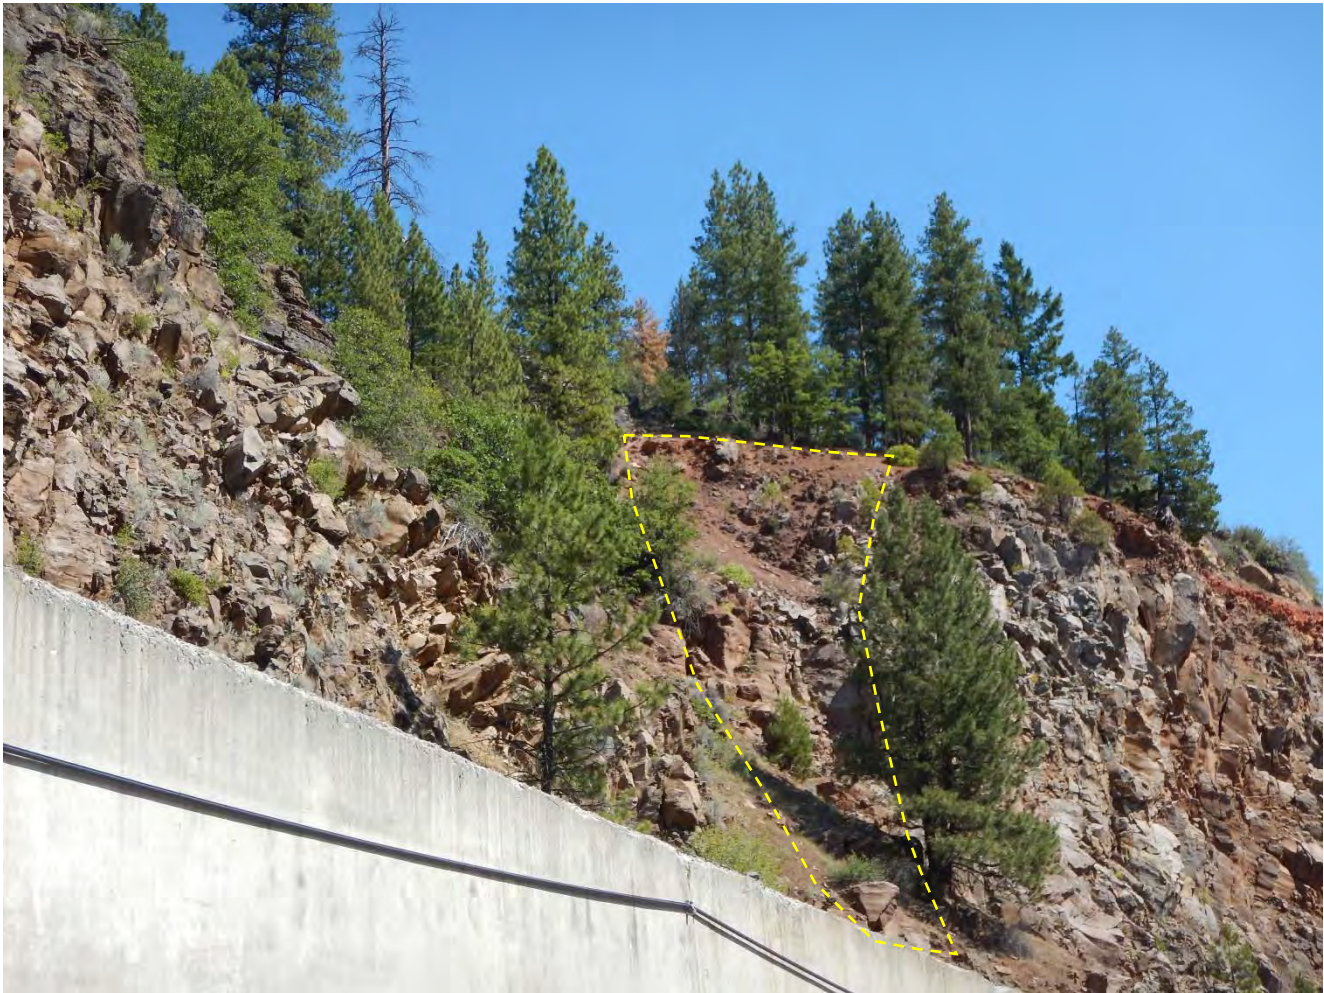
KIEWIT INFRASTRUCTURE WEST CO.	
					KLAMATH RIVER RENEWAL PROJECT	
					JC BOYLE POWER CANAL RECENT ROCK SLIDE AT CH. 63+00

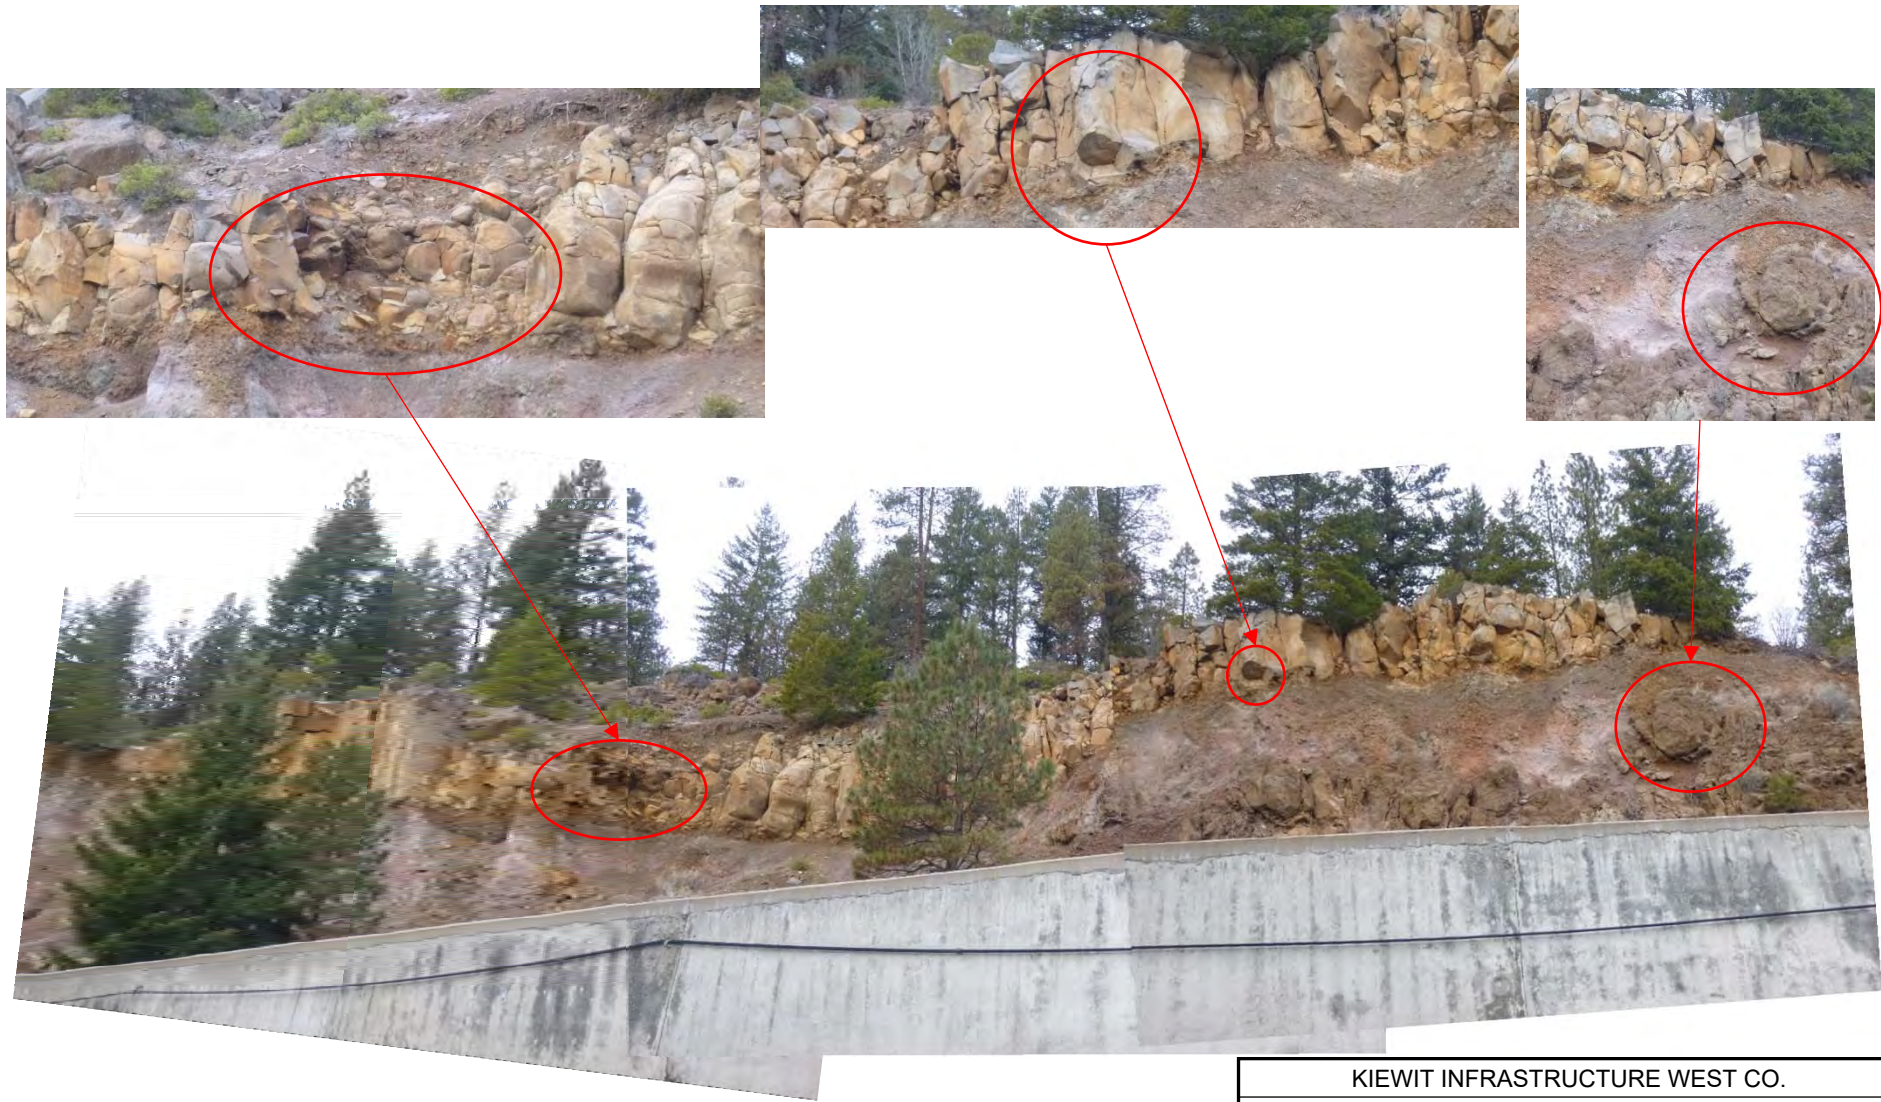
KIEWIT INFRASTRUCTURE WEST CO.		
KLAMATH RIVER RENEWAL PROJECT		
SITE RECONNAISSANCE J.C. BOYLE POWER CANAL ROAD ROCK OUTCROP AT APPROXIMATELY STA 24+00

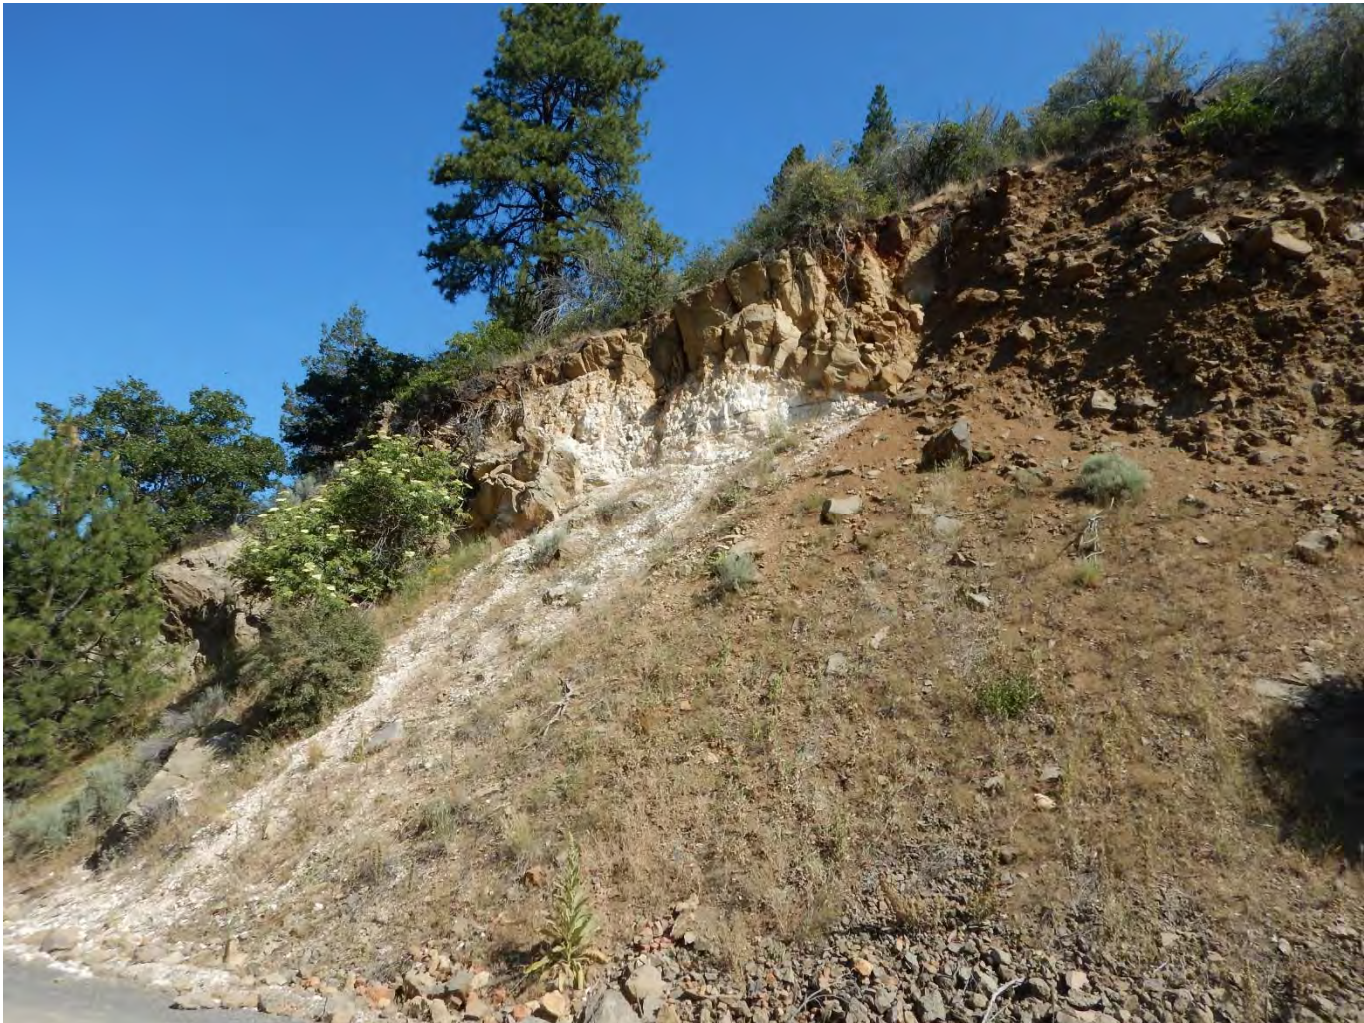
KIEWIT INFRASTRUCTURE WEST CO.			
					KLAMATH RIVER RENEWAL PROJECT			
					JC BOYLE POWERHOUSE ACCESS ROAD LOCATION A: ROCK FALL HAZARD IN CUT SLOPE

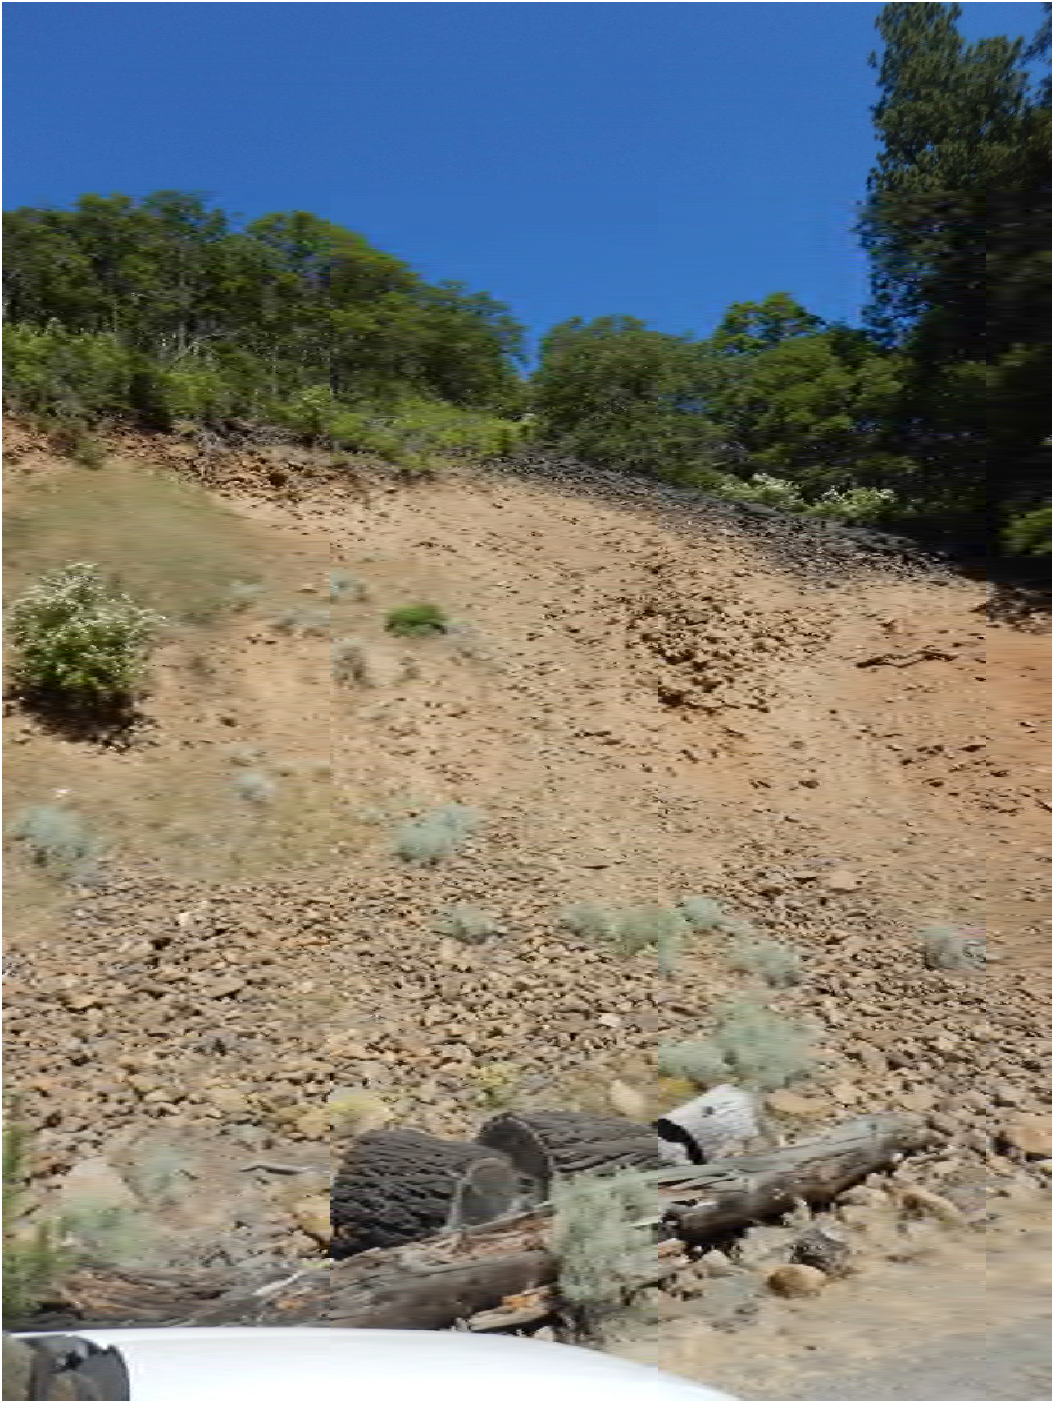
KIEWIT INFRASTRUCTURE WEST CO.	
KLAMATH RIVER RENEWAL PROJECT	
JC BOYLE POWERHOUSE ACCESS ROAD SLOPE INSTABILITY IN CUT SLOPE AT LOCATION 3

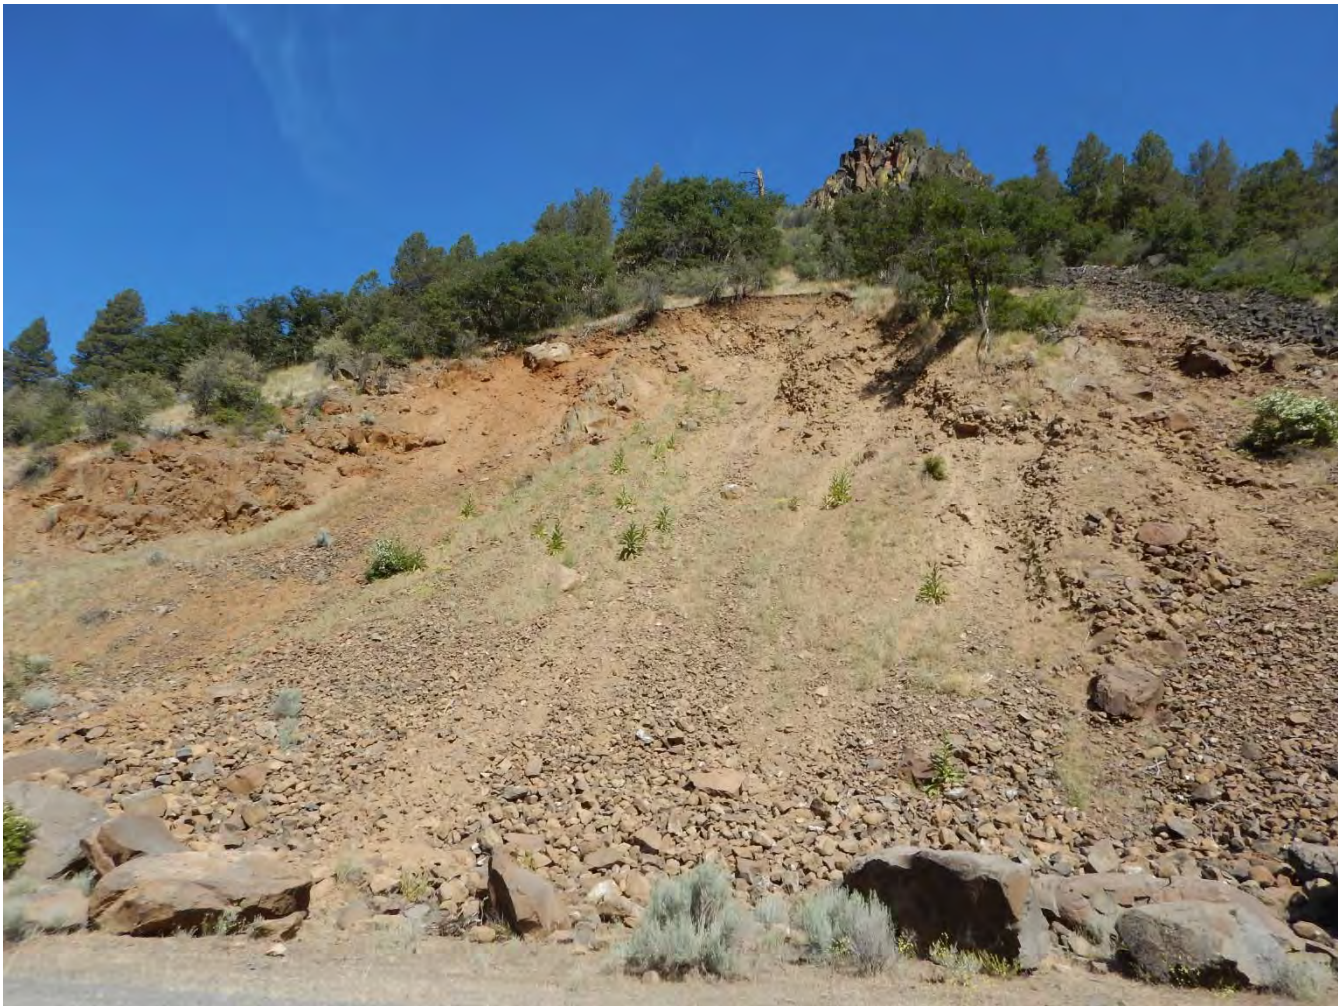
KIEWIT INFRASTRUCTURE WEST CO.	
					KLAMATH RIVER RENEWAL PROJECT	
					JC BOYLE POWERHOUSE ACCESS ROAD SLOPE INSTABILITY IN CUT SLOPE AT LOCATION 4	
					<div><div>

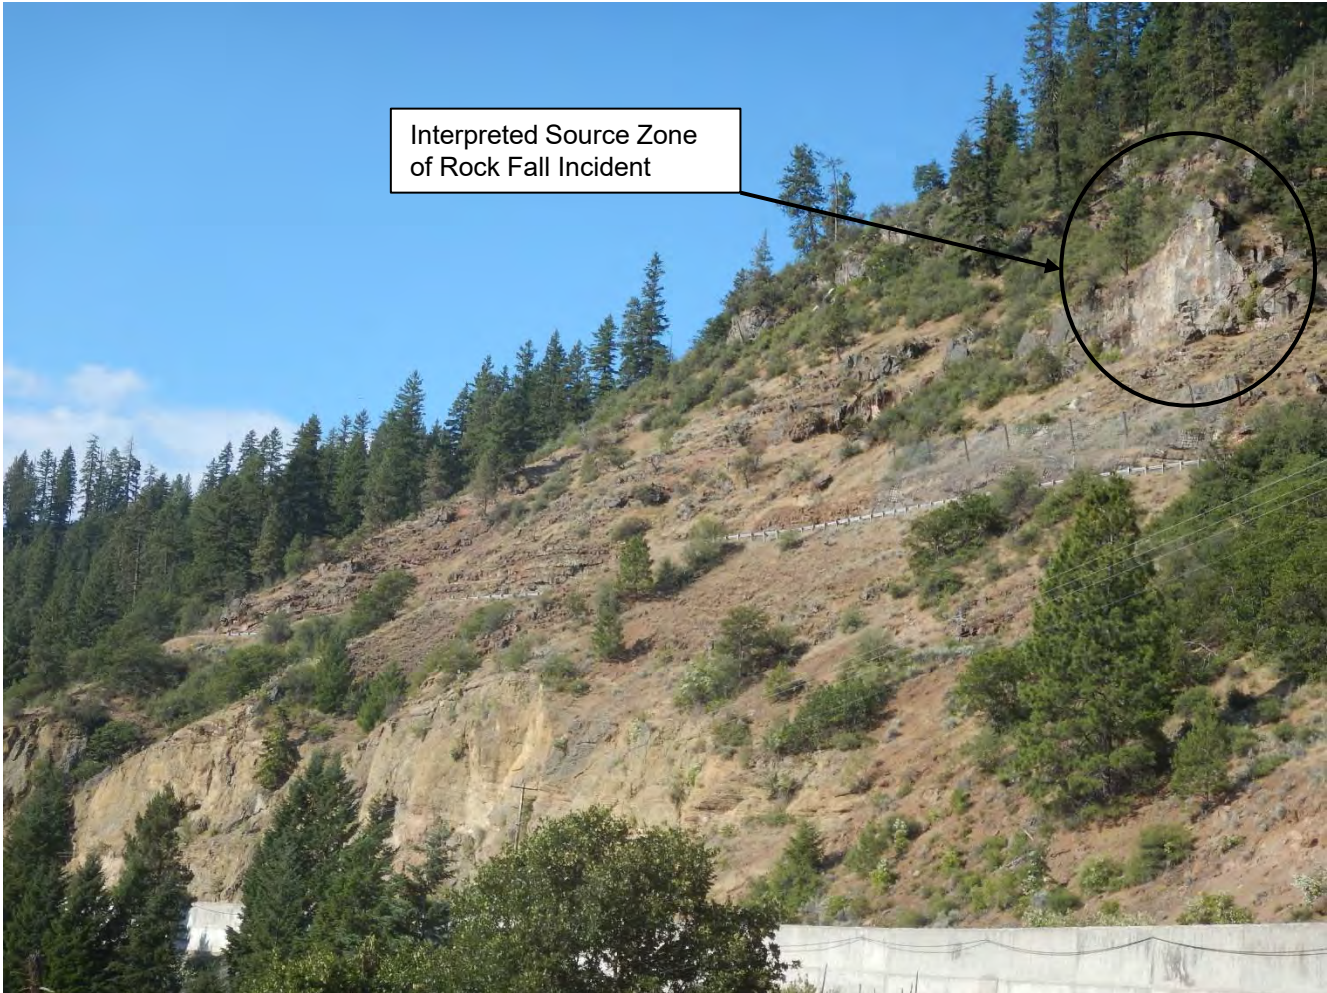
KIEWIT INFRASTRUCTURE WEST CO.			
KLAMATH RIVER RENEWAL PROJECT			
JC BOYLE POWERHOUSE ACCESS ROAD INTERPRETED SOURCE ZONE OF ROCK FALL INCIDENT (LOCATION 1)

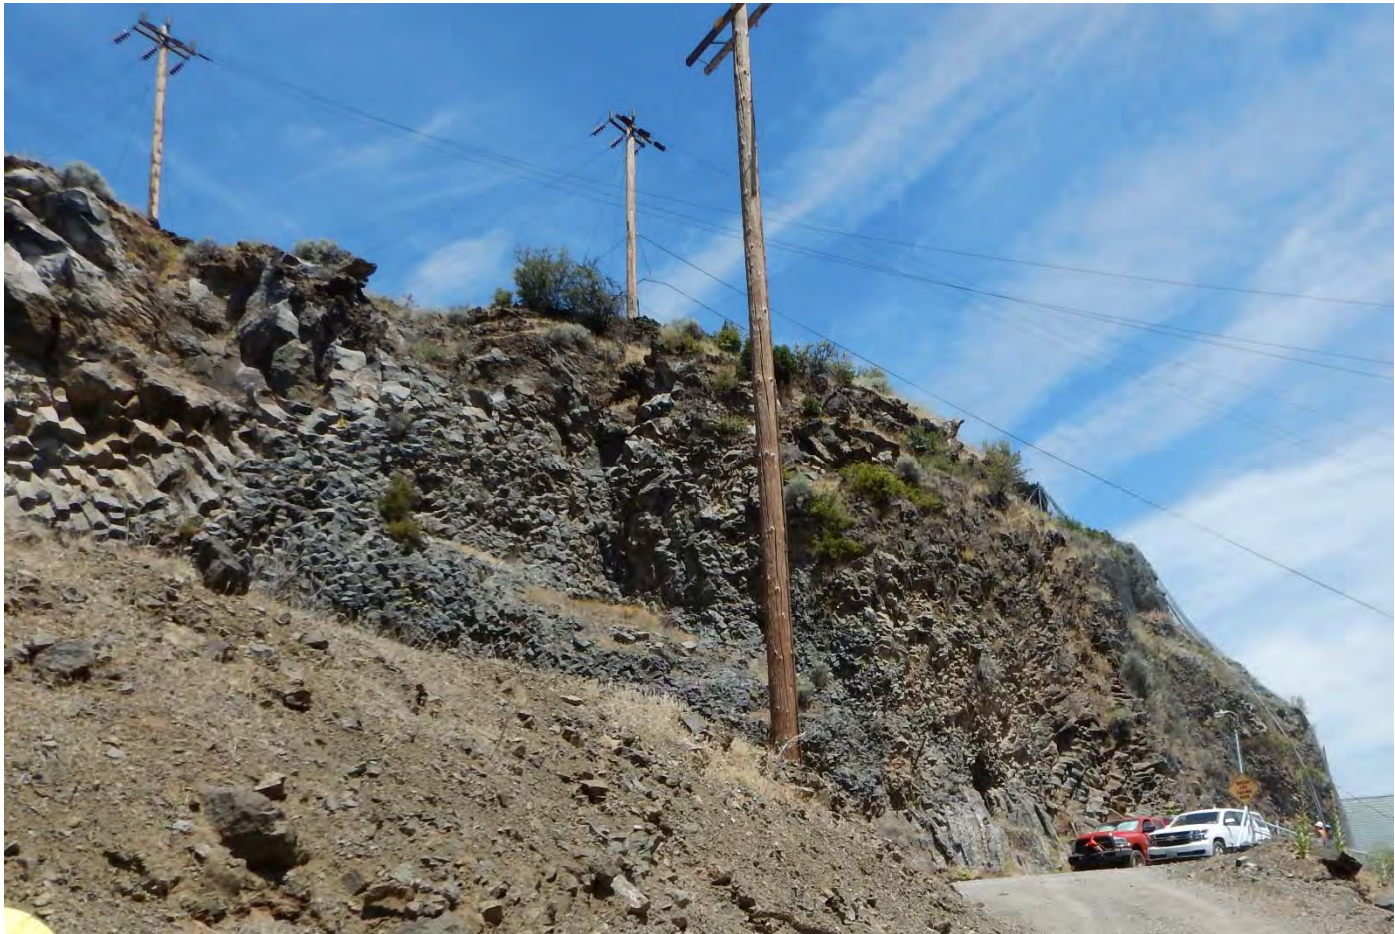
KIEWIT INFRASTRUCTURE WEST CO.				
KLAMATH RIVER RENEWAL PROJECT				
ROCK CLIFF AT THE WEST ABUTMENT OF THE COPCO 1 DAM

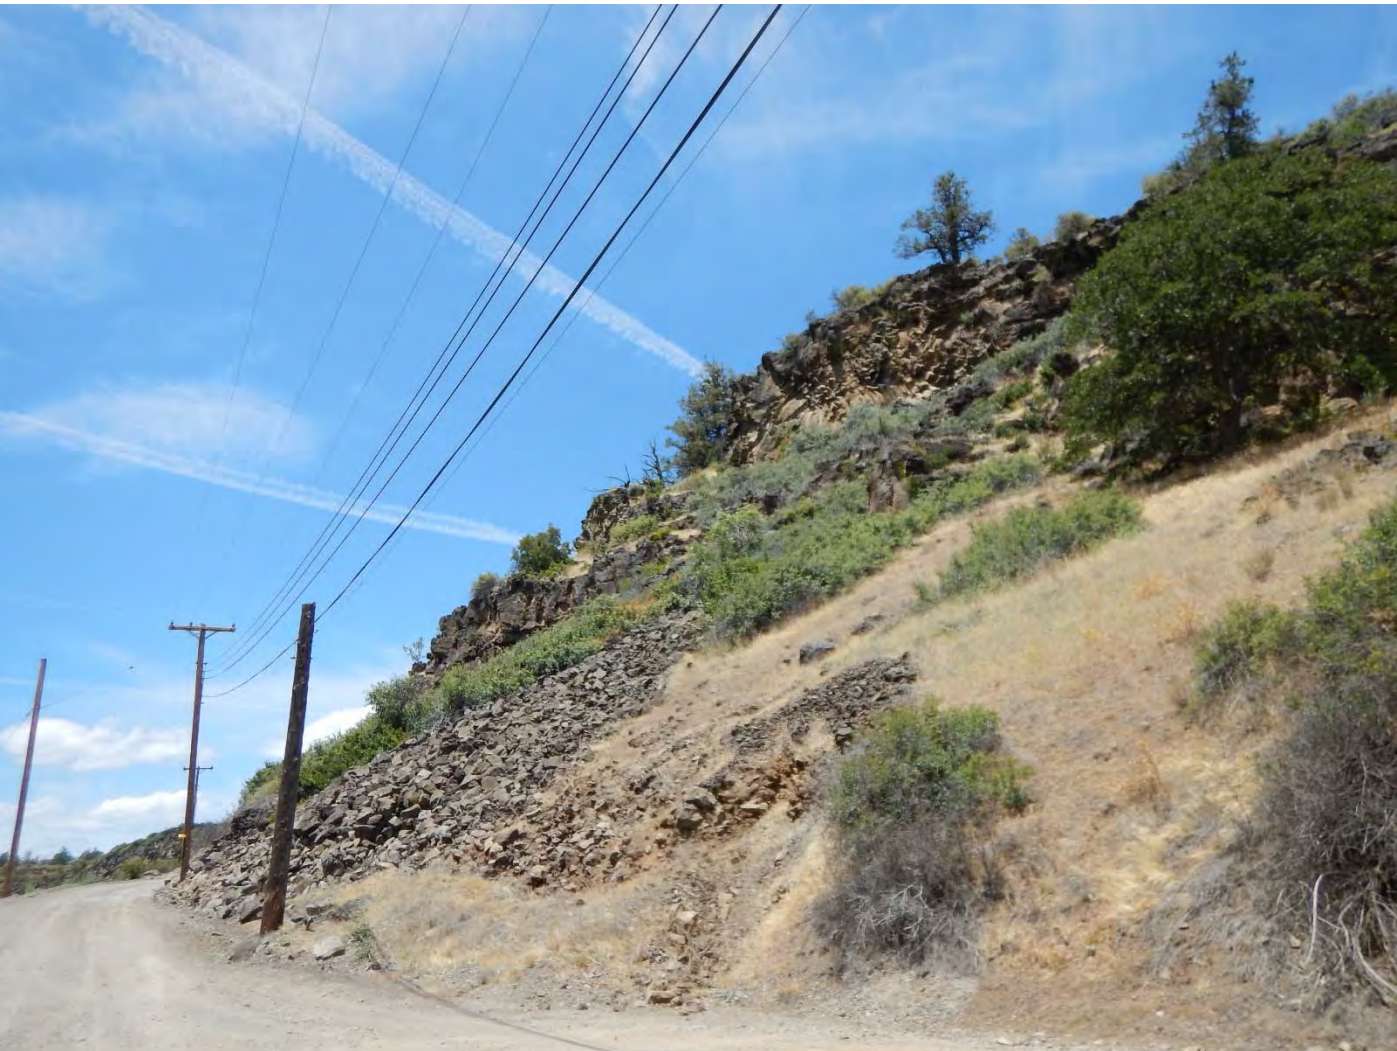
KIEWIT INFRASTRUCTURE WEST CO.		
					KLAMATH RIVER RENEWAL PROJECT		
					ROCK CLIFFS AMD TALUS SLOPES ON THE UPSLOPE SIDE OF THE ROAD

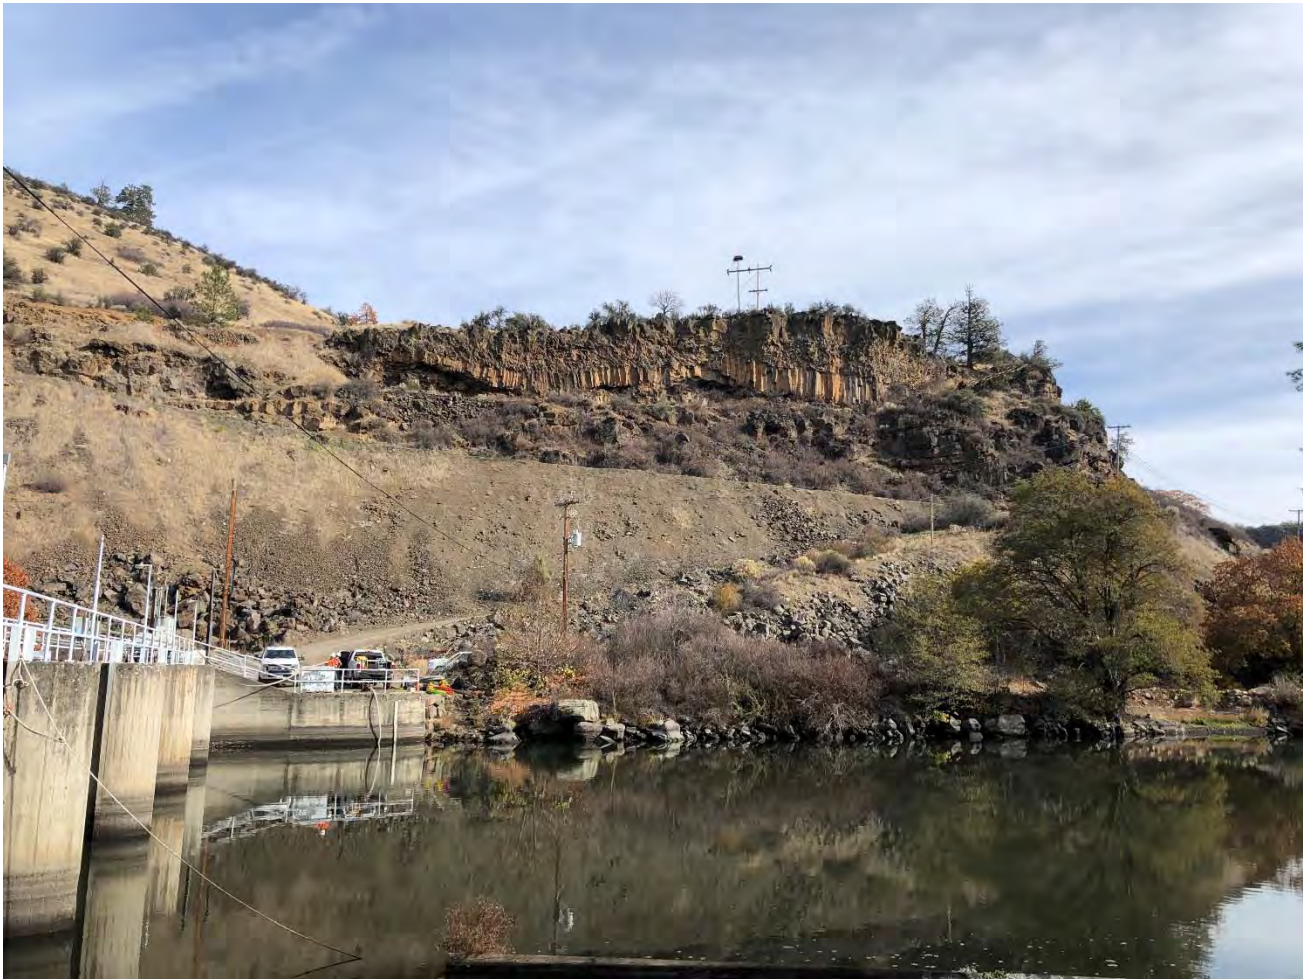
KIEWIT INFRASTRUCTURE WEST CO.			
KLAMATH RIVER RENEWAL PROJECT			
FILL SLOPE ADJACENT TO THE COPCO 2 DAM

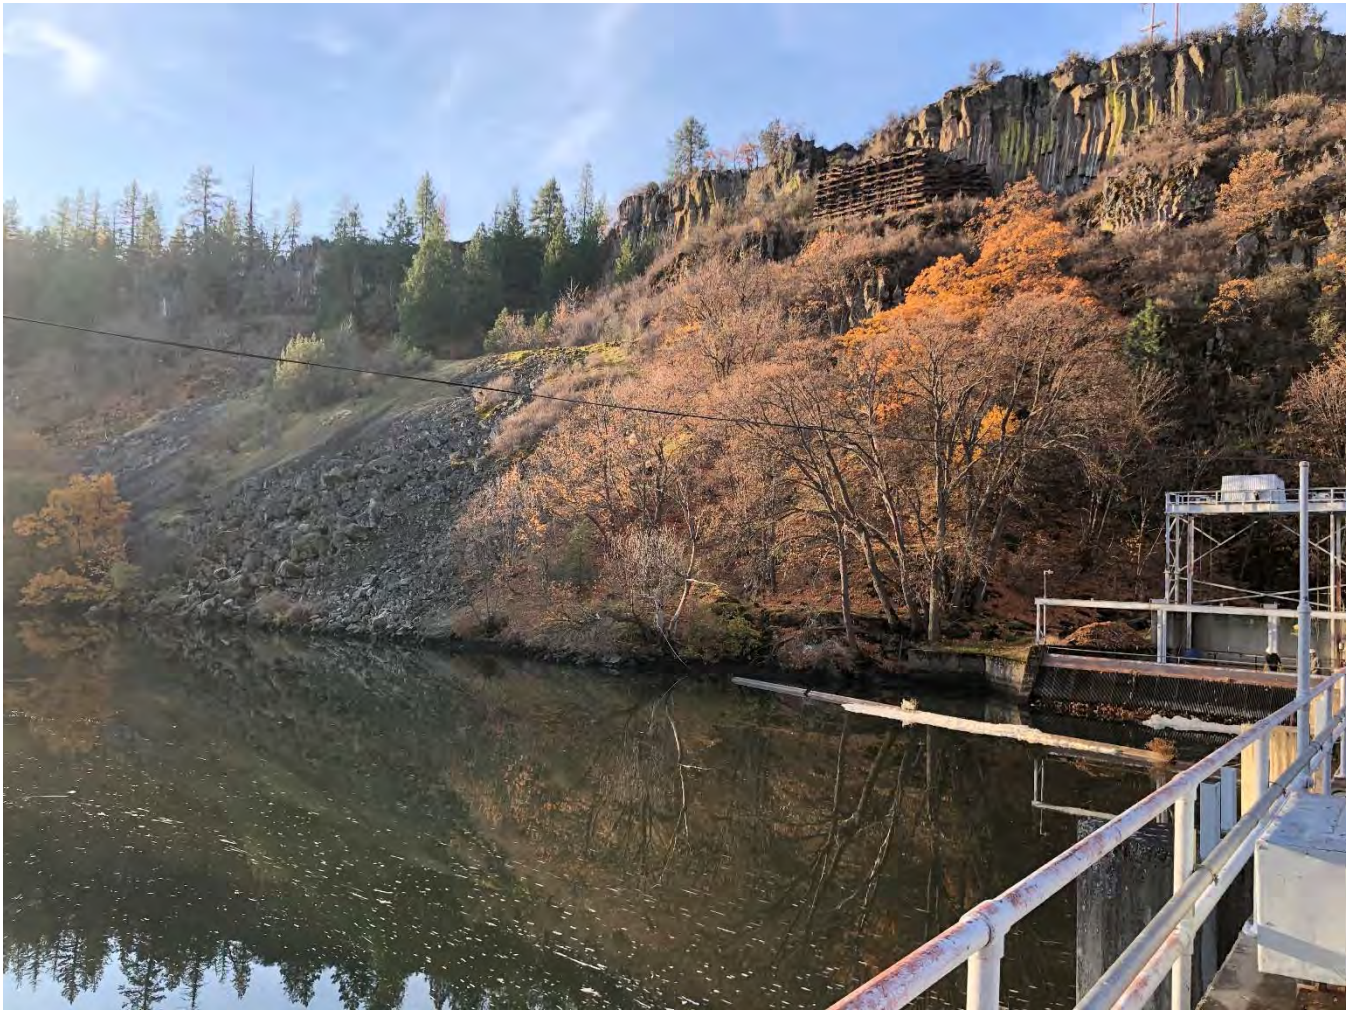
KIEWIT INFRASTRUCTURE WEST CO.			
					KLAMATH RIVER RENEWAL PROJECT			
					CRIB WALL LOCATED UPSLOPE FROM SOUTH ABUTMENT OF THE COPCO 2 DAM

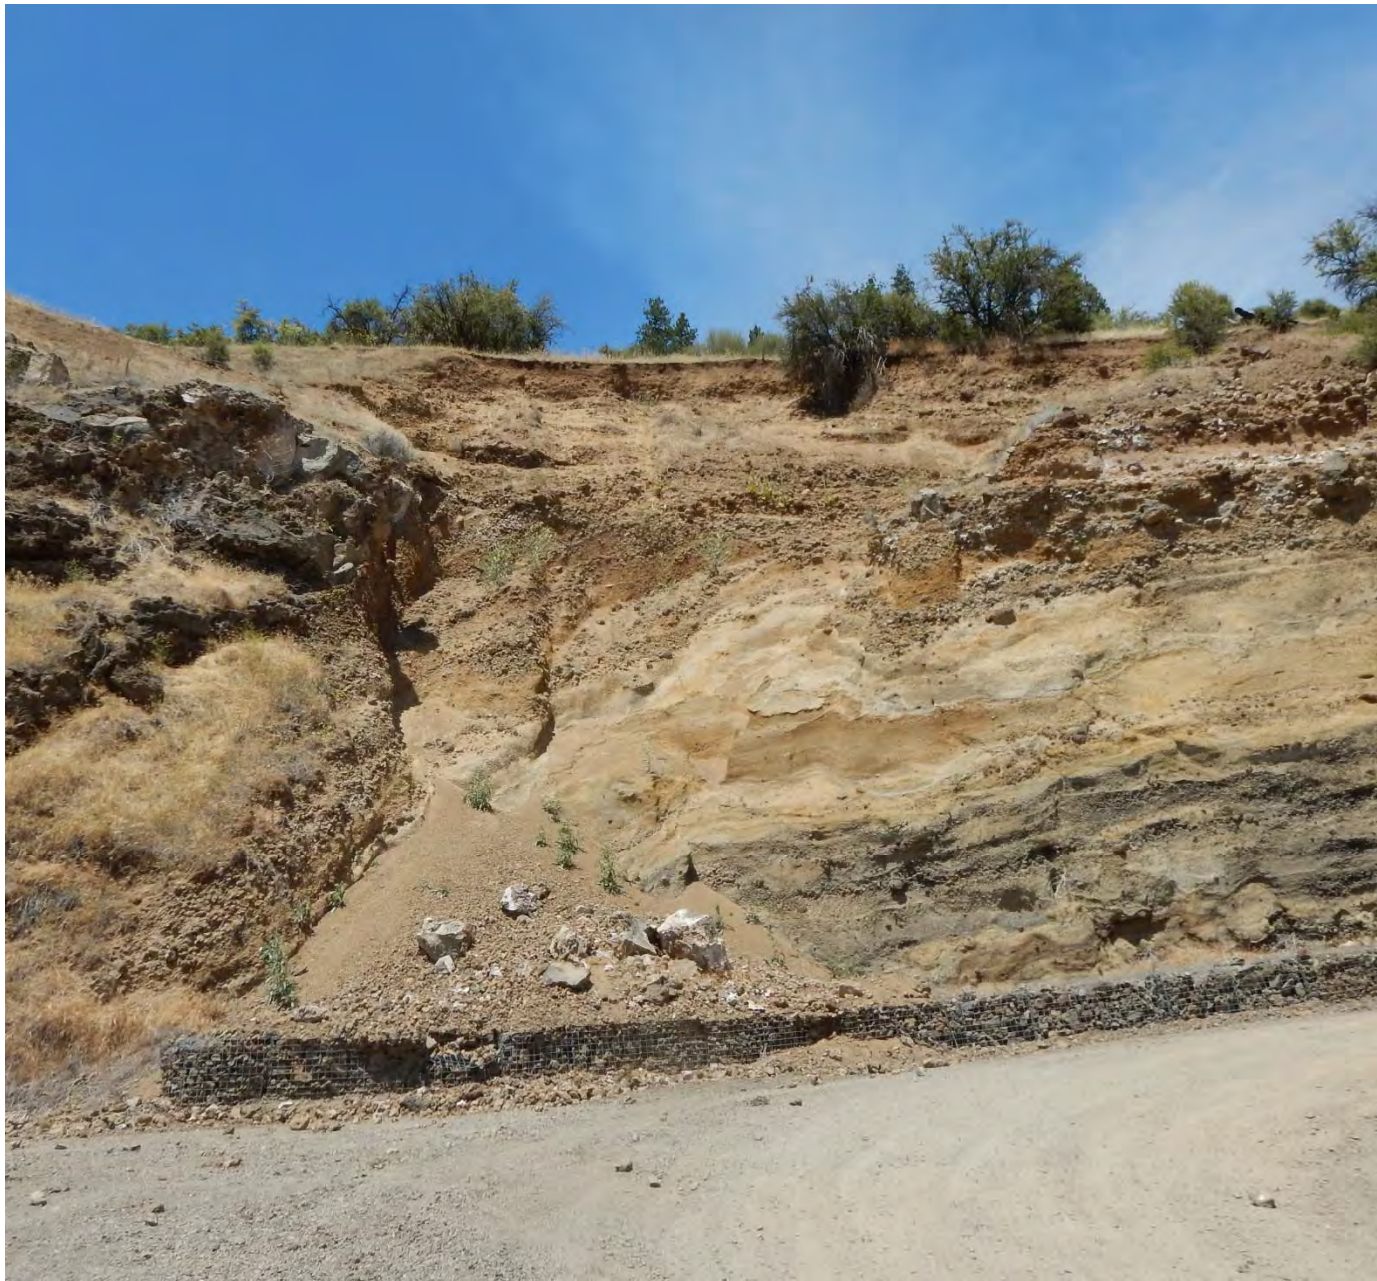
KIEWIT INFRASTRUCTURE WEST CO.	
KLAMATH RIVER RENEWAL PROJECT	
RECENT DEBRIS SLIDE AT SWITCH BAYK
