APPENDIX F1

ROADS, BRIDGES, AND CULVERTS

DESIGN DETAILS

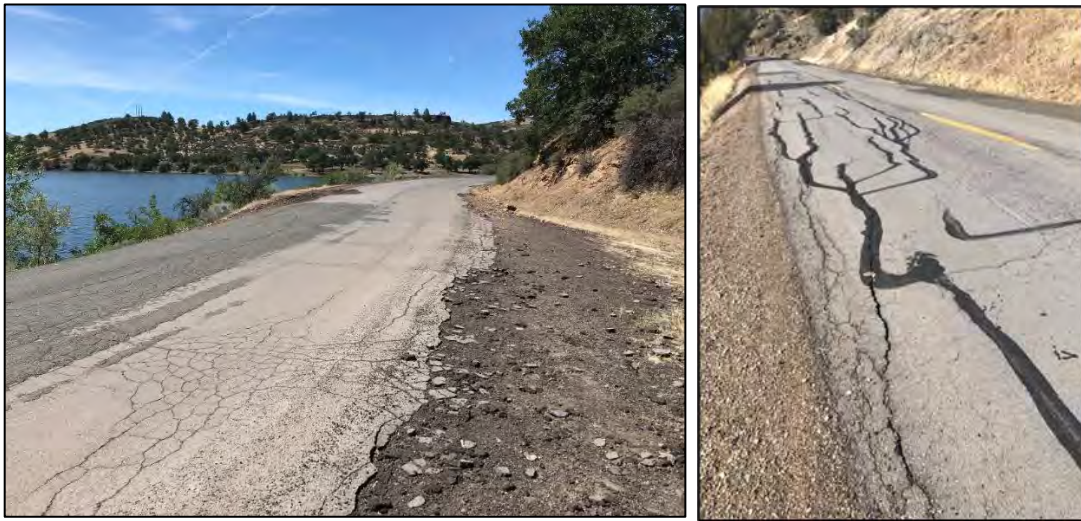
Figure 6.1 Copco Road Mill and Overlay Repair Examples

The potential road improvements are based on information obtained from visual inspection of the existing road surfaces. Appendix F2.1 contains photographs of various degradations currently existing on Copco Road. Two examples are shown on Figures 6.1 and 6.2 below. Asphalt pavement rehabilitation procedures currently include a mill and overlay option and an asphalt and base course replacement option to address surficial issues and subgrade issues, respectively.

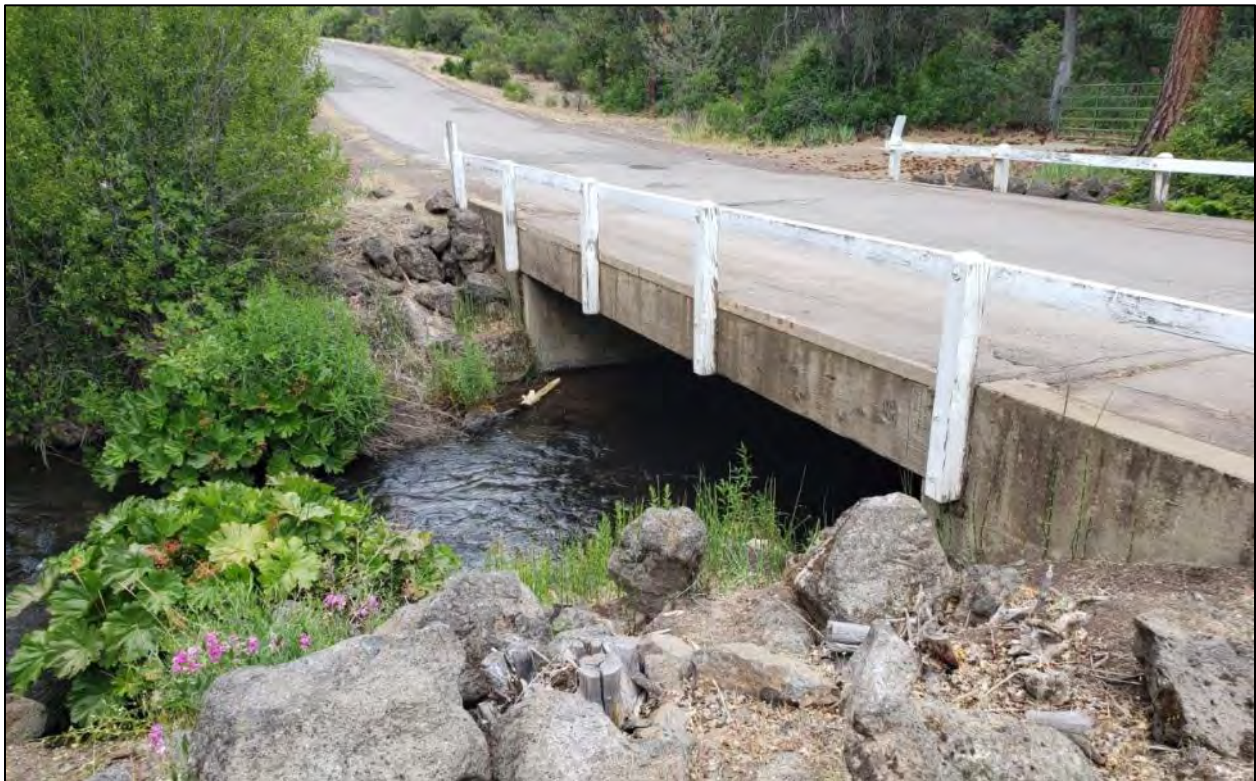
Figure 6.3 Existing Fall Creek Bridge

The existing bridge has been assessed for general condition and load carrying capacity. The bridge features a single-span deck with timber girders as primary structural (load-carrying) members.

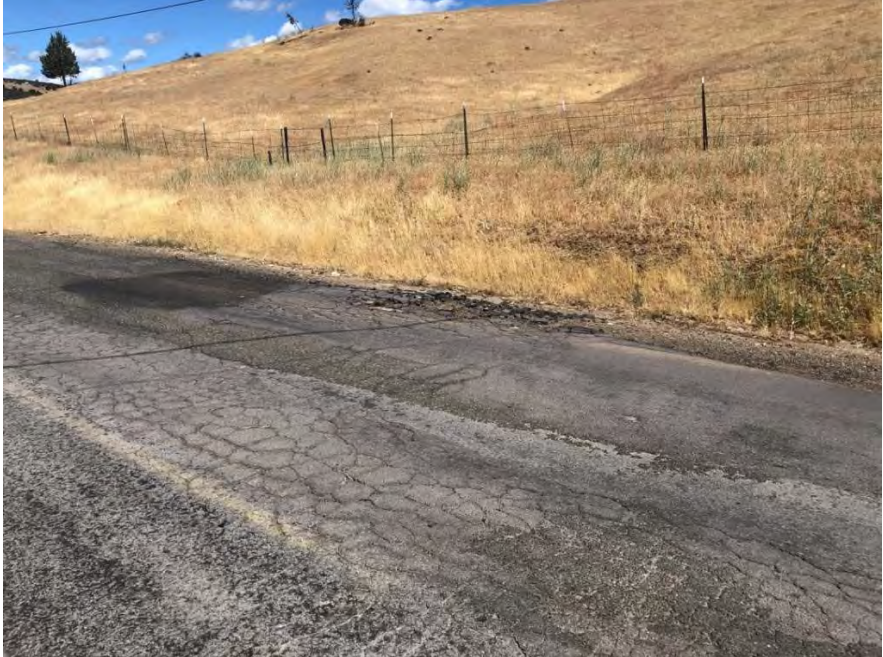
Photo No. 3.

Date: 06/26/19	
Description: Copco Road Approx. Sta. 19+600 Hot-mix asphalt concrete. Pothole located on edge of road. Raveling of surface material with exposed alligator cracks beneath surface material. No reflective cracks protrude into surface material.

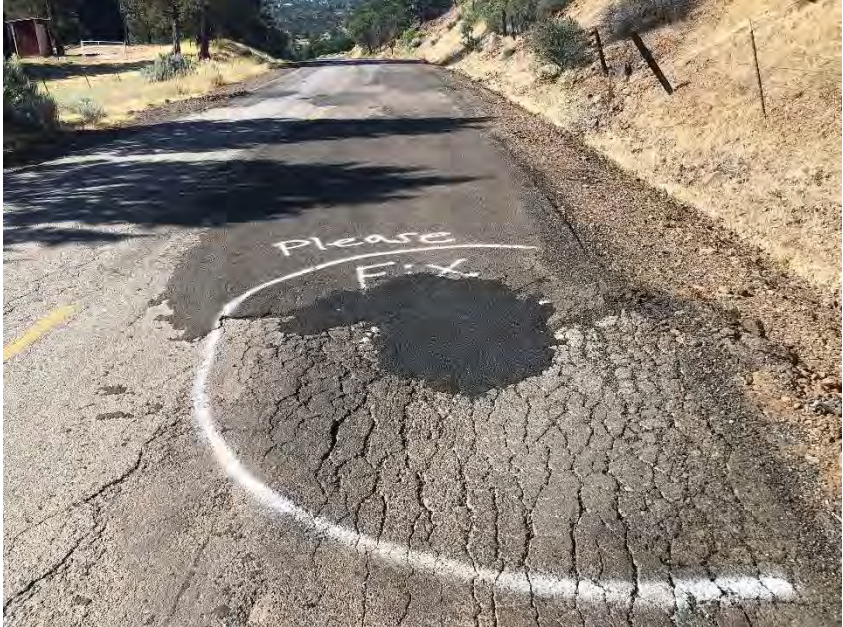
Photo No. 5.

Date: 07/17/19	
Description: Copco Road Approx. Sta. 31+600 Hot-mix asphalt concrete road. Cold patch covering faulting between two different pavements. Settlement and alligator cracking found at edge of old pavement.

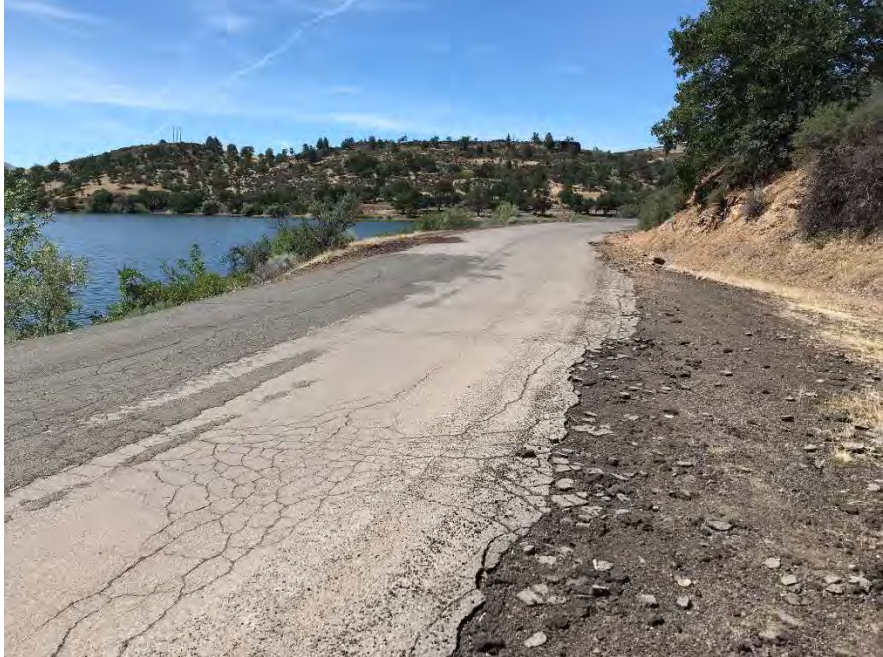
Photo No. 11.

Date: 07/17/19	
Description: Copco Road Approx. Sta. 61+800 Hot-mix asphalt concrete road. Significant spalling in pull off area. Alligator cracking and asphalt patches found along road.

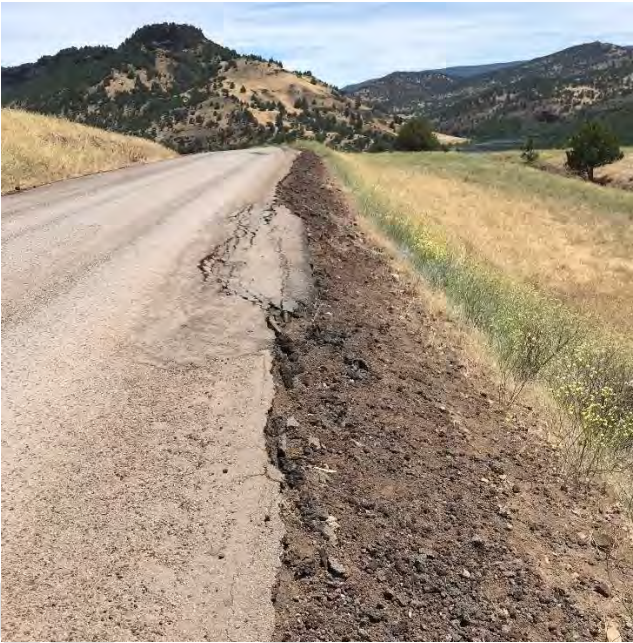
Photo No. 13.

Date: 07/17/19	
Description: Copco Road Approx. Sta. 62+900 Hot-mix asphalt concrete road. Significant spalling at edge of road. Slippage cracking found in portion of asphalt at edge of road.

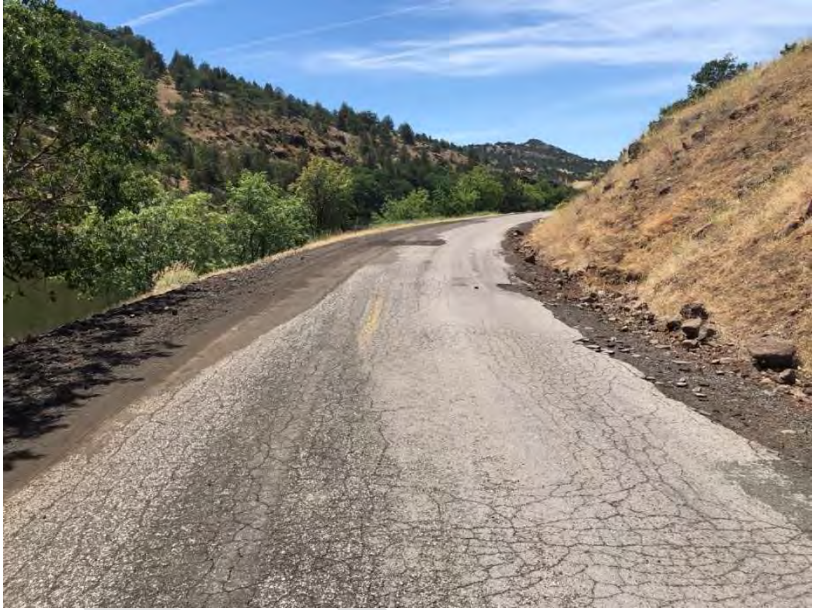
Photo No. 19.

Date: 07/17/19	
Description: Copco Road Approx. Sta. 90+000 Hot-mix asphalt concrete road. Significant spalling at edge of road. Asphalt patches and alligator cracking throughout road.	
Photo No. 20.

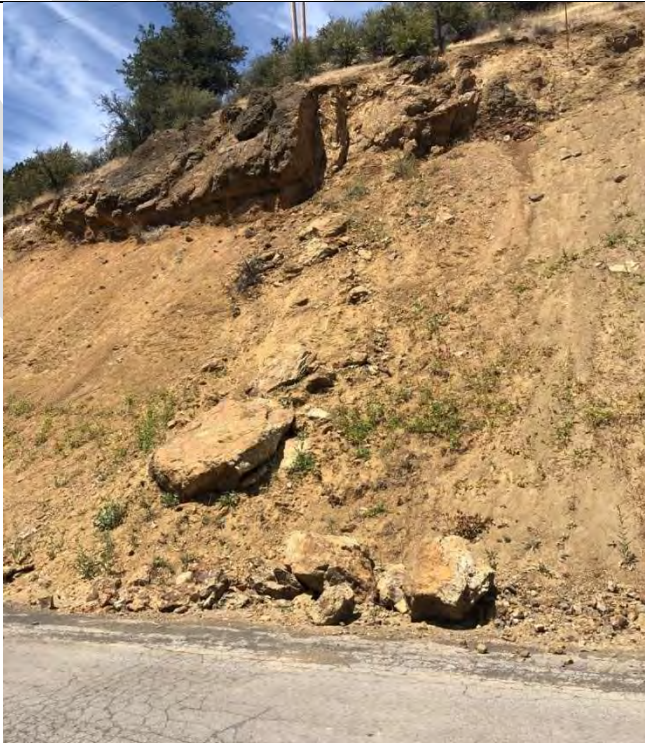
Date: 07/17/19	
Description: Copco Road Approx. Sta. 90+000 Rock fall found on side slope adjacent to Hot-mix asphalt concrete road.
