**AMENDED APPLICATION FOR SURRENDER OF LICENSE
FOR MAJOR PROJECT AND REMOVAL OF PROJECT WORKS**

**EXHIBIT M
Terrestrial and Wildlife Management Plan
(Amended December 15, 2021)**

**Lower Klamath Project
FERC Project No. 14803**

Terrestrial and Wildlife Management Plan

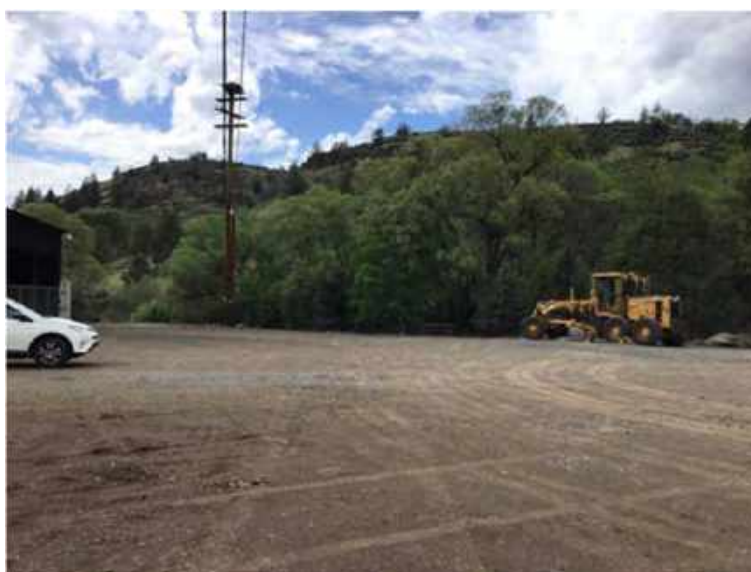
Photograph 2-1: Active Osprey Nest on a Utility Pole in the Staging Area West of the Iron Gate Dam

Biologists observed three active osprey nests in the vicinity of the Iron Gate Reservoir (Figures 2-1 and 2-2). Of these, one was on a utility pole in the staging area west of the Iron Gate Dam (Photograph 2-1); one was on a utility pole along the western side of the Iron Gate Reservoir; and one was on a utility pole along Copco Road where it turns north at the upstream end of the Iron Gate Reservoir. In addition, biologists observed four active osprey nests along the Klamath River downstream of Iron Gate Dam (excluding the one described above near the dam itself). These four nests were on utility poles along Copco Road between Iron Gate Dam and Interstate 5 (Figure 2-1).

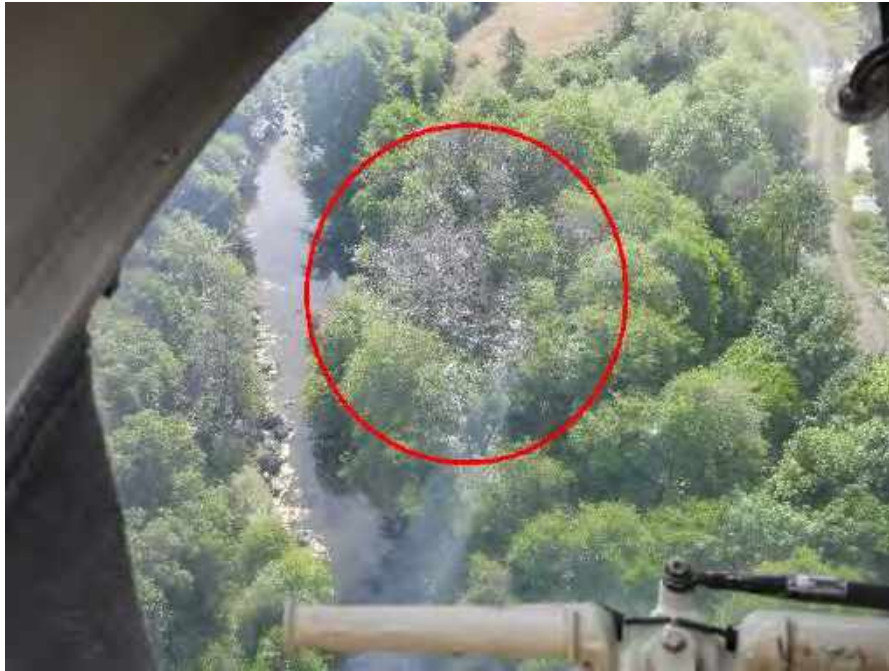
Photograph 2-2: Active Great Blue Heron Colony near the Copco No. 2 Penstock

During helicopter surveys for eagles (see Section 4) biologists observed a great blue heron colony along the Klamath River in the Copco No. 2 bypass reach (Figure 4-1). Biologists noted at least 12 nests during the helicopter survey, and herons were heard vocalizing in this area by ground crews. This colony is located in riparian habitat approximately 100 feet north of the Copco No. 2 penstock (Photograph 2-2).

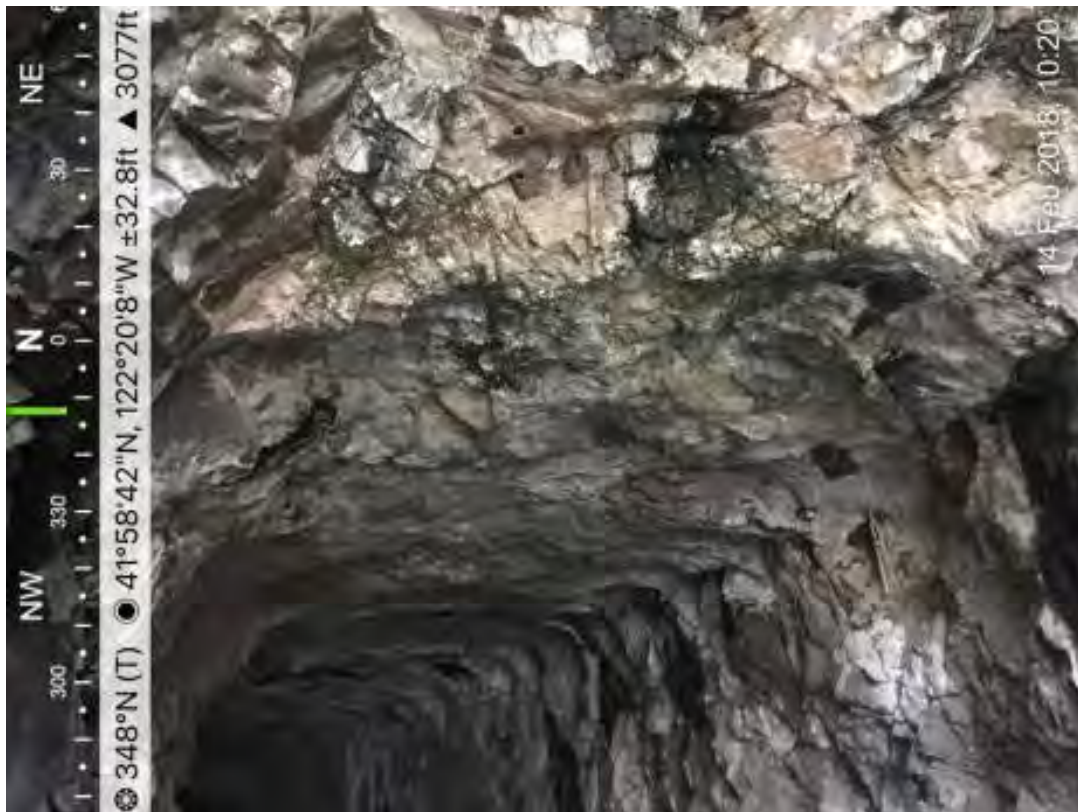
Photograph 5-7: Copco Diversion Tunnel Interior Substrate and Cliff Swallow Nests, February 14, 2018

On February 14, 2018, conditions were sunny and clear. Air temperatures outside the Copco tunnel were 41°F at 10:15 A.M. Inside the tunnel, temperatures were 48°F at the entrance (10:20 A.M.) and 44°F at the terminus (10:30 A.M.). The entire length of the Copco tunnel is unlined, exposed rock (~160 feet) (Photograph 5-7). Water depths in the tunnel ranged from 1.1 feet to 3.2 feet. The full length of the accessible portion of the tunnel was surveyed, from the entrance to the closure gate. Cliff swallow nests and a few pigeons were observed in the tunnel. No bats or signs of bat use were found; however, the tunnel provides suitable habitat.

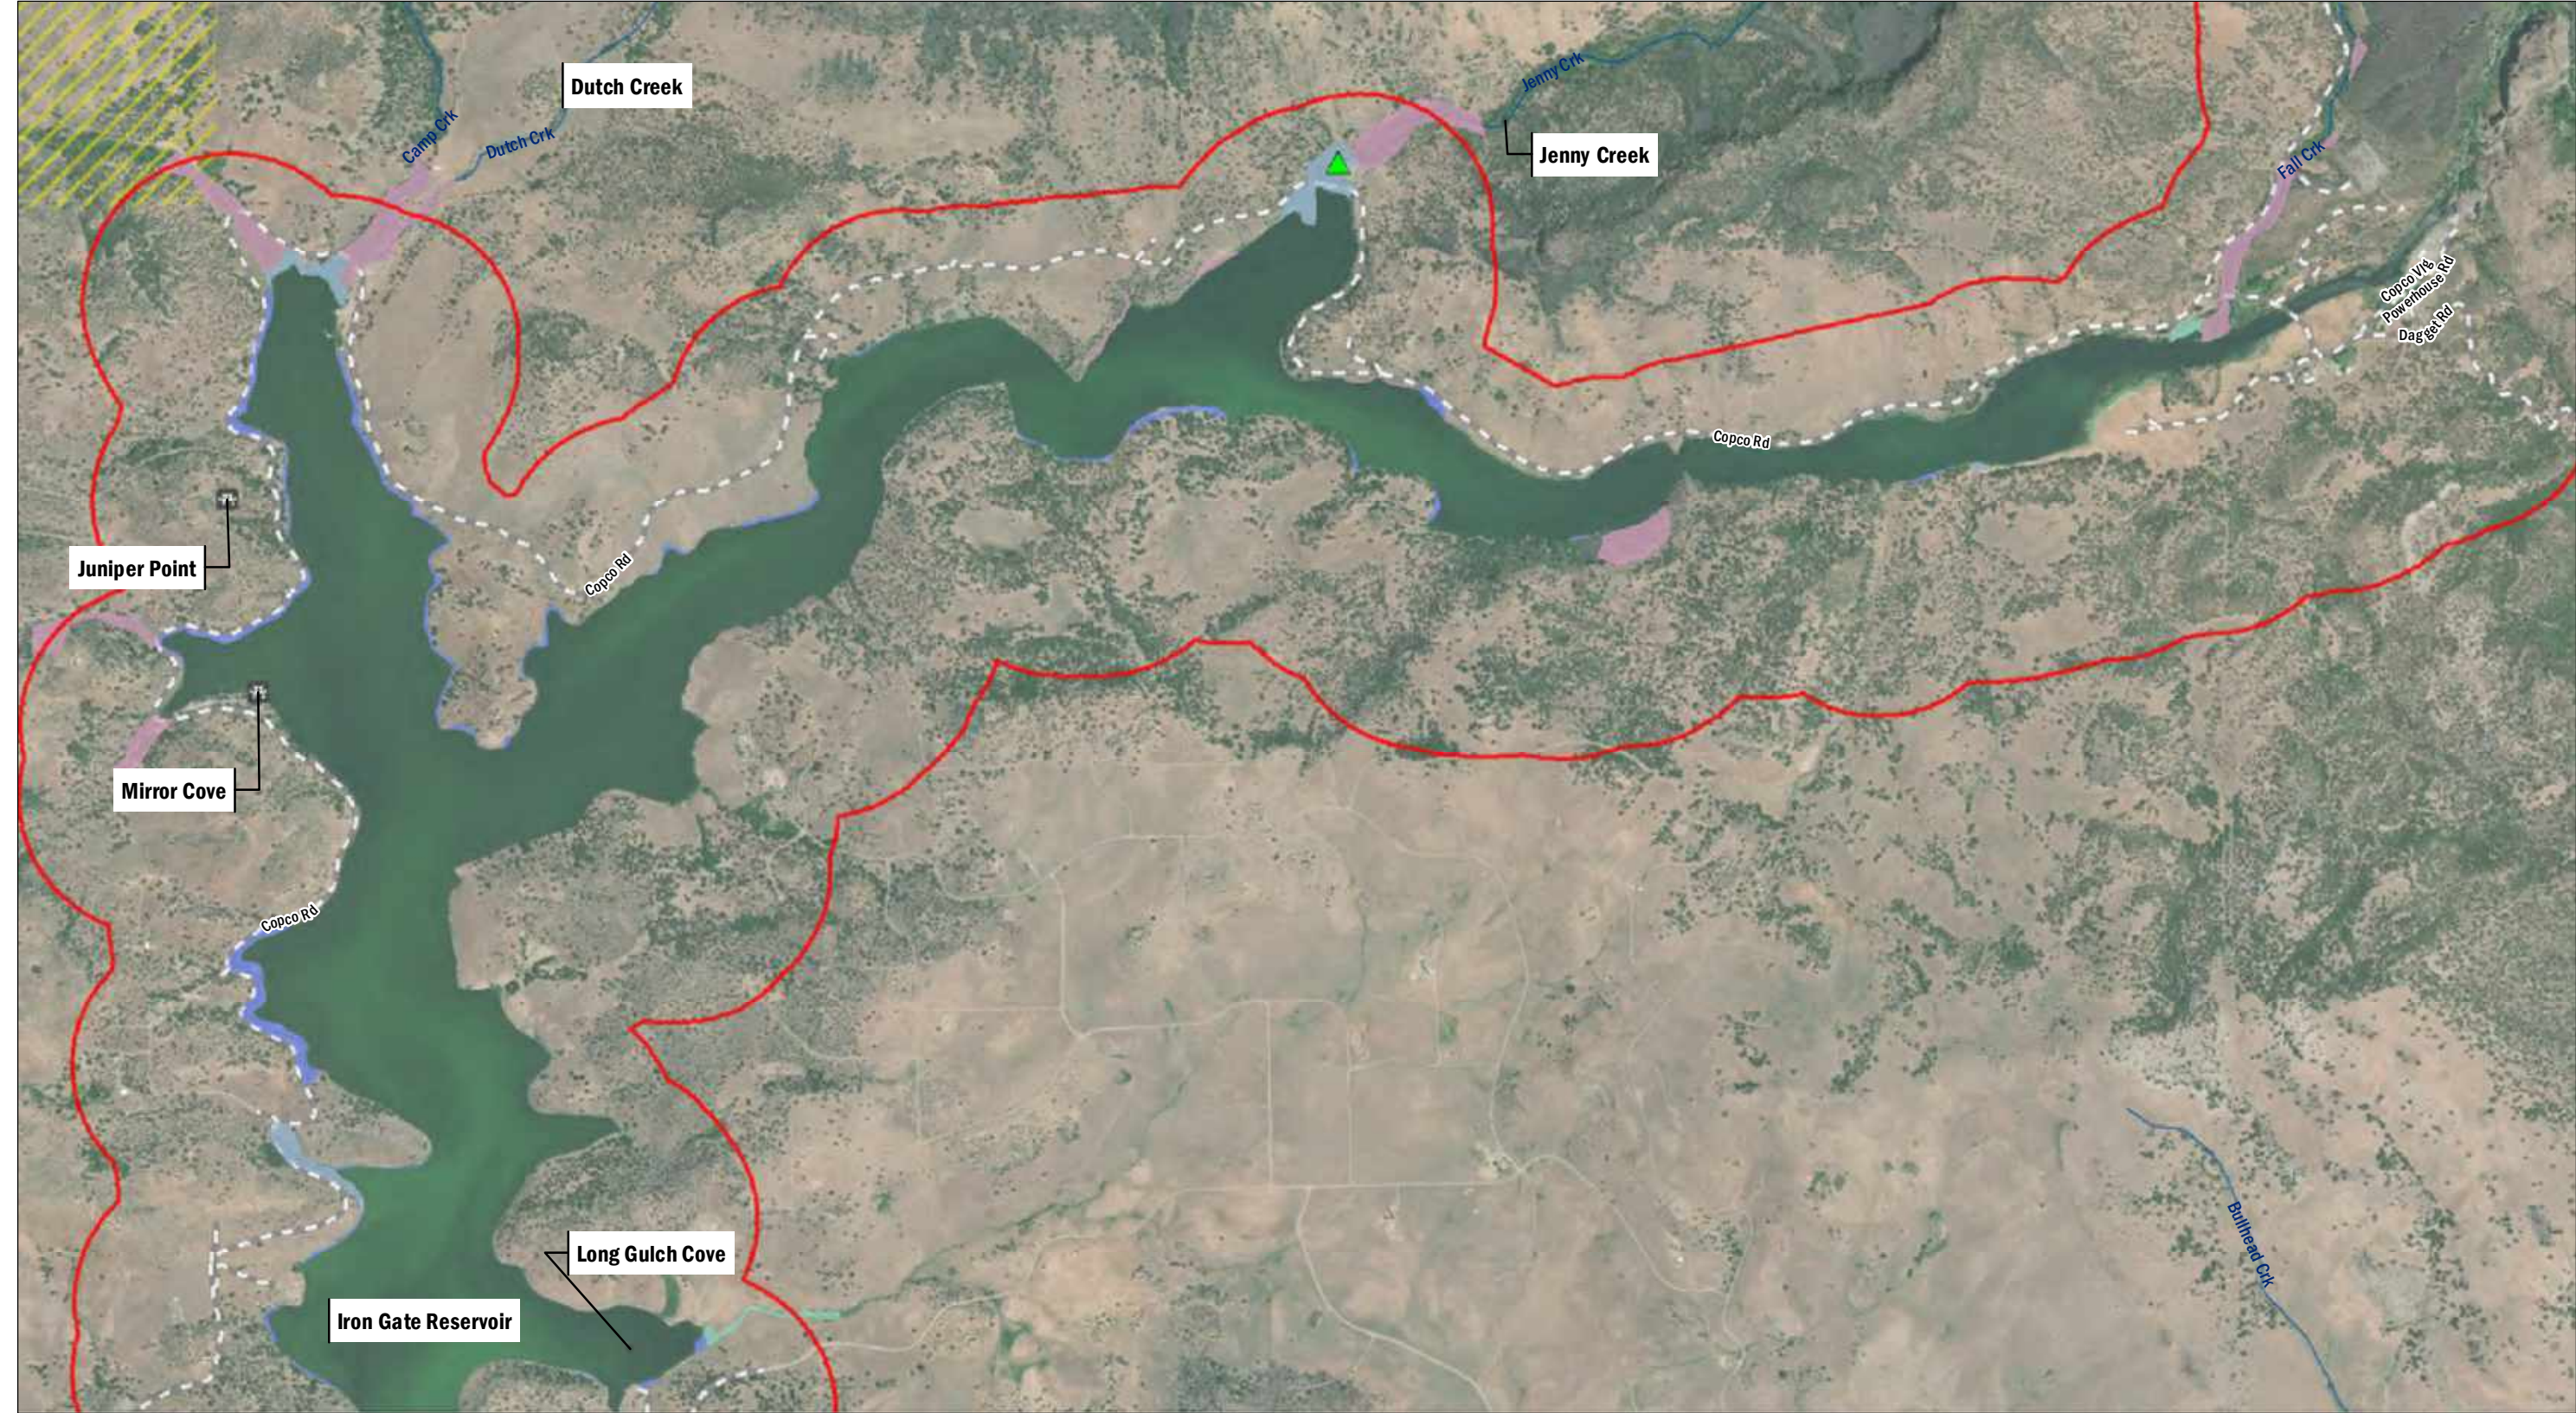
FIGURE 2-4

Osprey (Pandion haliaetus)
Observations and Nest Locations
J.C. Boyle Reservoir

Biologists observed a total of five active osprey nests in the vicinity of the J.C. Boyle Reservoir (Figure 2-4). Of these, one nest was on a utility pole along the Klamath River just south of the J.C. Boyle Dam, and two others were atop utility poles along the southern end of the J.C. Boyle Reservoir east of the dam. Biologists observed an additional inactive nest on a utility pole in that vicinity. Biologists observed an active nest along the southeastern side of the J.C. Boyle Reservoir and an active nest atop a utility pole in the proposed J.C. Boyle disposal site.

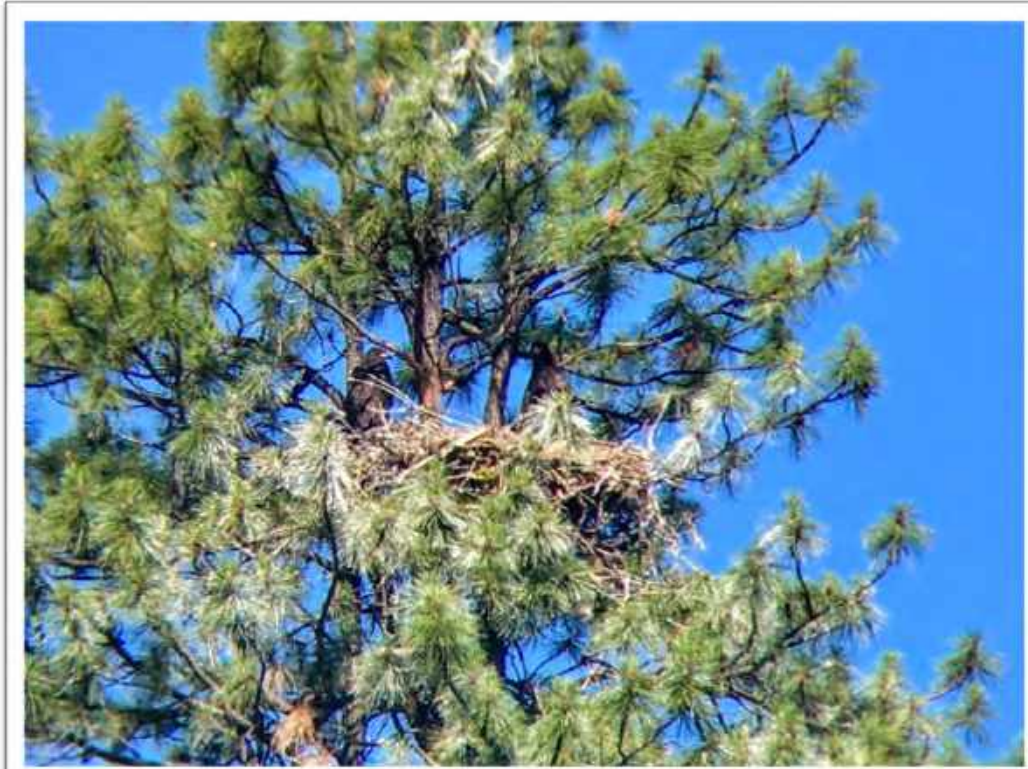
Photograph 2-1 Two Bald Eagle Nestlings at Nest F19_BE1

At Iron Gate Reservoir, biologists observed a bald eagle pair nest-building at one new bald eagle nest location that had not been historically documented (F19_BE1). No other nests at Iron Gate were accessible by car; however, biologists were able to observe adult bald and golden eagle pairs in the vicinity of each historically active nest (four golden eagle nests and one bald eagle nest: GE3-7, GE3-5, F_GE2, GE3-6, and F_BE1).

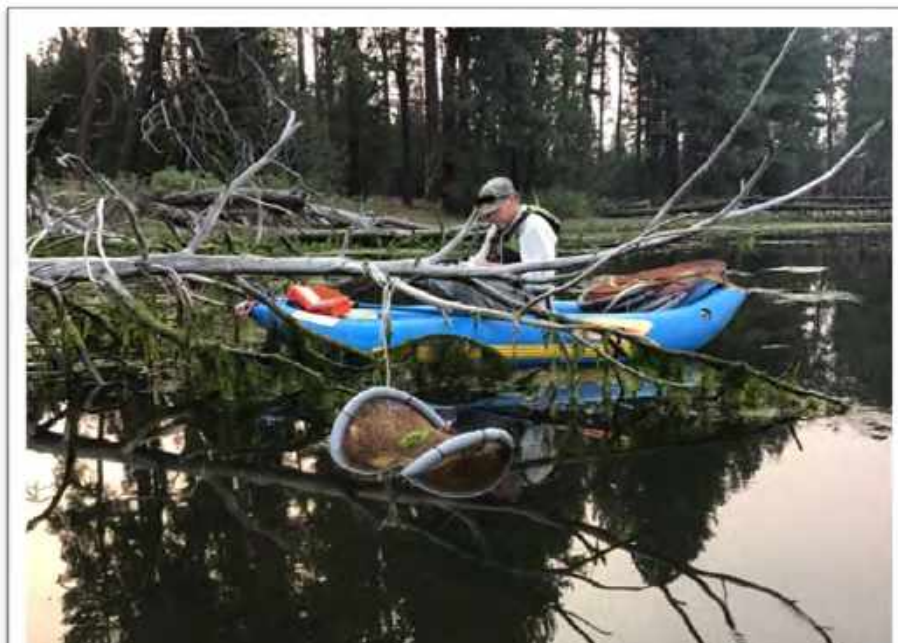
Photograph 4-1 Deployment of Turtle Trap near Large Woody Debris

Biologists placed twenty traps around the reservoir near large woody debris, rock crevices, and other refugia near where radio-tagged turtles were detected. Traps were left in place near radio-tagged turtles and were checked one or more times each day. Bait was replaced as necessary. If telemetry indicated that radio-tagged

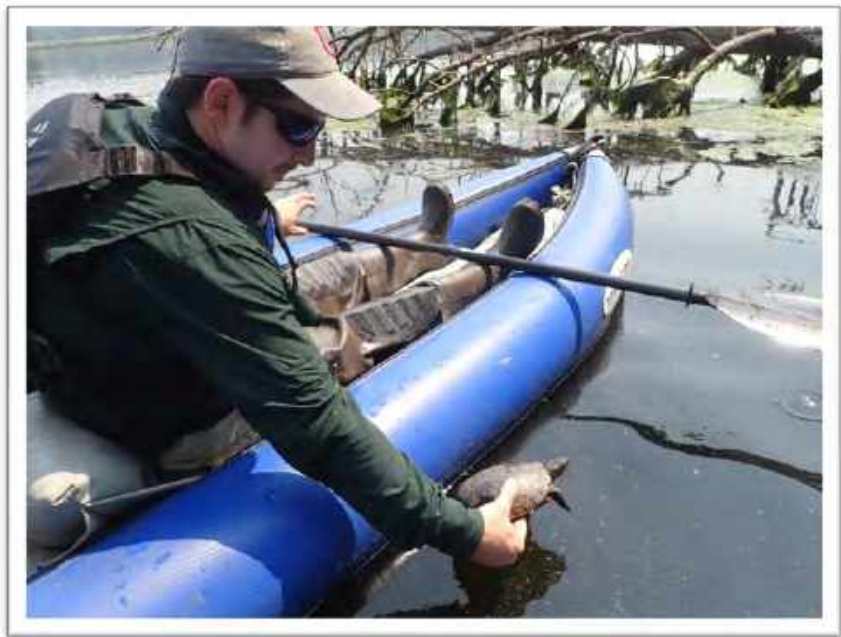
Photograph 4-2 Releasing a Captured Western Pond Turtle

Biologists captured several turtles during the first few days of trapping, but the capture rate declined after the first day. Turtles, including radio-tagged individuals, were consistently observed near trap locations, but the capture rate remained low. Eleven new turtles were caught in traps in 2019, but no recaptures occurred. One radio transmitter (radio #919) was recovered from a trap, but it was no longer attached to the turtle, indicating that the radio-tagged turtle had entered the trap and later escaped. A few turtles were caught by dip net; however, seine netting, snorkeling, and a drift fence trap did not capture any turtles. Due to extremely low underwater visibility and high water levels, active methods of turtle capture were not effective.

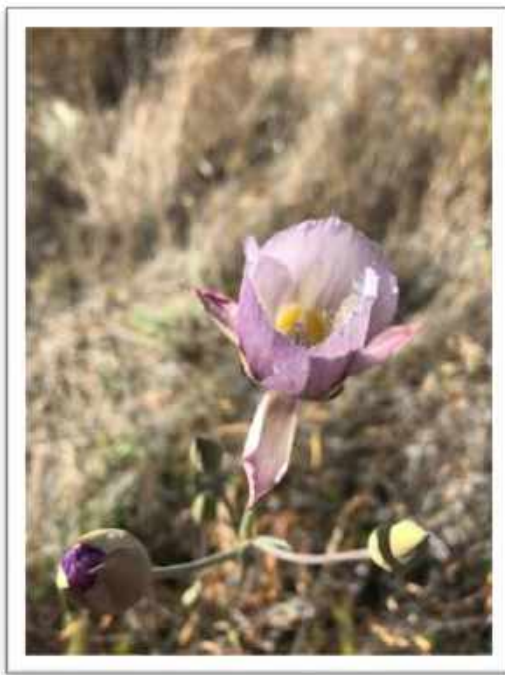
Photograph 5-3 Greene's Mariposa-lily (*Calochortus greenii*)

- Greene's mariposa-lily (*Calochortus greenii*): KRRC biologists observed numerous *Calochortus* plants in construction areas in the Project area, including at the Iron Gate alternative upland disposal site and along utility corridors in the vicinity of Iron Gate Reservoir and Copco Lake during surveys completed in April 2019. Although plants were not in bloom when first observed in April 2019; the species designation was confirmed as *Calochortus greenii* when sites were revisited in July 2019.

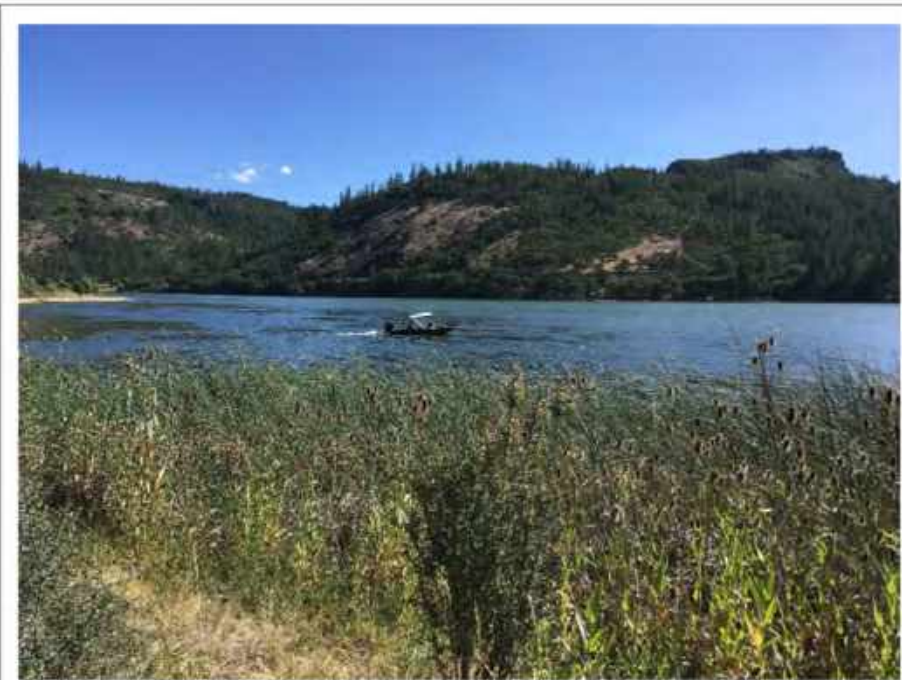
Photograph 6-1 Wetland along Shoreline of Copco Lake

To evaluate potential direct impacts on existing habitats, KRRC wetland scientists delineated wetlands in the portions of the Project area where ground-disturbing activities are anticipated to occur (e.g., disposal sites). KRRC wetland scientists also mapped wetlands along the reservoir margins, stream-associated wetlands, and non-wetland riparian vegetation outside of direct construction areas that may experience changes in hydrological conditions resulting from reservoir drawdown or the removal of other dam infrastructure.

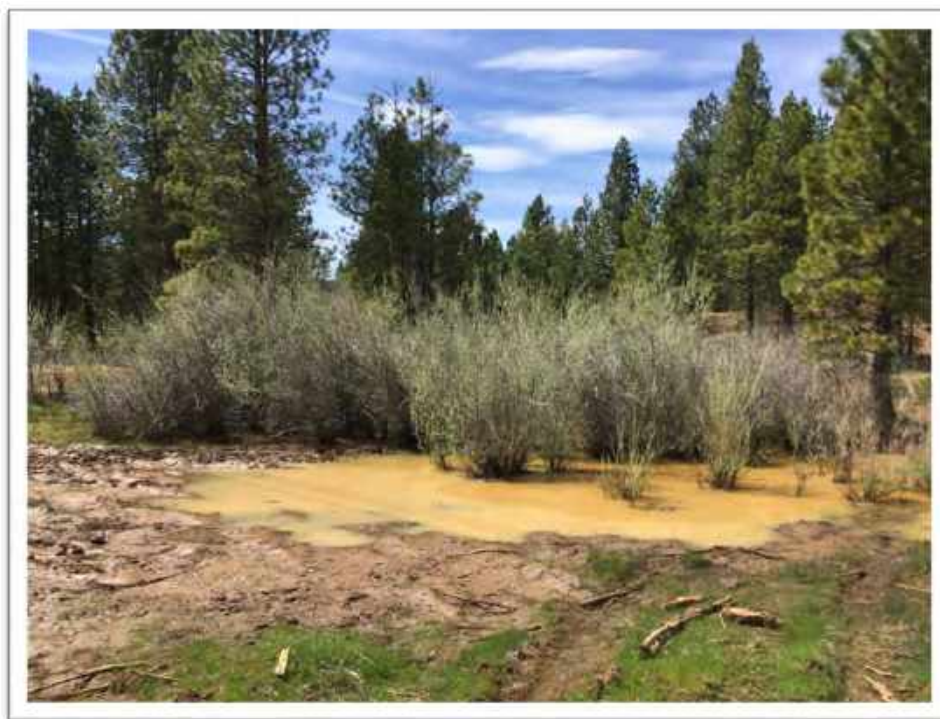
Photograph 6-2 Wetland with Hydrology Independent of the Reservoirs

Based on direction from ODSL, KRRC wetland scientists conducted an additional wetland functions and values assessment in the Oregon portion of the Project area using the ORWAP. ORWAP consists of a series of field and desktop evaluations that provide a standardized, regionally tailored, rapid procedure for estimating the functions and values of wetlands occurring in the state of Oregon (Adamus et al. 2016). ORWAP was conducted in areas where the hydrology is independent from the Klamath River or J.C. Boyle Reservoir (e.g., J.C. Boyle alternative upland disposal site).

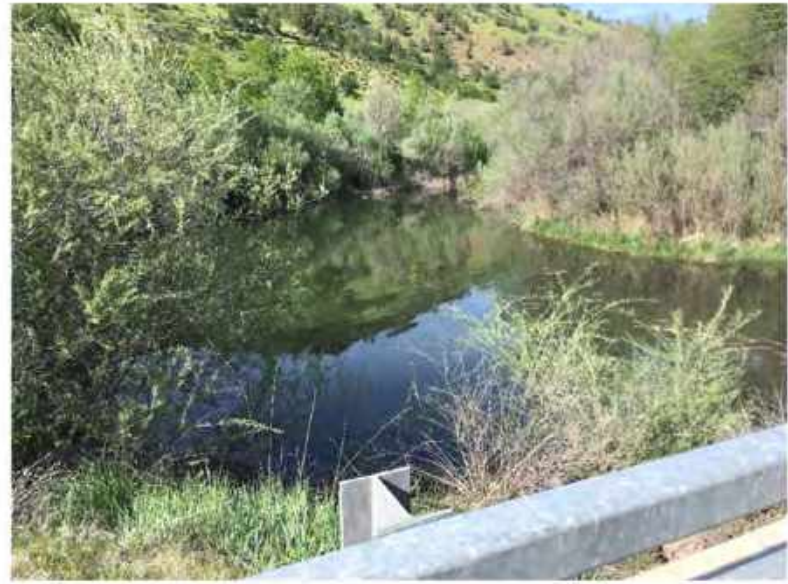
Photograph 6-3 Riparian Vegetation at Jenny Creek

of work. Riparian areas generally had hydrophytic vegetation but failed to meet one or more of the remaining wetland parameters (i.e., hydrology and hydric soils), and thus were classified as non-wetland, riparian habitat. KRRRC wetland scientists determined the upslope edge of riparian areas by mapping the line where vegetation transitioned from hydrophytic vegetation to vegetation more representative of dry, upland areas in terms of species composition and density. Upland habitat typically consisted of sparsely vegetated, rocky hillslopes. The riparian boundary was mapped to submeter accuracy using a handheld GPS device or ArcGIS Collector, as previously described for wetland delineations.

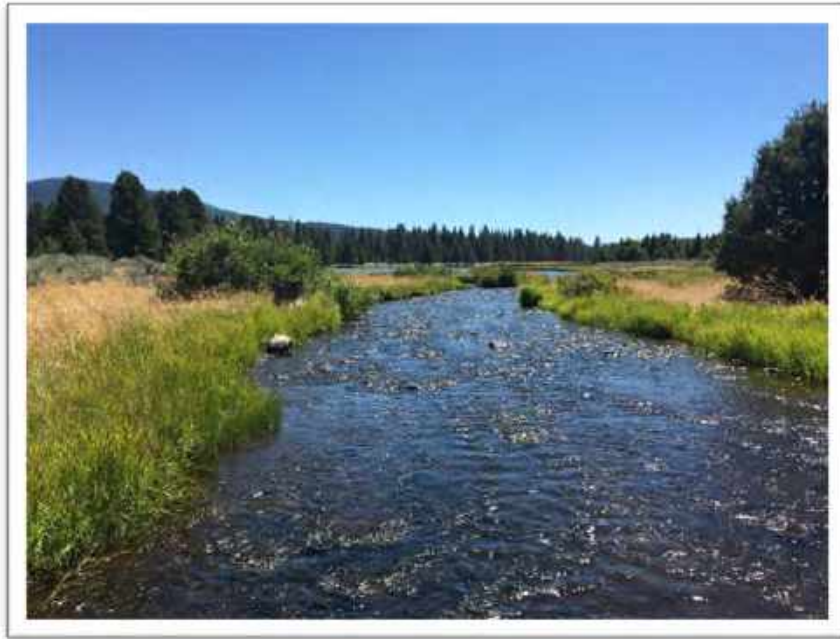
Photograph 6-4 Wetlands along Spencer Creek

- **Reservoir-dependent:** the primary hydrology is associated with one of the Project reservoirs.
- **Infrastructure-dependent:** the primary hydrology is associated with infrastructure related to operation of the dams that will be removed as part of the Project (e.g., the Copco wood-stave penstock).
- **Non-reservoir-dependent:** the primary hydrology is associated with the Klamath River, a stream or seep, precipitation, or another source.

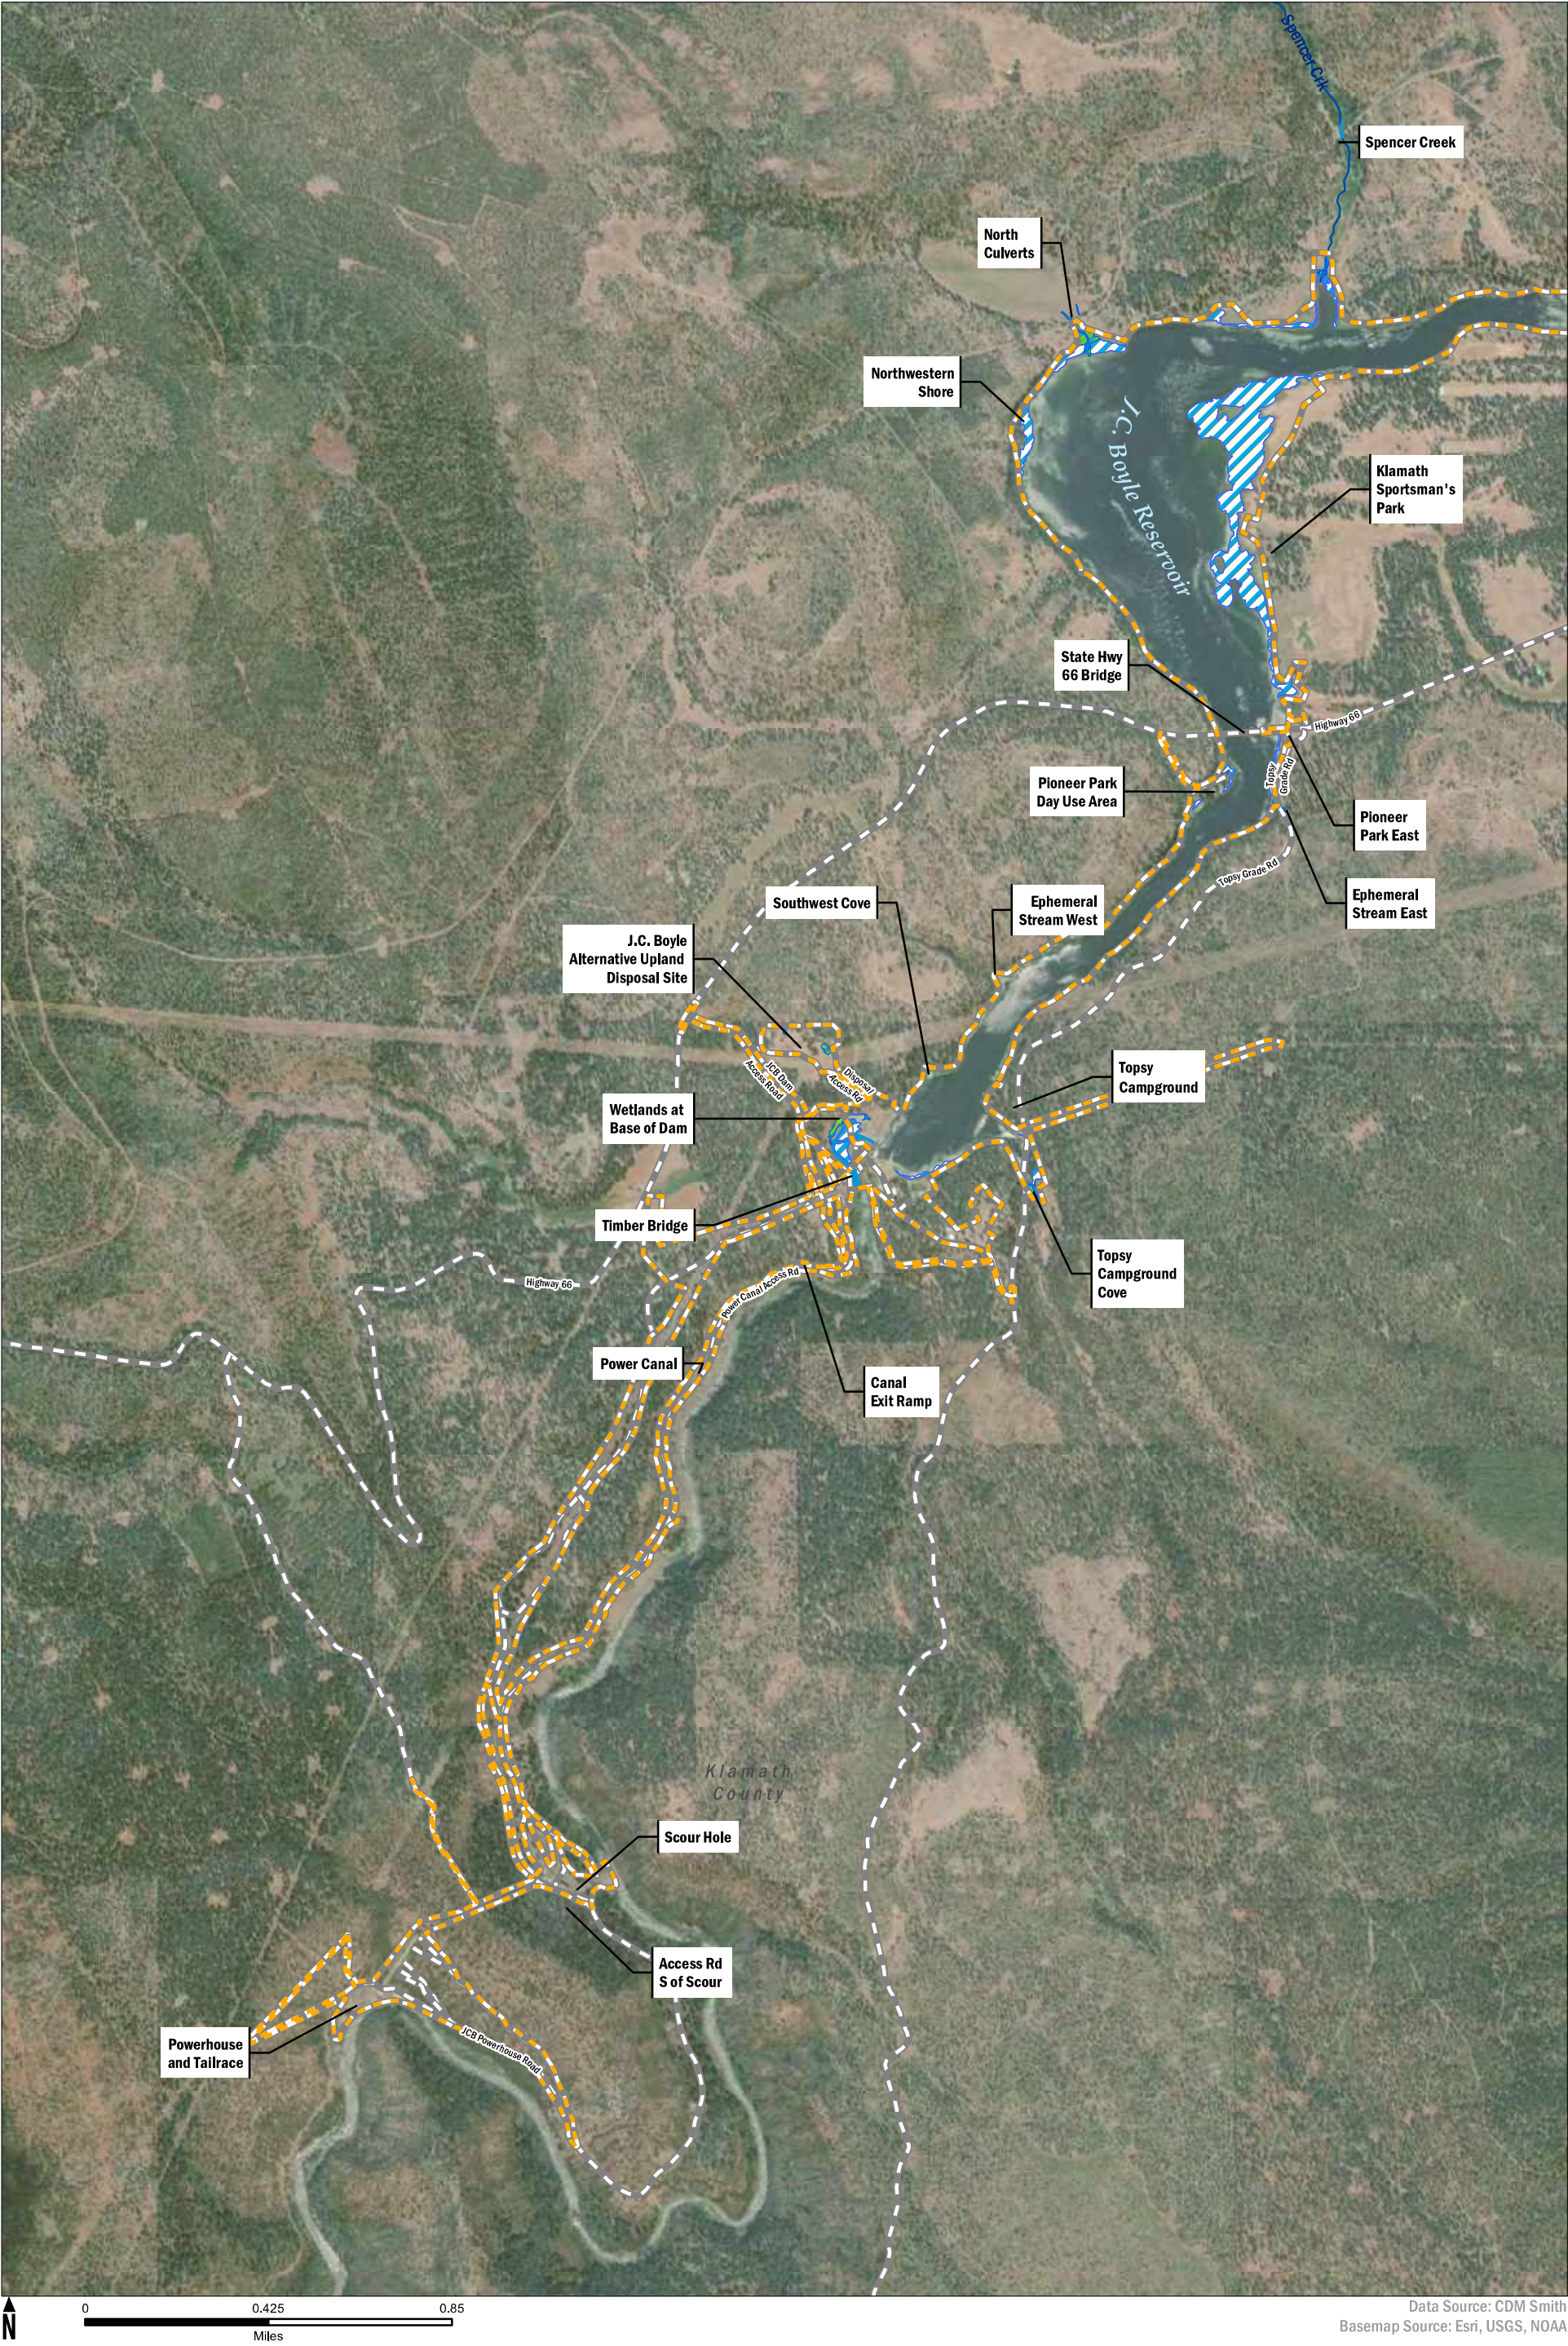
FIGURE 6-2
2019 Wetland Surveys
Copco Lake

- Legend**
- Access Route
 - Wetland Designation
 - Reservoir Dependent
 - Non-Reservoir Dependent
 - Infrastructure Dependent

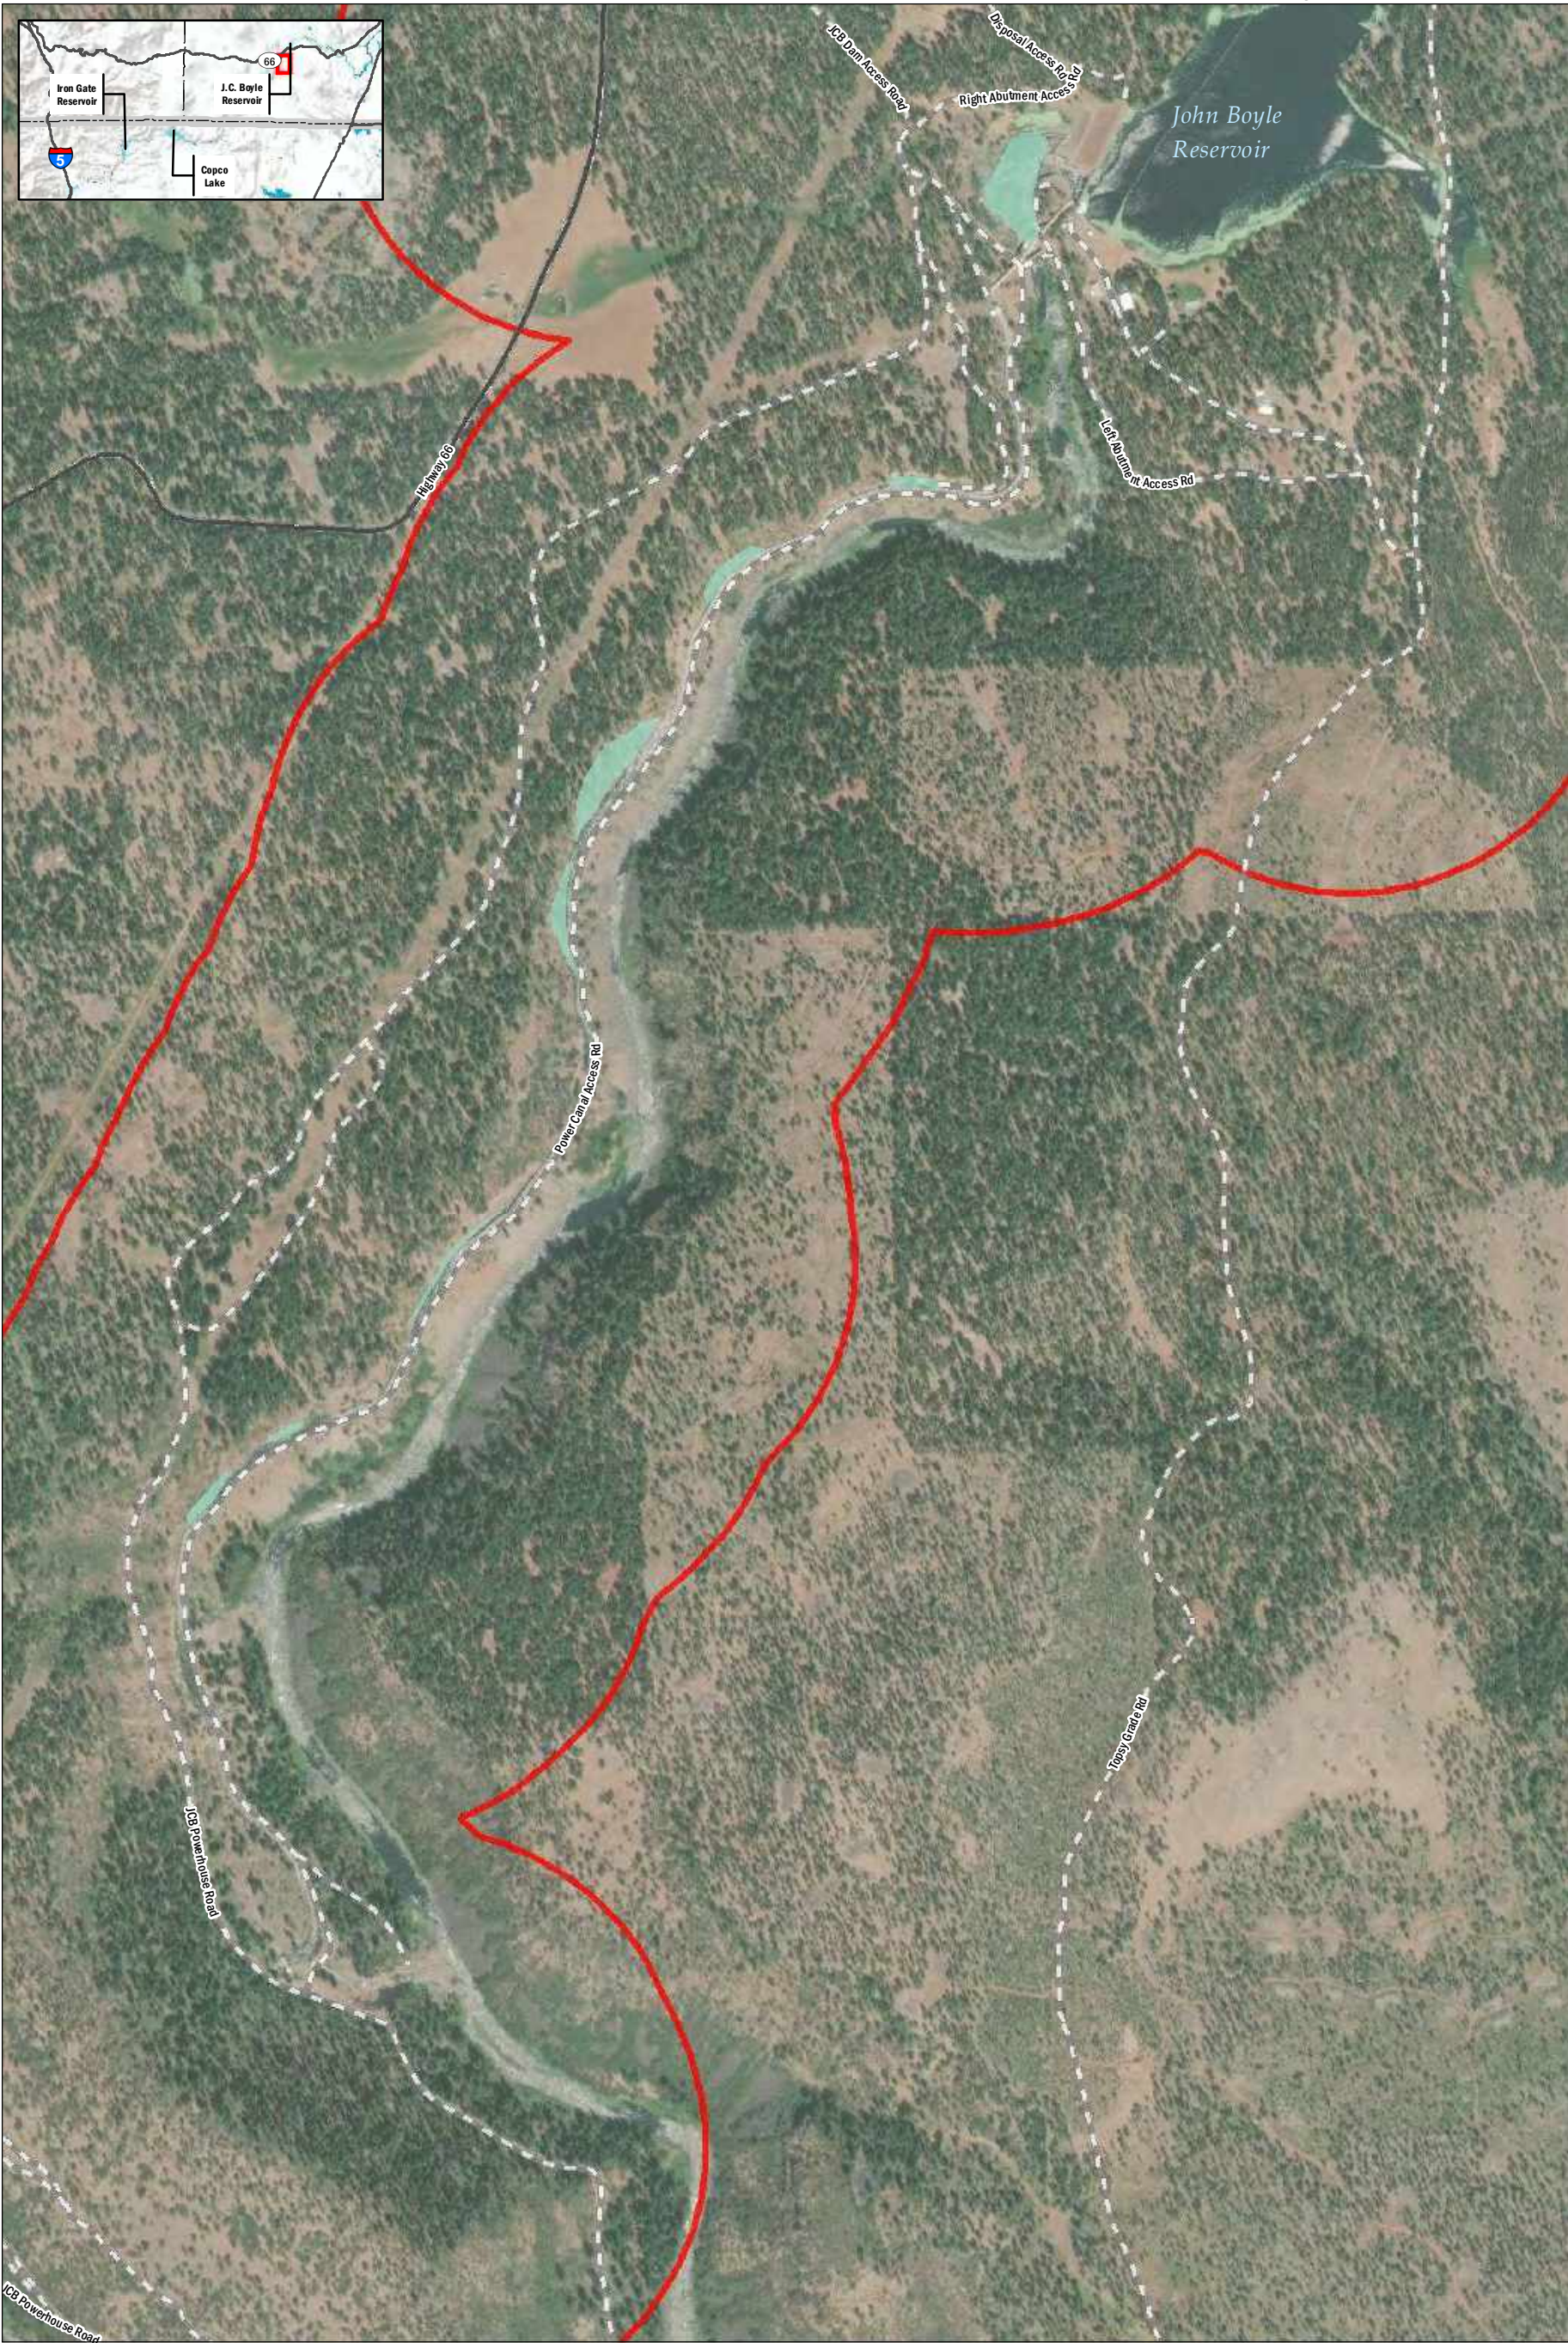
FIGURE 3-2

2018 Willow Flycatcher Habitat and Observations
Copco Lake
