**AMENDED APPLICATION FOR SURRENDER OF LICENSE
FOR MAJOR PROJECT AND REMOVAL OF PROJECT WORKS**

**EXHIBIT M
Terrestrial and Wildlife Management Plan
(Amended December 15, 2021)**

**Lower Klamath Project
FERC Project No. 14803**

Terrestrial and Wildlife Management Plan

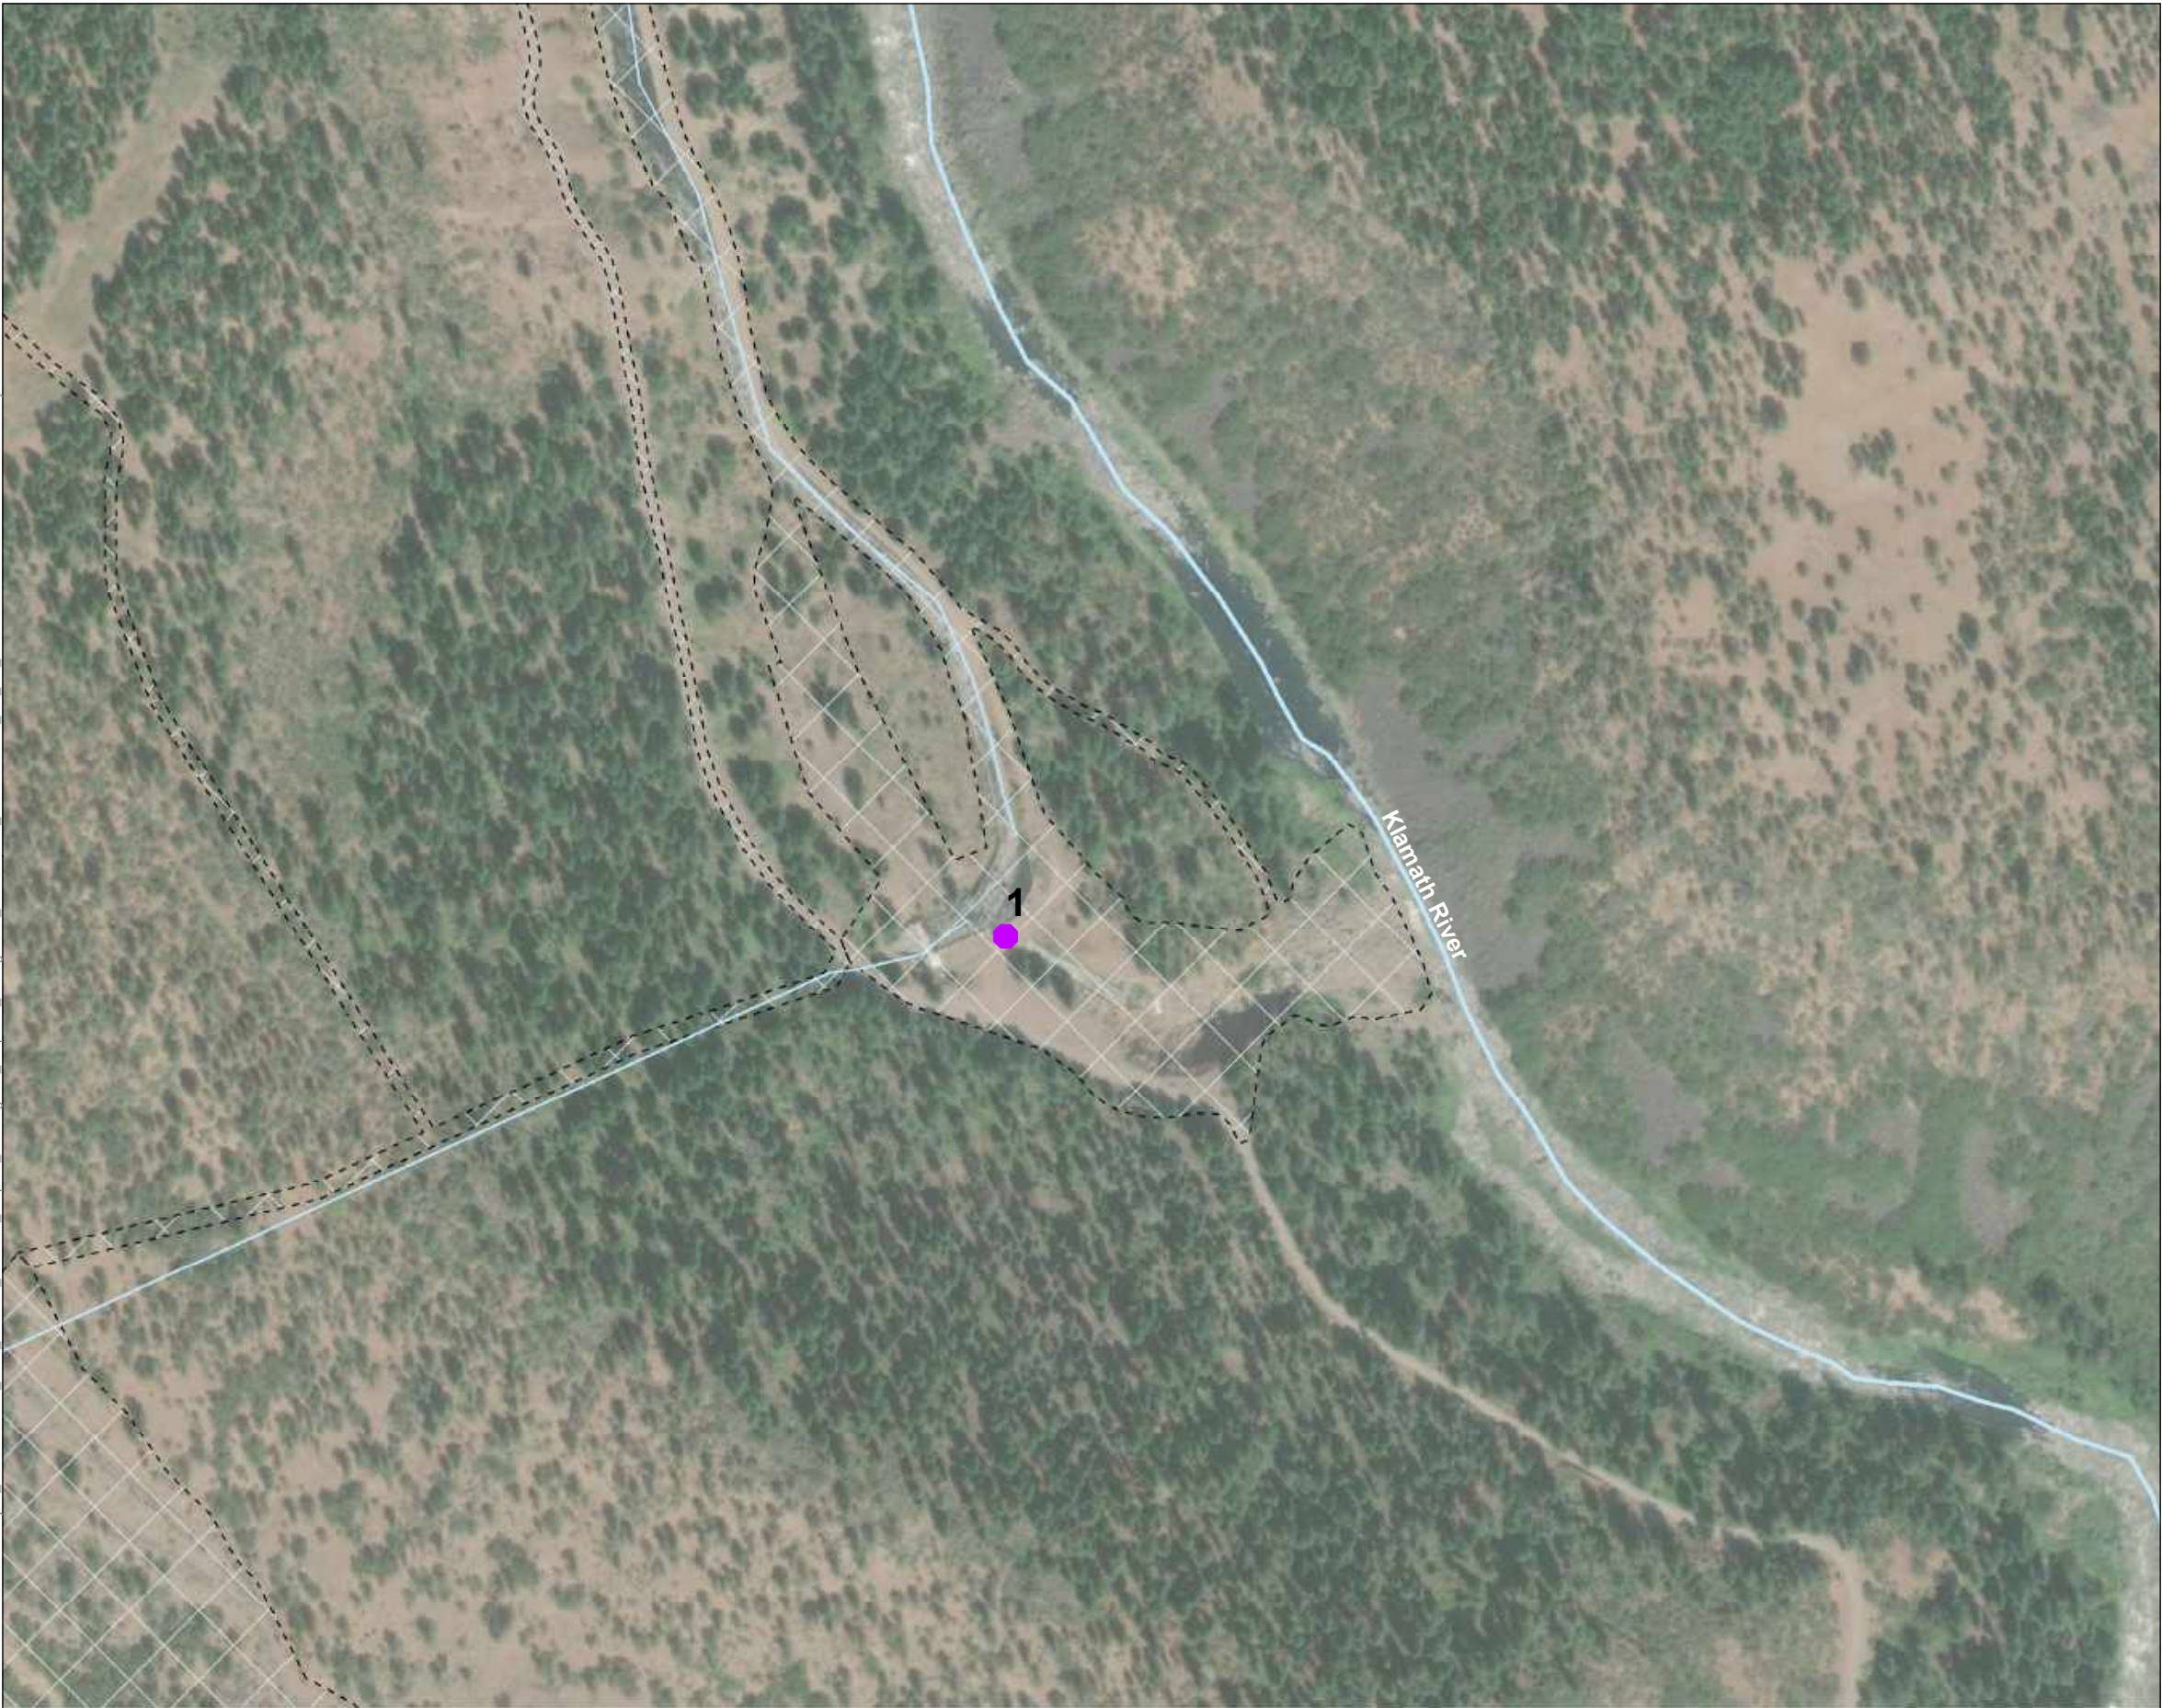
Figure 3. Structures with Potential Bat Roosts, Oregon

- 1 Spillway Control Center Building
- Limits of Work
- Klamath River

The Renewal Corporation conducted bat occupancy surveys at facilities impacted by the Proposed Action. During these surveys, surveyors assessed potential bat roosting features (e.g., buildings, bridges, trees) for bat utilization. A total of three structures were confirmed to have evidence of bat use and/or bat roosting, as shown in Table 3-3, Appendix A – Figure 3.

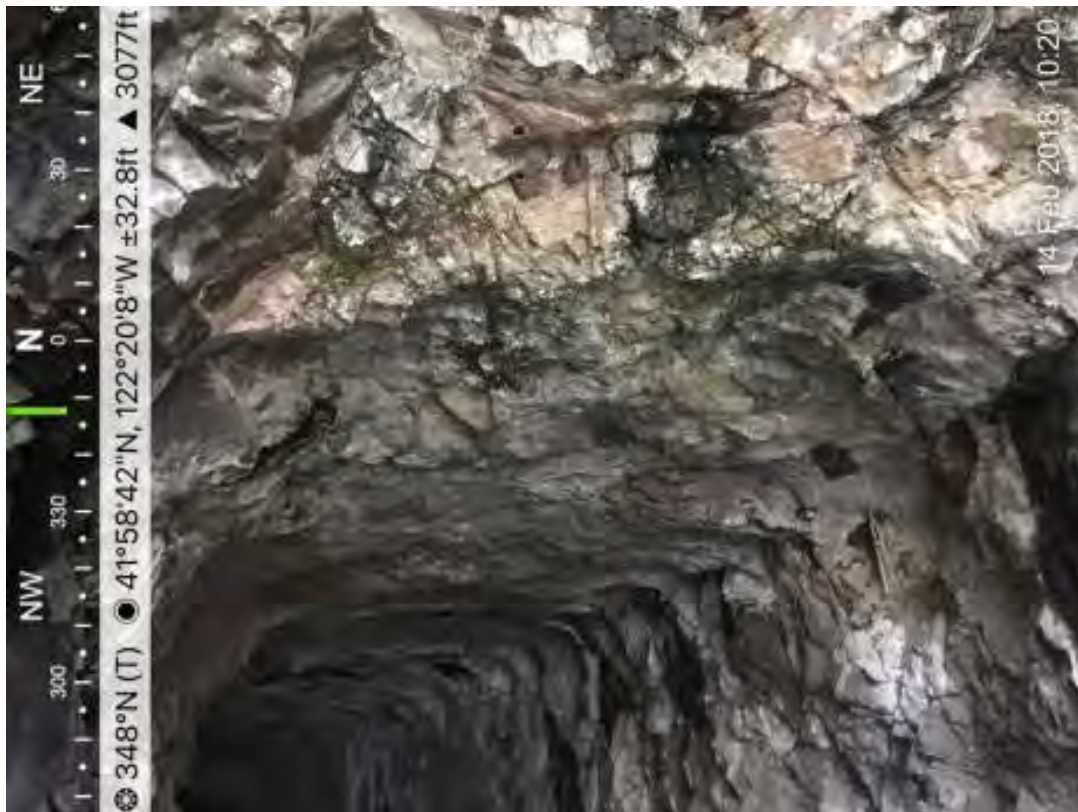
Photograph 5-7: Copco Diversion Tunnel Interior Substrate and Cliff Swallow Nests, February 14, 2018

On February 14, 2018, conditions were sunny and clear. Air temperatures outside the Copco tunnel were 41°F at 10:15 A.M. Inside the tunnel, temperatures were 48°F at the entrance (10:20 A.M.) and 44°F at the terminus (10:30 A.M.). The entire length of the Copco tunnel is unlined, exposed rock (~160 feet) (Photograph 5-7). Water depths in the tunnel ranged from 1.1 feet to 3.2 feet. The full length of the accessible portion of the tunnel was surveyed, from the entrance to the closure gate. Cliff swallow nests and a few pigeons were observed in the tunnel. No bats or signs of bat use were found; however, the tunnel provides suitable habitat.

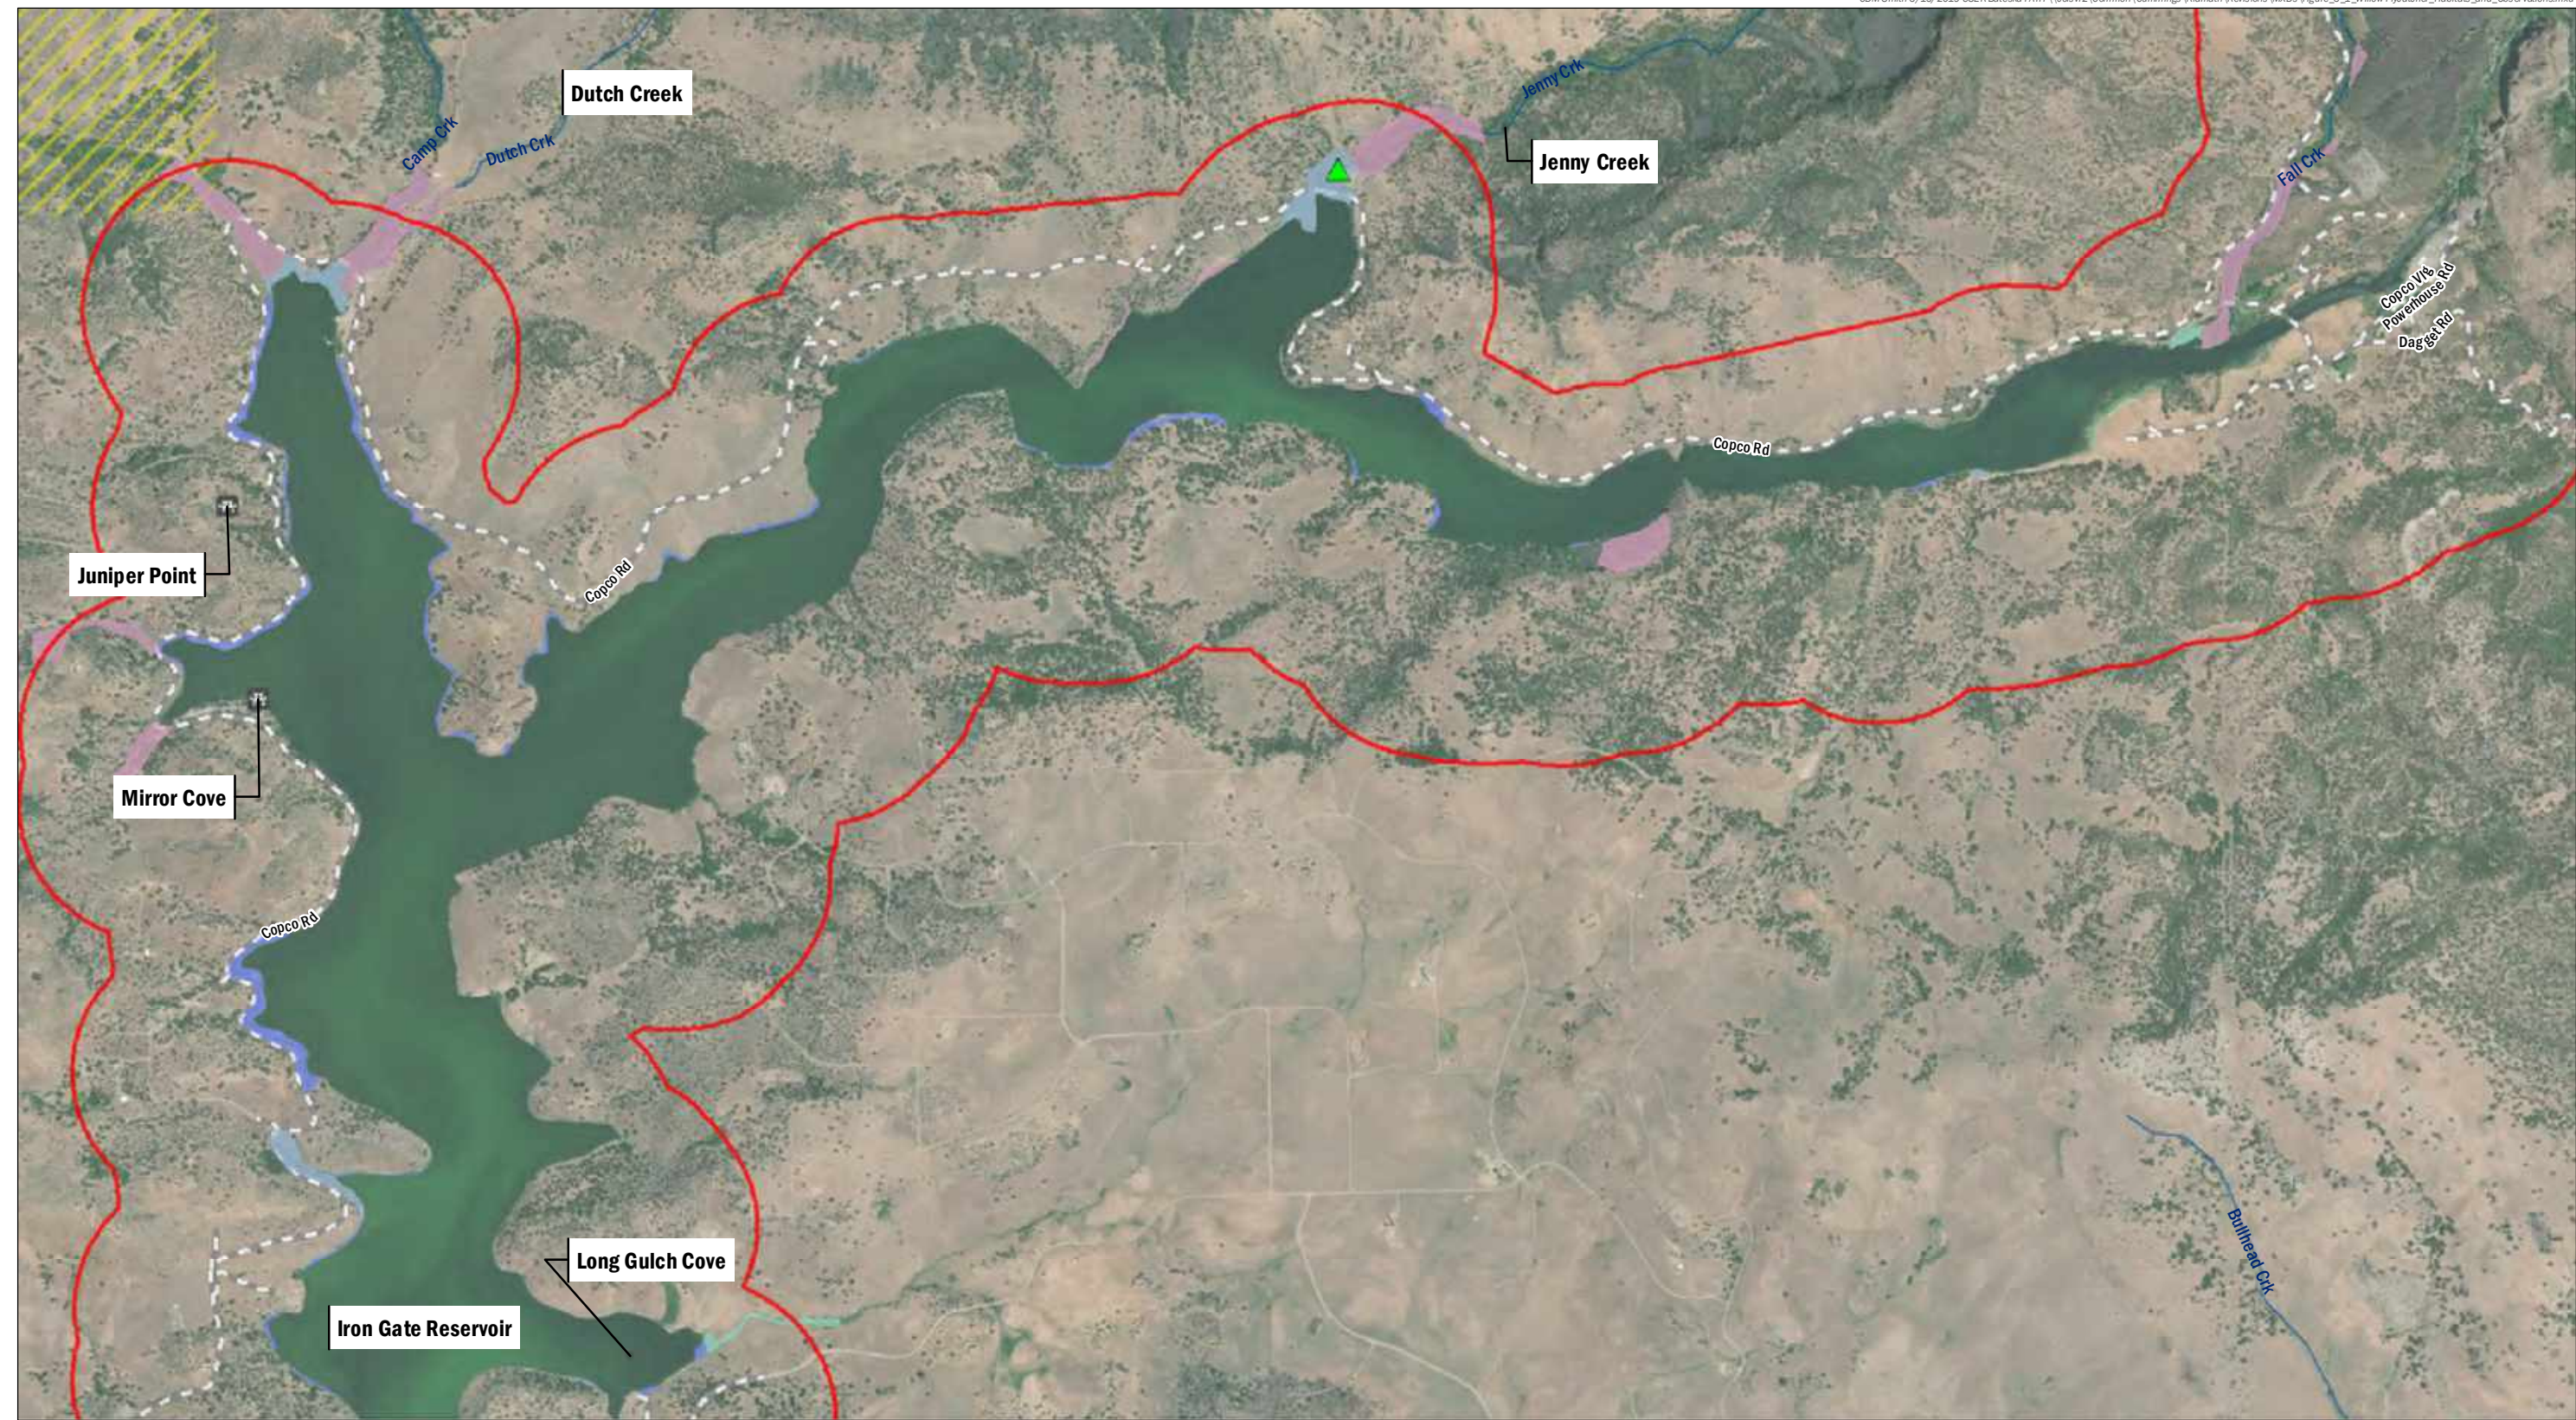
FIGURE 2-4

Osprey (Pandion haliaetus)
Observations and Nest Locations
J.C. Boyle Reservoir

Biologists observed a total of five active osprey nests in the vicinity of the J.C. Boyle Reservoir (Figure 2-4). Of these, one nest was on a utility pole along the Klamath River just south of the J.C. Boyle Dam, and two others were atop utility poles along the southern end of the J.C. Boyle Reservoir east of the dam. Biologists observed an additional inactive nest on a utility pole in that vicinity. Biologists observed an active nest along the southeastern side of the J.C. Boyle Reservoir and an active nest atop a utility pole in the proposed J.C. Boyle disposal site.

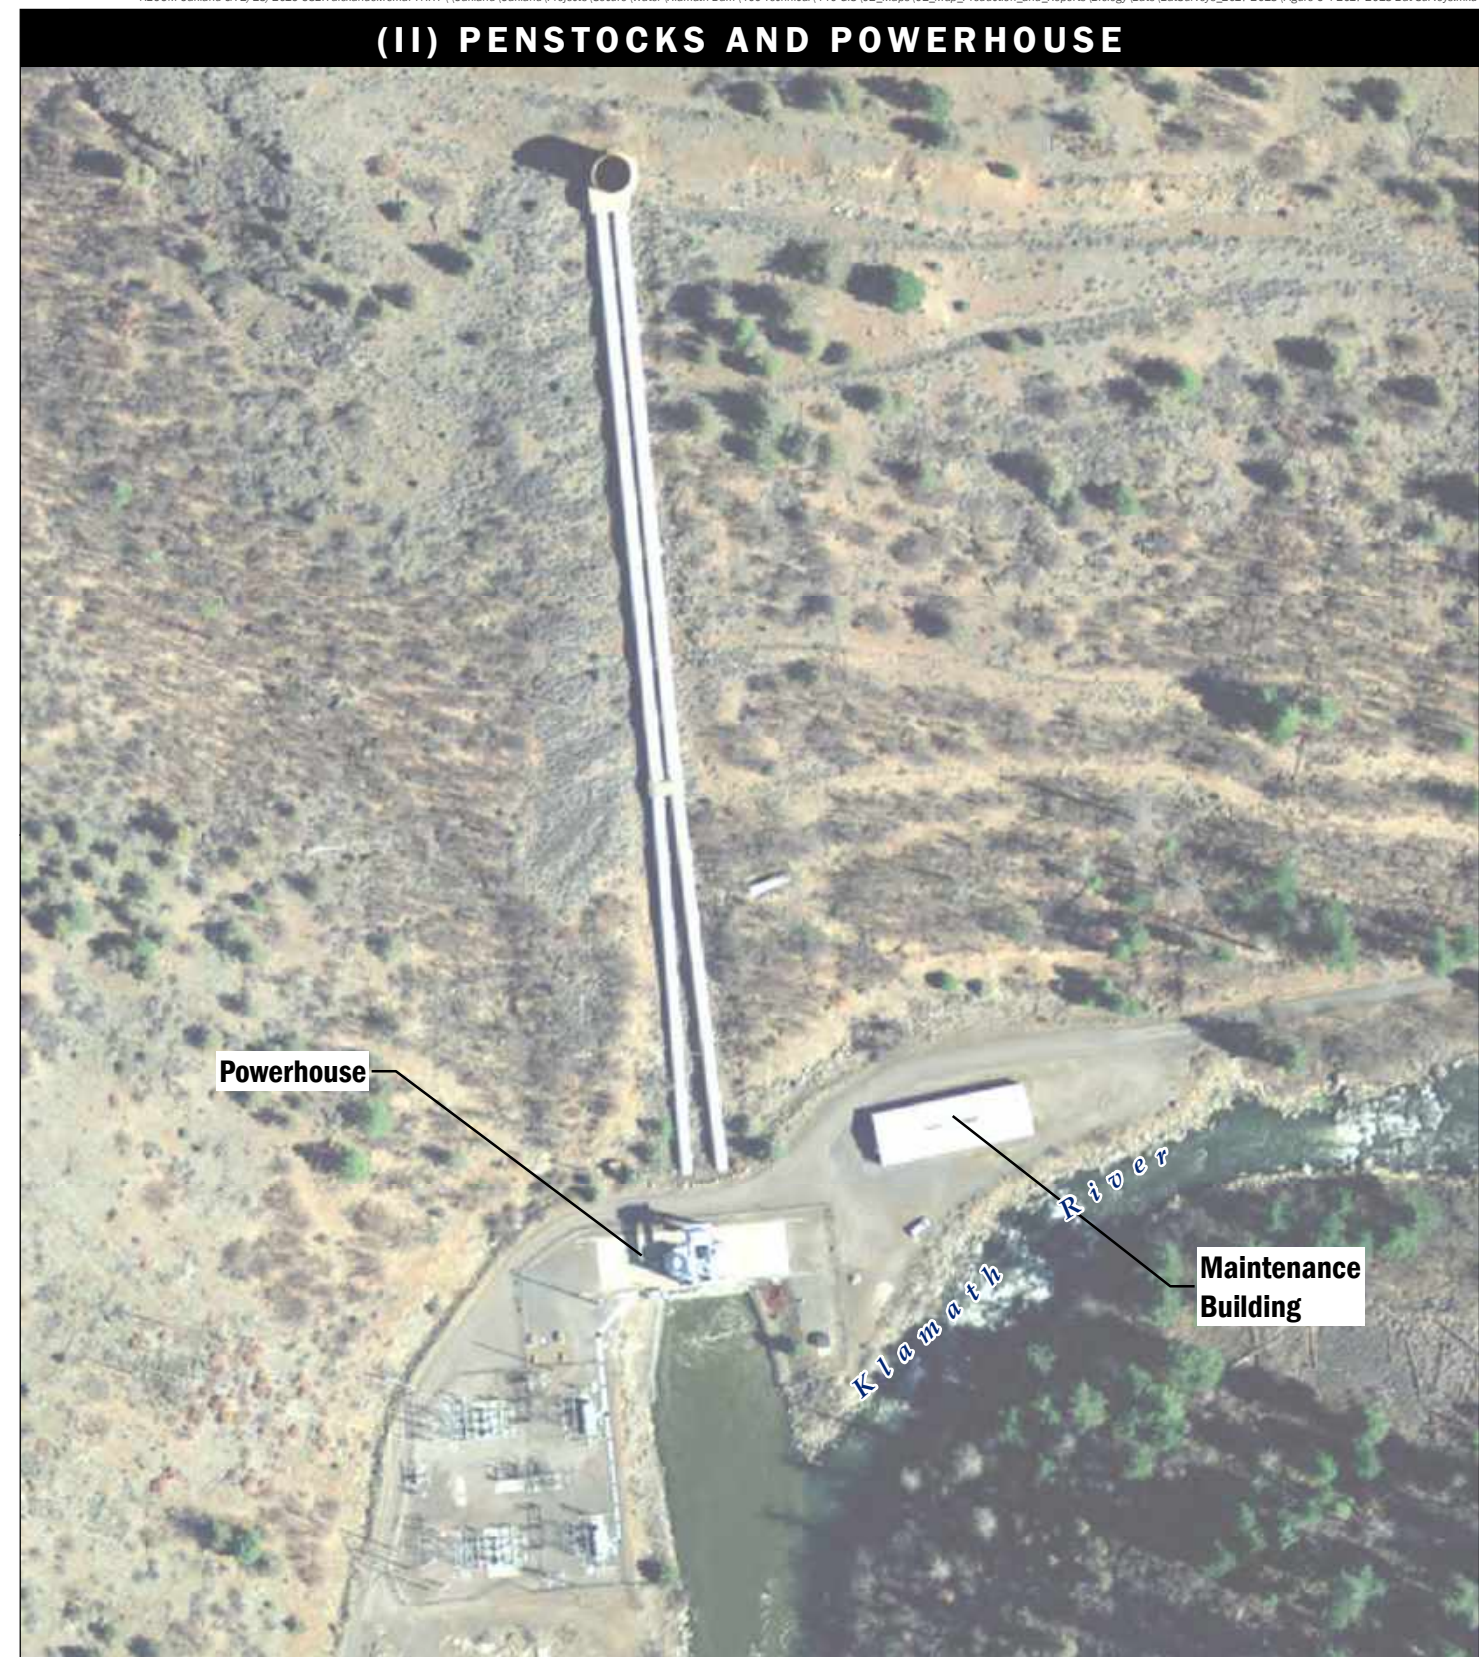
FIGURE 7-2
2017-2018 Bat Surveys
J.C. Boyle Forebay and Spillway Area,
Penstocks and Powerhouse Area

- Labels**
- Active Bat Roost Confirmed
 - Roosting Bats Not Found

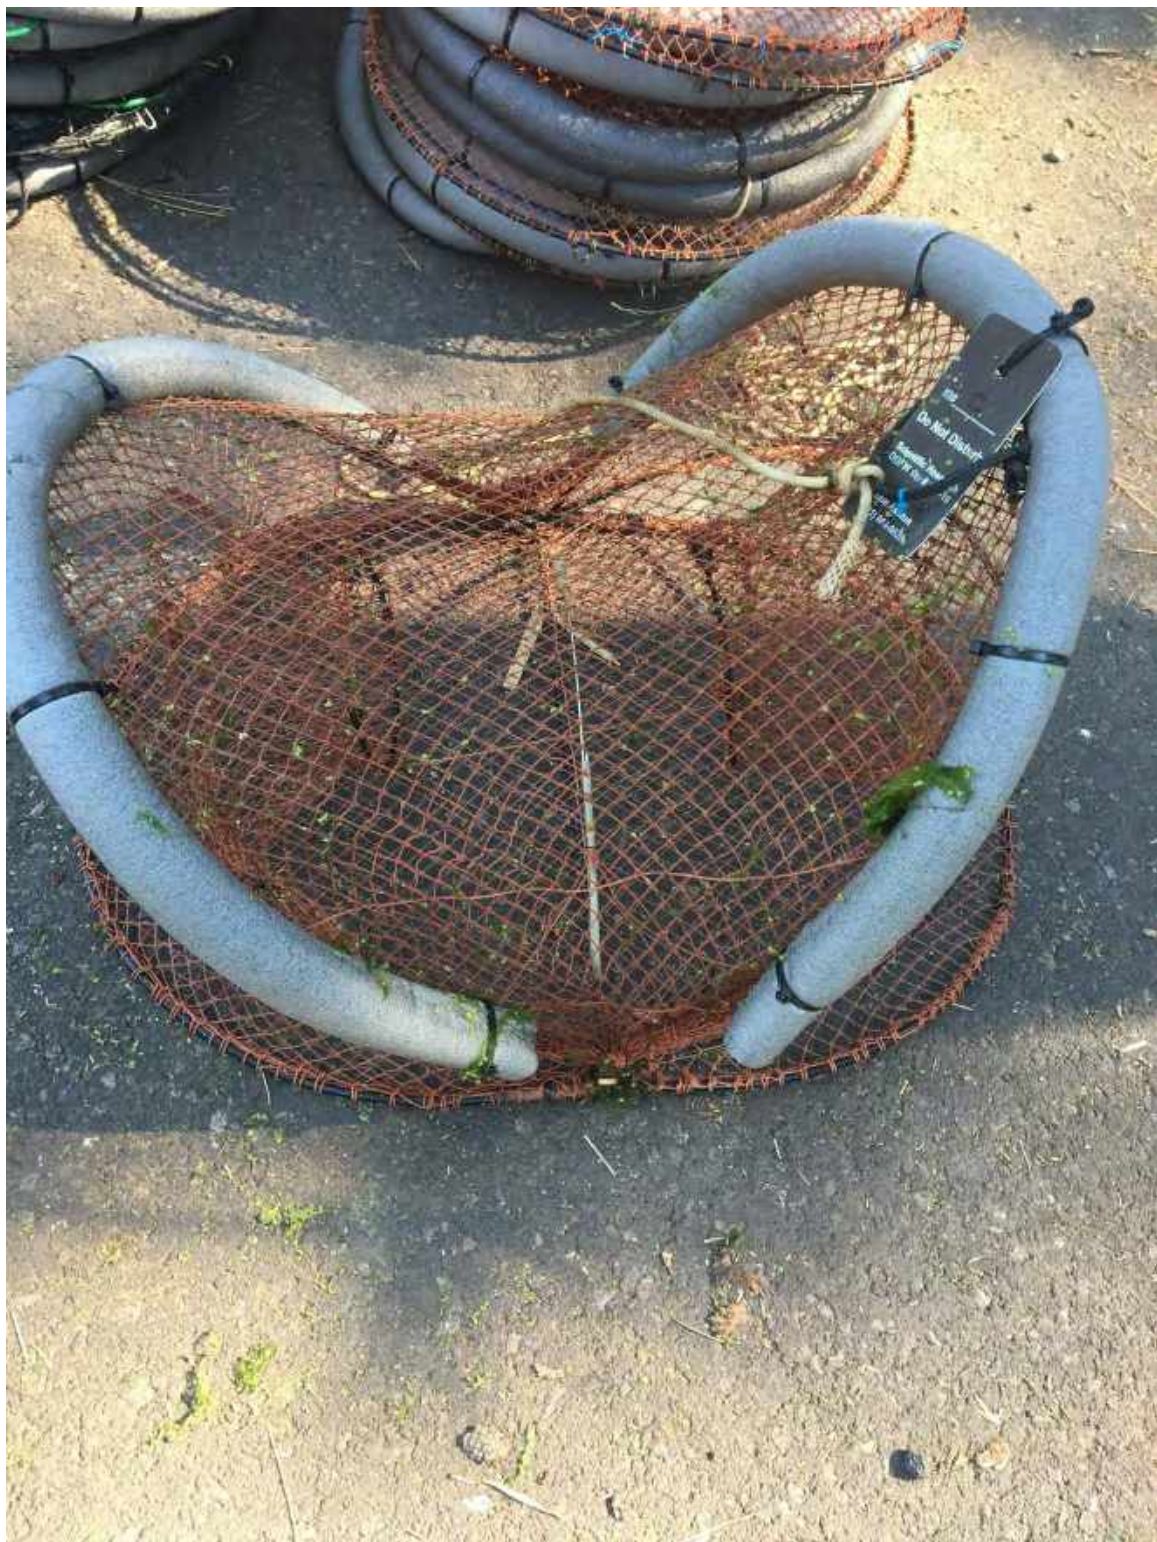
Photo 2. Side view of trap

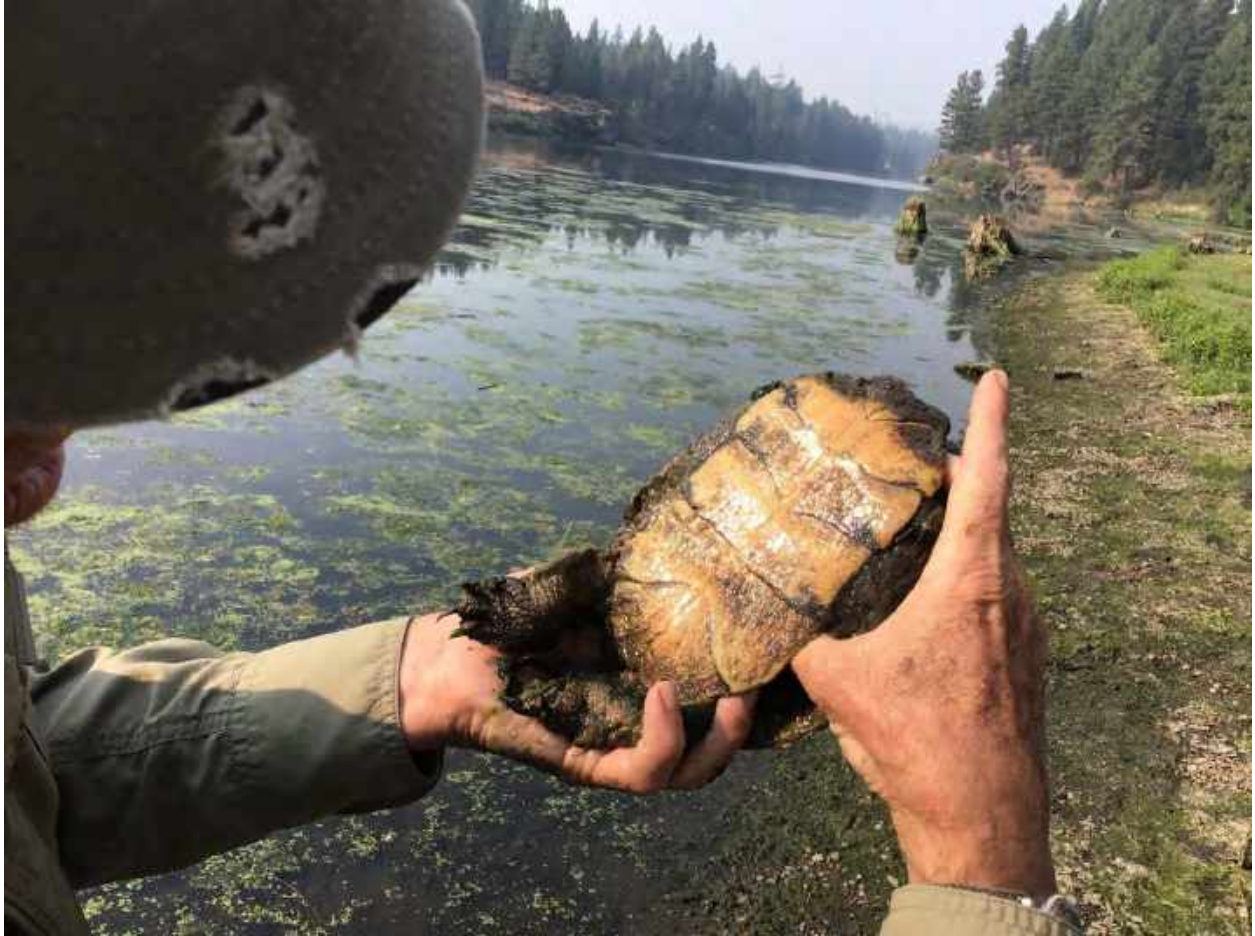
Photo 10. Checking female WPT for eggs

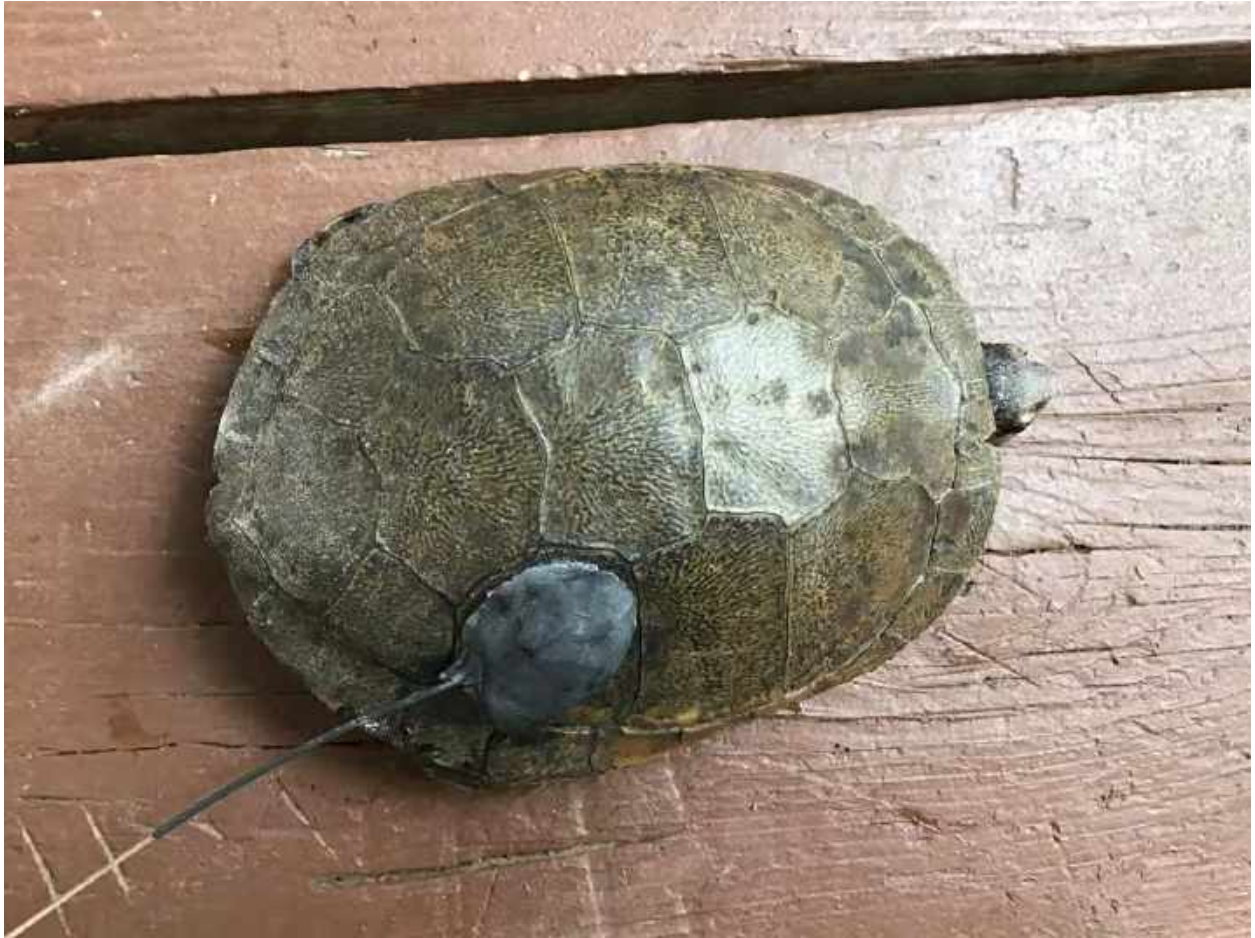
Photo 17. WPT with identification notches on marginal shields. Note notches at front and rear shields.

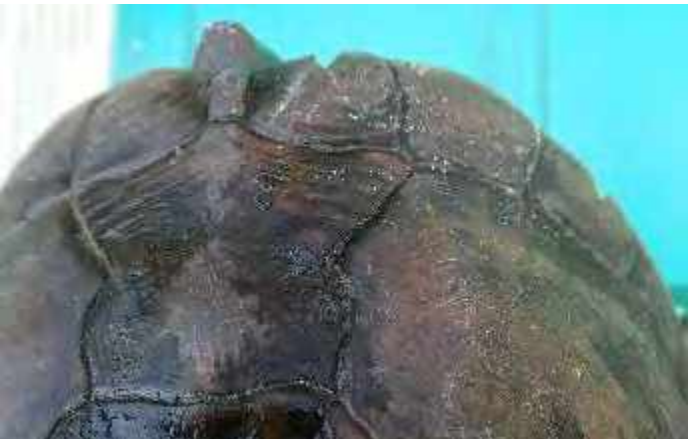
Photo 19. WPT morphology data

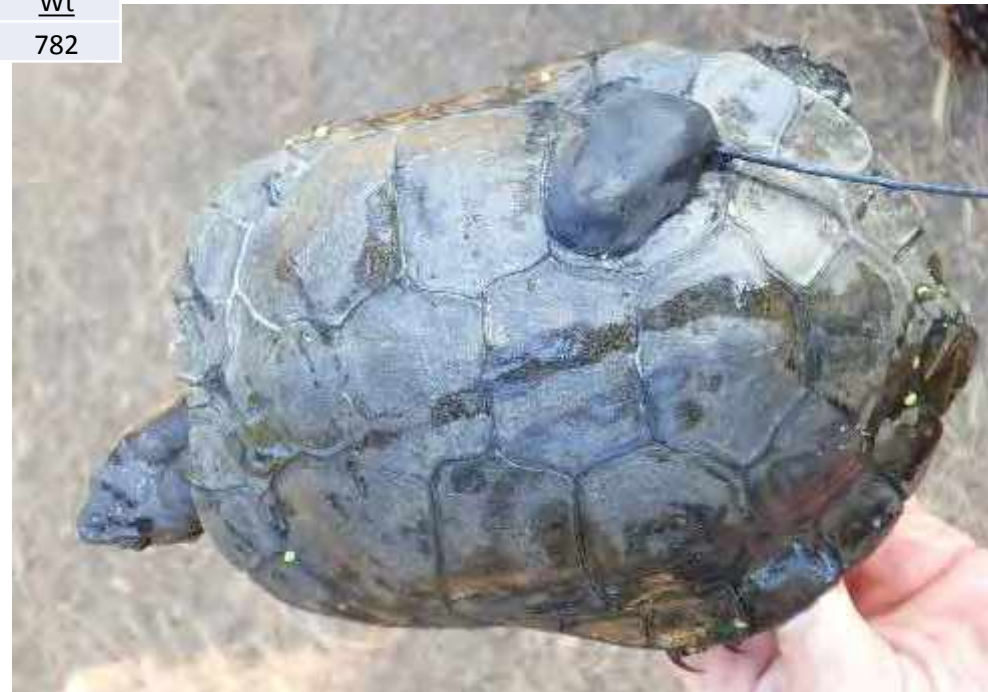
MARK	DATE	CapHist	SEX	AGE	AGE+	CL	cl	cw	PL	pl	pw	Ht	Wt
104	9/5/2018	1	M	99	99	180.9	175.1	131.8	165.0	153.5	89.6	60.0	782

- Transmitter
Freq **151.750**

Photo 22. WPT morphology data

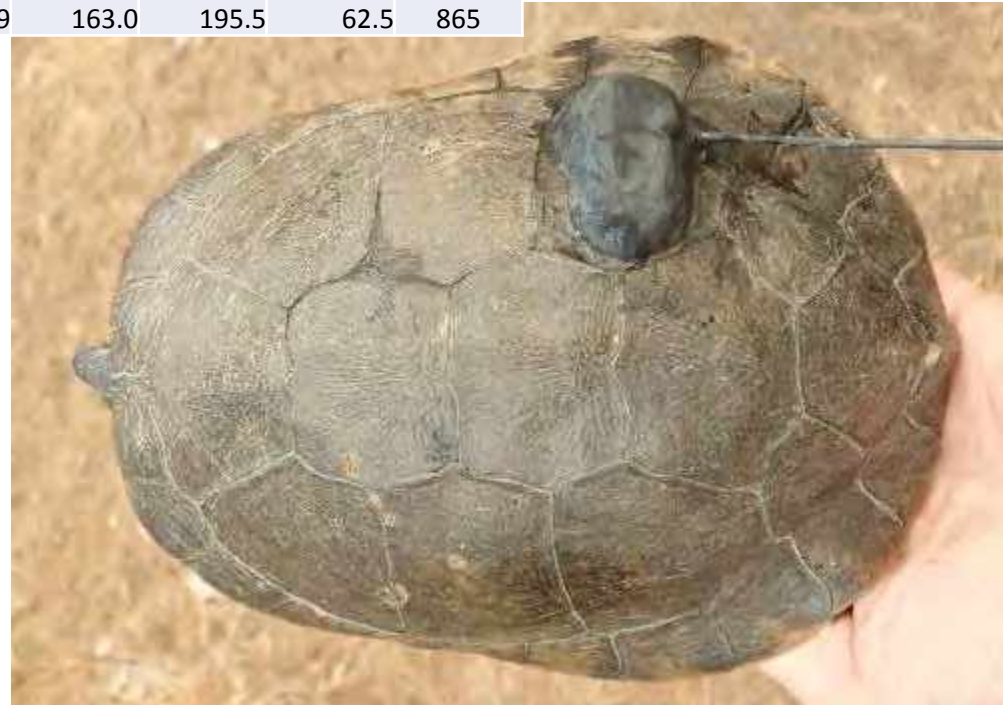
MARK	DATE	CapHist	SEX	AGE	AGE+	CL	cl	cw	PL	pl	pw	Ht	Wt
107	9/5/2018	1	M	99	99	188.8	186.9	141.0	170.9	163.0	195.5	62.5	865

- Transmitter
Freq **151.770**

Photo 25. WPT morphology data

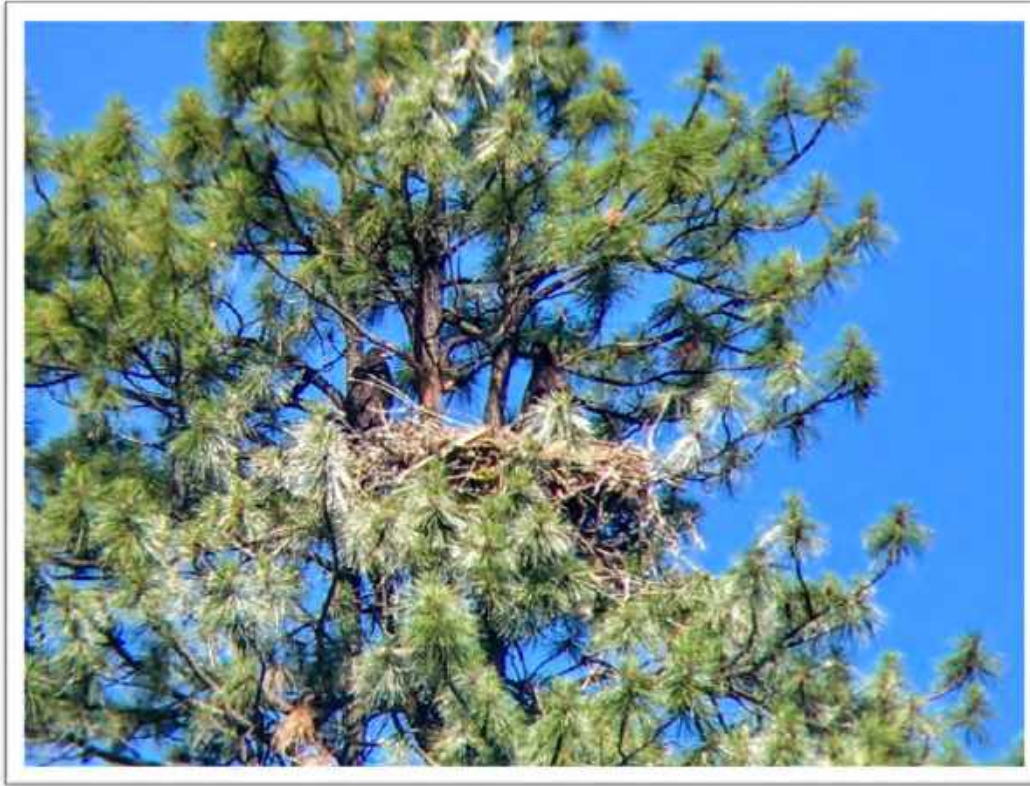
Photograph 2-1 Two Bald Eagle Nestlings at Nest F19_BE1

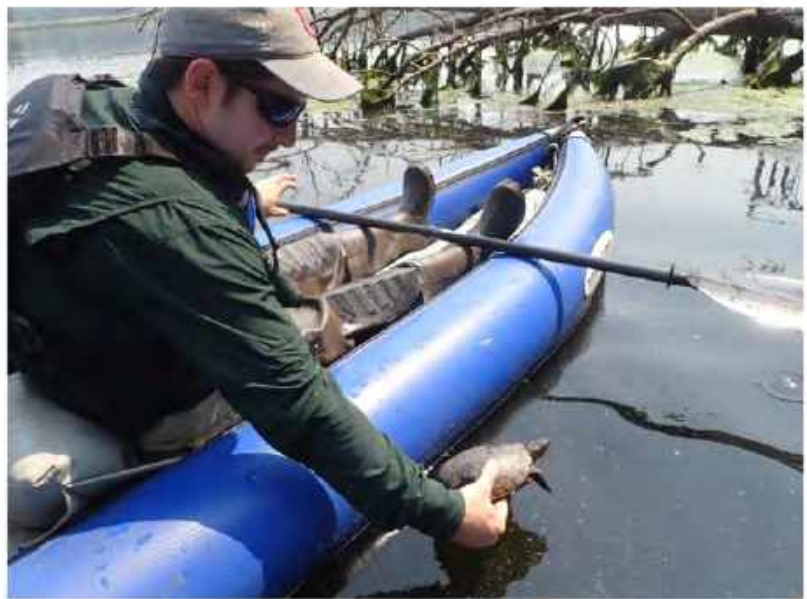
Photograph 4-2 Releasing a Captured Western Pond Turtle

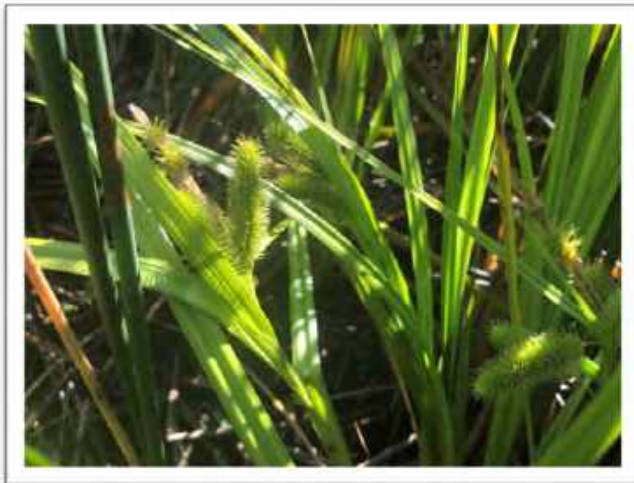
Photograph 5-2 Bristly Sedge (*Carex comosa*)

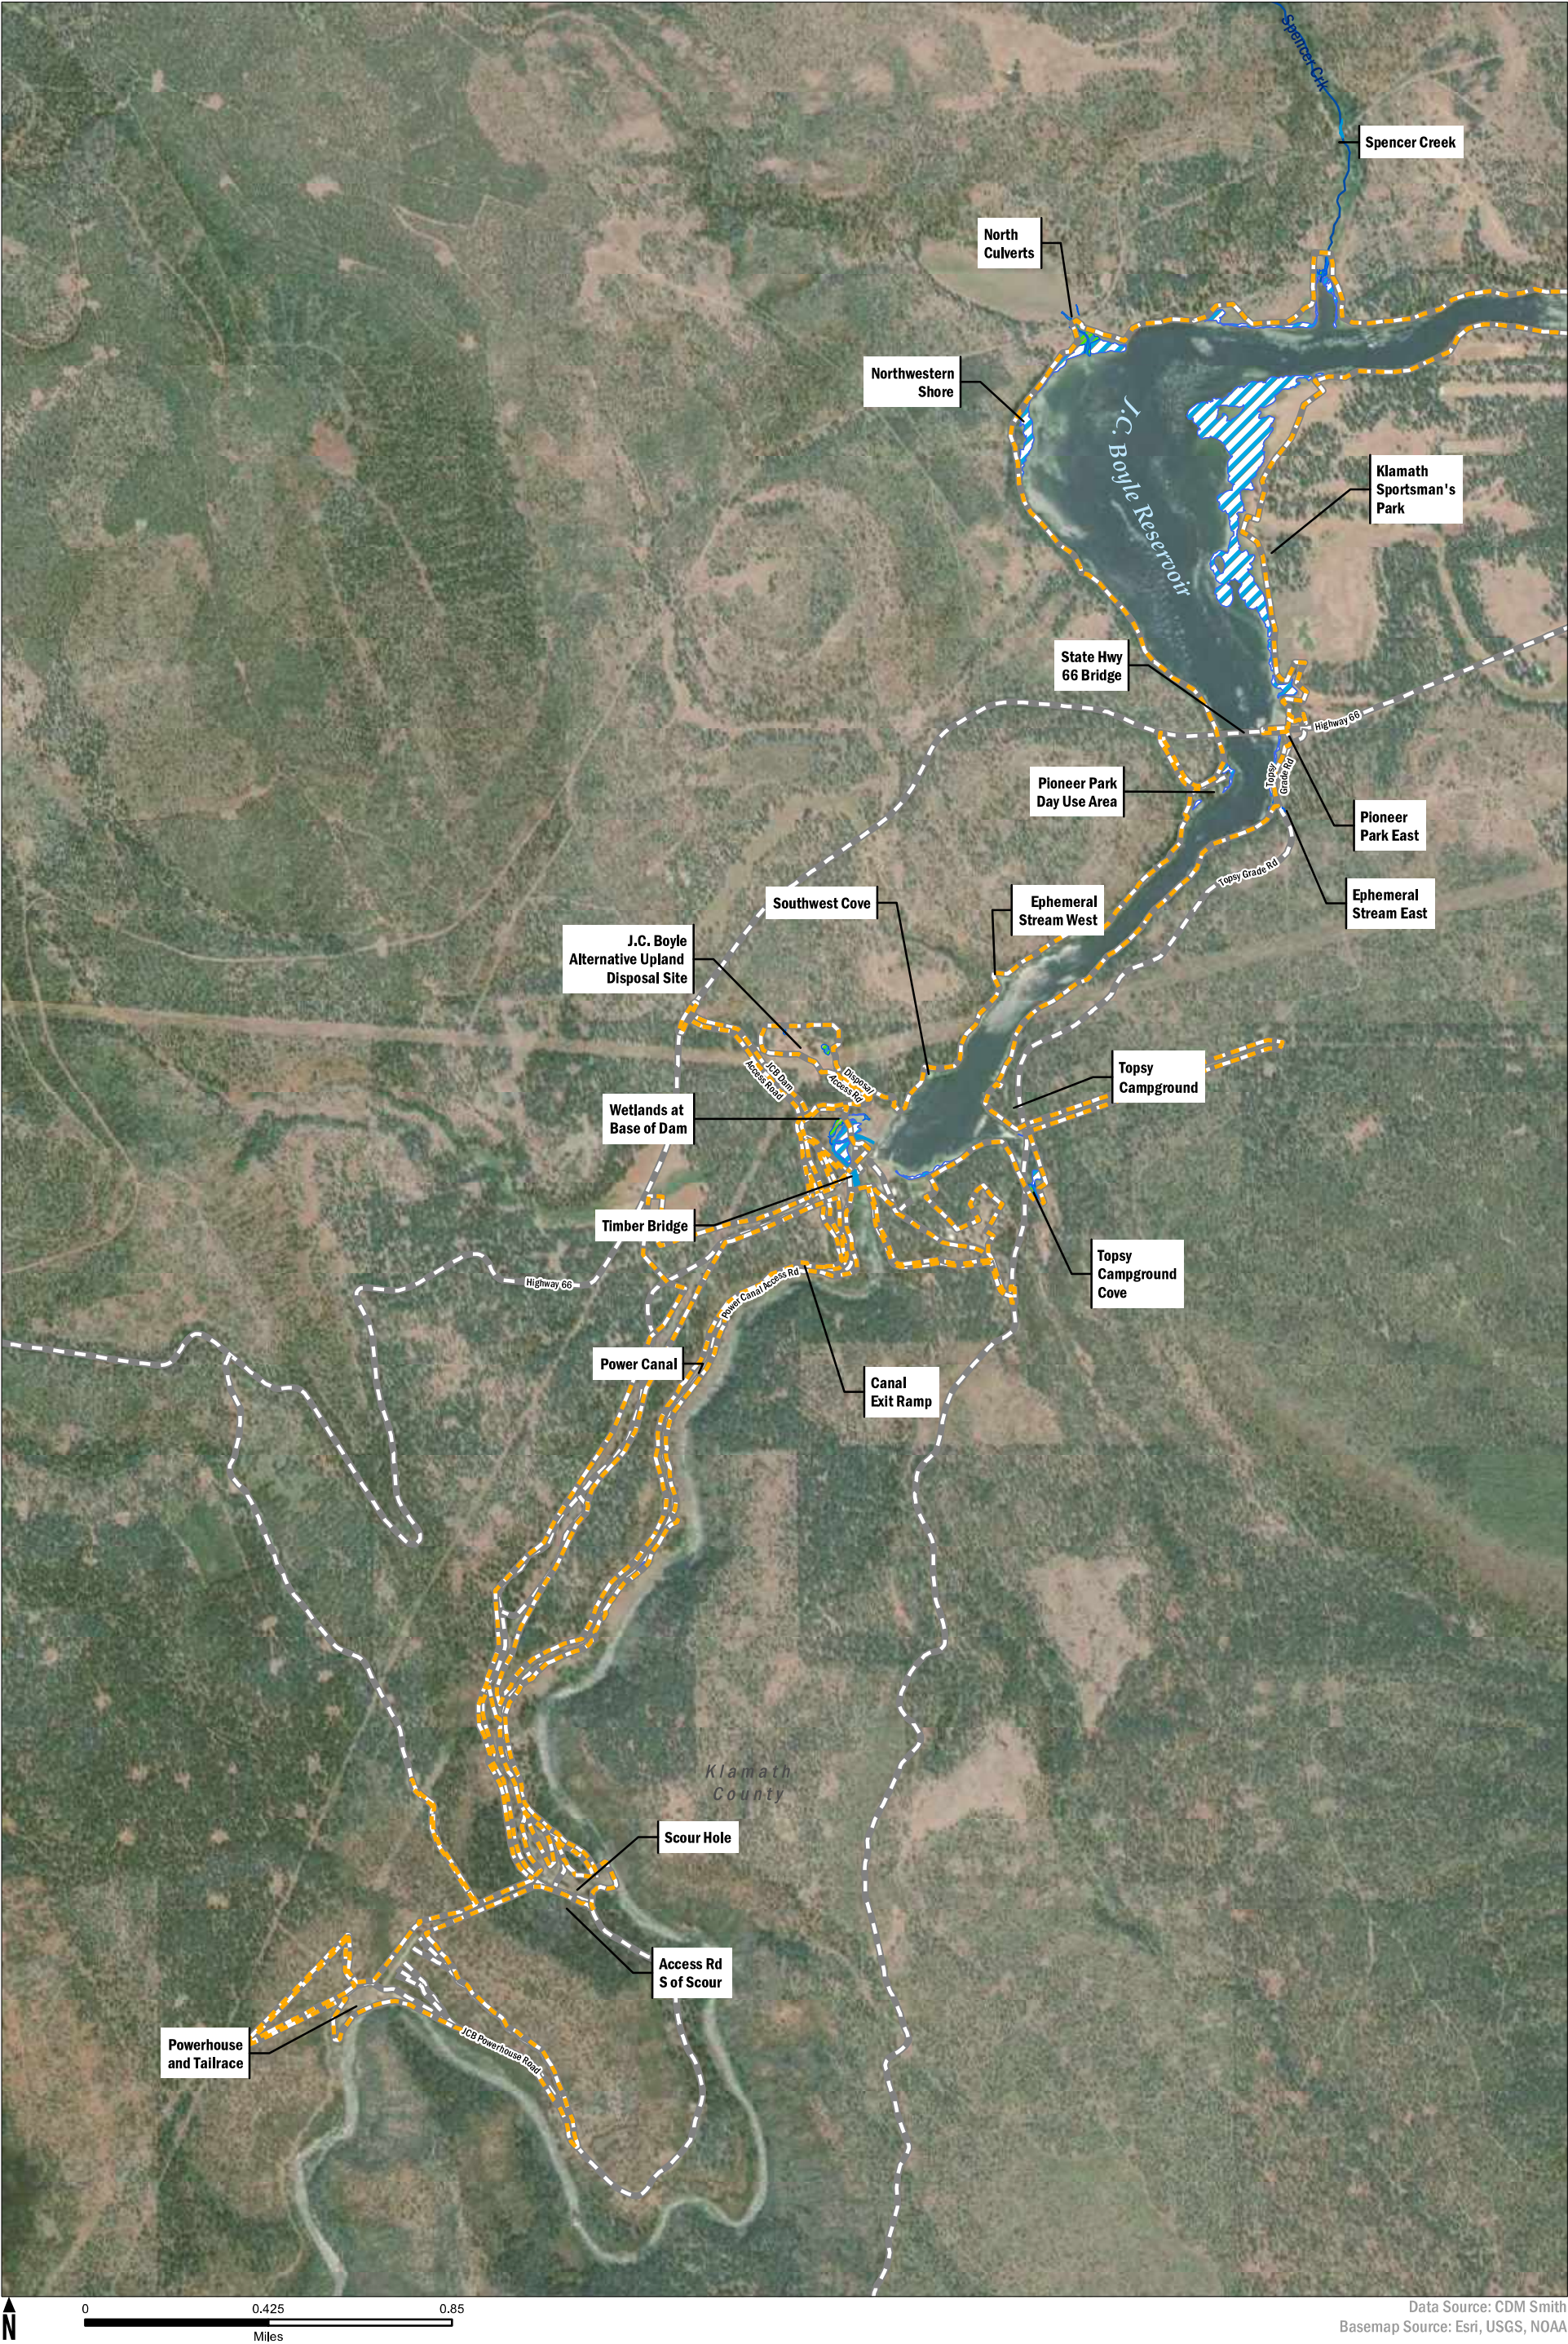
FIGURE 6-2
2019 Wetland Surveys
Copco Lake
