**AMENDED APPLICATION FOR SURRENDER OF LICENSE
FOR MAJOR PROJECT AND REMOVAL OF PROJECT WORKS**

**EXHIBIT M
Terrestrial and Wildlife Management Plan
(Amended December 15, 2021)**

**Lower Klamath Project
FERC Project No. 14803**

Terrestrial and Wildlife Management Plan

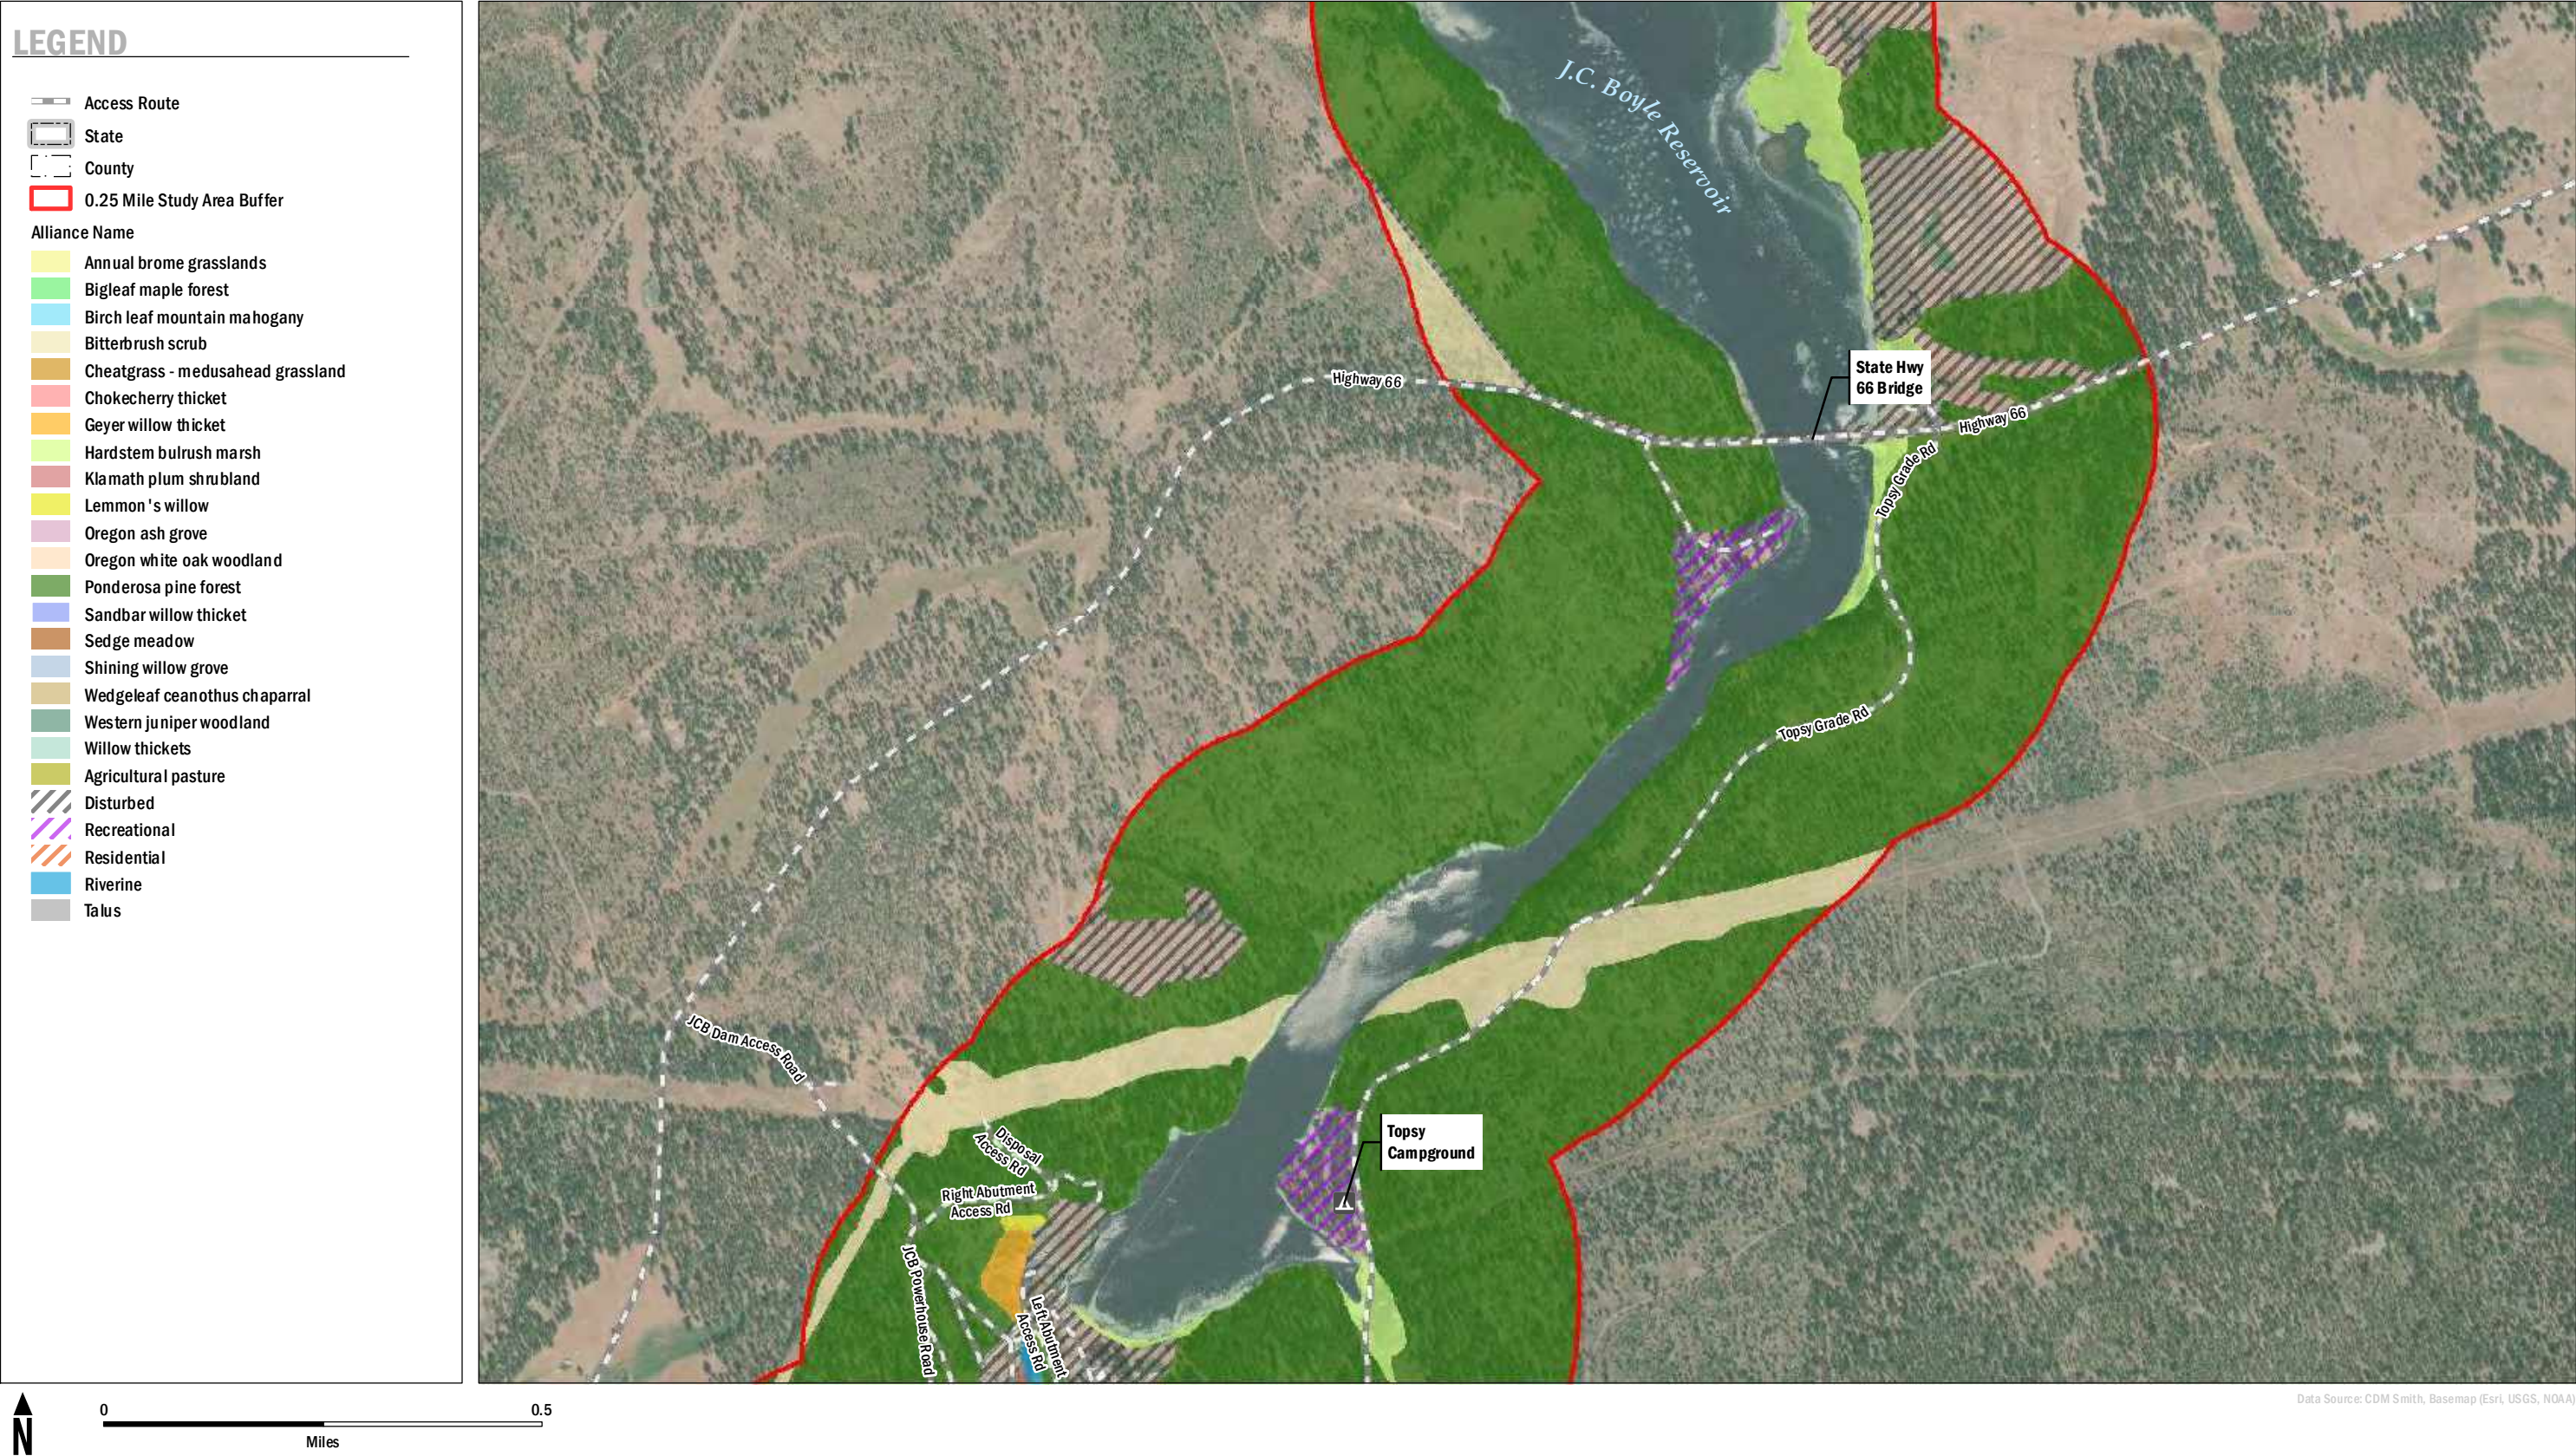
FIGURE 11-14
Vegetation Communities
JC Boyle Reservoir
