Subject: Borehole TelevIEWER Logging Survey  
Klamath River Project  
Iron Gate Reservoir  
Siskiyou County, California

This report presents the findings of a borehole geophysical investigation performed by NORCAL Geophysical Consultants, Inc. at the Klamath River Project at the northeast end of Iron Gate Reservoir. This investigation was part of a geotechnical study to assess subsurface conditions along a propose water tunnel alignment. The survey was performed on two separate mobilizations during the period of August 16 through 23, 2018 by NORCAL Professional Geophysicist William J. Henrich PGp 893. Logistical support and safety information were provided onsite by Mr. Tim VandeVoorde, Engineering Geologist of AECOM.

Subject: Project No.: 60537920  
Project Name: Klamath River Dam Removal Project  
Corrosivity Analysis – CalTrans Test Methods

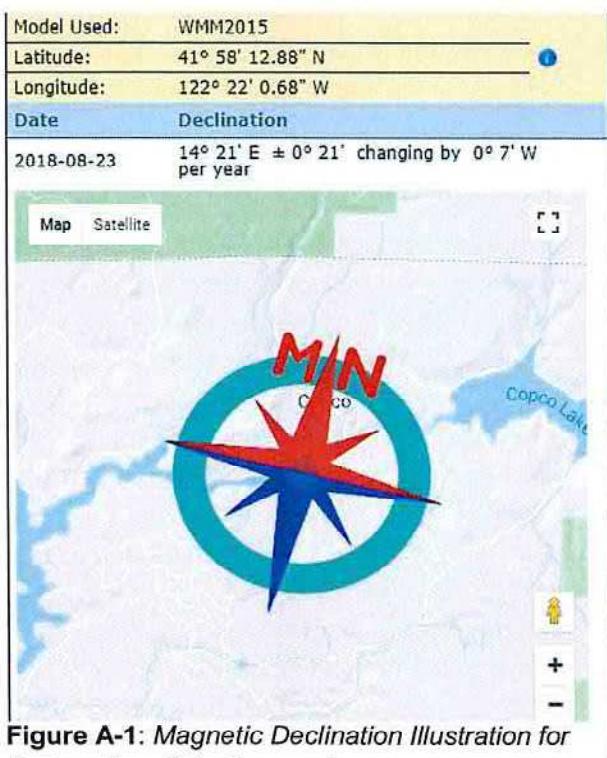
**Figure A-1:** Magnetic Declination Illustration for Eastern Iron Gate Reservoir.

Corrections for the magnetic declination in the survey area required adding 14.3 degrees to the magnetic compass bearings in order to orient the borehole images to true north (see Figure A-1 below). Since borehole diameter is a major reduction parameter in determining dip magnitude, we input caliper log measurements. In each borehole, discontinuity analyses were performed interactively on sections of the unwrapped optical or acoustic amplitude images as viewed on a computer monitor. An interpretable discontinuity on a two-dimensional unwrapped borehole televiewer log appears as a recognizable sinusoidal trace that usually extends across the full width of the borehole image. The sinusoidal shape is a manifestation of planar discontinuities intercepting a three-dimensional cylindrical borehole. Planar discontinuities can be geologic features that include discrete fractures or joints, bedding planes and planar intrusions such as veins and geologic contacts. The traces of discontinuities identified on the image logs were

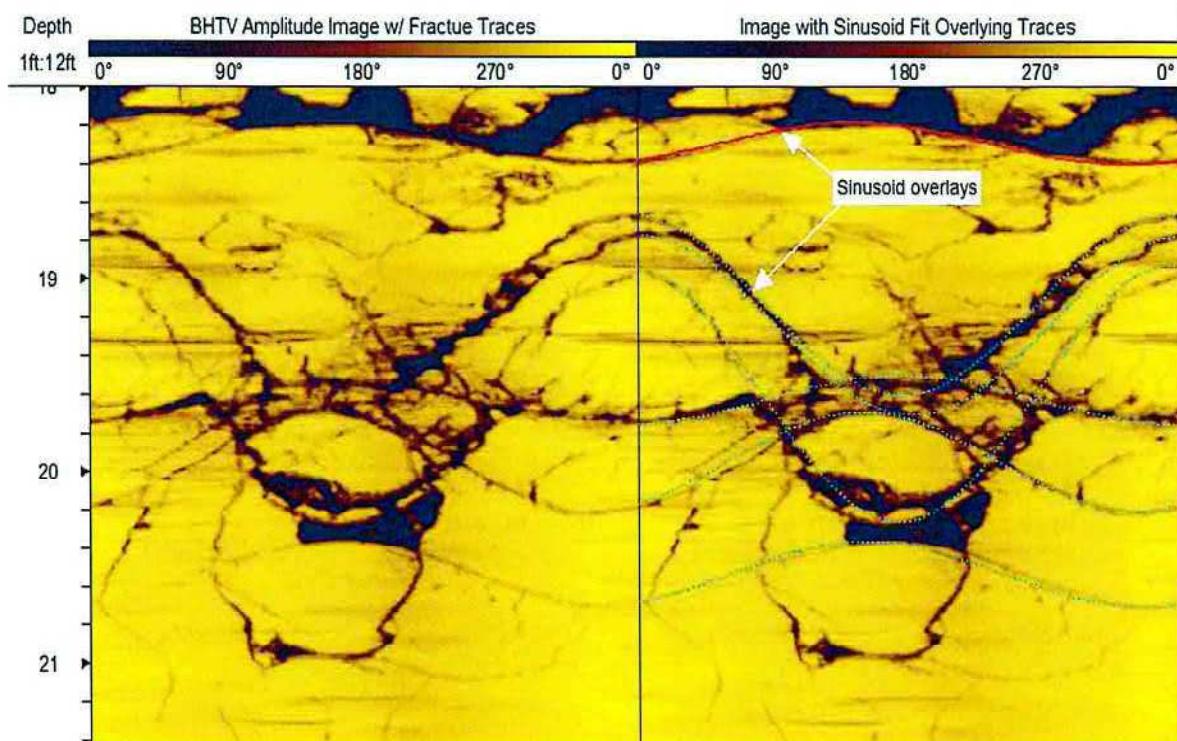
**Figure A-2:** A sample BHTV section showing observable discontinuity traces (left) versus the same image (right) with the addition of interpreted sinusoidal overlays (solid red and green colored traces).

fitted with a bendable sinusoid overlying the trace, as shown in Figure A-2. This provided data that were used by **WELLCAD** to calculate a plane representing the orientation of the discontinuity in terms of dip direction and dip magnitude. This process was repeated for every significant discontinuity until the entire borehole was interpreted. At this stage, the apparent dip direction and dip magnitude of the identified discontinuities were converted to true geographic dip azimuth and dip magnitude by factoring the borehole tilt (inclination) and azimuth at the depth of the discontinuity.

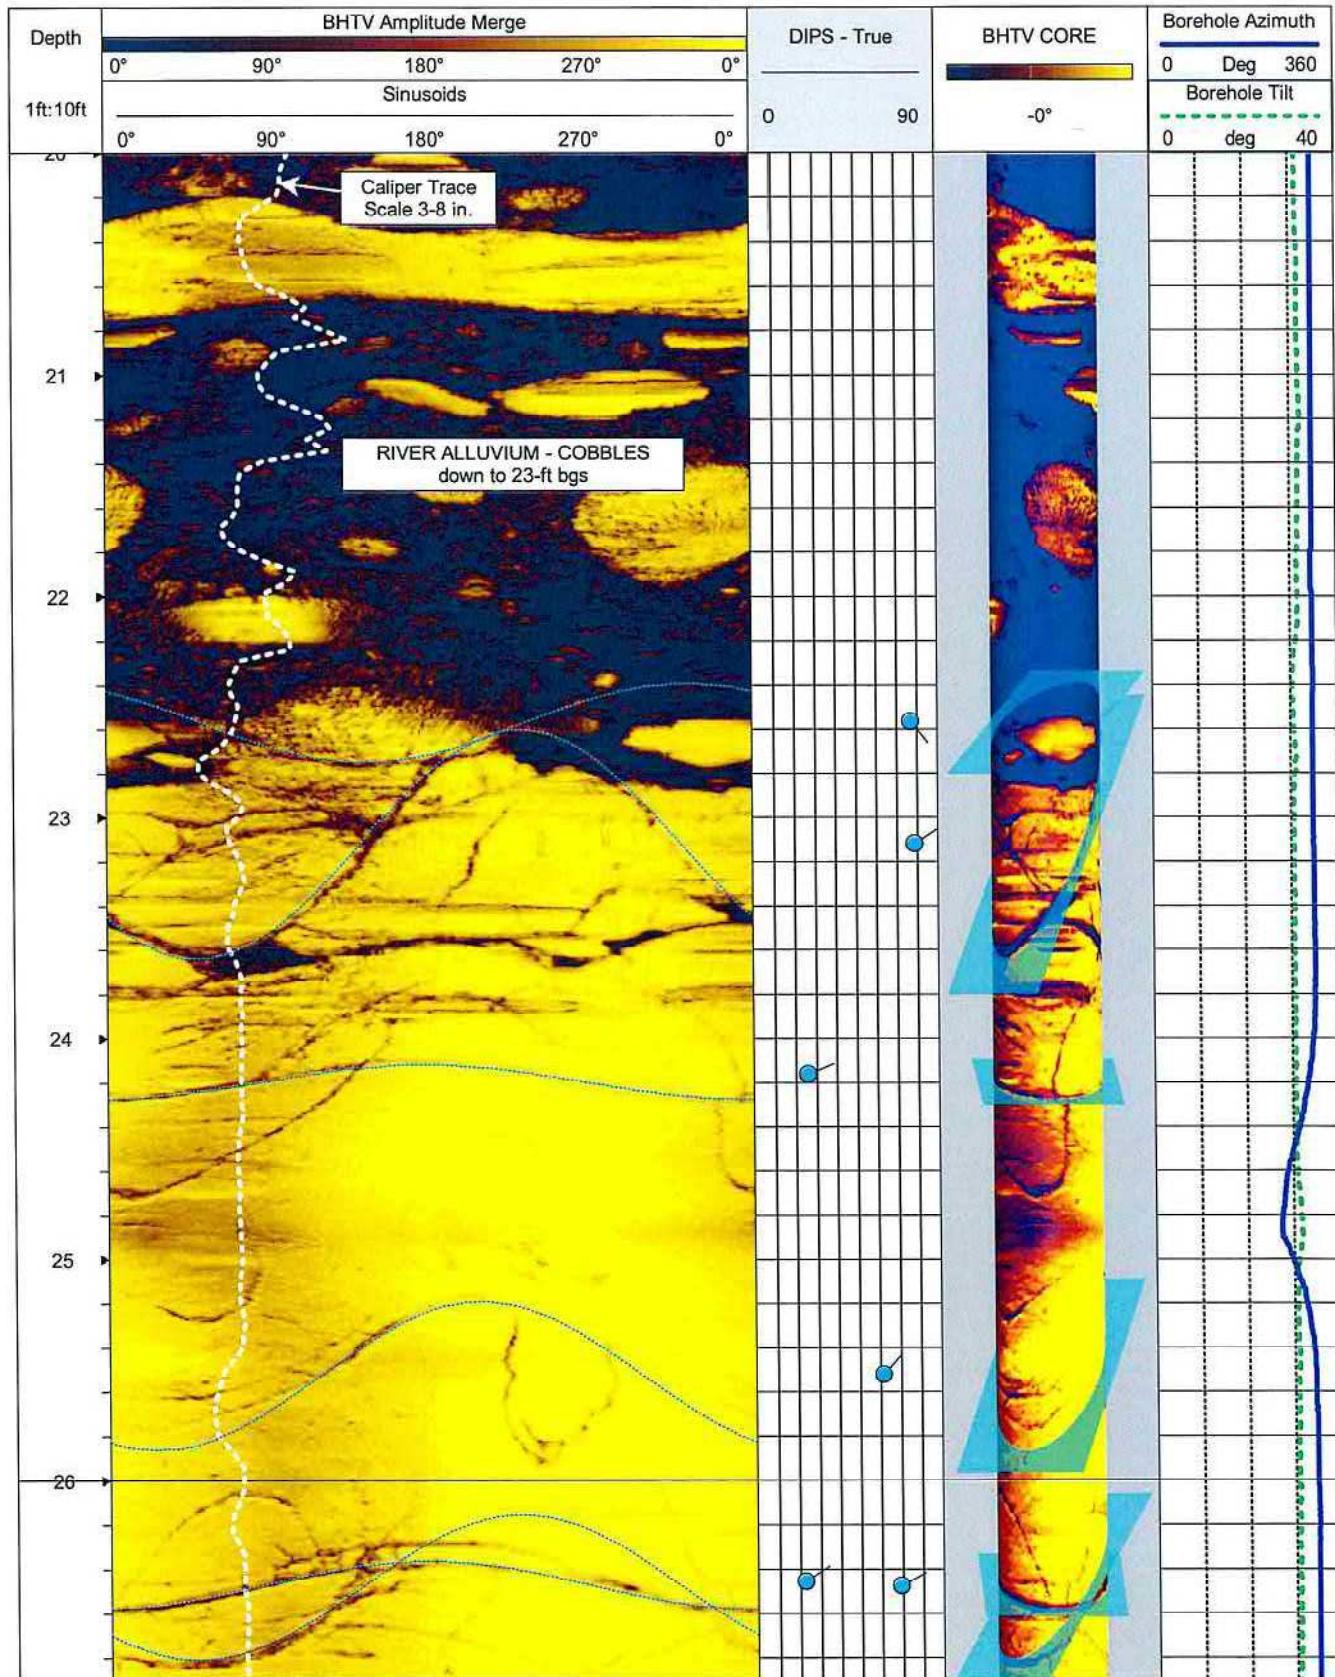
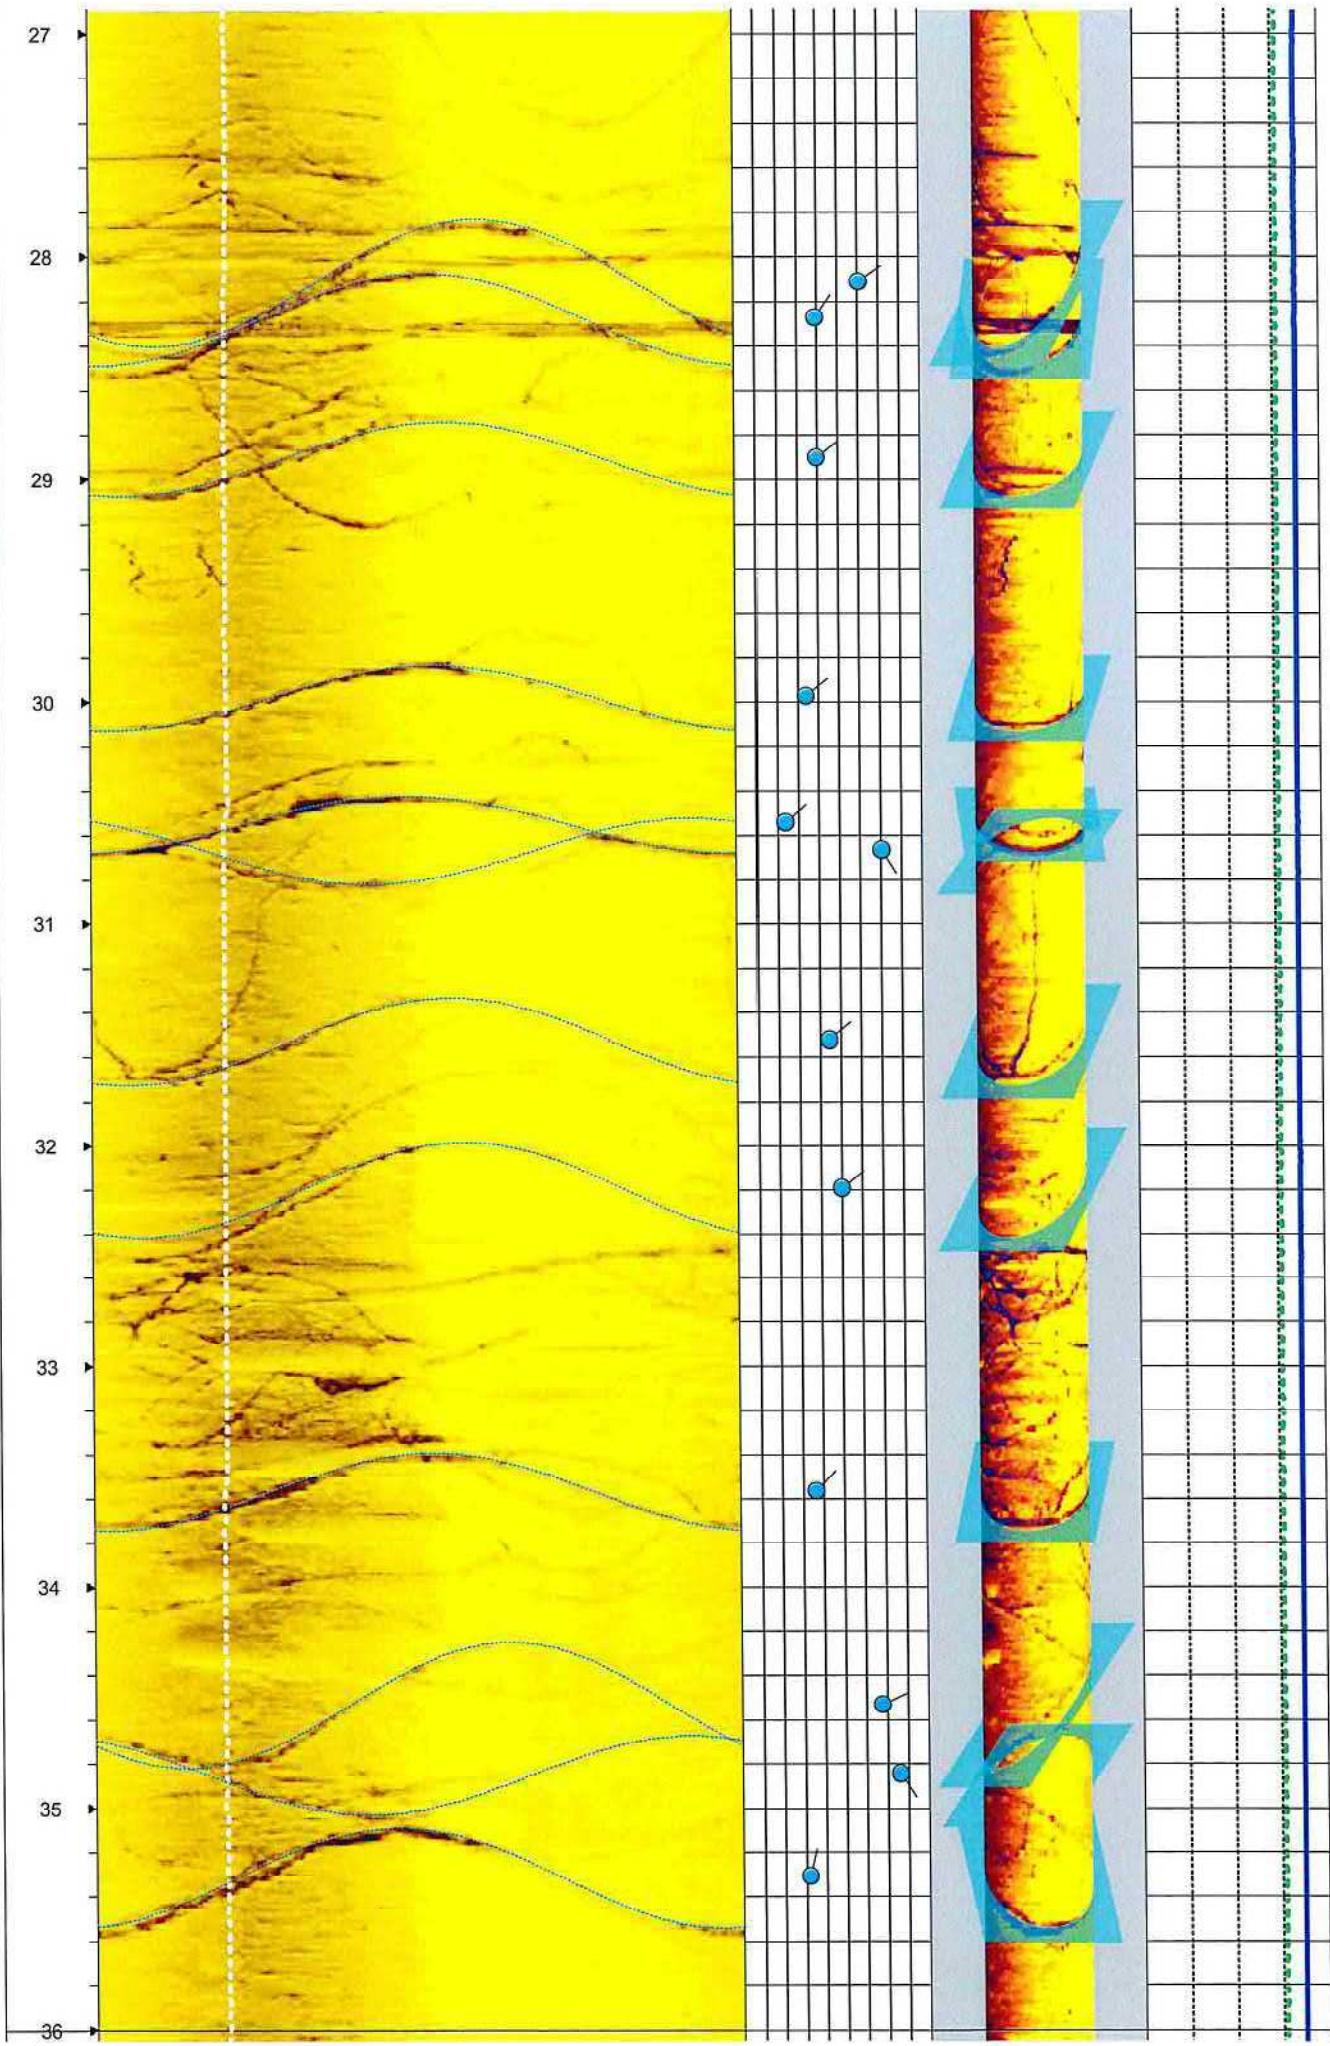
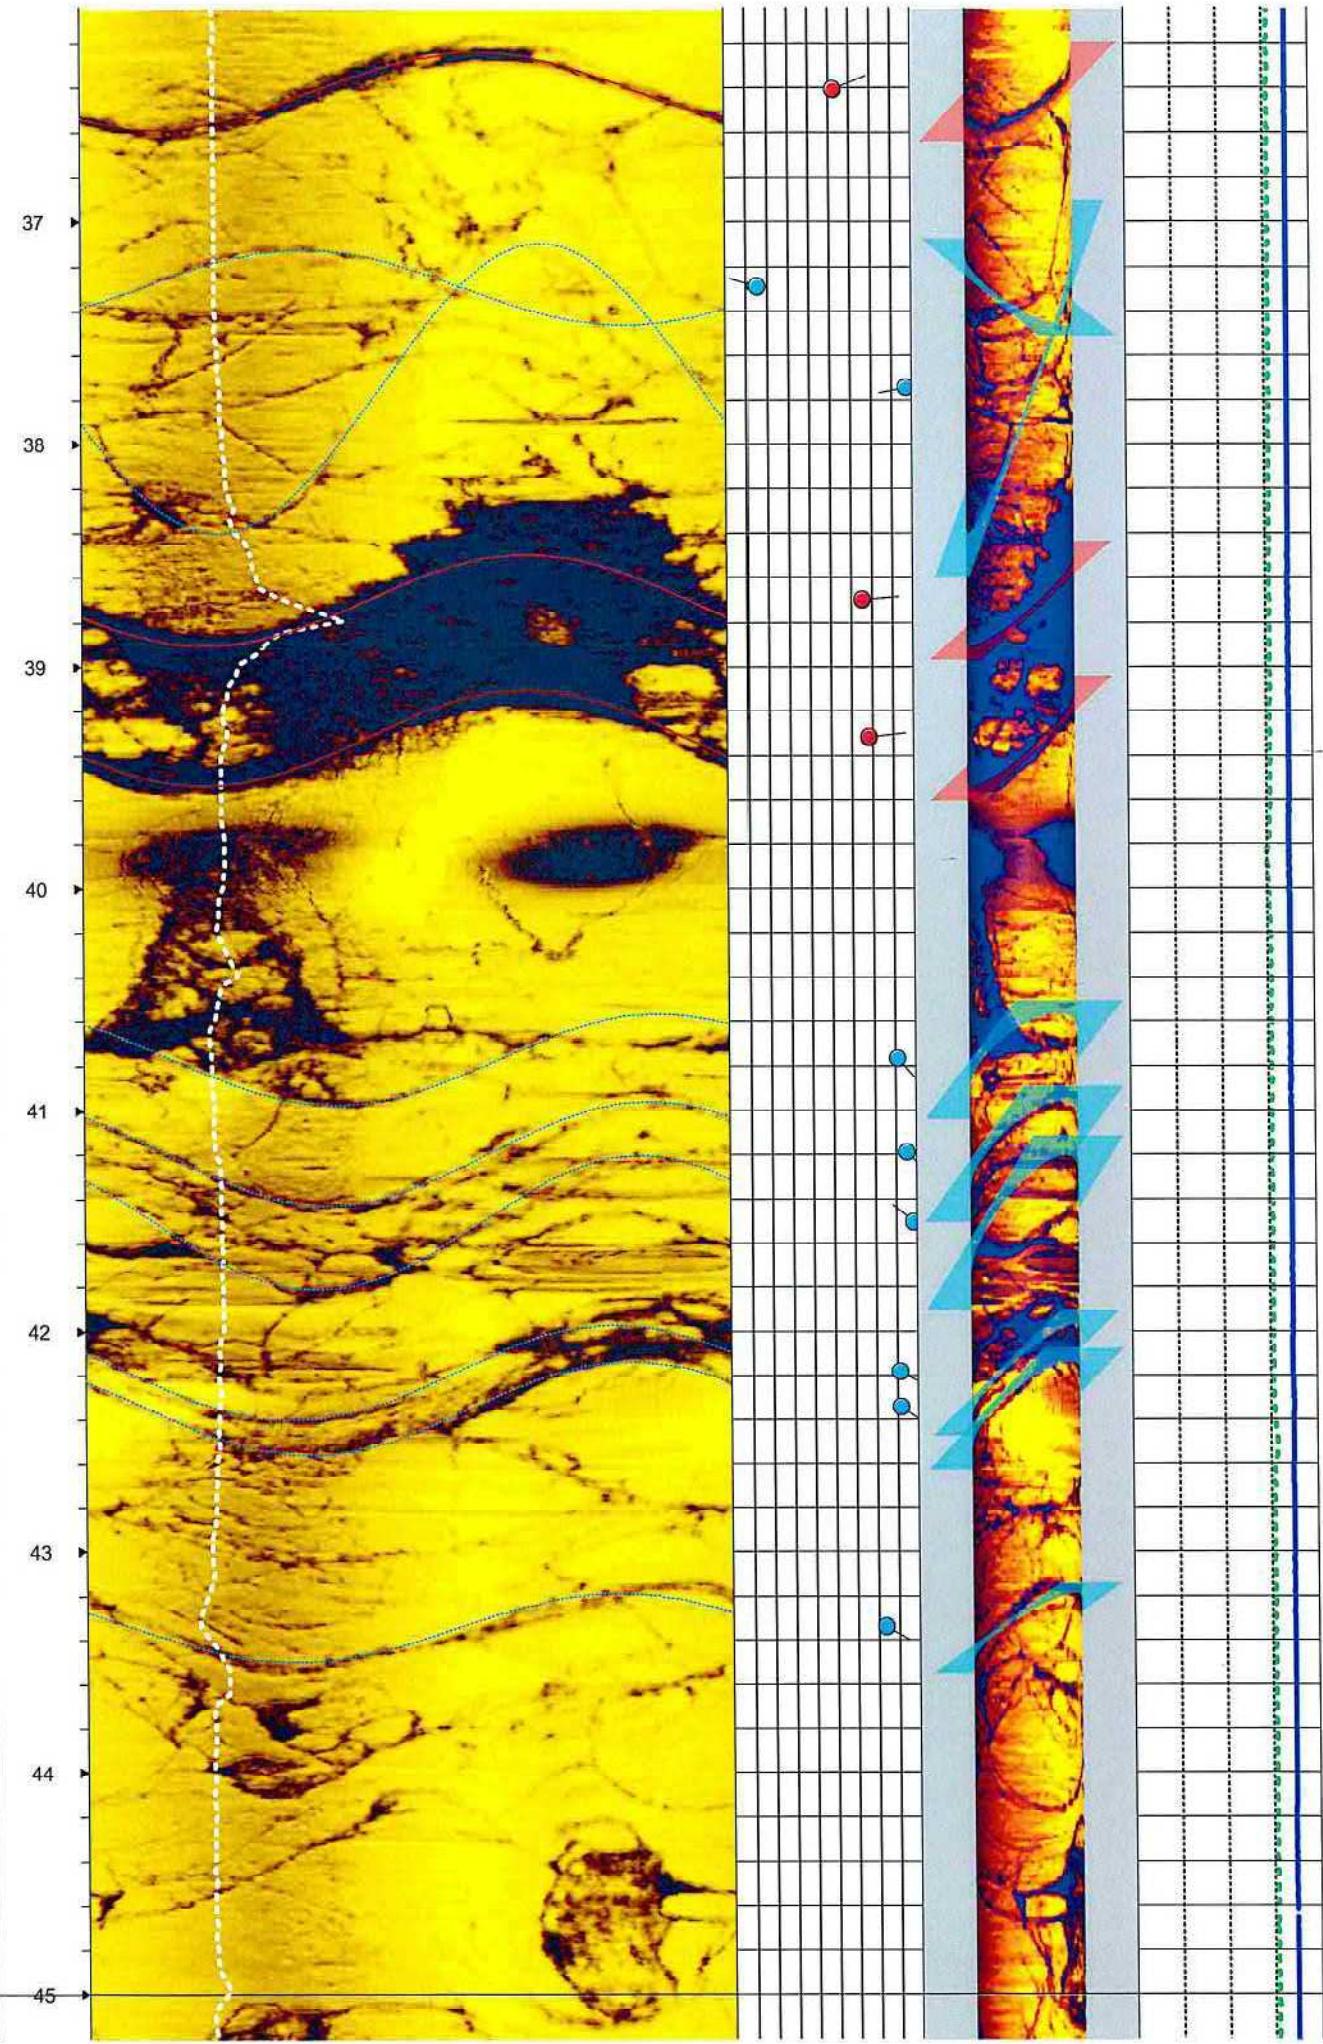
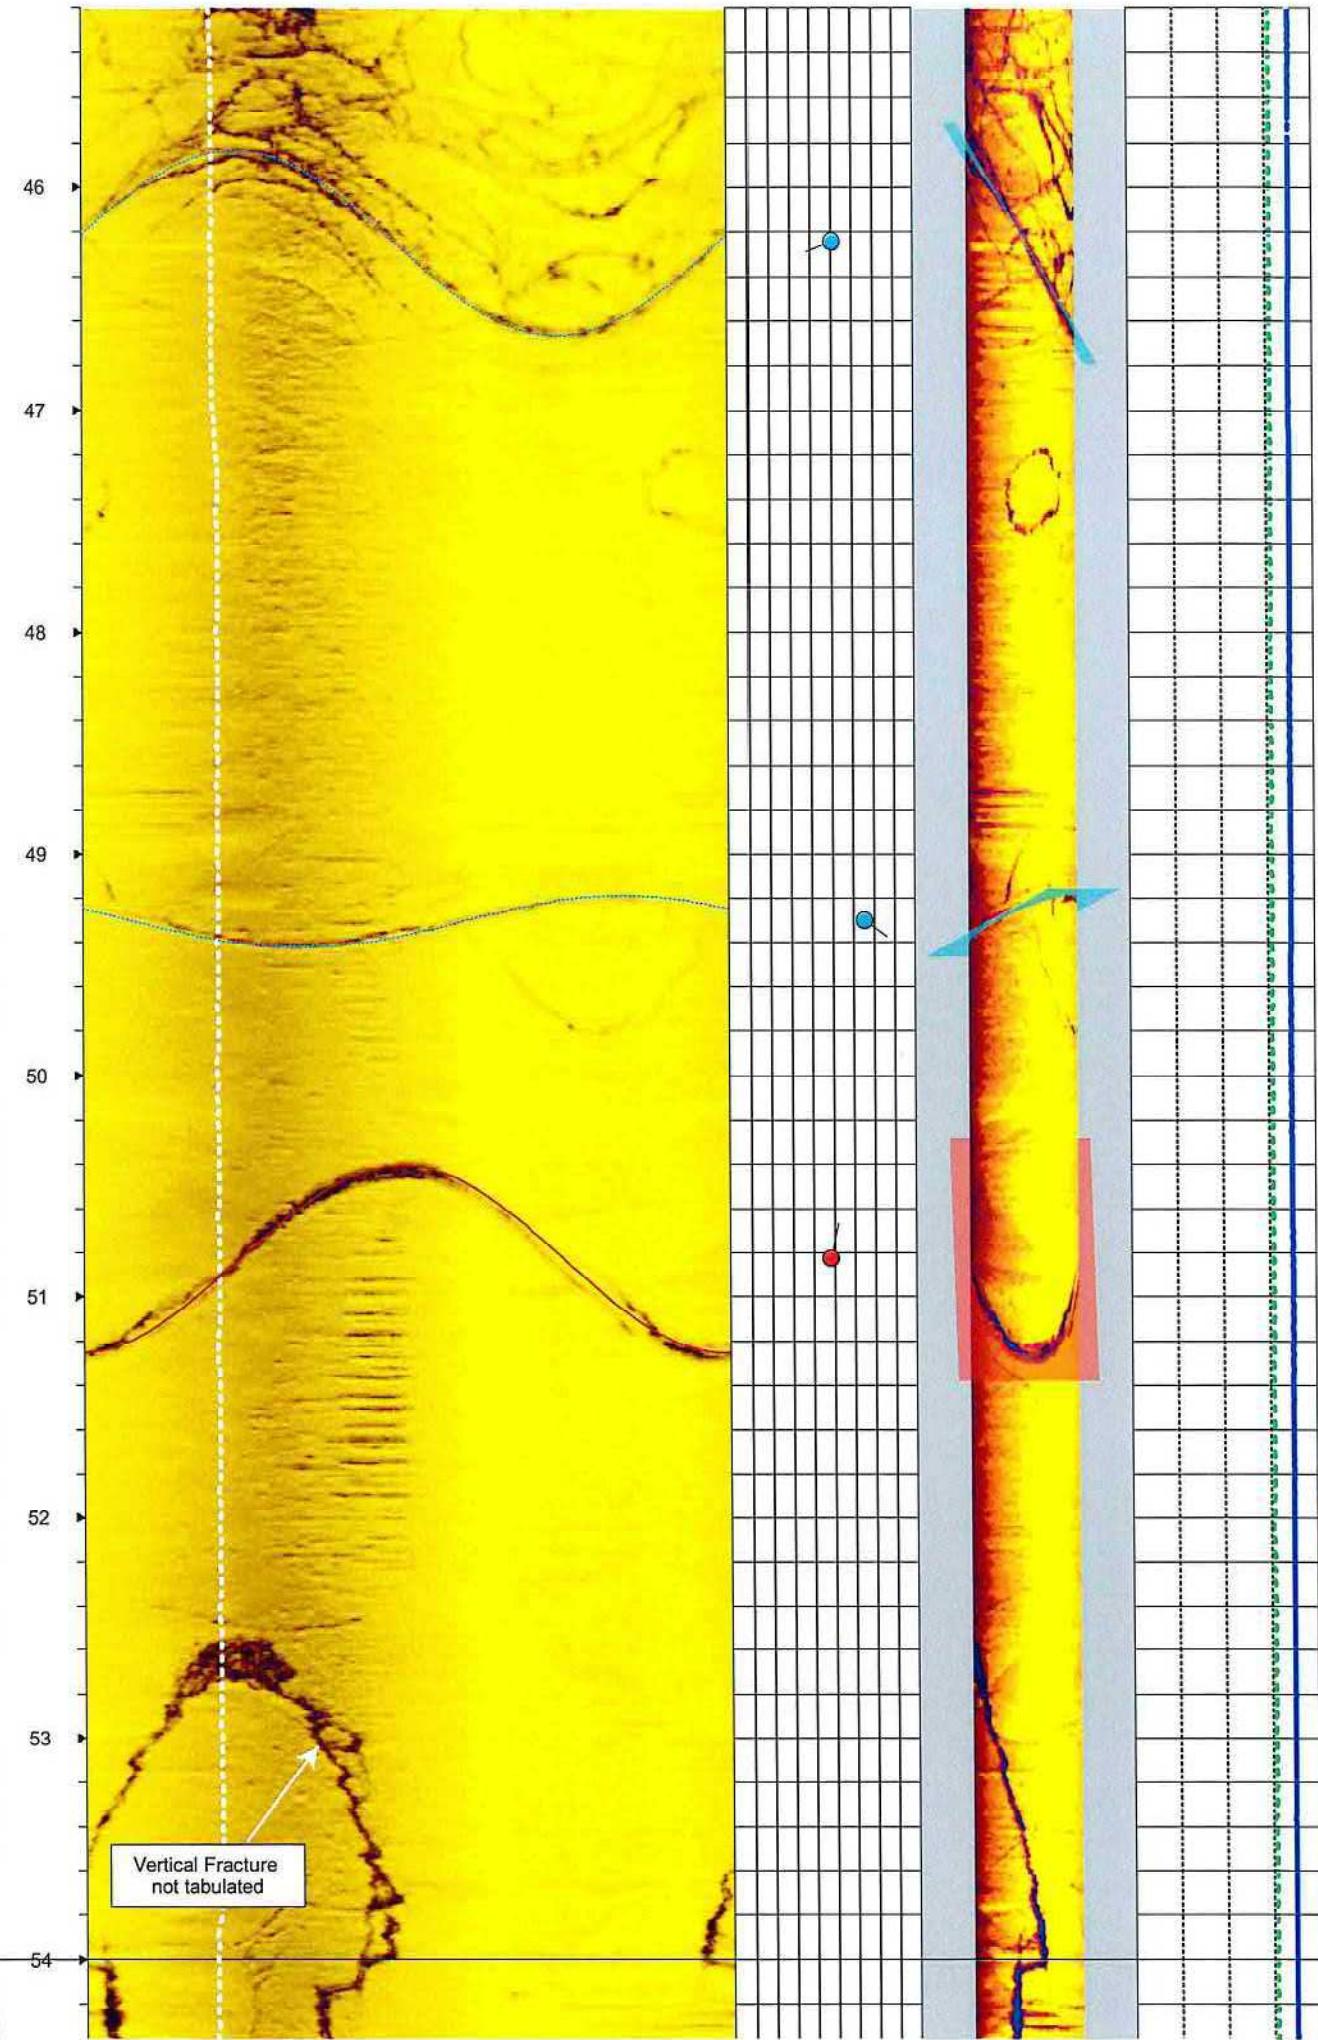
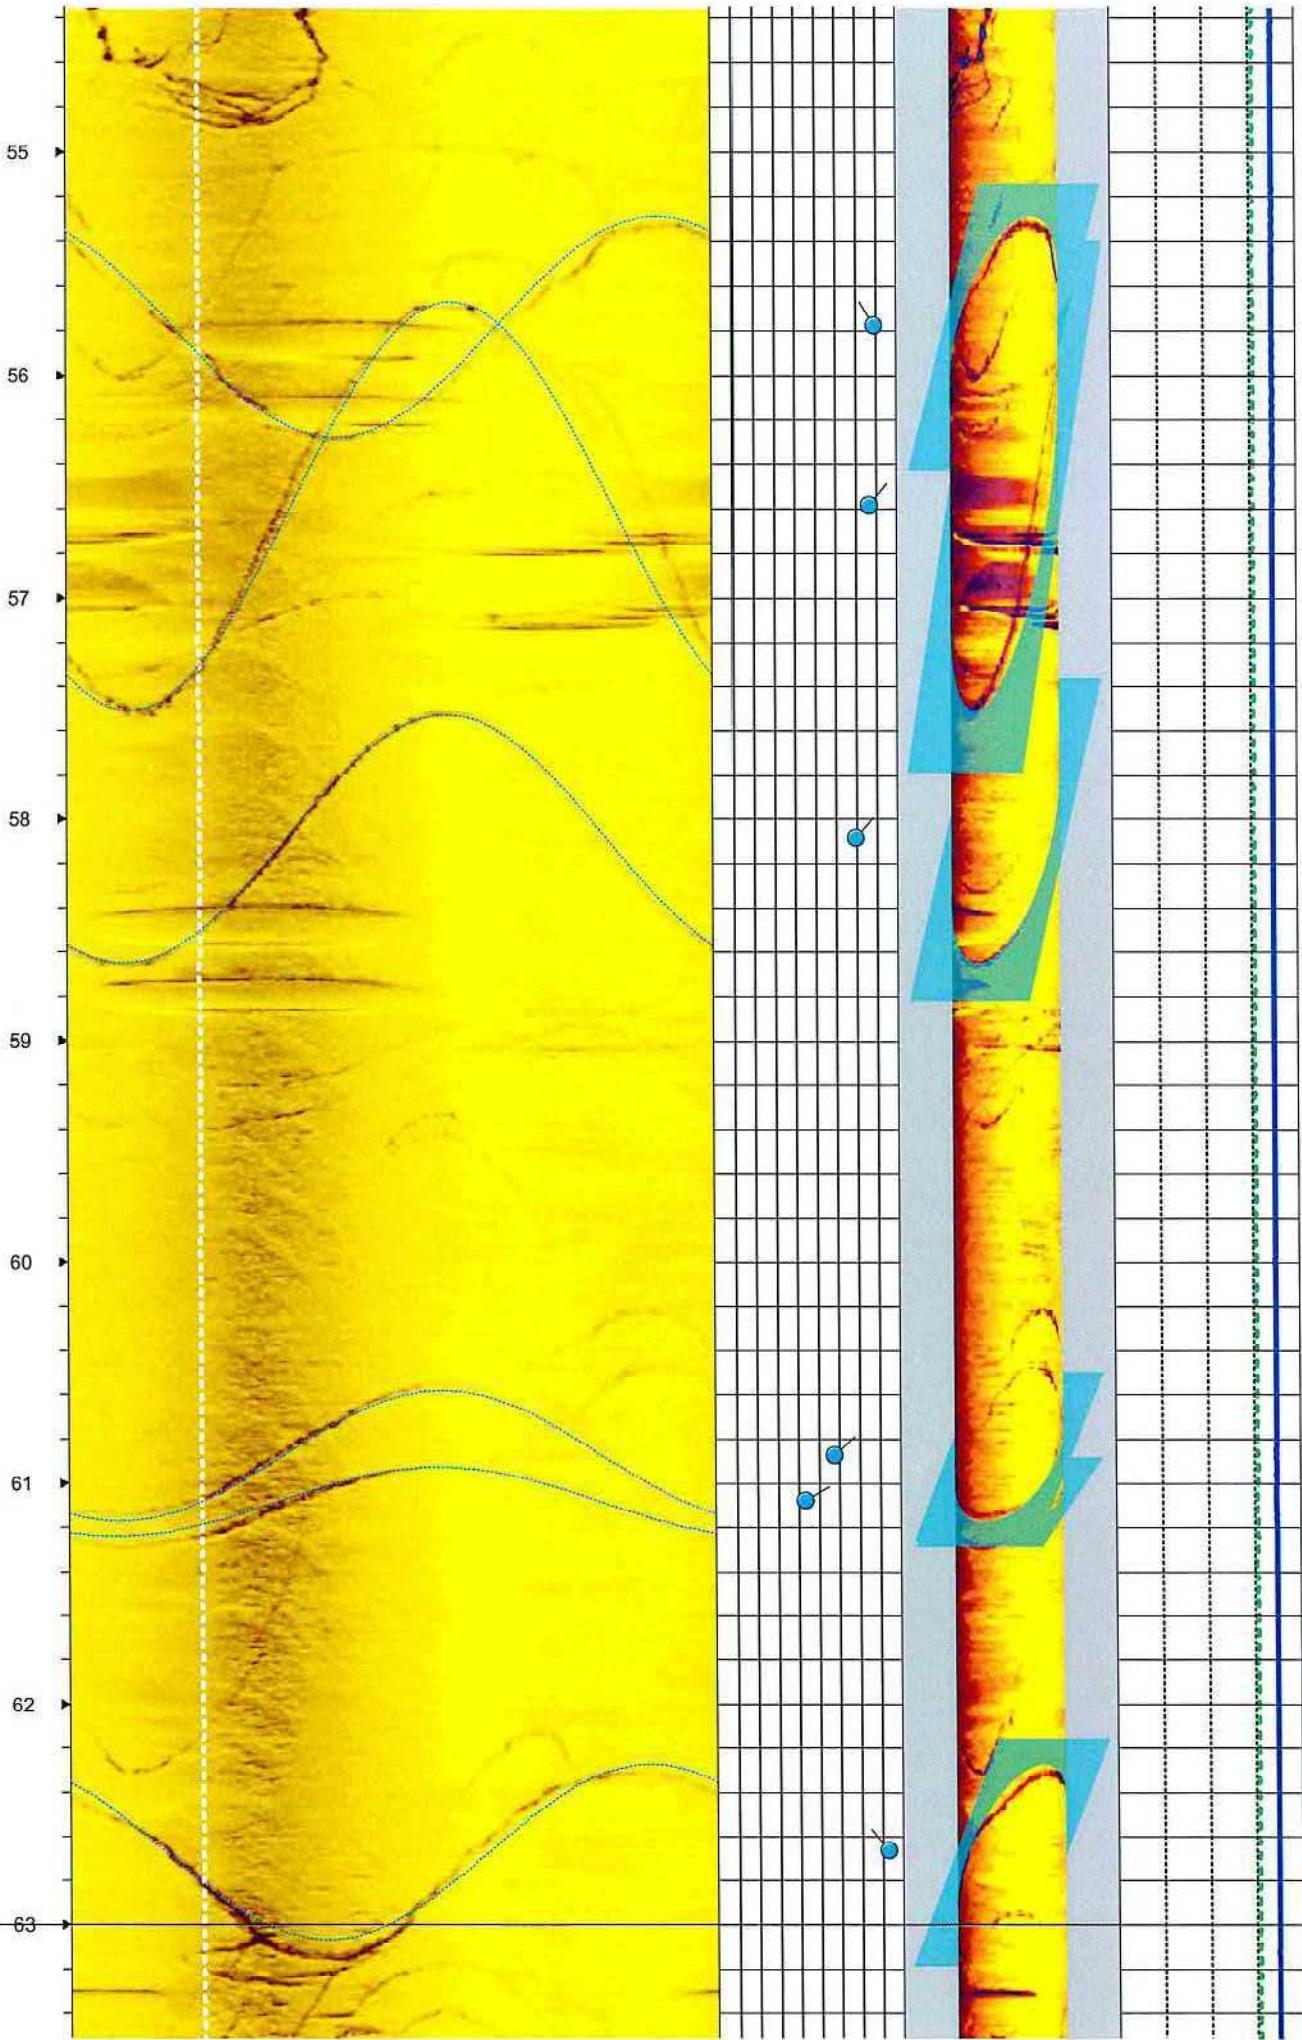
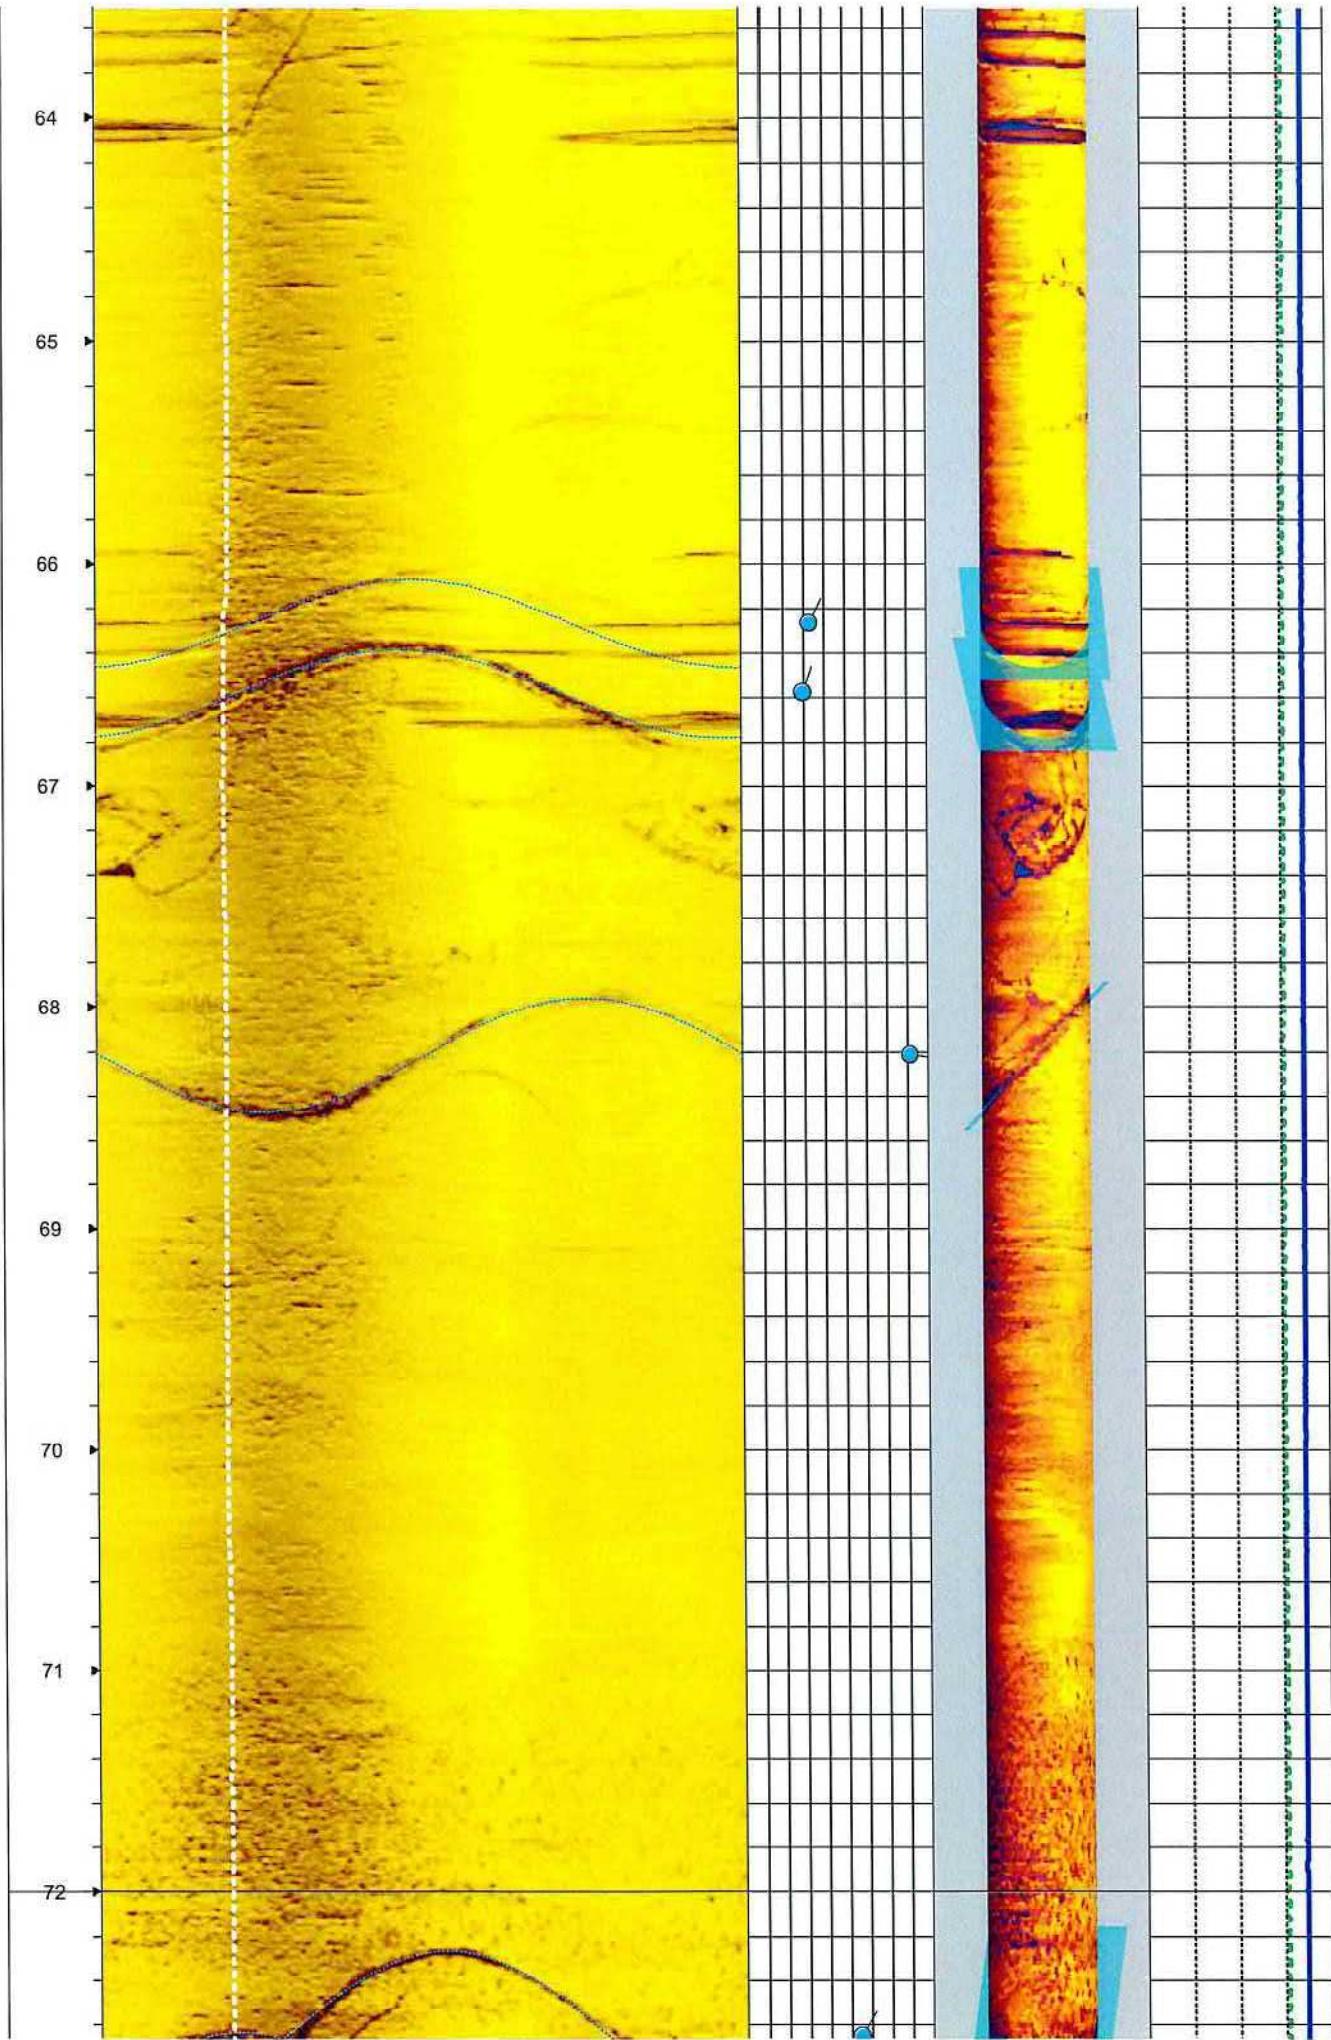
**Appendix C:**  
**TelevIEWER Analysis Plot**  
**Borehole B-206**

sinusoidal fracture/joint traces depict interpreted discontinuities. The colors of the lines relate to the fracture/joint classification as follows, red = open continuous fractures, teal = "thin", partial to complete fractures and blue = lithologic contacts. Note, that due to the wide apparent thickness of some fractures, we expanded the line trace into a broader hachured sinusoidal section.

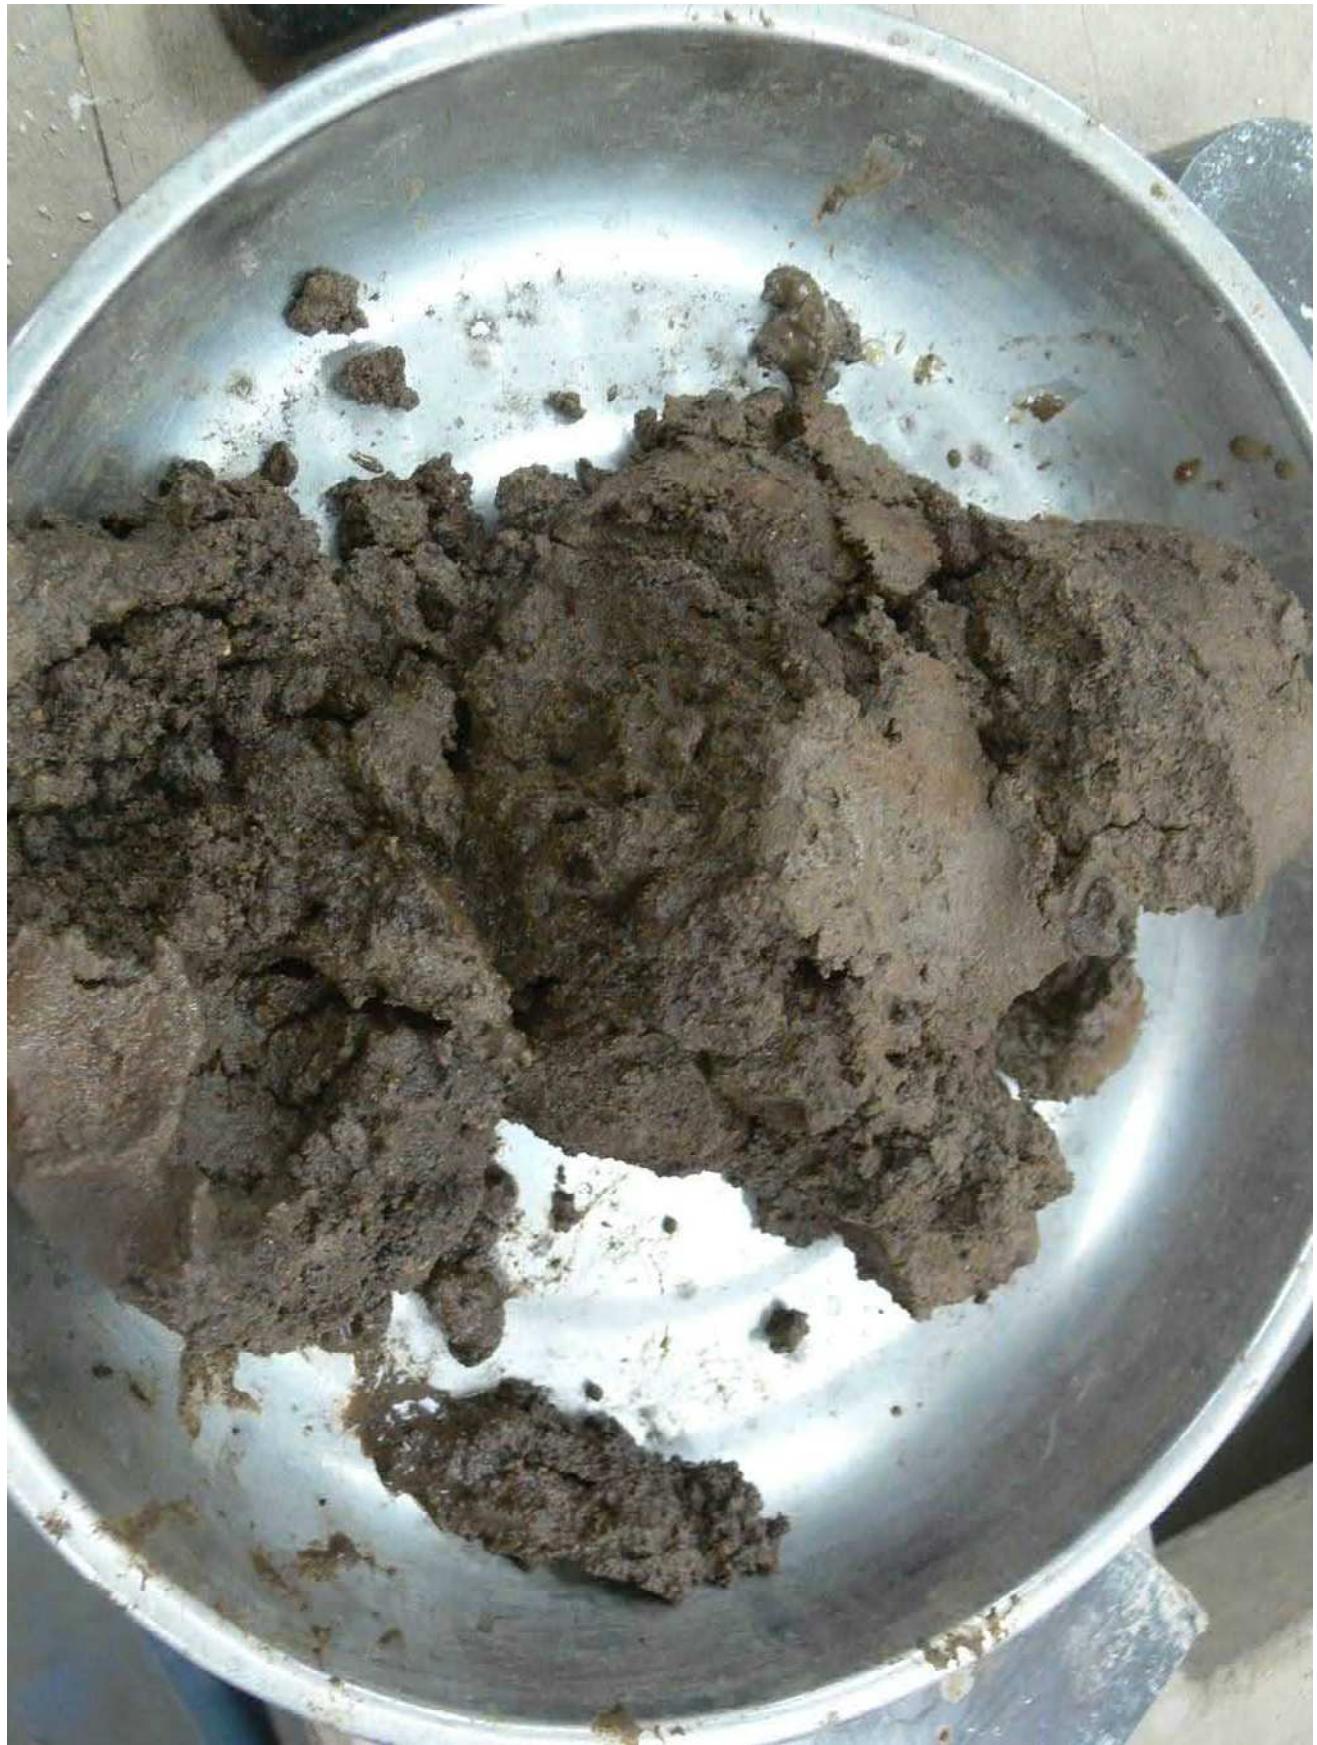
Photo 1: 020-272 BC-13 S01 @ 7' (Tip-4") After TXUU.JPG

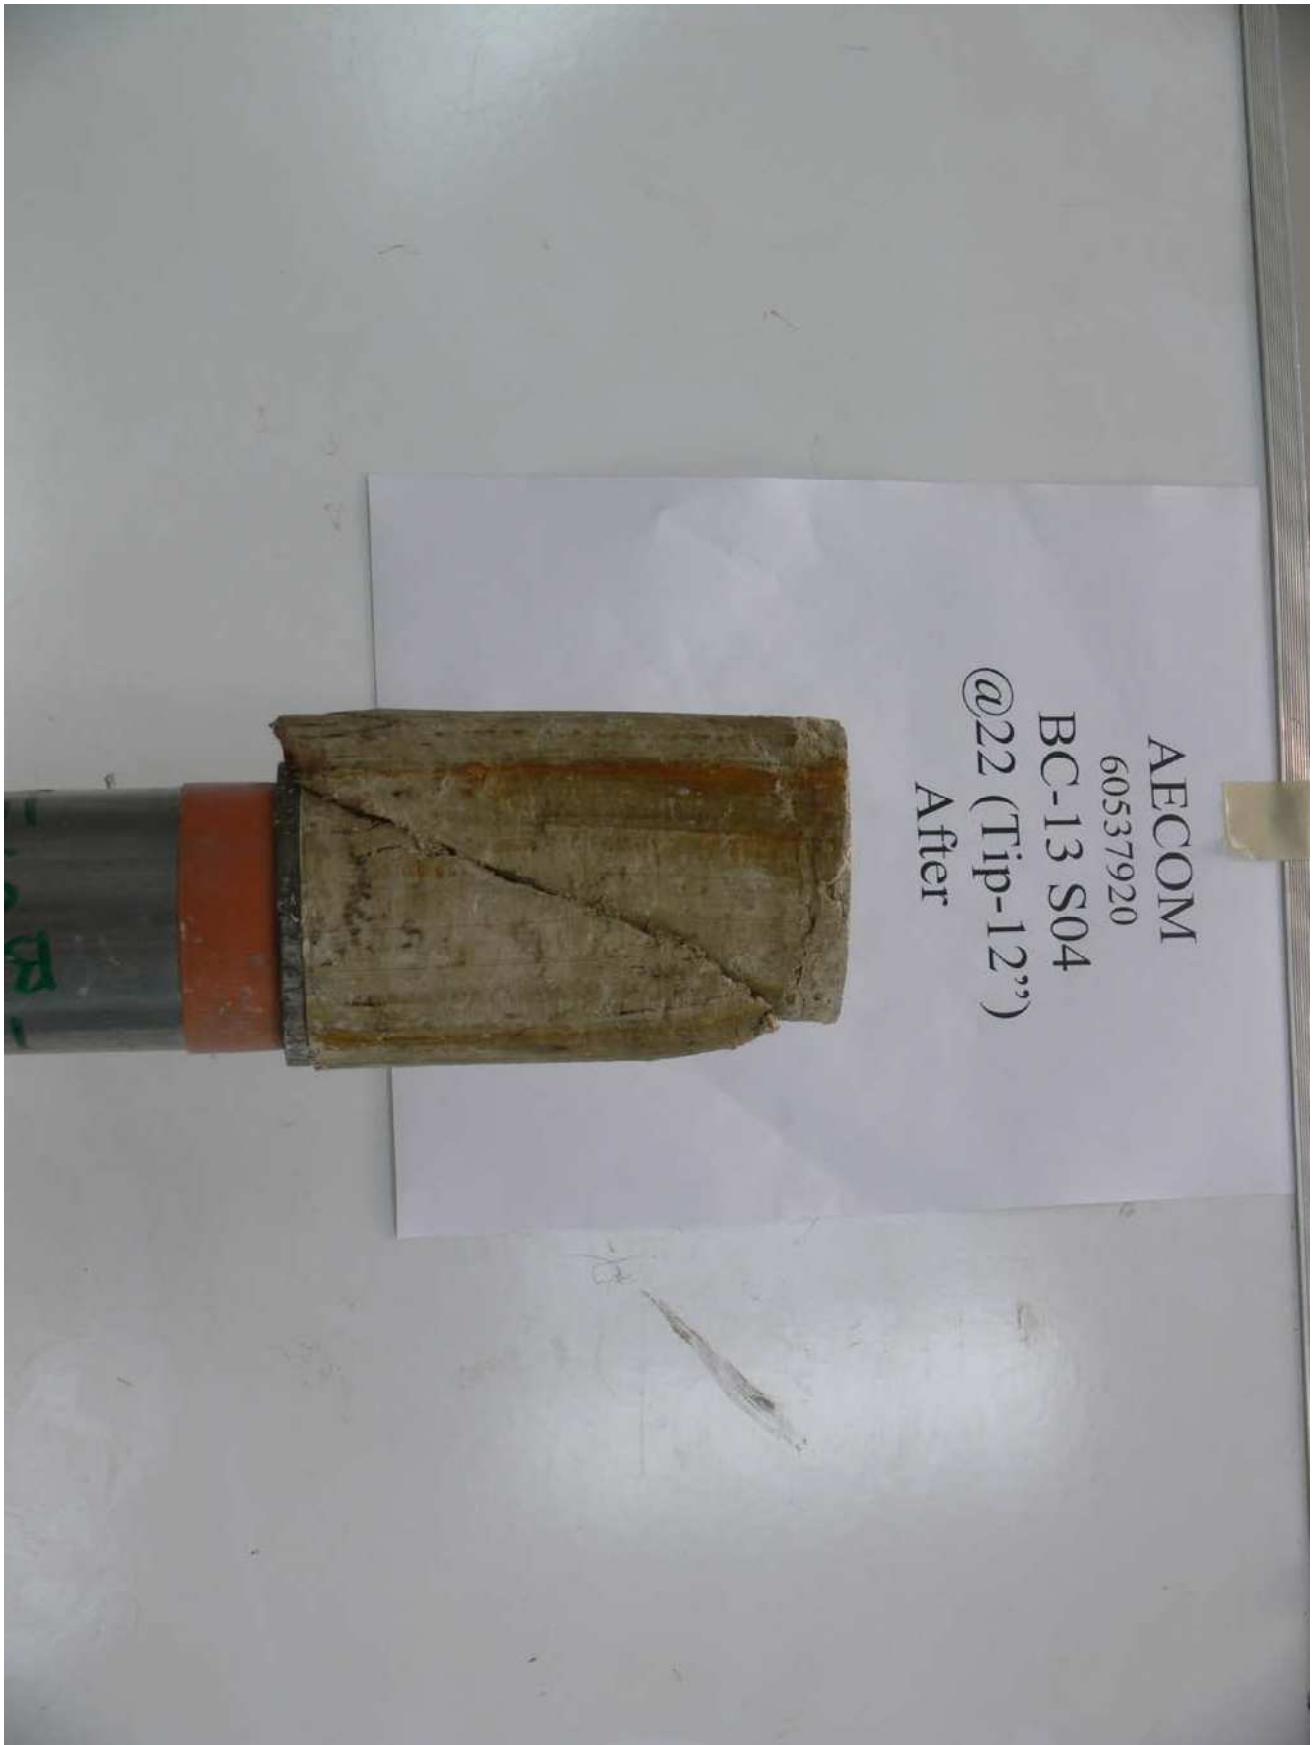
Photo 6: 020-272 BC-13 S04 @ 22' (Tip-12") After TXUU.JPG
