Subject: Borehole TelevIEWER Logging Survey  
Klamath River Project  
Iron Gate Reservoir  
Siskiyou County, California

This report presents the findings of a borehole geophysical investigation performed by NORCAL Geophysical Consultants, Inc. at the Klamath River Project at the northeast end of Iron Gate Reservoir. This investigation was part of a geotechnical study to assess subsurface conditions along a propose water tunnel alignment. The survey was performed on two separate mobilizations during the period of August 16 through 23, 2018 by NORCAL Professional Geophysicist William J. Henrich PGp 893. Logistical support and safety information were provided onsite by Mr. Tim VandeVoorde, Engineering Geologist of AECOM.

Subject: Project No.: 60537920  
Project Name: Klamath River Dam Removal Project  
Corrosivity Analysis – CalTrans Test Methods

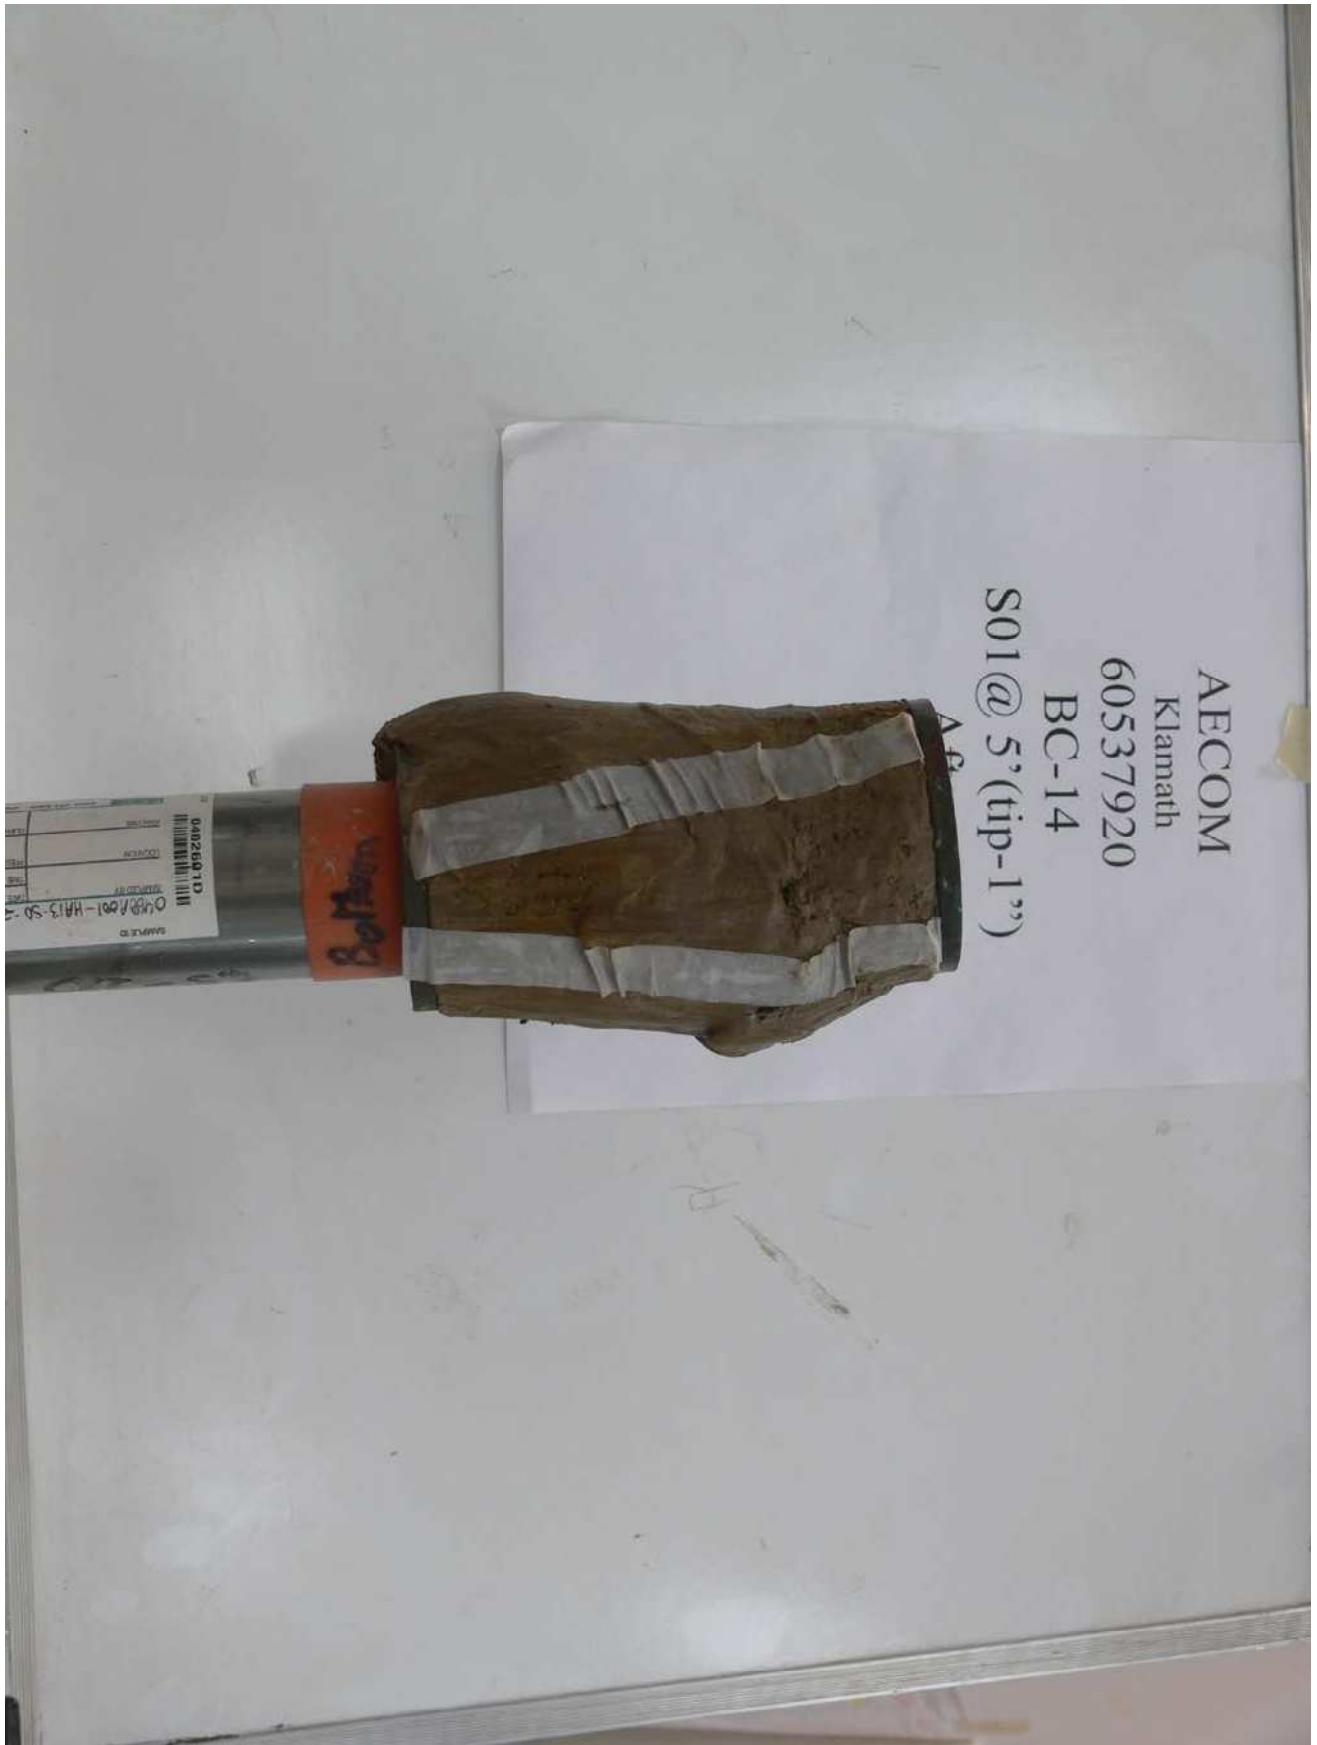
Photo 14: 020-272 BC-14 S01 @ 5' (Tip-1") After TXCUPP #1.JPG

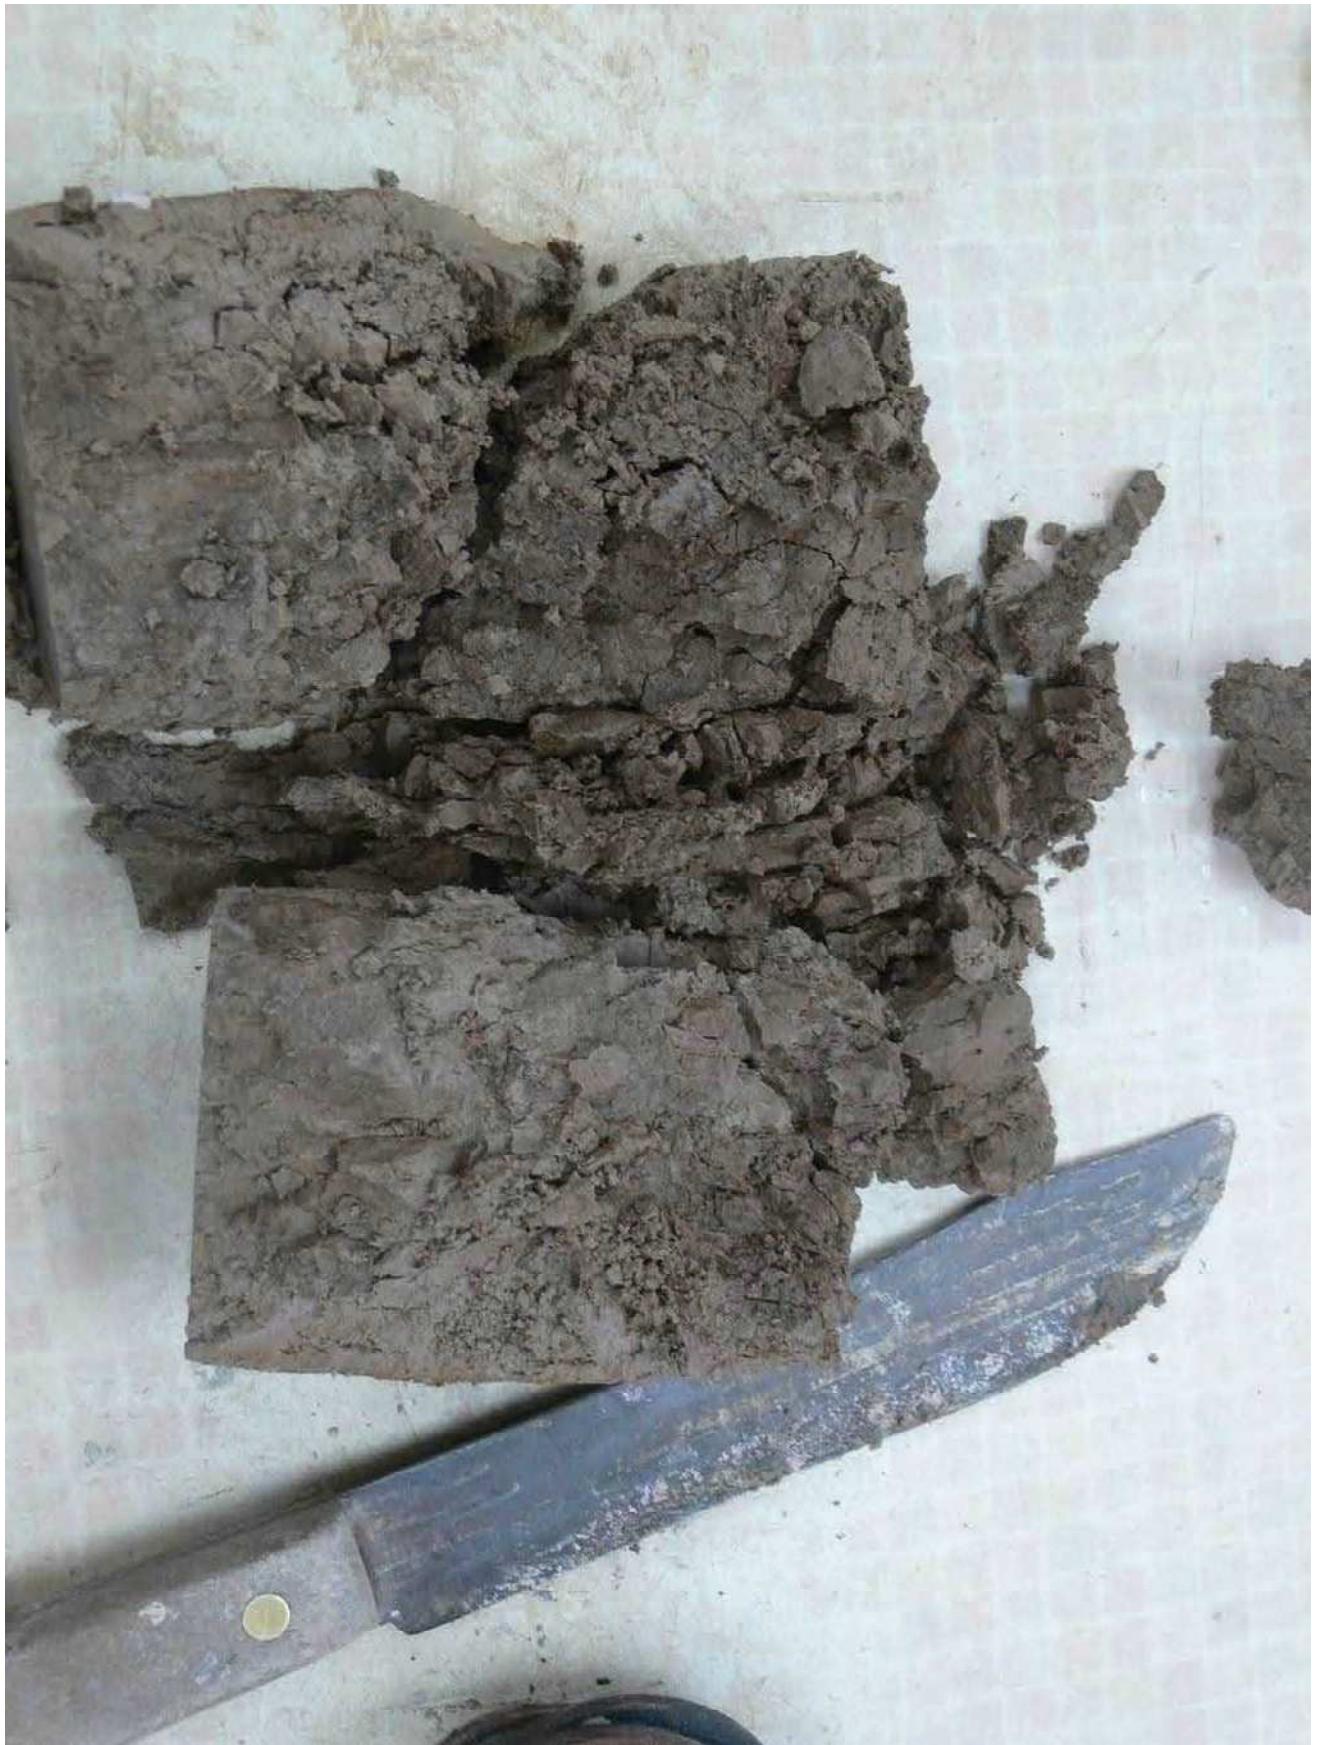
Photo 15: 020-272 BC-14 S01 @ 5' ("Tip-1") After TXCUPP #2.JPG

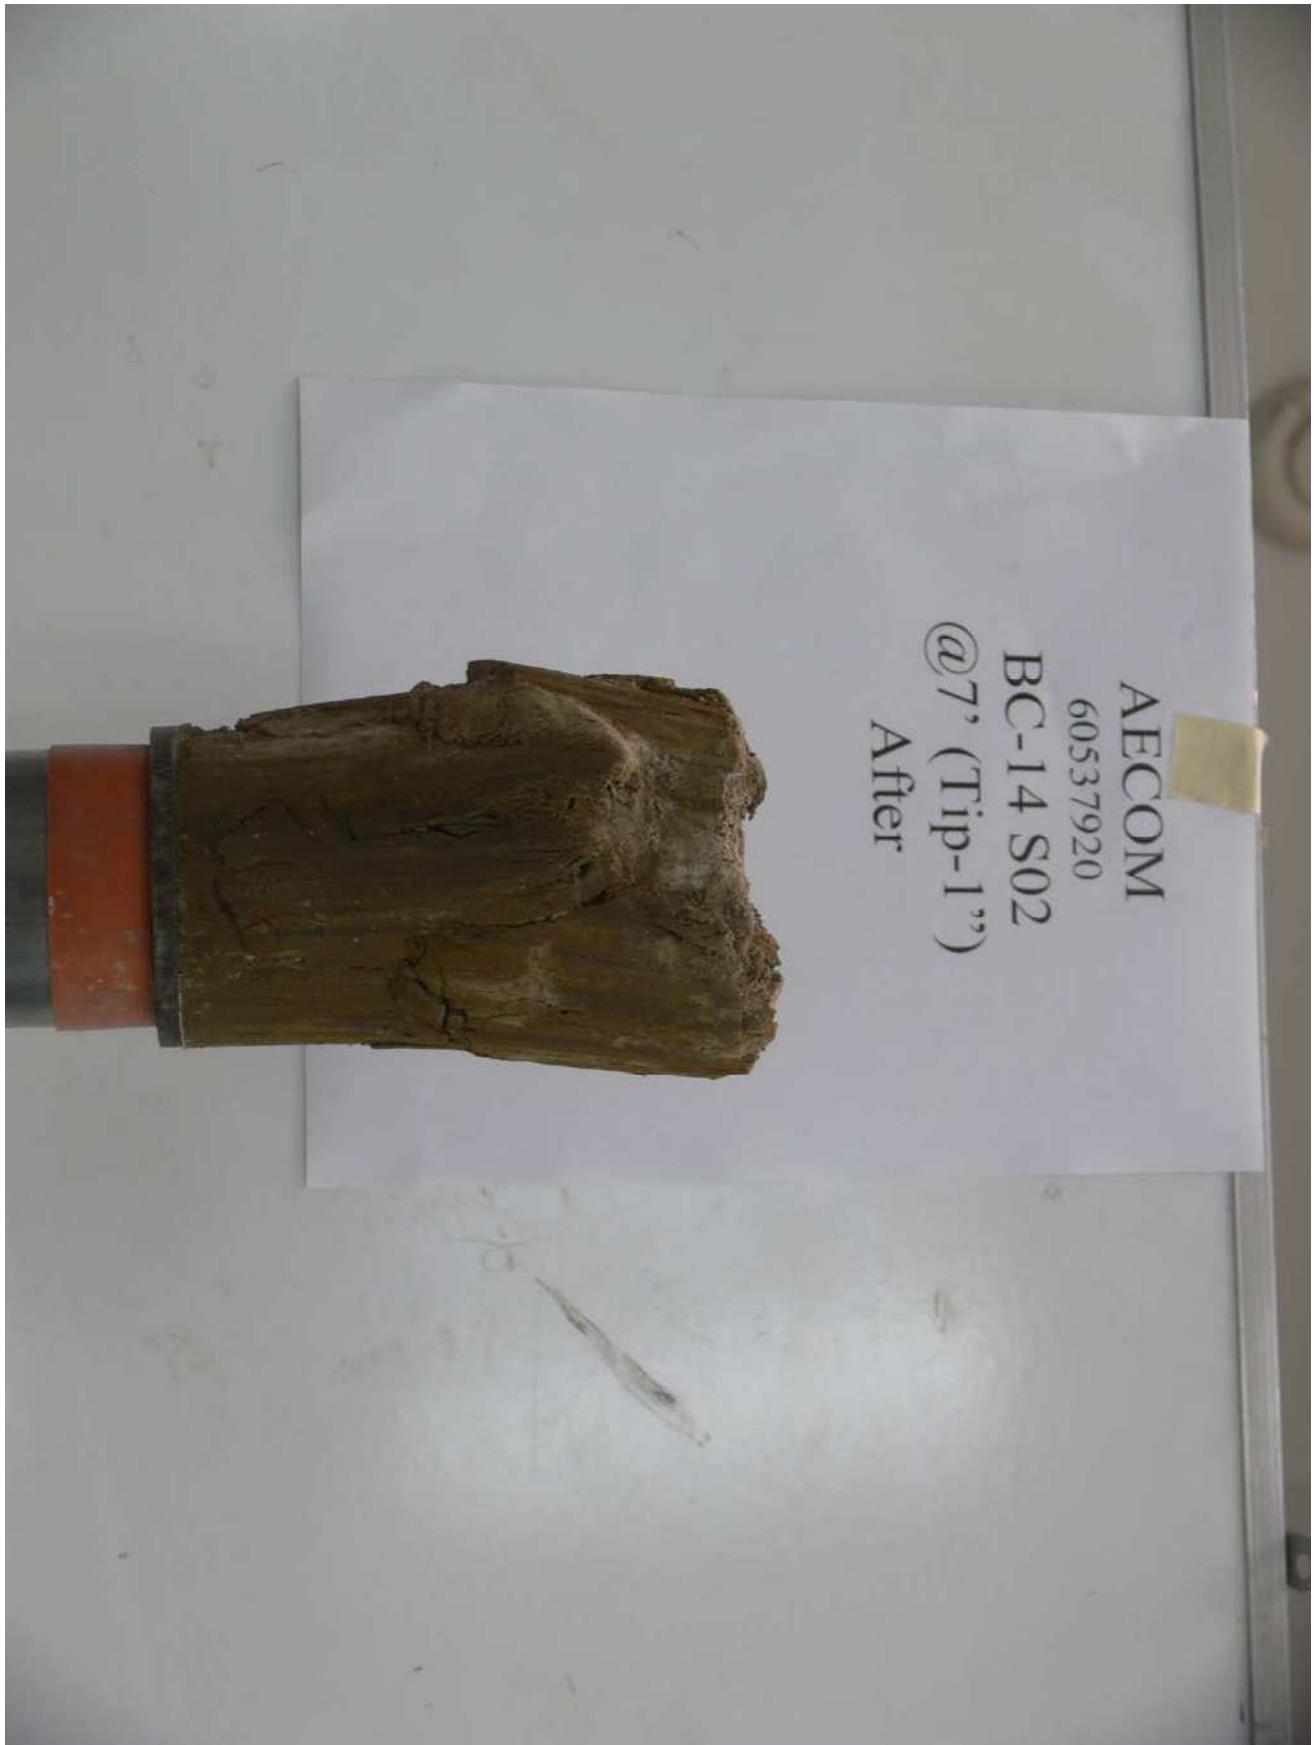
Photo 17: 020-272 BC-14 S02 @ 7' (Tip-1") After TXUUU #1.JPG

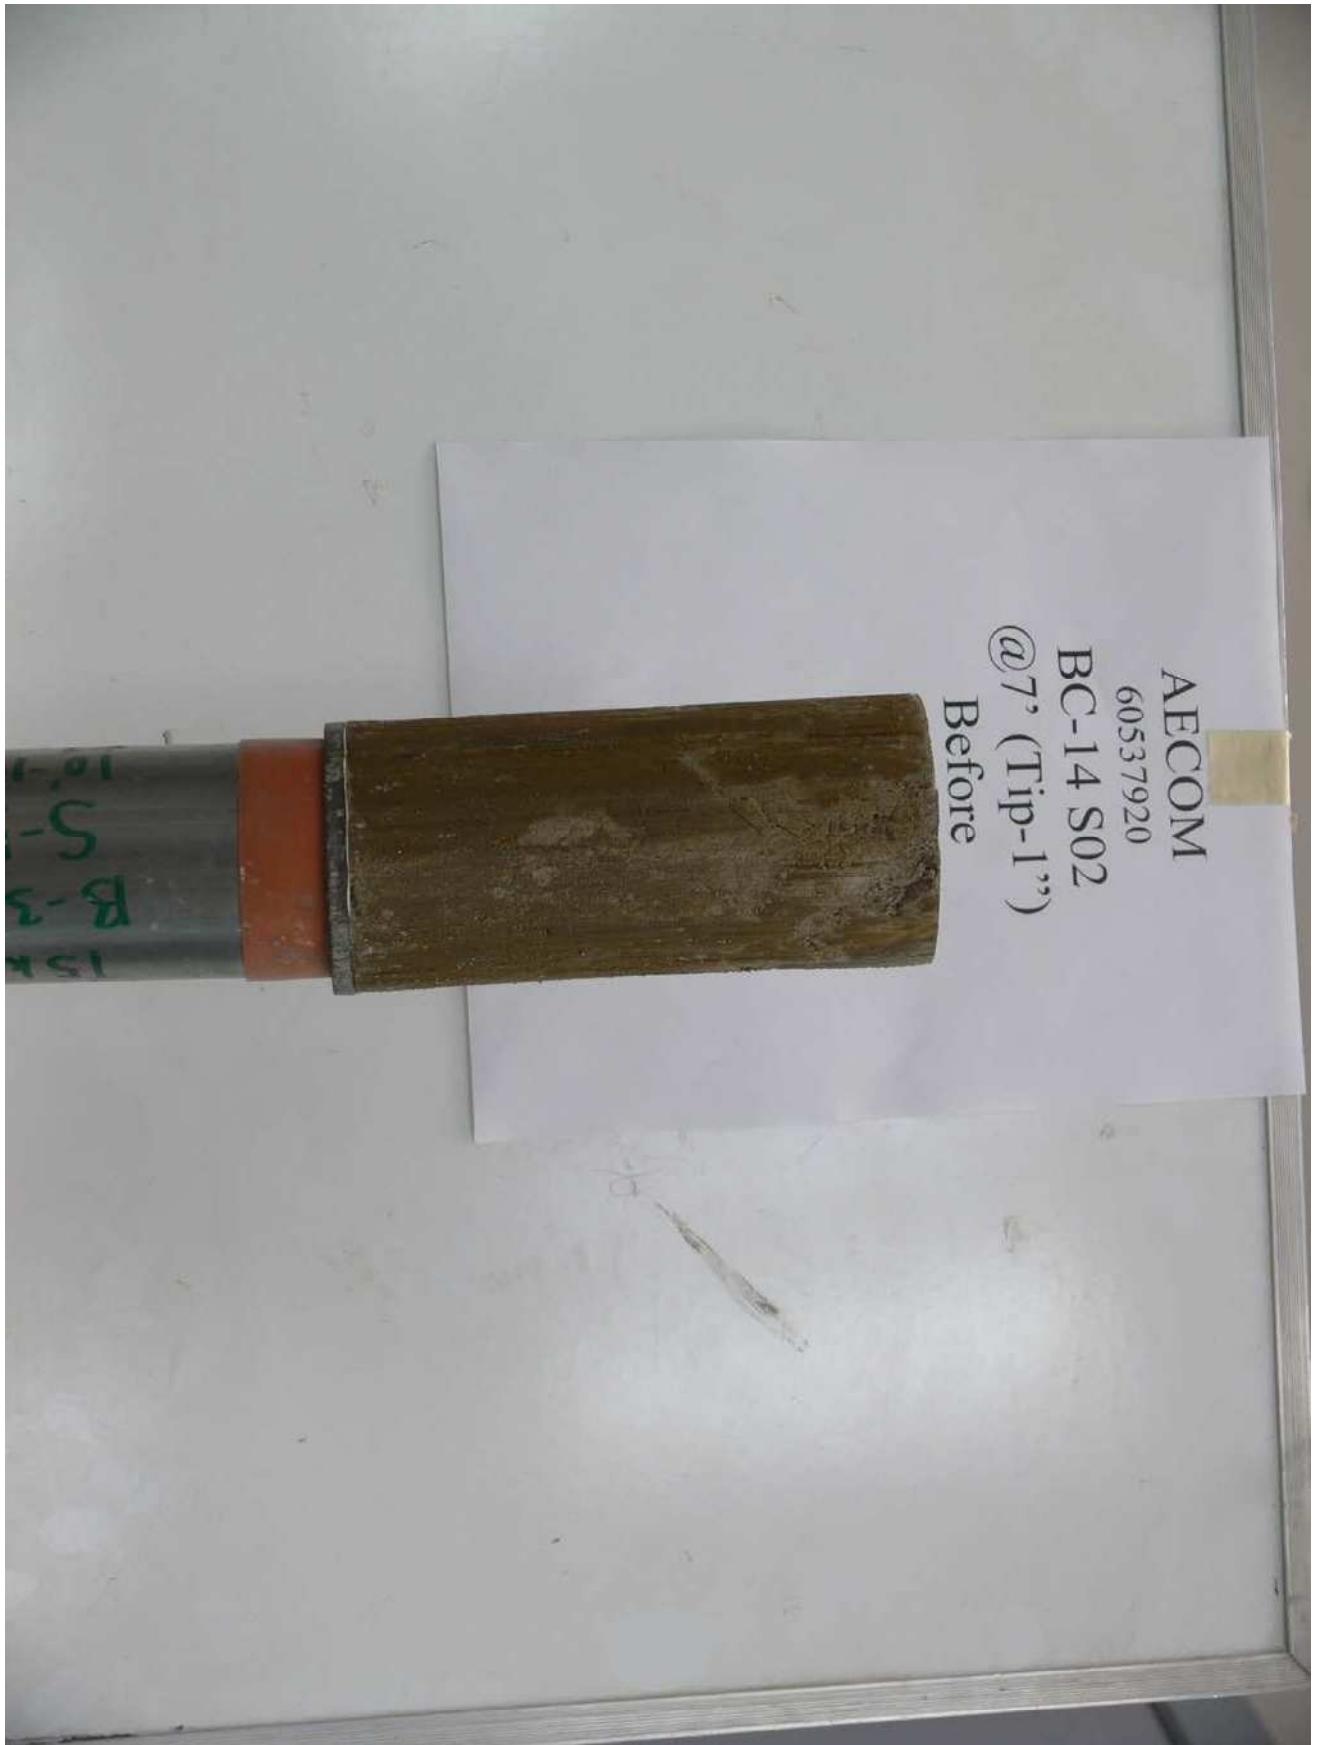
Photo 19: 020-272 BC-14 S02 @ 7' (Tip-1") Before TXUU.JPG

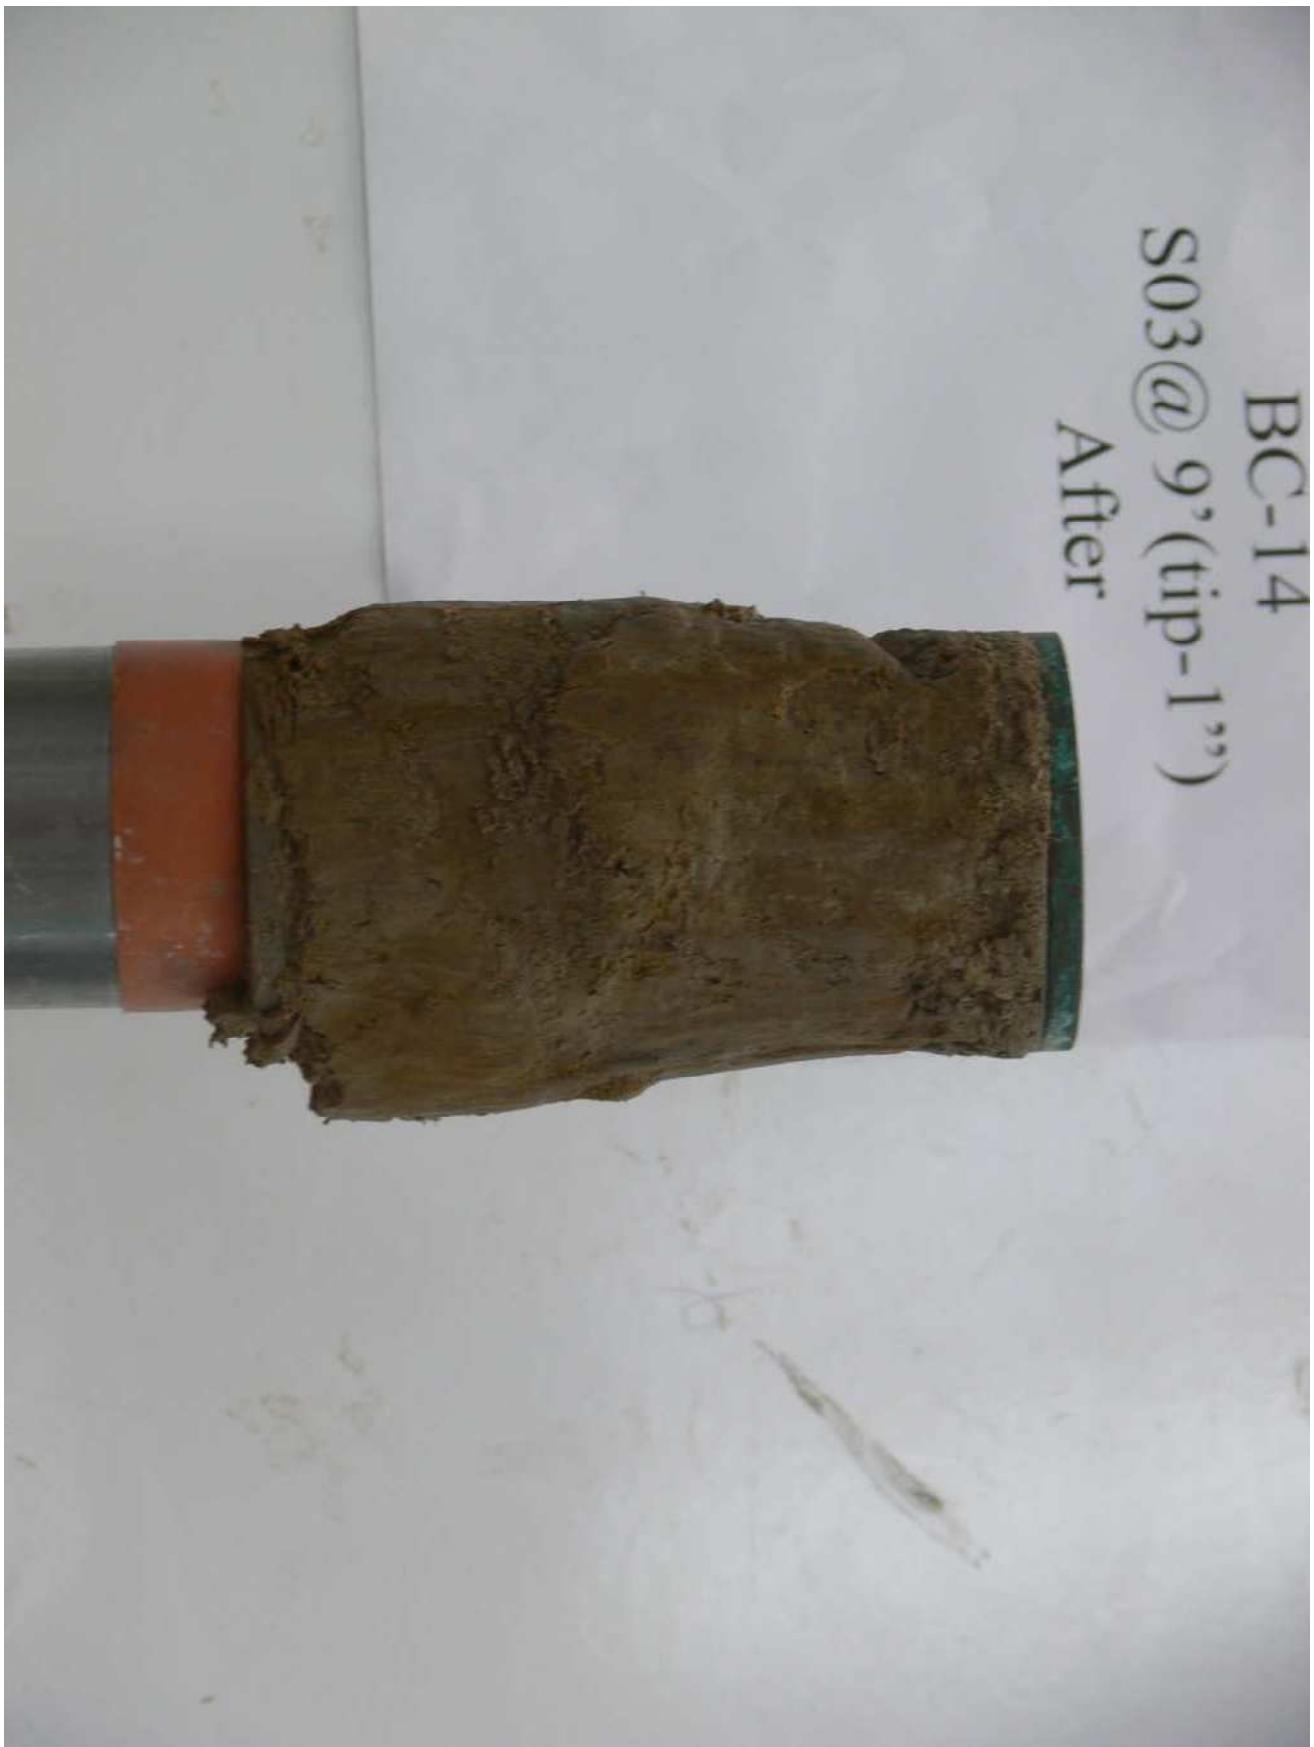
Photo 20: 020-272 BC-14 S03 @ 9' (Tip-1") After TXUU #1.JPG

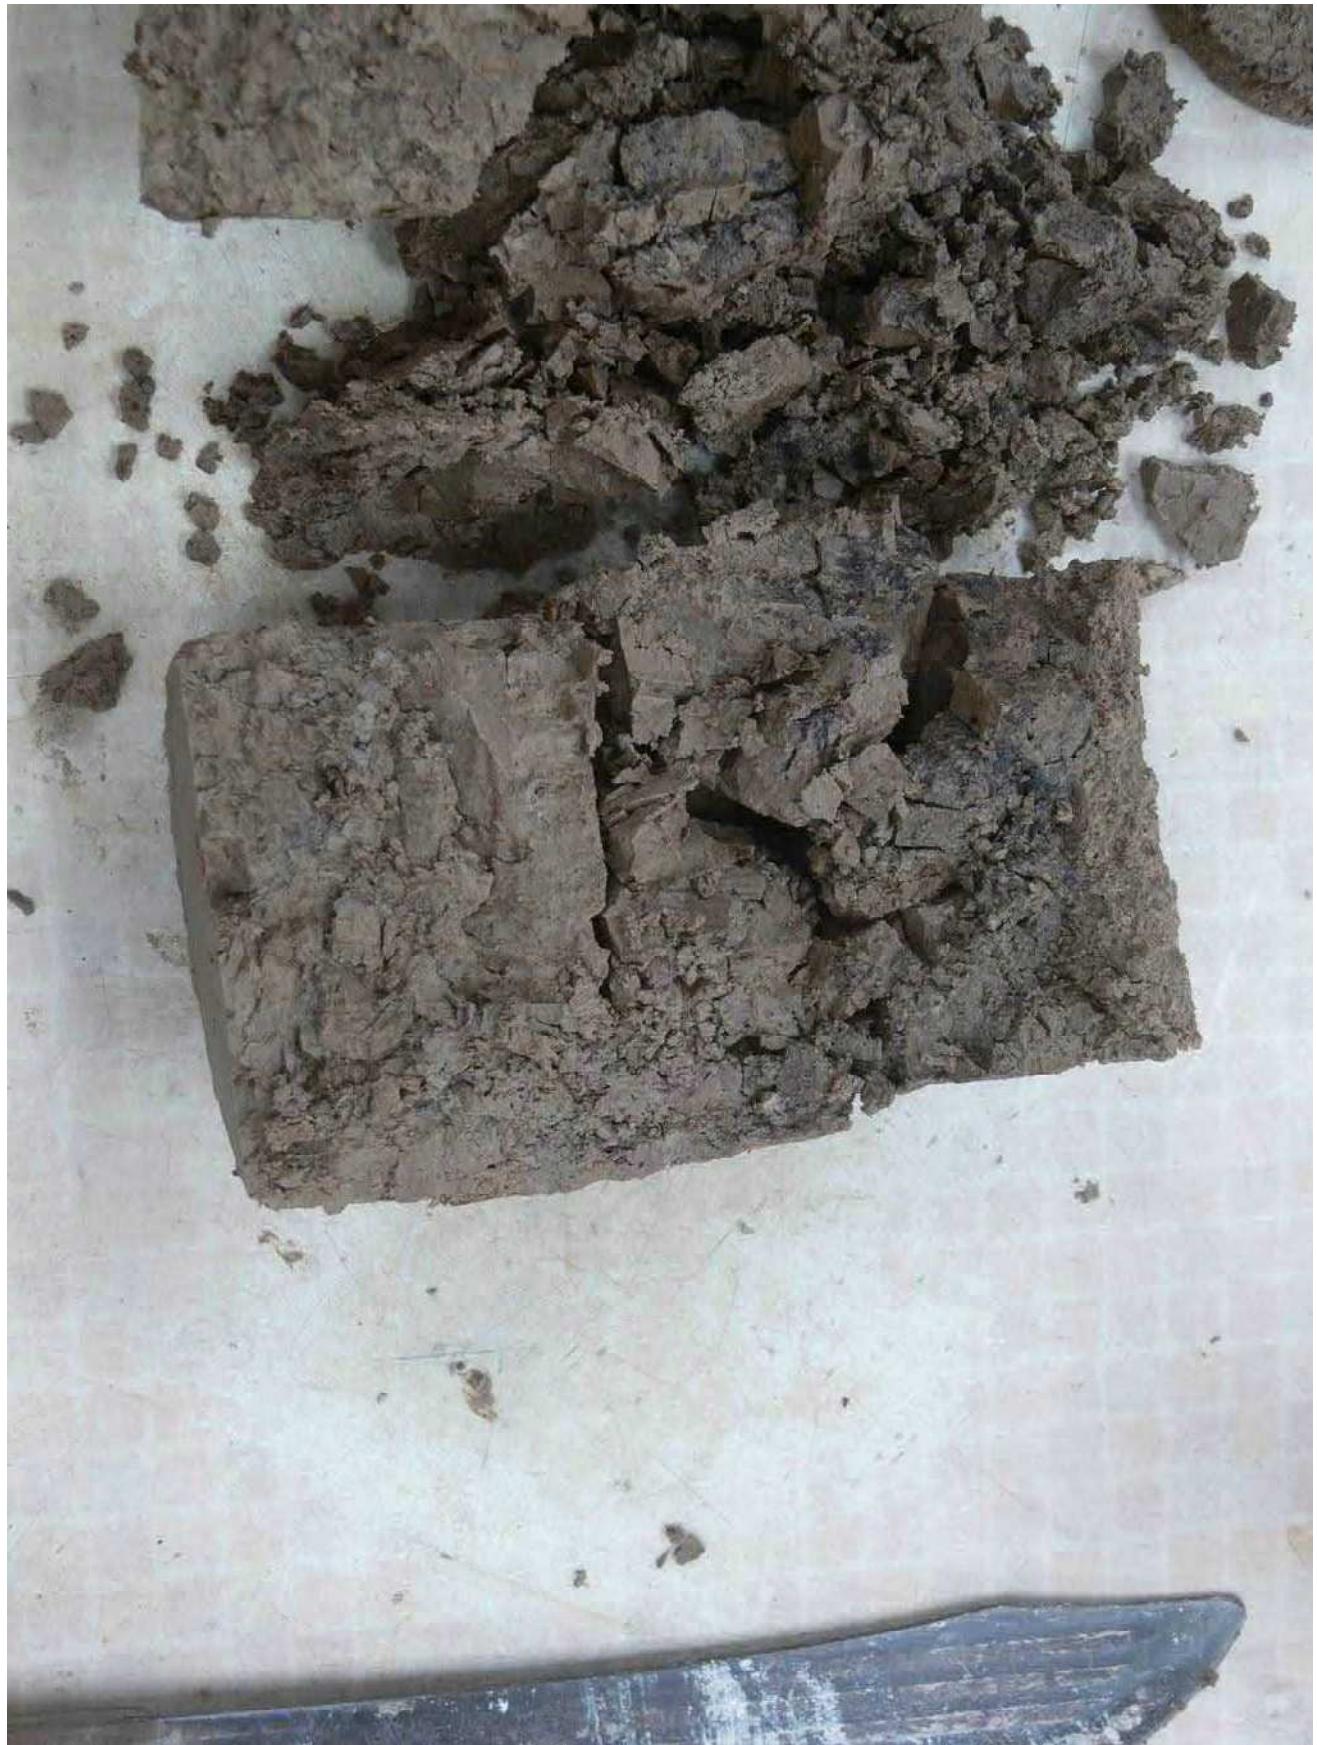
Photo 21: 020-272 BC-14 S03 @ 9' (Tip-1") After TXUU #2.JPG

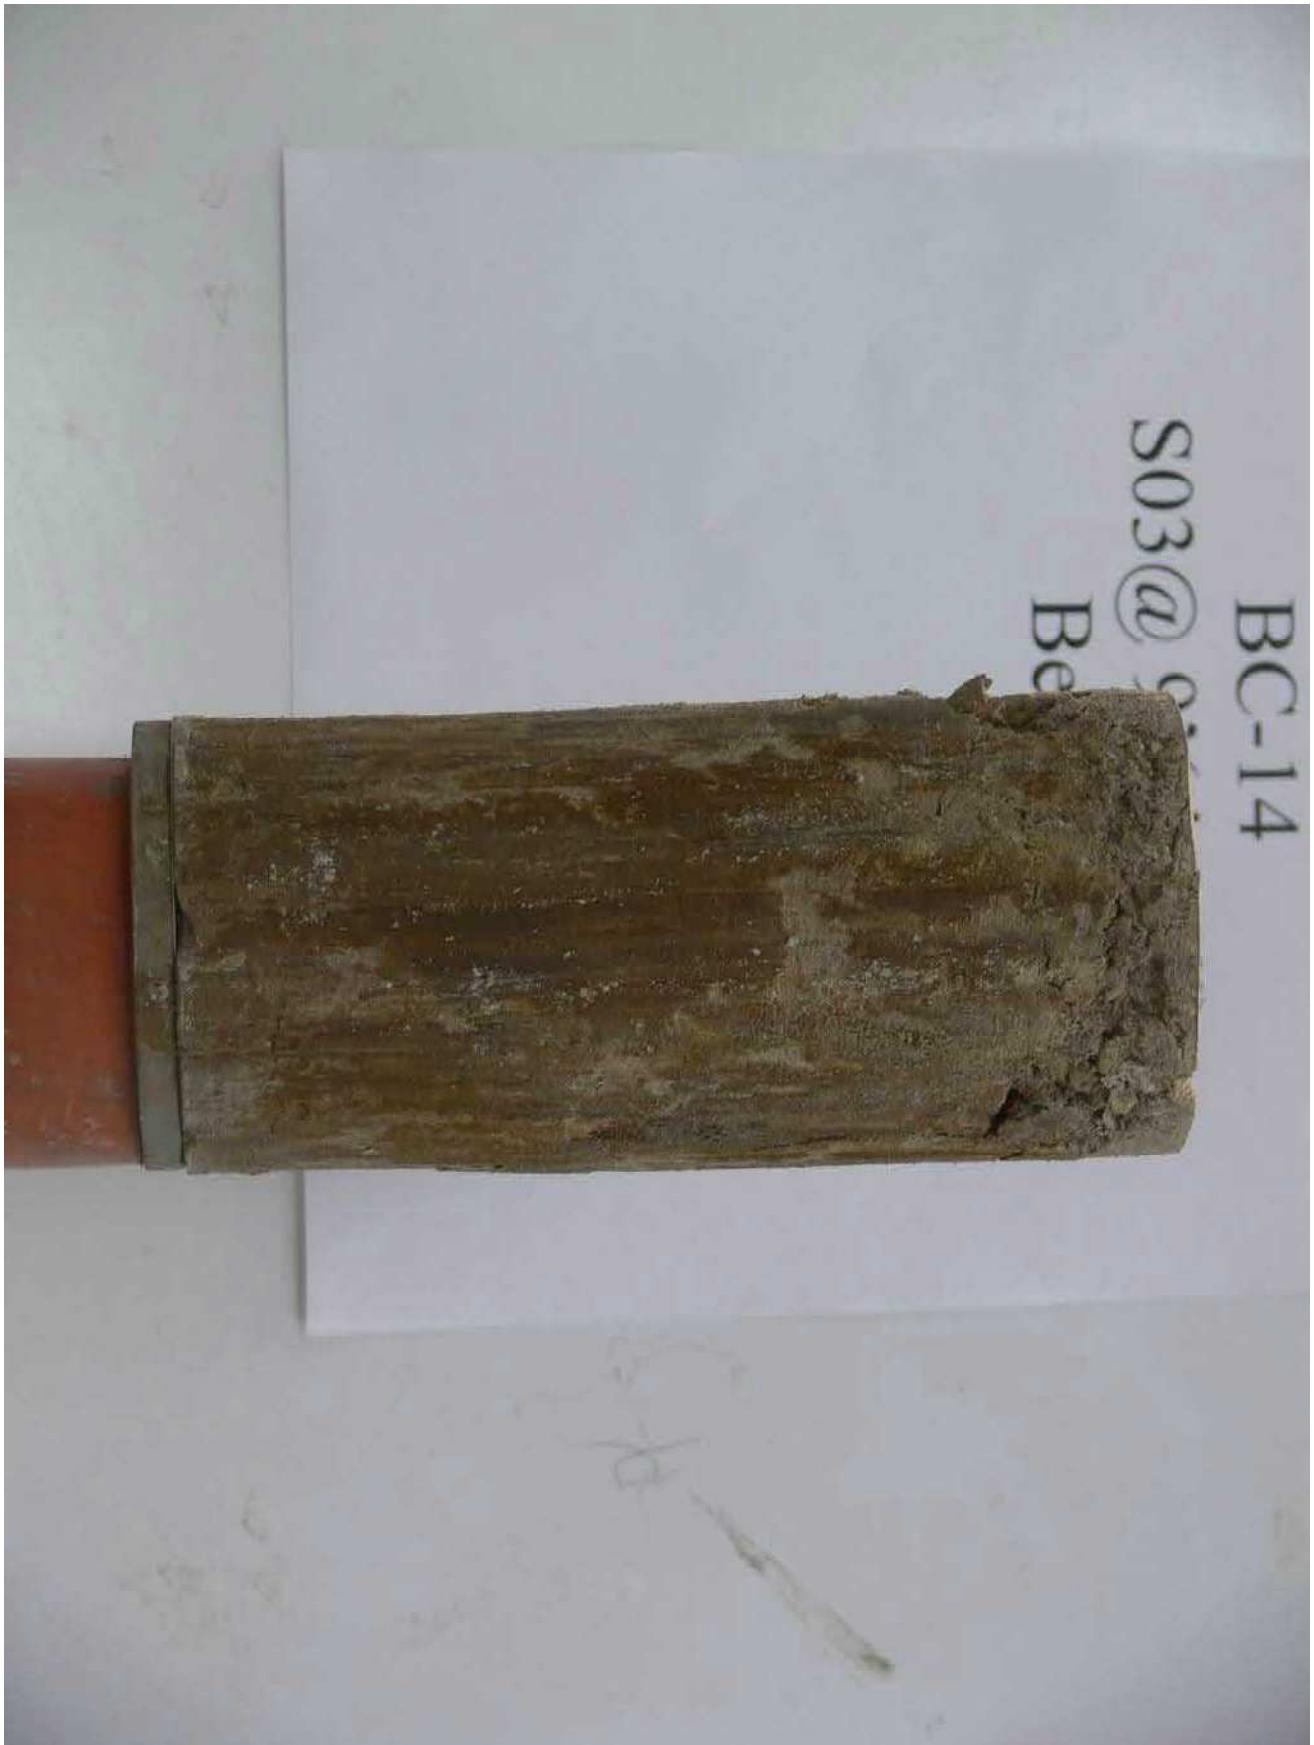
Photo 23: 020-272 BC-14 S03 @ 9' (Tip-1") Before TXCUPP.JPG

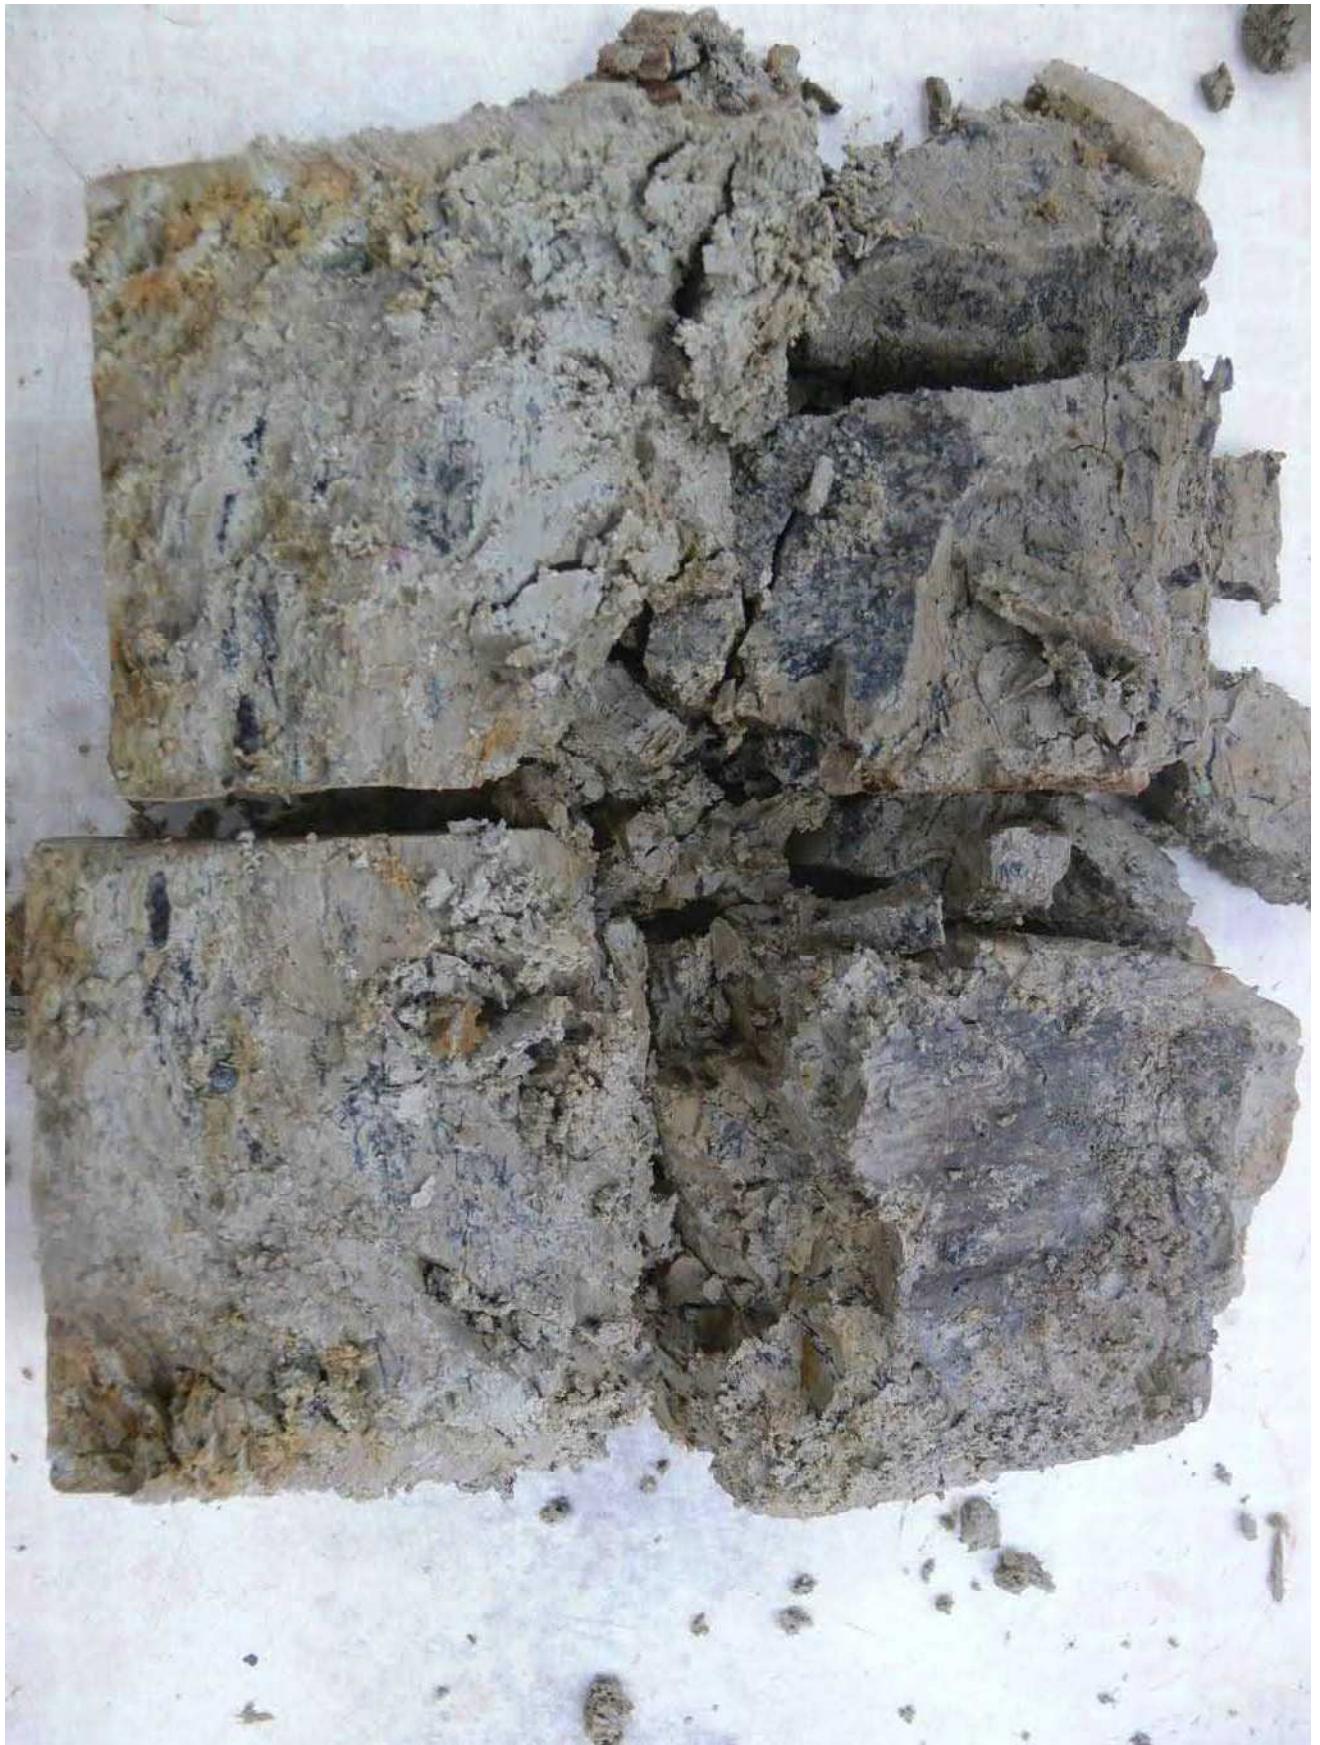
Photo 25: 020-272 BC-14 S04 @ 12' (Tip-1") After TXCUPP #2.JPG
