Preliminary Services Borrow Source Site Investigation

RE: Klamath River Renewal Project – Summary of Onsite Borrow Source Site Investigation – DRAFT Rev B

1.0 INTRODUCTION

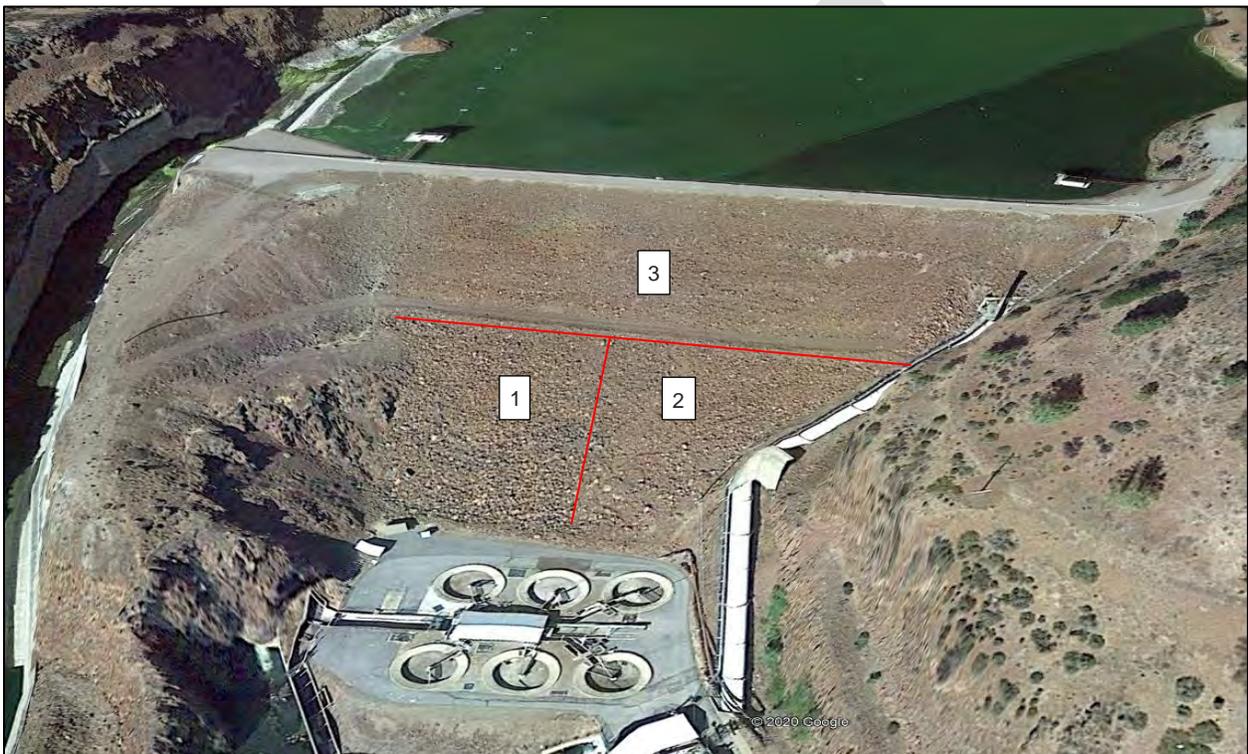
Figure 2.3 Iron Gate Downstream Dam Face

- Basalt is slightly weathered, angular, very strong, and difficult to break with rock hammer; Schmidt hammer strength values range from 35 to 39 ksi with no apparent sulfide mineralization.
- Observed gradation of the three sub-areas assessed on the downstream face:
 - Sub-area 1: $D_{50} = \sim 28''$, $D_{85} = 40''$, approximately 2,980 yd² based on aerial imaging. Split-NET gradation analysis was completed and is presented in C.5. Results indicated a $D_{85} = 36''$, $D_{50} = 18''$ and $D_{15} = 3.4''$.
 - Sub-area 2: $D_{50} = \sim 20''$, approximately 1,950 yd² based on aerial imaging. Split-NET gradation analysis was completed and is presented in C.6. Results indicated a $D_{85} = 26''$, $D_{50} = 12''$ and $D_{15} = 1.4''$, which were smaller than the observed average gradation.

- Sub-area 3: $D_{50} = \sim 9"$, $D_{85} = 12"$, $D_{15} = 3"$ approximately 5,900 yd² based on aerial imaging. Split-NET gradation analysis was completed and is presented in C.7. Results indicated a $D_{85} = 10"$, $D_{50} = 3.5"$ and $D_{15} = 0.4"$, which are smaller than the field observed average gradation.
- Erosion Protection sample IGDDS-1 was obtained for laboratory testing across lower half of embankment surface. Results are presented in Section 3.1 and Appendix D.
- The downstream dam face has a minimum erosion protection thickness of 5 ft, as per historic as-built drawing 5407-A-111.

The observed material quality and durability within all 3 sub-areas of the downstream shell are similar, however the material size varies across each sub-area. Sub-area 1 had the largest material, followed by Sub-areas 2, then Sub-area 3. Based field assessment results, this site can be used as a source for Erosion Protection of varying sizes.

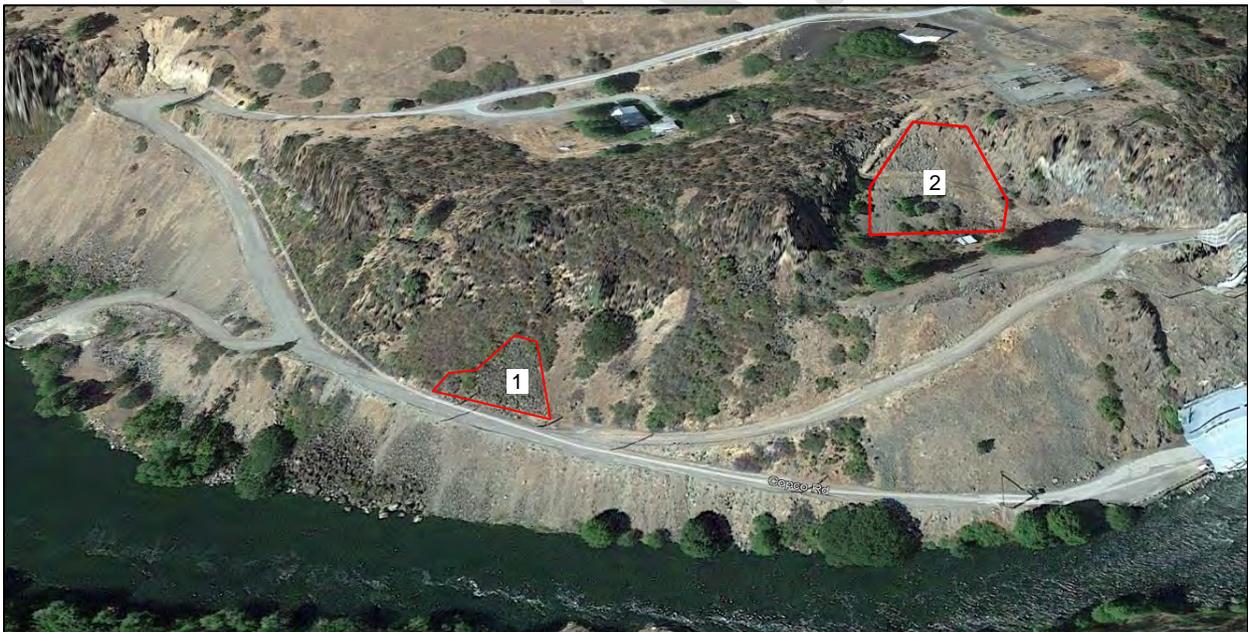
Figure 2.4 Copco No. 1 Access Road Potential Borrow Source

- Observed gradation of two Sub-areas assessed on the Copco No. 1 Access Road:
 - Sub-area 1: $D_{50} = \sim 15''$, <10% 3-inch minus material, approximately 365 yd² based on aerial imaging.

- Sub-area 2: Not considered an adequate source. Localized erosion protection material available.
- Two Split-NET gradation analyses were completed in Sub-area 1 and are presented in Appendix C - Figures C.8, and C.9. Results indicated a $D_{85} = 18''$, $D_{50} = 9''$ and $D_{15} = 1.6''$, and a $D_{85} = 15''$, $D_{50} = 7''$ and $D_{15} = 1.8''$, respectively, which are smaller than the field observed average gradation.

- Erosion Protection sample CRBR-1 obtained for laboratory testing in Sub-area 1. Results are presented in Section 3.1 and Appendix D.

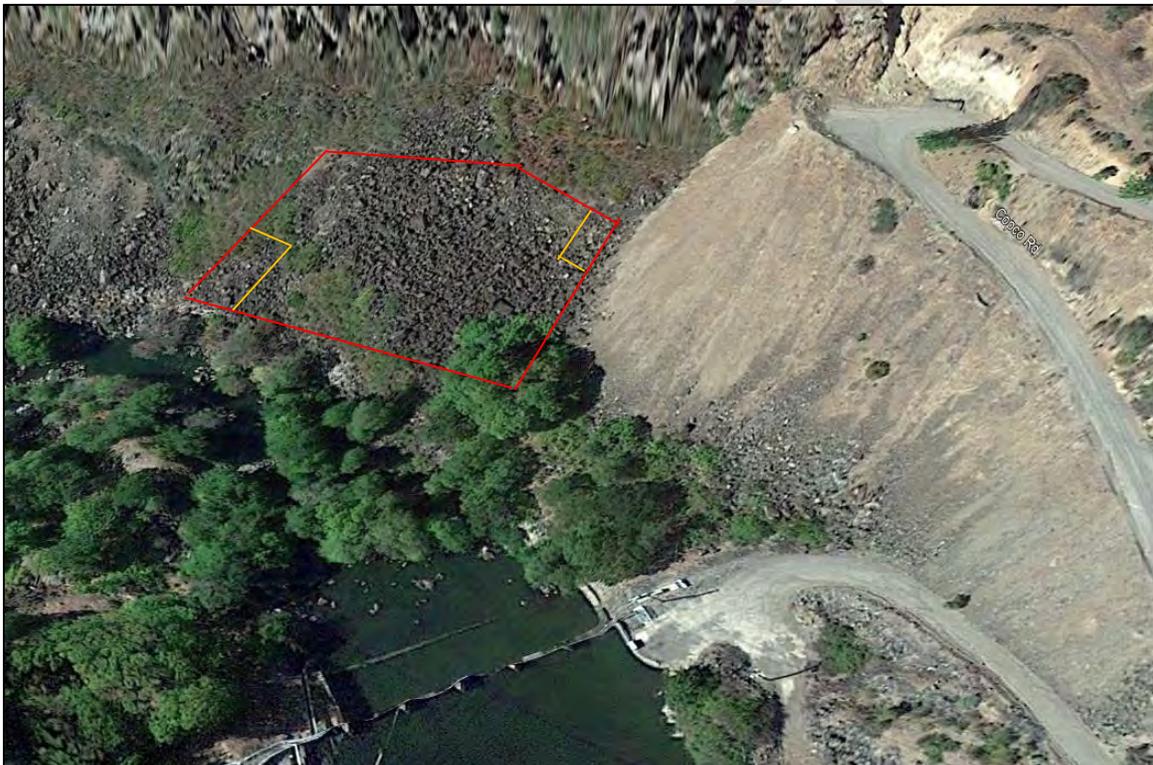
Figure 2.6 Copco No. 2 Downstream Right Bank Potential Borrow Source

- Fine-grained basalt, some vesicular, angular, slightly weathered, very strong, difficult to break with rock hammer, Schmidt hammer strength values ranging from 25 to 42 ksi with no apparent sulfide mineralization.
- Observed gradation: D_{50} value ~ 48 inches, 20% 7-ft minus, 20% 5-ft minus ft, 50% 4-ft minus, 10% 1-ft minus.

- In the areas denoted by the orange boundaries in Figure 2.6, the D_{50} was observed to be smaller, approximately 32" to 36".
- Two Split-NET gradation analyses were completed and are presented in Appendix C - Figures C.12, and C.13. Results indicated a $D_{85} = 46"$, $D_{50} = 32"$ and $D_{15} = 14"$, and a $D_{85} = 44"$, $D_{50} = 28"$ and $D_{15} = 5"$, respectively. The results of the analysis are suspected to be smaller than the field observed gradations due to the inability to place both scaling balls in the photograph to account for depth of field.
- Erosion Protection sample C2DSR-1 obtained for laboratory testing. Results are presented in Section 3.1 and Appendix D.
- No Granular Fill samples obtained at this site.
- Approximately 3,000 yd² based on aerial imaging.

The material found within the right bank talus pile is among the largest onsite sized boulders available and is appropriate for the large erosion protection sizes specified at the Copco No. 1 and No. 2 locations.

Unacceptable degradation was reported in the first sample sent for magnesium sulphate soundness and micro-deval testing for Copco No. 2 Downstream Right Bank, so a second test was completed, which confirmed the results. It is suspected this sample is not representative of the durable basalt observed in this location. The observed durability is supported by the results of the point load, specific gravity, and absorption tests completed on other specimens from the same location. Pumice and other altered rocks with excessive voids and vugs exist within the talus slopes and it is assumed one of these rocks of lesser quality was used for the durability tests. Operators will have to avoid the lower quality rocks when selecting pieces for erosion protection. To ensure the borrow source is acceptable, additional testing should be completed on more representative samples of the basalt once the contractor has access to the site.

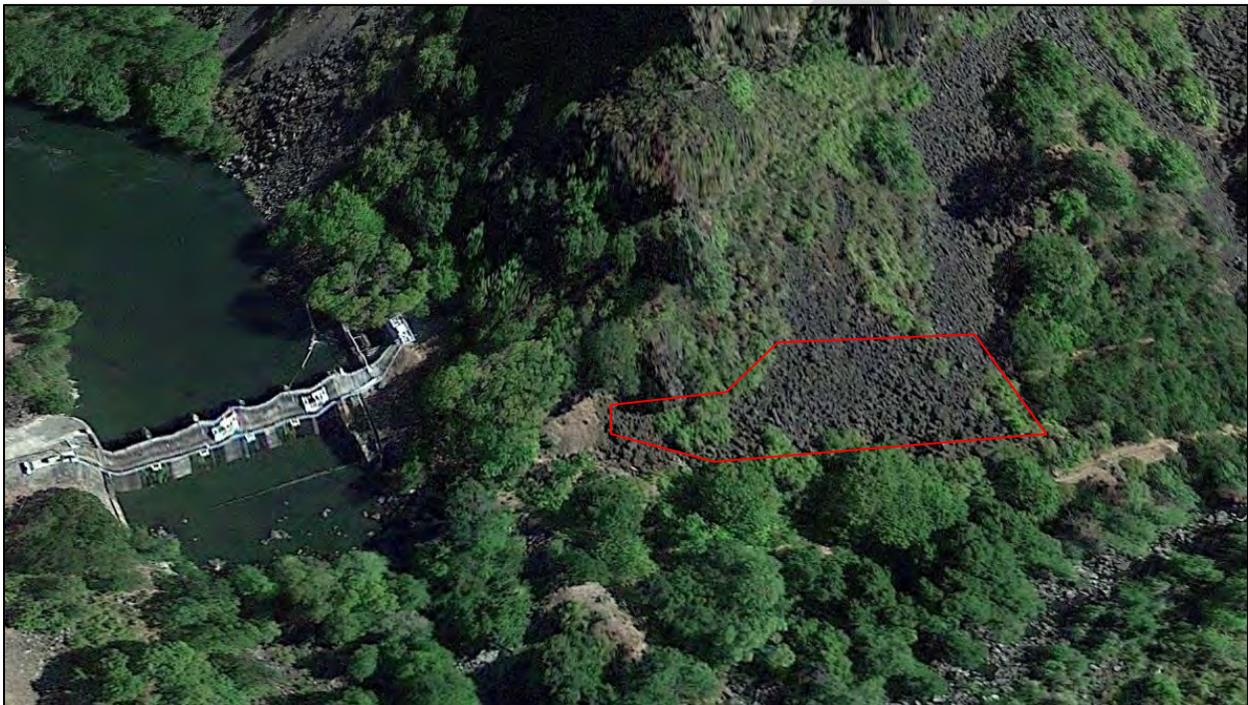
Figure 2.7 Copco No. 2 Downstream Left Bank Potential Borrow Source

- Observed Gradation: $D_{50} = 40''$, general material is 6-ft minus.
- Two Split-NET gradation analyses were completed and are presented in Appendix C -Figure C.14 and C.15. Results indicated a $D_{85} = 44''$, $D_{50} = 28''$, and $D_{15} = 15''$, and a $D_{85} = 60''$, $D_{50} = 33''$, and $D_{15} = 7.5''$, respectively. The two photographs are of the same area but at different setback distances. Figure C.15 photograph was taken further back, and the results were closer to the field observed gradation.
- Erosion Protection sample C2LB-1 was obtained for laboratory testing. Results are presented in Section 3.1 and Appendix D.
- No Granular Fill samples was obtained at this site.
- Approximately 1,940 square yards based on aerial imaging.

The material found within the talus pile on the left bank is among the largest sized boulders available onsite and is appropriate for the large erosion protection classes specified at the Copco No. 2 location.

The average absorption on the Copco No. 2 Left Bank is higher than the recommended 1%. According to the NCHRP report, however, other jurisdictions suggest an absorption up to 2% is acceptable. The higher absorption may also be caused by similar issues with altered basalt and the presence of vugs in some rocks, which based on photographs occur on the left bank, similar to the right bank. Given the results of the other tests and the low consequence environment, and the possibility of a lower quality sample, this material is deemed acceptable for use. Lower quality rocks will have to be avoided when selecting erosion protection material from this borrow source. Additional testing should be considered on better representative samples once the contractor has access to the site.

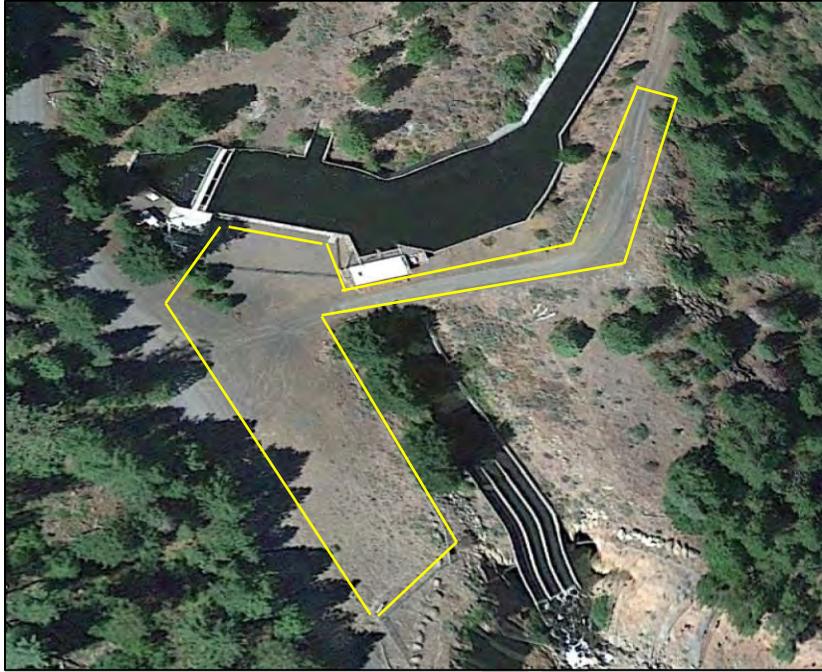
Figure 2.12 J.C. Boyle Forebay Potential Borrow Source

- Road course and parking lot generally 1-inch nominal with trace cobbles and boulders, zero to low plasticity, silty sand, and gravel, black in color when moistened. A Split-NET gradation analysis was completed and is presented in Appendix C - Figure C.21. Results indicated a $D_{85} = 0.75''$, $D_{50} = 0.2''$ and $D_{15} = 0.02''$.
- Approximately 0.2 ft in depth within gravel surfacing.
- Material adjacent to road covered areas, gravel with sand, 10-20% cobbles, low to medium plasticity, likely oxidized native material, reddish brown in color when moistened. Material with similar properties exists in access roads below road surfacing gravel (See Figure 2.13).
- Road surfacing area is approximately 2,800 square yards based on aerial imaging, however due to limited thickness of the pavement, there is limited salvageable road coarse material.
- No samples were obtained in this area.

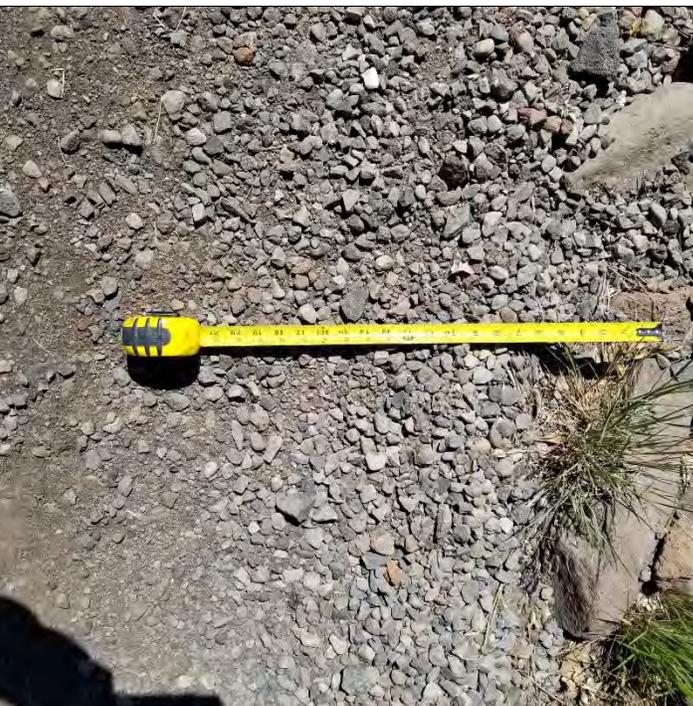
<p>Photo No. 8.</p>

<p>Date: May 6, 2020</p>	
<p>Description: J.C. Boyle Powerhouse, road wearing course, tape measure for scale.</p>

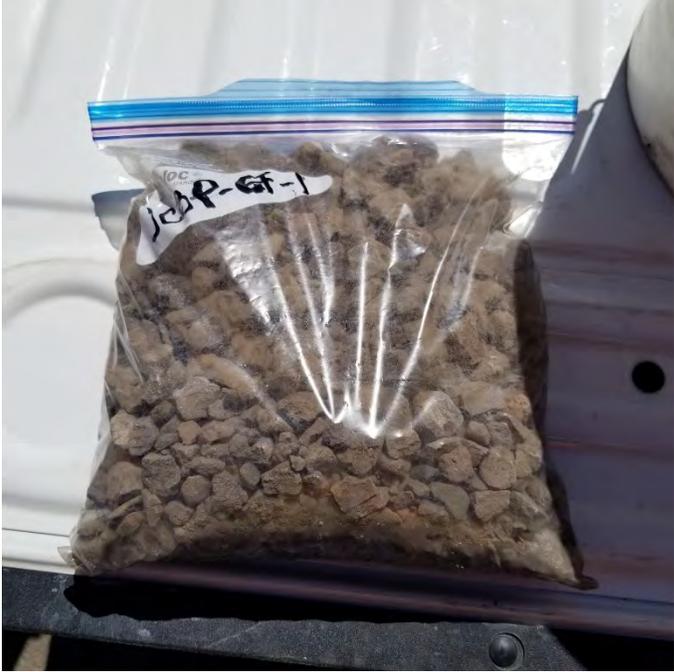
<p>Photo No. 17.</p>

<p>Date: May 6, 2020</p>	
<p>Description: J.C. Boyle Powerhouse, sample of road wearing course.</p>

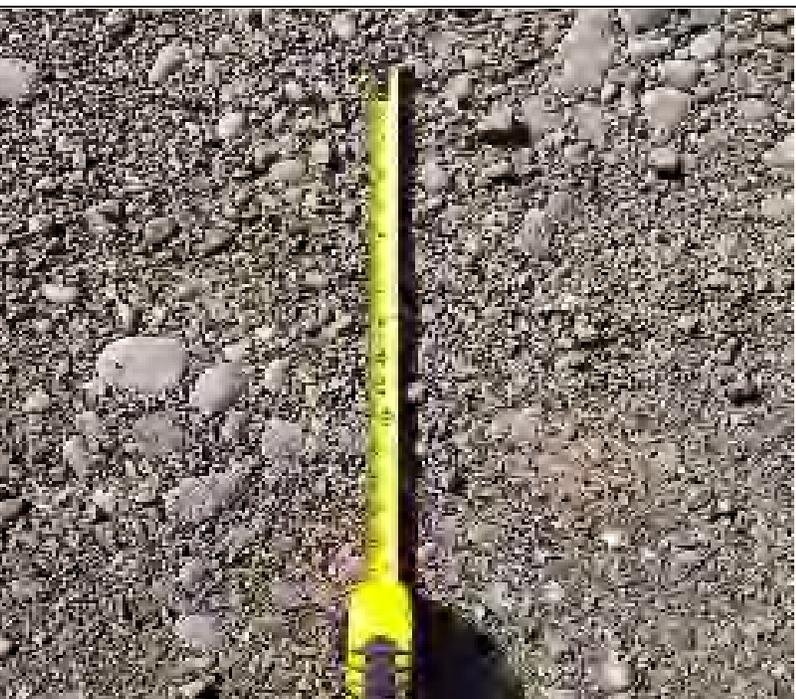
<p>Photo No. 10.</p>

<p>Date: May 7, 2020</p>	
<p>Description: Iron Gate Workers Accommodation Area, road wearing course.</p>

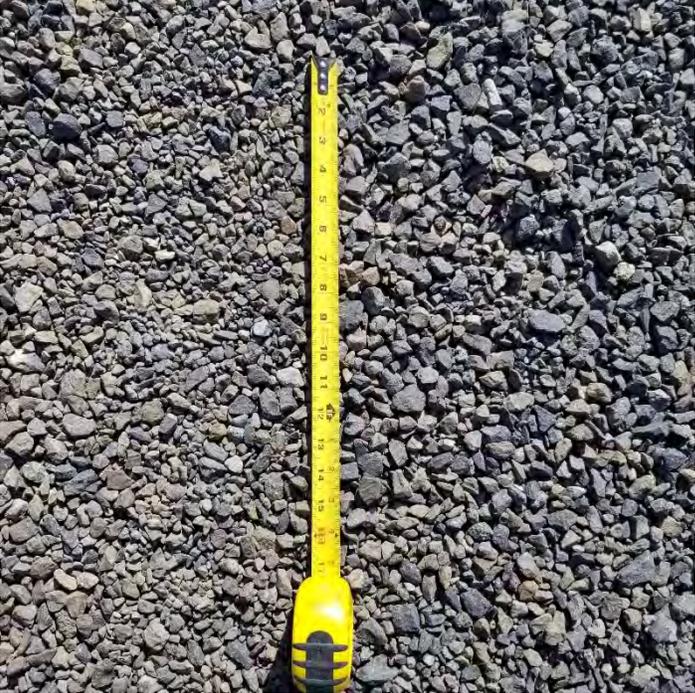
Photo No. 11.

Date: May 7, 2020	
Description: Iron Gate Workers Accommodation Area, road wearing course.

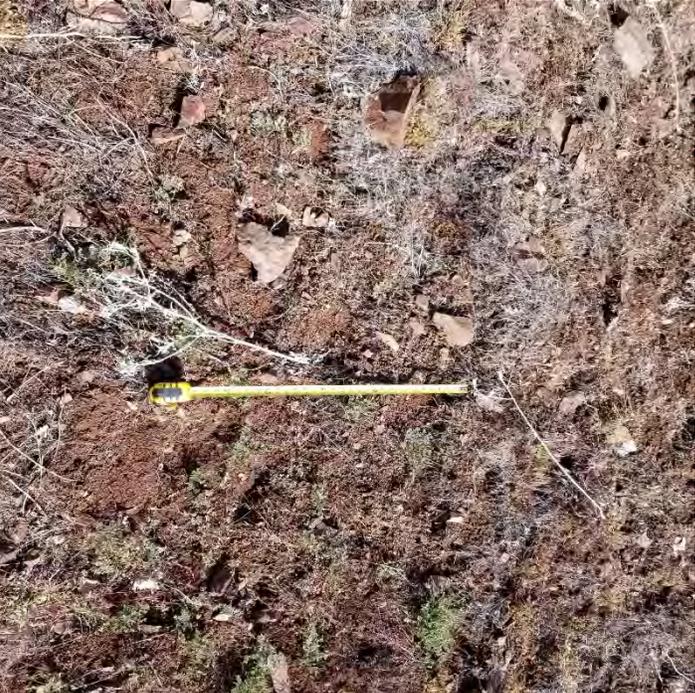
Photo No. 12.

Date: May 7, 2020	
Description: Iron Gate Workers Accommodation Area, face of slope.

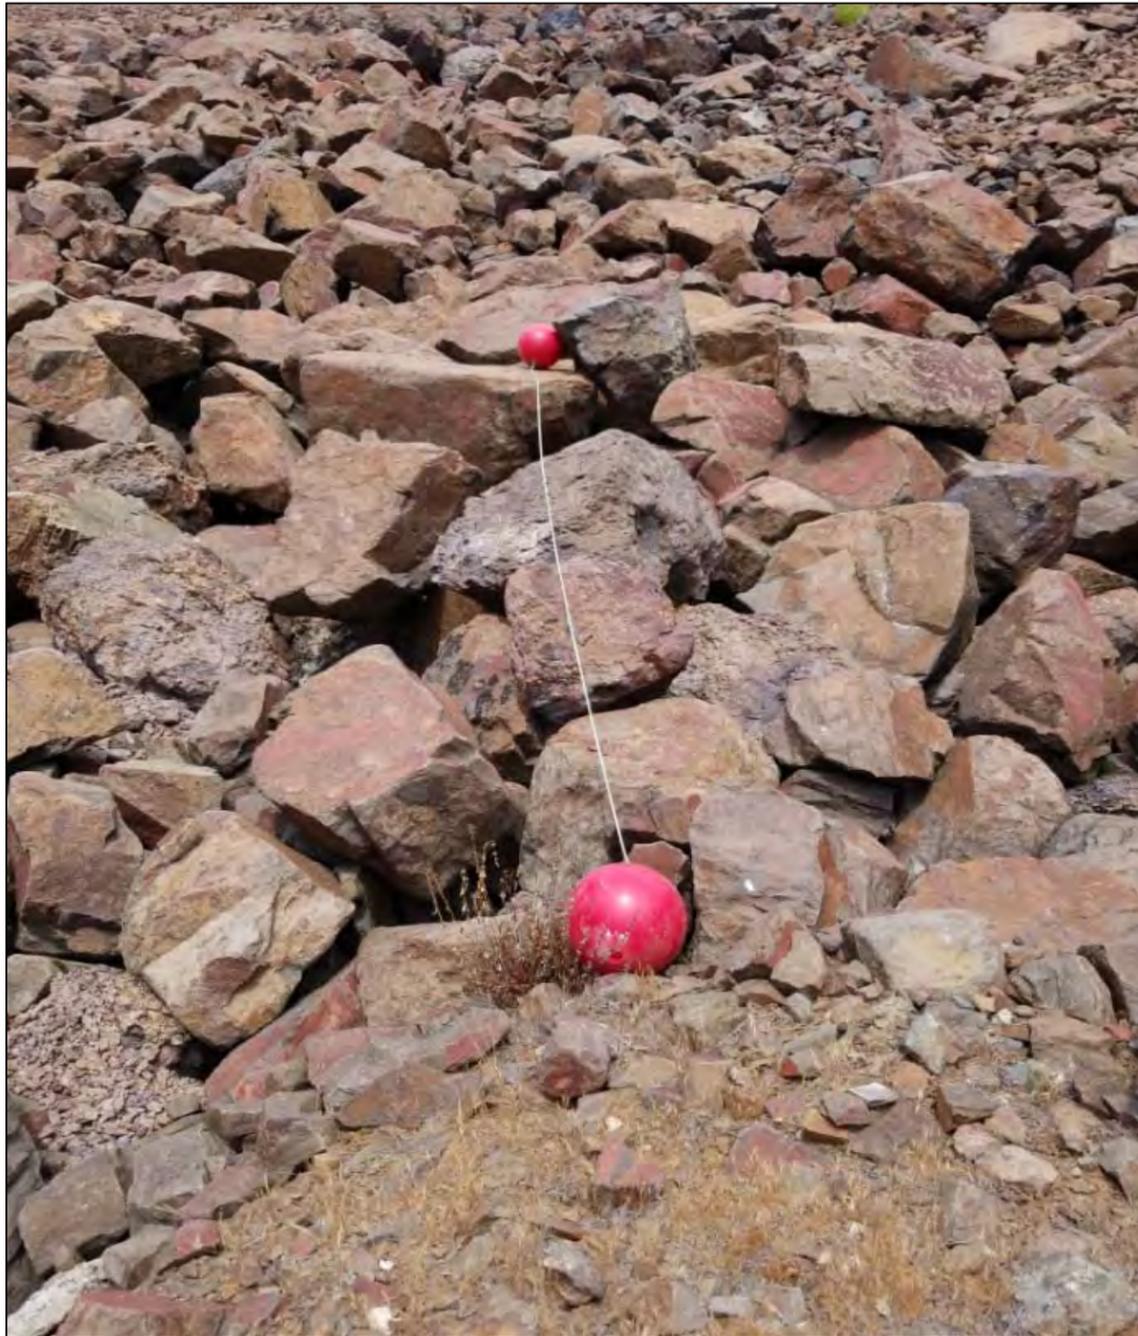
KIEWIT INFRASTRUCTURE WEST CO.	
KLAMATH RIVER RENEWAL PROJECT	
ONSITE BORROW SOURCE SITE INVESTIGATION SPLIT-NET PARTICLE SIZE ANALYSIS RESULTS IRON GATE DAM DOWNSTREAM FACE SUB-AREA 1	
	P/A NO. VA103-640/1
	REF. NO. VA20-01037
FIGURE C.5	
	REV B

Size[in]	% Passing
75	100.00
50	96.80
25	68.09
15	45.28
10	33.75
8	28.54
6	23.00
4	16.95
2	10.06
1	5.97
0.75	4.80
0.5	3.54
0.38	2.84
0.25	2.09
0.19	1.68
0.08	0.87

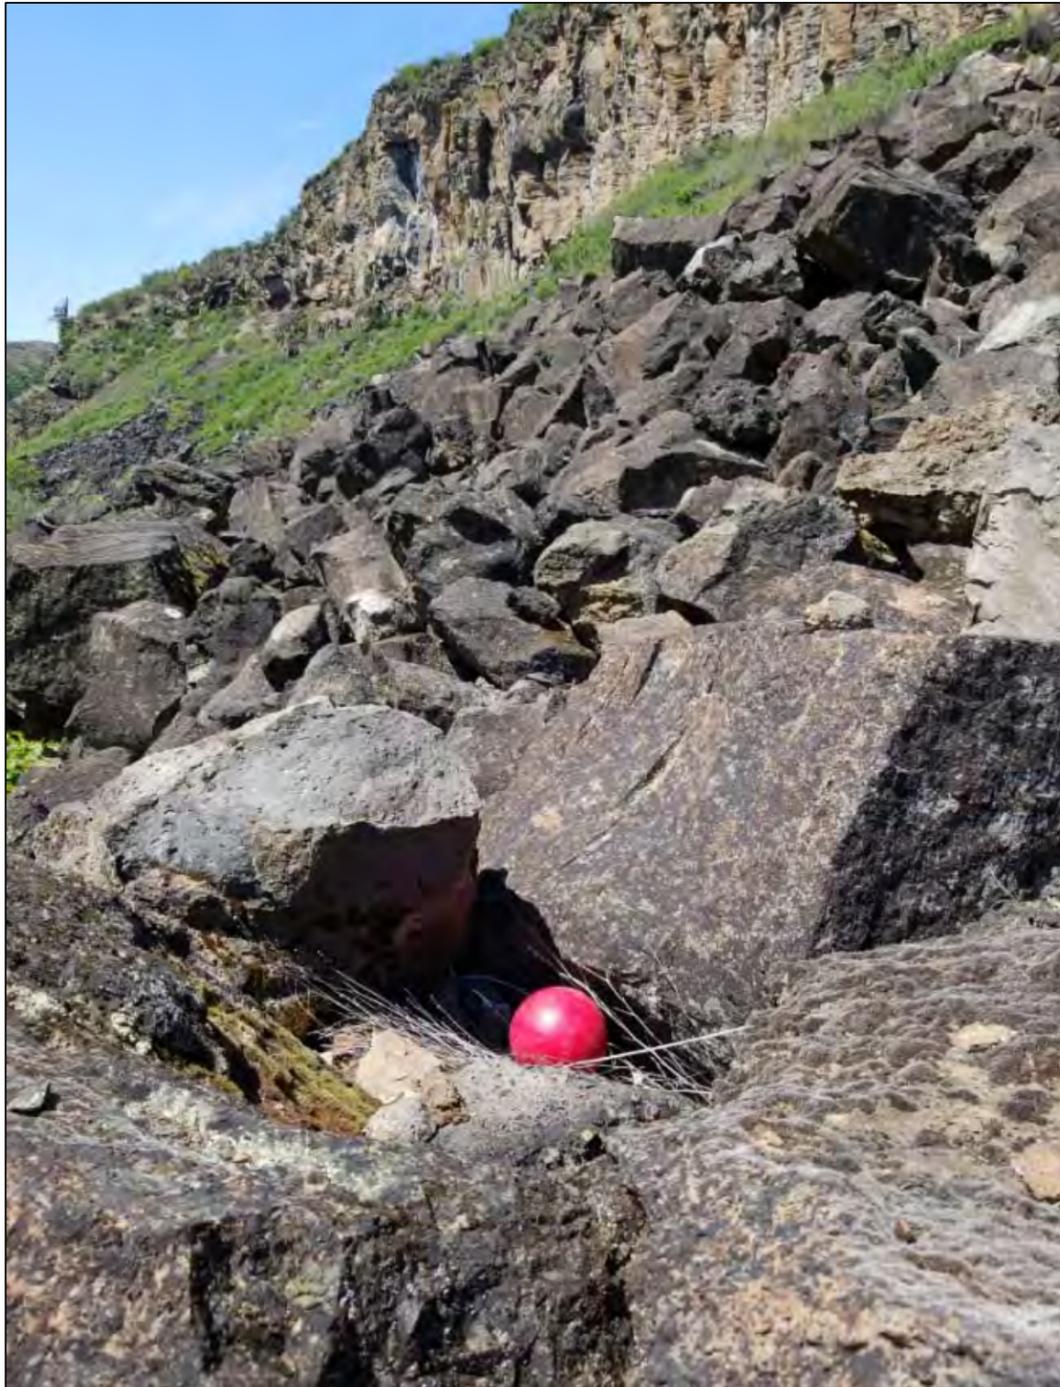
KIEWIT INFRASTRUCTURE WEST CO.	
KLAMATH RIVER RENEWAL PROJECT	
ONSITE BORROW SOURCE SITE INVESTIGATION SPILT-NET PARTICLE SIZE ANALYSIS RESULTS COPCO NO. 2 DOWNSTREAM RIGHT BANK - 2	
	P/A NO. VA103-640/1 REF. NO. VA20-01037
FIGURE C.13	
REV B

Size[in]	% Passing
75	100.00
50	93.97
25	47.08
15	31.32
10	23.41
8	20.57
6	18.09
4	15.44
2	9.59
1	5.95
0.75	4.88
0.5	3.68
0.38	3.02
0.25	2.28
0.19	1.86
0.08	1.02

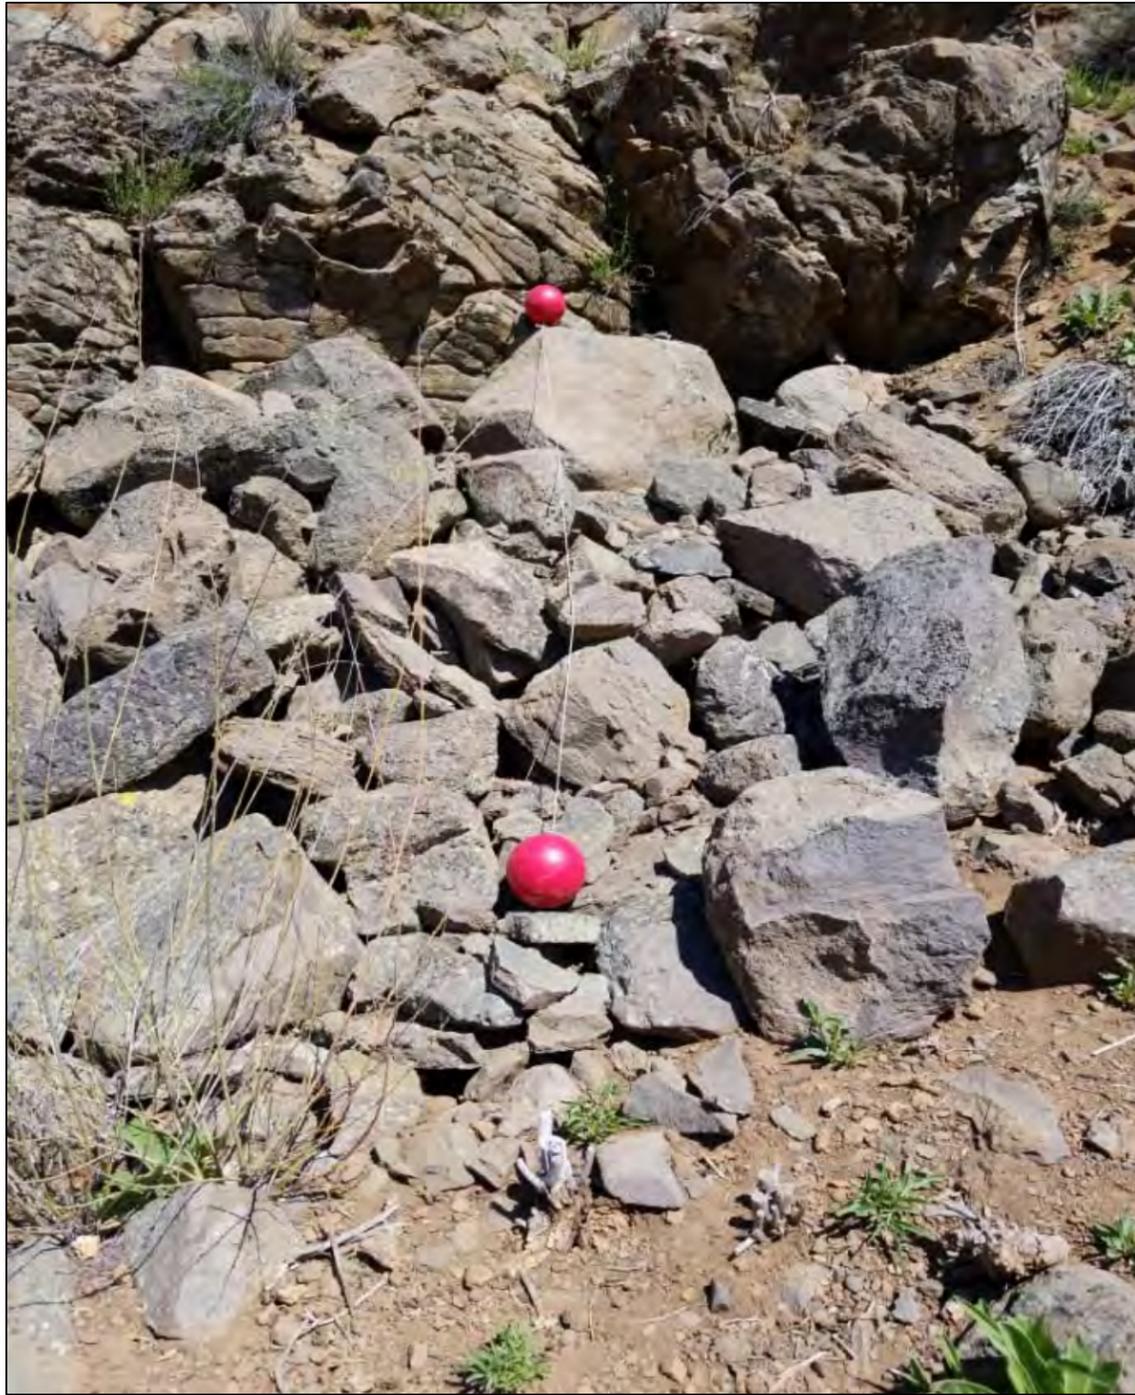
KIEWIT INFRASTRUCTURE WEST CO.	
KLAMATH RIVER RENEWAL PROJECT	
ONSITE BORROW SOURCE SITE INVESTIGATION SPLIT-NET PARTICLE SIZE ANALYSIS RESULTS J.C. BOYLE POWERHOUSE SUB-AREA 1	
	P/A NO. VA103-640/1
	REF. NO. VA20-01037
FIGURE C.22	
	REV B

Size[in]	% Passing
75	100.00
50	100.00
25	67.26
15	39.01
10	28.62
8	25.42
6	21.81
4	16.33
2	9.95
1	6.06
0.75	4.93
0.5	3.68
0.38	2.99
0.25	2.23
0.19	1.81
0.08	0.97
