CTL# 020-251  
AECOM  
Klamath River Dam Removal  
60537920

Subject: Project No.: 60537920  
Project Name: Klamath River Dam Removal Project  
Corrosivity Analysis – CalTrans Test Methods

Project Name	Klamath River Dam Removal
Location	Klamath River
Client	Klamath River Renewal Corporation
Client Project No.	60537920
Registry No.	2018-22
Report No.	2018-22-4-1
Report Date	5/17/2018
Drill Hole and Depth	BI-02; 27-27.9 ft
Rock Type	Volcanic Breccia
Geologic Unit	N/A
Moisture Condition	As-received

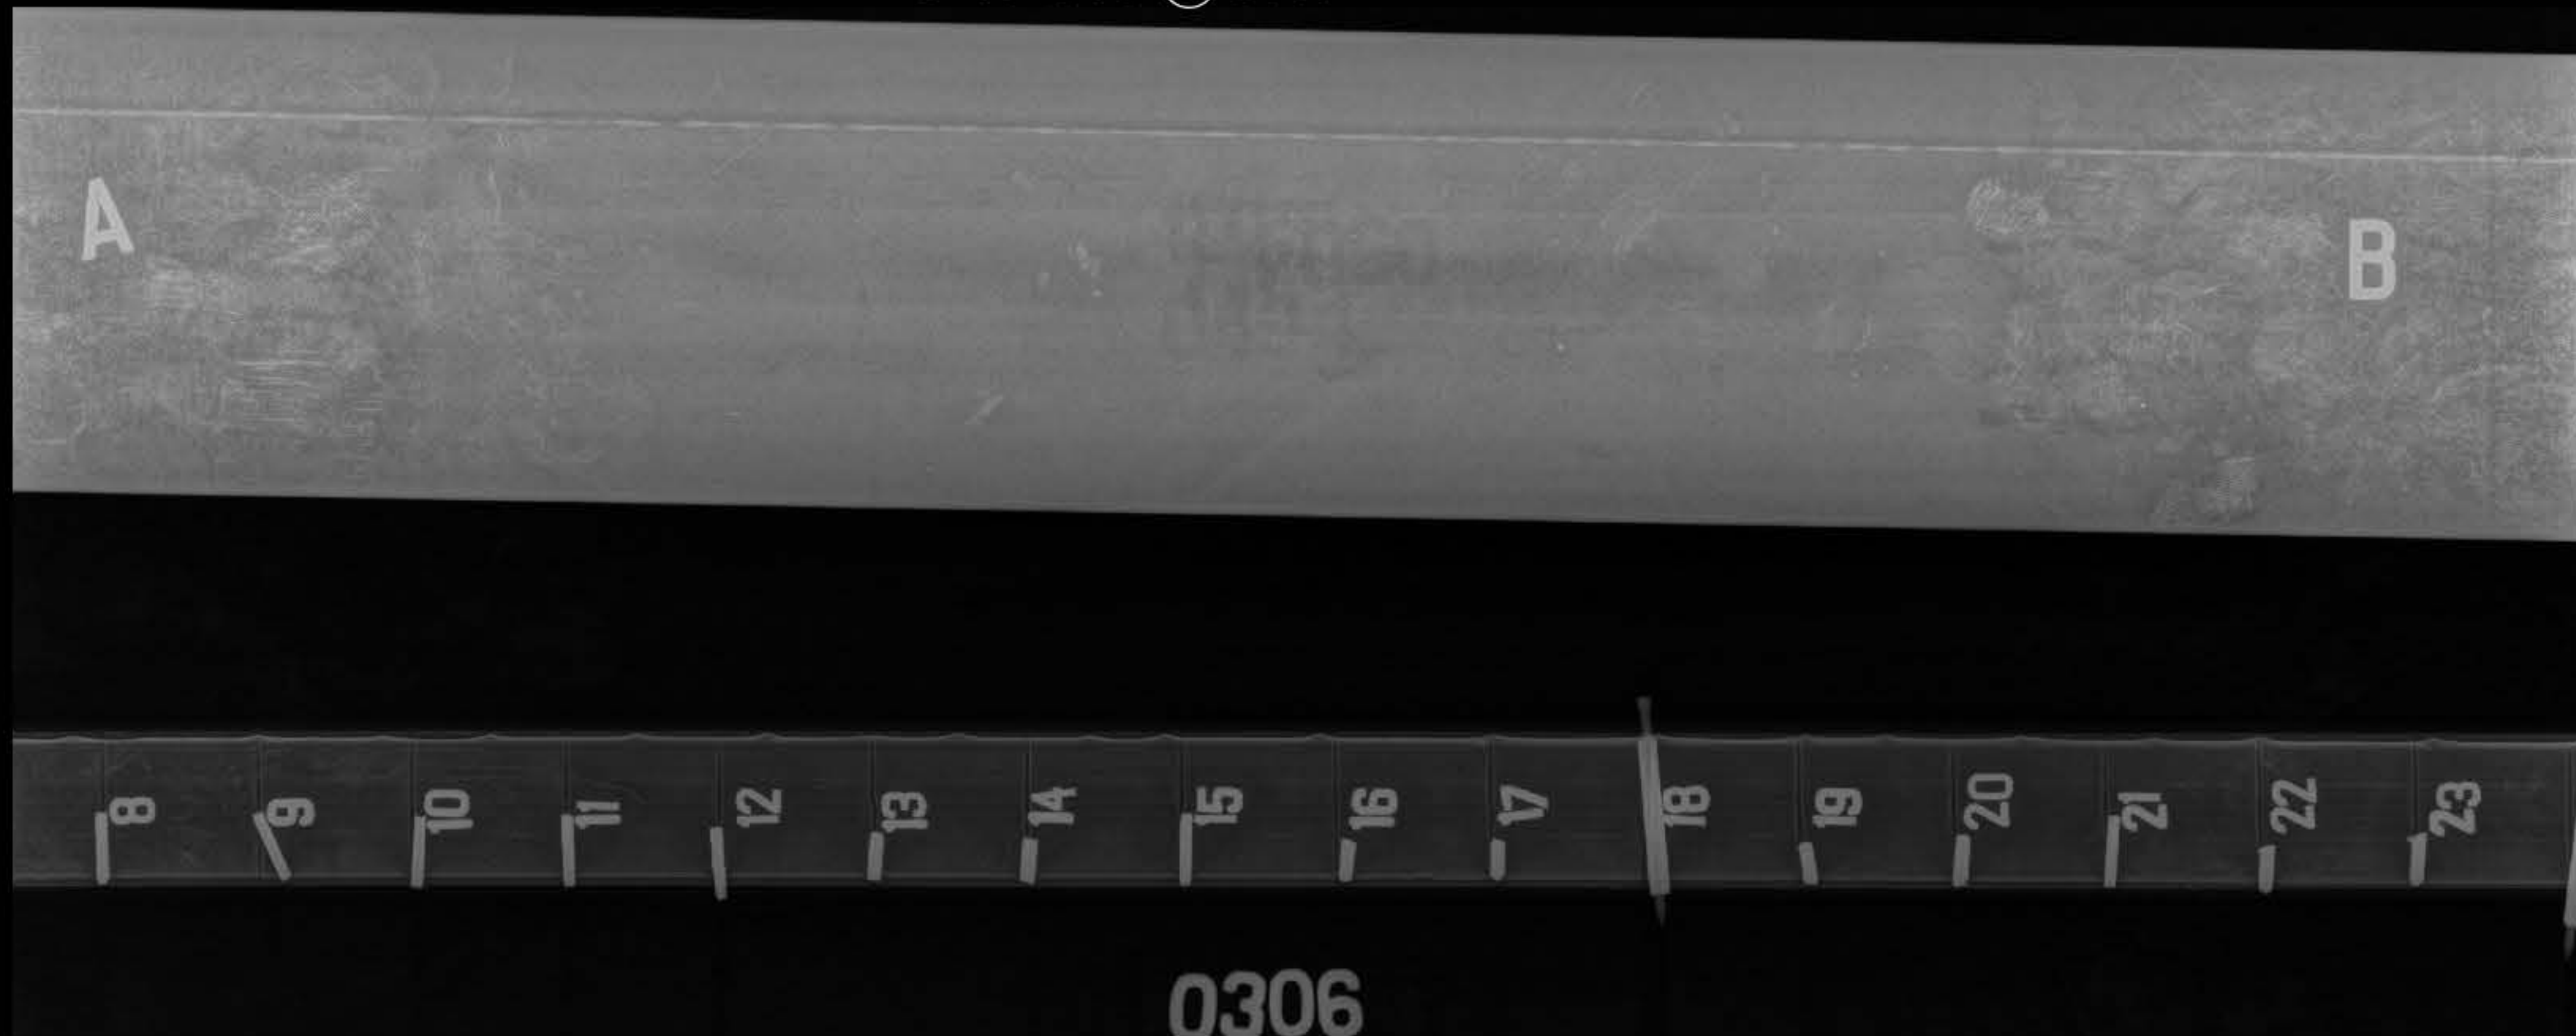
BC-03 S06 @ 39.5'

Scale in inches  
0 = Top of Tube

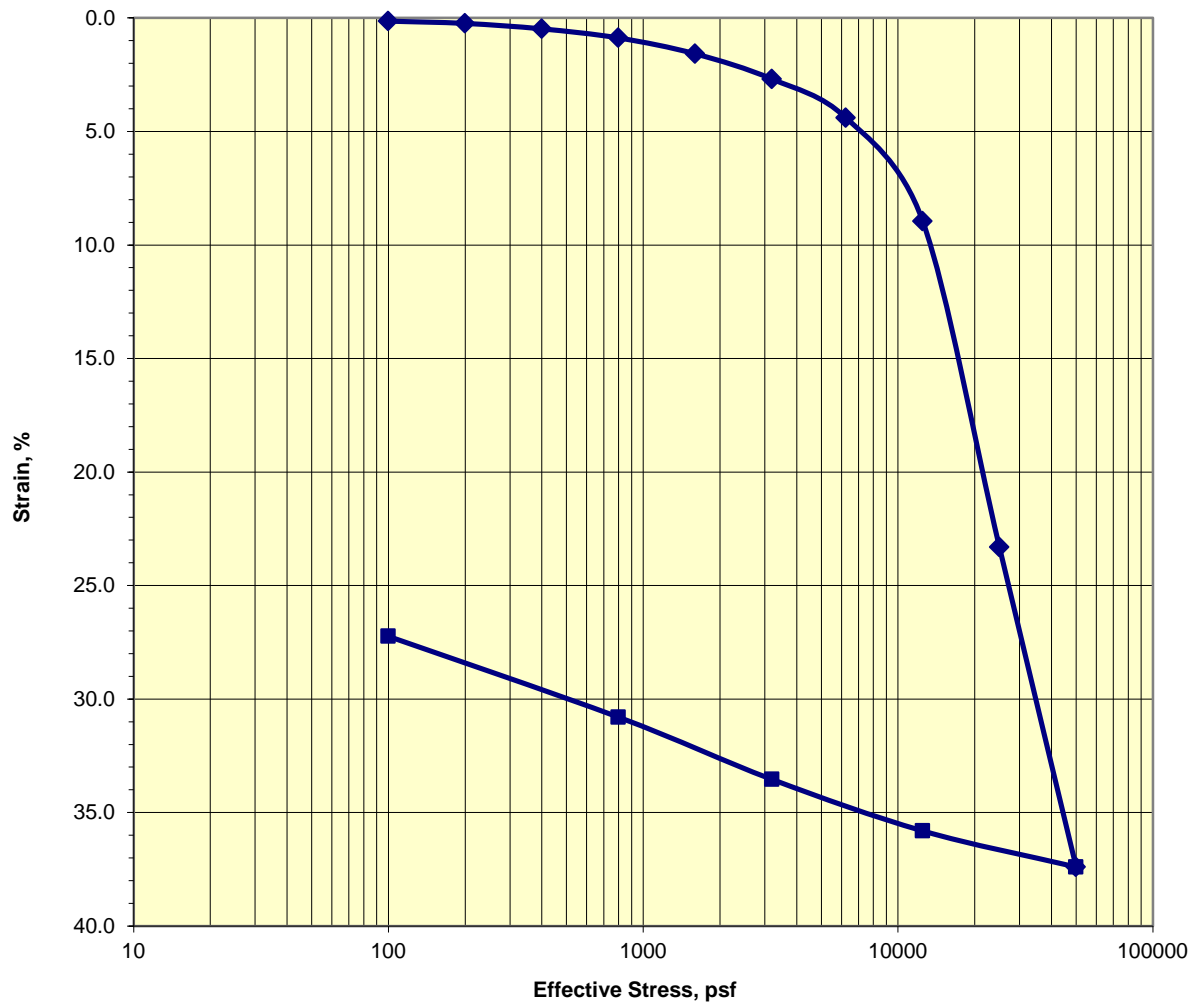
### Strain-Log-P Curve

Assumed Gs	2.6	Initial	Final
Moisture %:		149.5	104.4
Dry Density, pcf:		32.1	43.7
Void Ratio:		4.058	2.715
% Saturation:		95.8	100.0

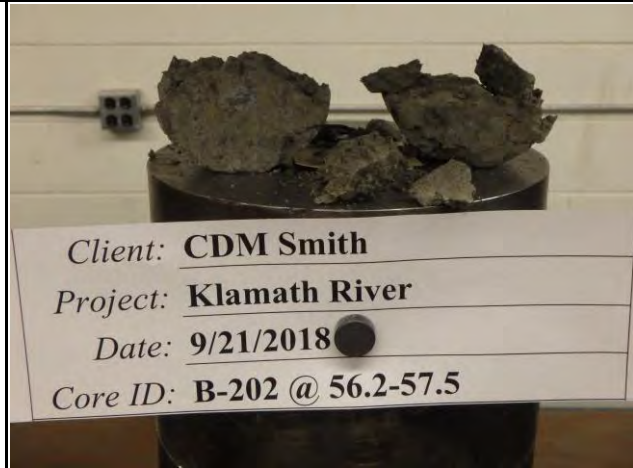
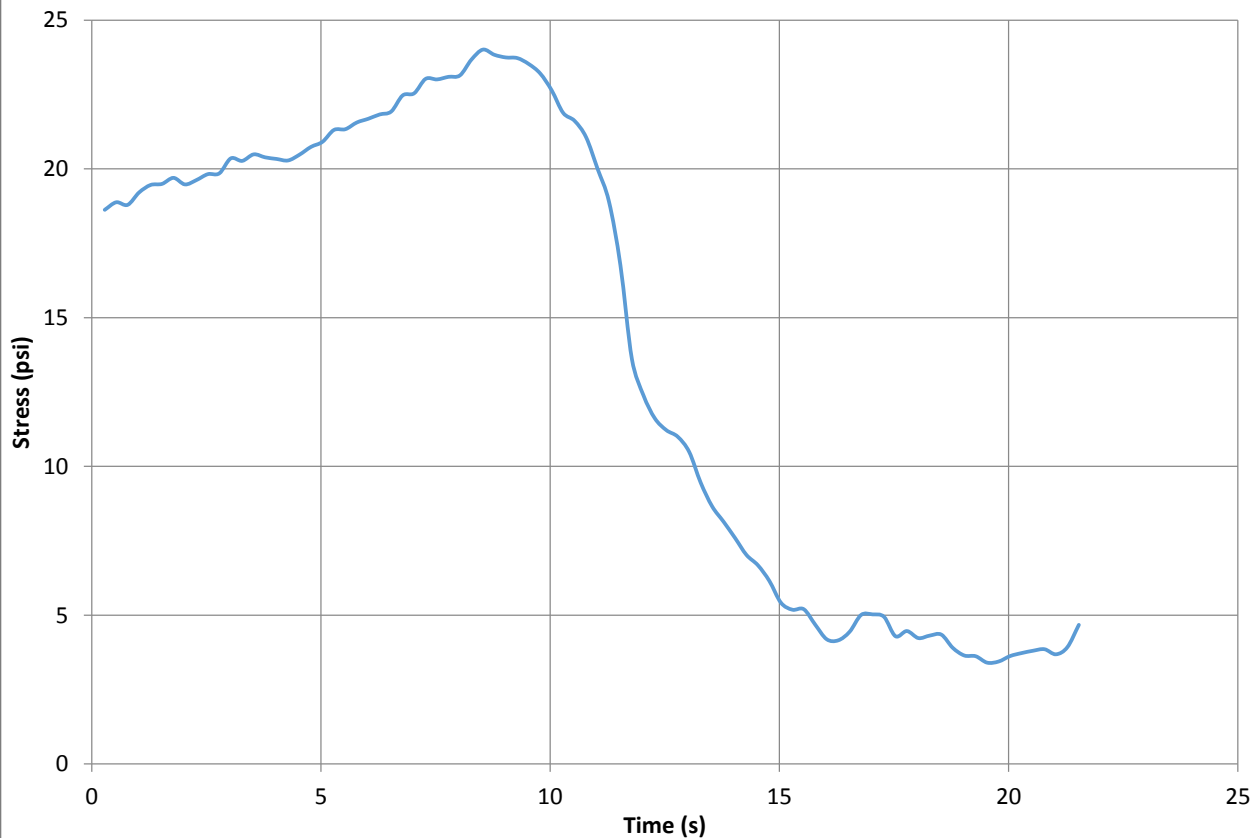
Disc Length		Disc Diameter		L/D Ratio
in	cm	in	cm	
1.46	3.7	2.452	6.23	0.60
Failure Load		BTS		Failure Mode
lbf	N	psi	MPa	
135	600	24	0.2	Non-Structural

**Note:** The sample was very soft and crushed within 10 seconds.

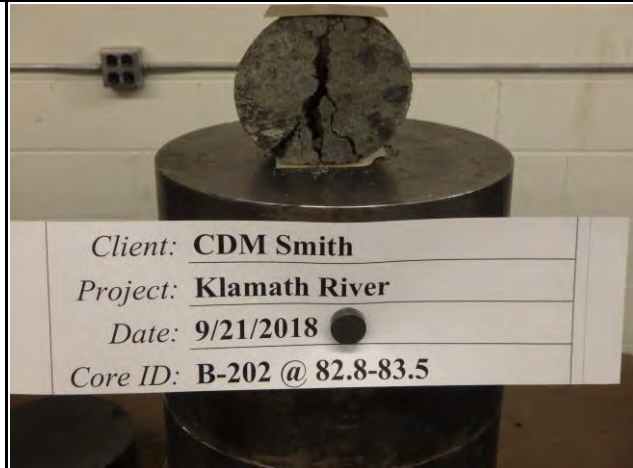
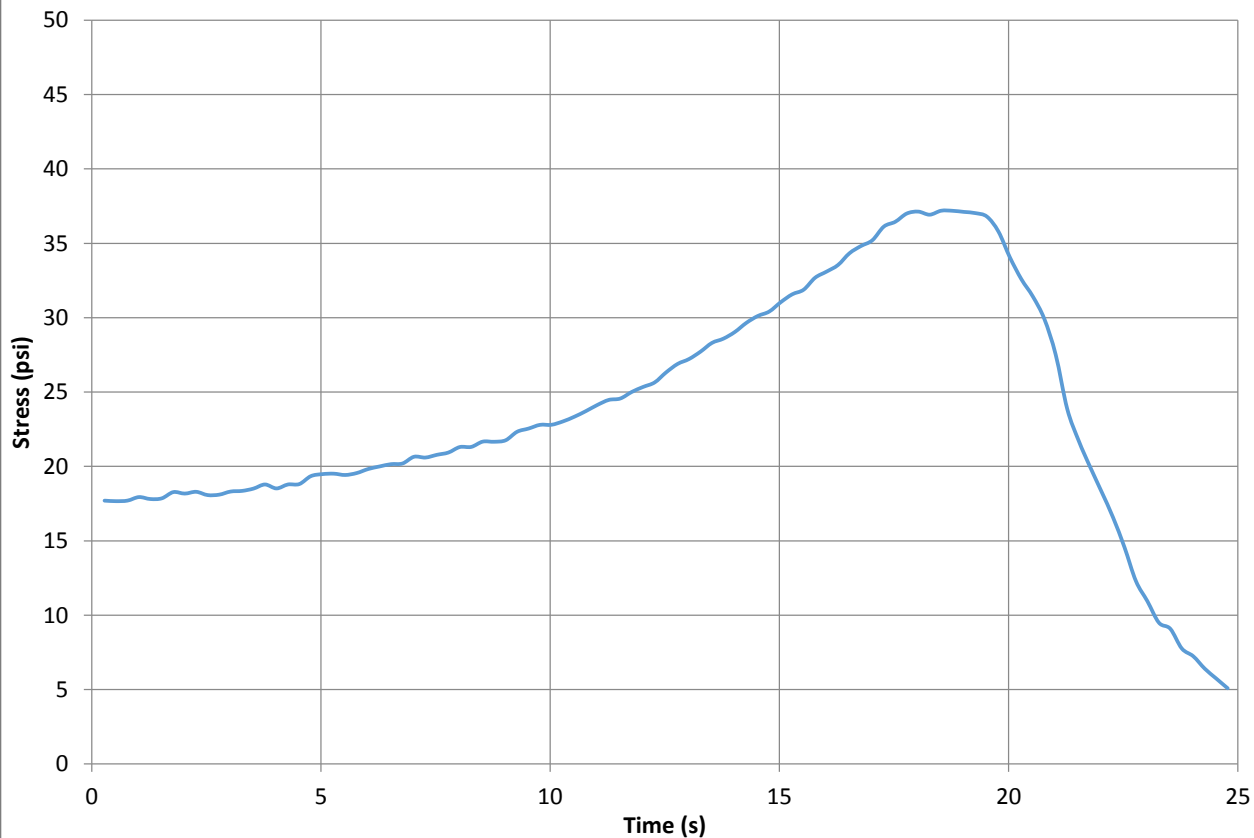
Disc Length		Disc Diameter		L/D Ratio
in	cm	in	cm	
1.48	3.8	2.407	6.11	0.62
Failure Load		BTS		Failure Mode
lbf	N	psi	MPa	
209	929	37	0.3	Non-Structural

**Note:** The sample was very soft and crushed within 20 seconds.

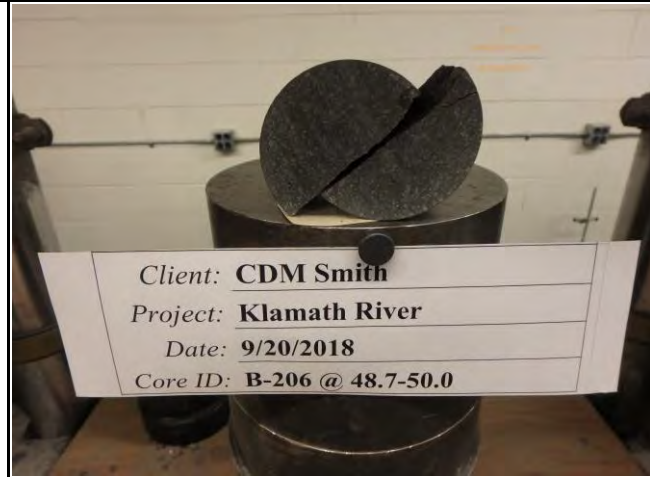
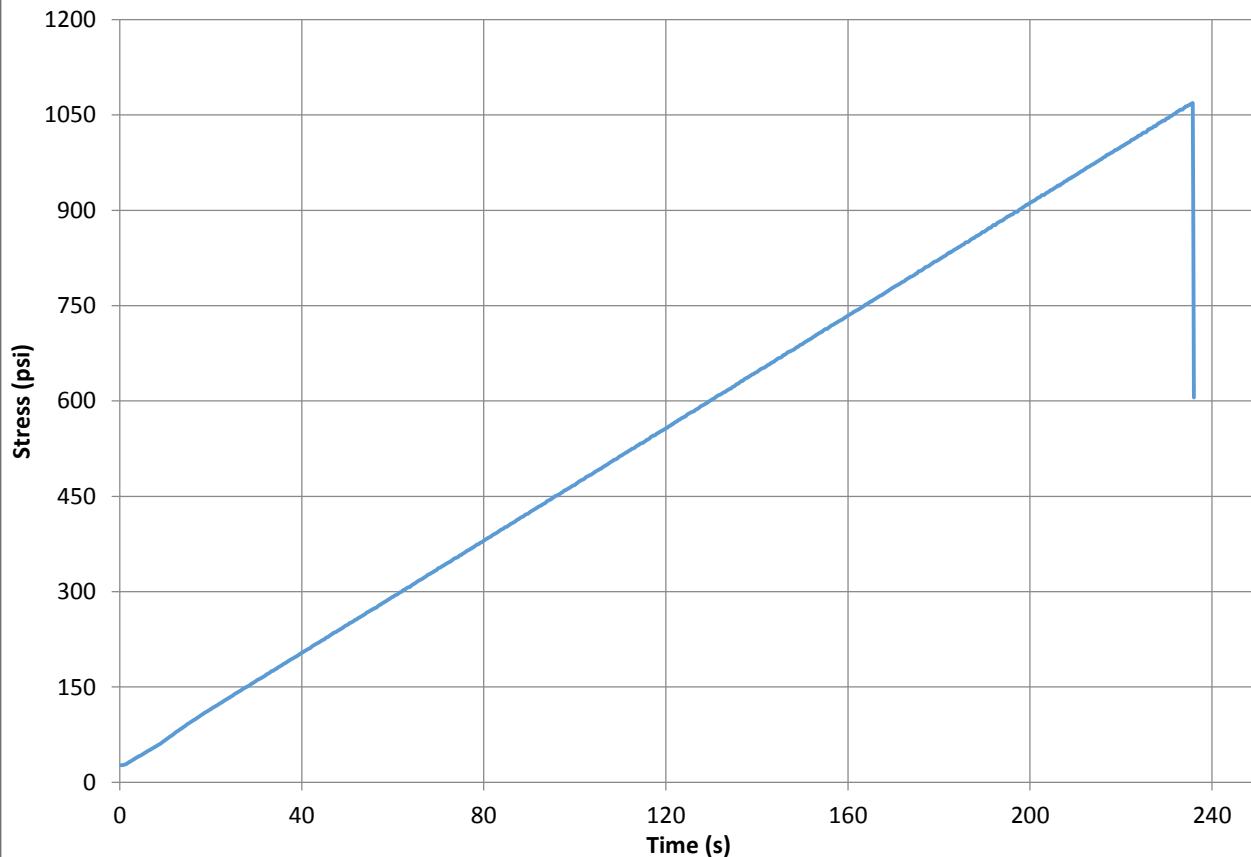
Disc Length		Disc Diameter		L/D Ratio
in	cm	in	cm	
1.49	3.8	2.406	6.11	0.62
Failure Load		BTS		Failure Mode
lbf	N	psi	MPa	
6,039	26,863	1,069	7.4	Non - Structural

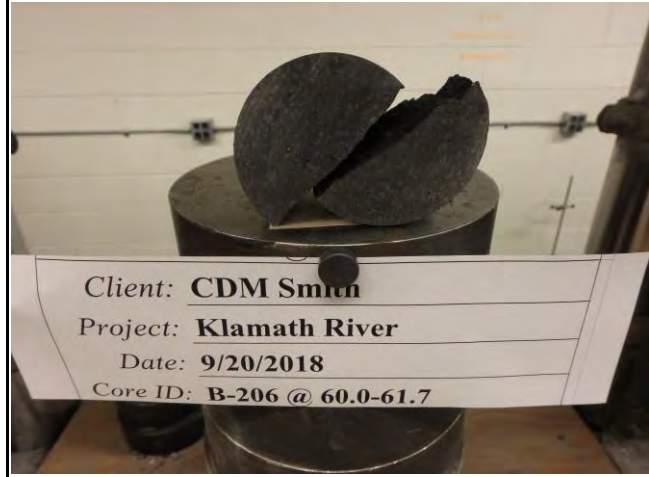
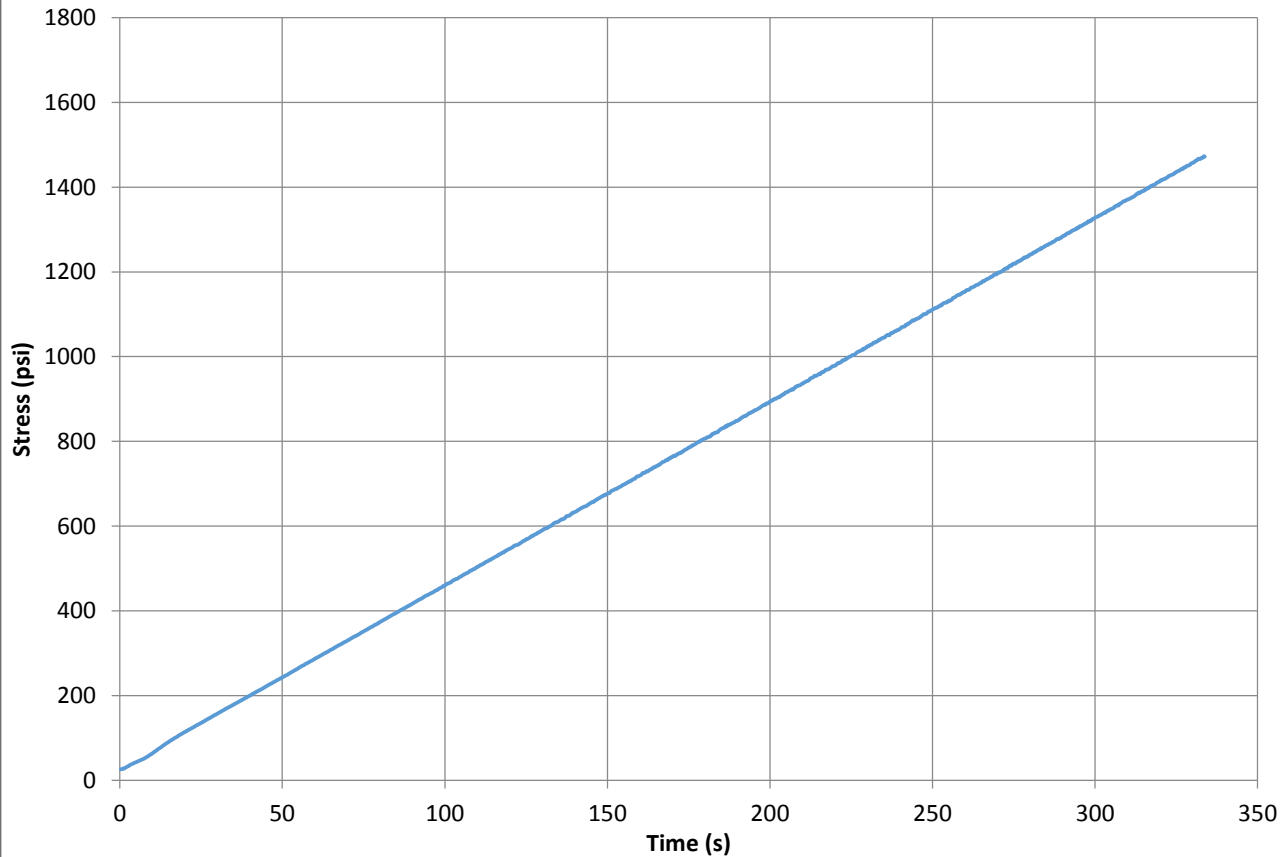
Disc Length		Disc Diameter		L/D Ratio
in	cm	in	cm	
1.53	3.9	2.403	6.10	0.64
Failure Load		BTS		Failure Mode
lbf	N	psi	MPa	
8,497	37,797	1,474	10.2	Non - Structural

Sample ID	Average Length	Average Diameter	Failure Load	Indirect (Brazilian) Tensile Strength		Notes ( <i>Failure type</i> )
	(in)	(in)	(lbs)	(psi)	(MPa)	
B-206 @ 60.0-61.7	1.53	2.403	8,497	1,474	10.2	Non - Structural
B-206 @ 48.7-50.0	1.49	2.406	6,039	1,069	7.4	Non - Structural
B-202 @ 82.8-83.5	1.48	2.407	209	37	0.3	Non - Structural
B-202 @ 56.2-57.5	1.46	2.452	135	24	0.2	Non - Structural

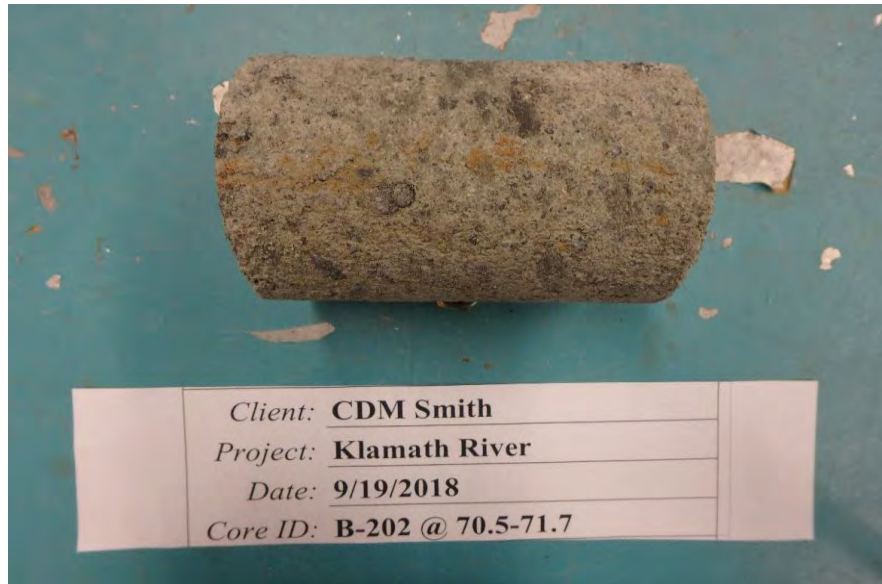
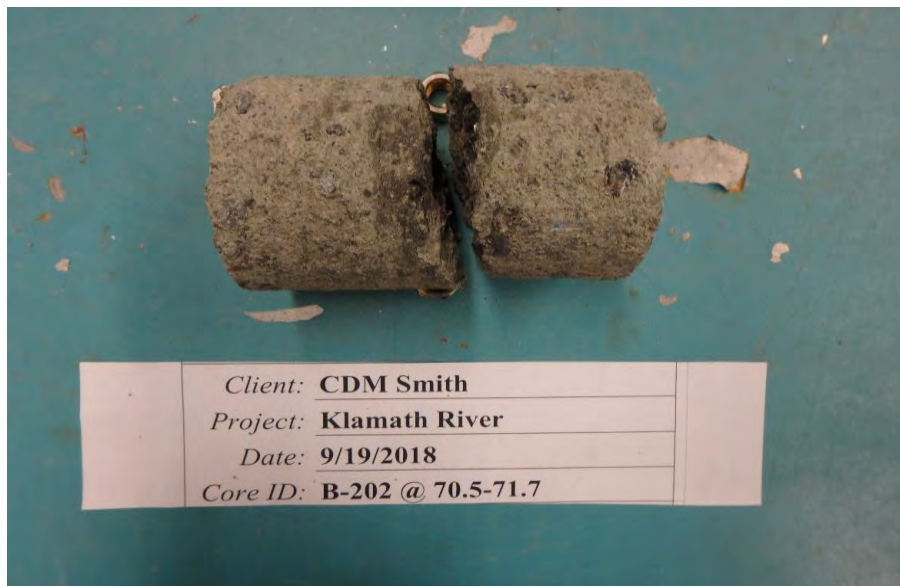
**Client Name:** CDM Smith  
**Project Name:** Klamath River  
**Date:** 9/20/2018  
**Sample ID:** B-202 @ 70.5-71.7

**Pictures of Sample Before and After**  
**Point Load Index Strength**

**Before**

**After**

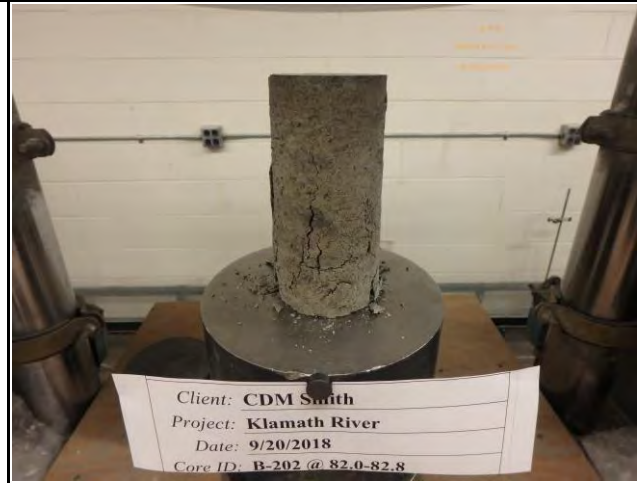
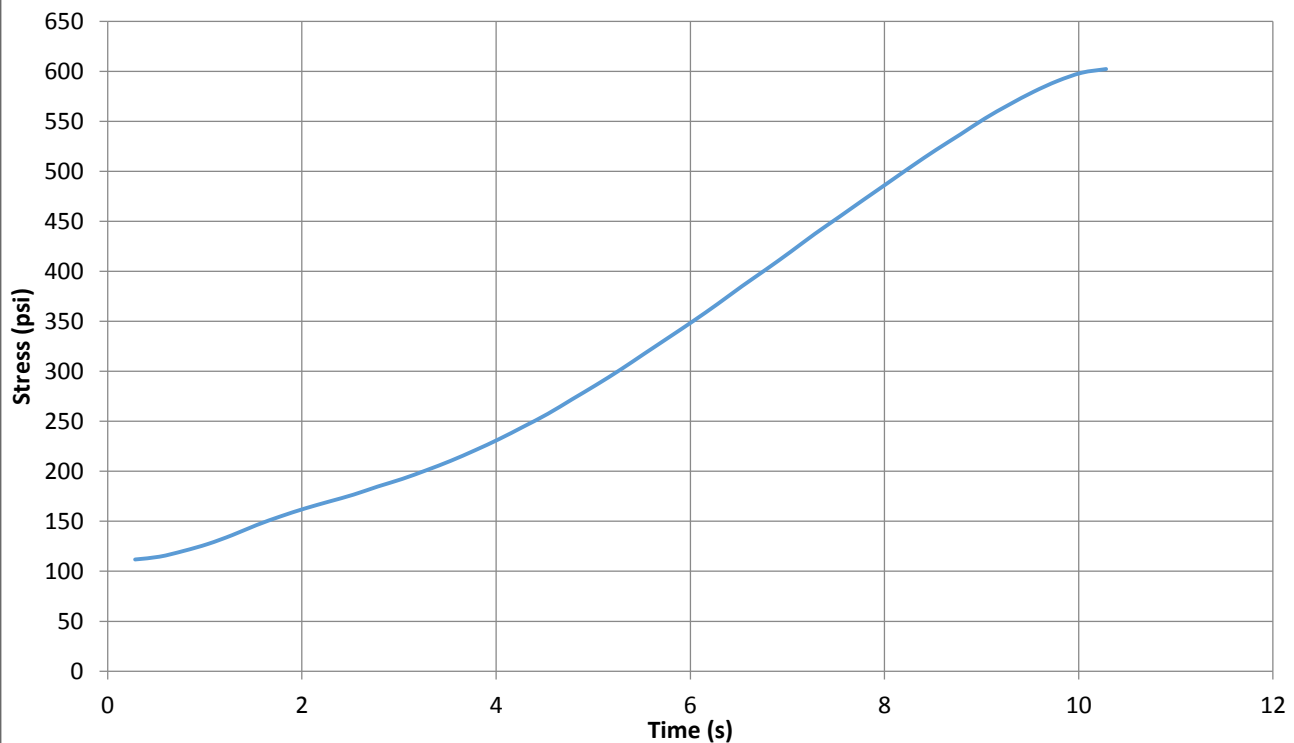
Core Length		Core Diameter		L/D Ratio	Density		
in	cm	in	cm		lb/ft <sup>3</sup>	g/cm <sup>3</sup>	
5.139	13.05	2.368	6.01	2.2	133	2.13	
Failure Load	Failure Stress	UCS 2:1		Static E		Static v	Failure Mode
lbf	psi	psi	MPa	ksi	GPa		
2,656	603	614	4.2	N/A	N/A	N/A	Non - Structural

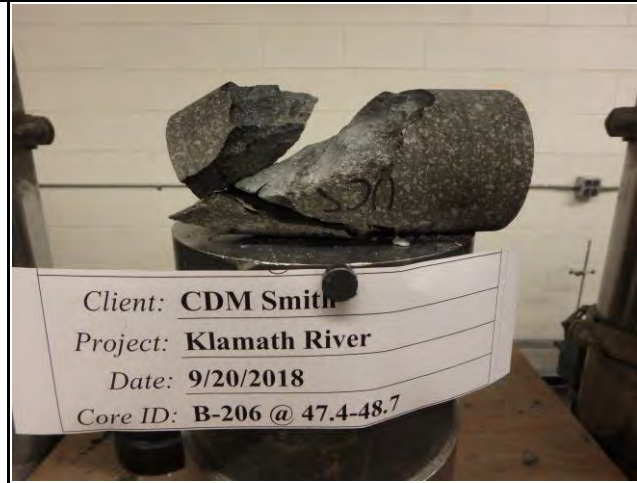
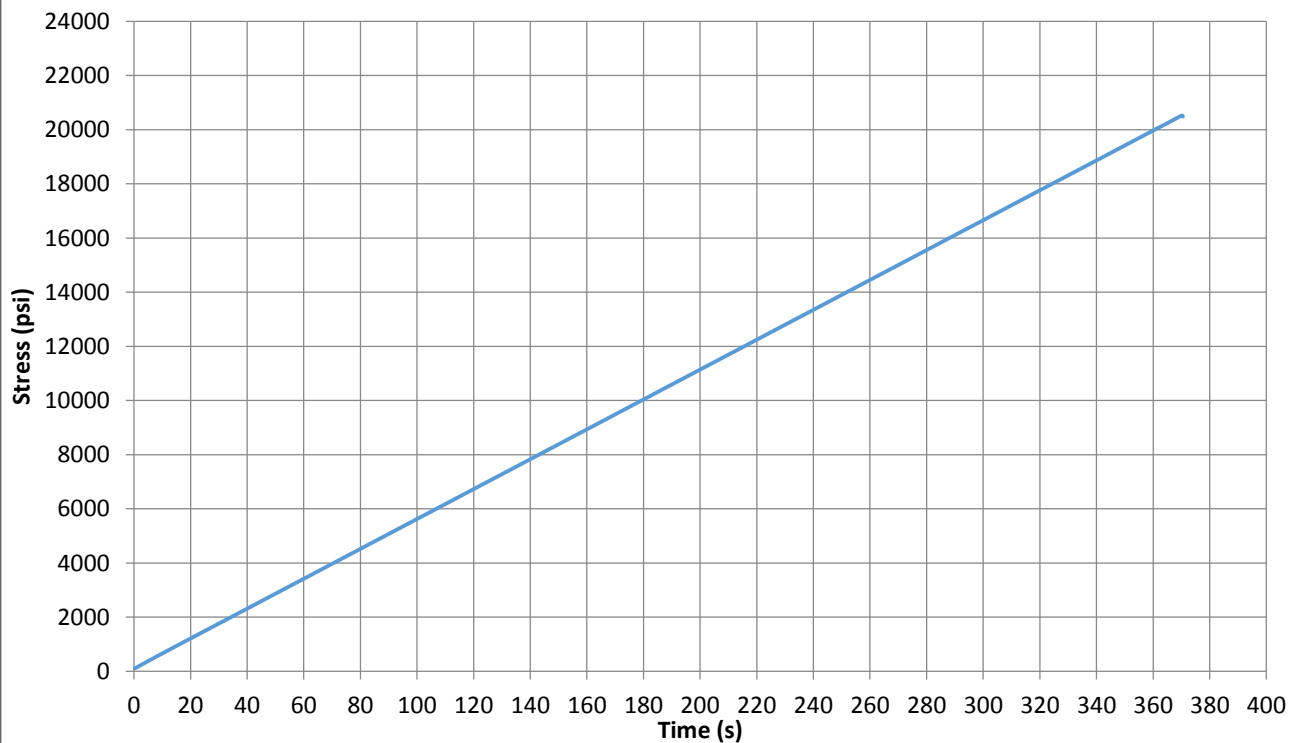
Core Length		Core Diameter		L/D Ratio	Density		
in	cm	in	cm		lb/ft <sup>3</sup>	g/cm <sup>3</sup>	
5.186	13.17	2.402	6.10	2.2	166	2.66	
Failure Load	Failure Stress	UCS 2:1		Static E		Static v	Failure Mode
lbf	psi	psi	MPa	ksi	GPa		
93,017	20,527	20,886	144.0	N/A	N/A	N/A	Non - Structural

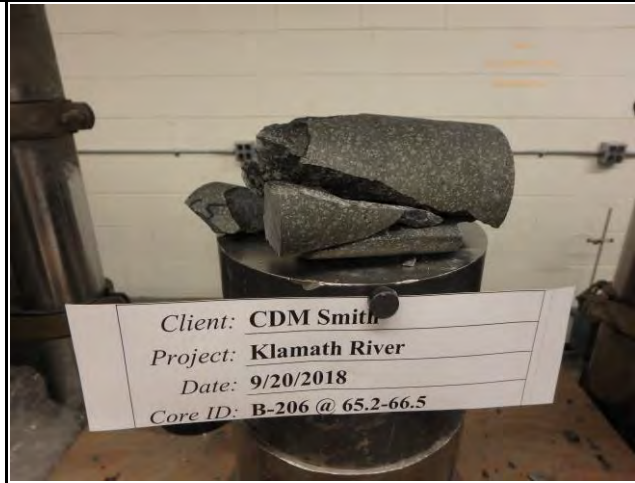
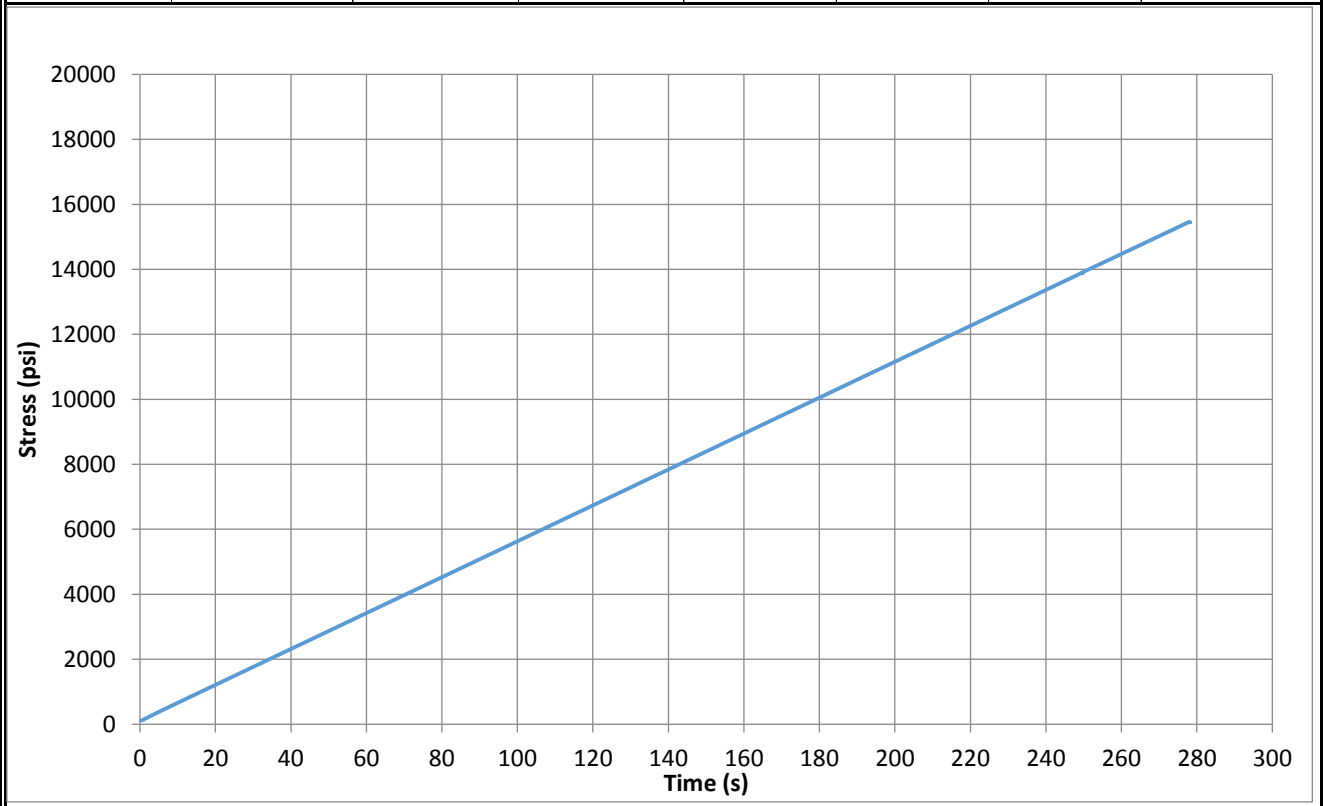
Core Length		Core Diameter		L/D Ratio	Density		
in	cm	in	cm		lb/ft <sup>3</sup>	g/cm <sup>3</sup>	
5.188	13.18	2.401	6.10	2.2	169	2.70	
Failure Load	Failure Stress	UCS 2:1		Static E		Static v	Failure Mode
lbf	psi	psi	MPa	ksi	GPa		
70,001	15,467	15,739	108.5	N/A	N/A	N/A	Non - Structural

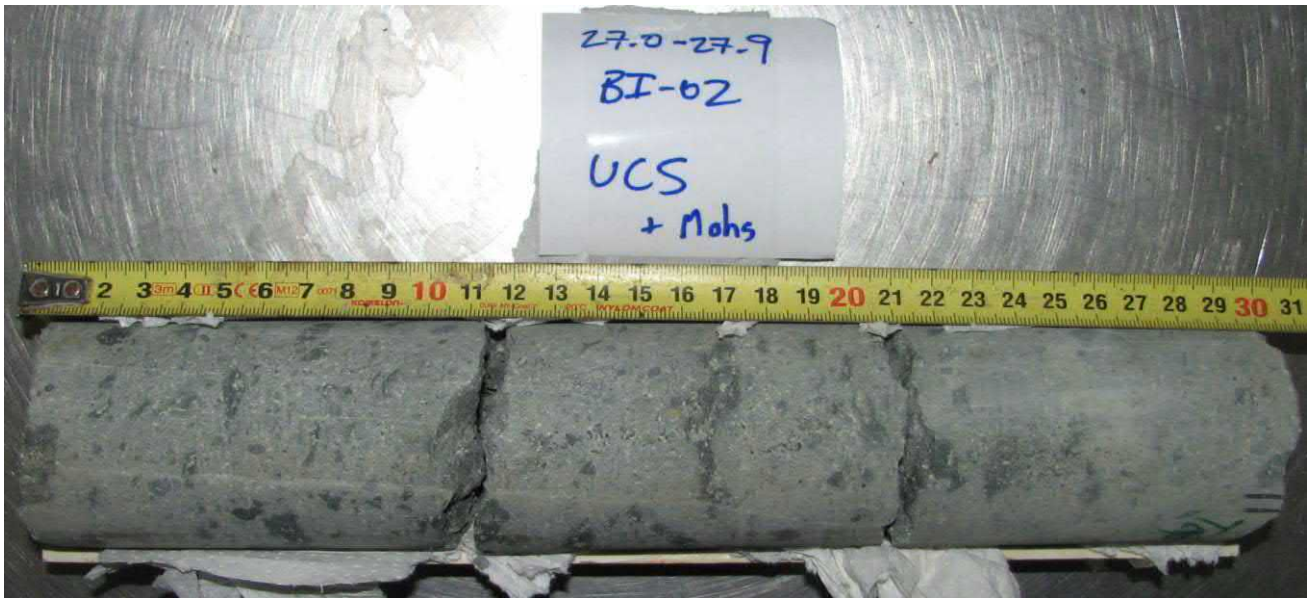
Picture of the sample upon arrival at Tonon USA Laboratory: no core piece allowed preparation of a specimen with a height-to-diameter ratio between 2 and 2.5.

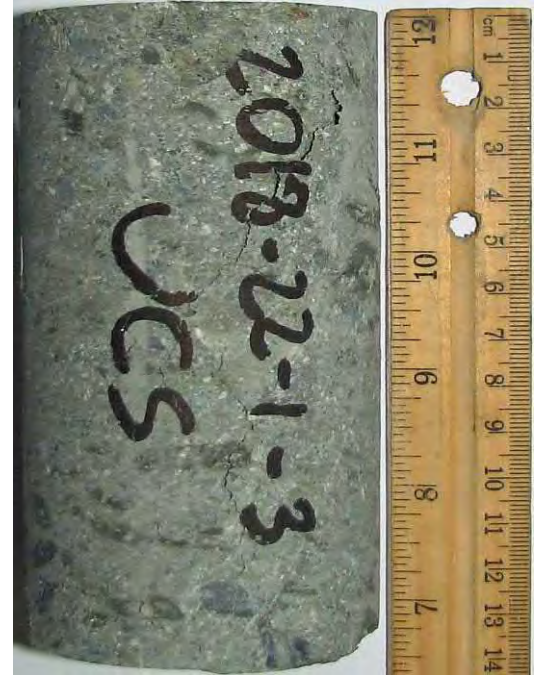
Photo After Test

Stress Rate	0.5 MPa/s	
Diameter of Specimen	60.59 mm	2.39 in
Height of Specimen	129.81 mm	5.11 in
Load at Peak	4.39 kN	987 lbf
Unconfined Compressive Strength	1.52 MPa	221 psi
Type of Failure	Non-Structural

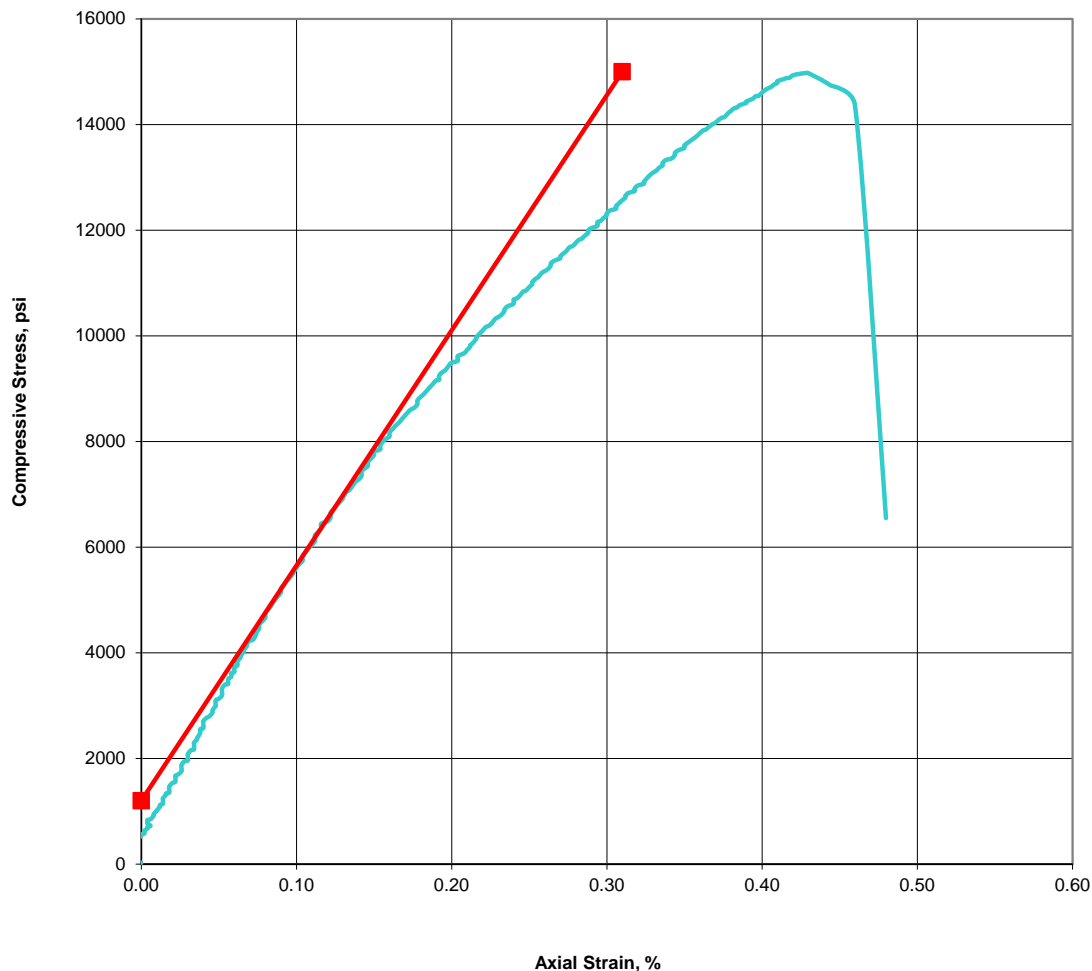
Sample Height, in.	5.00	<b>Unconfined Compressive Strength (psi)</b>	<b>14975</b>
Sample Diameter, in.	2.39		
Height / Diameter	2.1		
Sample Area, in <sup>2</sup>	4.50		
Wet Density, pcf	160.2	<b>Young's Modulus (E) (psi)</b>	<b>4,450,000</b>
Dry Density, pcf	159.1		
Moisture Content, %	0.7		
Strain Rate, % / min	0.25

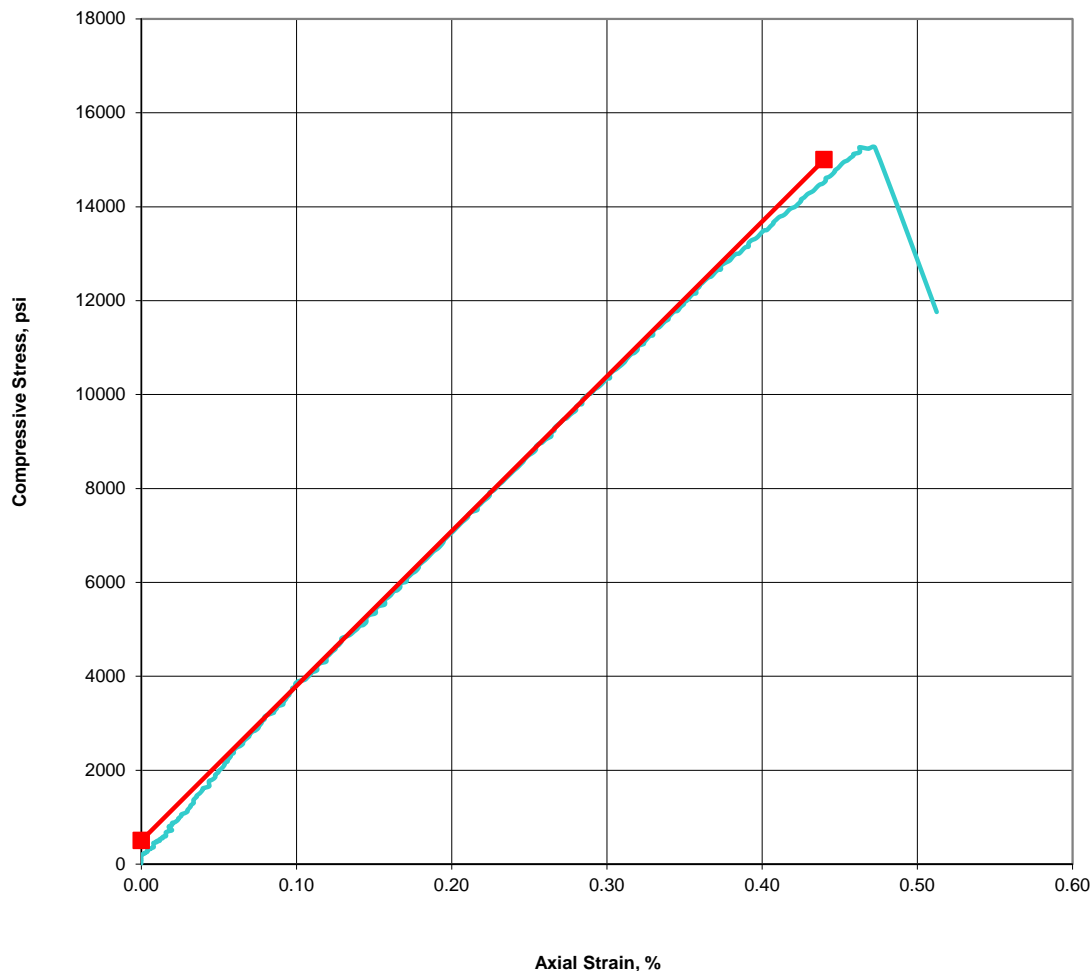
Sample Height, in.	5.03	<b>Unconfined Compressive Strength (psi)</b>	<b>15268</b>
Sample Diameter, in.	2.40		
Height / Diameter	2.1		
Sample Area, in <sup>2</sup>	4.54		
Wet Density, pcf	162.2	<b>Young's Modulus (E) (psi)</b>	<b>3,300,000</b>
Dry Density, pcf	159.3		
Moisture Content, %	1.8		
Strain Rate, % / min	0.25

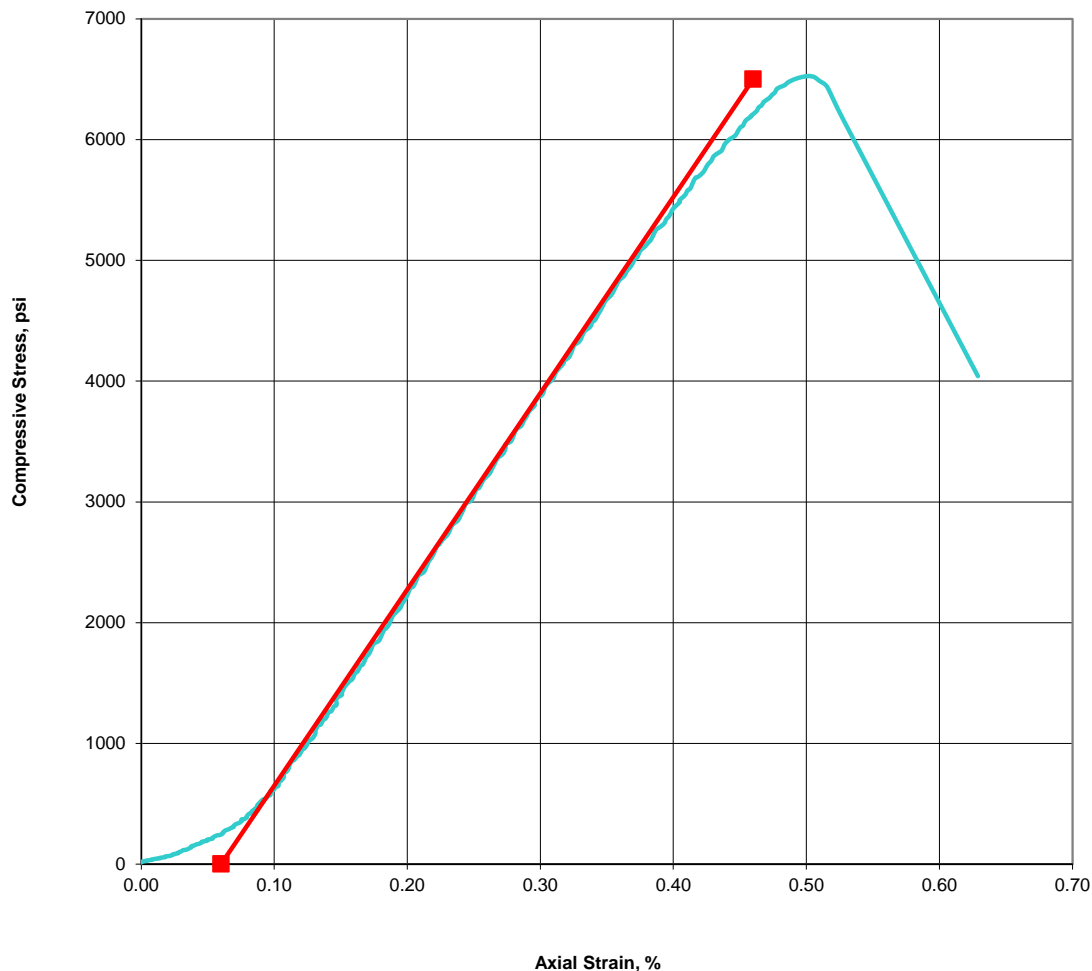
Sample Height, in.	5.04	<b>Unconfined Compressive Strength (psi)</b>	<b>6528</b>
Sample Diameter, in.	2.40		
Height / Diameter	2.1		
Sample Area, in <sup>2</sup>	4.52		
Wet Density, pcf	141.3	<b>Young's Modulus (E) (psi)</b>	<b>1,630,000</b>
Dry Density, pcf	140.1		
Moisture Content, %	0.9		
Strain Rate, % / min	0.25

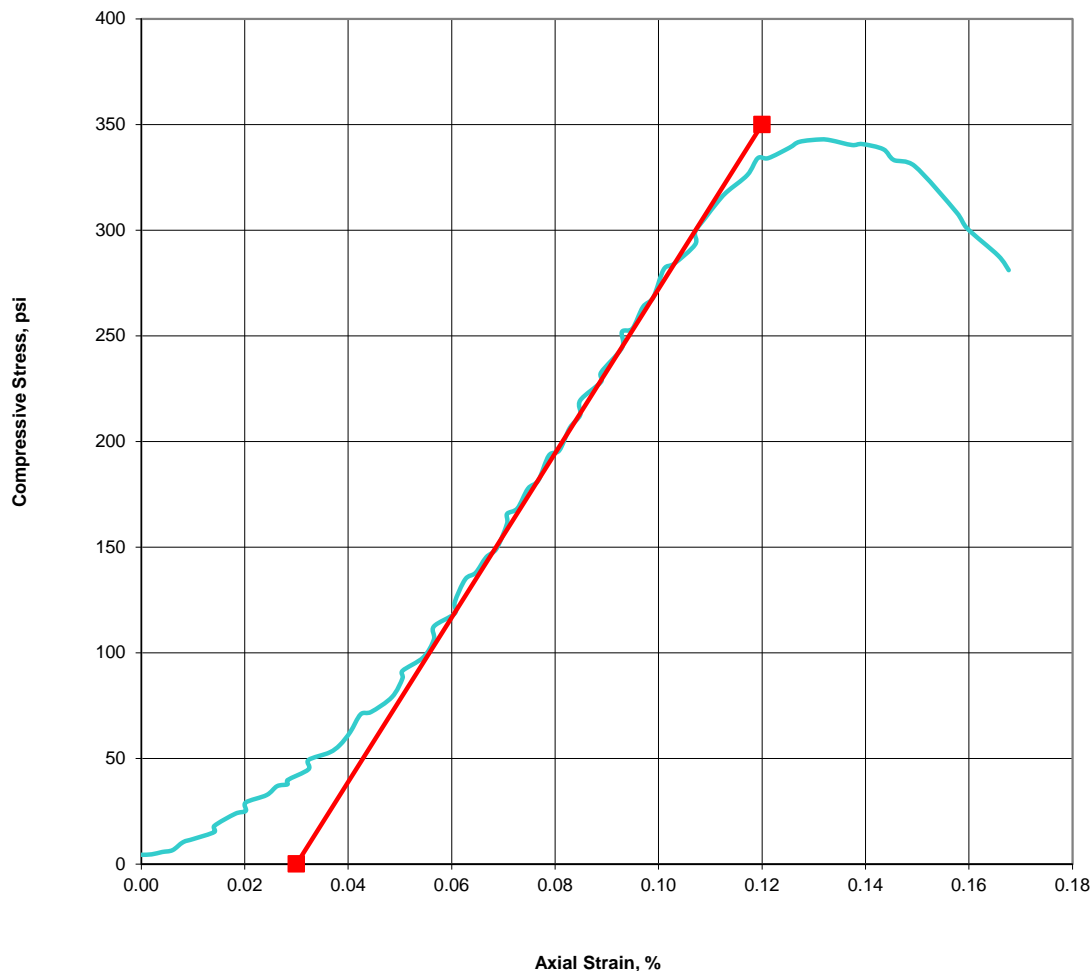
Sample Height, in.	4.95	<b>Unconfined Compressive Strength (psi)</b>	<b>343</b>
Sample Diameter, in.	2.40		
Height / Diameter	2.1		
Sample Area, in <sup>2</sup>	4.53		
Wet Density, pcf	163.7	<b>Young's Modulus (E) (psi)</b>	<b>388,900</b>
Dry Density, pcf	157.9		
Moisture Content, %	3.7		
Strain Rate, % / min	0.25

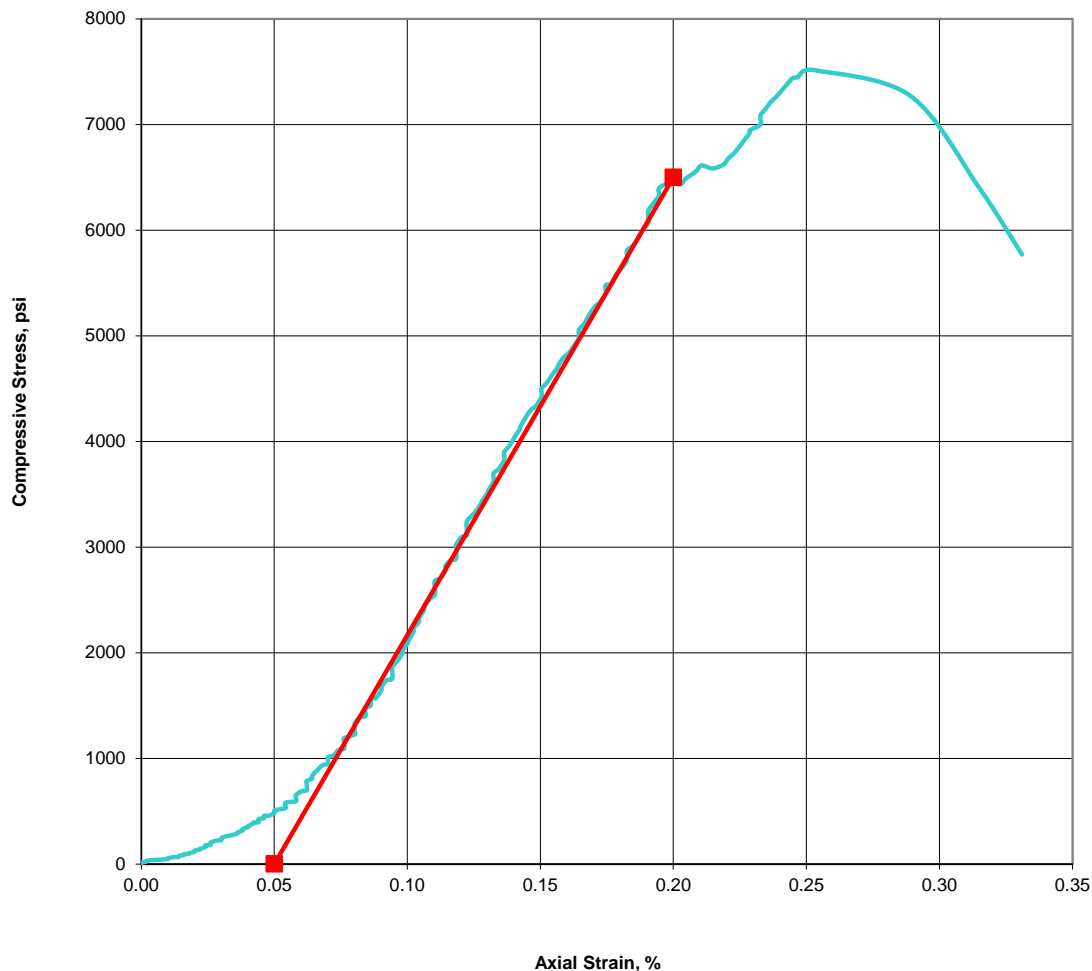
Sample Height, in.	4.98	<b>Unconfined Compressive Strength (psi)</b>	<b>7517</b>
Sample Diameter, in.	2.40		
Height / Diameter	2.1		
Sample Area, in <sup>2</sup>	4.54		
Wet Density, pcf	165.7	<b>Young's Modulus (E) (psi)</b>	<b>4,330,000</b>
Dry Density, pcf	160.3		
Moisture Content, %	3.4		
Strain Rate, % / min	0.25

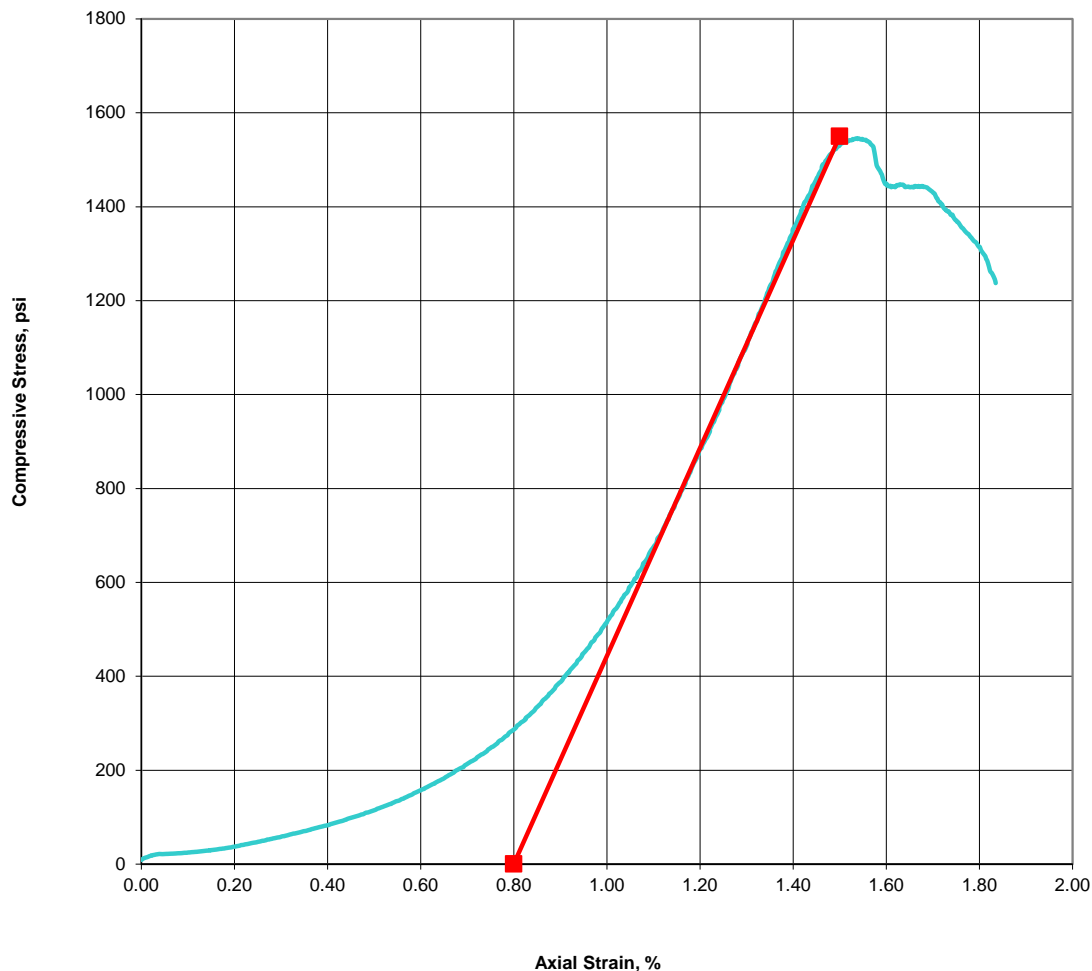
Sample Height, in.	4.95	<b>Unconfined Compressive Strength (psi)</b>	<b>1546</b>
Sample Diameter, in.	2.34		
Height / Diameter	2.1		
Sample Area, in <sup>2</sup>	4.30		
Wet Density, pcf	144.2	<b>Young's Modulus (E) (psi)</b>	<b>221,400</b>
Dry Density, pcf	136.3		
Moisture Content, %	5.8		
Strain Rate, % / min	0.25
