CTL# 020-251  
AECOM  
Klamath River Dam Removal  
60537920

Subject: Project No.: 60537920  
Project Name: Klamath River Dam Removal Project  
Corrosivity Analysis – CalTrans Test Methods

Project Name	Klamath River Dam Removal
Location	Klamath River
Client	Klamath River Renewal Corporation
Client Project No.	60537920
Registry No.	2018-22
Report No.	2018-22-4-1
Report Date	5/17/2018
Drill Hole and Depth	BI-02; 27-27.9 ft
Rock Type	Volcanic Breccia
Geologic Unit	N/A
Moisture Condition	As-received

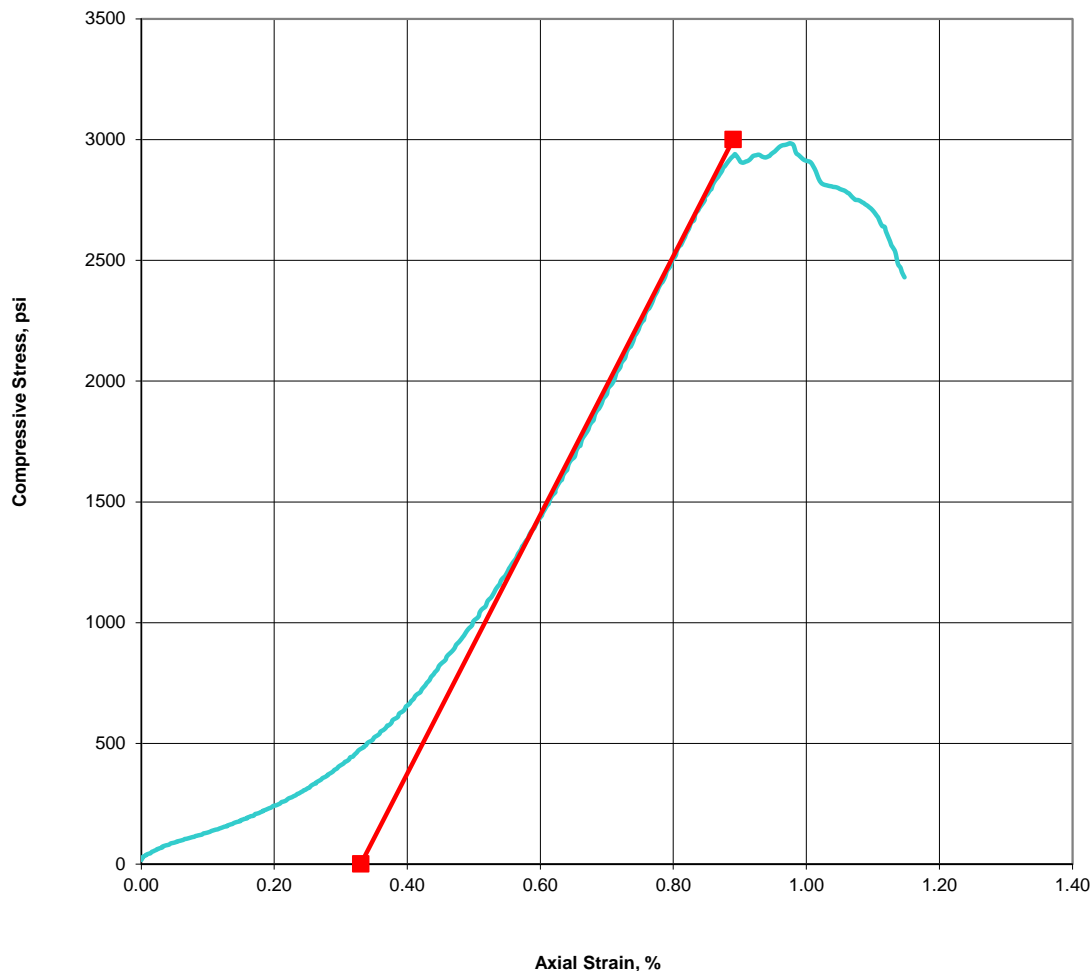
Sample Height, in.	5.03	<b>Unconfined Compressive Strength (psi)</b>	<b>2985</b>
Sample Diameter, in.	2.37		
Height / Diameter	2.1		
Sample Area, in <sup>2</sup>	4.41		
Wet Density, pcf	145.6	<b>Young's Modulus (E) (psi)</b>	<b>535,700</b>
Dry Density, pcf	140.1		
Moisture Content, %	3.9		
Strain Rate, % / min	0.25

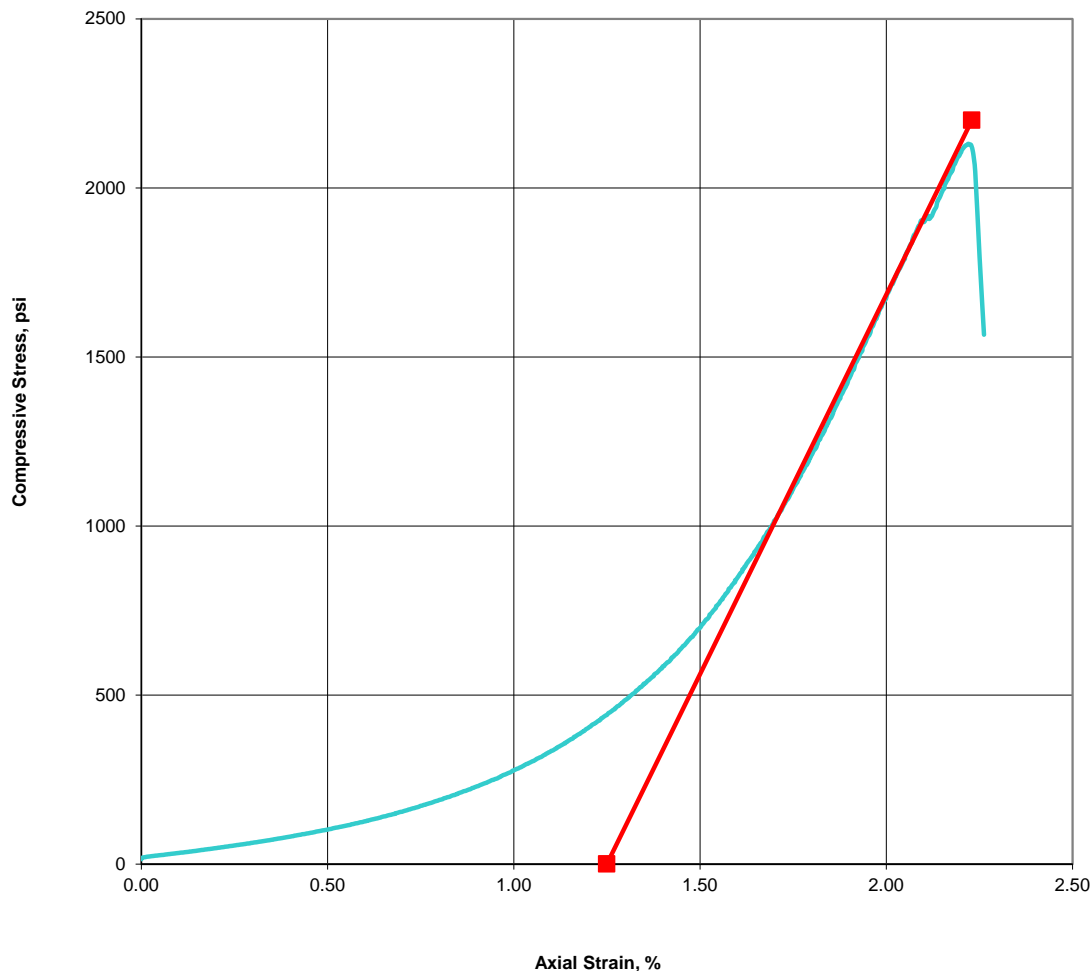
Sample Height, in.	5.09	<b>Unconfined Compressive Strength (psi)</b>	<b>2130</b>
Sample Diameter, in.	2.35		
Height / Diameter	2.2		
Sample Area, in <sup>2</sup>	4.33		
Wet Density, pcf	142.9	<b>Young's Modulus (E) (psi)</b>	<b>224,500</b>
Dry Density, pcf	134.9		
Moisture Content, %	5.9		
Strain Rate, % / min	0.25

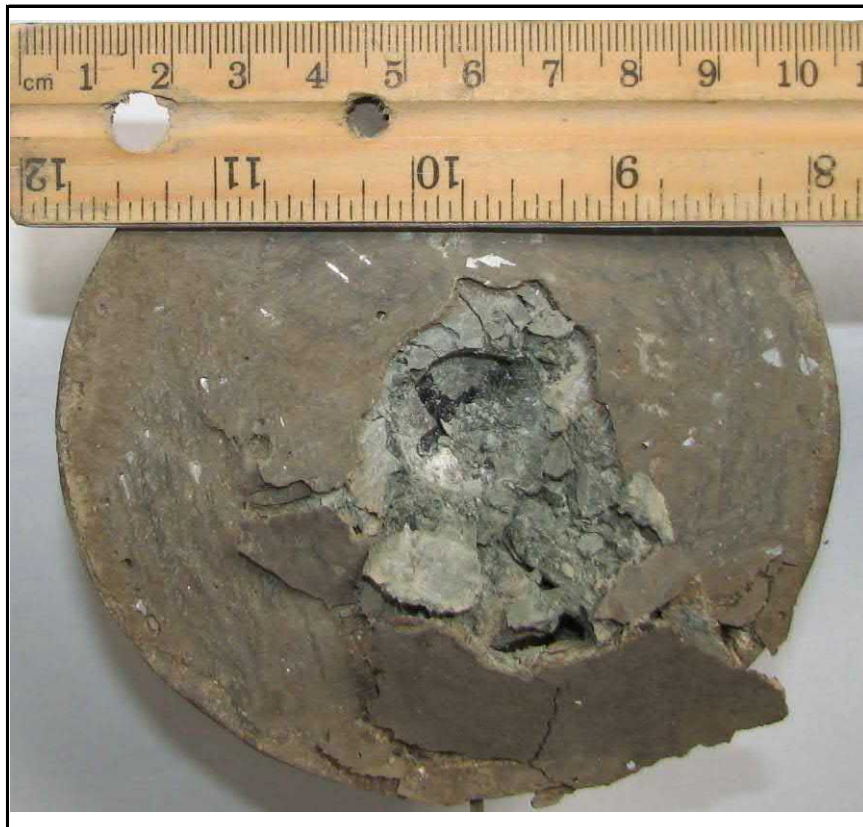
Photo After Test

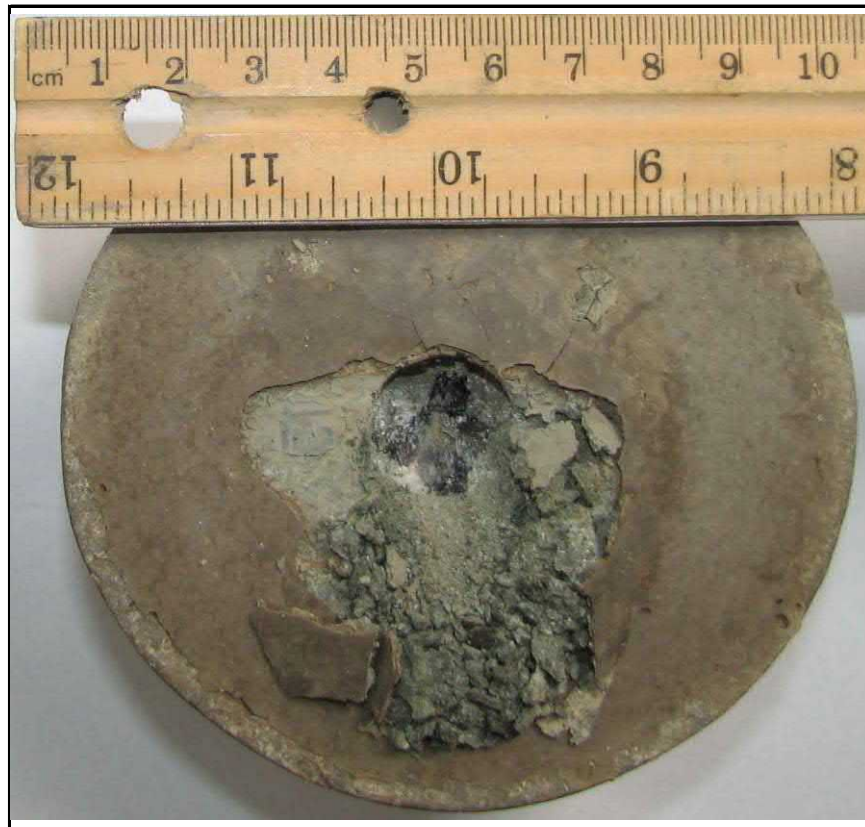
Photo After Test

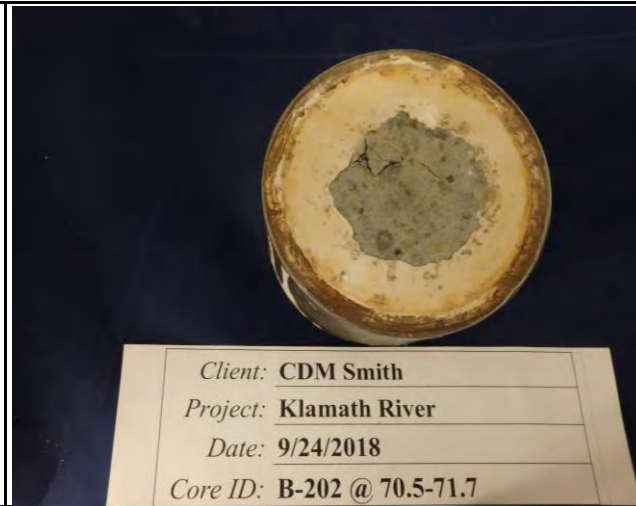
Penetration Rate		Maximum Load		45° (Standard) Index:	
in/s	mm/s	kip	kN	kip/in	kN/mm
0.001	0.025	2.306	10.256	180	31.5
Peak Slope Index		Average Slope Index		Energy Slope Index	
kip/in	kN/mm	kip/in	kN/mm	kip/in	kN/mm
9	1.6	34	5.9	12	2.0

**Note:** Indentor is made of Tungsten Carbide with base diameter of 7.5in, cone angle of 120° and tip radius of 2mm

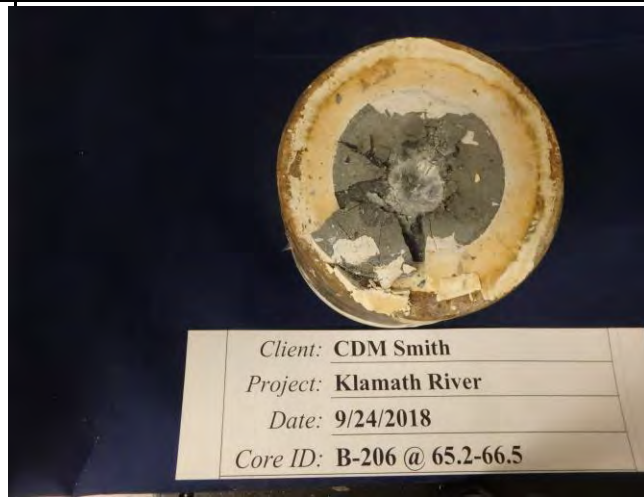
Penetration Rate		Maximum Load		45° (Standard) Index:	
in/s	mm/s	kip	kN	kip/in	kN/mm
0.001	0.025	48.777	216.972	180	31.5
Peak Slope Index		Average Slope Index		Energy Slope Index	
kip/in	kN/mm	kip/in	kN/mm	kip/in	kN/mm
195	34.2	129	22.6	124	21.7

**Note:** Indentor is made of Tungsten Carbide with base diameter of 7.5in, cone angle of 120° and tip radius of 2mm

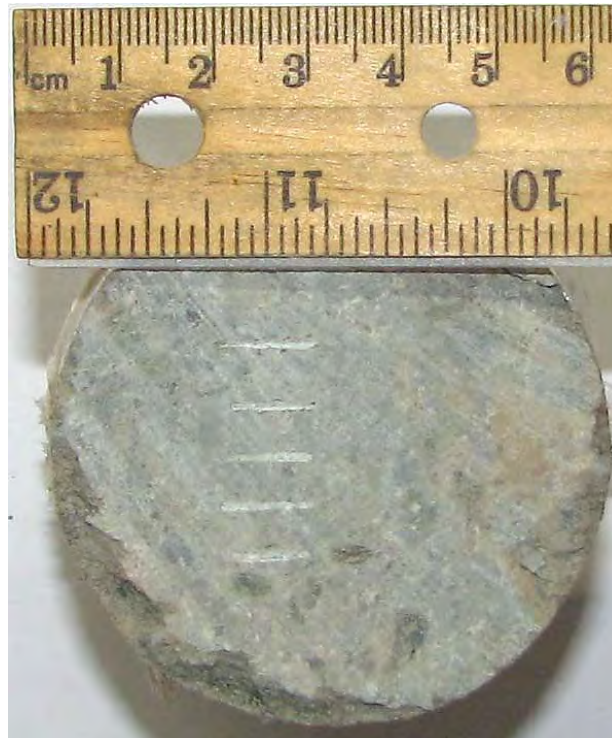
Project Name	Klamath River Dam Removal	Apparatus, Pin R.-H.	West Cerchar, 55/56	
Location	Klamath River	Direction of Scratch	Perpendicular to Core Axis	
Client	Klamath River Renewal Corporation	Pin Wear (mm)	0.156	0.145
Client Project No.	60537920		0.142	0.124
Registry No.	2018-22		0.144	0.133
Report No.	2018-22-5-1		0.162	0.129
Report Date	5/17/2018		0.150	0.140
Drill Hole and Depth	BI-02; 51.3-51.7 ft	Average (mm)	0.143	
Rock Type	Volcanic Breccia	CAIs	1.43	
Formation	N/A	CAI	1.89	
Surface Condition	Cut by Slab Saw	Classification	Medium Abrasiveness

Photo After Test

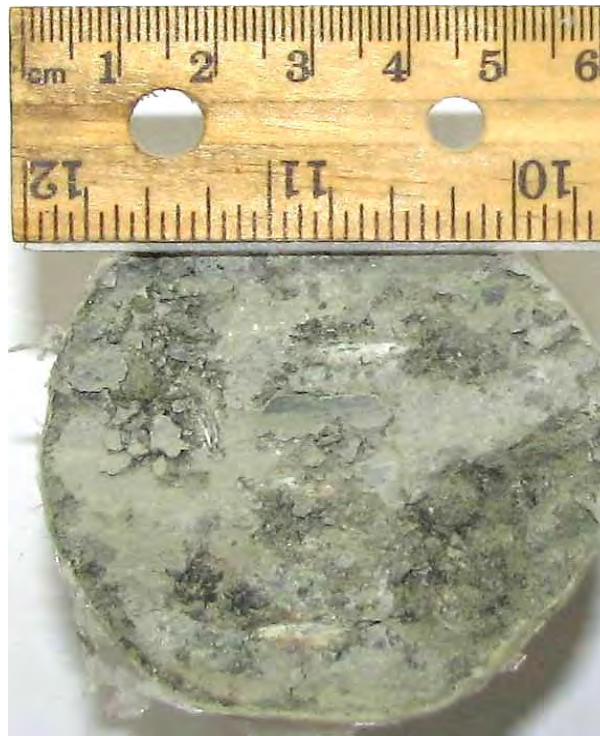
Project Name	Klamath River Dam Removal	Apparatus, Pin R.-H.	West Cerchar, 55/56	
Location	Klamath River	Direction of Scratch	Perpendicular to Core Axis	
Client	Klamath River Renewal Corporation	Pin Wear (mm)	0.046	0.037
Client Project No.	60537920		0.083	0.069
Registry No.	2018-22		0.104	0.090
Report No.	2018-22-5-2		0.087	0.098
Report Date	5/17/2018		0.100	0.093
Drill Hole and Depth	BI-03; 25.1-26.1 ft	Average (mm)	0.081	
Rock Type	Volcanic Breccia	CAIs	0.81	
Formation	N/A	CAI	1.28	
Surface Condition	Cut by Slab Saw	Classification	Medium Abrasiveness

Photo After Test

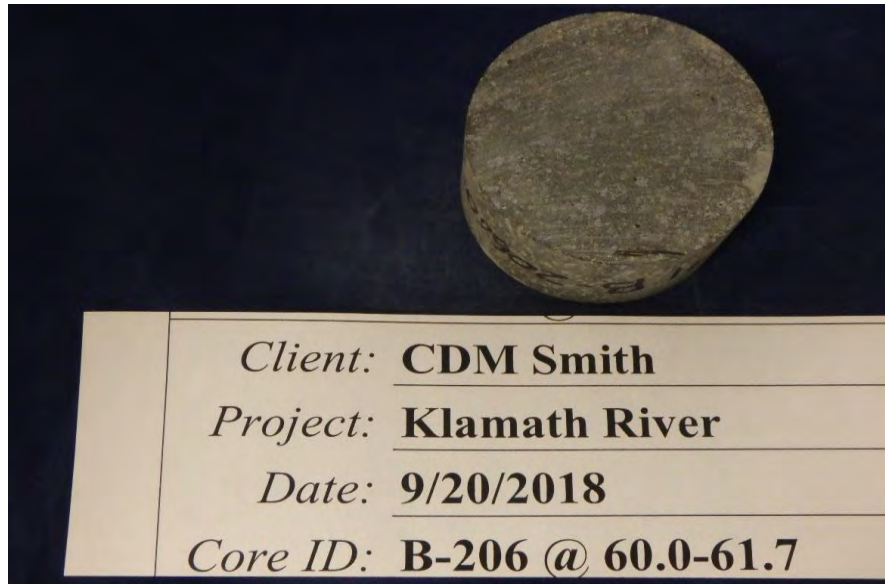
**Before**

**Pictures of Sample Before and After**  
**Cerchar Abrasivity Index**

**Client Name:** CDM Smith  
**Project Name:** Klamath River  
**Date:** 9/20/2018  
**Sample ID:** B-206 @ 60.0-61.7

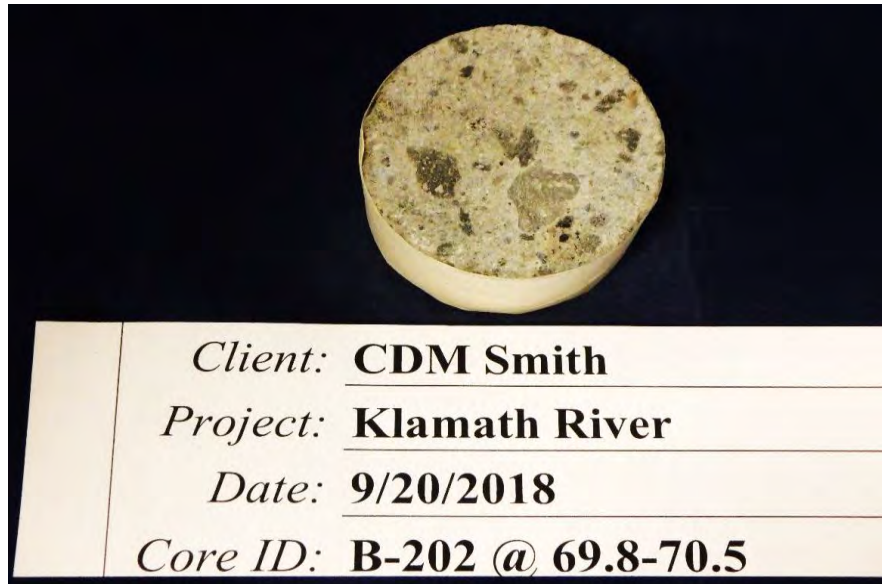
Pictures of Sample Before and After  
Cerchar Abrasivity Index

*Client Name:* CDM Smith  
*Project Name:* Klamath River  
*Date:* 9/20/2018  
*Sample ID:* B-202 @ 69.8-70.5

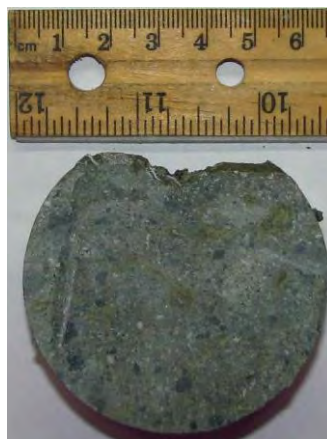
Visual inspection of the sample suggests an igneous origin.

**ROCK NAME: BRECCIATED-ALTERED BASALT** (according to EN 12670).

**Fig. 1** - Aspect of the studied sample (hand specimen).

**Alteration and Mineral Suture Condition:** The rock is highly altered: even the largest phenocrysts show traces of intense alteration acted upon by clayey minerals; Plagioclase crystals are intensively fractured. These fractures are commonly filled with secondary clayey material in a “quasi-stylolitic” pattern.

**Discontinuities:** The rock shows a very pervasive fracture system: many of these fractures have not been filled with secondary mineralization, and they predominantly cross the groundmass. Fractures crossing phenocrysts are instead filled with clay minerals.

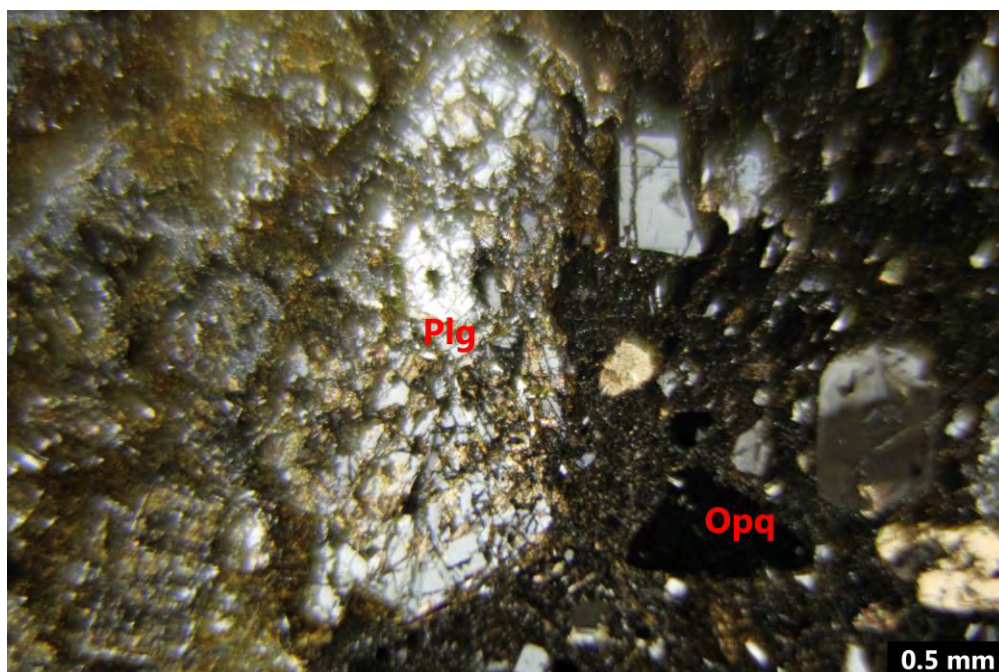
**Fig. 3** - Cross polarized light. Field of view = 4 mm wide (magnification 4X). Same as Figure 2, but under crossed polars.

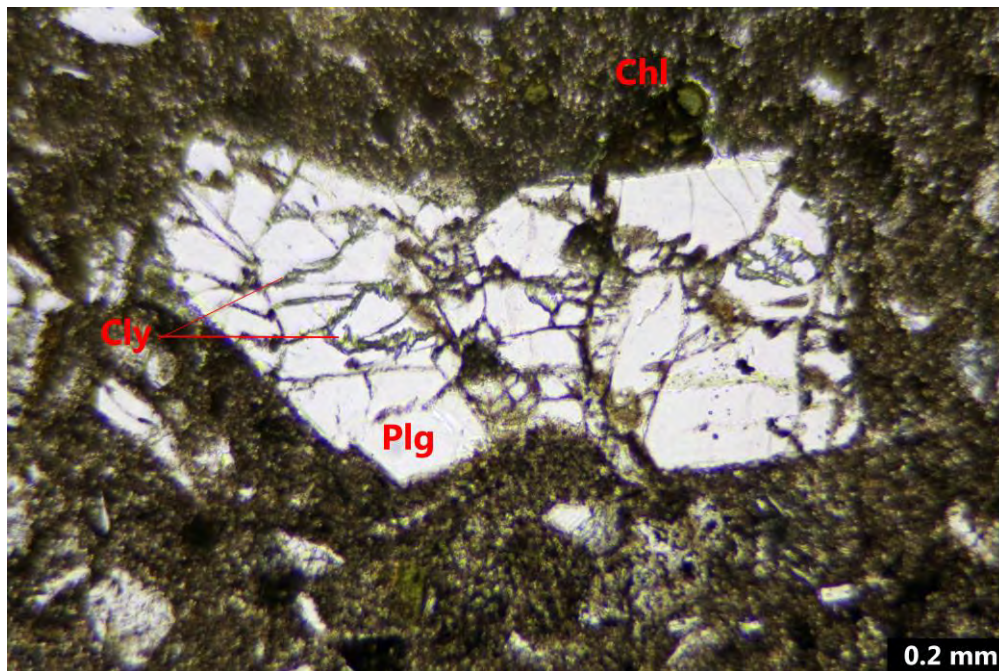
**Fig. 4** - Plane polarized light. Field of view = 1.7 mm wide (magnification 10X). A detail of a Plagioclase grain, crossed by many fractures, all filled with Clay Minerals (Cly). Some Chlorite individuals (Chl) may be identified in the upper part of the picture.

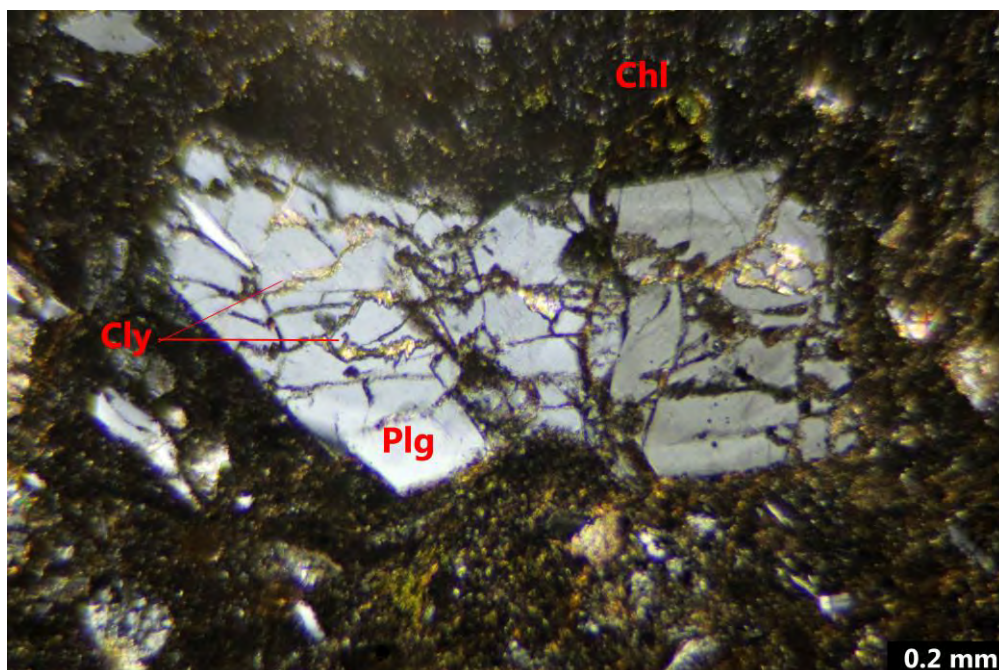
**Fig. 5** - Cross polarized light. Field of view = 1.7 mm wide (magnification 10X). Same as Figure 4, but under crossed polars.

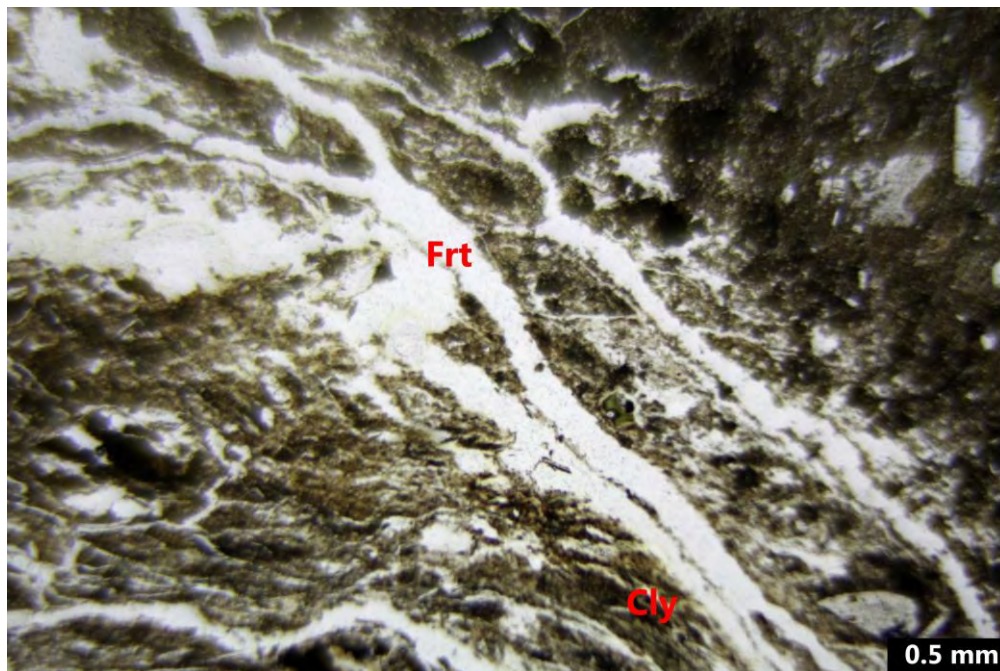
**Fig. 6** - Plane polarized light. Field of view = 4 mm wide (magnification 4X). A selected area of the section with a well-developed fracture system (Frt).

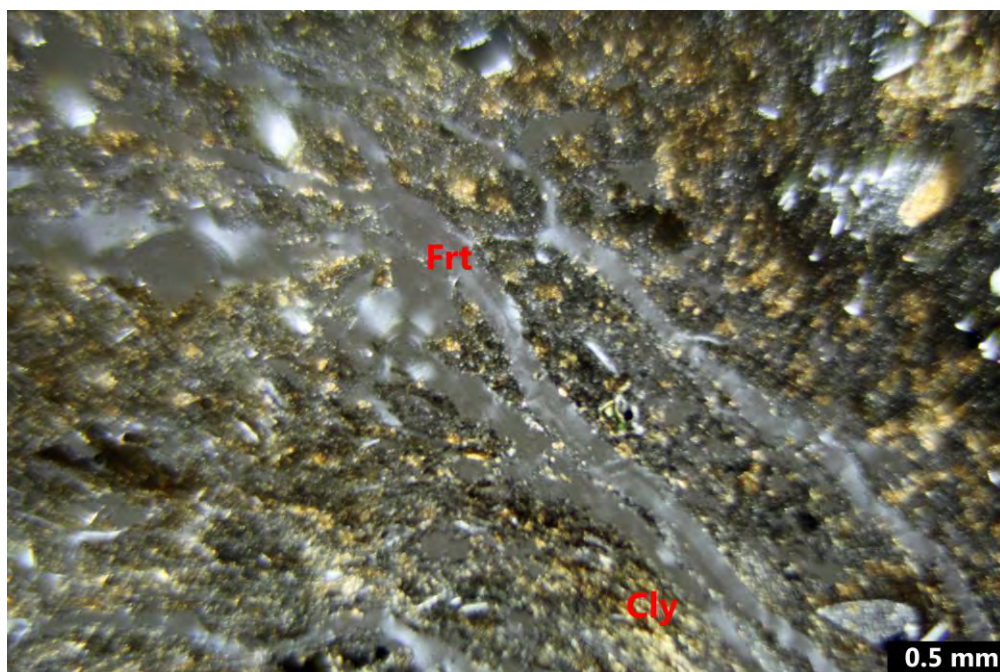
**Fig. 7** - Cross polarized light. Field of view = 4 mm wide (magnification 4X). Same as Figure 6, but under crossed polars.

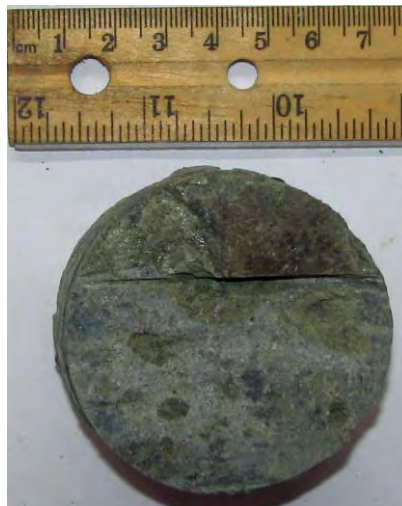
Visual inspection of the sample suggests an igneous origin.

**ROCK NAME: ALTERED VOLCANIC BRECCIA** (according to EN 12670).

**Fig. 1** - Aspect of the studied sample (hand specimen).

**Alteration and Mineral Suture Condition:** The sample shows a substantial clayey alteration, with clear Chlorite individuals associated with very fine-grained Clay Minerals. Spotted secondary Carbonates can be found as fracture filling material.

Crystals in this thin section have well defined rims, but they are also affected by pervasive fractures both within the crystals and all around their boundaries.

**Discontinuities:** The rock is heavily fractured, with two classes of discontinuities: a first one made up of empty cracks crossing the groundmass and the crystals, and a second one made up of Carbonate-filled fractures, sometimes surrounding single crystals or clasts.

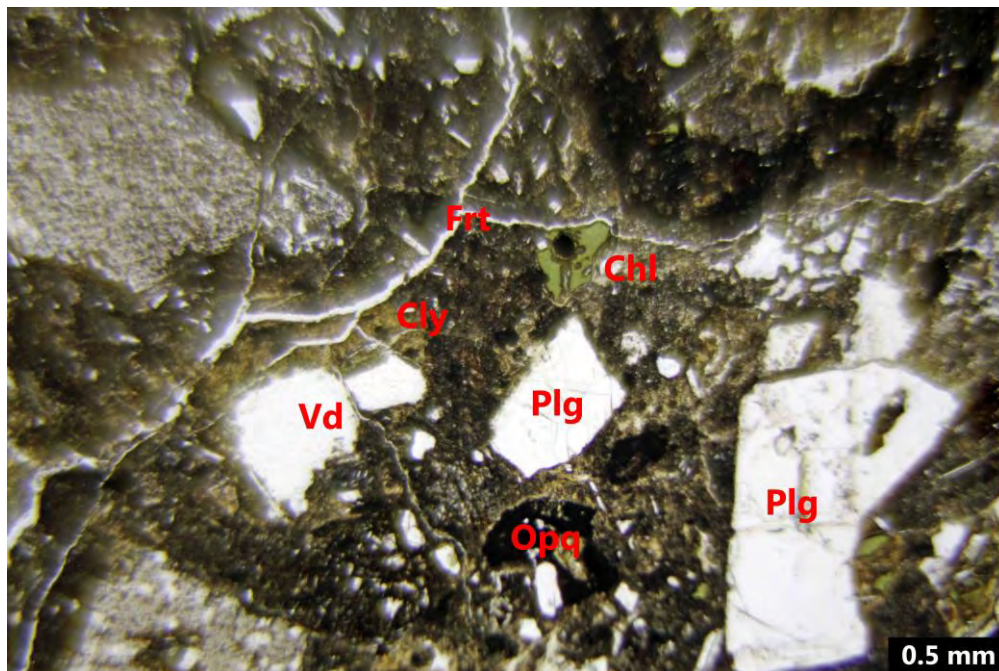
**Fig. 2** - Plane polarized light. Field of view = 4 mm wide (magnification 4X). A view of the studied sample. The most common minerals are: Plagioclase (Plg), Clay Minerals (Cly), Opaque Minerals (Opq), and Chlorite (Chl). Also highlighted here are some structural features, such as fractures (Frt) and voids (Vd).

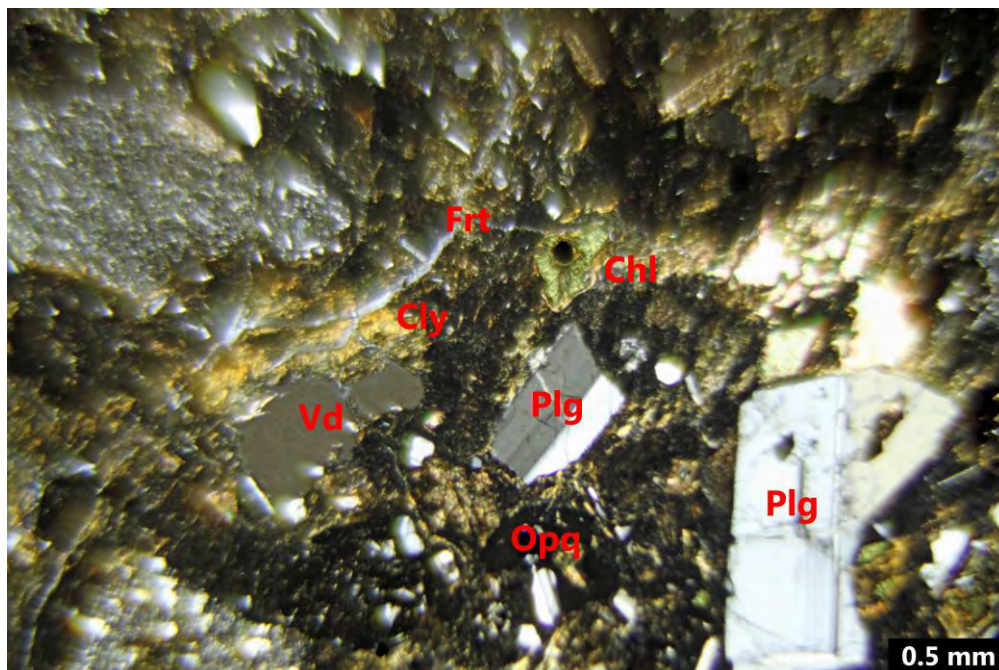
**Fig. 3** - Cross polarized light. Field of view = 4 mm wide (magnification 4X). Same as Figure 2, but under crossed polars.

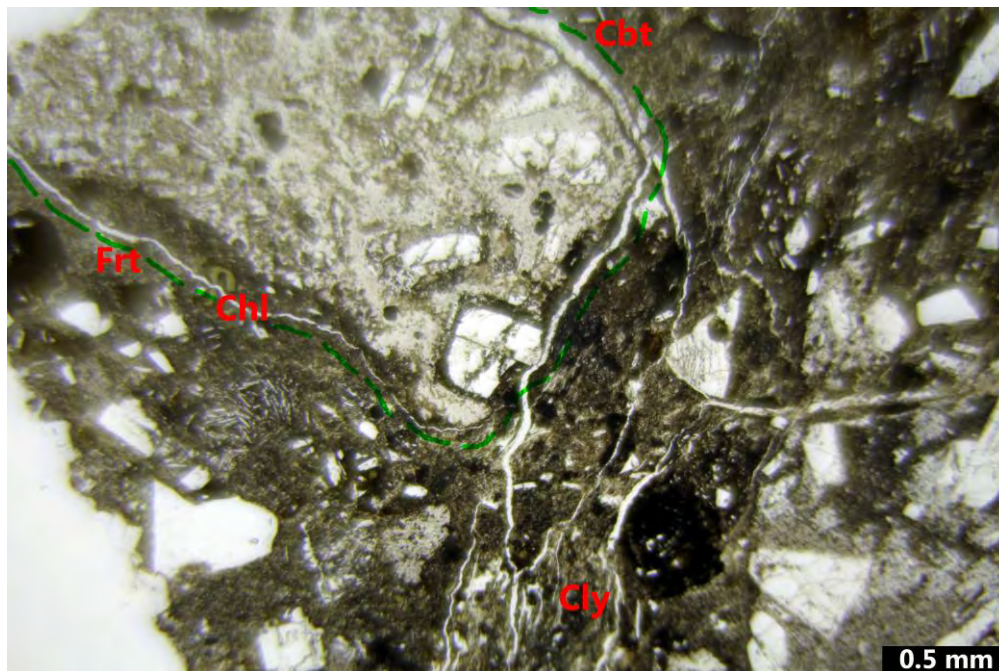
**Fig. 4** - Plane polarized light. Field of view = 4 mm wide (magnification 4X). A view of a volcanic clast. A common feature of all the clasts in this thin section is the presence of fractures surrounding clast boundaries (follow the green dashed line). In this case the fracture is filled with secondary Carbonates (Cbt).

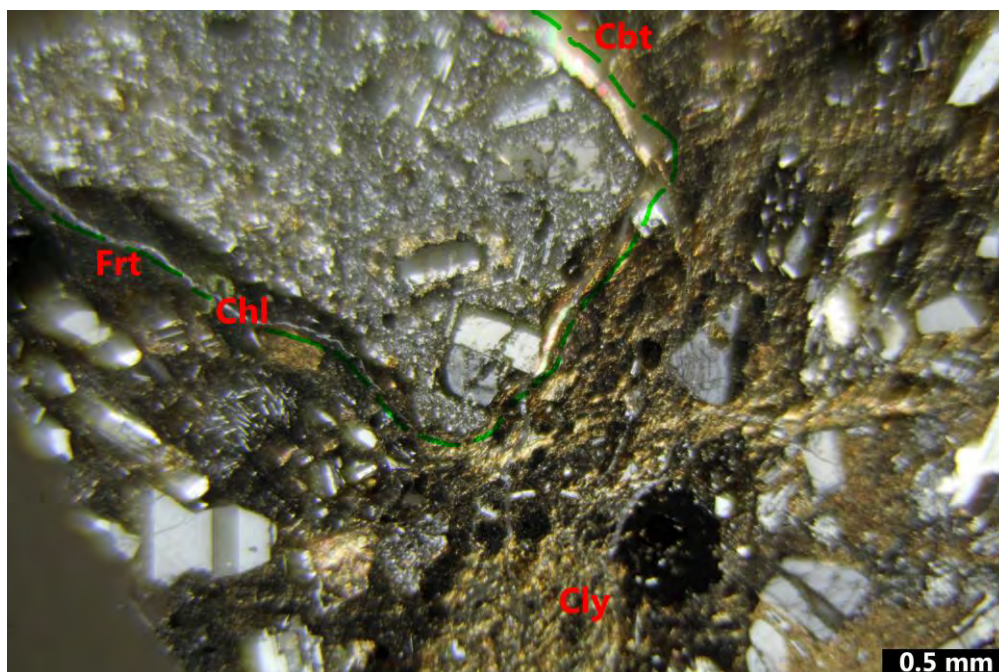
**Fig. 5** - Cross polarized light. Field of view = 4 mm wide (magnification 4X). Same as Figure 4, but under crossed polars.

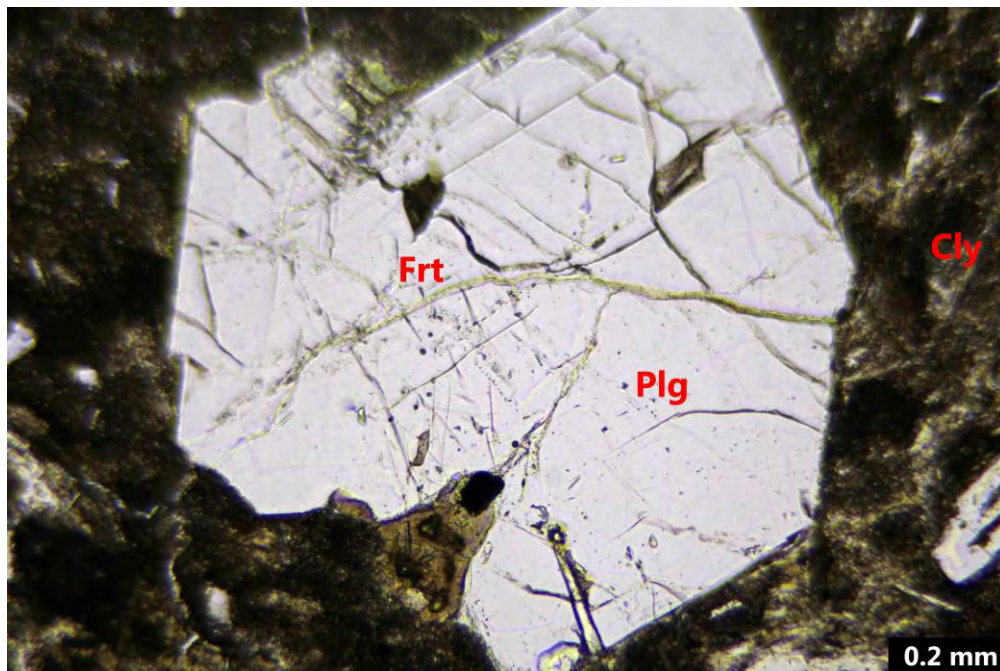
**Fig. 6** - Plane polarized light. Field of view = 1.7 mm wide (magnification 10X). A detail of a Plagioclase crystal, showing grain alteration and suturing features: fractures cross the crystal and are also filled with Clay Minerals.

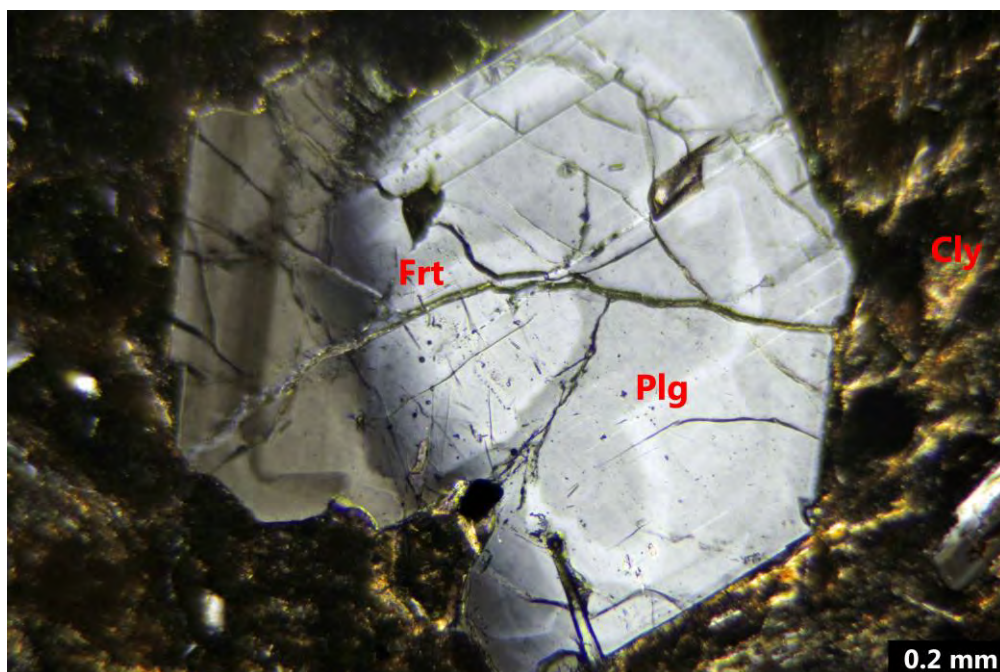
**Fig. 7** - Cross polarized light. Field of view = 1.7 mm wide (magnification 10X). Same as Figure 6, but under crossed polars.

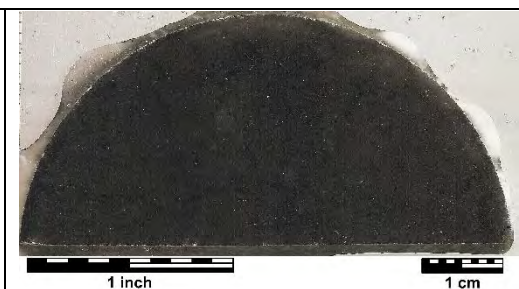
wt%	norm. wt%	Na <sub>2</sub> O	0.6	0.7	MgO	1.6	1.9	Al <sub>2</sub> O <sub>3</sub>	15.9	19.6	SiO <sub>2</sub>	47.8	58.8	P <sub>2</sub> O <sub>5</sub>	0.2	0.2	SO <sub>2</sub>	0.1	0.1	K <sub>2</sub> O	0.8	1.0	CaO	7.1	8.8	TiO <sub>2</sub>	0.9	1.2	FeO	6.3	7.7	Total	81.3	100.0	<p><b>Billet of porphyritic augite basalt</b> Dark gray blocky plagioclase phenocrysts in black aphanitic groundmass.</p> <p><b>Thin section slide of porphyritic augite basalt</b> Blocky white crystals of plagioclase in dark glassy groundmass. 2-mm wide late-stage aphanitic “dike” cuts sample (between arrows). Blue epoxy impregnation indicates 0% porosity.</p>		
	wt%	norm. wt%																																							
Na <sub>2</sub> O	0.6	0.7																																							
MgO	1.6	1.9																																							
Al <sub>2</sub> O <sub>3</sub>	15.9	19.6																																							
SiO <sub>2</sub>	47.8	58.8																																							
P <sub>2</sub> O <sub>5</sub>	0.2	0.2																																							
SO <sub>2</sub>	0.1	0.1																																							
K <sub>2</sub> O	0.8	1.0																																							
CaO	7.1	8.8																																							
TiO <sub>2</sub>	0.9	1.2																																							
FeO	6.3	7.7																																							
Total	81.3	100.0																																							
<p>Photograph of cut drill core of porphyritic augite basalt. Sample lacks late-stage veins or other hydrothermal features – very fresh volcanic rock.</p>

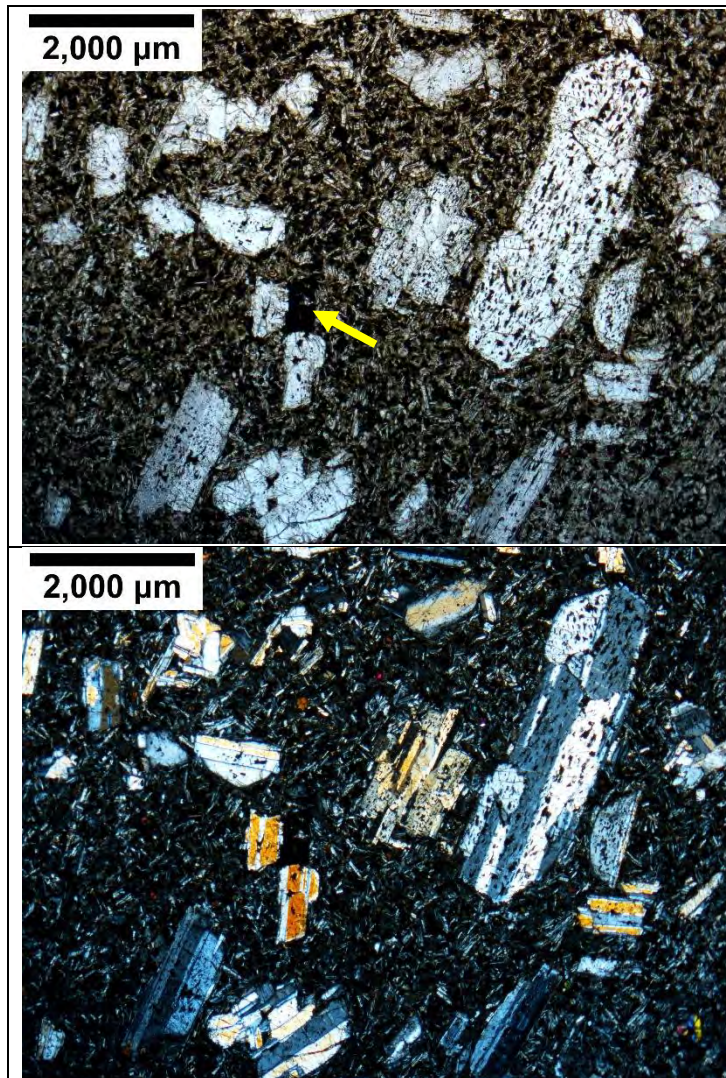
Plane-polarized photomicrograph of main body of sample at very low magnification documenting large sub- to euhedral plagioclase phenocrysts (large blocky crystals) with slight local alignment set in aphanitic groundmass (very dark gray) of glass and plagioclase microlites (tiny white spines). Black grain indicated by arrow is opaque (possibly magnetite).

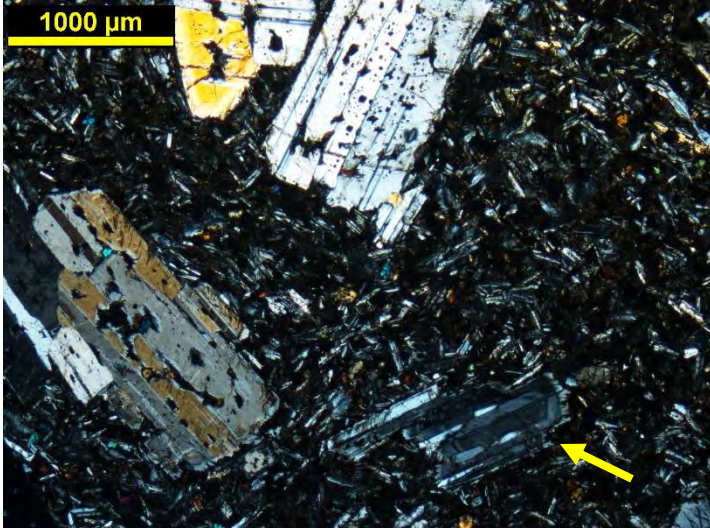
<p>Cross-polarized photomicrograph of compositionally-zoned plagioclase crystal (yellow arrow) and sieve texture in most plagioclase phenocrysts in sample display (other large, blocky grains with dark holes). Sieve texture suggests partial resorption (dissolution) of plagioclase phenocrysts prior to precipitation of outermost growth zone (because phenocryst outlines lack well-developed resorption embayments). Sharp compositional zonation results from pressure fluctuations in magma shifting crystallization conditions – very common in volcanic or subvolcanic igneous rocks.</p>

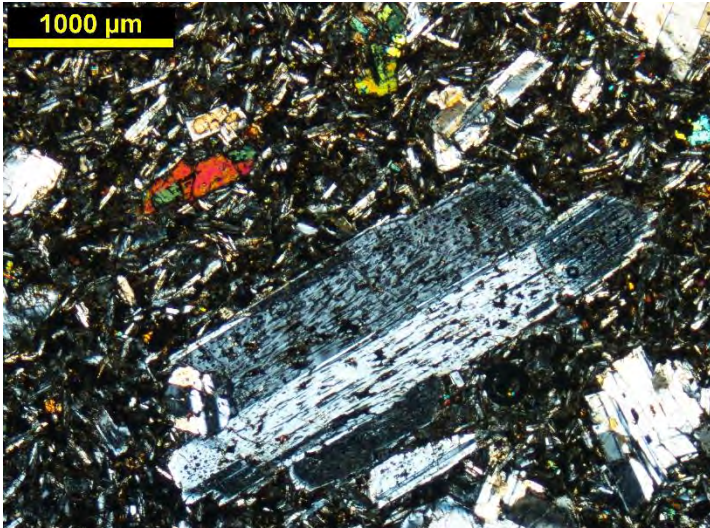
<p>Cross-polarized photomicrograph documenting unusual sieve texture in large plagioclase phenocrysts, and bimodal grain size of augite (i.e., &gt;500 μm phenocrysts and 80-100 μm groundmass crystals).</p>
