Klamath River Renewal Corporation
Klamath River Renewal Project

This report summarizes the terrestrial resources surveys conducted in 2019 for the Klamath River Renewal Project (Project). The Klamath River Renewal Corporation (KRRRC) and its consultants carried out field investigations to collect existing condition information on the following terrestrial resources:

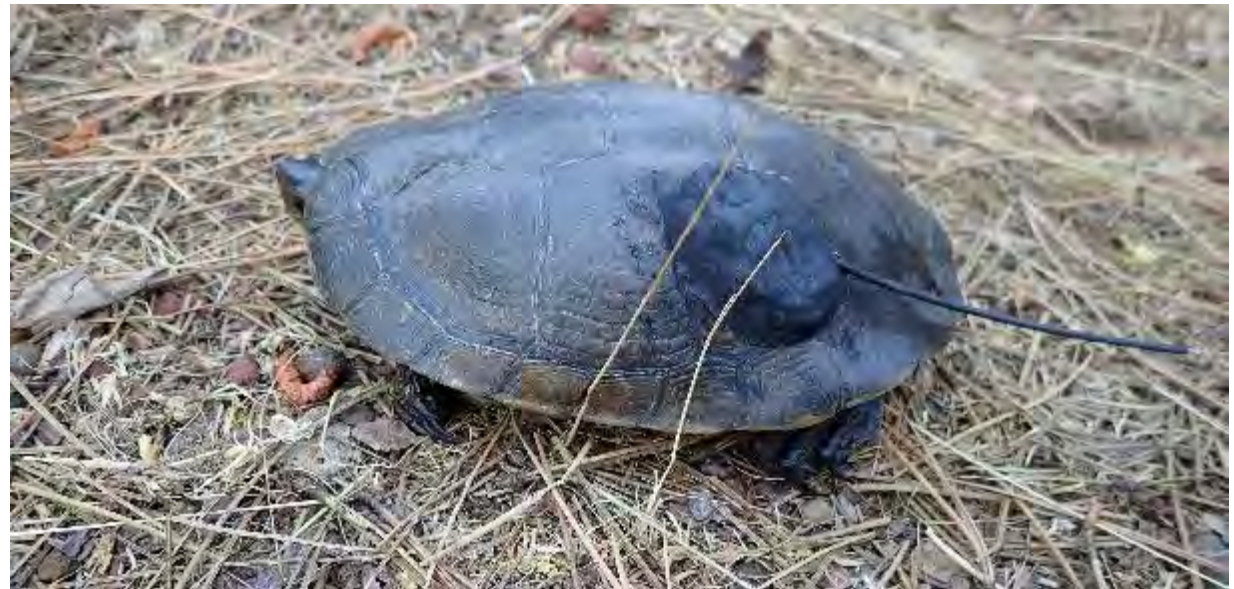
<u>MARK</u>	<u>DATE</u>	<u>CapHist</u>	<u>SEX</u>	<u>AGE</u>	<u>AGE+</u>	<u>CL</u>	<u>cl</u>	<u>cw</u>	<u>PL</u>	<u>pl</u>	<u>pw</u>	<u>Ht</u>	<u>Wt</u>
100	8/7/2018	1	M	>10	20+	163.0	159.5	117.7	149.4	143.5	82.9	53.4	552

Transmitter

Freq 151.790

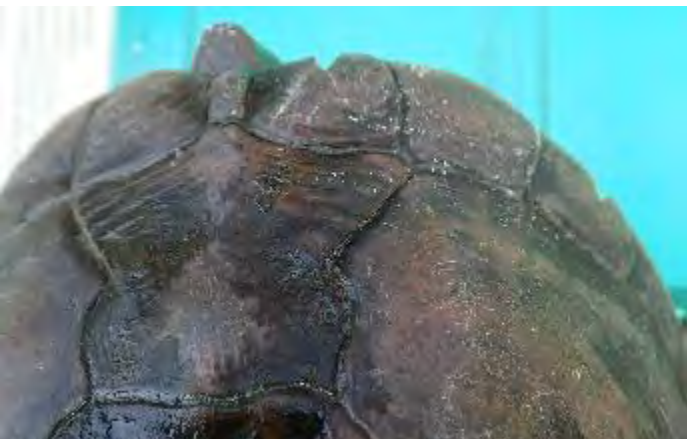
<u>MARK</u>	<u>DATE</u>	<u>CapHist</u>	<u>SEX</u>	<u>AGE</u>	<u>AGE+</u>	<u>CL</u>	<u>cl</u>	<u>cw</u>	<u>PL</u>	<u>pl</u>	<u>pw</u>	<u>Ht</u>	<u>Wt</u>
101	8/8/2018	1	F	13	20+	182.2	176.3	138.5	176.9	168.0	96.2	68.1	662

Peeling verbal shields,
No transmitter applied

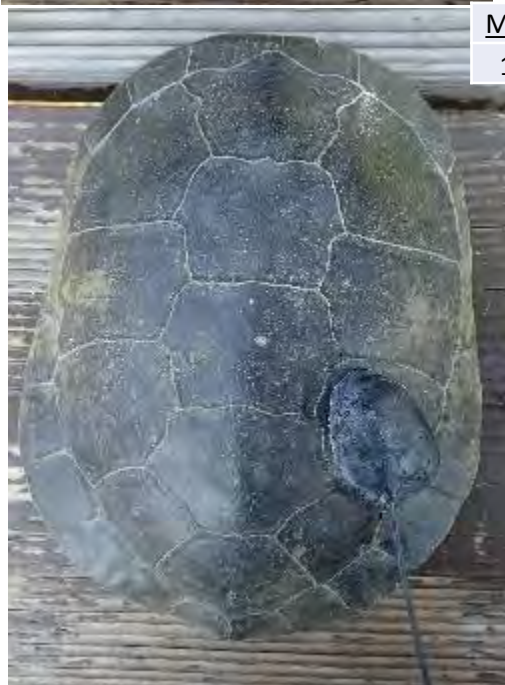
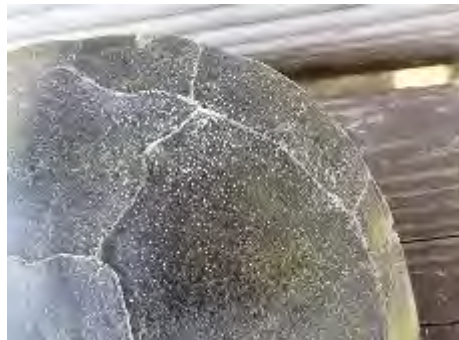
MARK	DATE	CapHist	SEX	AGE	AGE+	CL	cl	cw	PL	pl	pw	Ht	Wt
102	8/8/2018	1	M	99	99	187.7	186.1	140.1	166.1	159.5	97.3	64.8	905

- Transmitter
Freq **151.701**

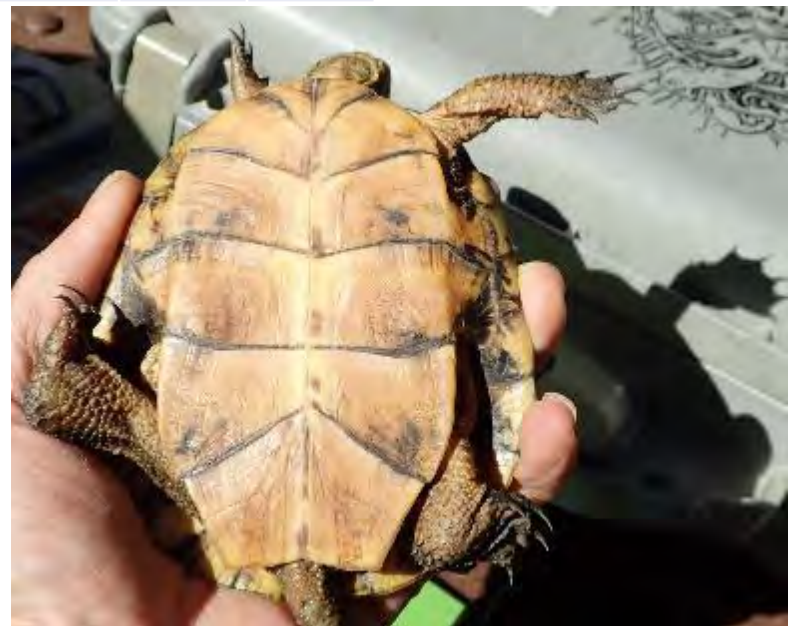
Photo 21. WPT morphology data

MARK	DATE	CapHist	SEX	AGE	AGE+	CL	cl	cw	PL	pl	pw	Ht	Wt
103	9/5/2018	1	F	3	4	121.3	117.0	97.3	112.2	110.2	63.4	44.0	258

- Juvenile
- No Transmitter

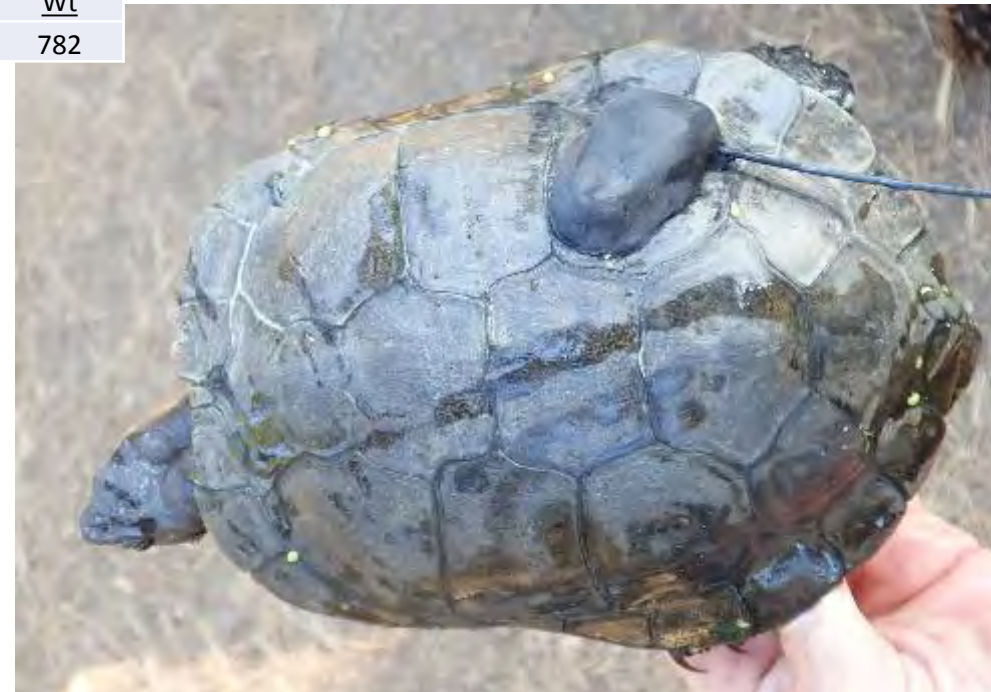
Photo 22. WPT morphology data

MARK	DATE	CapHist	SEX	AGE	AGE+	CL	cl	cw	PL	pl	pw	Ht	Wt
104	9/5/2018	1	M	99	99	180.9	175.1	131.8	165.0	153.5	89.6	60.0	782

- Transmitter
Freq **151.750**

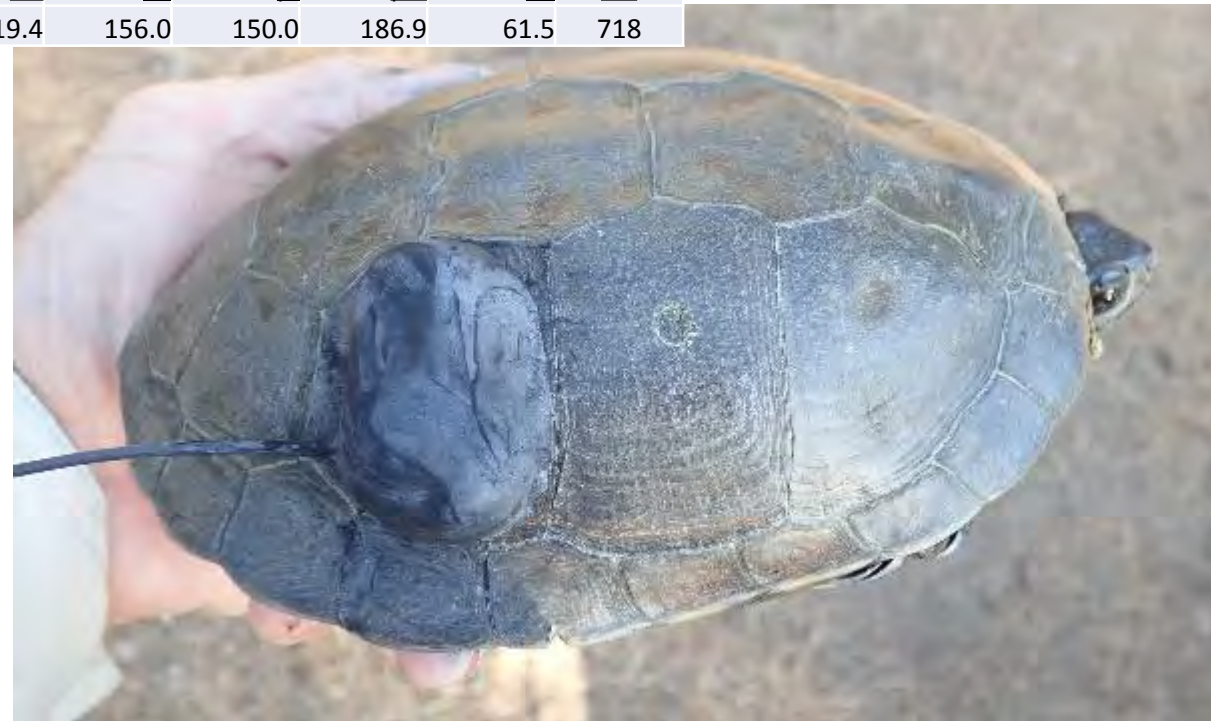
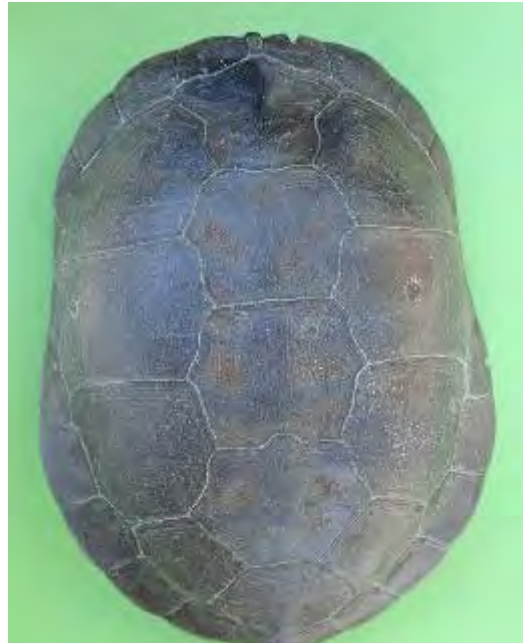
Photo 23. WPT morphology data

MARK	DATE	CapHist	SEX	AGE	AGE+	CL	cl	cw	PL	pl	pw	Ht	Wt
105	9/5/2018	1	F	20	20+	166.3	164.0	119.4	156.0	150.0	186.9	61.5	718

- Transmitter
Freq **151.760**

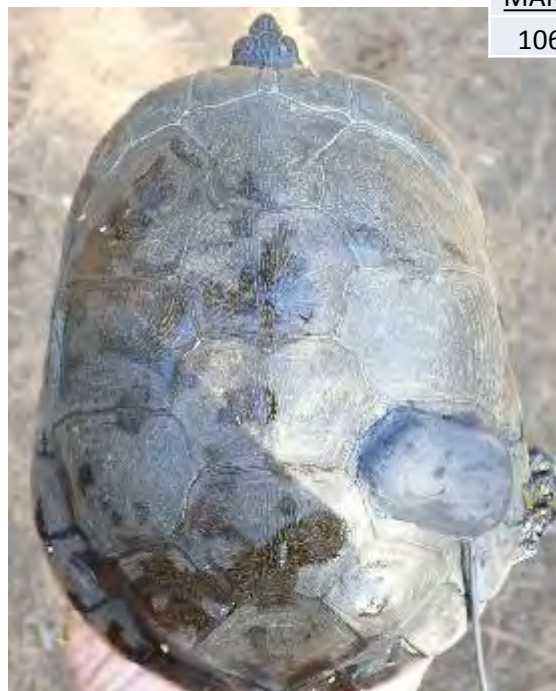
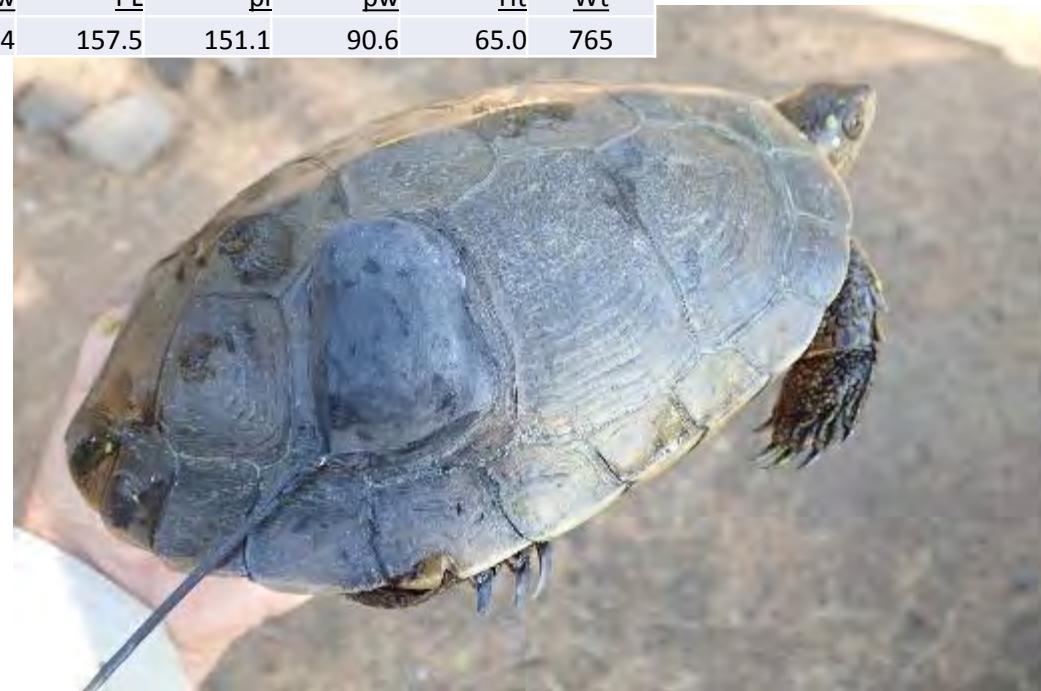
Photo 24. WPT morphology data

MARK	DATE	CapHist	SEX	AGE	AGE+	CL	cl	cw	PL	pl	pw	Ht	Wt
106	9/5/2018	1	F	20	20+	170.7	167.4	126.4	157.5	151.1	90.6	65.0	765

- Transmitter
Freq **151.729**

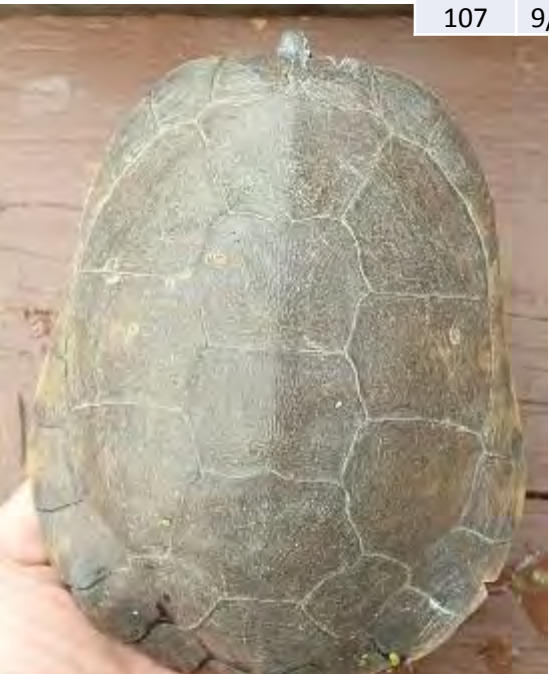
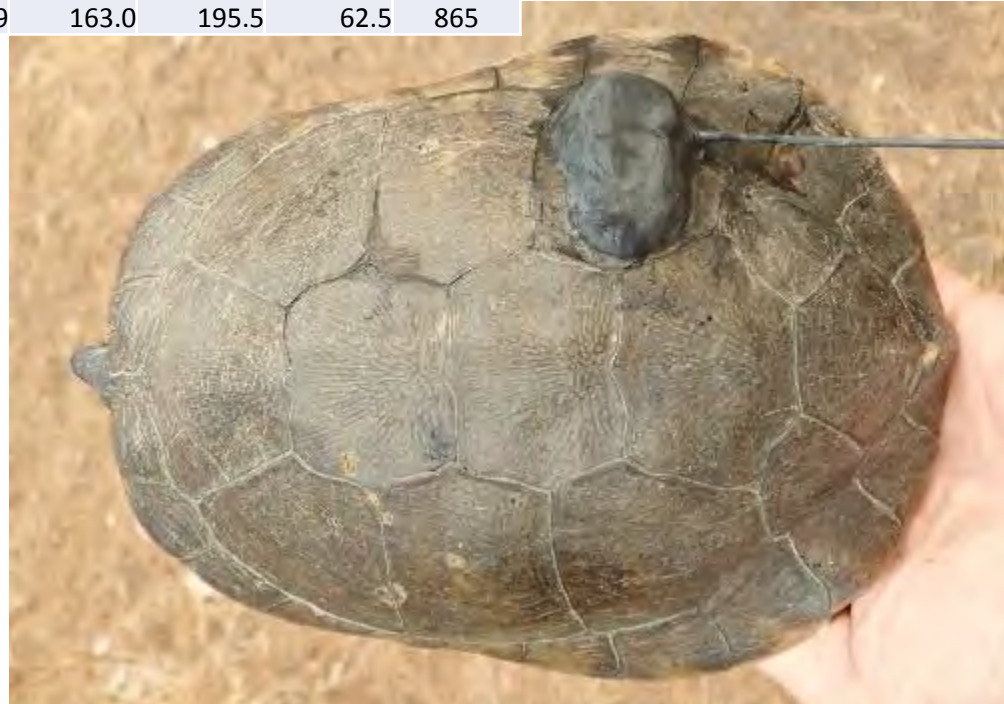
Photo 25. WPT morphology data

MARK	DATE	CapHist	SEX	AGE	AGE+	CL	cl	cw	PL	pl	pw	Ht	Wt
107	9/5/2018	1	M	99	99	188.8	186.9	141.0	170.9	163.0	195.5	62.5	865

- Transmitter
Freq **151.770**

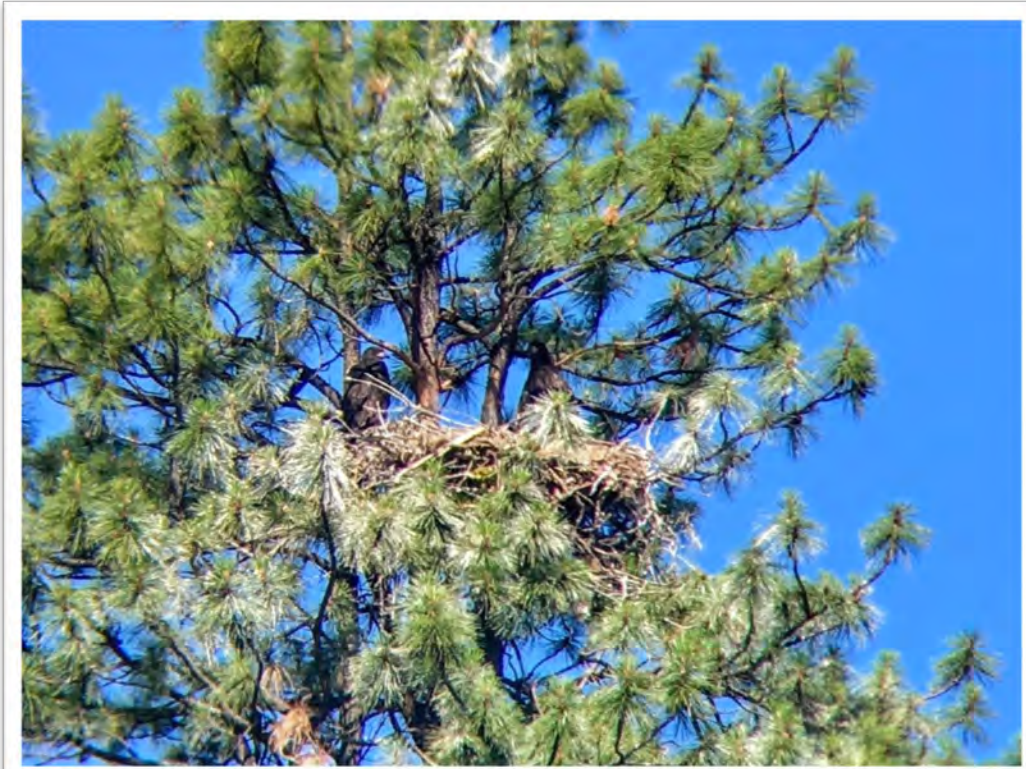
Photograph 2-1 Two Bald Eagle Nestlings at Nest F19_BE1

At Iron Gate Reservoir, biologists observed one active bald eagle nest (F19_BE1) immediately adjacent to Copco Road and the reservoir. There were two chicks about 6 to 8 weeks old in the nest, often with one or

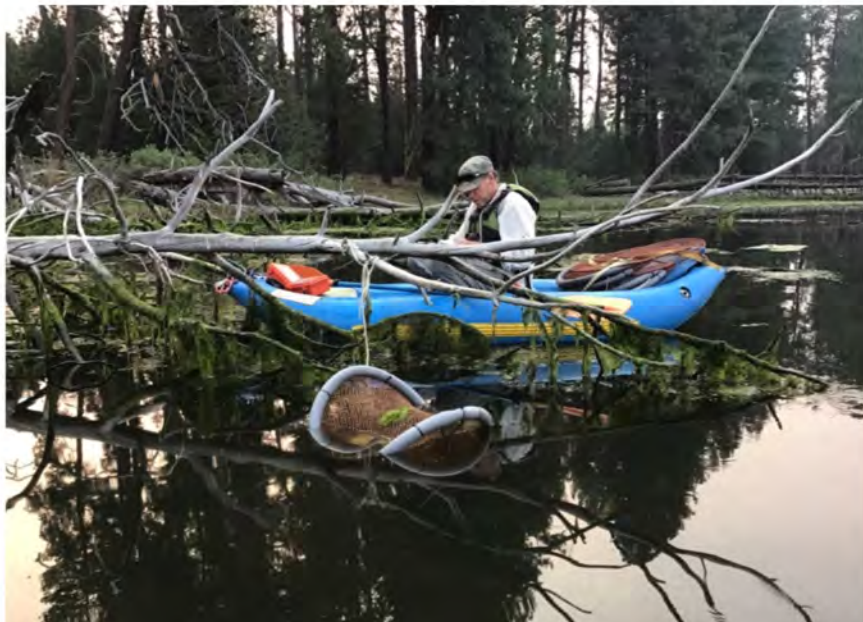
Photograph 4-1 Deployment of Turtle Trap near Large Woody Debris

Biologists placed twenty traps around the reservoir near large woody debris, rock crevices, and other refugia near where radio-tagged turtles were detected. Traps were left in place near radio-tagged turtles and were checked one or more times each day. Bait was replaced as necessary. If telemetry indicated that radio-tagged

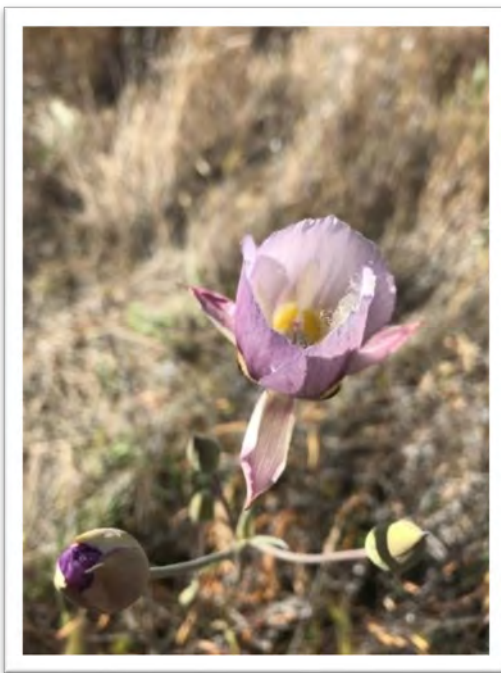
Photograph 5-3 Greene's Mariposa-lily (*Calochortus greenii*)

- Greene's mariposa-lily (*Calochortus greenii*): KRRC biologists observed numerous *Calochortus* plants in construction areas in the Project area, including at the Iron Gate alternative upland disposal site and along utility corridors in the vicinity of Iron Gate Reservoir and Copco Lake during surveys completed in April 2019. Although plants were not in bloom when first observed in April 2019; the species designation was confirmed as *Calochortus greenii* when sites were revisited in July 2019.

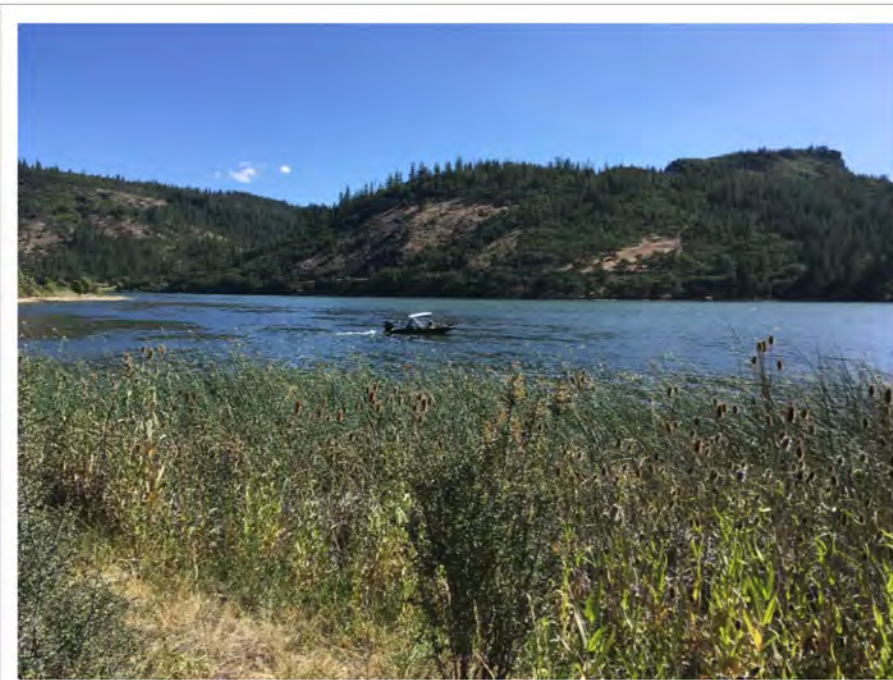
Photograph 6-1 Wetland along Shoreline of Copco Lake

Wetland and riparian habitats occur throughout the Project area wherever persistent surface water features occur (e.g., streams, seeps, springs, Project reservoirs, or other sources of hydrology). Wetlands are regulated at both the state and federal levels by resource agencies including the United States Army Corps of Engineers (USACE), CDFW, and the Oregon Department of State Lands (ODSL); riparian habitats are only subject to jurisdiction by California agencies (i.e., CDFW and the State Water Resources Control Board). Restoration of the historical Klamath River channel following dam removal is expected to result in a net increase of wetland and riparian acreage; however, some areas may experience a reduction or a loss of associated water sources resulting from reservoir drawdown. This could result in the temporary or permanent loss of some wetlands or riparian areas that primarily depend on reservoir waters for hydrology. Consequently, KRRC developed wetland investigation methodologies in close coordination with USACE, ODSL, and CDFW to characterize existing conditions for wetlands and other waters (including riparian habitats in California). The methodology included determining the primary hydrology source maintaining each assessment area. The results of the wetland delineation work are provided in detail in the separate *2019 Wetland Investigation Summary Report* (KRRC 2020).

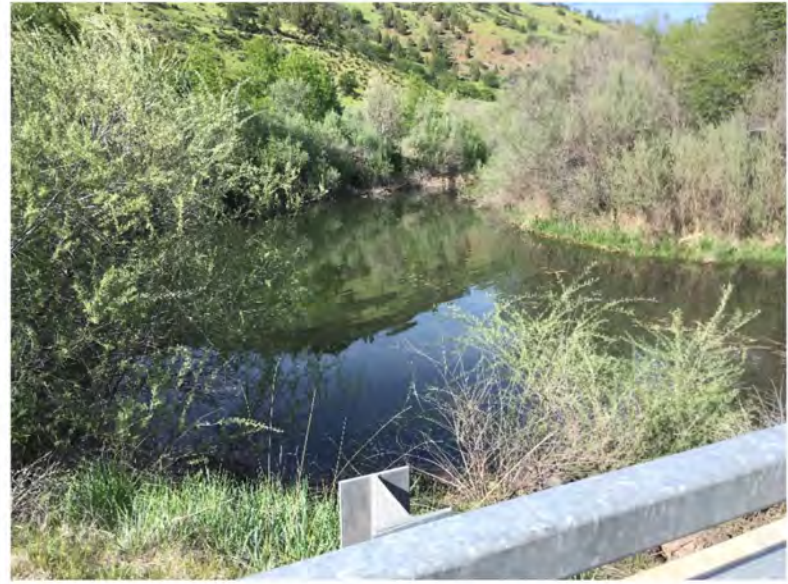
Photograph 6-3 Riparian Vegetation at Jenny Creek

of work. Riparian areas generally had hydrophytic vegetation but failed to meet one or more of the remaining wetland parameters (i.e., hydrology and hydric soils), and thus were classified as non-wetland, riparian habitat. KRRRC wetland scientists determined the upslope edge of riparian areas by mapping the line where vegetation transitioned from hydrophytic vegetation to vegetation more representative of dry, upland areas in terms of species composition and density. Upland habitat typically consisted of sparsely vegetated, rocky hillslopes. The riparian boundary was mapped to submeter accuracy using a handheld GPS device or ArcGIS Collector, as previously described for wetland delineations.

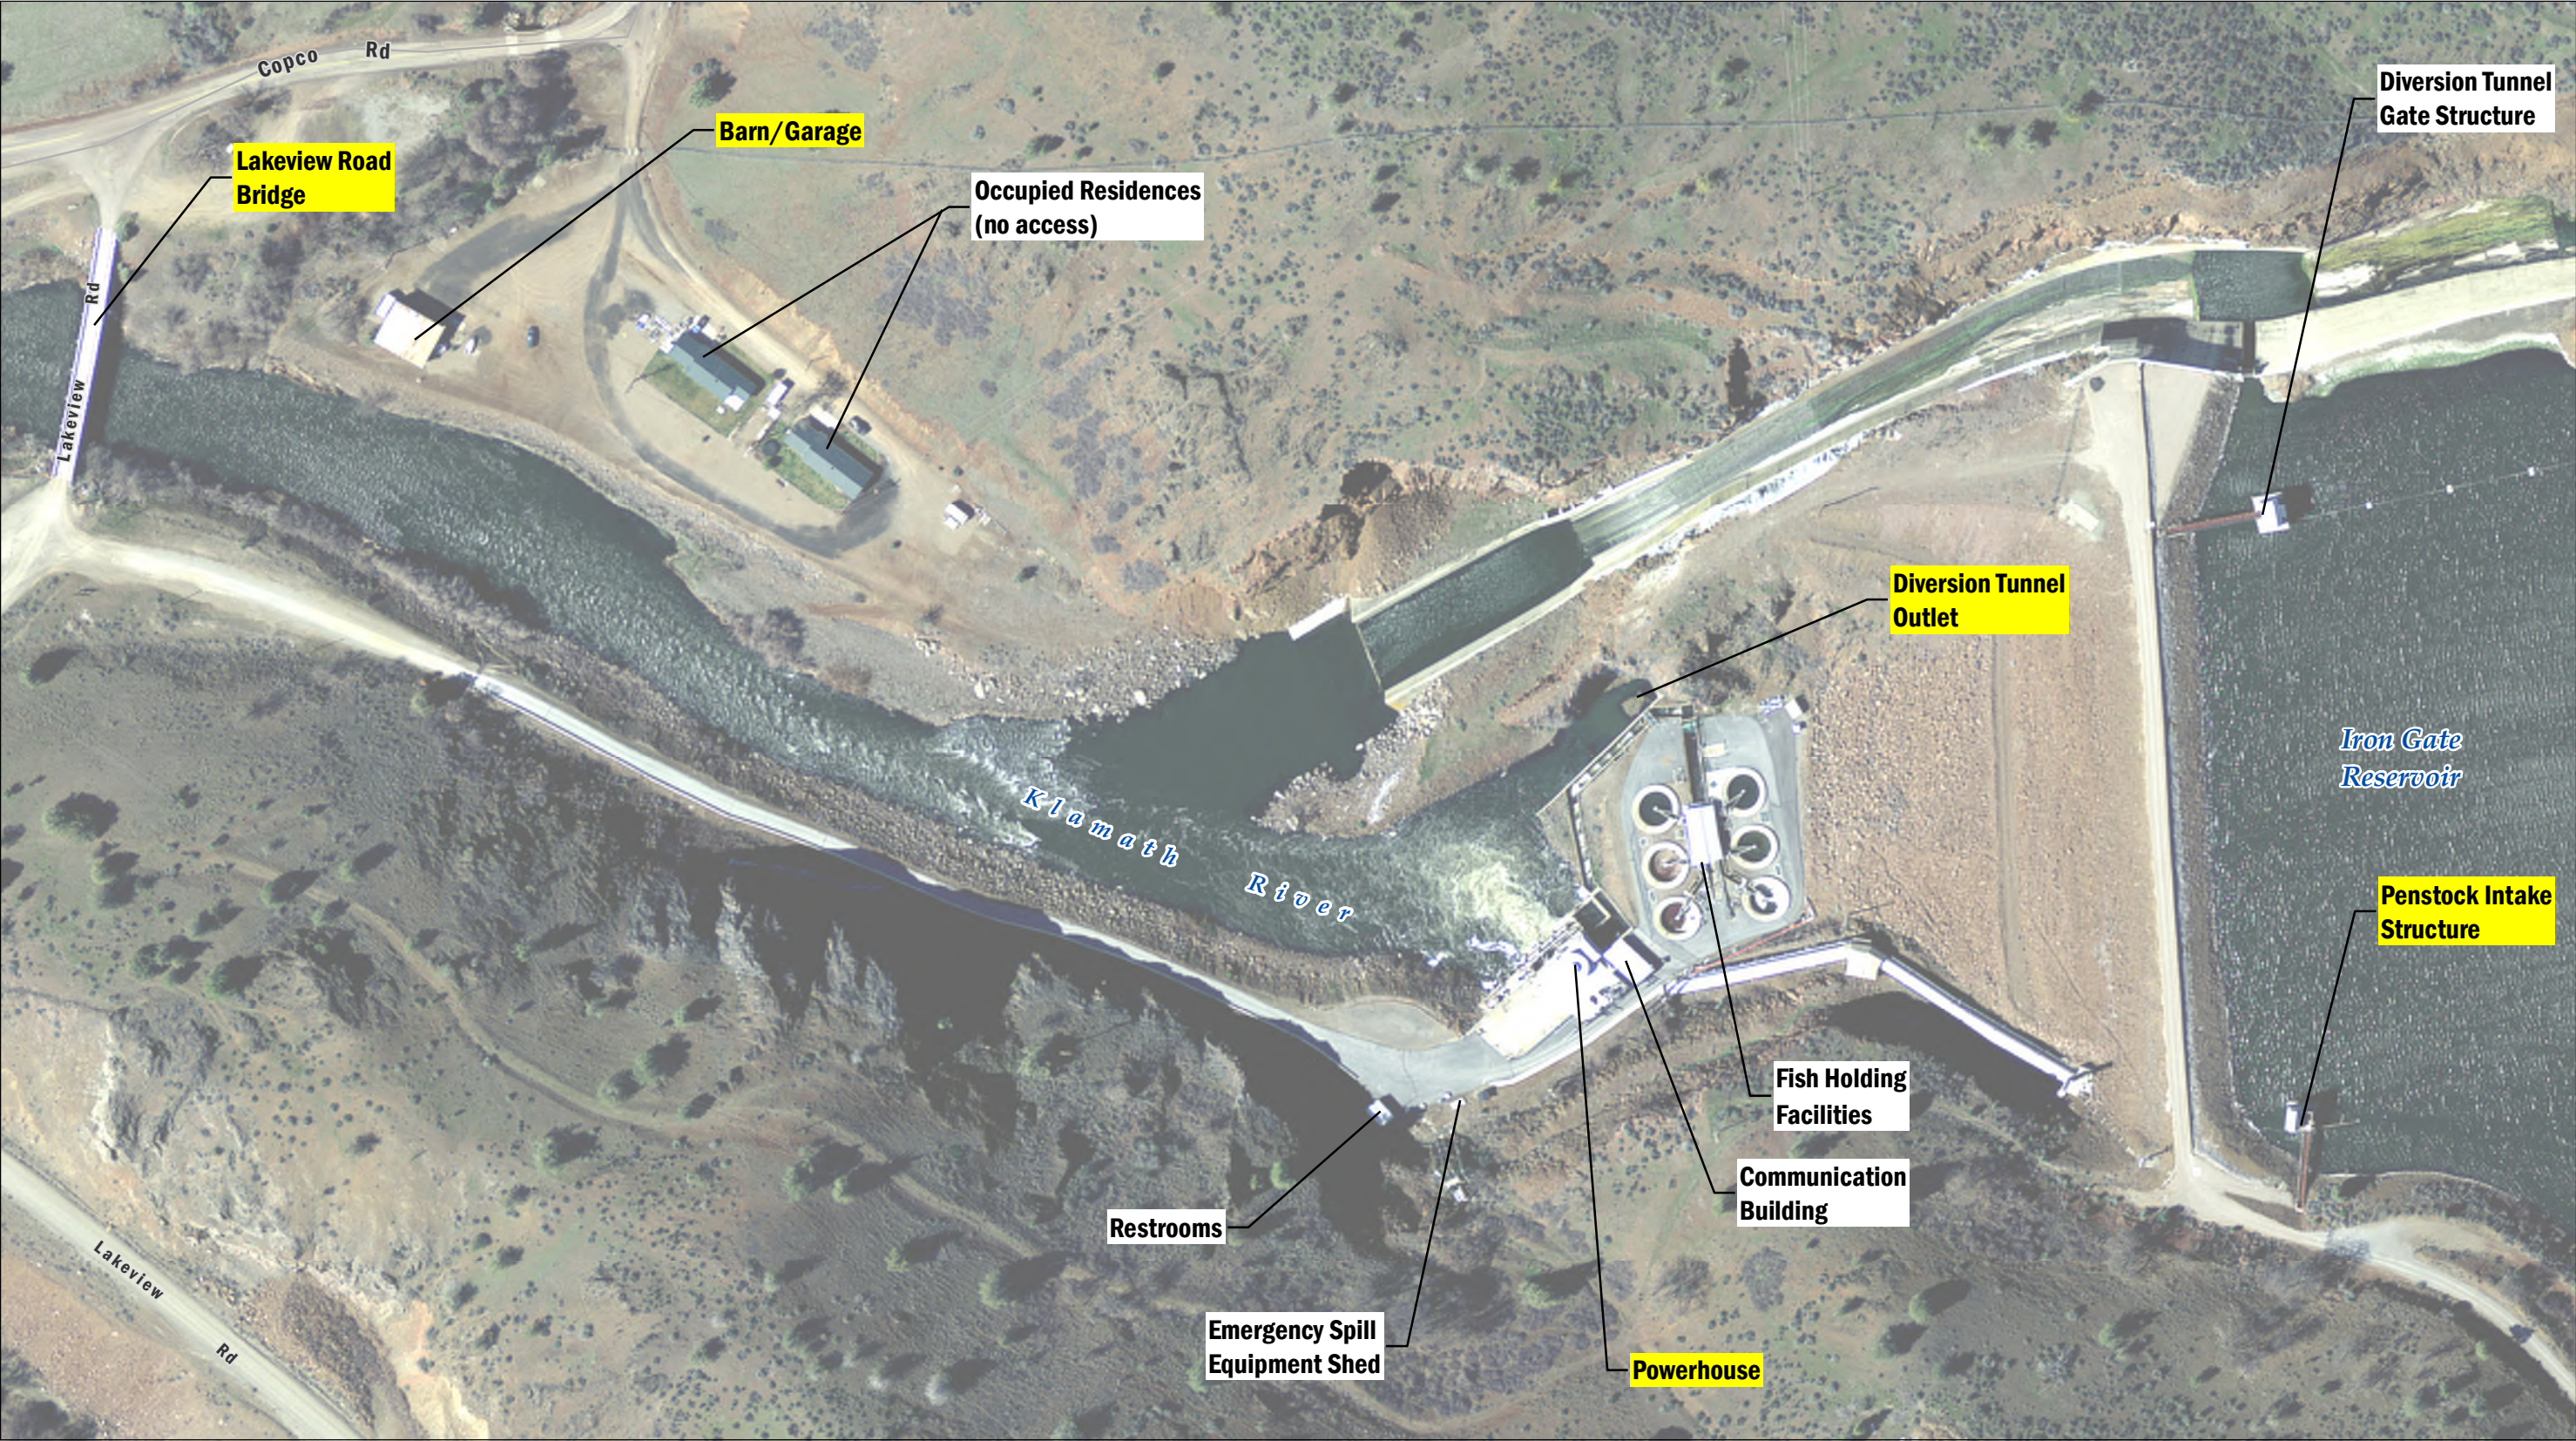
FIGURE 3-1
2017-2019 Bat Surveys
Iron Gate Dam Area

- Labels**
- Active Bat Roost Confirmed
 - Roosting Bats Not Found

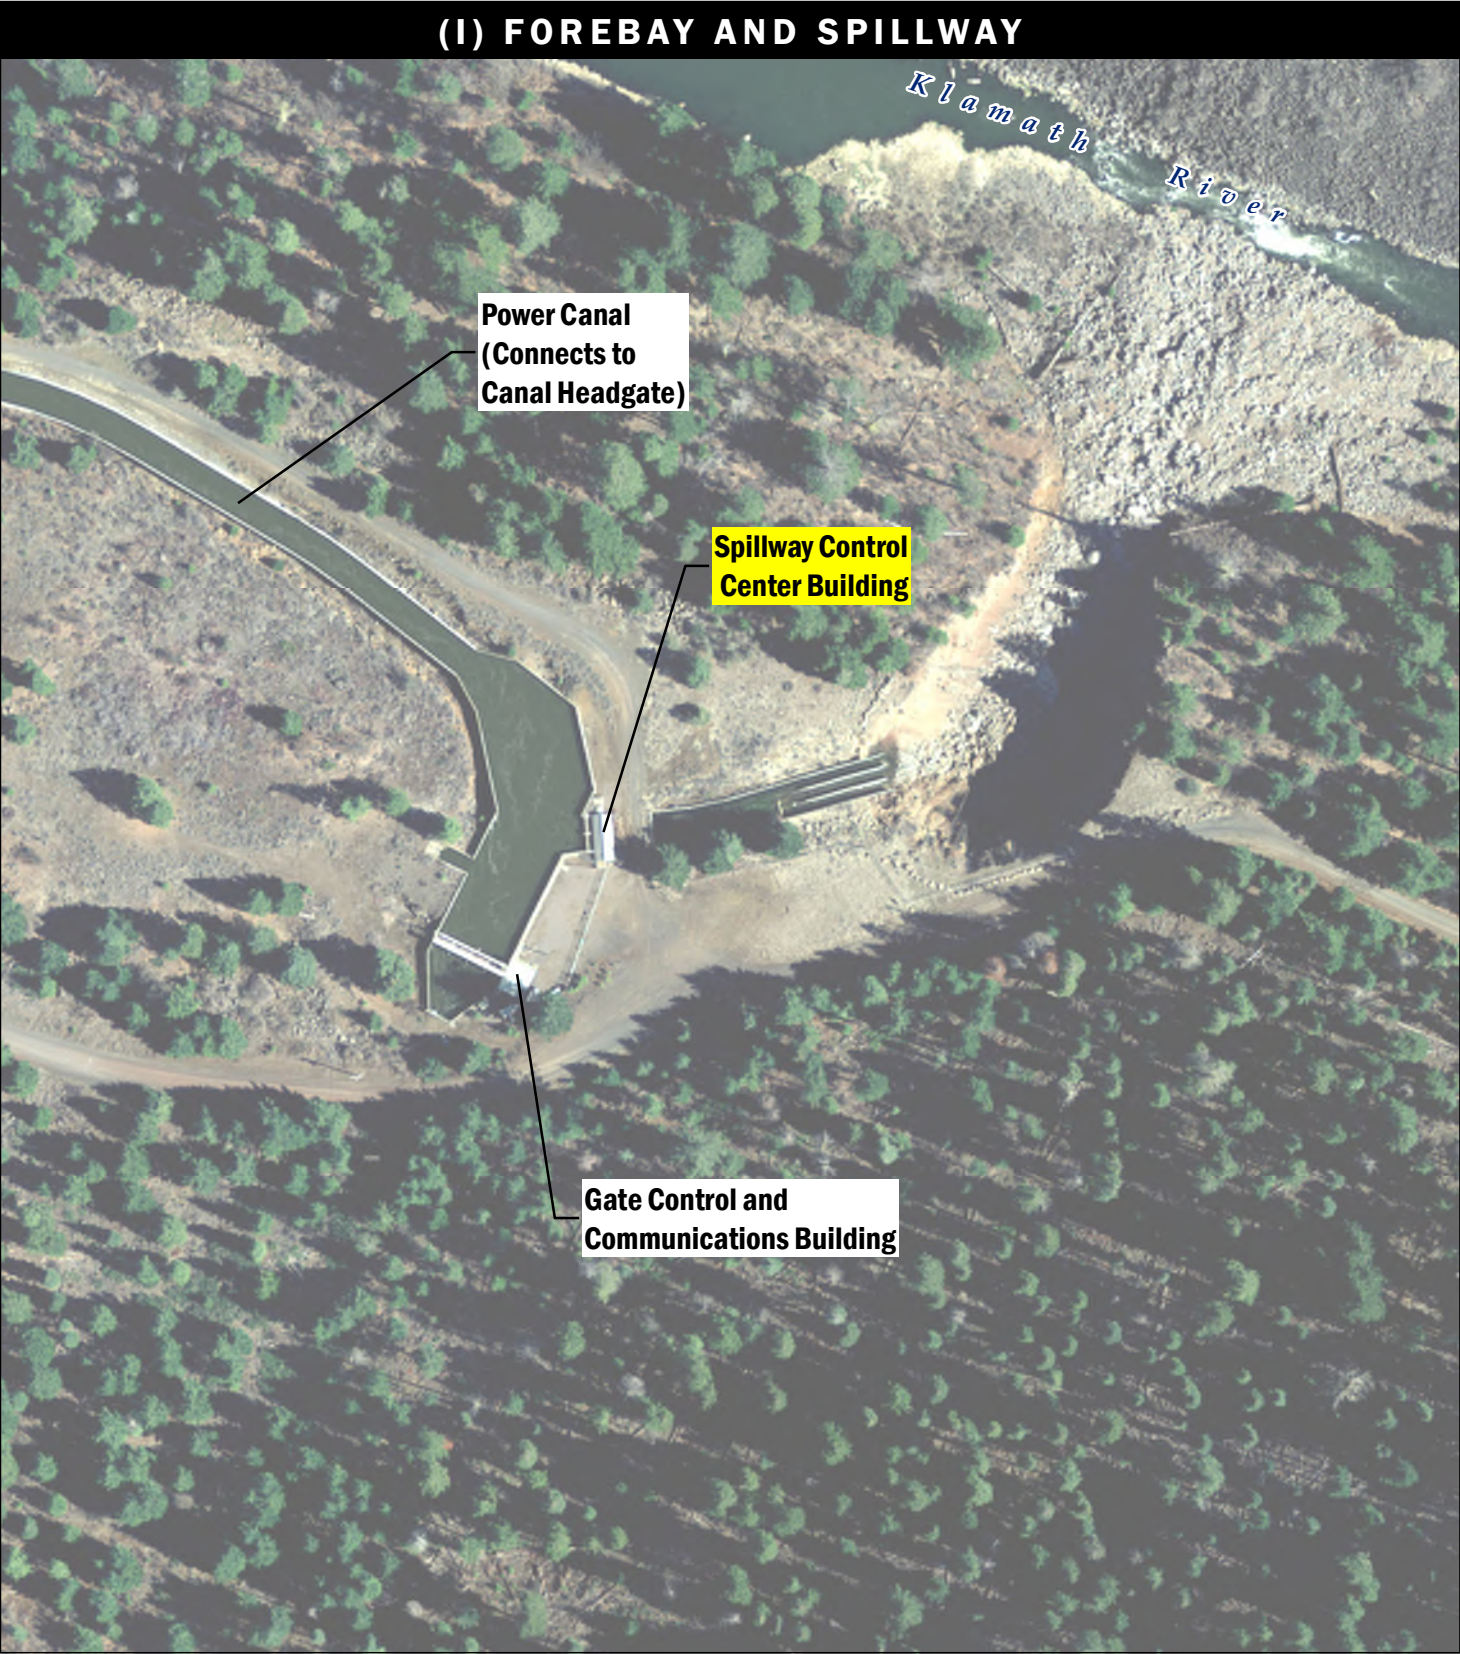
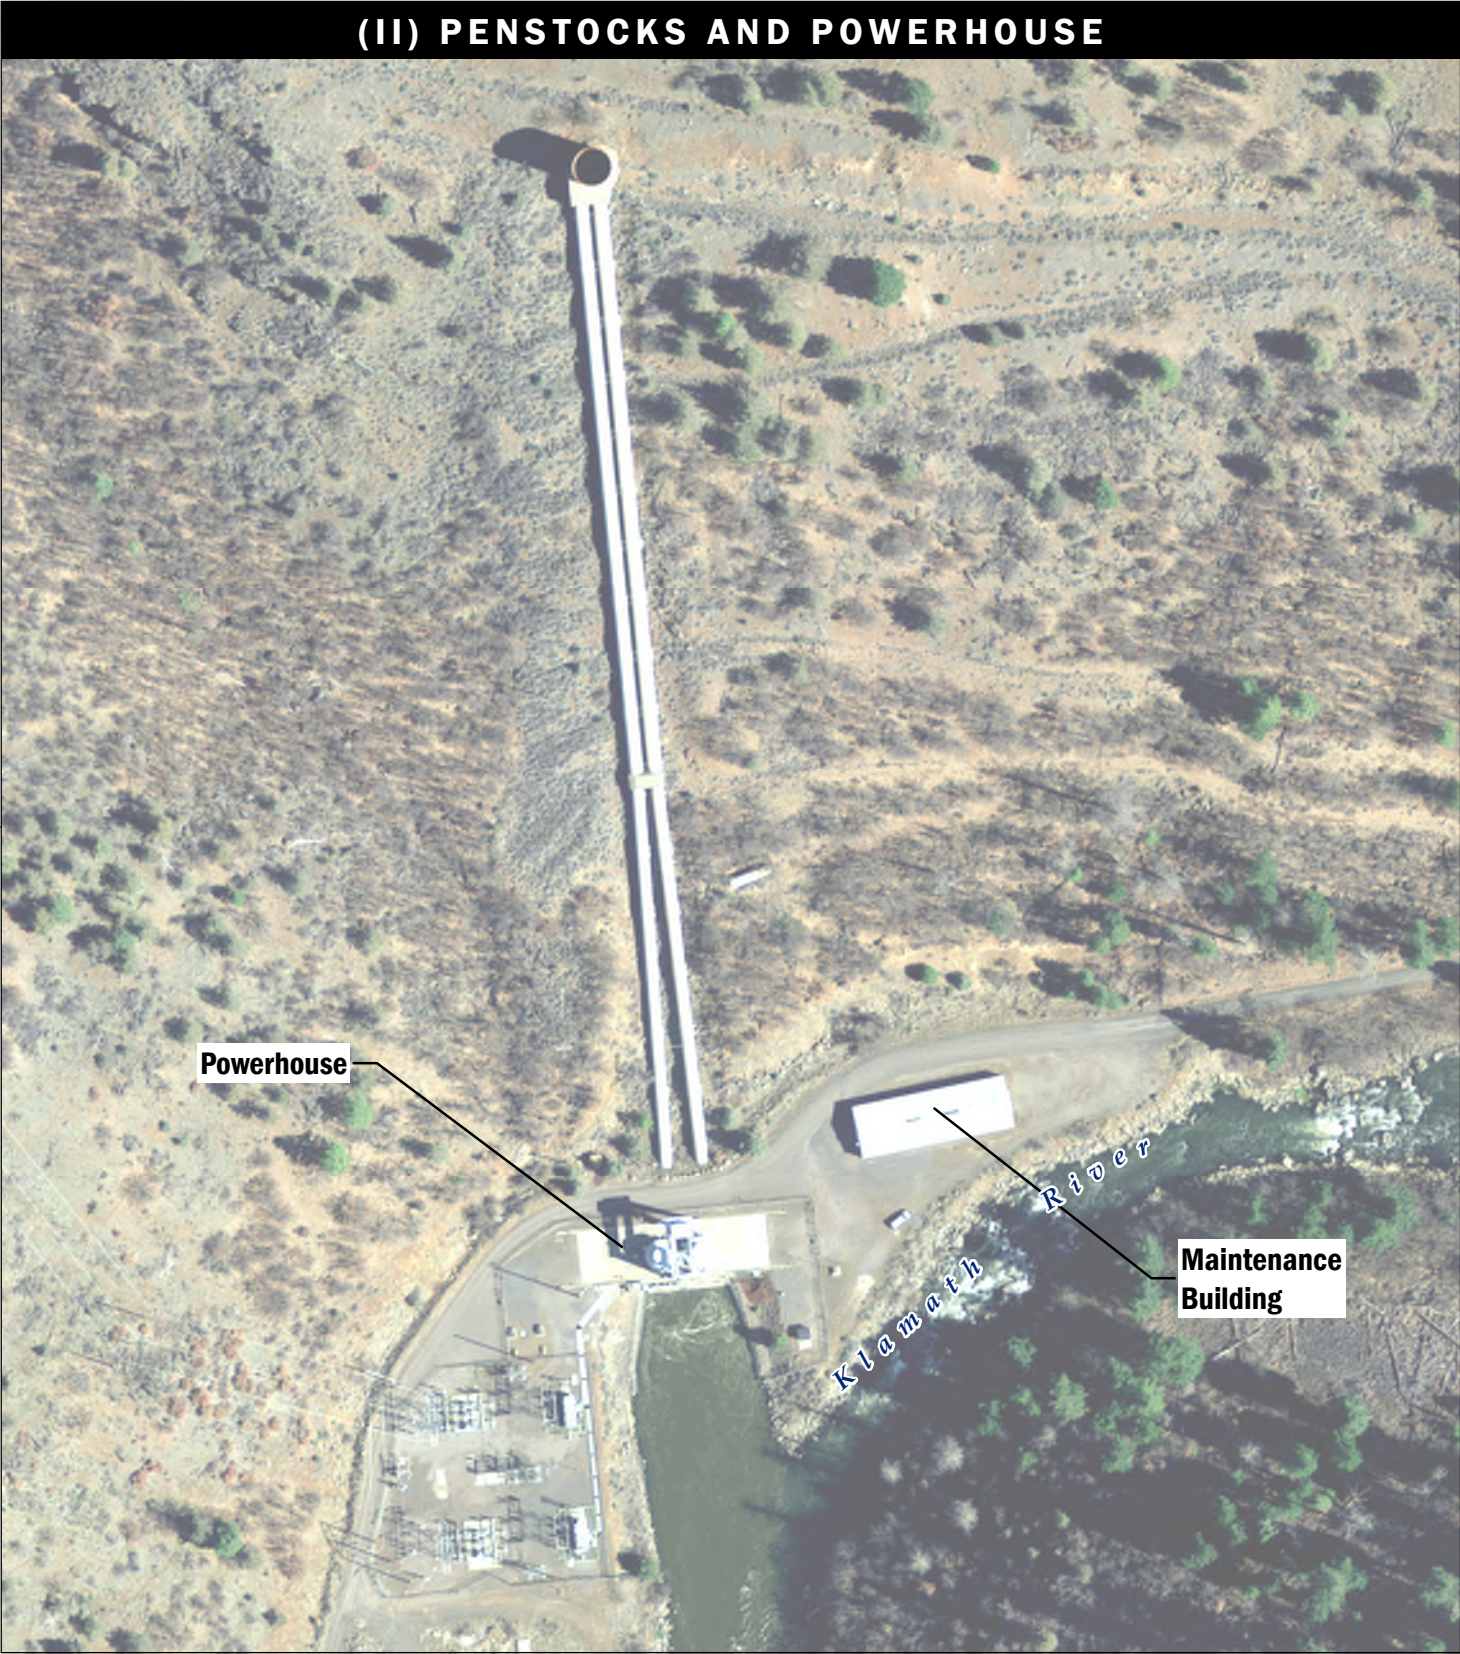
FIGURE 3-3
2017-2019 Bat Surveys
Copco No. 1 Dam Area and
Copco No. 2 Dam Area

- Labels**
- Active Bat Roost Confirmed
 - Roosting Bats Not Found

Additionally, during meetings with the design-build contractor in September 2019, KRRRC biologists were informed that an engineering team observed one bat in a cavity in a historic concrete gate control structure on the upstream side of the Copco No. 1 dam (Figure 3-3) in March 2018. This structure has not been inspected by KRRRC biologists to-date for potential bat roosting.

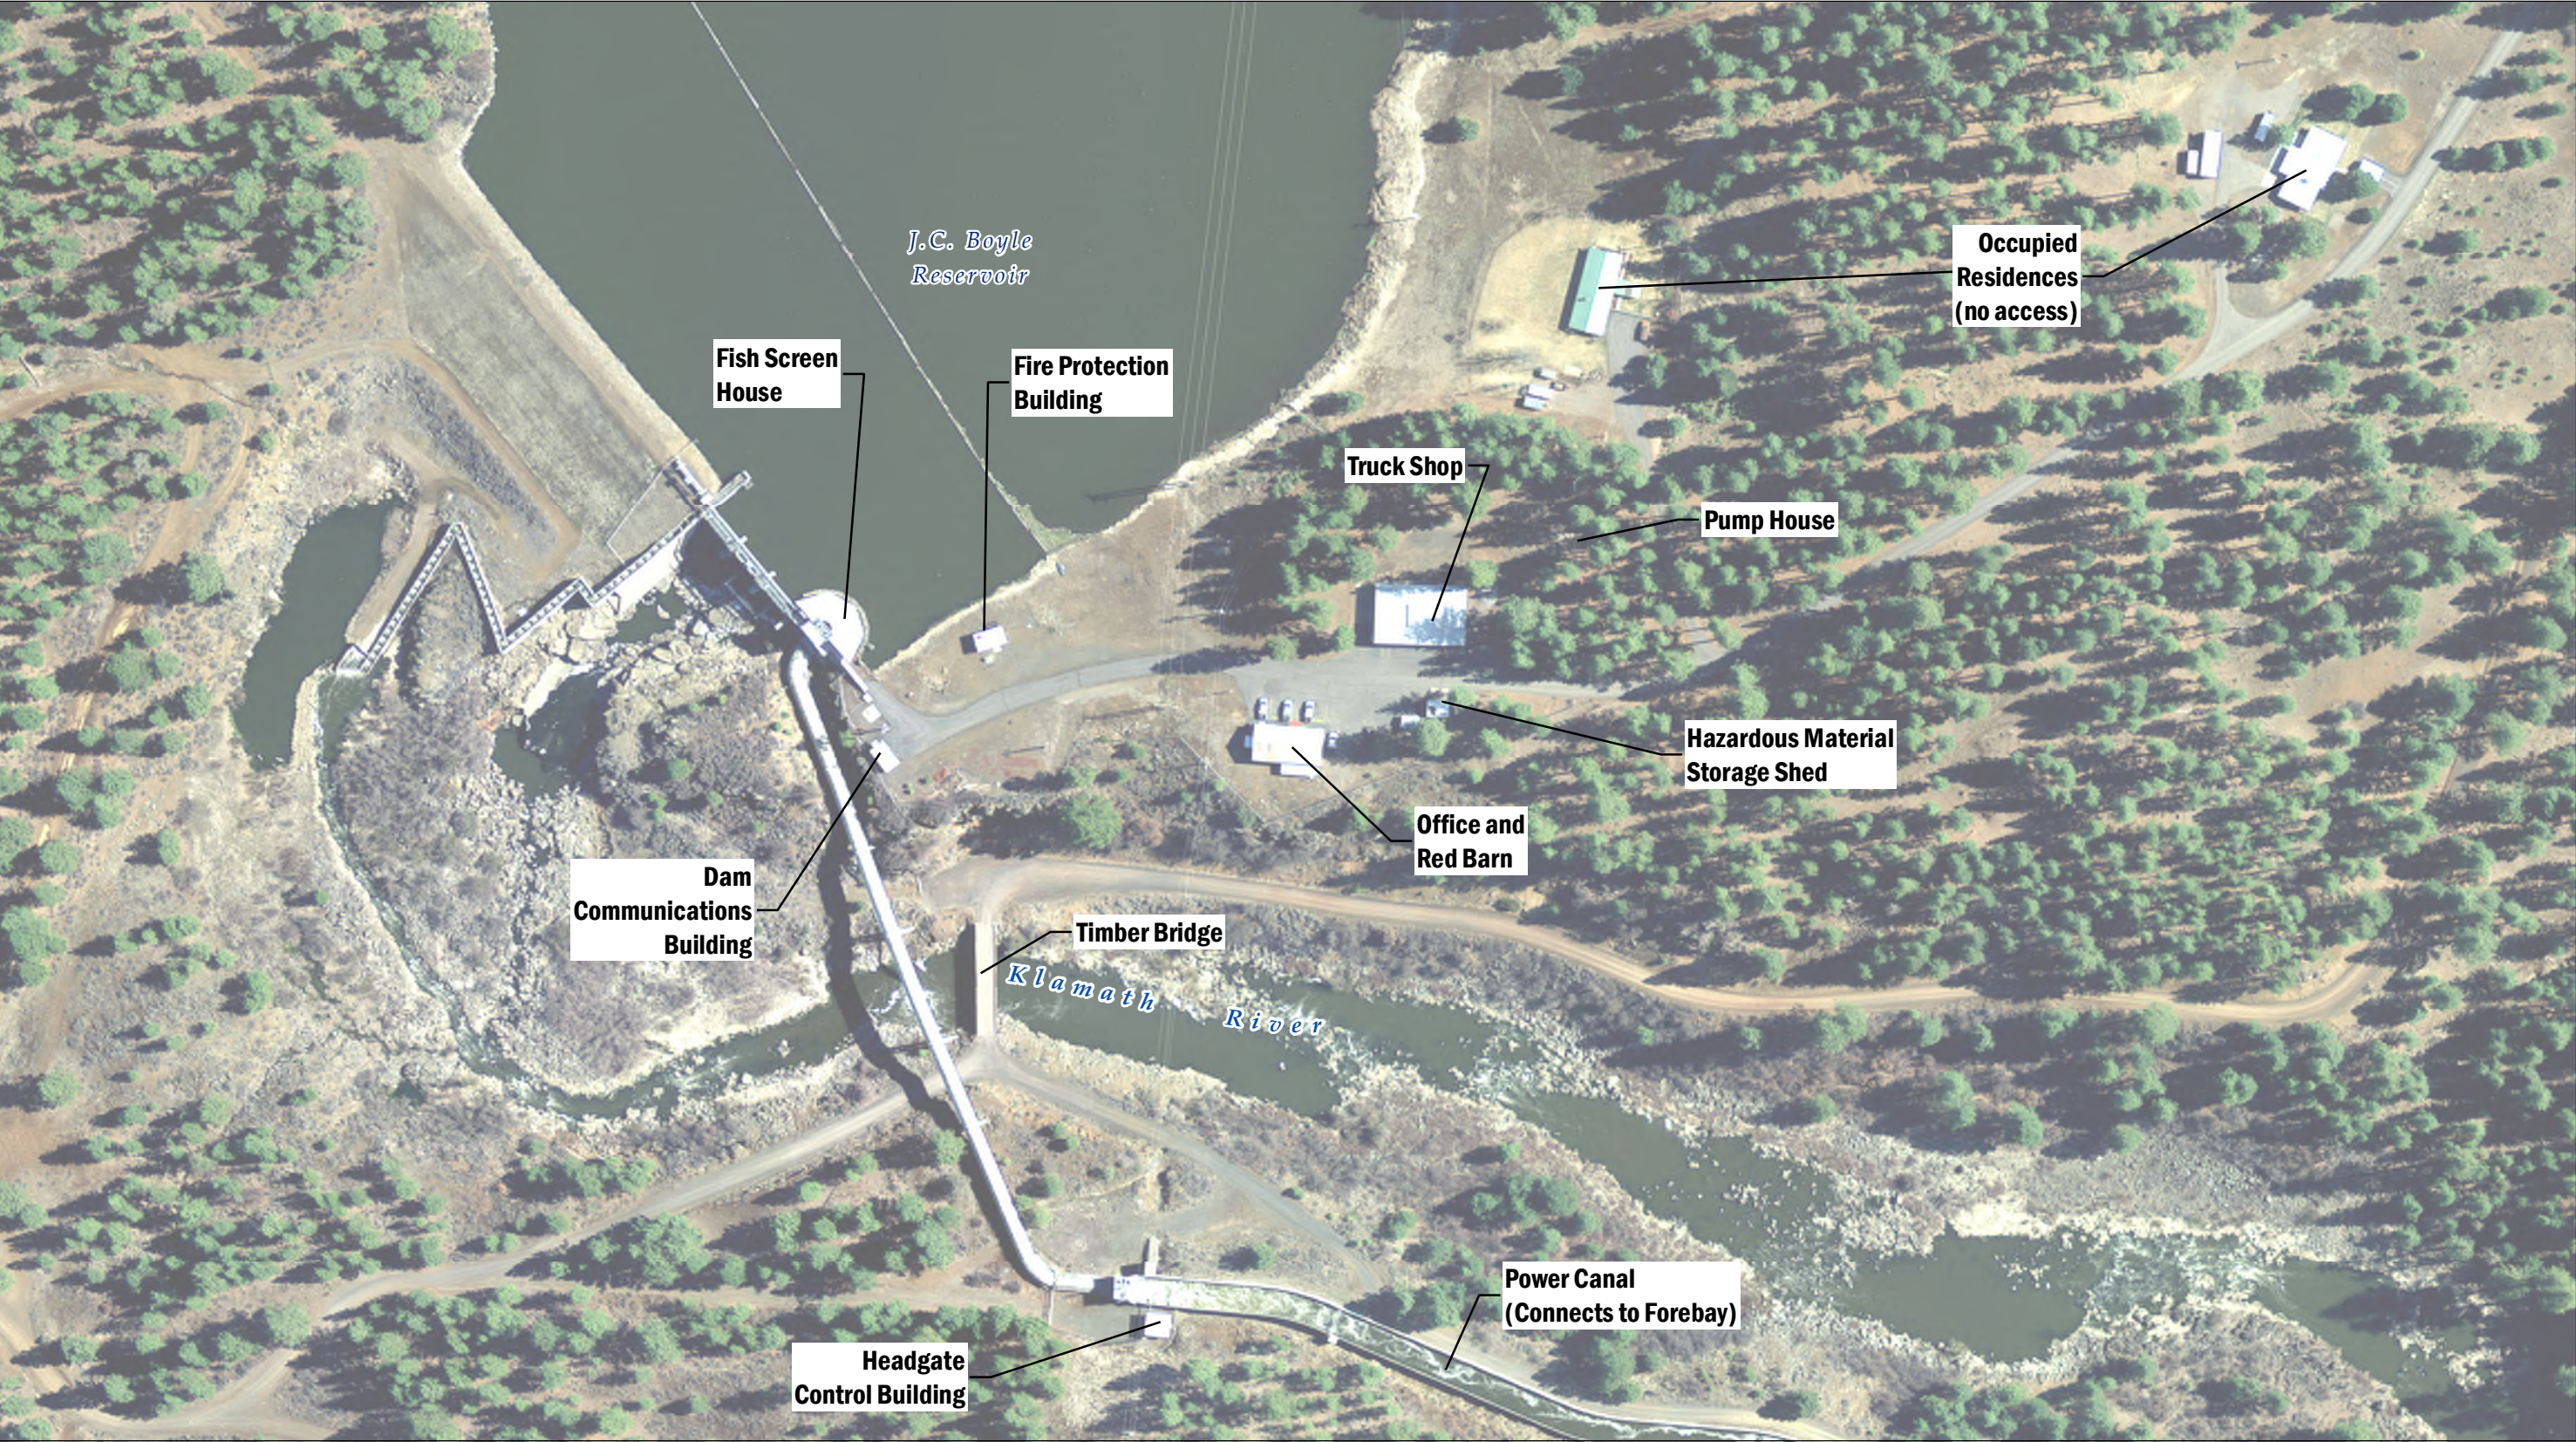
FIGURE 3-4
2017-2019 Bat Surveys
J.C. Boyle Forebay and Spillway Area,
Penstocks and Powerhouse Area

Roosting Bats Not Found
