Klamath River Renewal Corporation
Klamath River Renewal Project

This report summarizes the terrestrial resources surveys conducted in 2019 for the Klamath River Renewal Project (Project). The Klamath River Renewal Corporation (KRRRC) and its consultants carried out field investigations to collect existing condition information on the following terrestrial resources:

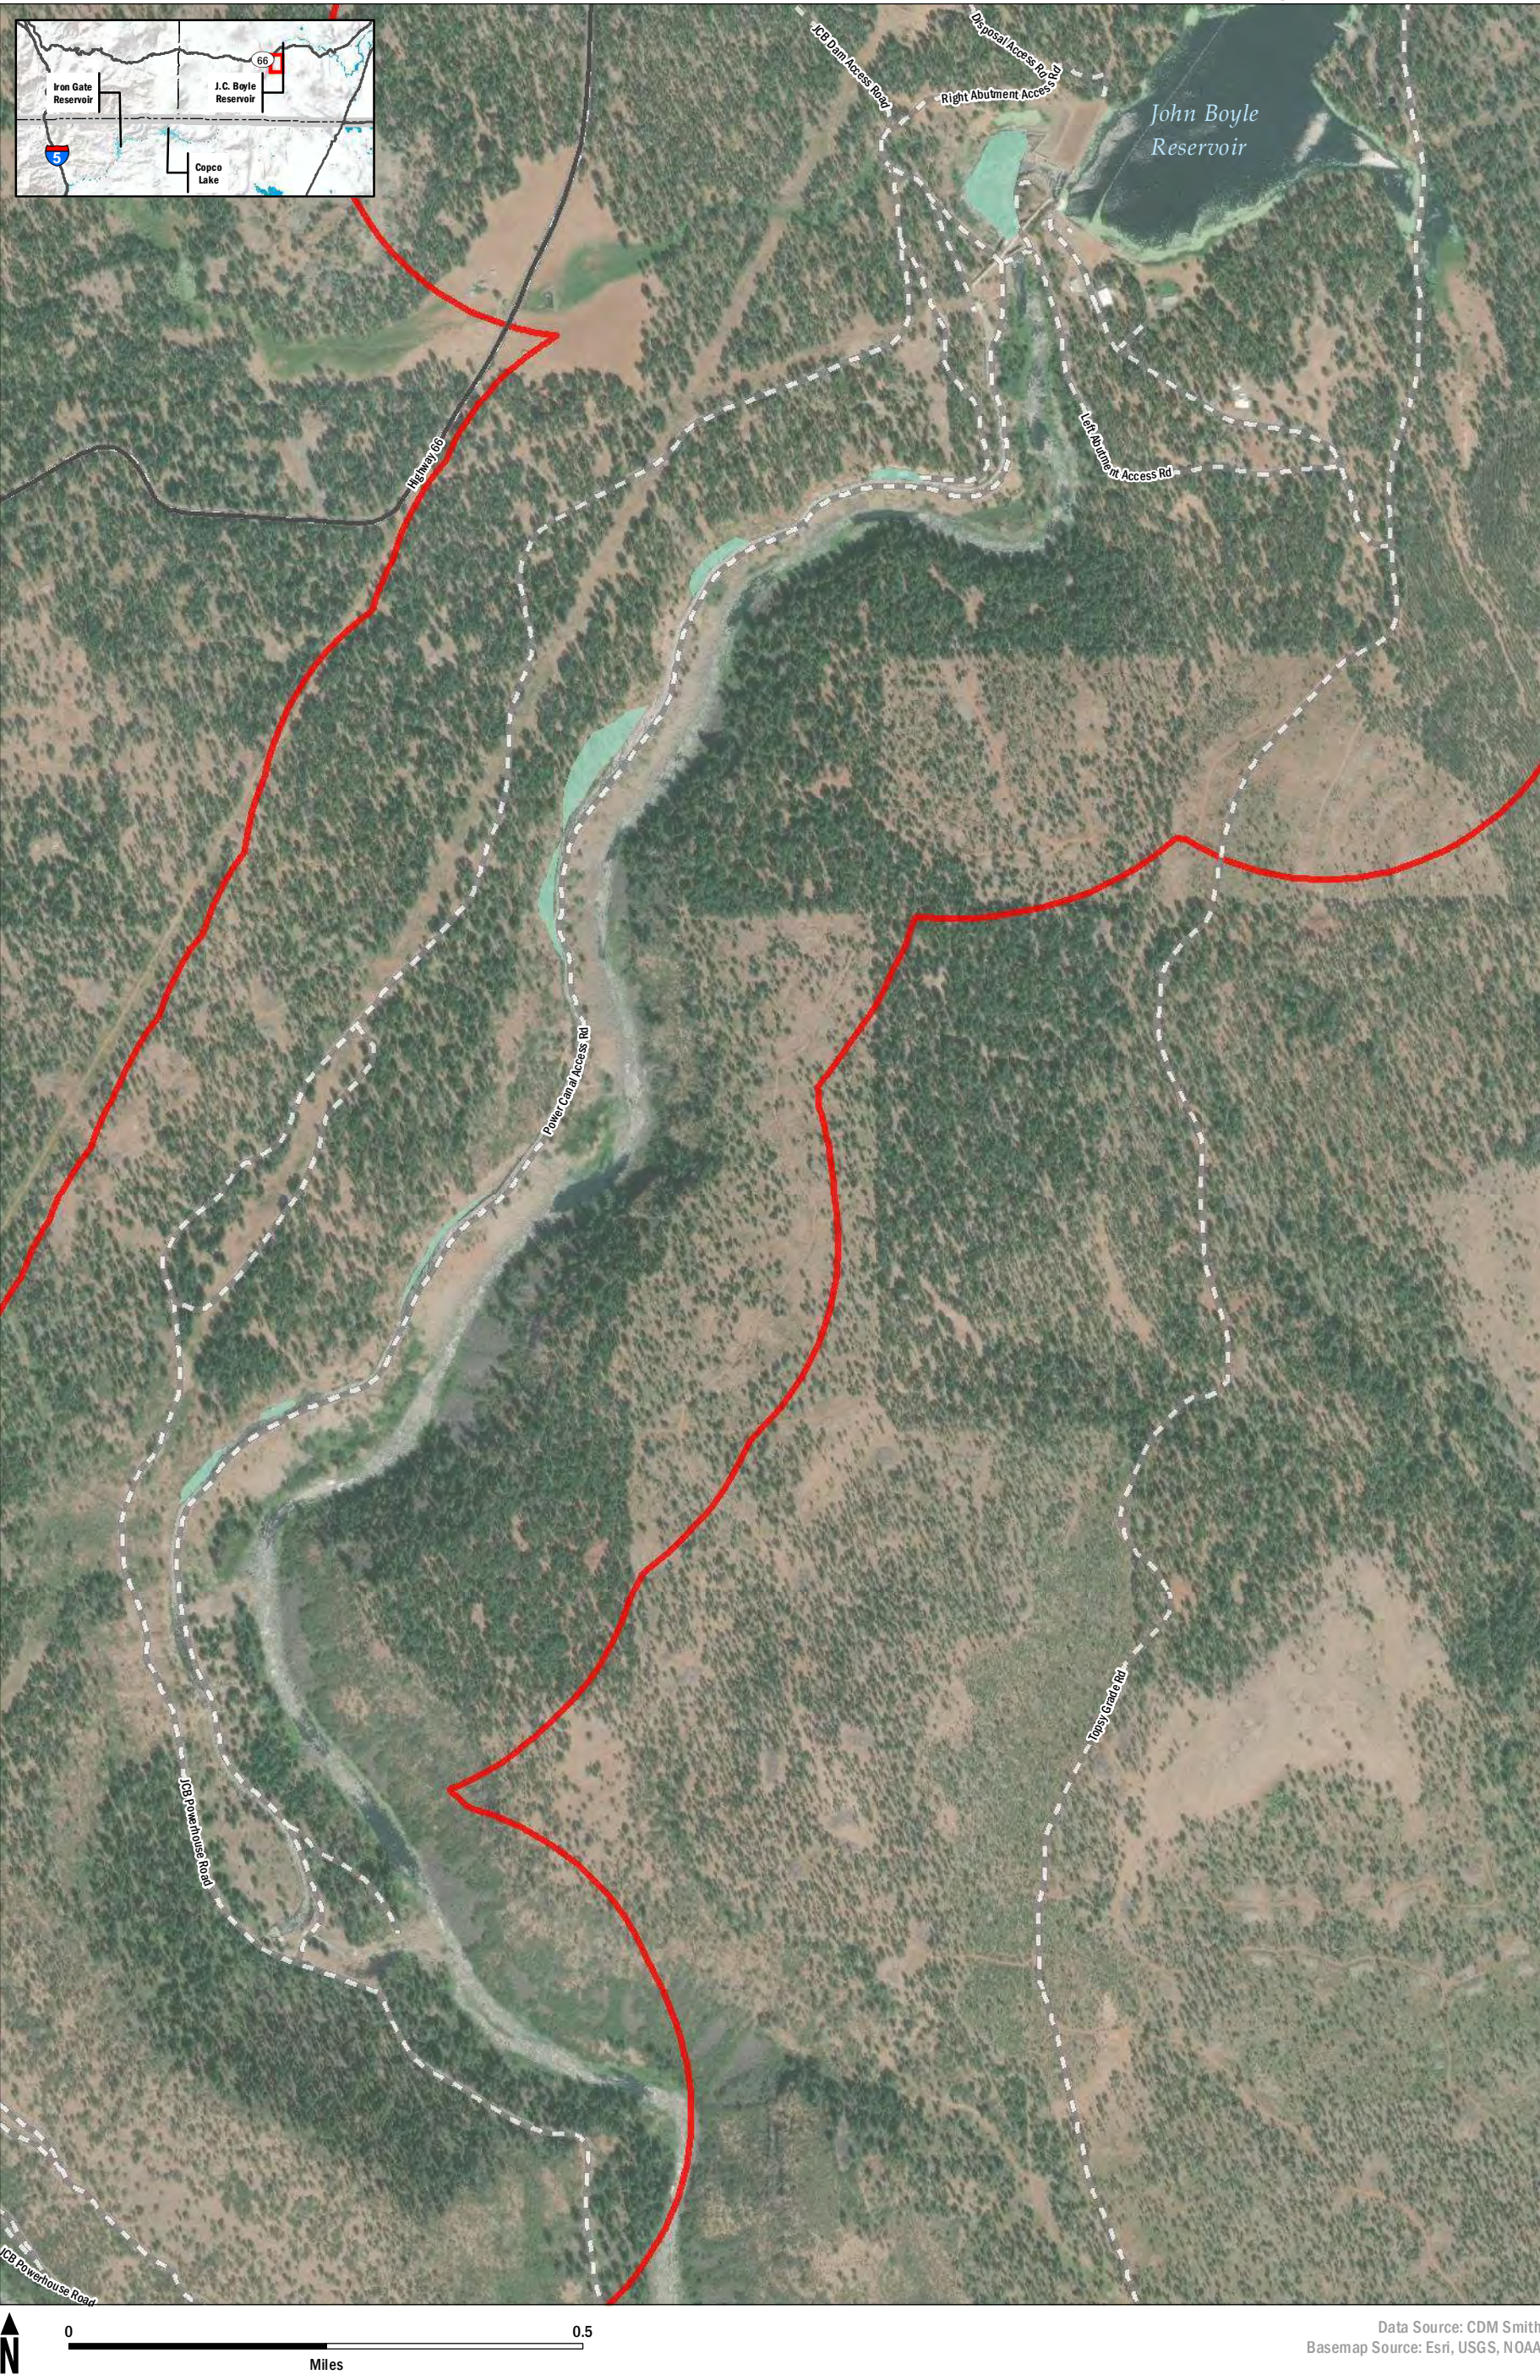
FIGURE 3-3
*2018 Willow Flycatcher Habitat and Observations
J.C. Boyle Reservoir and Canal*

- Willow Flycatcher Observation
- Willow Flycatcher Habitat
 - Bigleaf maple forest
 - Sandbar willow thicket
 - Oregon ash grove
 - Shining willow grove
 - Willow thickets
- State
- County
- Stream
- 0.25 Mile Study Area Buffer
- Access Route

Previous Text	Revised Text	Figure Numbers
Geyer willow thicket	Sandbar willow thicket	Figures 3-1 through 3-3; 2018 Willow Flycatcher Habitat and Observations
Geyer willow thicket	Sandbar willow thicket	Figures 11-1 through 11-16 Vegetation Communities
