**UNITED STATES OF AMERICA
BEFORE THE
FEDERAL ENERGY REGULATORY COMMISSION**

**Project Nos. 14803-001;
2082-063**

**EXHIBIT N (1 of 2)
Waste Disposal and Hazardous Materials Management Plan**

**Waste Disposal and
Hazardous Materials
Management Plan**

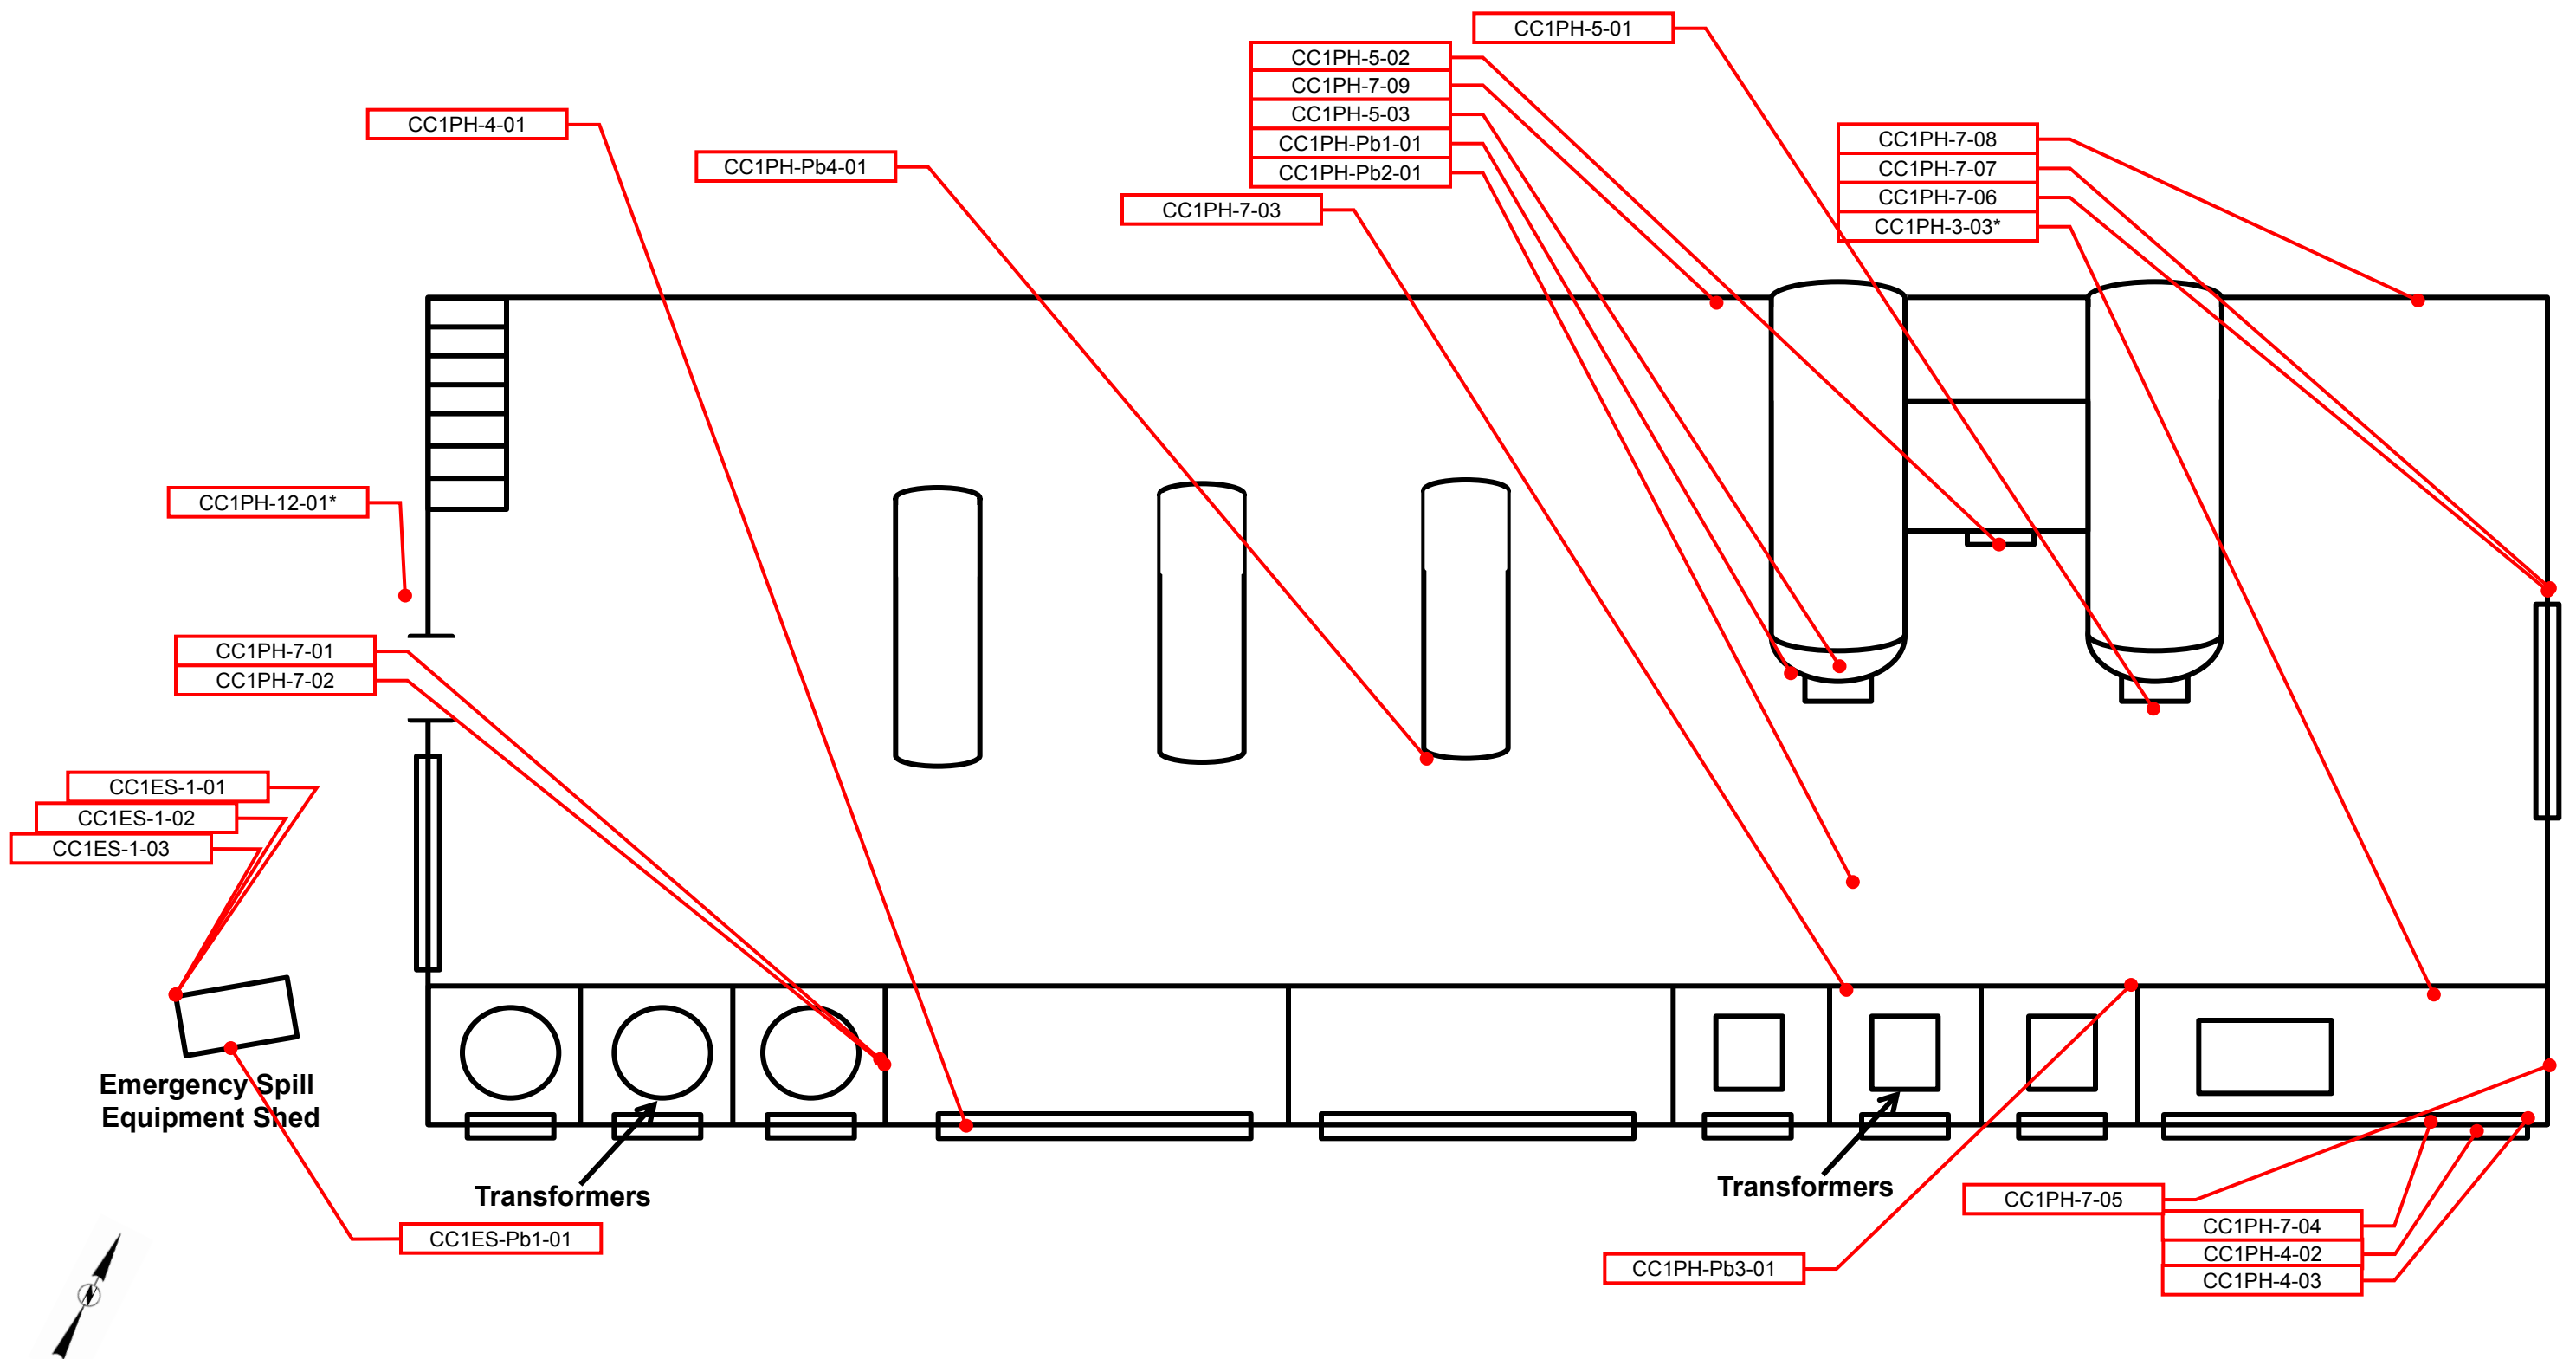
Figure 3
Asbestos and Lead Sample Locations
Powerhouse Ground Level and Emergency Spill Equipment Shed

Legend
 CC1PH – HSA# – ## = Asbestos sample location
 CC1PH – Pb# – ## = Lead paint sample location
 *Concrete sample analyzed via PLM CARB (Detection limit of .25%)

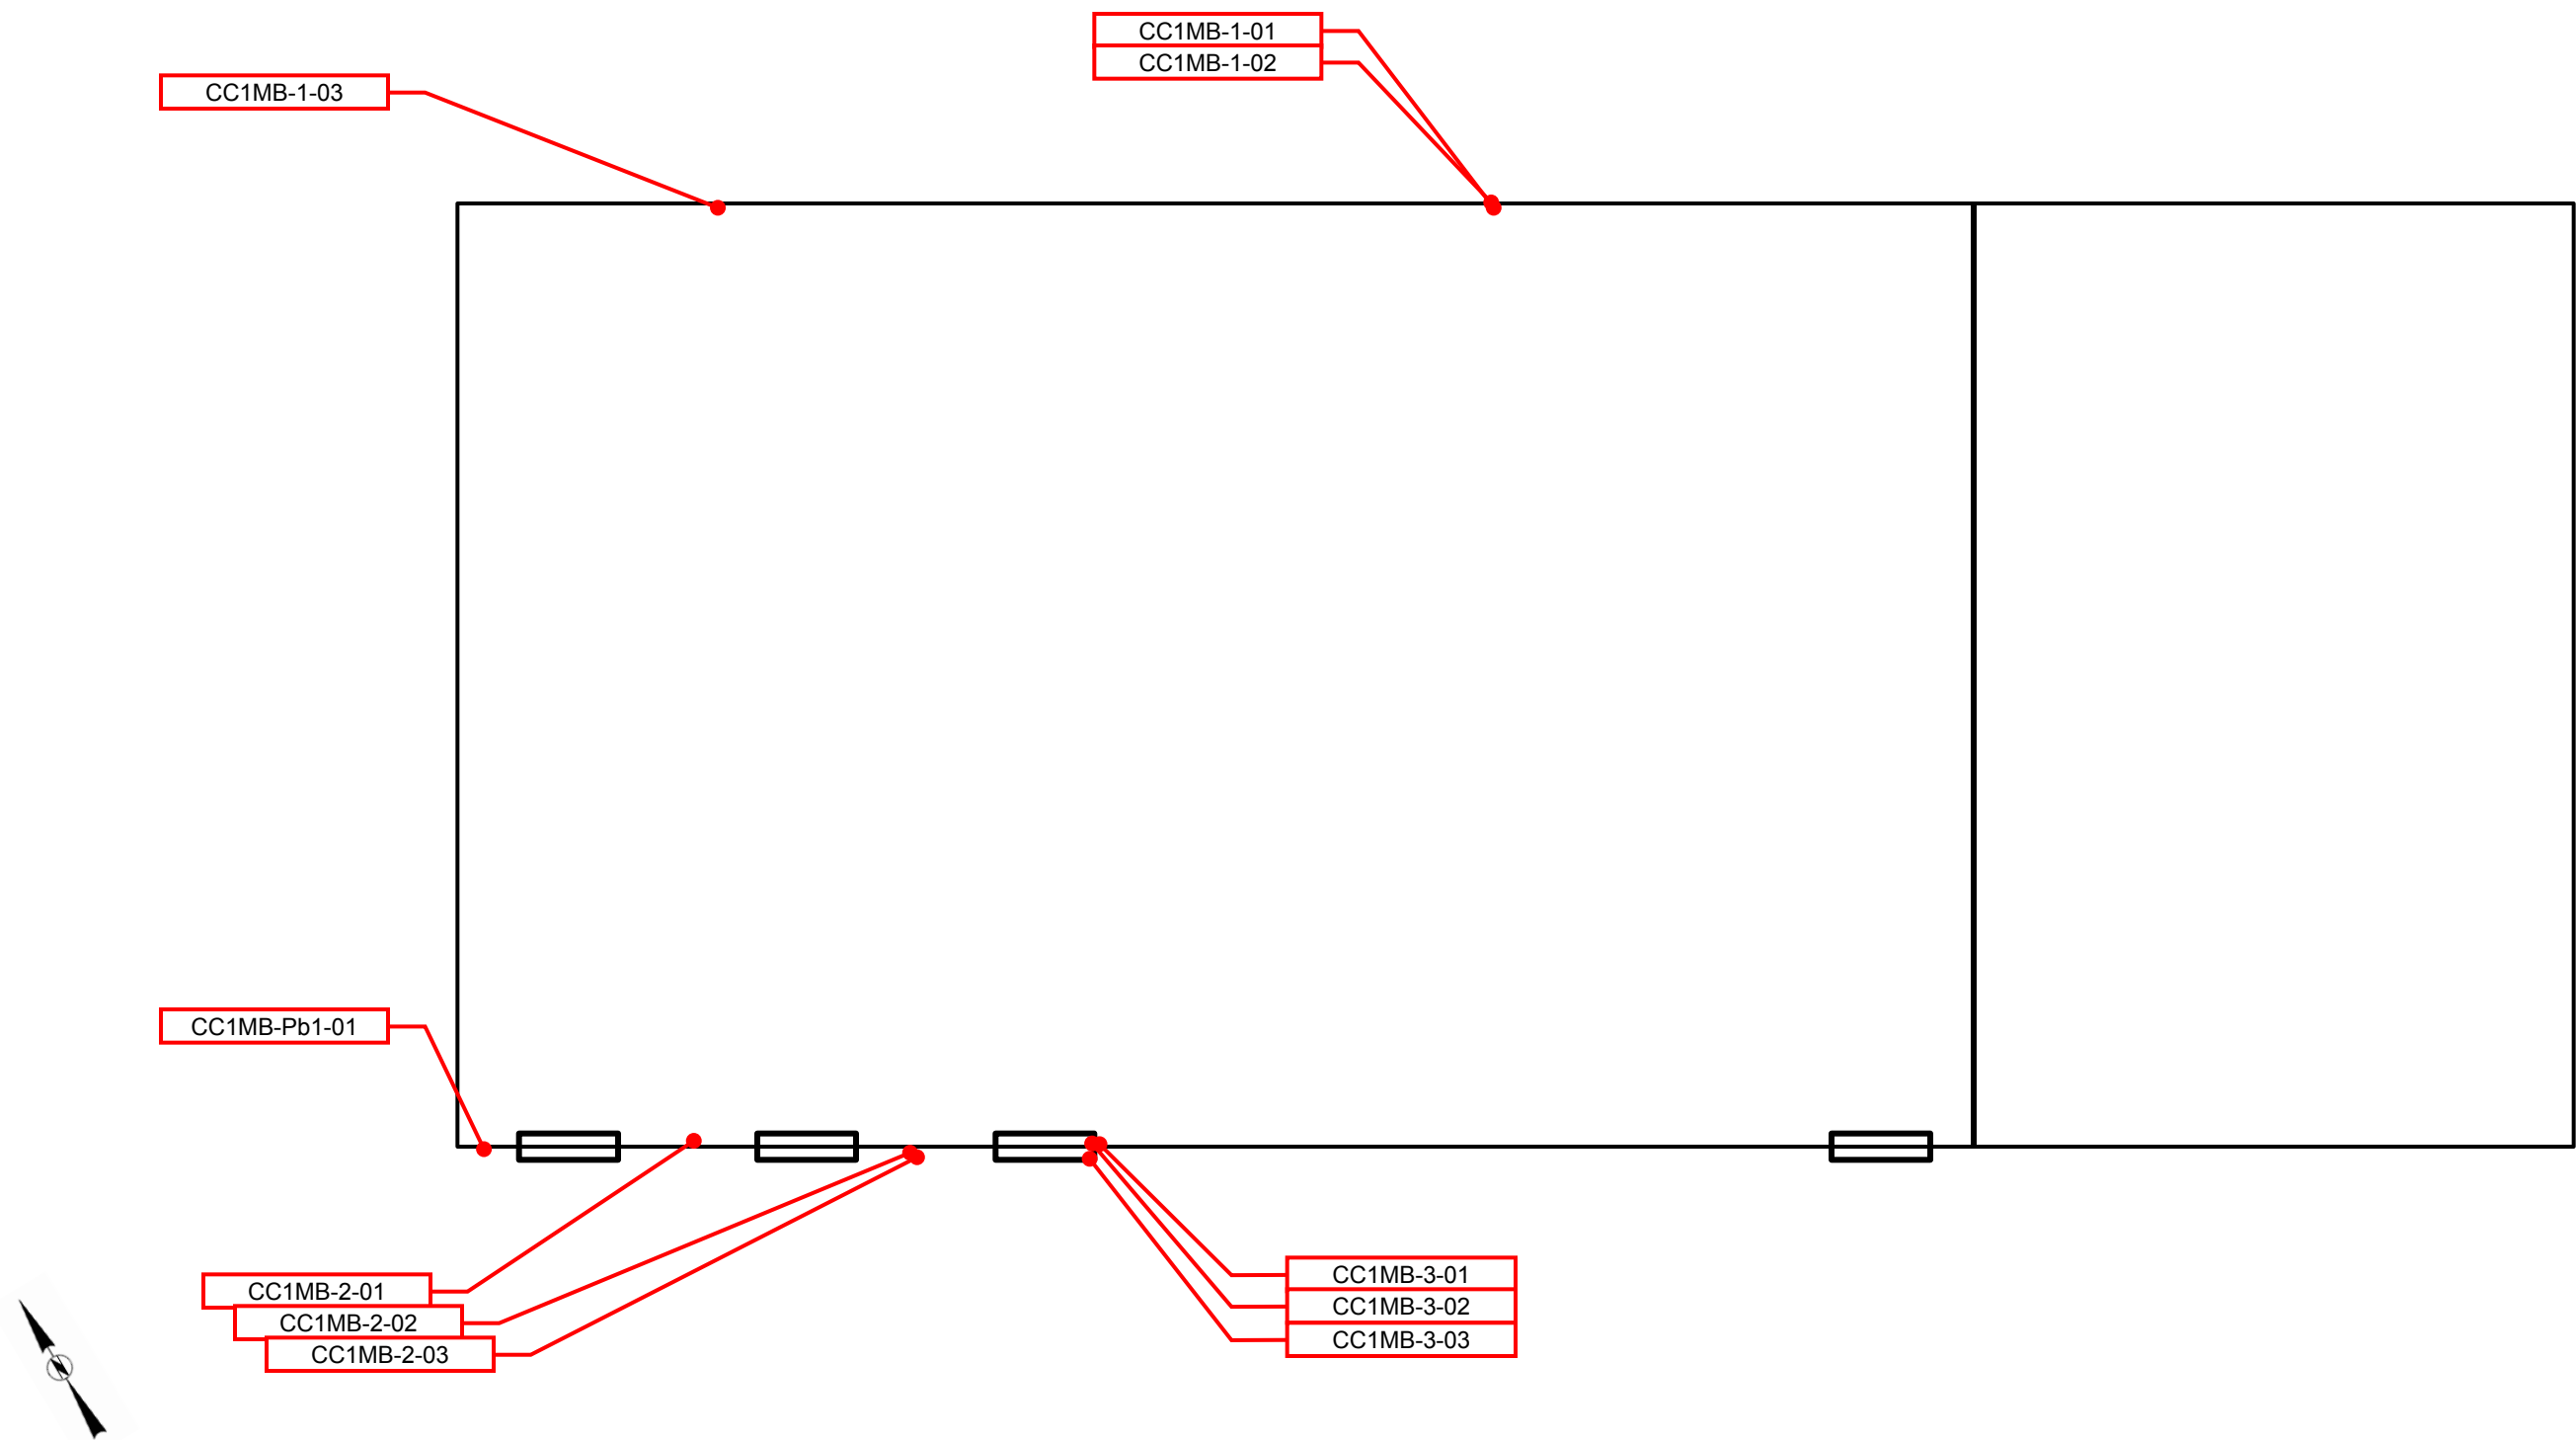
Figure 4
Asbestos and Lead Sample Locations
Maintenance Building

Legend
CC1MB – HSA# – ## = Asbestos sample location
CC1MB – Pb# – ## = Lead paint sample location

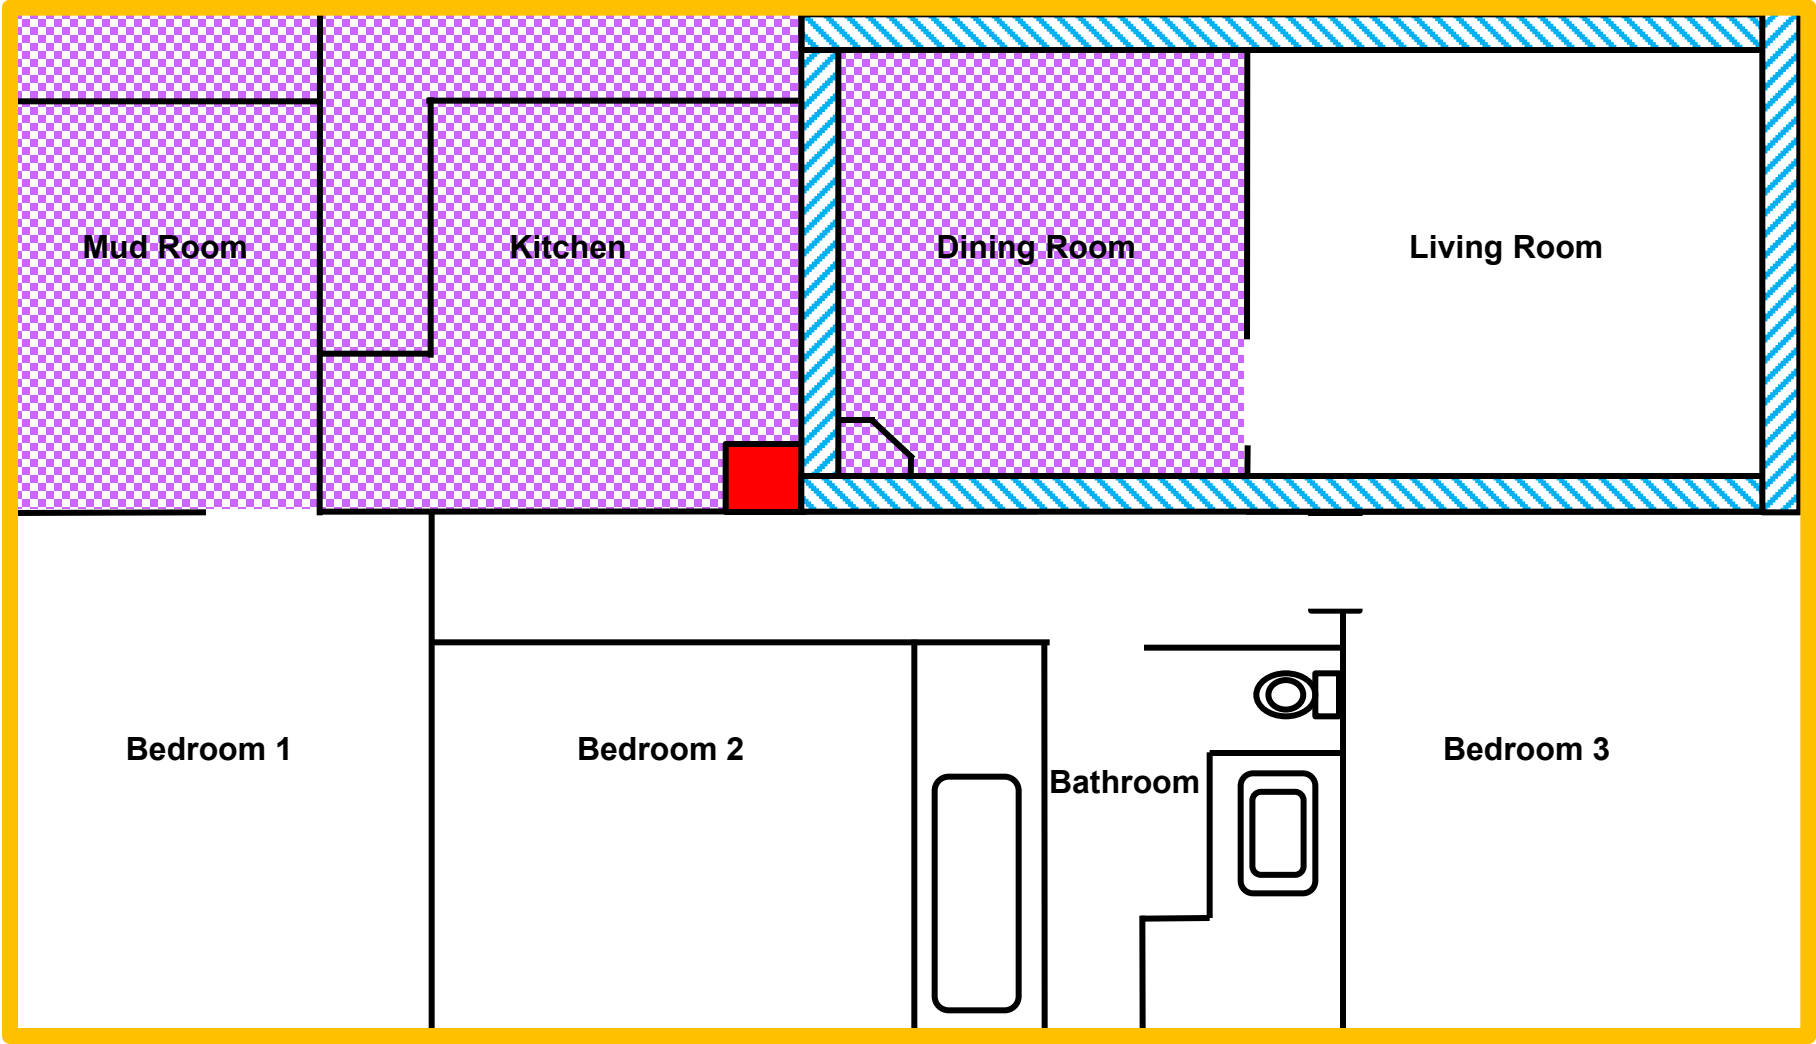
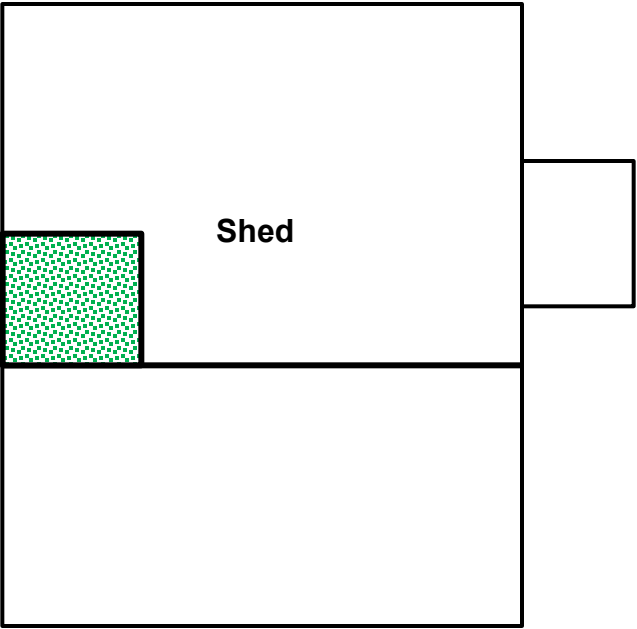
Figure 10
Approximate ACM Locations
Former Residence 1 and Detached Shed

HSA CC1R1-14: Assumed asbestos-containing mastic behind wood wall paneling (M)

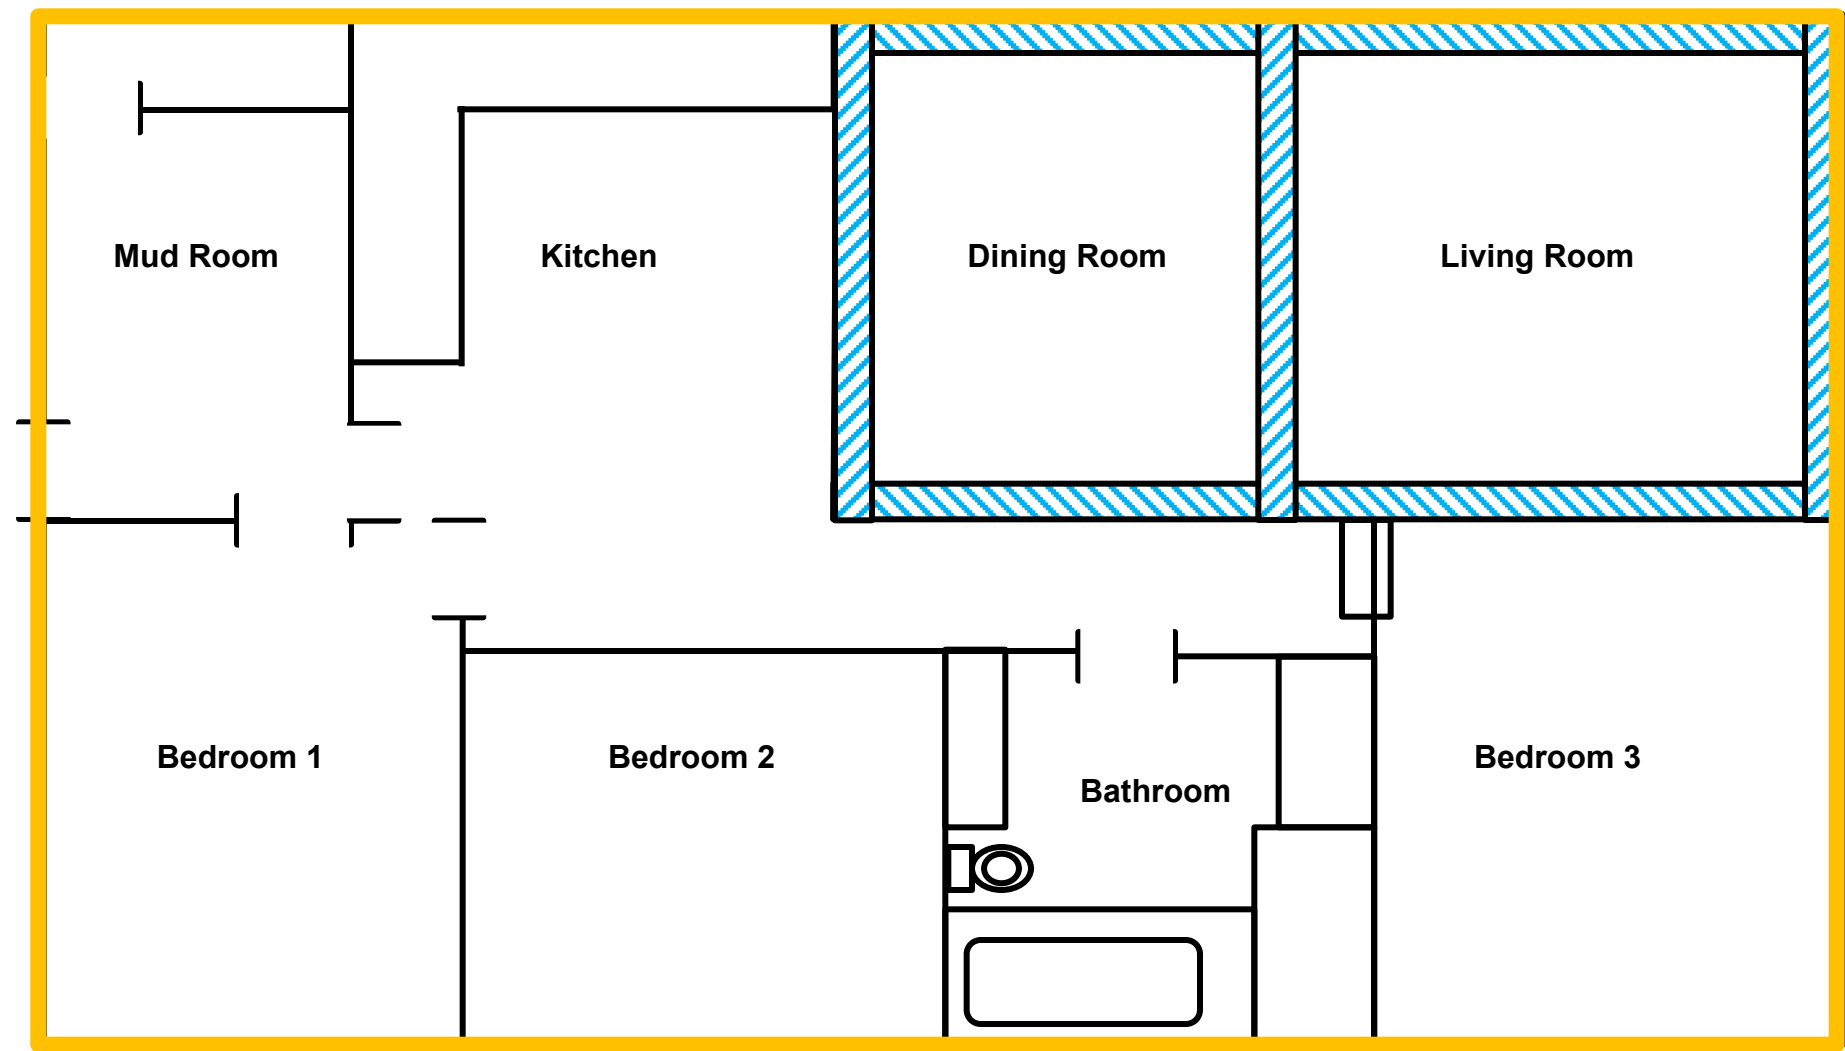
Figure 12
Asbestos and Lead Sample Locations
Former Residence 2

Not shown: HSA CC1R2-05: : Assumed asbestos-containing asphaltic woven electrical wire insulation (throughout) (M)

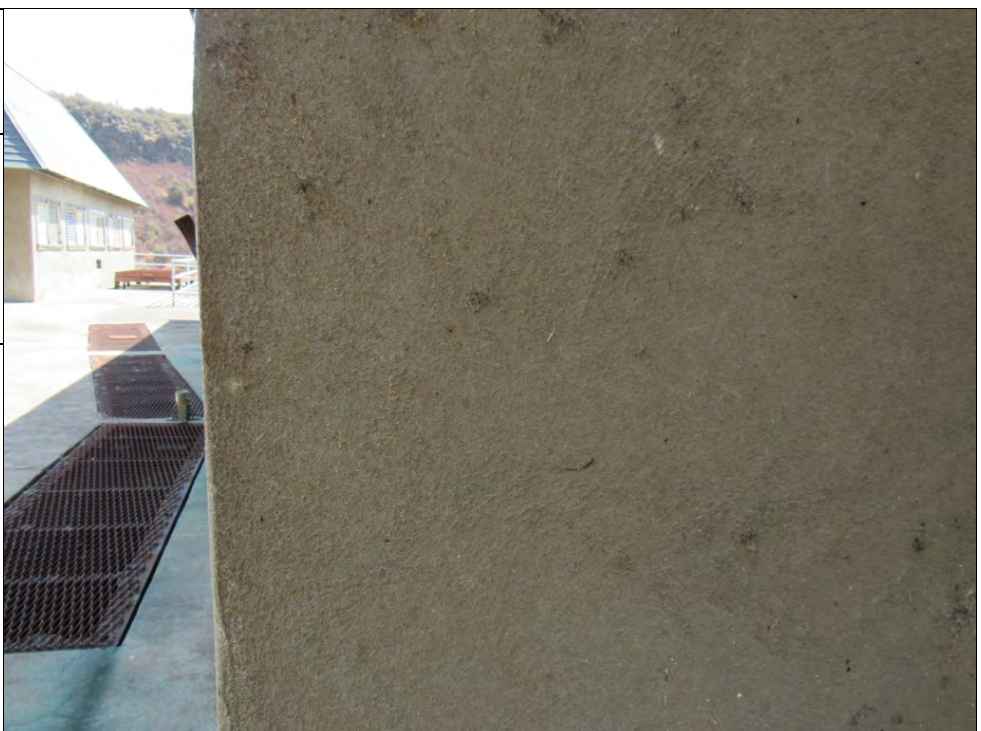
Structure/Material Location: Copco No. 1 Dam, Dam and Gatehouses C11 and C12/ Throughout exterior of Gatehouses		
*Description (by layer): 1: Gray brittle stucco (S)

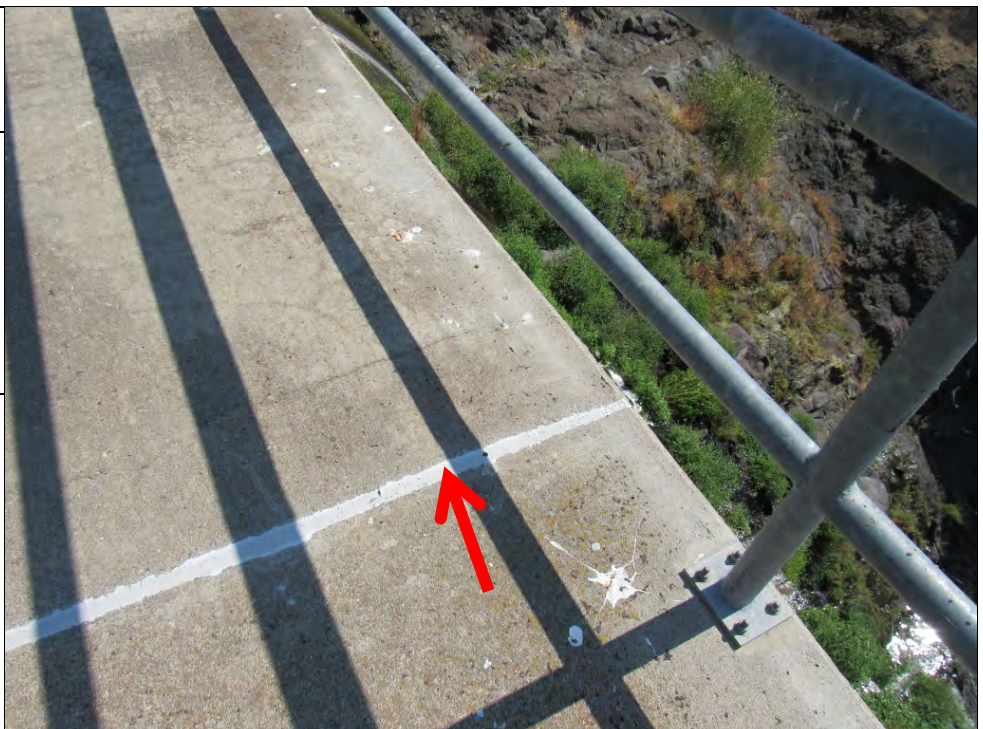
Photo No./ Material ID: CC1GH - 03	Date: 9/10/2018 to 9/11/2018
Structure/Material Location: Copco No. 1 Dam, Dam and Gatehouses C11 and C12/ Walkway expansion joints associated with the Gatehouses, the Right Abutment Intake Structure, and the Copco 1 Dam	
*Description (by layer): 1: Gray sealant (M)

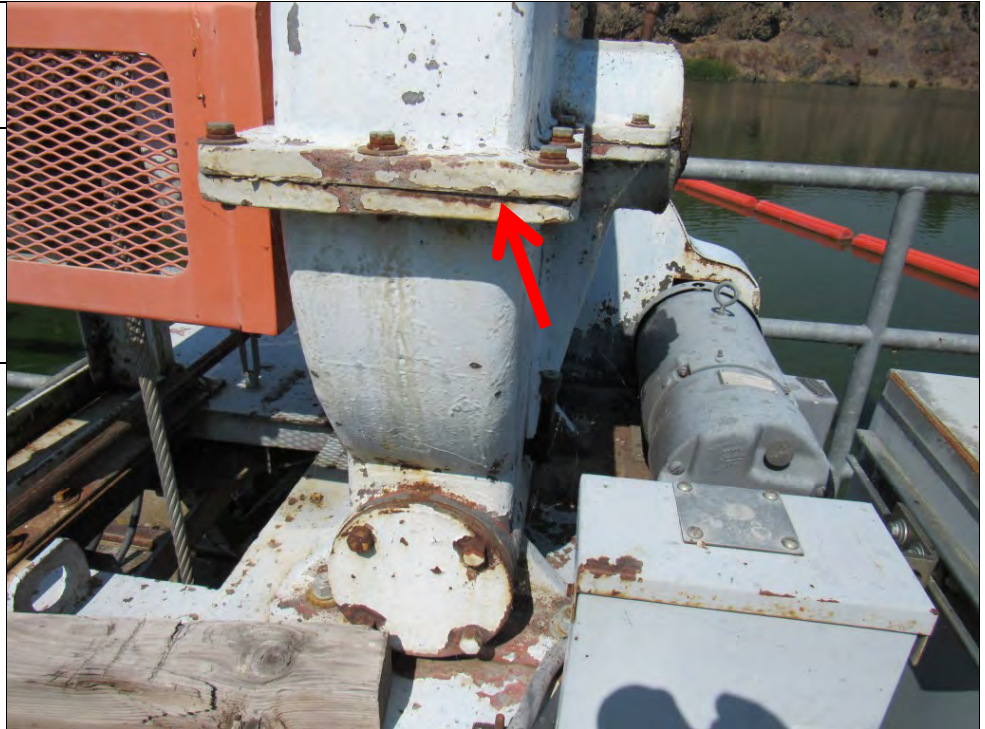
**Assumed asbestos-containing
gaskets**

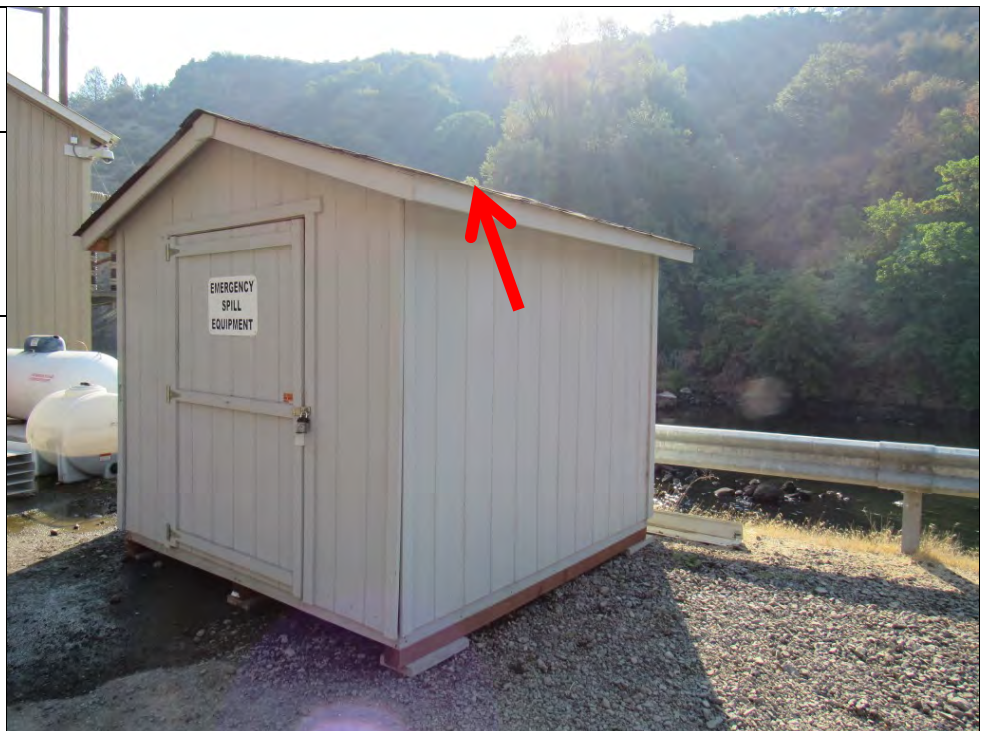
CC1ES - 01

- 1: Black asphaltic roofing
shingles with granules (M)
- 2: Black asphaltic mastic (M)

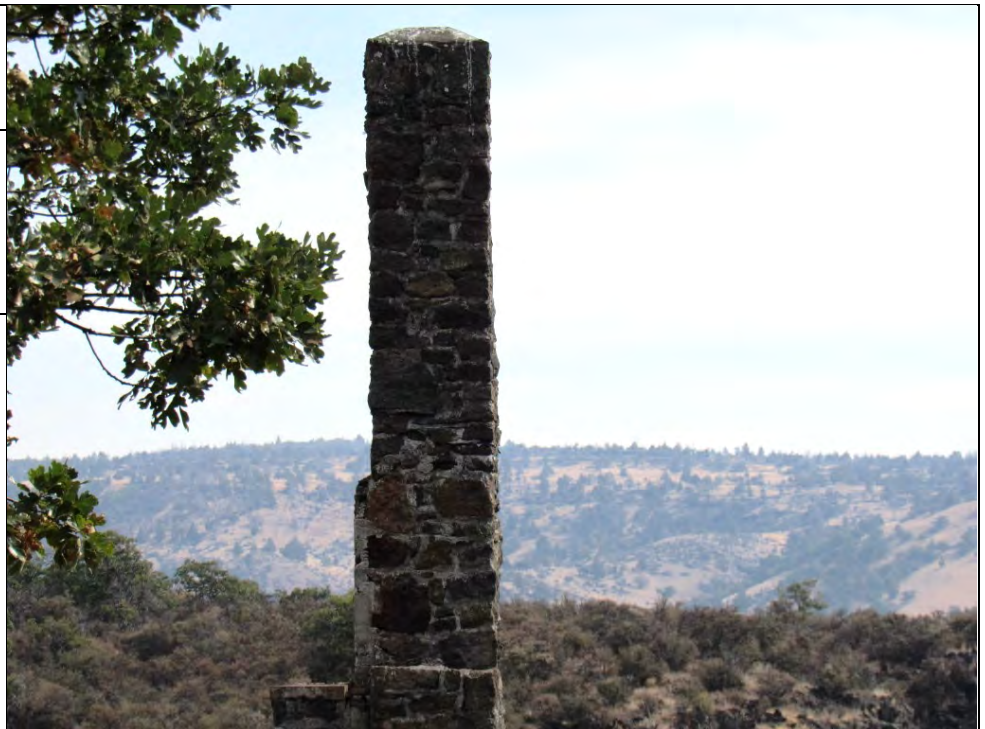
**Assumed gray grout
associated with river rock
chimney (M)**

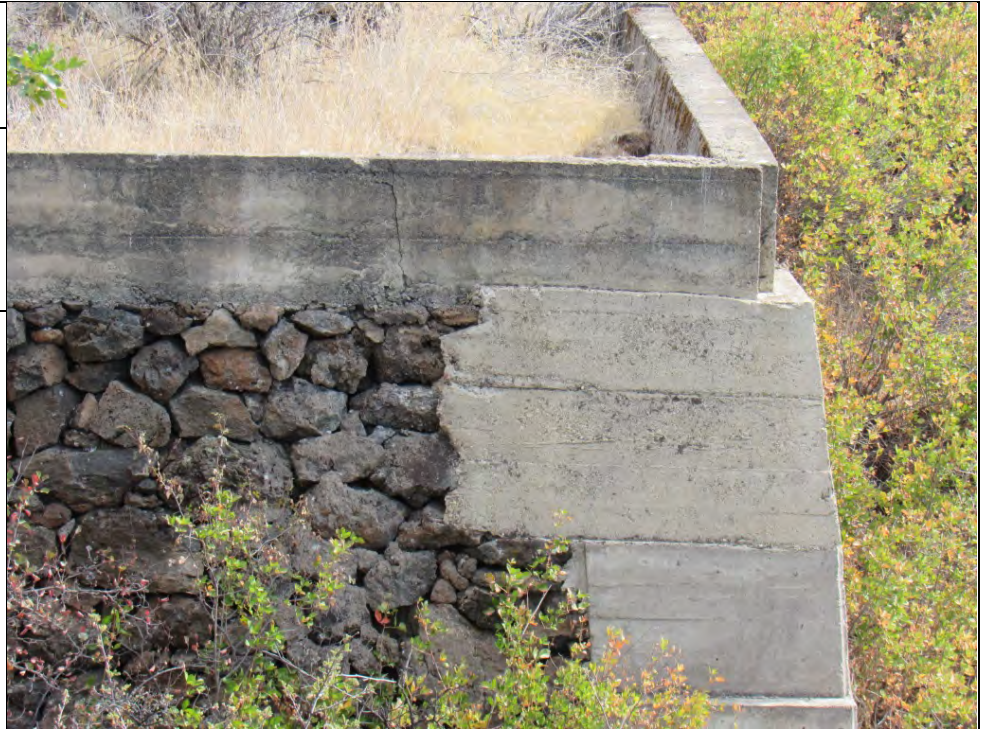
**Assumed gray grout
associated with foundation
(M)**

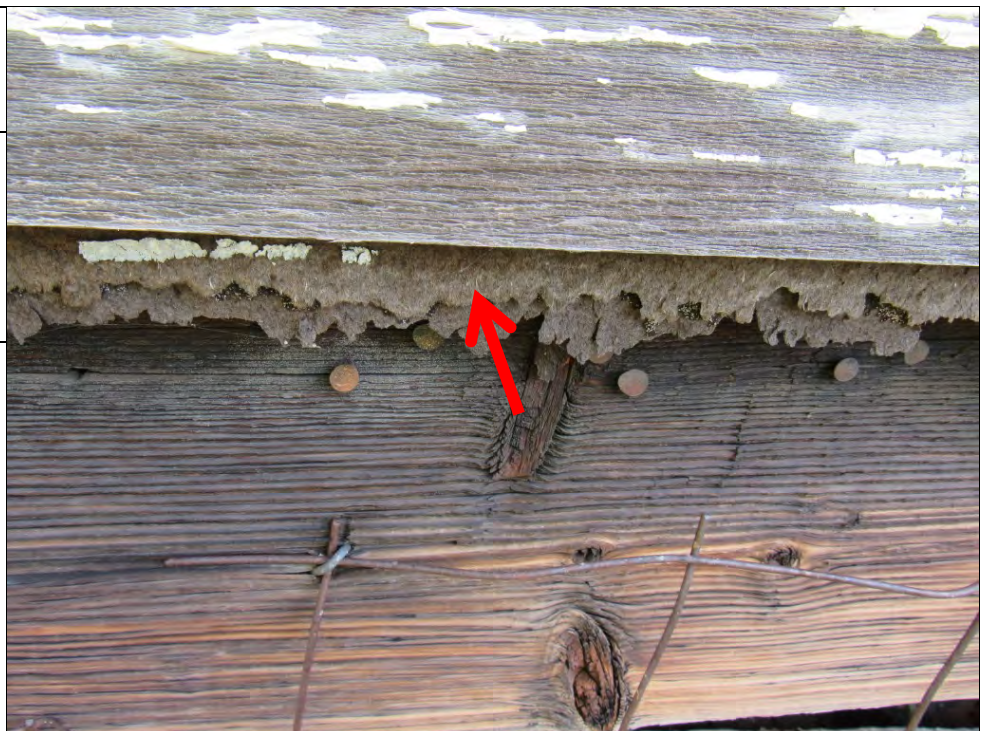
CC1MB - 01

- 1: Black asphaltic vapor barrier
paper (M))
- 2: Black asphaltic vapor barrier
paper (M)
- 3: Black asphaltic material (M)

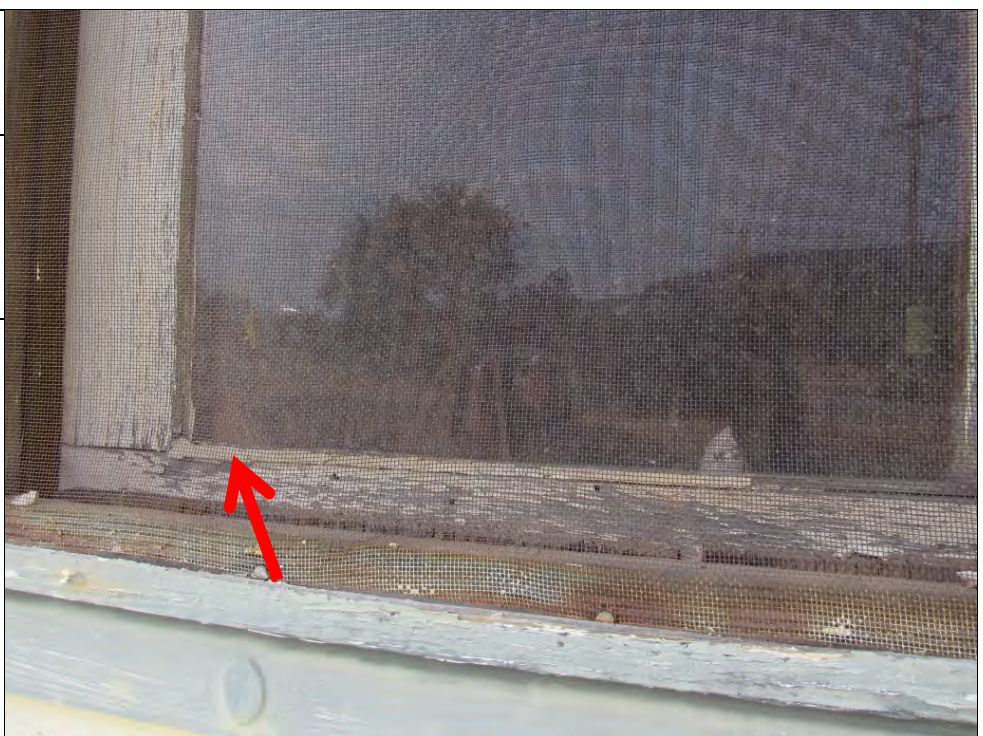
CC1MB - 03

Date:9/10/2018 to
9/11/2018**Structure/Material Location:**Copco No. 1 Maintenance
Building/
Exterior window panes***Description (by layer):**

- 1: White brittle window putty (M)

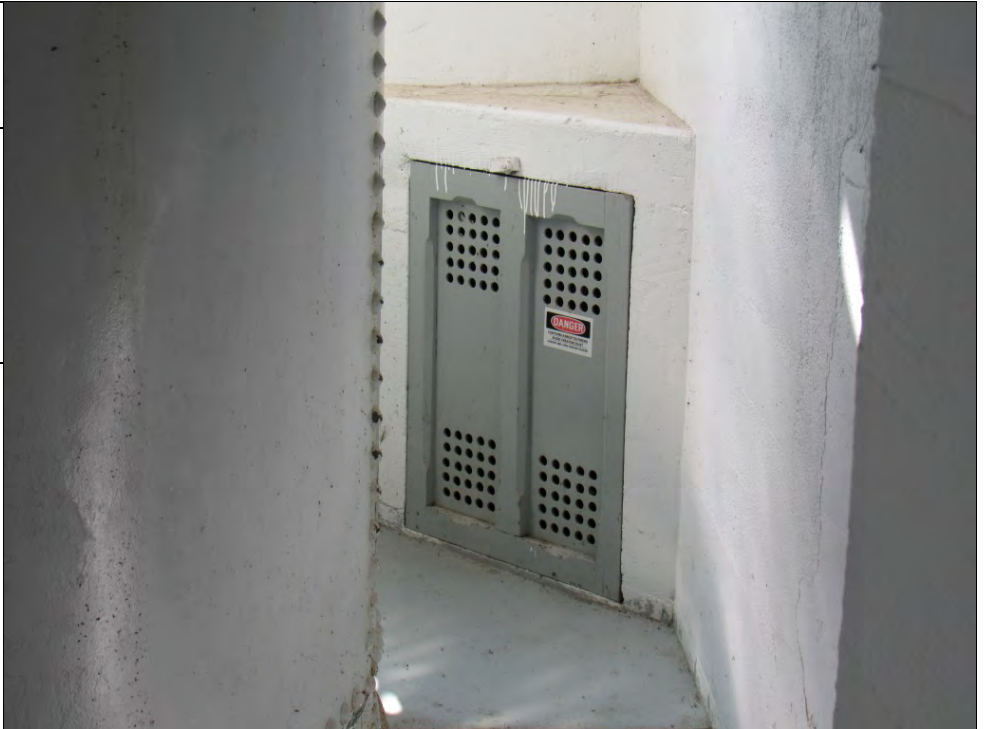
Photo No./ Material ID: CC1PH - 06	Date: 9/10/2018
Structure/Material Location: Copco No. 1 Powerhouse/ Panels in various places throughout the main floor and basement. Labeled with ACM stickers.	
*Description (by layer): Assumed asbestos-containing cement asbestos board (CAB) (M)

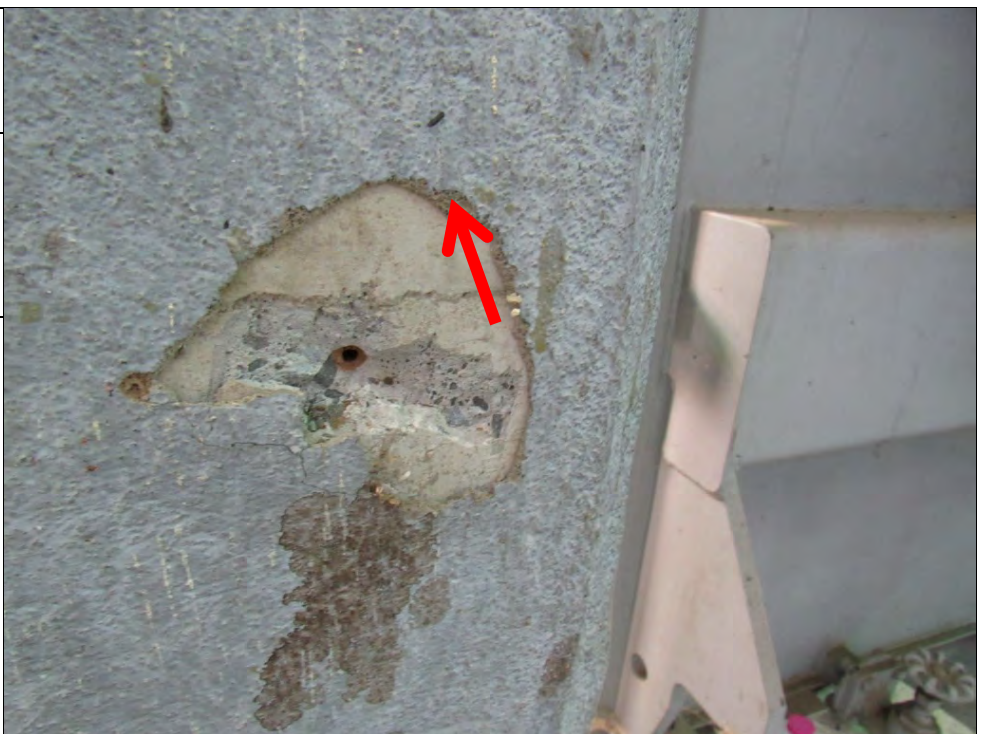
Photo No./ Material ID: CC1PH - 07	Date: 9/10/2018
Structure/Material Location: Copco No. 1 Powerhouse/ Concrete walls throughout main floor	
*Description (by layer): 1: Cementitious troweled-on surface coat (S)

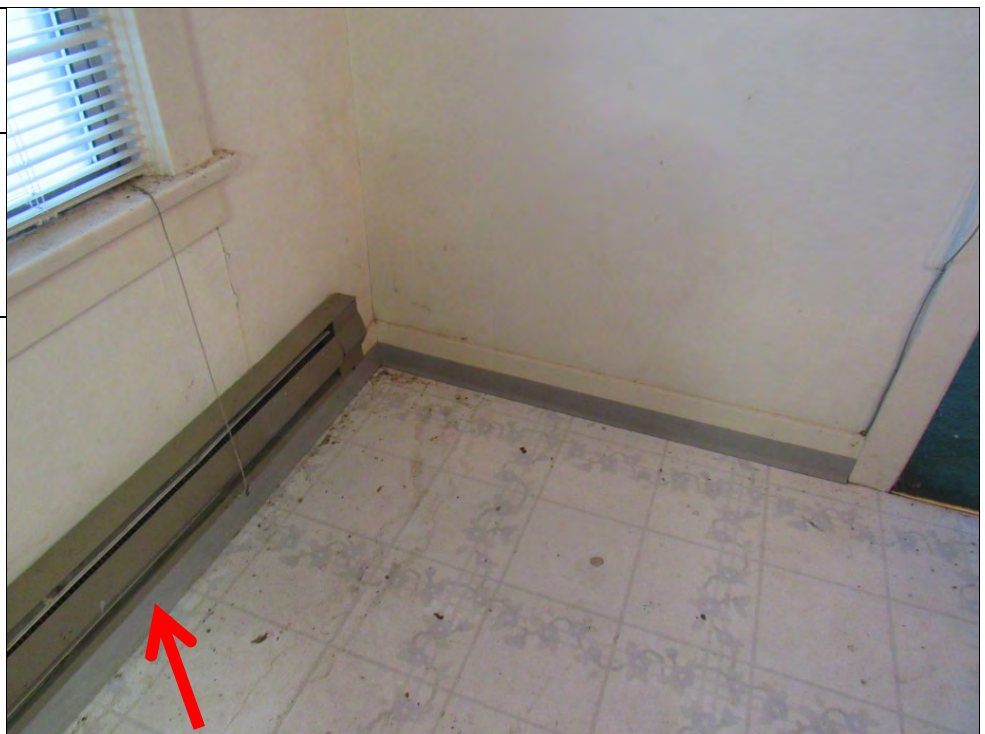
Photo No./ Material ID:	Date:
CC1R1 - 03	9/10/2018
Structure/Material Location:	
Copco No. 1 Residence 1/ Walls in mud room and dining room	
*Description (by layer):	
1: 3" gray rubber cove base (M)	
2: White mastic (M)

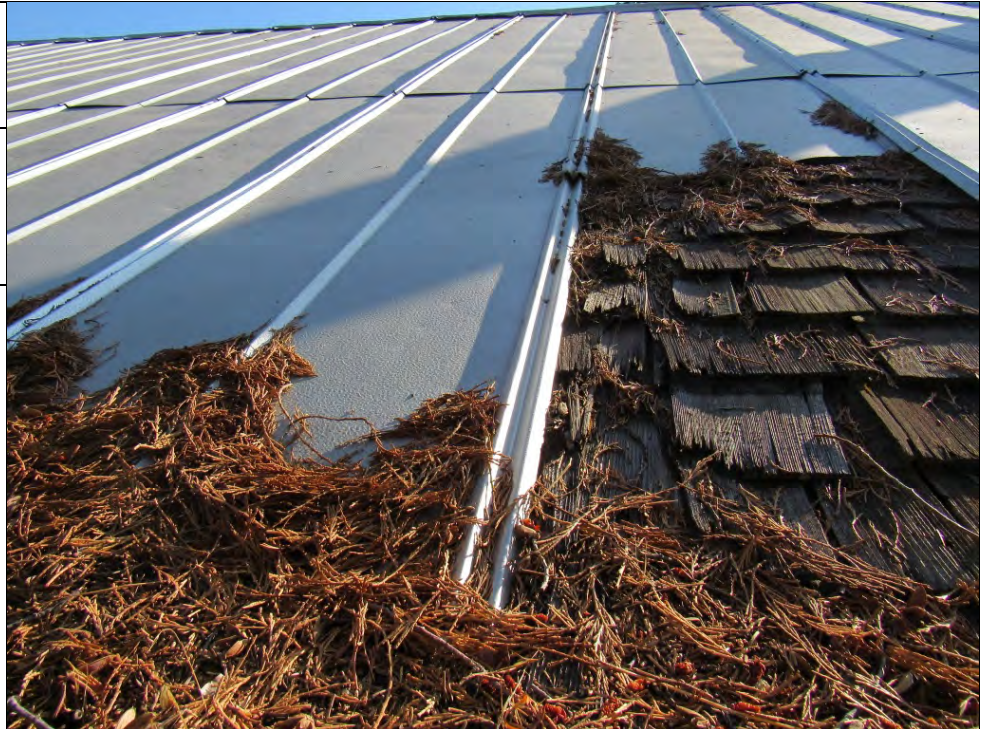
Photo No./ Material ID: CC1R1 - 08	Date: 9/10/2018
Structure/Material Location: Copco No. 1 Residence 1/ Throughout roof	
*Description (by layer): 1: Black asphaltic roofing paper (M) 2: Black asphaltic fibrous material (M) 3: Black asphaltic fibrous material (M)

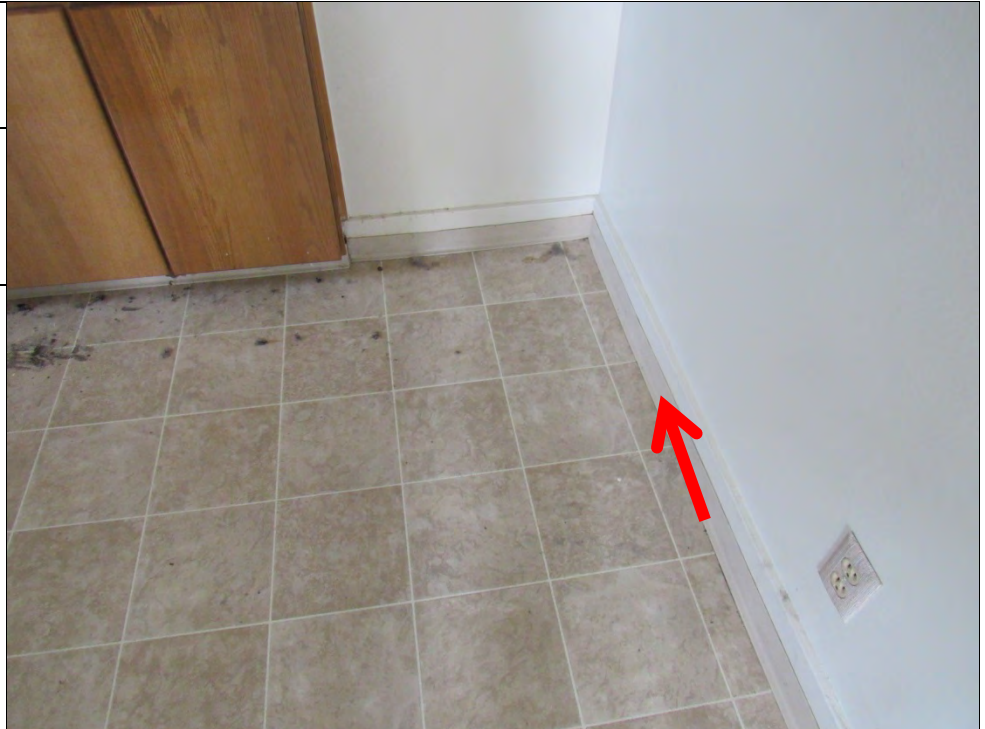
Photo No./ Material ID: CC1R2 - 02	Date: 9/10/2018 to 9/11/2018
Structure/Material Location: Copco No. 1 Residence 2/ Throughout roof	
*Description (by layer): 1: 3" off-white rubber cove base (M) 2: White mastic (M) 3: White troweled-on surface coat (S) (HSA 01)

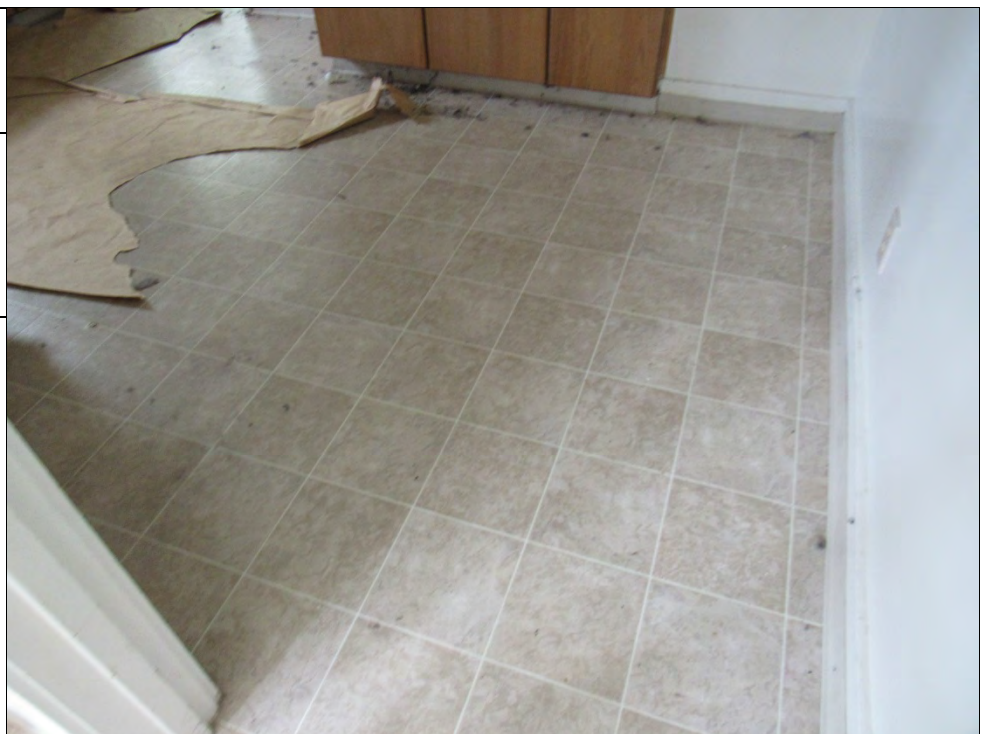
Photo No./ Material ID: CC1R2 - 03	Date: 9/10/2018 to 9/11/2018
Structure/Material Location: Copco No. 1 Residence 2/ Walls in kitchen, mud room, and bathroom	
*Description (by layer): 1: Light gray vinyl floor sheeting with swirl and square pattern (M) 2: White paper backing with tan mastic (M)

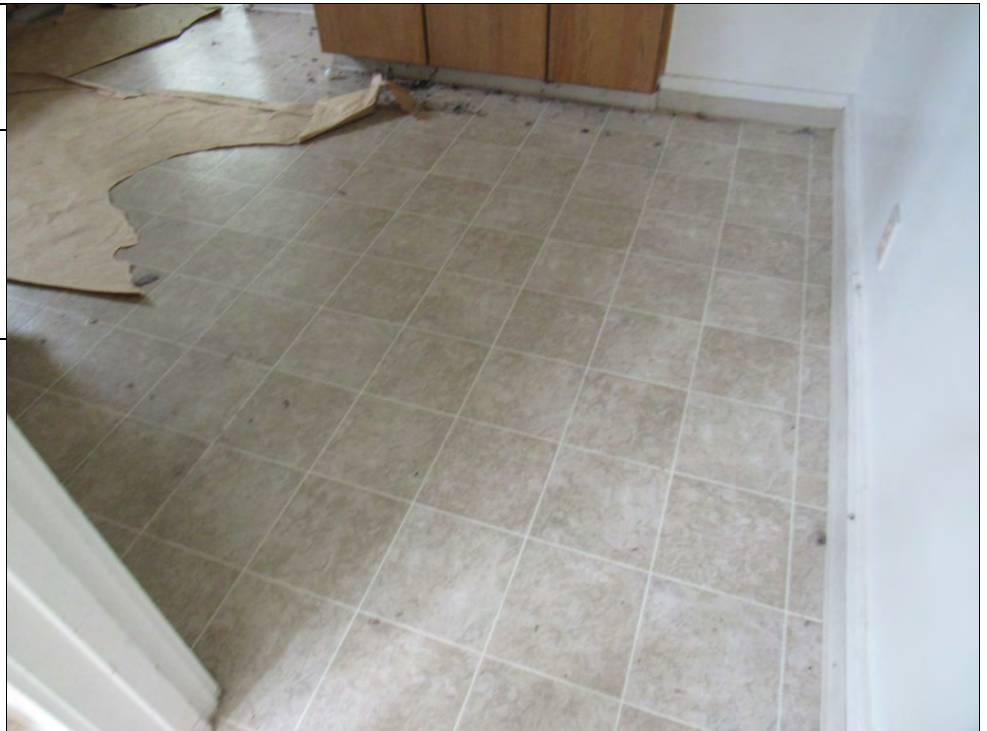
Photo No./ Material ID: CC1R2 - 04	Date: 9/10/2018 to 9/11/2018
Structure/Material Location: Copco No. 1 Residence 2/ Flooring in kitchen, mud room, and bathroom (underneath HSA 3)	
*Description (by layer): 1: Gray vinyl floor sheeting with gray pattern and yellow mastic (M) 2: White firm material (M) 3: White paper backing with mastic (M) 4: Tan mastic (M)
