**UNITED STATES OF AMERICA
BEFORE THE
FEDERAL ENERGY REGULATORY COMMISSION**

**Project Nos. 14803-001;
2082-063**

**EXHIBIT N (1 of 2)
Waste Disposal and Hazardous Materials Management Plan**

**Waste Disposal and
Hazardous Materials
Management Plan**

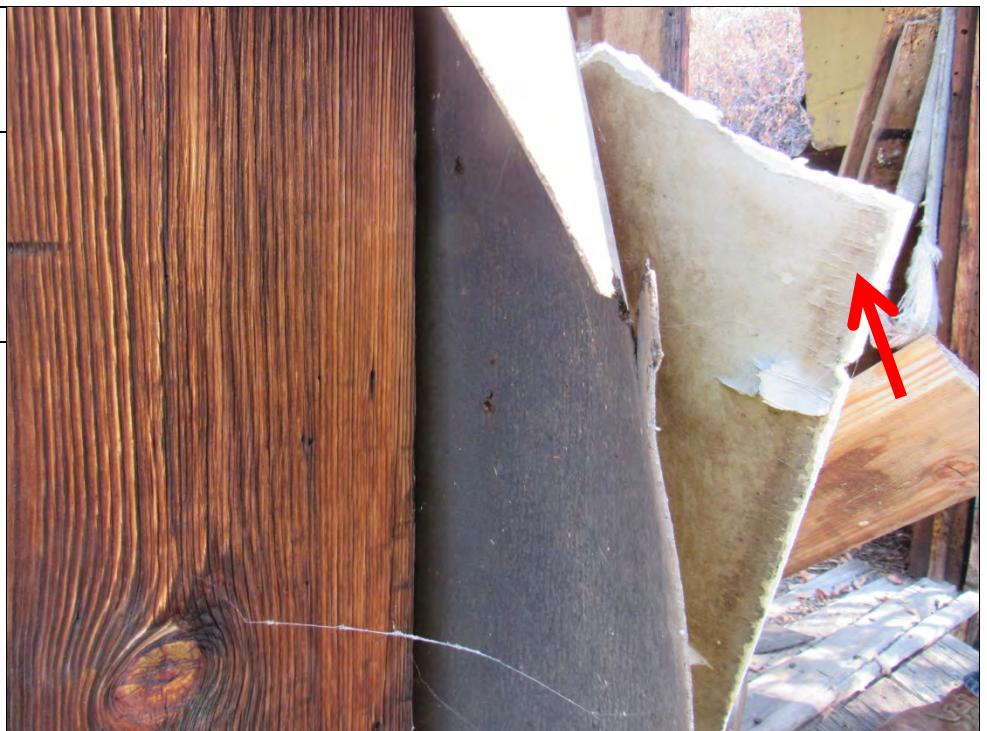
Photo No./ Material ID: CC1RS - 01	Date: 9/10/2018 to 9/11/2018
Structure/Material Location: Copco No. 1 Residence Shed/ Walls of residence shed, adjacent to lot area of Residence 1	
*Description (by layer): 1: White gypsum wallboard (M)

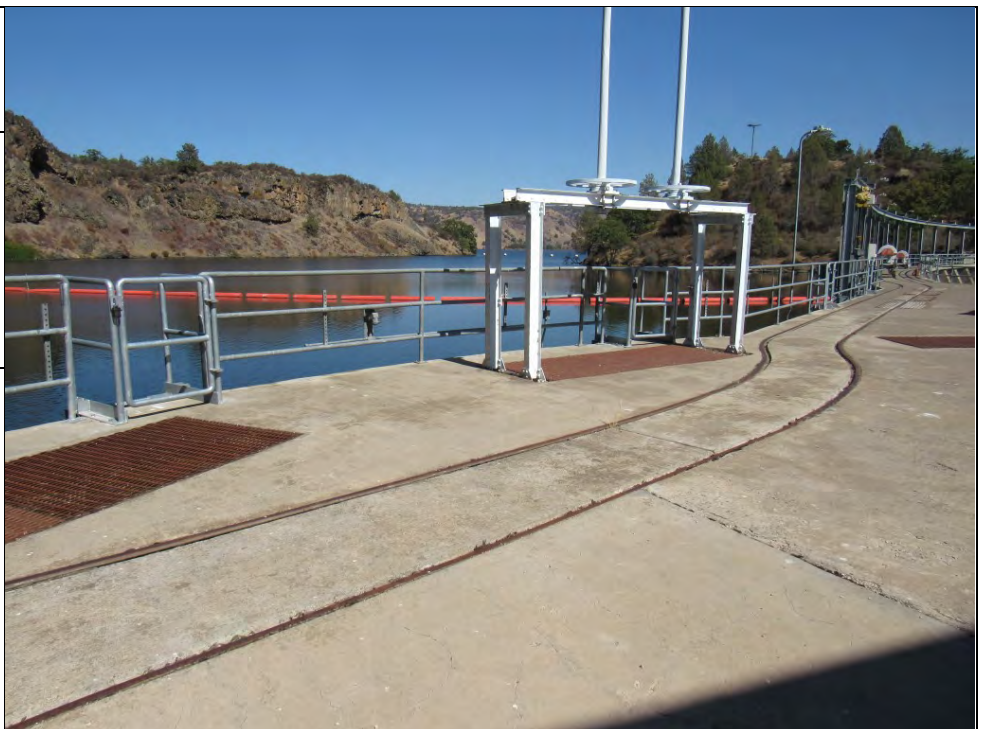
Photo No./ Material ID: CC1RAIS - 01	Date: 9/10/2018 to 9/11/2018
Structure/Material Location: Copco No. 1 Dam, Right Abutment Intake Structure/ Walkway above right abutment intake structure	
*Description (by layer): 1: Poured concrete (M)

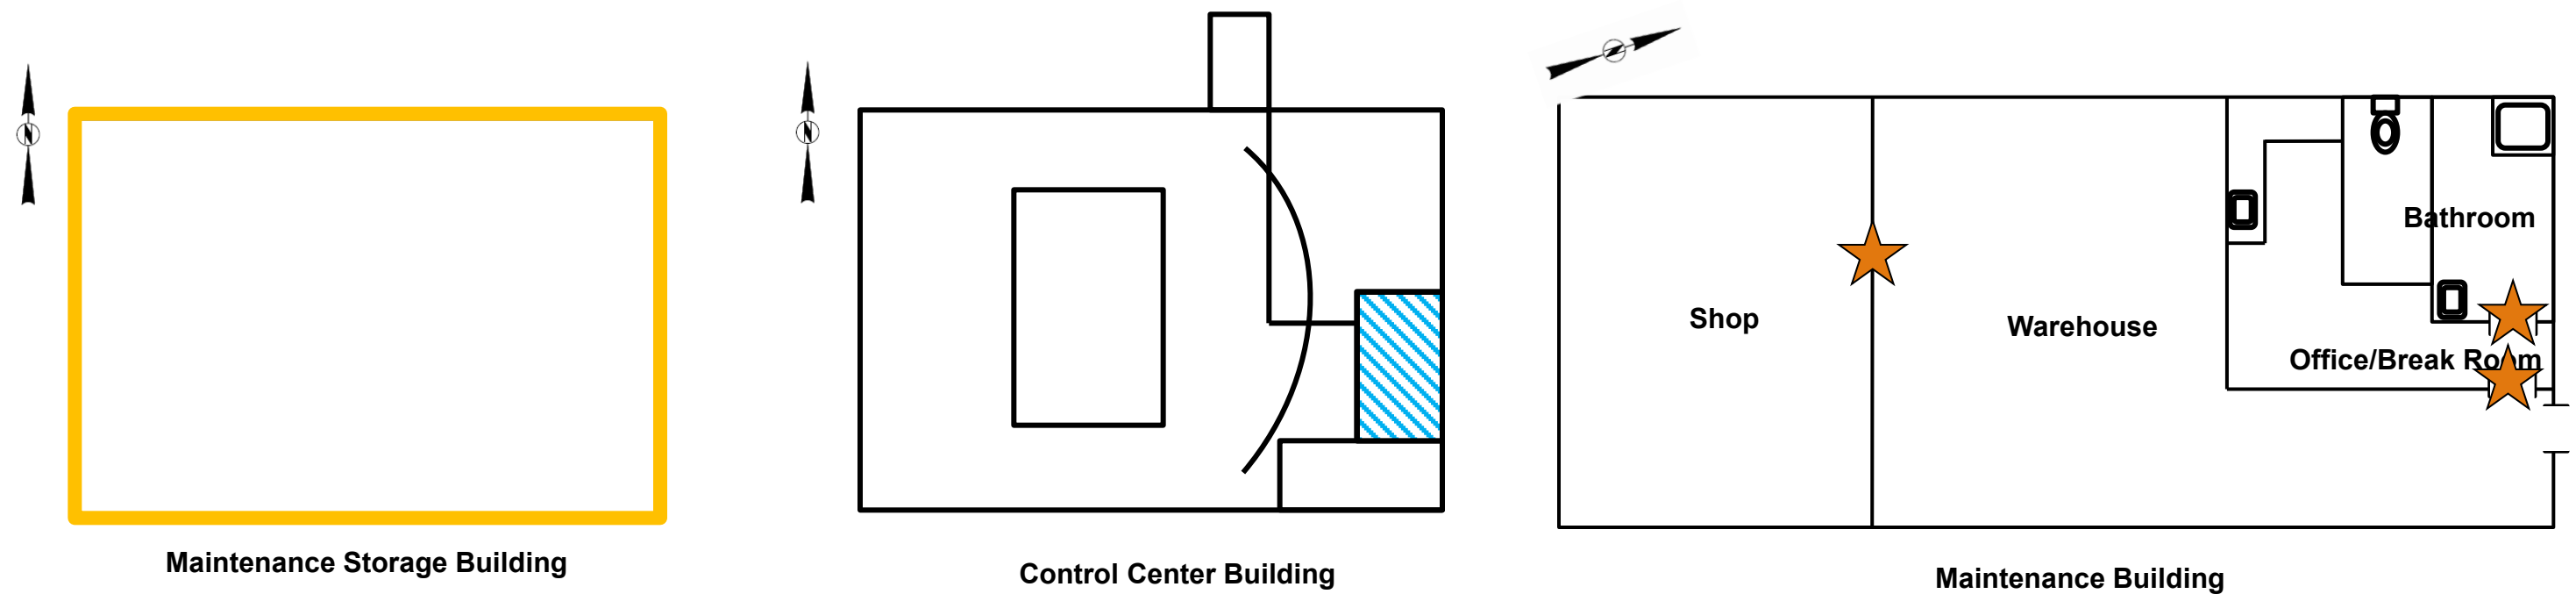
CC2MB-08: Assumed asbestos-containing metal-clad fire door insulation (M)

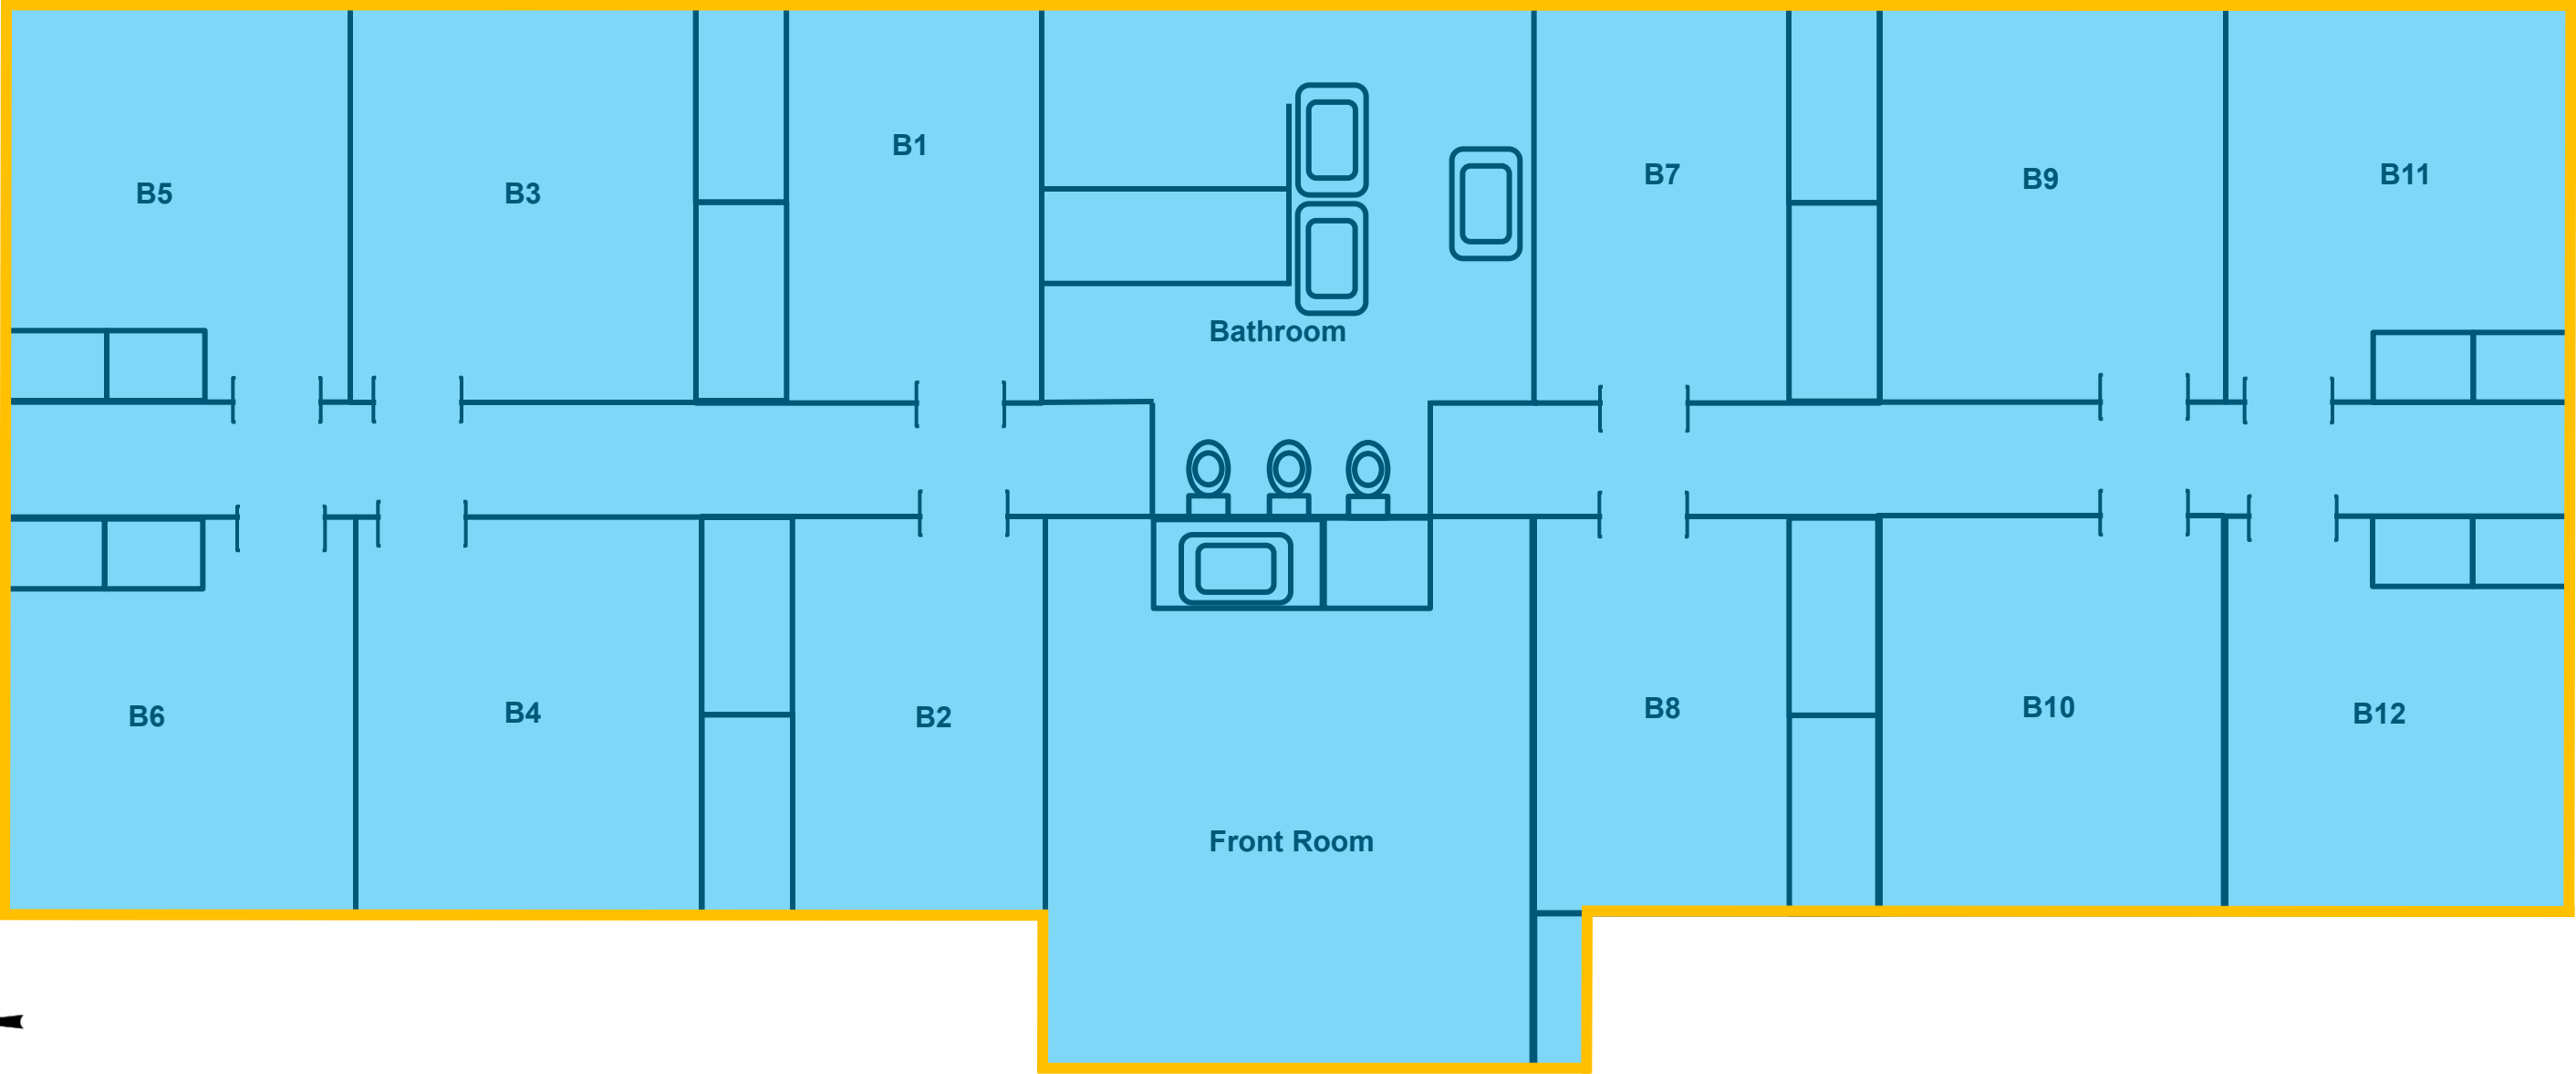
Figure 17
Approximate ACM Locations
Former Bunkhouse

Not shown: CC2FBH-13: Asbestos-containing brown/gray cementitious material debris scattered throughout exterior in landscaping cover rock (M)

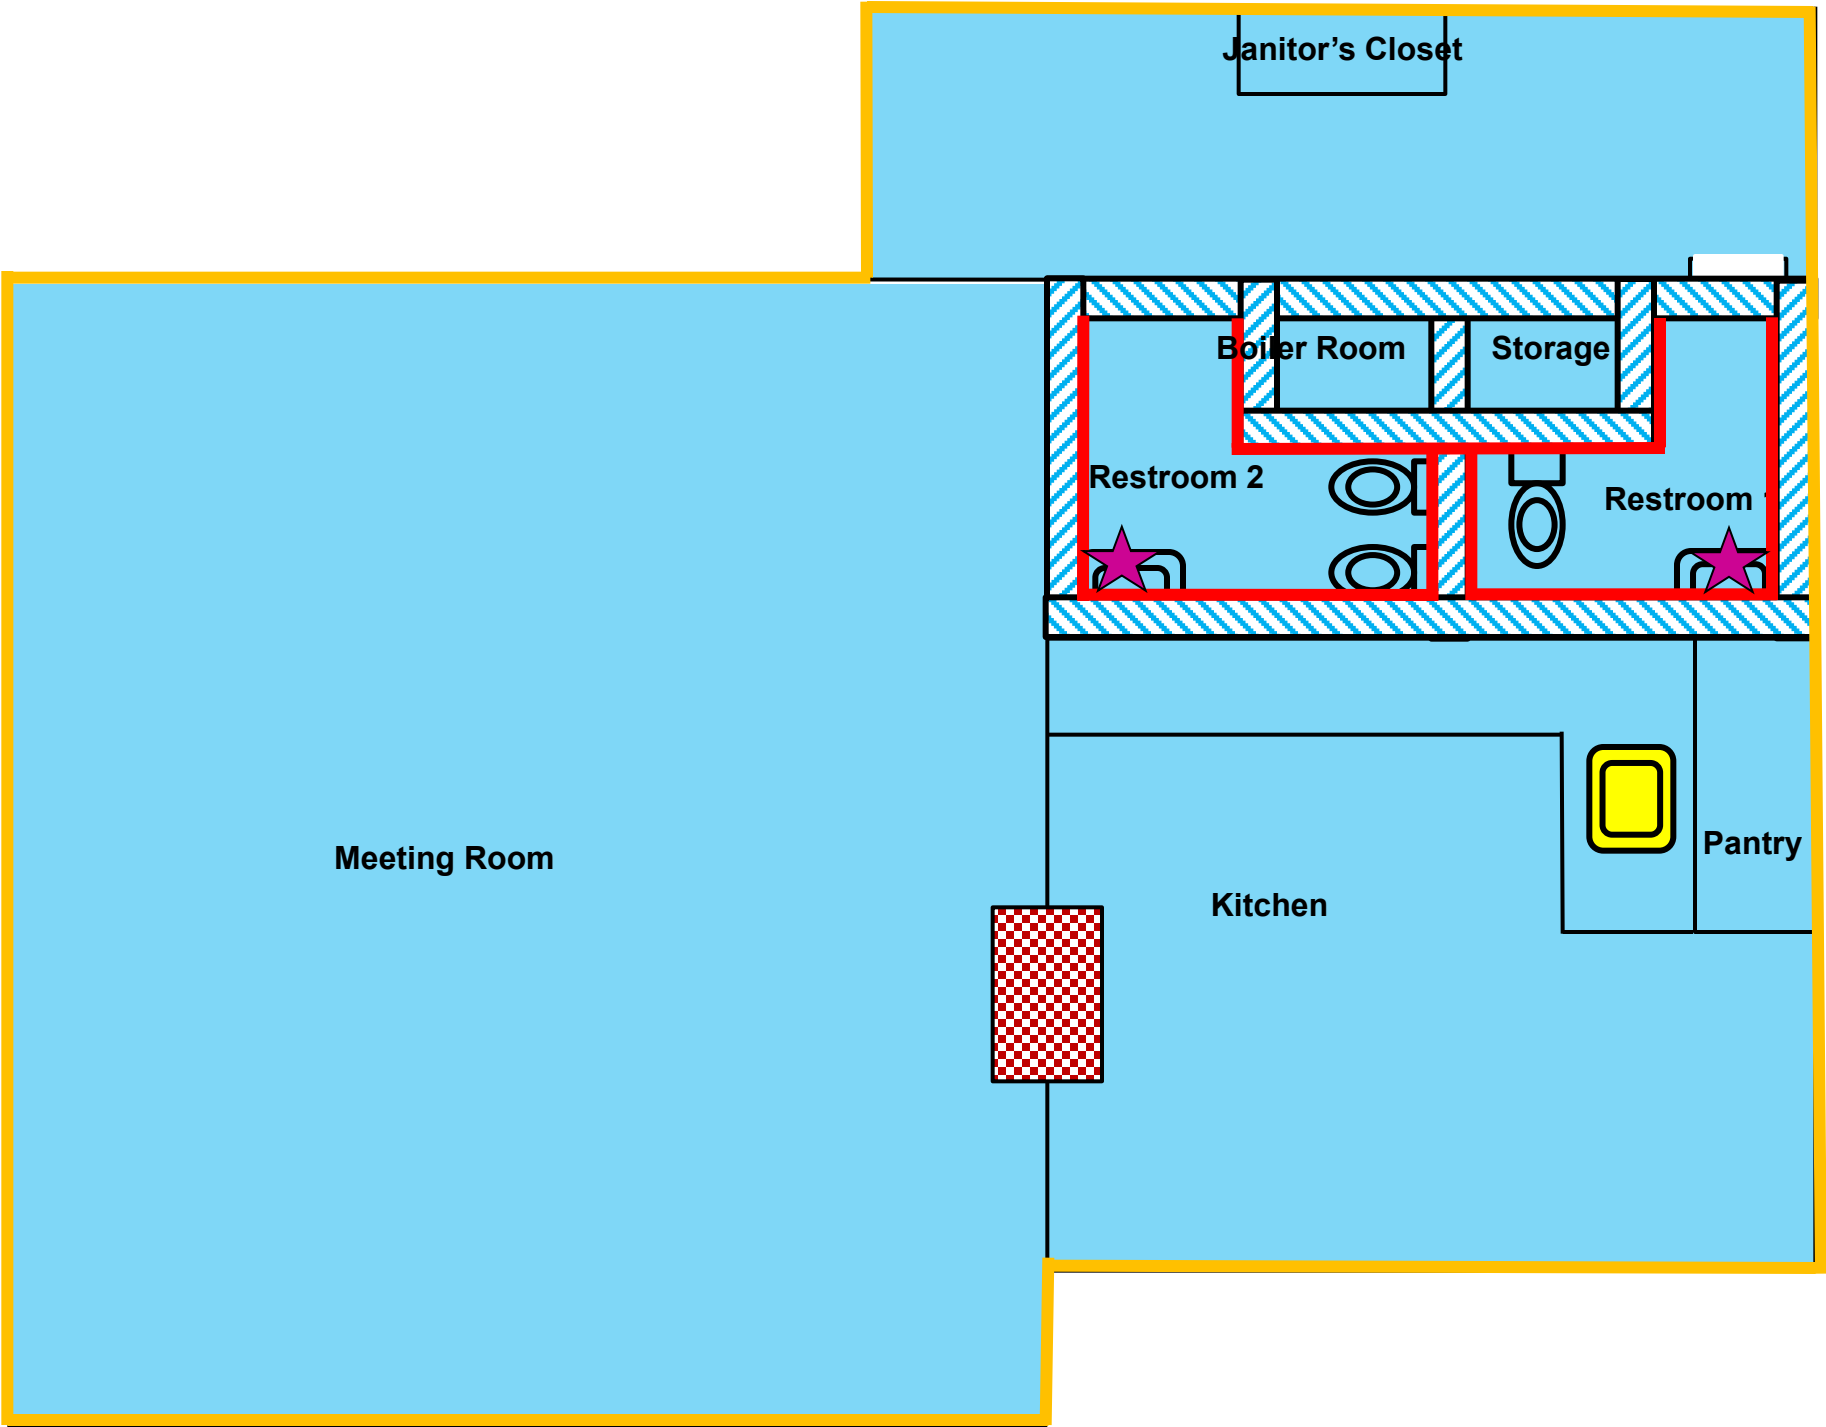
Figure 18
Approximate ACM Locations
Former School

CC2FS-12: Assumed asbestos-containing mirror mastic (M)
- CC2FS-12: Assumed asbestos-containing mirror mastic (M)
- CC2FS-12: Assumed asbestos-containing mirror mastic (M)

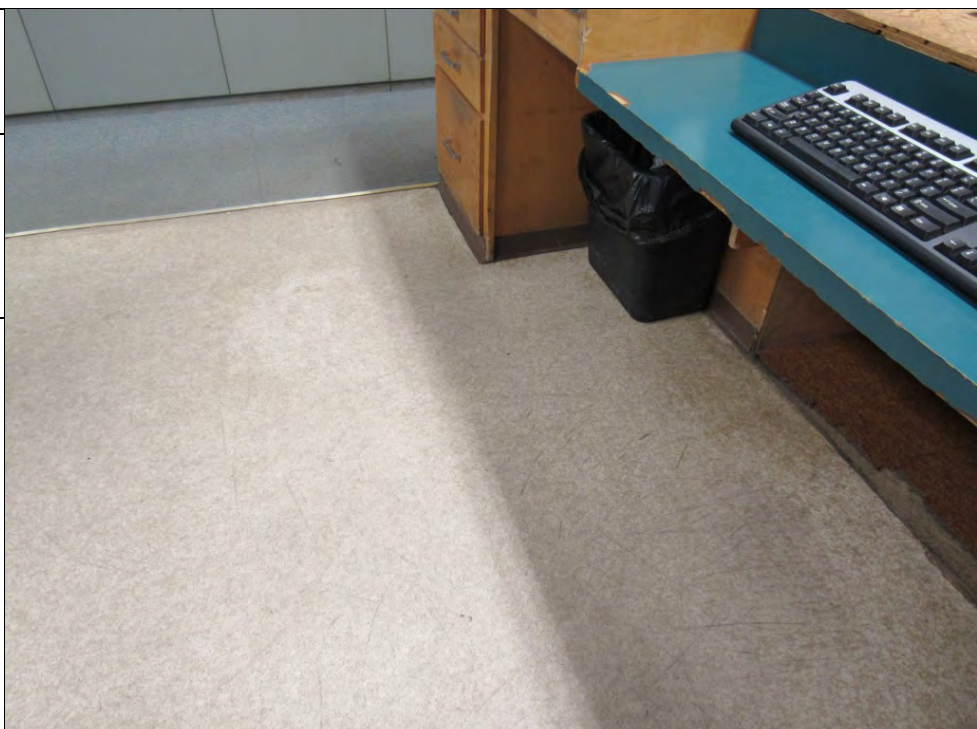
CC2CCB - 01	9/11/2018 to 9/13/2018	
Structure/Material Location:		
Copco No. 2 Control Center Building/ Throughout roof		
*Description (by layer):		
1: Off-white vinyl floor sheeting with tan terrazzo pattern (M)		
2: Gray paper backing with yellow mastic (M)

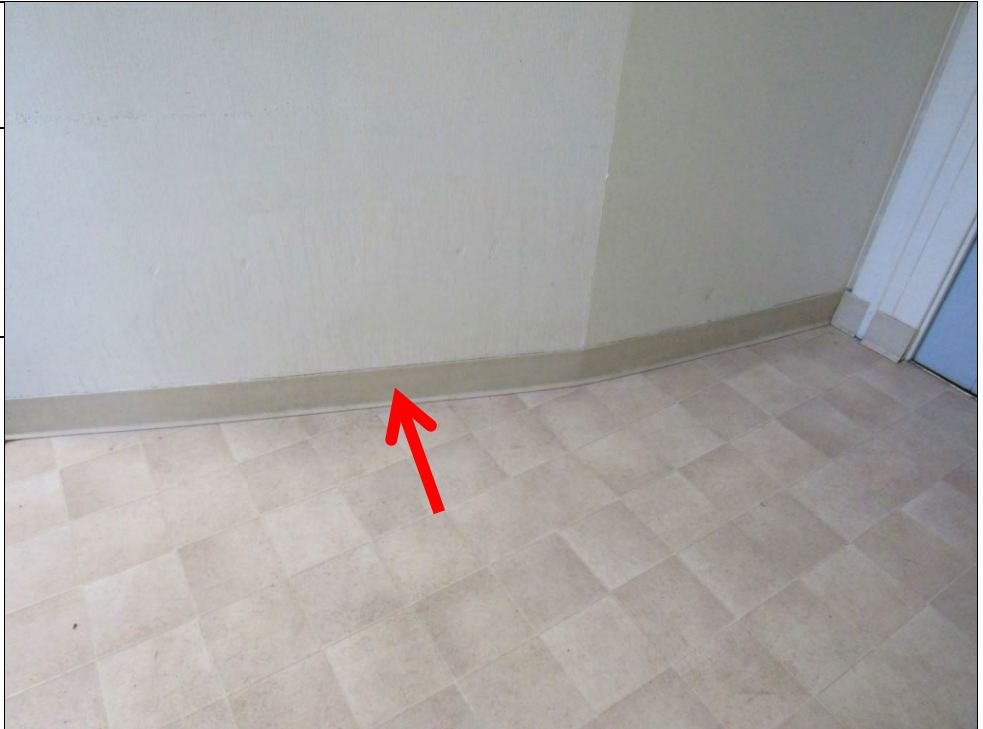
Photo No./ Material ID: CC2CCB - 04	Date: 9/11/2018 to 9/13/2018
Structure/Material Location: Copco No. 2 Control Center Building/ Walls in bathroom and storage closet	
*Description (by layer): 1: 4" white vinyl cove base (M) 2: Off-white mastic (M)

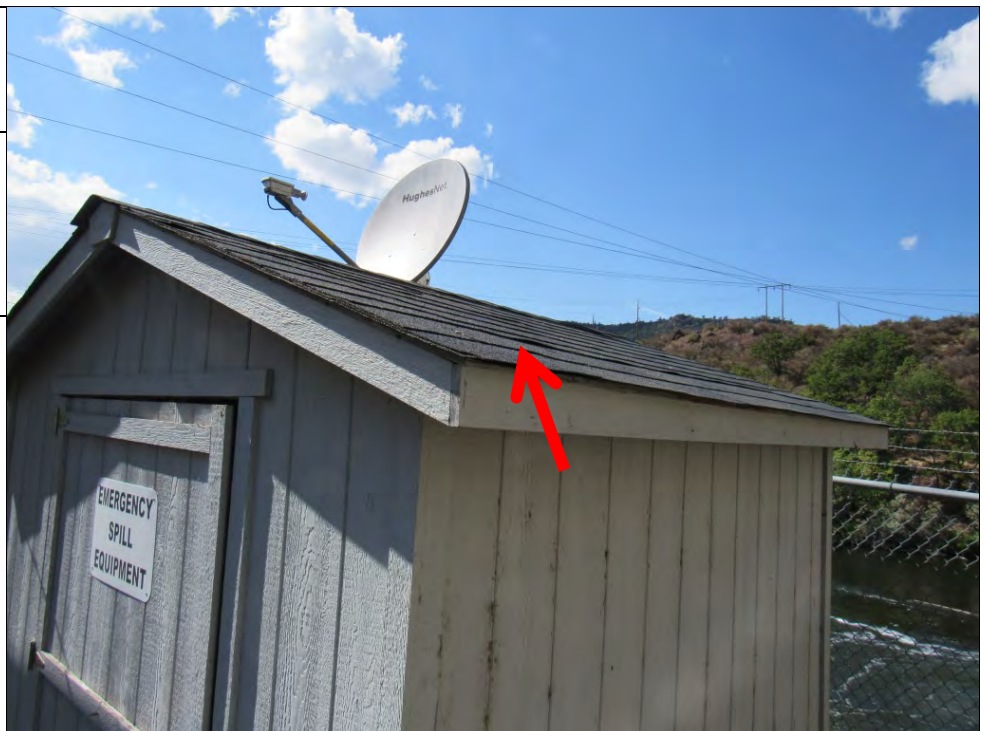
CC2ES - 01

- 1: Black asphaltic roofing
shingles with granules (M)
- 2: Black asphaltic mastic (M)

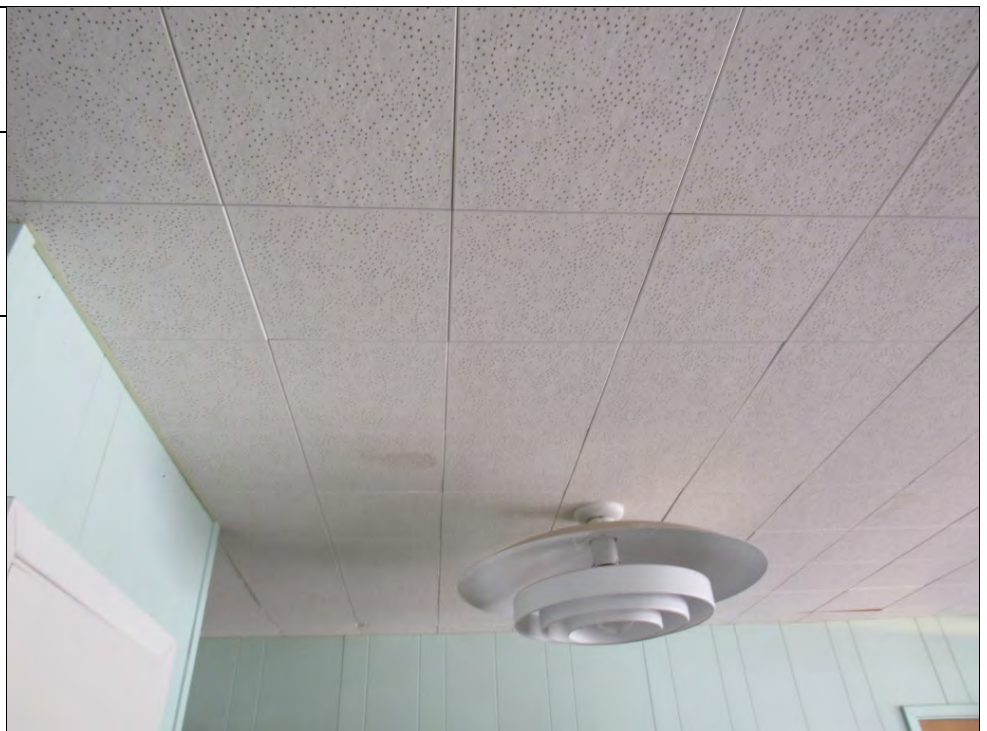
Photo No./ Material ID: CC2FBH - 01	Date: 9/11/2018 to 9/13/2018
Structure/Material Location: Copco No. 2 Former Bunkhouse/ Ceiling throughout Former Bunkhouse	
*Description (by layer): 1: 12"x12" white glued-on ceiling tile with pinholes (associated with HSA 8 - brown glue dots) (M)

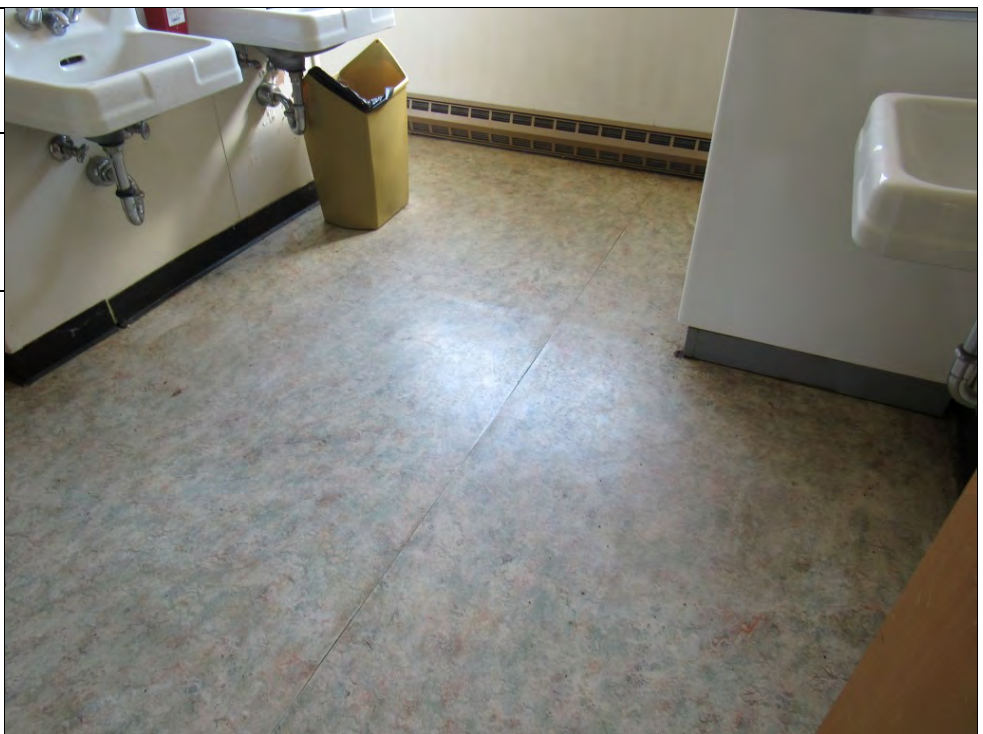
CC2FBH - 03

- 1: Light blue linoleum with pink
and gray marble pattern (M)**
**2: Tan woven canvas backing
with white mastic (M)**

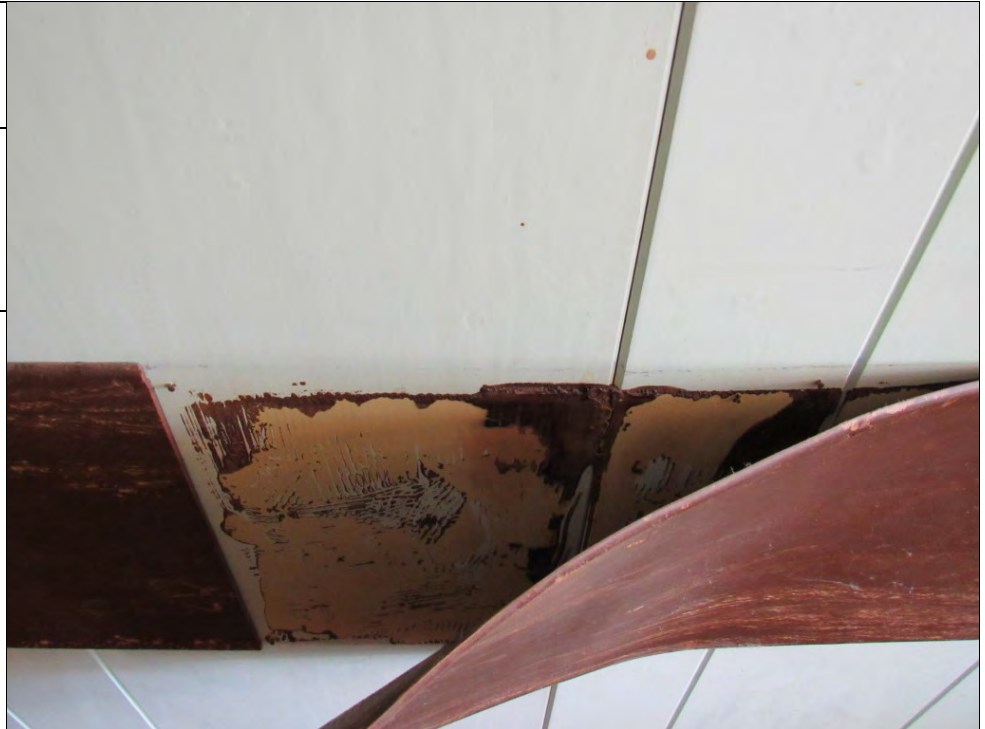
Photo No./ Material ID: CC2FBH - 04	Date: 9/11/2018 to 9/13/2018
Structure/Material Location: Copco No. 2 Former Bunkhouse/ Walls in front room	
*Description (by layer): 1: Dark brown rubber wall strips (M) 2: Brown brittle mastic (M)

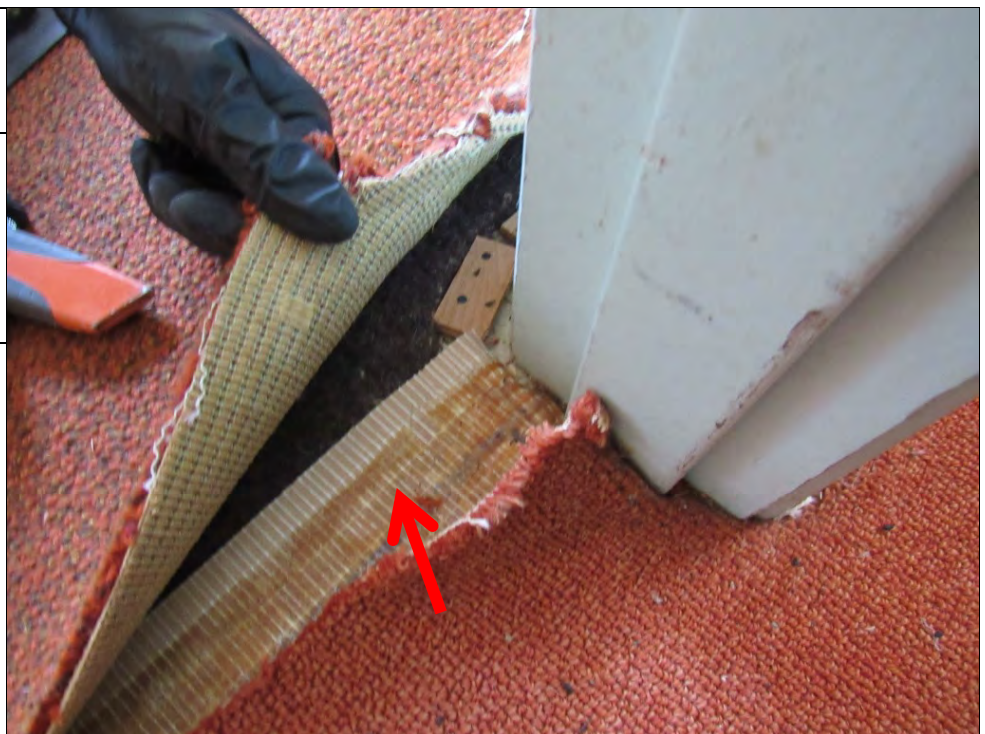
Photo No./ Material ID: CC2FBH - 05	Date: 9/11/2018 to 9/13/2018
Structure/Material Location: Copco No. 2 Former Bunkhouse/ Carpet seam at tack down wood strips at base of doors throughout	
*Description (by layer): 1: Orange carpet mastic (M)

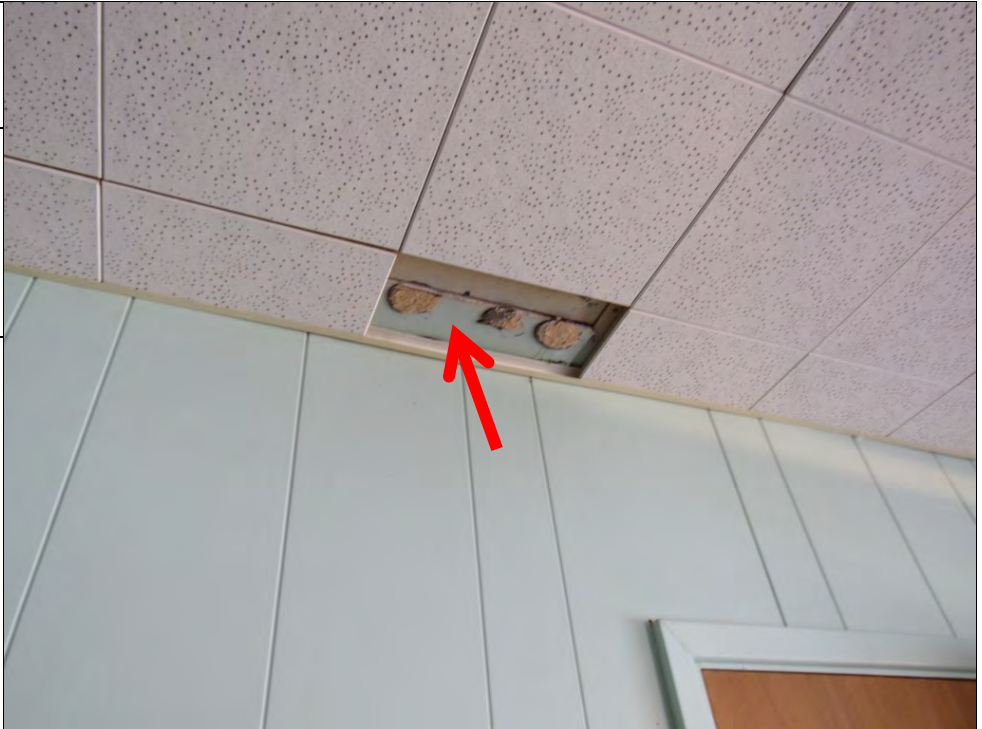
Photo No./ Material ID: CC2FBH - 06	Date: 9/11/2018 to 9/13/2018
Structure/Material Location: Copco No. 2 Former Bunkhouse/ Ceilings throughout, above 12"x12" white glued-on ceiling tiles	
*Description (by layer): 1: White gypsum wallboard with paper (M)

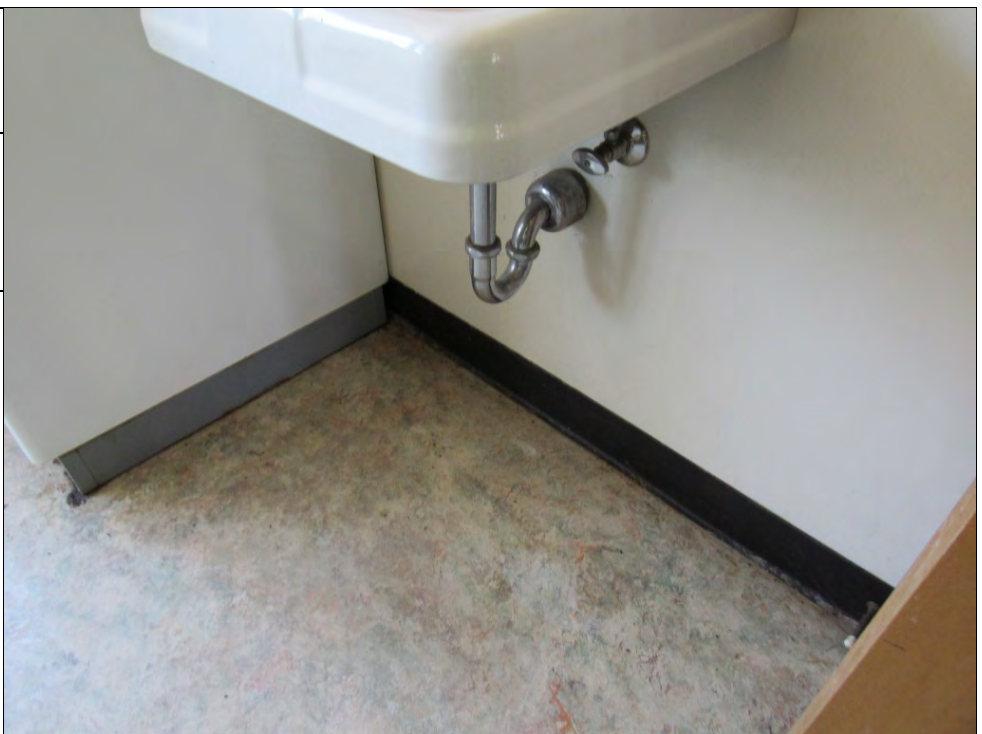
Photo No./ Material ID: CC2FBH - 07	Date: 9/11/2018 to 9/13/2018
Structure/Material Location: Copco No. 2 Former Bunkhouse/ Walls in bathroom	
*Description (by layer): 1: 4" black rubber cove base (M) 2: Brown brittle mastic (M)

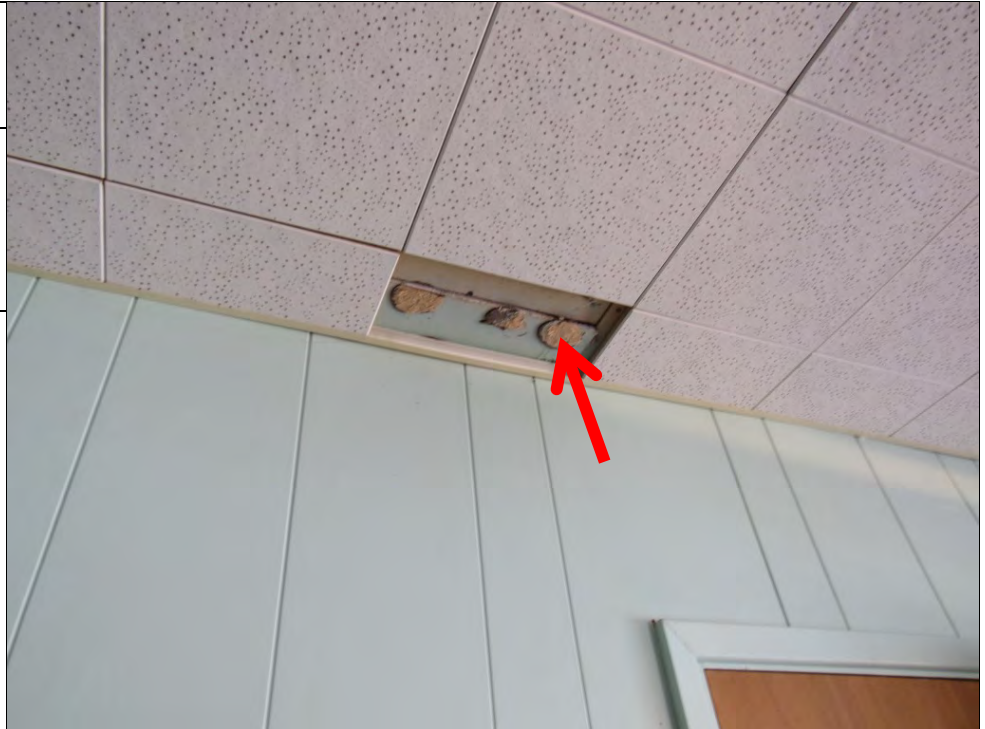
Photo No./ Material ID: CC2FBH - 08	Date: 9/11/2018 to 9/13/2018
Structure/Material Location: Copco No. 2 Former Bunkhouse/ Associated with HSA 1, throughout all rooms	
*Description (by layer): 1: Dark brown glue dots (M)

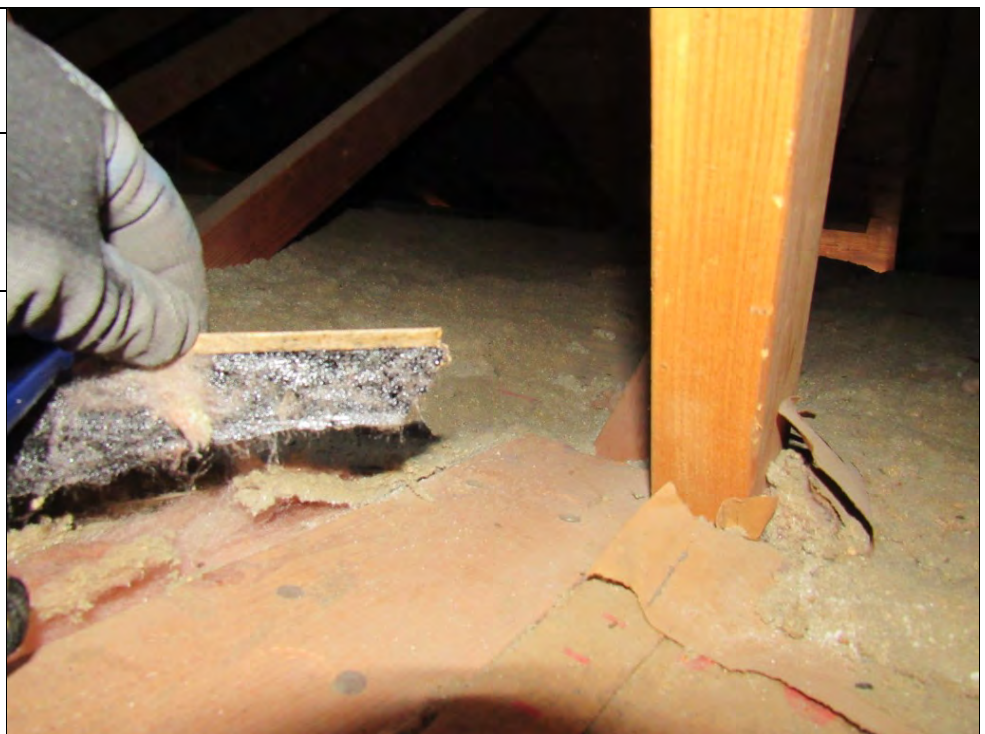
Photo No./ Material ID: CC2FBH - 09	Date: 9/11/2018 to 9/13/2018
Structure/Material Location: Copco No. 2 Former Bunkhouse/ Insulation in attic	
*Description (by layer): 1: Black asphaltic material on paper (M) 2: Pink fibrous material (M)

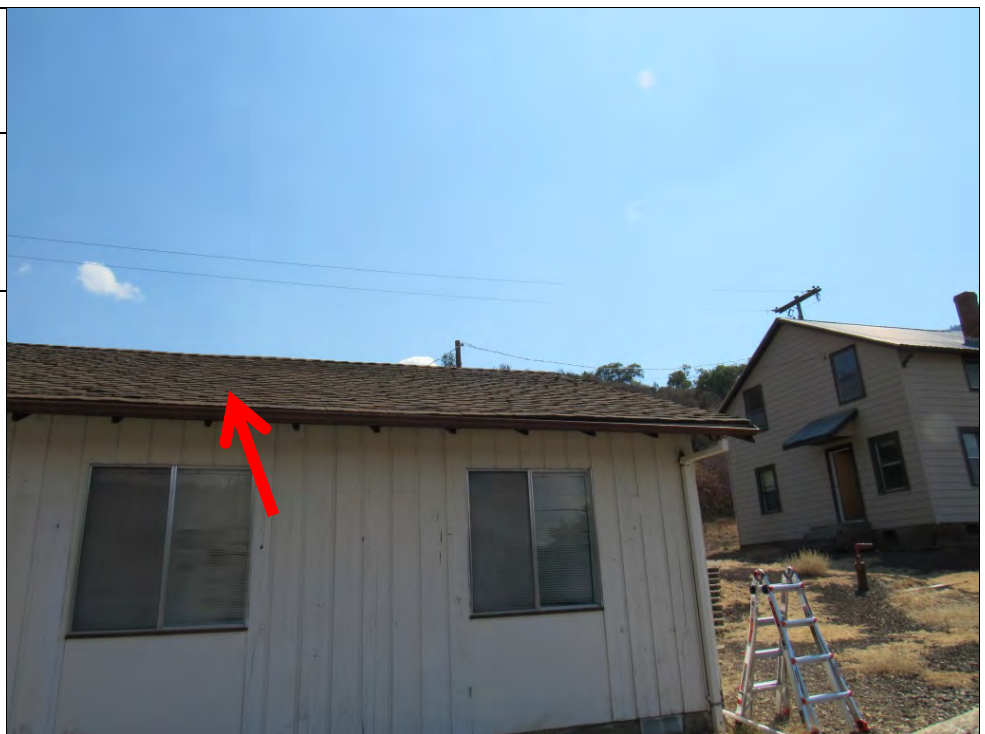
Photo No./ Material ID: CC2FBH - 11	Date: 9/11/2018 to 9/13/2018
Structure/Material Location: Copco No. 2 Former Bunkhouse/ Throughout roof	
*Description (by layer): 1: Asphaltic roof shingles with granules (M) 2: Black asphaltic material (M) 3: Asphaltic roof shingles with granules (M) 4: Black asphaltic material (M)

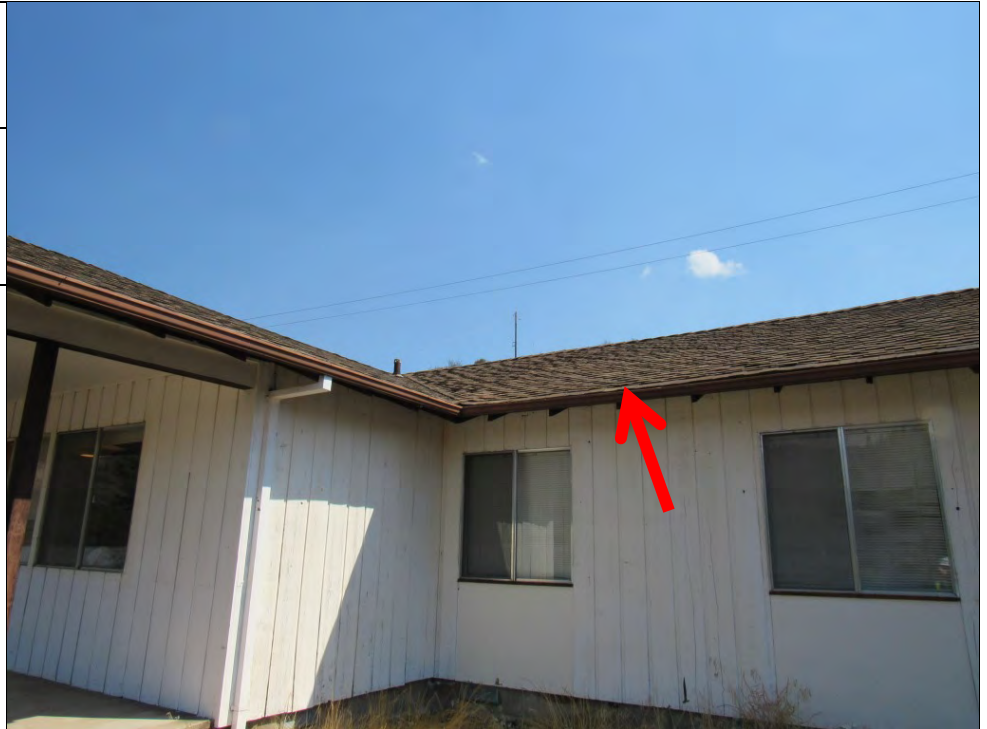
Photo No./ Material ID: CC2FBH - 12	Date: 9/11/2018 to 9/13/2018
Structure/Material Location: Copco No. 2 Former Bunkhouse/ Throughout roof	
*Description (by layer): Assumed asbestos-containing roofing paper (M)

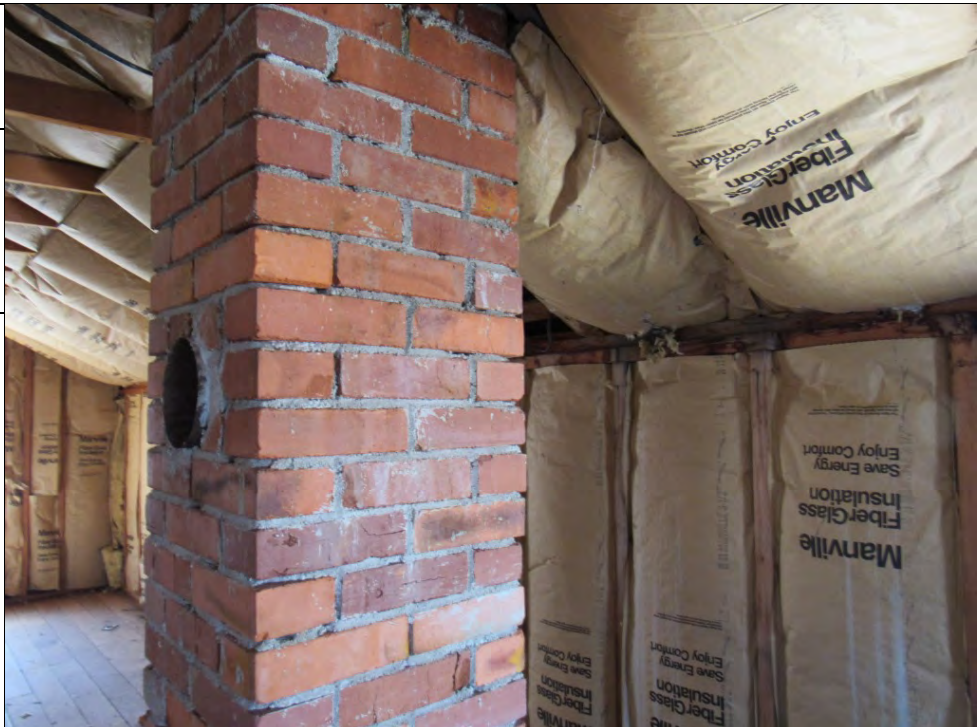
CC2FCH - 07	9/11/2018 to 9/13/2018	
Structure/Material Location:		
Copco No. 2 Former Cookhouse/ Chimney in attic space		
*Description (by layer):		
1: Red chimney brick (M)

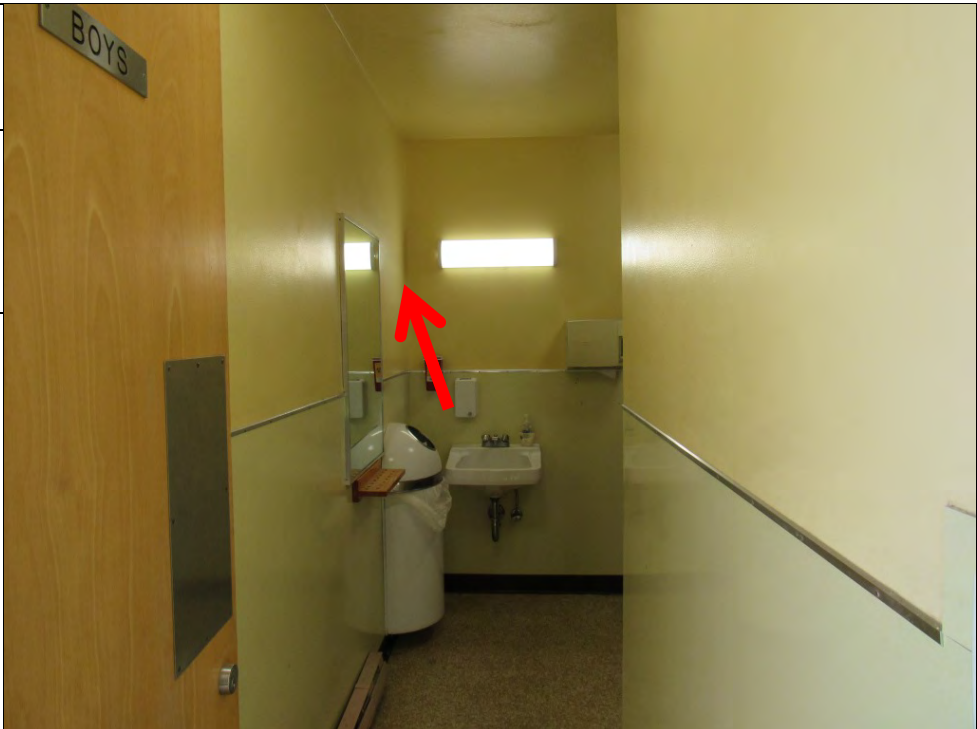
Structure/Material Location: Copco No. 2 Former School/ Walls throughout all rooms		
*Description (by layer): 1: Off-white joint compound (M) 2: Off-white joint compound (M) 3: Beige gypsum wallboard (M) 4: Off-white joint compound (M)

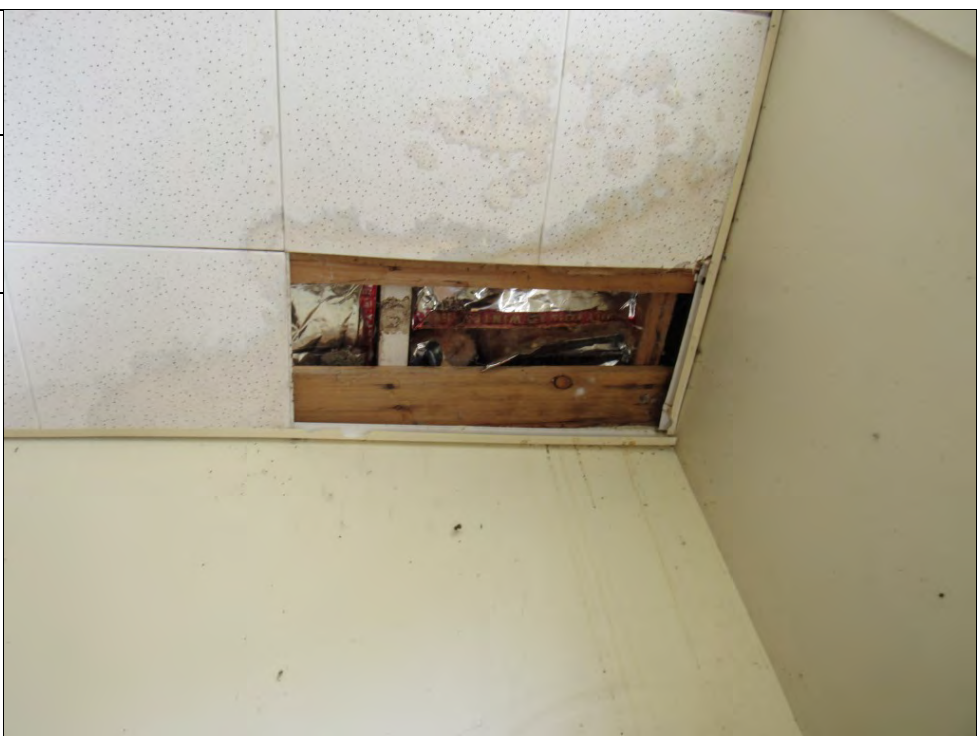
Structure/Material Location: Copco No. 2 Former School/ Chimney in attic space		
*Description (by layer): 1: Fiberglass batt insulation with foil back (TSI)

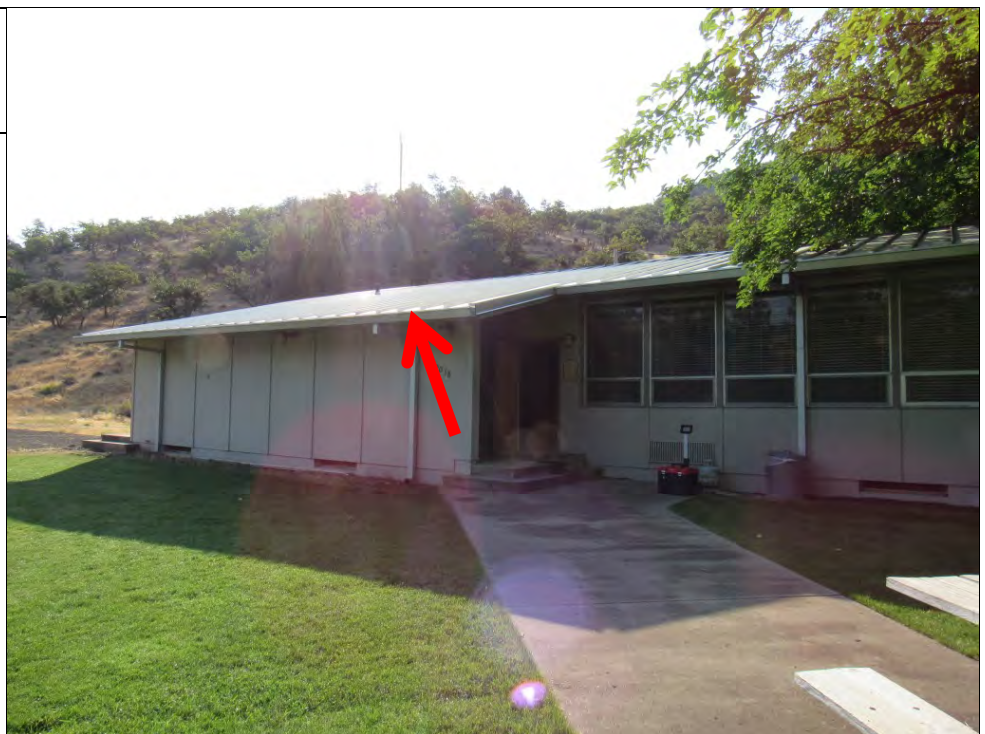
CC2FS - 09

**Assumed asbestos-containing
roofing paper (M)**

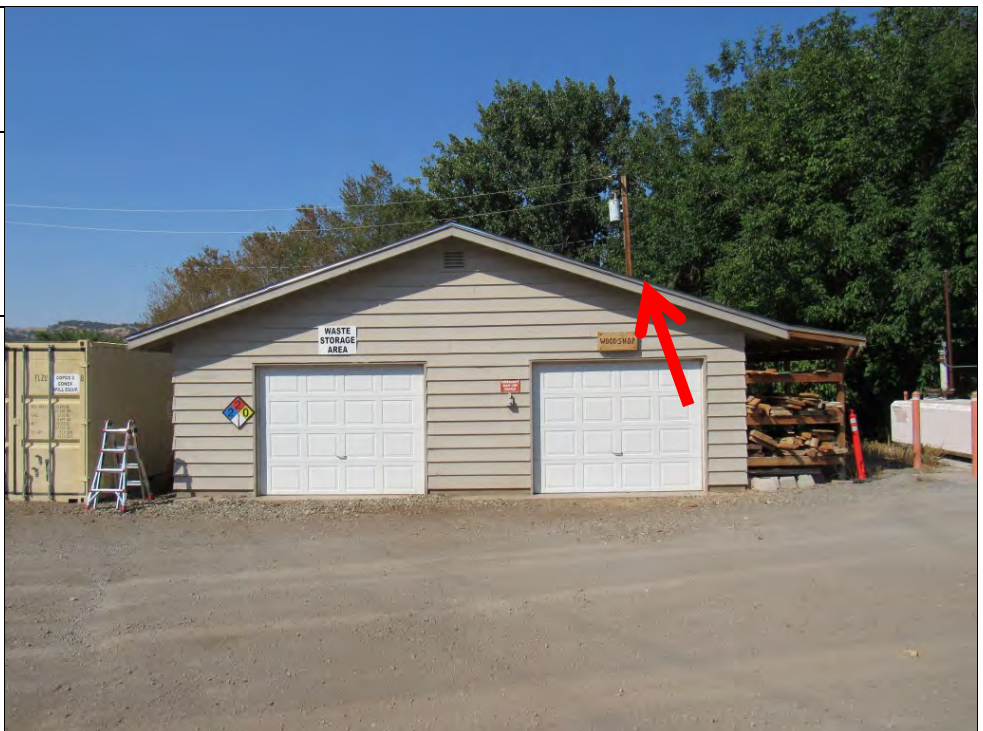
Copco No. 2 Hazardous Waste
Storage/
Throughout roof

- 1: Black asphaltic roofing
shingles with granules (M)
- 2: Black asphaltic mastic (M)
- 3: Black asphaltic roofing
shingles with granules (M)
