**UNITED STATES OF AMERICA
BEFORE THE
FEDERAL ENERGY REGULATORY COMMISSION**

**Project Nos. 14803-001;
2082-063**

**EXHIBIT N (1 of 2)
Waste Disposal and Hazardous Materials Management Plan**

**Waste Disposal and
Hazardous Materials
Management Plan**

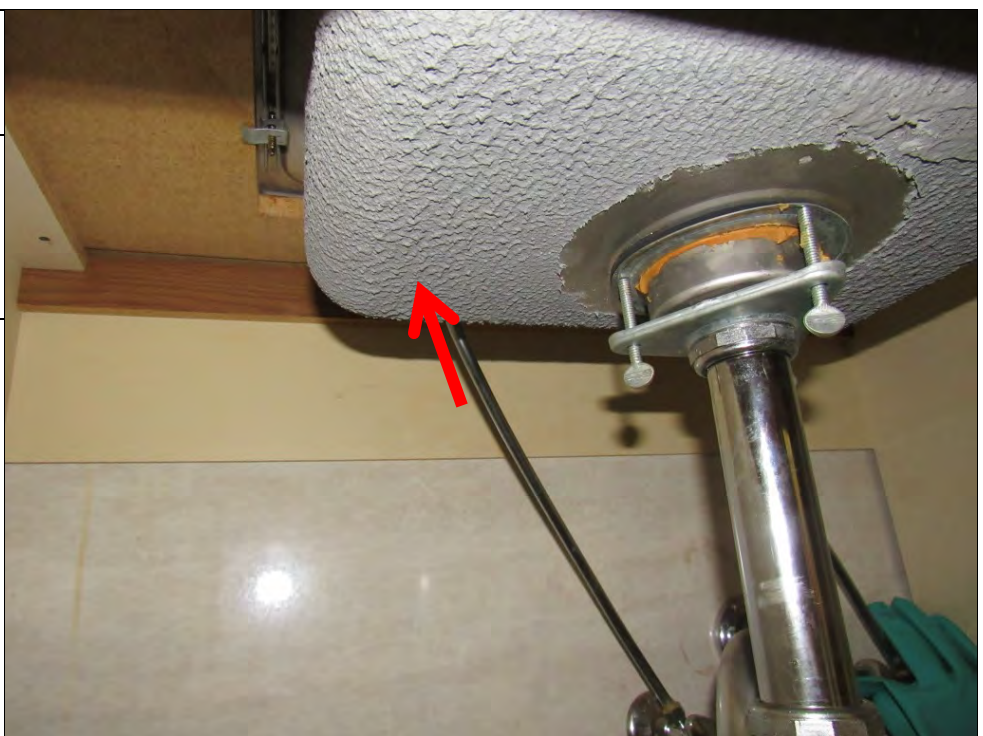
CC2MB - 05

Date:9/11/2018 to
9/13/2018**Structure/Material Location:**Copco No. 2 Maintenance/ Sink
in breakroom area***Description (by layer):**

1: Gray sink undercoating (M)

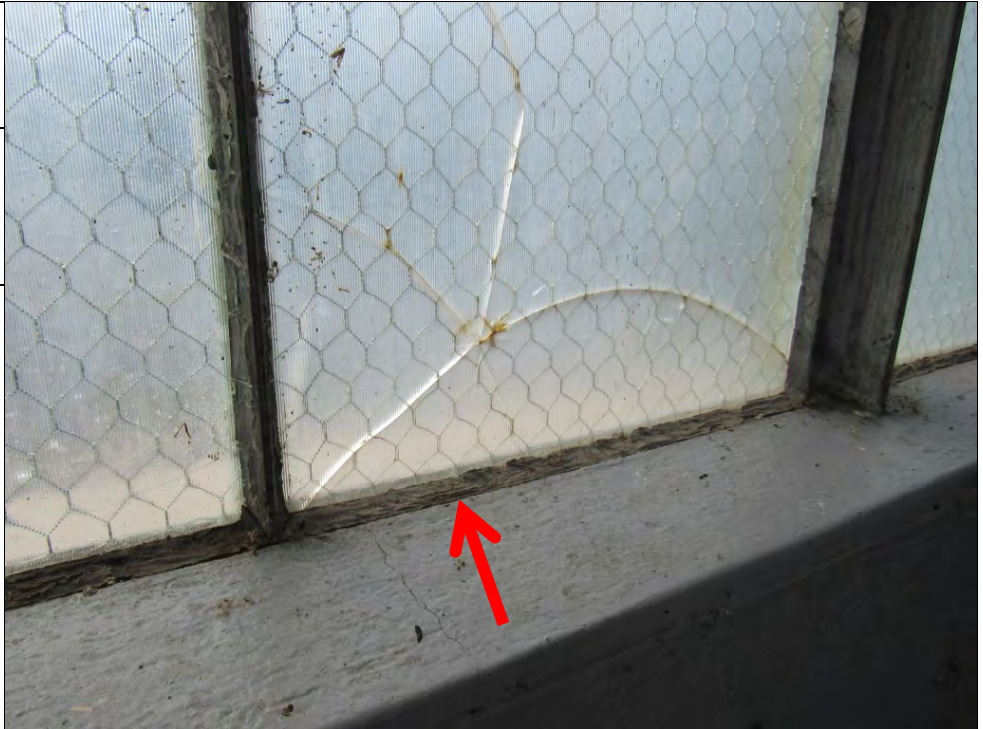
Date:9/11/2018 to
9/13/2018**Structure/Material Location:**Copco No. 2 Powerhouse/
Windows throughout main floor***Description (by layer):**

1: Gray brittle window putty (M)

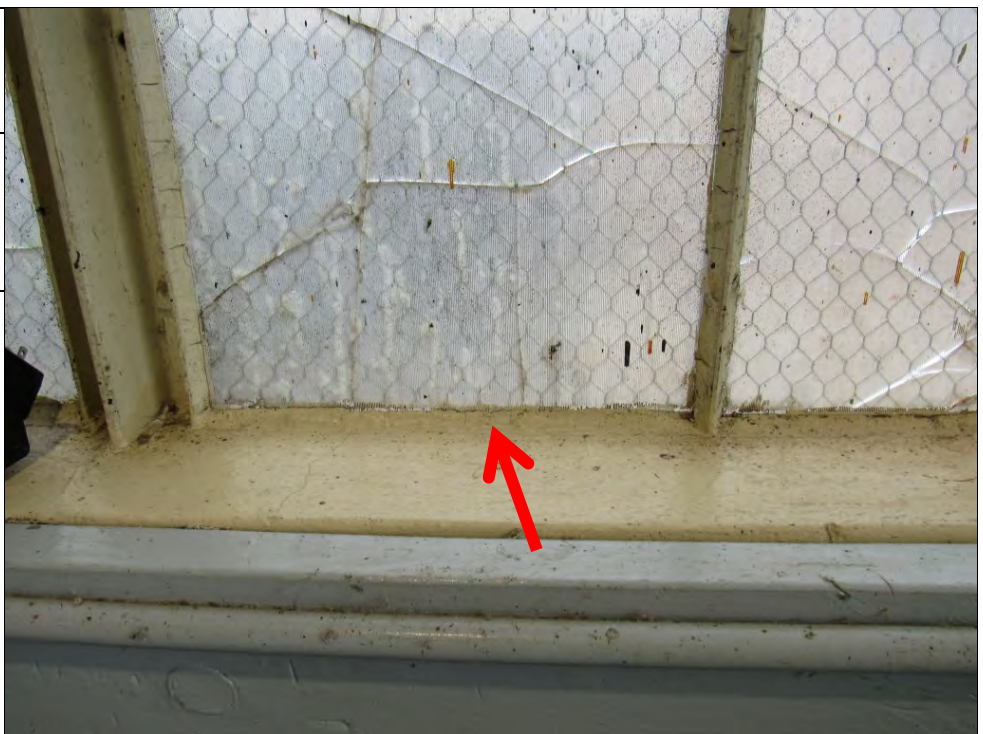
CC2PH - 03

Date:9/11/2018 to
9/13/2018**Structure/Material Location:**Copco No. 2 Powerhouse/
Windows throughout main floor***Description (by layer):**

1: Gray brittle window putty (M)

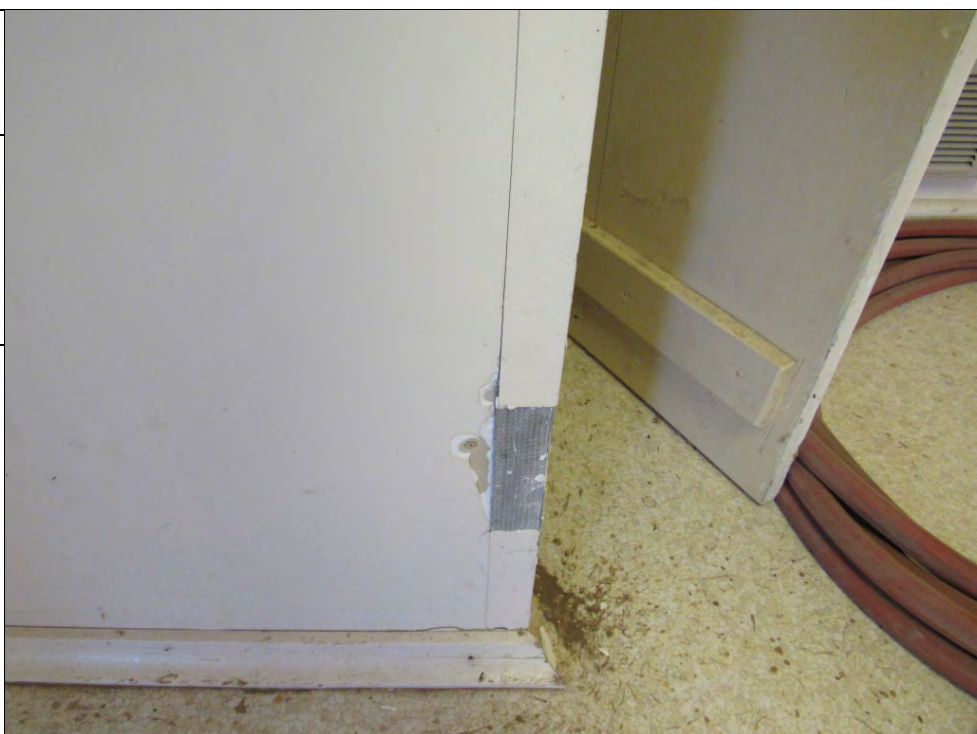
CC2R3 - 05	9/11/2018 to 9/13/2018	
Structure/Material Location: Copco No. 2 Residence 3/ Kitchen water heater closet and hallway closet		
*Description (by layer): 1: Off-white joint compound (M)

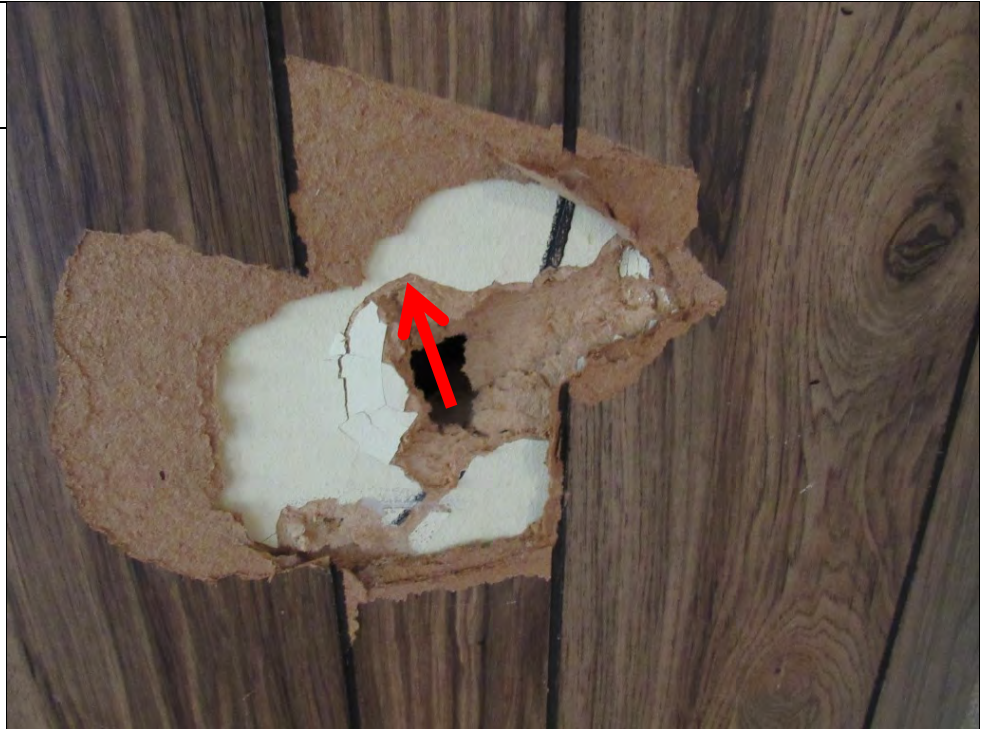
Photo No./ Material ID: CC2R3 - 06	Date: 9/11/2018 to 9/13/2018
Structure/Material Location: Copco No. 2 Residence 3/ Behind wood wall paneling in dining room and living room	
*Description (by layer): 1: Black mastic (M) 2: Brown plywood walls (M)

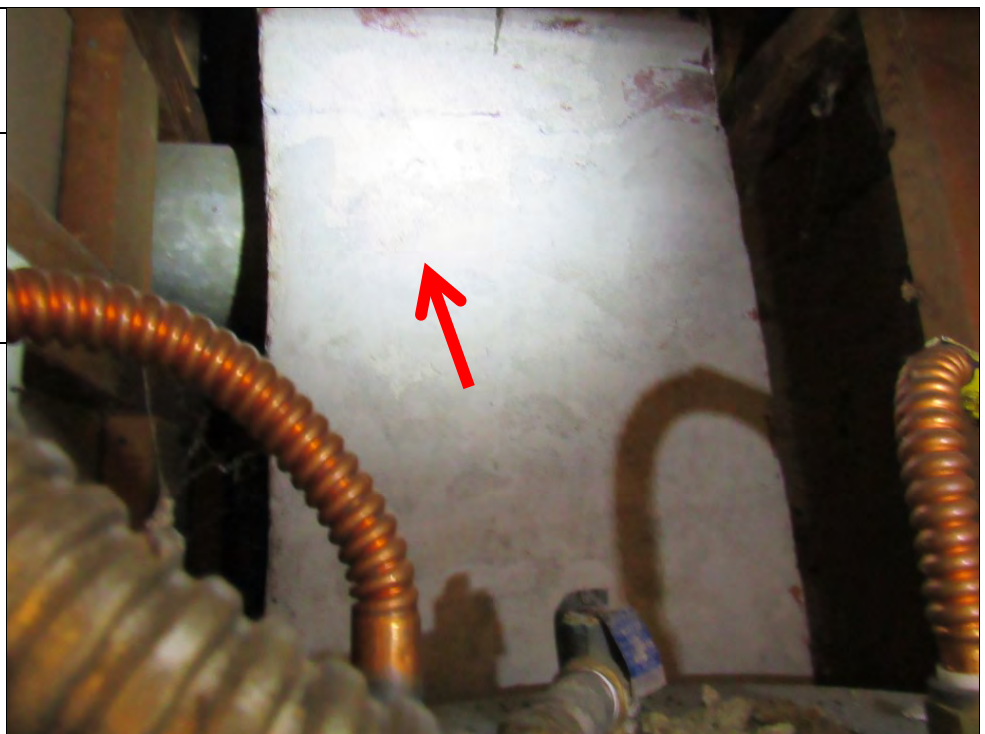
Photo No./ Material ID: CC2R3 - 07	Date: 9/11/2018 to 9/13/2018
Structure/Material Location: Copco No. 2 Residence 3/ Coating on chimney, very hard to access (could not reach actual brick and grout)	
*Description (by layer): 1: Troweled-on plaster coat on chimney behind water heater in kitchen (S)

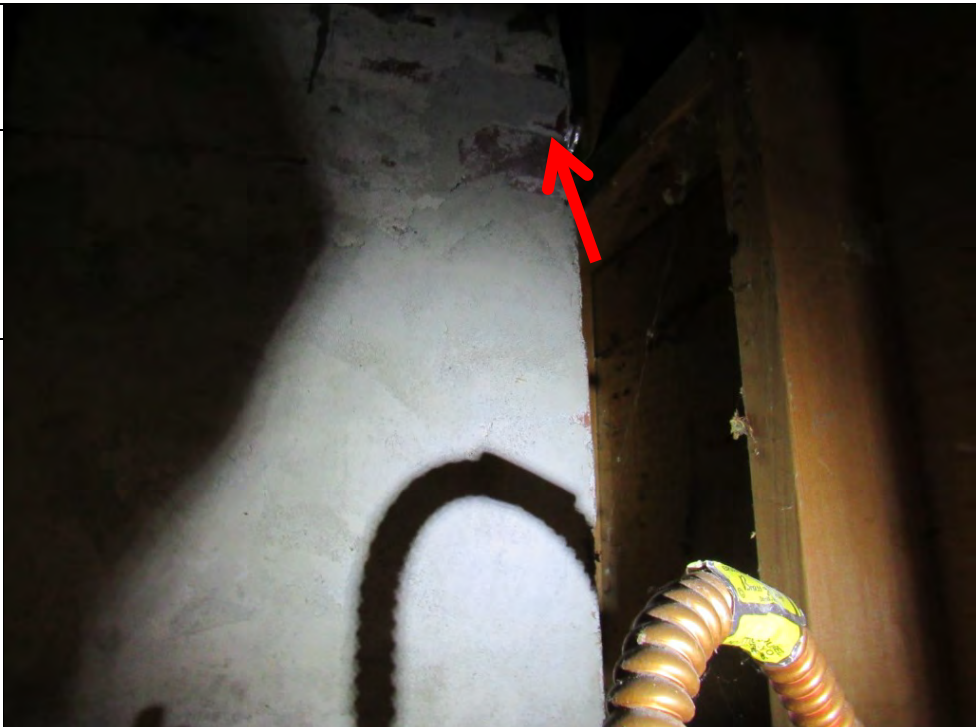
CC2R3 - 08	9/11/2018 to 9/13/2018	
Structure/Material Location: Copco No. 2 Residence 3/ Coating on chimney, very hard to access (could not reach actual brick and grout)		
*Description (by layer): 1: Assumed asbestos-containing gray chimney grout (M)

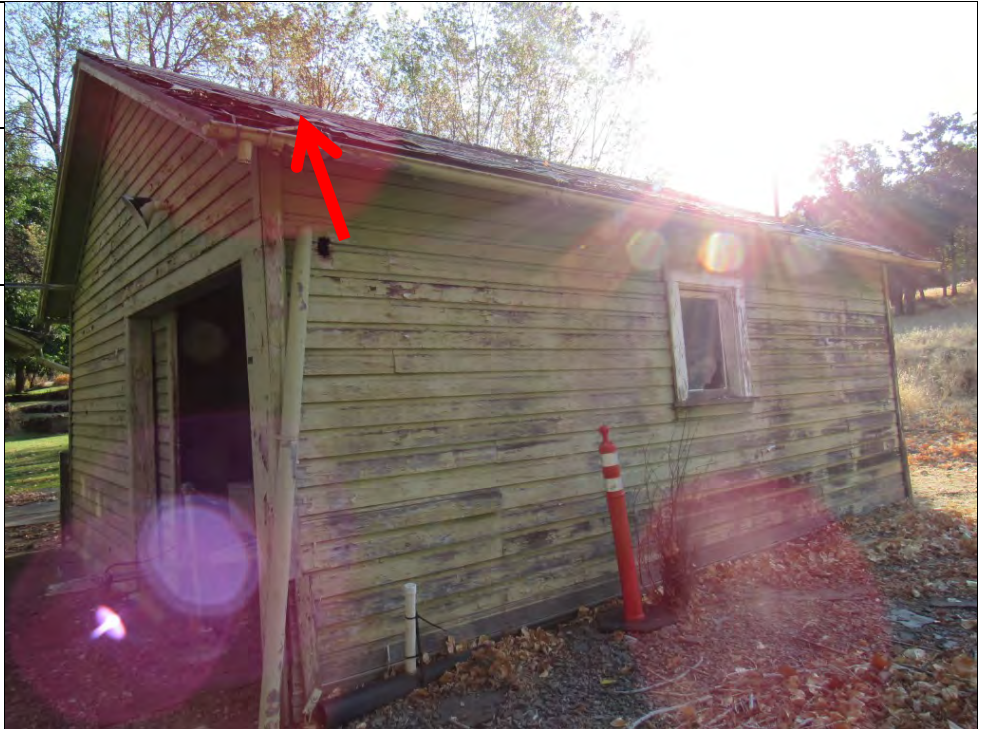
1: Black asphaltic roofing
shingles with granules (M)

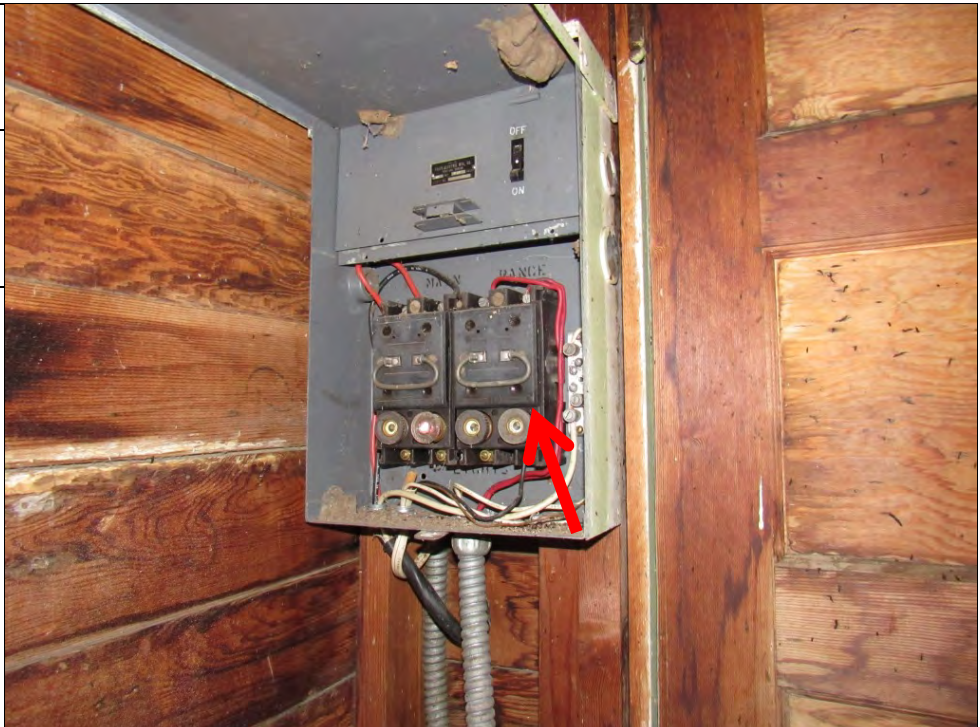
CC2R3 - 14	9/11/2018 to 9/13/2018	
Structure/Material Location: Copco No. 2 Residence 3/ Interior of shed		
*Description (by layer): Assumed asbestos-containing electrical panel backing in older electrical panels (M)

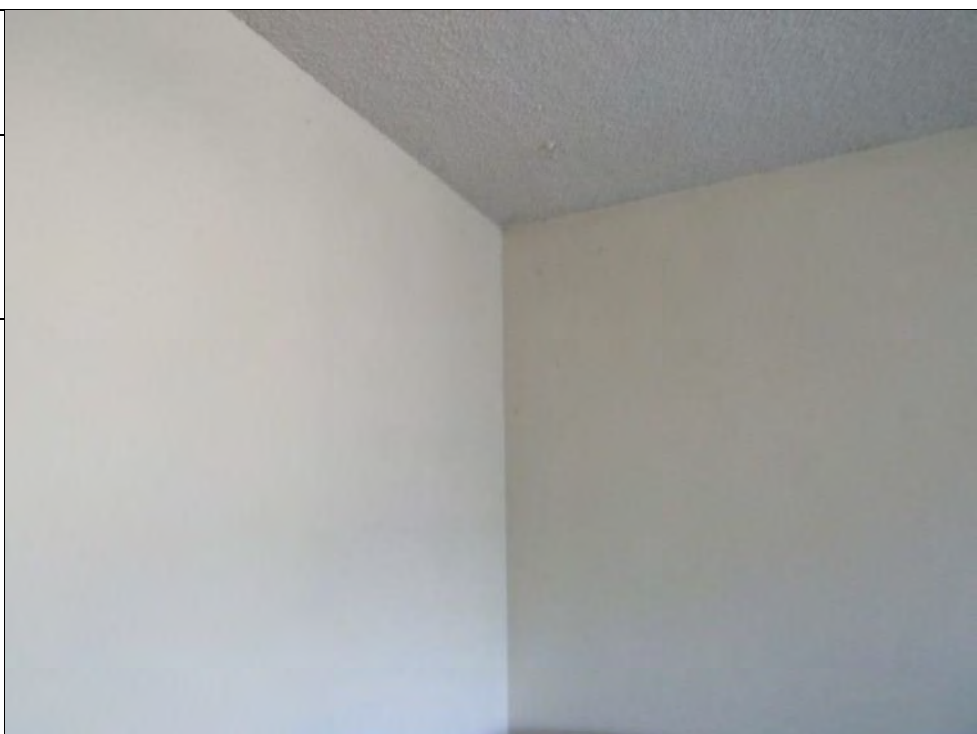
CC2R4 - 05	9/11/2018 to 9/13/2018	
Structure/Material Location: Copco No. 2 Residence 4/ Walls throughout all rooms		
*Description (by layer): 1: Off-white spray-applied wall texture (S)

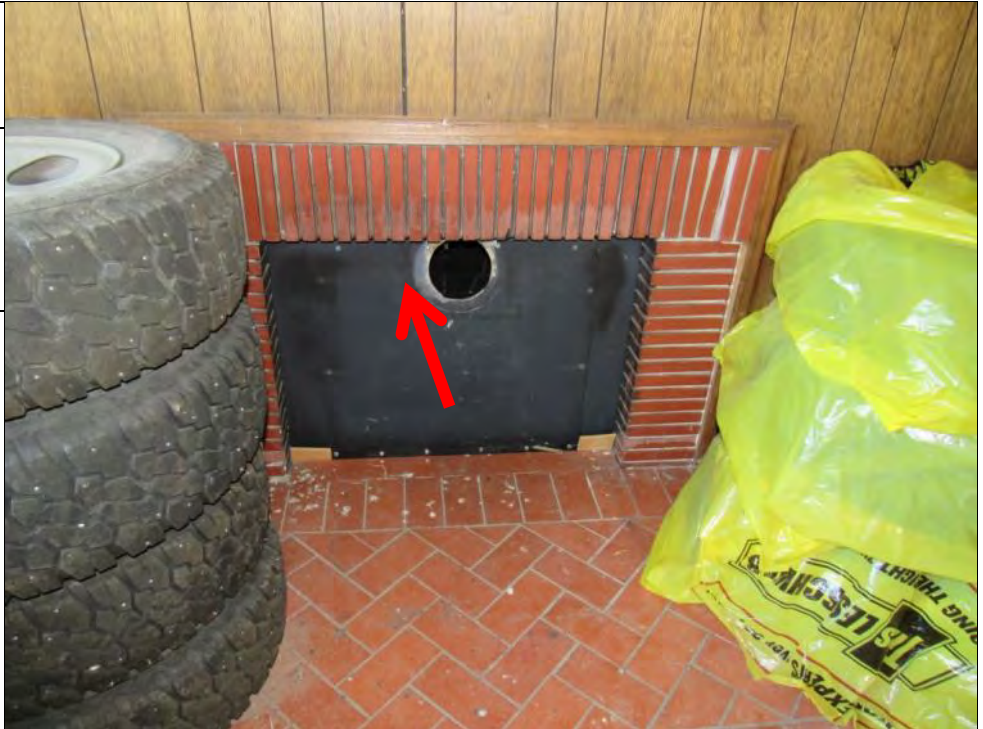
Photo No./ Material ID: CC2R4 - 06	Date: 9/11/2018 to 9/13/2018
Structure/Material Location: Copco No. 2 Residence 4/ Living room wall	
*Description (by layer): 1: Off-white grout associated with fireplace bricks on wall (M)

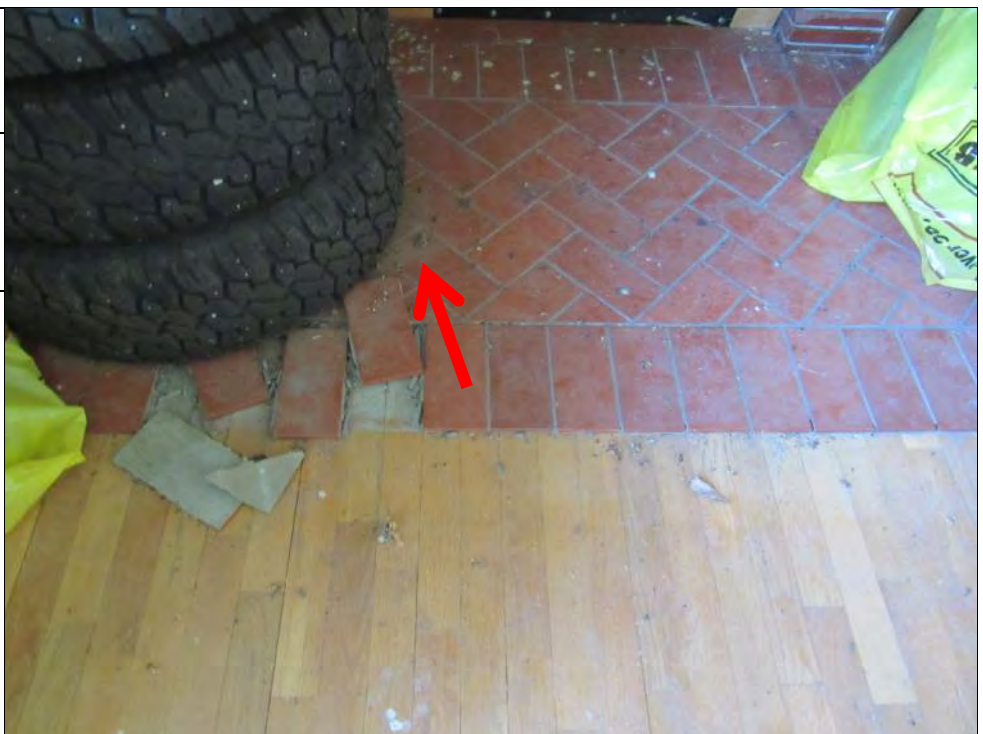
Photo No./ Material ID: CC2R4 - 07	Date: 9/11/2018 to 9/13/2018
Structure/Material Location: Copco No. 2 Residence 4/ Living room floor	
*Description (by layer): 1: Dark gray grout associated with fireplace bricks on floor (M)

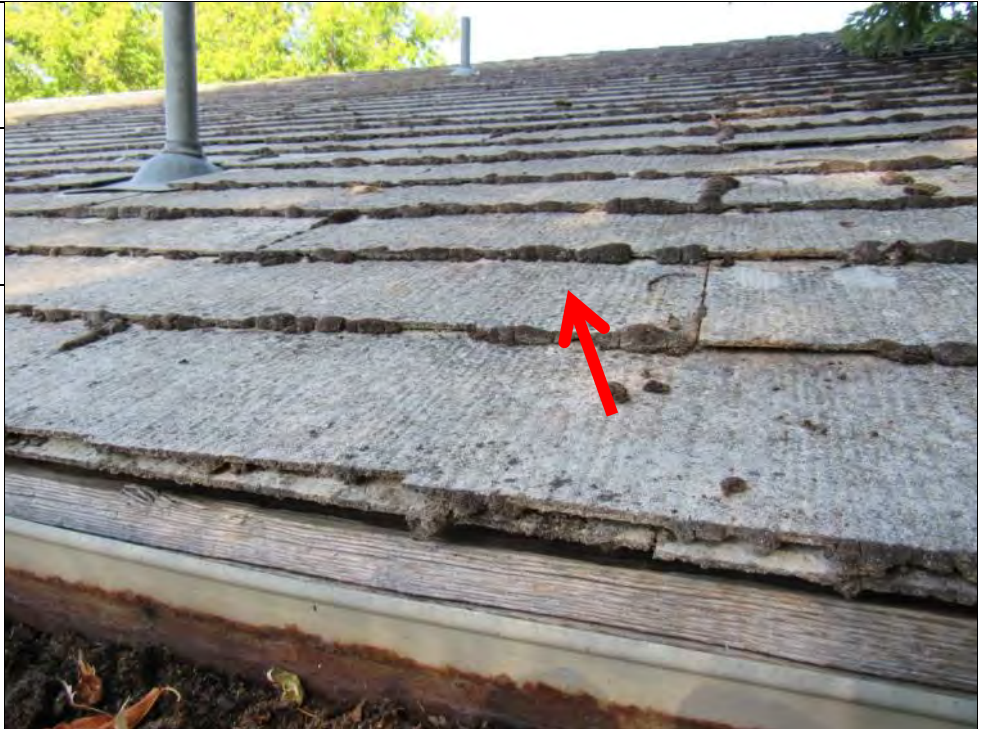
Photo No./ Material ID: CC2R4 - 10	Date: 9/11/2018 to 9/13/2018
Structure/Material Location: Copco No. 2 Residence 4/ Throughout roof of main house	
*Description (by layer): 1: Cement asbestos board roof shingles (M)

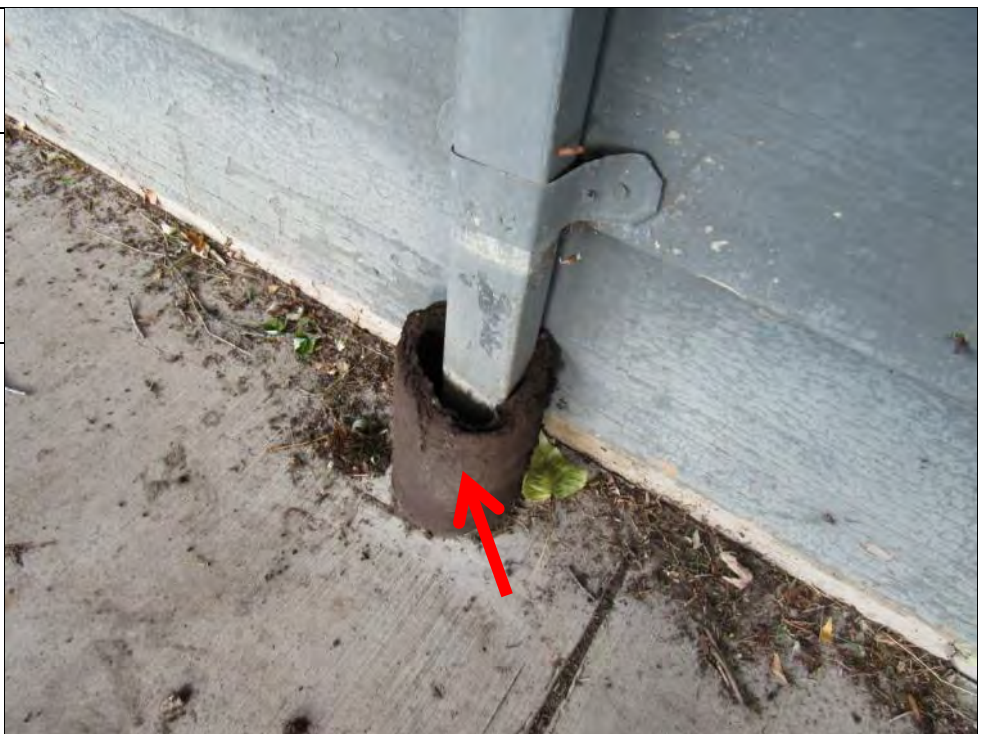
Photo No./ Material ID: CC2R4 - 11	Date: 9/11/2018 to 9/13/2018
Structure/Material Location: Copco No. 2 Residence 4/ Exterior of house, at base of one roof drain	
*Description (by layer): 1: Dark brown brittle papery roof drain residual insulation (M)

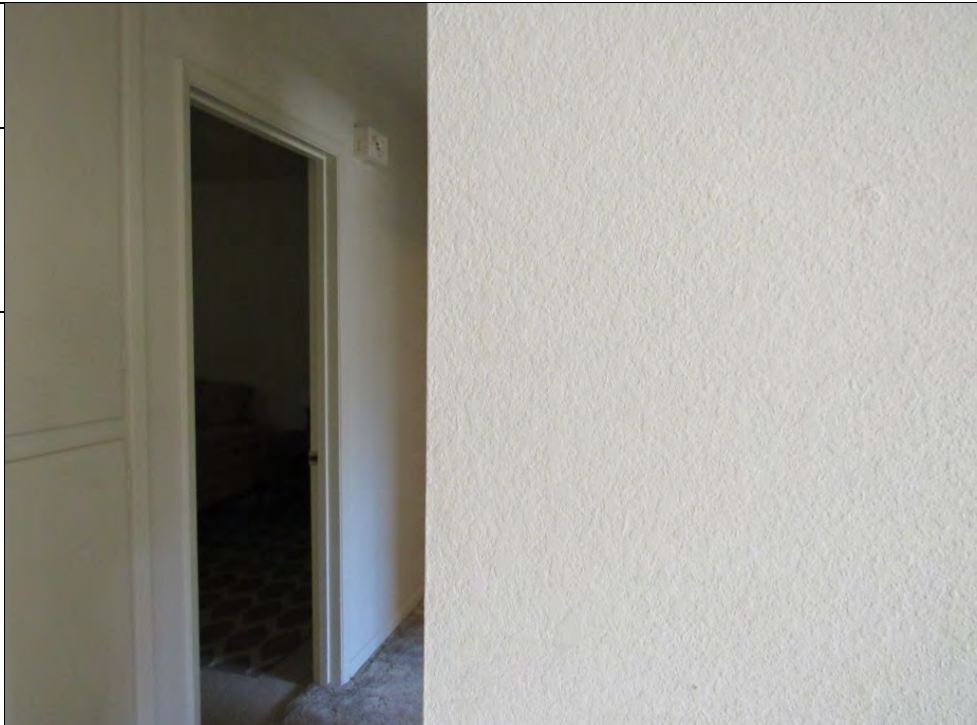
CC2R6 - 05	9/11/2018 to 9/13/2018	
Structure/Material Location: Copco No. 2 Residence 6/ Walls throughout all rooms		
*Description (by layer): 1: White spray-applied wall texture (S) 2: Beige gypsum wallboard (M) 3: White gypsum wallboard with paper (M)

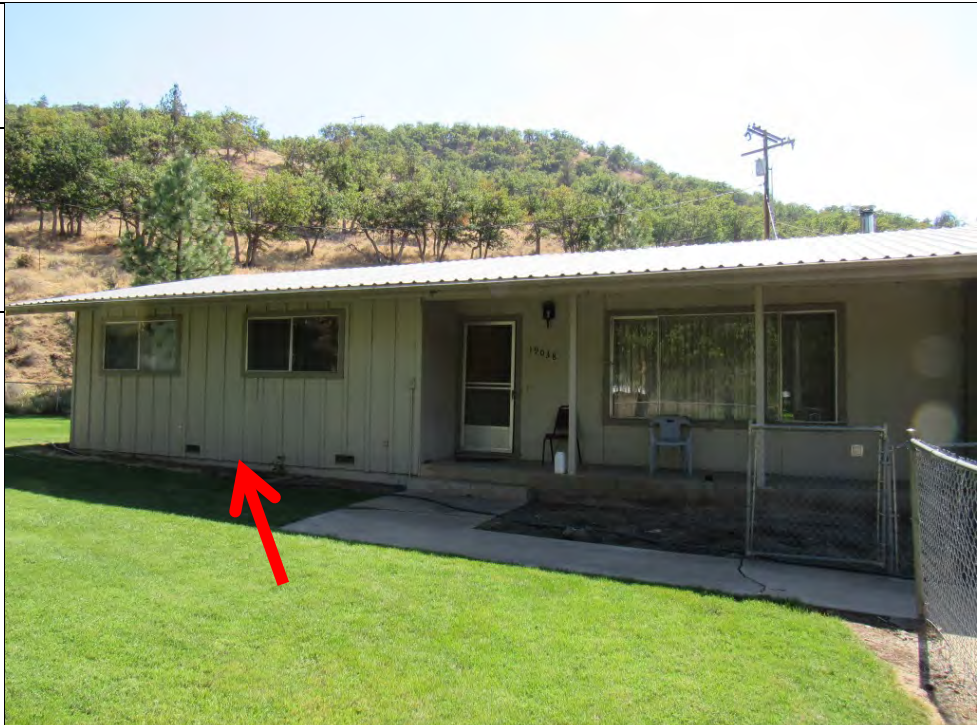
CC2R6 - 07	9/11/2018 to 9/13/2018	
Structure/Material Location: Copco No. 2 Residence 6/ Underneath metal siding		
*Description (by layer): Assumed asbestos-containing vapor barrier paper (M)
