**Klamath River Renewal Corporation  
PacifiCorp**

**AMENDED APPLICATION FOR SURRENDER OF LICENSE  
FOR MAJOR PROJECT AND REMOVAL OF PROJECT WORKS**

**EXHIBIT N (1 of 2)  
Waste Disposal and Hazardous Materials Management Plan  
(Amended December 15, 2021)**

**Waste Disposal and  
Hazardous Materials  
Management Plan**

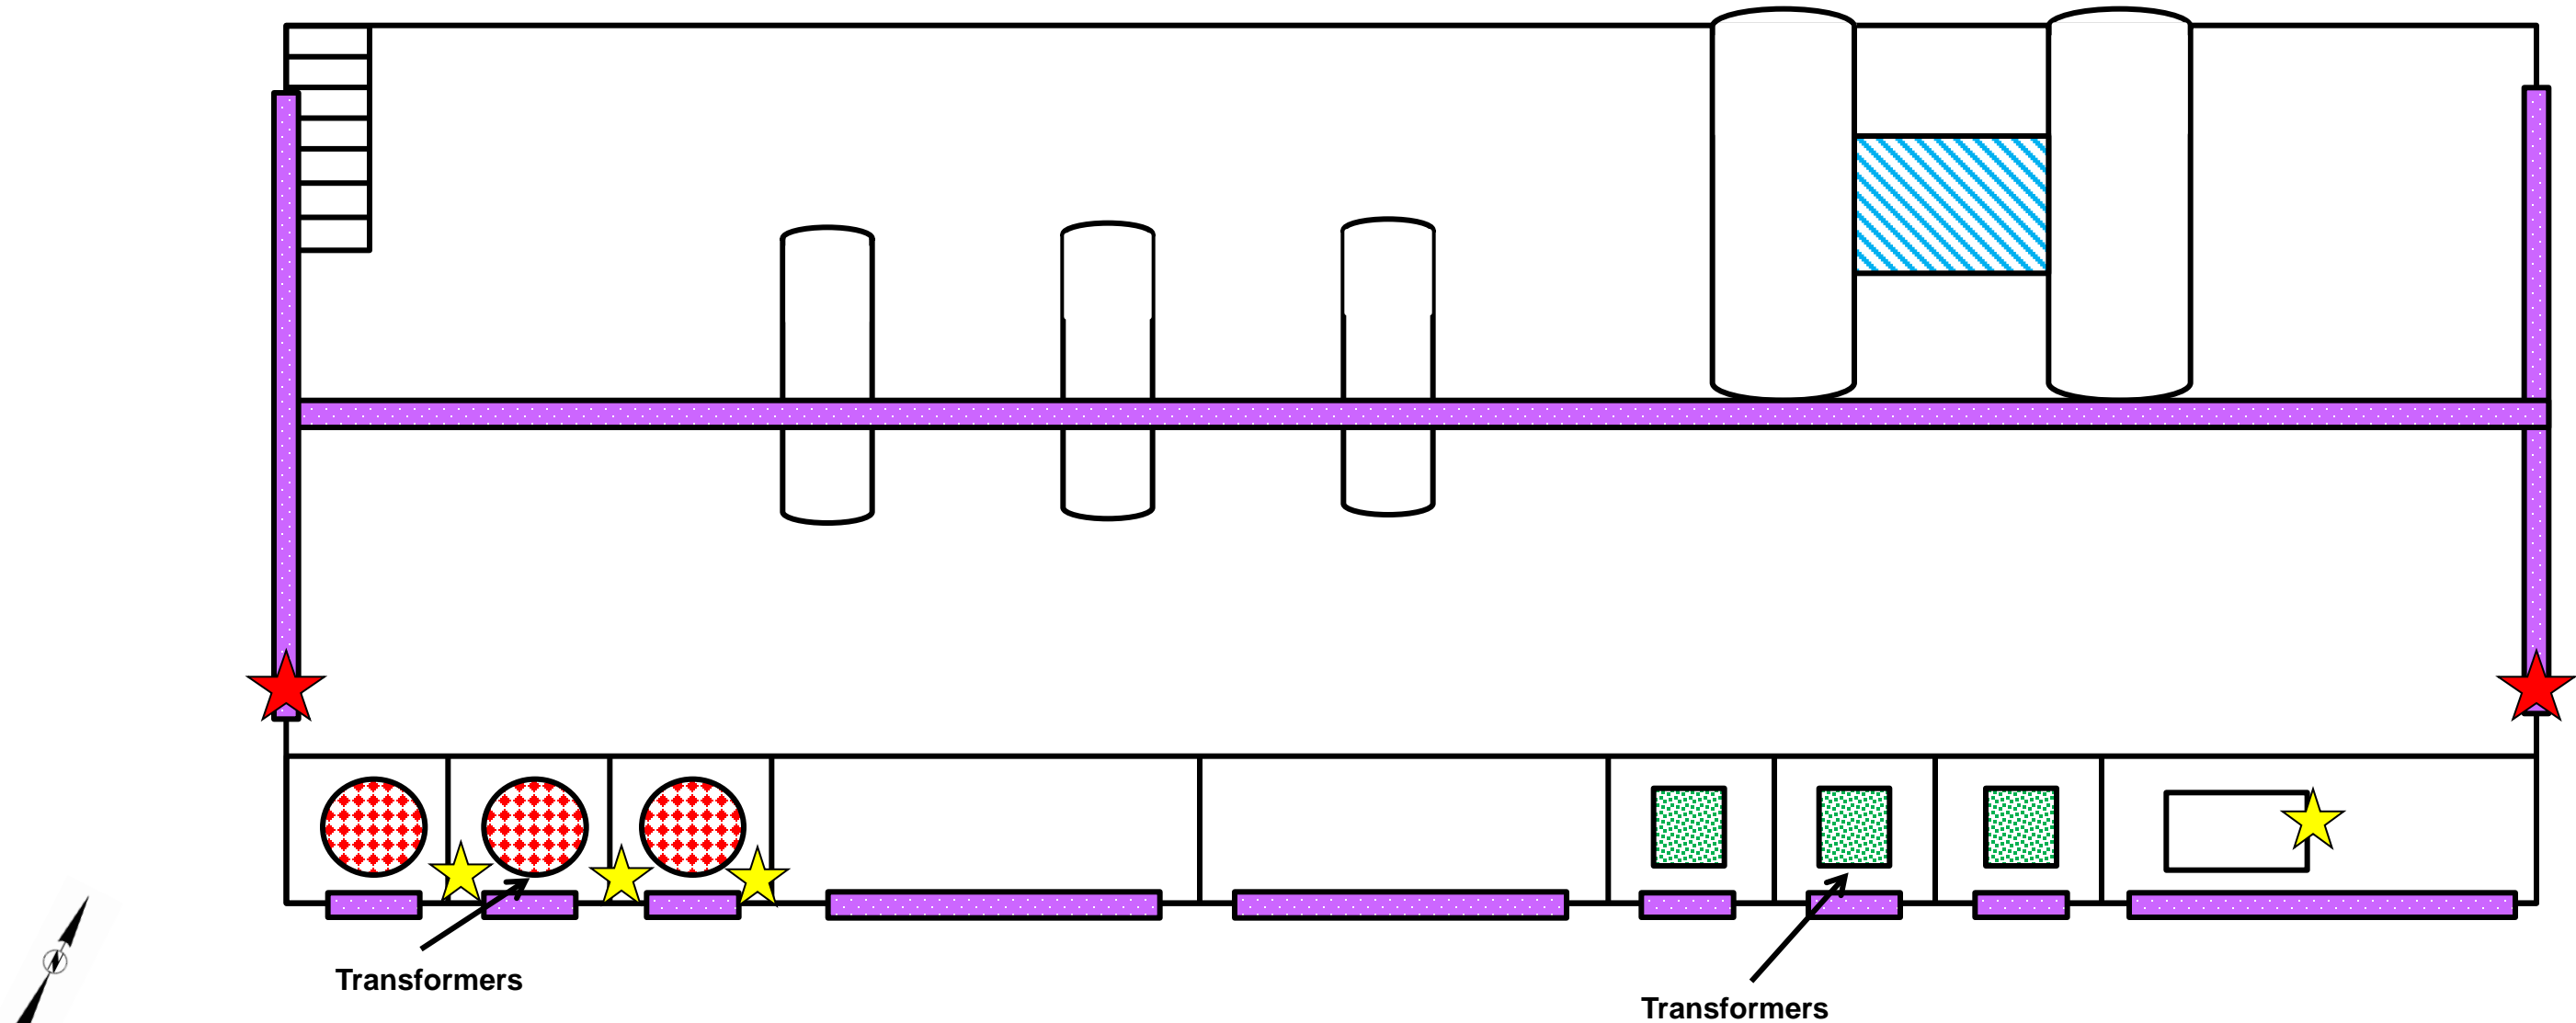
**Figure 8**  
Approximate ACM Locations  
Powerhouse Ground Level

HSA CC1PH-13: Assumed asbestos-containing metal-clad fire door insulation (M)
- Not shown: CC1PH-02: Assumed asbestos-containing gaskets throughout (M)

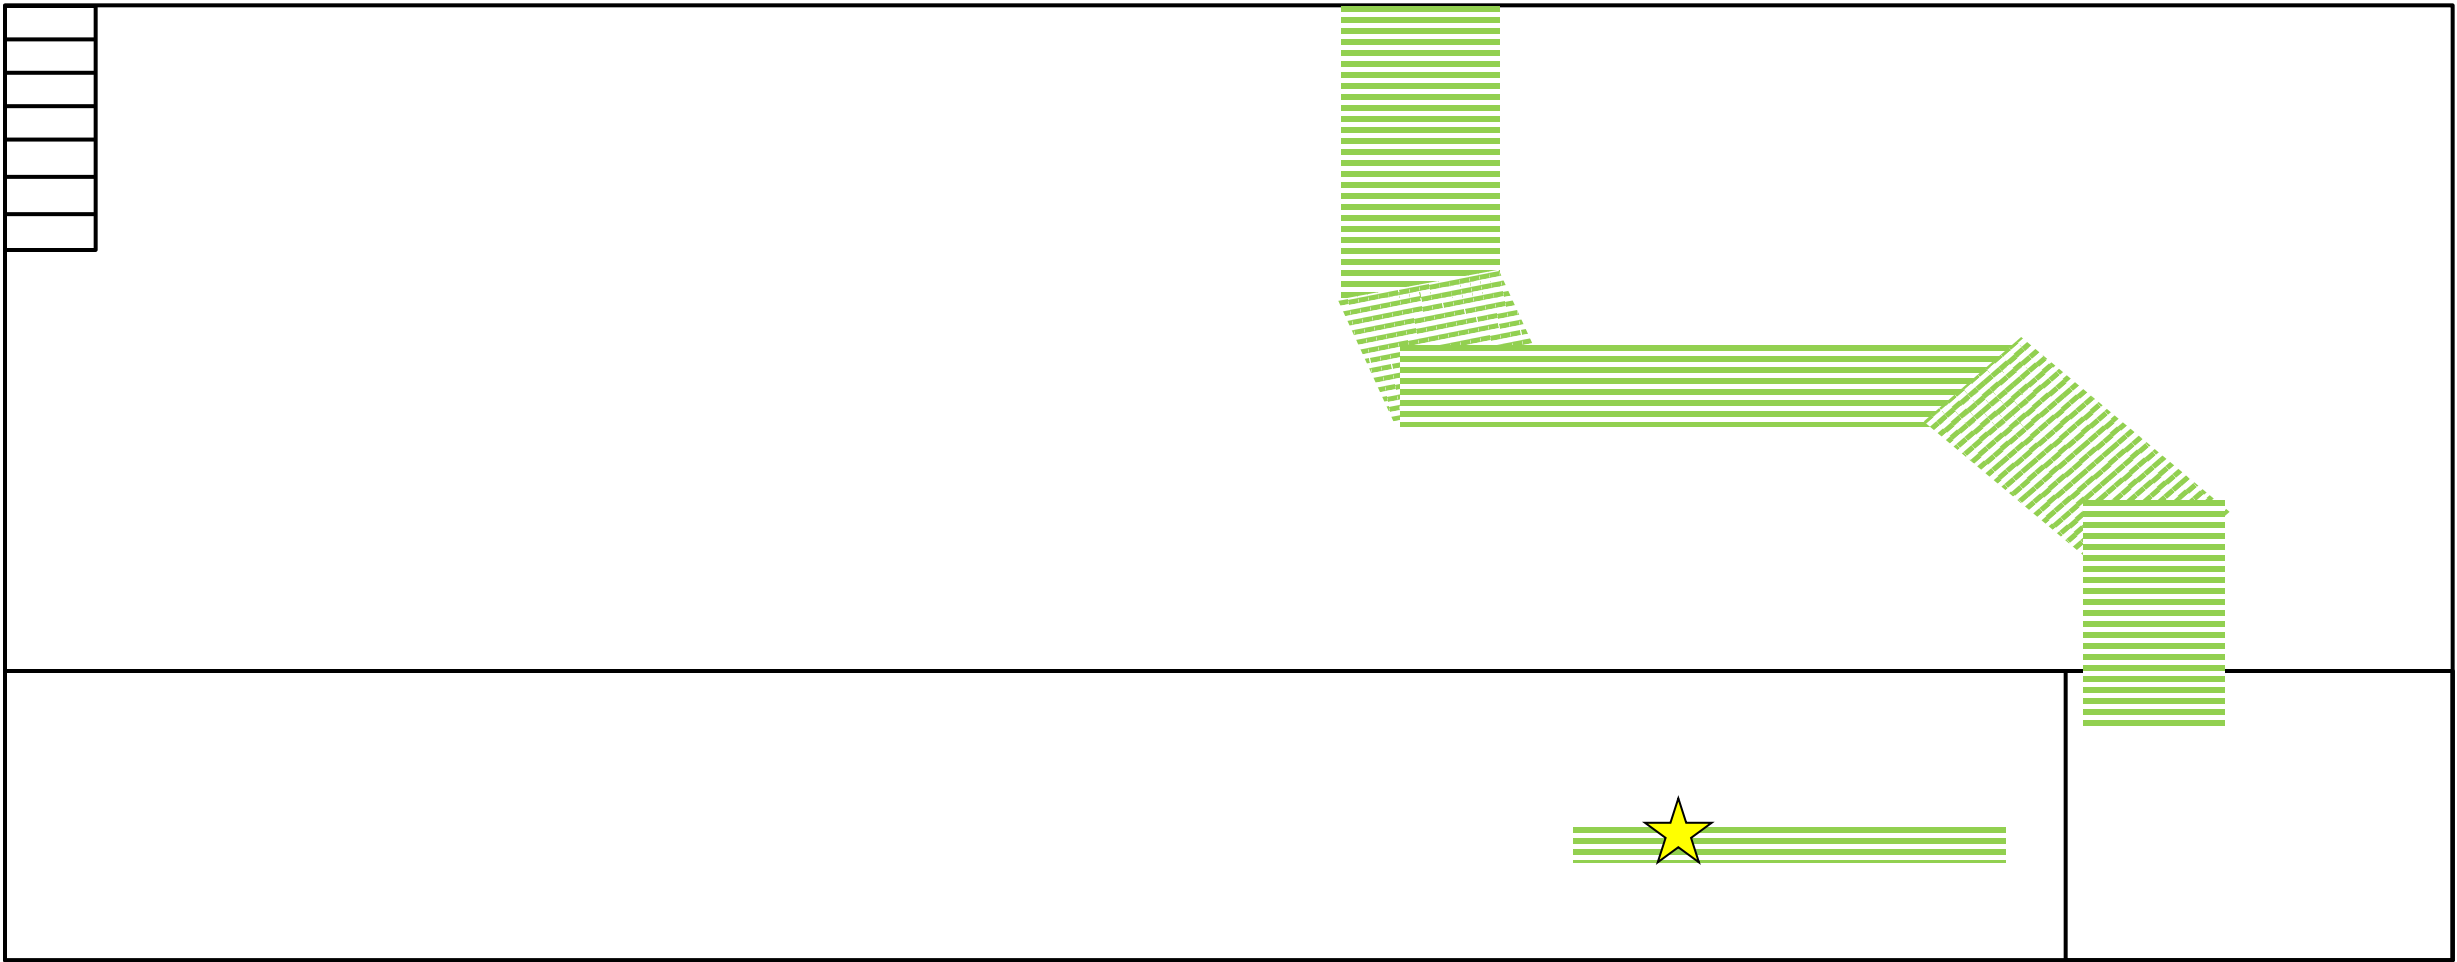
**Figure 9**  
**Approximate ACM Locations**  
**Powerhouse Basement Level**

HSA CC1PH-06: Assumed asbestos-containing Cement Asbestos Board (CAB) (M)

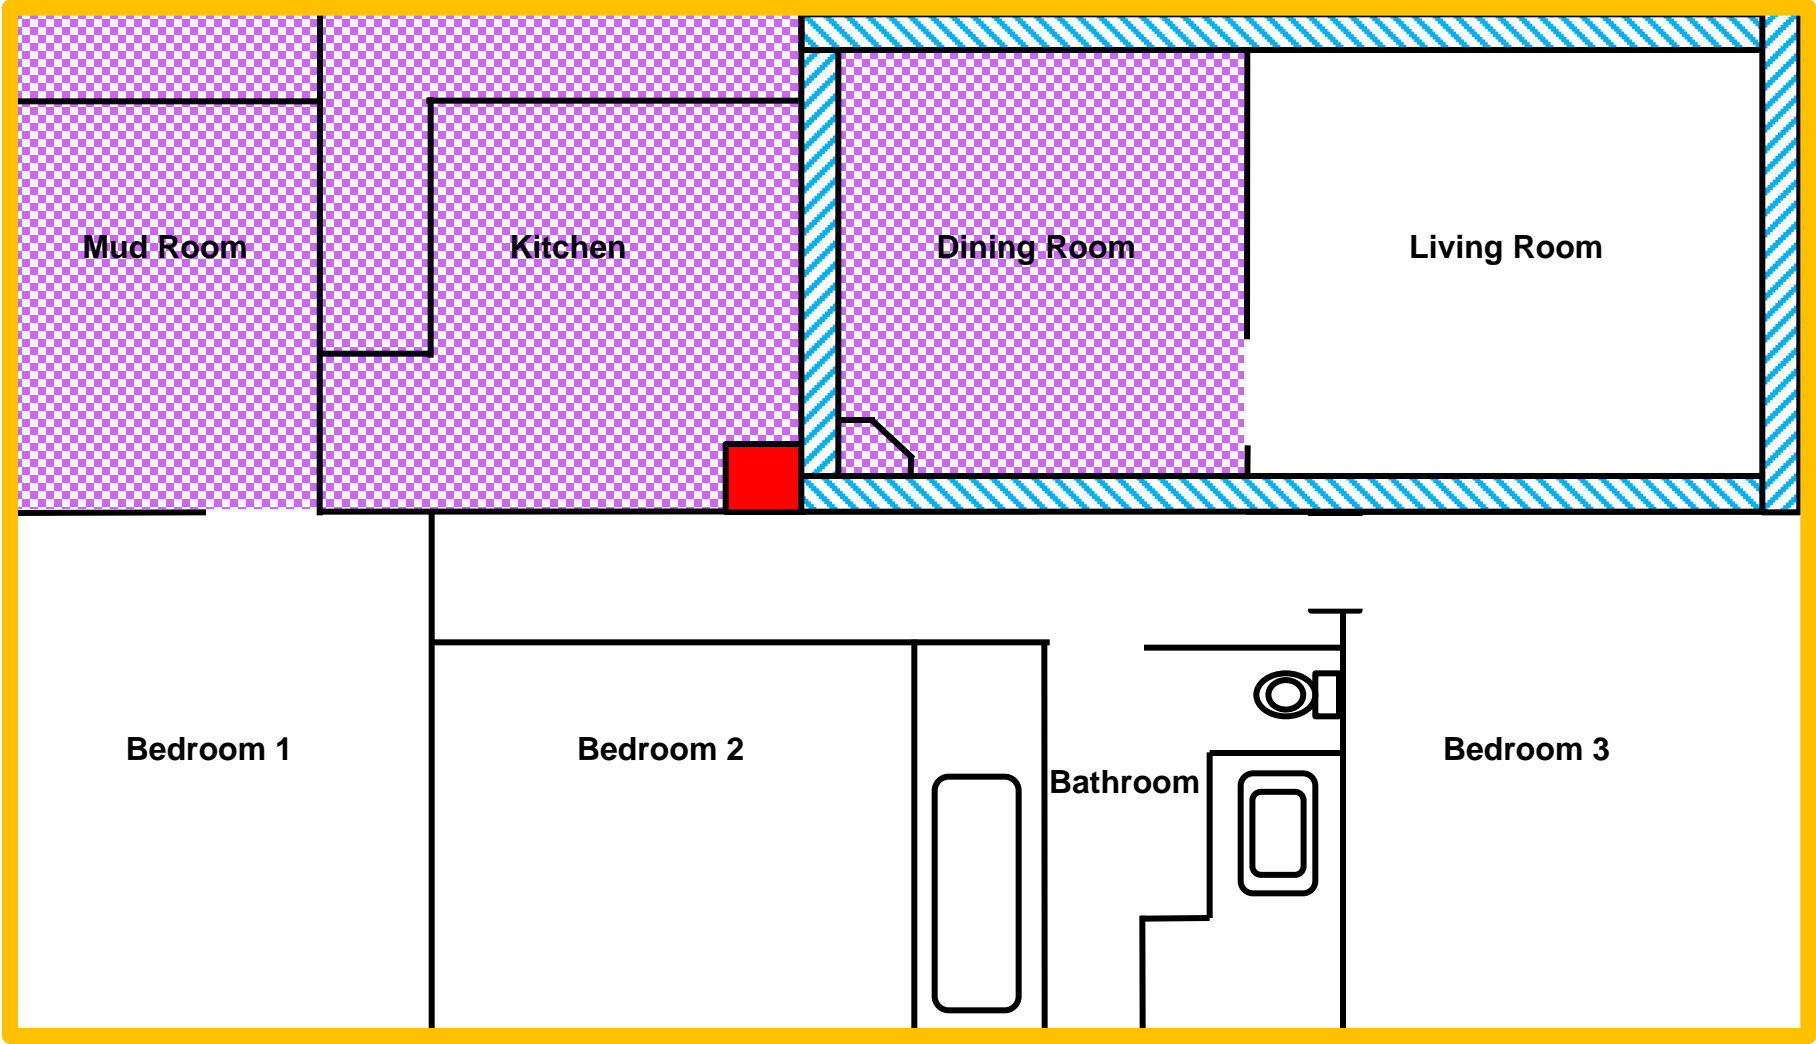
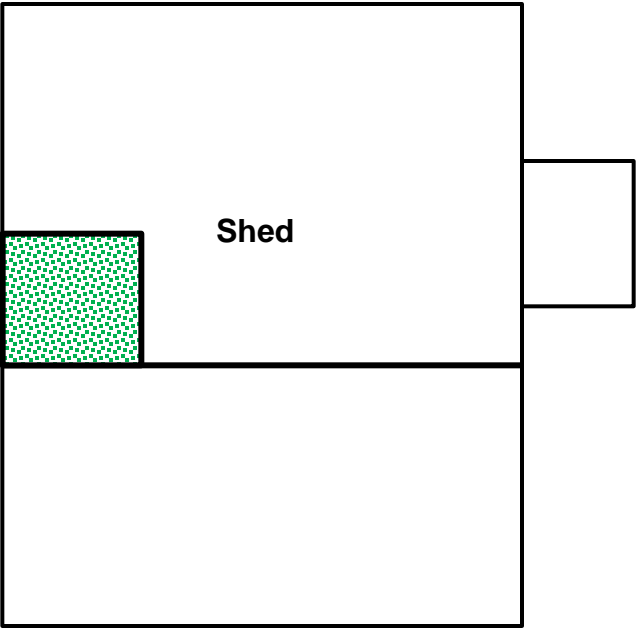
**Figure 10**  
**Approximate ACM Locations**  
**Former Residence 1 and Detached Shed**

HSA CC1R1-14: Assumed asbestos-containing mastic behind wood wall paneling (M)

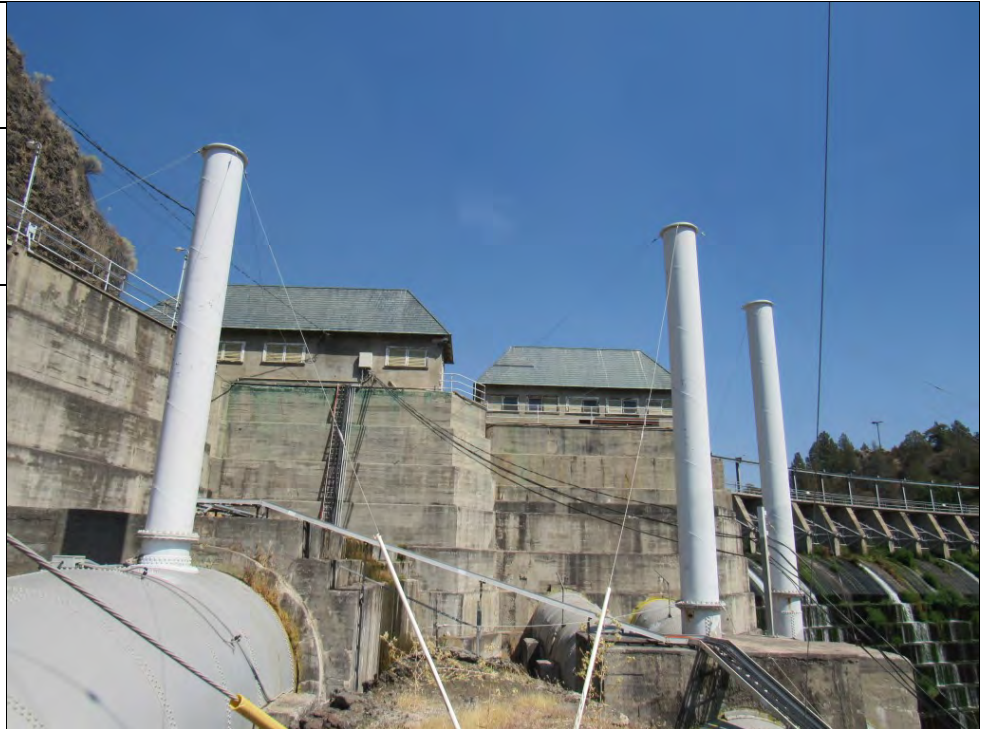
<b>Photo No./ Material ID:</b>  CC1GH - 01	<b>Date:</b>  9/10/2018 to 9/11/2018
<b>Structure/Material Location:</b>  Copco No. 1 Dam, Dam and Gatehouses C11 and C12/ Throughout exterior of Gatehouses	
<b>*Description (by layer):</b>  1: Gray brittle stucco (S)

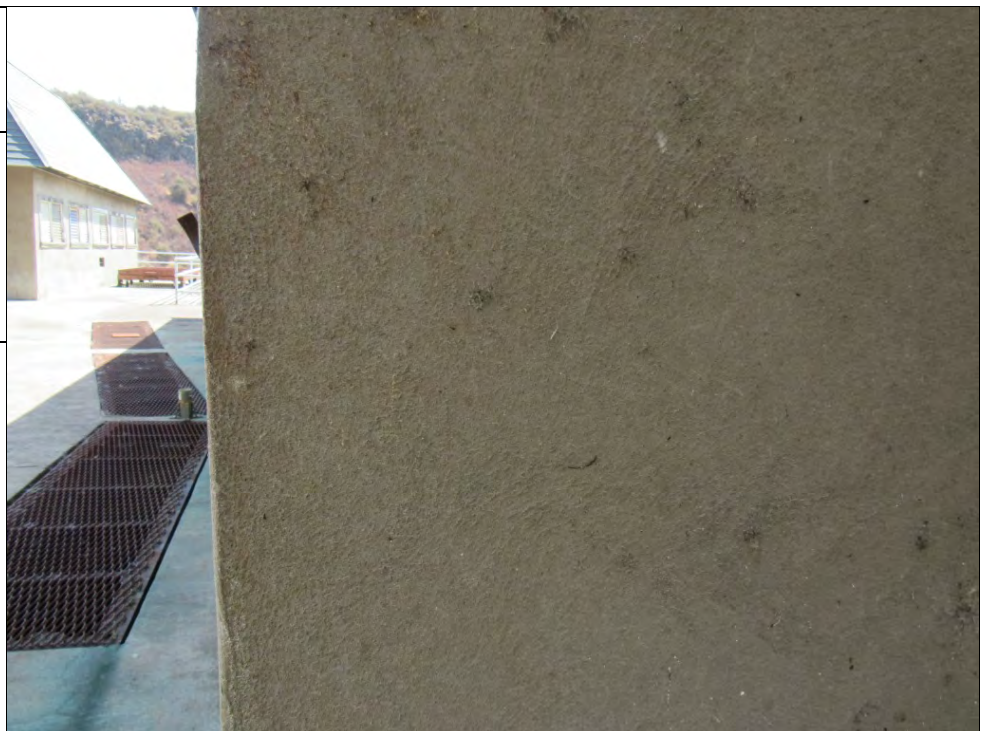
<b>Photo No./ Material ID:</b>  CC1GH - 02	<b>Date:</b>  9/10/2018 to 9/11/2018
<b>Structure/Material Location:</b>  Copco No. 1 Dam, Dam and Gatehouses C11 and C12/ Underneath copper shingle roof	
<b>*Description (by layer):</b>  1: Black asphaltic roofing paper (M) 2: Black asphaltic roofing material (M)

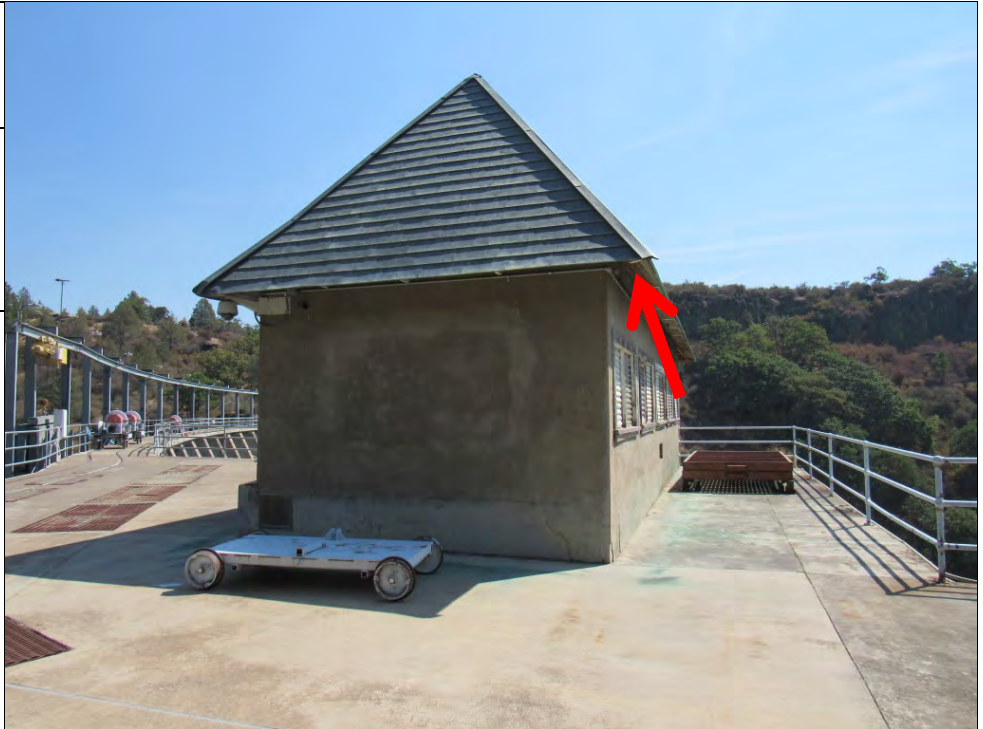
<b>Photo No./ Material ID:</b>  CC1GH - 03	<b>Date:</b>  9/10/2018 to 9/11/2018
<b>Structure/Material Location:</b>  Copco No. 1 Dam, Dam and Gatehouses C11 and C12/ Walkway expansion joints associated with the Gatehouses, the Right Abutment Intake Structure, and the Copco 1 Dam	
<b>*Description (by layer):</b>  1: Gray sealant (M)

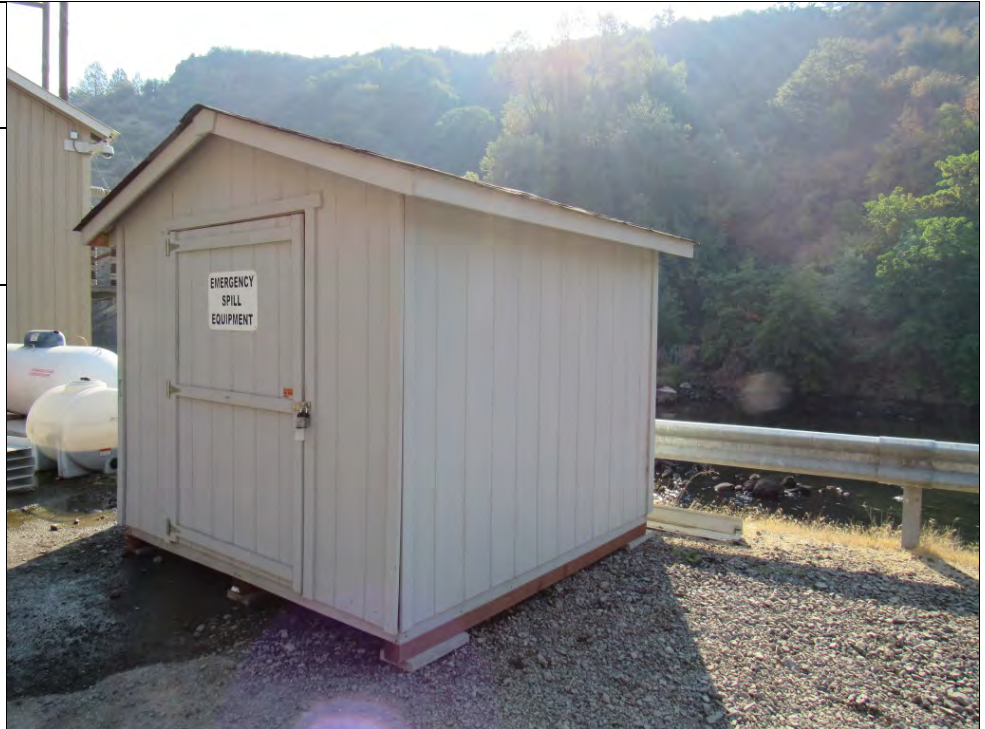
CC1ES - 01

- 1: Black asphaltic roofing  
shingles with granules (M)
- 2: Black asphaltic mastic (M)

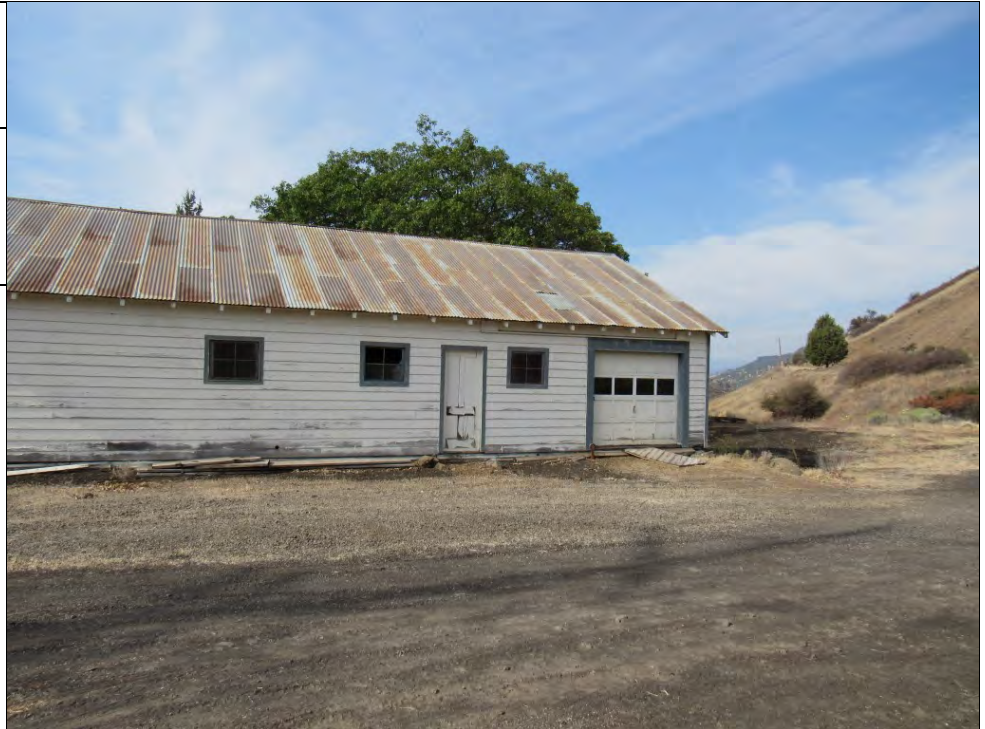
CC1MB - 01

- 1: Black asphaltic vapor barrier  
paper (M))
- 2: Black asphaltic vapor barrier  
paper (M)
- 3: Black asphaltic material (M)

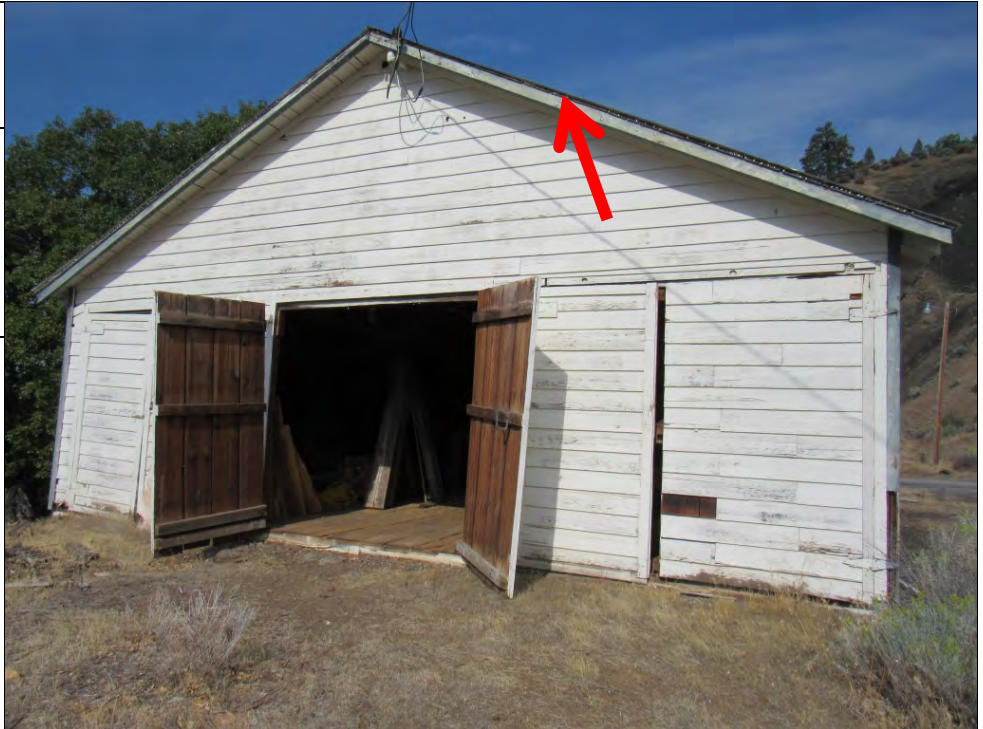
CC1MB - 03

- 1: White brittle window putty (M)

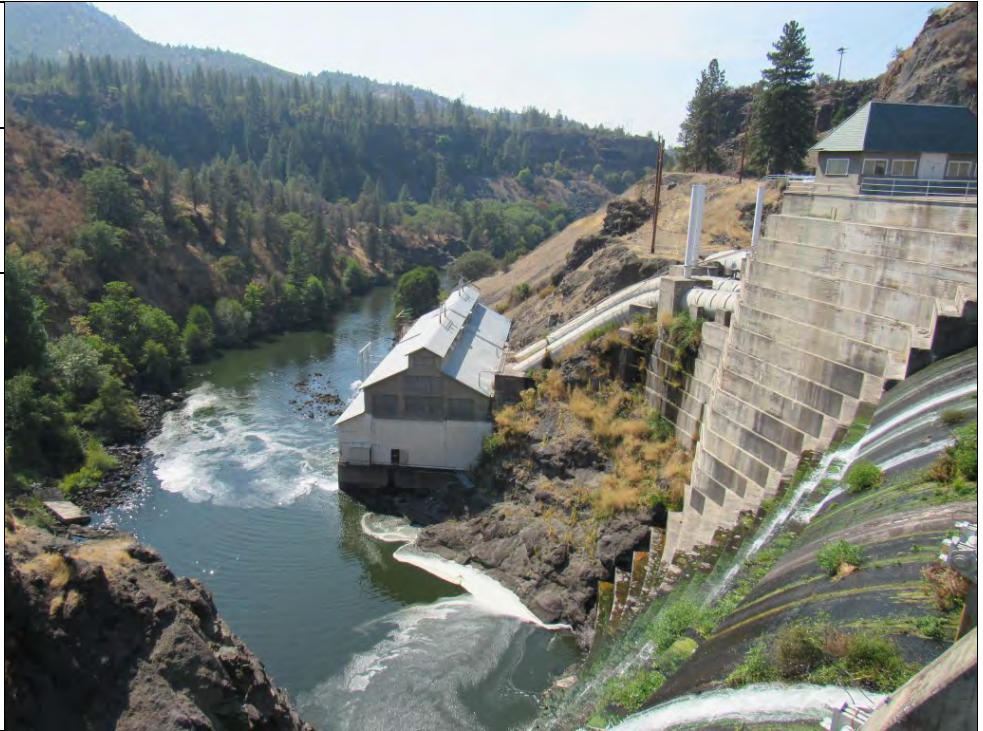
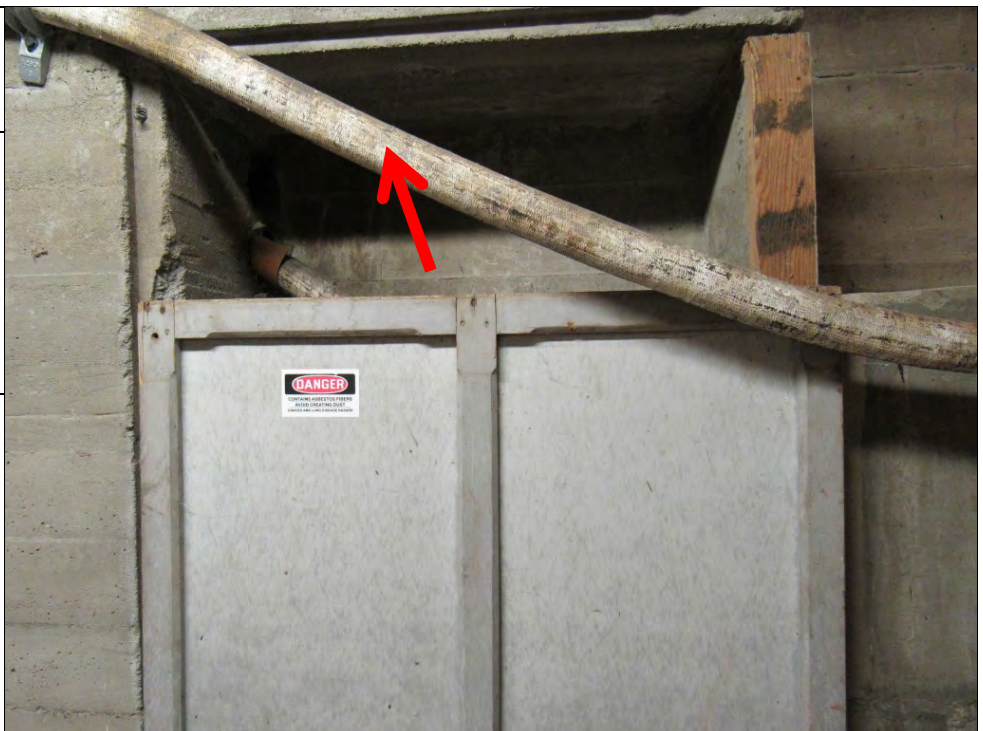
CC1PH - 01

**Assumed asbestos-containing  
white woven electrical wire  
insulation (M)**

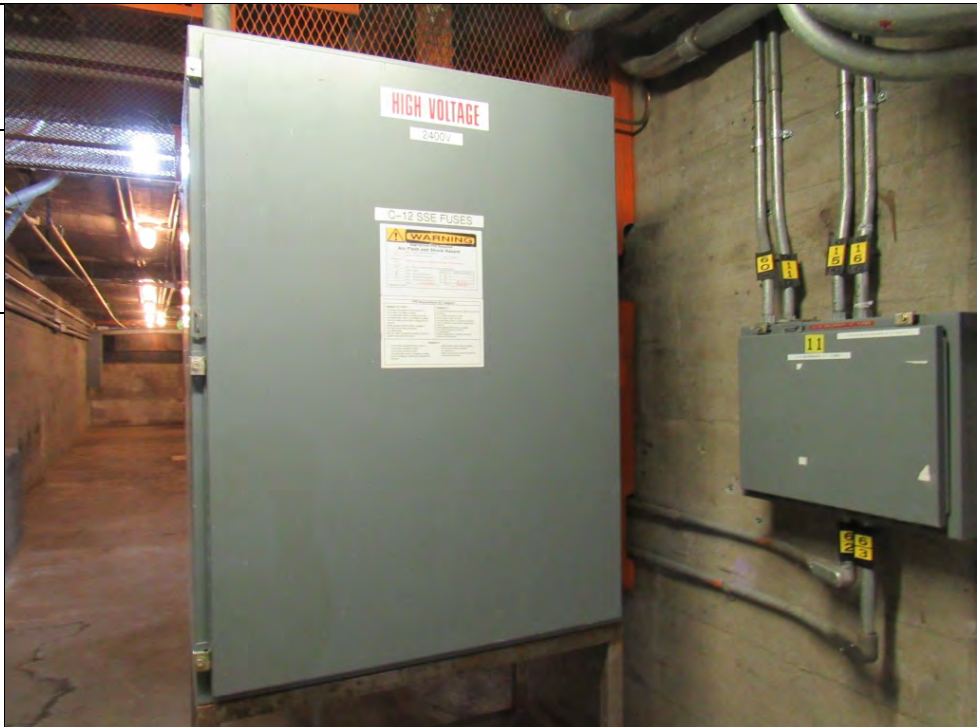
CC1PH - 02	9/10/2018	
<b>Structure/Material Location:</b>  Copco No. 1 Powerhouse/ Throughout main floor and basement		
<b>*Description (by layer):</b>  Assumed asbestos-containing electrical panel backing in older electrical panels (M)

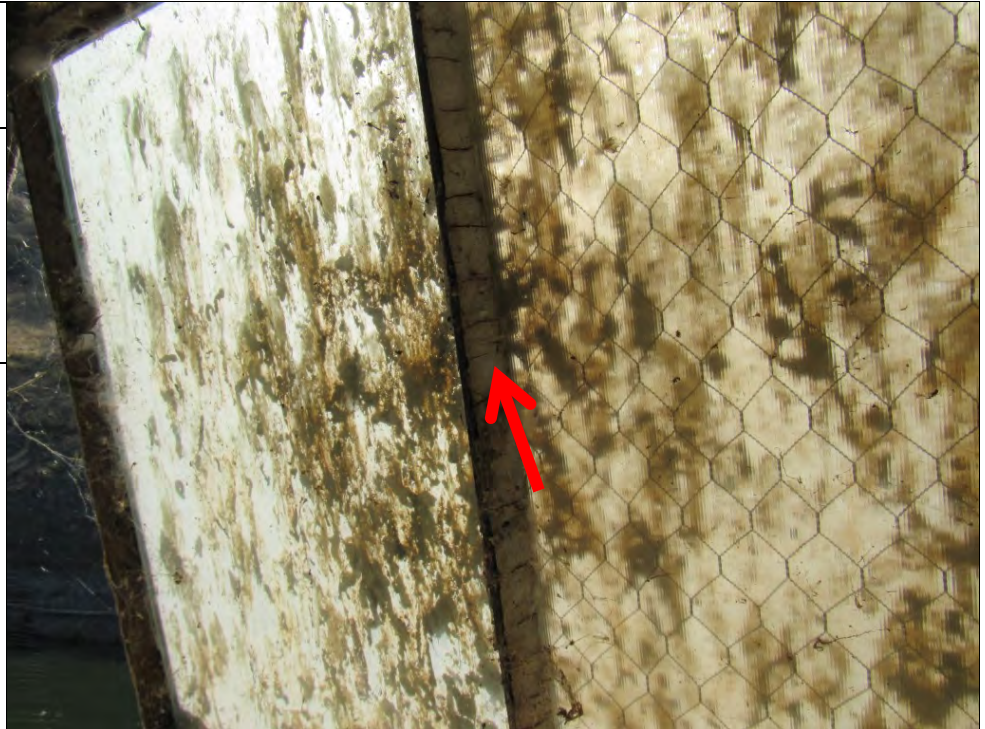
<b>Photo No./ Material ID:</b>  CC1PH - 04	<b>Date:</b>  9/10/2018
<b>Structure/Material Location:</b>  Copco No. 1 Powerhouse/ Window panes throughout main floor, not including clerestory roof level windows (inaccessible - see HSA 08)	
<b>*Description (by layer):</b>  <b>1: Gray brittle window putty (M)</b>

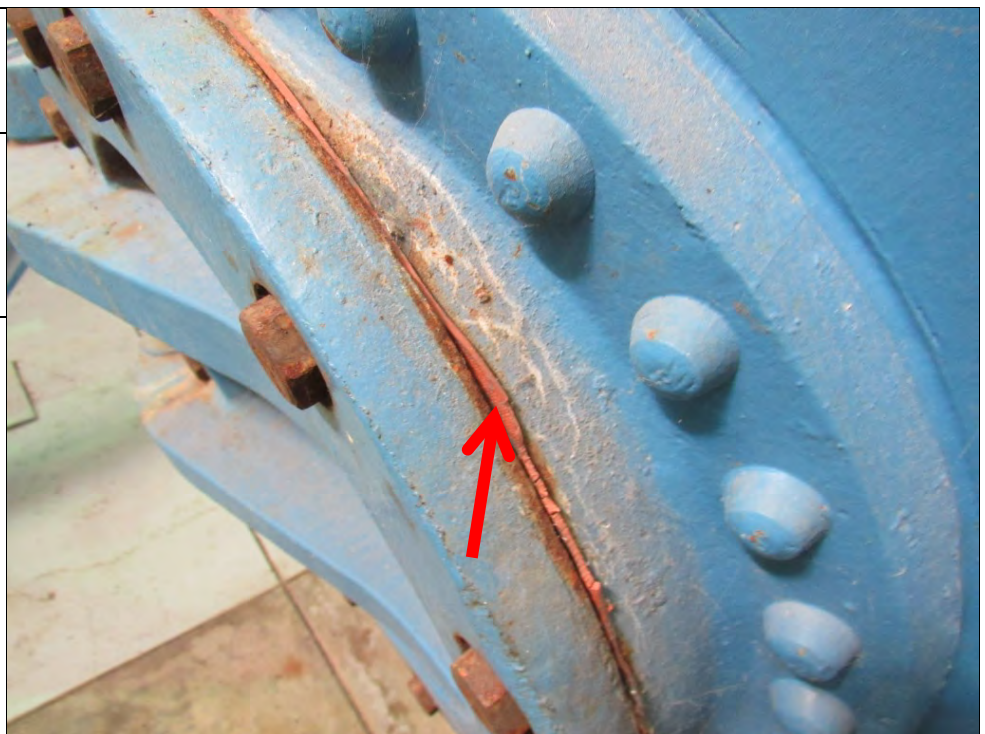
<b>Photo No./ Material ID:</b>  CC1PH - 05	<b>Date:</b>  9/10/2018
<b>Structure/Material Location:</b>  Copco No. 1 Powerhouse/ Penstock piping and penstock hydraulic turbine	
<b>*Description (by layer):</b>  1: Silver paint (M) 2: Red gasket (M)

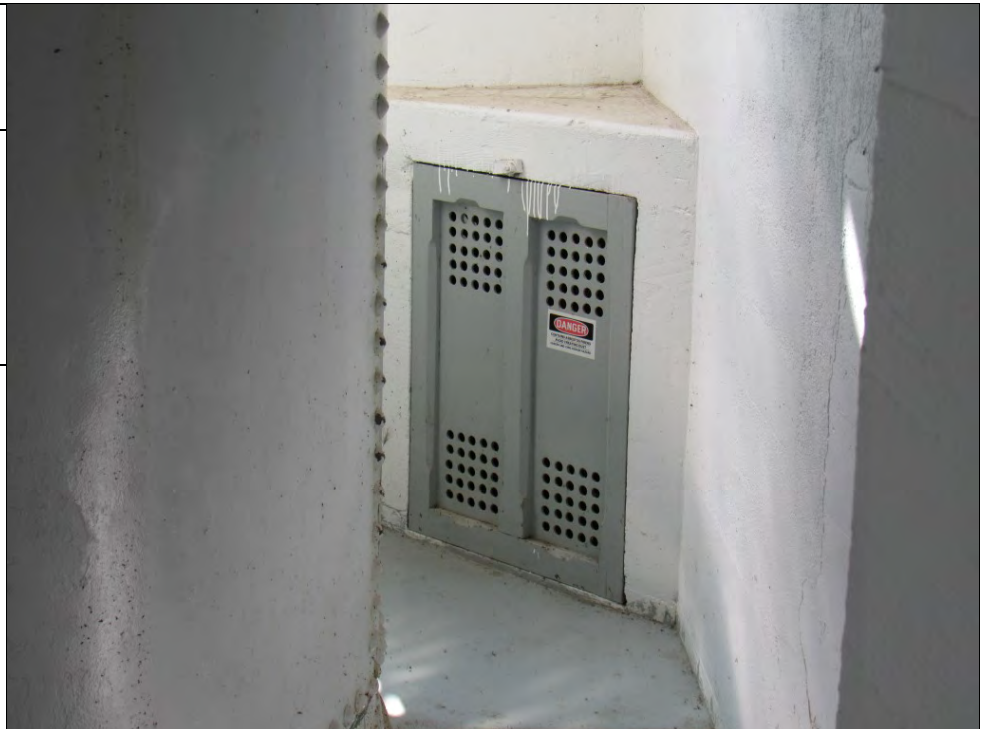
<b>Photo No./ Material ID:</b>	<b>Date:</b>
CC1PH - 06	9/10/2018
<b>Structure/Material Location:</b>	
Copco No. 1 Powerhouse/ Panels in various places throughout the main floor and basement. Labeled with ACM stickers.	
<b>*Description (by layer):</b>	
<b>Assumed asbestos-containing cement asbestos board (CAB) (M)</b>

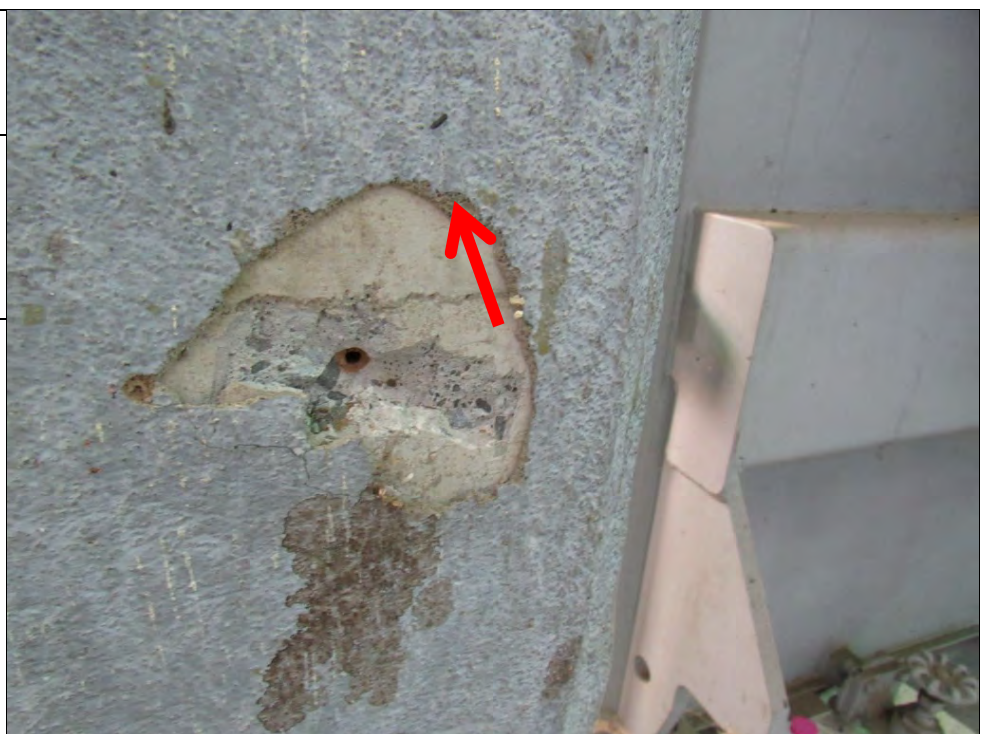
<b>Photo No./ Material ID:</b>	<b>Date:</b>
CC1PH - 07	9/10/2018
<b>Structure/Material Location:</b>	
Copco No. 1 Powerhouse/ Concrete walls throughout main floor	
<b>*Description (by layer):</b>	
1: Cementitious troweled-on surface coat (S)

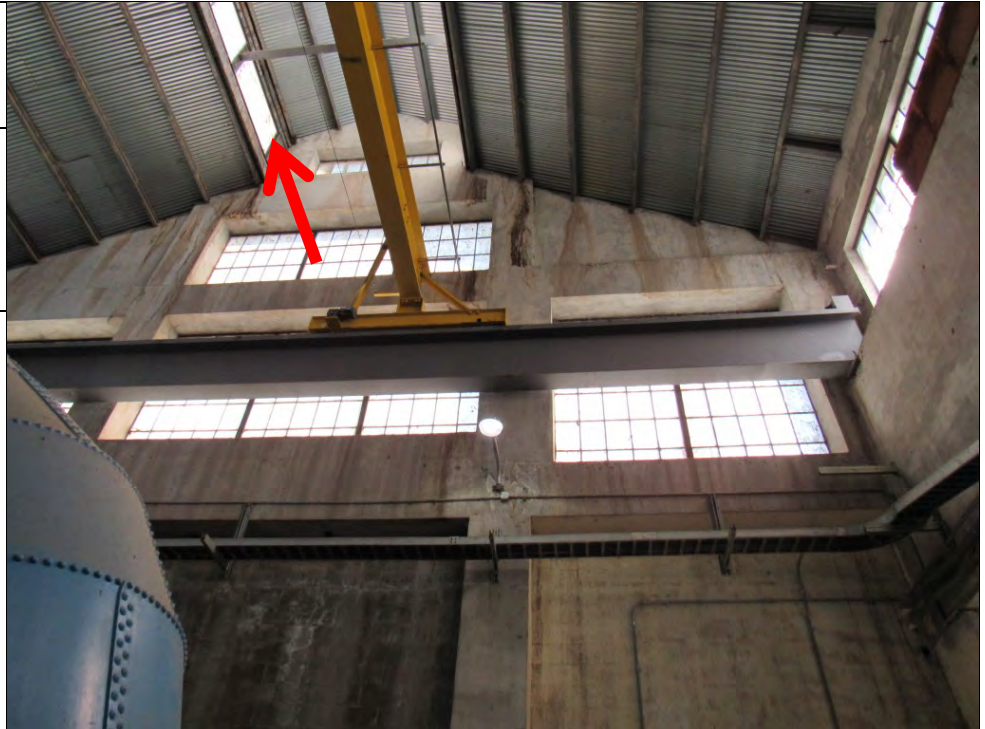
<b>Photo No./ Material ID:</b>  CC1PH - 08	<b>Date:</b>  9/10/2018
<b>Structure/Material Location:</b>  Copco No. 1 Powerhouse/ Clerestory windows at roof level of Powerhouse	
<b>*Description (by layer):</b>  <b>Assumed asbestos-containing window putty (M)</b>

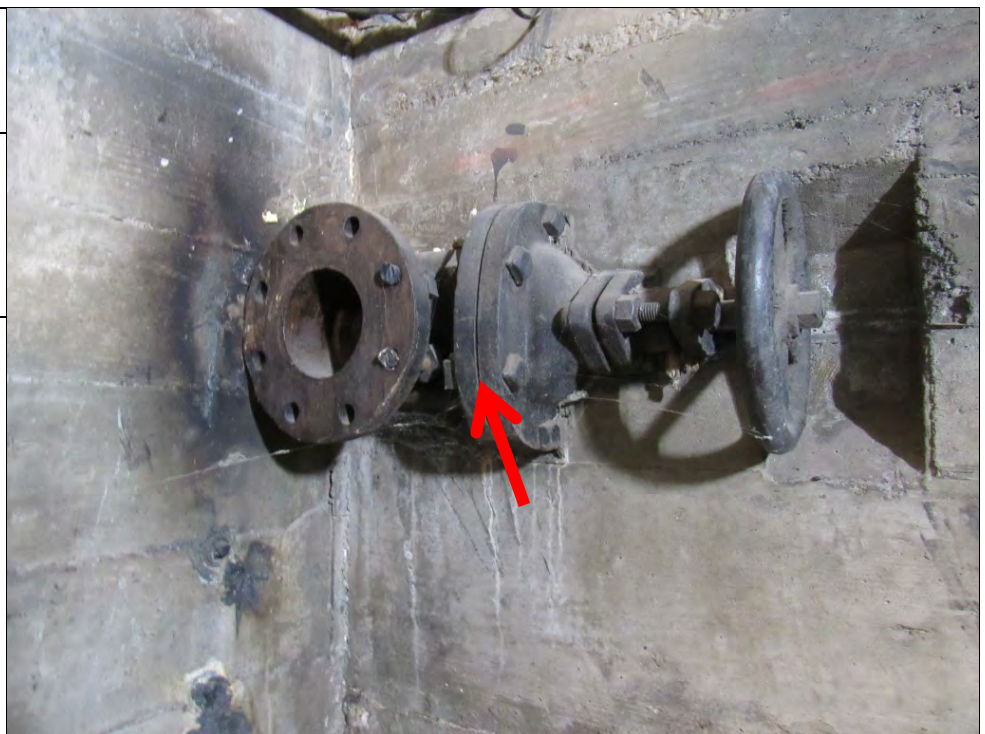
<b>Photo No./ Material ID:</b>  CC1PH - 09	<b>Date:</b>  9/10/2018
<b>Structure/Material Location:</b>  Copco No. 1 Powerhouse/ Throughout Powerhouse piping and mechanical equipment	
<b>*Description (by layer):</b>  <b>Assumed asbestos-containing gaskets (M)</b>

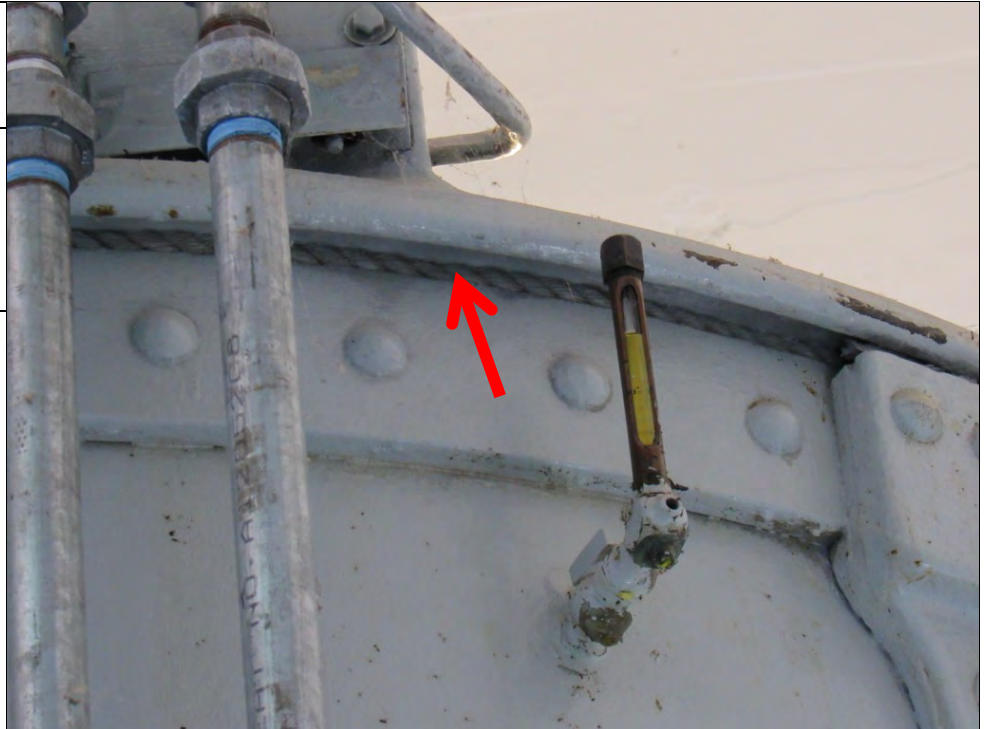
<b>Photo No./ Material ID:</b>  CC1PH - 10	<b>Date:</b>  9/10/2018
<b>Structure/Material Location:</b>  Copco No. 1 Powerhouse/ On transformers on main level of Powerhouse	
<b>*Description (by layer):</b>  <b>Assumed asbestos-containing rope gasket (M)</b>

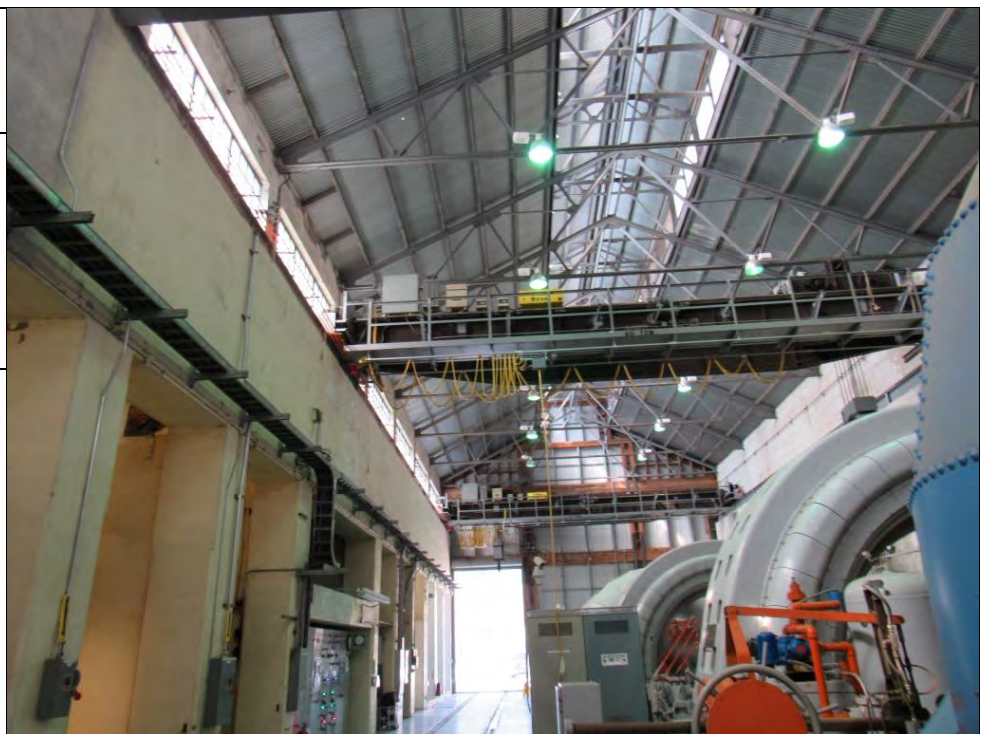
<b>Photo No./ Material ID:</b>  CC1PH - 11	<b>Date:</b>  9/10/2018
<b>Structure/Material Location:</b>  Copco No. 1 Powerhouse/ Associated with turbines on main level of Powerhouse, inaccessible unless turbines are removed	
<b>*Description (by layer):</b>  <b>Assumed asbestos-containing wicket gates (M)</b>

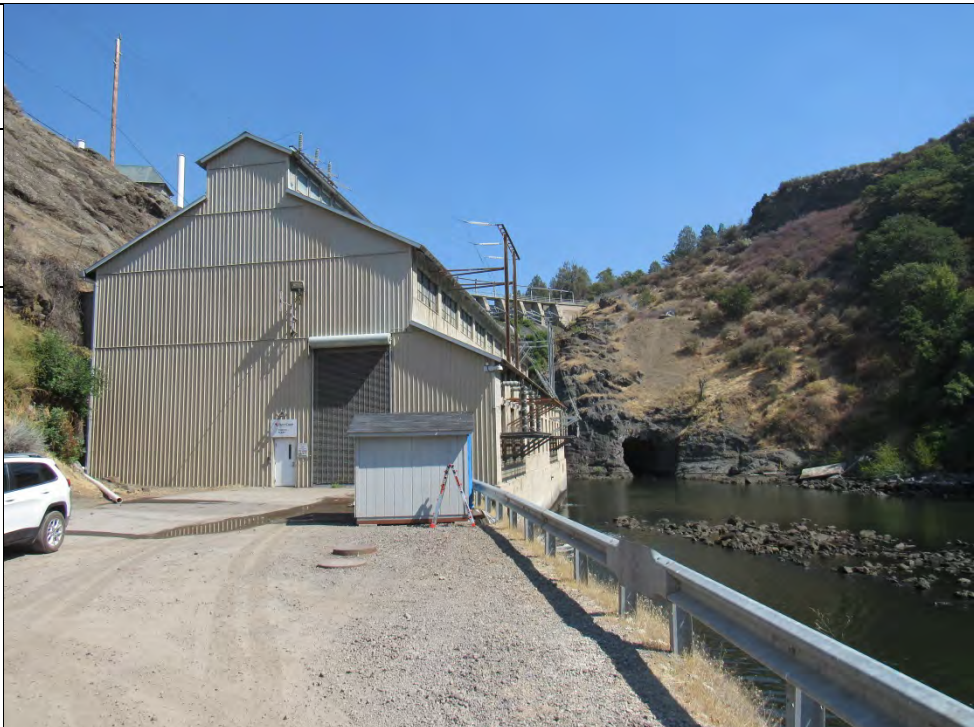
CC1PH - 13	9/10/2018	
<b>Structure/Material Location:</b>  Copco No. 1 Powerhouse/ Main floor of Powerhouse		
<b>*Description (by layer):</b>  Assumed asbestos-containing metal-clad fire door insulation (M)

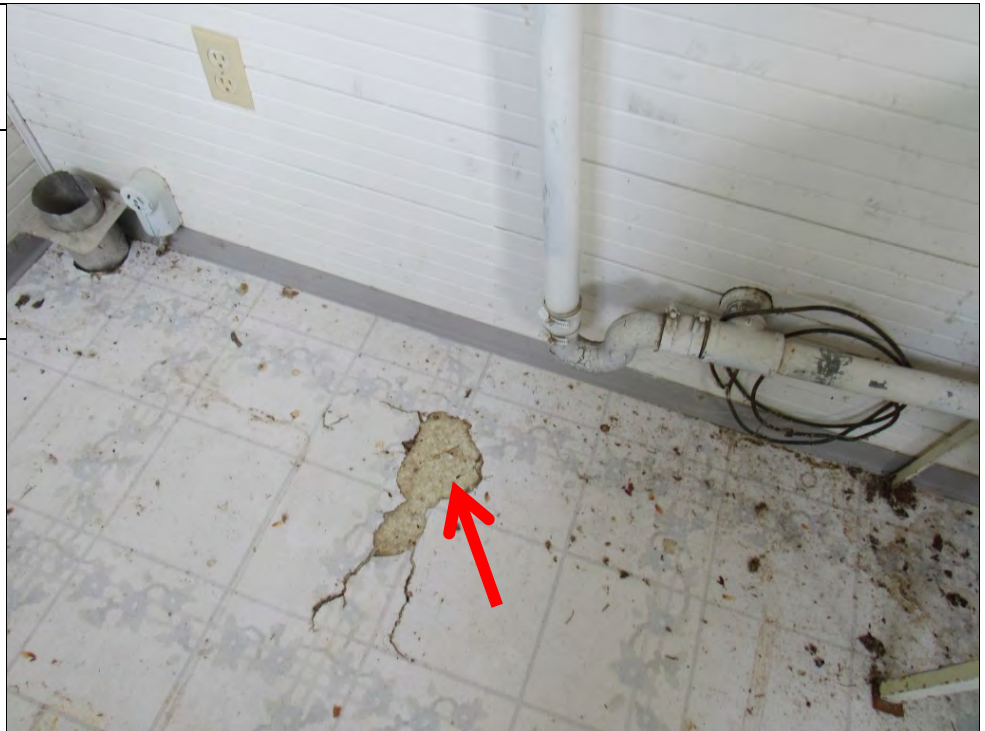
<b>Photo No./ Material ID:</b>	<b>Date:</b>
CC1R1 - 03	9/10/2018
<b>Structure/Material Location:</b>	
Copco No. 1 Residence 1/ Walls in mud room and dining room	
<b>*Description (by layer):</b>	
1: 3" gray rubber cove base (M)	
2: White mastic (M)

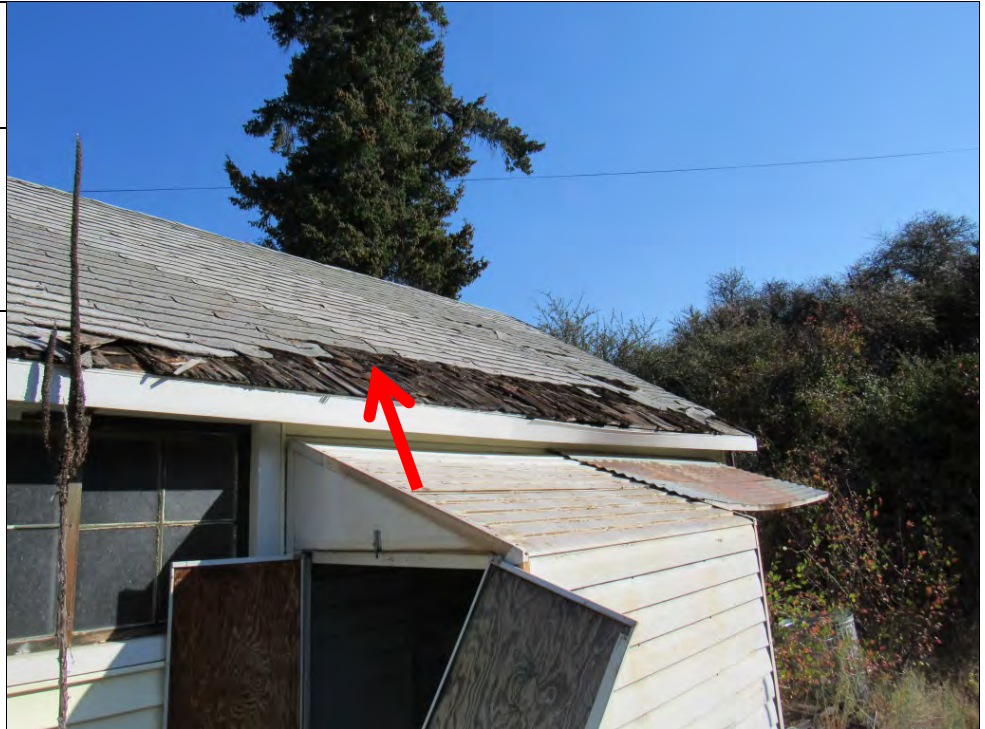
<b>Photo No./ Material ID:</b>  CC1R1 - 06	<b>Date:</b>  9/10/2018
<b>Structure/Material Location:</b>  Copco No. 1 Residence 1/ Roof of Residence 1 shed, over wood shake shingles	
<b>*Description (by layer):</b>  1: Black asphaltic roof shingles with granules (M)
