**Klamath River Renewal Corporation  
PacifiCorp**

**AMENDED APPLICATION FOR SURRENDER OF LICENSE  
FOR MAJOR PROJECT AND REMOVAL OF PROJECT WORKS**

**EXHIBIT N (1 of 2)  
Waste Disposal and Hazardous Materials Management Plan  
(Amended December 15, 2021)**

**Waste Disposal and  
Hazardous Materials  
Management Plan**

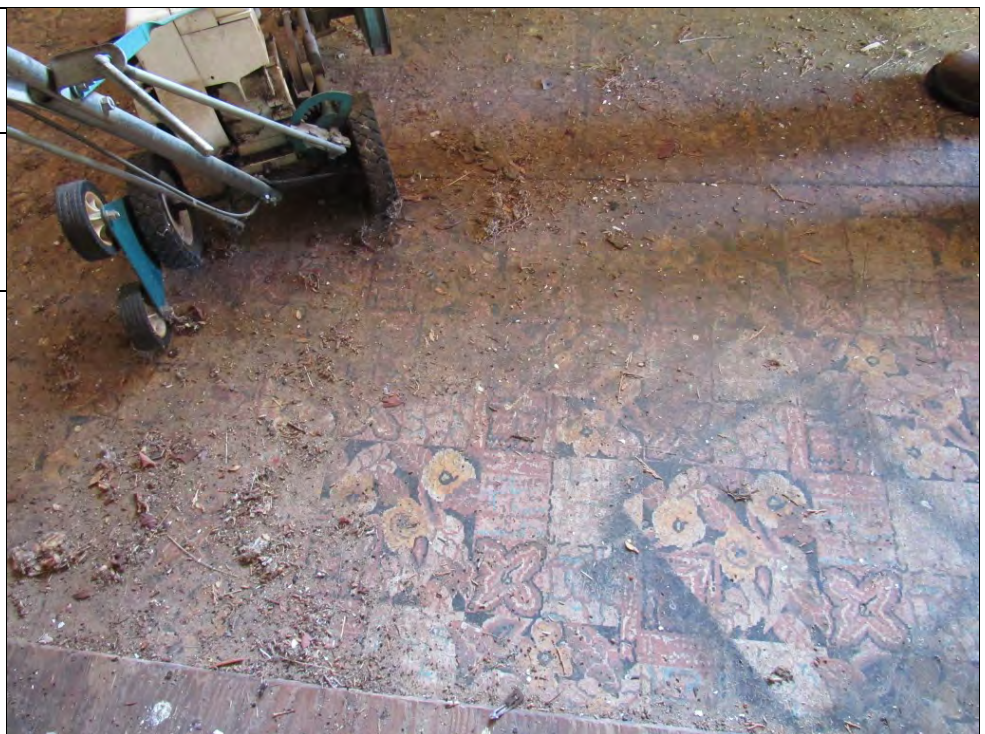
<b>Photo No./ Material ID:</b>  CC1R1 - 07	<b>Date:</b>  9/10/2018
<b>Structure/Material Location:</b>  Copco No. 1 Residence 1/ Flooring in Residence 1 Shed	
<b>*Description (by layer):</b>  1: Thin crumbly brown mastic (M) 2: Black and pink vinyl floor sheeting with square and flower pattern (M) 3: Black asphaltic paper backing with mastic (M)

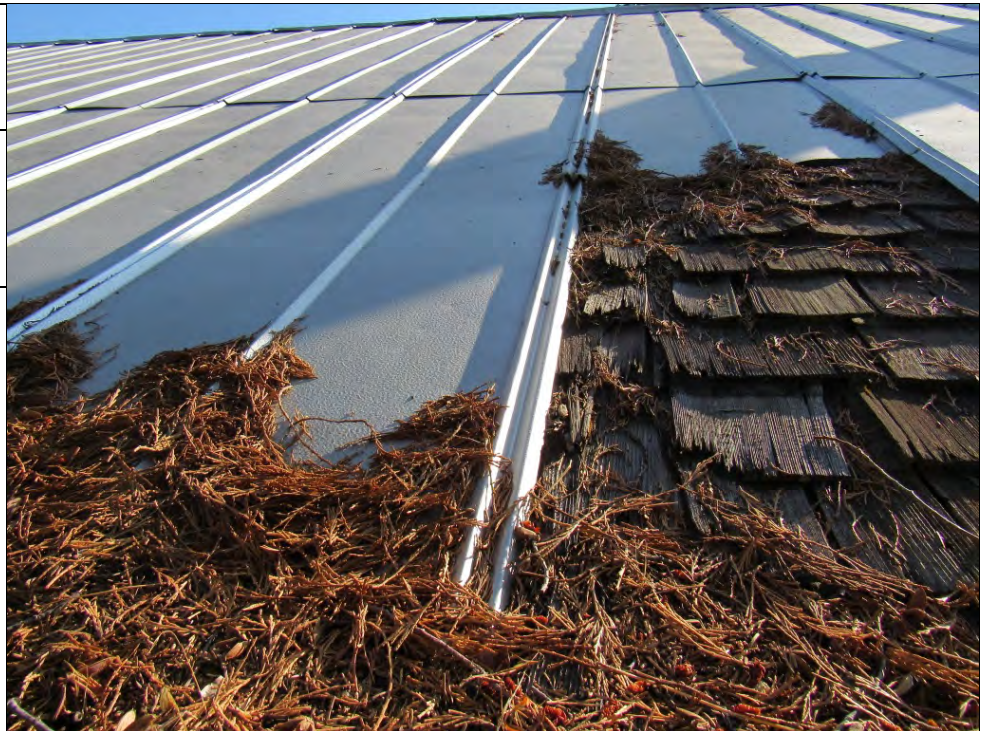
<b>Photo No./ Material ID:</b>  CC1R1 - 08	<b>Date:</b>  9/10/2018
<b>Structure/Material Location:</b>  Copco No. 1 Residence 1/ Throughout roof	
<b>*Description (by layer):</b> 1: Black asphaltic roofing paper (M) 2: Black asphaltic fibrous material (M) 3: Black asphaltic fibrous material (M)

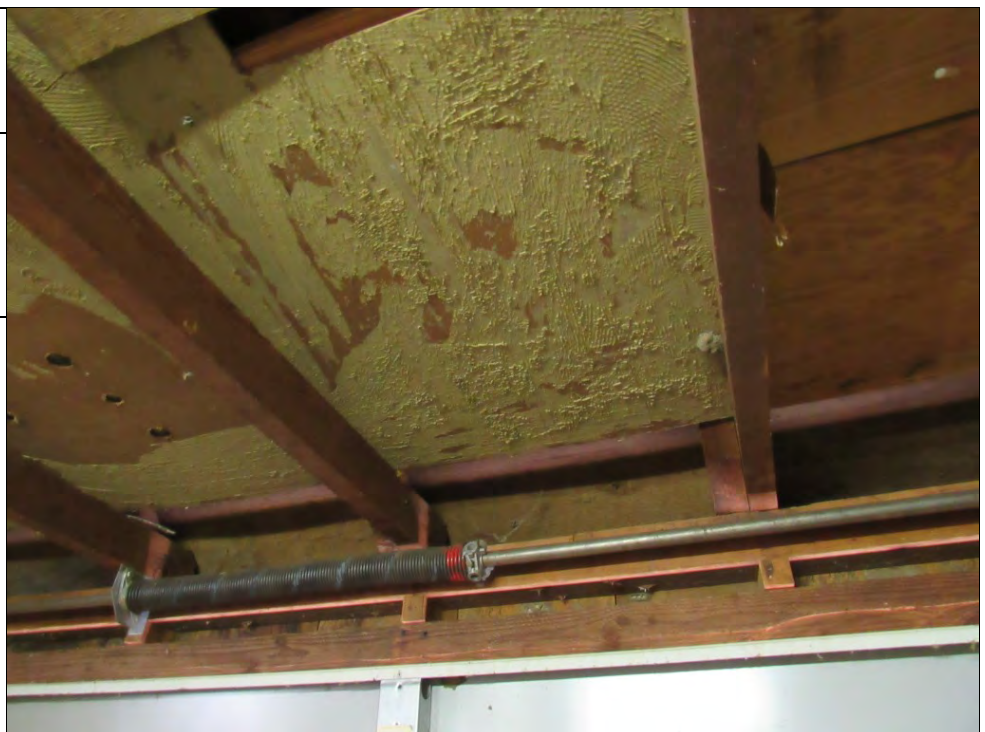
<b>Photo No./ Material ID:</b>  CC1R1 - 09	<b>Date:</b>  9/10/2018
<b>Structure/Material Location:</b>  Copco No. 1 Residence 1/ Residual mastic on plywood above garage rafters	
<b>*Description (by layer):</b> <b>1: Yellow mastic (M)</b>

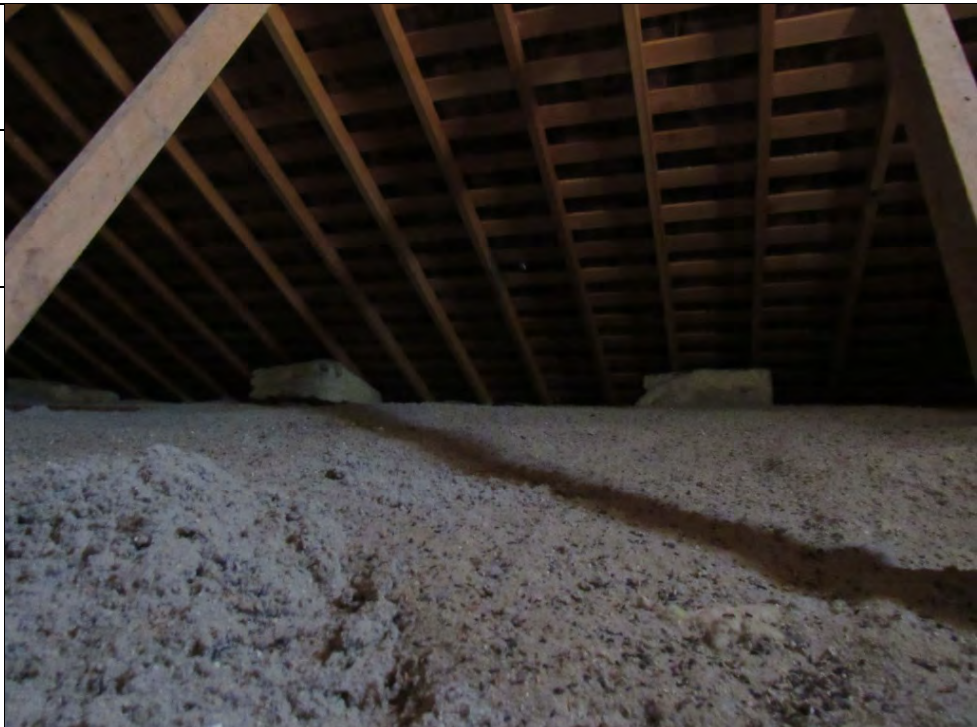
CC1R1 - 10	9/10/2018	
<b>Structure/Material Location:</b>  Copco No. 1 Residence 1/ Throughout attic		
<b>*Description (by layer):</b>  Visually assessed and determined to be non-suspect blown in cellulose insulation (TSI)

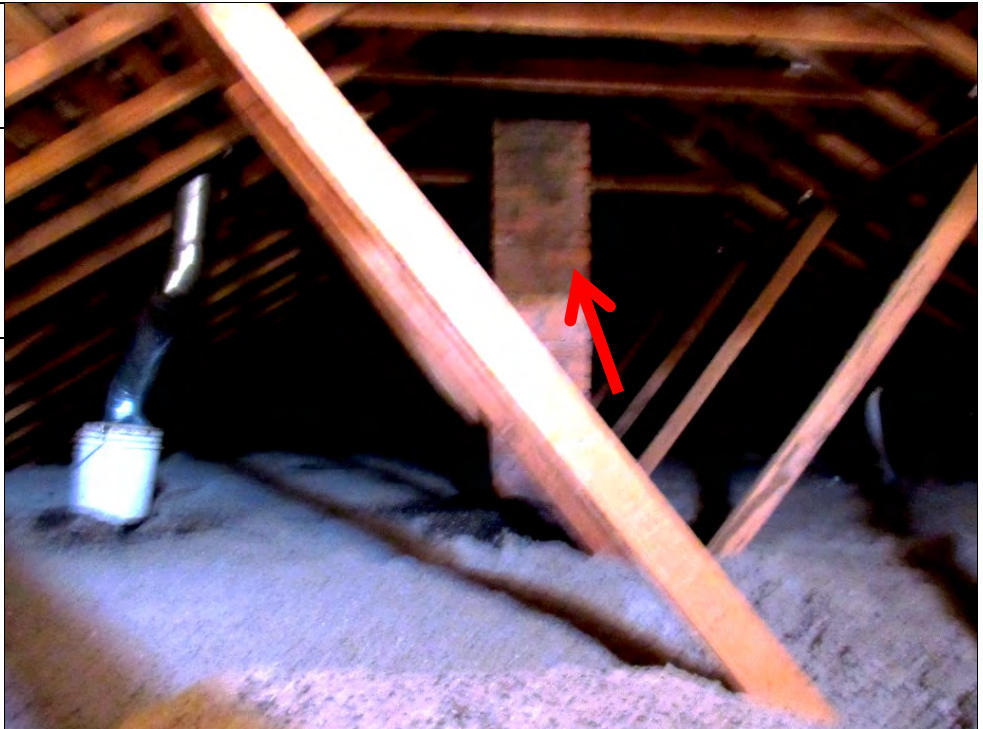
<b>Photo No./ Material ID:</b>	<b>Date:</b>
CC1R1 - 12	9/10/2018
<b>Structure/Material Location:</b>	
Copco No. 1 Residence 1/ Center of house, walled in with gypsum. Inaccessible at time of inspection.	
<b>*Description (by layer):</b>	
Assumed asbestos-containing gray chimney grout (M)

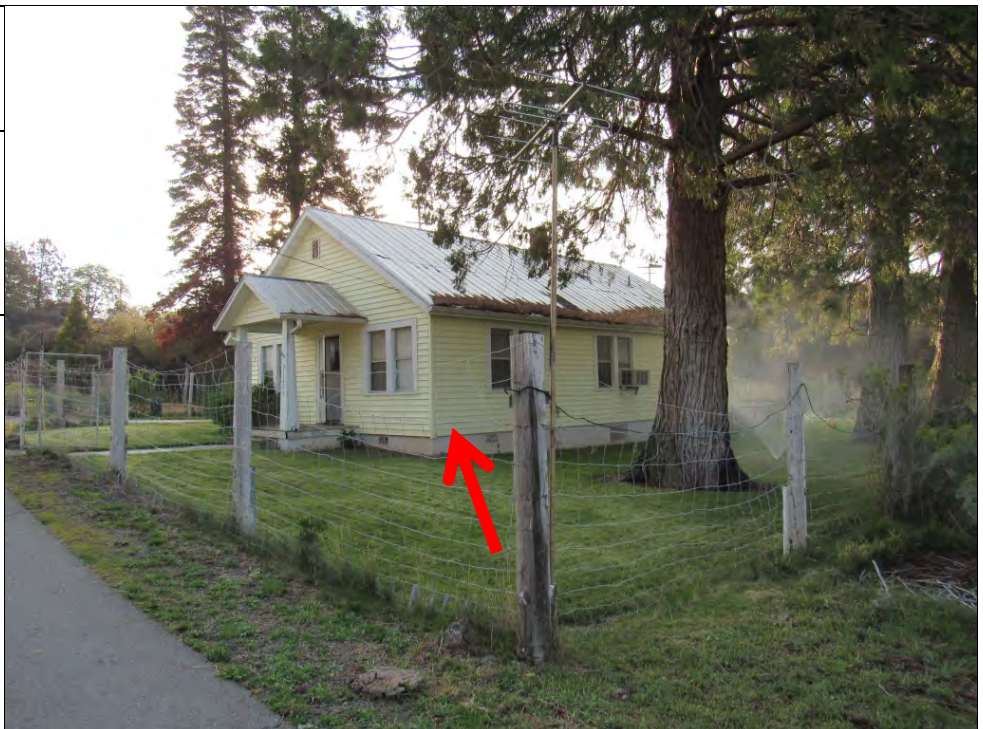
<b>Photo No./ Material ID:</b>	<b>Date:</b>
CC1R1 - 13	9/10/2018
<b>Structure/Material Location:</b>	
Copco No. 1 Residence 1/ Throughout exterior underneath metal siding	
<b>*Description (by layer):</b>	
Assumed asbestos-containing vapor barrier paper (M)

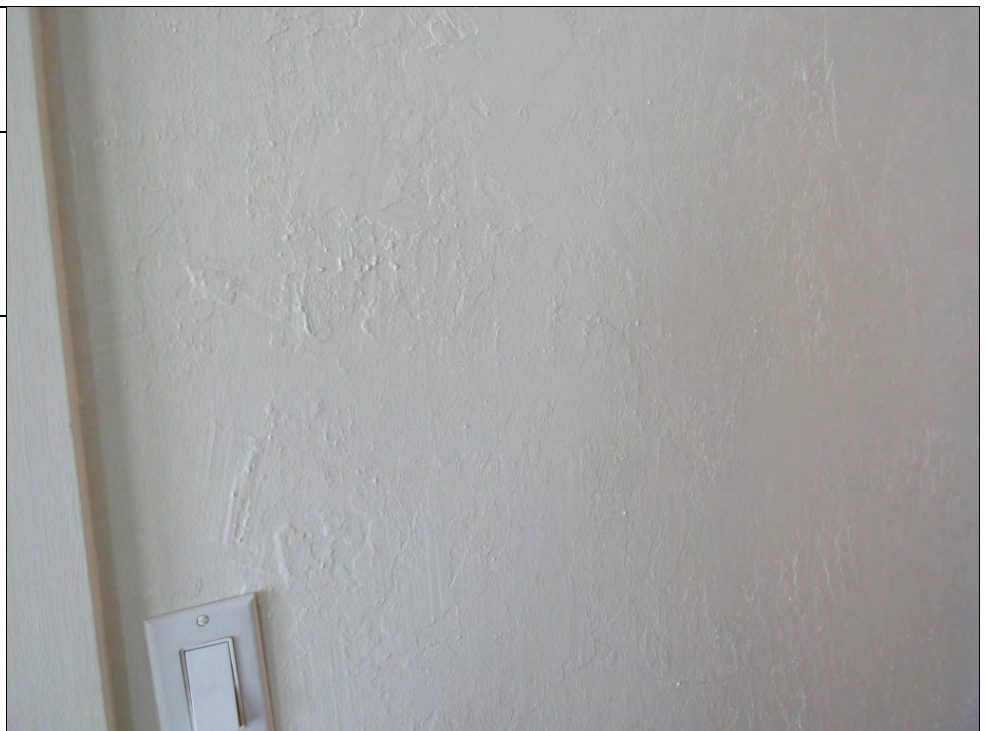
CC1R2 - 01

**1: White troweled-on surface  
coat (S)**

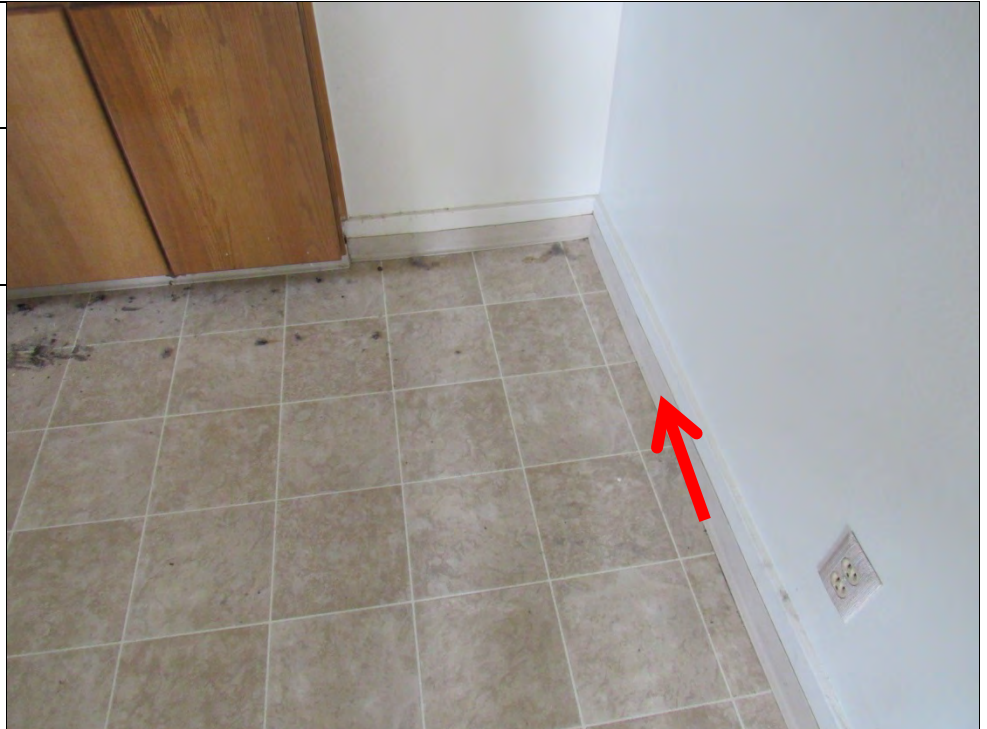
<b>Photo No./ Material ID:</b>  CC1R2 - 02	<b>Date:</b>  9/10/2018 to 9/11/2018
<b>Structure/Material Location:</b>  Copco No. 1 Residence 2/ Throughout roof	
<b>*Description (by layer):</b> 1: 3" off-white rubber cove base (M) 2: White mastic (M) <b>3: White troweled-on surface coat (S) (HSA 01)</b>

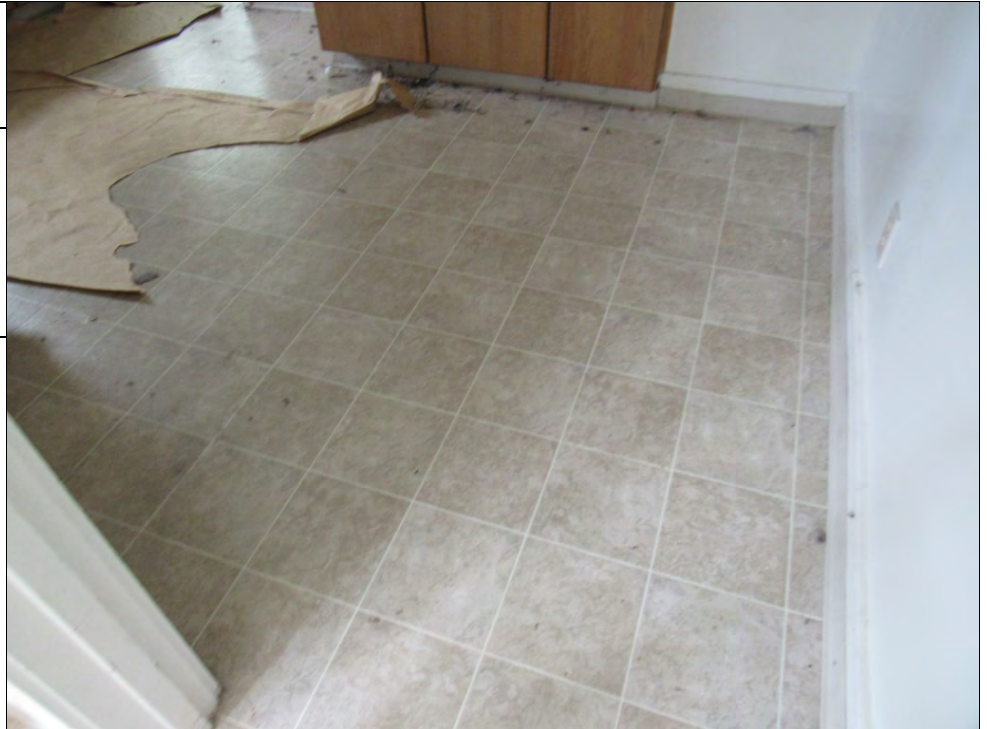
<b>Photo No./ Material ID:</b>  CC1R2 - 04	<b>Date:</b>  9/10/2018 to 9/11/2018
<b>Structure/Material Location:</b>  Copco No. 1 Residence 2/ Flooring in kitchen, mud room, and bathroom (underneath HSA 3)	
<b>*Description (by layer):</b>  1: Gray vinyl floor sheeting with gray pattern and yellow mastic (M) 2: White firm material (M) 3: White paper backing with mastic (M) 4: Tan mastic (M)

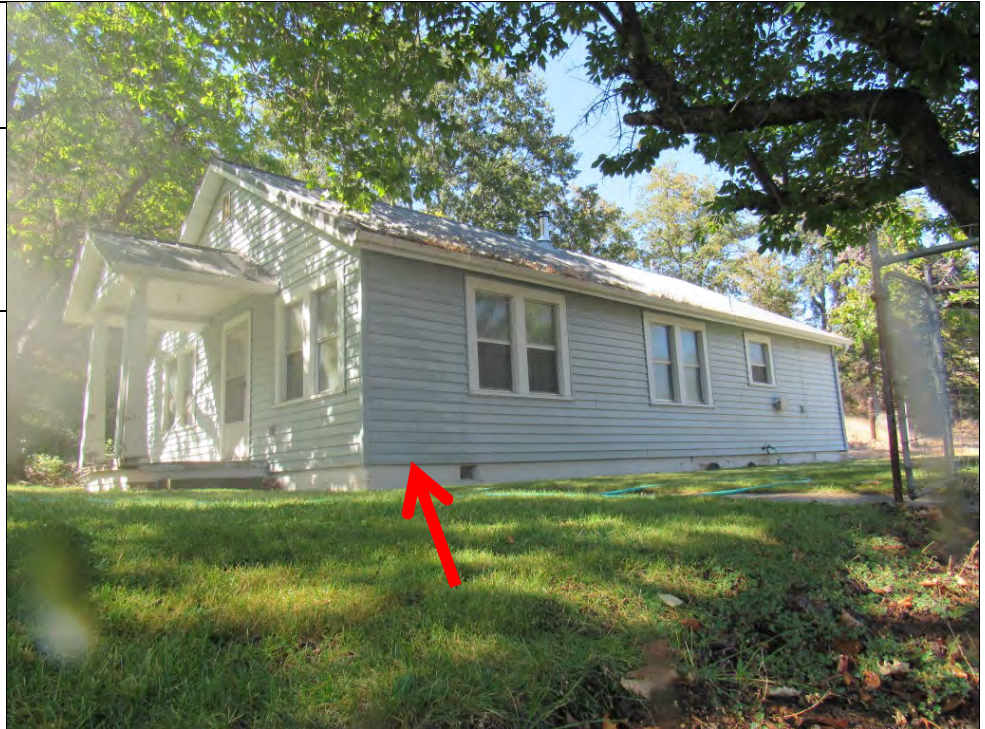
**Assumed asbestos-containing  
vapor barrier paper**

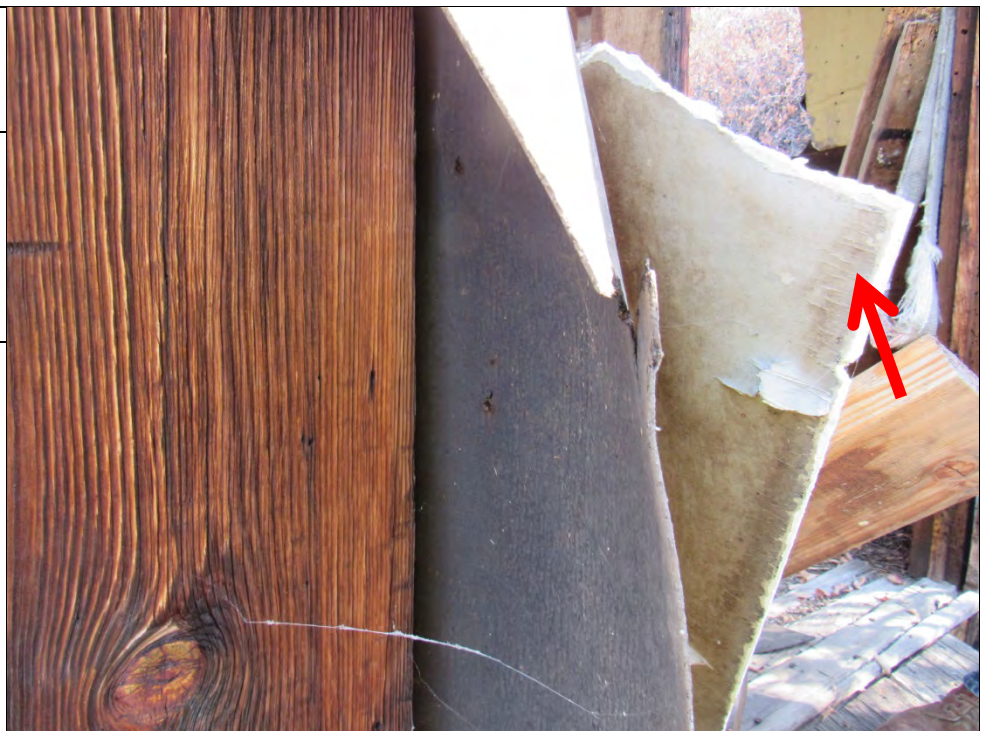
<b>Photo No./ Material ID:</b>  CC1RS - 01	<b>Date:</b>  9/10/2018 to 9/11/2018
<b>Structure/Material Location:</b>  Copco No. 1 Residence Shed/ Walls of residence shed, adjacent to lot area of Residence 1	
<b>*Description (by layer):</b>  1: White gypsum wallboard (M)

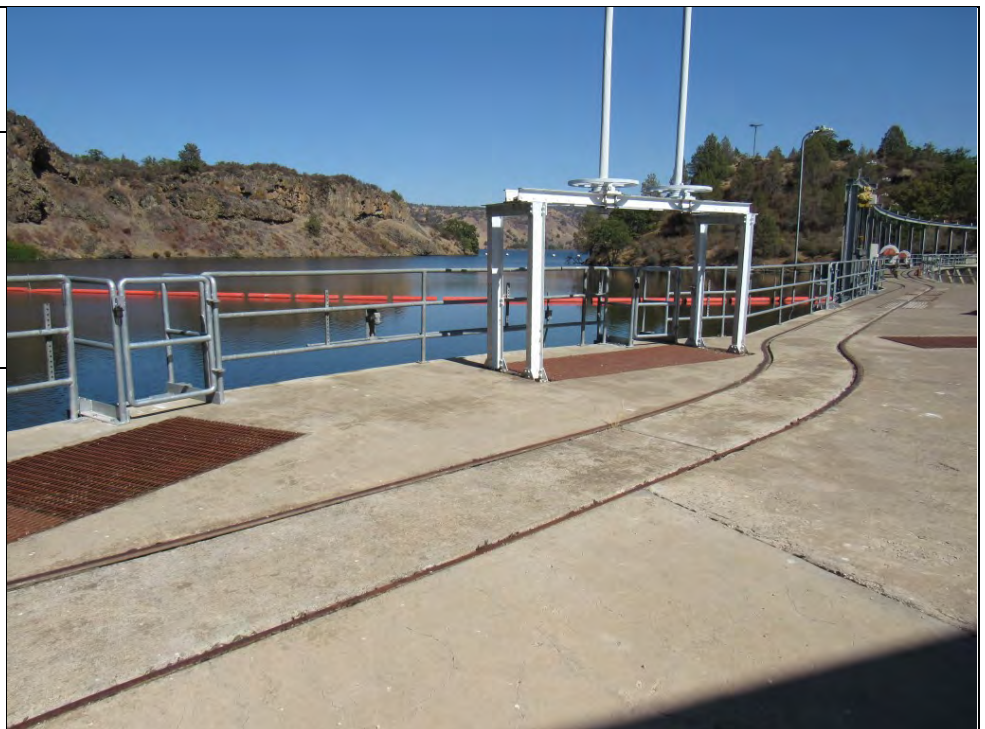
<b>Photo No./ Material ID:</b>  CC1RAIS - 01	<b>Date:</b>  9/10/2018 to 9/11/2018
<b>Structure/Material Location:</b>  Copco No. 1 Dam, Right Abutment Intake Structure/ Walkway above right abutment intake structure	
<b>*Description (by layer):</b>  1: Poured concrete (M)

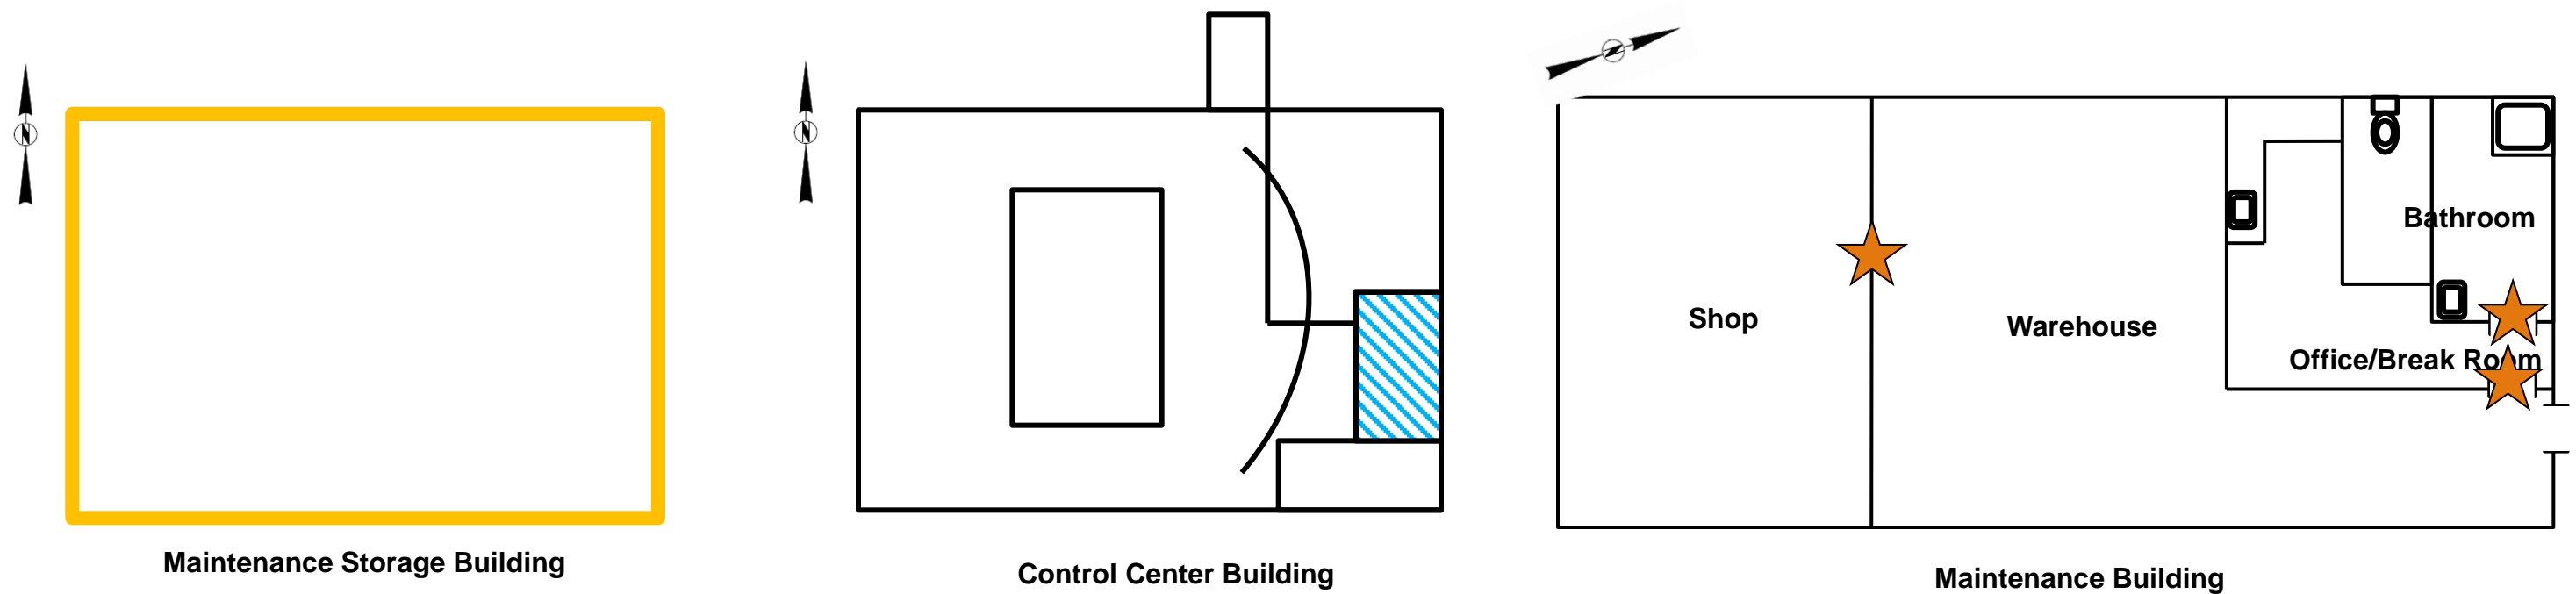
**Figure 16**  
**Approximate ACM Locations**  
**Control Center Building, Maintenance Storage Building, and Maintenance Building**

CC2MB-08: Assumed asbestos-containing metal-clad fire door insulation (M)

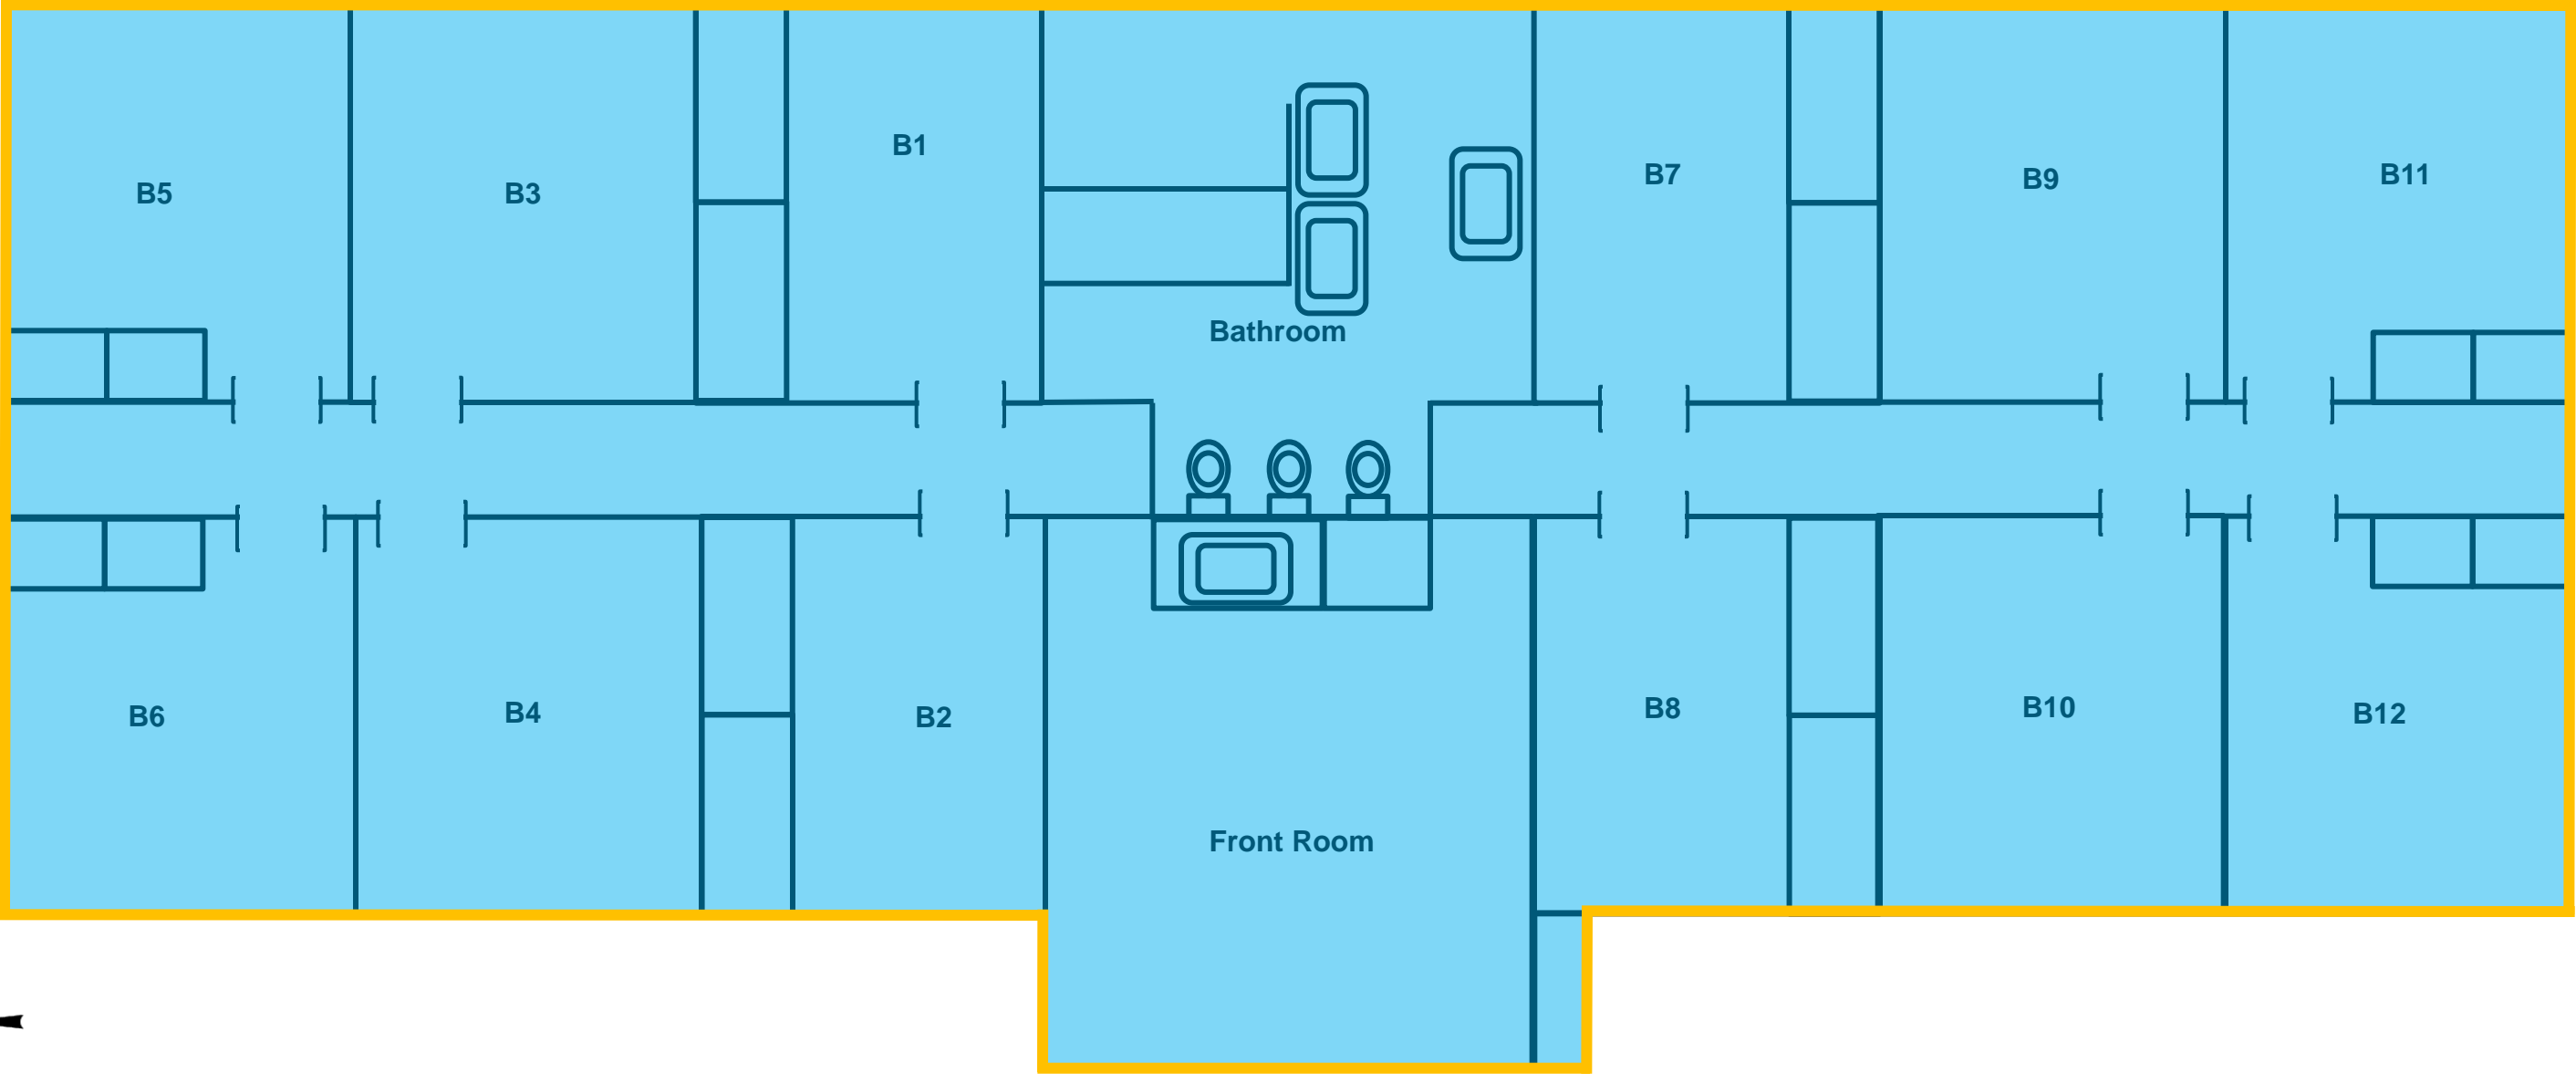
**Figure 17**  
**Approximate ACM Locations**  
**Former Bunkhouse**

Not shown: CC2FBH-13: Asbestos-containing brown/gray cementitious material debris scattered throughout exterior in landscaping cover rock (M)

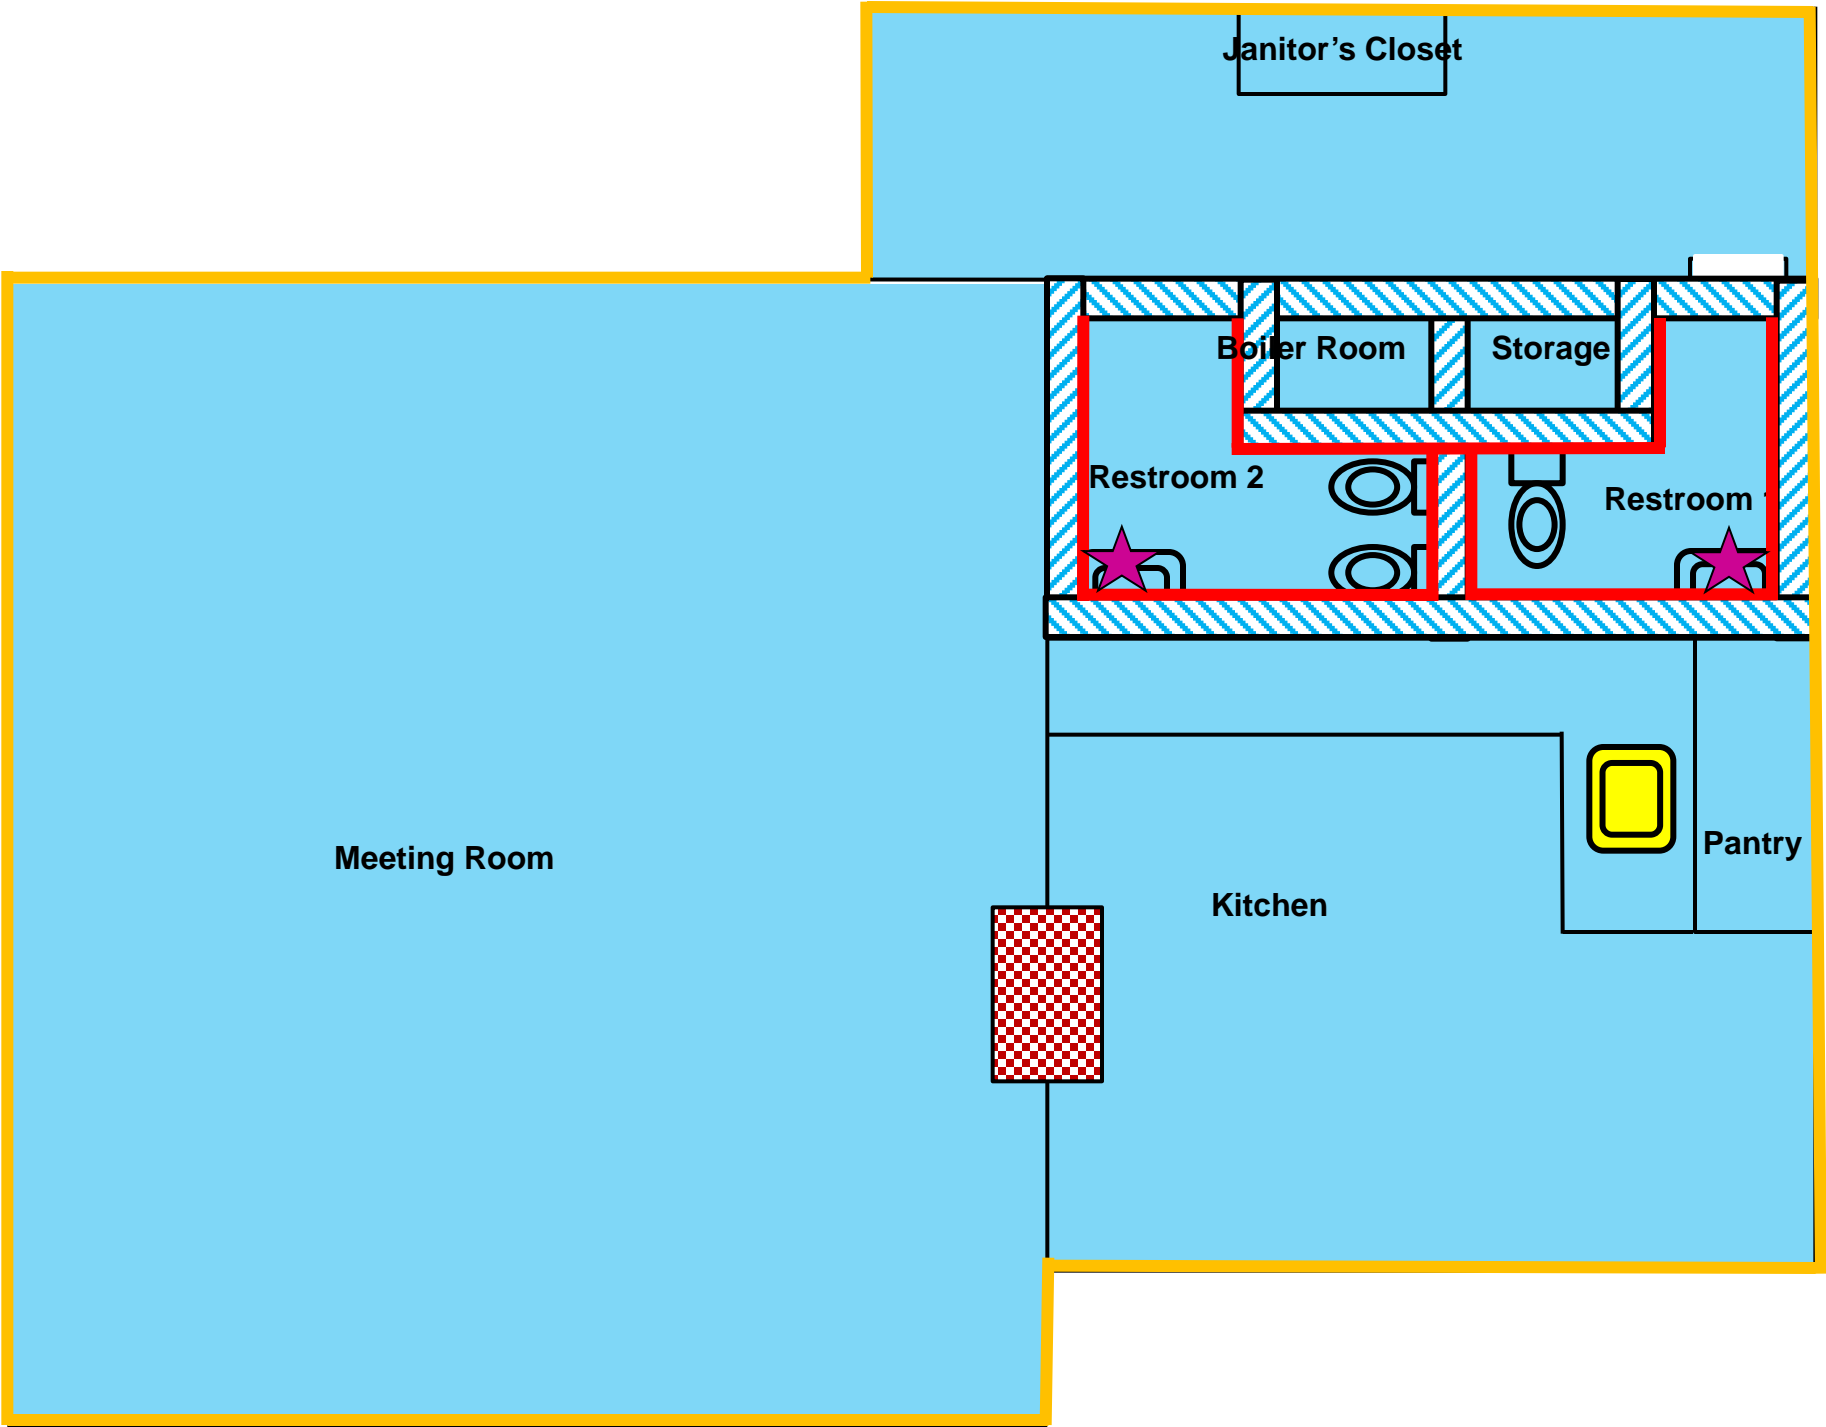
**Figure 18**  
**Approximate ACM Locations**  
**Former School**

CC2FS-12: Assumed asbestos-containing mirror mastic (M)
- CC2FS-12: Assumed asbestos-containing mirror mastic (M)
- CC2FS-12: Assumed asbestos-containing mirror mastic (M)

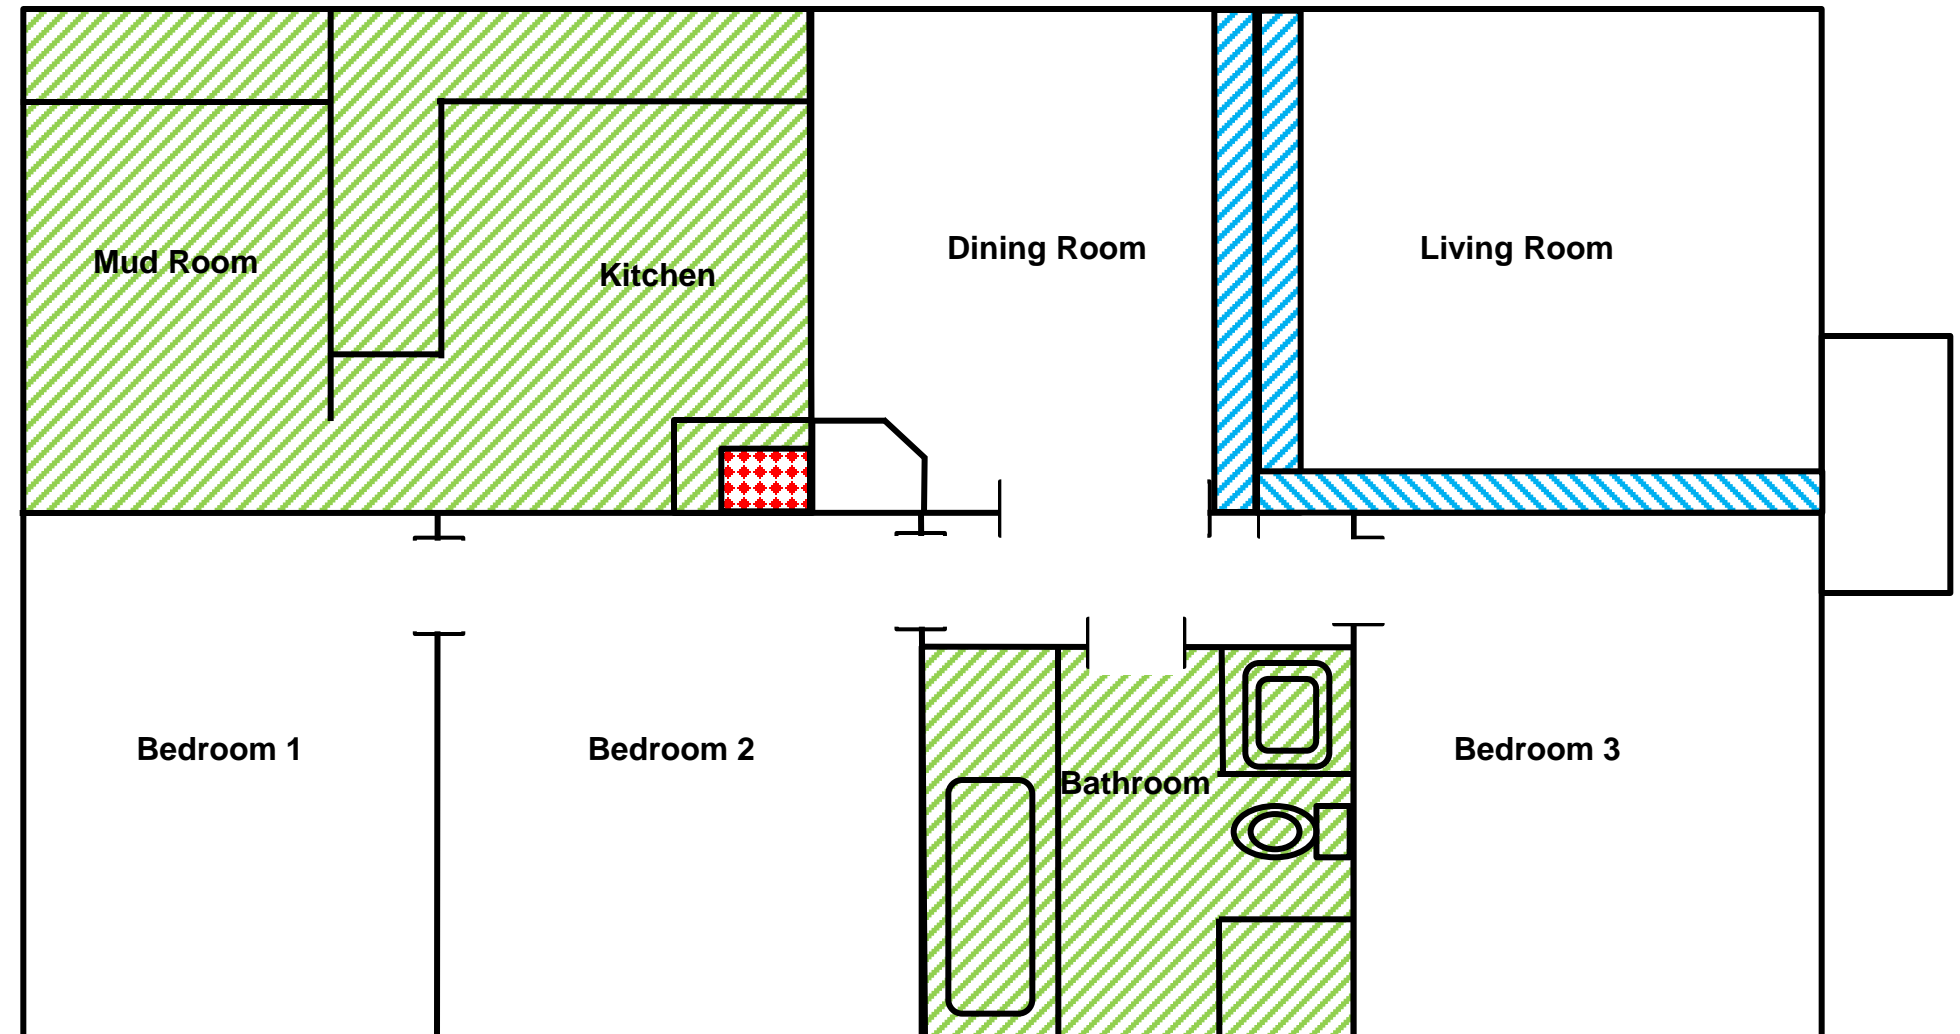
**Figure 20**  
Approximate ACM Locations  
Fomer Residence 3

CC2R3-14: Assumed asbestos-containing electrical panel backing in older electrical panels (M)

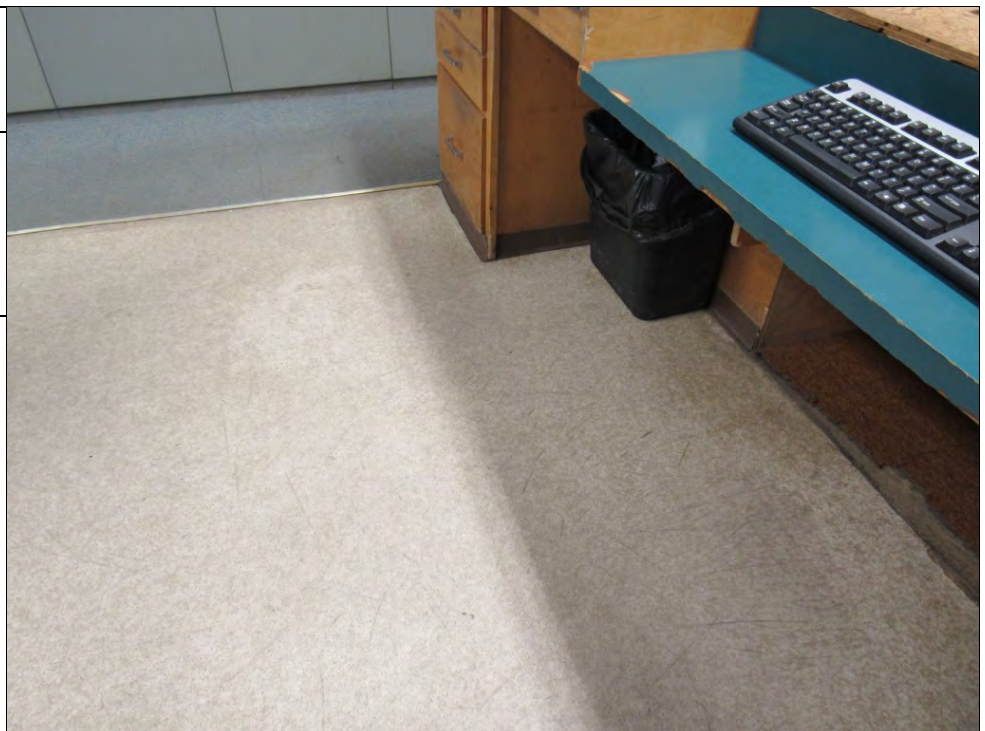
CC2CCB - 01

- 1: Off-white vinyl floor sheeting  
with tan terrazzo pattern (M)
- 2: Gray paper backing with  
yellow mastic (M)

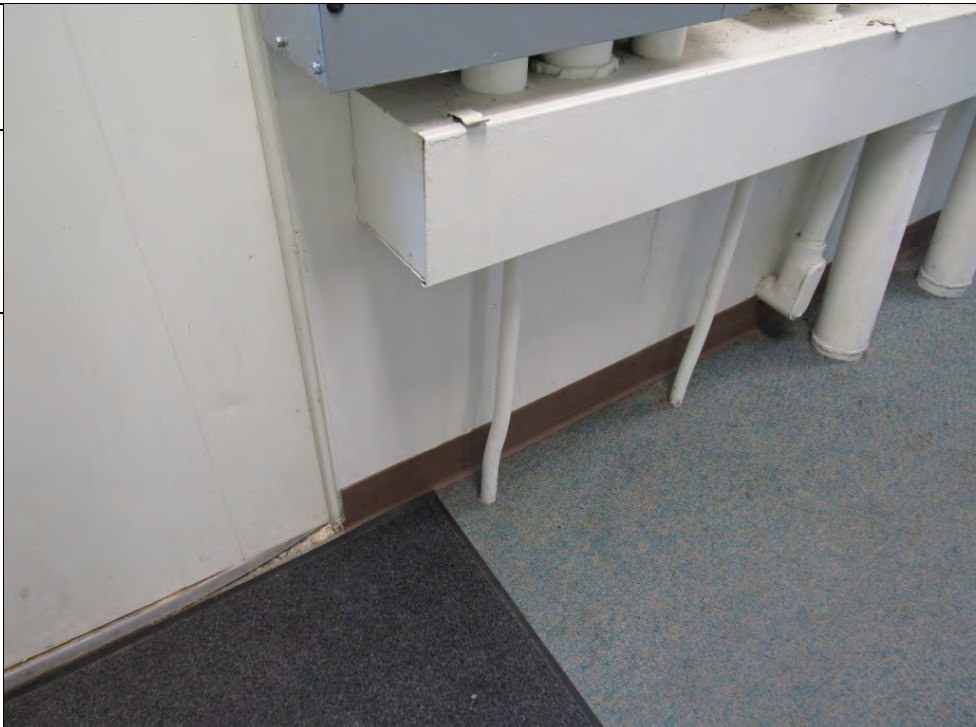
CC2CCB - 02	9/11/2018 to 9/13/2018	
<b>Structure/Material Location:</b>  Copco No. 2 Control Center Building/ Walls in operations room		
<b>*Description (by layer):</b>  1: 4" brown rubber cove base (M) 2: Yellow mastic (M) 3: Silver paint (M)

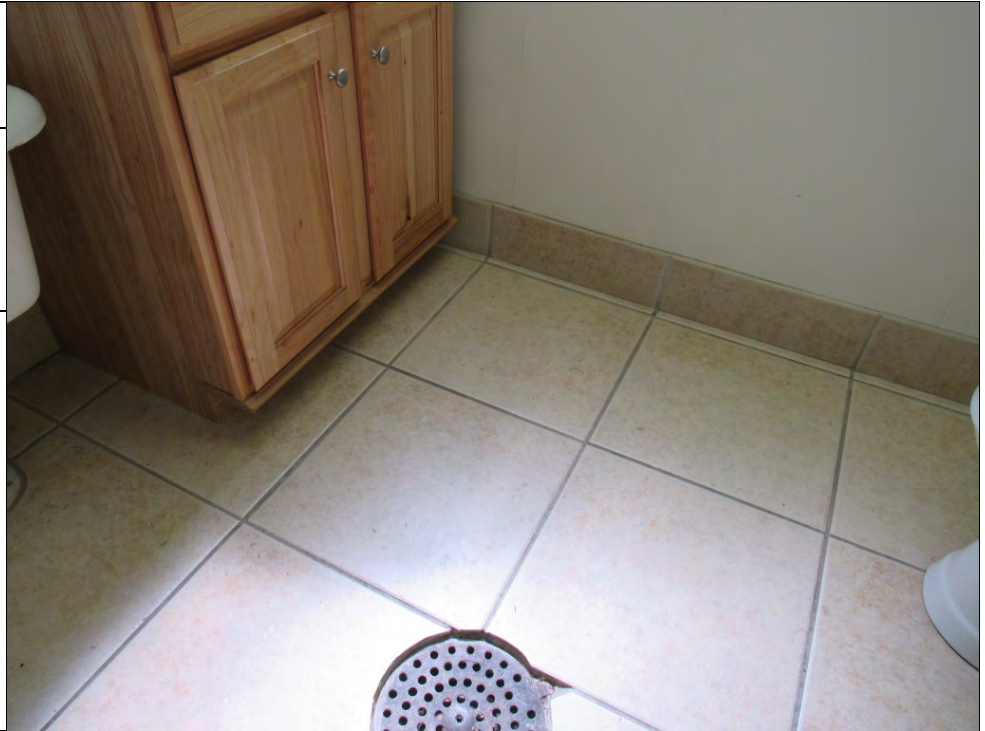
**Assumed asbestos-containing  
grouts and mastics associated  
with ceramic tiles (M)**

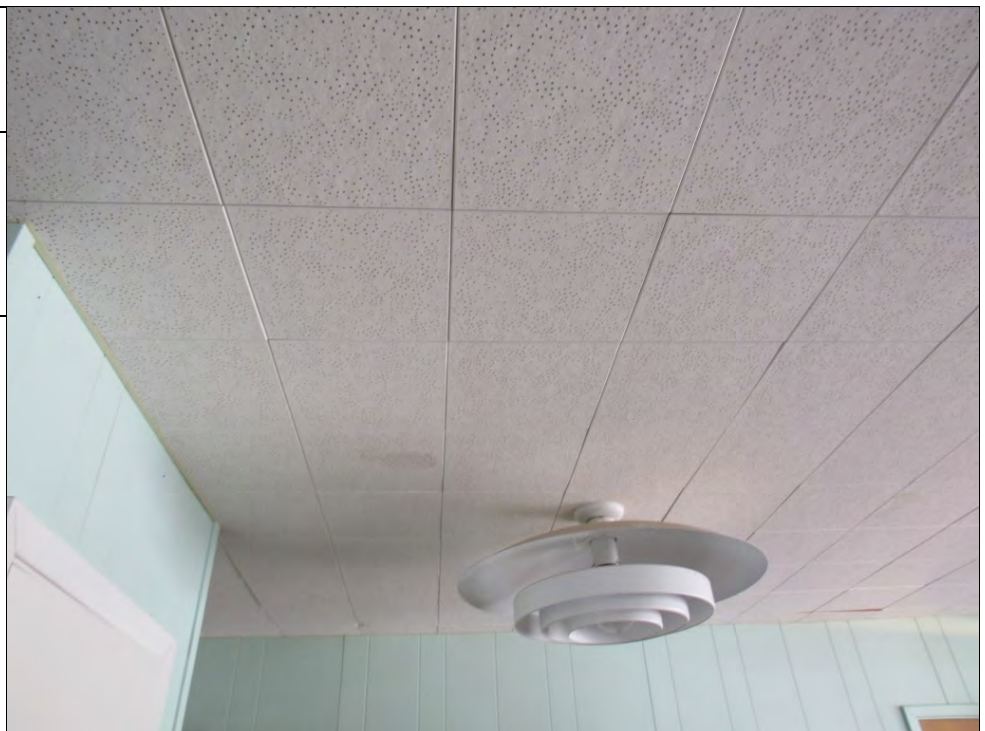
CC2FBH - 01

1: 12"x12" white glued-on ceiling  
tile with pinholes (associated  
with HSA 8 - brown glue dots)  
(M)

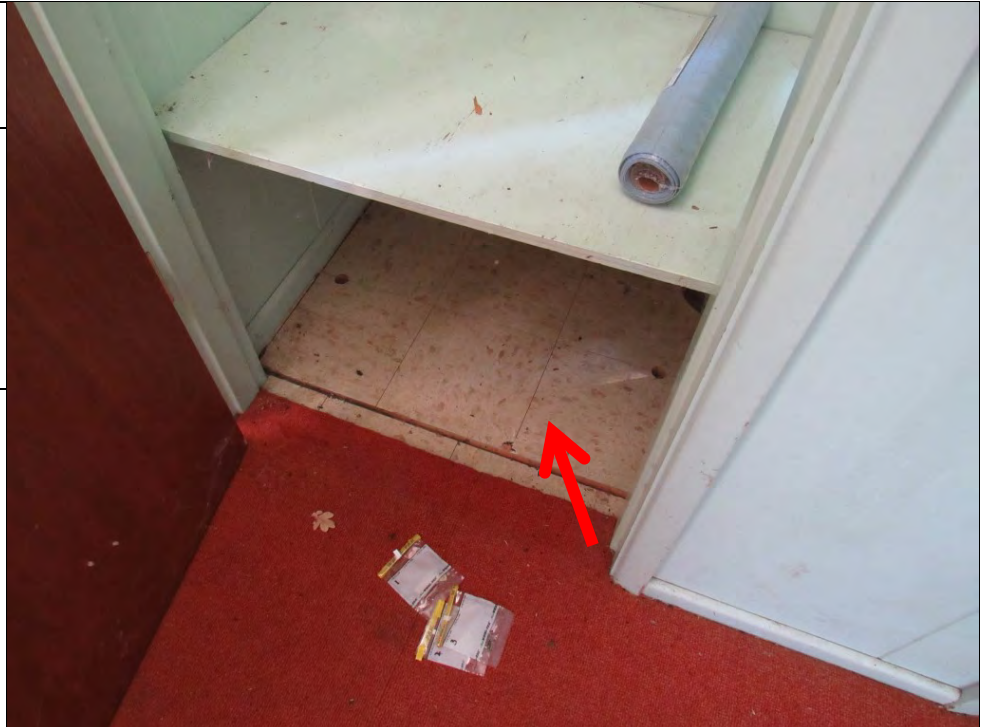
<b>Photo No./ Material ID:</b>  CC2FBH - 02	<b>Date:</b>  9/11/2018 to 9/13/2018
<b>Structure/Material Location:</b>  Copco No. 2 Former Bunkhouse/ Flooring throughout all rooms except bathroom, underneath orange carpeting except in bunk room closets where there is no carpeting	
<b>*Description (by layer):</b>  <b>1: 9"x9" off-white vinyl floor tile with gray and tan streak pattern (M)</b> <b>2: Black asphaltic mastic (M)</b>
