**Klamath River Renewal Corporation  
PacifiCorp**

**AMENDED APPLICATION FOR SURRENDER OF LICENSE  
FOR MAJOR PROJECT AND REMOVAL OF PROJECT WORKS**

**EXHIBIT N (1 of 2)  
Waste Disposal and Hazardous Materials Management Plan  
(Amended December 15, 2021)**

**Waste Disposal and  
Hazardous Materials  
Management Plan**

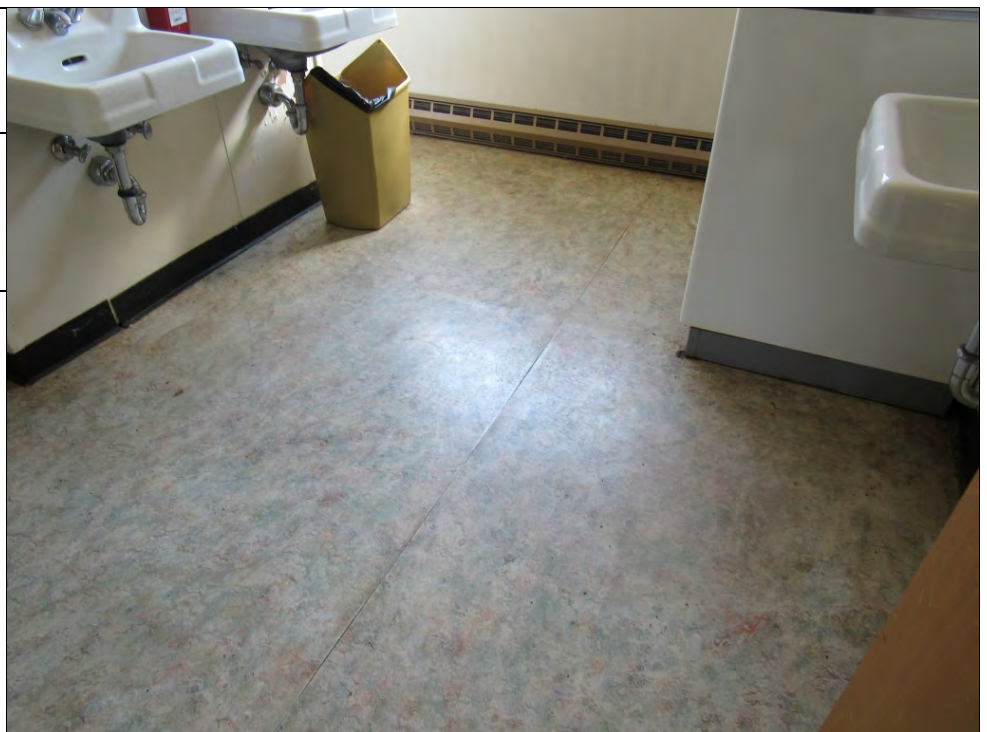
<b>Photo No./ Material ID:</b>  CC2FBH - 03	<b>Date:</b>  9/11/2018 to 9/13/2018
<b>Structure/Material Location:</b>  Copco No. 2 Former Bunkhouse/ Flooring in bathroom	
<b>*Description (by layer):</b>  <b>1: Light blue linoleum with pink and gray marble pattern (M)</b> <b>2: Tan woven canvas backing with white mastic (M)</b>

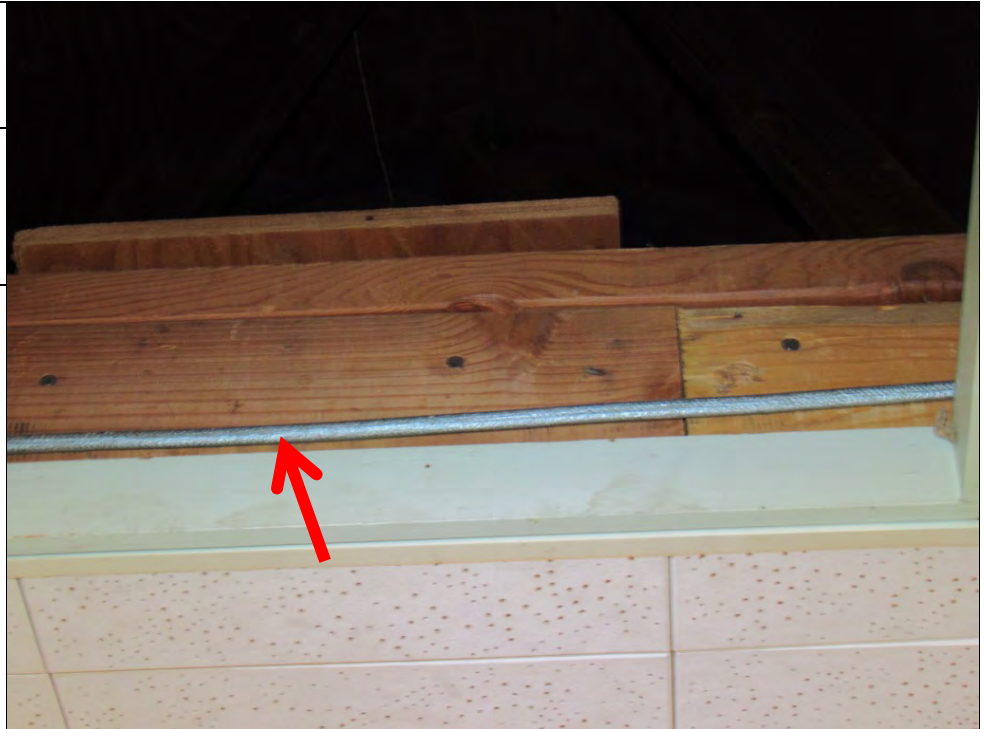
<b>Photo No./ Material ID:</b>  CC2FBH - 10	<b>Date:</b>  9/11/2018 to 9/13/2018
<b>Structure/Material Location:</b>  Copco No. 2 Former Bunkhouse/ In attic	
<b>*Description (by layer):</b>  <b>Assumed asbestos-containing silver woven fiberglass electrical wire insulation (M)</b>

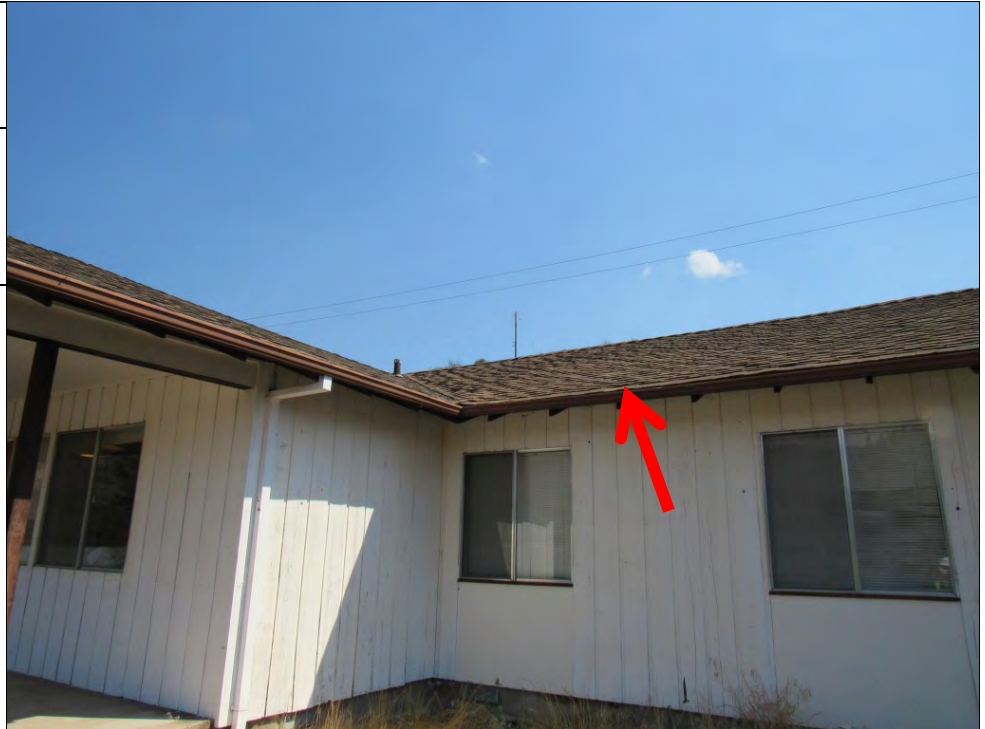
<b>Photo No./ Material ID:</b>  CC2FBH - 12	<b>Date:</b>  9/11/2018 to 9/13/2018
<b>Structure/Material Location:</b>  Copco No. 2 Former Bunkhouse/ Throughout roof	
<b>*Description (by layer):</b>  <b>Assumed asbestos-containing roofing paper (M)</b>

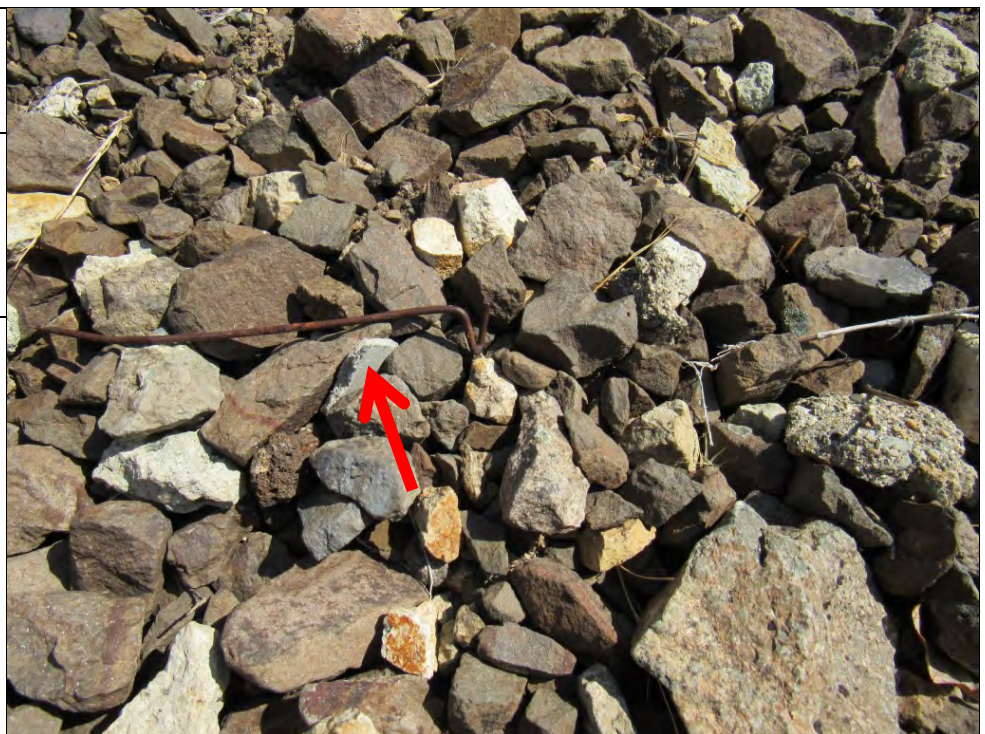
<b>Photo No./ Material ID:</b>  CC2FBH - 13	<b>Date:</b>  9/11/2018 to 9/13/2018
<b>Structure/Material Location:</b>  Copco No. 2 Former Bunkhouse/ Scattered throughout exterior in landscaping rock cover	
<b>*Description (by layer):</b>  <b>1: Cement asbestos board (CAB) debris (M)</b>

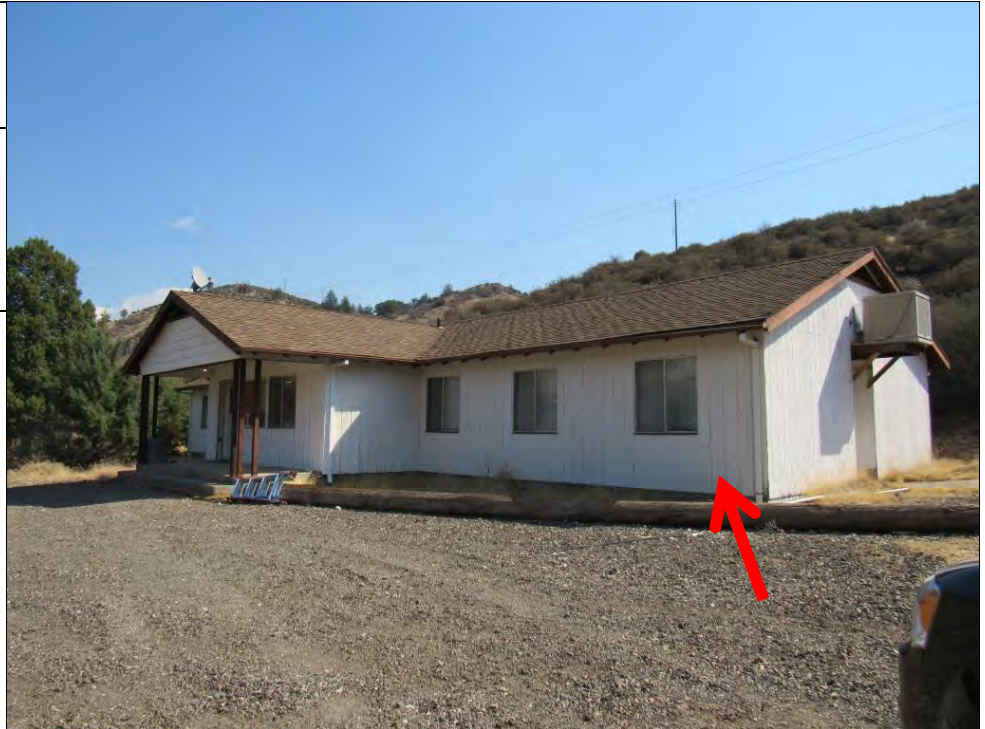
**1: Assumed asbestos-  
containing vapor barrier paper  
(M)**

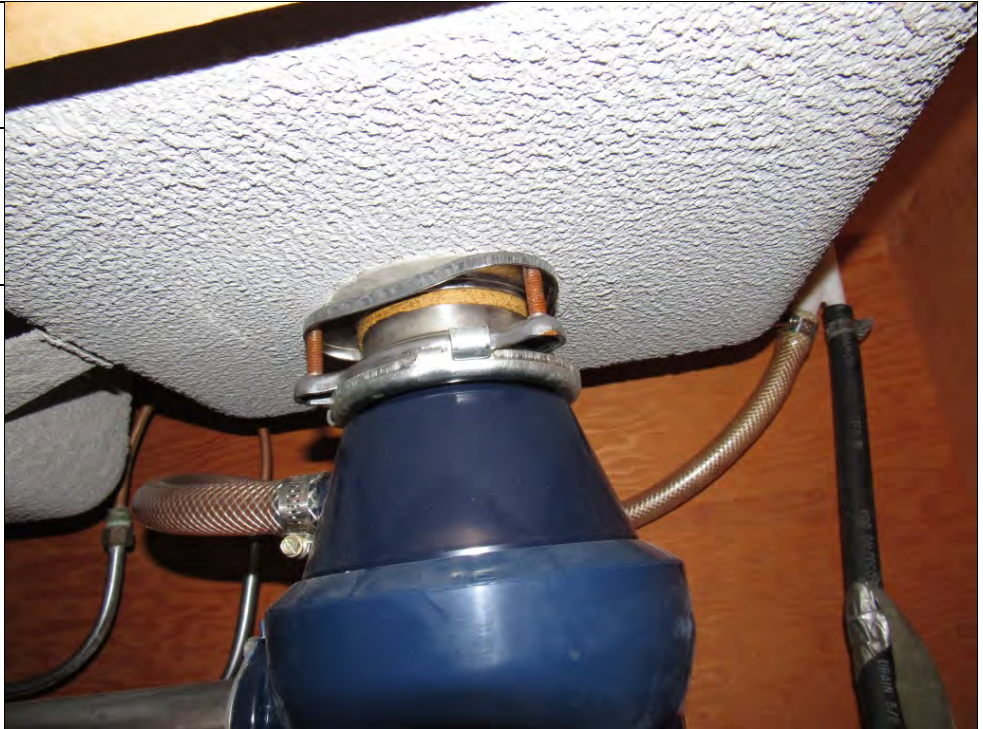
CC2FS - 02

**Date:**9/11/2018 to  
9/13/2018**Structure/Material Location:**Copco No. 2 Former School/  
Kitchen sink**\*Description (by layer):****1: Gray sink undercoating (M)**

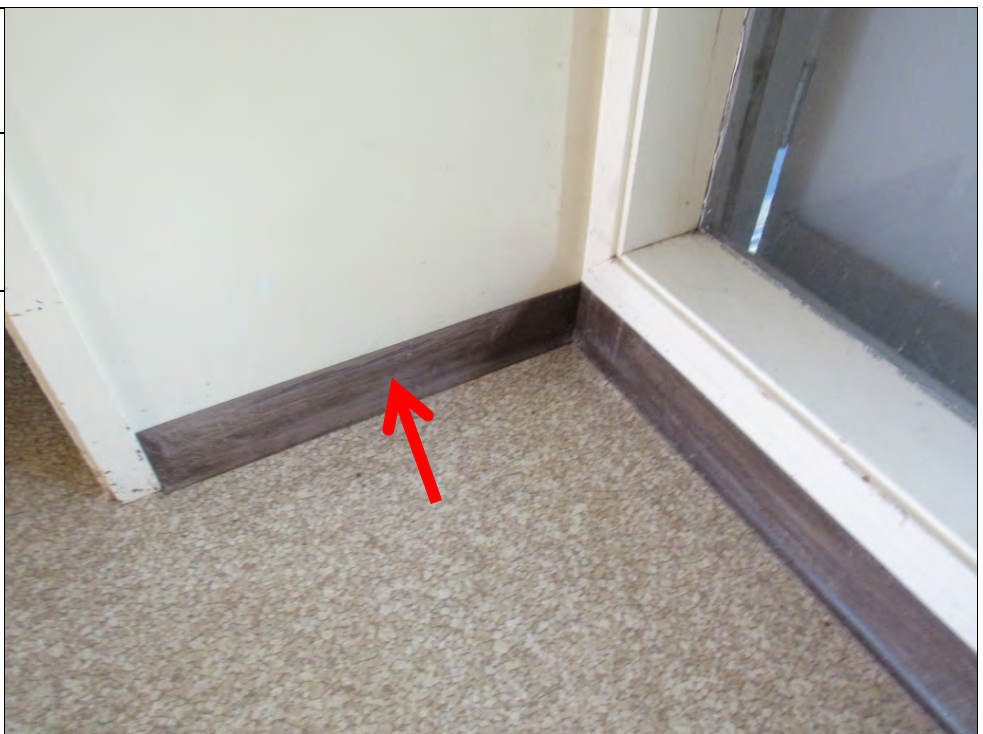
CC2FS - 03

**Date:**9/11/2018 to  
9/13/2018**Structure/Material Location:**Copco No. 2 Former School/  
Walls throughout all rooms**\*Description (by layer):****1: 4" brown rubber cove base (M)**  
**2: Off-white mastic (M)**

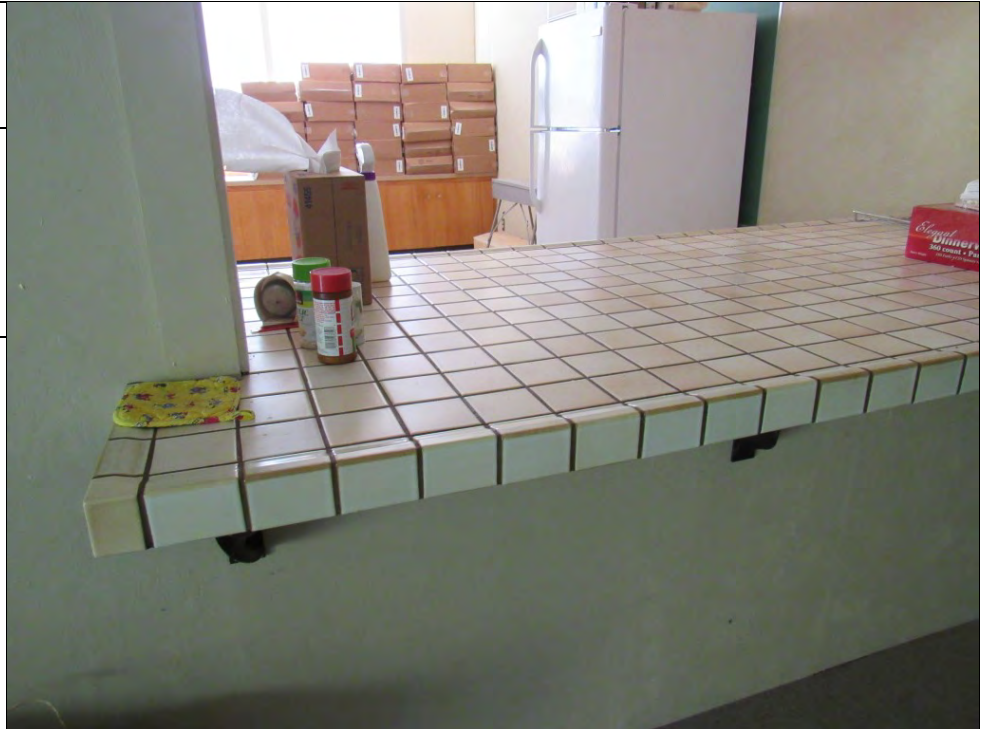
**Assumed-asbestos containing  
grouts and mastics associated  
with 4"x4" white ceramic  
counter tile (M)**

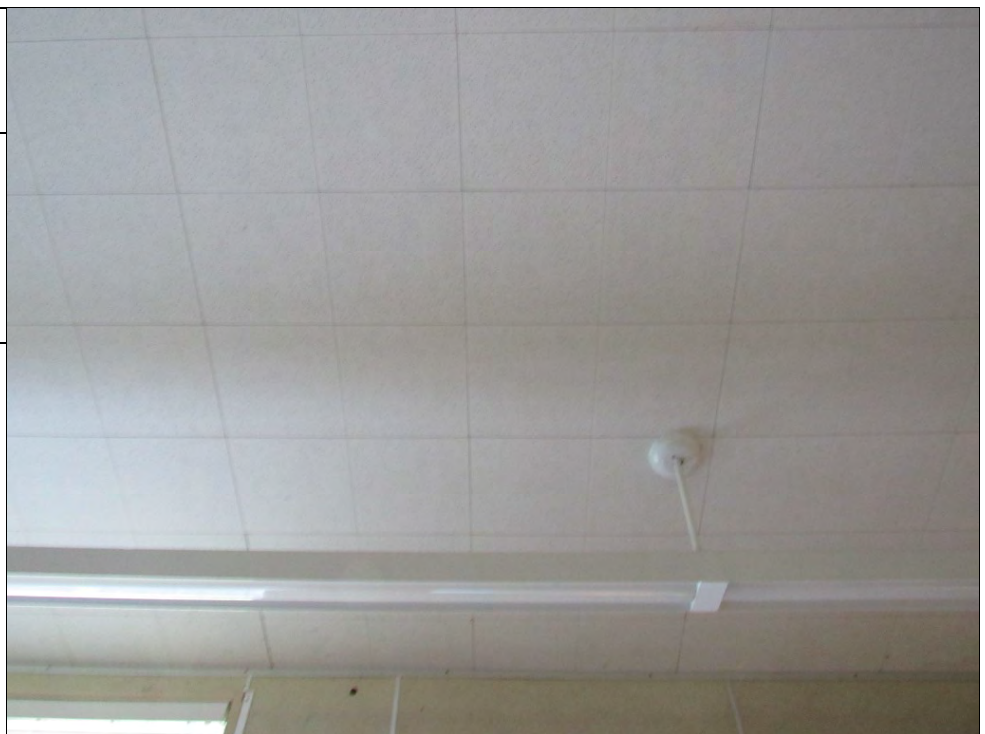
**1: 12"x12" white tongue and  
groove nailed-on ceiling tiles (M)**

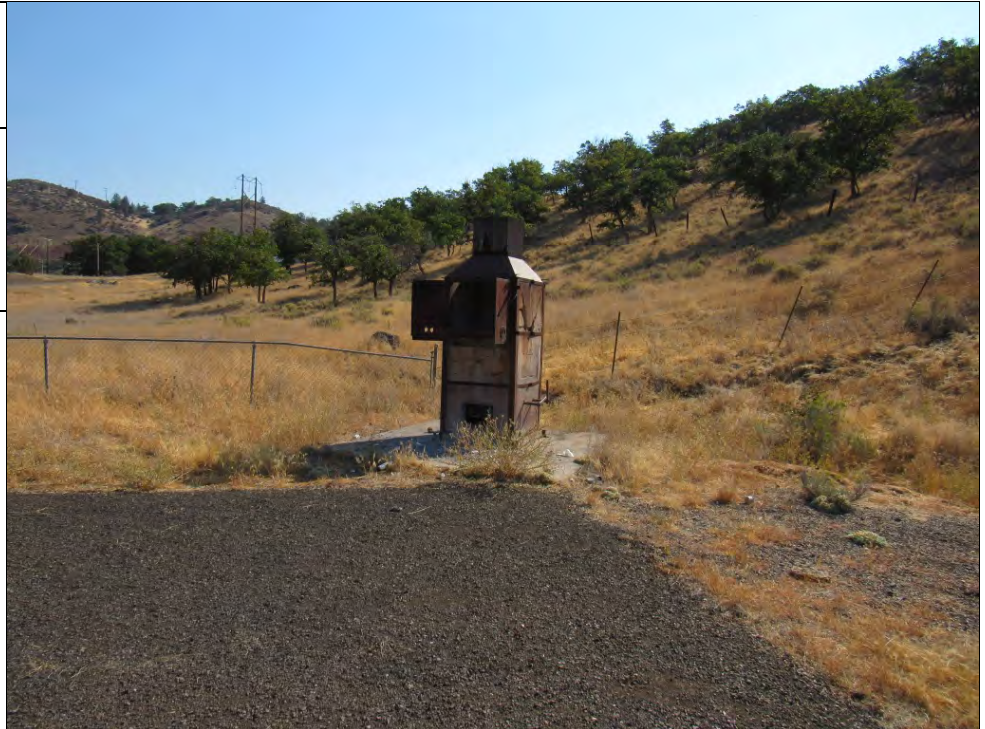
1: Light pink fire brick (M)

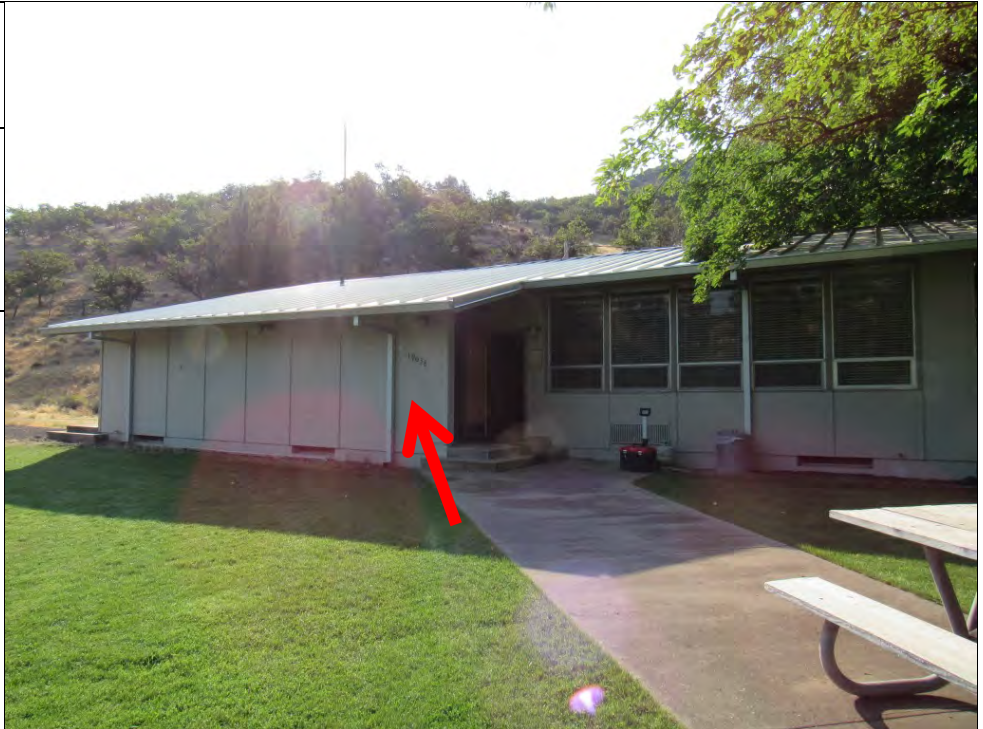
**Assumed asbestos-containing  
vapor barrier paper**

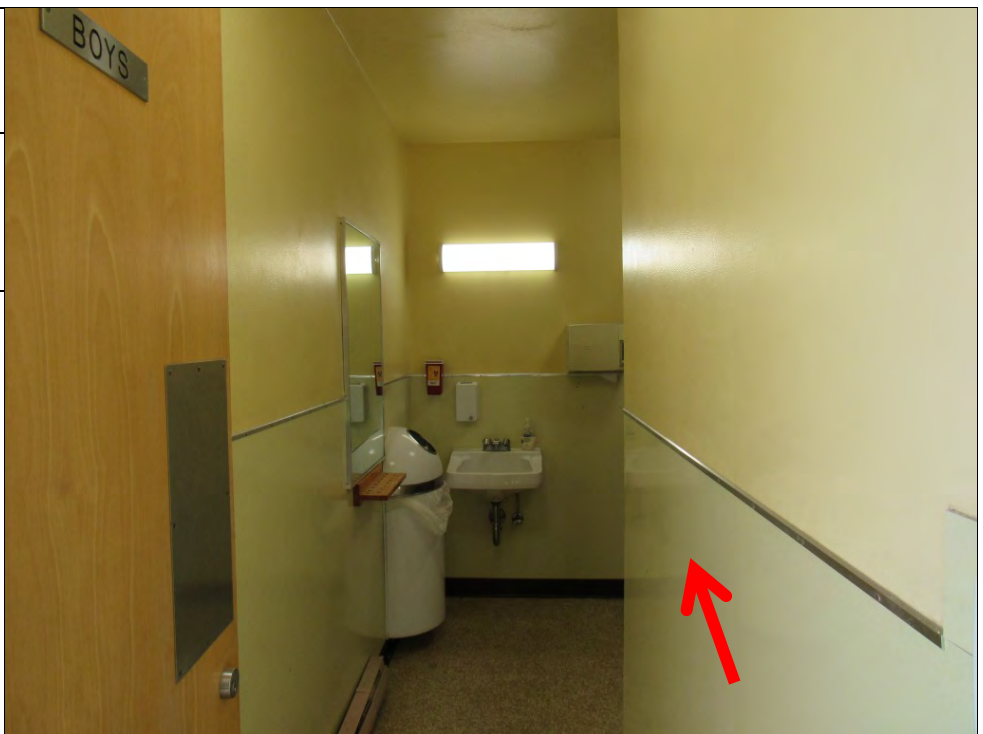
**Assumed asbestos-containing  
mastic behind plastic wall  
panels (M)**

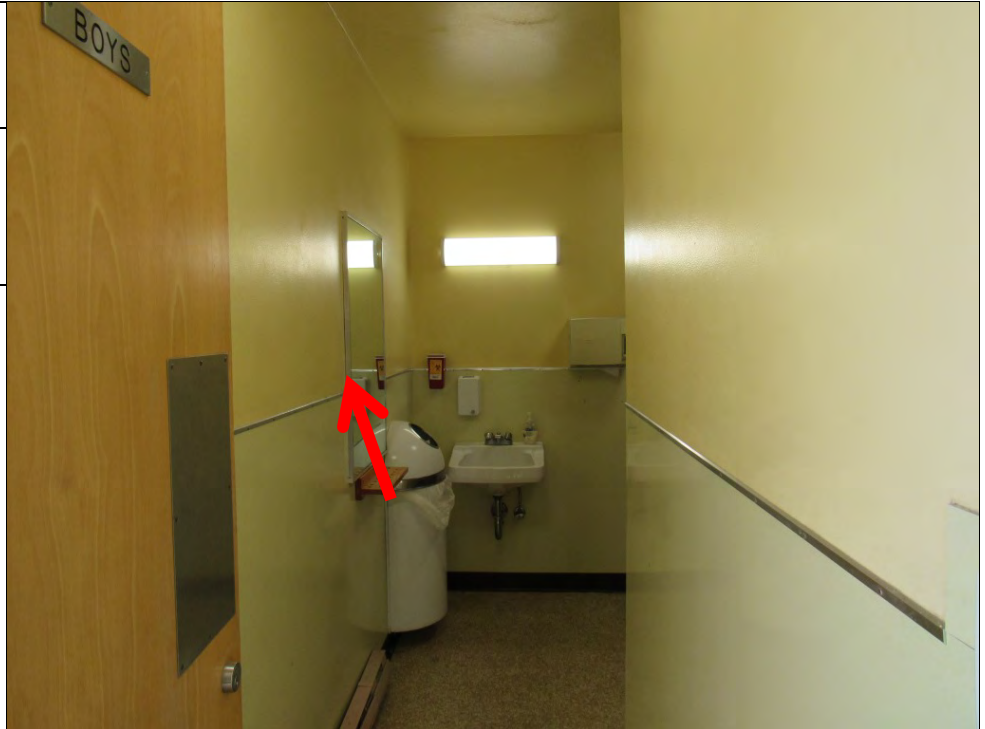
**Assumed asbestos-containing  
mirror mastic (M)**

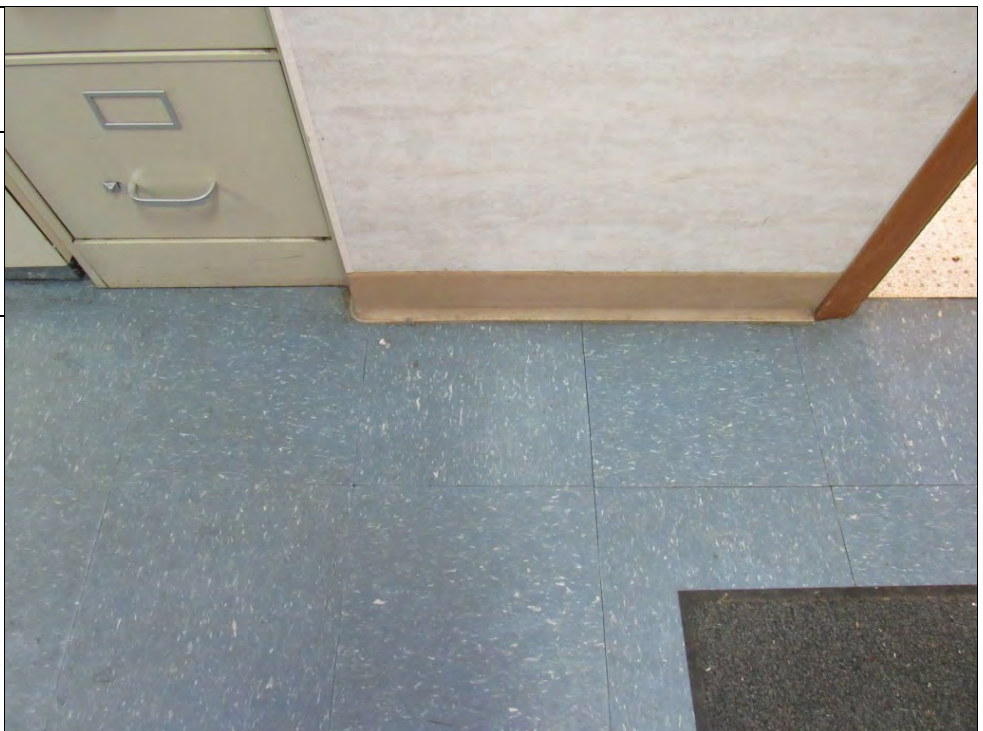
- 1: 12"x12" blue vinyl floor tile  
with clear adhesive (M)
- 2: Off-white soft mastic (M)

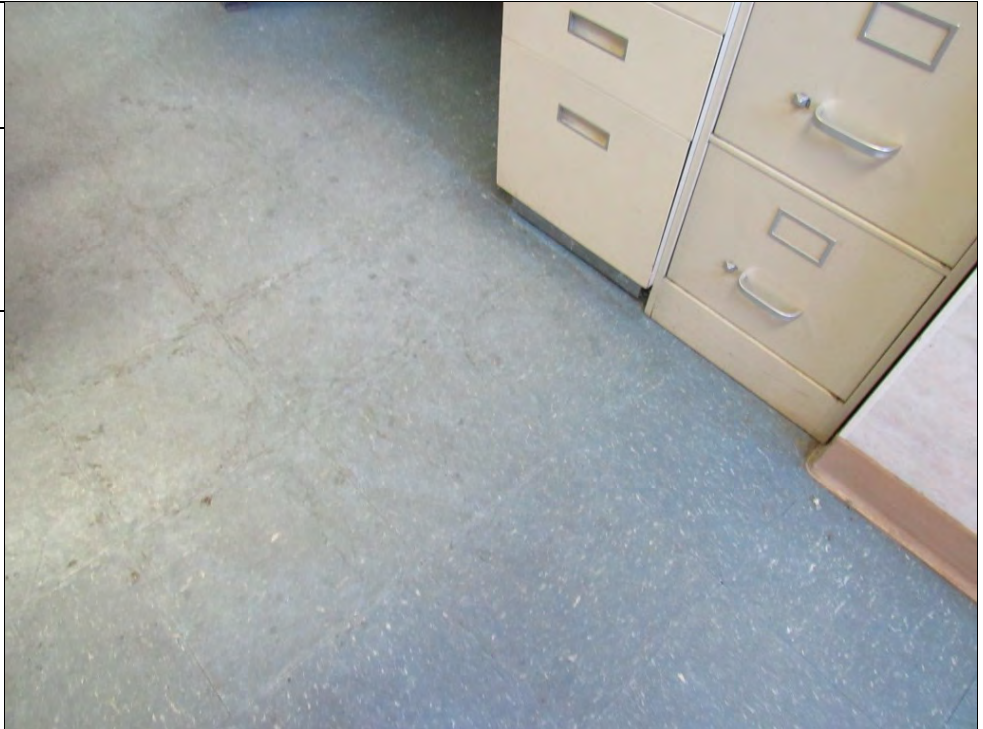
CC2MB - 02

**Date:**9/11/2018 to  
9/13/2018**Structure/Material Location:**Copco No. 2 Maintenance  
Building/  
Walls in office area**\*Description (by layer):**

- 1: 4" tan rubber cove base (M)
- 2: Gold brittle mastic (M)

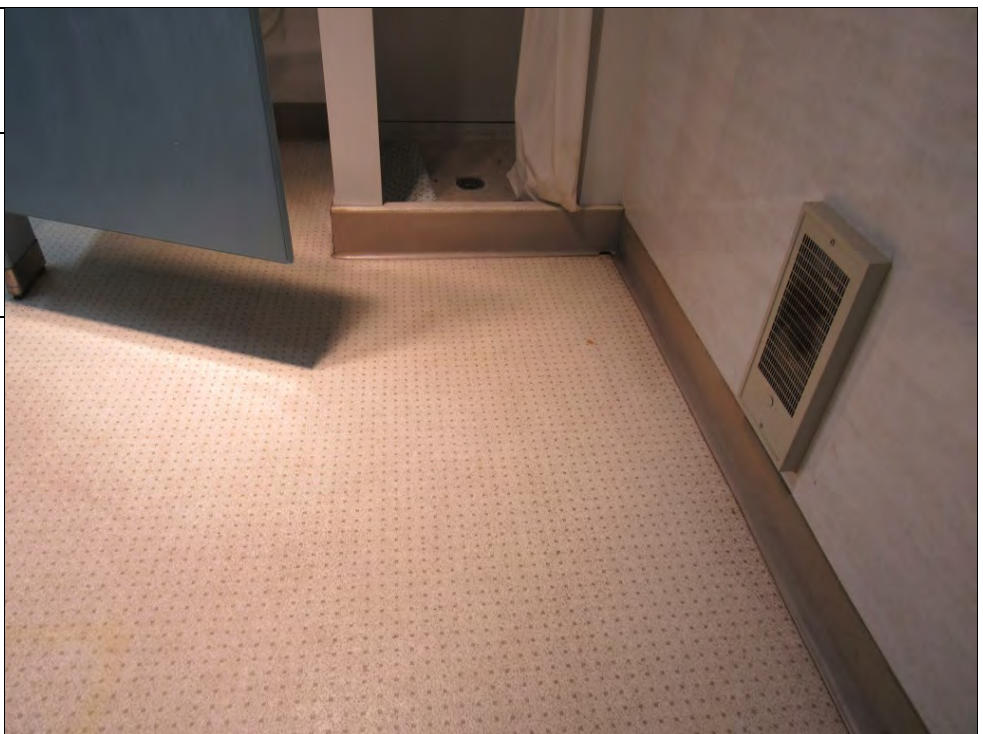
CC2MB - 03

**Date:**9/11/2018 to  
9/13/2018**Structure/Material Location:**Copco No. 2 Maintenance  
Building/  
Flooring in bathroom**\*Description (by layer):**

- 1: Off-white mastic (M)
- 2: Off-white vinyl floor sheeting  
with square dot pattern (M)
- 3: Tan paper backing with tan  
mastic (M)

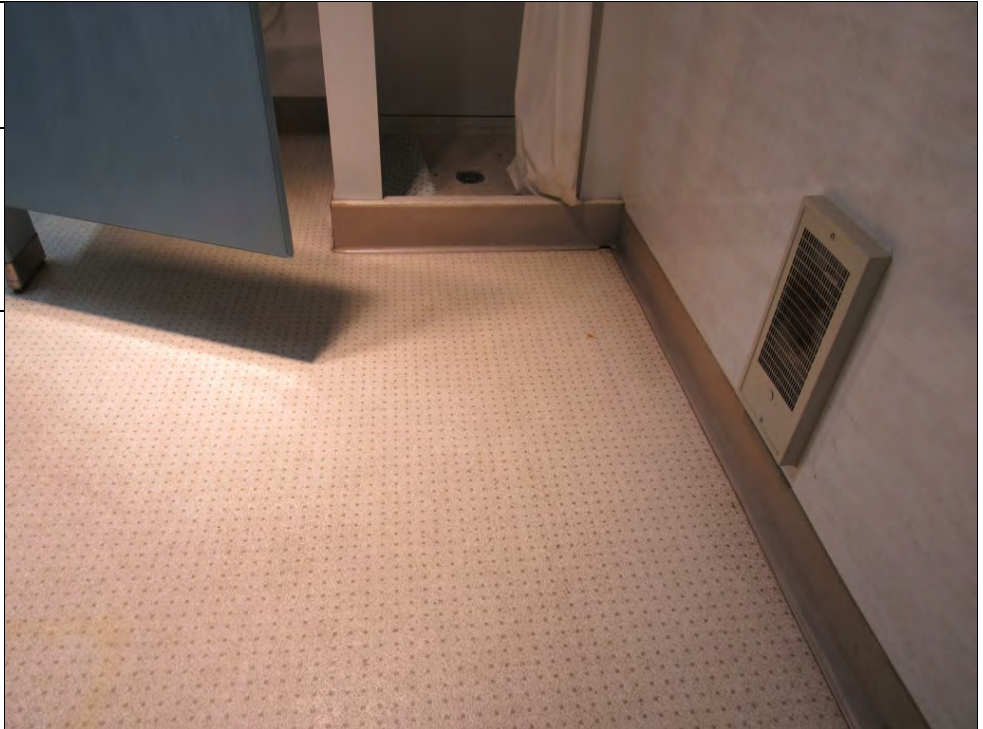
CC2MB - 04

**Date:**9/11/2018 to  
9/13/2018**Structure/Material Location:**Copco No. 2 Maintenance  
Building/ Walls in bathroom**\*Description (by layer):**1: 6" tan cove base with mastic  
(M)  
2: Off-white mastic (M)

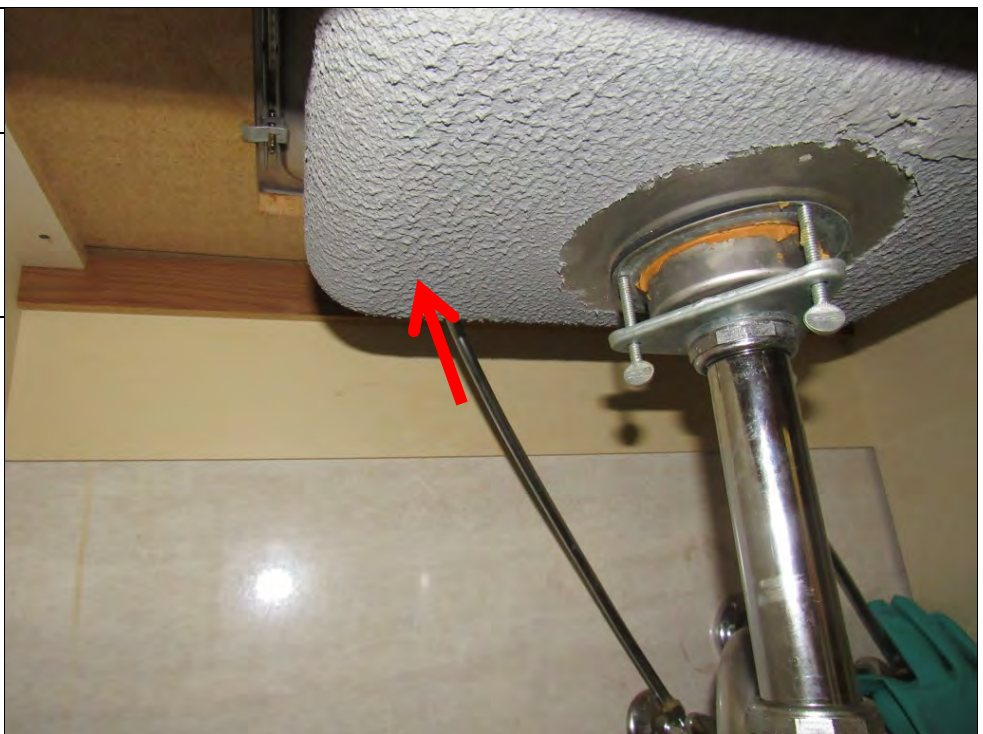
CC2MB - 05

**Date:**9/11/2018 to  
9/13/2018**Structure/Material Location:**Copco No. 2 Maintenance/ Sink  
in breakroom area**\*Description (by layer):**

1: Gray sink undercoating (M)

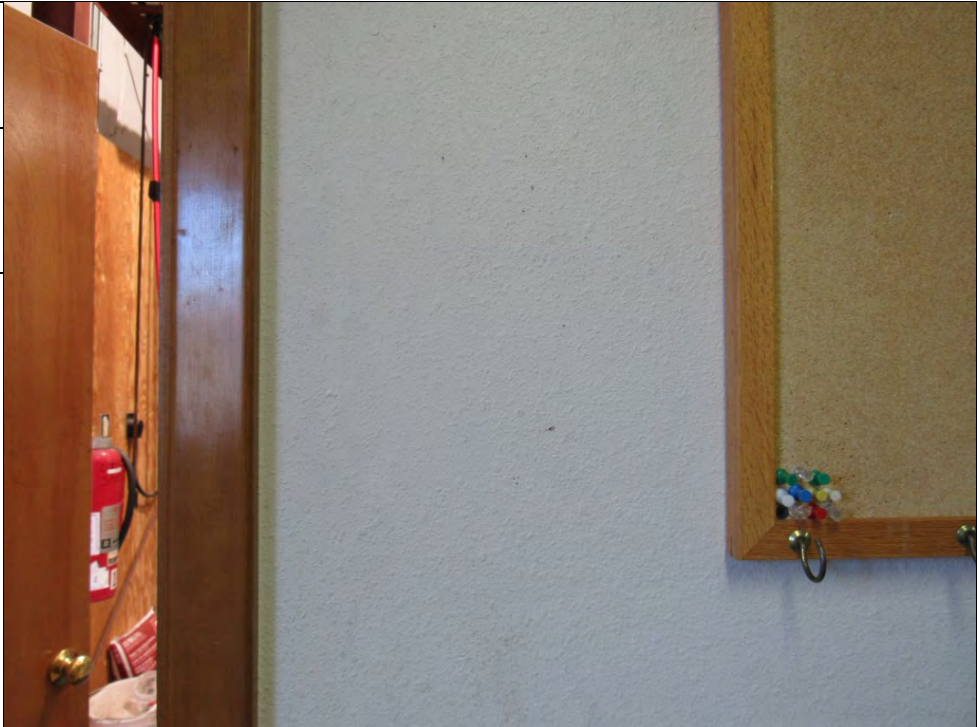
<b>Photo No./ Material ID:</b>  CC2MB - 06	<b>Date:</b>  9/11/2018 to 9/13/2018

<b>Structure/Material Location:</b>		
<b>*Description (by layer):</b>  1: White sprayed-on wall texture (M) 2: White gypsum wallboard (M) 3: Peach gypsum wallboard with paper (M)

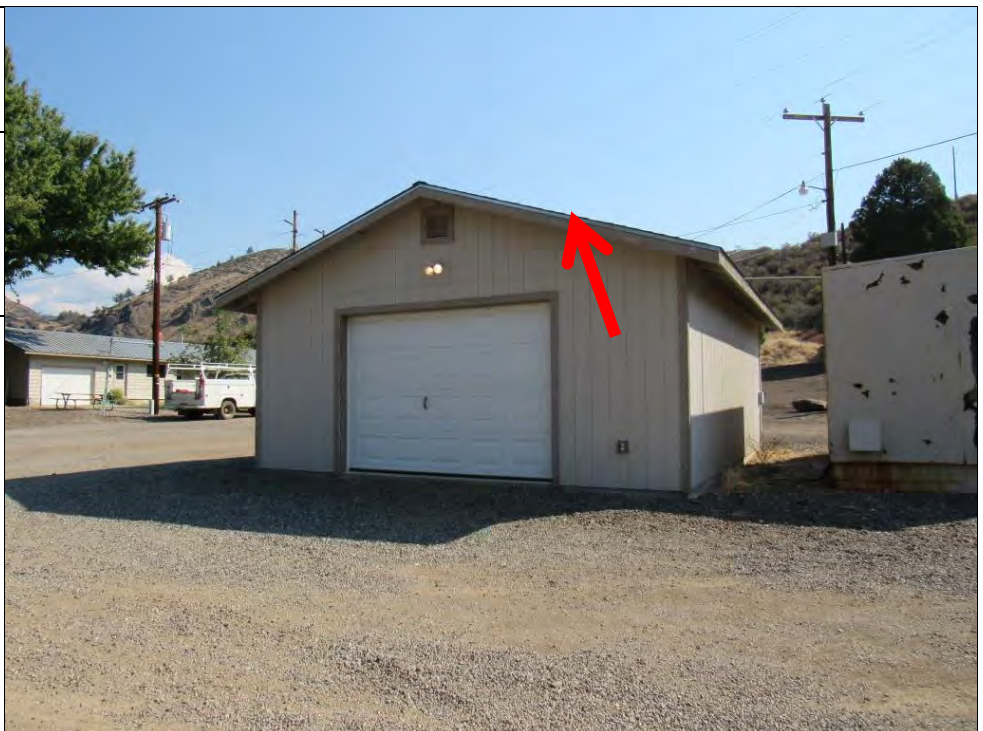
- 1: Asphaltic roofing shingle with granules (M)
- 2: Black asphaltic mastic (M)
- 3: Asphaltic roofing shingle with granules (M)

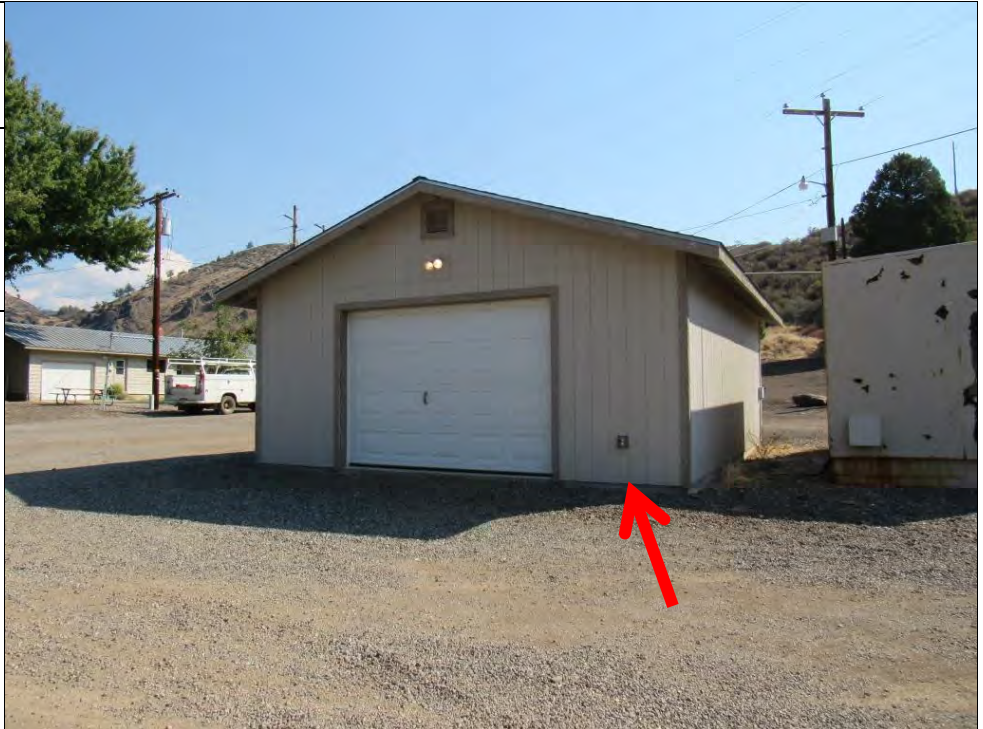
CC2MSB - 02

**Date:**9/11/2018 to  
9/13/2018**Structure/Material Location:**Copco No. 2 Maintenance  
Storage Building/  
Throughout roof**\*Description (by layer):****Assumed asbestos-containing  
vapor barrier paper behind  
wood siding**

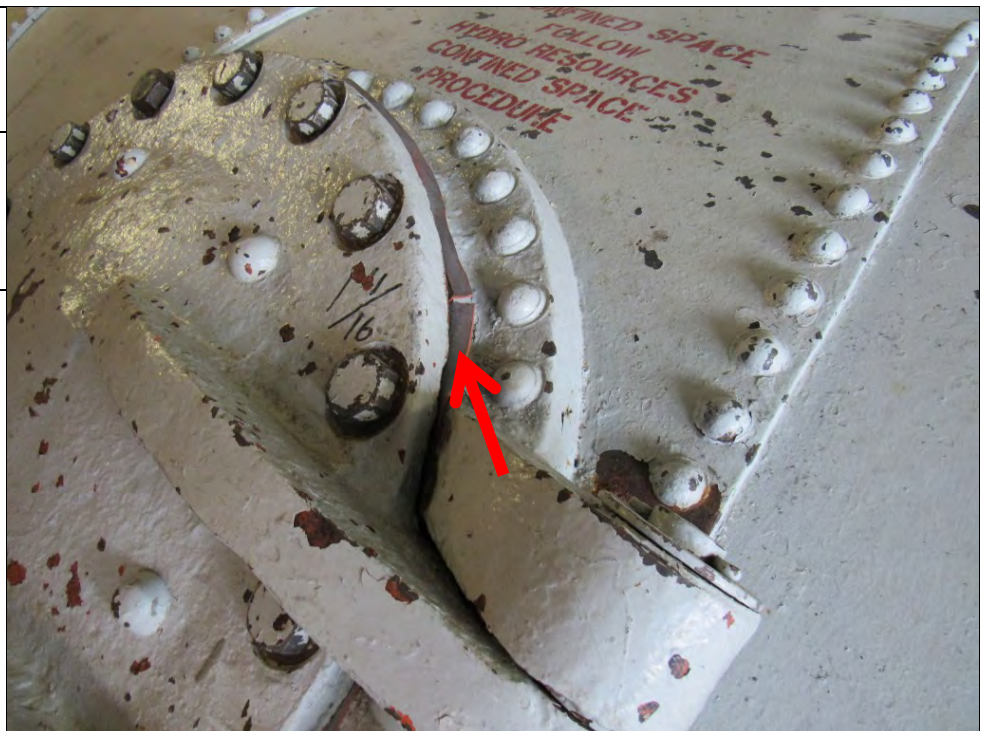
<b>Photo No./ Material ID:</b>  CC2PH - 01	<b>Date:</b>  9/11/2018 to 9/13/2018
<b>Structure/Material Location:</b>  Copco No. 2 Powerhouse/ Flooring in office area	
<b>*Description (by layer):</b> 1: Silver paint (M) 2: Red gasket (M)

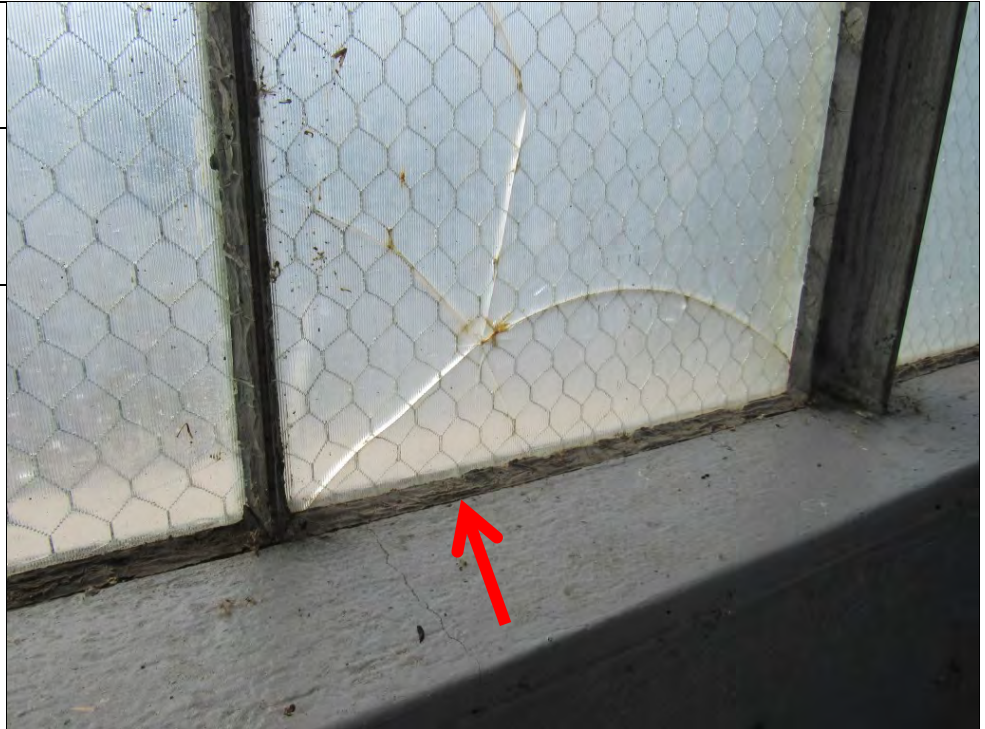
<b>Photo No./ Material ID:</b>  CC2PH - 02	<b>Date:</b>  9/11/2018 to 9/13/2018
<b>Structure/Material Location:</b>  Copco No. 2 Powerhouse/ Windows throughout main floor	
<b>*Description (by layer):</b>  1: Gray brittle window putty (M)

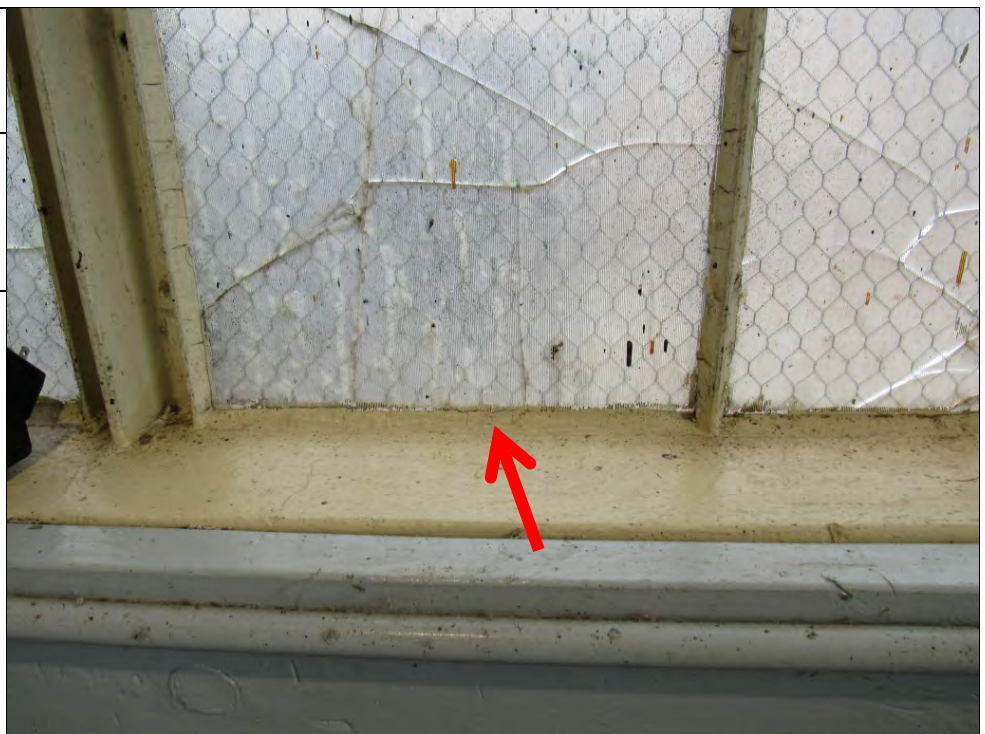
<b>Photo No./ Material ID:</b>  CC2PH - 03	<b>Date:</b>  9/11/2018 to 9/13/2018
<b>Structure/Material Location:</b>  Copco No. 2 Powerhouse/ Windows throughout main floor	
<b>*Description (by layer):</b>  1: Gray brittle window putty (M)

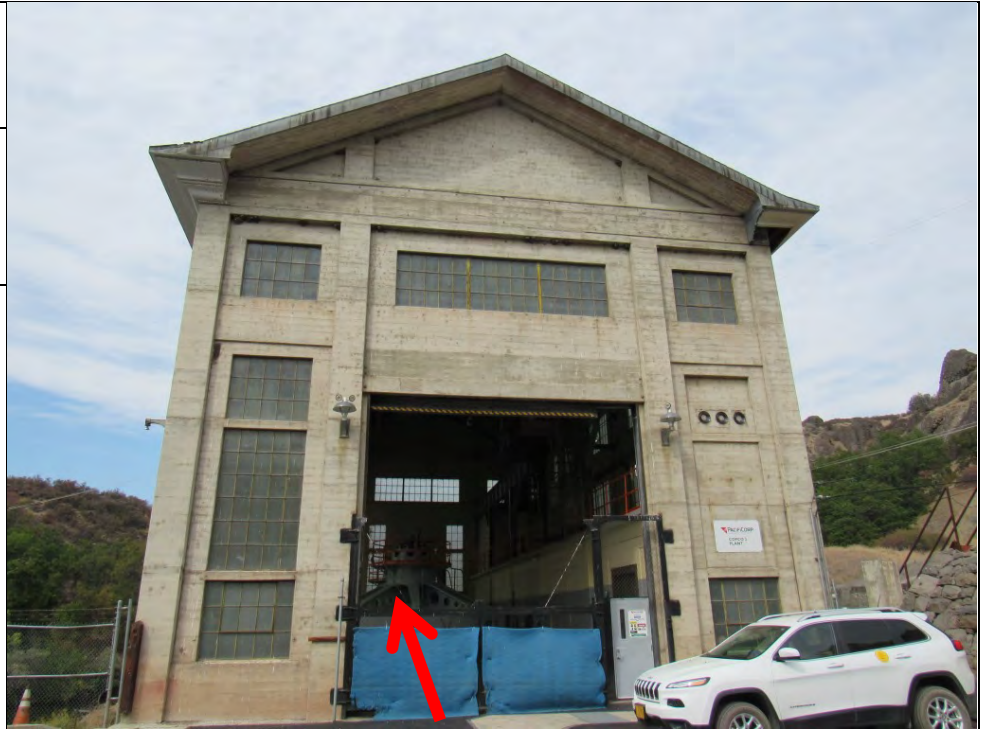
<b>Photo No./ Material ID:</b>  CC2PH - 04	<b>Date:</b>  9/11/2018 to 9/13/2018
<b>Structure/Material Location:</b>  Copco No. 2 Powerhouse/ Turbines in Powerhouse	
<b>*Description (by layer):</b>  <b>1: Assumed asbestos- containing wickete gate (M)</b>

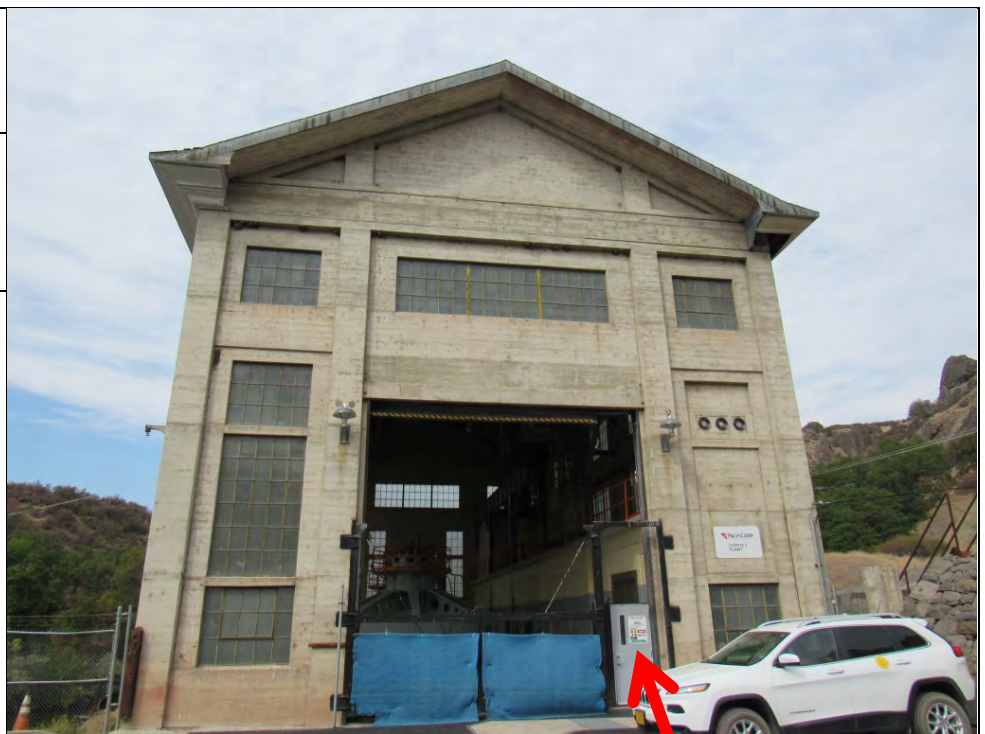
<b>Photo No./ Material ID:</b>  CC2PH - 05	<b>Date:</b>  9/11/2018 to 9/13/2018
<b>Structure/Material Location:</b>  Copco No. 2 Powerhouse/ Windows throughout main floor	
<b>*Description (by layer):</b>  <b>1: Assumed asbestos- containing metal-clad fire door insulation (M)</b>

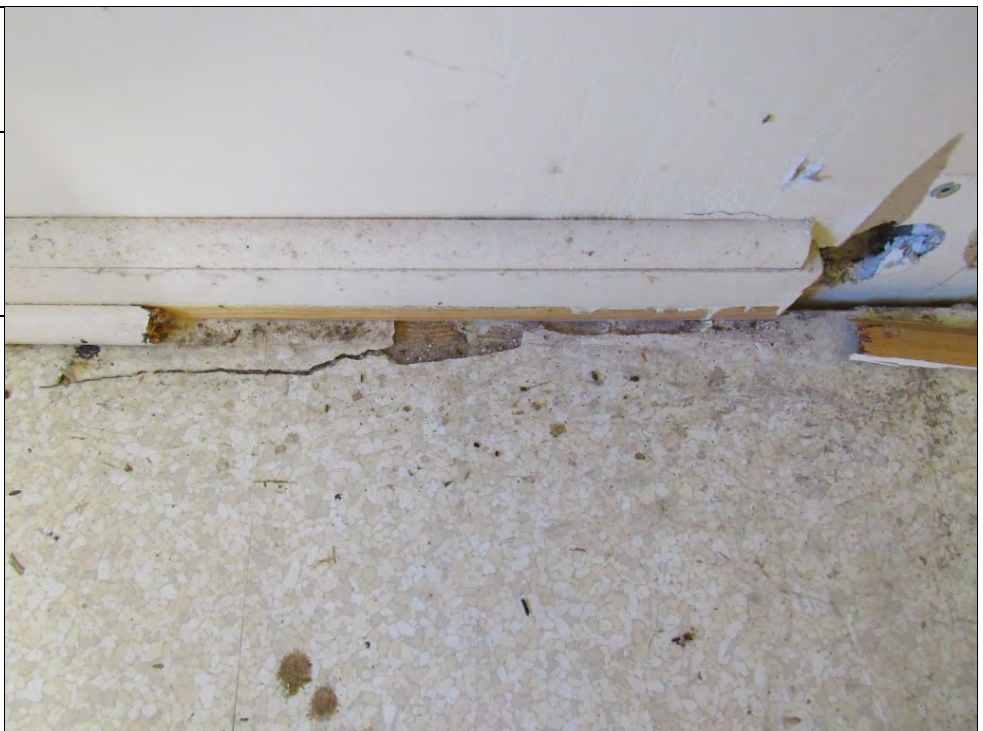
1: Beige patterned vinyl (M)  
2: **Off-white fibrous backing  
with crumbly yellow mastic  
(M)**

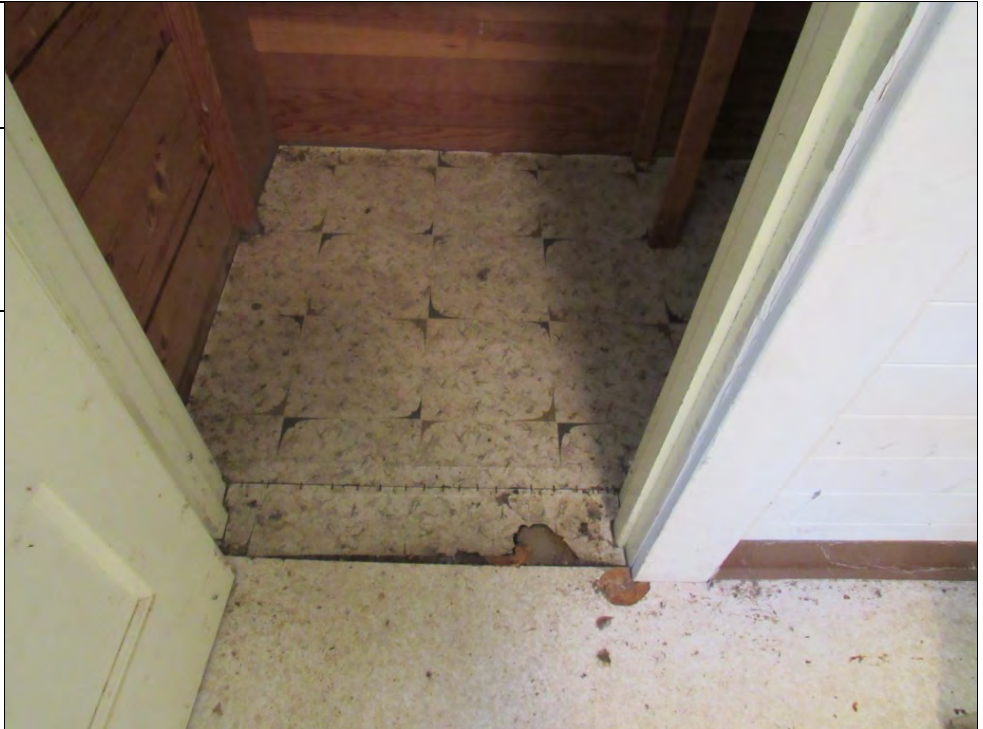
1: Off-white vinyl floor sheeting  
with gray 9"x9" gray square  
pattern (M)  
2: **Black paper backing with  
mastic (M)**

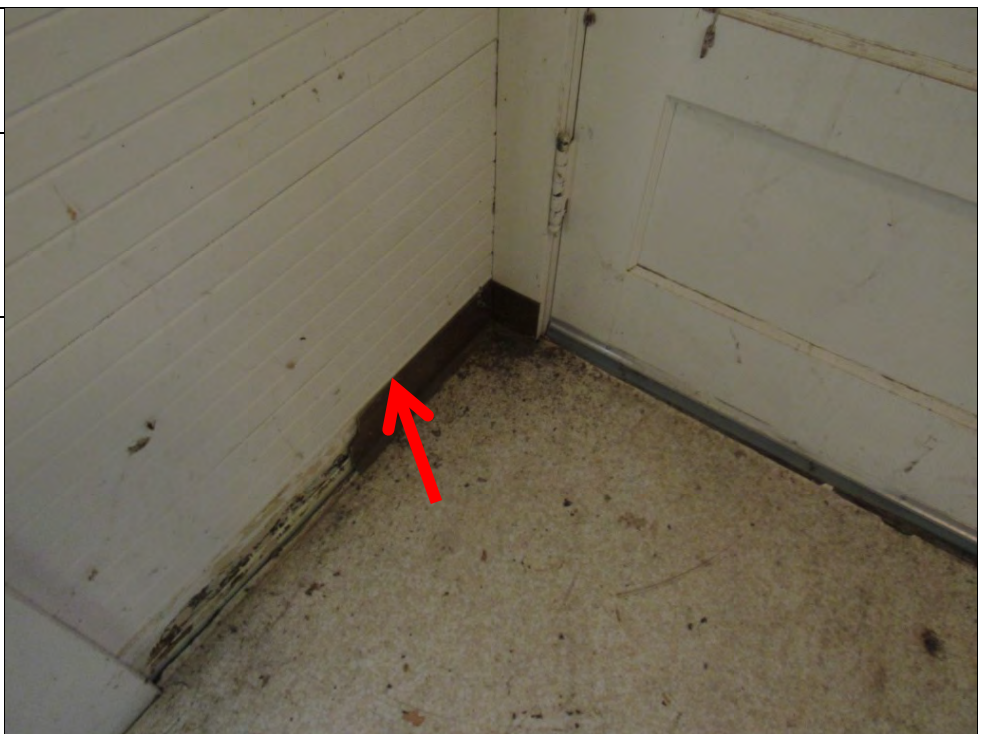
1: **4" brown rubber cove base  
(M)**  
2: Off-white mastic (M)

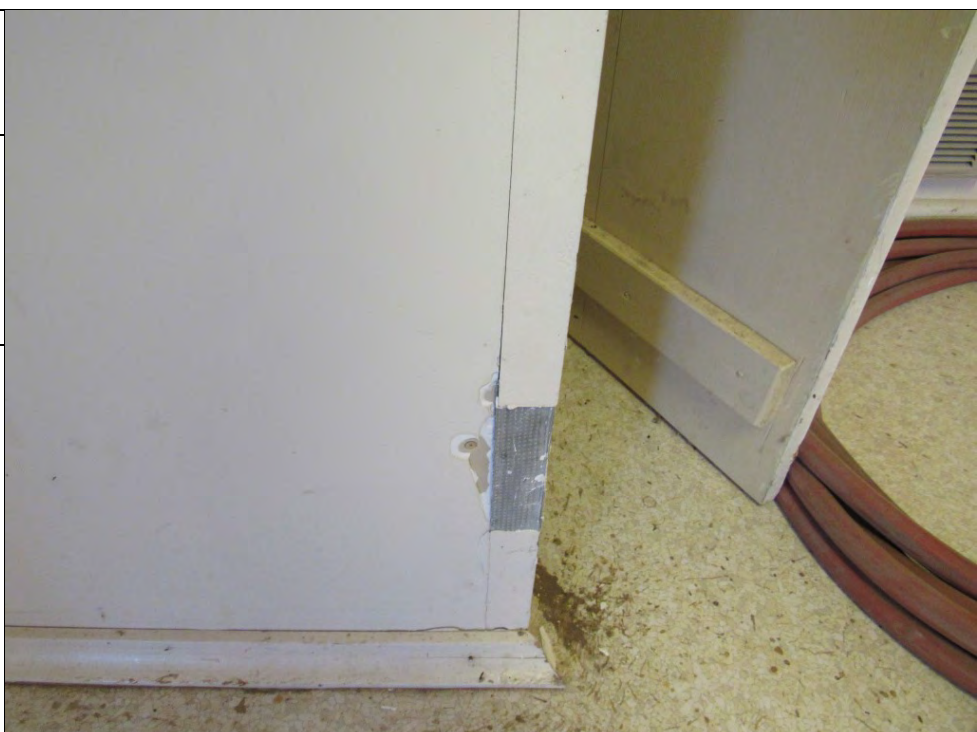
<b>Photo No./ Material ID:</b>	<b>Date:</b>	 
CC2R3 - 04	9/11/2018 to 9/13/2018	
<b>Structure/Material Location:</b>  Copco No. 2 Residence 3/ Counter between kitchen and conference room		
<b>*Description (by layer):</b>  1: White chalky material with paper (M) 2: Off-white compacted powdery material with paint (M)
