**Klamath River Renewal Corporation  
PacifiCorp**

**AMENDED APPLICATION FOR SURRENDER OF LICENSE  
FOR MAJOR PROJECT AND REMOVAL OF PROJECT WORKS**

**EXHIBIT N (1 of 2)  
Waste Disposal and Hazardous Materials Management Plan  
(Amended December 15, 2021)**

**Waste Disposal and  
Hazardous Materials  
Management Plan**

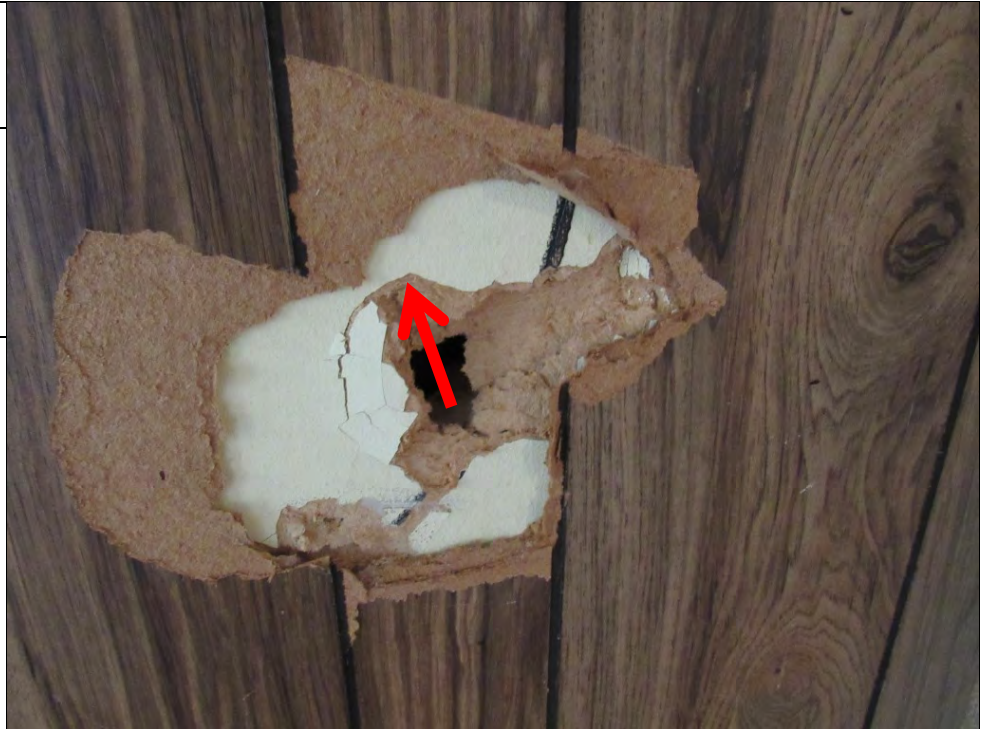
<b>Photo No./ Material ID:</b>  CC2R3 - 06	<b>Date:</b>  9/11/2018 to 9/13/2018
<b>Structure/Material Location:</b>  Copco No. 2 Residence 3/ Behind wood wall paneling in dining room and living room	
<b>*Description (by layer):</b>  <b>1: Black mastic (M)</b> 2: Brown plywood walls (M)

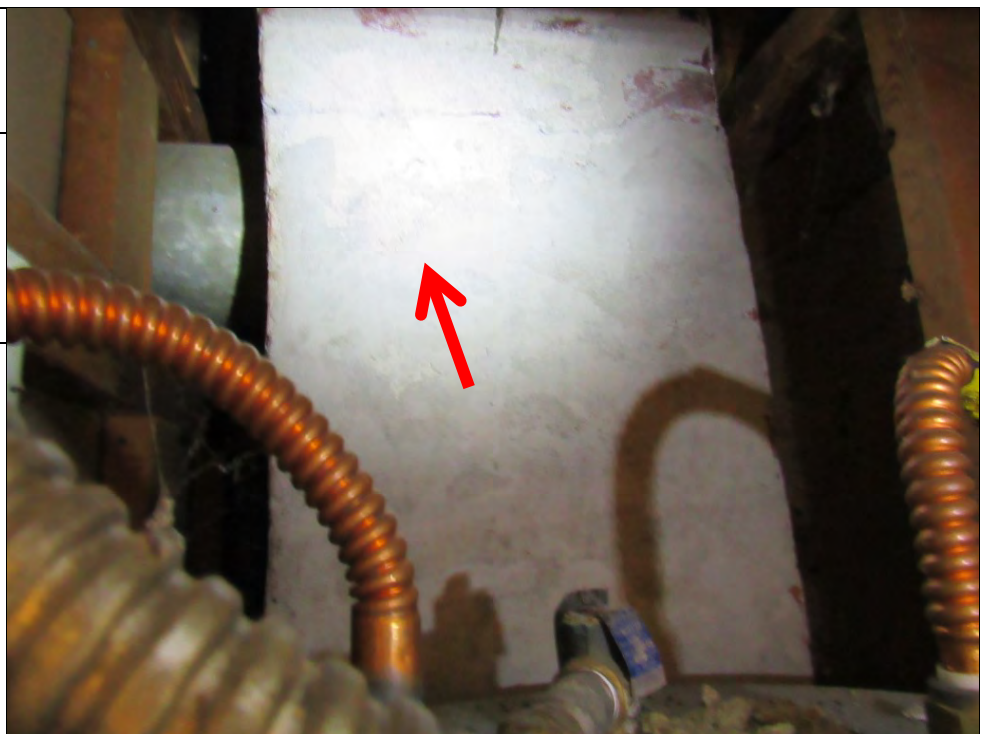
<b>Photo No./ Material ID:</b>  CC2R3 - 07	<b>Date:</b>  9/11/2018 to 9/13/2018
<b>Structure/Material Location:</b>  Copco No. 2 Residence 3/ Coating on chimney, very hard to access (could not reach actual brick and grout)	
<b>*Description (by layer):</b>  1: Troweled-on plaster coat on chimney behind water heater in kitchen (S)

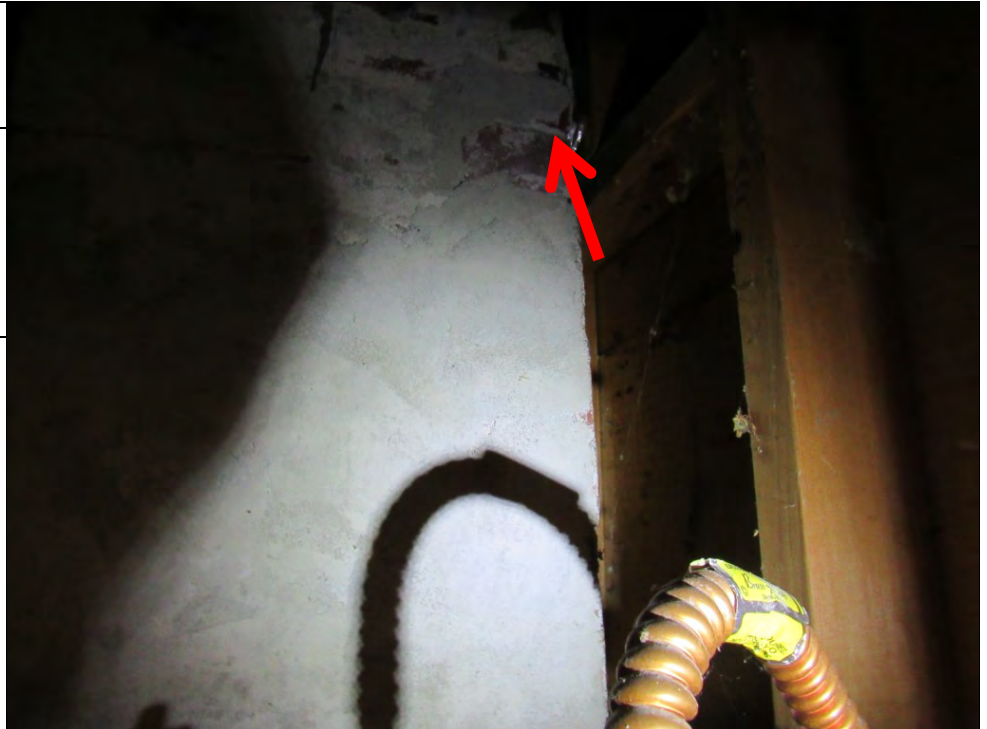
<b>Photo No./ Material ID:</b>  CC2R3 - 08	<b>Date:</b>  9/11/2018 to 9/13/2018
<b>Structure/Material Location:</b>  Copco No. 2 Residence 3/ Coating on chimney, very hard to access (could not reach actual brick and grout)	
<b>*Description (by layer):</b>  1: Assumed asbestos-containing gray chimney grout (M)

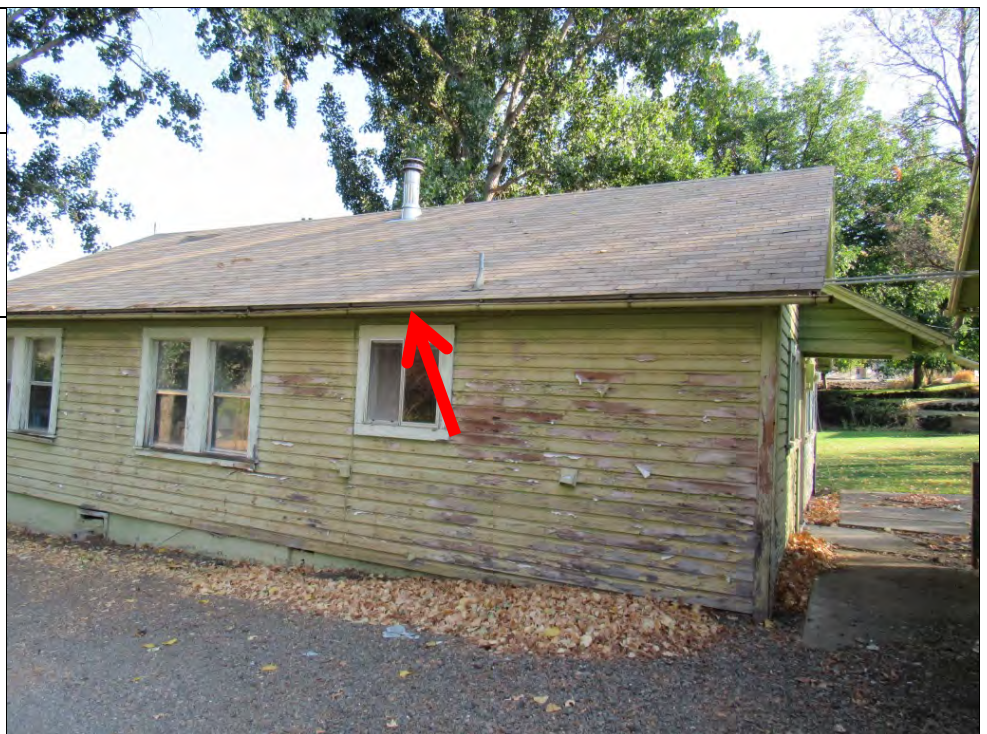
<b>Photo No./ Material ID:</b>  CC2R3 - 09	<b>Date:</b>  9/11/2018 to 9/13/2018
<b>Structure/Material Location:</b>  Copco No. 2 Residence 3/ Throughout roof of main house	
<b>*Description (by layer):</b>  1: Black asphaltic roofing shingles with granules (M)

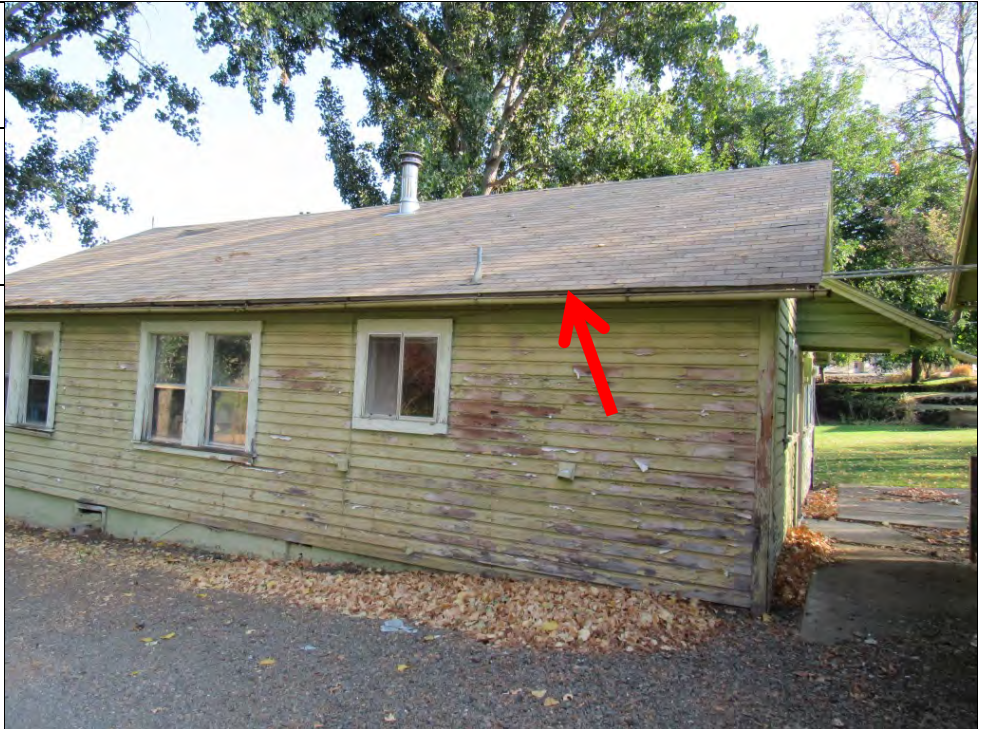
CC2R3 - 10

**Date:**9/11/2018 to  
9/13/2018**Structure/Material Location:**Copco No. 2 Residence 3/  
Throughout roof of main house**\*Description (by layer):**1: Black asphaltic roofing paper  
(M)

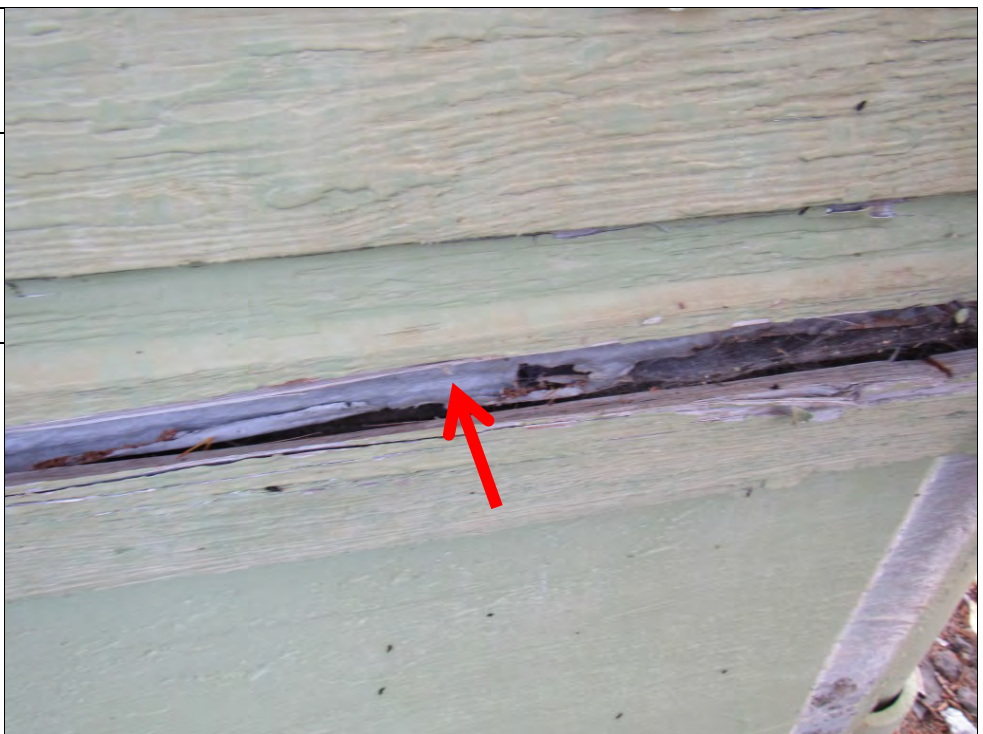
CC2R3 - 11

**Date:**9/11/2018 to  
9/13/2018**Structure/Material Location:**Copco No. 2 Residence 3/  
Throughout exterior, underneath  
wood siding**\*Description (by layer):**1: Exterior white vapor barrier  
paper (M)

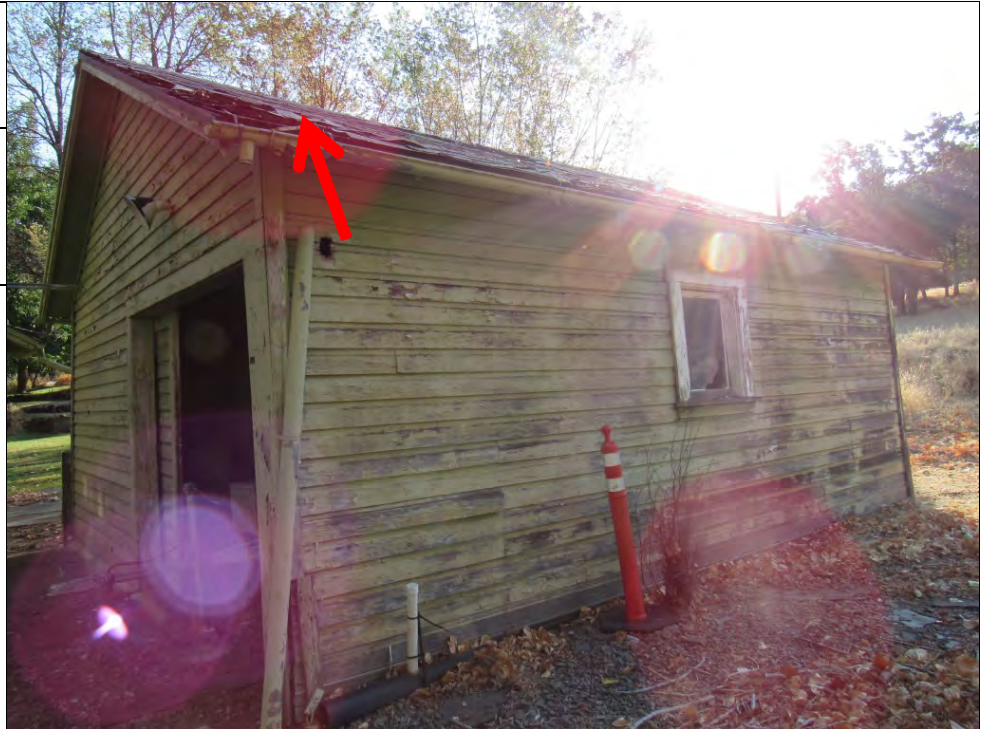
1: Black asphaltic roofing  
shingles with granules (M)

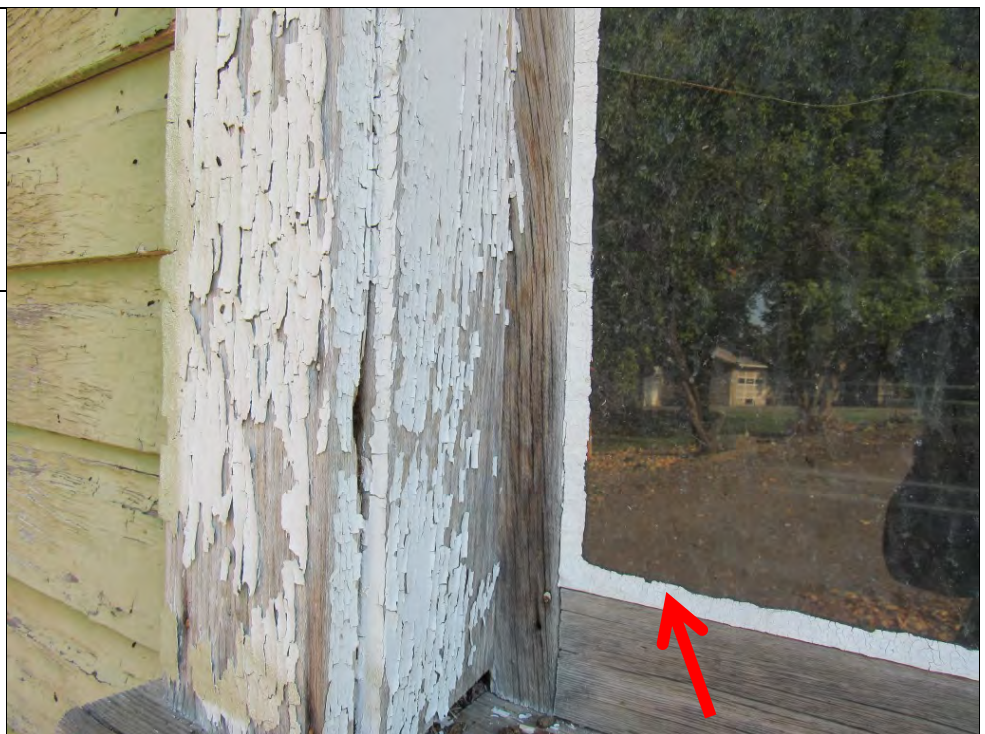
CC2R3 - 13

1: Gray window putty (M)

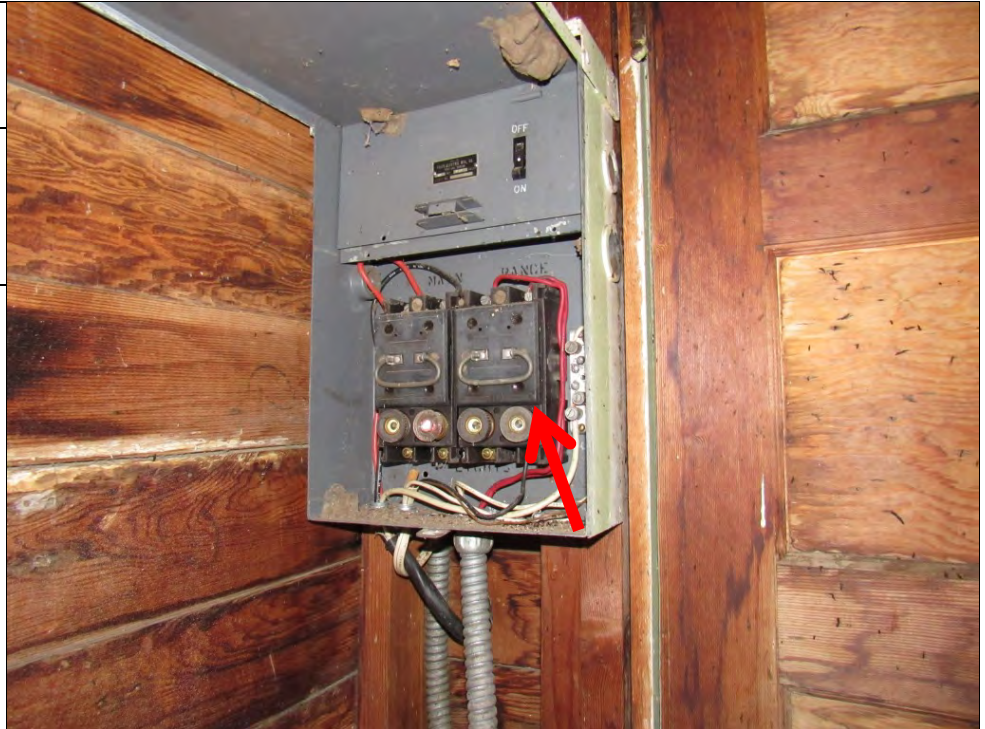
**Assumed asbestos-containing  
electrical panel backing in  
older electrical panels (M)**

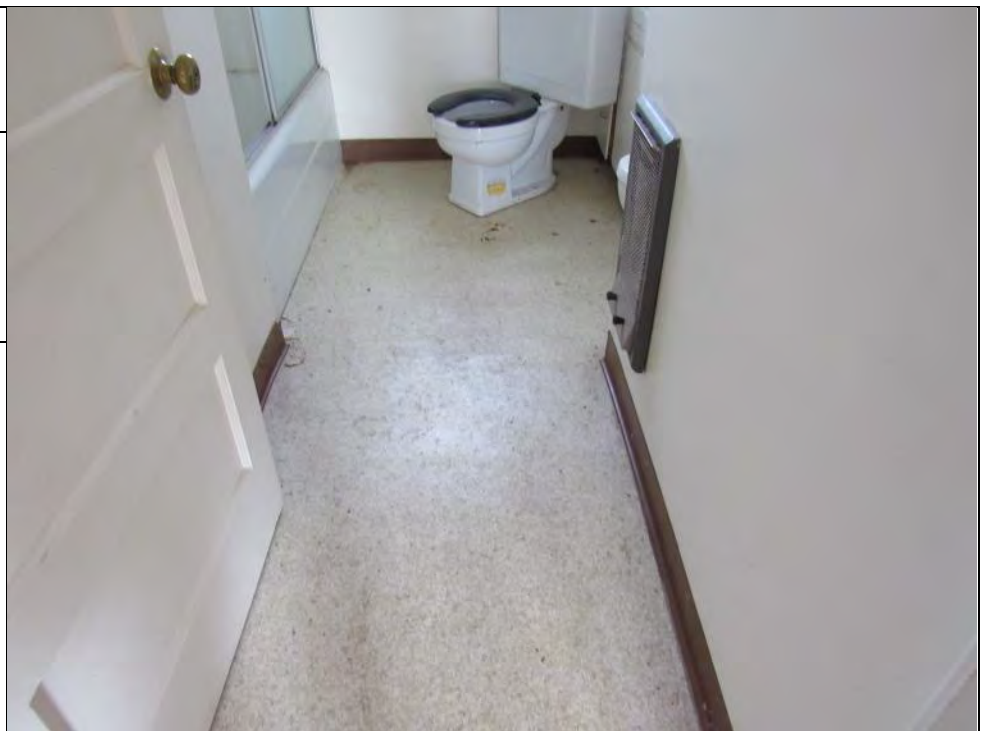
- 1: Tan vinyl floor sheeting with  
multi-colored mosaic pattern (M)
- 2: Gray paper backing with  
mastic (M)

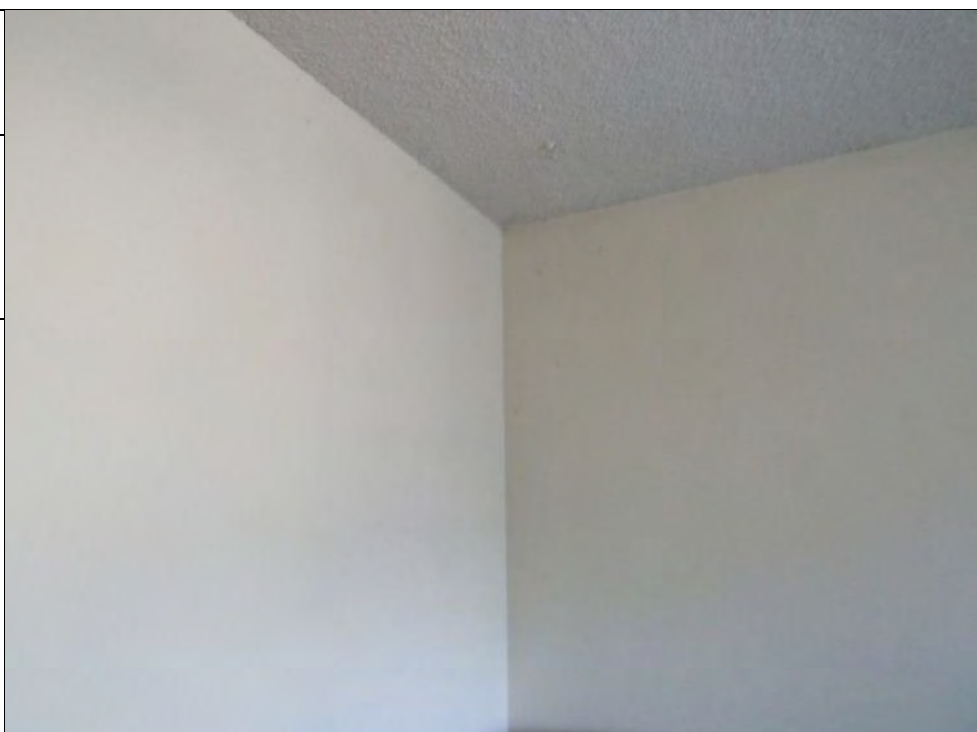
CC2R4 - 05	9/11/2018 to 9/13/2018	
<b>Structure/Material Location:</b>  Copco No. 2 Residence 4/ Walls throughout all rooms		
<b>*Description (by layer):</b>  1: Off-white spray-applied wall texture (S)

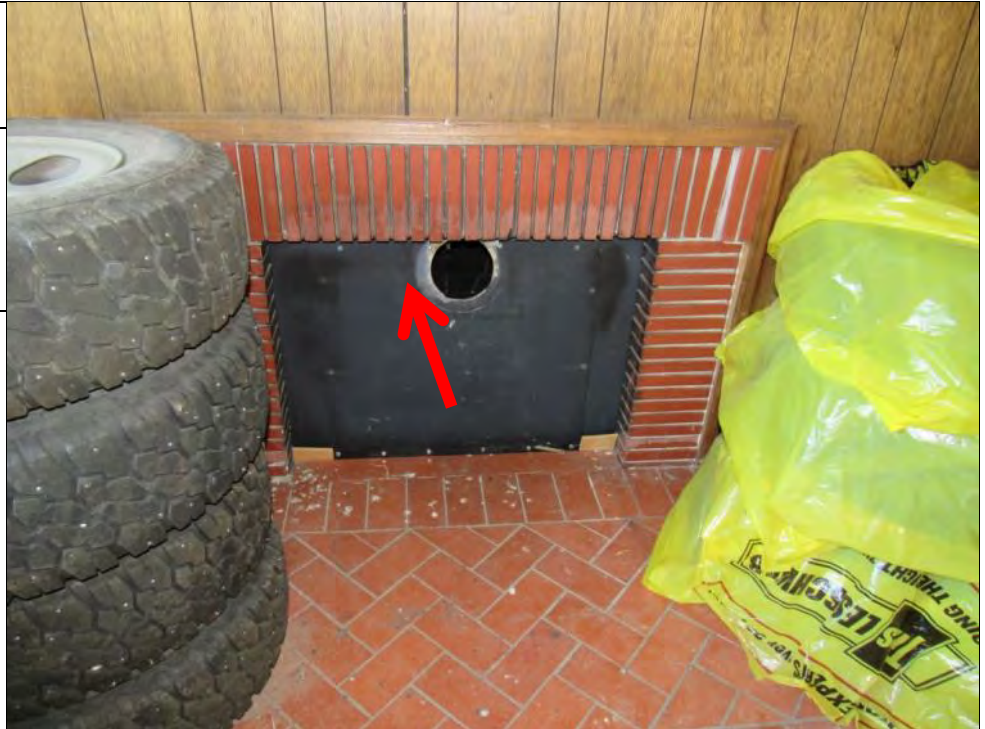
<b>Photo No./ Material ID:</b>  CC2R4 - 06	<b>Date:</b>  9/11/2018 to 9/13/2018
<b>Structure/Material Location:</b>  Copco No. 2 Residence 4/ Living room wall	
<b>*Description (by layer):</b>  1: Off-white grout associated with fireplace bricks on wall (M)

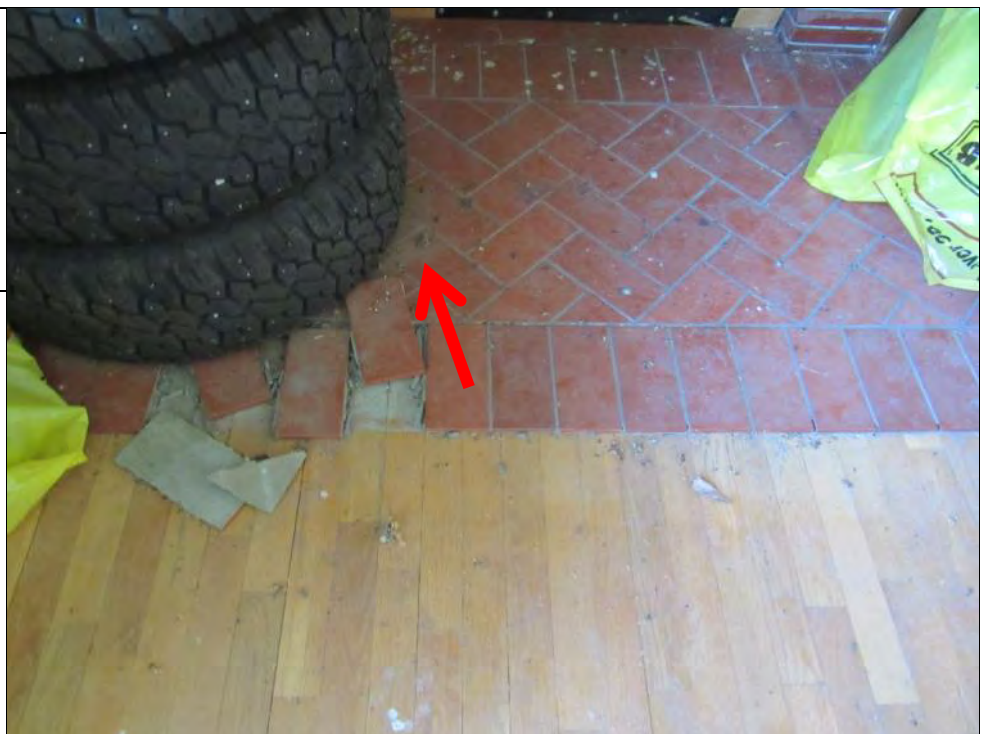
<b>Photo No./ Material ID:</b>  CC2R4 - 07	<b>Date:</b>  9/11/2018 to 9/13/2018
<b>Structure/Material Location:</b>  Copco No. 2 Residence 4/ Living room floor	
<b>*Description (by layer):</b>  1: Dark gray grout associated with fireplace bricks on floor (M)

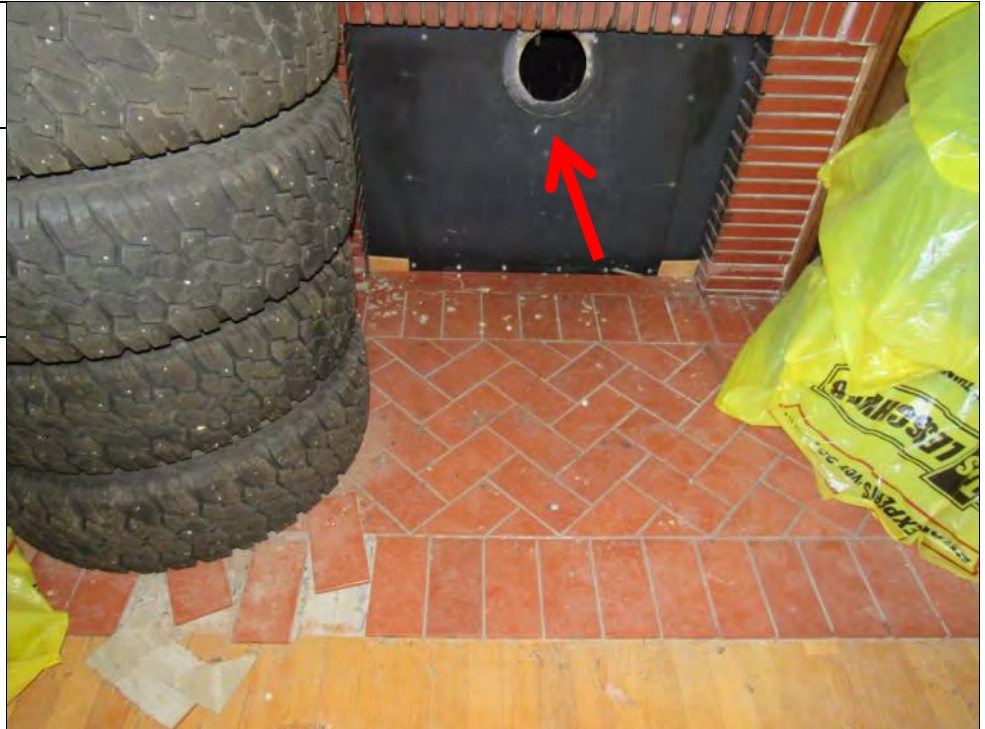
<b>Photo No./ Material ID:</b>  CC2R4 - 08	<b>Date:</b>  9/11/2018 to 9/13/2018
<b>Structure/Material Location:</b>  Copco No. 2 Residence 4/ Coating on chimney, very hard to access (could not reach actual brick and grout)	
<b>*Description (by layer):</b>  1: Cement asbestos board fireplace panel (M)

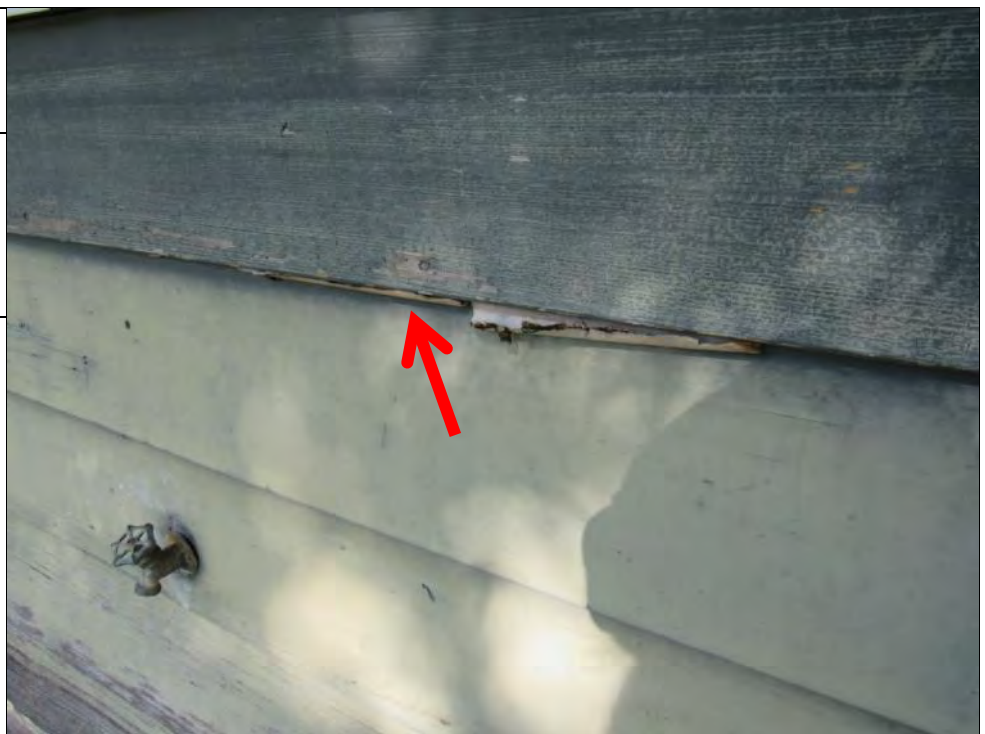
<b>Photo No./ Material ID:</b>  CC2R4 - 09	<b>Date:</b>  9/11/2018 to 9/13/2018
<b>Structure/Material Location:</b>  Copco No. 2 Residence 4/ Behind exterior wood siding	
<b>*Description (by layer):</b>  1: Black asphaltic vapor barrier paper (M)

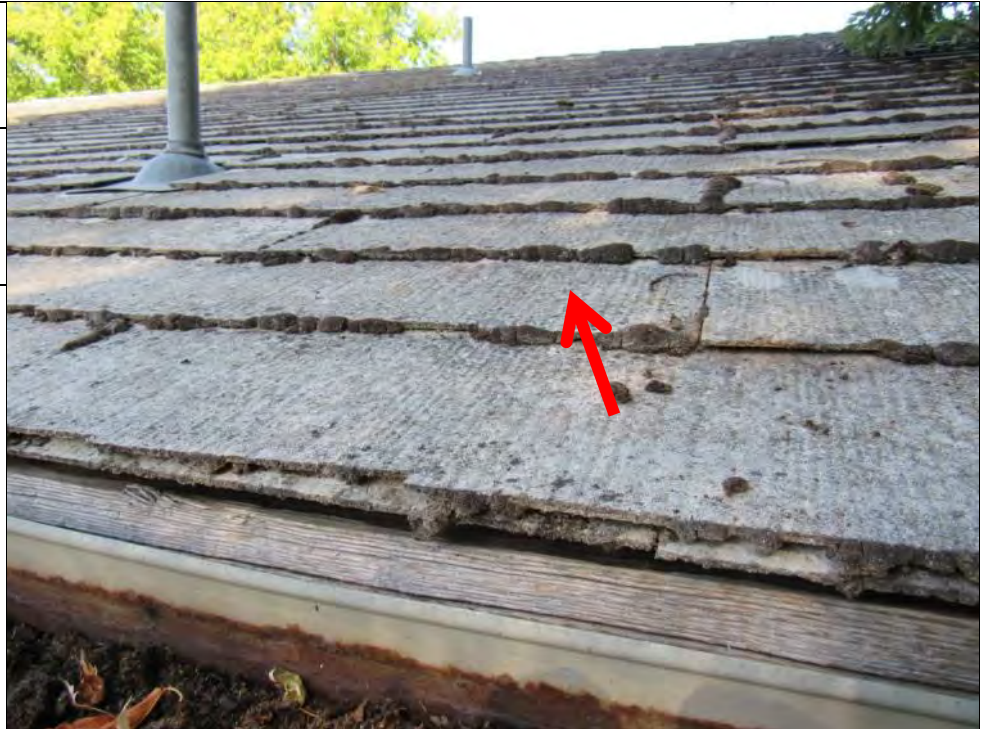
<b>Photo No./ Material ID:</b>  CC2R4 - 10	<b>Date:</b>  9/11/2018 to 9/13/2018
<b>Structure/Material Location:</b>  Copco No. 2 Residence 4/ Throughout roof of main house	
<b>*Description (by layer):</b>  <b>1: Cement asbestos board roof shingles (M)</b>

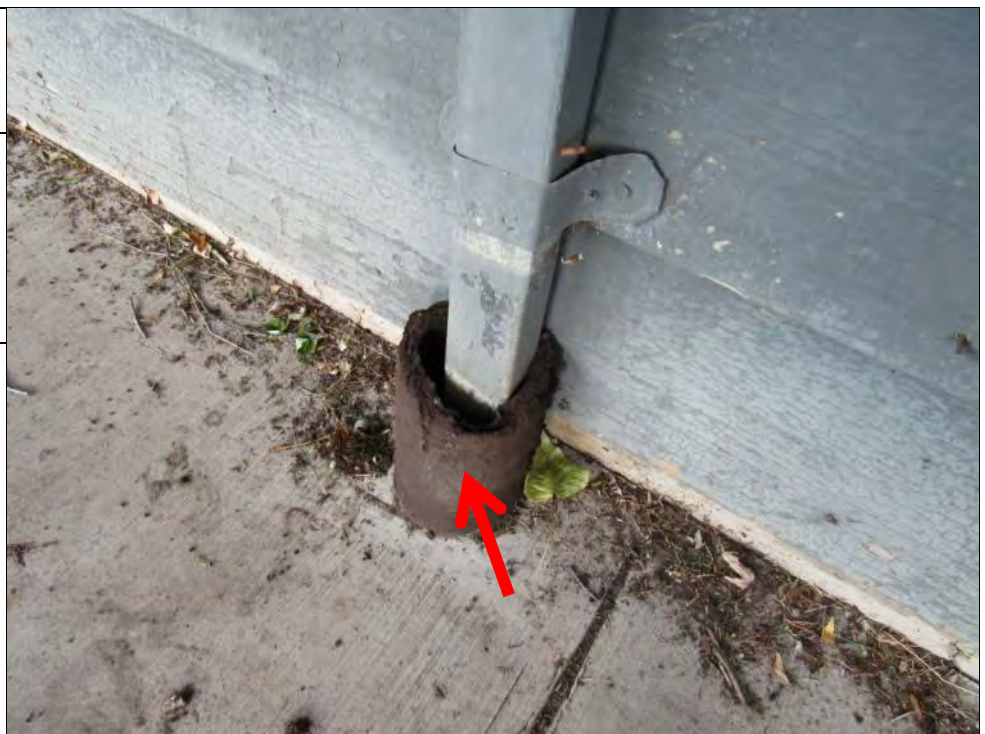
<b>Photo No./ Material ID:</b>  CC2R4 - 11	<b>Date:</b>  9/11/2018 to 9/13/2018
<b>Structure/Material Location:</b>  Copco No. 2 Residence 4/ Exterior of house, at base of one roof drain	
<b>*Description (by layer):</b>  <b>1: Dark brown brittle papery roof drain residual insulation (M)</b>

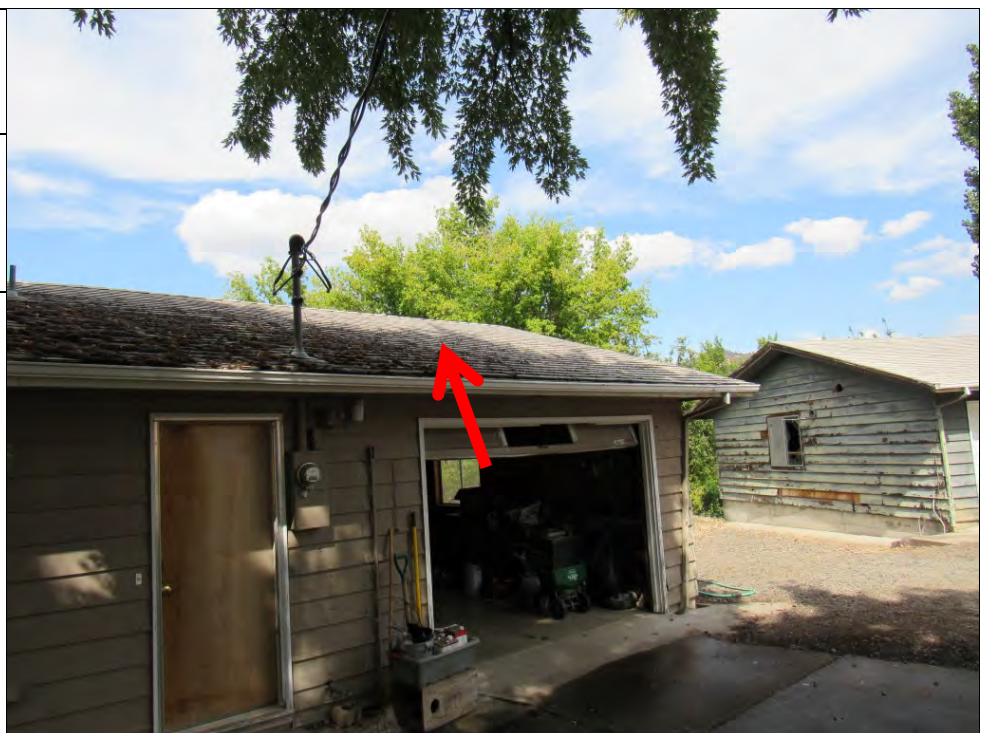
**1: Cement asbestos board  
roof shingles (M)**

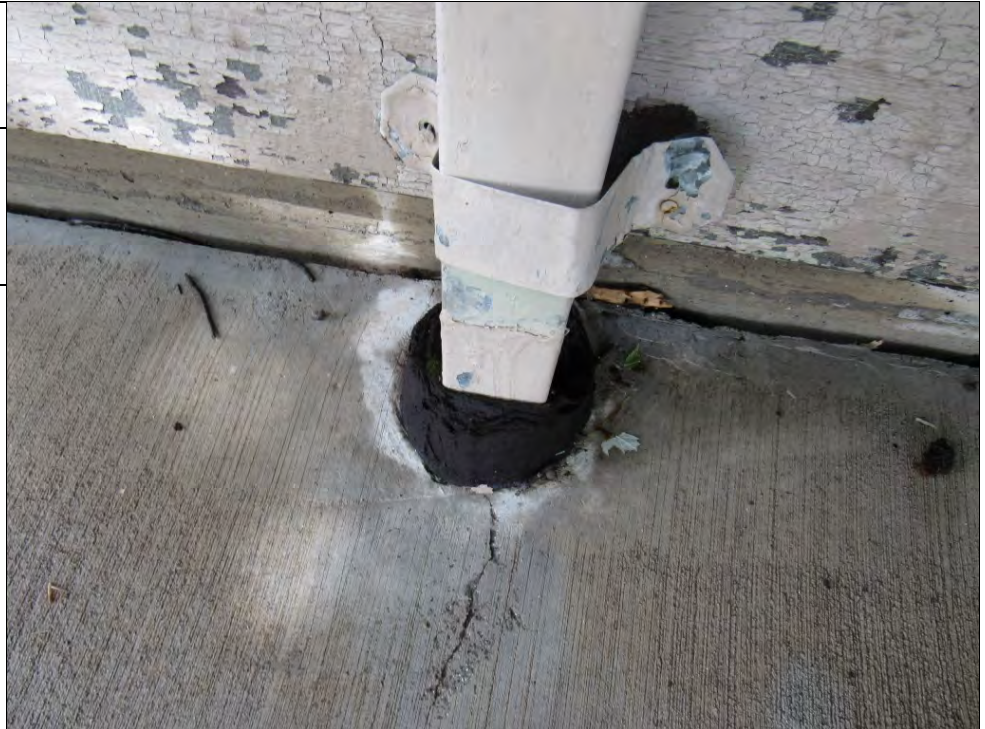
<b>Photo No./ Material ID:</b>  CC2R5 - 02	<b>Date:</b>  9/11/2018 to 9/13/2018
<b>Structure/Material Location:</b>  Copco No. 2 Residence 5/ Ceiling throughout all rooms	
<b>*Description (by layer):</b>  1: Black brittle papery roof drain residual insulation (S)

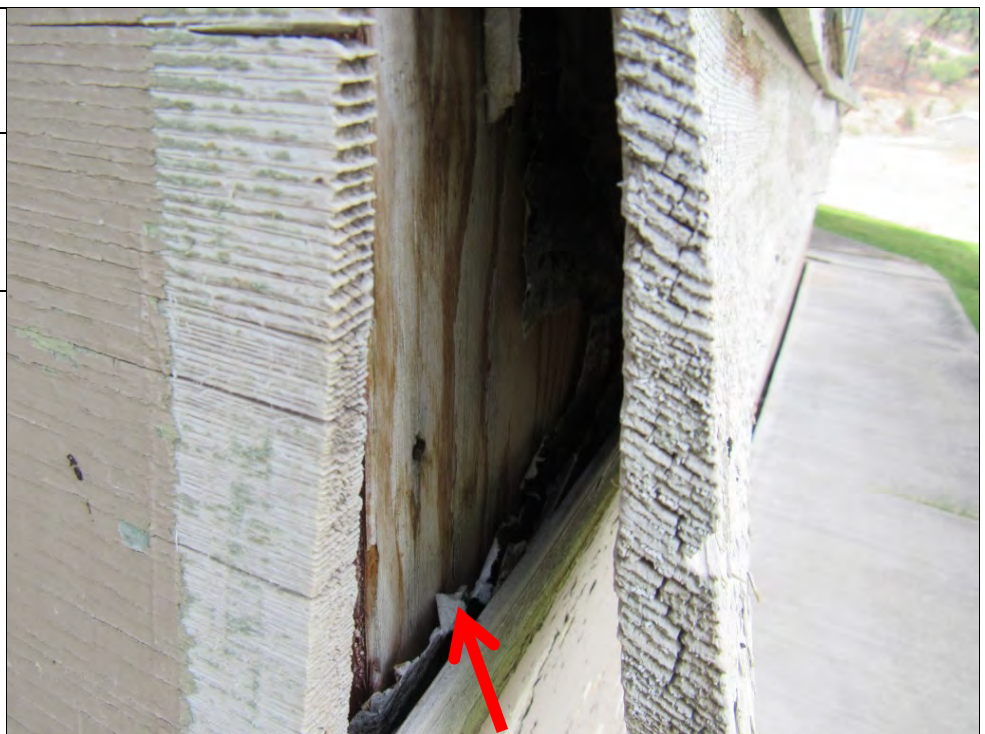
<b>Photo No./ Material ID:</b>  CC2R5 - 03	<b>Date:</b>  9/11/2018 to 9/13/2018
<b>Structure/Material Location:</b>  Copco No. 2 Residence 5/ Walls throughout all rooms	
<b>*Description (by layer):</b>  1: Black asphaltic vapor barrier paper (M)

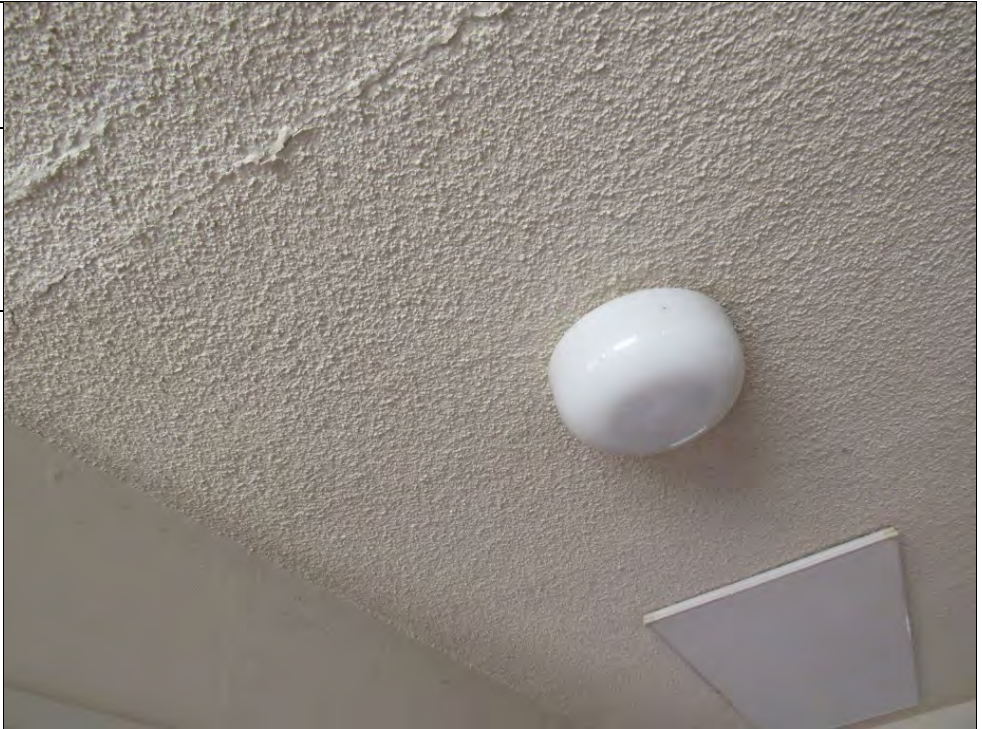
<b>Photo No./ Material ID:</b>  CC2R5 - 04	<b>Date:</b>  9/11/2018 to 9/13/2018
<b>Structure/Material Location:</b>  Copco No. 2 Residence 5/ Ceiling throughout all rooms	
<b>*Description (by layer):</b>  <b>1: White spray-applied acoustical ceiling texture (S)</b>

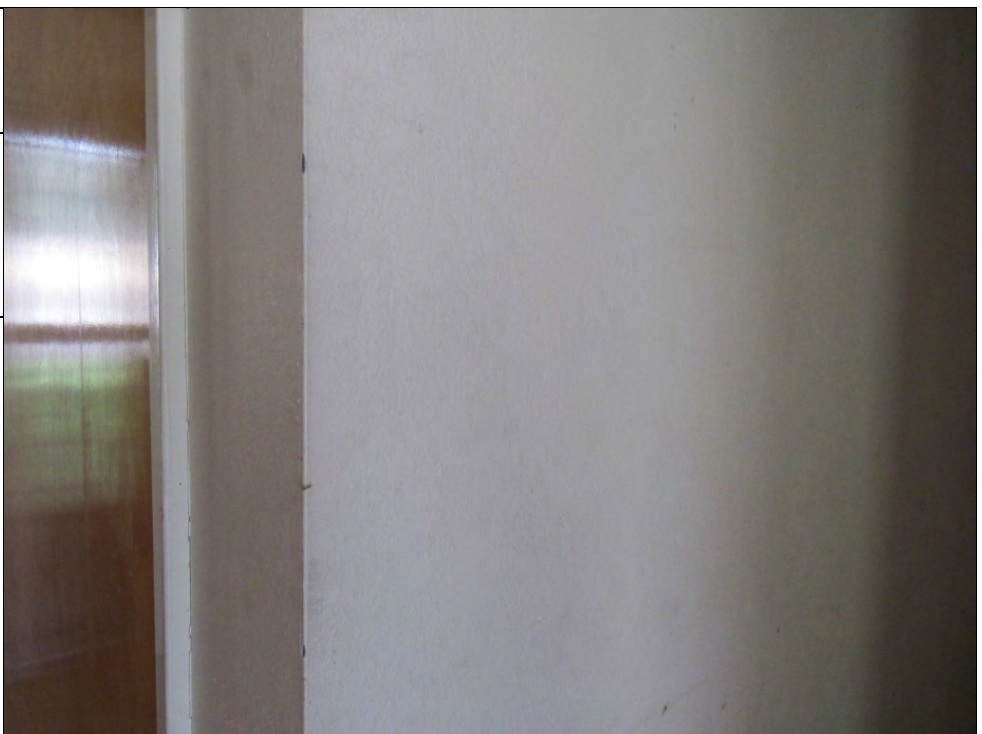
<b>Photo No./ Material ID:</b>  CC2R5 - 05	<b>Date:</b>  9/11/2018 to 9/13/2018
<b>Structure/Material Location:</b>  Copco No. 2 Residence 5/ Walls throughout all rooms	
<b>*Description (by layer):</b>  <b>1: White joint compound with paper (M)</b> <b>2: White gypsum wallboard with paper (M)</b>

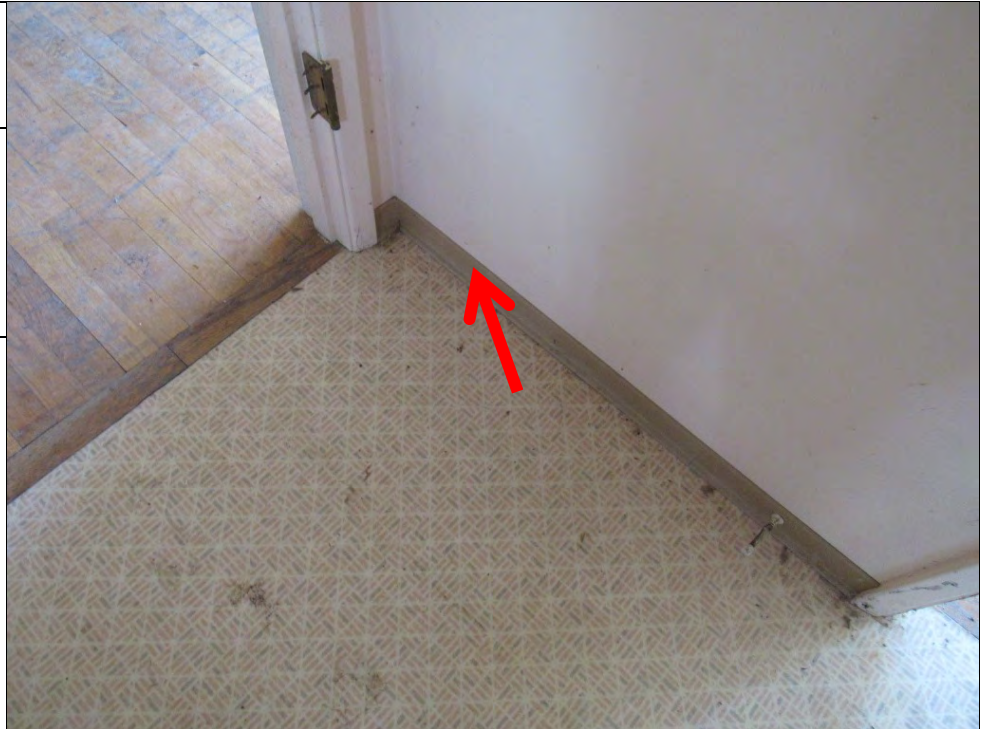
<b>Photo No./ Material ID:</b>  CC2R5 - 06	<b>Date:</b>  9/11/2018 to 9/13/2018
<b>Structure/Material Location:</b>  Copco No. 2 Residence 5/ Walls in kitchen, hallway, and mud room	
<b>*Description (by layer):</b>  1: 3" light gray rubber cove base (M) 2: Beige mastic (M)

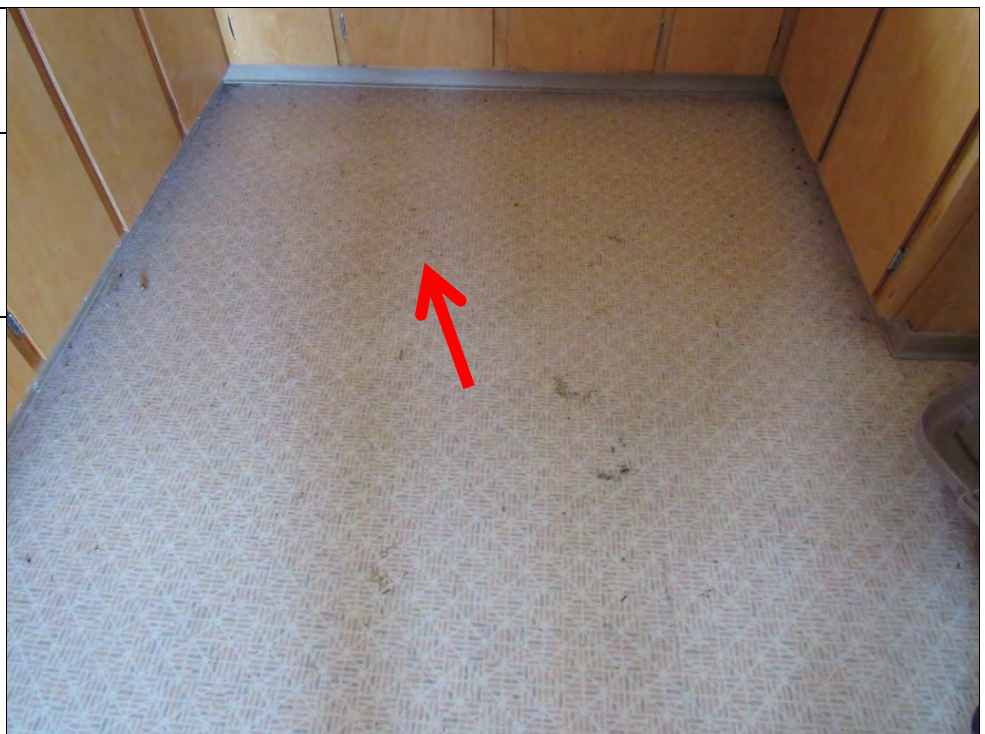
<b>Photo No./ Material ID:</b>  CC2R5 - 07	<b>Date:</b>  9/11/2018 to 9/13/2018
<b>Structure/Material Location:</b>  Copco No. 2 Residence 5/ Floors in kitchen, hallway, and mud room	
<b>*Description (by layer):</b>  1: Off-white vinyl floor sheeting with pink and blue diamond pattern (M) 2: Tan paper backing with mastic (M)

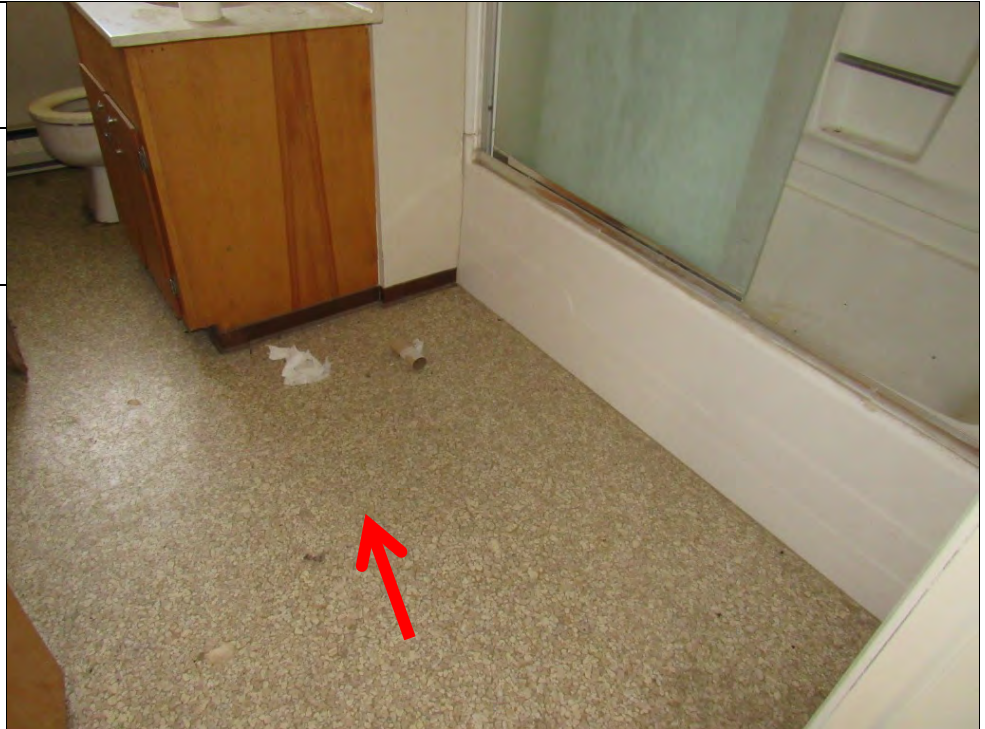
- 1: Brown vinyl floor sheeting with  
mosaic pattern (M)
- 2: Gray paper backing with  
mastic (M)

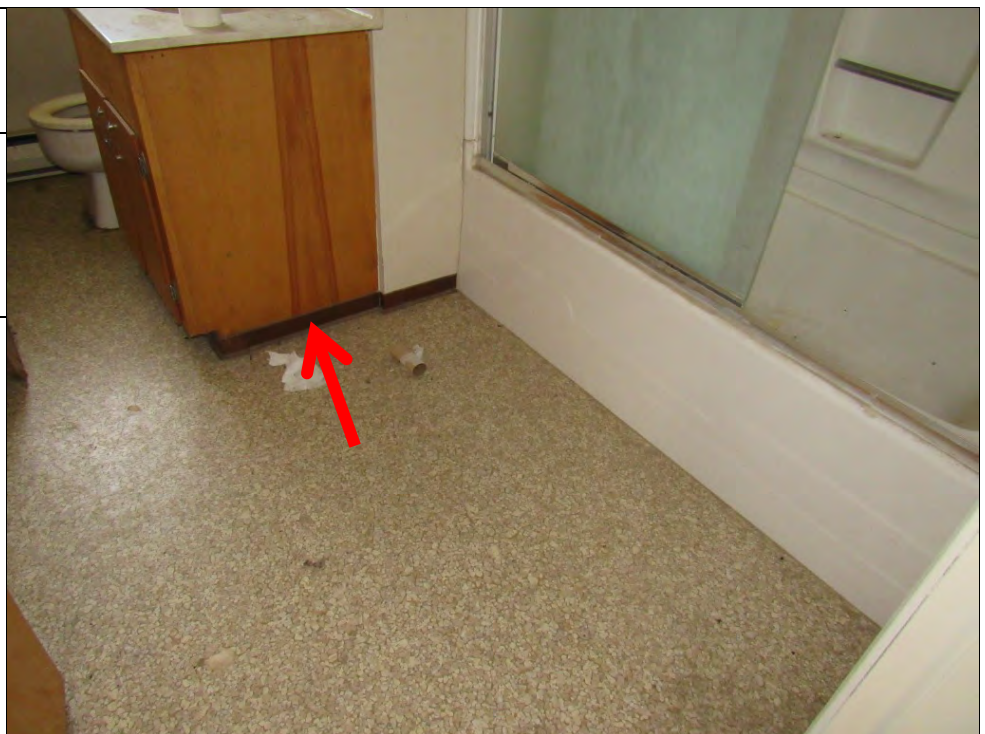
CC2R5 - 09

- 1: 3" brown rubber cove base  
(M)
- 2: Beige mastic (M)

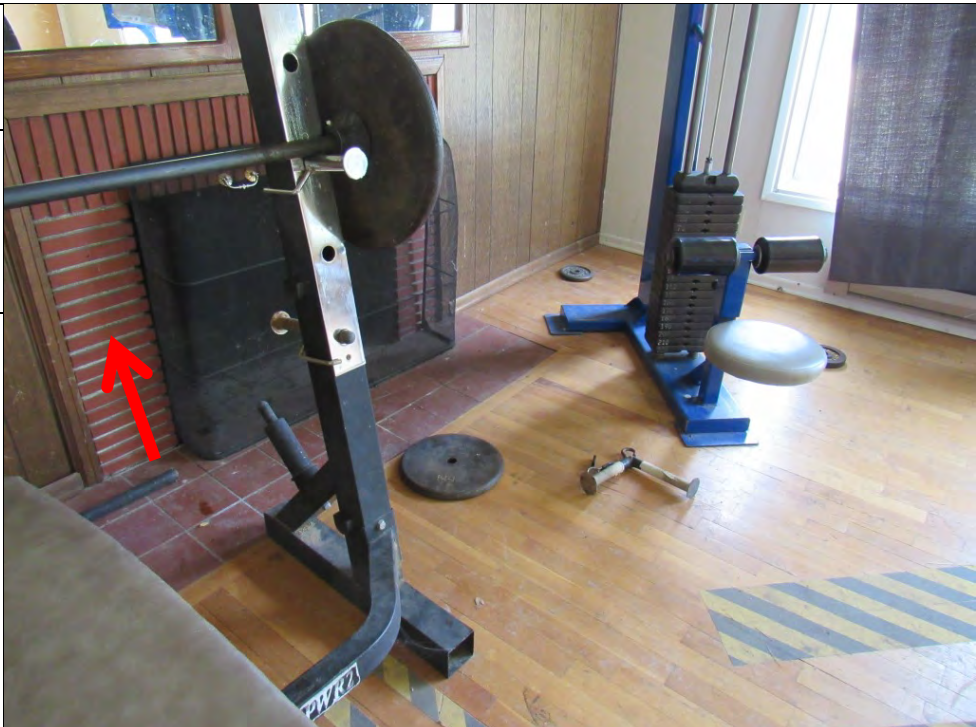
CC2R5 - 12	9/11/2018 to 9/13/2018	
<b>Structure/Material Location:</b>  Copco No. 2 Residence 5/ Wall in living room		
<b>*Description (by layer):</b>  1: Gray grout associated with fireplace (M)

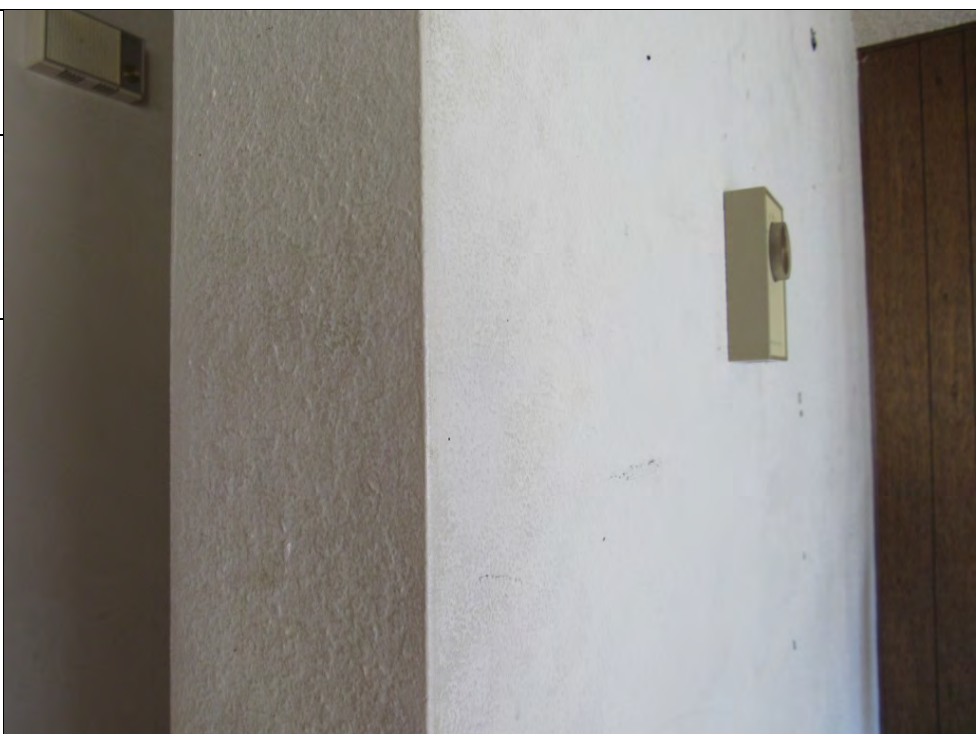
CC2R5 - 13	9/11/2018 to 9/13/2018	
<b>Structure/Material Location:</b>  Copco No. 2 Residence 5/ Walls throughout all rooms		
<b>*Description (by layer):</b>  1: White spray-applied wall texture (S)

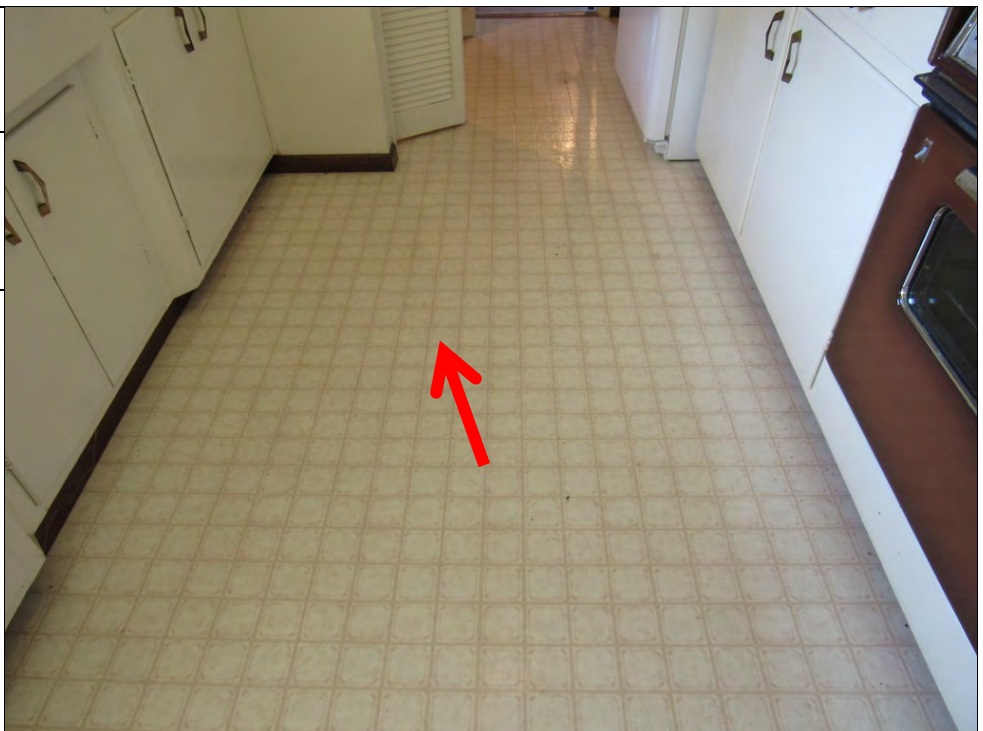
- 1: Off-white vinyl floor sheeting  
with pink square pattern (M)
- 2: Tan paper backing with mastic  
(M)
- 3: Brown brittle mastic (M)
