**Klamath River Renewal Corporation  
PacifiCorp**

**AMENDED APPLICATION FOR SURRENDER OF LICENSE  
FOR MAJOR PROJECT AND REMOVAL OF PROJECT WORKS**

**EXHIBIT N (1 of 2)  
Waste Disposal and Hazardous Materials Management Plan  
(Amended December 15, 2021)**

**Waste Disposal and  
Hazardous Materials  
Management Plan**

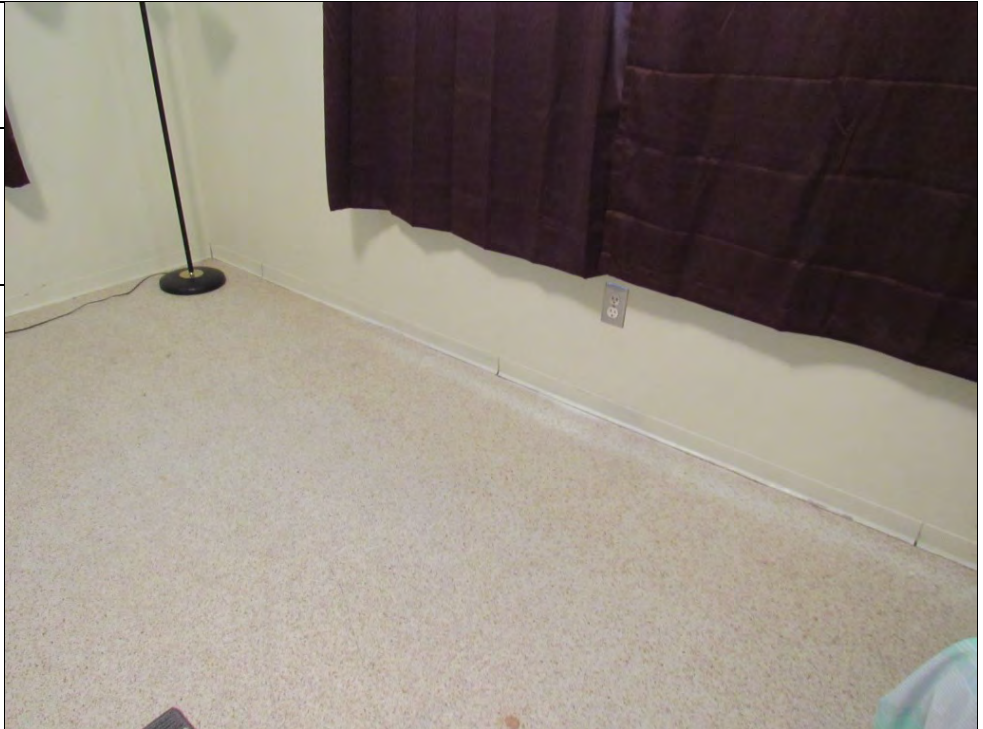
- 1: Off-white vinyl floor sheeting  
with multi-colored speckle  
pattern (M)
- 2: Brown paper backing with  
brown mastic (M)
- 3: Tan wood compressed  
material (M)

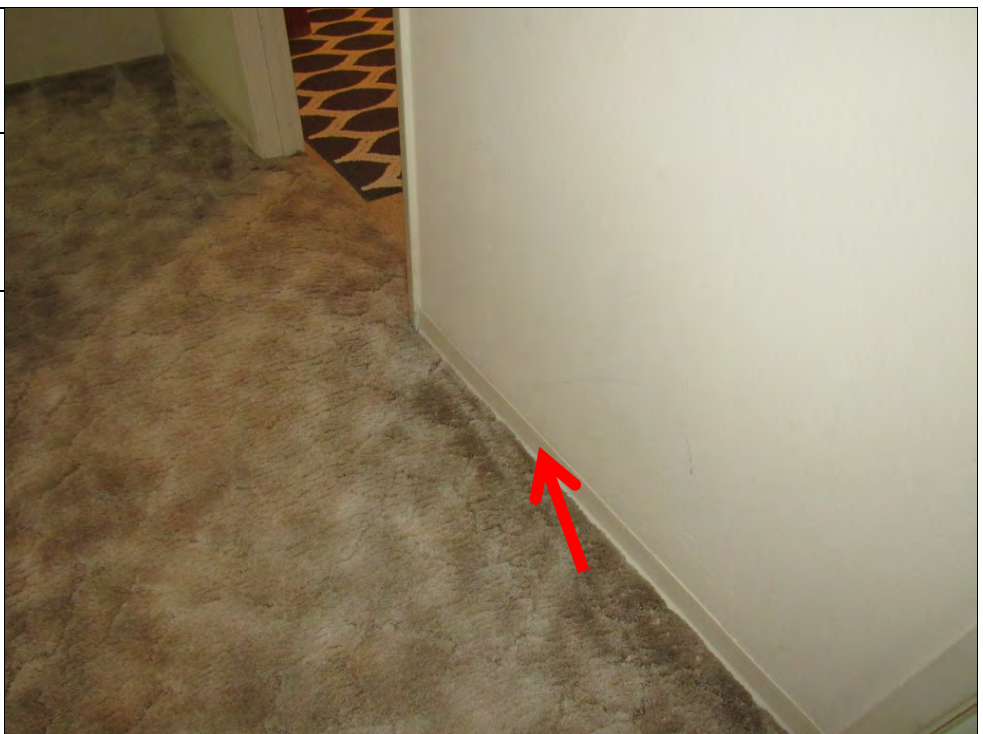
CC2R6 - 03

- 1: 3" white painted rubber cove  
base (M)
- 2: Tan mastic (M)

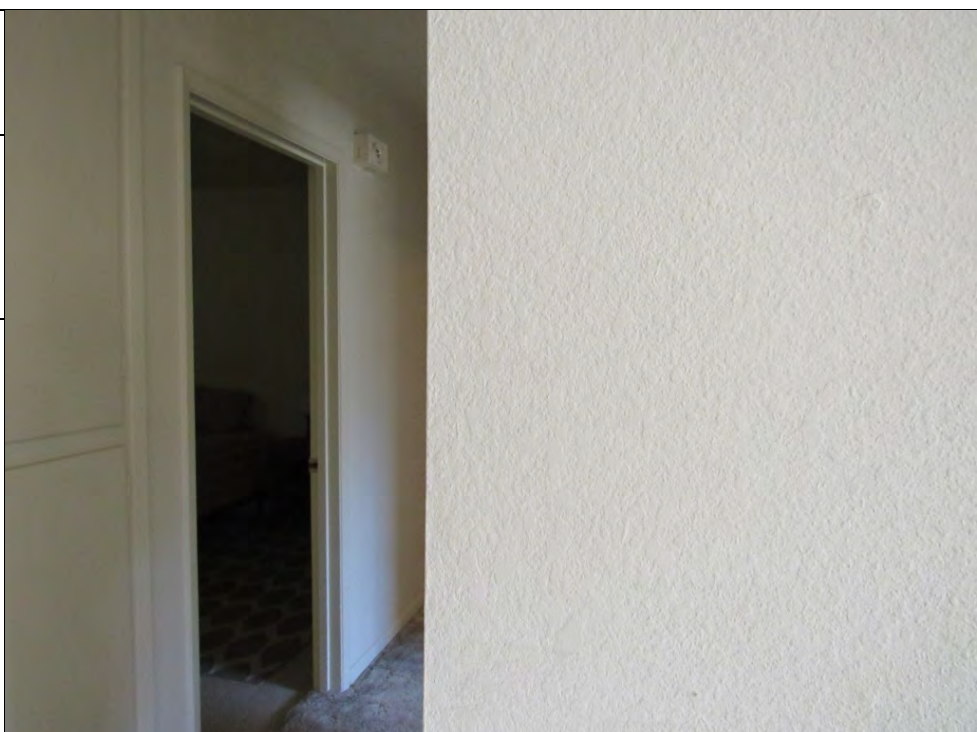
CC2R6 - 05	9/11/2018 to 9/13/2018	
<b>Structure/Material Location:</b>  Copco No. 2 Residence 6/ Walls throughout all rooms		
<b>*Description (by layer):</b>  <b>1: White spray-applied wall texture (S)</b> 2: Beige gypsum wallboard (M) 3: White gypsum wallboard with paper (M)

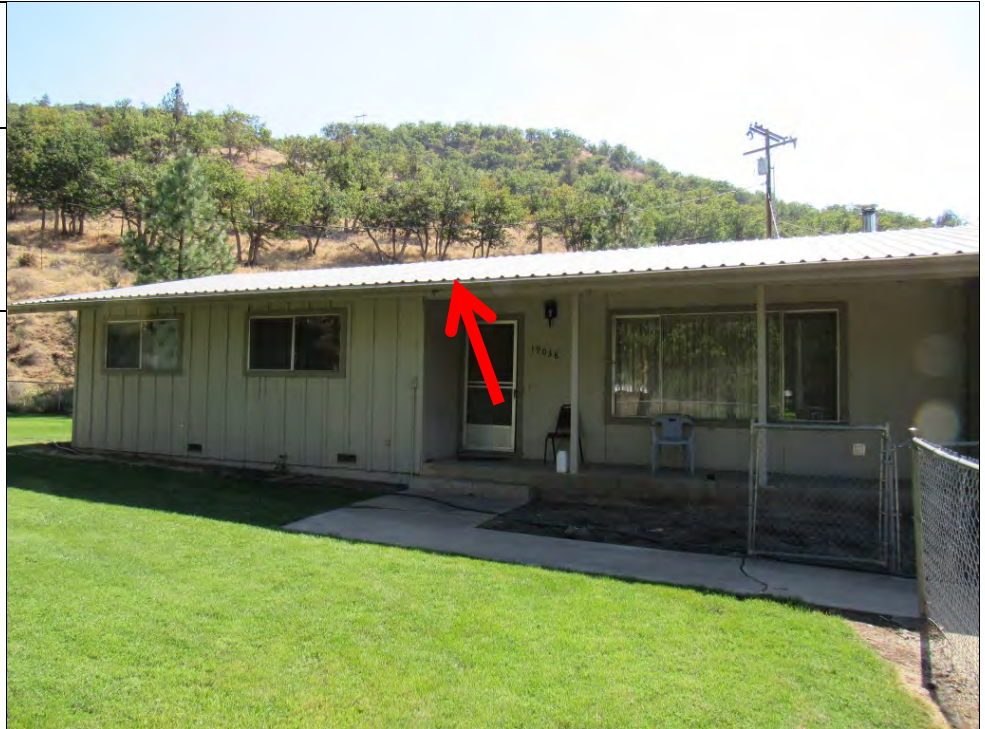
<b>Photo No./ Material ID:</b>  CC2R6 - 06	<b>Date:</b>  9/11/2018 to 9/13/2018
<b>Structure/Material Location:</b>  Copco No. 2 Residence 6/ Underneath corrugated metal roofing	
<b>*Description (by layer):</b>  <b>Assumed asbestos-containing roofing paper (M)</b>

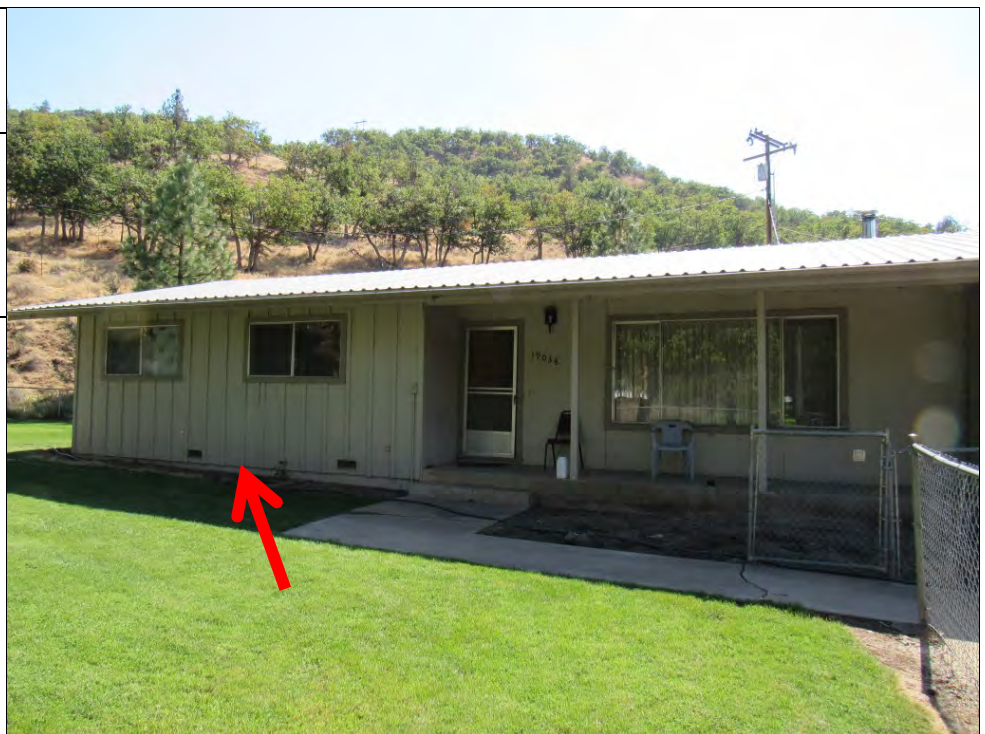
<b>Photo No./ Material ID:</b>  CC2R6 - 07	<b>Date:</b>  9/11/2018 to 9/13/2018
<b>Structure/Material Location:</b>  Copco No. 2 Residence 6/ Underneath metal siding	
<b>*Description (by layer):</b>  <b>Assumed asbestos-containing vapor barrier paper (M)</b>
