**UNITED STATES OF AMERICA
BEFORE THE
FEDERAL ENERGY REGULATORY COMMISSION**

**AMENDED APPLICATION FOR SURRENDER OF LICENSE
FOR MAJOR PROJECT AND REMOVAL OF PROJECT WORKS**

**EXHIBIT N (2 of 2)
Waste Disposal and Hazardous Materials Management Plan
(Amended December 15, 2021)**

**HAZARDOUS MATERIALS SURVEY
FINAL REPORT**

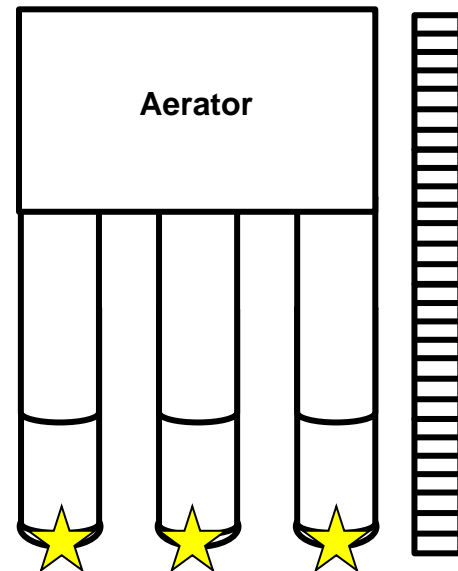
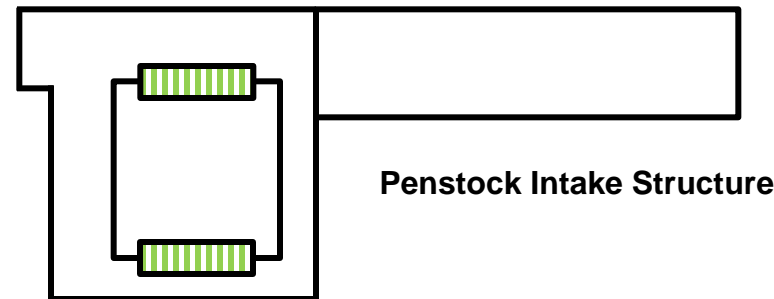
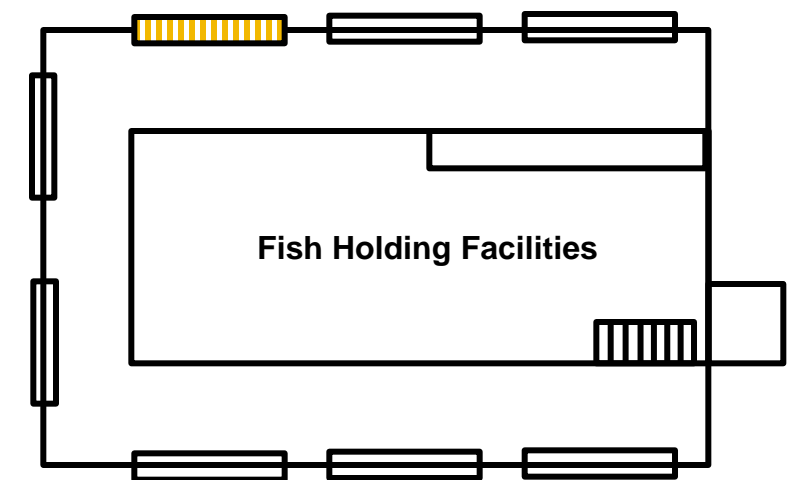
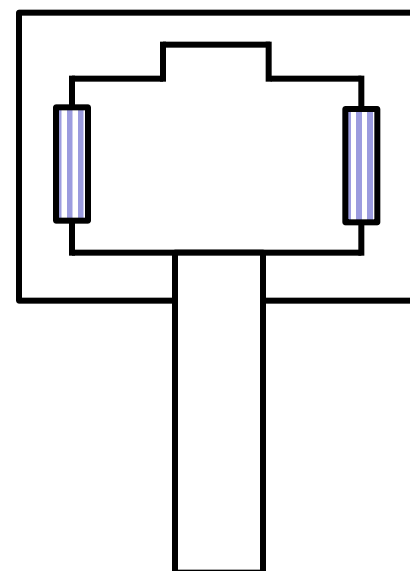
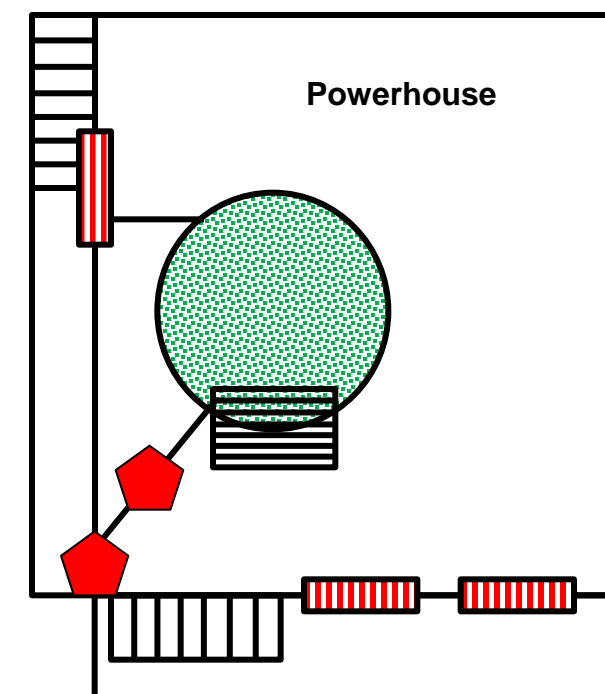
Figure 9
Approximate ACM Locations
Aerator, Penstock Intake Structure,
Fish Holding Facilities, Maintenance Shed,
Diversion Tunnel Intake Structure,
and Powerhouse

IGDPH-06: Assumed asbestos-containing metal-clad fire door insulation (M)

Assumed asbestos-containing buried Transite piping is assumed to be throughout the Iron Gate Development. Not shown on figures.

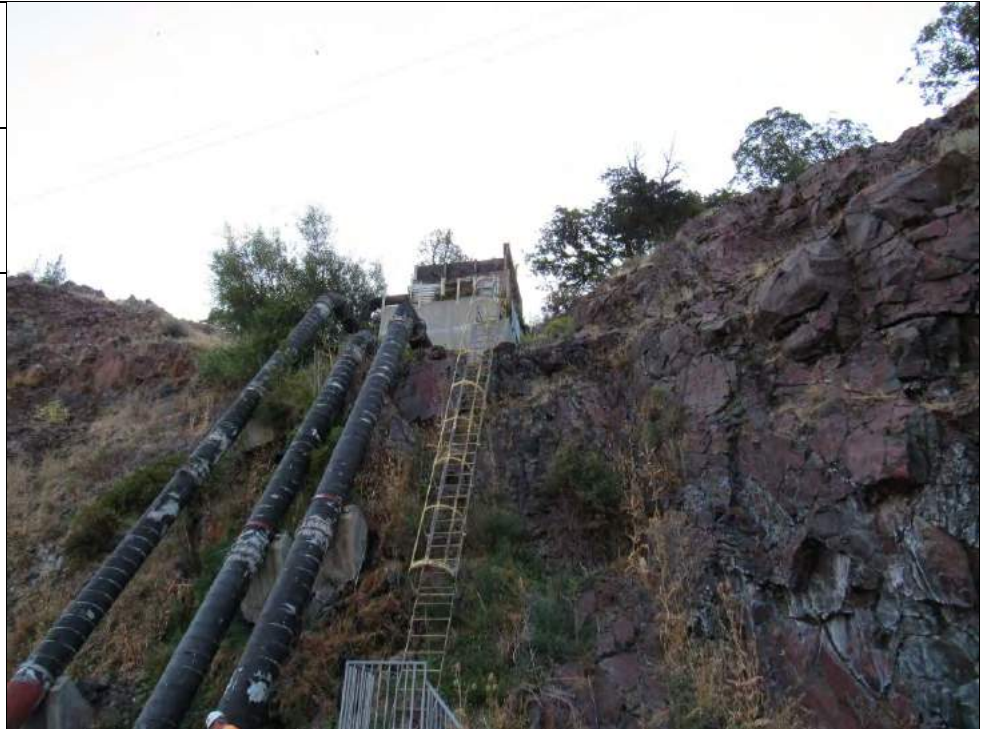
IGDAE - 01

1: Black asphaltic pipe wrap (M)

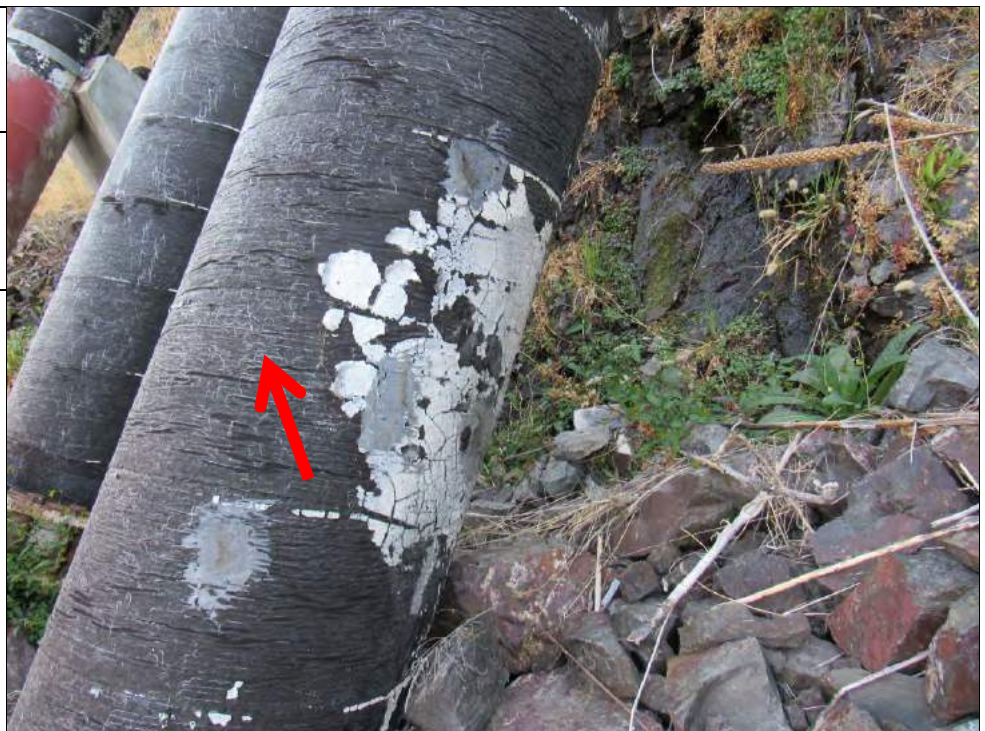
- 1: Silver paint (M)
- 2: Black asphaltic pipe wrap (M)

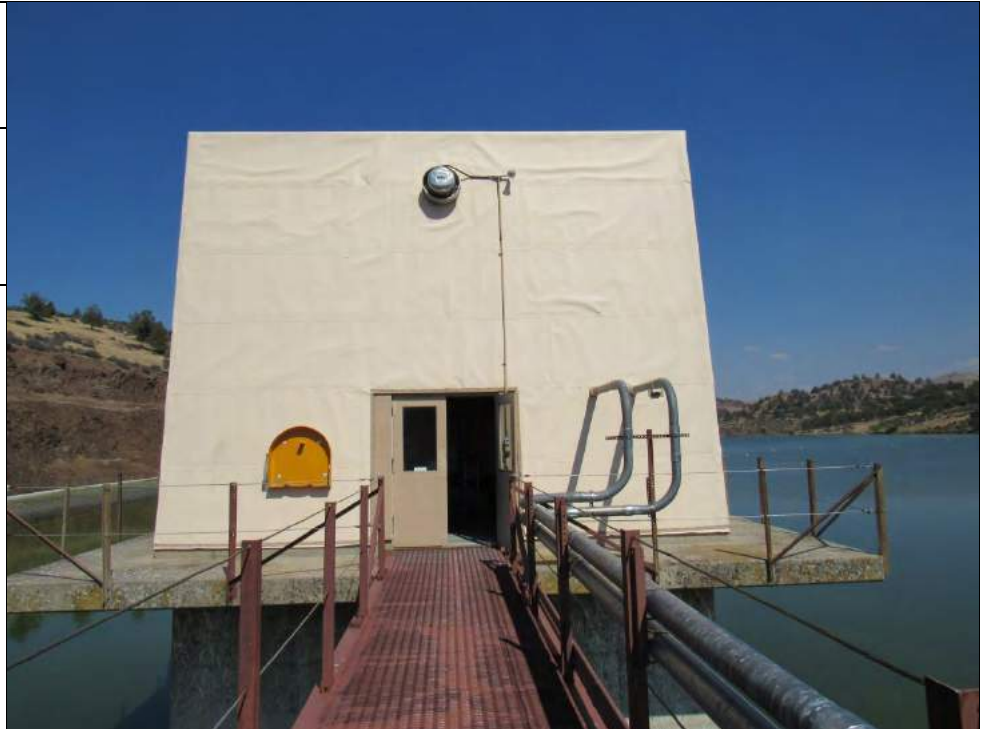
IDGDTI - 01

- 1: Silver paint (M)
- 2: **Gray window putty (M)**

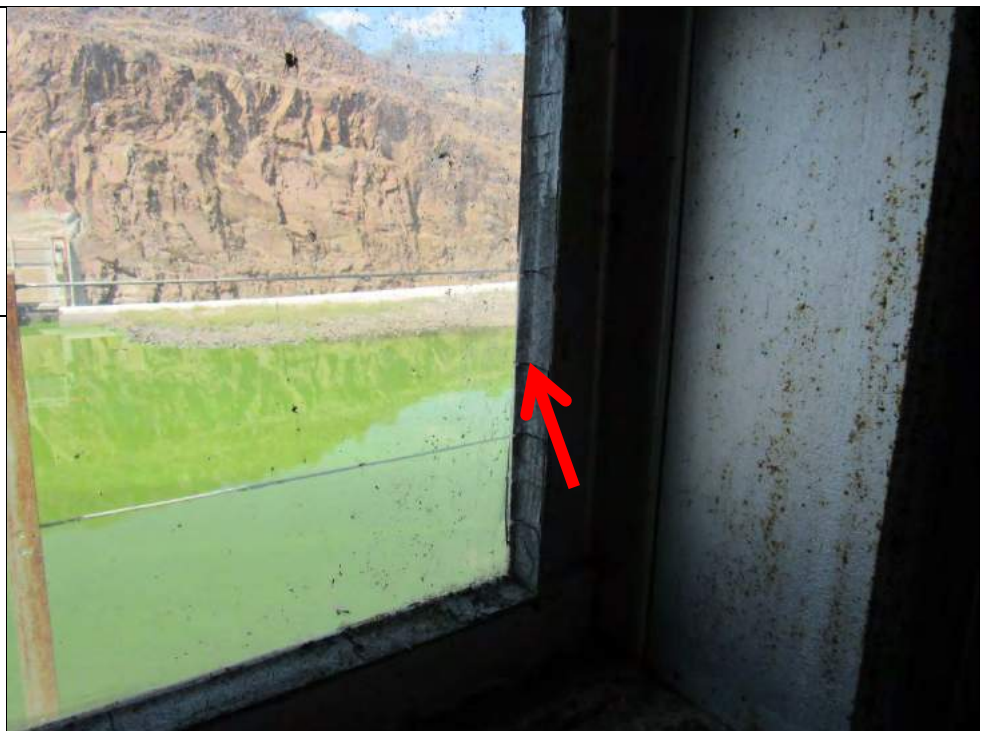
1: Beige exterior window
caulking (M)

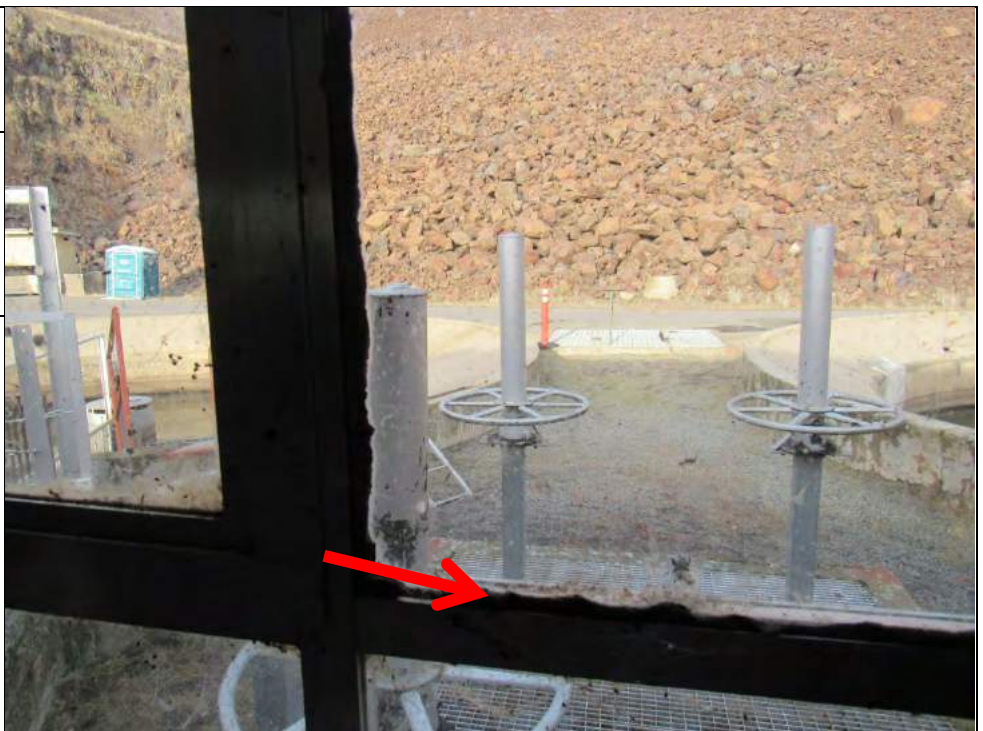
IGDFHF - 01

**1: Gray brittle window putty
(M)**

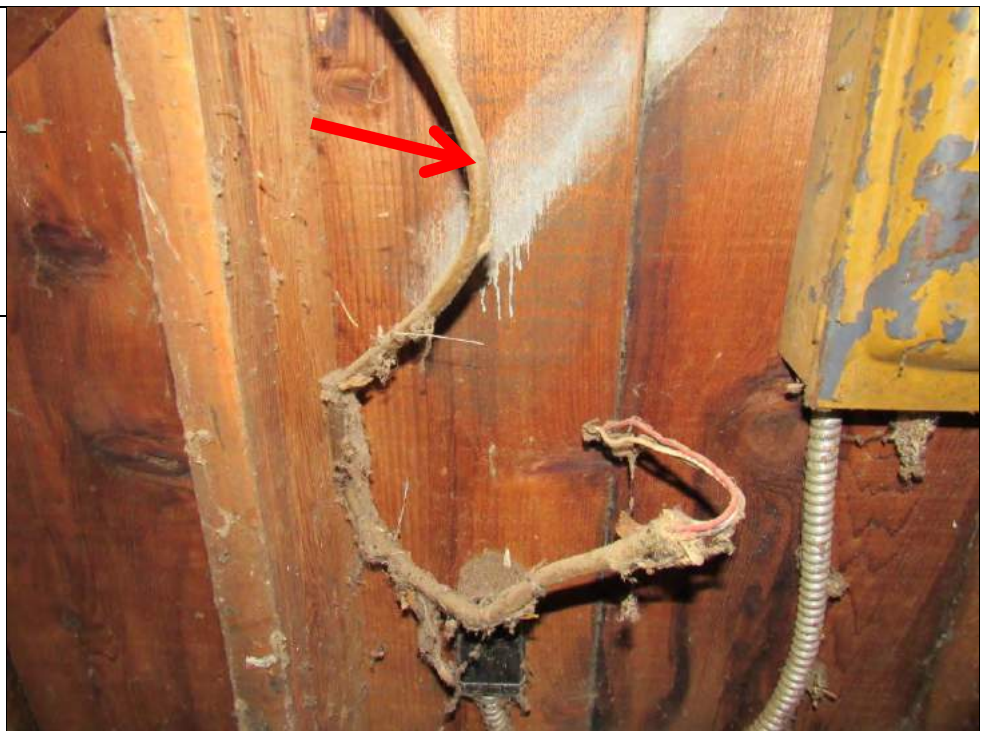
IGDMS - 01

**Assumed asbestos-containing
silver woven electrical wire
insulation**

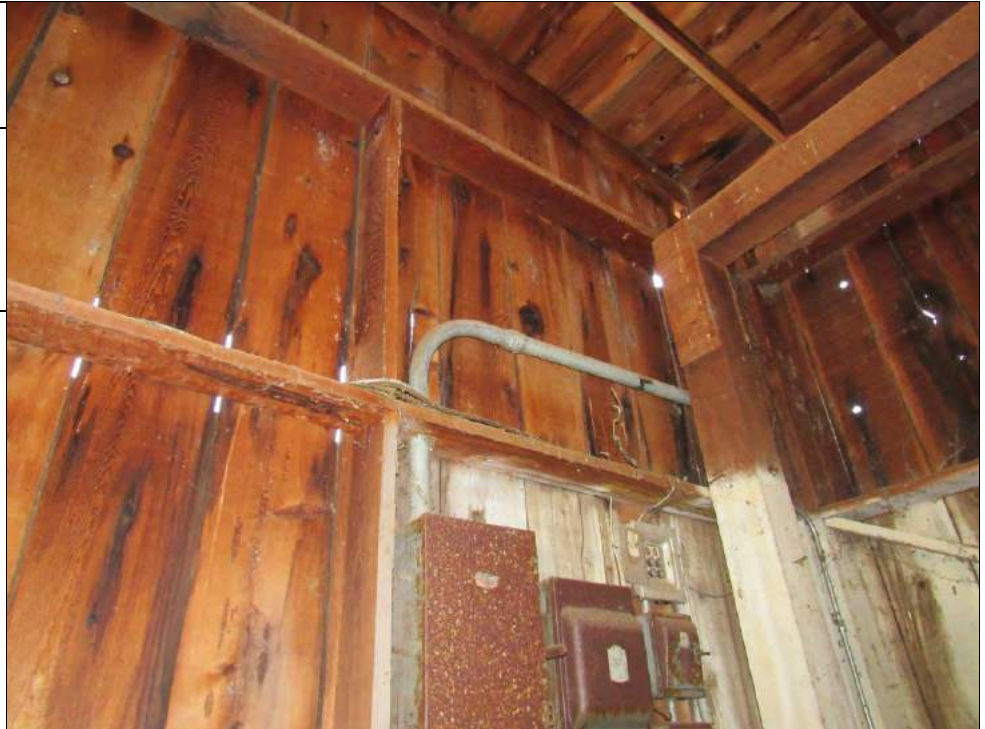
Photo No./ Material ID: IGDMS - 02	Date: 9/14/2018
Structure/Material Location: Iron Gate Dam Maintenance Shed/ Throughout Maintenance Shed	
*Description (by layer): Assumed asbestos-containing electrical panel backing in older electrical panels

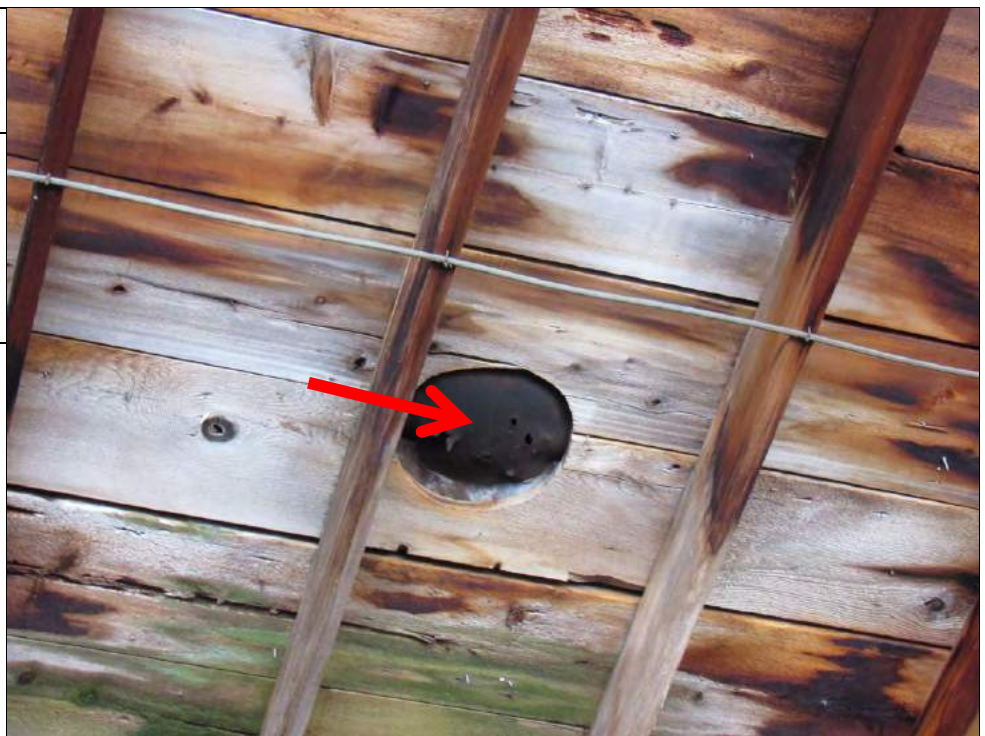
Photo No./ Material ID: IGDMS - 03	Date: 9/14/2018
Structure/Material Location: Iron Gate Dam Maintenance Shed/ Throughout Maintenance Shed roof, underneath corrugated metal roofing	
*Description (by layer): Assumed asbestos-containing roofing paper

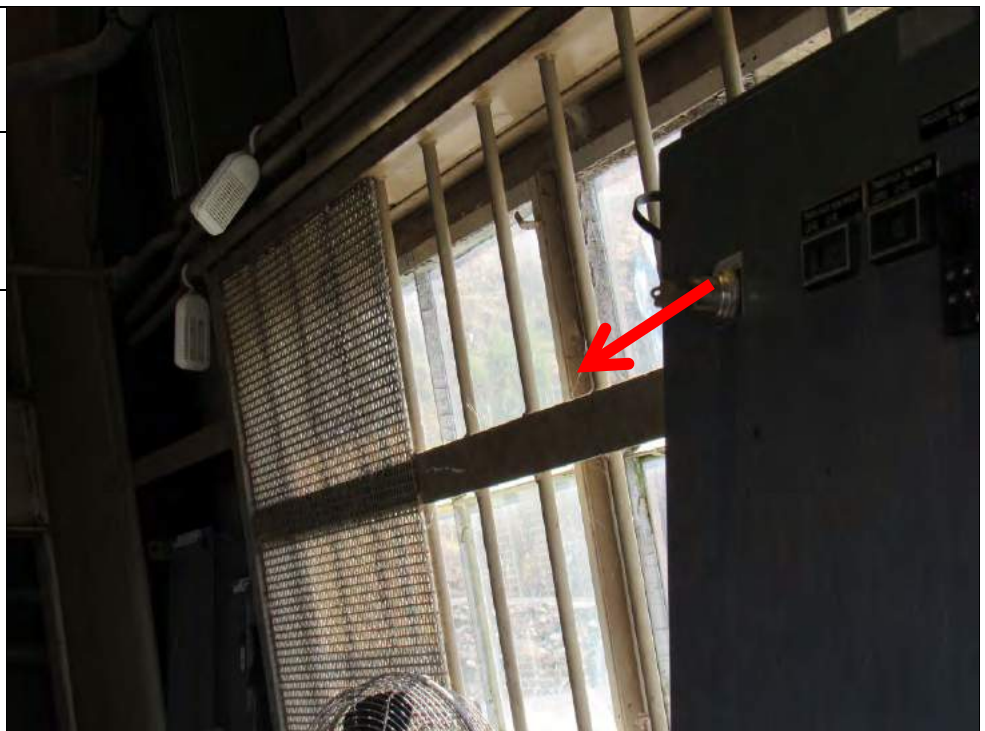
Photo No./ Material ID: IGDPIS - 01	Date: 9/14/2018
Structure/Material Location: Iron Gate Dam Penstock Intake Structure/ Interior window panes	
*Description (by layer): 1: Gray putty material (M)

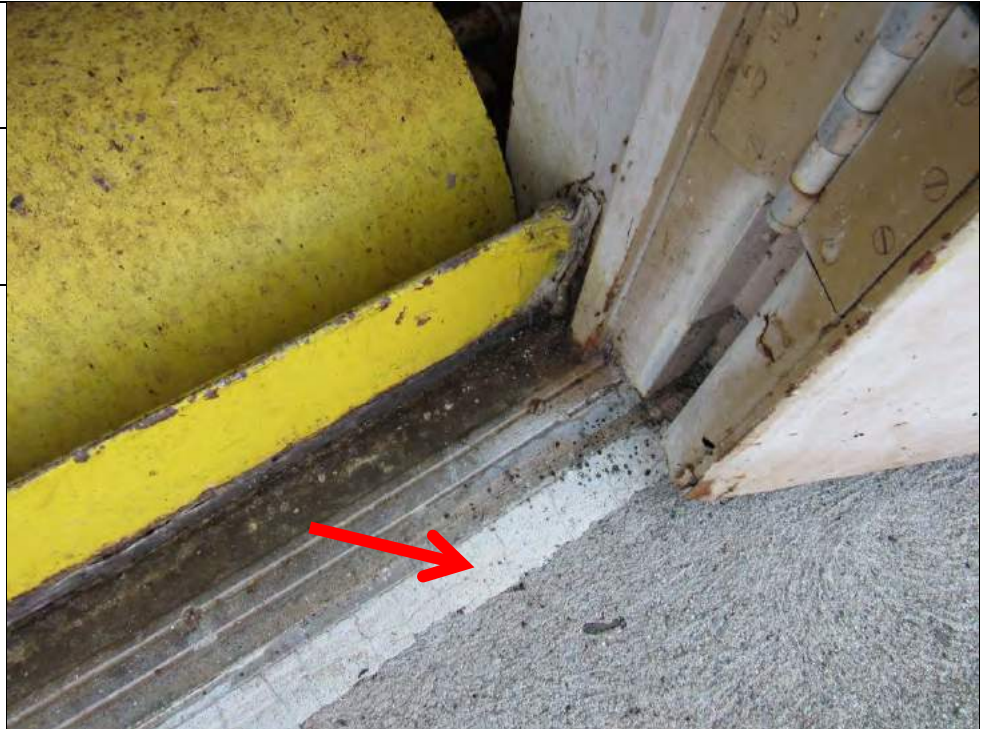
Photo No./ Material ID: IGDPIS - 02	Date: 9/14/2018
Structure/Material Location: Iron Gate Dam Penstock Intake Structure/ Doorway to interior	
*Description (by layer): 1: White caulking at base of doorway (M) 2: Gray brittle material (M)

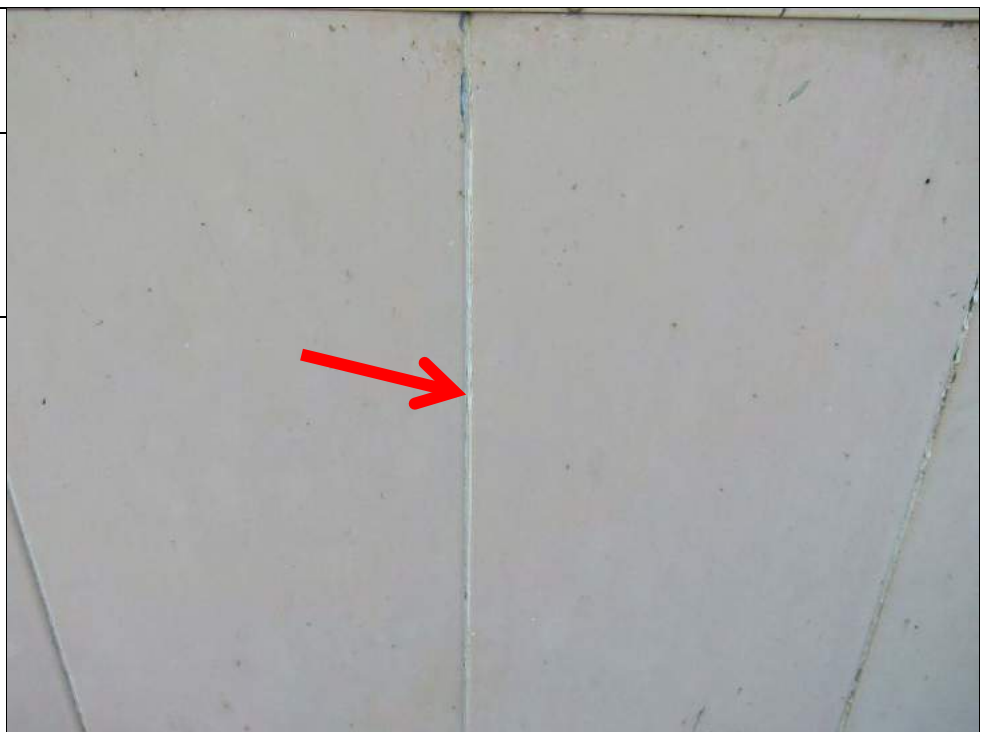
Photo No./ Material ID: IGDPIS - 03	Date: 9/14/2018
Structure/Material Location: Iron Gate Dam Penstock Intake Structure/ Exterior metal siding seams	
*Description (by layer): 1: White caulking (M) 2: Beige soft material with paint (M)

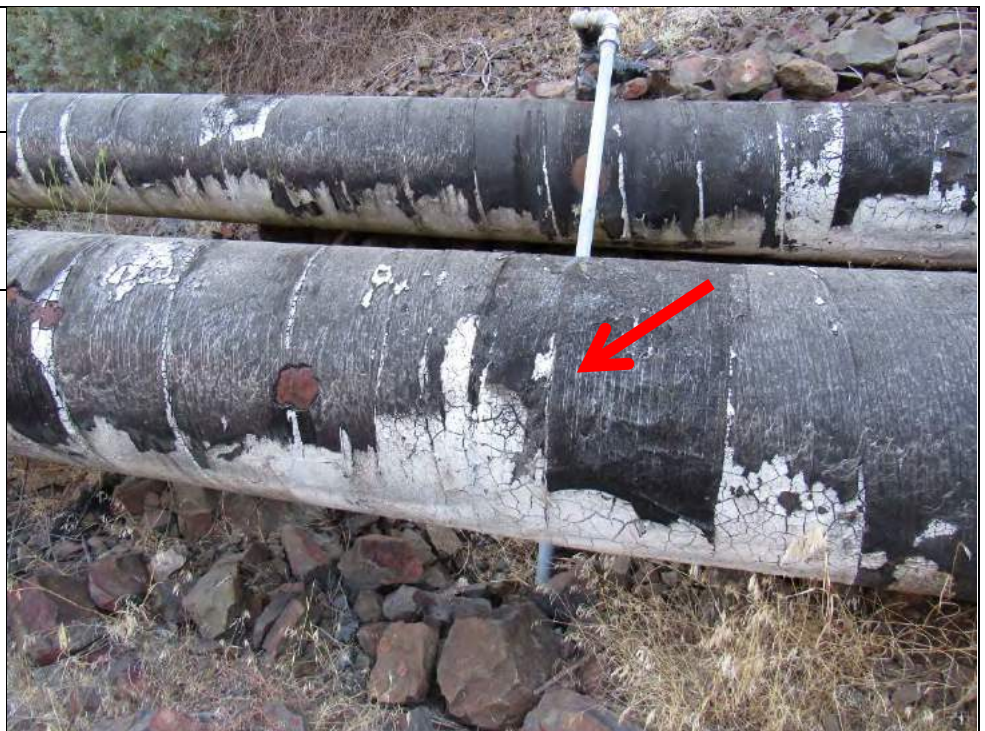
**Photo No./
Material ID:**
IGDPS - 01

***Description (by layer):**
1:Black asphaltic pipe wrap (M)

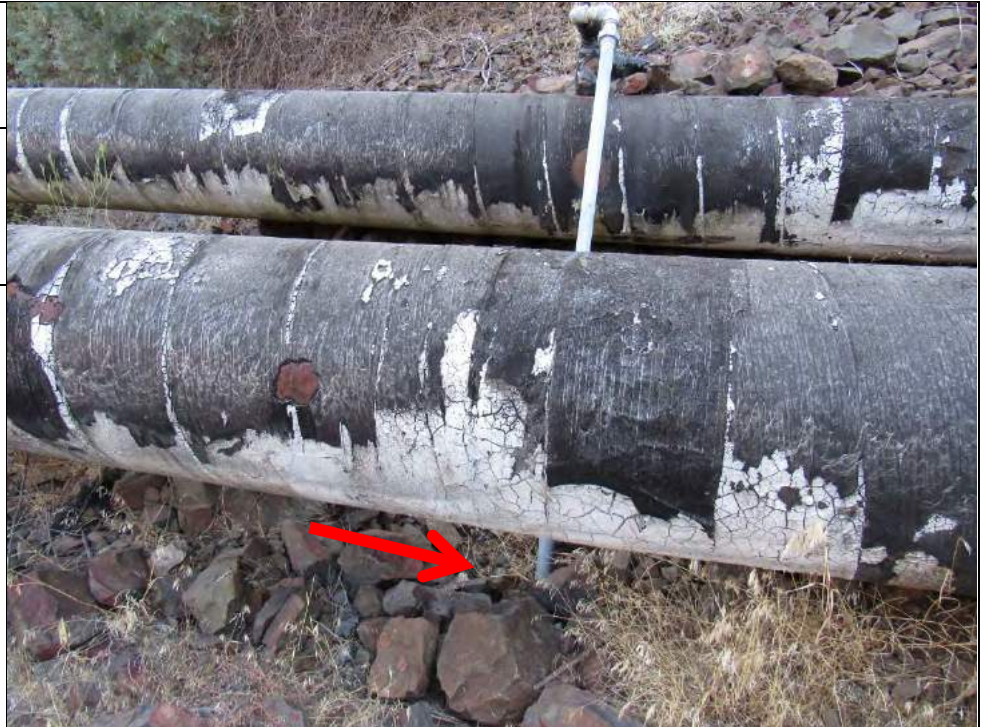
Photo No./ Material ID: IGDPS - 02	Date: 9/14/2018
Structure/Material Location: Iron Gate Dam Penstock/ Hatchery water supply piping	
*Description (by layer): 1: Thick silver paint (M) 2: Black asphaltic pipe wrap (M)

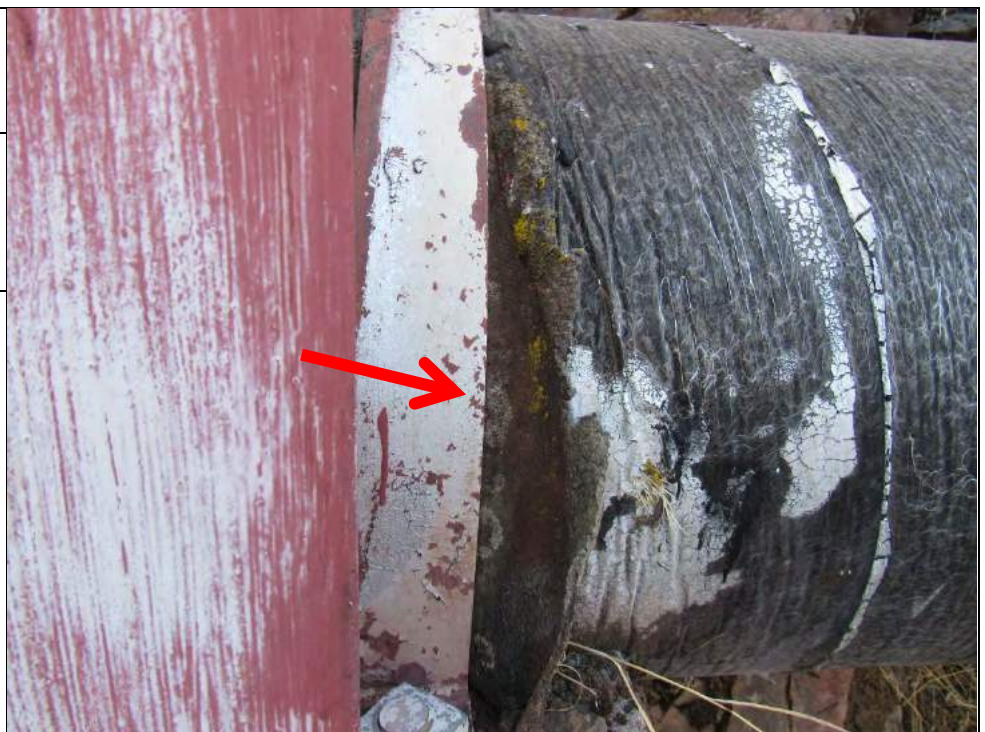
Photo No./ Material ID: IGDPS - 03	Date: 9/14/2018
Structure/Material Location: Iron Gate Dam Penstock/ Hatchery water supply piping	
*Description (by layer): 1: Brown fibrous gasket at pipe line saddles (M)

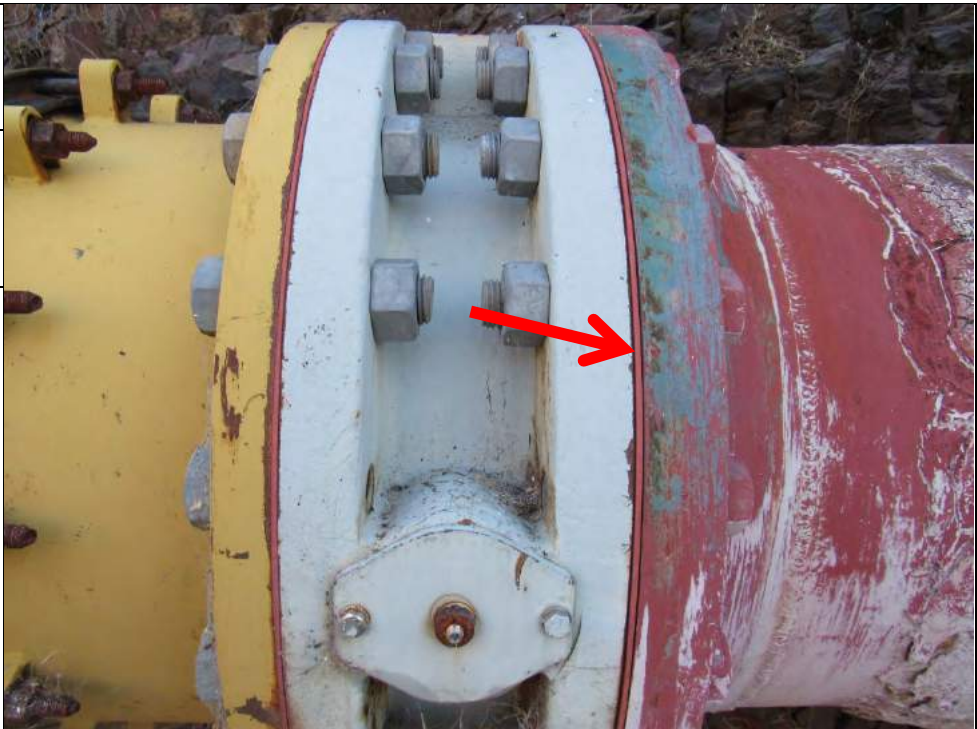
Photo No./ Material ID: IGDPS - 04	Date: 9/14/2018

Structure/Material Location: Iron Gate Dam Penstock/ Hatchery water supply piping		
*Description (by layer): 1: Red gasket (M)

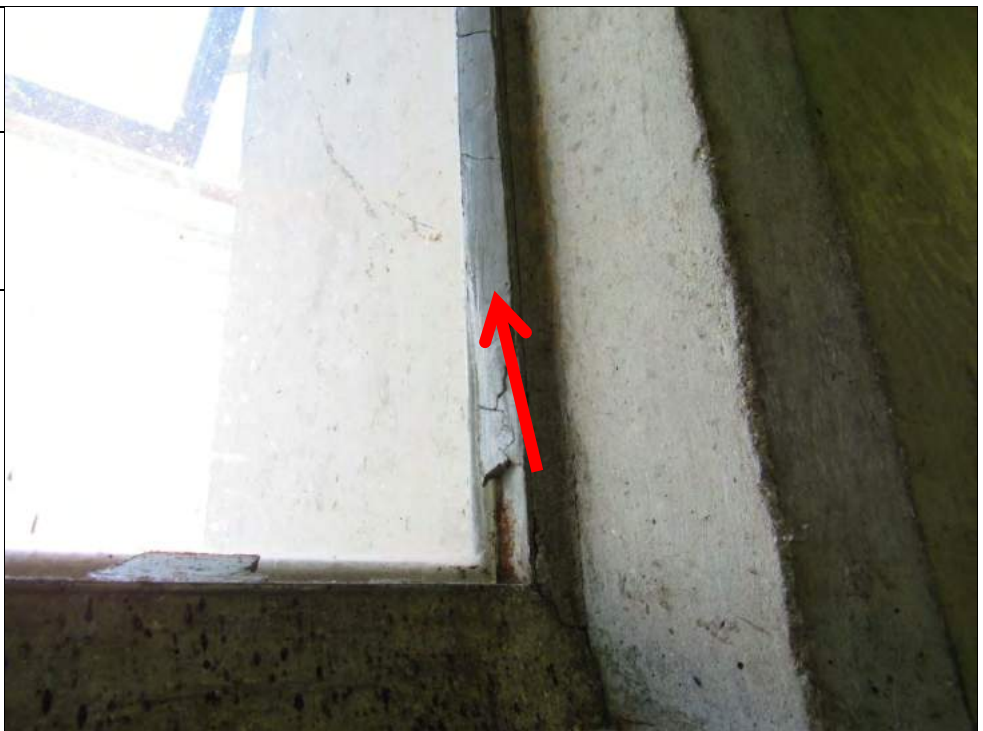
IGDPH - 01

1: Gray brittle window putty (M)

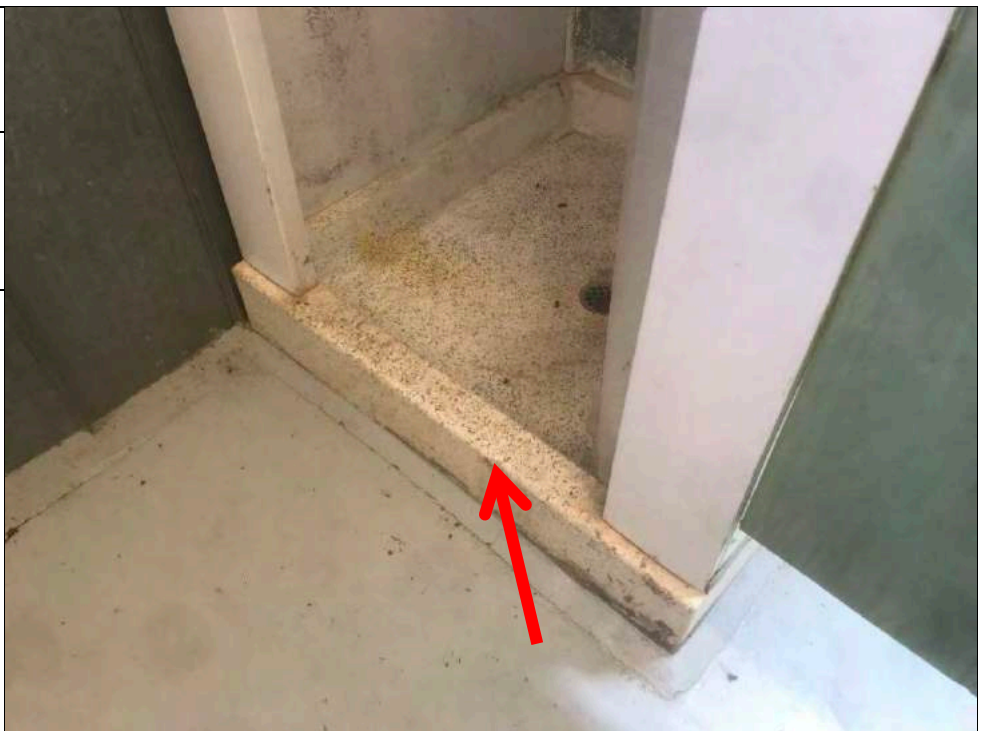
IGDRR - 01

1: White brittle terrazzo (M)

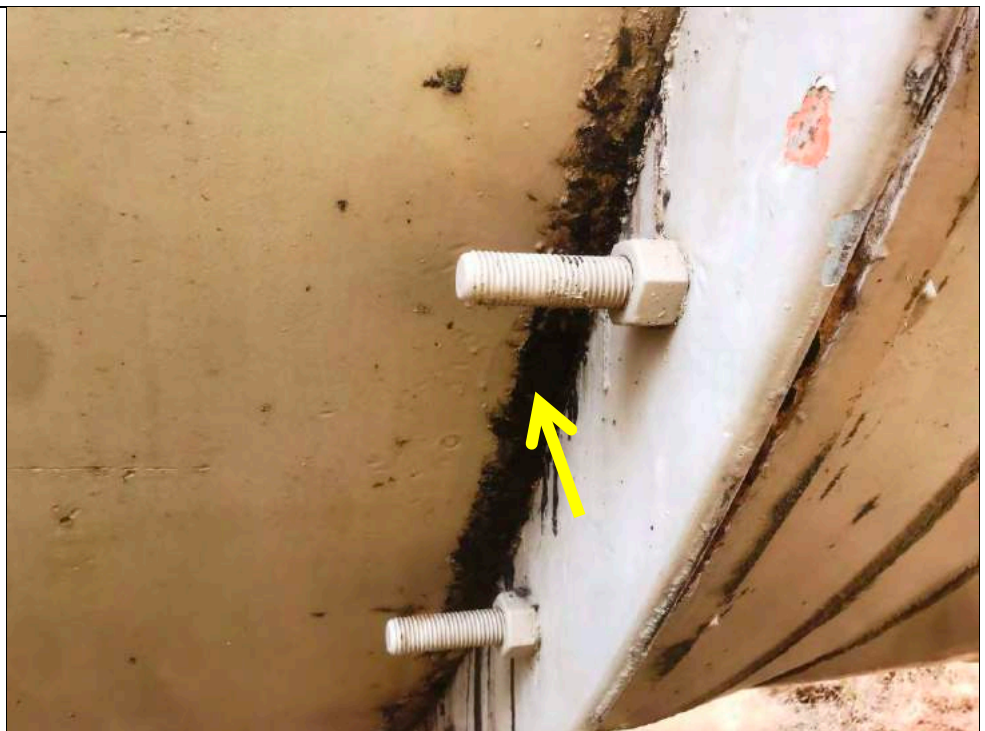
Photo No./ Material ID: JCCH - 01	Date: 8/20/2018 to 8/23/2018
Structure/Material Location: JC Boyle Dam Canal Headgate and 14' Pipeline/ Around 14' diversion pipeline	
*Description (by layer): 1: Black asphaltic sealant (M)

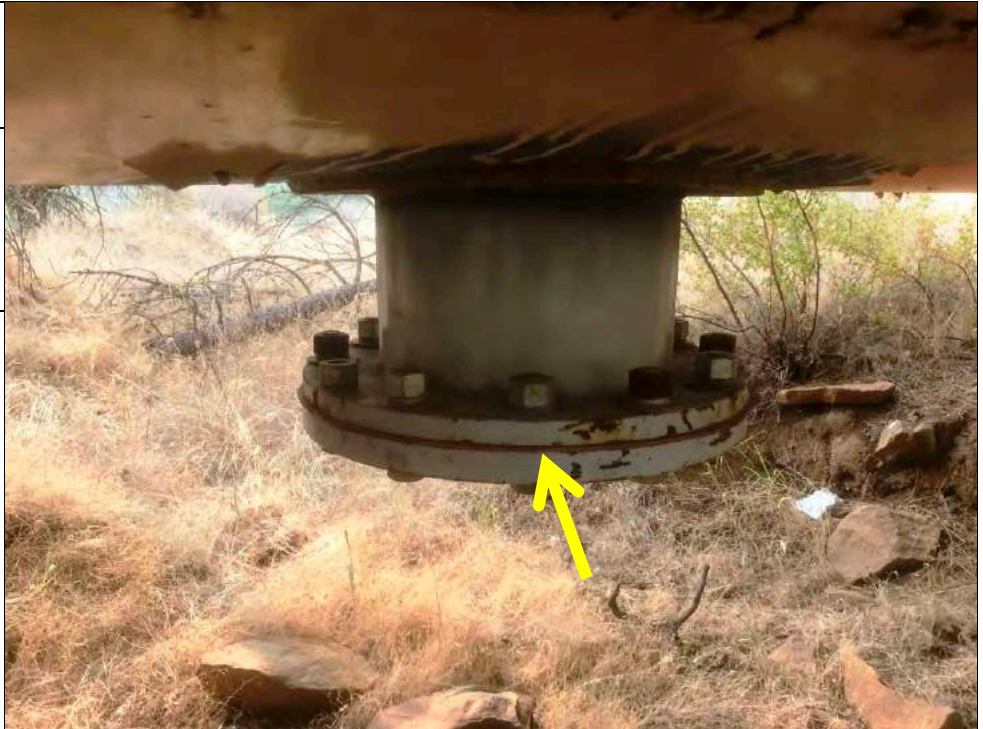
Photo No./ Material ID: JCCH - 02	Date: 8/20/2018 to 8/23/2018
Structure/Material Location: JC Boyle Dam Canal Headgate and 14' Pipeline/ Around 14' diversion pipe down spout	
*Description (by layer): 1: Red gasket (M)

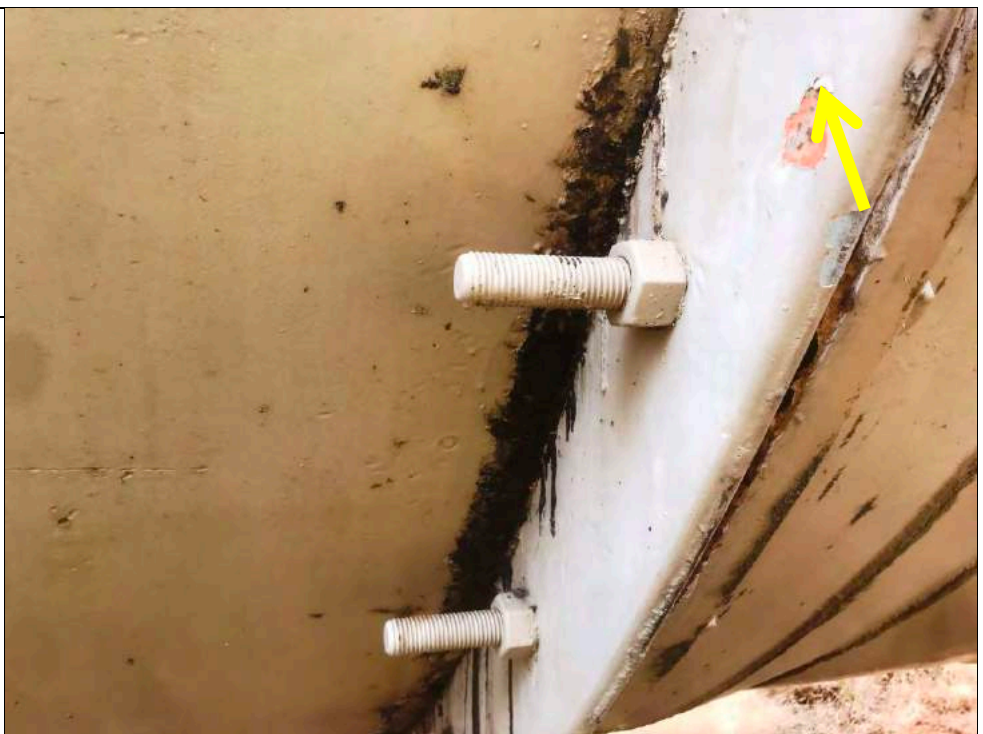
Photo No./ Material ID: JCCH - 03	Date: 8/20/2018 to 8/23/2018
Structure/Material Location: JC Boyle Dam Canal Headgate and 14' Pipeline/ 14' diversion pipeline	
*Description (by layer): 1: Silver paint (M)

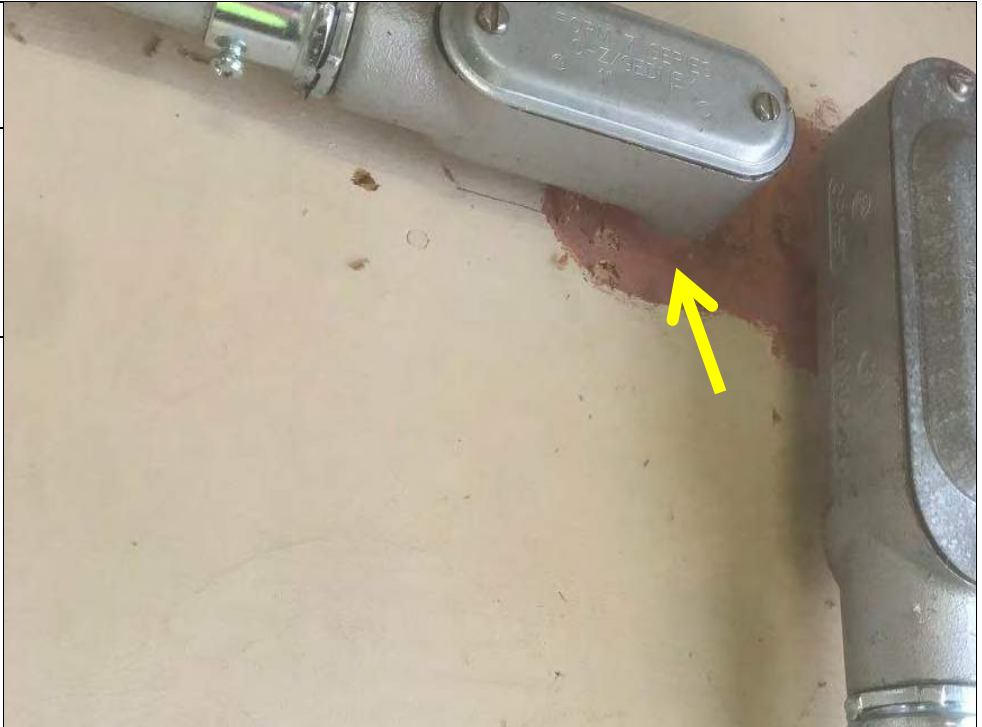
Photo No./ Material ID: JCGCB - 02	Date: 12/06/2018
Structure/Material Location: JC Boyle Dam Gate Control and Communications Building / Interior wall at electrical conduit penetrations	
*Description (by layer): 1: Red fire stop sealant (M)

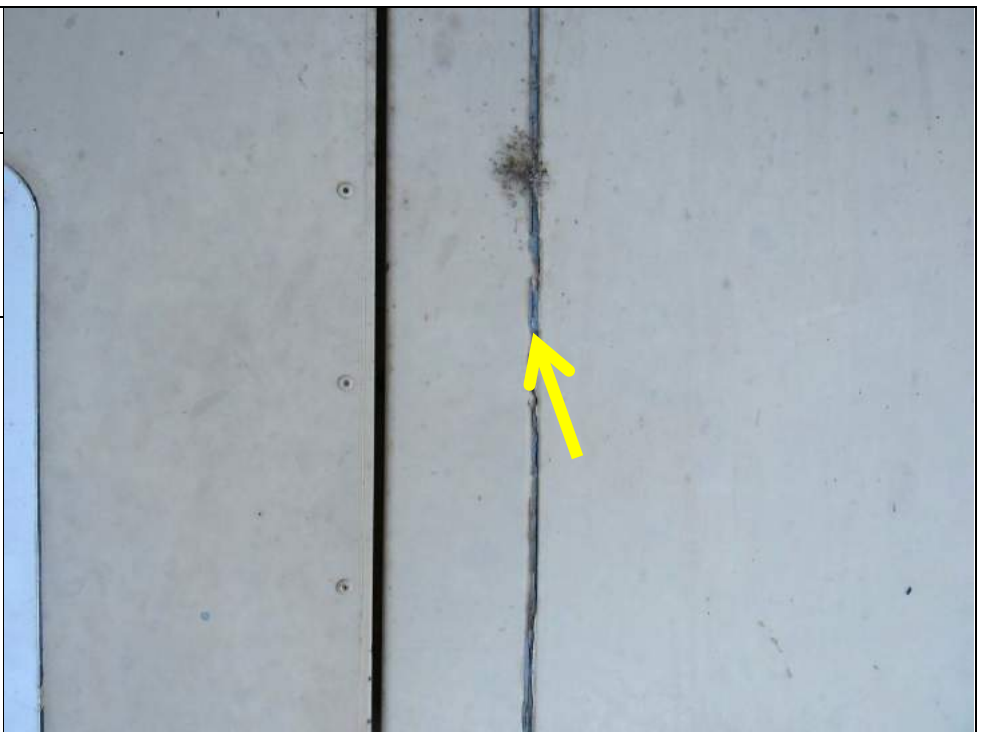
Photo No./ Material ID: JCGCB - 03	Date: 12/06/2018
Structure/Material Location: JC Boyle Dam Gate Control and Communications Building / Exterior siding seams	
*Description (by layer): 1: Gray sealant (M)

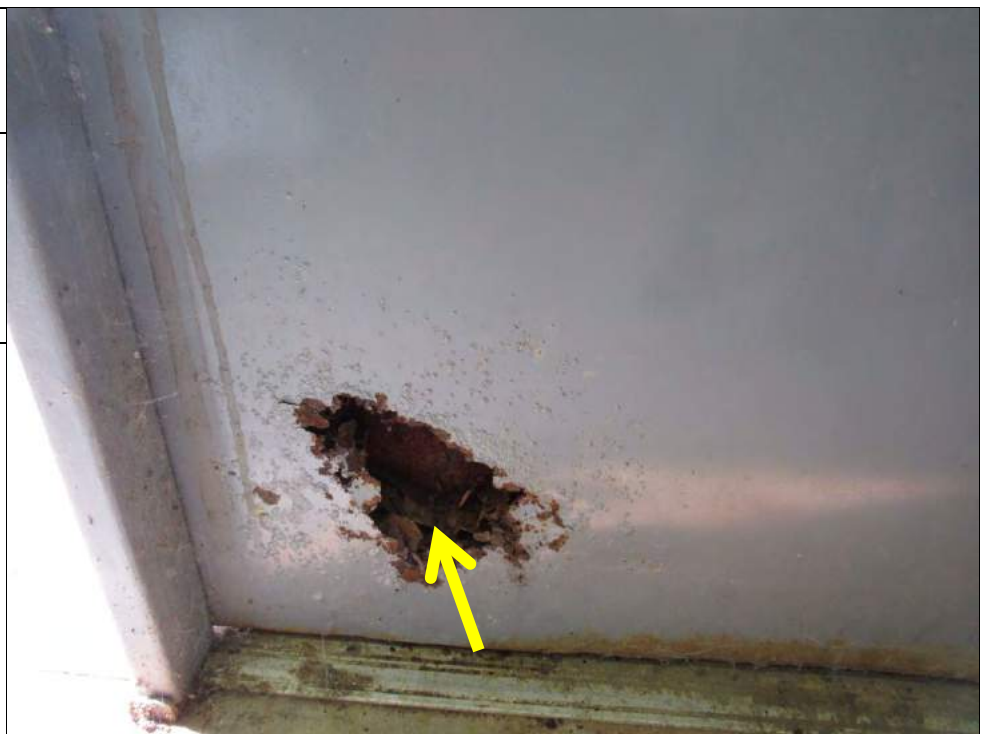
JCFP - 03

JC Boyle Dam Fire Protection
Building/ Interior of metal double
doors (deterioration exposed
insulation)

1: Fire door insulation (M)

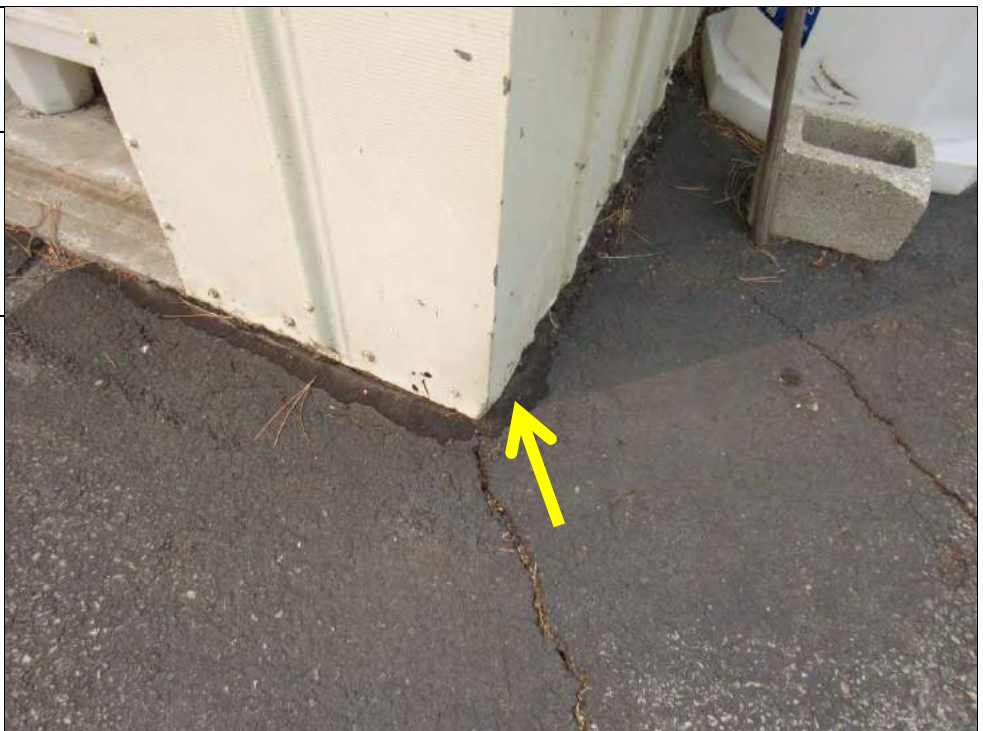
JCHM - 01

1: Asphalt (M)
**2: Asphaltic concrete crack
sealant (M)**

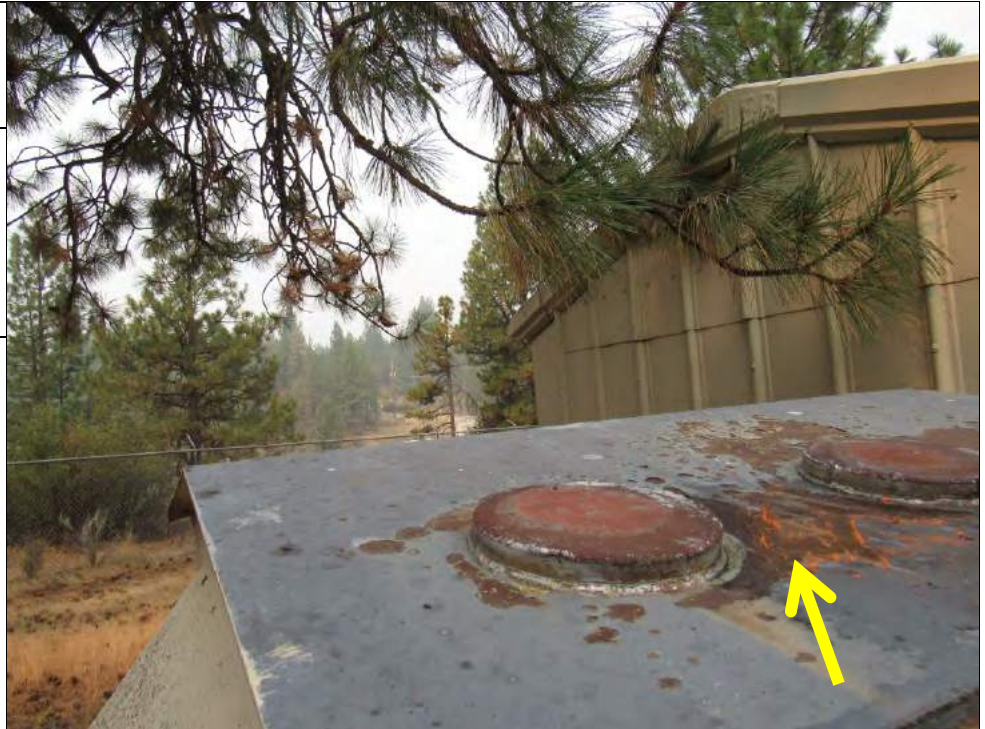
Photo No./ Material ID: JCHM - 04	Date: 8/20/2018 to 8/23/2018
Structure/Material Location: JC Boyle Dam HazMat Shed and Above Ground Storage Tanks/ Roof of small storage shed adjacent to HazMat Shed	
*Description (by layer): 1: Thick silver paint (M)

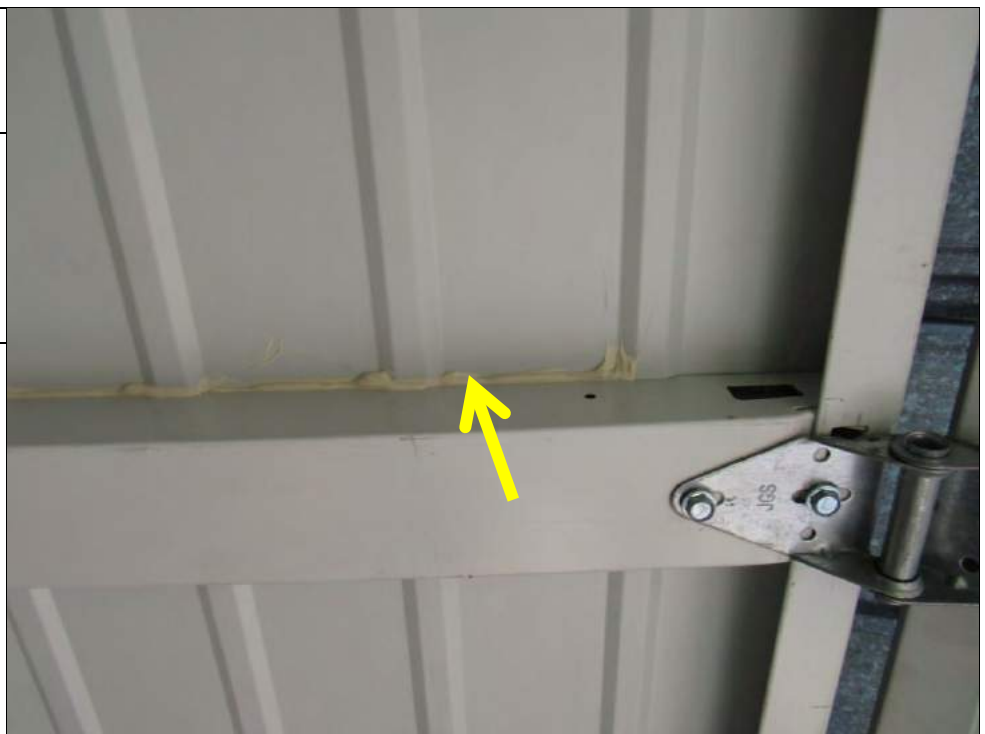
Photo No./ Material ID: JCHM - 05	Date: 8/20/2018 to 8/23/2018
Structure/Material Location: JC Boyle Dam HazMat Shed and Above Ground Storage Tanks/ On roll-up door to HazMat Shed	
*Description (by layer): 1: White caulking (M)

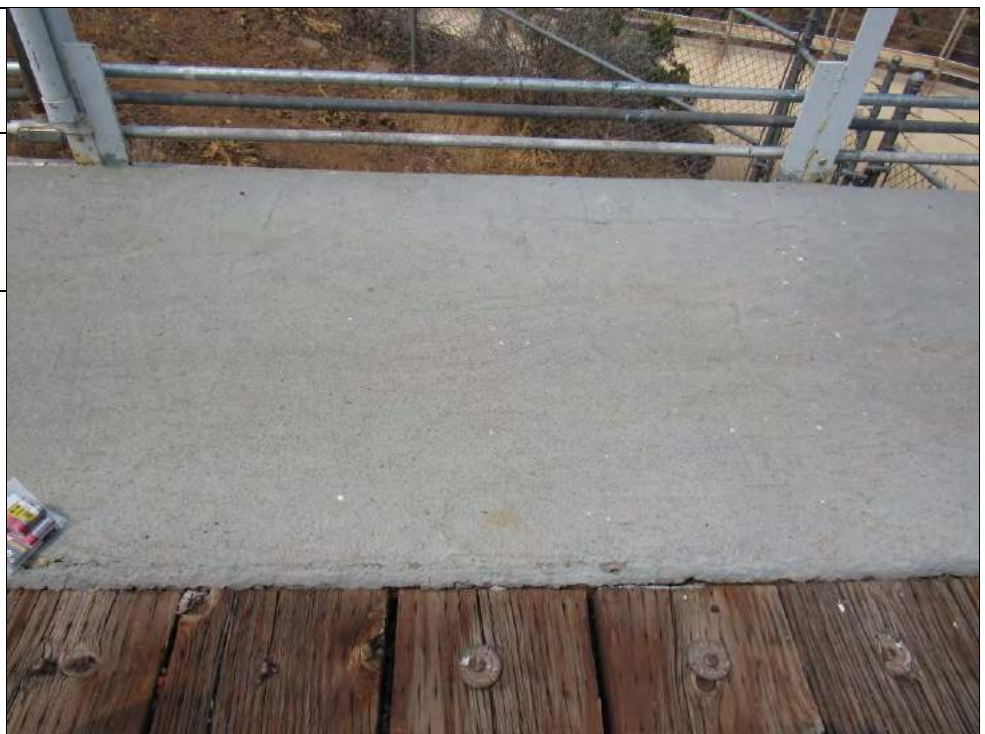
Photo No./ Material ID: JCIS - 03	Date: 8/20/2018 to 8/23/2018
Structure/Material Location: JC Boyle Dam Intake Structure/ Intake structure walkway	
*Description (by layer): 1: Textured cementitious coating on walkway (M)

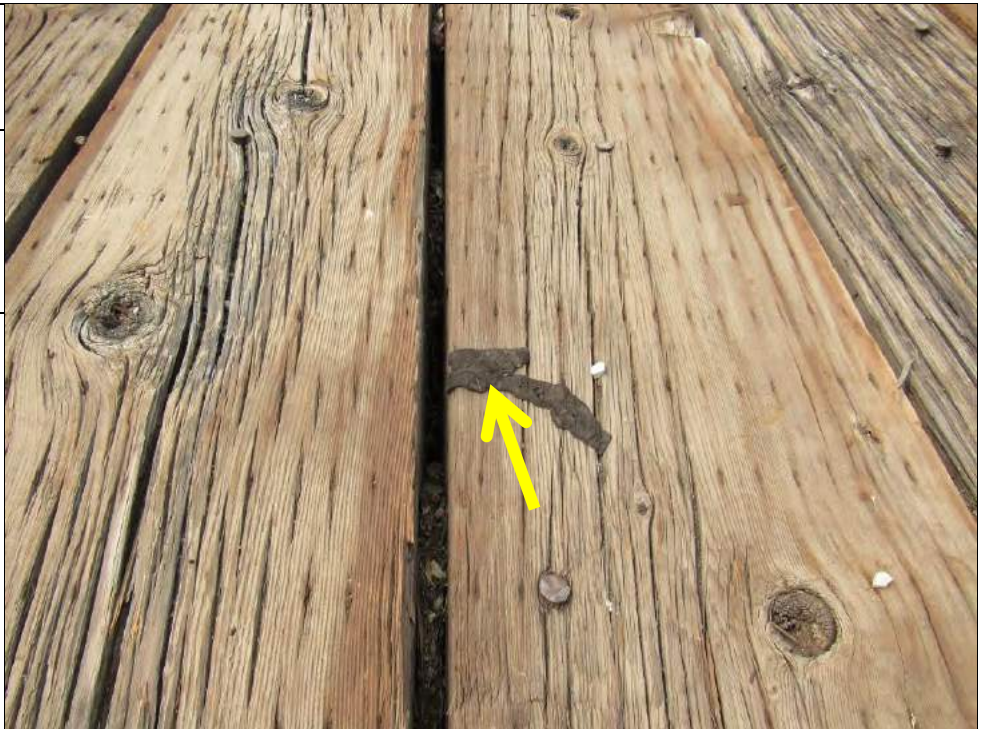
Photo No./ Material ID: JCIS - 04	Date: 8/20/2018 to 8/23/2018
Structure/Material Location: JC Boyle Dam Intake Structure/ On wood bridge to intake structure	
*Description (by layer): 1: Asphaltic creosote (M)
