**UNITED STATES OF AMERICA
BEFORE THE
FEDERAL ENERGY REGULATORY COMMISSION**

**AMENDED APPLICATION FOR SURRENDER OF LICENSE
FOR MAJOR PROJECT AND REMOVAL OF PROJECT WORKS**

**EXHIBIT N (2 of 2)
Waste Disposal and Hazardous Materials Management Plan
(Amended December 15, 2021)**

**HAZARDOUS MATERIALS SURVEY
FINAL REPORT**

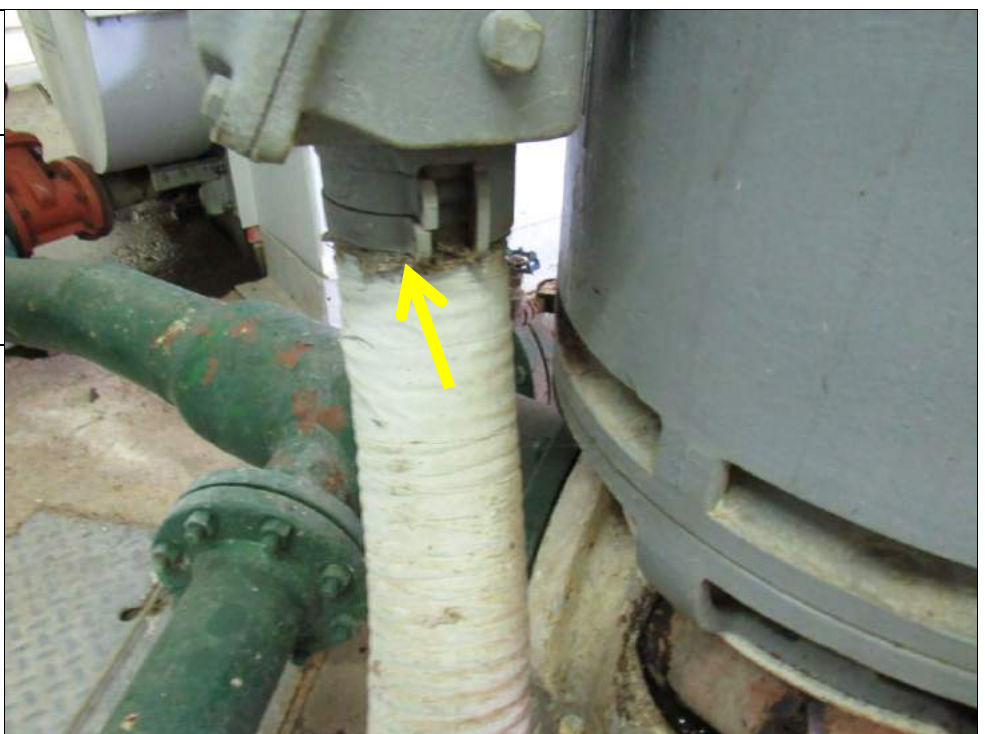
Photo No./ Material ID: JCIS - 05	Date: 8/20/2018 to 8/23/2018
Structure/Material Location: JC Boyle Dam Intake Structure/ Flex pipe connection associated with pump inside Fish Screen Building	
*Description (by layer): 1: Brown woven gasket (M)

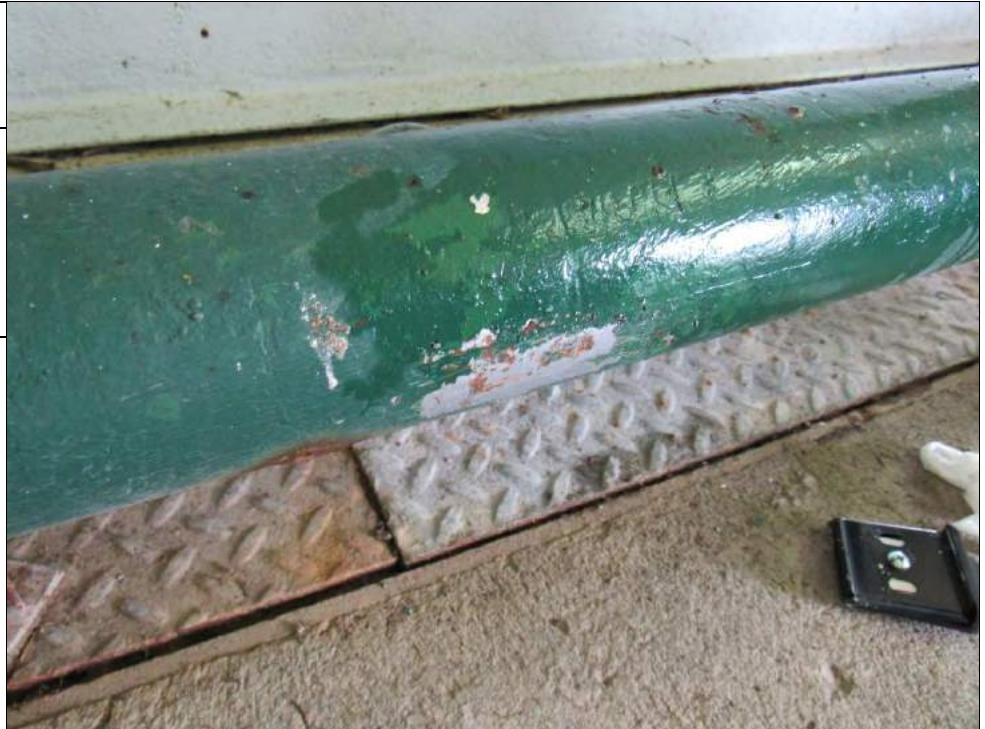
Photo No./ Material ID: JCIS - 06	Date: 8/20/2018 to 8/23/2018
Structure/Material Location: JC Boyle Dam Intake Structure/ Piping connecting traveling water screens inside Fish Screen Building	
*Description (by layer): 1: Thick silver paint (M) 2: Paint on piping (M)

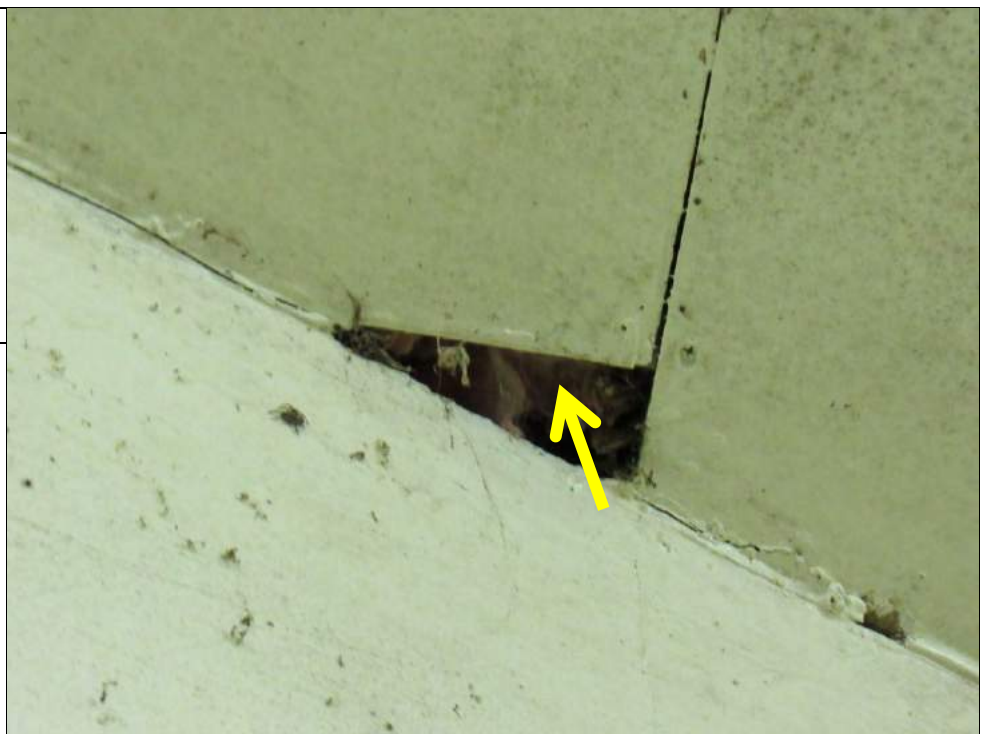
Photo No./ Material ID: JCIS - 07	Date: 8/20/2018 to 8/23/2018
Structure/Material Location: JC Boyle Dam Intake Structure/ At concrete wall/wood ceiling interface inside Fish Screen Building	
*Description (by layer): 1: White caulking (M) 2: Brown caulking (M)

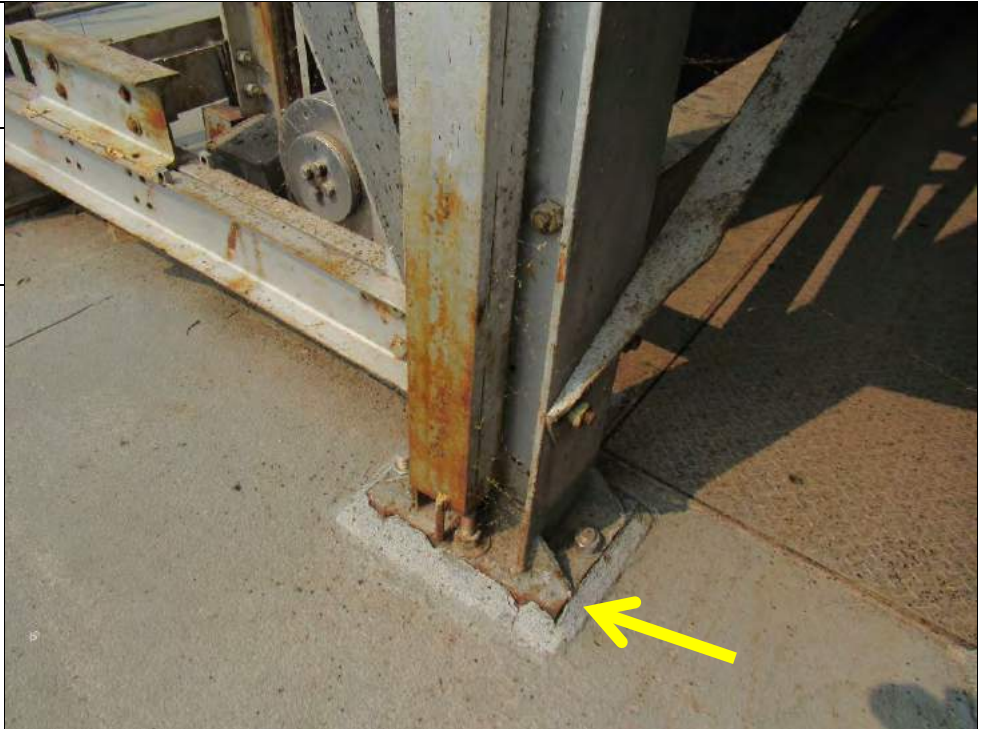
Photo No./ Material ID: JCIS - 10	Date: 8/20/2018 to 8/23/2018
Structure/Material Location: JC Boyle Dam Intake Structure/ Structure around stop logs	
*Description (by layer): 1: Concrete stop log gate structural bed (M)

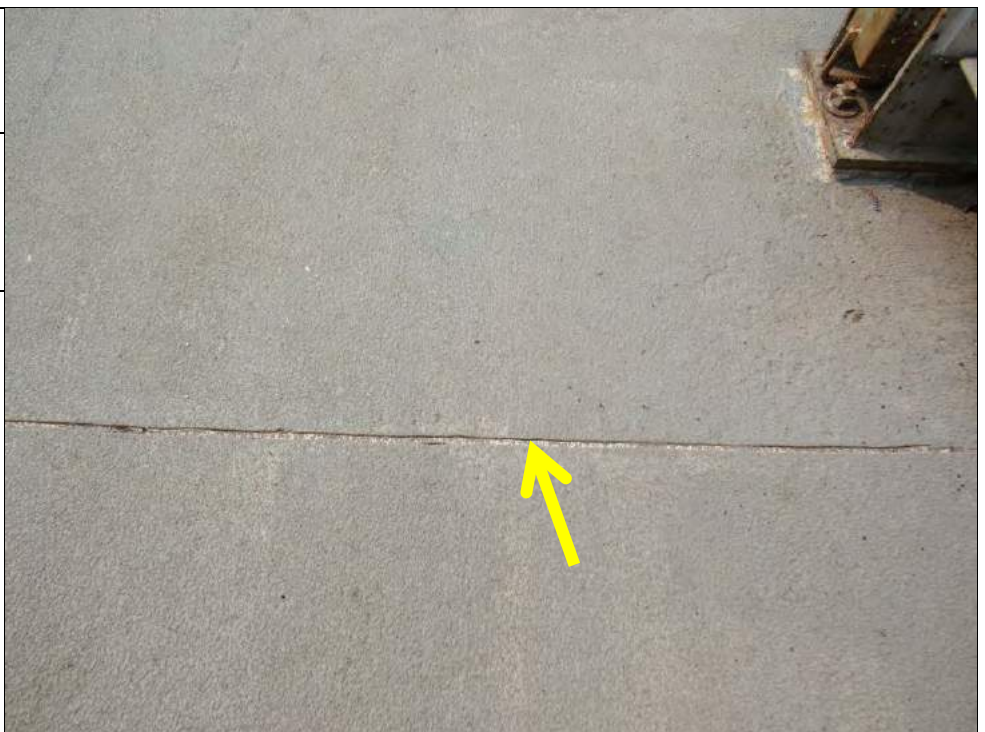
Photo No./ Material ID: JCIS - 11	Date: 8/20/2018 to 8/23/2018
Structure/Material Location: JC Boyle Dam Intake Structure/ At walkway expansion joints	
*Description (by layer): 1: White sealant (M)

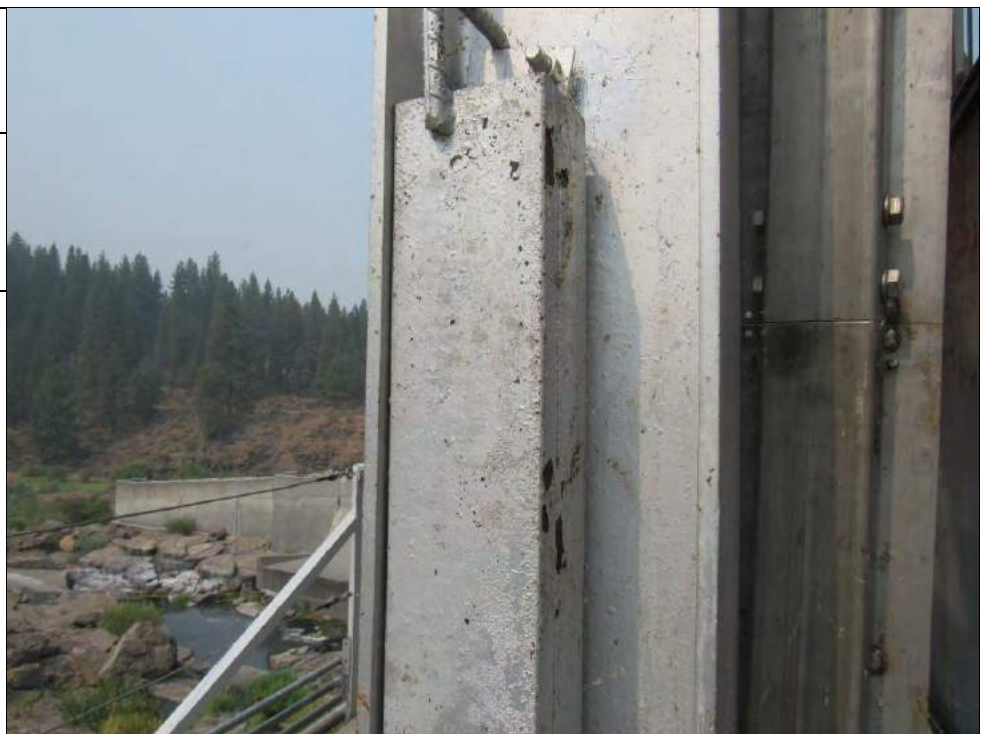
Photo No./ Material ID:	Date:
JCIS - 13	8/20/2018 to 8/23/2018
Structure/Material Location:	
JC Boyle Dam Intake Structure/ Stop log structural cage frame	
*Description (by layer):	
1: Thick silver paint (M)	
2: Residual corroded metal (M)

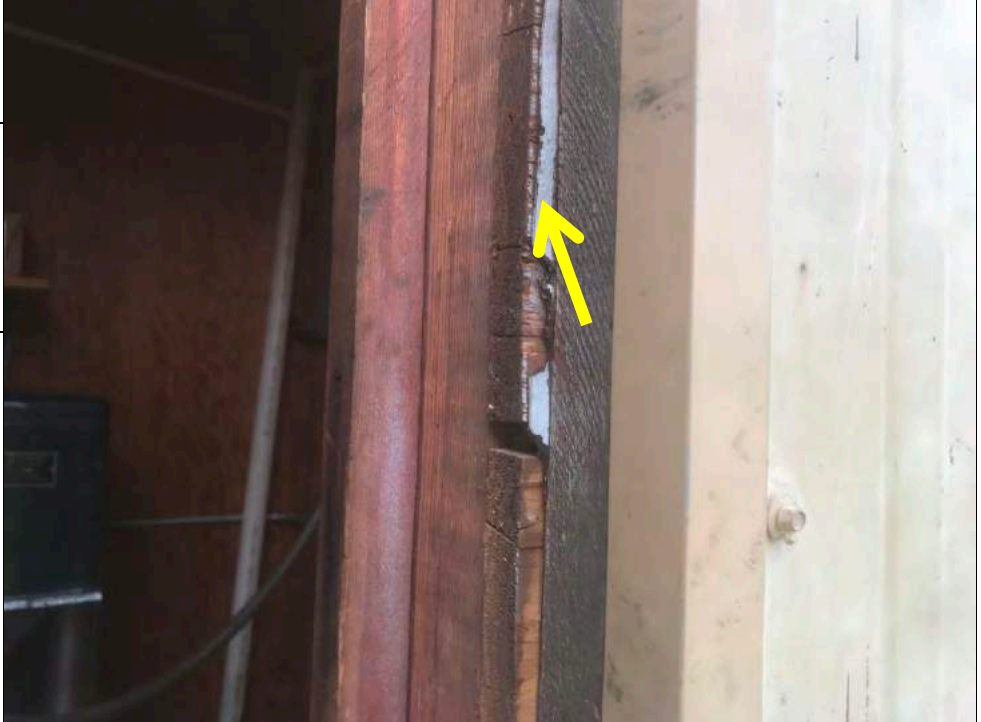
<p>Photo No./ Material ID:</p> <p>JCIS - 16</p>	<p>Date:</p> <p>8/20/2018 to 8/23/2018</p>

<p>Structure/Material Location:</p> <p>JC Boyle Dam Intake Structure/ Underneath wood walls of Intake Structure Reservoir Level Building</p>		
<p>*Description (by layer):</p> <p>1: Black asphaltic vapor barrier paper (M)</p>

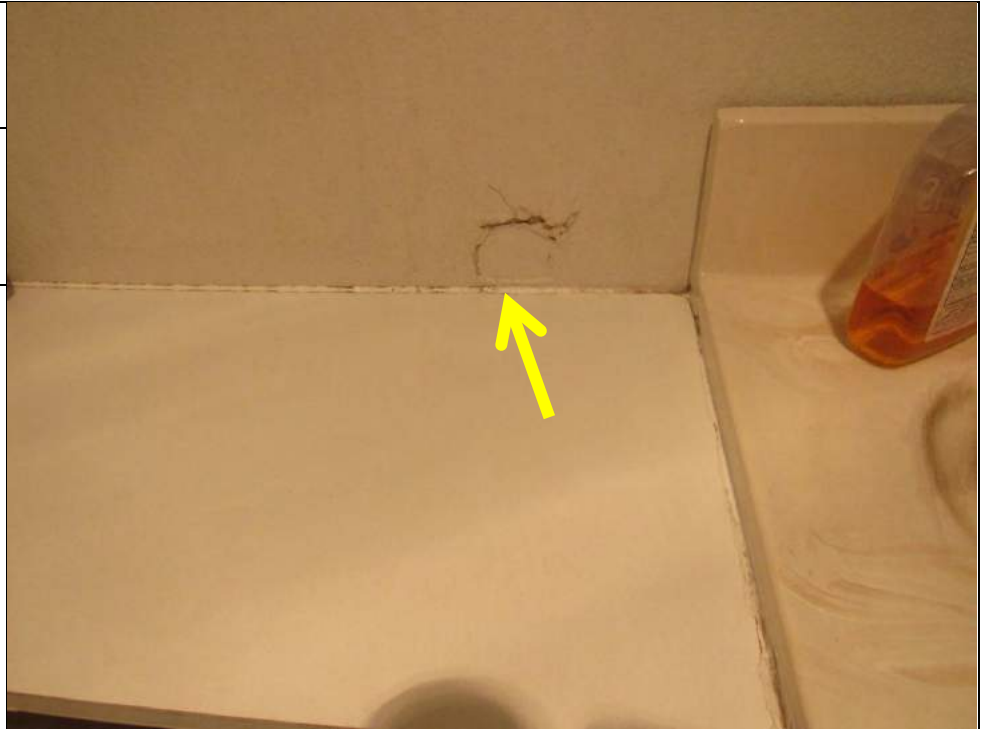
Photo No./ Material ID: JCOW - 06	Date: 8/20/2018 to 8/23/2018
Structure/Material Location: JC Boyle Dam Office and Warehouse/ Restroom counter	
*Description (by layer): 1: White sink caulking (M)

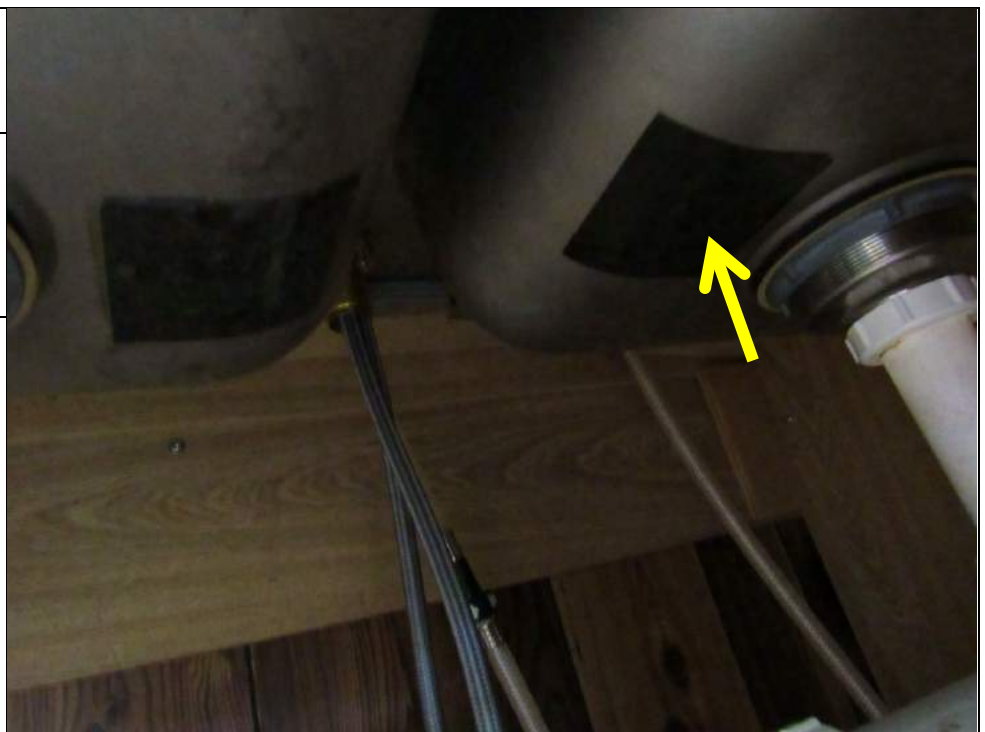
Photo No./ Material ID: JCOW - 07	Date: 8/20/2018 to 8/23/2018
Structure/Material Location: JC Boyle Dam Office and Warehouse/ Underneath restroom counter	
*Description (by layer): 1: Black plastic sink patch (M) 2: Yellow mastic (M)

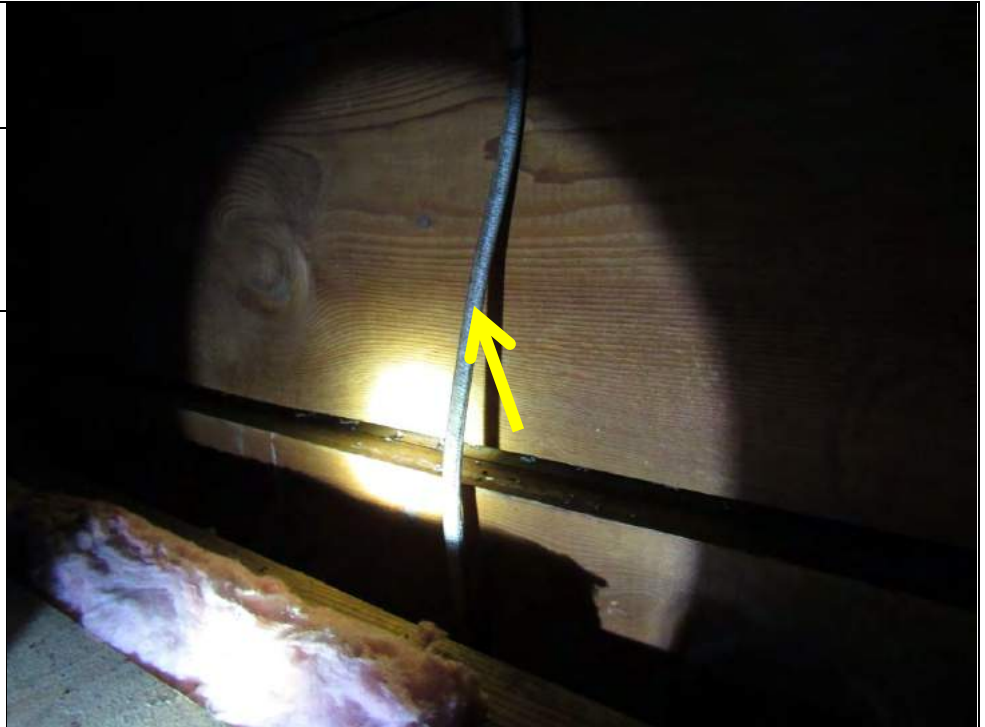
Photo No./ Material ID: JCOW - 08	Date: 8/20/2018 to 8/23/2018
Structure/Material Location: JC Boyle Dam Office and Warehouse/ Throughout Office and Warehouse	
*Description (by layer): Assumed asbestos-containing silver woven electrical wire insulation (M)

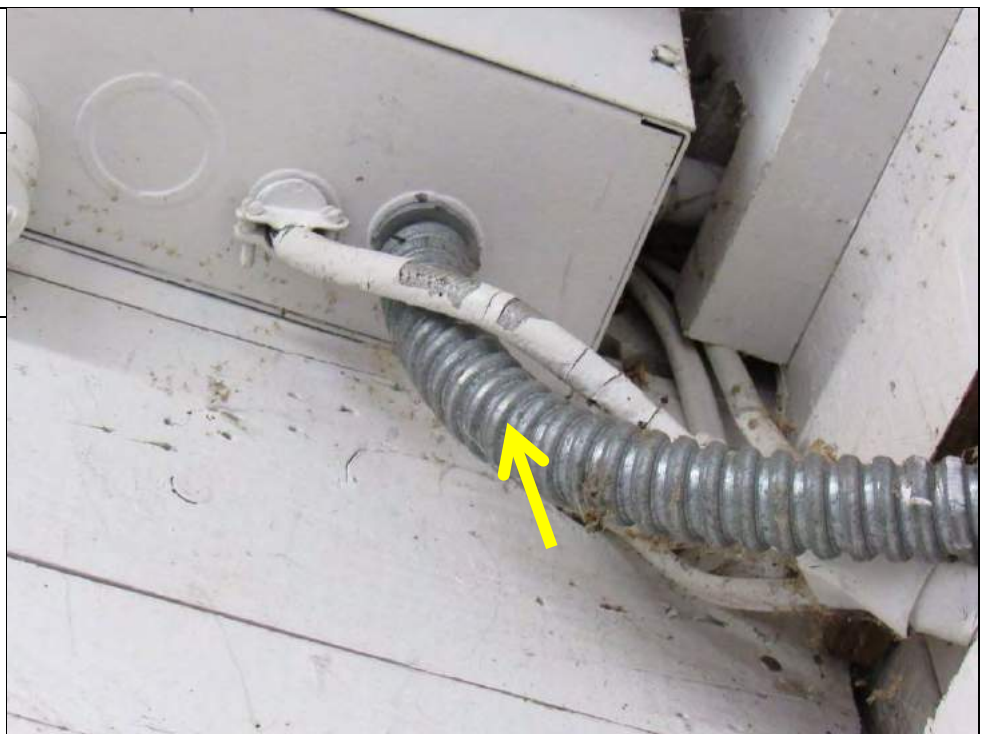
Photo No./ Material ID: JCOW - 09	Date: 8/20/2018 to 8/23/2018
Structure/Material Location: JC Boyle Dam Office and Warehouse/ Throughout Office and Warehouse	
*Description (by layer): Assumed electrical wire insulation inside conduit (M)

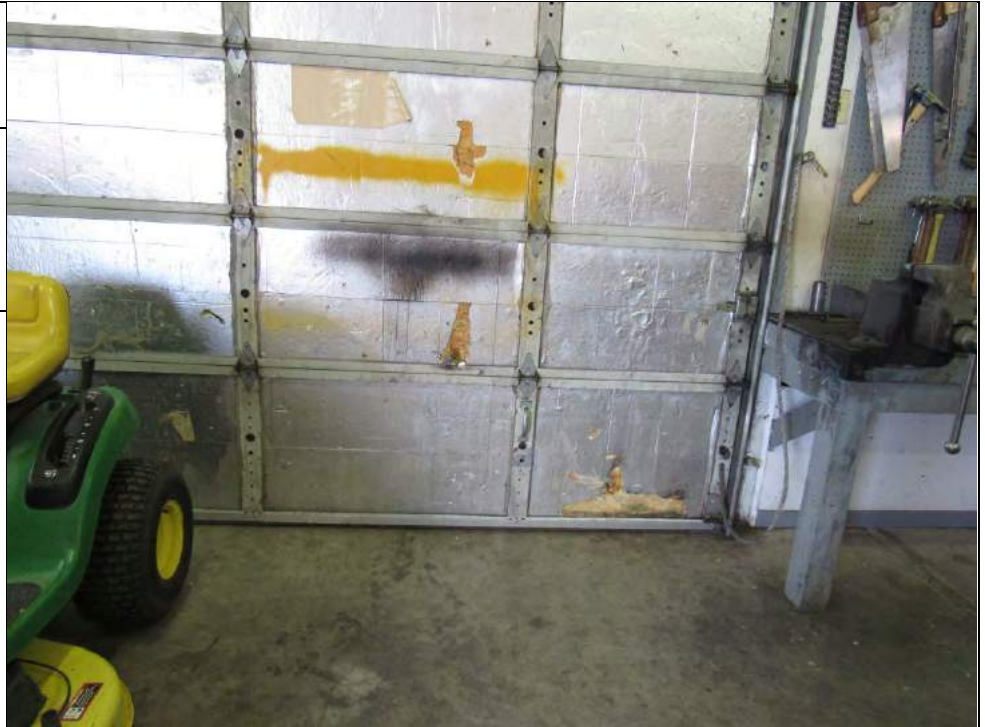
Photo No./ Material ID: JCOW - 10	Date: 8/20/2018 to 8/23/2018
Structure/Material Location: JC Boyle Dam Office and Warehouse/ Insulation inside two roll-up doors in Warehouse	
*Description (by layer): 1: Yellow mastic with foam and foil backing (M) 2: Off-white foam material (M)

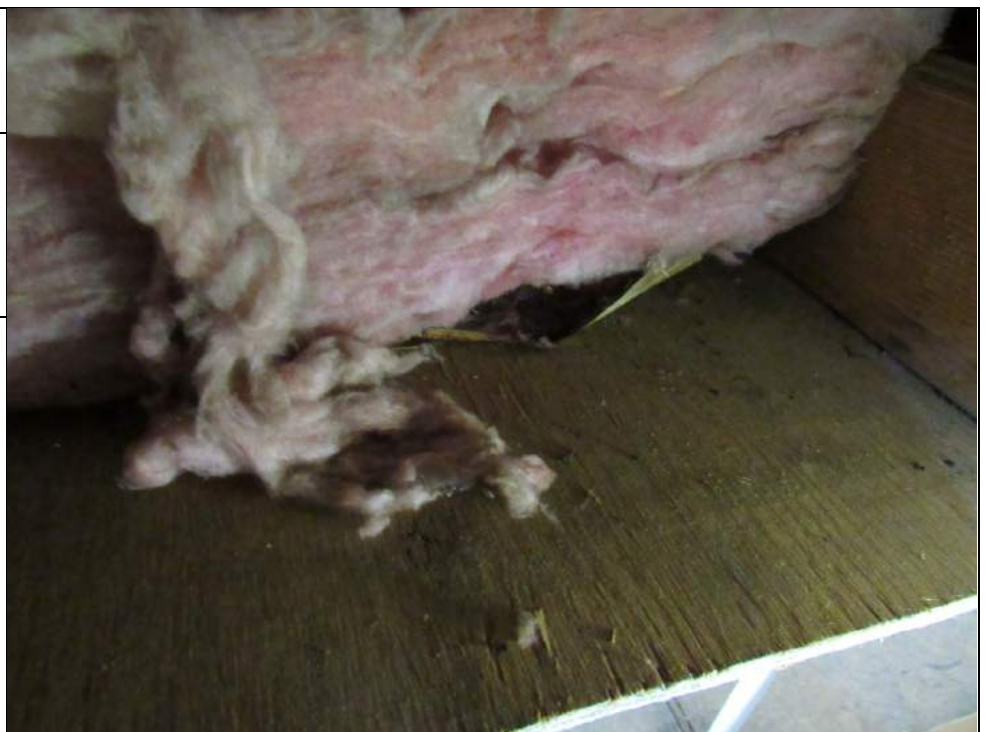
Photo No./ Material ID: JCOW - 11	Date: 8/20/2018 to 8/23/2018
Structure/Material Location: JC Boyle Dam Office and Warehouse/ Above ceiling in attic of Warehouse	
*Description (by layer): 1: Black asphaltic mastic with paper (M) 2: Pink fiberglass batt insulation (T)

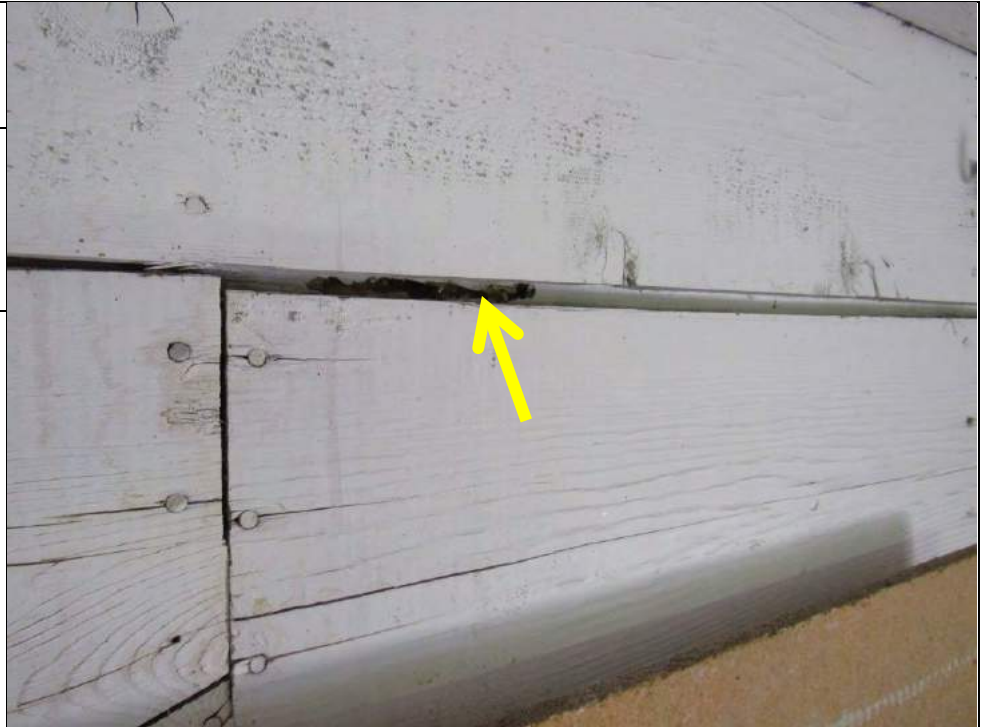
Photo No./ Material ID: JCOW - 12	Date: 8/20/2018 to 8/23/2018
Structure/Material Location: JC Boyle Dam Office and Warehouse/ Behind wood wall, loft area of Warehouse	
*Description (by layer): 1: Black asphaltic mastic with paper (M) 2: Yellow fiberglass batt insulation (T)

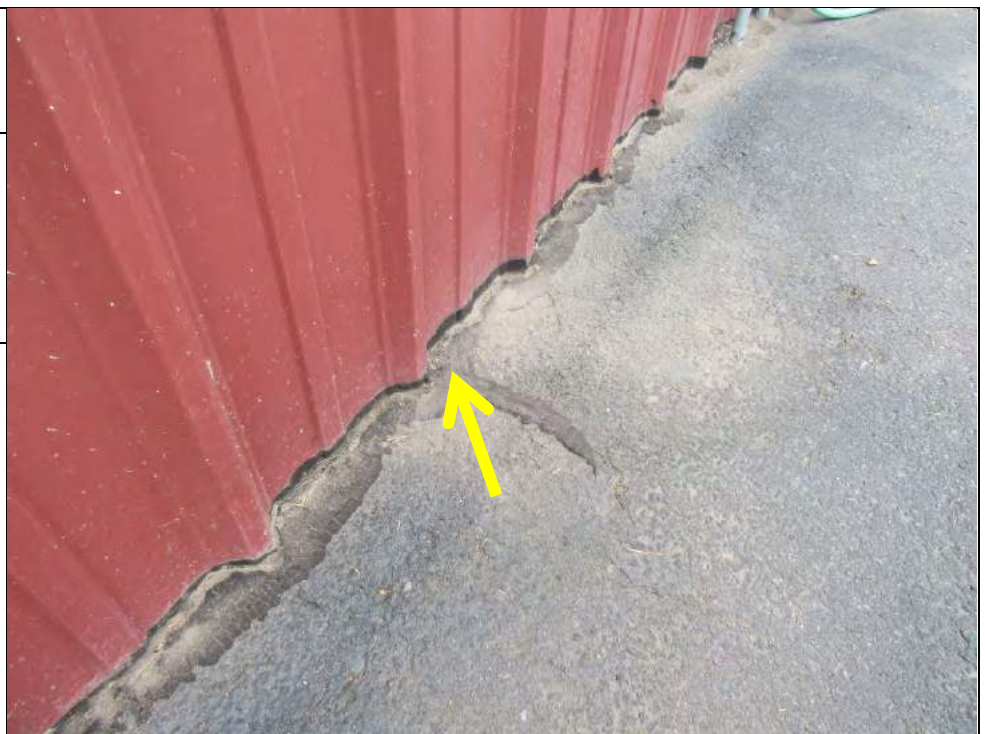
Photo No./ Material ID: JCOW - 13	Date: 8/20/2018 to 8/23/2018
Structure/Material Location: JC Boyle Dam Office and Warehouse/ At base of exterior metal walls, at wall/concrete interface	
*Description (by layer): 1: Black caulking (M)

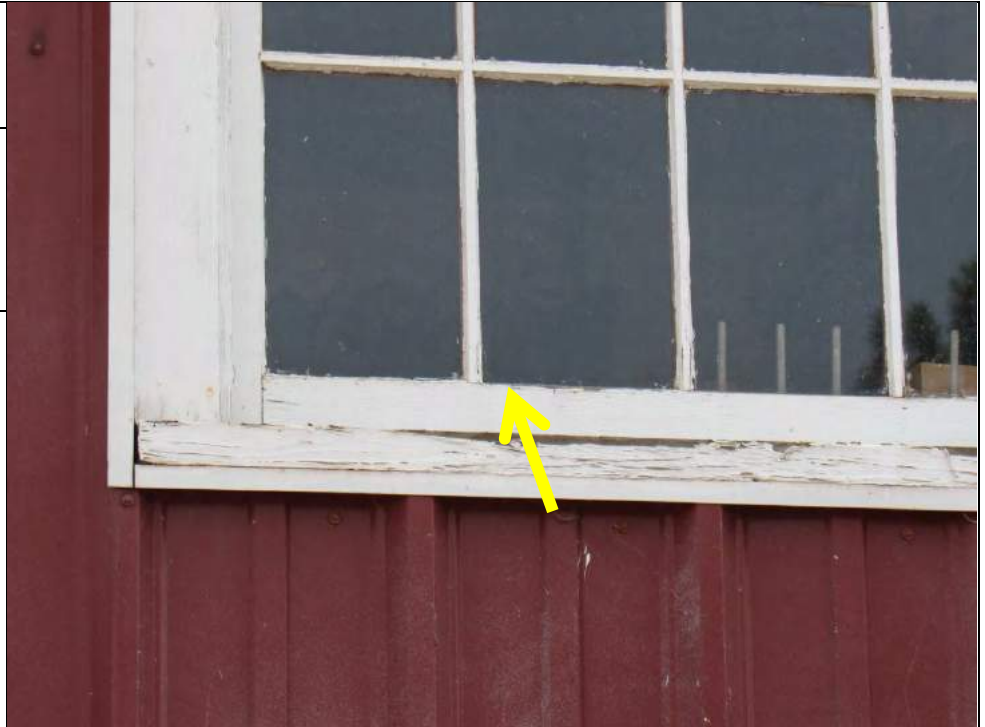
Photo No./ Material ID: JCOW - 14	Date: 8/20/2018 to 8/23/2018
Structure/Material Location: JC Boyle Dam Office and Warehouse/ Exterior window panes	
*Description (by layer): 1: White brittle window putty (M)

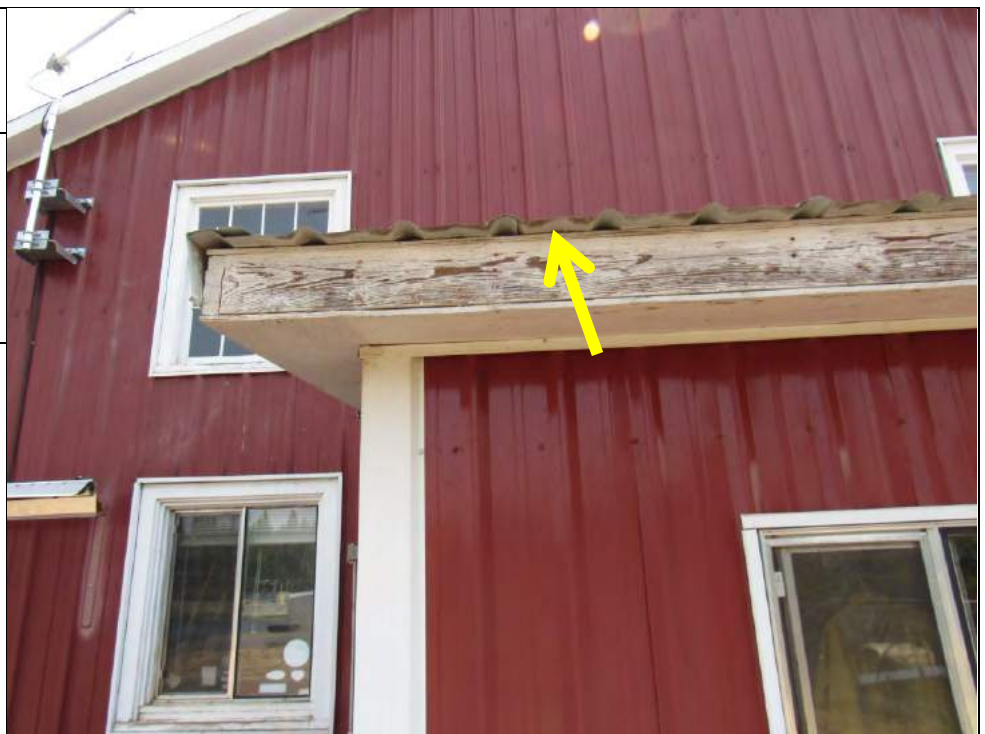
Photo No./ Material ID: JCOW - 15	Date: 8/20/2018 to 8/23/2018
Structure/Material Location: JC Boyle Dam Office and Warehouse/ Underneath corrugated metal roof, throughout	
*Description (by layer): 1: Black asphaltic roofing paper (M)

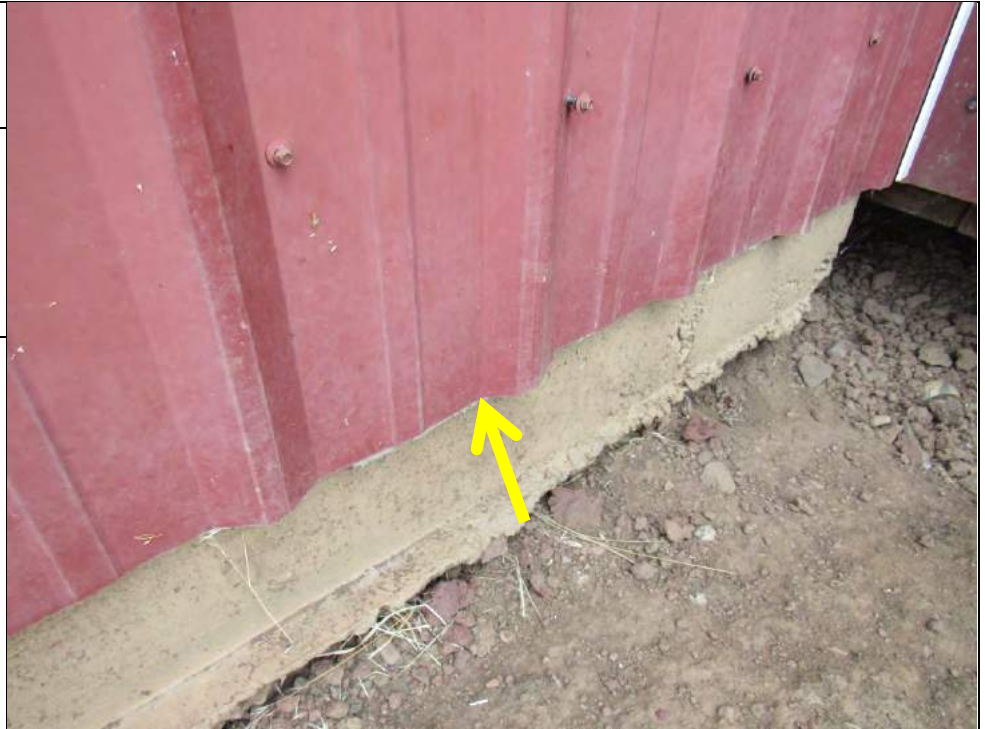
Photo No./ Material ID: JCOW - 16	Date: 8/20/2018 to 8/23/2018
Structure/Material Location: JC Boyle Dam Office and Warehouse/ Underneath corrugated metal siding of Office Warehouse shed	
*Description (by layer): 1: Brown asphaltic vapor barrier paper (M)

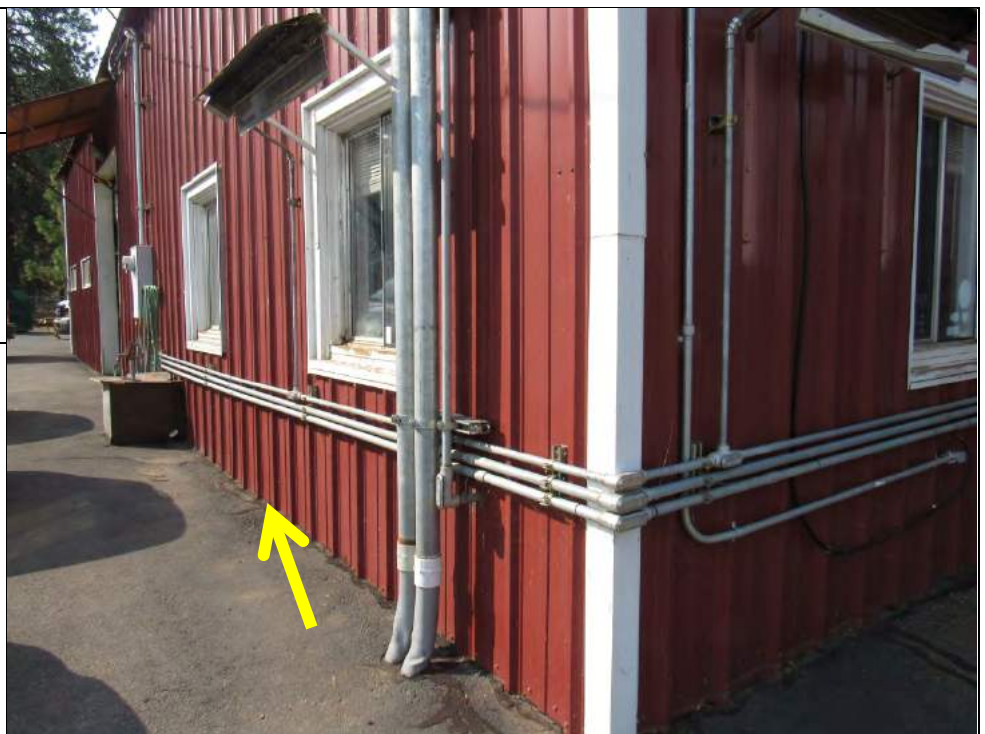
Photo No./ Material ID: JCOW - 17	Date: 8/20/2018 to 8/23/2018
Structure/Material Location: JC Boyle Dam Office and Warehouse/ Underneath corrugated metal siding throughout Office Warehouse	
*Description (by layer): 1: Brown asphaltic vapor barrier paper (M)

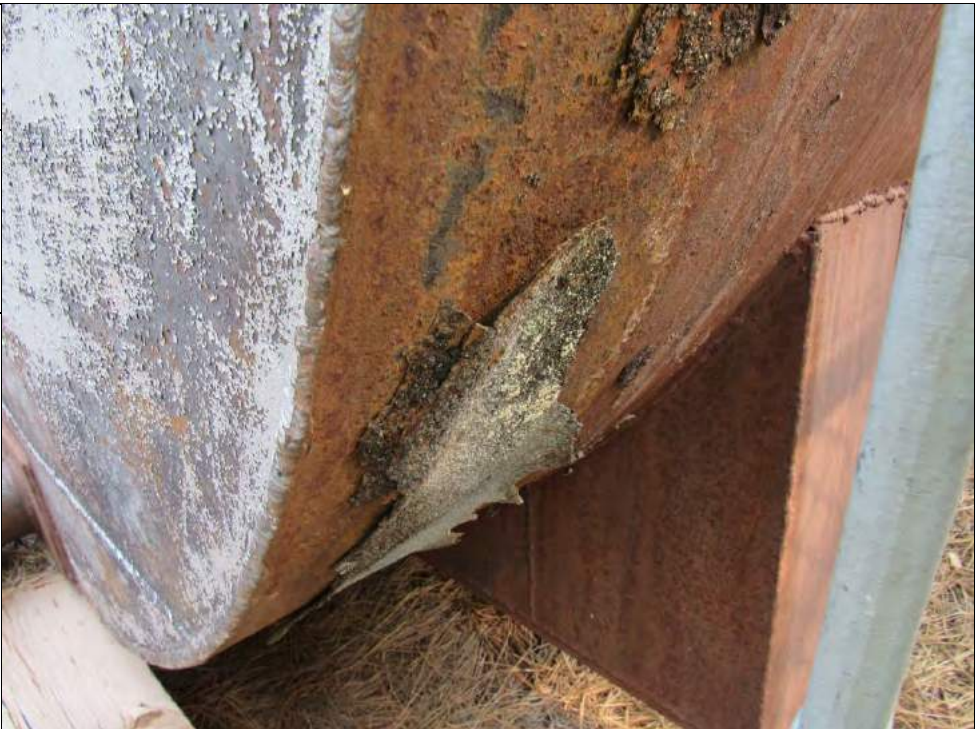
Photo No./ Material ID: JCBY - 02	Date: 9/17/2018

Structure/Material Location: JC Boyle Dam Outdoor Storage Area/ Out of service storage tank in Outdoor Storage Area		
*Description (by layer): 1: Residual black asphaltic material with granules (M)

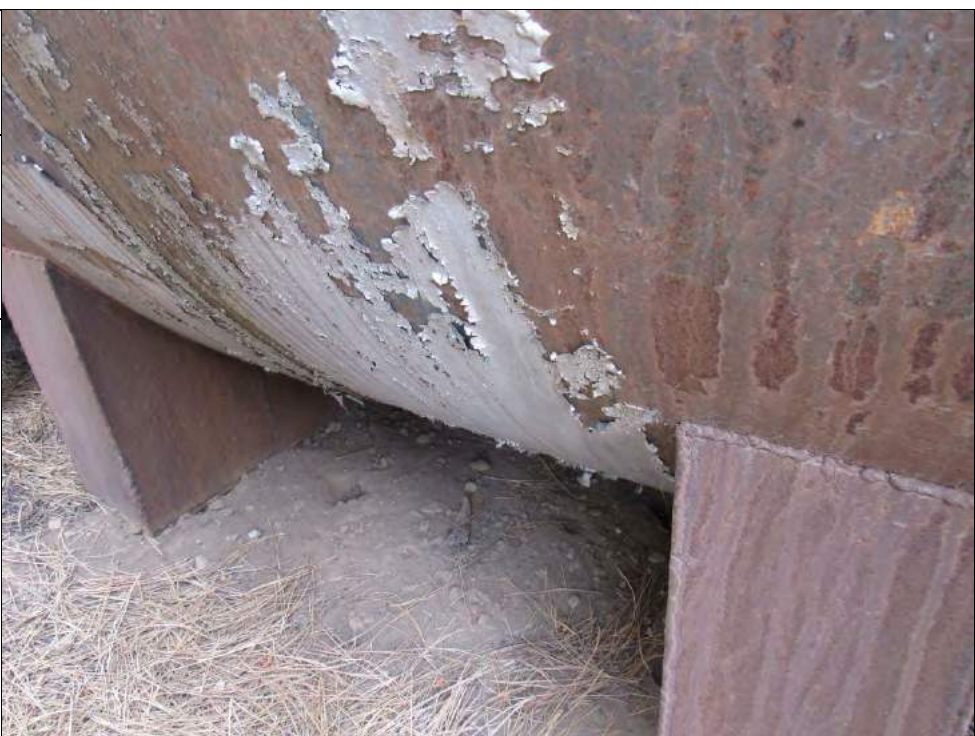
Photo No./ Material ID: JCBY - 03	Date: 9/17/2018

Structure/Material Location: JC Boyle Dam Outdoor Storage Area/ Walls throughout office main floor		
*Description (by layer): 1: Silver paint (M) 2: Yellow brittle material (M)

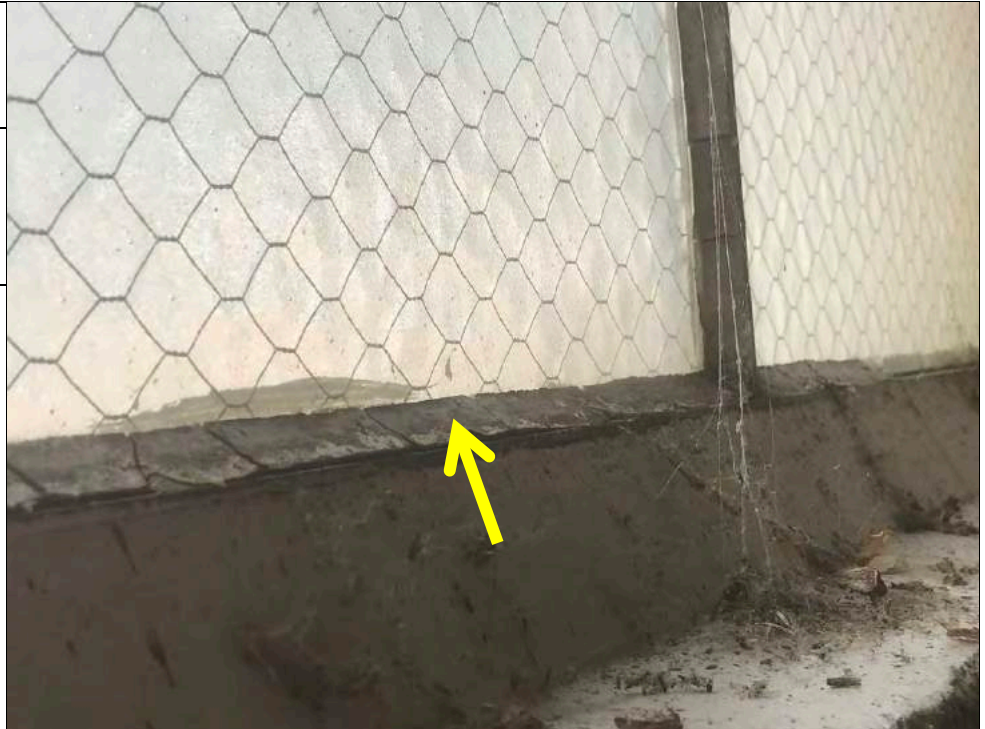
Photo No./ Material ID: JCPH - 02	Date: 8/20/2018 to 8/23/2018
Structure/Material Location: JC Boyle Dam Powerhouse/ Interior window panes	
*Description (by layer): 1: Gray window putty (M)

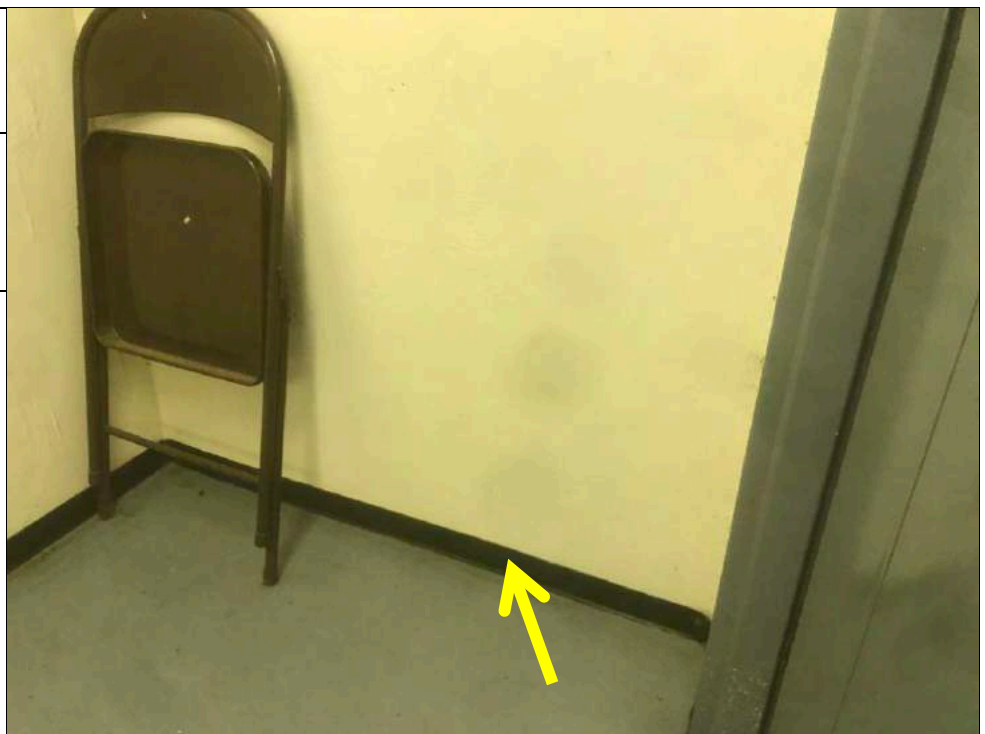
Photo No./ Material ID: JCPH - 03	Date: 8/20/2018 to 8/23/2018
Structure/Material Location: JC Boyle Dam Powerhouse/ Restroom walls	
*Description (by layer): 1: 2" black rubber cove base (M) 2: Yellow mastic (M)

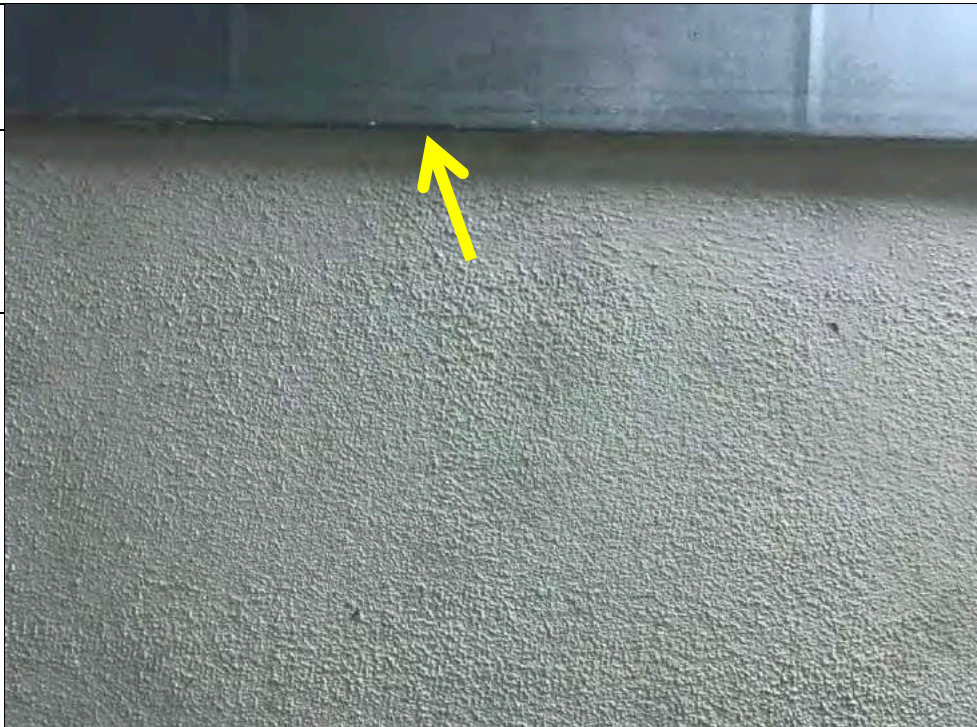
JCPH - 06	8/20/2018 to 8/23/2018	
Structure/Material Location: JC Boyle Dam Powerhouse/ Entry into switchgear room, associated with HVAC system		
*Description (by layer): 1: White spray-applied texture wall coating (S) 2: White gypsum wallboard with paper (M)

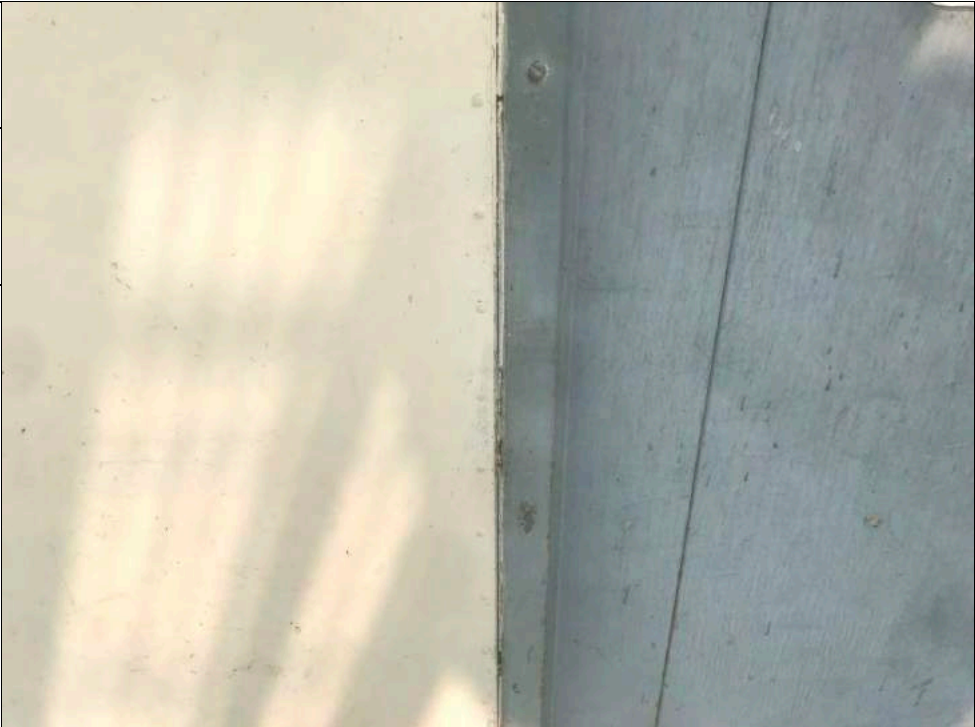
Photo No./ Material ID: JCPH - 08	Date: 8/20/2018 to 8/23/2018

Structure/Material Location: JC Boyle Dam Powerhouse/ Throughout Powerhouse		
*Description (by layer): 1: White door sealant (M) 2: Gray door sealant (M)

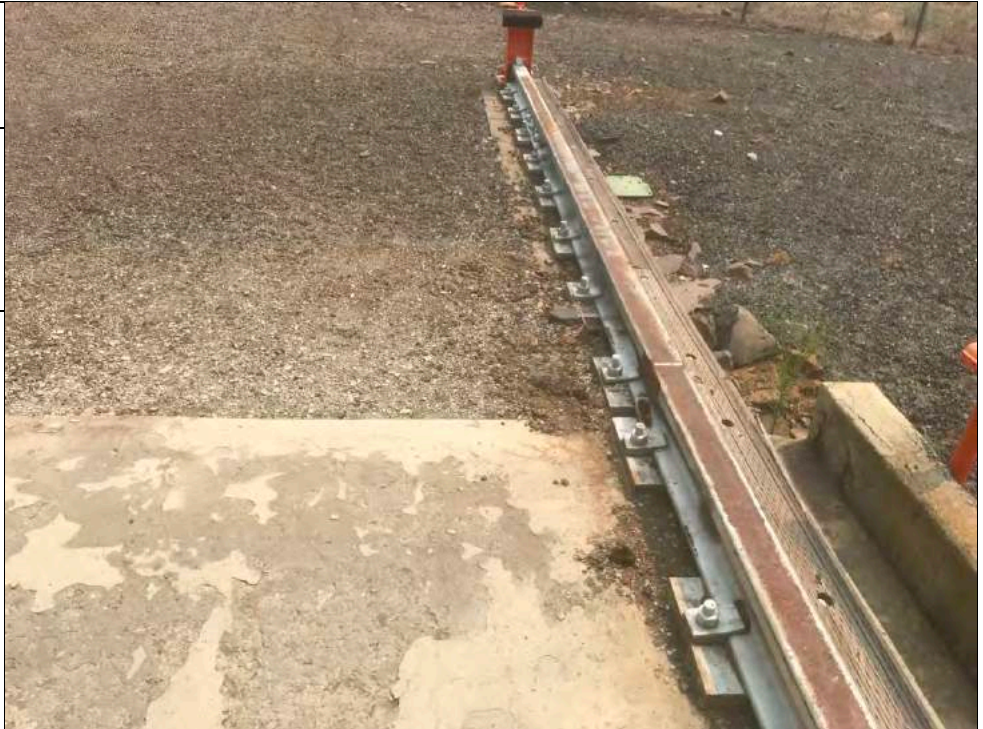
Photo No./ Material ID: JCPH - 13	Date: 8/20/2018 to 8/23/2018
Structure/Material Location: JC Boyle Dam Powerhouse/ At base of exterior metal walls, at wall/concrete interface	
*Description (by layer): 1: Black caulking (M)

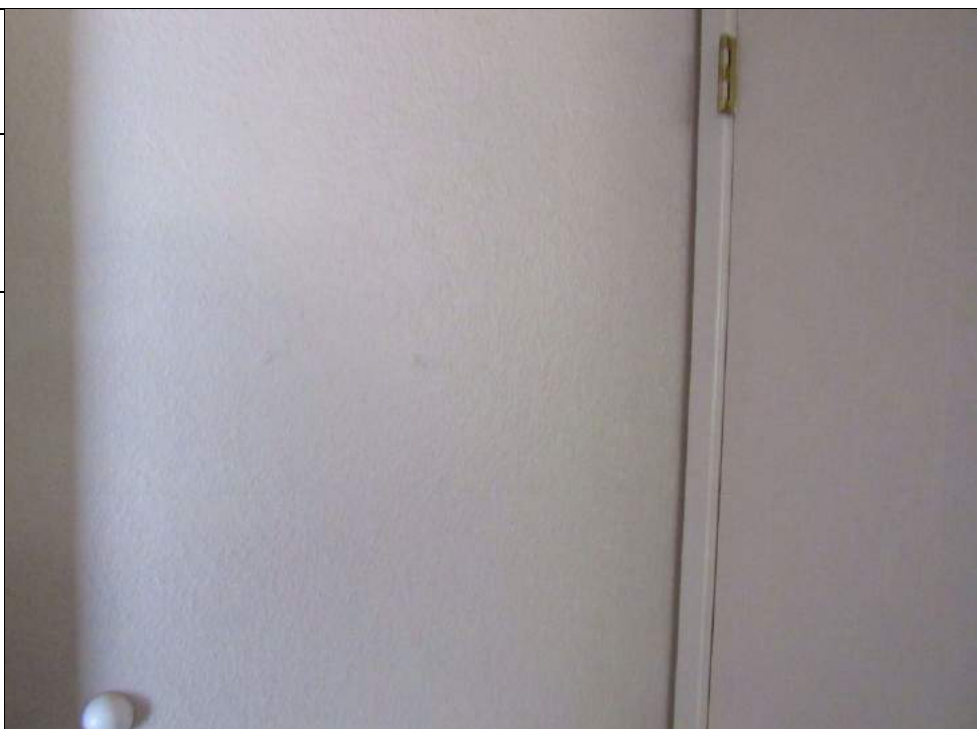
JCR1 - 01	8/20/2018 to 8/23/2018	
Structure/Material Location:		
JC Boyle Dam Residence 1/ Walls throughout Residence 1		
*Description (by layer):		
1: White spray-applied texture wall coating (S)		
2: White gypsum wallboard with paper (M)

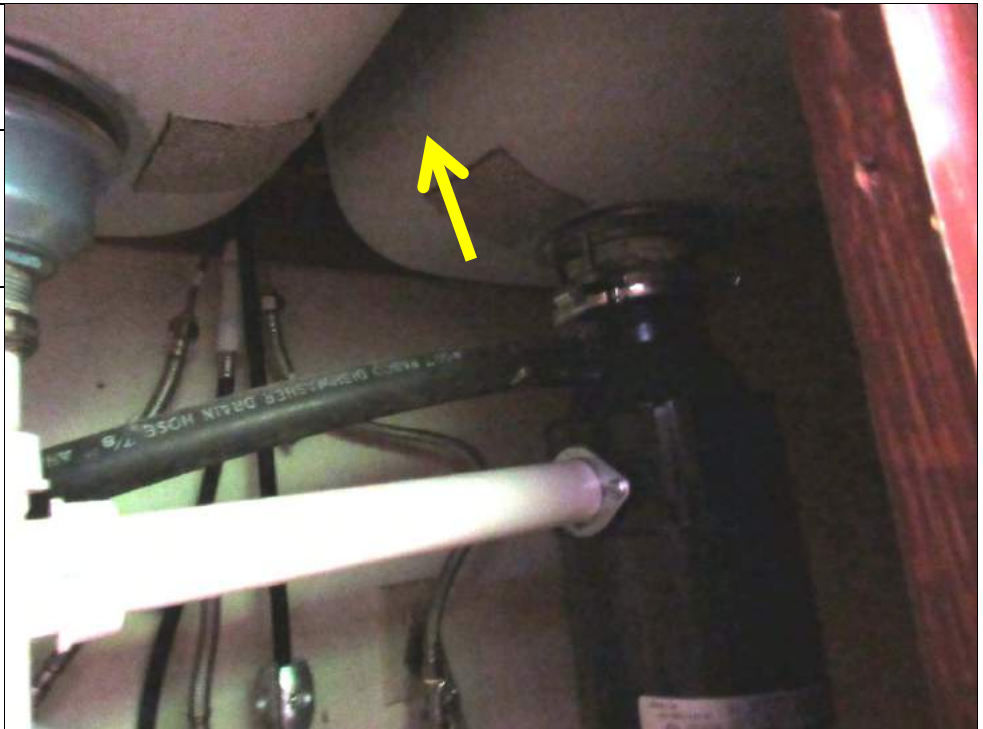
Photo No./ Material ID:	Date:
JCR1 - 07	8/20/2018 to 8/23/2018
Structure/Material Location:	
JC Boyle Dam Residence 1/ Entry into switchgear room, associated with HVAC system	
*Description (by layer):	
1: White sink undercoating (M)	
2: Black sink patch (M)

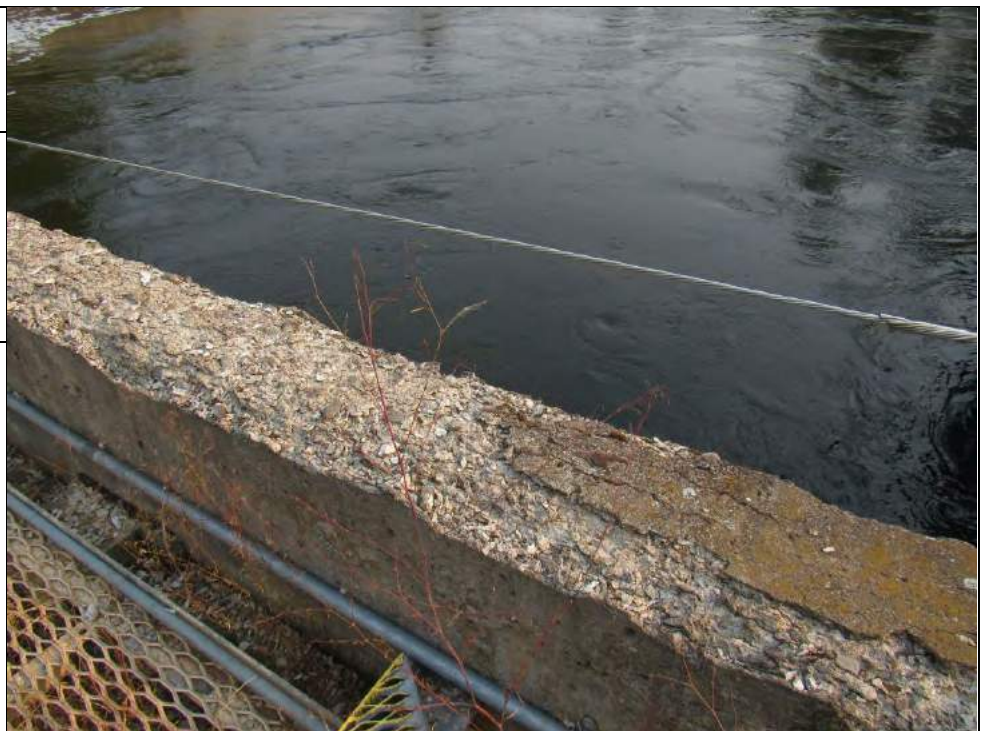
Photo No./ Material ID: JCSW - 01	Date: 8/20/2018 to 8/23/2018
Structure/Material Location: JC Boyle Dam Spillway Control Center Building/ Support concrete associated with Spillway Control Center Building	
*Description (by layer): 1: Concrete (M)
