**UNITED STATES OF AMERICA
BEFORE THE
FEDERAL ENERGY REGULATORY COMMISSION**

**AMENDED APPLICATION FOR SURRENDER OF LICENSE
FOR MAJOR PROJECT AND REMOVAL OF PROJECT WORKS**

**EXHIBIT N (2 of 2)
Waste Disposal and Hazardous Materials Management Plan
(Amended December 15, 2021)**

**HAZARDOUS MATERIALS SURVEY
FINAL REPORT**

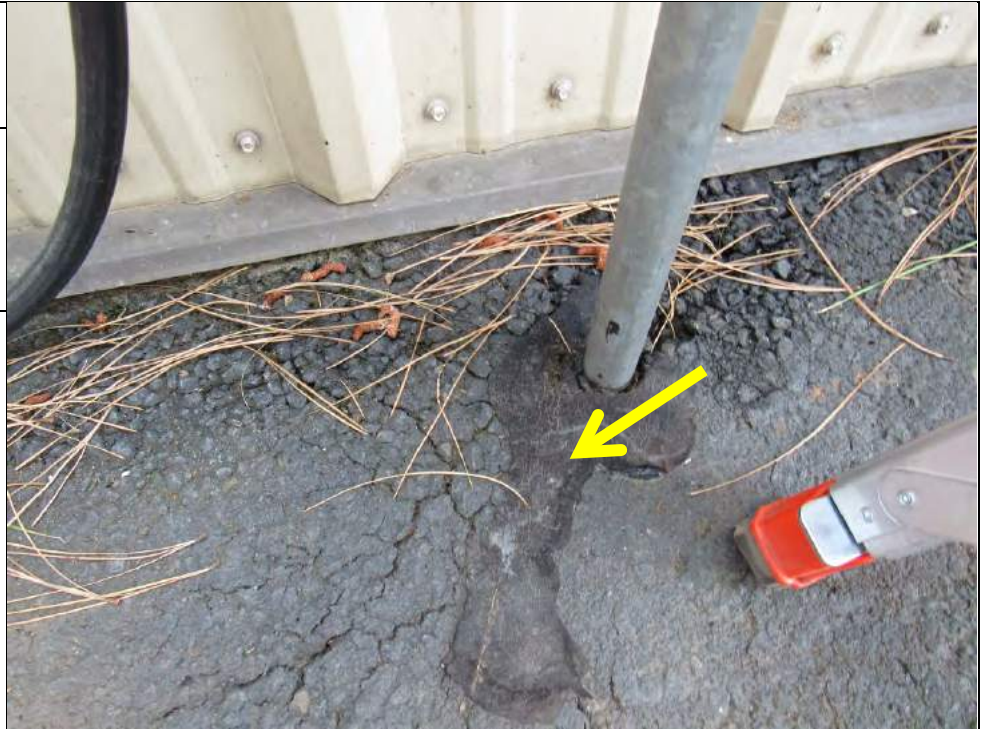
JCVS - 06

Date:8/20/2018 to
8/23/2018**Structure/Material Location:**JC Boyle Dam Vehicle Storage
Shed/ Penetrations around
exterior perimeter***Description (by layer):**

1: Black sealant (M)

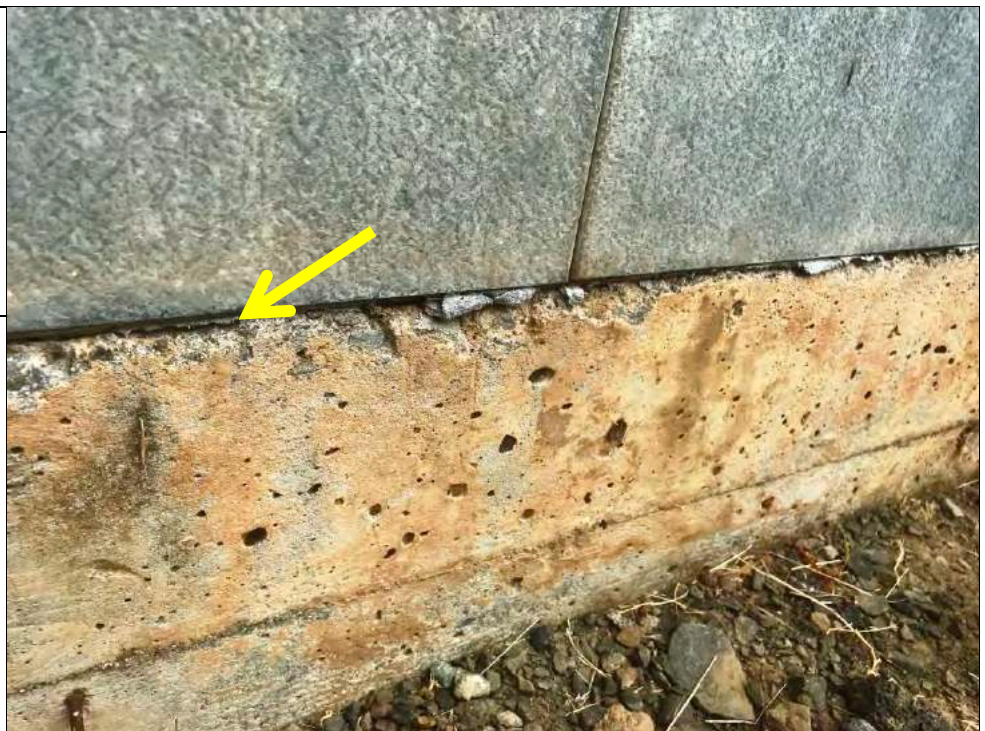
JC Boyle Dam Warehouse/
Exterior interface between metal
siding and concrete foundation

**1: Black asphaltic slip sheet
with cementitious material (M)**
