Klamath River Renewal Corporation

Project No. 14803-001

**LICENSE SURRENDER ORDER
LOWER KLAMATH PROJECT**

Waste Disposal and Hazardous Materials Management Plan

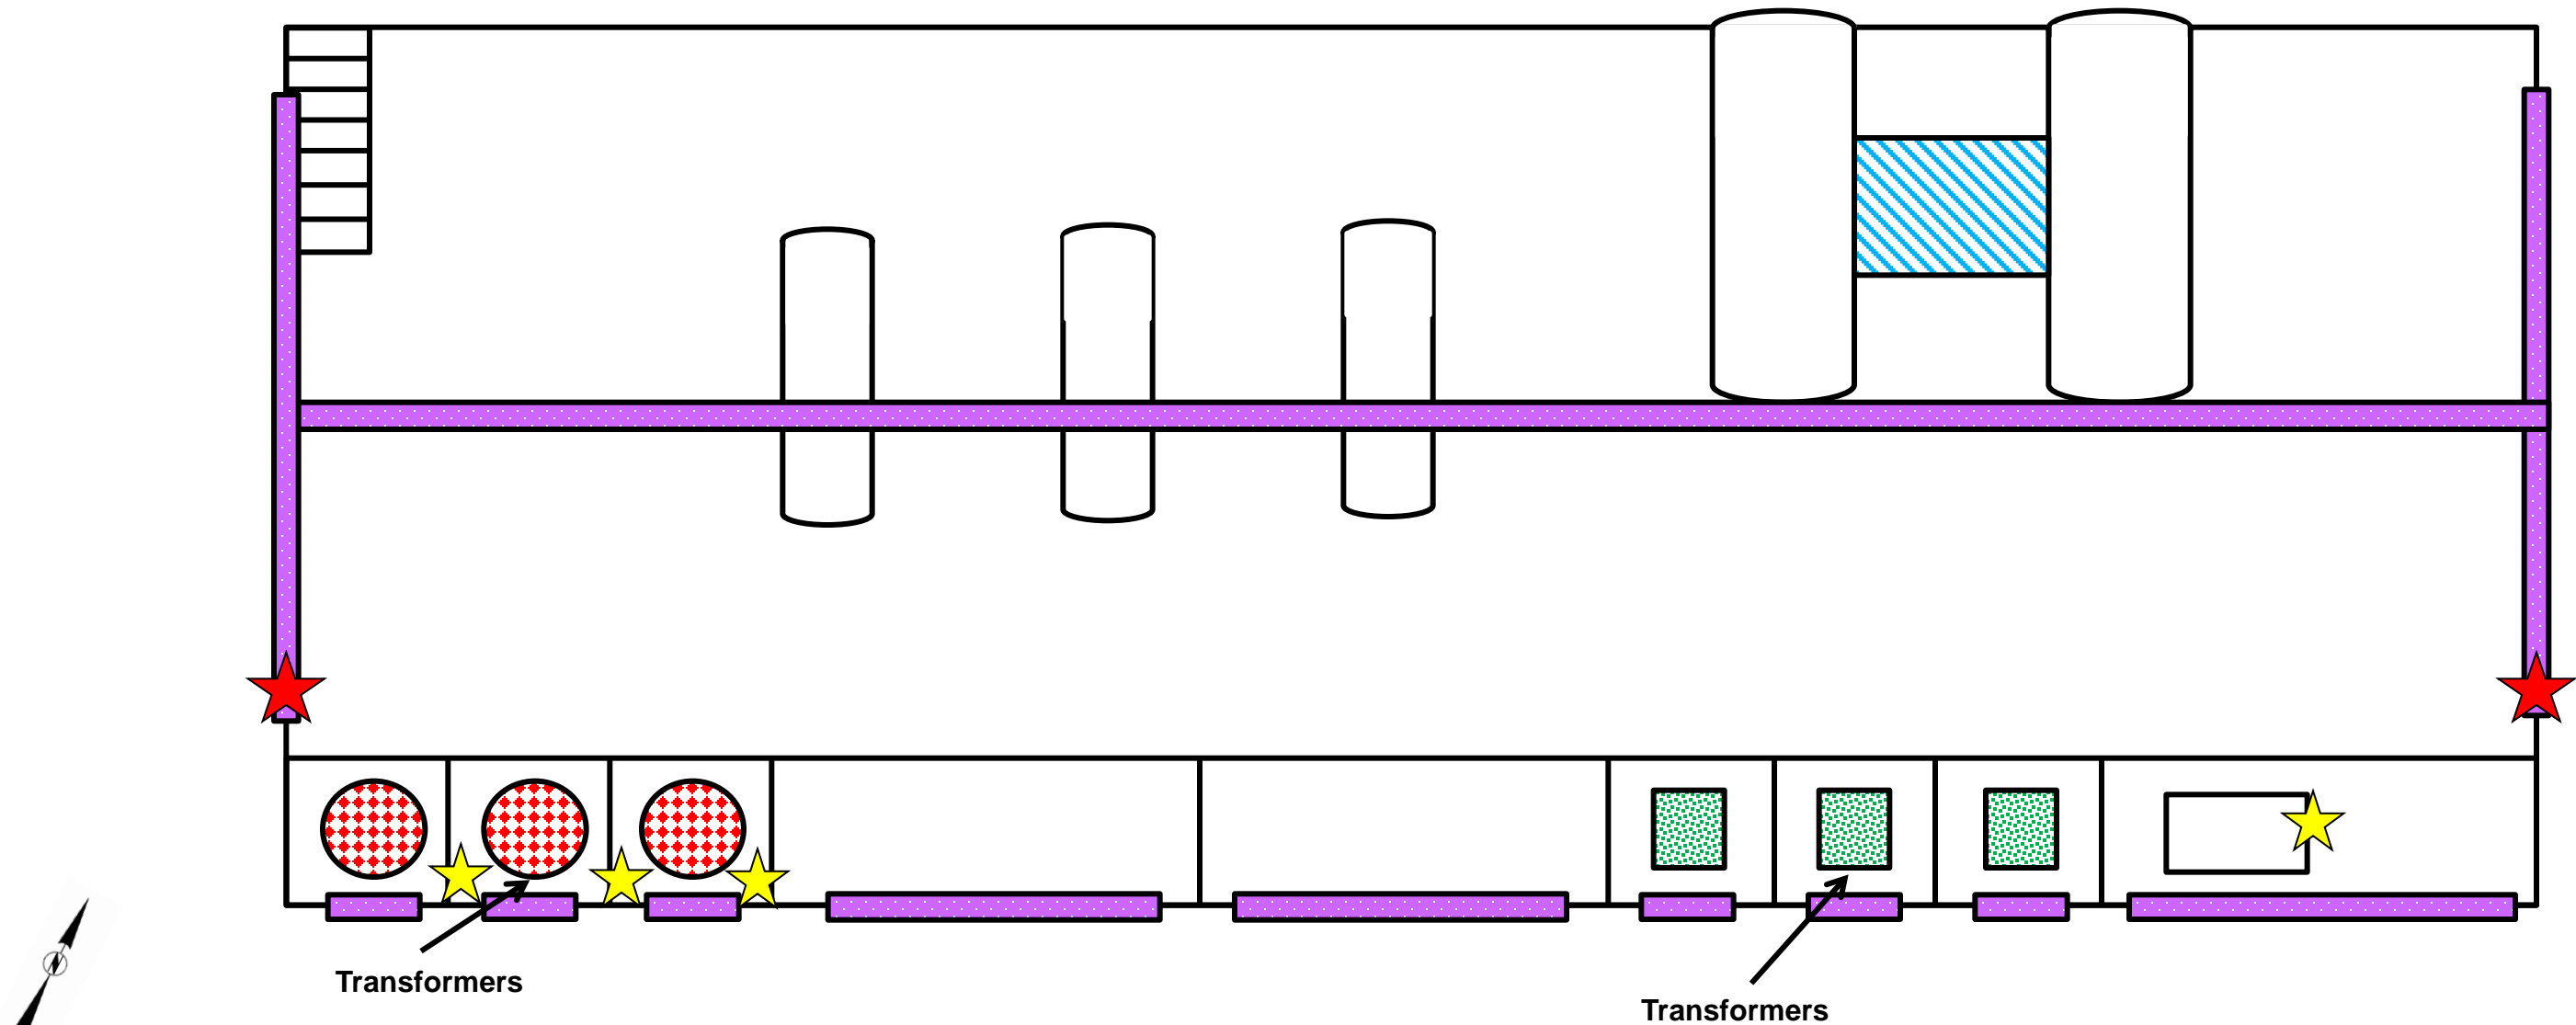
Figure 8
Approximate ACM Locations
Powerhouse Ground Level

HSA CC1PH-13: Assumed asbestos-containing metal-clad fire door insulation (M)
- Not shown: CC1PH-02: Assumed asbestos-containing gaskets throughout (M)

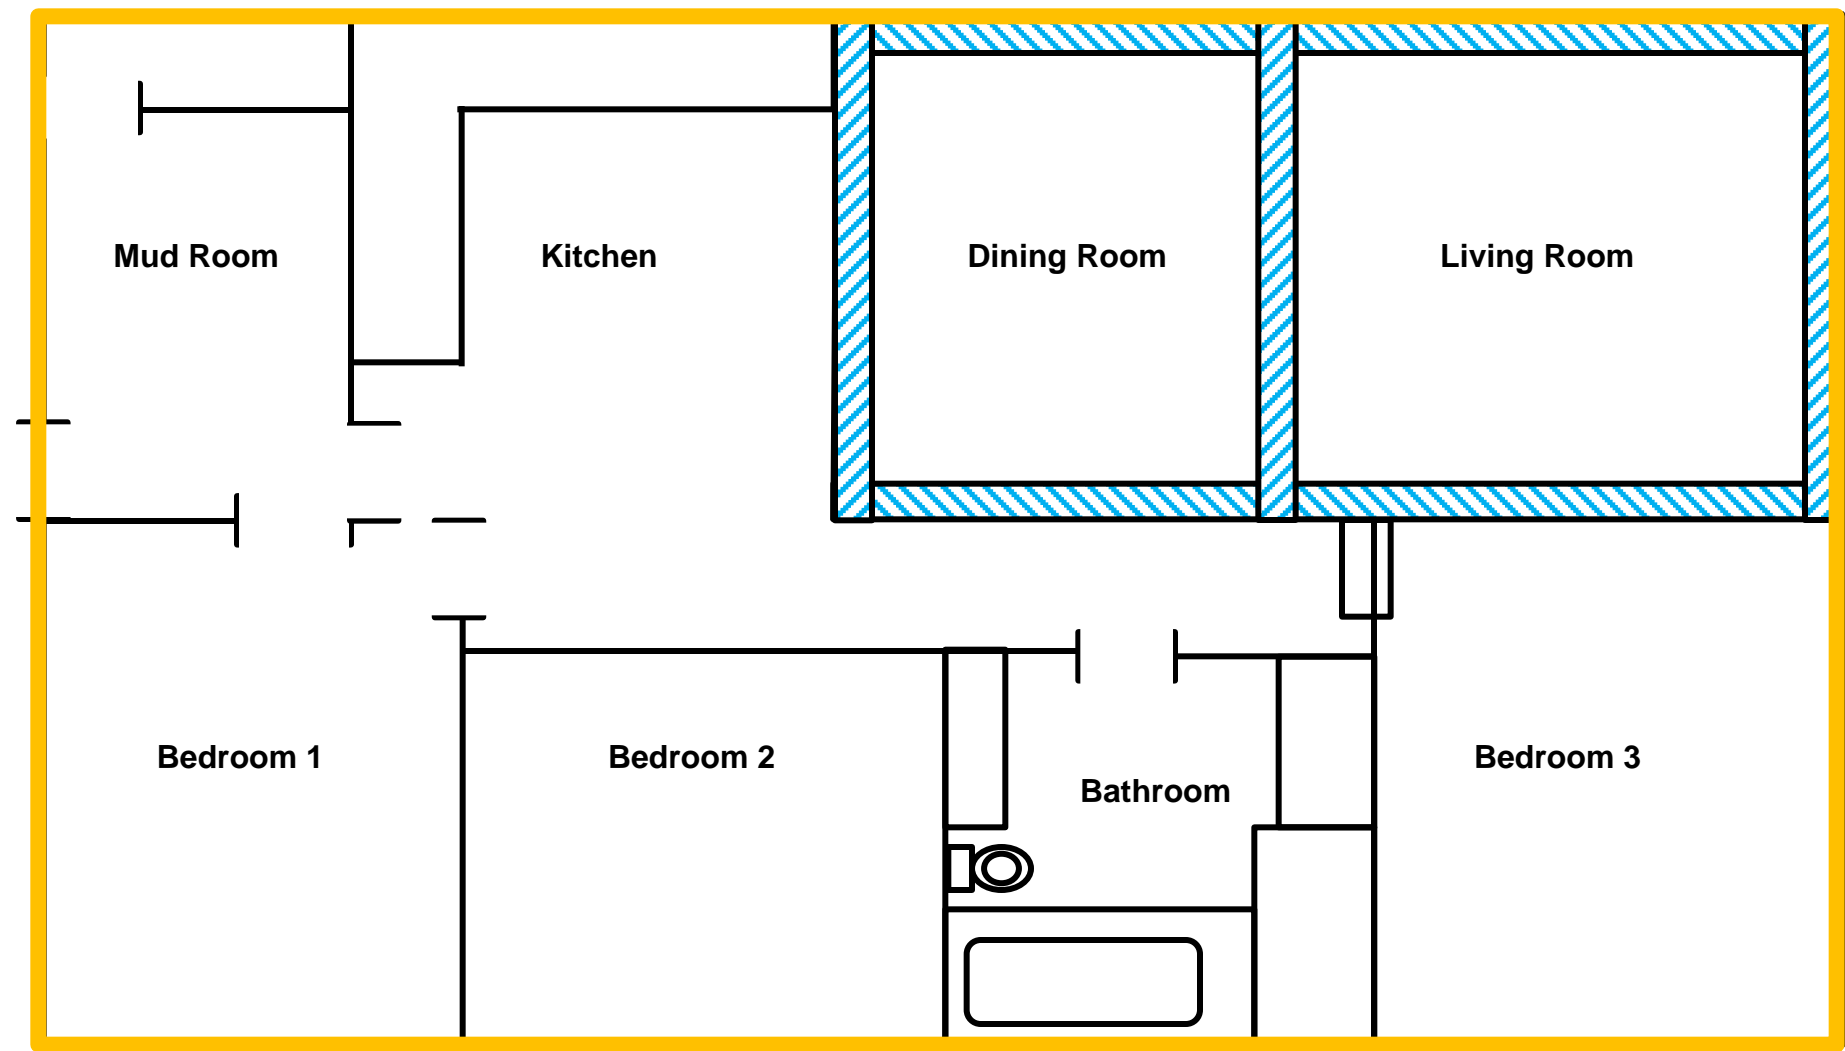
Figure 12
Asbestos and Lead Sample Locations
Former Residence 2

Not shown: HSA CC1R2-05: : Assumed asbestos-containing asphaltic woven electrical wire insulation (throughout) (M)

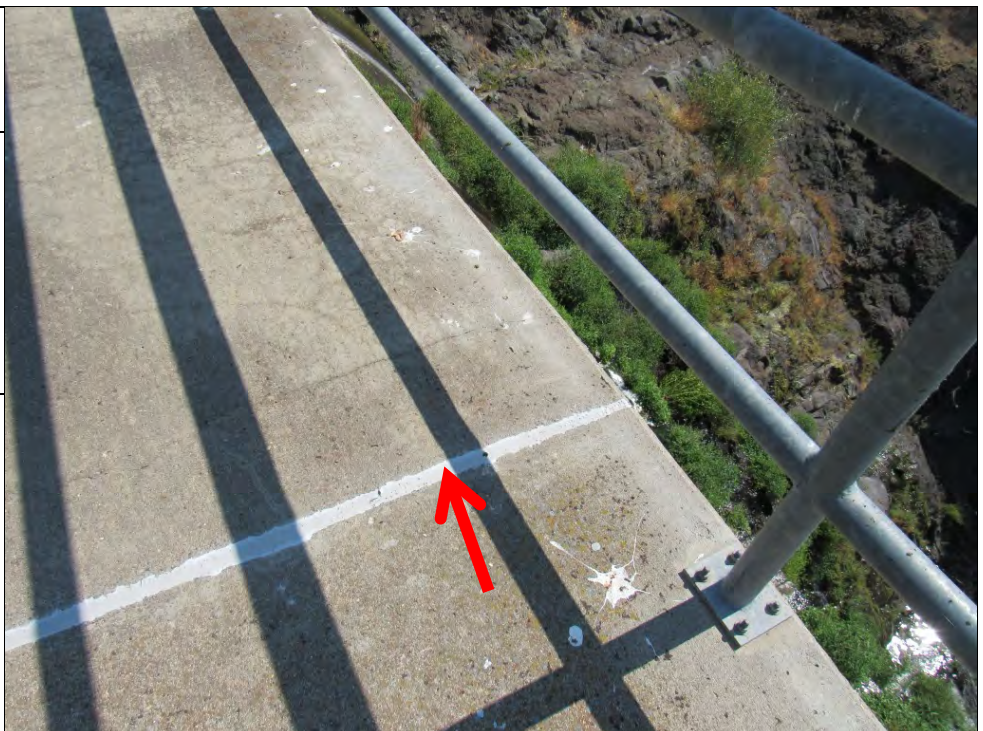
Photo No./ Material ID: CC1GH - 03	Date: 9/10/2018 to 9/11/2018
Structure/Material Location: Copco No. 1 Dam, Dam and Gatehouses C11 and C12/ Walkway expansion joints associated with the Gatehouses, the Right Abutment Intake Structure, and the Copco 1 Dam	
*Description (by layer): 1: Gray sealant (M)

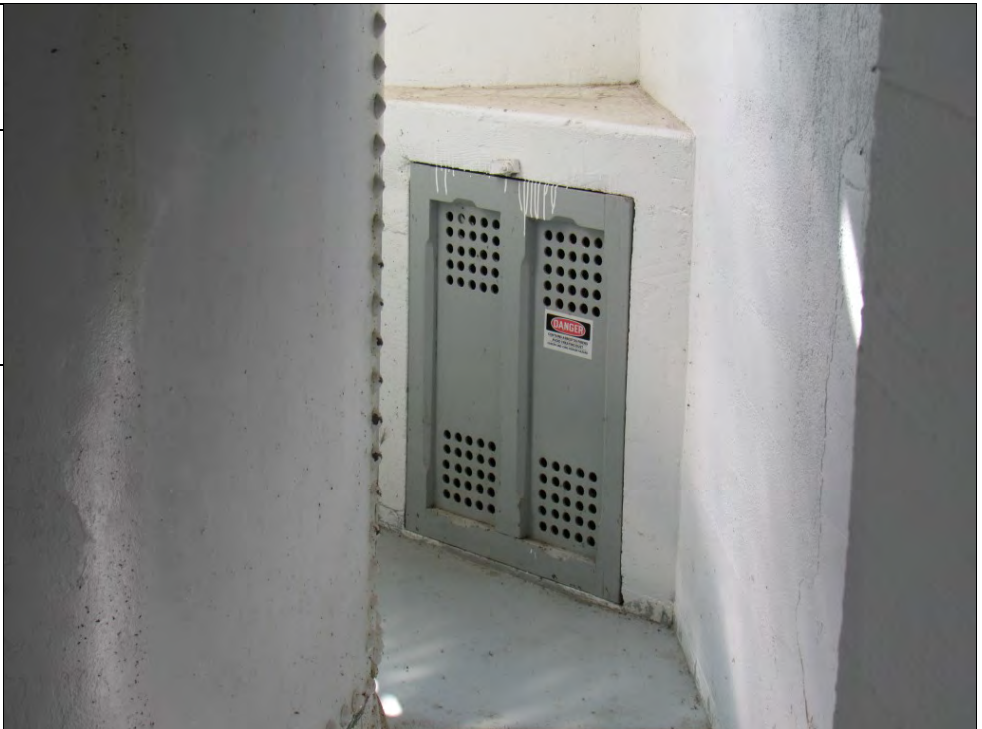
Photo No./ Material ID:	Date:
CC1PH - 06	9/10/2018
Structure/Material Location:	
Copco No. 1 Powerhouse/ Panels in various places throughout the main floor and basement. Labeled with ACM stickers.	
*Description (by layer):	
Assumed asbestos-containing cement asbestos board (CAB) (M)

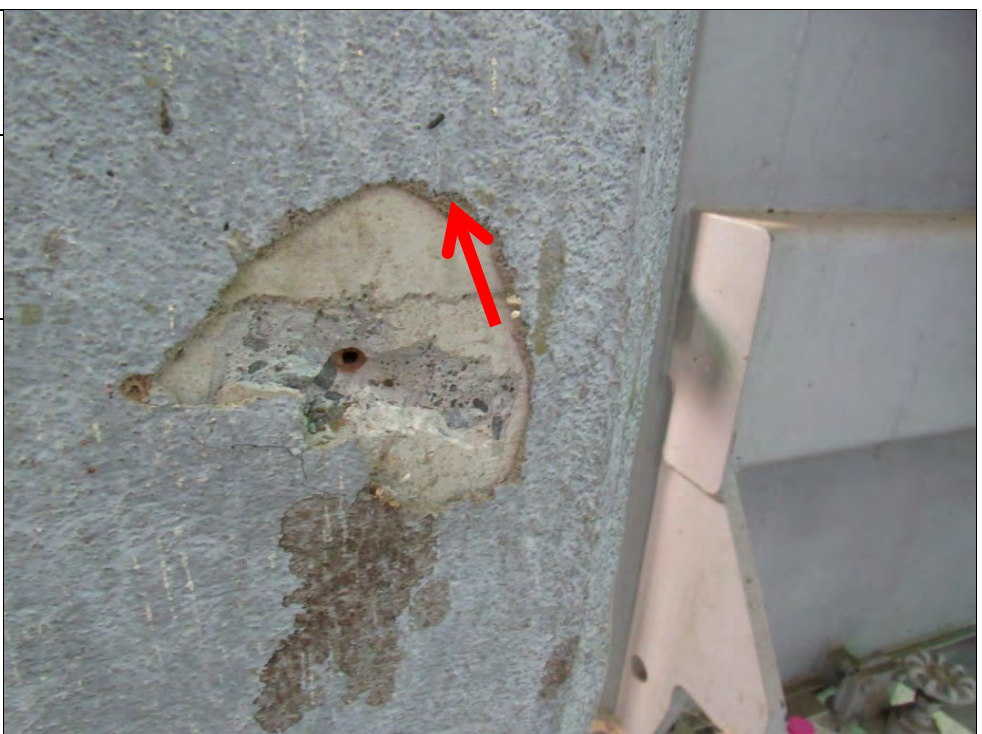
Photo No./ Material ID:	Date:
CC1PH - 07	9/10/2018
Structure/Material Location:	
Copco No. 1 Powerhouse/ Concrete walls throughout main floor	
*Description (by layer):	
1: Cementitious troweled-on surface coat (S)

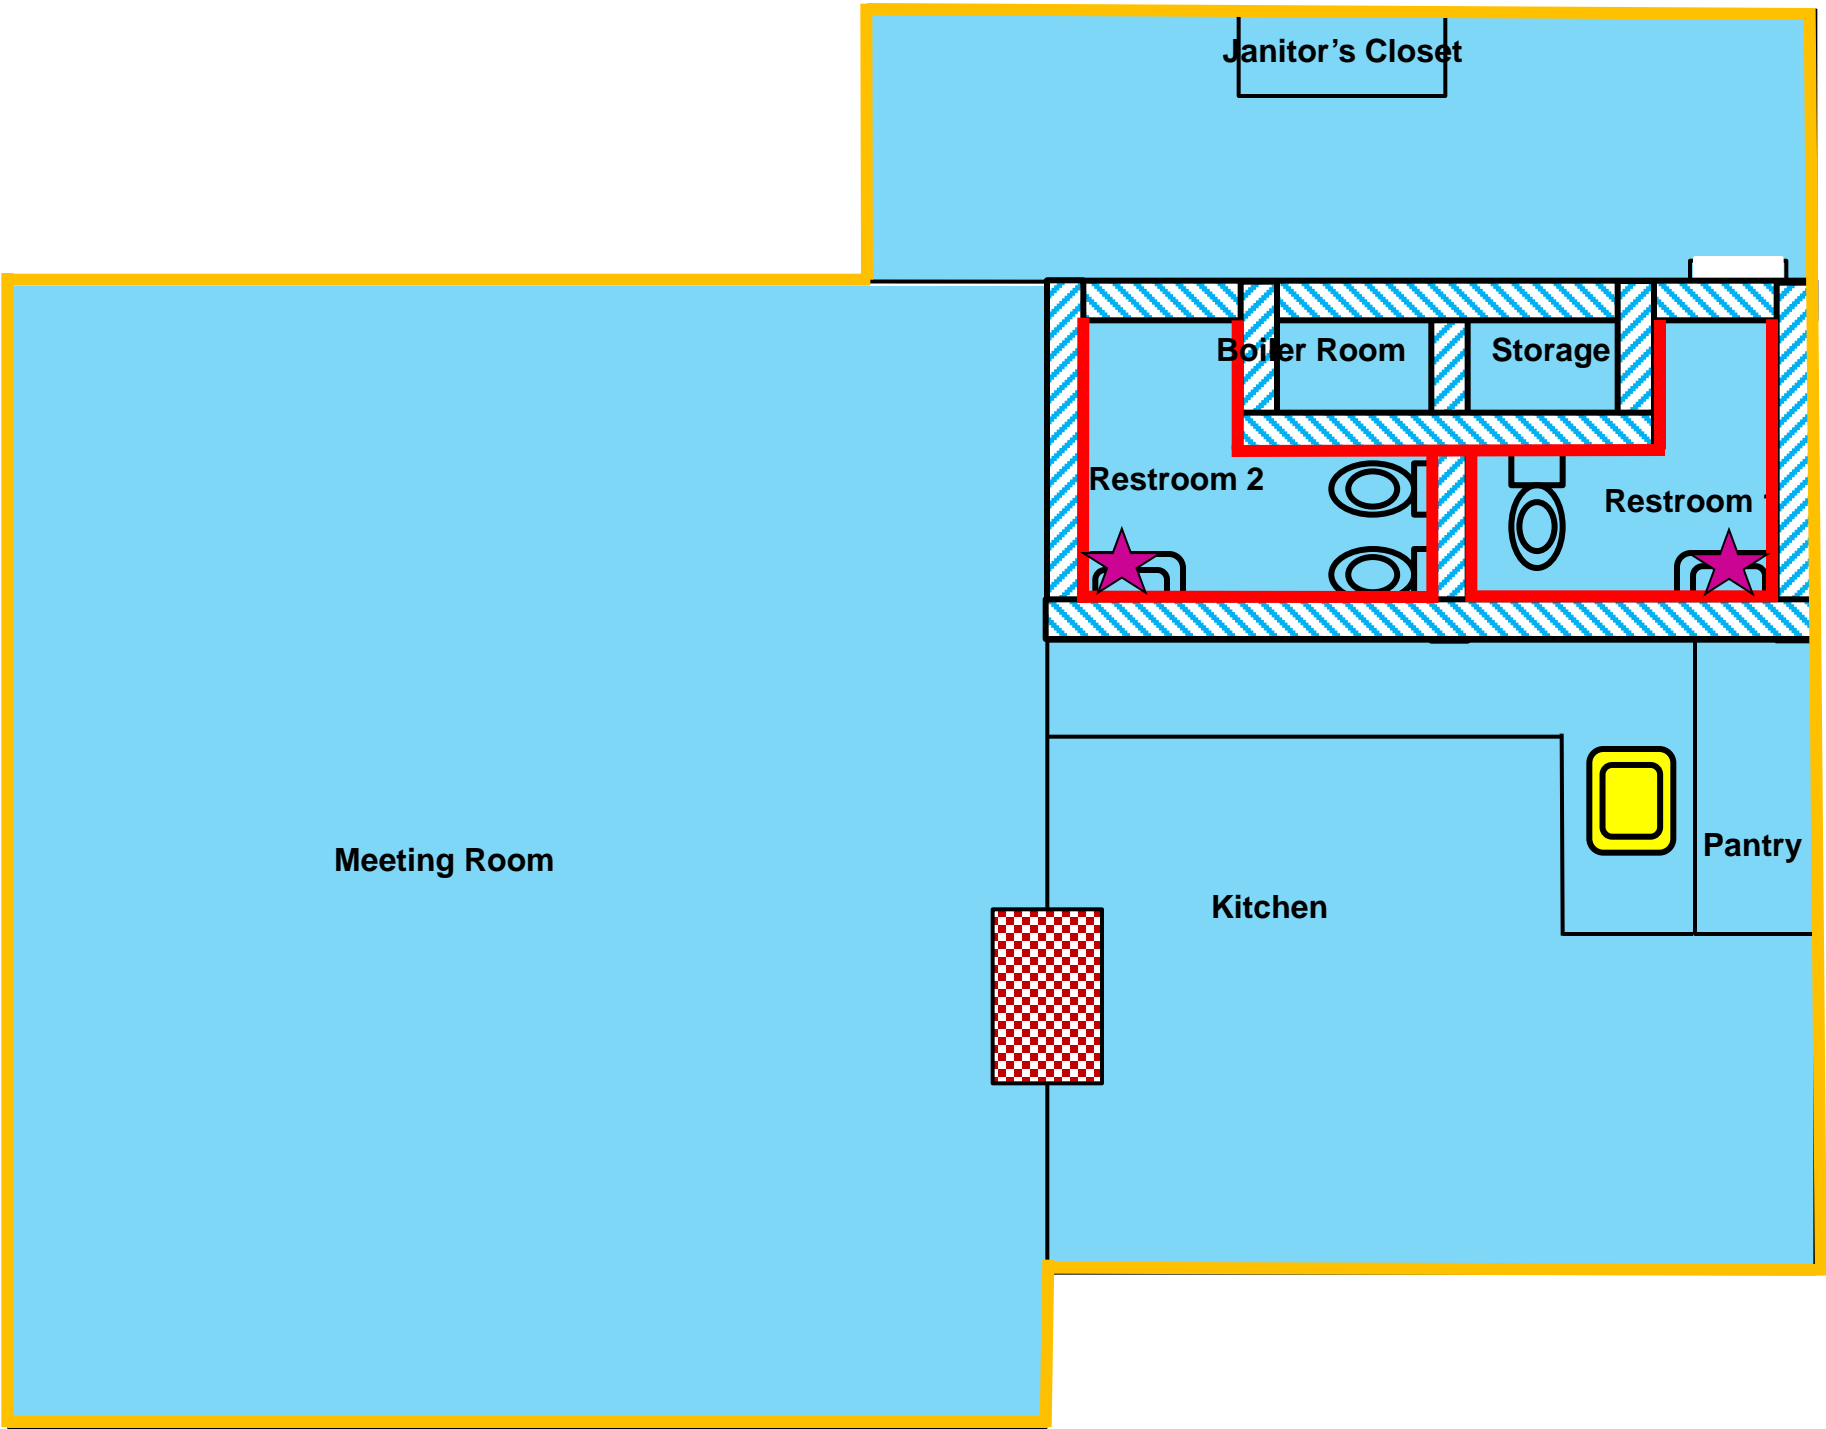
Figure 18
Approximate ACM Locations
Former School

CC2FS-12: Assumed asbestos-containing mirror mastic (M)
- CC2FS-12: Assumed asbestos-containing mirror mastic (M)
- CC2FS-12: Assumed asbestos-containing mirror mastic (M)

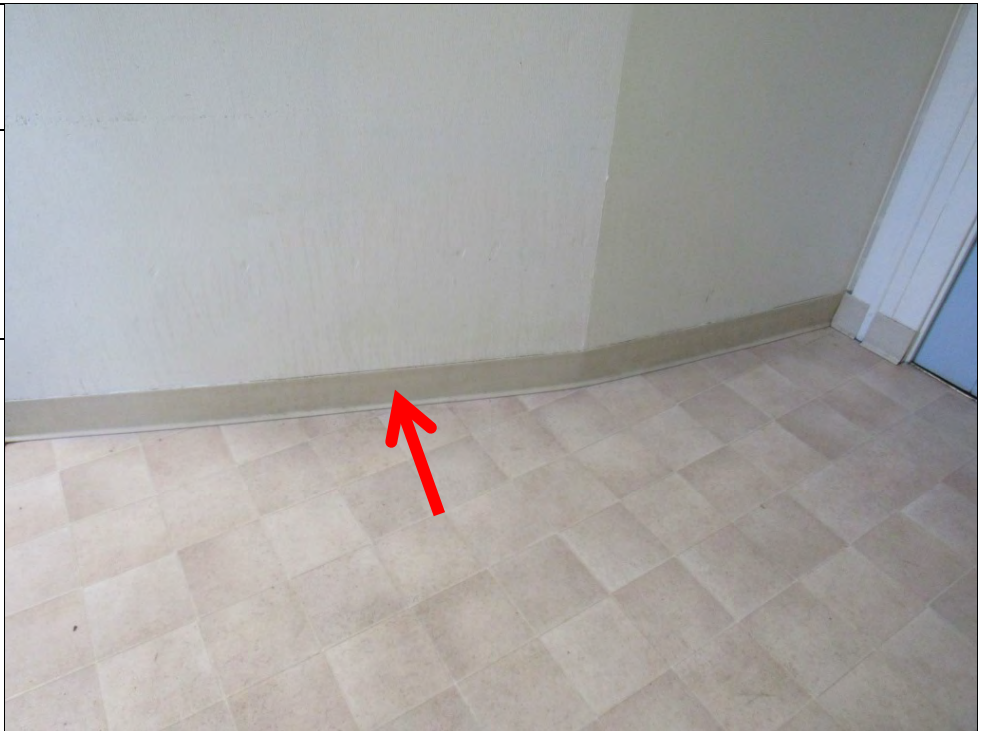
Photo No./ Material ID: CC2CCB - 04	Date: 9/11/2018 to 9/13/2018
Structure/Material Location: Copco No. 2 Control Center Building/ Walls in bathroom and storage closet	
*Description (by layer): 1: 4" white vinyl cove base (M) 2: Off-white mastic (M)

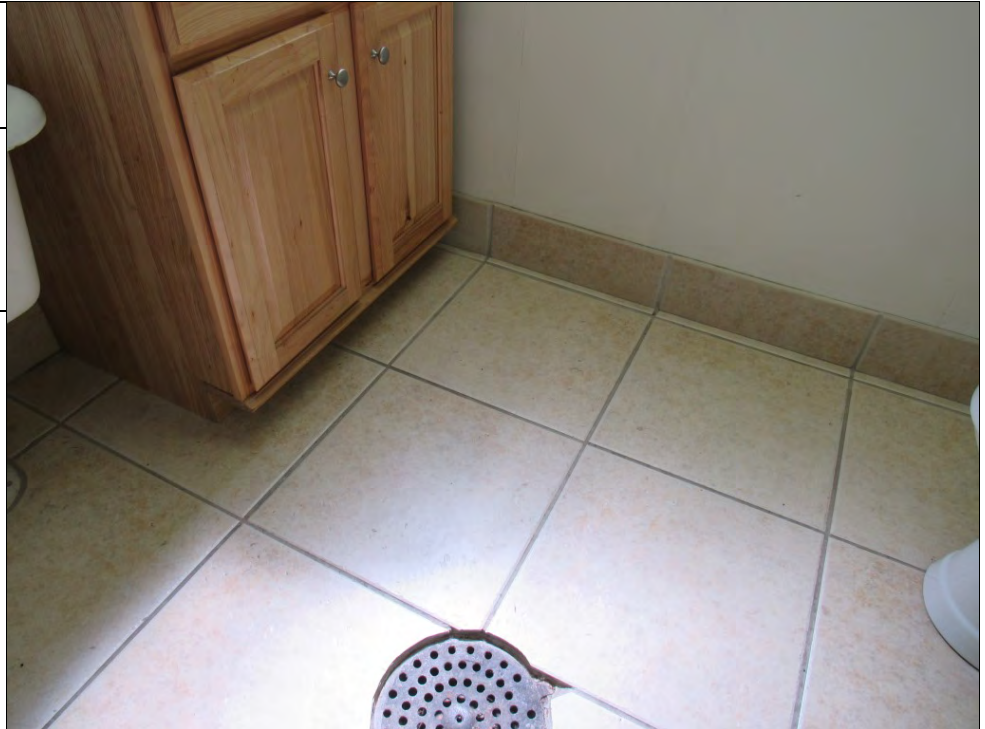
**Assumed asbestos-containing
grouts and mastics associated
with ceramic tiles (M)**

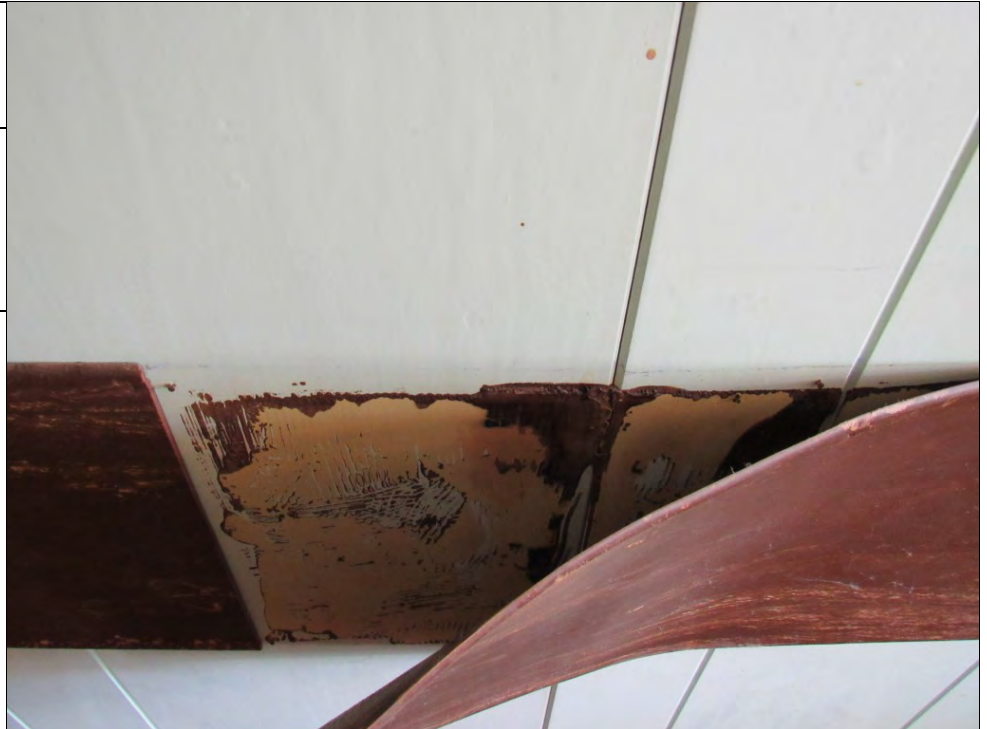
Photo No./ Material ID: CC2FBH - 04	Date: 9/11/2018 to 9/13/2018
Structure/Material Location: Copco No. 2 Former Bunkhouse/ Walls in front room	
*Description (by layer): 1: Dark brown rubber wall strips (M) 2: Brown brittle mastic (M)

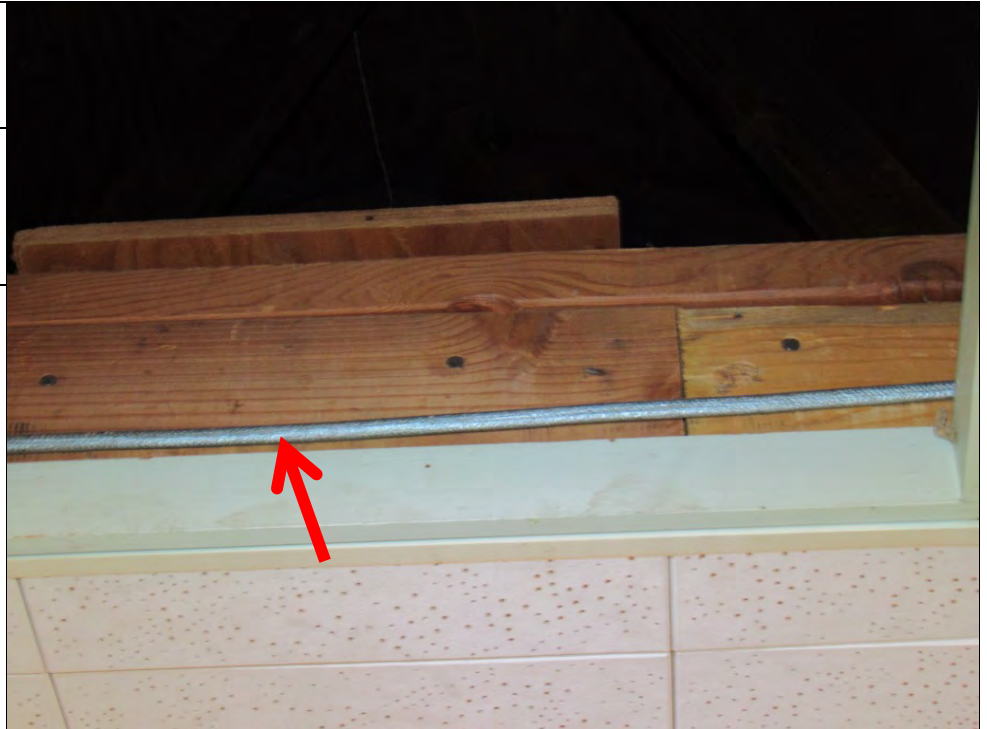
Photo No./ Material ID: CC2FBH - 10	Date: 9/11/2018 to 9/13/2018
Structure/Material Location: Copco No. 2 Former Bunkhouse/ In attic	
*Description (by layer): Assumed asbestos-containing silver woven fiberglass electrical wire insulation (M)

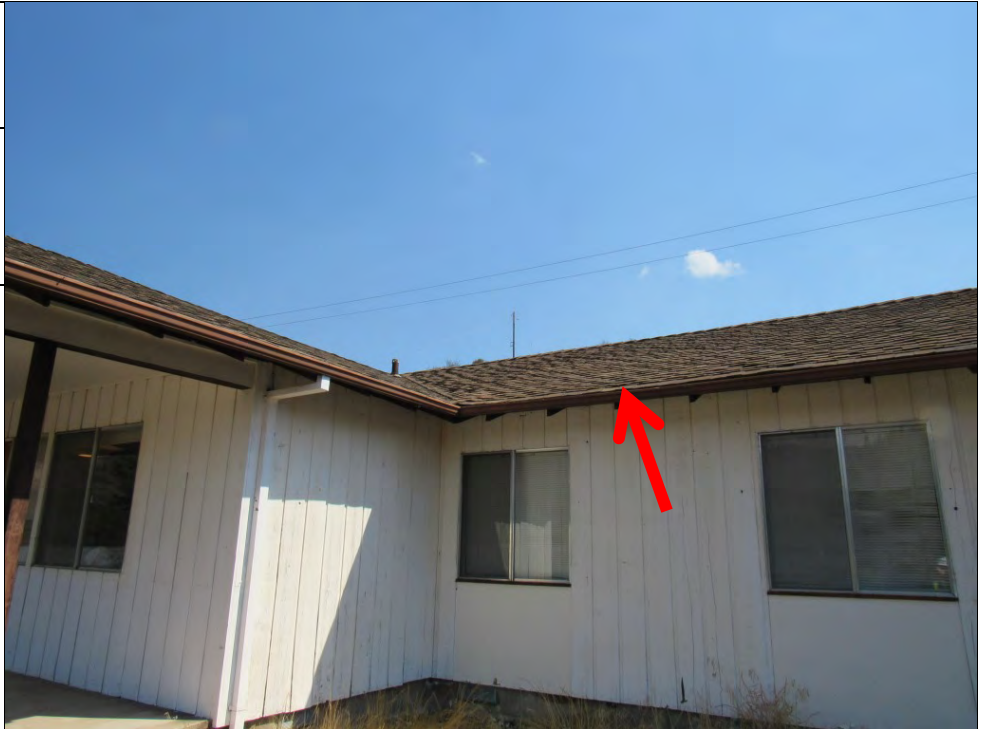
CC2FBH - 12

Date:9/11/2018 to
9/13/2018**Structure/Material Location:**Copco No. 2 Former Bunkhouse/
Throughout roof***Description (by layer):****Assumed asbestos-containing
roofing paper (M)**

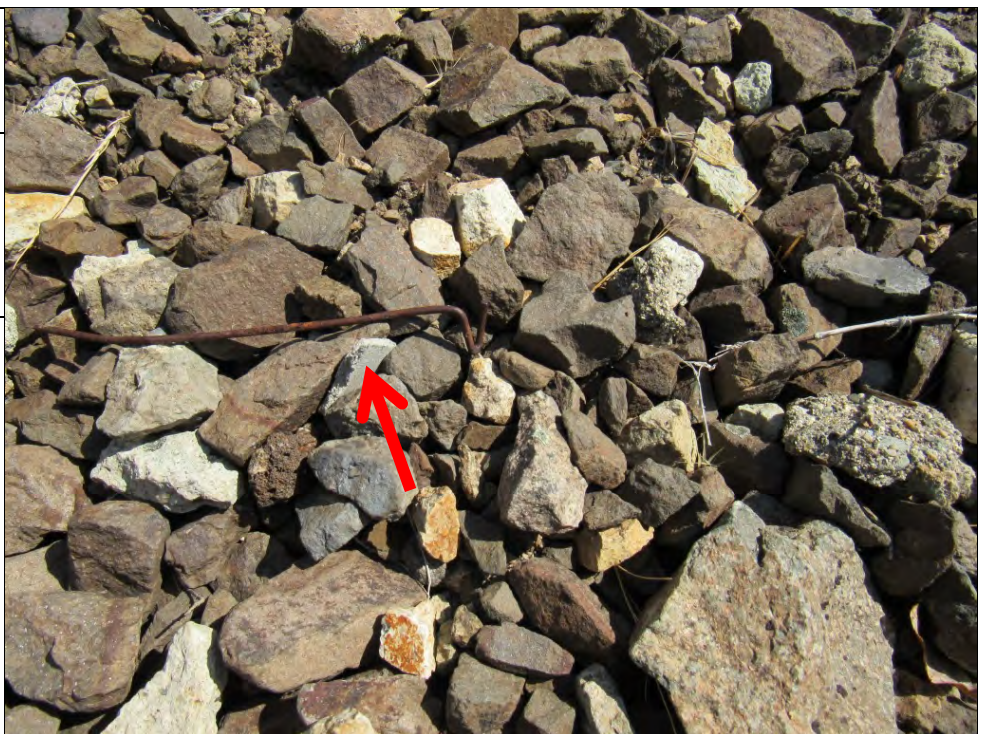
CC2FBH - 13

Date:9/11/2018 to
9/13/2018**Structure/Material Location:**Copco No. 2 Former Bunkhouse/
Scattered throughout exterior in
landscaping rock cover***Description (by layer):****1: Cement asbestos board
(CAB) debris (M)**

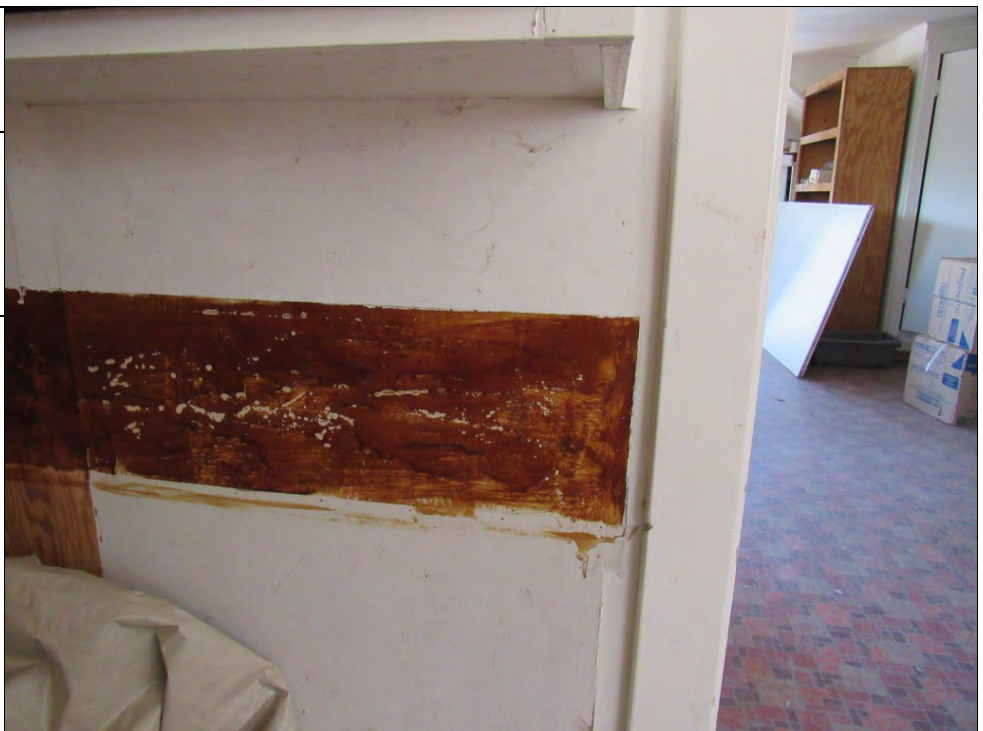
CC2FCH - 01

1: Brown residual mastic (M)

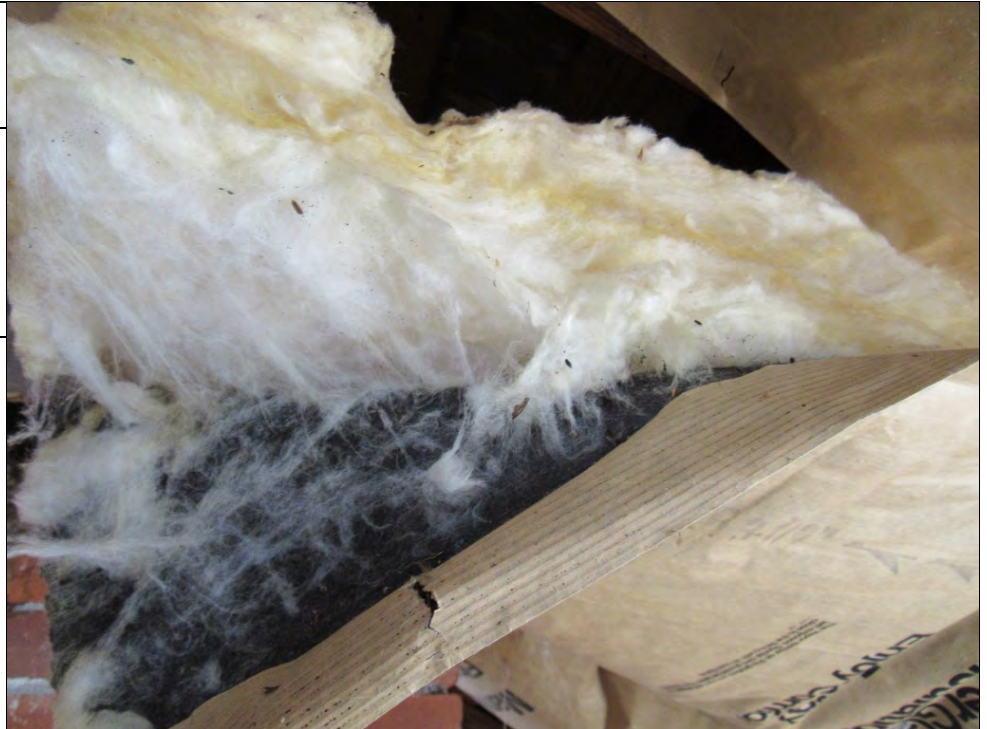
Photo No./ Material ID: CC2FCH - 02	Date: 9/11/2018 to 9/13/2018
Structure/Material Location: Copco No. 2 Former Cookhouse/ Exposed ceiling and walls in second floor attic space	
*Description (by layer): 1: Black mastic on paper backing (M) 2: Yellow fiberglass batt insulation (TSI)

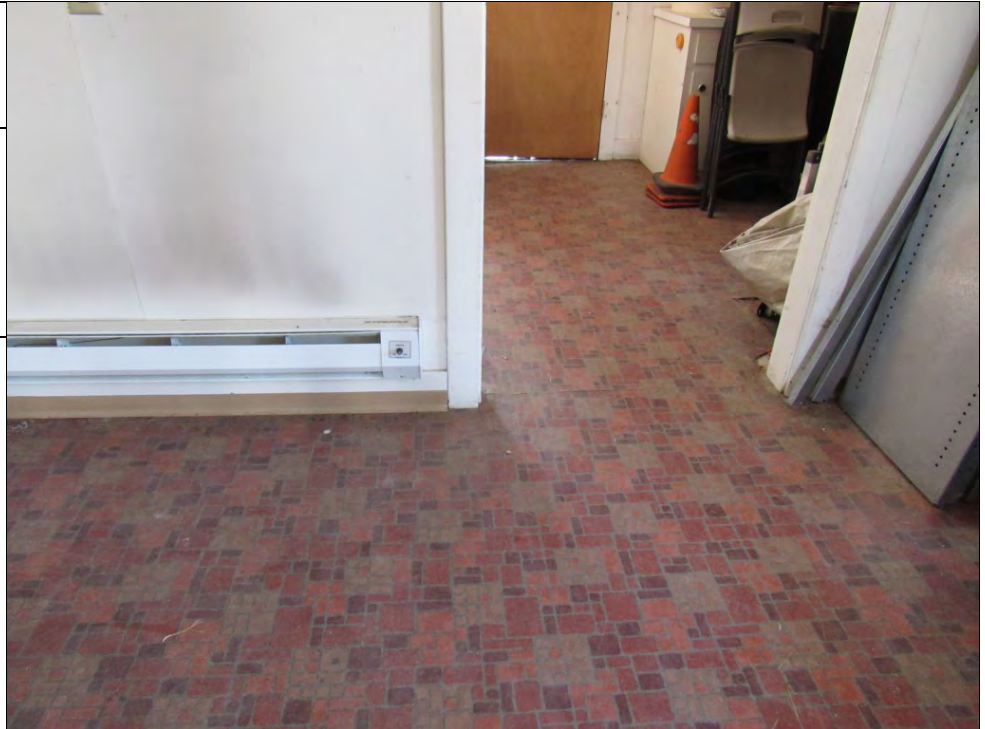
Photo No./ Material ID: CC2FCH - 04	Date: 9/11/2018 to 9/13/2018
Structure/Material Location: Copco No. 2 Former Cookhouse/ Flooring throughout main floor	
*Description (by layer): 1: Red square pattern vinyl floor sheeting (M) 2: Brown paper backing with mastic (M)

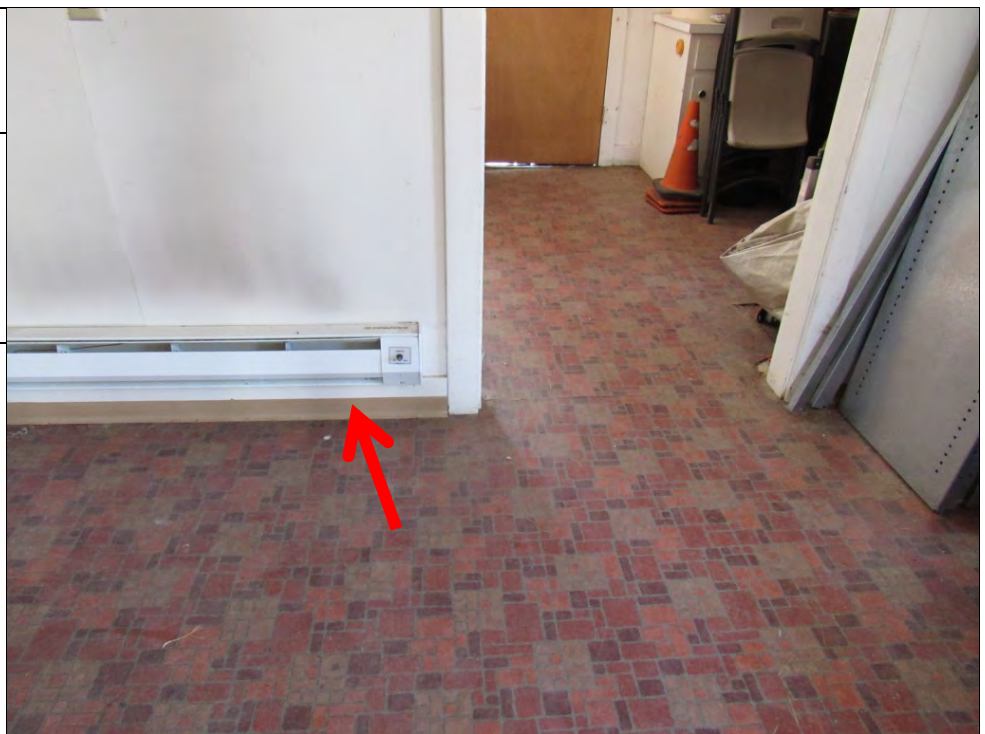
Photo No./ Material ID: CC2FCH - 05	Date: 9/11/2018 to 9/13/2018
Structure/Material Location: Copco No. 2 Former Cookhouse/ Walls throughout main floor	
*Description (by layer): 1: 3" tan rubber cove base (M) 2: Brown brittle mastic (M)

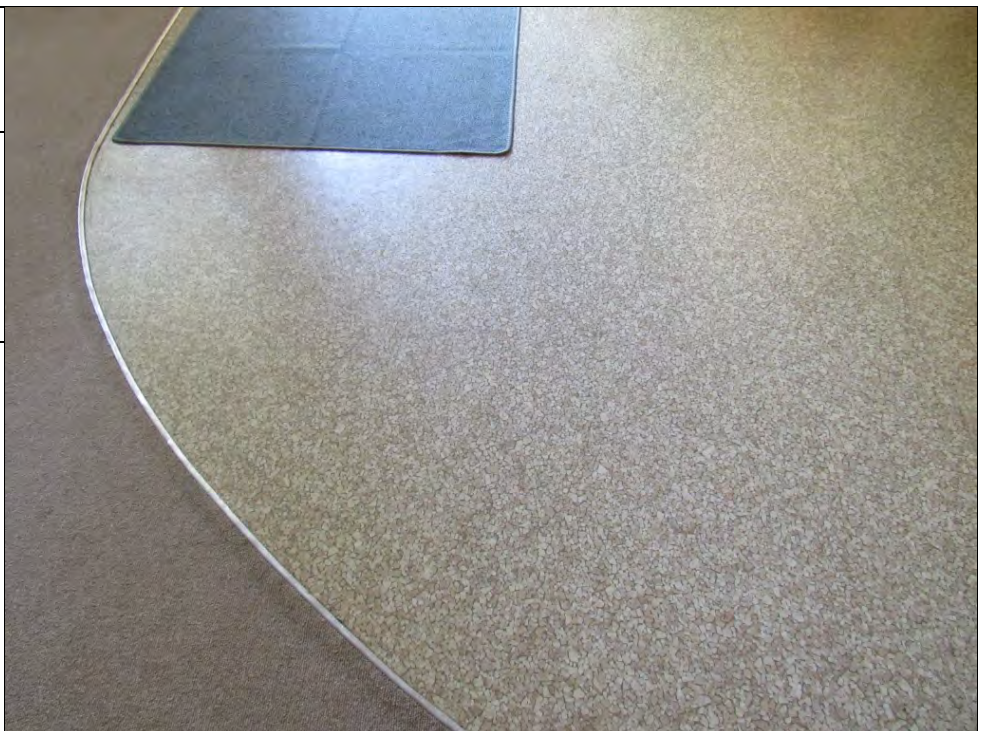
CC2FS - 01

- 1: Beige vinyl floor sheeting with
terrazzo pattern (M)
- 2: Gray paper backing with
yellow mastic (M)

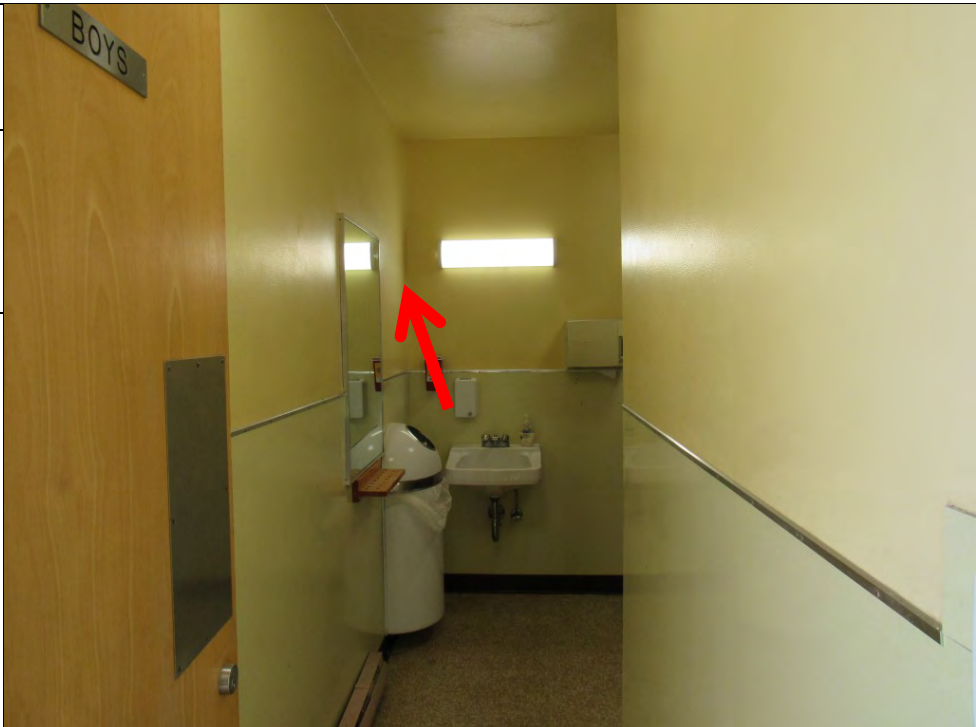
CC2FS - 06	9/11/2018 to 9/13/2018	
Structure/Material Location: Copco No. 2 Former School/ Walls throughout all rooms		
*Description (by layer): 1: Off-white joint compound (M) 2: Off-white joint compound (M) 3: Beige gypsum wallboard (M) 4: Off-white joint compound (M)

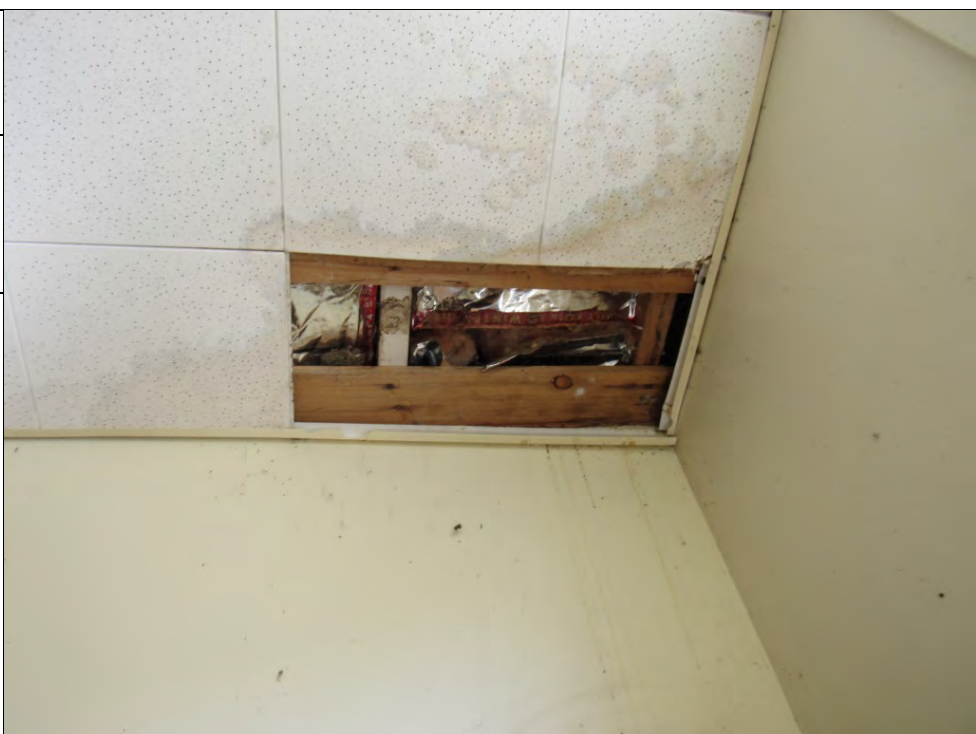
CC2FS - 07	9/11/2018 to 9/13/2018	
Structure/Material Location: Copco No. 2 Former School/ Chimney in attic space		
*Description (by layer): 1: Fiberglass batt insulation with foil back (TSI)

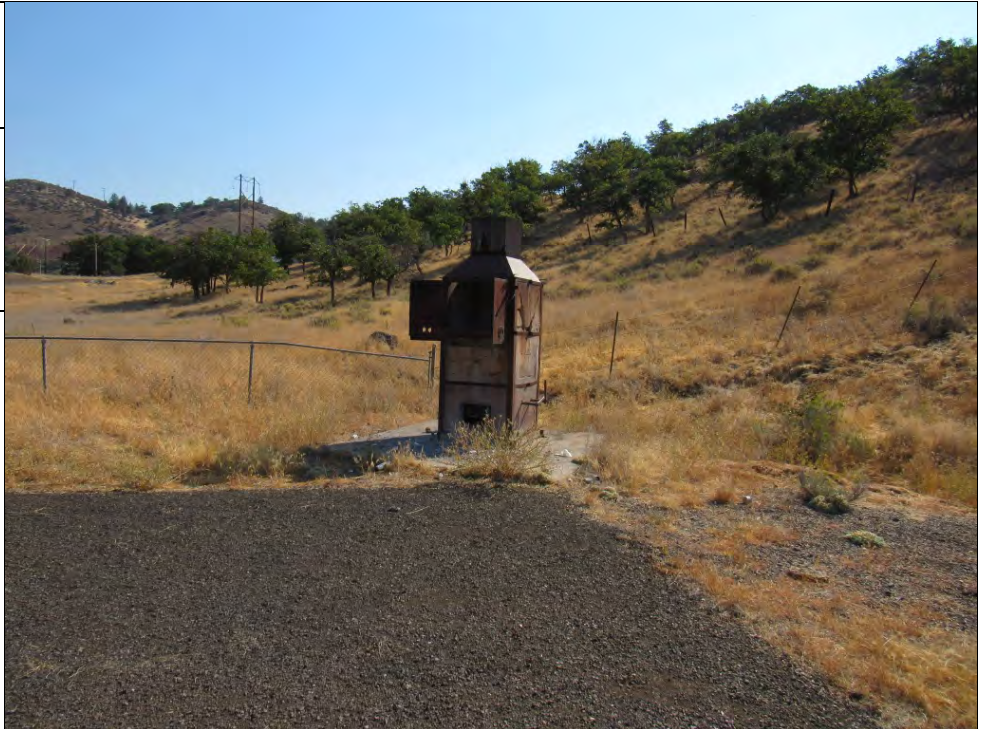
1: Light pink fire brick (M)

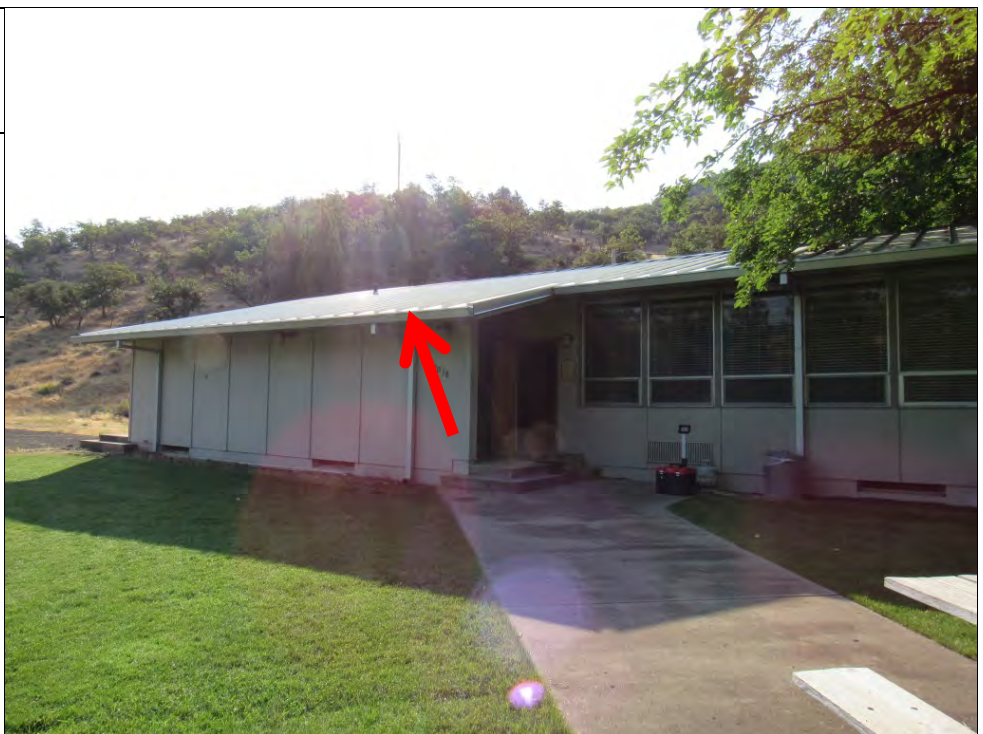
CC2FS - 09

**Assumed asbestos-containing
roofing paper (M)**

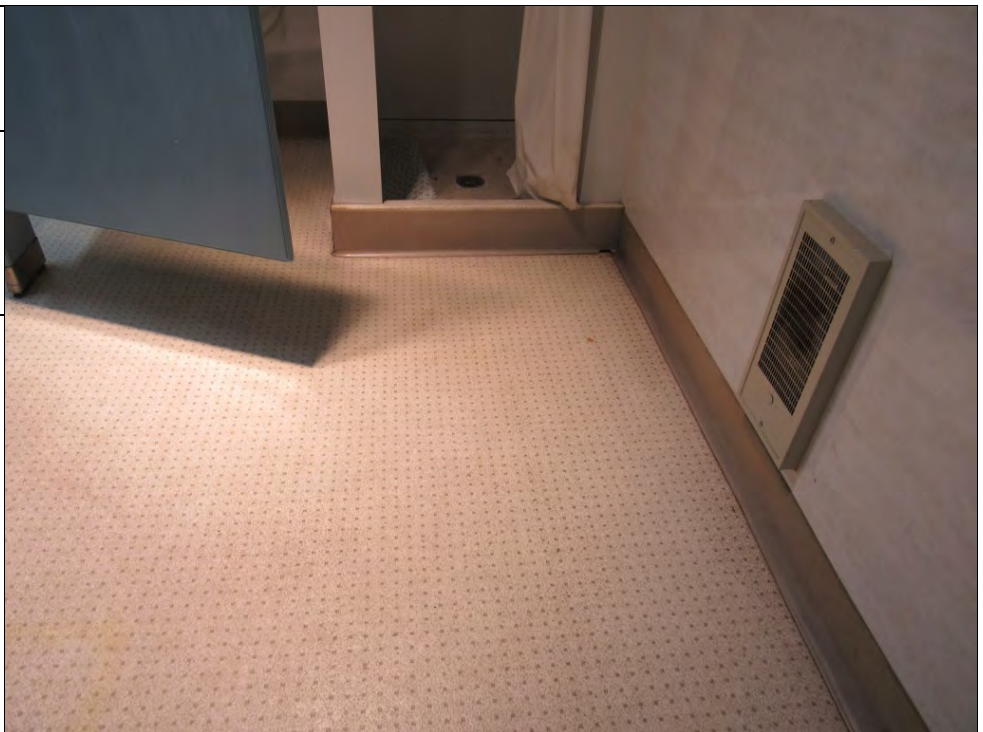
CC2MB - 03

Date:9/11/2018 to
9/13/2018**Structure/Material Location:**Copco No. 2 Maintenance
Building/
Flooring in bathroom***Description (by layer):**

- 1: Off-white mastic (M)
- 2: Off-white vinyl floor sheeting
with square dot pattern (M)
- 3: Tan paper backing with tan
mastic (M)

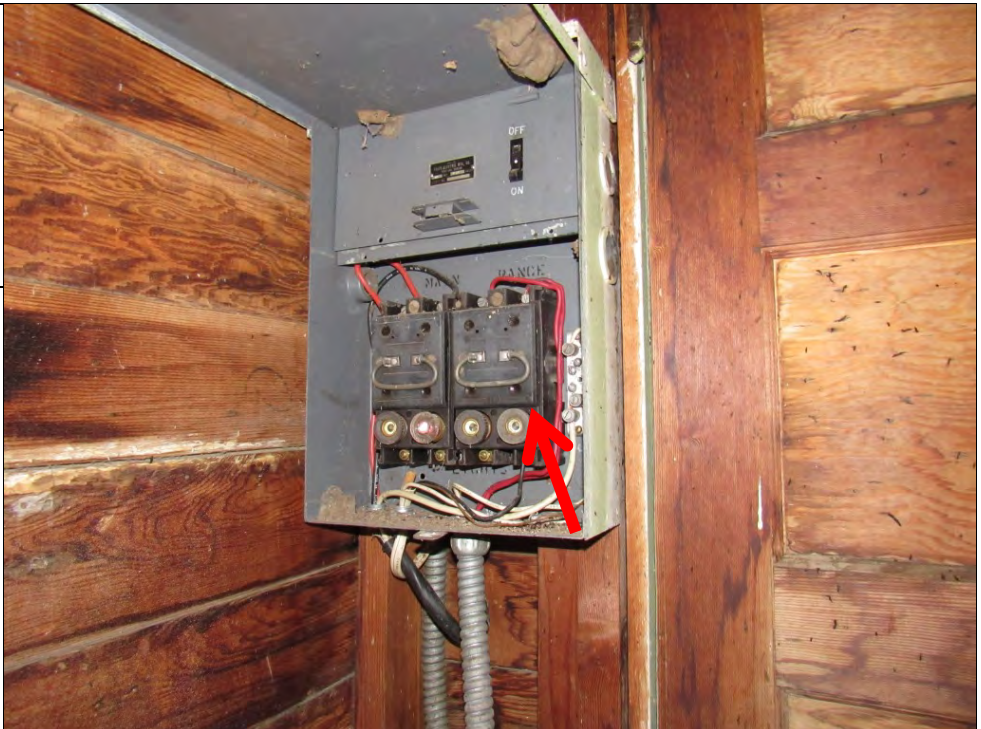
Photo No./ Material ID: CC2R3 - 14	Date: 9/11/2018 to 9/13/2018

Structure/Material Location: Copco No. 2 Residence 3/ Interior of shed		
*Description (by layer): Assumed asbestos-containing electrical panel backing in older electrical panels (M)
