Klamath River Renewal Corporation

Project No. 14803-001

**LICENSE SURRENDER ORDER
LOWER KLAMATH PROJECT**

Waste Disposal and Hazardous Materials Management Plan

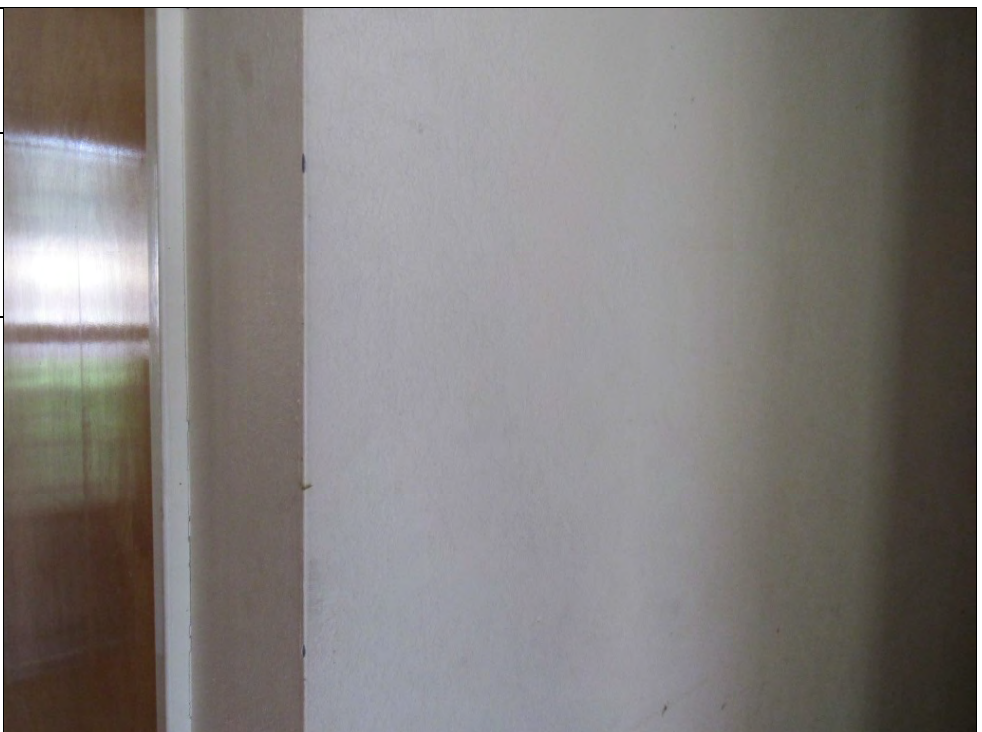
Photo No./ Material ID: CC2R5 - 05	Date: 9/11/2018 to 9/13/2018
Structure/Material Location: Copco No. 2 Residence 5/ Walls throughout all rooms	
*Description (by layer): 1: White joint compound with paper (M) 2: White gypsum wallboard with paper (M)

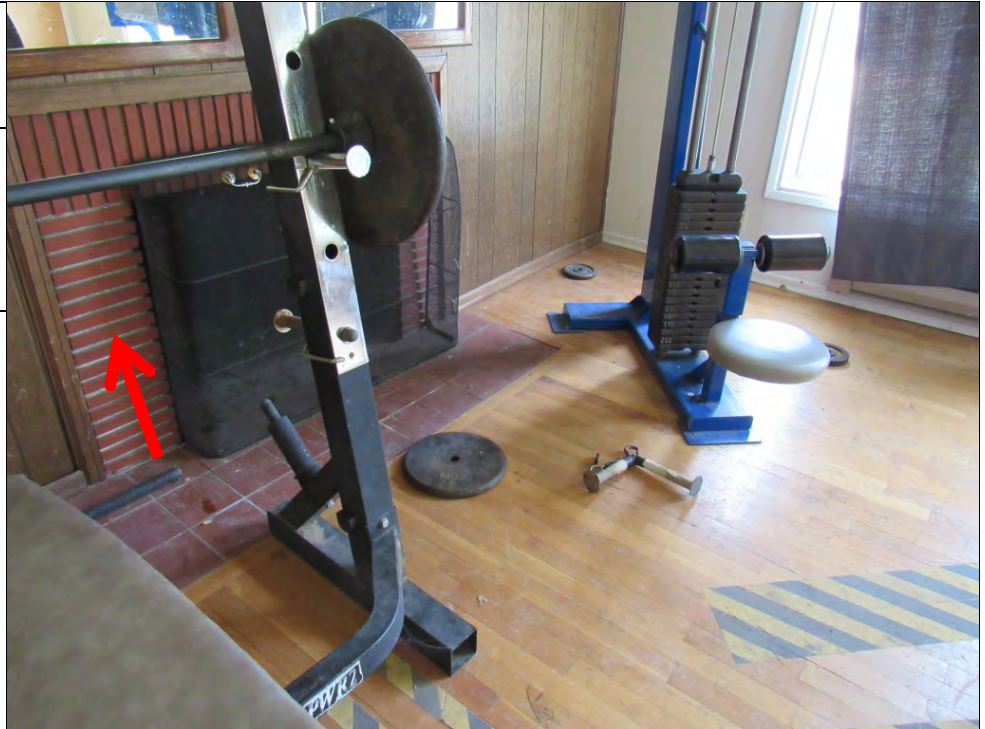
Photo No./ Material ID: CC2R5 - 12	Date: 9/11/2018 to 9/13/2018
Structure/Material Location: Copco No. 2 Residence 5/ Wall in living room	
*Description (by layer): 1: Gray grout associated with fireplace (M)

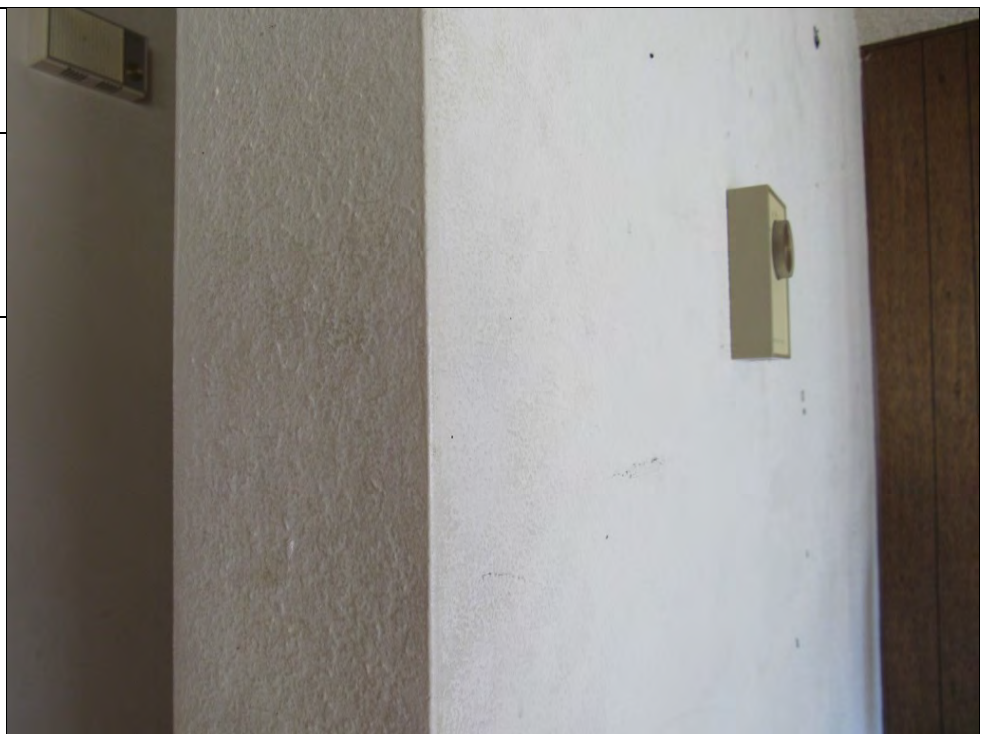
Photo No./ Material ID: CC2R5 - 13	Date: 9/11/2018 to 9/13/2018
Structure/Material Location: Copco No. 2 Residence 5/ Walls throughout all rooms	
*Description (by layer): 1: White spray-applied wall texture (S)

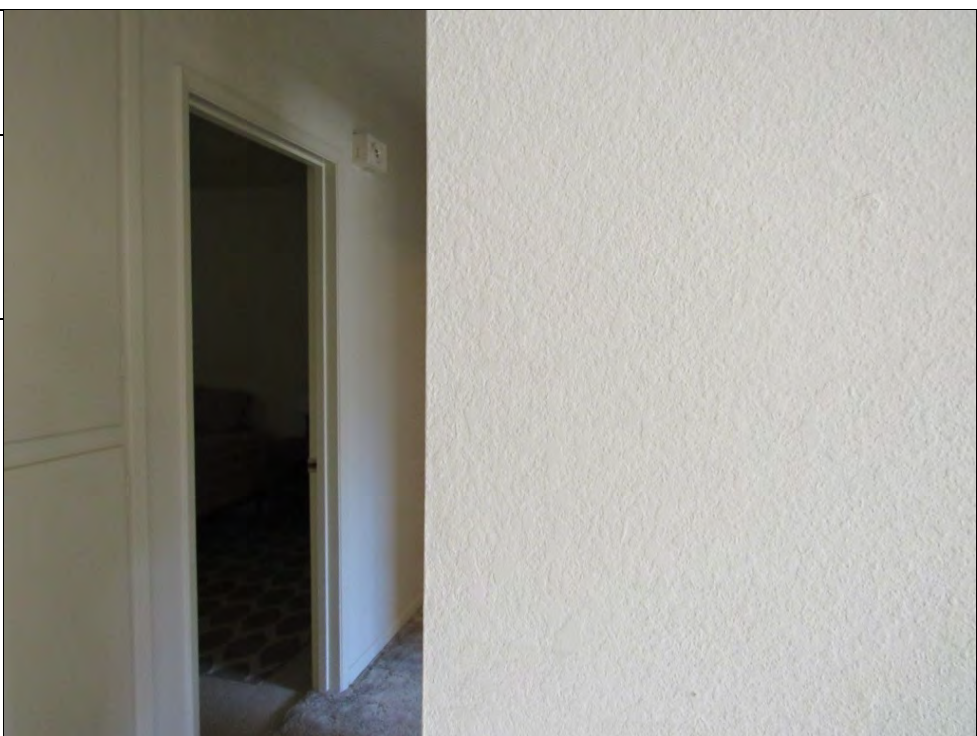
Photo No./ Material ID: CC2R6 - 05	Date: 9/11/2018 to 9/13/2018

Structure/Material Location: Copco No. 2 Residence 6/ Walls throughout all rooms		
*Description (by layer): 1: White spray-applied wall texture (S) 2: Beige gypsum wallboard (M) 3: White gypsum wallboard with paper (M)
