BULK ASBESTOS MATERIAL *Analysis Request*

ENTEK CONSULTING GROUP, INC.

Site Address: Iron Gate Dam

Iron Gate Development
Hazardous Building Materials Survey

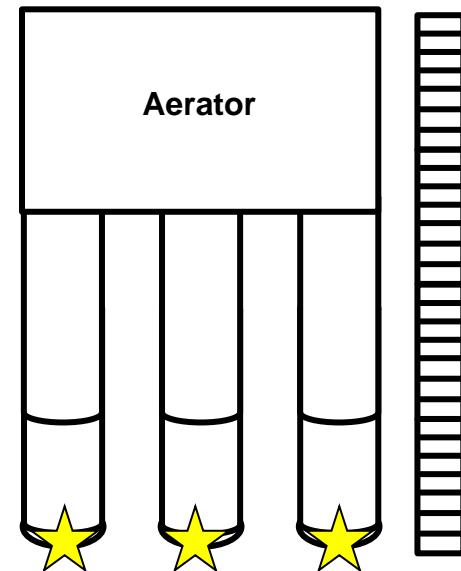
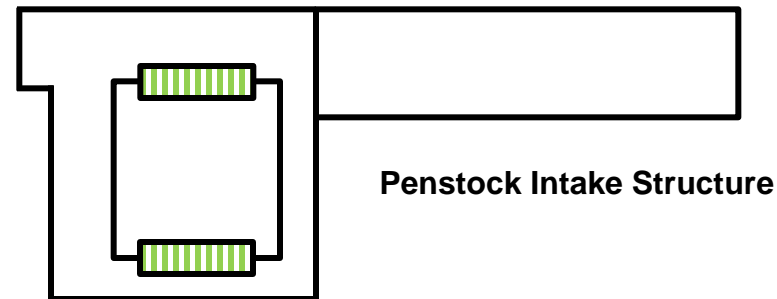
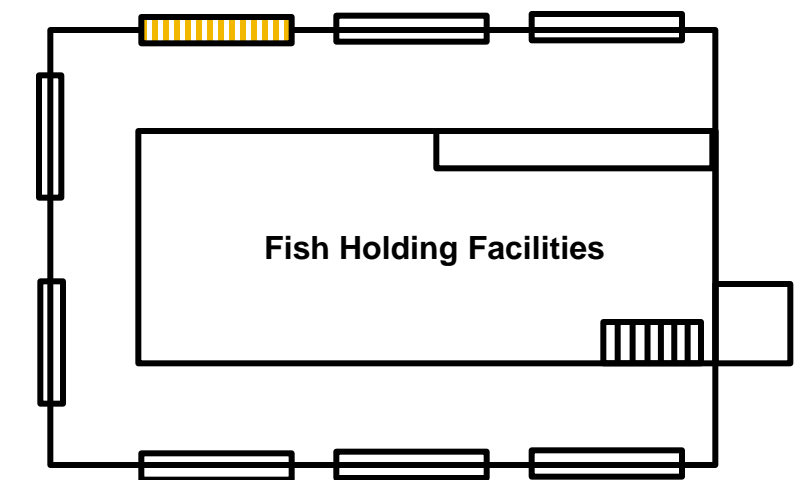
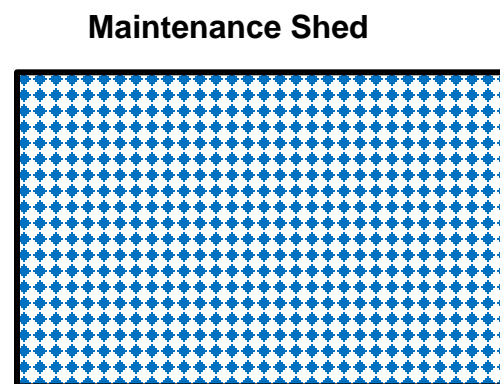
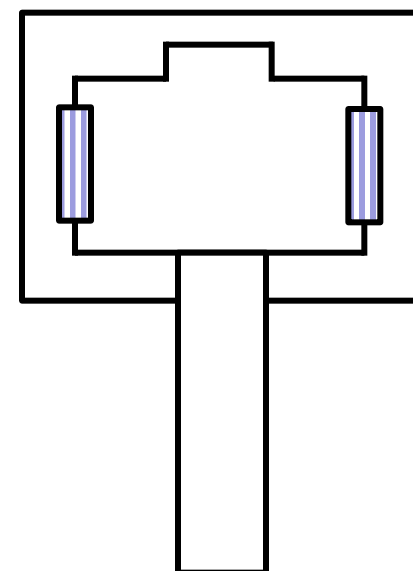
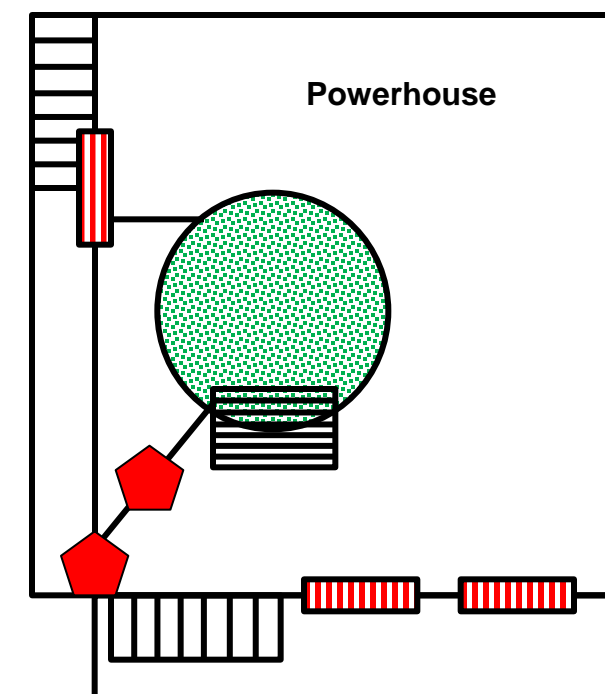
Figure 9
Approximate ACM Locations
Aerator, Penstock Intake Structure,
Fish Holding Facilities, Maintenance Shed,
Diversion Tunnel Intake Structure,
and Powerhouse

IGDPH-06: Assumed asbestos-containing metal-clad fire door insulation (M)

Assumed asbestos-containing buried Transite piping is assumed to be throughout the Iron Gate Development. Not shown on figures.

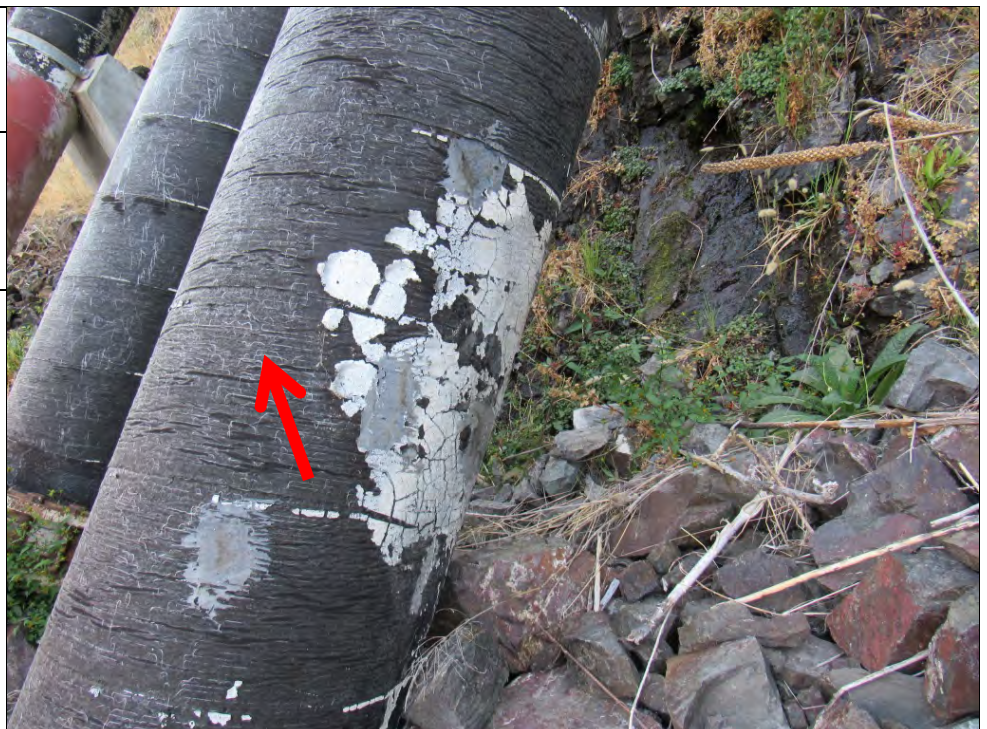
Photo No./ Material ID: IGDAE - 01	Date: 9/12/2018
Structure/Material Location: Iron Gate Dam Aerator/ Aerator piping, hatchery water supply	
*Description (by layer): 1: Black asphaltic pipe wrap (M)

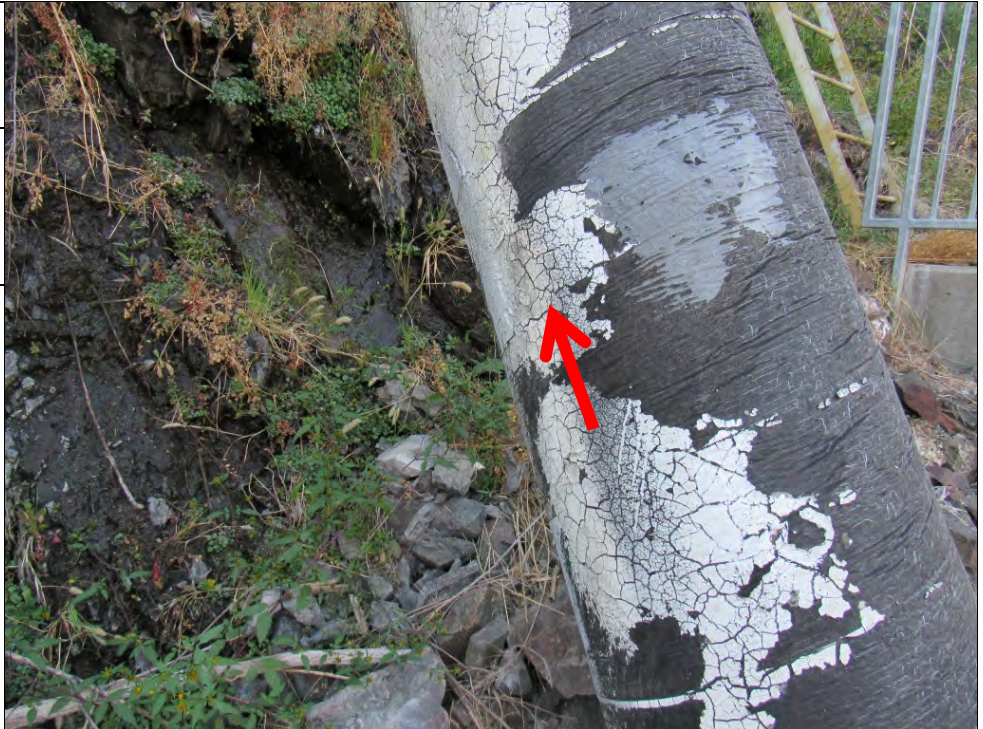
IGDAE - 03

Structure/Material Location:Iron Gate Dam Aerator/
Ceiling throughout all rooms***Description (by layer):**

- 1: Silver paint (M)
- 2: Black asphaltic pipe wrap (M)

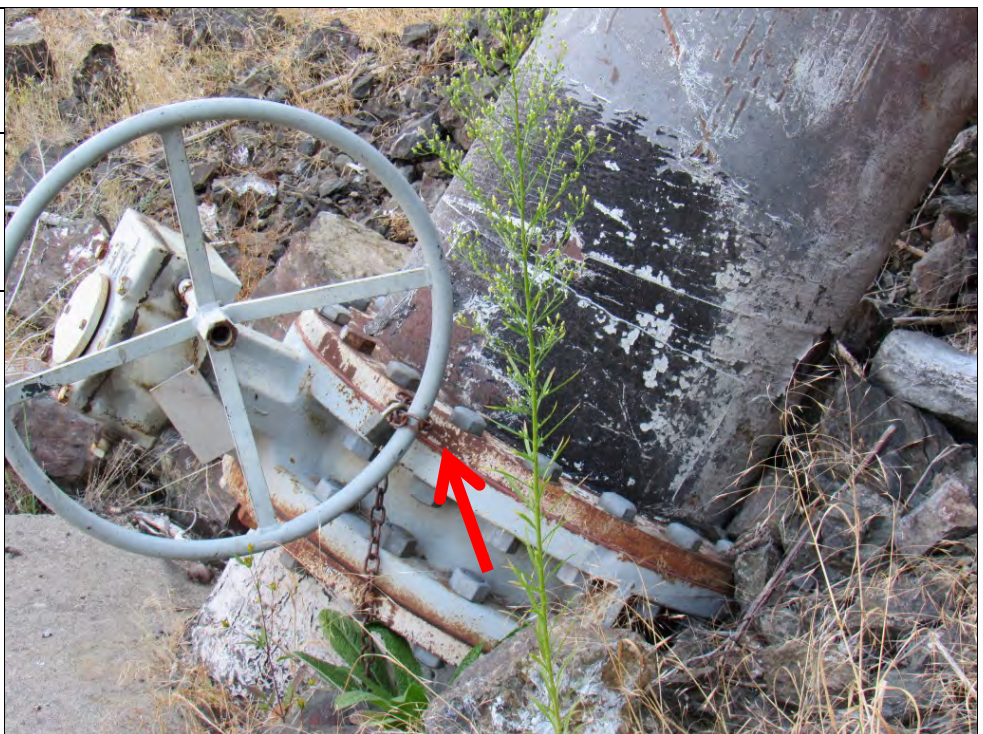
Structure/Material Location:Iron Gate Dam Aerator/
Ceiling throughout all rooms***Description (by layer):**

- 1: Red gasket (M)

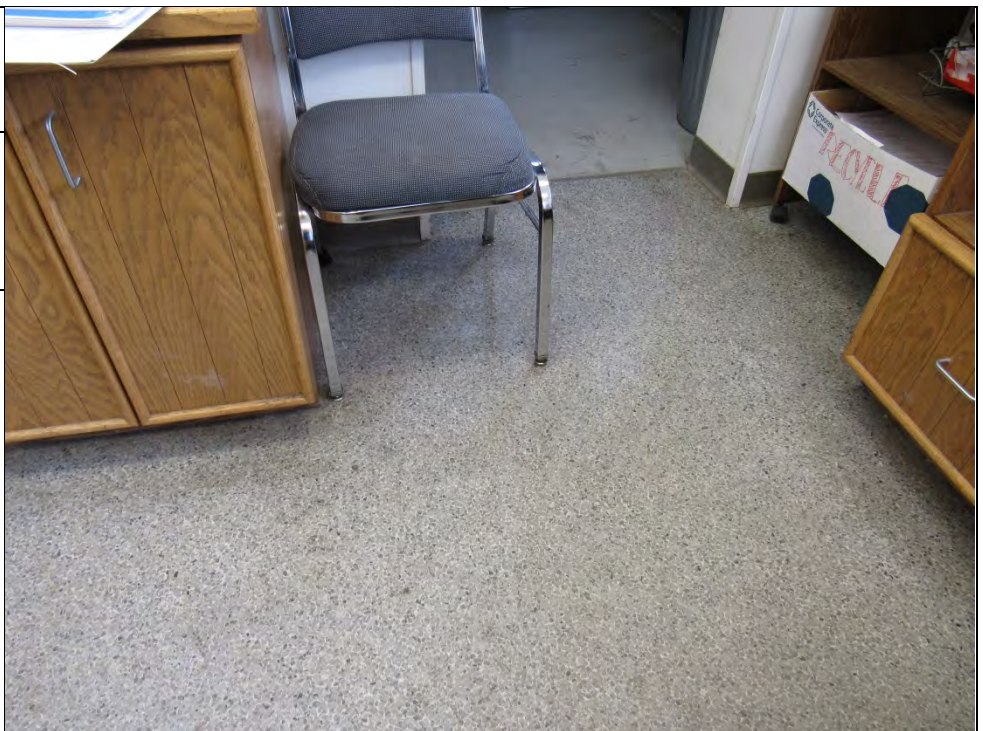
***Description (by layer):**

- 1: Gray vinyl floor sheeting with
terrazzo pattern (M)
- 2: Gray paper backing with
mastic (M)
- 3: Tan mastic (M)

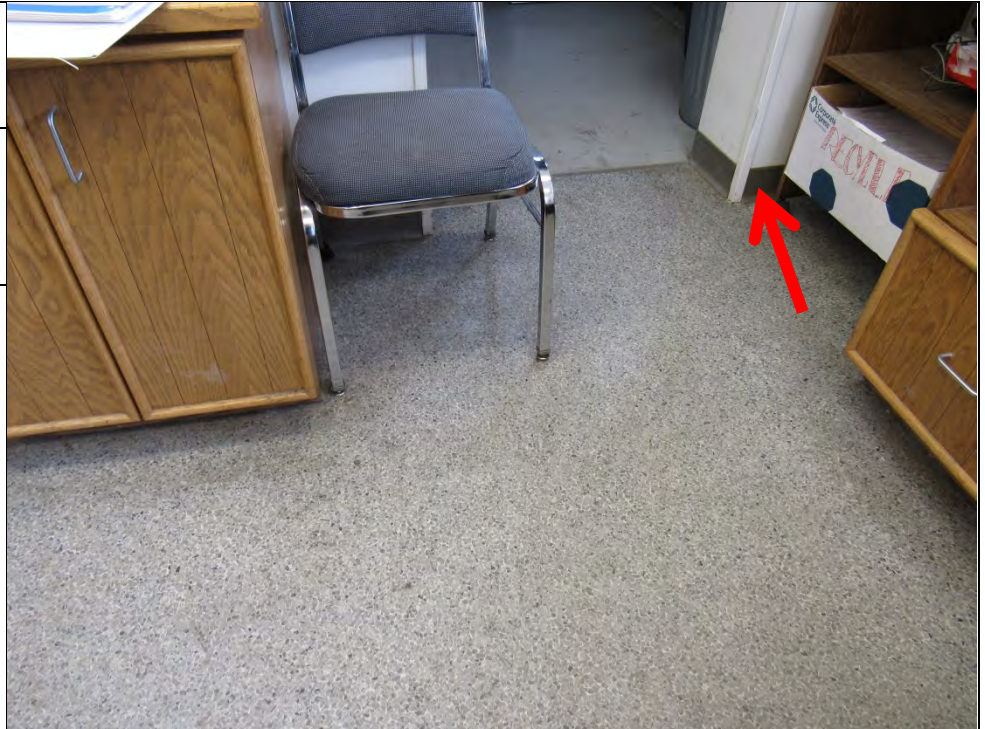
***Description (by layer):**

- 1: 4" gray rubber cove base (M)
- 2: White mastic (M)

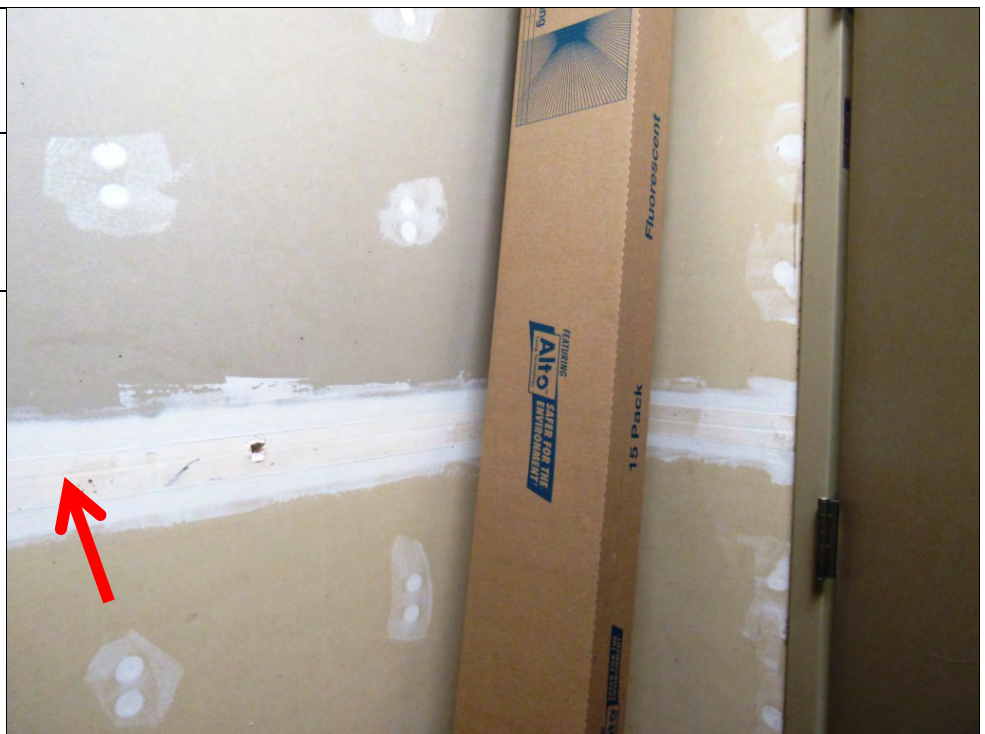
***Description (by layer):**

- 1: White joint compound with paper (M)
- 2: White gypsum wallboard with paper (M)
- 3: White joint compound with paper (M)
- 4: Peach gypsum wallboard with paper (M)

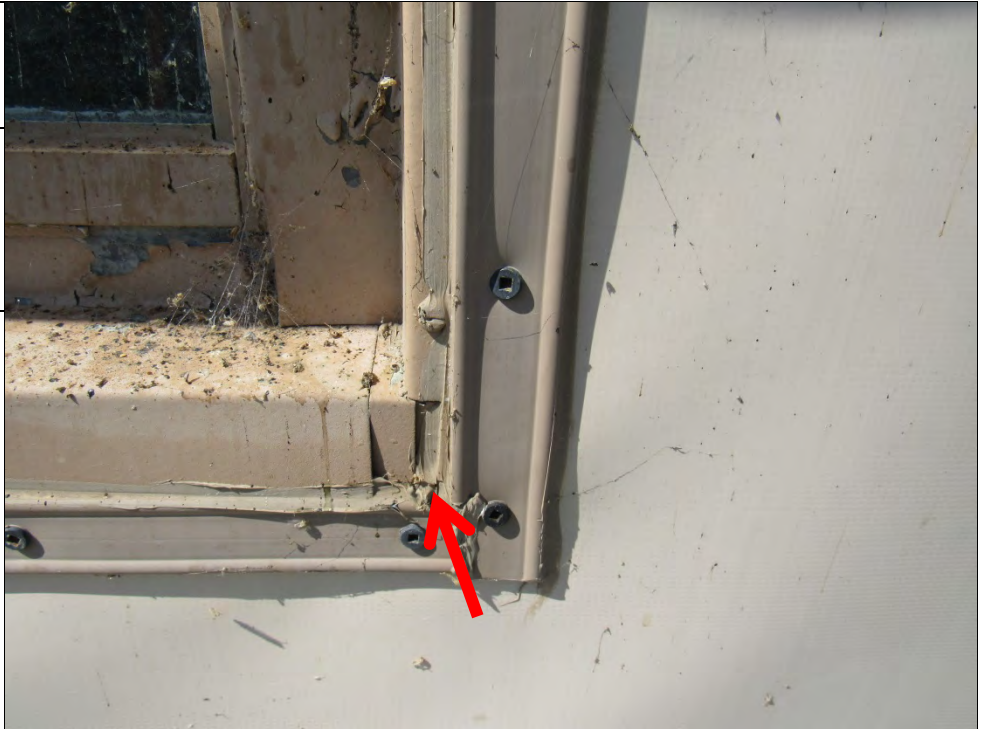
Structure/Material Location:Iron Gate Dam Diversion Tunnel
Intake Structure/ Exterior
window frames***Description (by layer):**1: Beige exterior window
caulking (M)

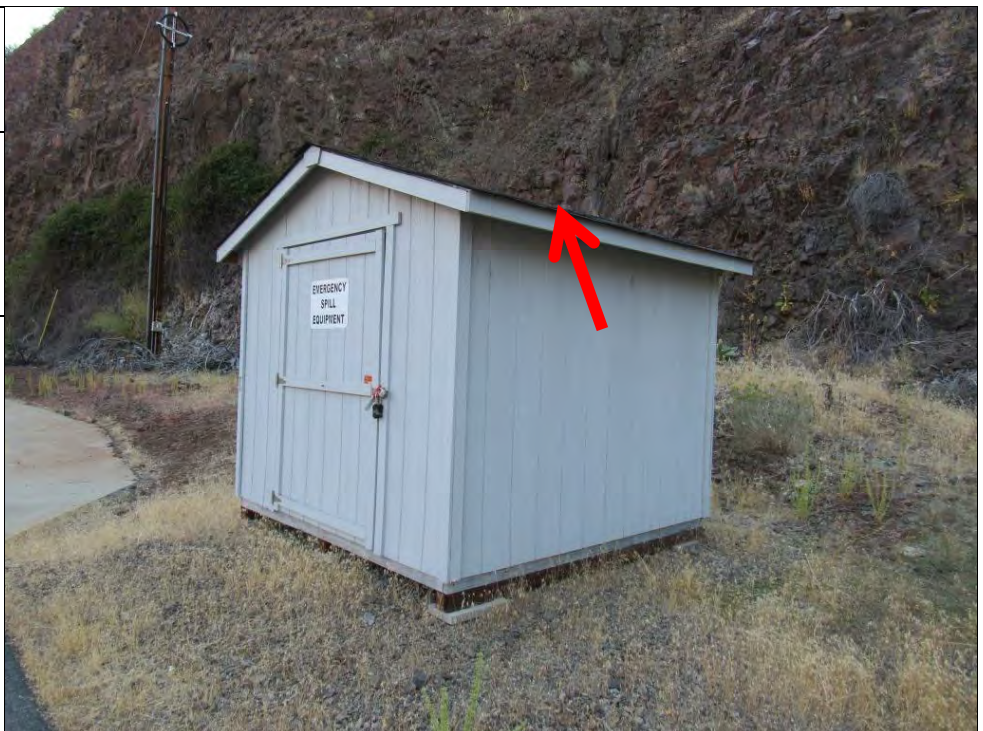
***Description (by layer):**

1: Asphaltic roofing shingle with
granules (M)

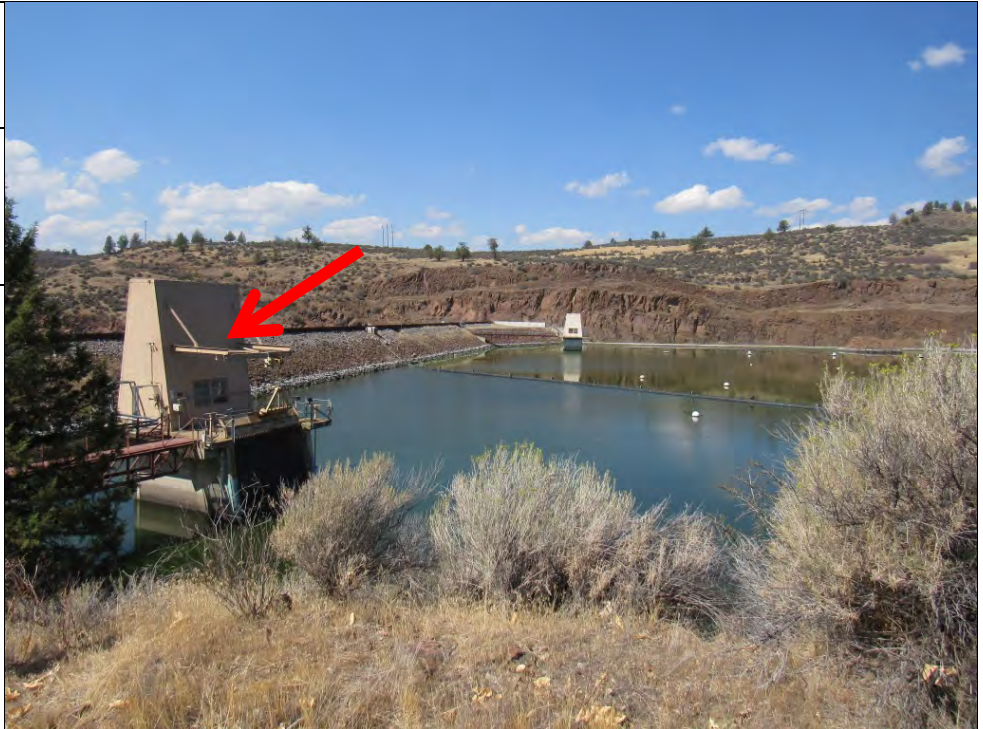
IGDPIS - 01

1: Gray putty material (M)

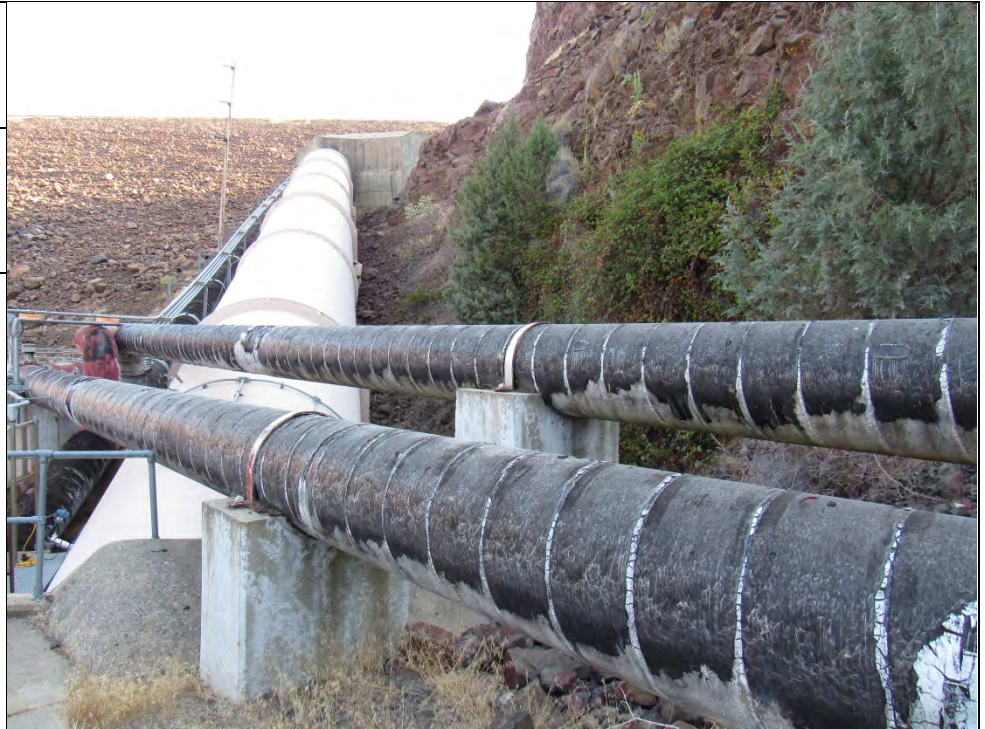
Photo No./ Material ID: IGDPS - 01	Date: 9/14/2018
Structure/Material Location: Iron Gate Dam Penstock/ Hatchery water supply piping (M)	
*Description (by layer): 1:Black asphaltic pipe wrap (M)

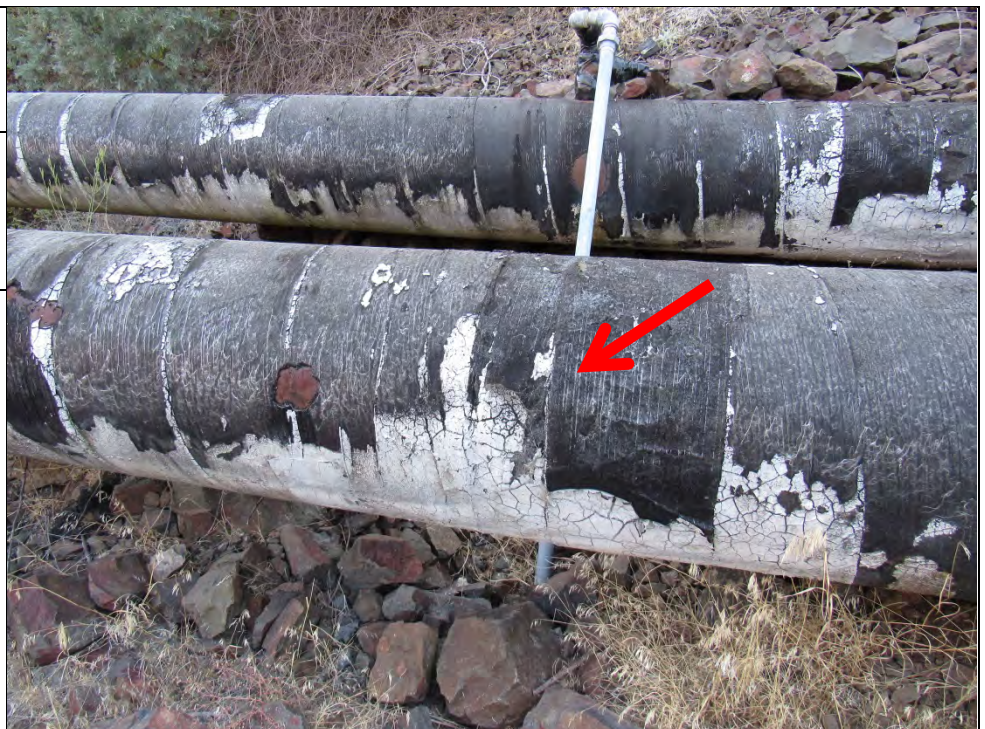
Photo No./ Material ID: IGDPS - 02	Date: 9/14/2018
Structure/Material Location: Iron Gate Dam Penstock/ Hatchery water supply piping	
*Description (by layer): 1: Thick silver paint (M) 2: Black asphaltic pipe wrap (M)

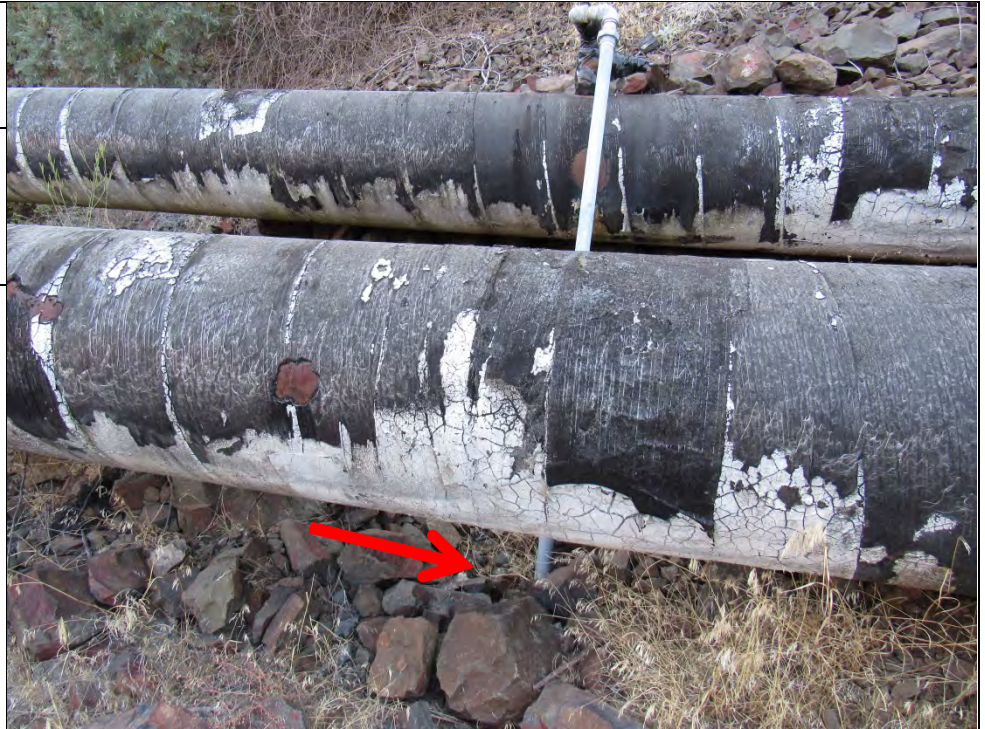
Photo No./ Material ID: IGDPS - 03	Date: 9/14/2018
Structure/Material Location: Iron Gate Dam Penstock/ Hatchery water supply piping	
*Description (by layer): 1: Brown fibrous gasket at pipe line saddles (M)

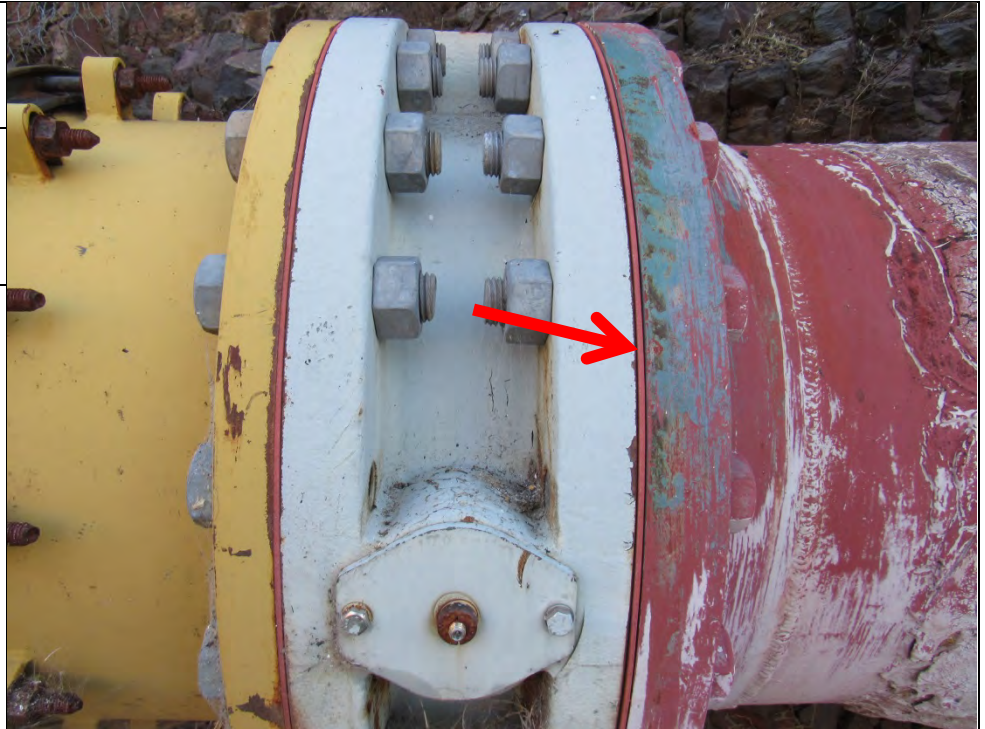
Photo No./ Material ID: IGDPS - 05	Date: 9/14/2018
Structure/Material Location: Iron Gate Dam Penstock/ Hatchery water supply piping	
*Description (by layer): 1: Black gasket (M)

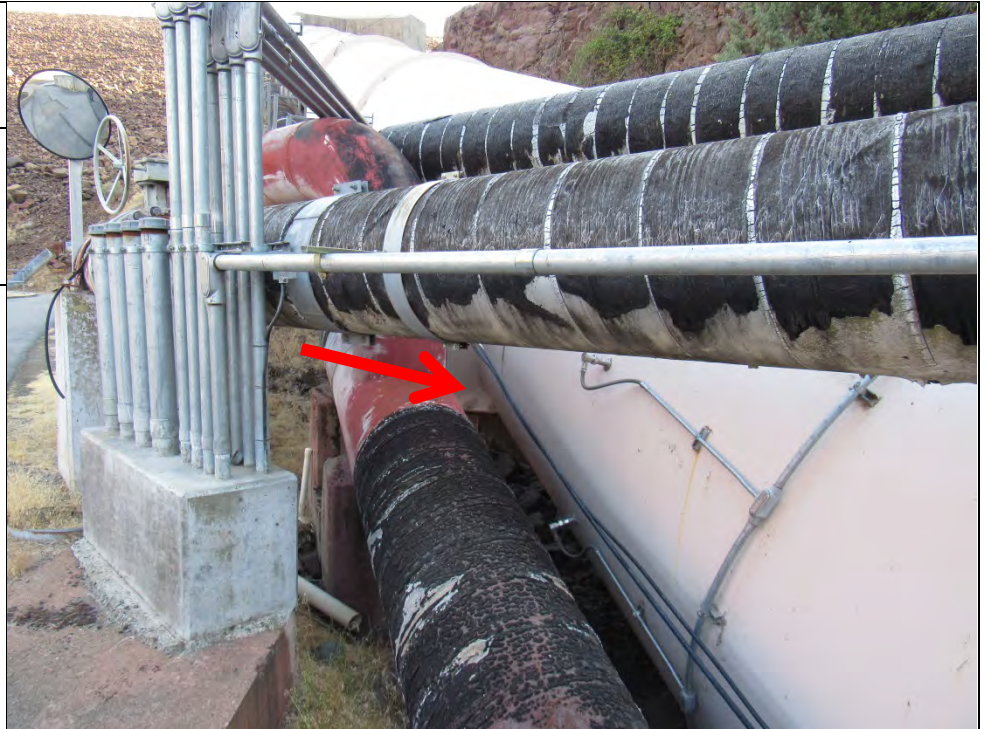
1: Tar coating on fish hatchery
water supply (M)

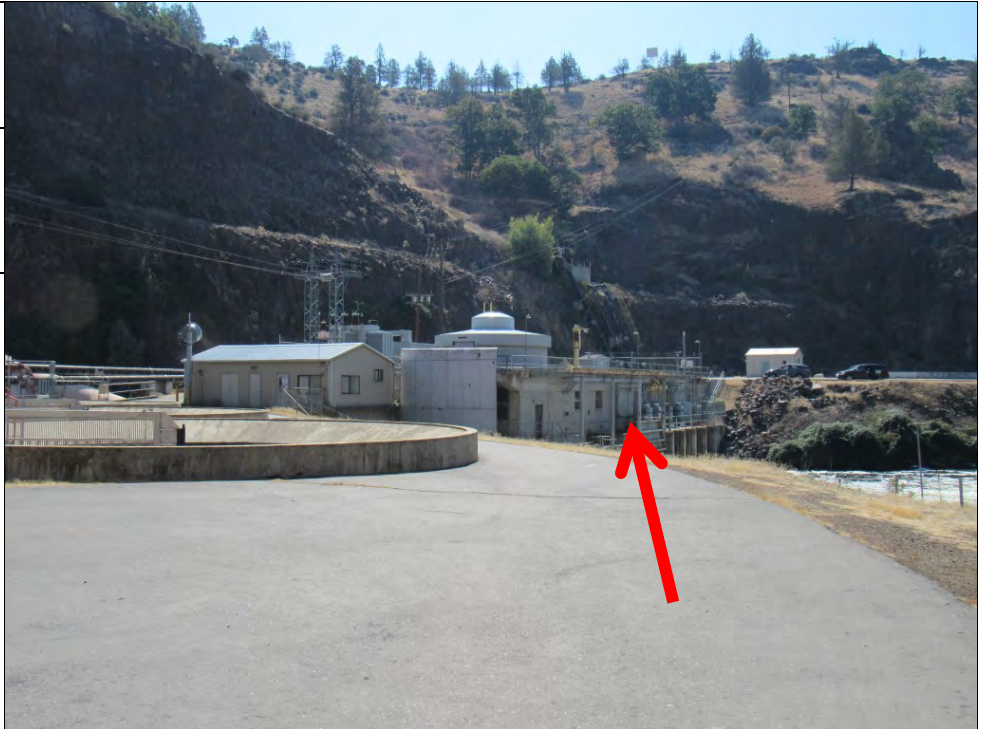
IGDPH - 01

1: Gray brittle window putty (M)

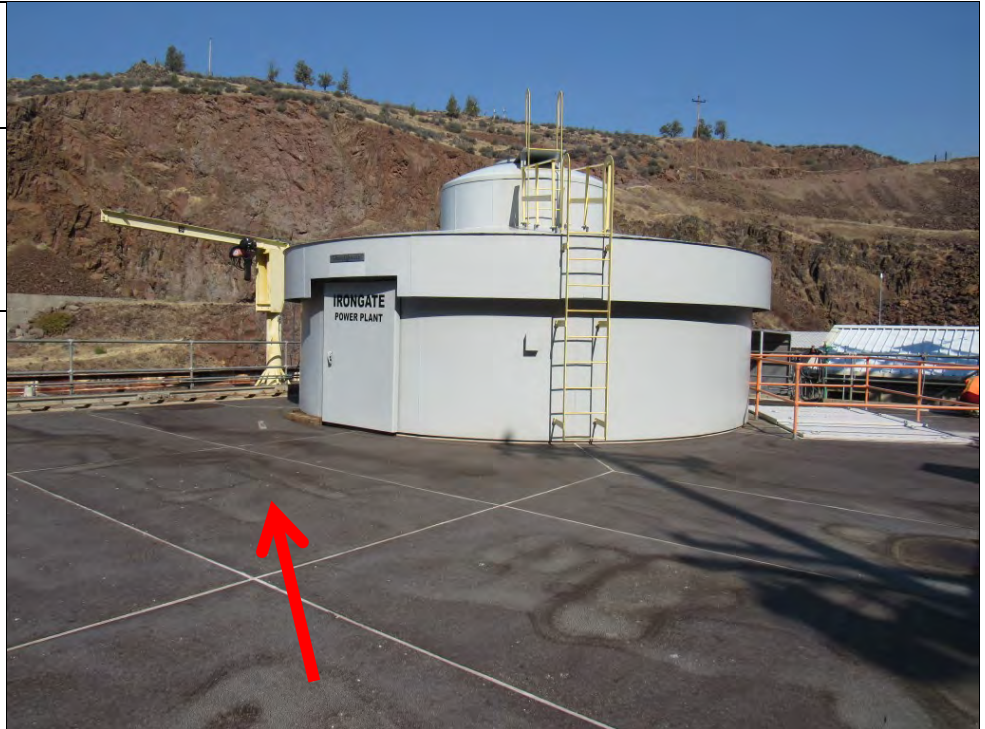
1: Brown epoxy coating (M)

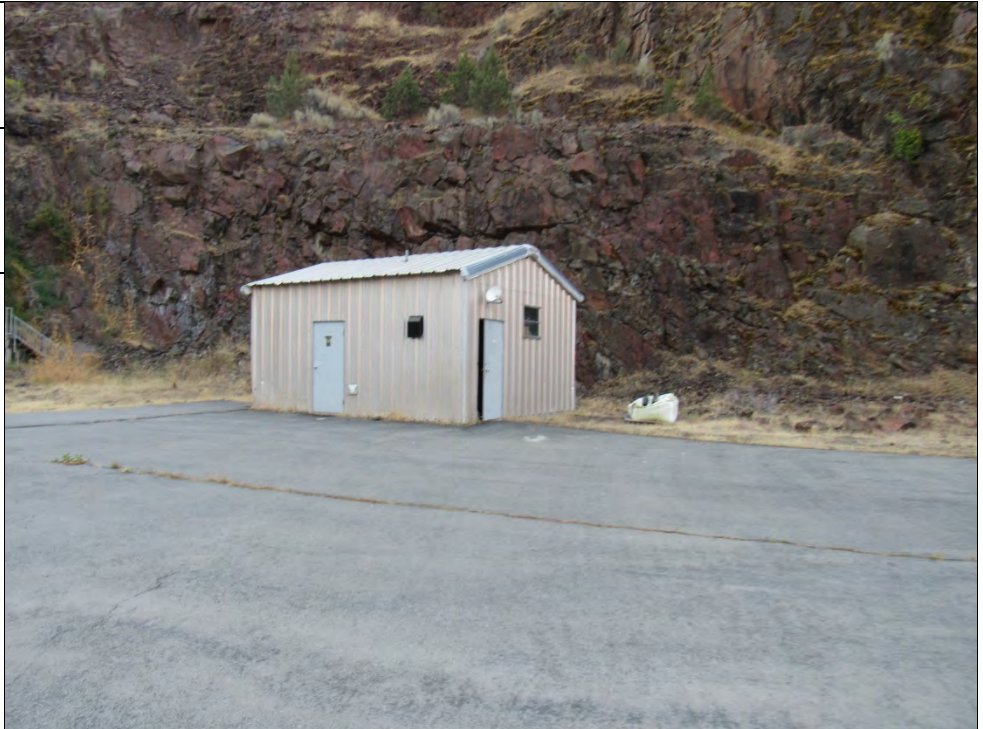
IGDRR - 01

Structure/Material Location:Iron Gate Dam Restrooms/
Shower base interior of restroom***Description (by layer):**

1: White brittle terrazzo (M)
