APPENDIX A FIGURES

JC Boyle Dam
 Keno, OR

APPENDIX B HSA PHOTOLOGS

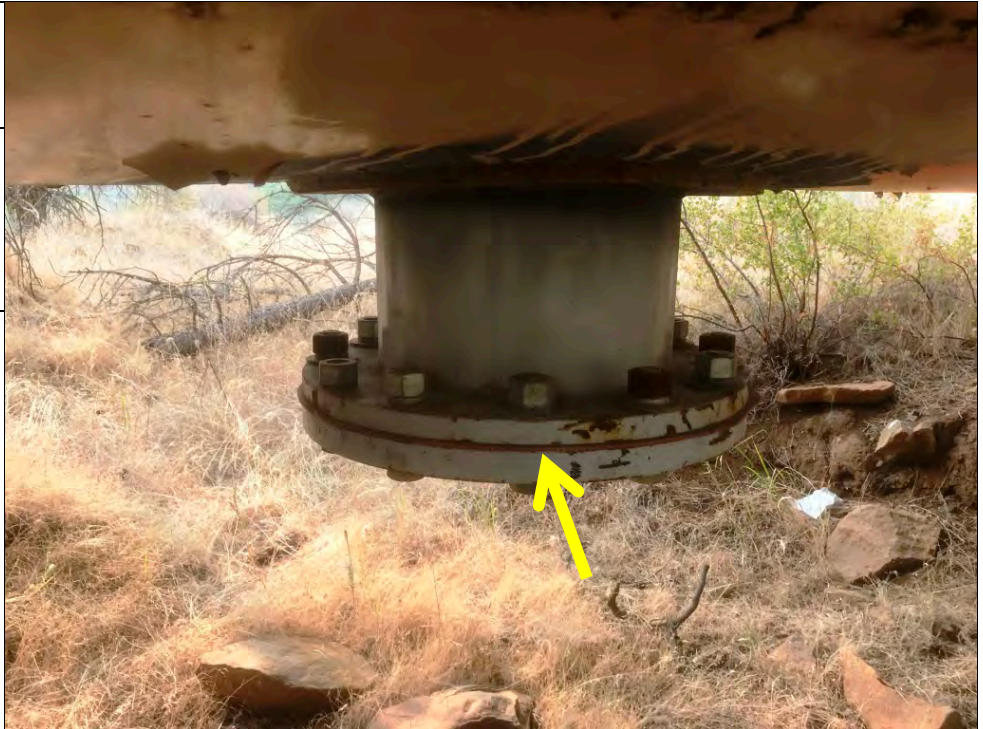
JCCH - 03

Date:8/20/2018 to
8/23/2018**Structure/Material Location:**JC Boyle Dam Canal Headgate
and 14' Pipeline/ 14' diversion
pipeline***Description (by layer):**

1: Silver paint (M)

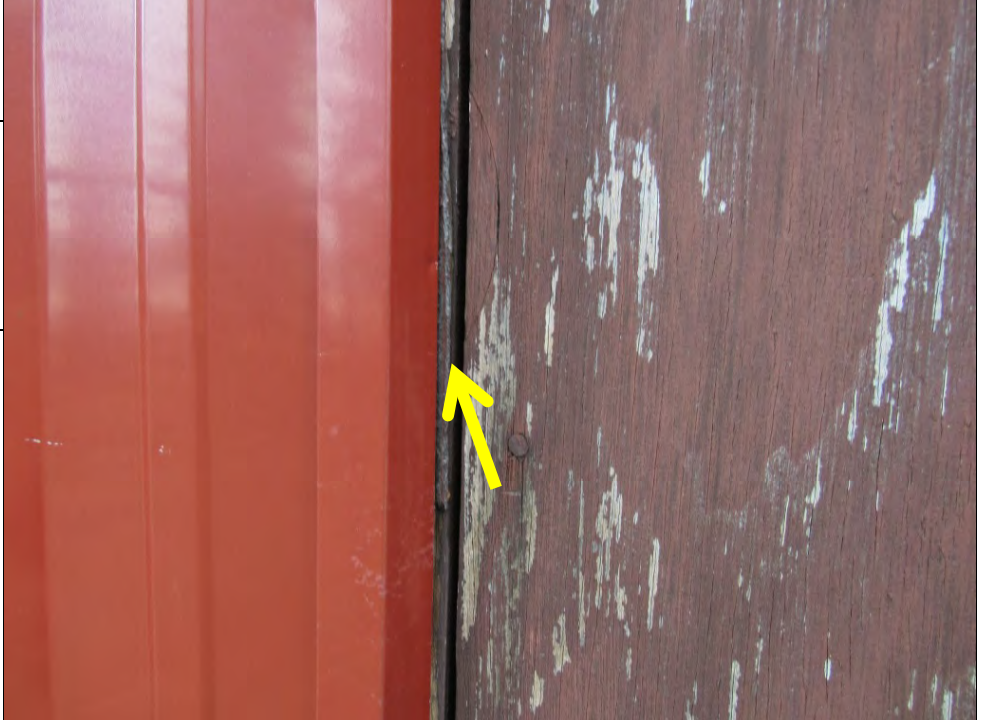
<p>Photo No./ Material ID:</p> <p>JCPH - 02</p>	<p>Date:</p> <p>8/20/2018 to 8/23/2018</p>

<p>Structure/Material Location:</p> <p>JC Boyle Dam Groundwater Pumphouse/ Underneath corrugated metal siding, throughout exterior</p>		
<p>*Description (by layer):</p> <p>1: Black asphaltic vapor barrier paper (M)</p>

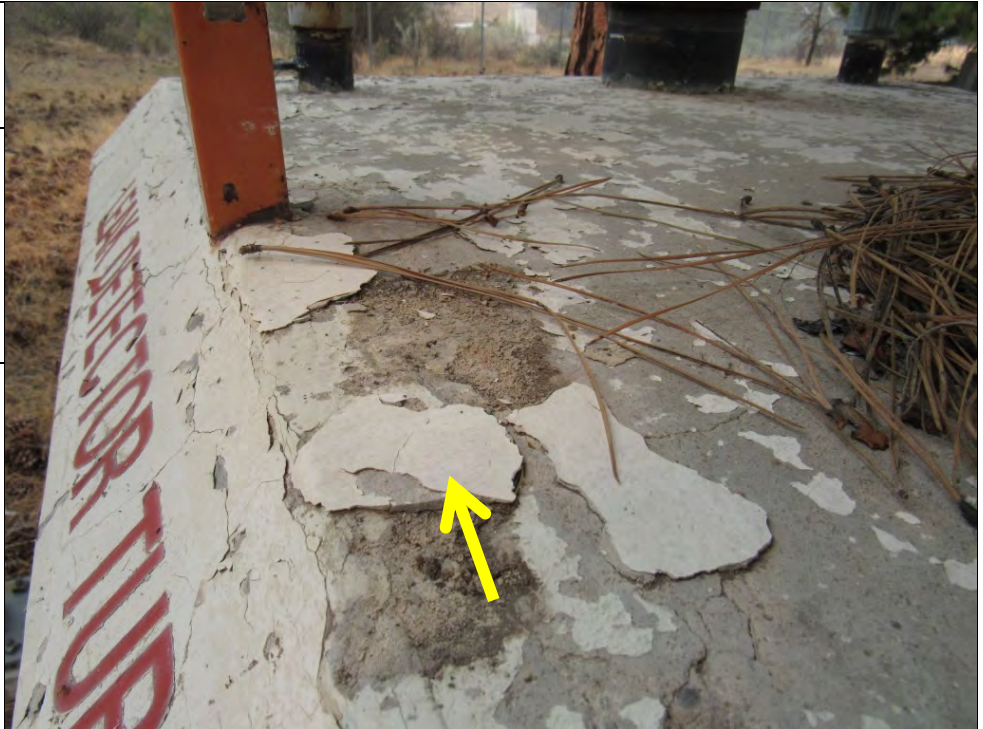
JCHM - 03

1: Off-white caulking (M)

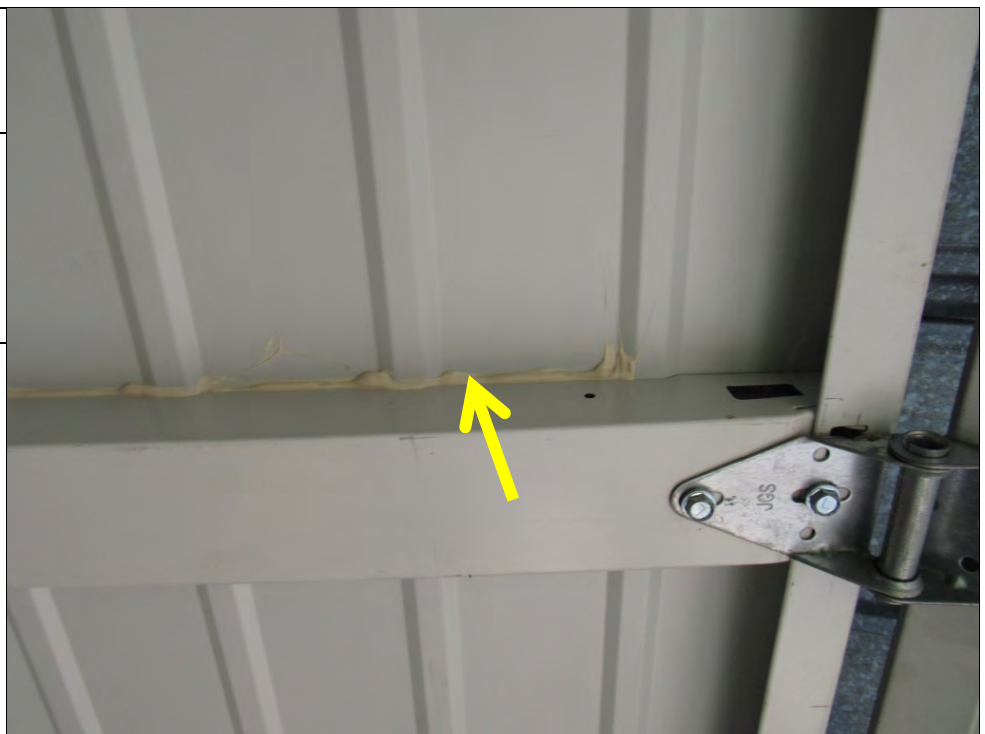
1: White caulking (M)

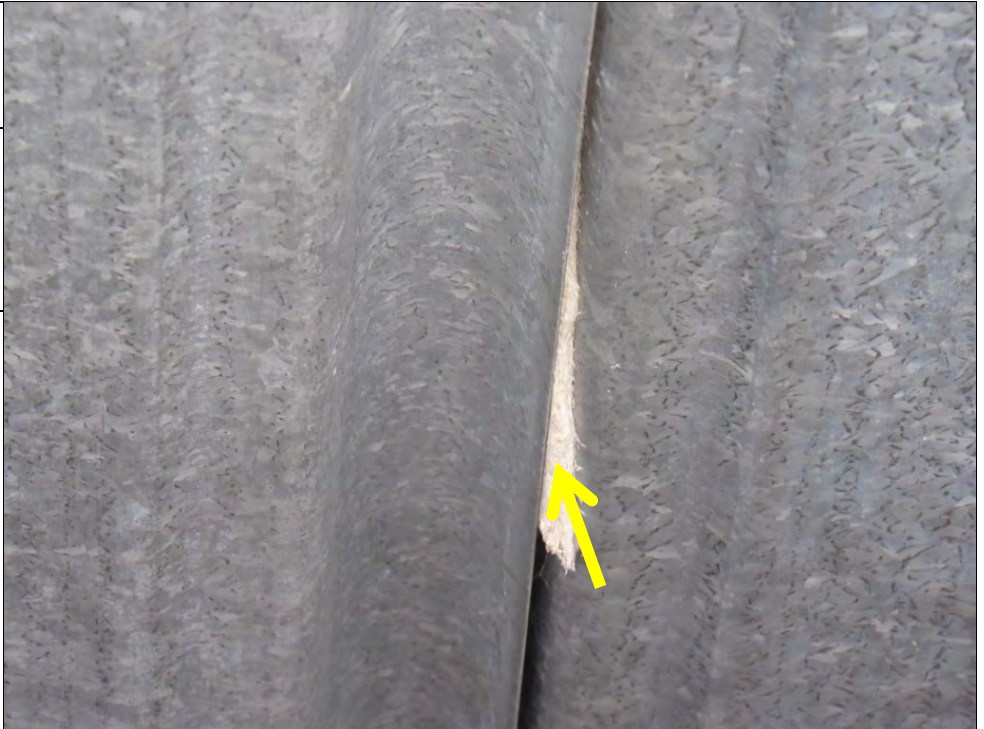
Photo No./ Material ID: JCHM - 06	Date: 8/20/2018 to 8/23/2018
Structure/Material Location: JC Boyle Dam HazMat Shed and Above Ground Storage Tanks/ Around exterior vents	
*Description (by layer): 1: Off-white sealant (M)

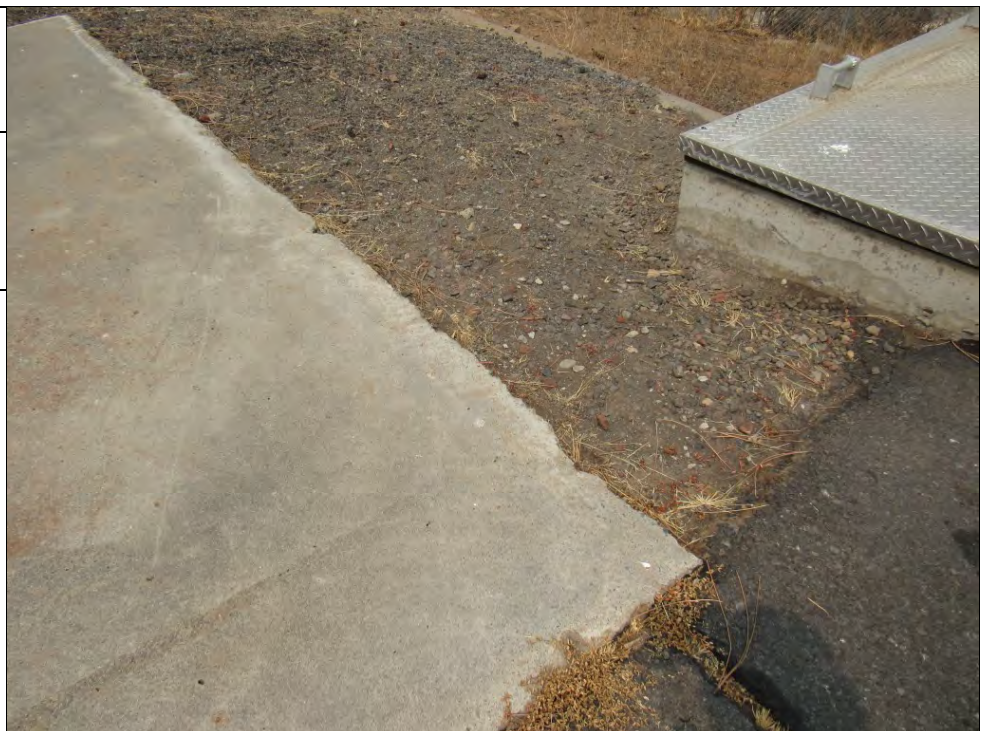
1: Concrete pad (M)

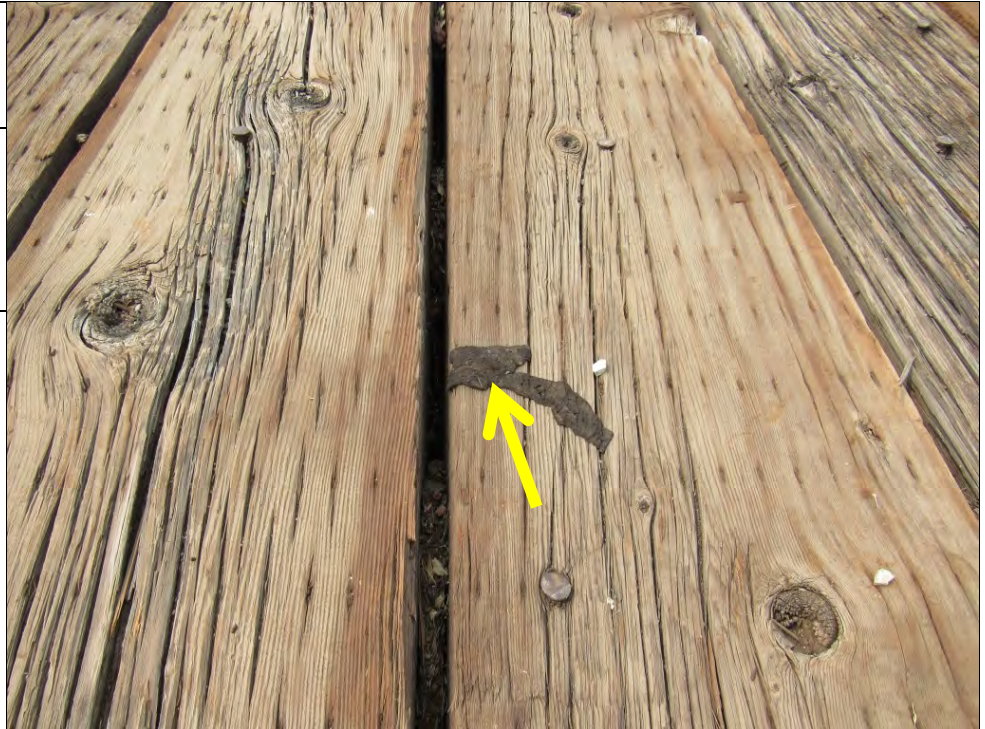
Photo No./ Material ID: JCIS - 04	Date: 8/20/2018 to 8/23/2018
Structure/Material Location: JC Boyle Dam Intake Structure/ On wood bridge to intake structure	
*Description (by layer): 1: Asphaltic creosote (M)

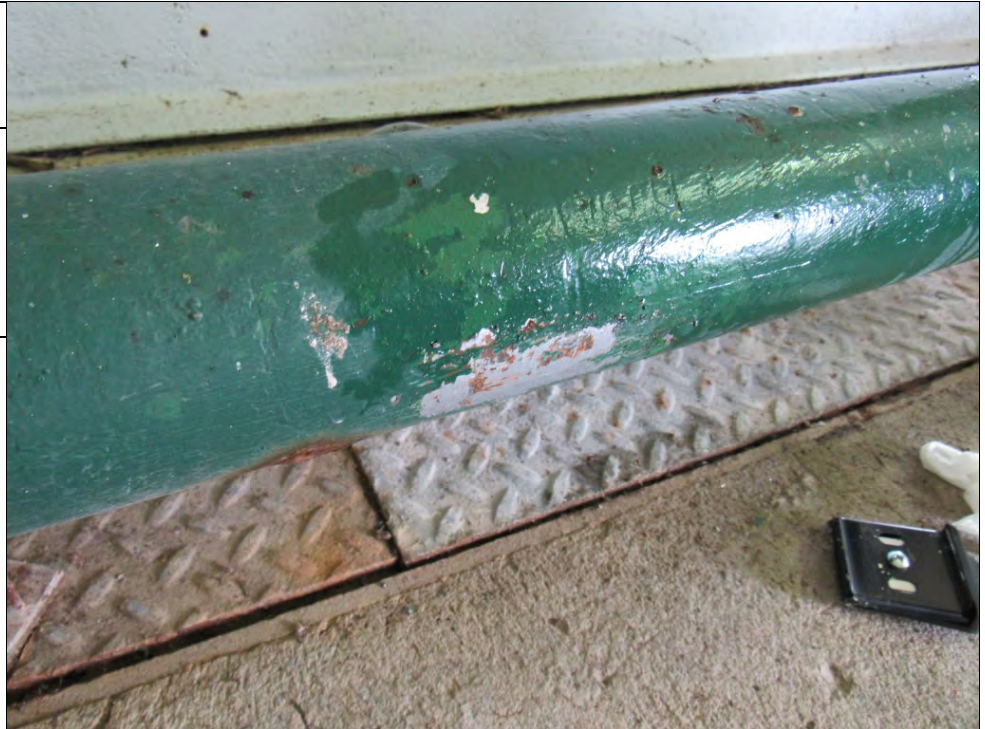
Photo No./ Material ID: JCIS - 06	Date: 8/20/2018 to 8/23/2018
Structure/Material Location: JC Boyle Dam Intake Structure/ Piping connecting traveling water screens inside Fish Screen Building	
*Description (by layer): 1: Thick silver paint (M) 2: Paint on piping (M)

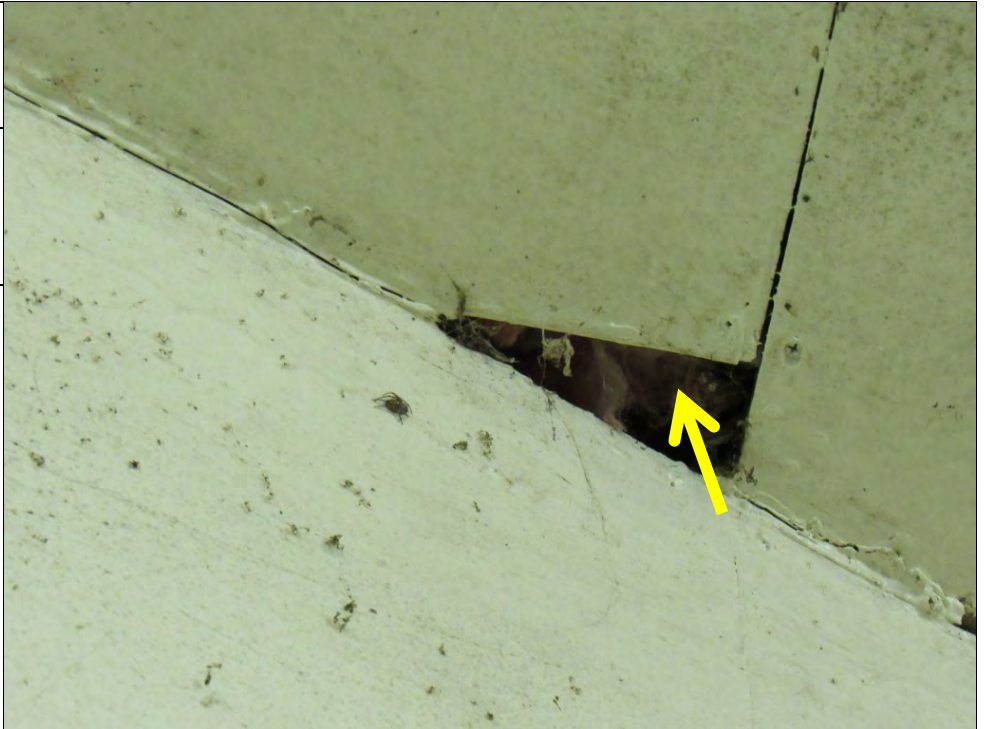
Photo No./ Material ID: JCIS - 08	Date: 8/20/2018 to 8/23/2018
Structure/Material Location: JC Boyle Dam Intake Structure/ Around exterior vents	
*Description (by layer): 1: Black asphaltic mastic and paper (M) 2: Fiberglass batt insulation (T) 3: Off-white paint (M)

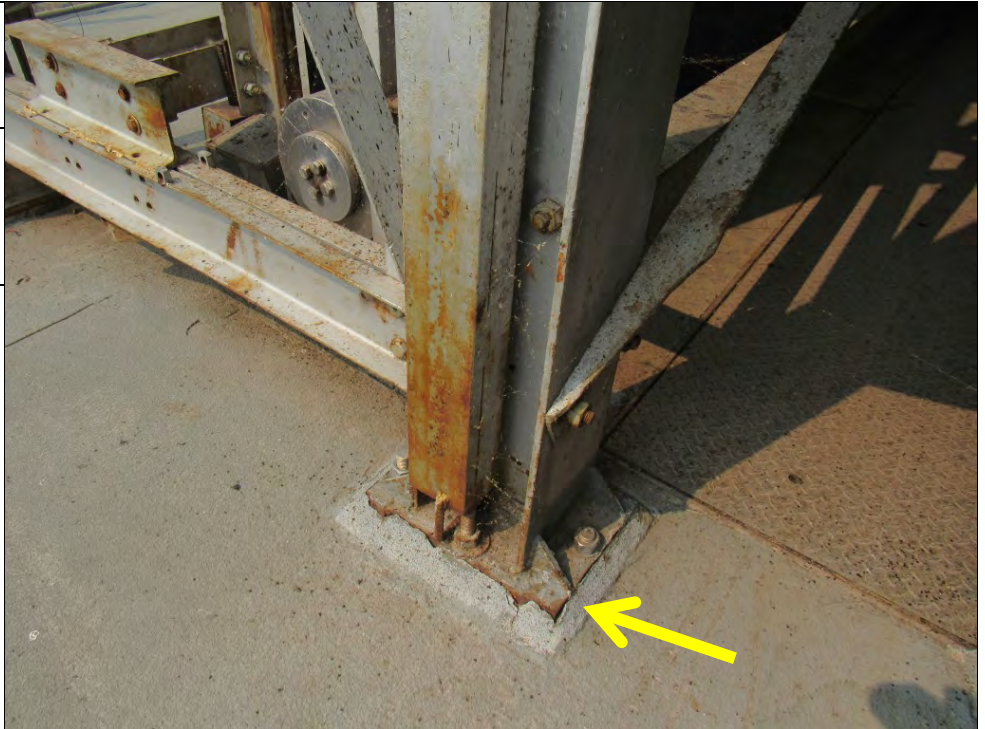
Photo No./ Material ID:	Date:
JCIS - 10	8/20/2018 to 8/23/2018
Structure/Material Location:	
JC Boyle Dam Intake Structure/ Structure around stop logs	
*Description (by layer):	
1: Concrete stop log gate structural bed (M)

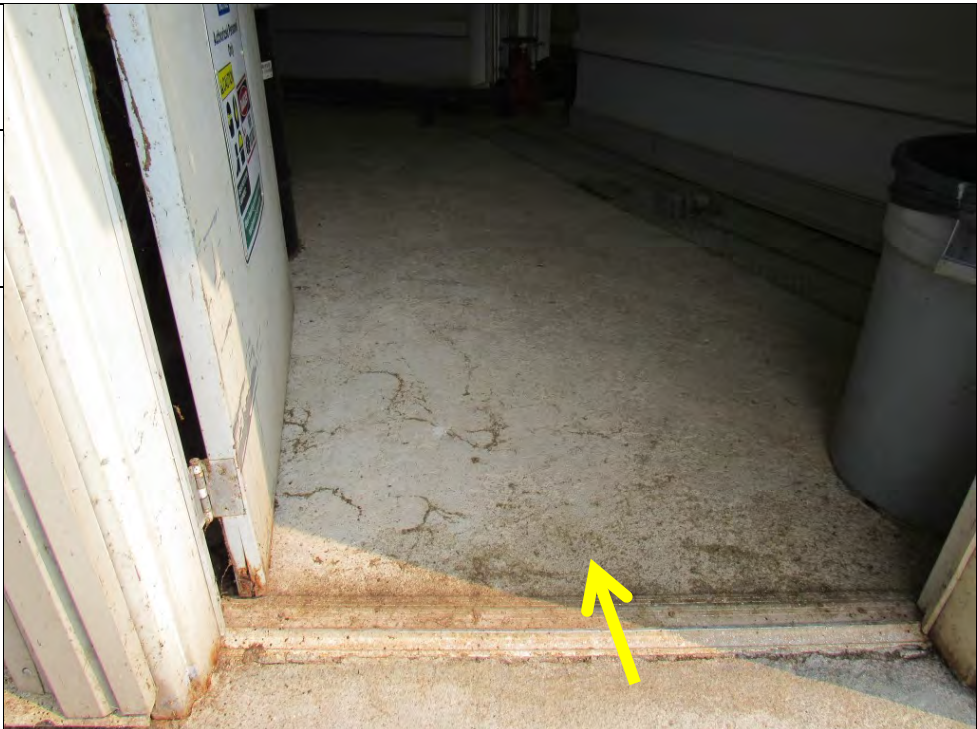
Photo No./ Material ID: JCIS - 12	Date: 8/20/2018 to 8/23/2018

Structure/Material Location: JC Boyle Dam Intake Structure/ Around exterior vents		
*Description (by layer): 1: Light weight concrete coating (M) 2: Light weight concrete coating (M)

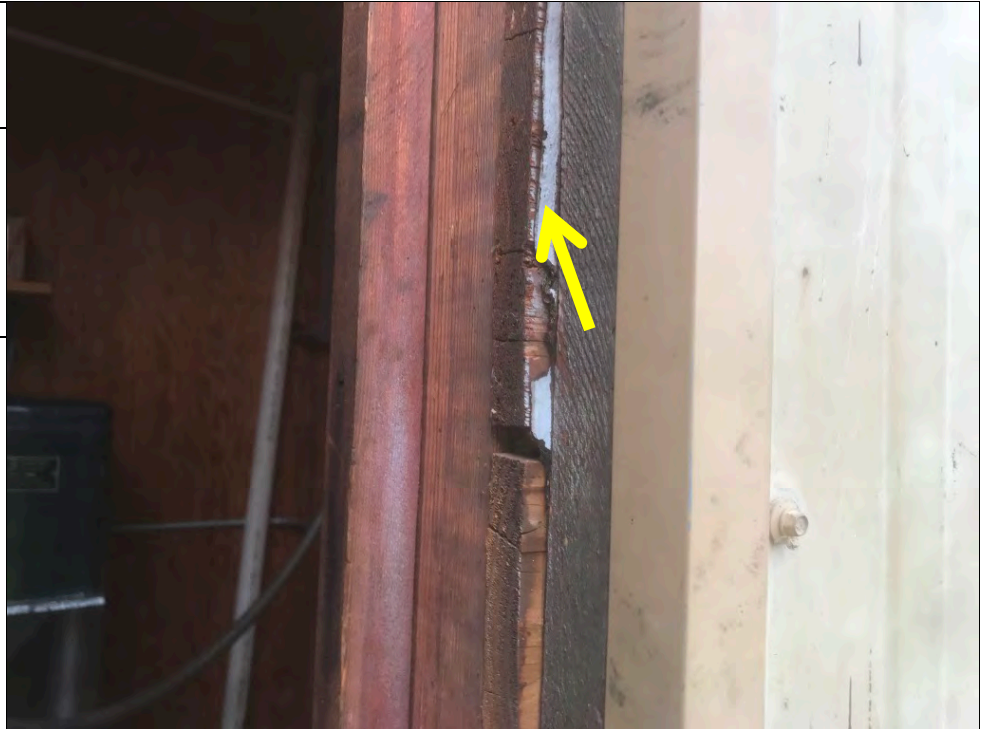
1: Black asphaltic vapor barrier
paper (M)

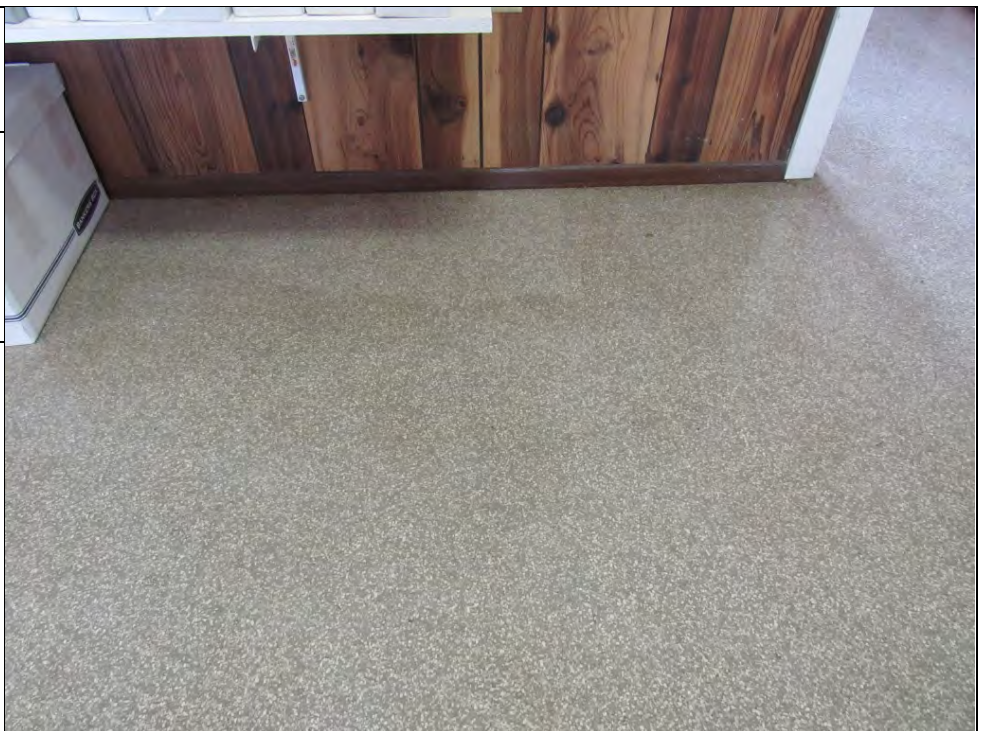
- 1: Gray vinyl floor sheeting with
light gray pebble pattern (M)
- 2: Gray paper backing with
mastic (M)

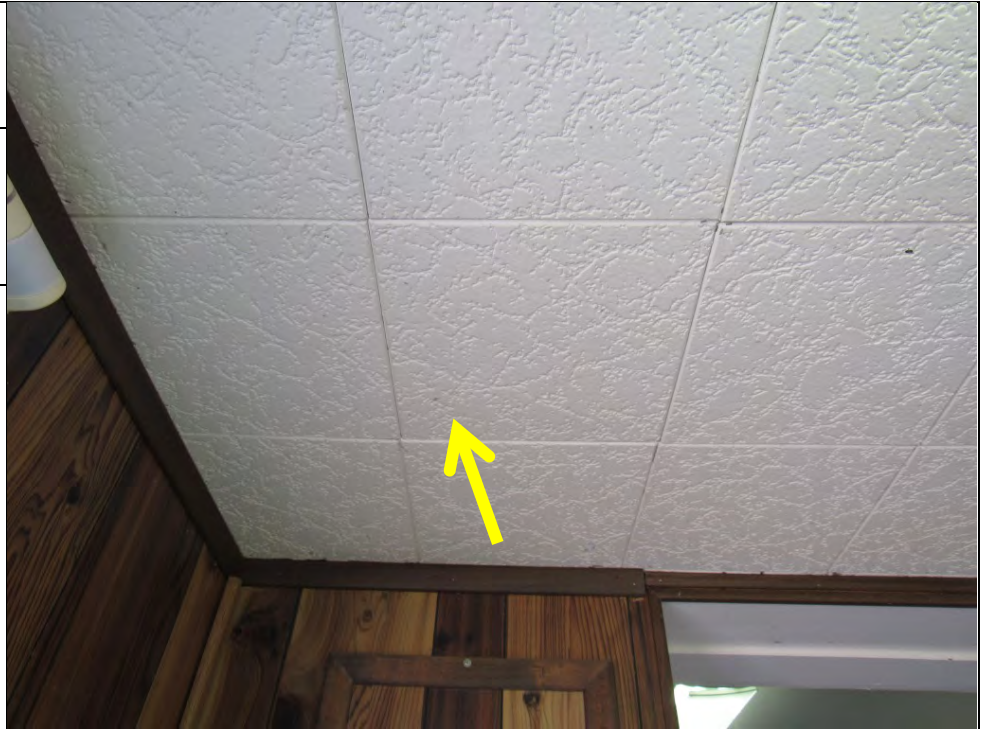
JCOW - 02

Date:8/20/2018 to
8/23/2018**Structure/Material Location:**JC Boyle Dam Office and
Warehouse/ Ceiling in entry way***Description (by layer):**1: 12"x12" white tongue and
groove nailed-on ceiling tiles
with fissure pattern (M)

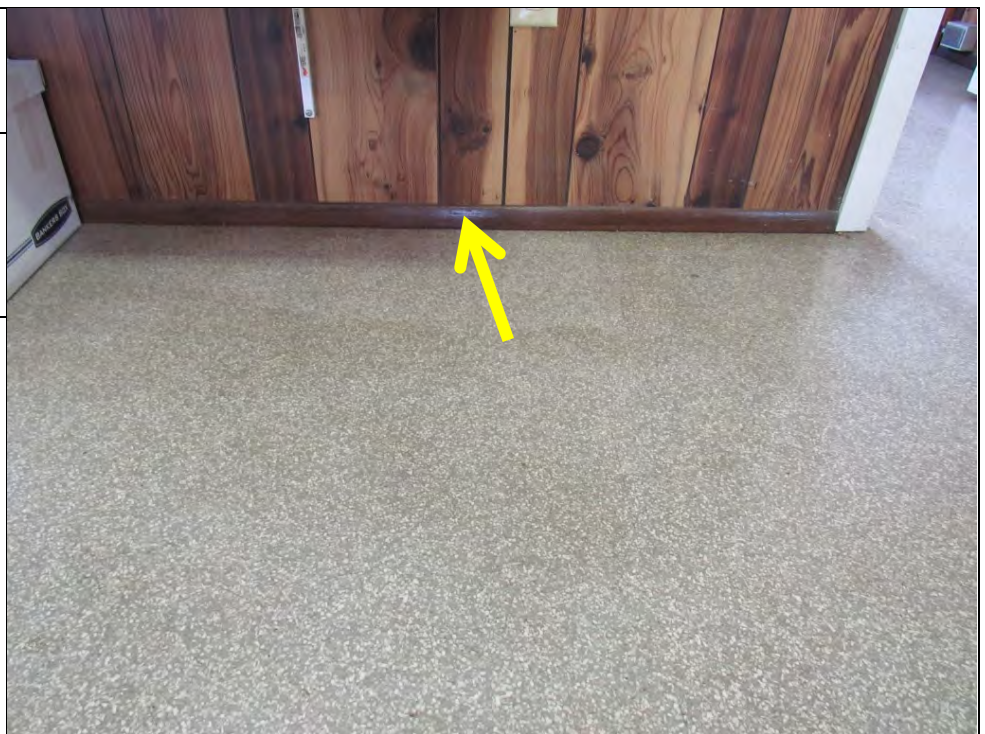
JCOW - 03

Date:8/20/2018 to
8/23/2018**Structure/Material Location:**JC Boyle Dam Office and
Warehouse/ Walls throughout
office main floor***Description (by layer):**1: 4" tan rubber cove base (M)
2: White mastic (M)

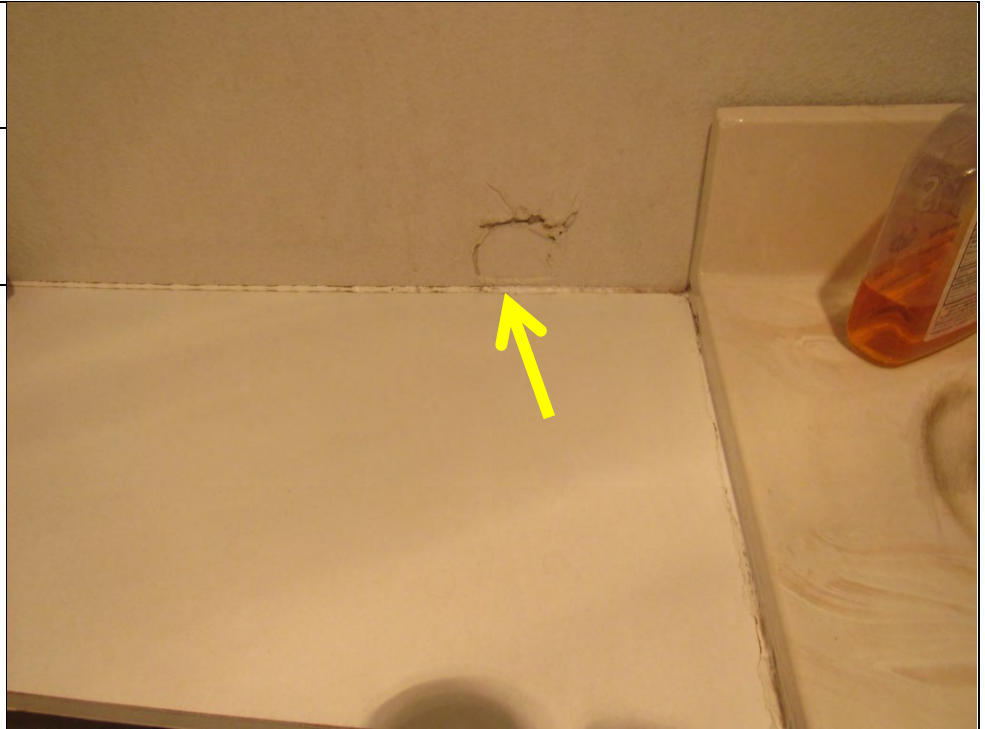
Date:8/20/2018 to
8/23/2018**Structure/Material Location:**JC Boyle Dam Office and
Warehouse/ Restroom counter***Description (by layer):**

1: White sink caulking (M)

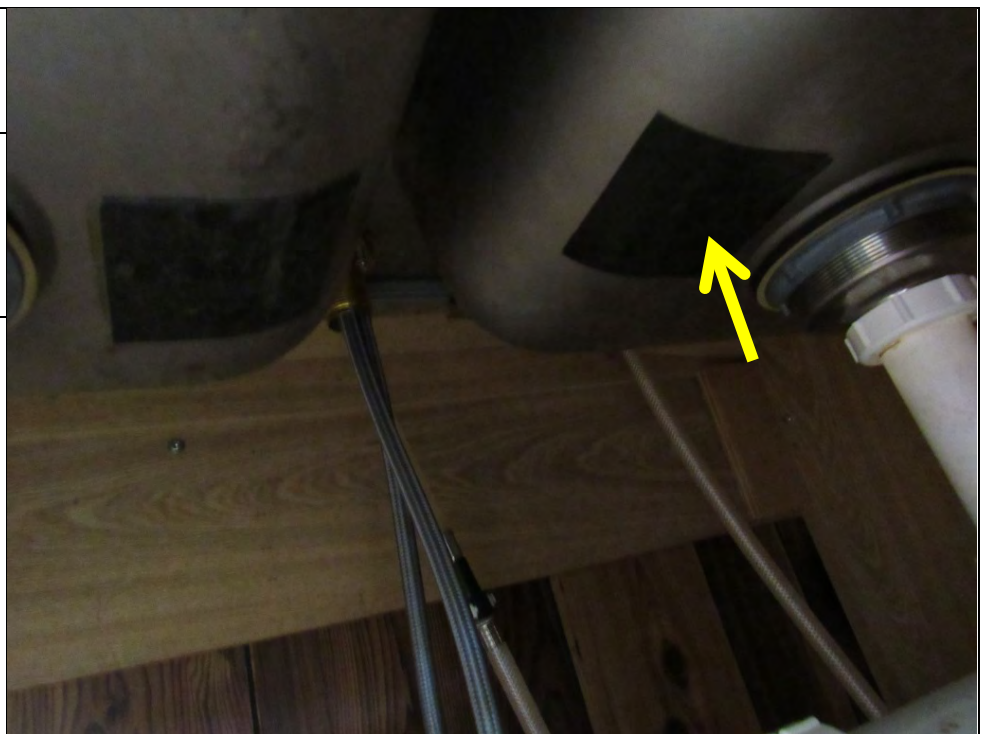
JCOW - 07

Date:8/20/2018 to
8/23/2018**Structure/Material Location:**JC Boyle Dam Office and
Warehouse/ Underneath
restroom counter***Description (by layer):**1: Black plastic sink patch (M)
2: Yellow mastic (M)

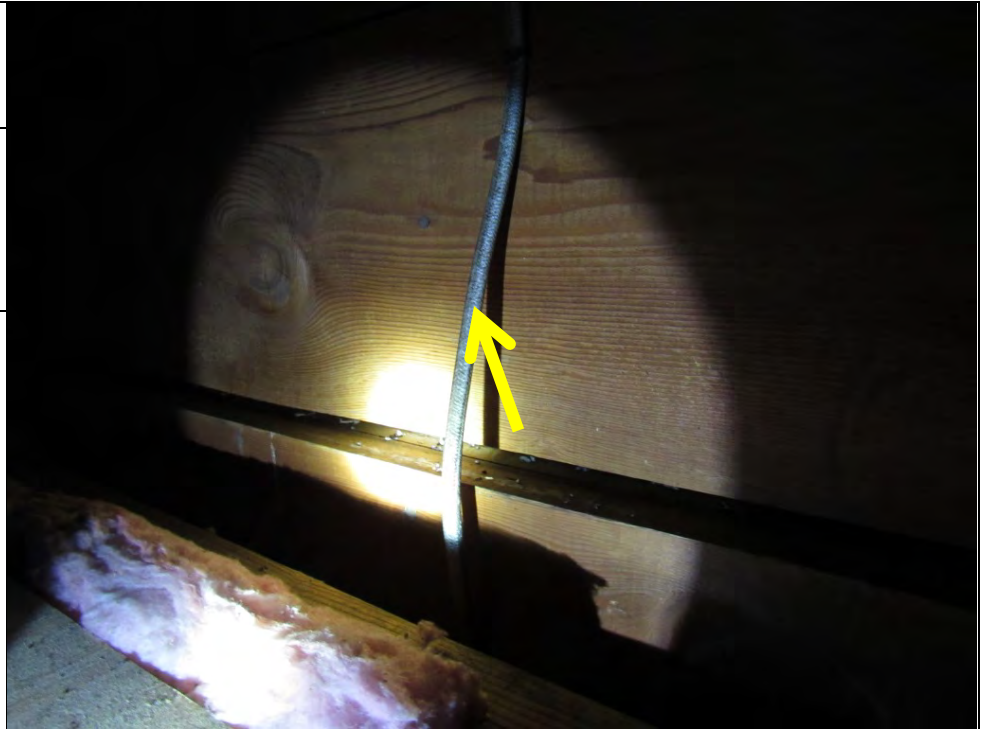
Photo No./ Material ID: JCOW - 08	Date: 8/20/2018 to 8/23/2018
Structure/Material Location: JC Boyle Dam Office and Warehouse/ Throughout Office and Warehouse	
*Description (by layer): Assumed asbestos-containing silver woven electrical wire insulation (M)

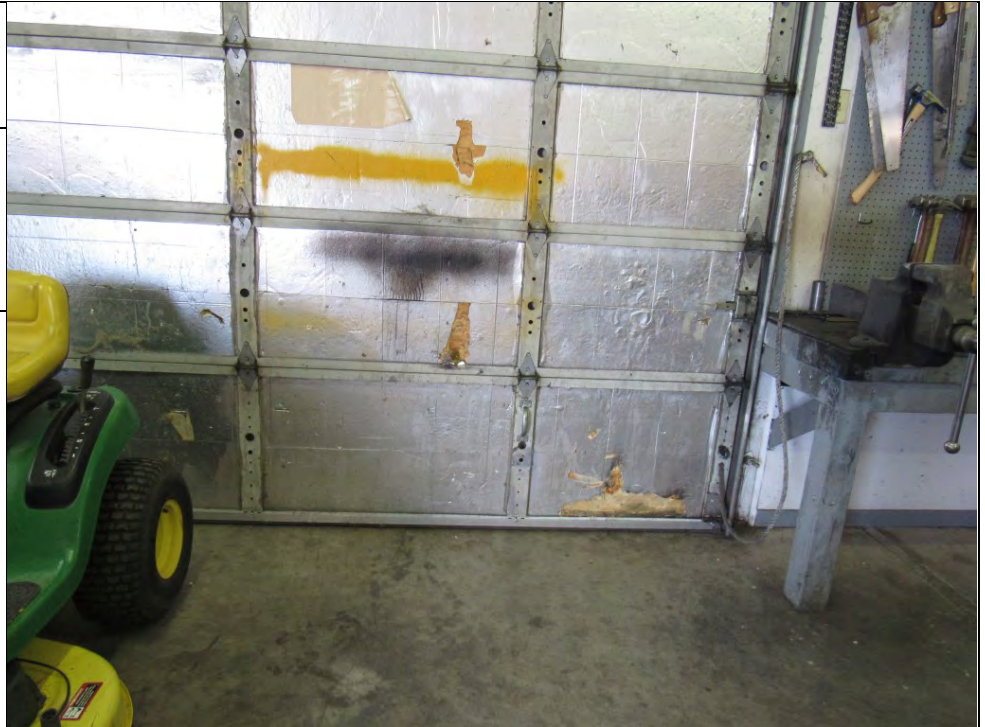
Photo No./ Material ID: JCOW - 10	Date: 8/20/2018 to 8/23/2018
Structure/Material Location: JC Boyle Dam Office and Warehouse/ Insulation inside two roll-up doors in Warehouse	
*Description (by layer): 1: Yellow mastic with foam and foil backing (M) 2: Off-white foam material (M)

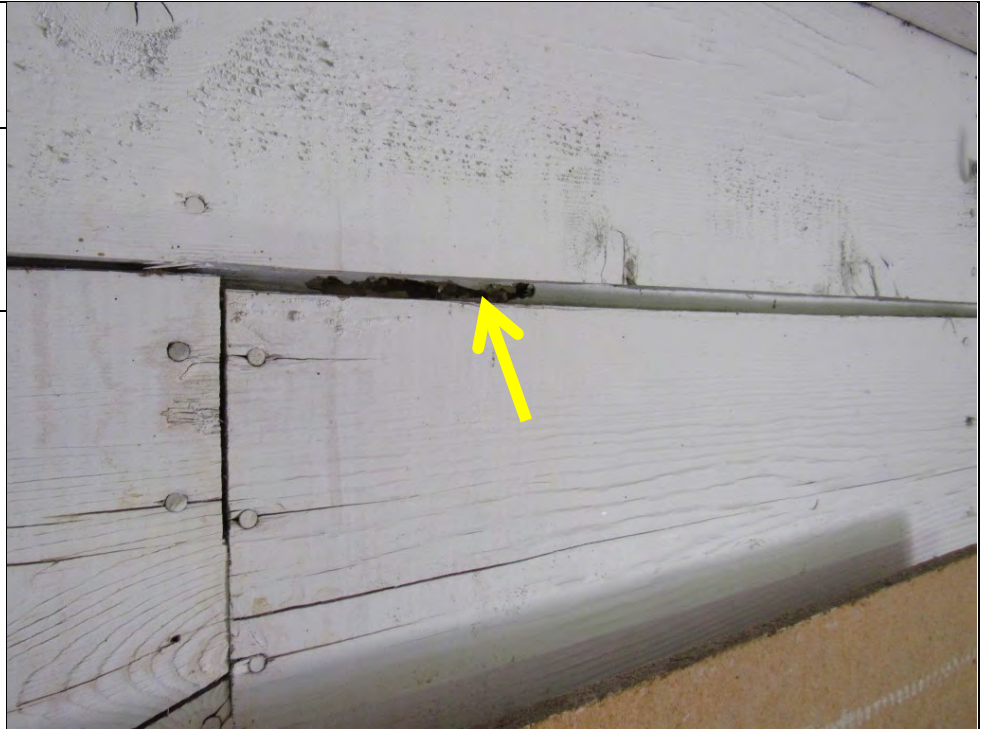
Photo No./ Material ID: JCOW - 12	Date: 8/20/2018 to 8/23/2018
Structure/Material Location: JC Boyle Dam Office and Warehouse/ Behind wood wall, loft area of Warehouse	
*Description (by layer): 1: Black asphaltic mastic with paper (M) 2: Yellow fiberglass batt insulation (T)

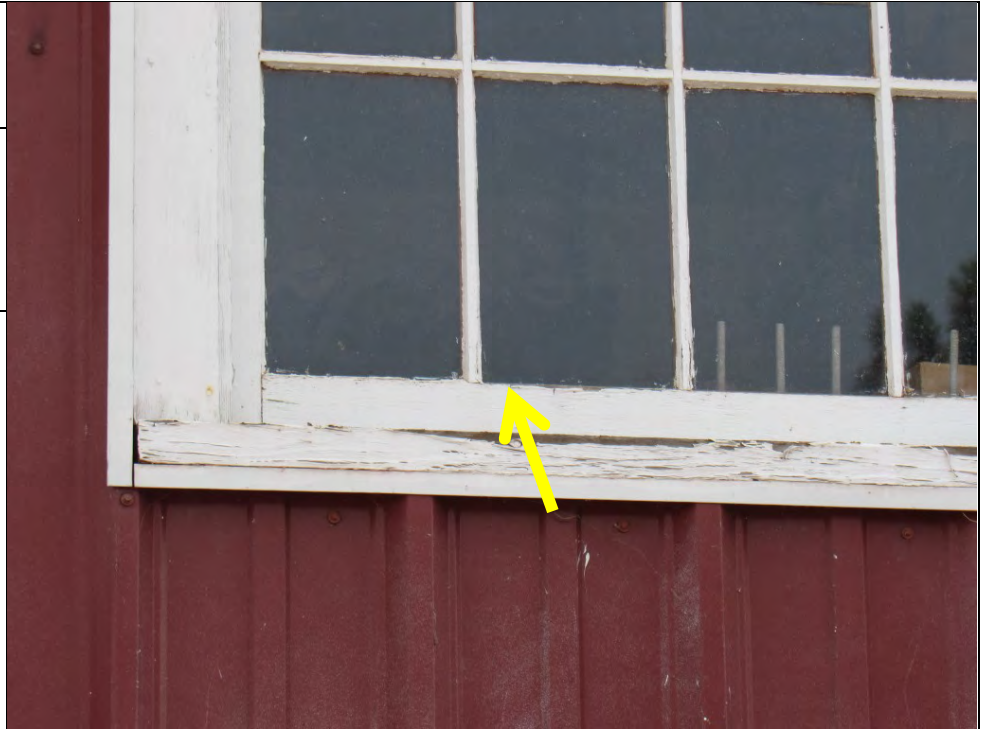
1: White brittle window putty (M)

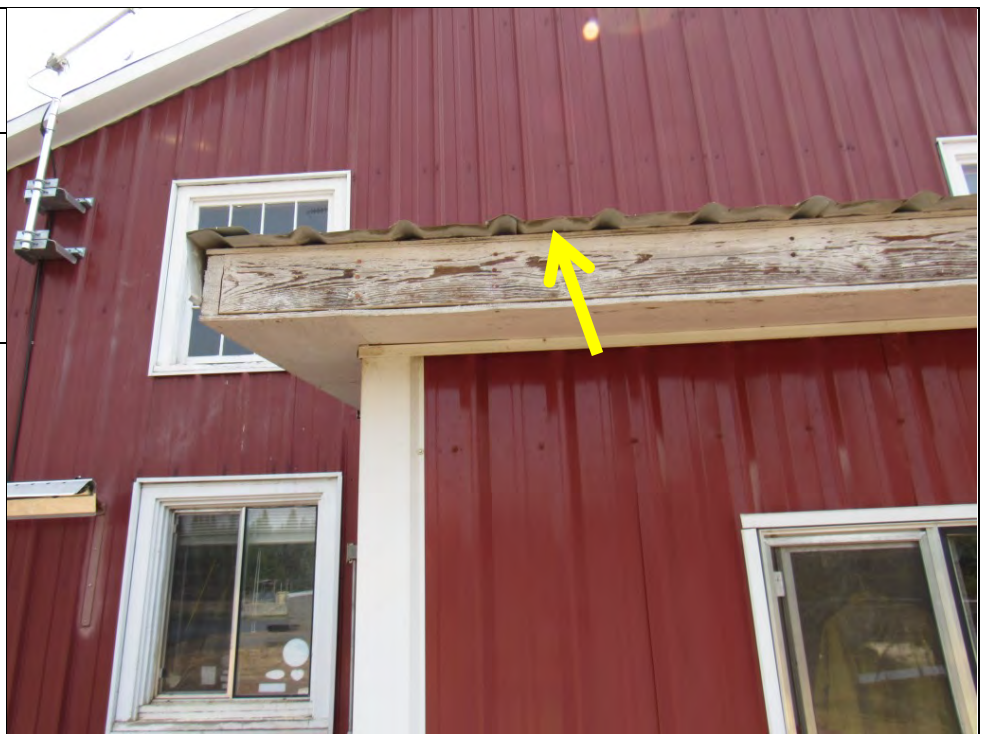
1: Black asphaltic roofing paper
(M)

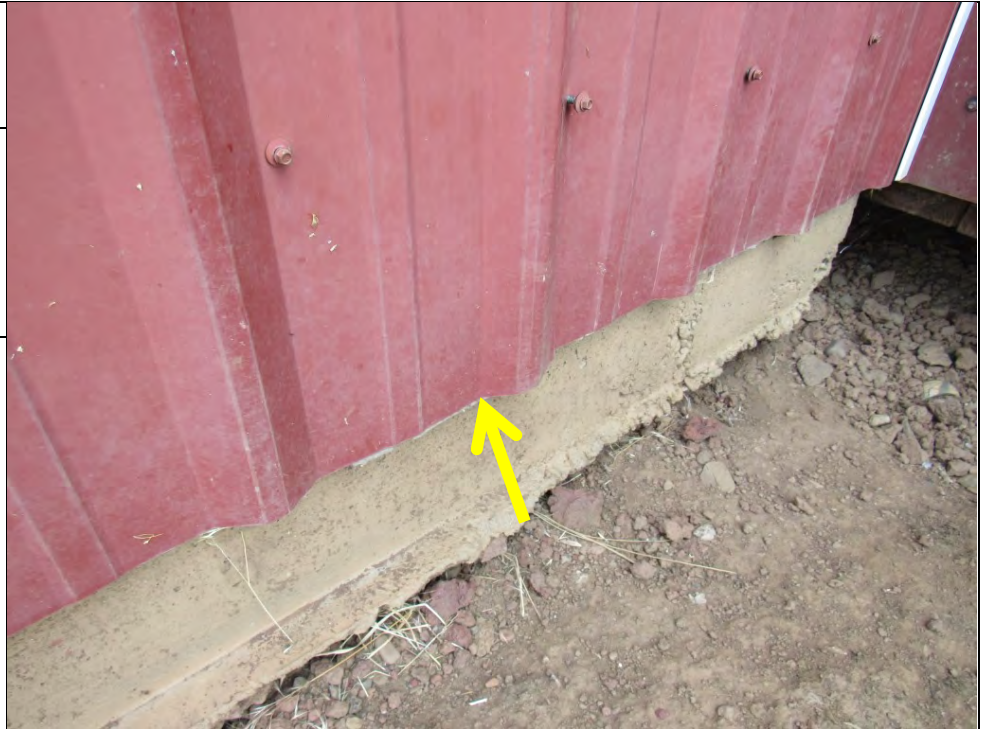
Photo No./ Material ID: JCOW - 16	Date: 8/20/2018 to 8/23/2018
Structure/Material Location: JC Boyle Dam Office and Warehouse/ Underneath corrugated metal siding of Office Warehouse shed	
*Description (by layer): 1: Brown asphaltic vapor barrier paper (M)

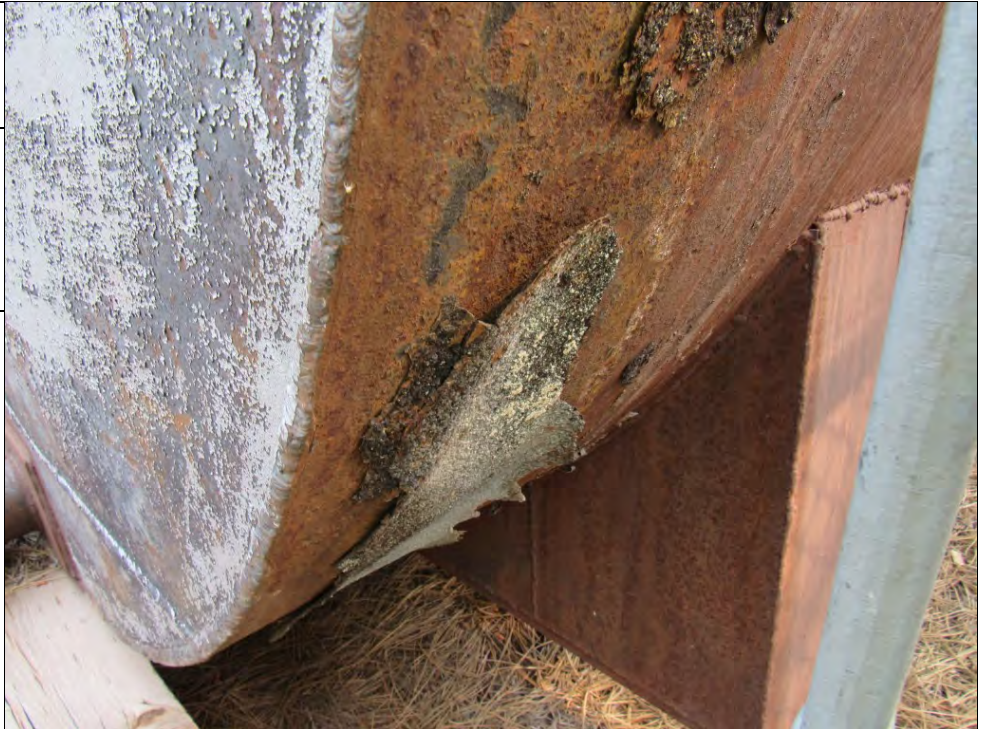
Photo No./ Material ID:	Date:
JCBY - 02	9/17/2018
Structure/Material Location: JC Boyle Dam Outdoor Storage Area/ Out of service storage tank in Outdoor Storage Area	
*Description (by layer): 1: Residual black asphaltic material with granules (M)

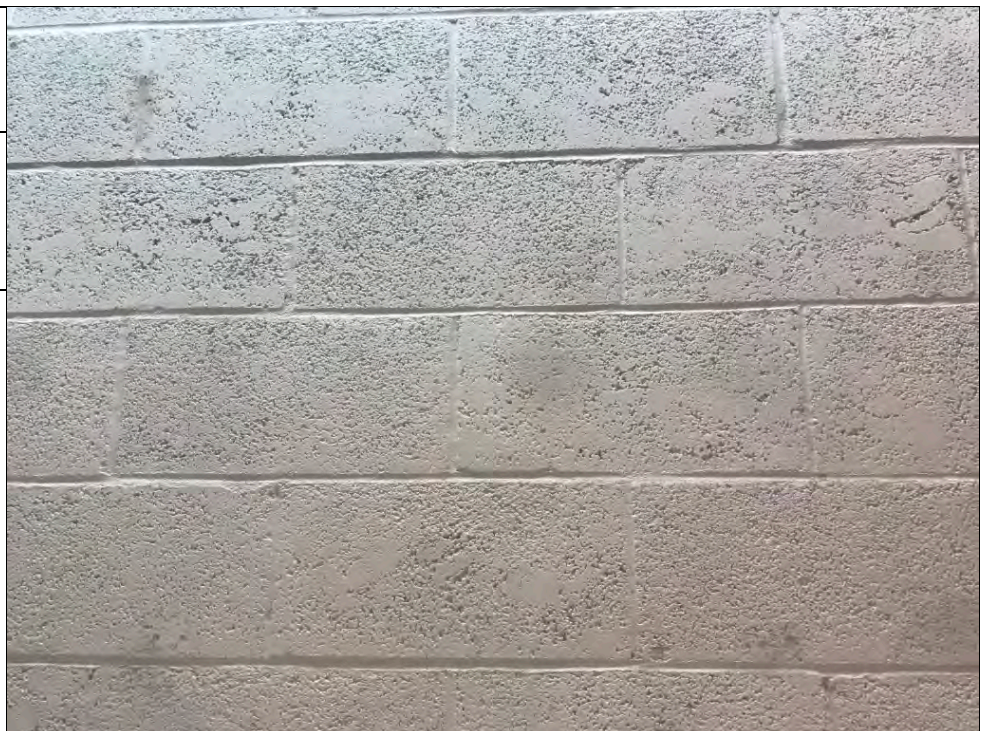
- 1: Grout associated with CMU
(M)
- 2: Grout associated with CMU
(M)

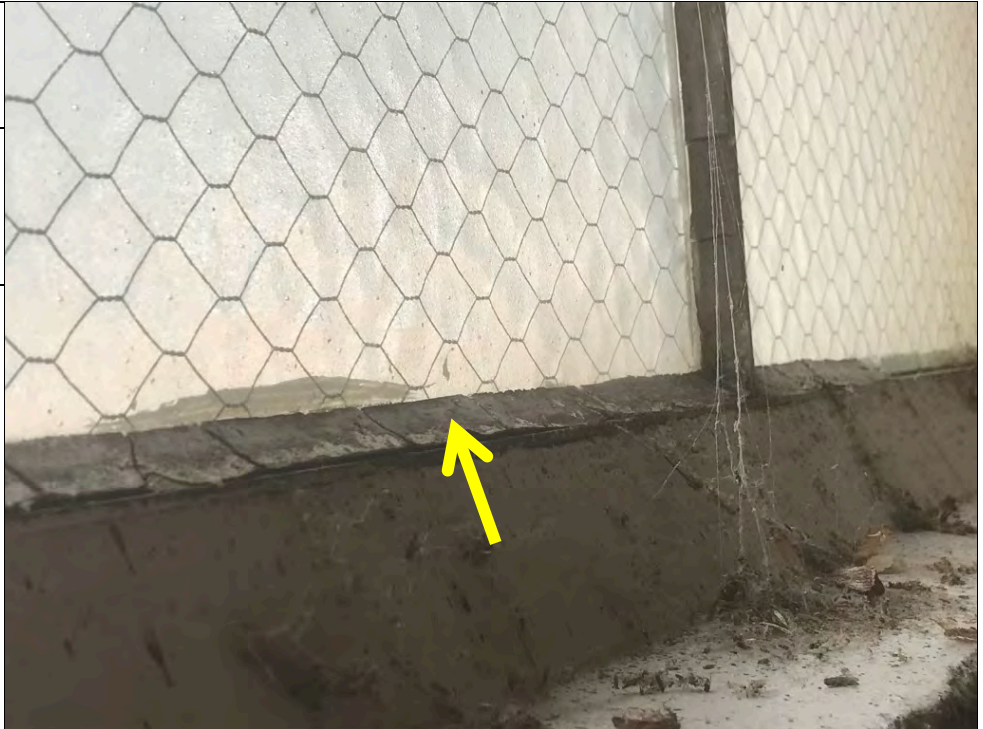
Photo No./ Material ID: JCPH - 02	Date: 8/20/2018 to 8/23/2018
Structure/Material Location: JC Boyle Dam Powerhouse/ Interior window panes	
*Description (by layer): 1: Gray window putty (M)

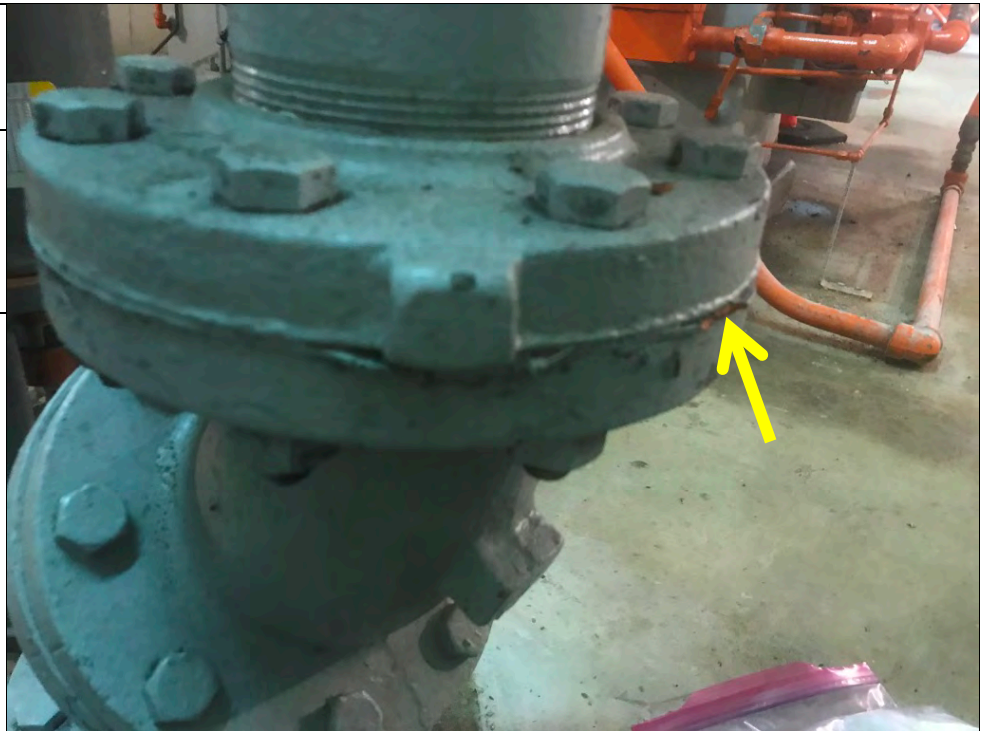
Photo No./ Material ID: JCPH - 04	Date: 8/20/2018 to 8/23/2018
Structure/Material Location: JC Boyle Dam Powerhouse/ Associated with generator piping, pumphouse lower level	
*Description (by layer): 1: Red gasket (M) 2: Black mastic (M)

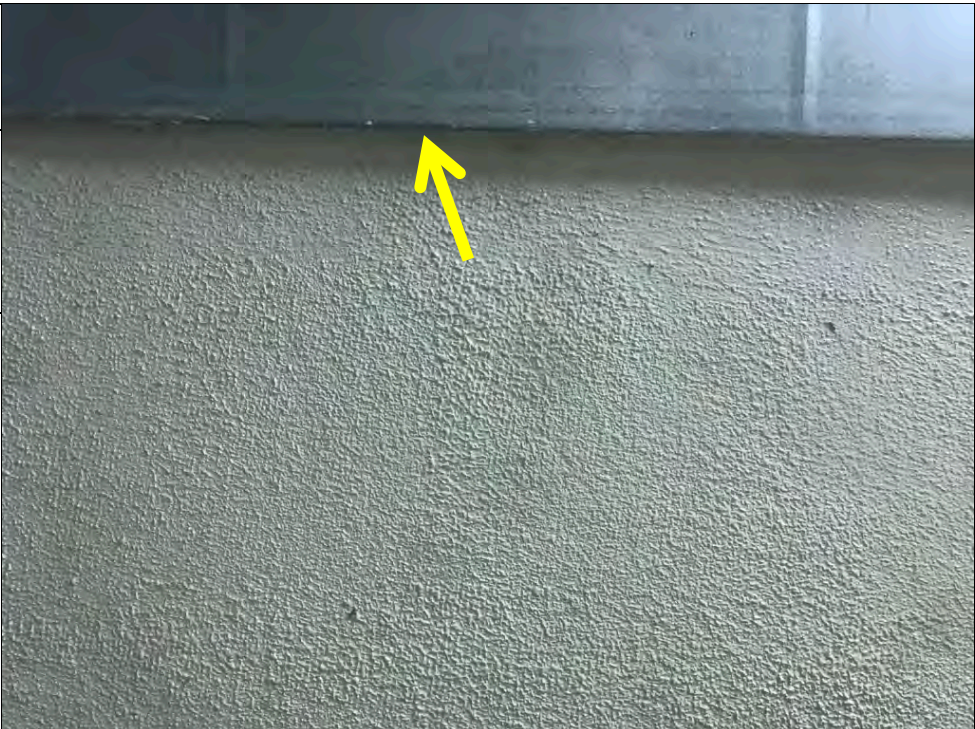
Photo No./ Material ID: JCPH - 06	Date: 8/20/2018 to 8/23/2018

Structure/Material Location: JC Boyle Dam Powerhouse/ Entry into switchgear room, associated with HVAC system		
*Description (by layer): 1: White spray-applied texture wall coating (S) 2: White gypsum wallboard with paper (M)

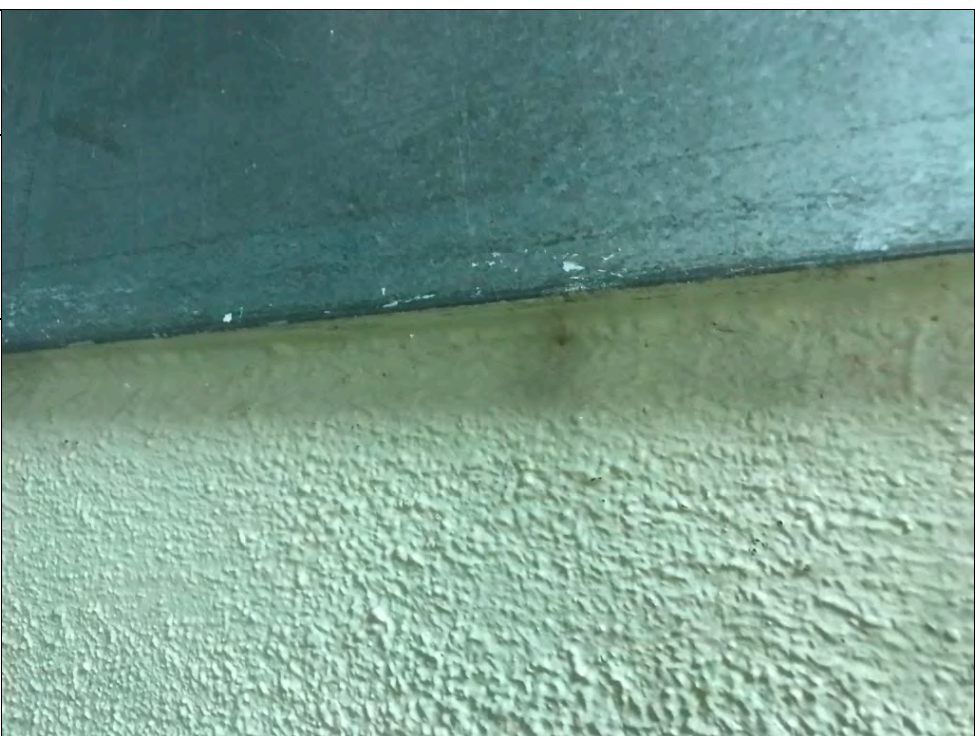
Photo No./ Material ID: JCPH - 07	Date: 8/20/2018 to 8/23/2018

Structure/Material Location: JC Boyle Dam Powerhouse/ Entry into switchgear room, associated with HVAC system		
*Description (by layer): 1: White sealant (M)

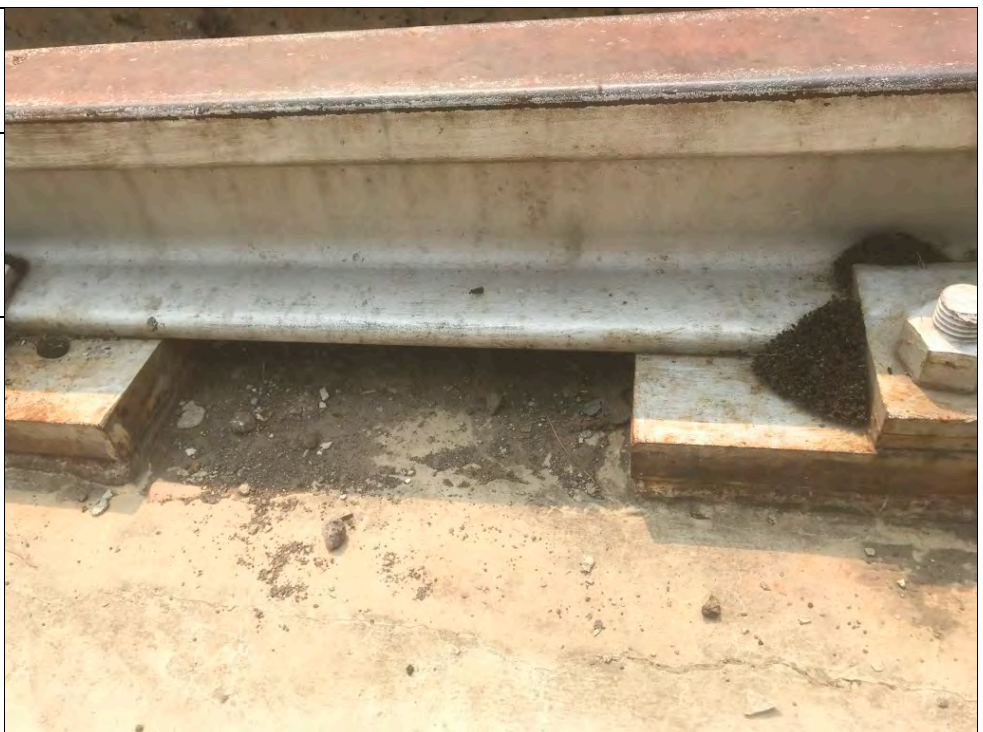
Photo No./ Material ID: JCPH - 13	Date: 8/20/2018 to 8/23/2018
Structure/Material Location: JC Boyle Dam Powerhouse/ At base of exterior metal walls, at wall/concrete interface	
*Description (by layer): 1: Black caulking (M)
