APPENDIX A FIGURES

JC Boyle Dam
 Keno, OR

APPENDIX B HSA PHOTOLOGS

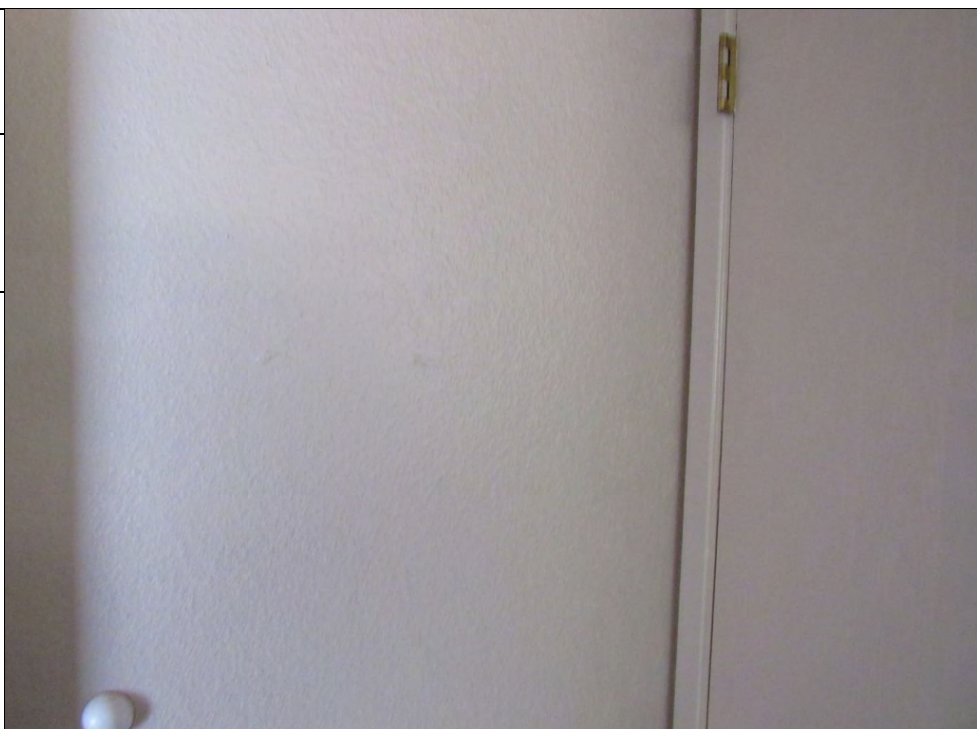
JCR1 - 01	8/20/2018 to 8/23/2018	
Structure/Material Location: JC Boyle Dam Residence 1/ Walls throughout Residence 1		
*Description (by layer): 1: White spray-applied texture wall coating (S) 2: White gypsum wallboard with paper (M)

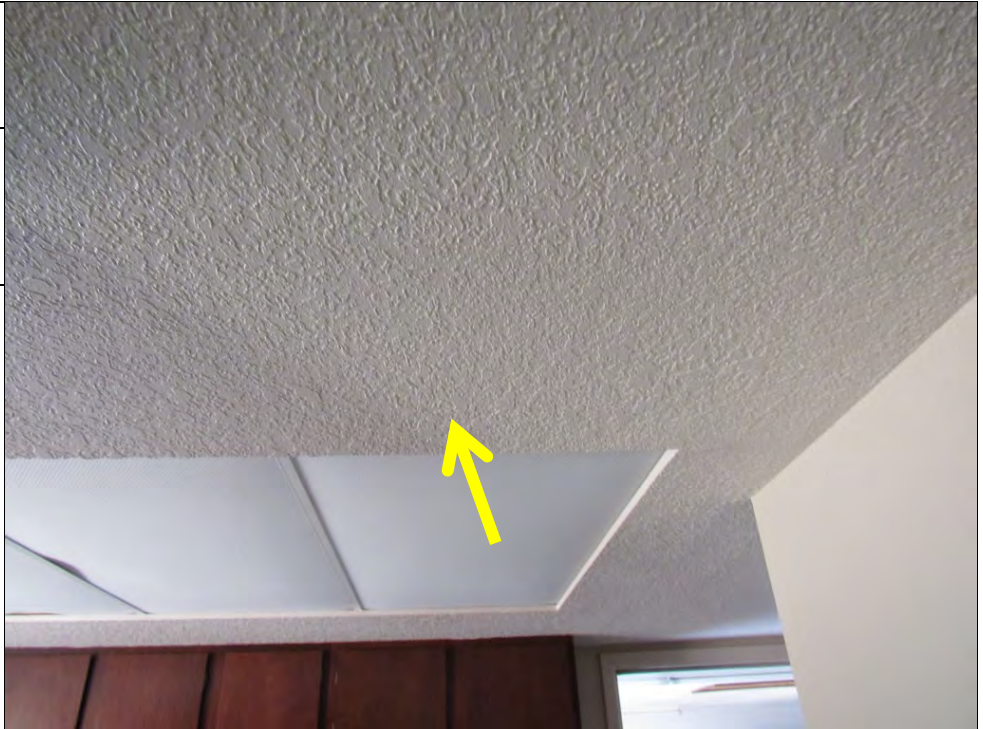
JCR1 - 02

Date:8/20/2018 to
8/23/2018**Structure/Material Location:**JC Boyle Dam Residence 1/
Ceilings throughout***Description (by layer):****1: White troweled-on surface
ceiling coat (S)**

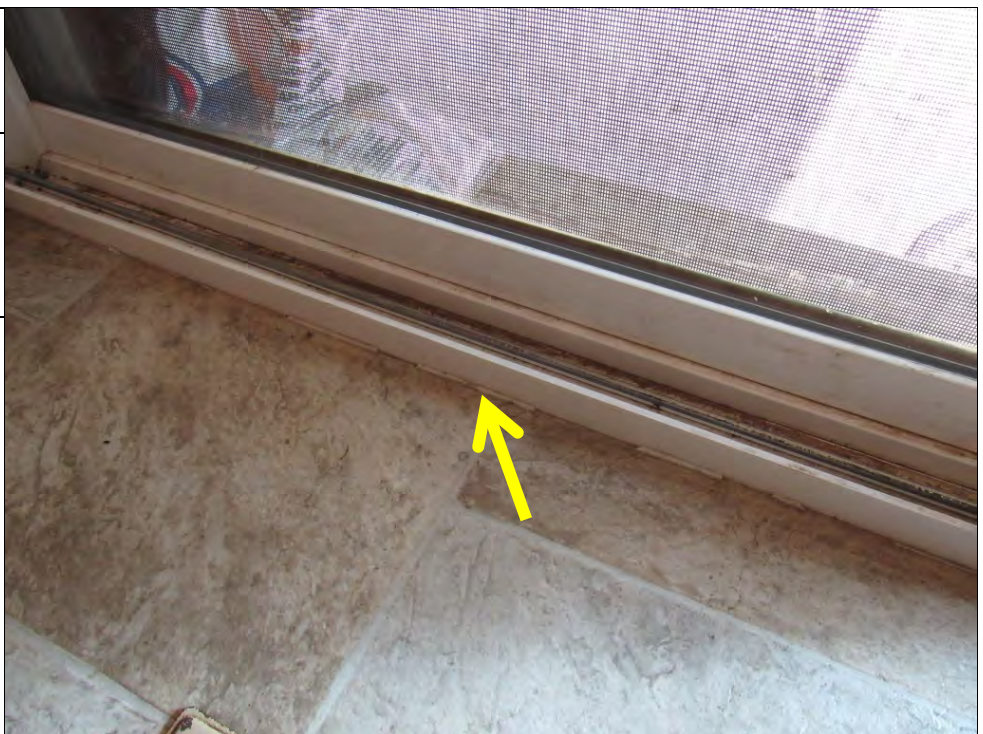
JCR1 - 03

Date:8/20/2018 to
8/23/2018**Structure/Material Location:**JC Boyle Dam Residence 1/ At
base of french doors in dining
room***Description (by layer):****1: White caulking (M)**
**2: Gray vinyl floor sheeting with
marble and cobblestone pattern
(M)**

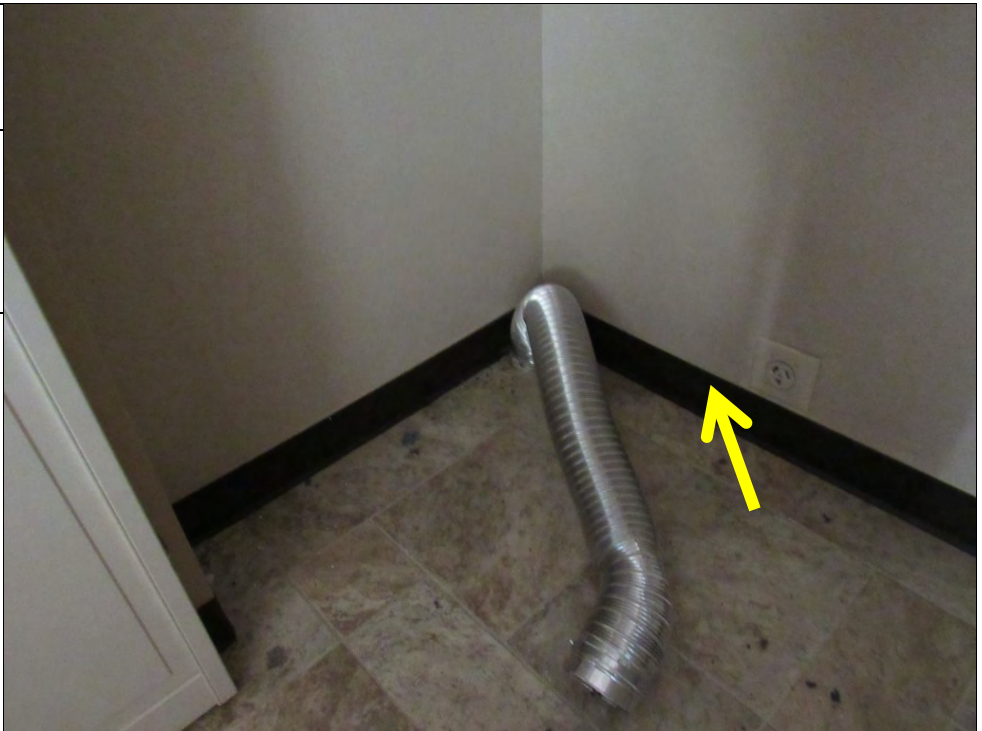
Photo No./ Material ID:	Date:
JCR1 - 04	8/20/2018 to 8/23/2018
Structure/Material Location: JC Boyle Dam Residence 1/ Associated with generator piping, pumphouse lower level	
*Description (by layer): 1: 4" black rubber cove base (M) 2: Yellow mastic (M) 3: White spray-applied texture wall coating (S)

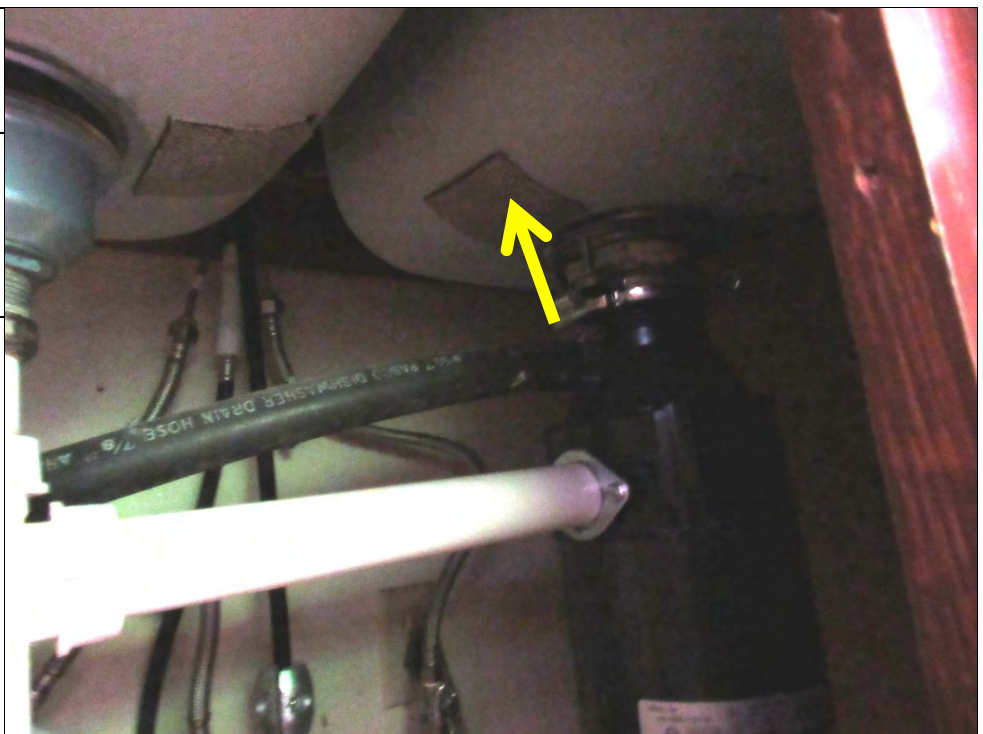
1: White sink undercoating (M)
2: Black sink patch (M)

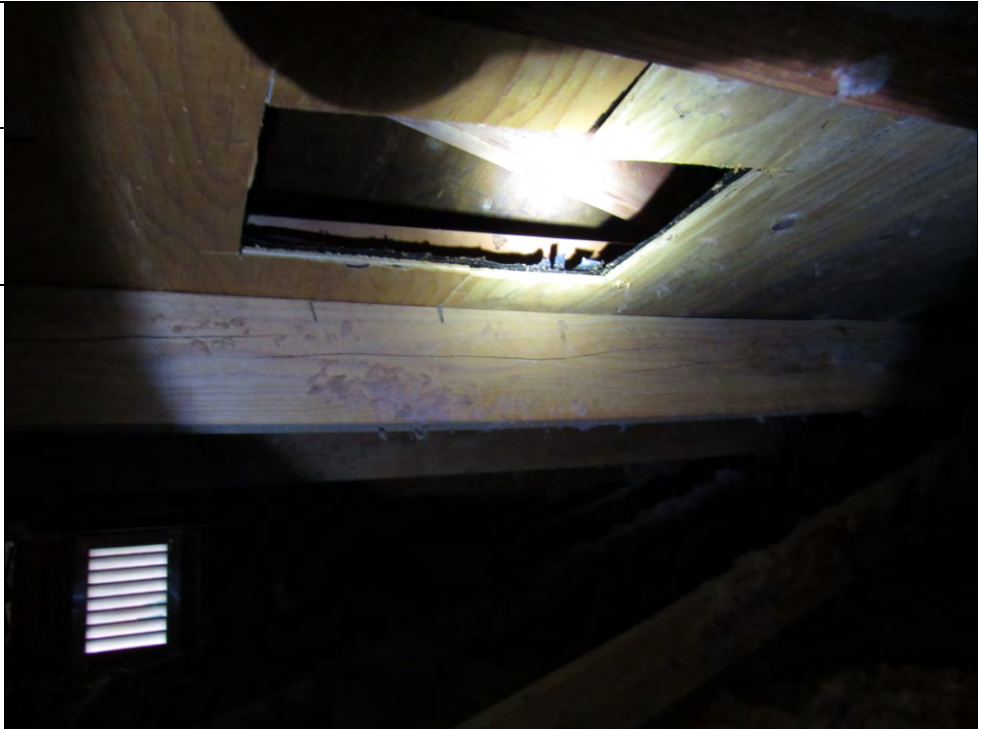
JCR1 - 08

Date:8/20/2018 to
8/23/2018**Structure/Material Location:**JC Boyle Dam Residence 1/
Above rafters in attic, throughout***Description (by layer):**

1: Black asphaltic paper (M)

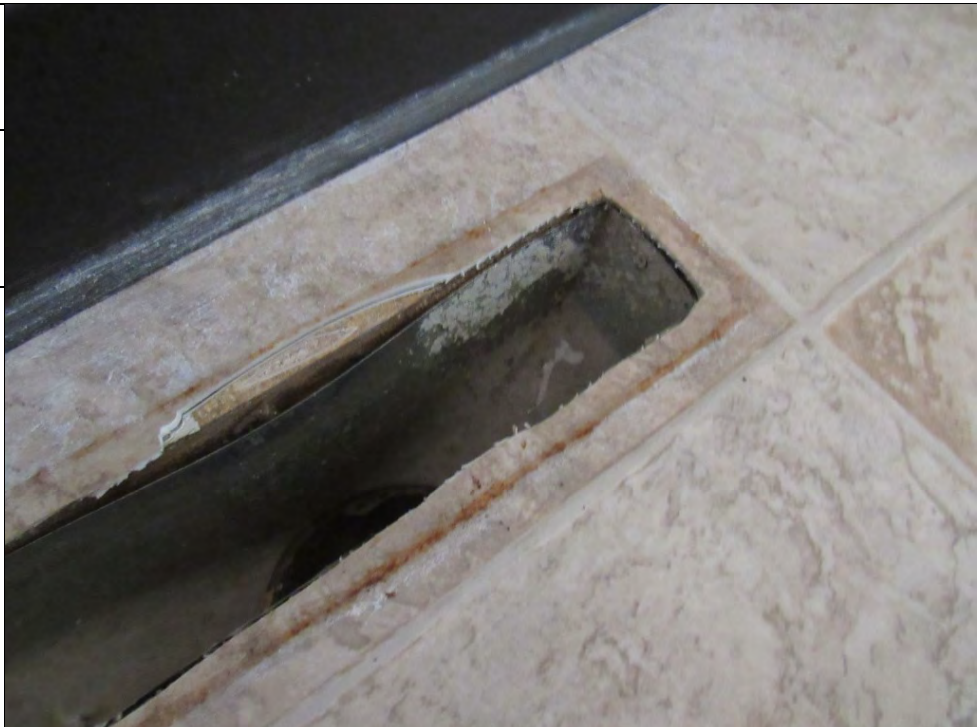
JCR1 - 10	8/20/2018 to 8/23/2018	
Structure/Material Location: JC Boyle Dam Residence 1/ Around vent in bathroom		
*Description (by layer): 1: Gray leveling compound (M)

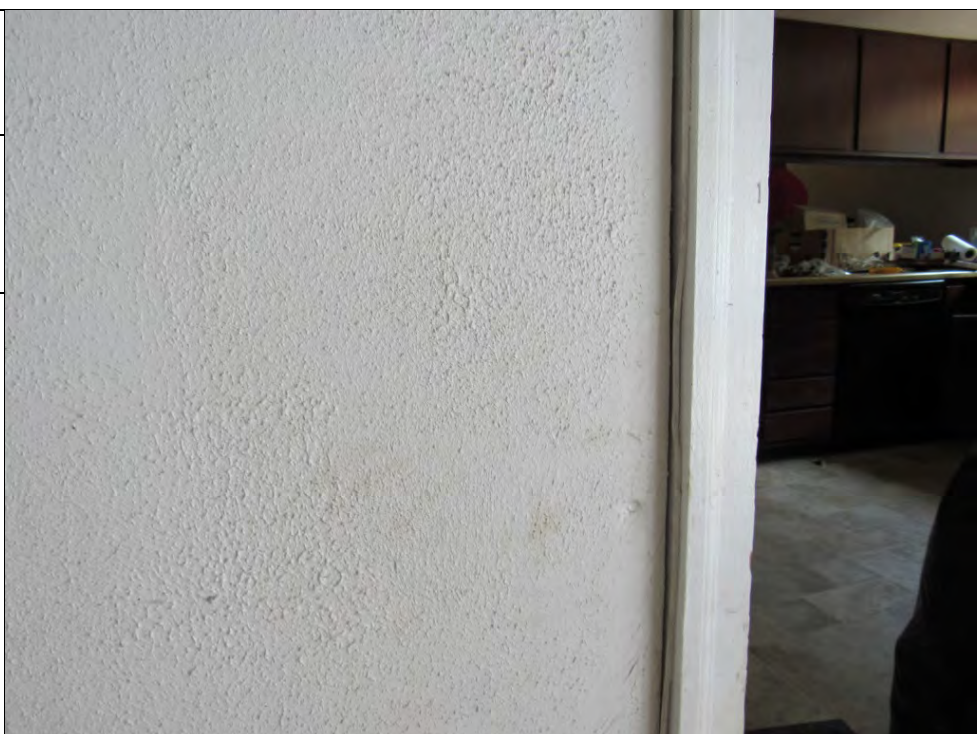
JCR1 - 11	8/20/2018 to 8/23/2018	
Structure/Material Location:		
JC Boyle Dam Residence 1/ Walls throughout		
*Description (by layer):		
1: White spray-applied texture wall coating (S)		
2: White joint compound with paper (M)		
3: White gypsm wallboard with paper (M)

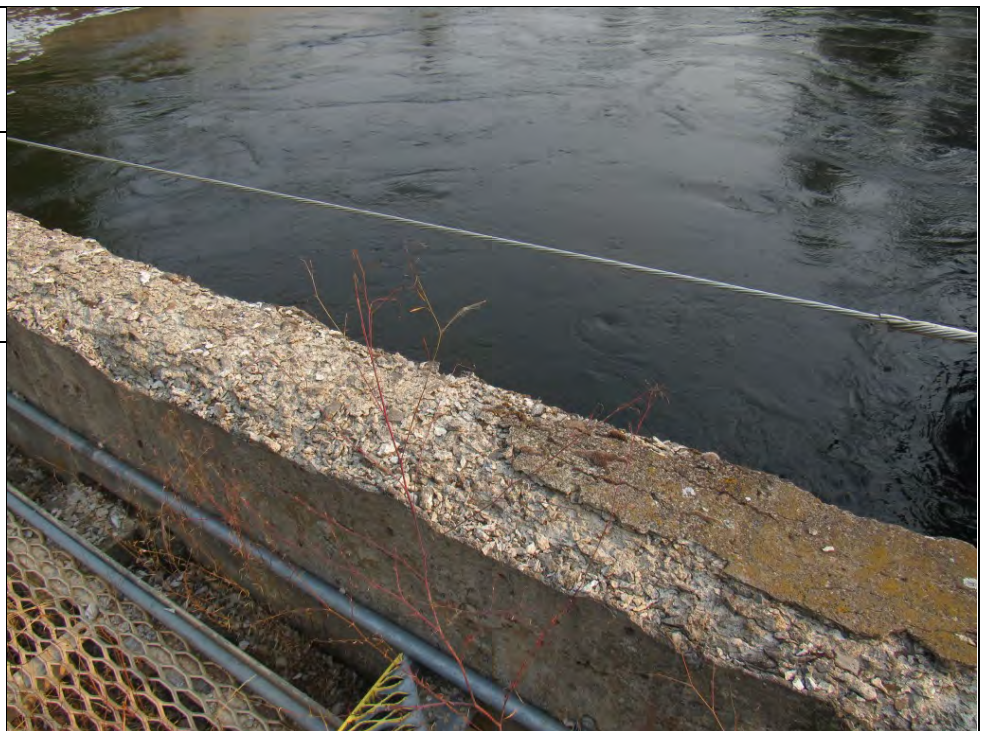
Photo No./ Material ID: JCSW - 01	Date: 8/20/2018 to 8/23/2018
Structure/Material Location: JC Boyle Dam Spillway Control Center Building/ Support concrete associated with Spillway Control Center Building	
*Description (by layer): 1: Concrete (M)

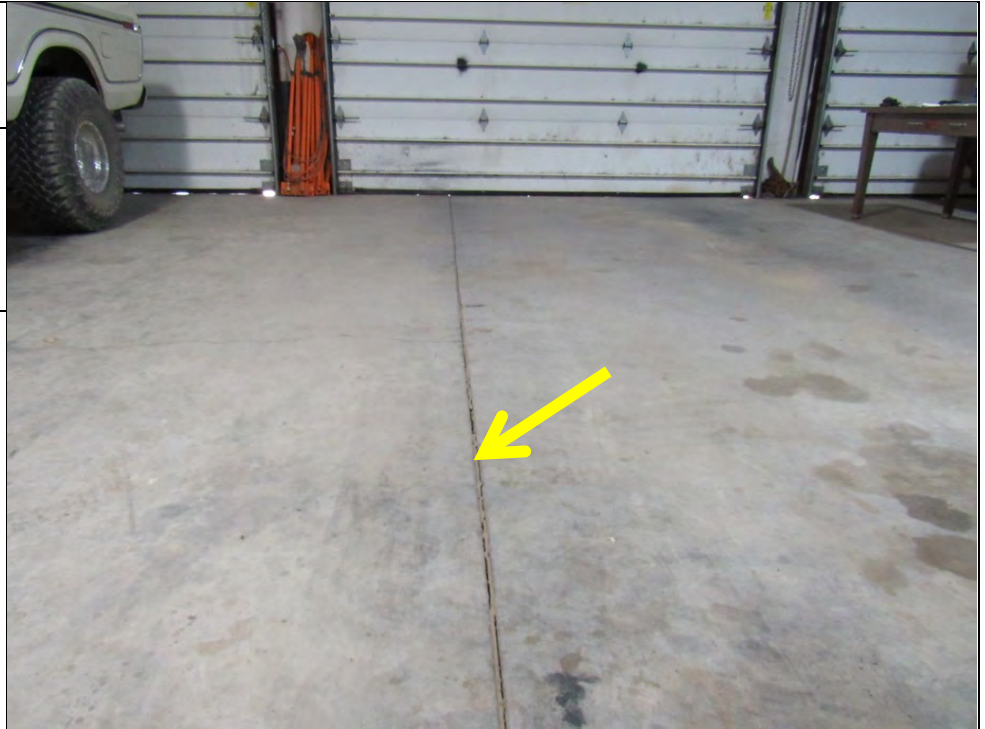
Photo No./ Material ID: JCVS - 02	Date: 8/20/2018 to 8/23/2018
Structure/Material Location: JC Boyle Dam Vehicle Storage Shed/ Expansion joints throughout interior flooring	
*Description (by layer): 1: Gray residual concrete (M) 2: Gray caulking (M)

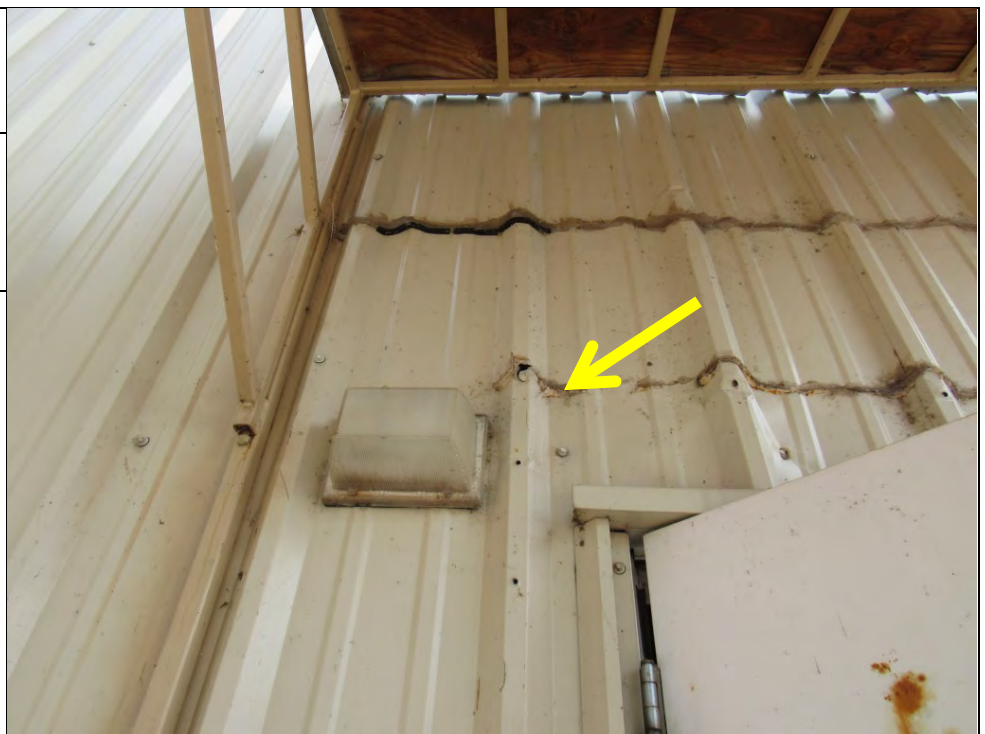
Photo No./ Material ID: JCVS - 03	Date: 8/20/2018 to 8/23/2018
Structure/Material Location: JC Boyle Dam Vehicle Storage Shed/ Exterior siding	
*Description (by layer): 1: White caulking (M)

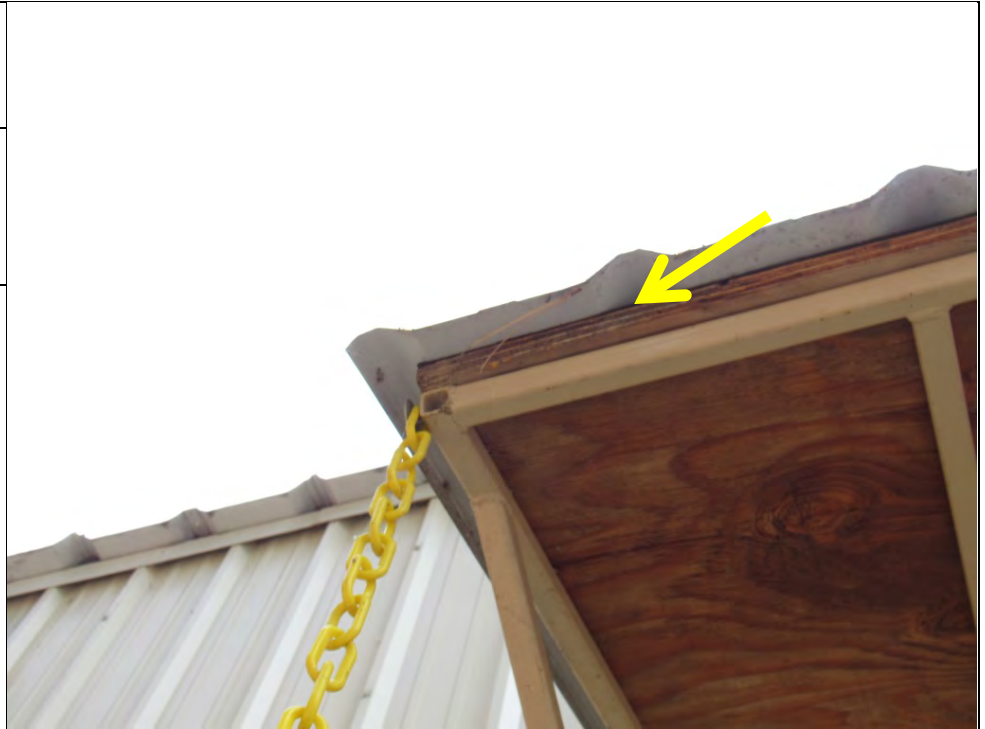
Photo No./ Material ID:	Date:
JCVS - 04	8/20/2018 to 8/23/2018
Structure/Material Location:	
JC Boyle Dam Vehicle Storage Shed/ Roof of entry way	
*Description (by layer):	
1: Black asphaltic paper under corrugated metal roof (M)

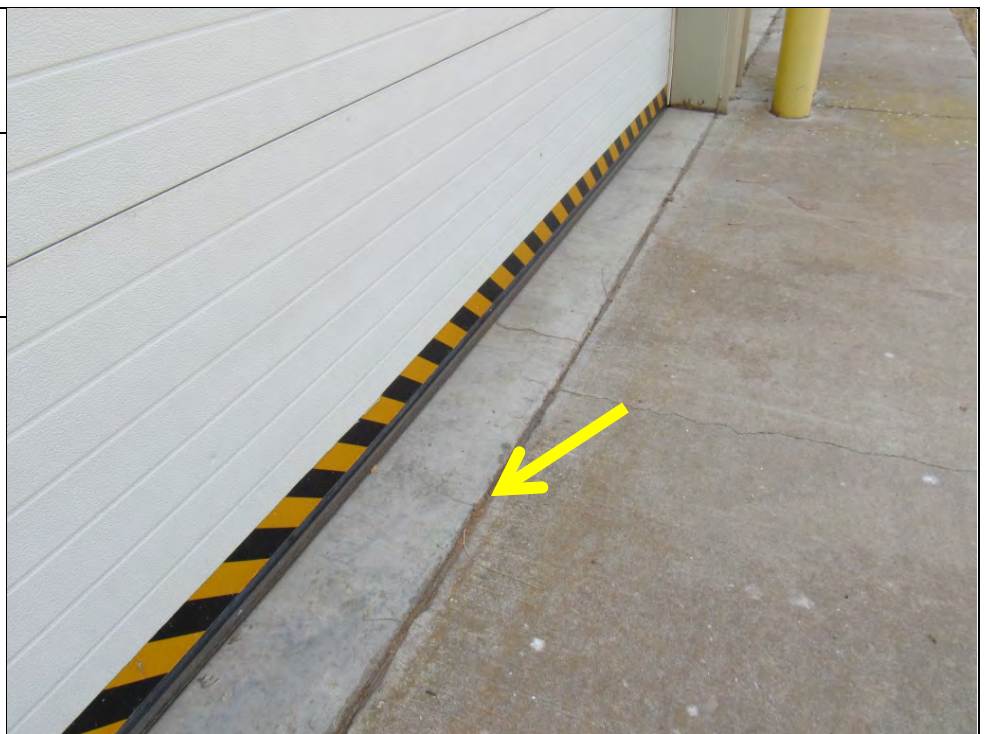
Photo No./ Material ID:	Date:
JCVS - 05	8/20/2018 to 8/23/2018
Structure/Material Location:	
JC Boyle Dam Vehicle Storage Shed/ Seams around exterior perimeter - at roll-up doors	
*Description (by layer):	
1: Black brittle sealant (M)

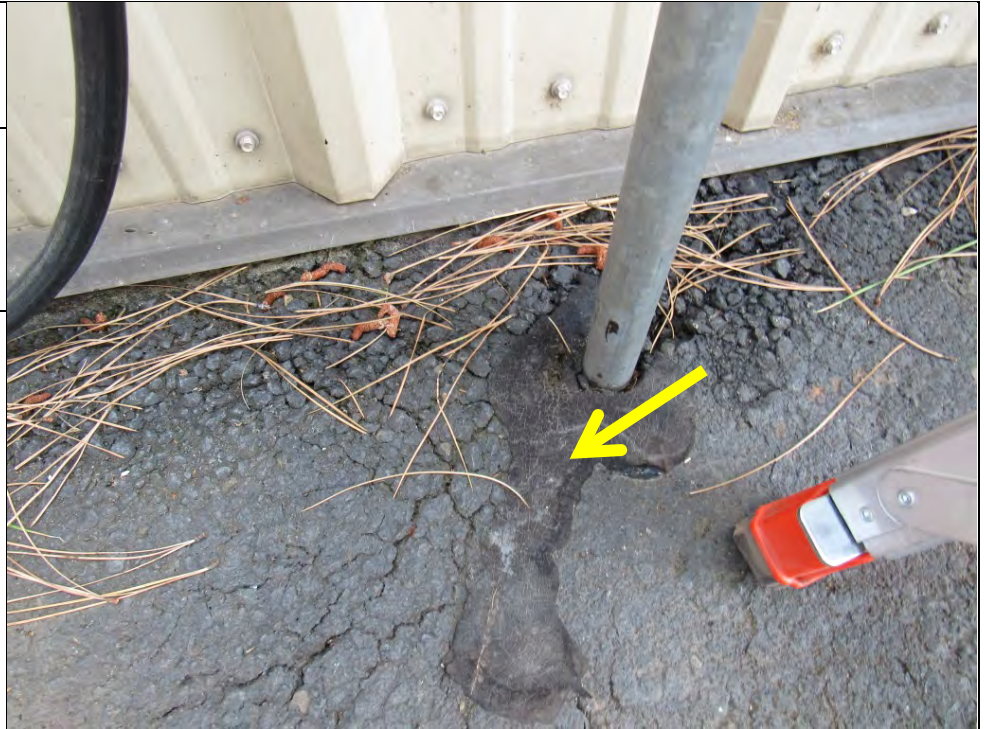
JCVS - 06

Date:8/20/2018 to
8/23/2018**Structure/Material Location:**JC Boyle Dam Vehicle Storage
Shed/ Penetrations around
exterior perimeter***Description (by layer):**

1: Black sealant (M)

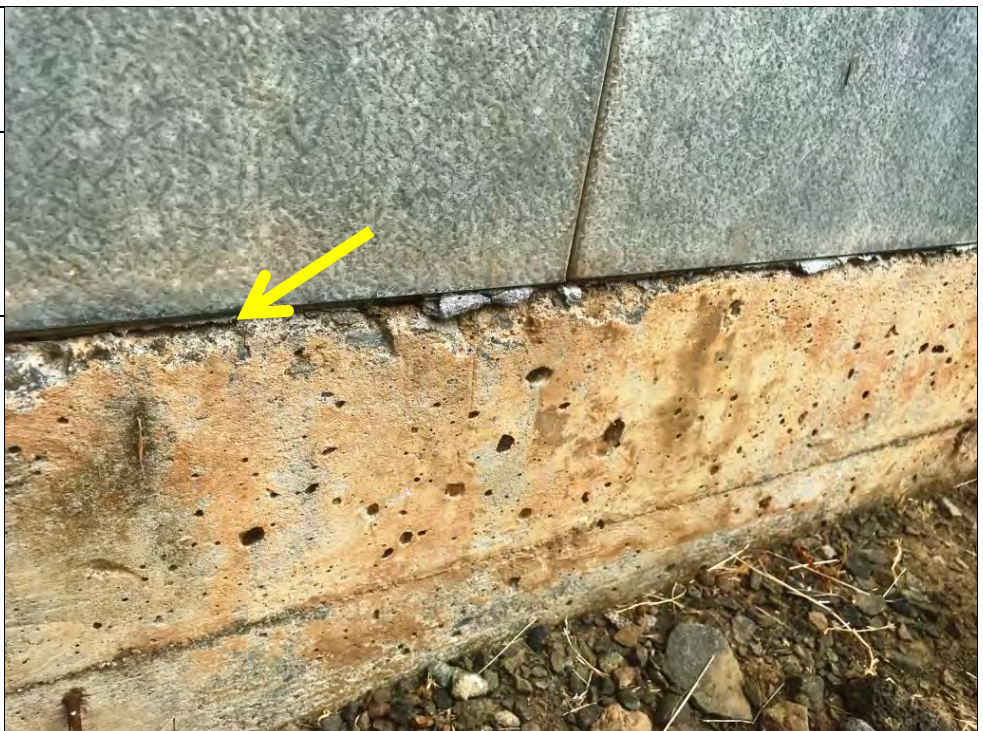
JC Boyle Dam Warehouse/
Exterior interface between metal
siding and concrete foundation

**1: Black asphaltic slip sheet
with cementitious material (M)**

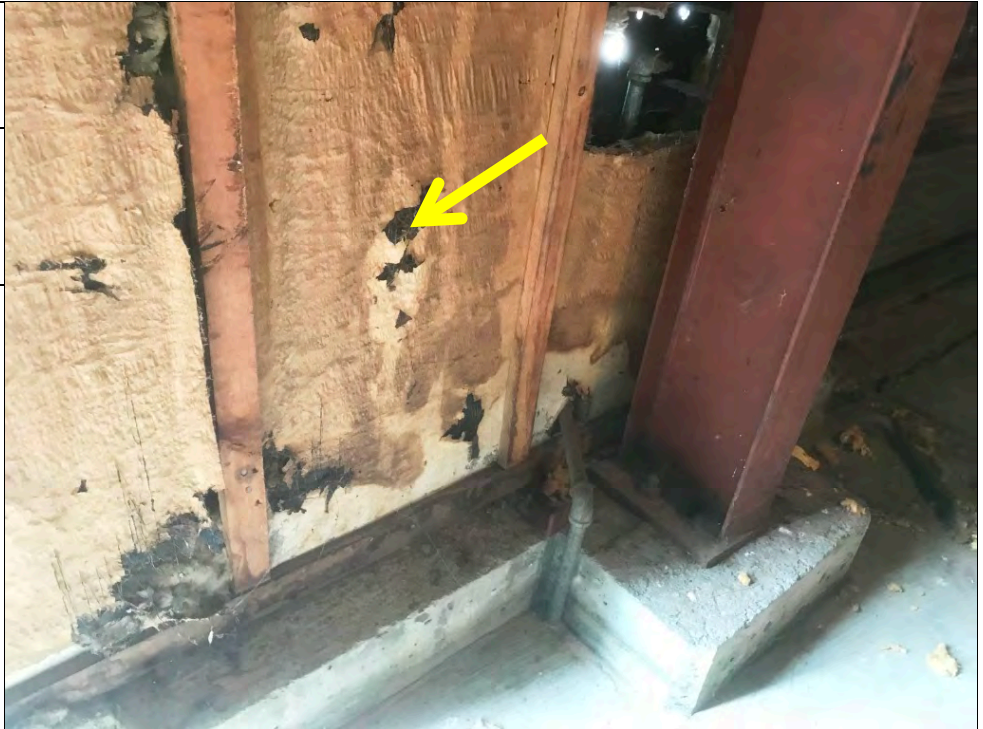
Date:8/20/2018 to
8/23/2018**Structure/Material Location:**JC Boyle Dam Warehouse/ Old
insulation throughout interior***Description (by layer):**

- 1: Paper backing with asphaltic
mastic (M)
- 2: Yellow fiberglass batt
insulation (T)

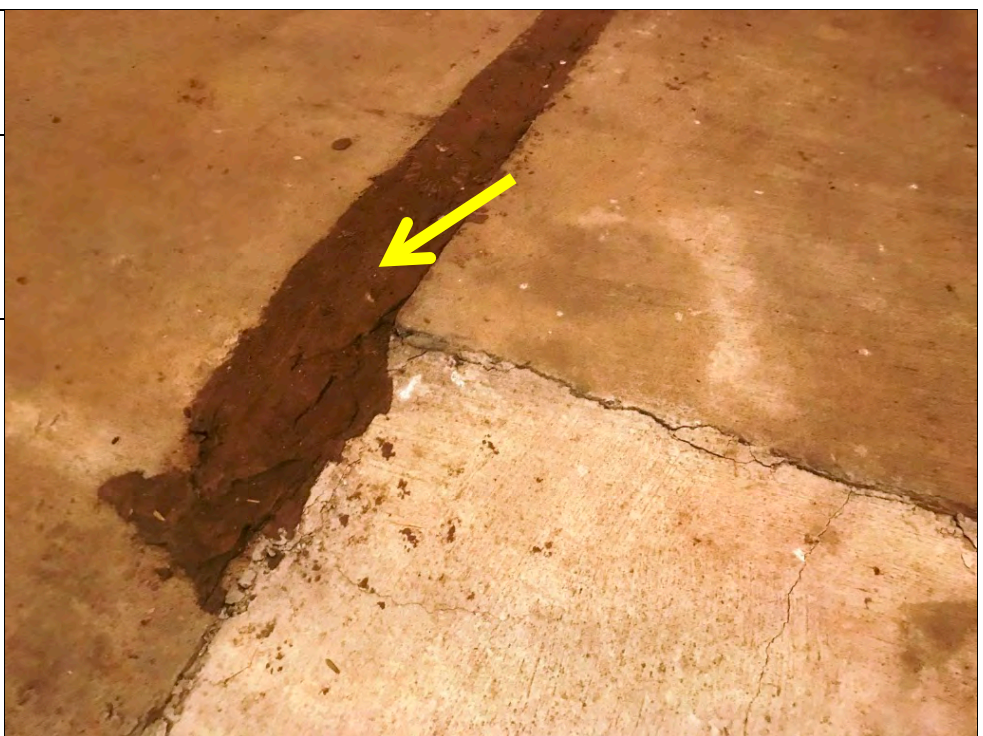
JCWH - 03

Date:8/20/2018 to
8/23/2018**Structure/Material Location:**JC Boyle Dam Warehouse/ At
uneven expansion joints,
concrete floor throughout interior***Description (by layer):**

- 1: Black asphaltic leveling
compound (M)

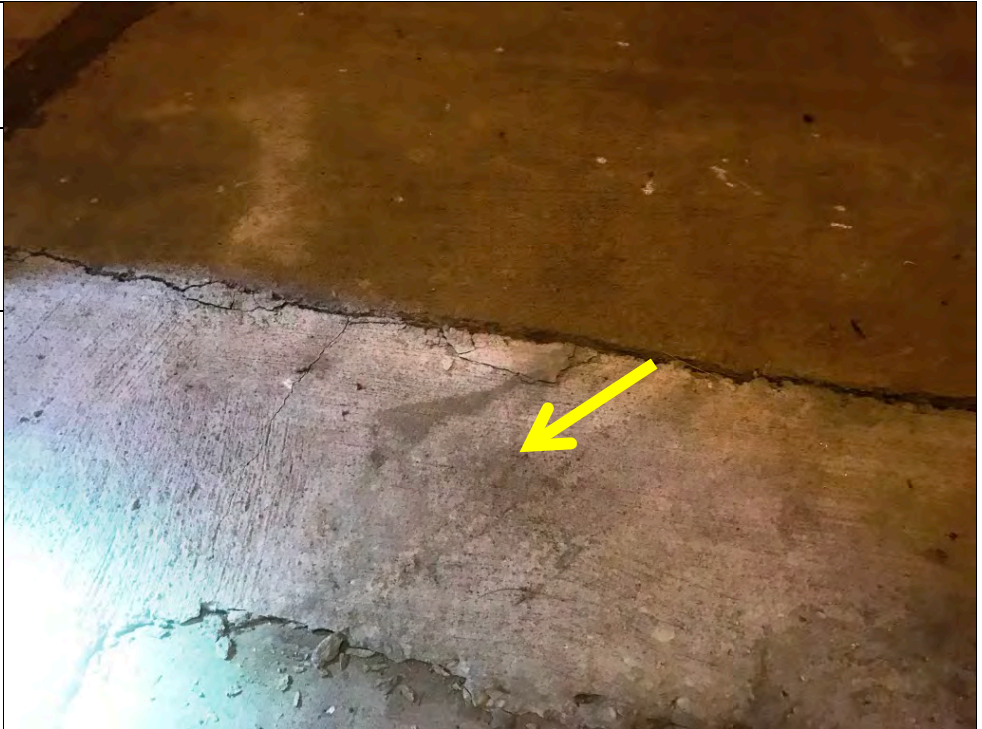
Photo No./ Material ID: JCWH - 04	Date: 8/20/2018 to 8/23/2018
Structure/Material Location: JC Boyle Dam Warehouse/ At uneven expansion joints, concrete floor throughout interior	
*Description (by layer): 1: Gray leveling compound (M)

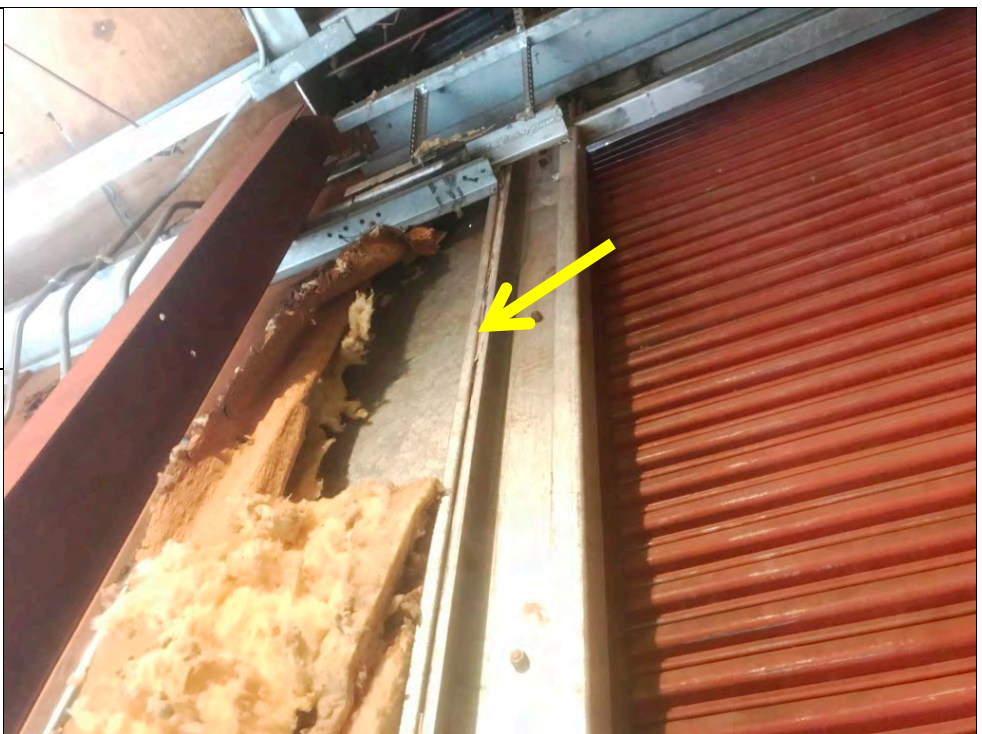
Photo No./ Material ID: JCWH - 05	Date: 8/20/2018 to 8/23/2018
Structure/Material Location: JC Boyle Dam Warehouse/ At metal seams around interior roll - up door (potentially at all seams, but more was not visible during inspection)	
*Description (by layer): 1: Tan brittle caulking (M)

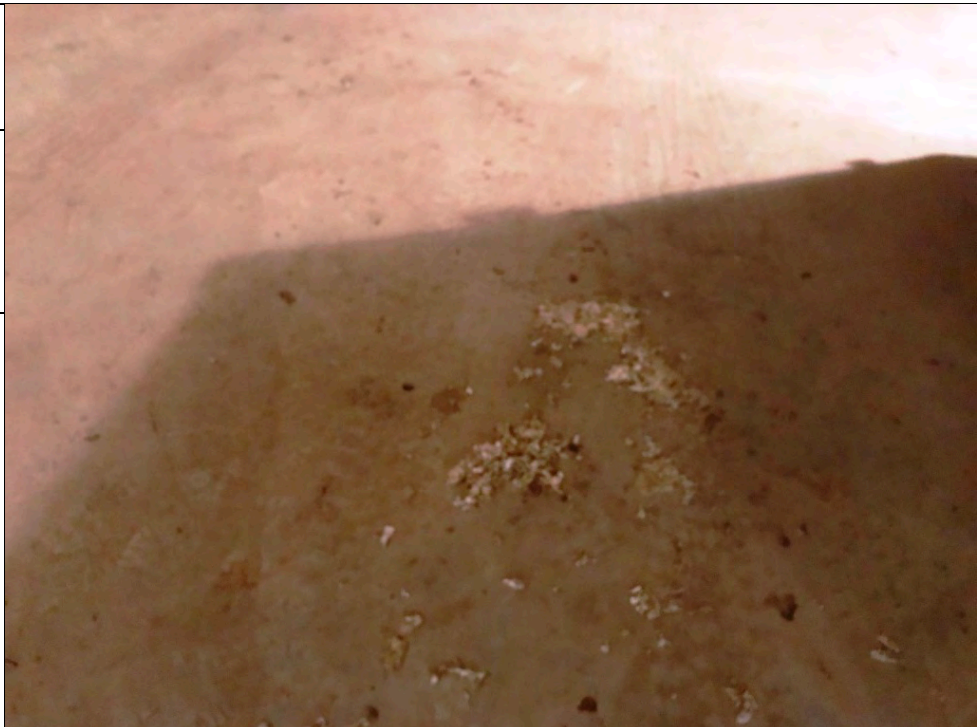
JCWH - 06	8/20/2018 to 8/23/2018	
Structure/Material Location: JC Boyle Dam Warehouse/ Penetrations around exterior perimeter		
*Description (by layer): 1: White fiberglass insulation with paper (T) 2: Tan fiberglass insulation with paper (M) 3: Black asphaltic mastic (M)
