**Klamath River Renewal Corporation
PacifiCorp**

**Project Nos. 14803-001;
2082-063**

**AMENDED APPLICATION FOR SURRENDER OF LICENSE
FOR MAJOR PROJECT AND REMOVAL OF PROJECT WORKS**

**EXHIBIT K (2 of 2)
Reservoir Drawdown and Diversion Plan**

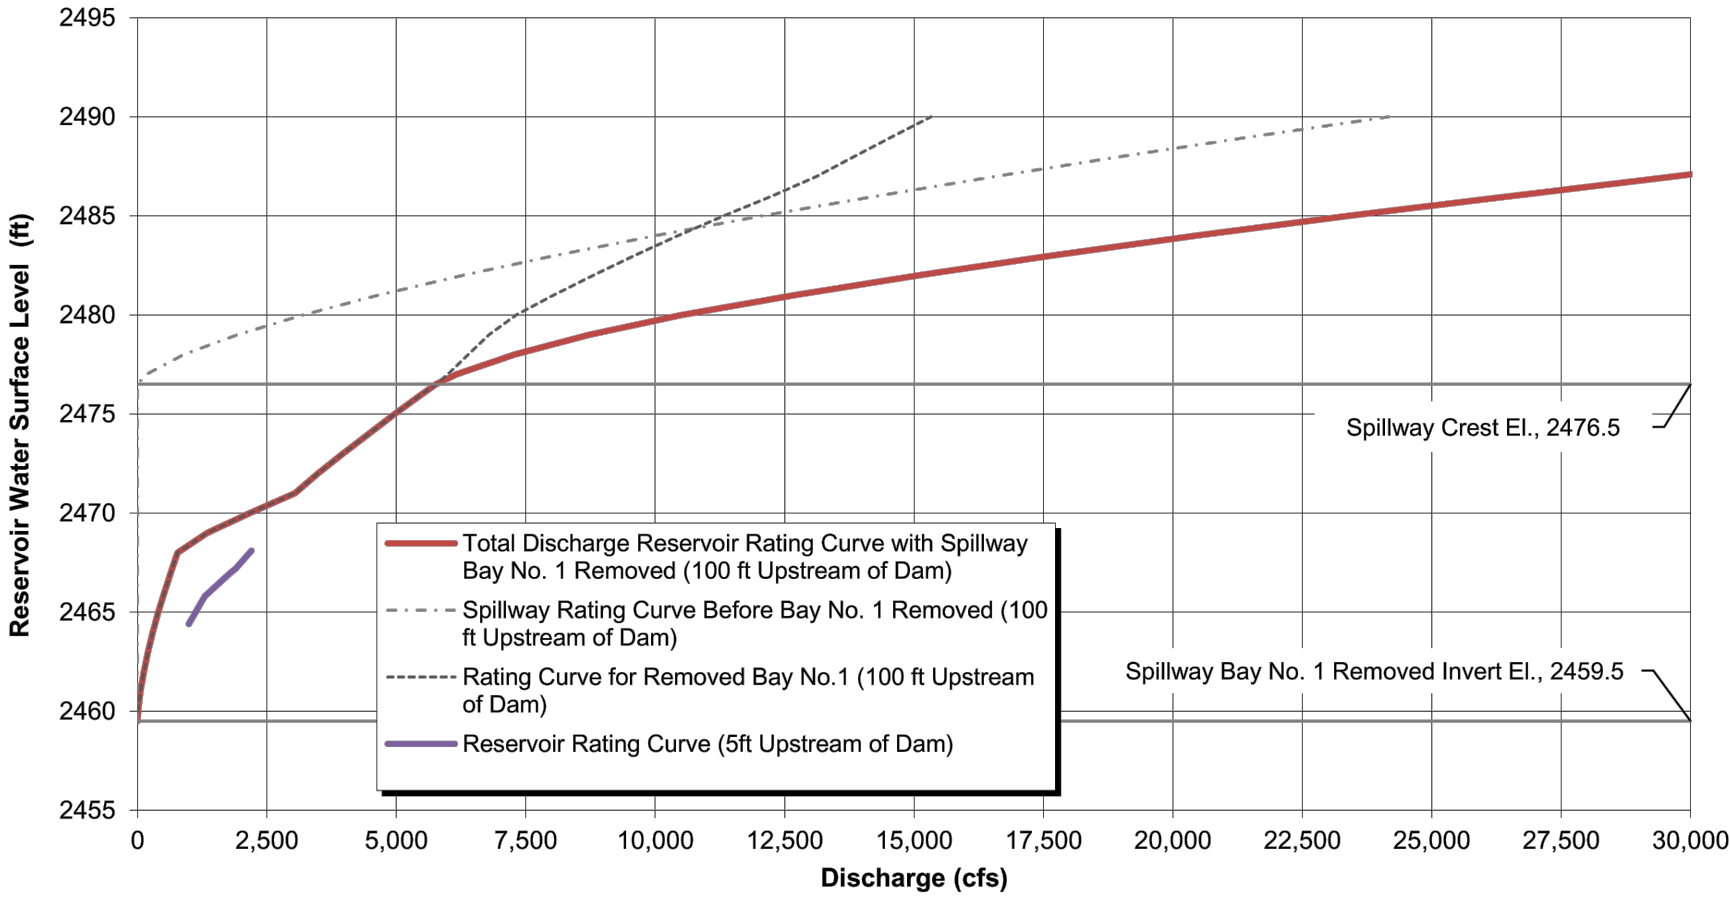
FIGURE 2 – RESERVOIR DISCHARGE RATING CURVE

- DISCHARGE CAPACITY OF THE SPILLWAY AND OF THE REMOVED SPILLWAY BAY NO. 1 ON FIGURE 2 ARE FOR FREE DISCHARGE CONDITIONS. THE DISCHARGE CAPACITY FOR THE SPILLWAY IS FOR ALL 5 SPILLWAY GATES FULLY OPENED.

- DISCHARGE RATING CURVES ON FIGURE 2 ARE FOR RESERVOIR WATER SURFACE LEVELS APPROXIMATELY 100 ft UPSTREAM OF THE DAM FACE, EXCEPT AS NOTED FOR THE RESERVOIR RATING CURVE DURING LOW FLOWS (<2,200 cfs), WHICH INDICATES CONDITIONS 5 ft UPSTREAM OF THE DAM FACE.

- RESERVOIR WATER SURFACE LEVELS IN TABLE 1 ARE DETERMINED USING THE STEADY-STATE INFLOWS SHOWN IN TABLE 1 AND THE DISCHARGE RATING CURVES ON FIGURE 2.

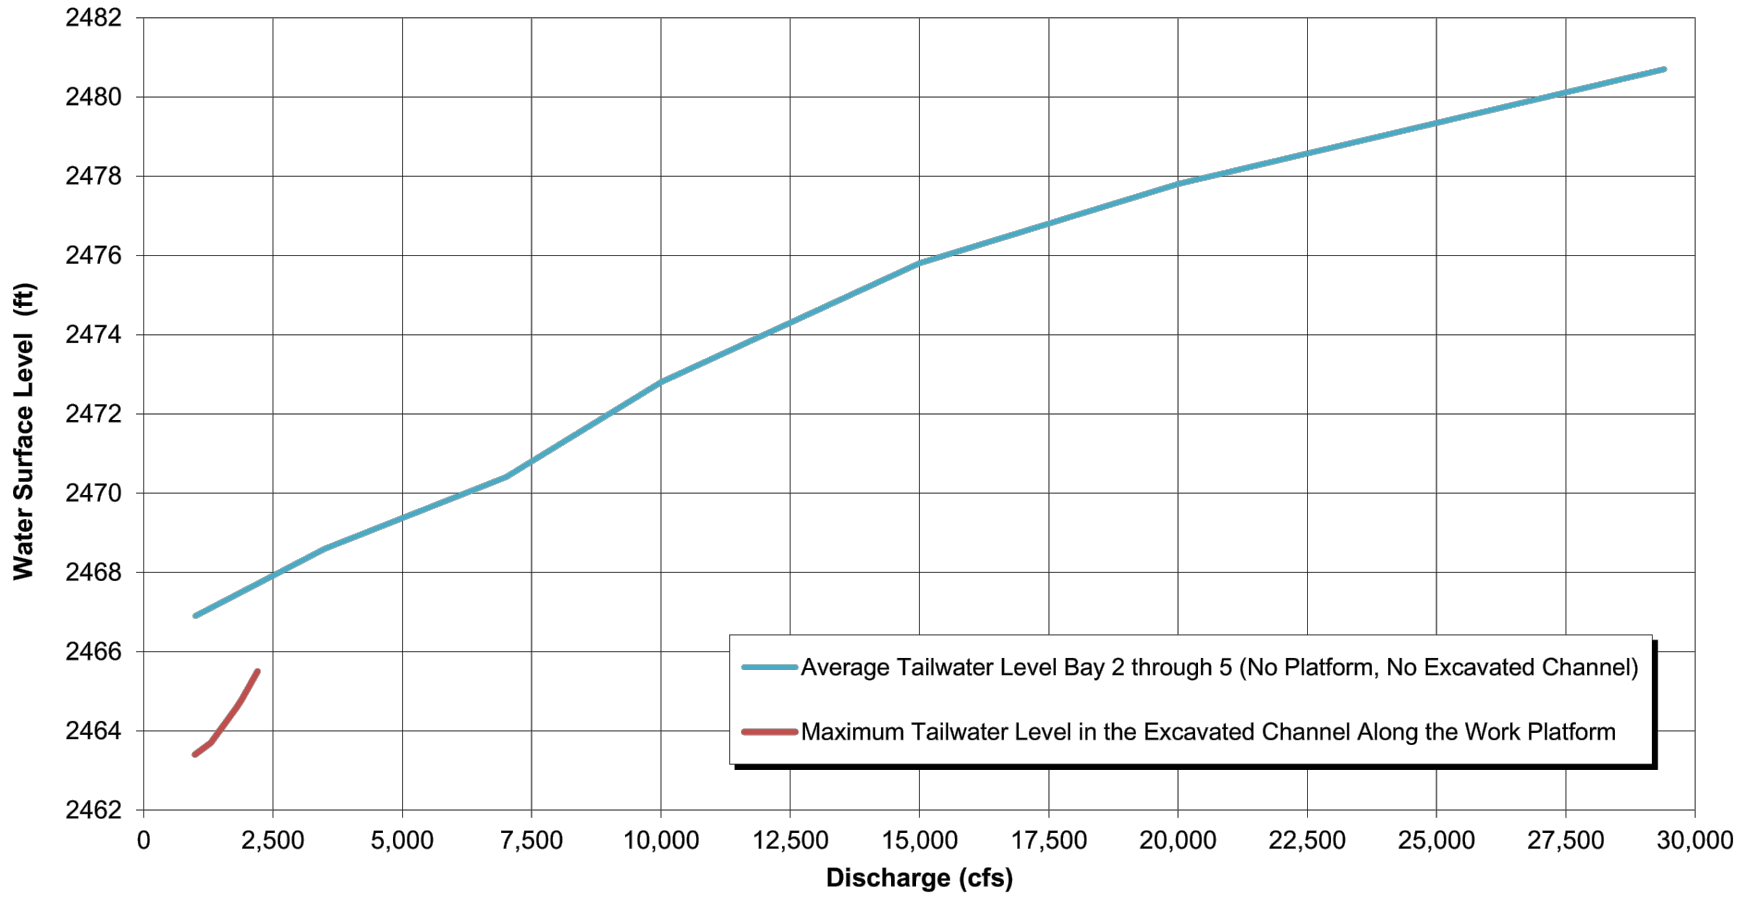
FIGURE 3 – TAILWATER DISCHARGE RATING CURVE

- THE TAILWATER RATING CURVE ON FIGURE 3 INDICATES THE AVERAGE TAILWATER LEVELS ACROSS SPILLWAY BAYS 2 THROUGH 5 APPROXIMATELY 34 ft DOWNSTREAM OF THE DAM FACE FOR THE FULL RANGE OF FLOWS. THE SECOND RATING CURVE IDENTIFIES WATER LEVELS IN THE EXCAVATED CHANNEL THROUGH BAY 1 ALONG THE WORK PLATFORM DURING LOW FLOWS (<2,200 cfs).

- RESERVOIR WATER SURFACE LEVELS DO NOT INCLUDE THE RECOMMENDED 3 ft FREEBOARD.
- TAILWATER SURFACE LEVELS IN TABLE 1 ARE DETERMINED USING THE STEADY-STATE INFLOWS SHOWN IN TABLE 1 AND THE DISCHARGE RATING CURVES ON FIGURE 3.
