RE: KRRP Value Engineering Summary and Advancement to 90% Design

VE-1 Submittals: Drawdown Model and Assessment

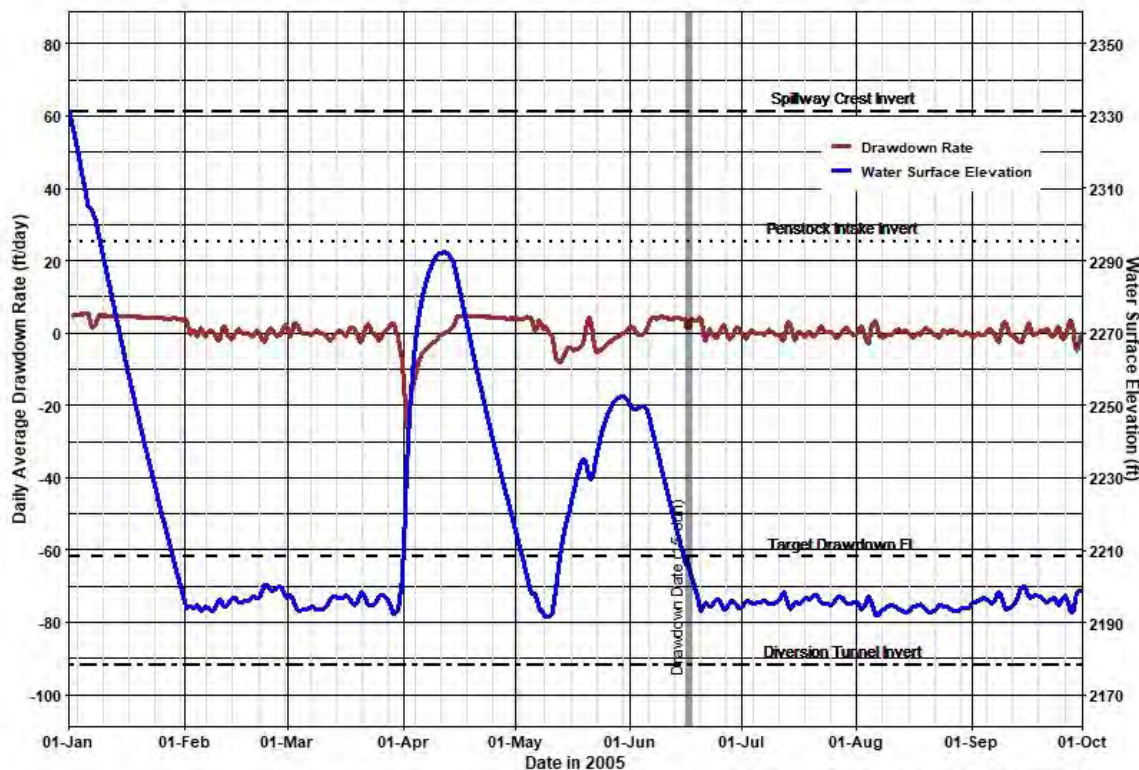
L37 of 329
A3-8 of 25

Preliminary Results: 2005 – Avg. Vol. Year

Preliminary Result. Folder: .IGD_S57_20200519

- Target Drawdown WSE reached:
 - Early Feb, early May and mid-Jun
- Reservoir refills from freshet
 - Drawdown limited to 5ft/day after 2nd refilling
- Post June15/July WSE
 - around 2190 ft +/-
- Outflows through individual outlets not properly represented in current model when drawdown limited to 5 ft/day (total outflow is correct) – to be visited in 90%

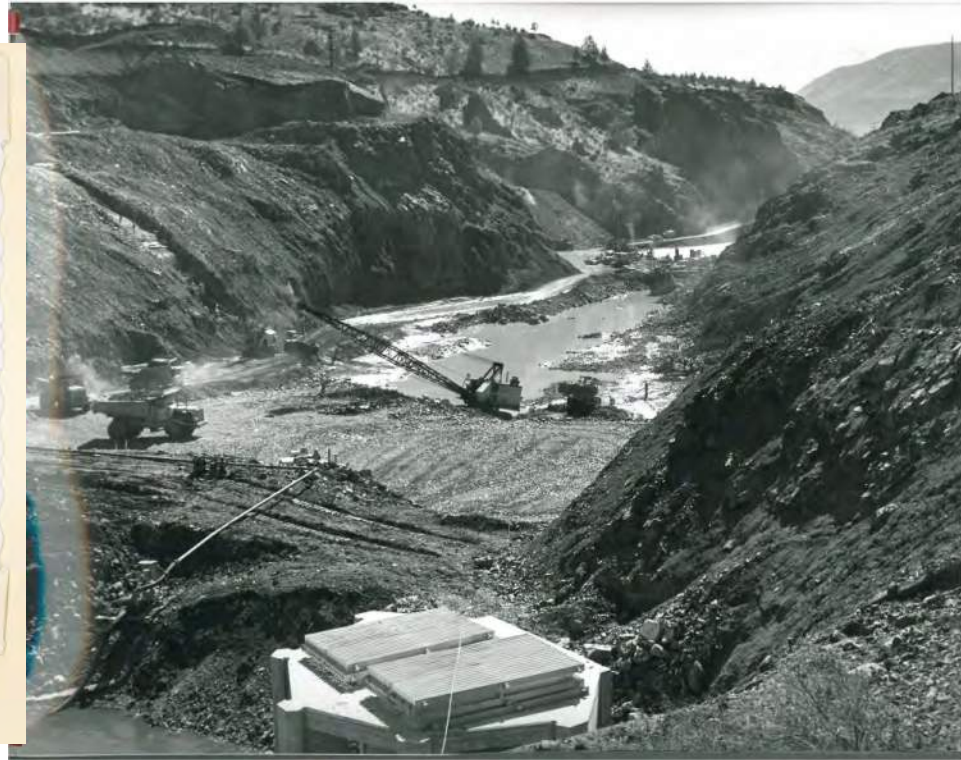
BB 234

Dam. Unwatered foundation.
7/25/57

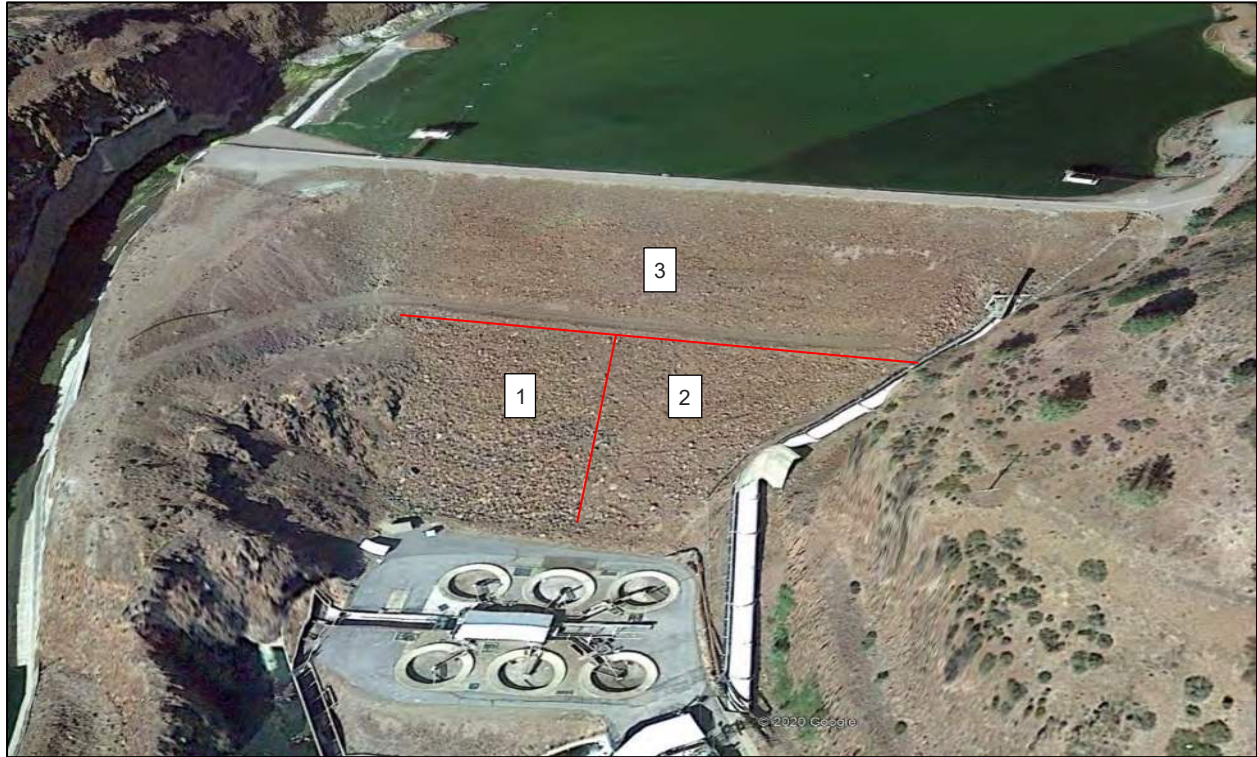
Figure 2.3 Iron Gate Downstream Dam Face

The Iron Gate Dam Downstream Face has existing Erosion Protection placed from the dam crest to the fish hatchery at the dam toe. The dam face was sub-divided into three separate sub-areas based on the apparent surface erosion protection particle size, as shown on Figure 2.3.

- Observed gradation of the three sub-areas assessed on the downstream face:
 - Sub-area 1: $D_{50} = \sim 28"$, $D_{85} = 40"$, approximately 2,980 yd² based on aerial imaging. Split-NET gradation analysis was completed and is presented in C.5. Results indicated a $D_{85} = 36"$, $D_{50} = 18"$ and $D_{15} = 3.4"$.

- Sub-area 2: $D_{50} = \sim 20"$, approximately 1,950 yd² based on aerial imaging. Split-NET gradation analysis was completed and is presented in C.6. Results indicated a $D_{85} = 26"$, $D_{50} = 12"$ and $D_{15} = 1.4"$, which were smaller than the observed average gradation.

- Sub-area 3: $D_{50} = \sim 9"$, $D_{85} = 12"$, $D_{15} = 3"$ approximately 5,900 yd² based on aerial imaging. Split-NET gradation analysis was completed and is presented in C.7. Results indicated a $D_{85} = 10"$, $D_{50} = 3.5"$ and $D_{15} = 0.4"$, which are smaller than the field observed average gradation.

- Erosion Protection sample IGDDS-1 was obtained for durability properties testing across lower half of embankment surface.
- The downstream dam face has a minimum erosion protection thickness of 5 ft, as per historic as-built drawing 5407-A-111.

The observed material quality and durability within all 3 sub-areas of the downstream shell are similar, however the material size varies across each sub-area. Sub-area 1 had the largest material, followed by Sub-areas 2, then Sub-area 3. Based field assessment results, this site can be used as a source for Erosion Protection of varying sizes.

Borrow Source	Approximate Gradation	Surface Area (yd ²) ¹	Assumed Depth (yd)	Expected Volume (CY)
Iron Gate Dam Downstream Face Sub-area 1 Figure 2.3	D ₅₀ = 28" D ₈₅ = 40"	2,980	1.67	4,400 – 4,800
Iron Gate Dam Downstream Face Sub-area 2 Figure 2.3	D ₅₀ = 20"	1,950	1.67	2,900 – 3,200
Iron Gate Dam Downstream Face Sub-area 3 Figure 2.3	D ₁₅ = 3" D ₅₀ = 9" D ₈₅ = 12"	5,900	1.67	9,000 – 9,800
Iron Gate Lakeview Road Figure 2.2	D ₁₅ = 1" D ₅₀ = 6" D ₈₅ = 14"	825	2 – 4	1,600 – 3,200
Copco No. 1 Access Road Sub-area 1 Figure 2.4	D ₁₅ = 3" D ₅₀ = 15" D ₈₅ = 28"	365	0.5 – 2	200 – 700
Copco No. 2 Downstream Right Bank Figure 2.6	D ₁₅ = 36" D ₅₀ = 48" D ₈₅ = 72"	3,000	2 – 5	9,000 – 18,000 ²
Copco No. 2 Downstream Left Bank Figure 2.7	D ₁₅ = 12" D ₅₀ = 40" D ₈₅ = 60"	1,940	1 – 3	2,000 – 6,000 ²
J.C. Boyle Downstream of Dam Sub-area 1 Figure 2.10	D ₁₅ = 1" D ₅₀ = 9" D ₈₅ = 20"	850	0.5 – 2	500 – 1,500
J.C. Boyle Downstream of Dam Sub-area 2 Figure 2.10	D ₁₅ = 8" D ₅₀ = 24" D ₈₅ = 36"	250	0.5 – 1.5	150 - 400

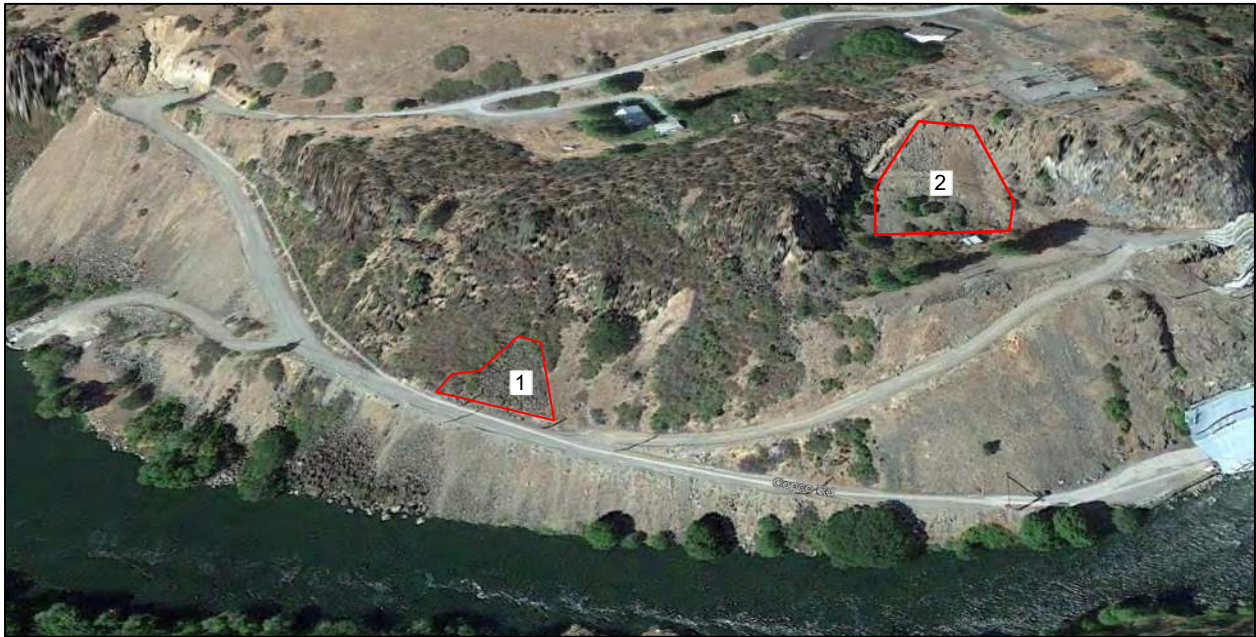
Figure 2.4 Copco No. 1 Access Road Potential Borrow Source

The Copco No. 1 Access Road potential borrow source is located along the existing Copco No. 1 right bank access road and along the proposed future road alignment shown on drawing C2510. The access road construction will produce a surplus material, of which some is expected to be used as source of erosion protection or granular fill. This investigation, however, was limited to surface observations and was unable to ascertain the gradation and material type of the proposed bulk excavation. Two areas that had visible erosion protection material on surface were investigated, as shown on Figure 2.4.

- Fine-grained basalt, some vesicular, angular, lightly weathered, very strong, breaks with hard strikes from rock hammer, Schmidt hammer strength values ranging from 23 to 41 ksi with no apparent sulfide mineralization.
- Observed gradation of two Sub-areas assessed on the Copco No. 1 Access Road:
 - Sub-area 1: $D_{50} = \sim 15"$, $<10\%$ 3-inch minus material, approximately 365 yd² based on aerial imaging.
 - Sub-area 2: Not considered an adequate source. Localized erosion protection material available.

- Two Split-NET gradation analyses were completed in Sub-area 1 and are presented in Appendix C - Figures C.8, and C.9. Results indicated a $D_{85} = 18"$, $D_{50} = 9"$ and $D_{15} = 1.6"$, and a $D_{85} = 15"$, $D_{50} = 7"$ and $D_{15} = 1.8"$, respectively, which are smaller than the field observed average gradation.
- Erosion Protection sample CRBR-1 obtained for durability properties testing in Sub-area 1

Based on the results of the investigation, Sub-area 1 may be an acceptable source of small size Erosion Protection, Riverbed, or Bedding Material. The surface material at Sub-area 2 does not have adequate coverage of large sized rocks to be a reliable borrow source.

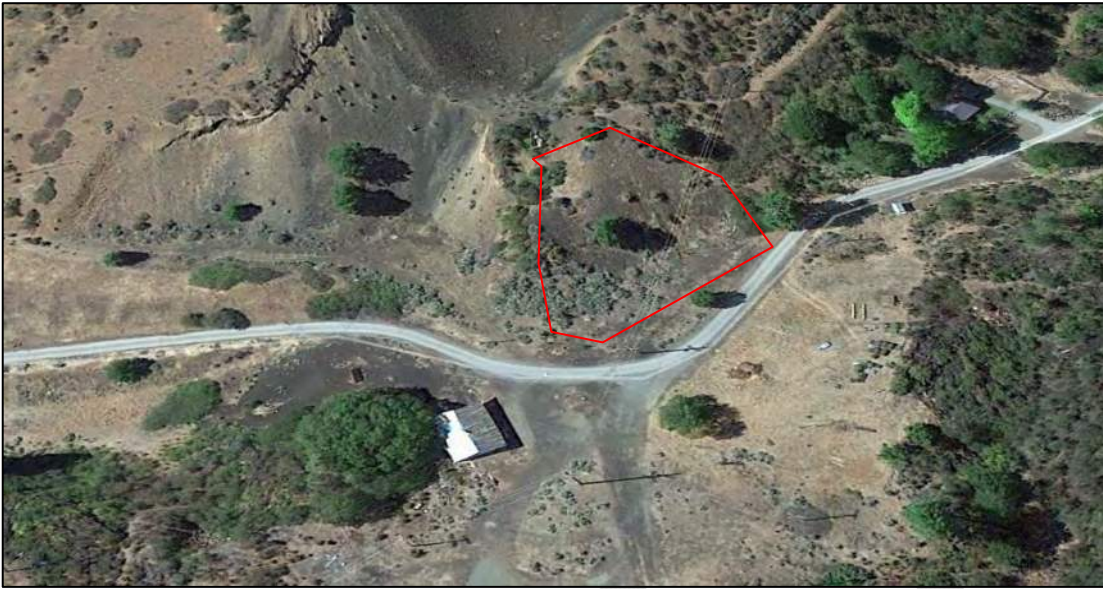
Figure 2.5 Copco No. 1 Village Potential Borrow Source

Copco No. 1 Village potential borrow source is located the north of the Copco No. 1 Dam Right Abutment and lies adjacent to an existing historic borrow source, as shown in Figure 2.5. The material was assessed as a potential source of granular fill.

- USCS, SC, 1 to $\frac{1}{2}"$ minus, clayey sand with gravel. Two Split-NET gradation analyses were completed and are presented in Figures C.10, and C.11 in Appendix C. Results indicated a $D_{85} = 0.9"$, $D_{50} = 0.2"$ and $D_{15} = 0.03"$, and a $D_{85} = 0.6"$, $D_{50} = 0.2"$ and $D_{15} = 0.03"$, respectively.
- Granular Fill sample C1V-1 obtained for sieve analysis and soil classification.
- Approximately 2,070 yd² based on aerial imaging.

Area may be possible source for finer grained granular fill.

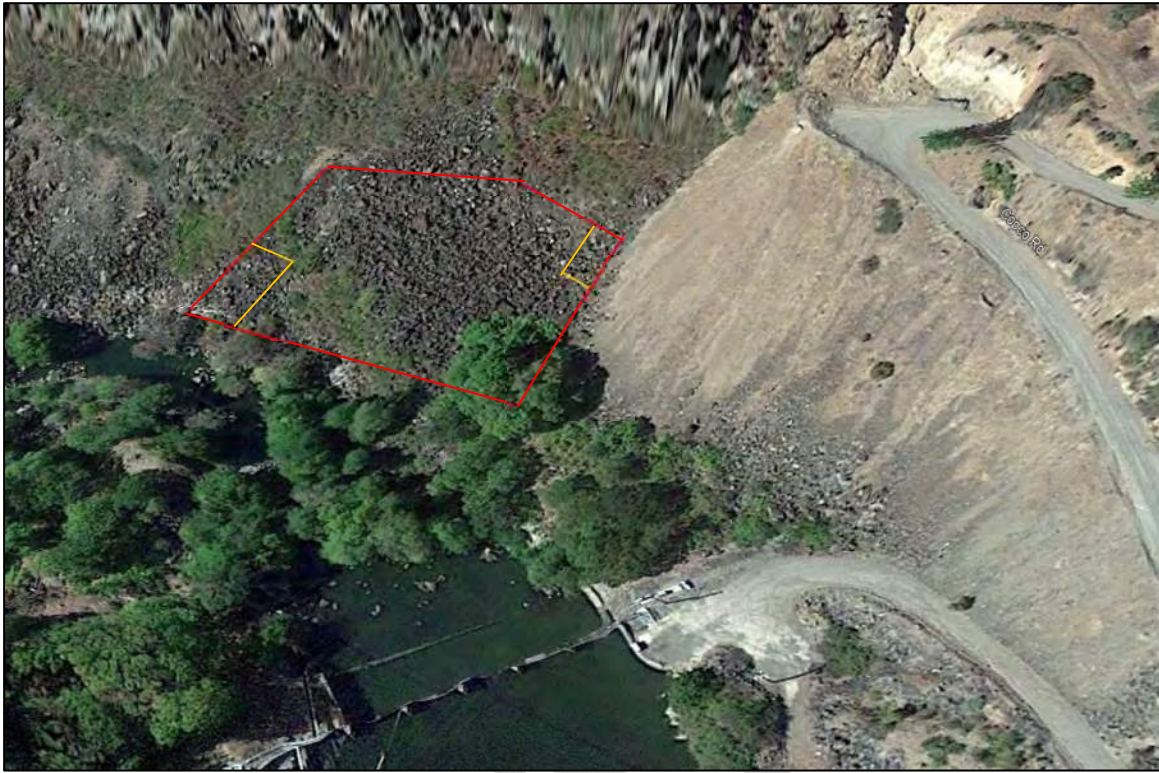
Figure 2.6 Copco No. 2 Downstream Right Bank Potential Borrow Source

The Copco No. 2 downstream right bank potential borrow source is a talus slope located approximately 250 ft downstream of the Copco No. 2 diversion dam, as shown on Figure 2.6. The talus comprises erosion protection material.

- Observed gradation: D_{50} value ~ 48 inches, 20% 7-ft minus, 20% 5-ft minus ft, 50% 4-ft minus, 10% 1-ft minus.
 - In the areas denoted by the orange boundaries in Figure 2.6, the D_{50} was observed to be smaller, approximately 32" to 36".

- Two Split-NET gradation analyses were completed and are presented in Appendix C - Figures C.12, and C.13. Results indicated a $D_{85} = 46"$, $D_{50} = 32"$ and $D_{15} = 14"$, and a $D_{85} = 44"$, $D_{50} = 28"$ and $D_{15} = 5"$, respectively. The results of the analysis are suspected to be smaller than the field observed gradations due to the inability to place both scaling balls in the photograph to account for depth of field.

The material found within the right bank talus pile is among the largest onsite sized boulders available and is appropriate for the large erosion protection sizes specified at the Copco No. 1 and No. 2 locations.

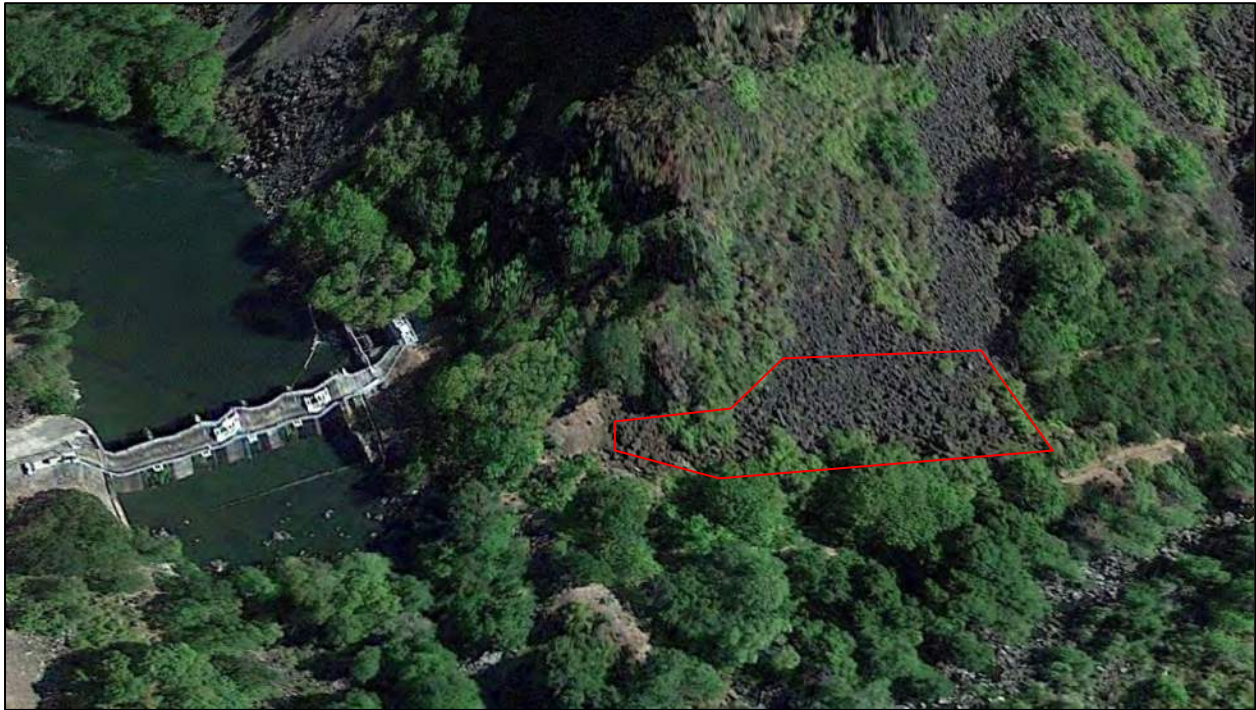
Figure 2.7 Copco No. 2 Downstream Left Bank Potential Borrow Source

The Copco No. 2 downstream left bank potential borrow source is a talus slope located approximately 300 ft downstream of the Copco No. 2 diversion dam, as shown on Figure 2.7. The talus comprises erosion protection material.

- Observed Gradation: $D_{50} = 40''$, general material is 6-ft minus.
- Two Split-NET gradation analyses were completed and are presented in Appendix C -Figure C.14 and C.15. Results indicated a $D_{85} = 44''$, $D_{50} = 28''$, and $D_{15} = 15''$, and a $D_{85} = 60''$, $D_{50} = 33''$, and $D_{15} = 7.5''$, respectively. The two photographs are of the same area but at different setback distances. Figure C.15 photograph was taken further back and the results were closer to the field observed gradation.

The material found within the talus pile on the left bank is among the largest sized boulders available onsite and is appropriate for the large erosion protection classes specified at the Copco No. 2 location.

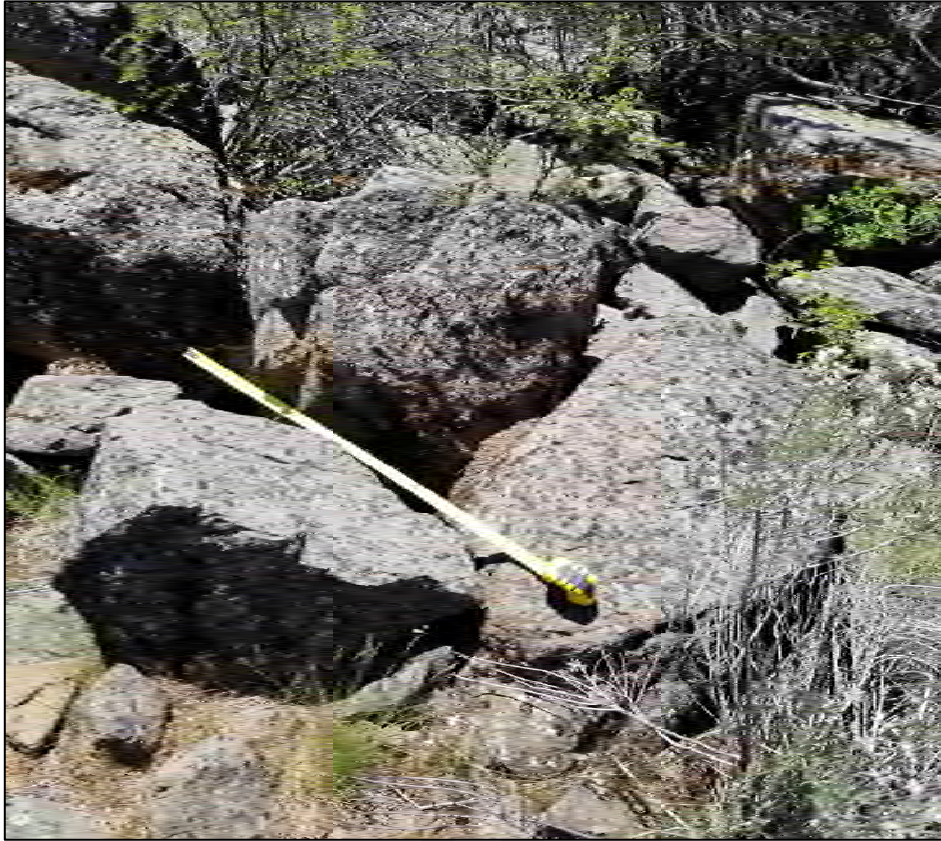
Figure 2.11 Sub-area 4 Downstream, Left Slope coarse particles are scattered and bedded

- Sub-area 3: not a significant source of material.
 - Sub-area 4: not a significant source, localized piles of approximately $D_{50} = 36"$ material (see Figure 2.11).

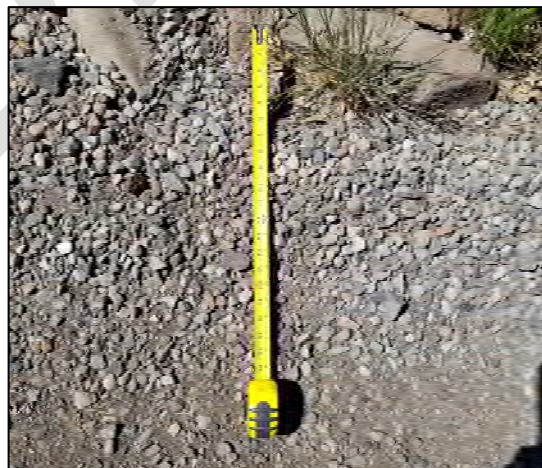
Figure 2.15 J.C Boyle Powerhouse Road Surfacing Material

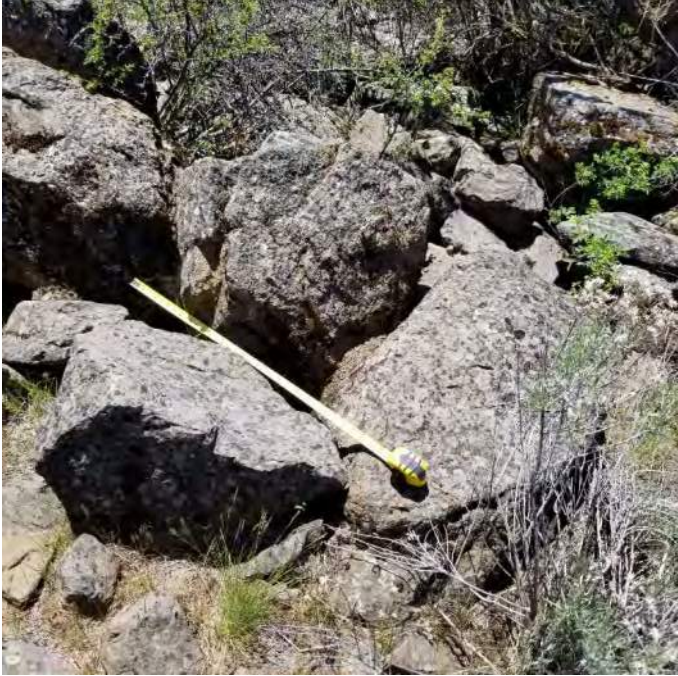
Photo No. 27.

Date: May 6, 2020	
Description: J.C. Boyle Dam – Downstream, tape measure for scale.

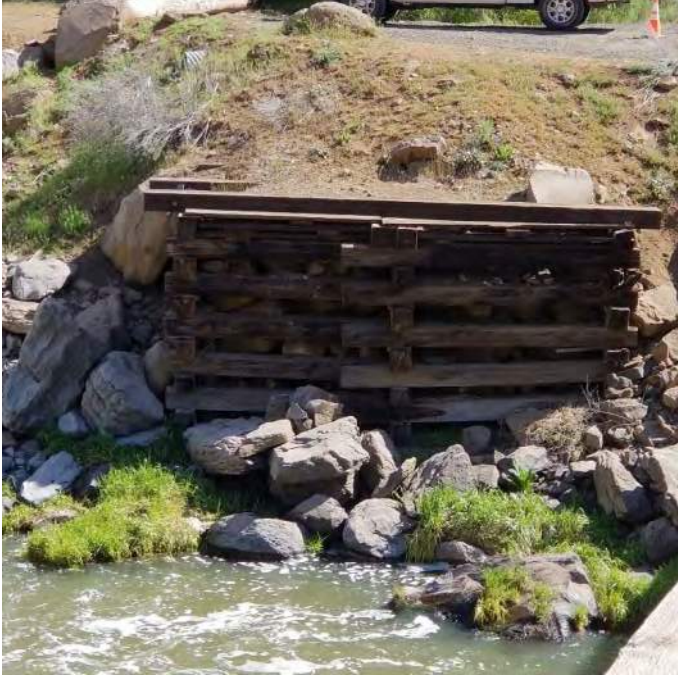
Photo No. 31.

Date: May 6, 2020	
Description: J.C. Boyle Bridge, old timber abutment.

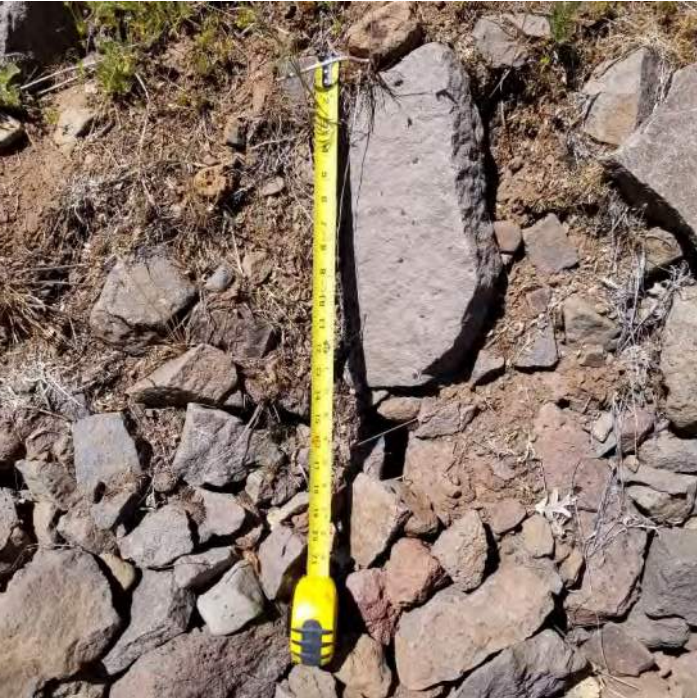
Photo No. 9.	
Date: May 6, 2020	
Description: J.C. Boyle Powerhouse, berm at side of road, tape measure for scale.

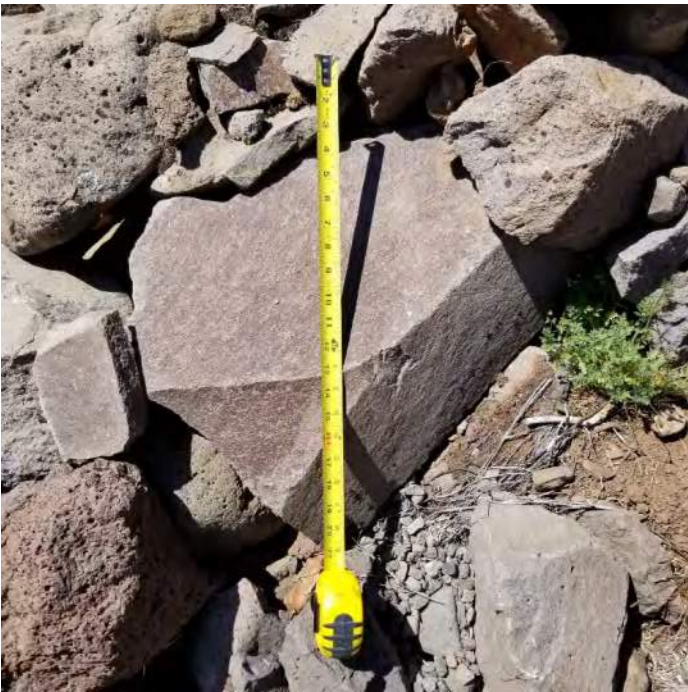
Photo No. 10.	
Date: May 6, 2020	
Description: J.C. Boyle Powerhouse, slope north of road, tape measure for scale.

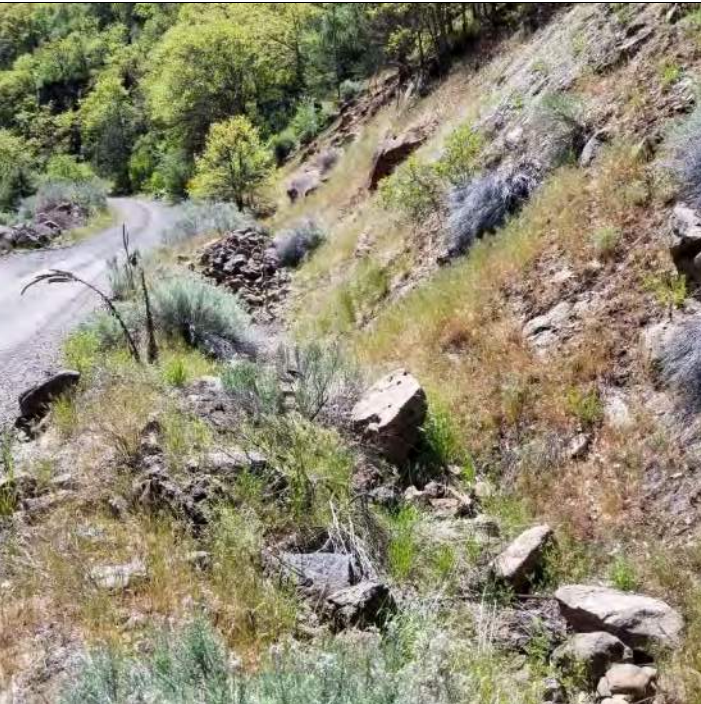
Photo No. 12.

Date: May 6, 2020			
Description: J.C. Boyle Powerhouse, toe of slope north of road, photo facing west.

- Sub-area 1: Variable material, typically clayey sand and gravel to clayey gravel with sand, 1-foot minus with boulders and cobbles. Localized concentrated cobble to boulder sized particles present on surface adjacent to road (see JCB Powerhouse Photo 11 in Appendix B). Localized pile was analyzed using Split-NET, as shown in Appendix C - Figure C.22. Results indicated a $D_{85} = 14"$, $D_{50} = 8."$ and $D_{15} = 1.5"$.
- Sub-area 2: Road surfacing gravel nominal size nominal 1-inch; grey sandy gravel; 0.05 to 0.1 ft. in thickness, approximately 3,700 yd², however due to limited thickness of the pavement, there is limited salvageable road coarse material. A Split-NET analysis was complete on the road material, as shown in Appendix C – Figure C.23, however the large cobbles in the top of created unrepresentative results.

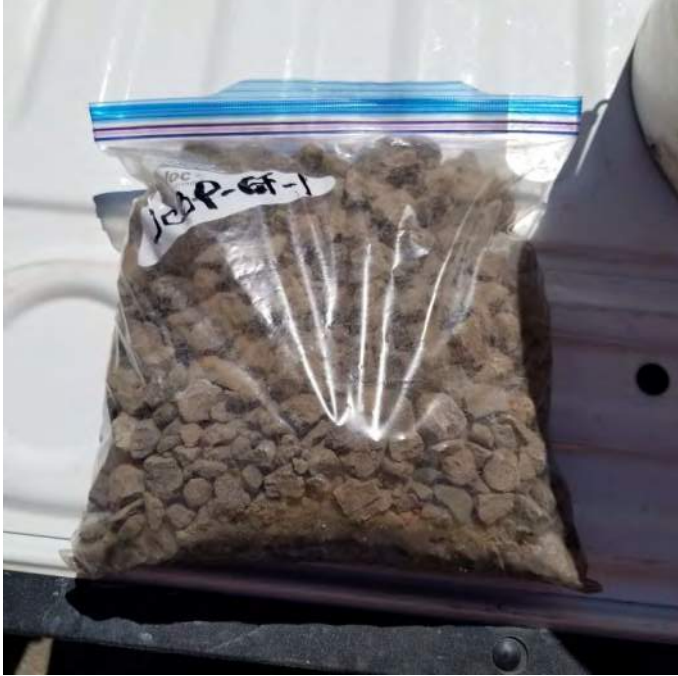
Photo No. 17.

Date: May 6, 2020	
Description: J.C. Boyle Powerhouse, sample of road wearing course.

- Road course and parking lot generally 1-inch nominal with trace cobbles and boulders, zero to low plasticity, silty sand, and gravel, black in color when moistened. A Split-NET gradation analysis was completed and is presented in Appendix C - Figure C.21. Results indicated a $D_{85} = 0.75"$, $D_{50} = 0.2"$ and $D_{15} = 0.02"$.
- Approximately 0.2 ft in depth within gravel surfacing.
- Material adjacent to road covered areas, gravel with sand, 10-20% cobbles, low to medium plasticity, likely oxidized native material, reddish brown in color when moistened. Material with similar properties exists in access roads below road surfacing gravel (See Figure 2.13).
- Road surfacing area is approximately 2,800 square yards based on aerial imaging, however due to limited thickness of the pavement, there is limited salvageable road coarse material.
- No samples were obtained in this area.

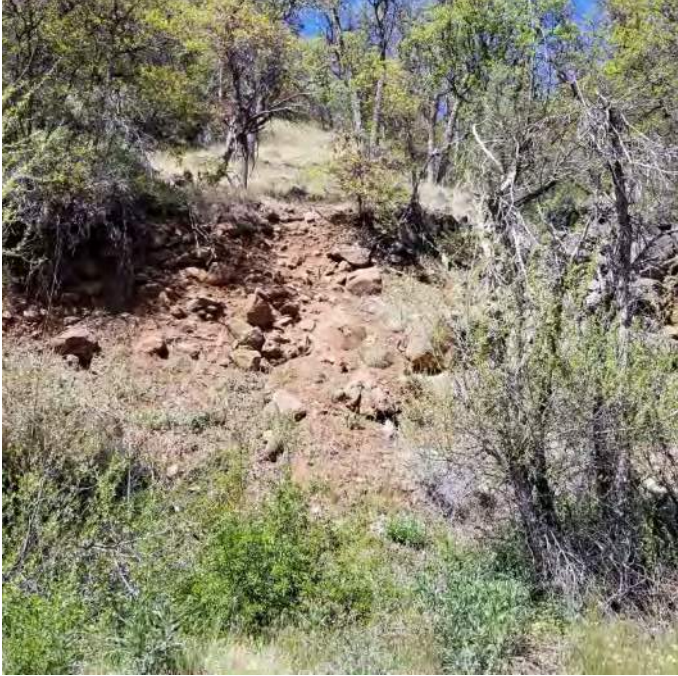
Photo No. 19.

Date: May 6, 2020	
Description: J.C. Boyle Powerhouse, slope north of road.

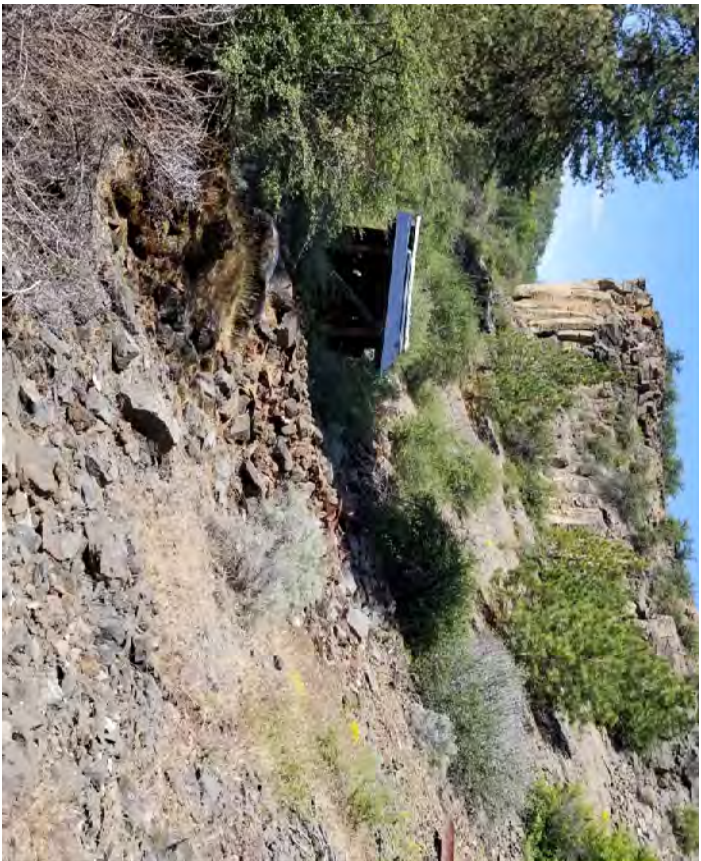
Photo No. 7.	
Date: May 5, 2020	
Description: Copco 1 Right Bank road – Zone 2

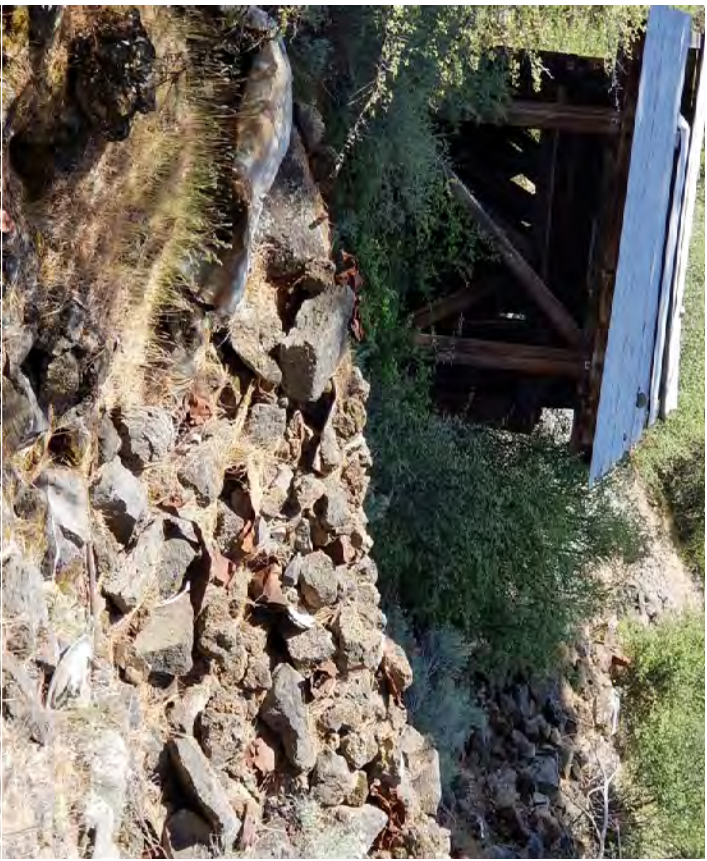
Photo No. 8.	
Date: May 5, 2020	
Description: Copco 1 Right Bank road – Zone 2, toe of slope

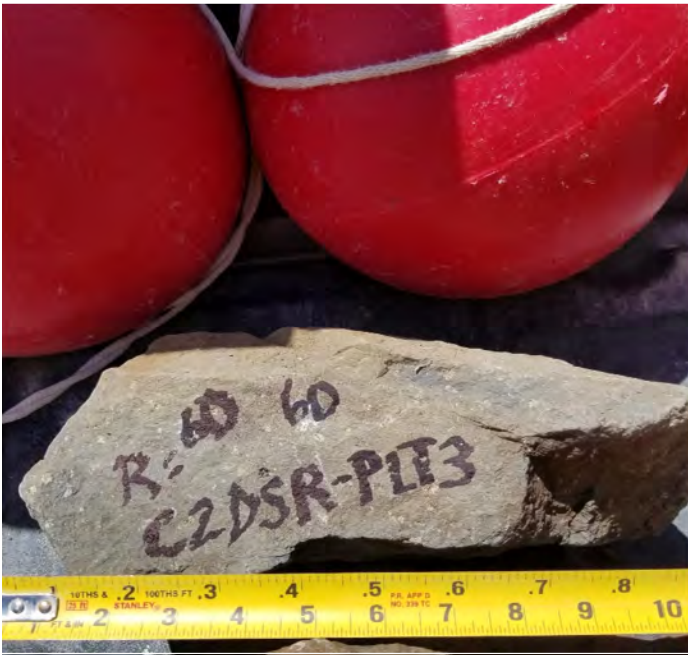
Photo No. 10.

Date: May 5, 2020	
Description: Copco 2, Right Bank Downstream – PLT sample 3

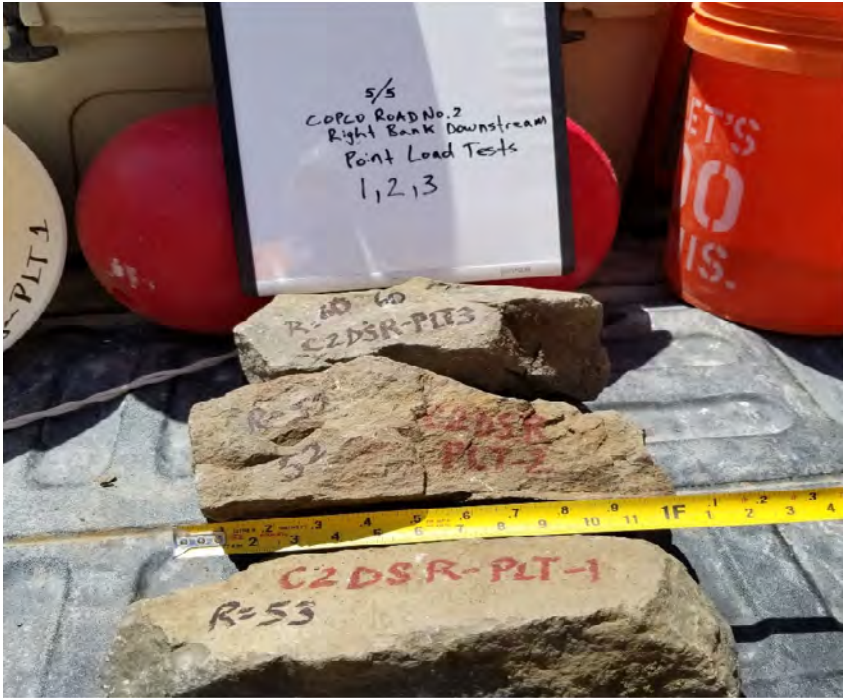
Photo No. 11.

Date: May 5, 2020		
Description: Copco 2, Right Bank Downstream – All 3 PLT samples

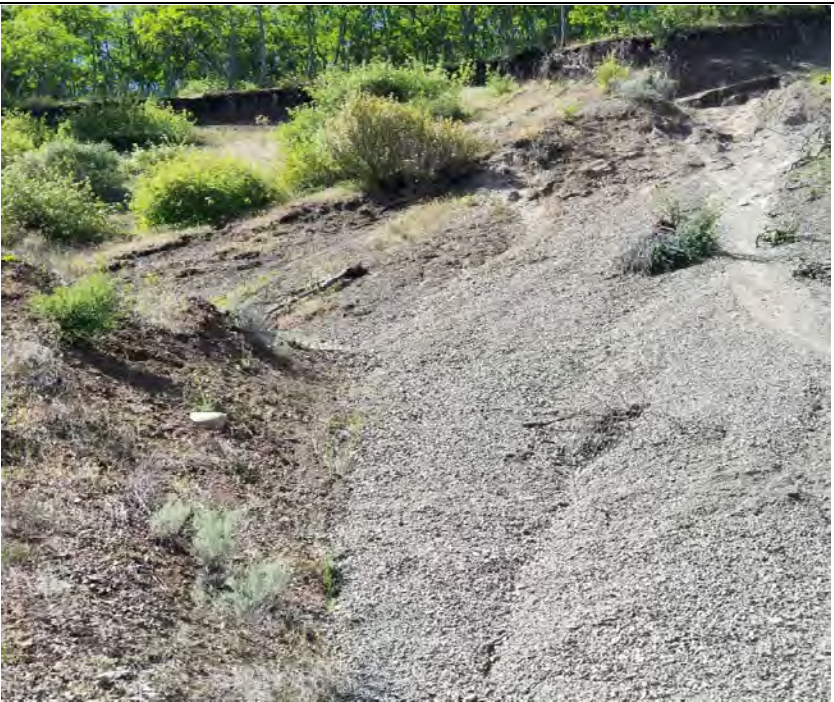
Photo No. 7.

Date: May 7, 2020	
Description: Copco 2 wood-stave Penstock

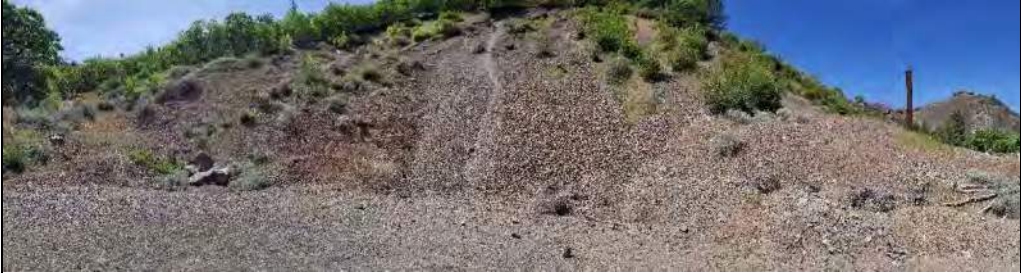
Photo No. 16.

Date: May 7, 2020	
Description: Copco 2 wood-stave Penstock - panorama

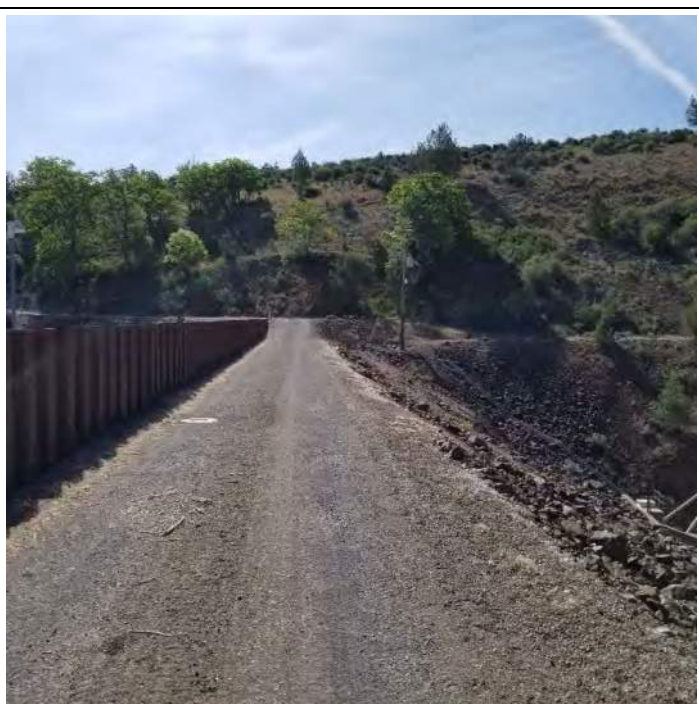
Photo No. 10.

Date: May 7, 2020		
Description: Iron Gate DS Dam Shell – along crest facing east

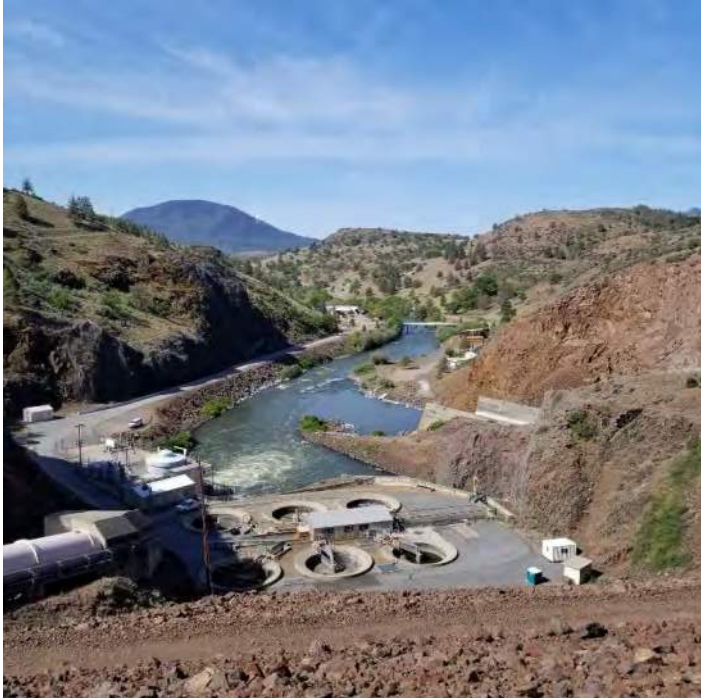
Photo No. 13.

Date: May 7, 2020			
Description: Iron Gate DS Dam Shell – facing downstream

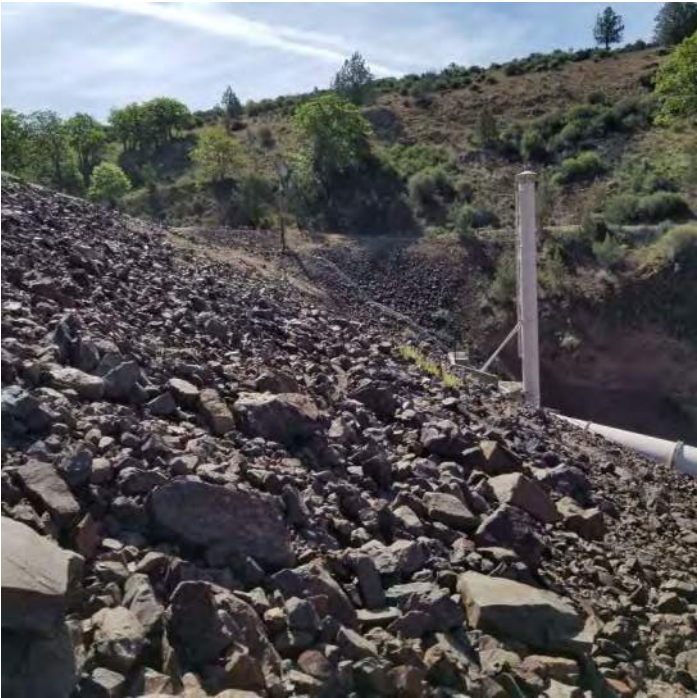
Photo No. 17.

Date: May 7, 2020		
Description: Iron Gate DS Dam Shell – Zone 3, facing east

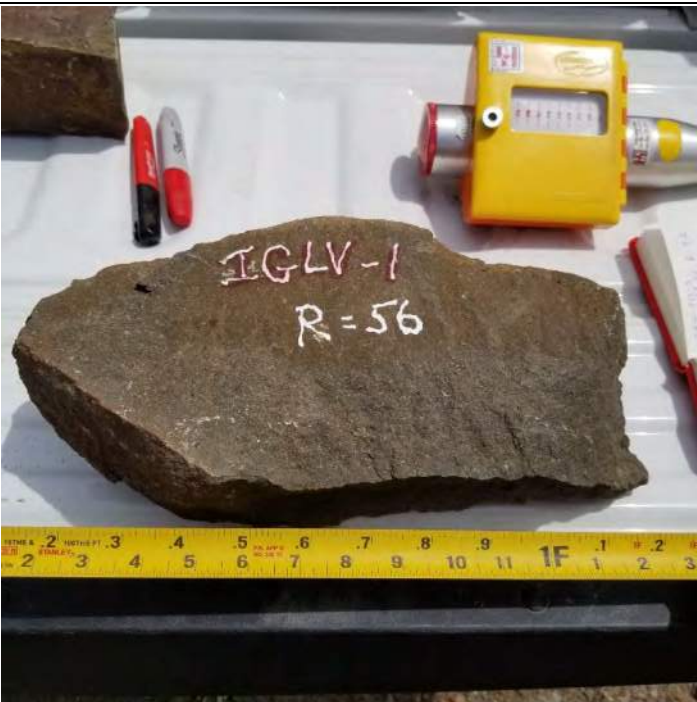
Photo No. 1.	
Date: May 4, 2020	
Description: Iron Gate – Lakeview Road PLT sample.

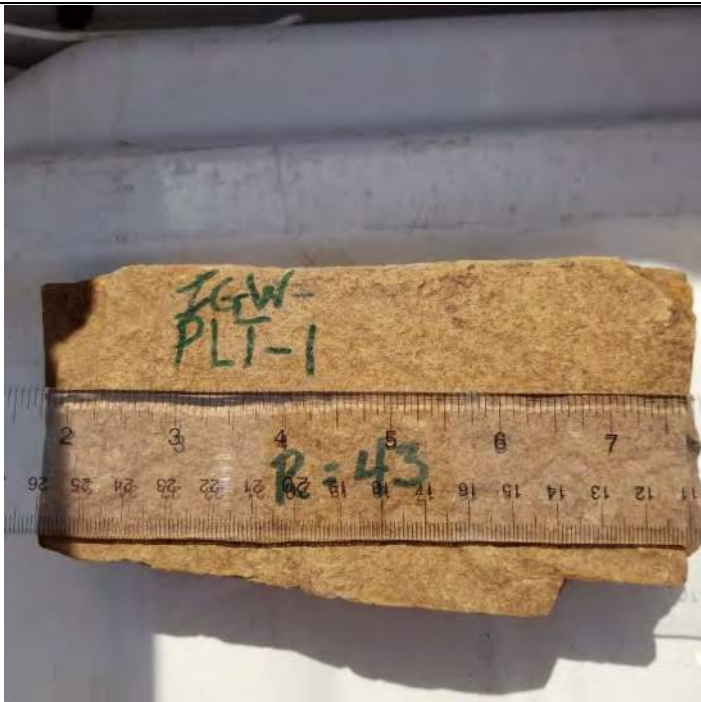
Photo No. 9.

Date: May 4, 2020	
Description: Iron Gate Workers Accommodation Area PLT sample.

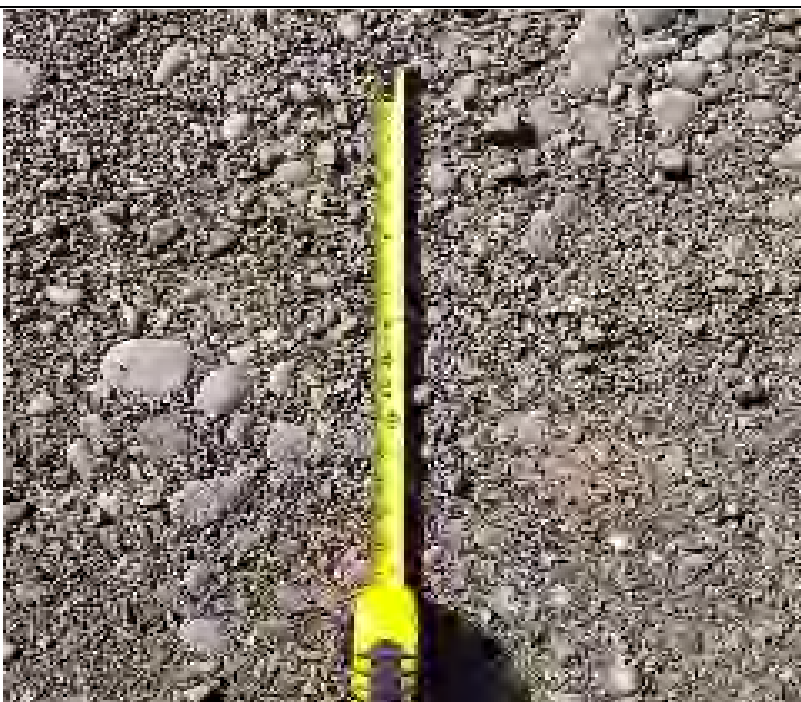
Photo No. 10.

Date: May 7, 2020	
Description: Iron Gate Workers Accommodation Area, road wearing course.

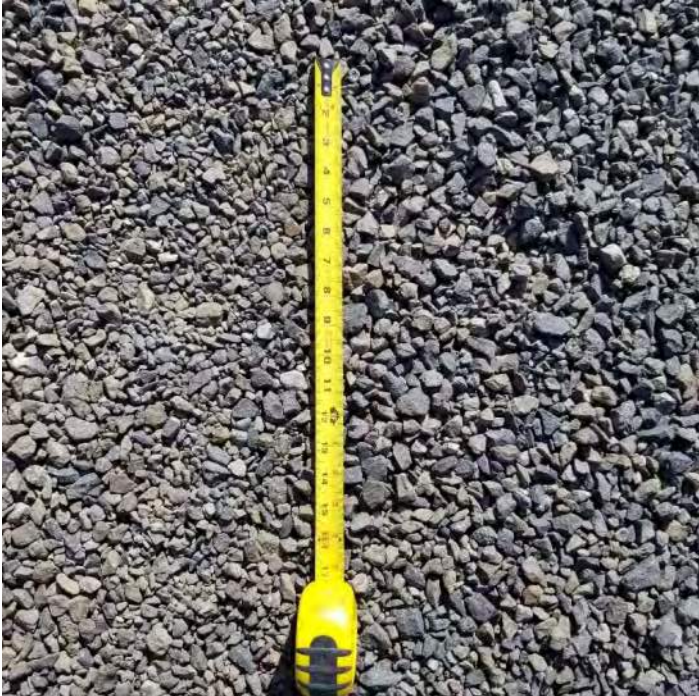
Photo No. 11.

Date: May 7, 2020			
Description: Iron Gate Workers Accommodation Area, road wearing course.

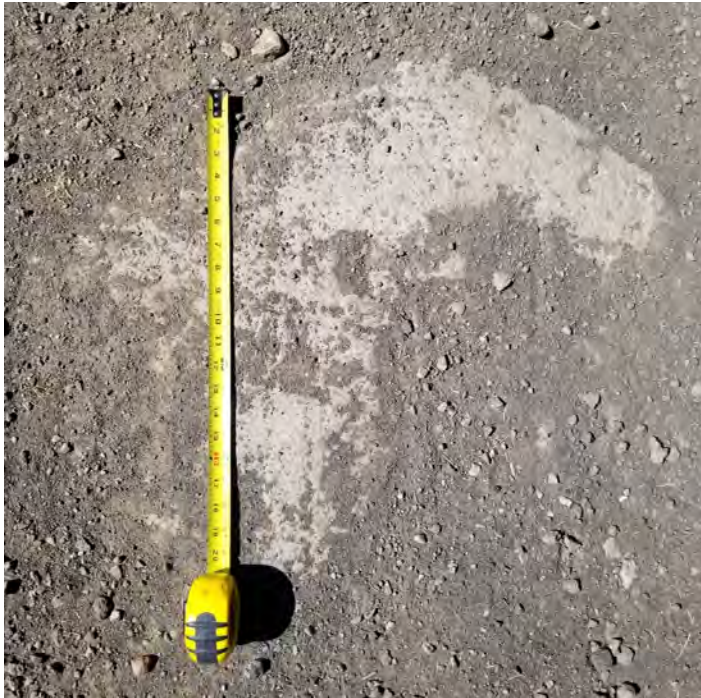
Photo No. 9.

Date: May 6, 2020			
Description: Forebay road surface – Dmax view

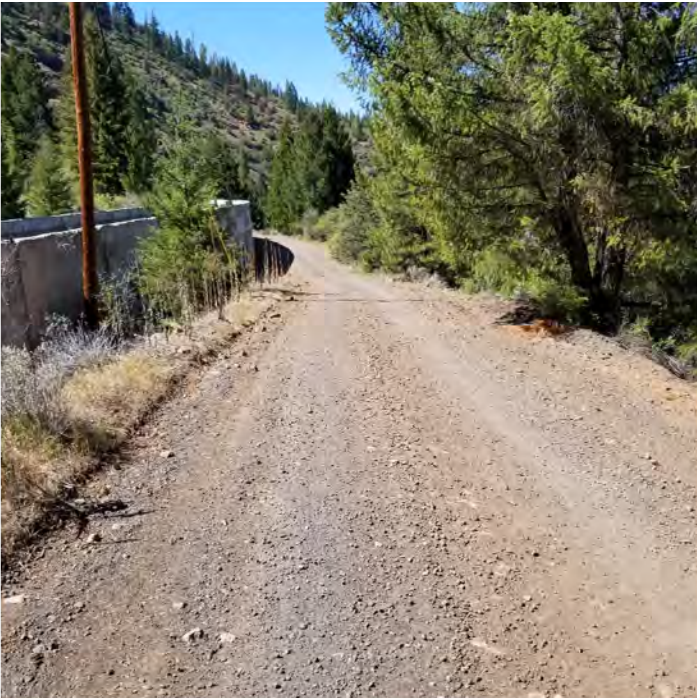
Photo No. 11.

Date: May 6, 2020			
Description: Forebay road surface – Northern portion of site access road

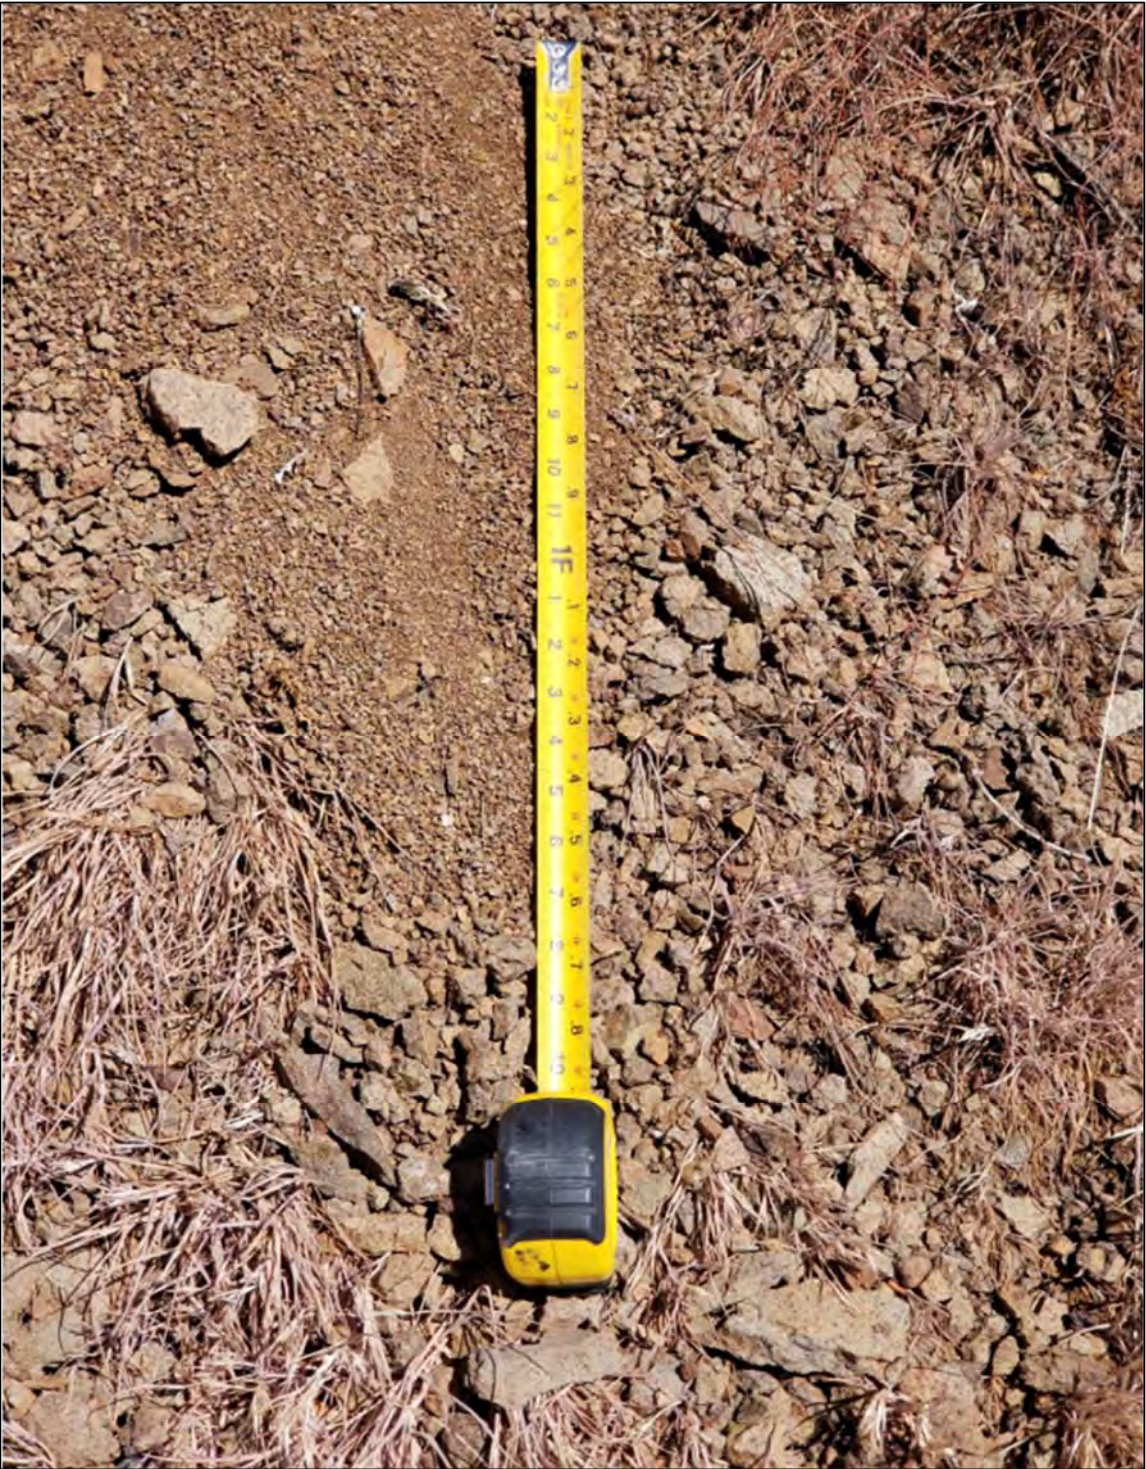
(Figures C.1 to C.23)

Split-NET Analysis Results

Size[in]	% Passing
75	100.00
50	100.00
25	100.00
15	100.00
10	100.00
8	100.00
6	100.00
4	100.00
2	93.67
1	76.83
0.75	69.19
0.5	60.10
0.38	54.11
0.25	45.18
0.19	39.64
0.08	26.91

% Passing	Size[in]
F10	0.01
F20	0.04
F30	0.10
F40	0.19
F50	0.31
F60	0.50
F70	0.77
F80	1.13
F90	1.67
Topsize (99.95%)	3.41
