RE: KRRP Value Engineering Summary and Advancement to 90% Design

VE-1 Submittals: Drawdown Model and Assessment

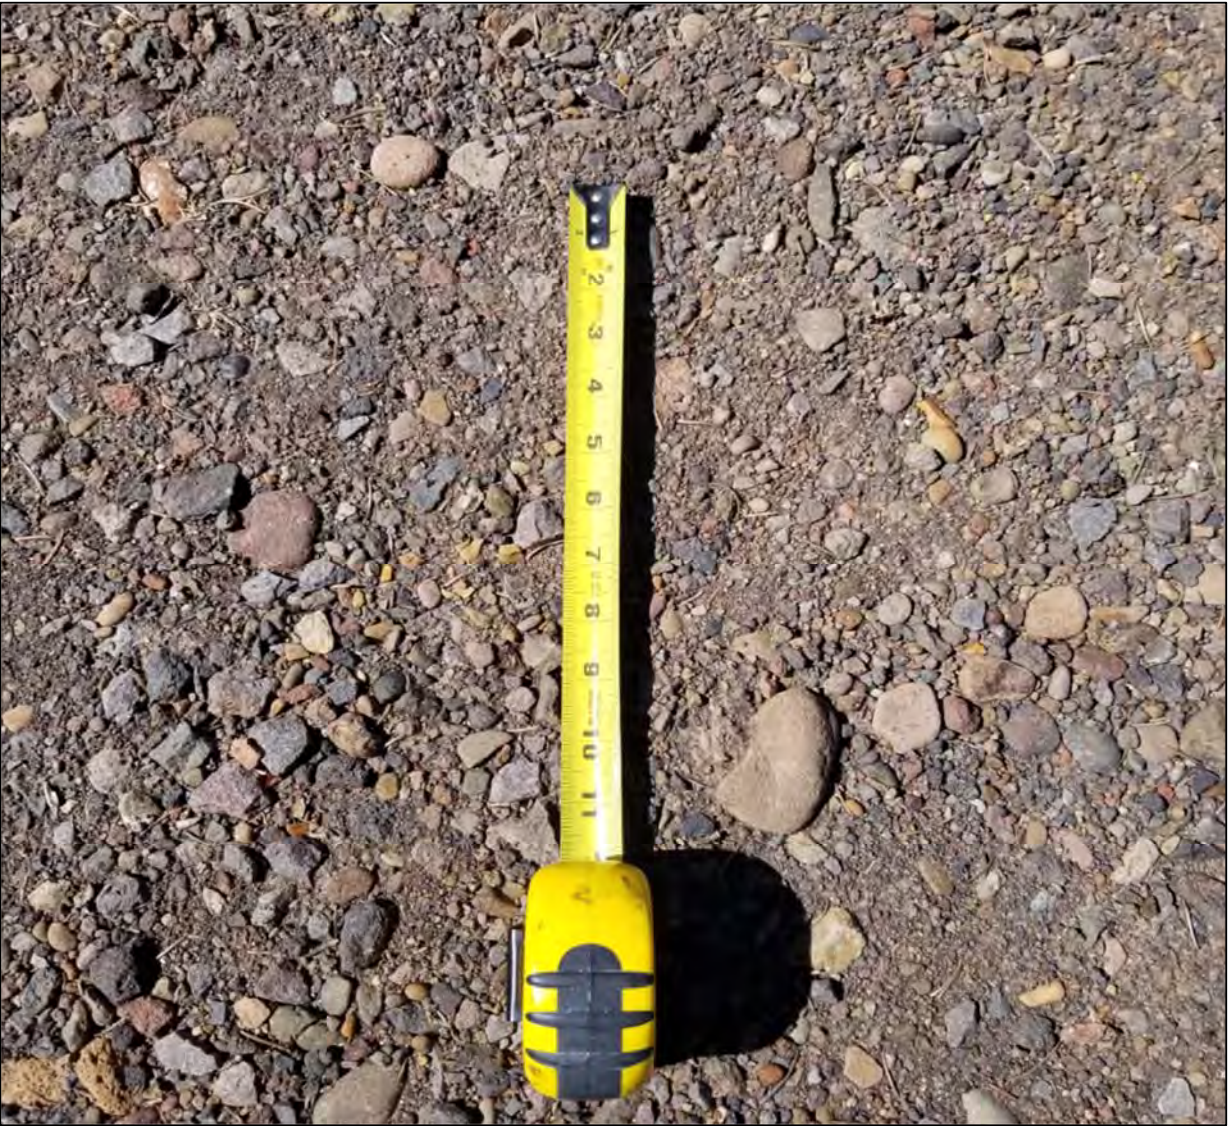
FIGURE C.21

Size[in]	% Passing
75	100.00
50	100.00
25	100.00
15	100.00
10	100.00
8	100.00
6	100.00
4	100.00
2	98.83
1	91.72
0.75	85.23
0.5	73.52
0.38	66.08
0.25	55.91
0.19	48.19
0.08	30.01

% Passing	Size[in]
F10	0.01
F15	0.02
F20	0.04
F30	0.08
F40	0.13
F50	0.20
F60	0.29
F70	0.44
F80	0.62
F85	0.74
F90	0.91
Topsize (99.95%)	2.29

- NOTES:
- 1. STANDARD TAPE MEASURE FOR SCALE
 - 2. ANALYSIS CONDUCTED BY SPLIT ENGINEERING

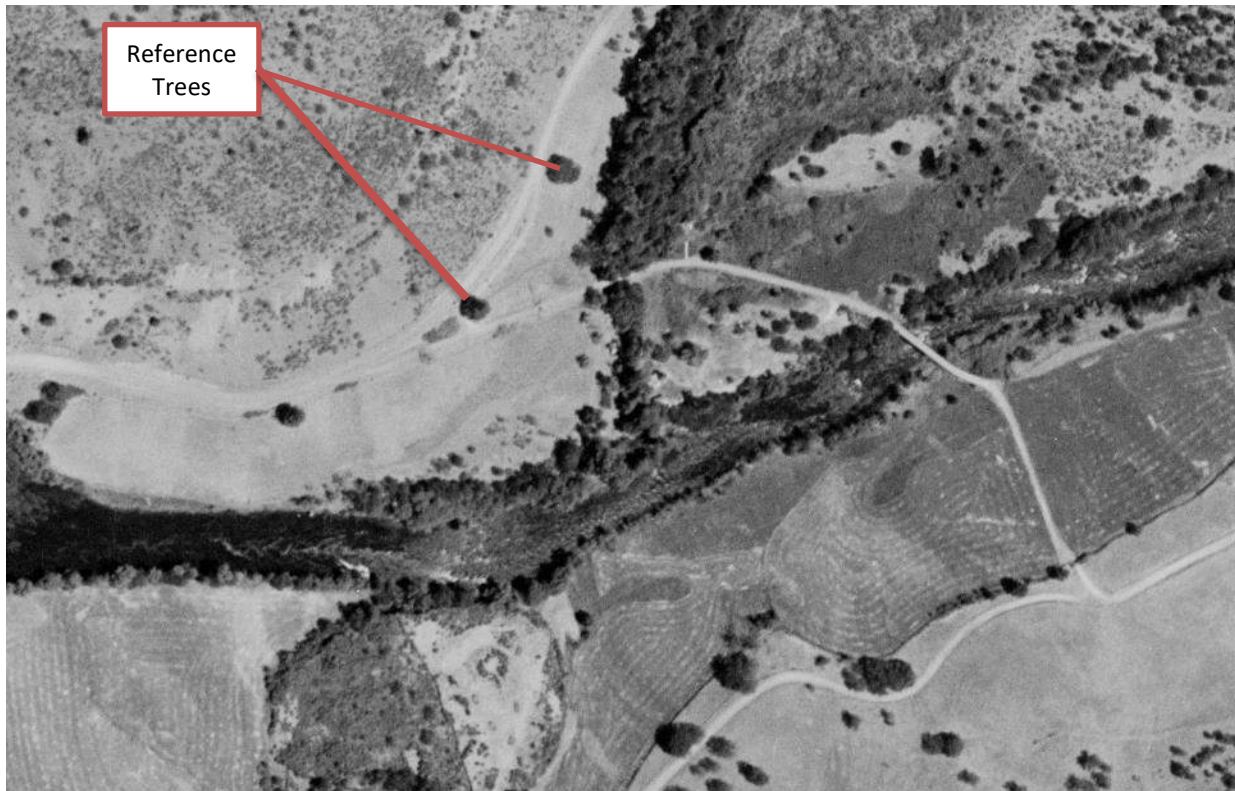
Figure 5. 1955 Pre-Iron Gate Dam

Review of field surveyed topographic data shows the average slope from downstream of Daggett Road crossing to upstream of the Substation Access Road crossing is about 0.028 ft/ft. NHC observed local slopes within instream geomorphic units near 8 percent (0.08 ft/ft) within this reach. LiDAR and bathymetric data suggest the average stream slope between the Daggett Road crossing and the post dam confluence elevation with the Klamath River will range from about 0.03 to 0.05 ft/ft. Aerial images are provided of the confluence in 2019 (Figure 4) and in 1955 (Figure 5), prior to dam construction.

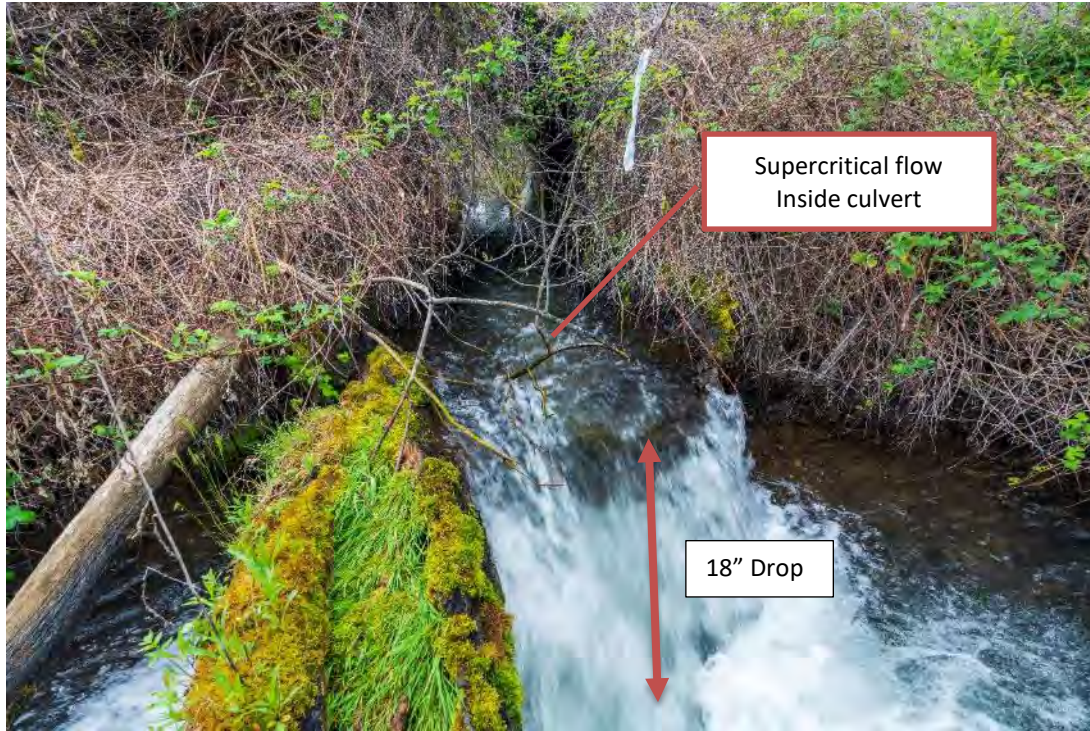
Image 5. Looking upstream at Daggett Road Culvert

The Daggett Road Culvert slopes at about 4.3 percent (0.043 ft/ft). Flows within the culvert are supercritical and the outlet is perched. During low flows, the hydraulic drop at the culvert outlet is about 18 inches. This drop likely increases during higher flows. These hydraulic/geometric factors could create conditions that are likely to be a complete barrier to juvenile and adult salmonids. Channel conditions near the culvert are shown in Image 3 through Image 7. The active channel width ranges from about 15 to 25 feet near the crossing (Image 8).

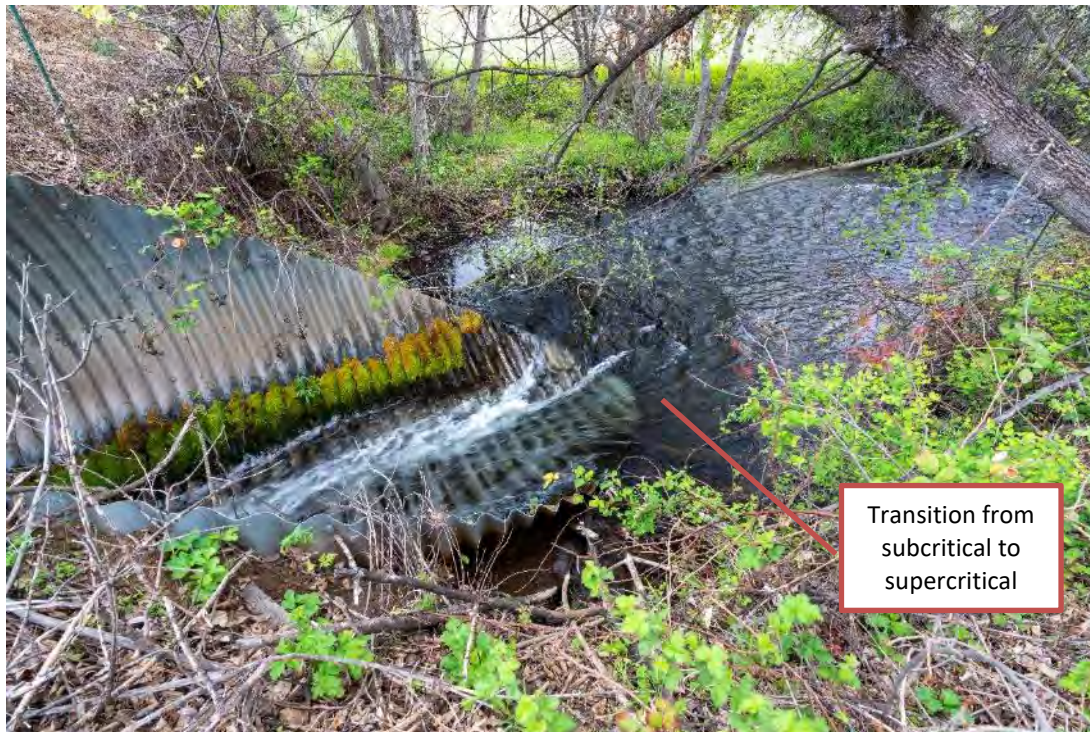
Image 6. Daggett Road Culvert Inlet

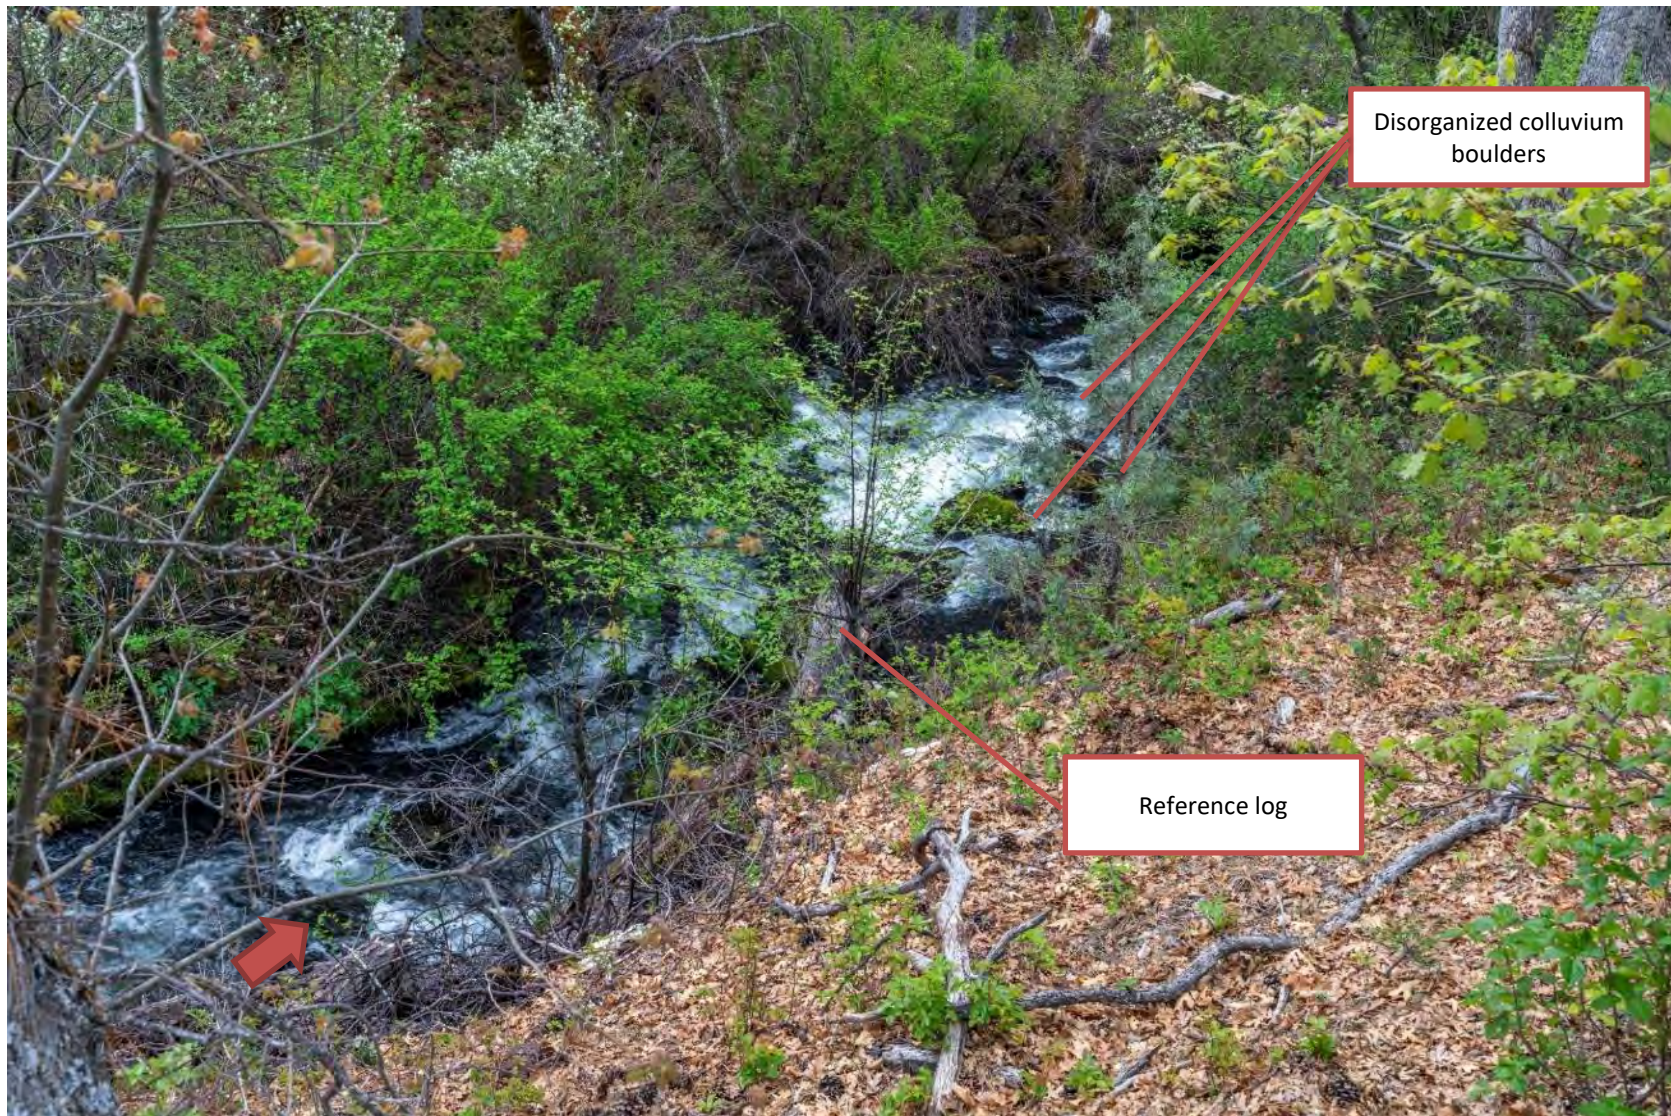
Image 10. Cascade along the gorge reach between Daggett and the Substation Access Road

The creek becomes confined upstream of Daggett Road as the natural valley slopes converge constricting the channel. Valley bottom confinement increases as road construction further encroaches on the stream corridor. Several wood jams exist within this reach (Image 9). The creek morphology consists of a cascade (Image 10 and Image 11) and a series of step pools (Image 12 and Image 13). Channel widths are highly constrained in this reach (Image 14). However, isolated floodplain pockets consisting of dense vegetation growing on talus and debris exist. These channel units are relatively stable. Adjustment likely only occurs during extreme flood flows or during moderate to high flows shortly after rock slides or boulder detachment from the basalt flow. Bed material ranges from boulder, to cobbles with some gravel.

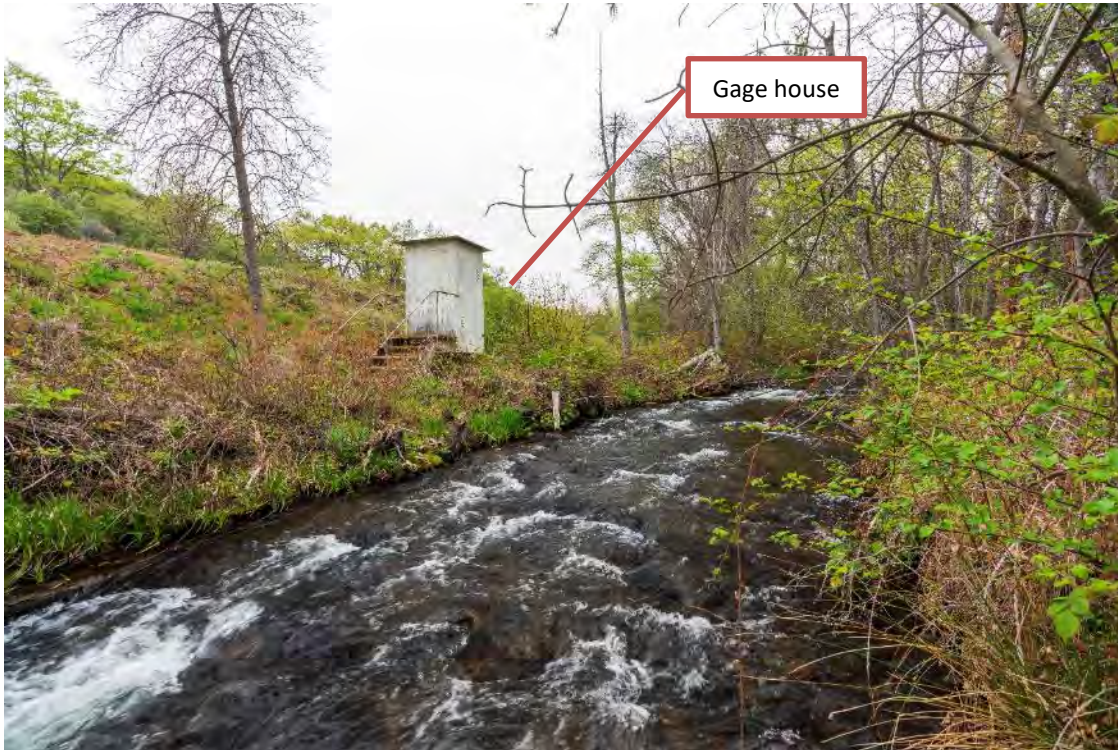
Image 16. Riffle near gage location looking upstream

The creek slope appears to lessen upstream of the gorge from the USGS gage to upstream of the Substation Access Road Bridge (Image 16 and Image 17). Upstream of the USGS gage, the active channel bifurcates forming two channels separated by a vegetated island. Debris jams span both channels near the island head (Image 18). The two channels converge into one, about 100 feet downstream of the bridge. The wetted channel width ranged from 15 to 18 feet and the active channel width appeared to range from about 18 to 22 feet (Image 19, Image 20, and Image 21). The wetted channel width beneath the bridge is about 15 feet and the active channel width is about 20 feet (Image 22). On the east side (river left), an alder tree downstream of the bridge and a cluster of trees upstream of the bridge influence the hydraulics through the bridge. The left channel bank beneath the bridge is comprised of erosion resistant clay. Rock slope protection and tree roots stabilize the right bank beneath the bridge (Image 23). Review of the bank material and vegetation along the banks did not suggest that measurable incision or bank erosion near the bridge has occurred over the last several decades. Active channel widths upstream of the bridge range from about 18 feet to about 25 feet.

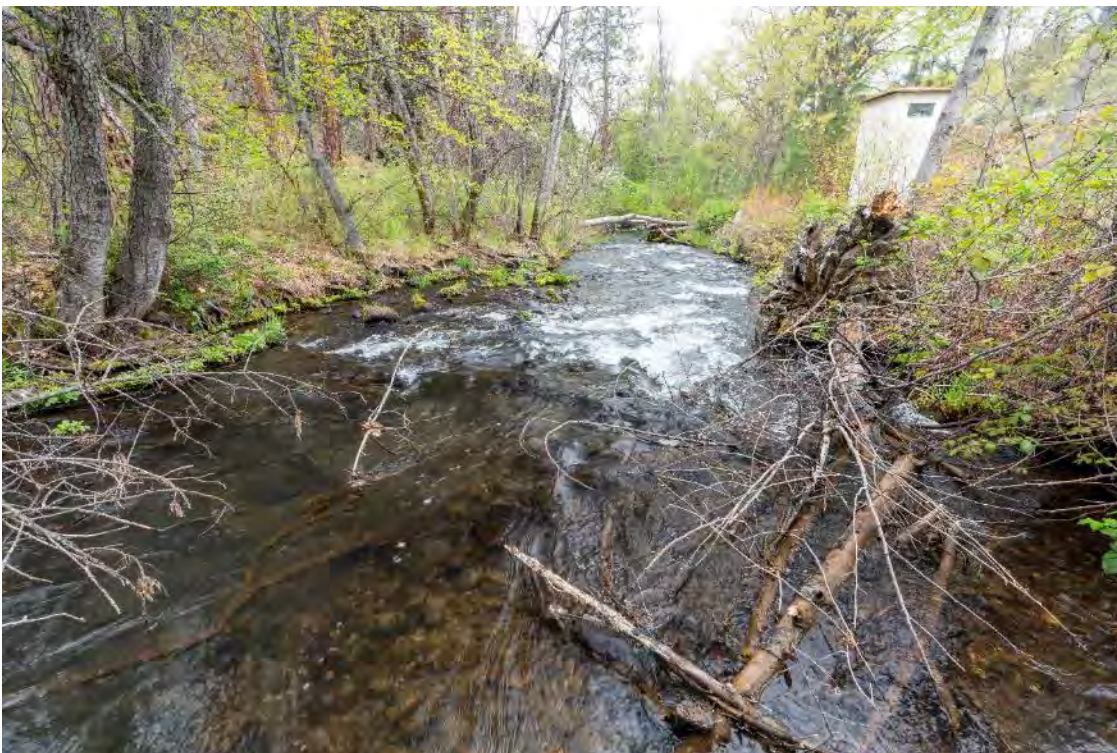
Image 17. Riffle near gage location looking downstream

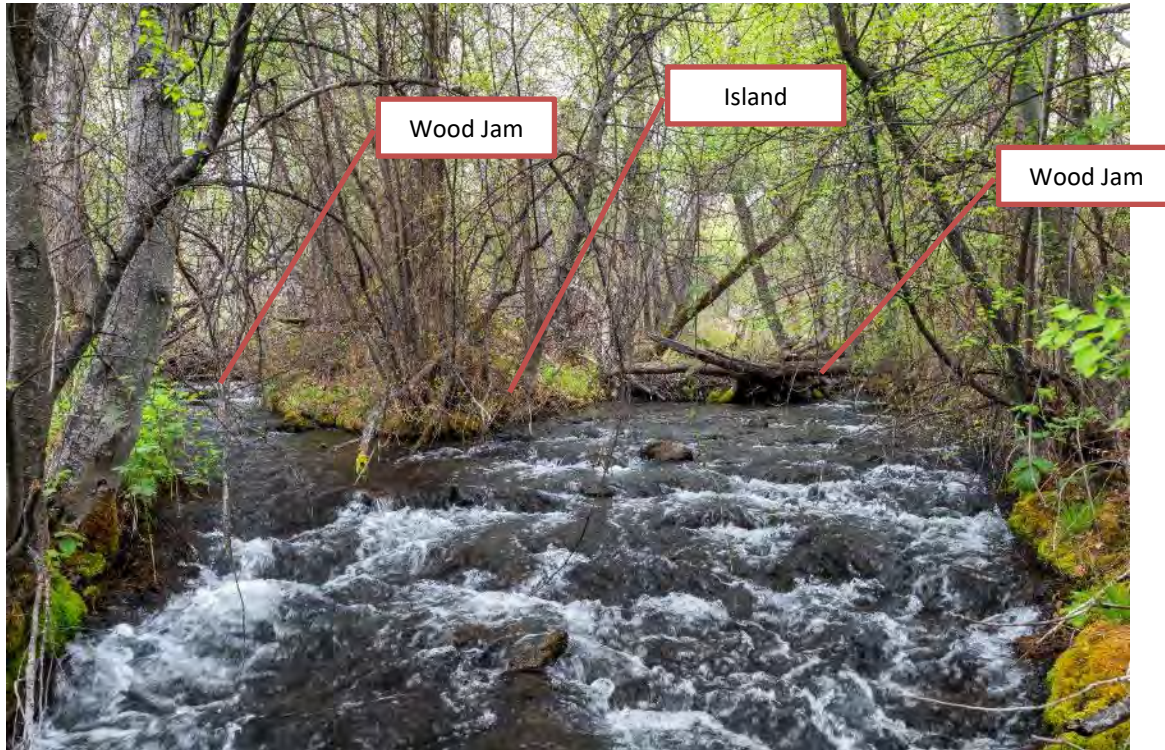
Image 18. Island upstream of stream gage.

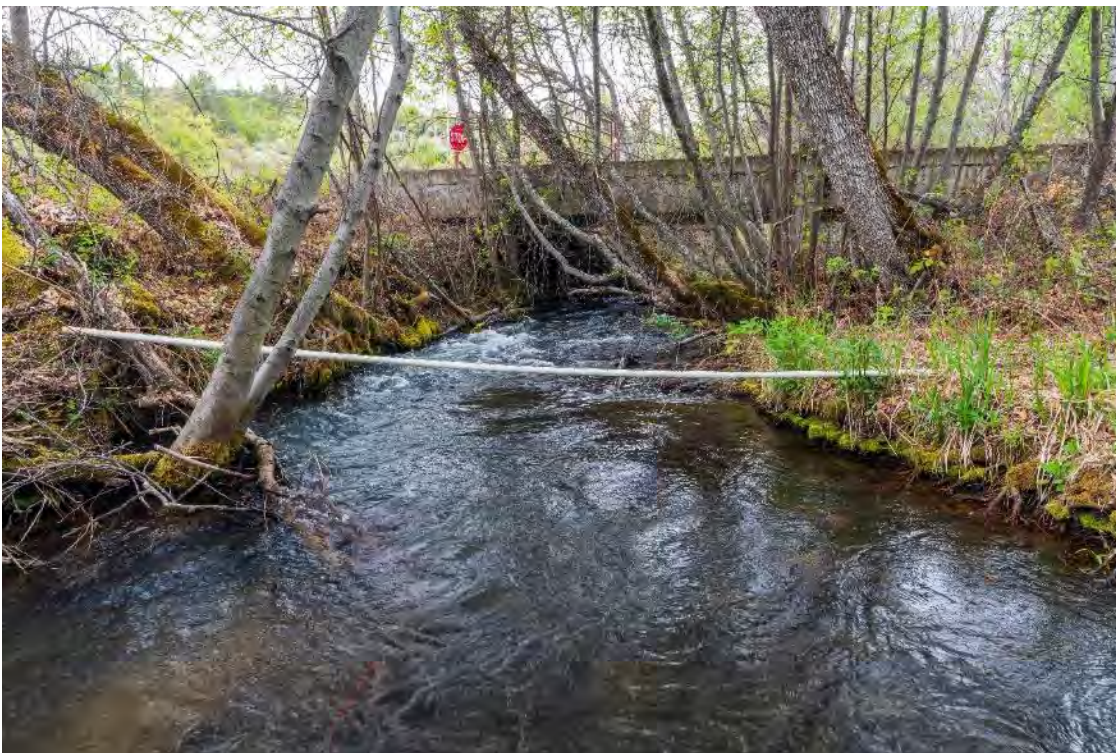
Image 21. Measurement Location about 30 ft downstream of Substation Access Road Bridge

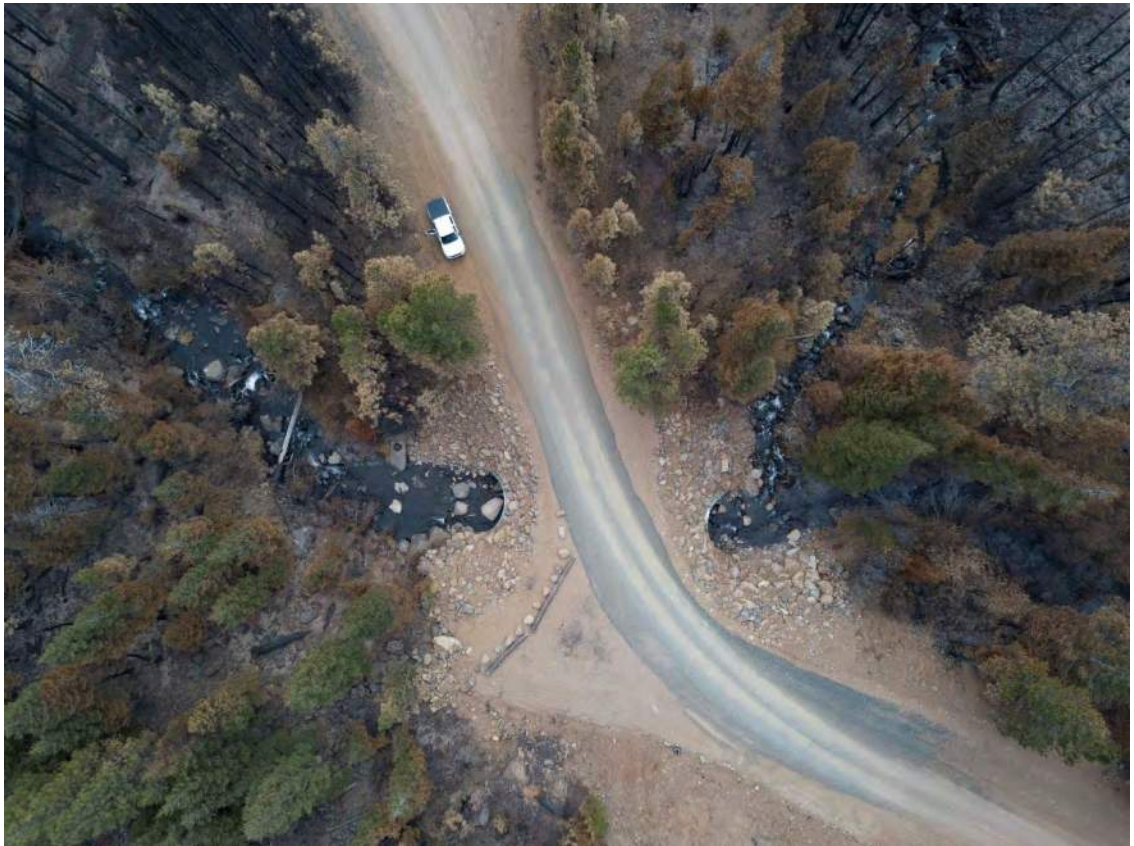
Image 1. Elder Creek Multi-plate sunken culvert 21 ft span, 13 ft rise

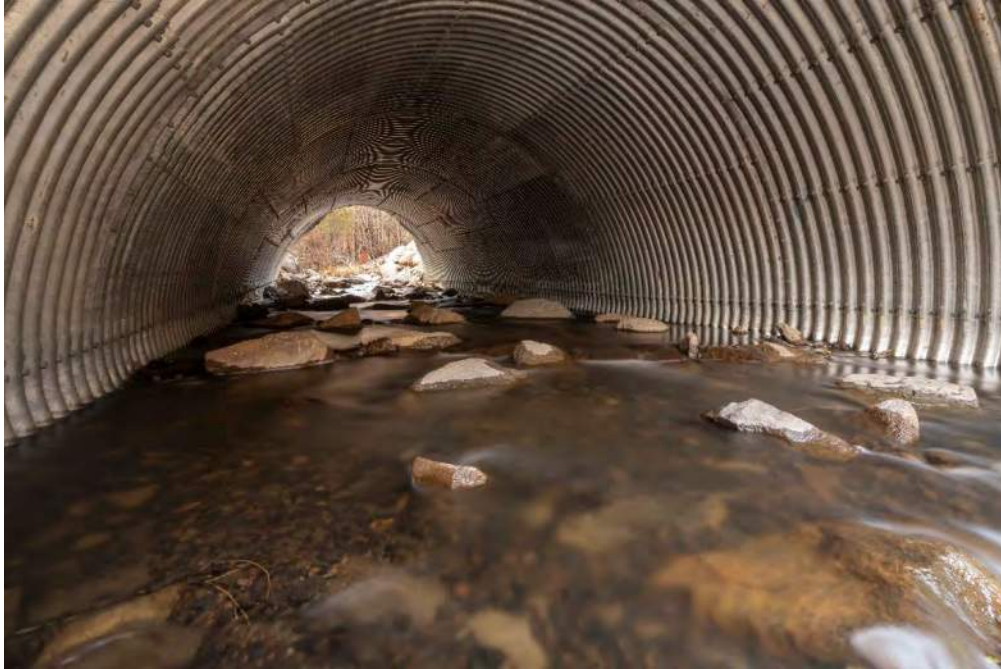
Image 2. Elder Creek Multi-plate sunken culvert 21 ft span, 13 ft rise

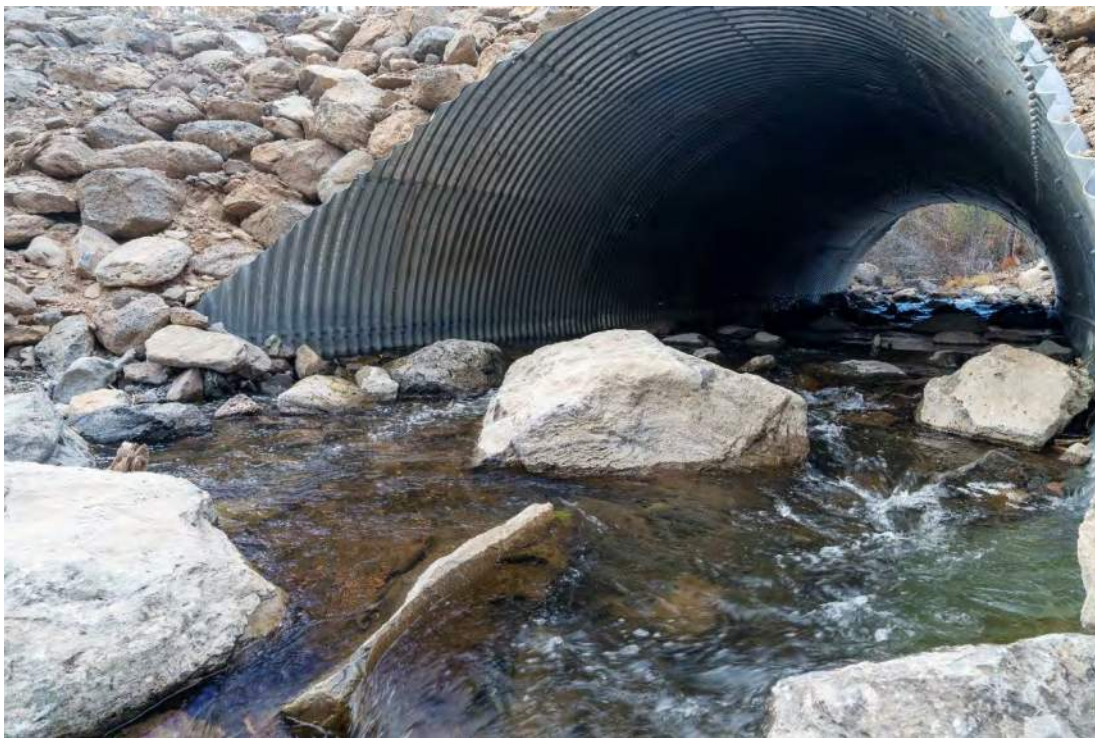
Image 3. Elder Creek Multi-plate sunken culvert (span 21 ft, rise 13 ft)

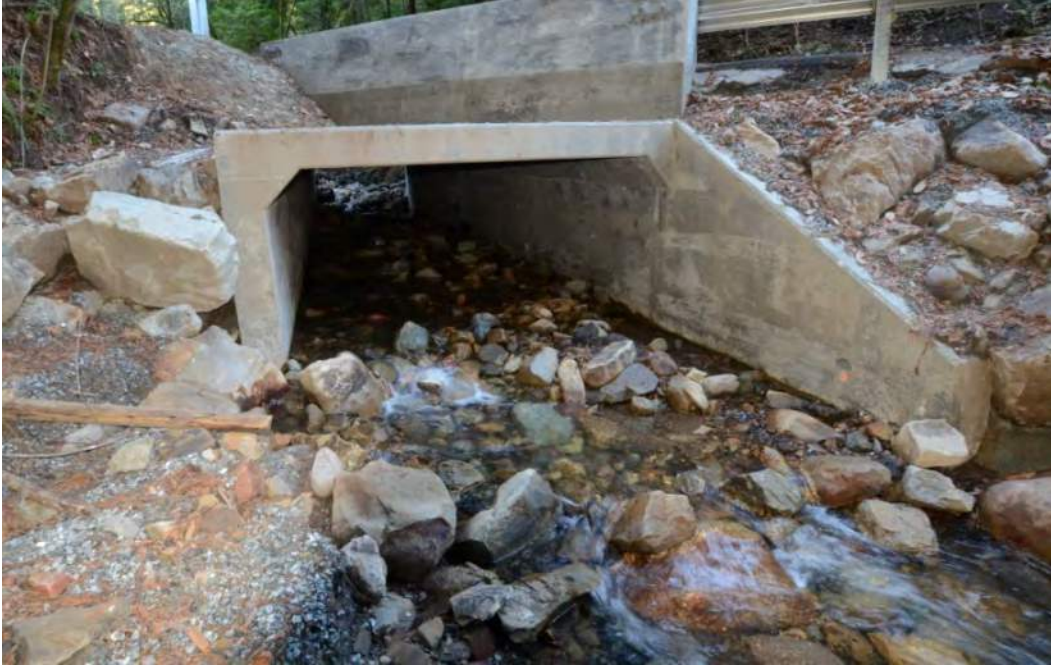
Image 4. Corrolitos Creek Sunken Box Culvert

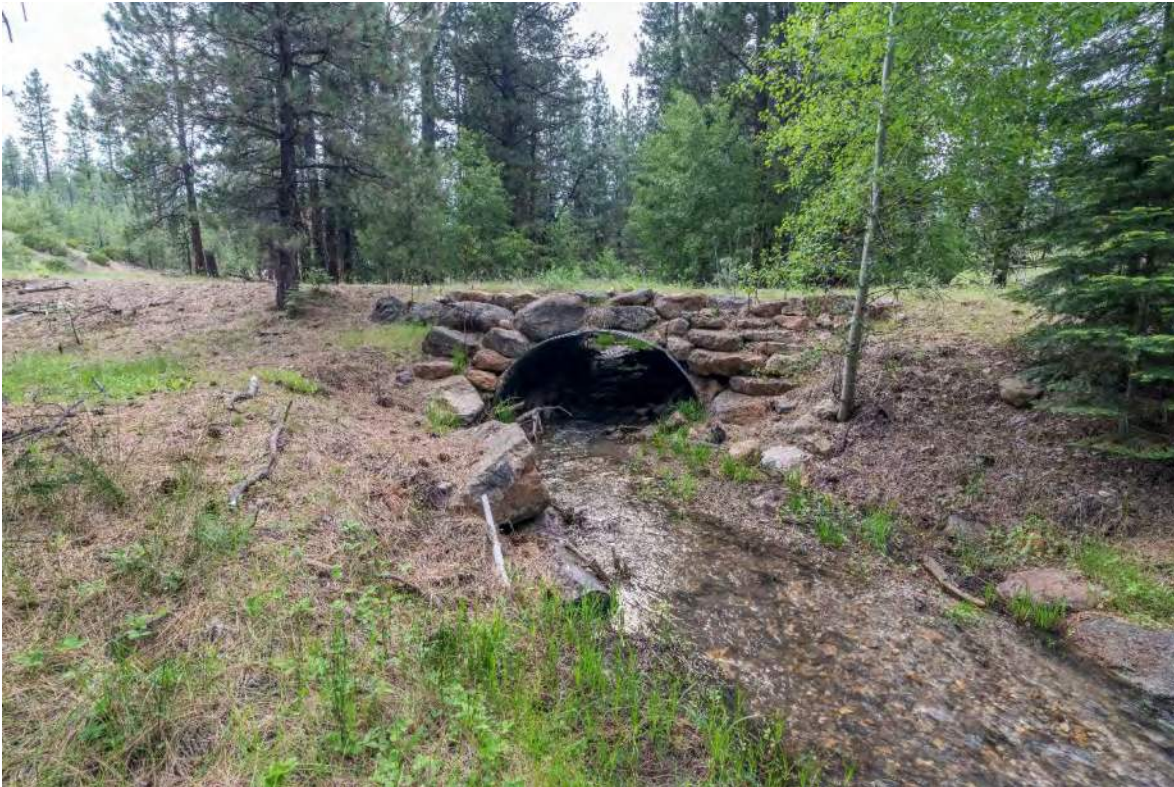
Image 5. Howard Creek Tributary sunken culvert (span 12 ft, 8 ft rise)

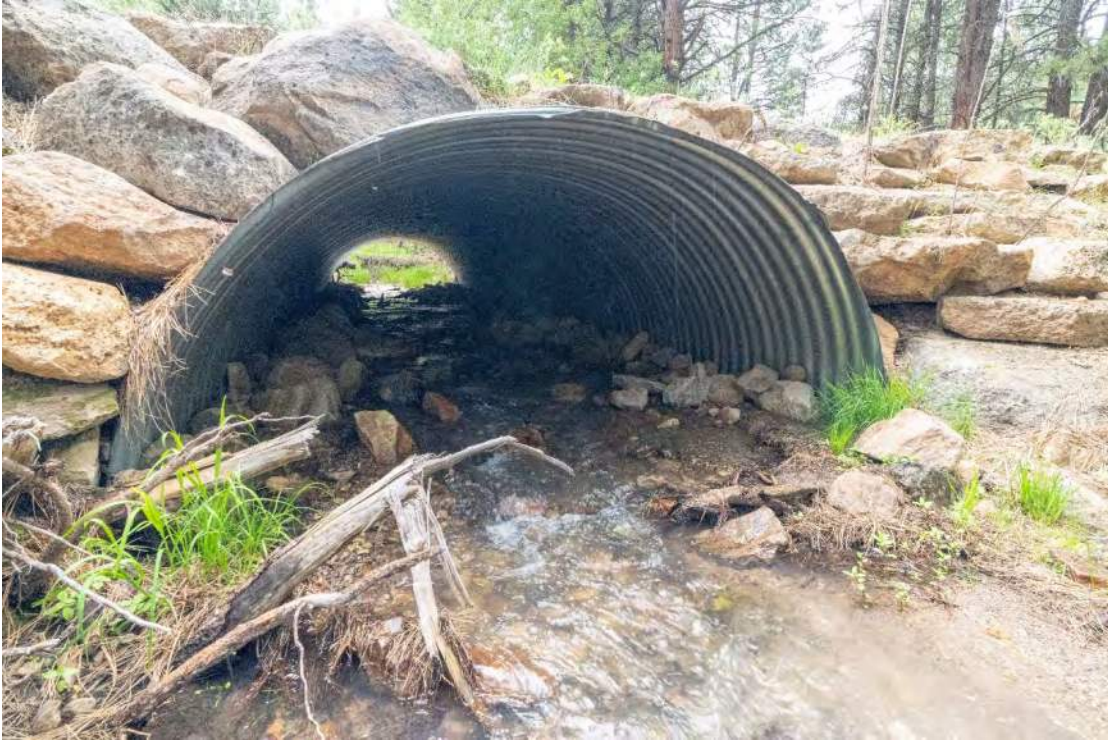
Image 6Howard Creek Tributary sunken culvert (span 12 ft, 8 ft rise)
