Klamath River Renewal Corporation

**LICENSE SURRENDER ORDER
LOWER KLAMATH PROJECT**

Reservoir Drawdown and Diversion Plan

**Lower Klamath Project
FERC Project No. 14803**

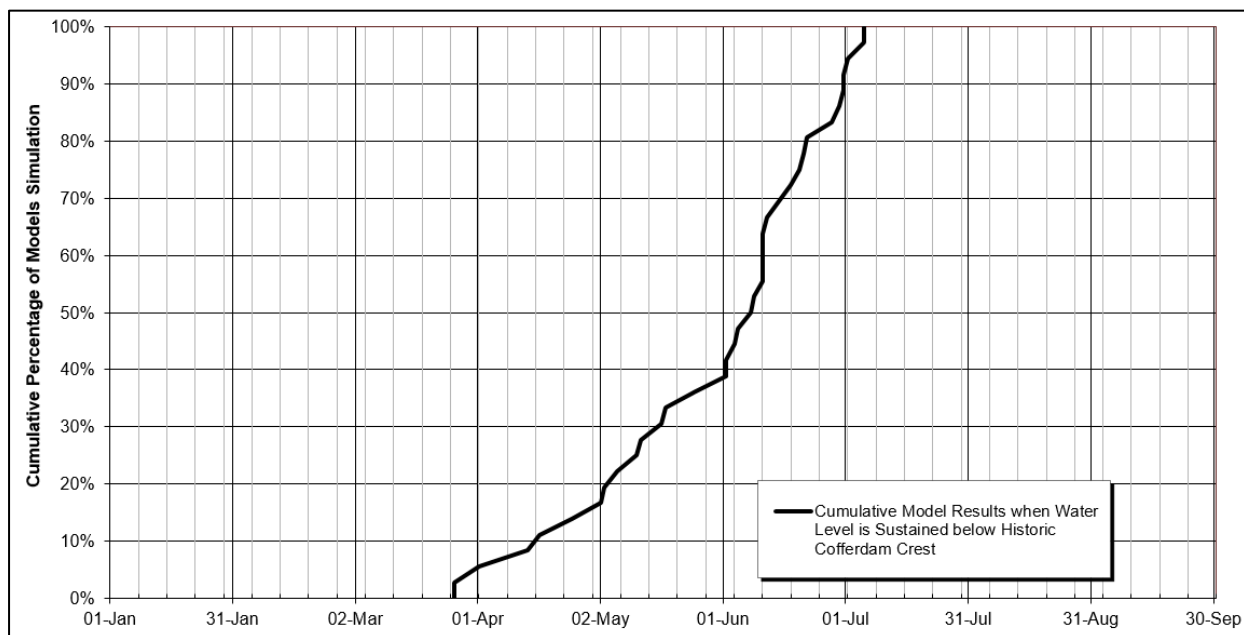
Figure 2-8. Iron Gate Reservoir Drawdown Cumulative Model Simulation Dates to Achieve and Sustain Reservoir Water Surface Levels below the Crest of the Historic Cofferdam Crest

Figure 2-8 shows the cumulative percent of model simulations and the date when the reservoir water surface level is lower, and sustained, below the crest of the historic cofferdam. The drawdown model indicates that approximately 40% of the simulations have reservoir water levels sustained below the crest of the historic cofferdam by June 1, with 100% of the

simulations by July 7. Note that these water levels are for average daily conditions and do not account for the low probability flood flows (i.e., the 1% and 5% probable flood flows).

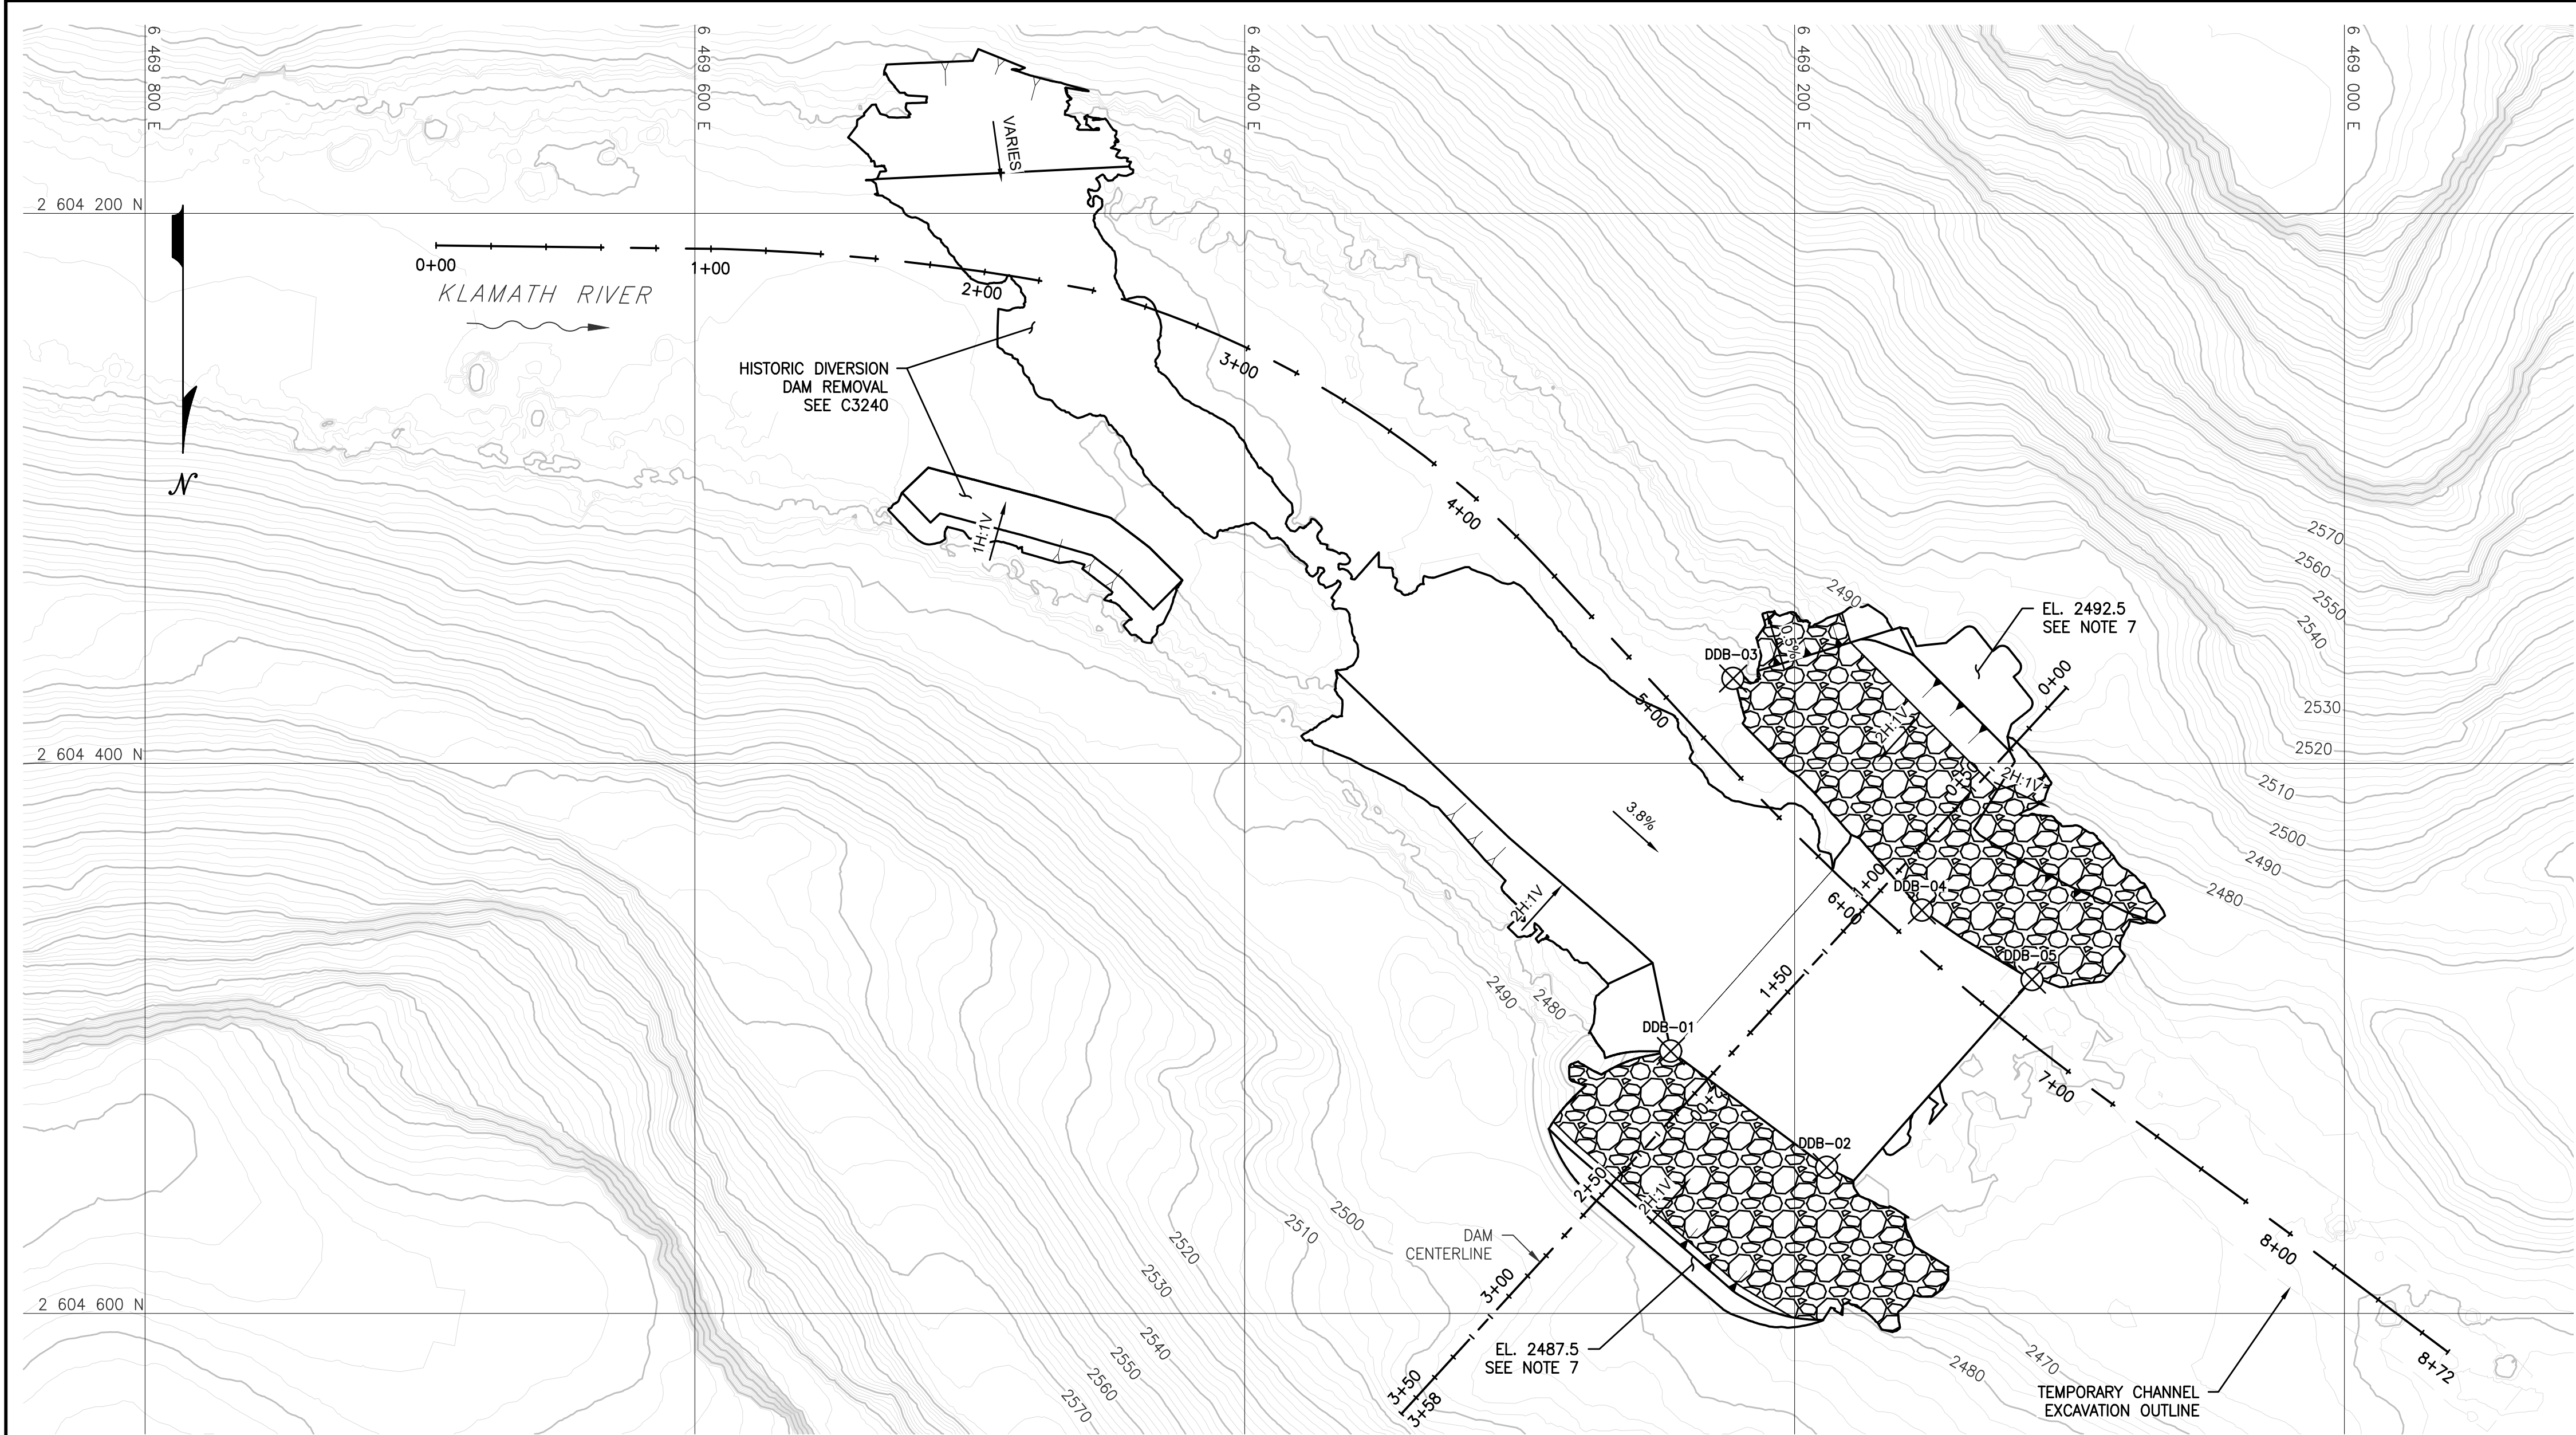
PLAN
1" = 40'

PROFILE
1" = 50'

TYPICAL LEFT BANK EROSION PROTECTION DETAIL

TYPICAL RIGHT BANK EROSION PROTECTION DETAIL

PROJECT		PROJ #	VA103-640/1
KLAMATH RIVER RENEWAL PROJECT		DATE	05/27/2022
SHEET TITLE		DWG	C3234
COPCO NO. 2 FACILITY DIVERSION DAM REMOVAL CHANNEL GRADING PLAN AND PROFILE

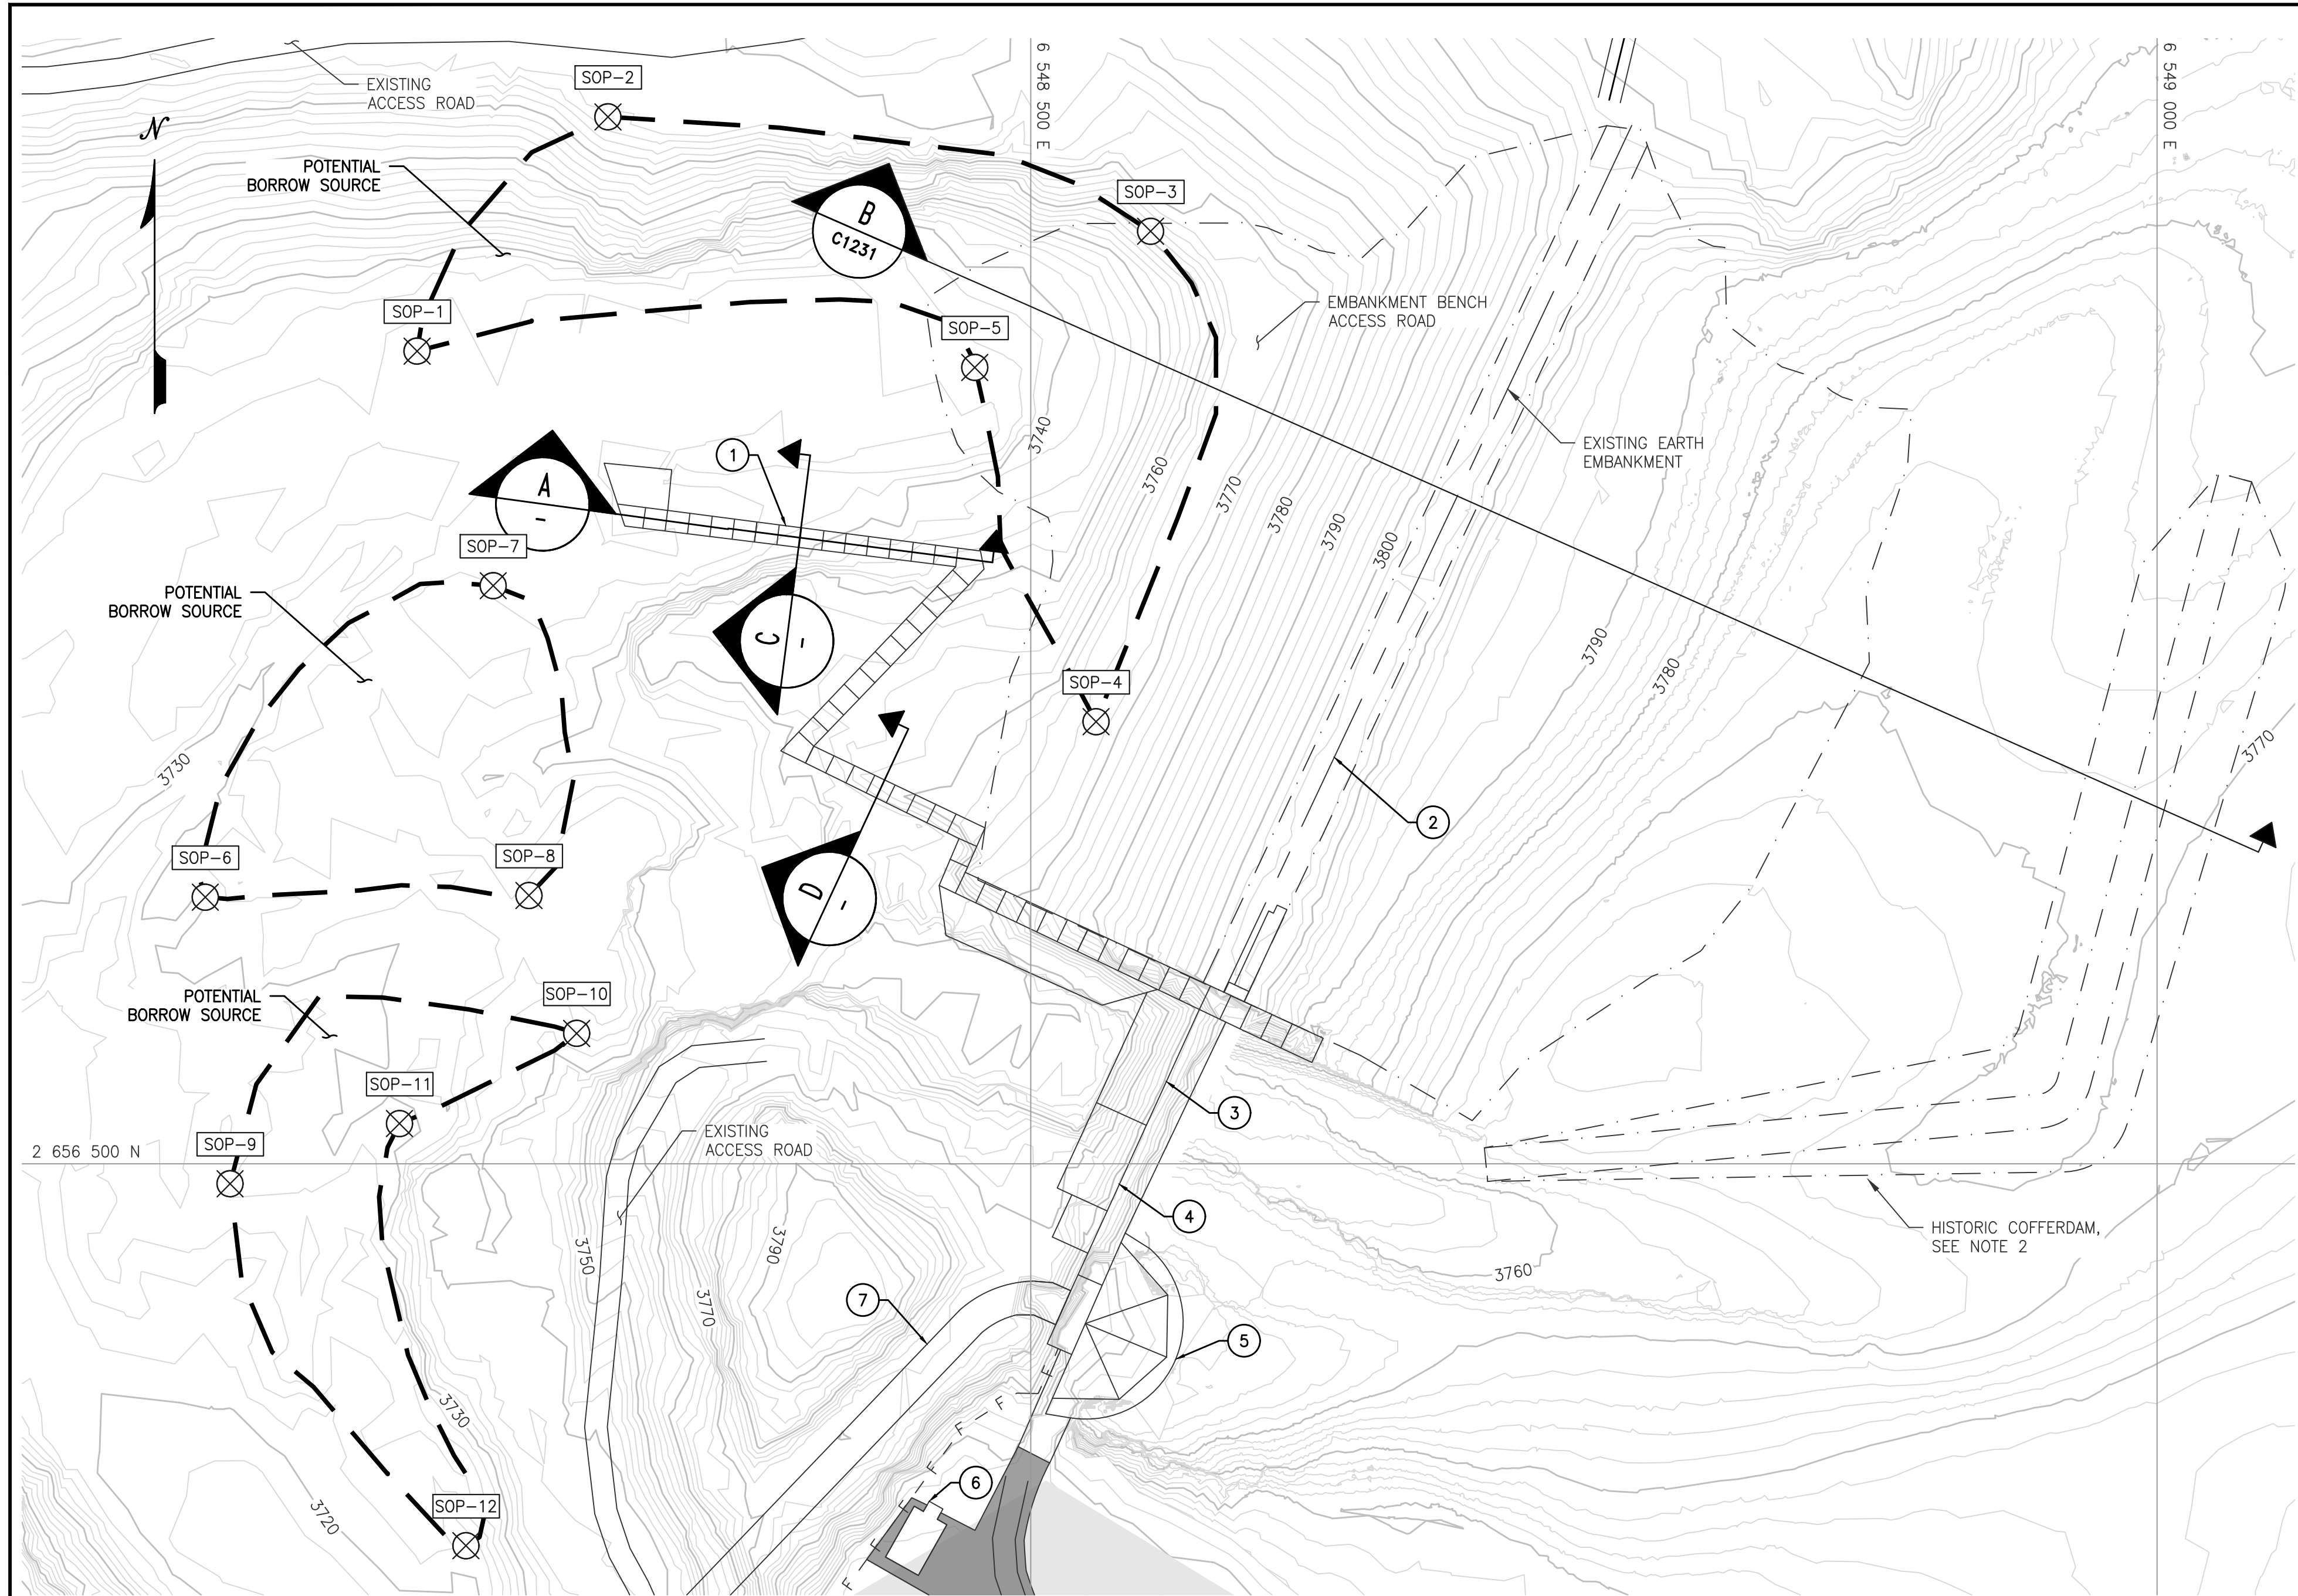
C1056 J.C. BOYLE HYDROLOGIC AND HYDRAULIC INFORMATION

PLAN

SECTION - FISH LADDER
