RE: KRRP Value Engineering Summary and Advancement to 90% Design

KP was tasked with leading seven VE analyses, which are listed below and described in the following sections of this letter:

VE-1 Submittals: Drawdown Model and Assessment

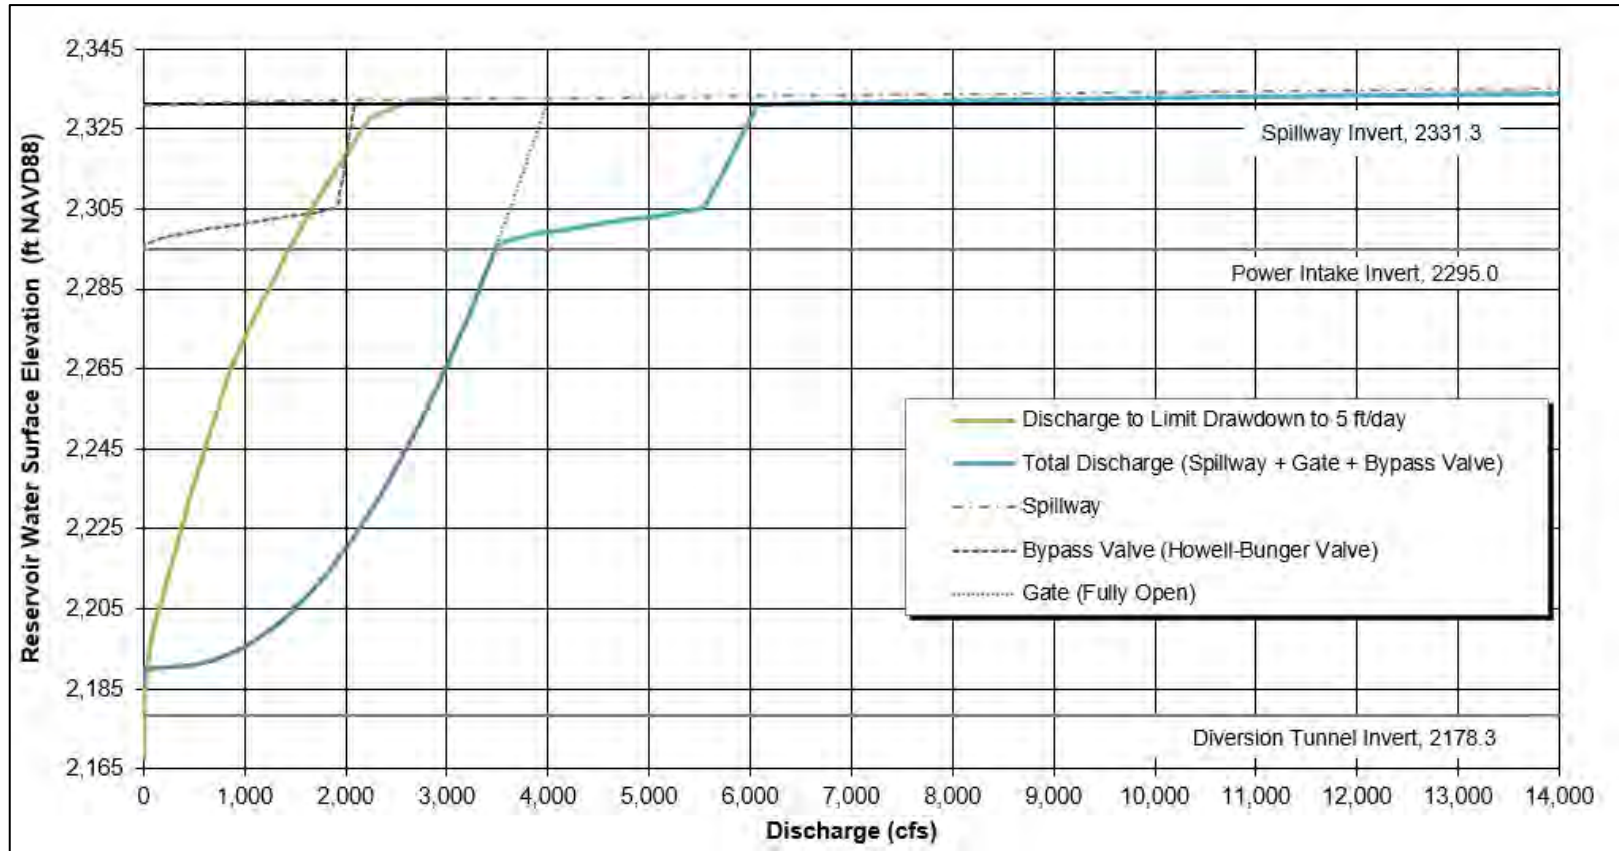
Iron Gate

Rating Curve

- Upper Gate (fully open to 57 inches) developed with CFD
- Spillway and Bypass valve (Howell-Bunger) empirical equations
- Outflow limiting drawdown to 5 ft/day calculated based on 2018 bathymetry

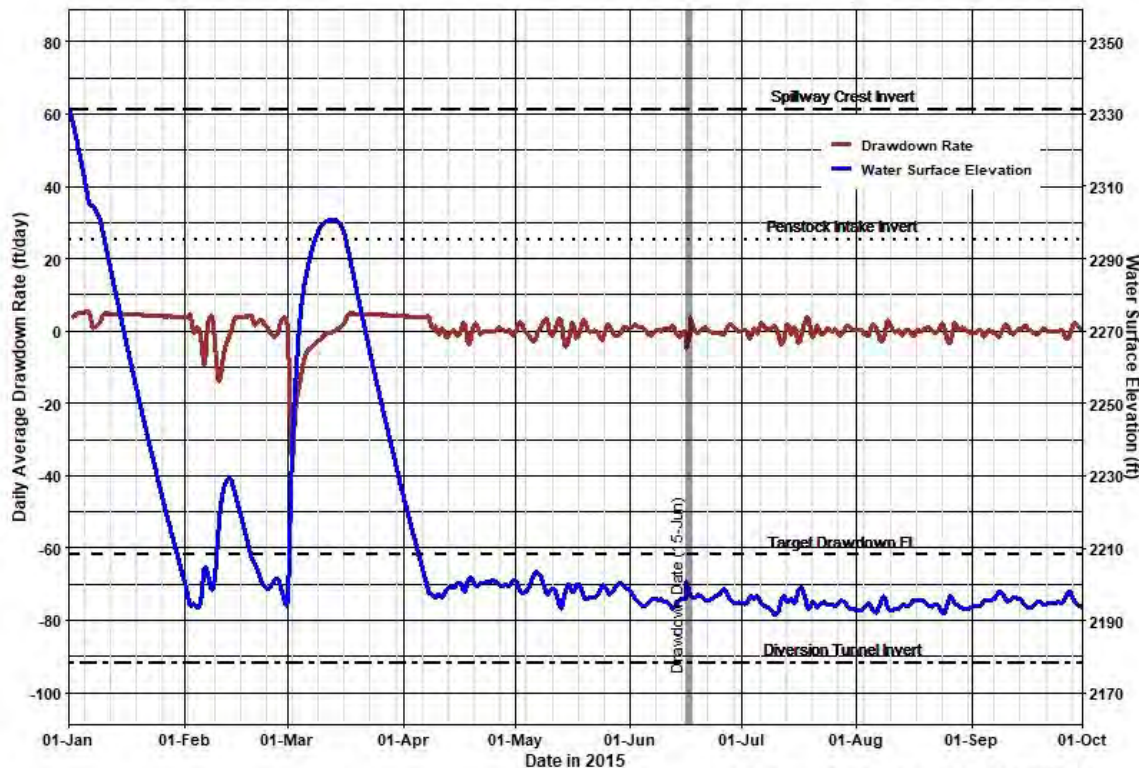
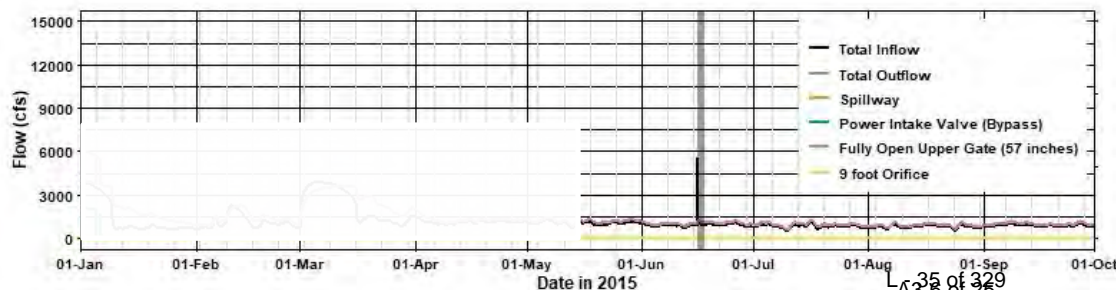
L35 of 329
A3-6 of 25

Iron Gate

Preliminary Results: 2015 – Driest Volume Year

- Target Drawdown WSE reached:
 - End of Jan, and early Apr
- Reservoir refills from freshet
 - Drawdown limited to 5ft/day after 2nd refilling
- Post June15/July WSE
 - around 2190 ft
- Outflows through individual outlets not properly represented in current model when drawdown limited to 5 ft/day (total outflow is correct) – to be visited in 90%

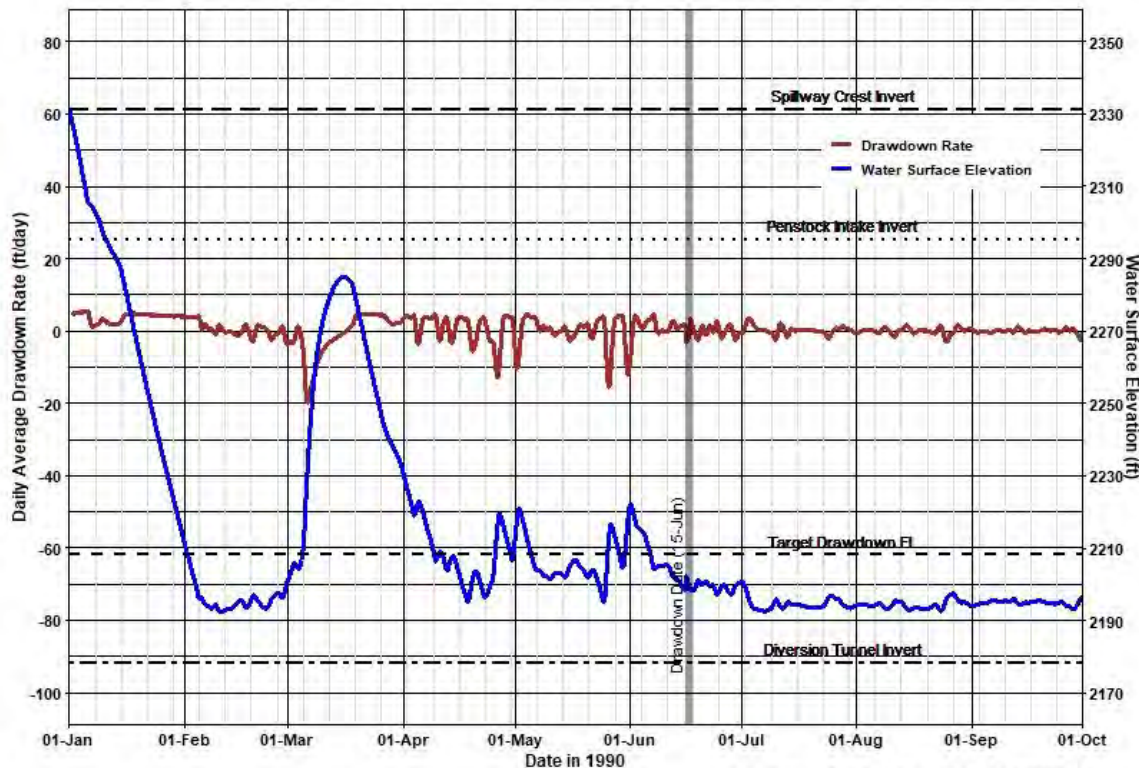
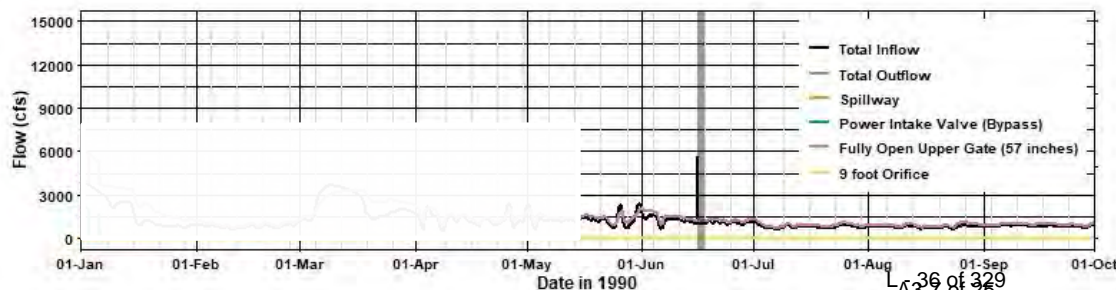
L36 of 329
A3-7 of 25

Iron Gate

Preliminary Results: 1990 – Dry Volume Year

- Target Drawdown WSE reached:
 - Early Feb, and mid Apr
- Reservoir refills from freshet
 - Drawdown limited to 5ft/day after 2nd refilling
- Post June15/July WSE
 - around 2190 ft
- Outflows through individual outlets not properly represented in current model when drawdown limited to 5 ft/day (total outflow is correct) – to be visited in 90%

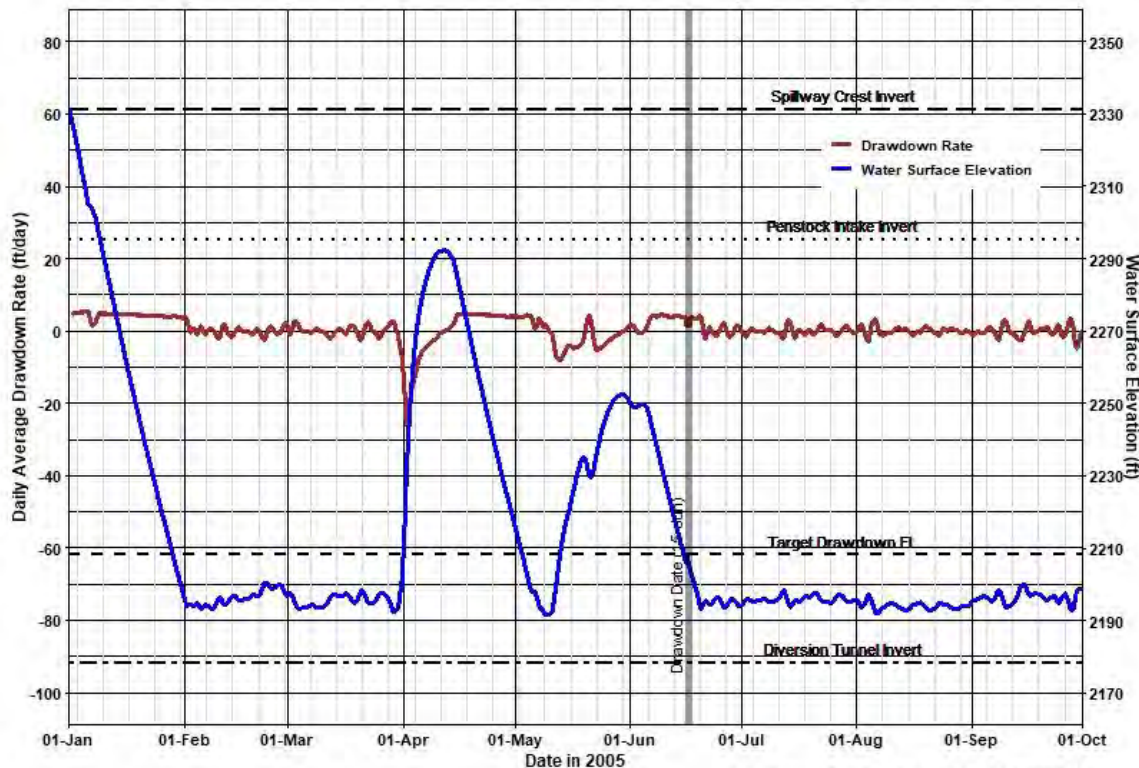
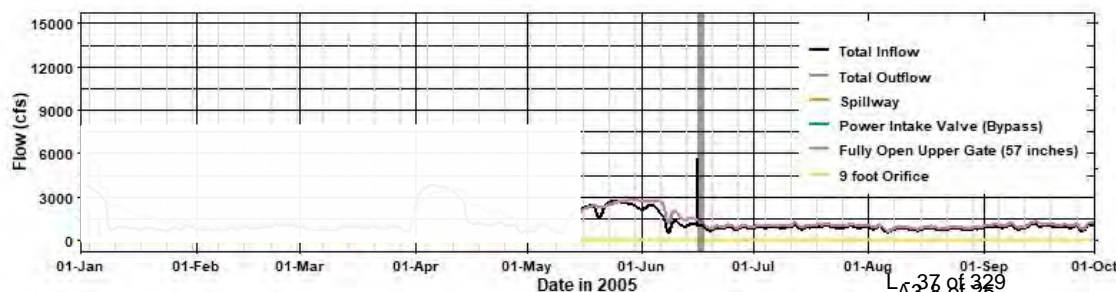
L37 of 329
A3-8 of 25

Iron Gate

Preliminary Results: 2005 – Avg. Vol. Year

- Target Drawdown WSE reached:
 - Early Feb, early May and mid-Jun
- Reservoir refills from freshet
 - Drawdown limited to 5ft/day after 2nd refilling
- Post June15/July WSE
 - around 2190 ft +/-
- Outflows through individual outlets not properly represented in current model when drawdown limited to 5 ft/day (total outflow is correct) – to be visited in 90%

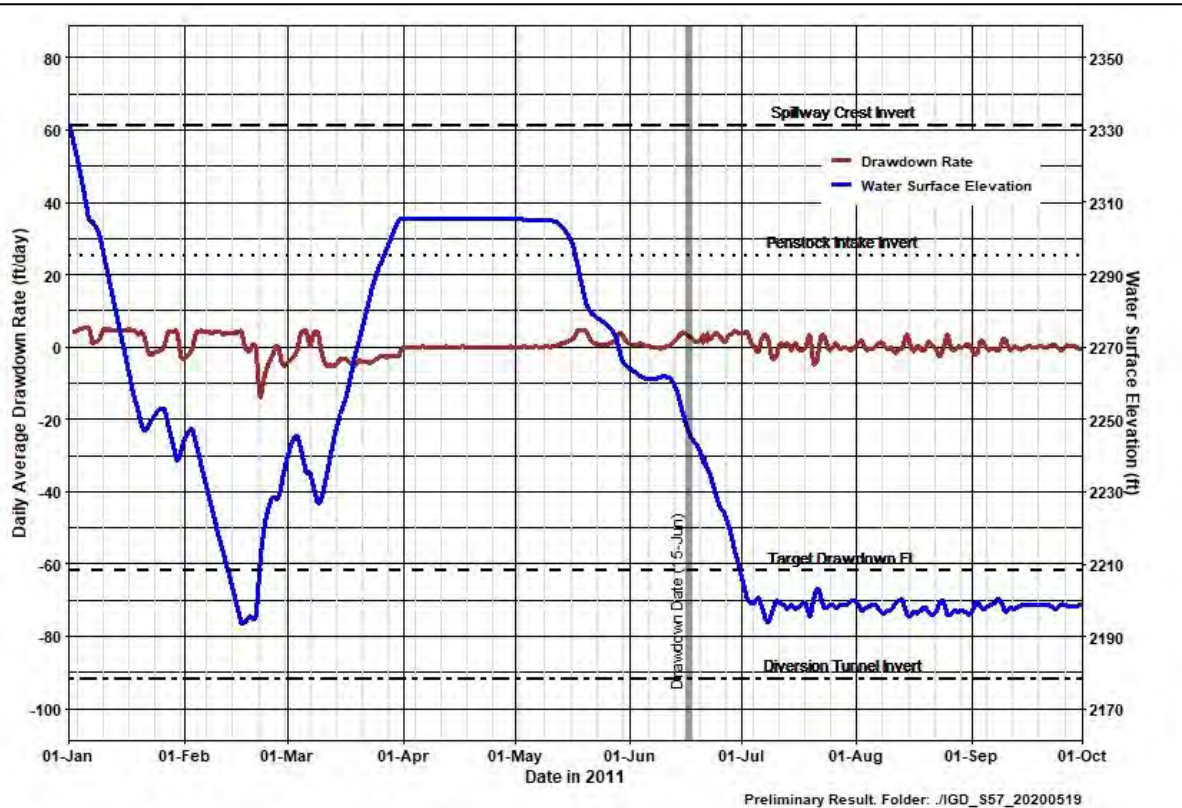
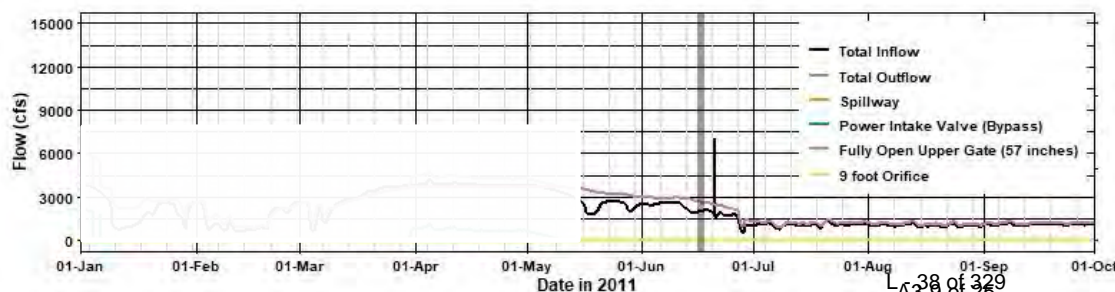
Iron Gate

Preliminary Results: 2011 –Wet Year

- Target Drawdown WSE reached:
 - Mid Feb, and early Jul
- Reservoir refills from freshet
 - Drawdown limited to 5ft/day after 2nd refilling
- Post June15/July WSE
 - around 2190 ft +/-
- Outflows through individual outlets not properly represented in current model when drawdown limited to 5 ft/day (total outflow is correct) – to be visited in 90%

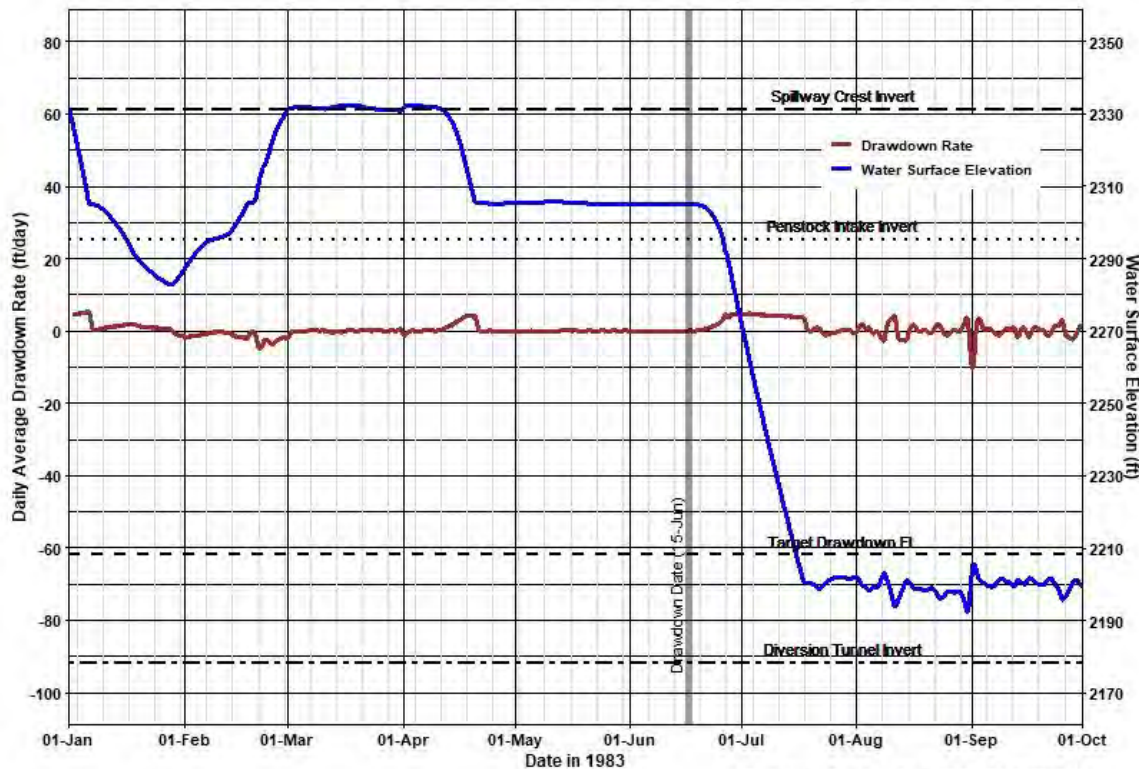
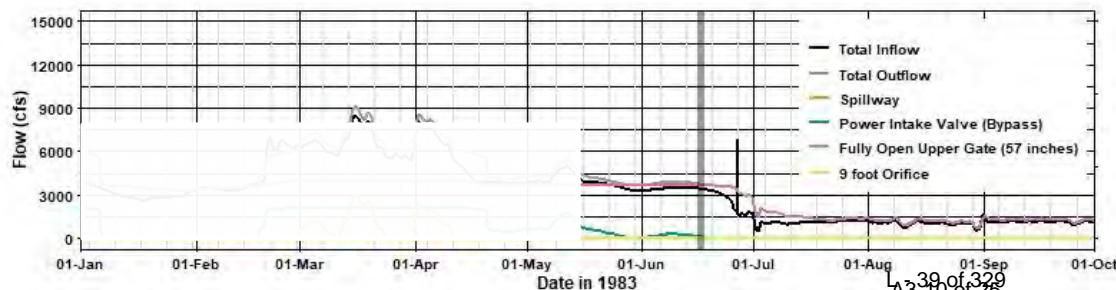
Iron Gate

Preliminary Results: 1983 – Very Wet Year

- Target Drawdown WSE reached:
 - Mid-July
- Drawdown limited to 5ft/day
- Post June15/July WSE
 - around 2190 ft +/-
- Outflows through individual outlets not properly represented in current model when drawdown limited to 5 ft/day (total outflow is correct) – to be visited in 90%

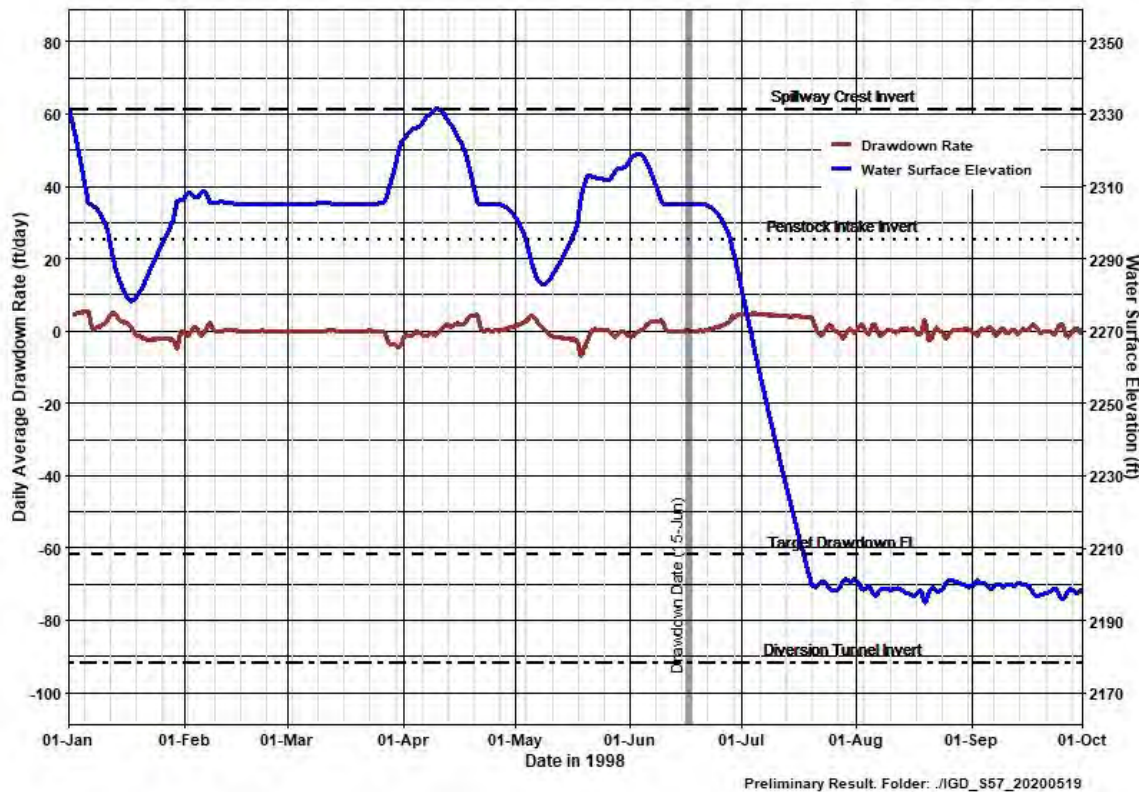
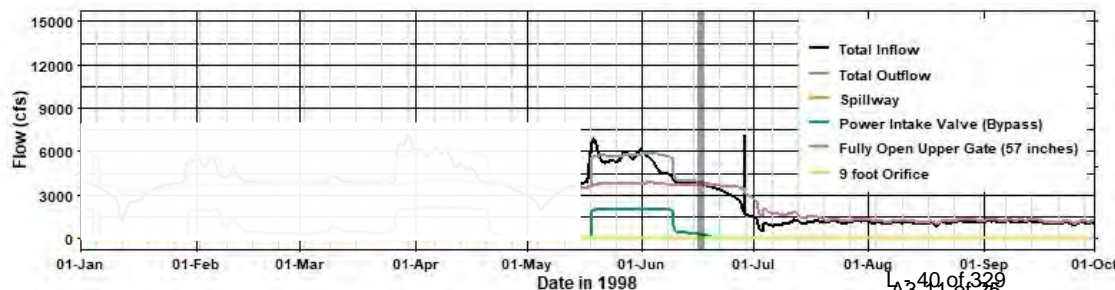
Iron Gate

Preliminary Results: 1998 –Very Wet Year

- Target Drawdown WSE reached:
 - Mid-July
- Drawdown limited to 5ft/day until 9 ft orifice is the control
- Post June15/July WSE
 - around 2190 ft +/-
- Outflows through individual outlets not properly represented in current model when drawdown limited to 5 ft/day (total outflow is correct) – to be visited in 90%

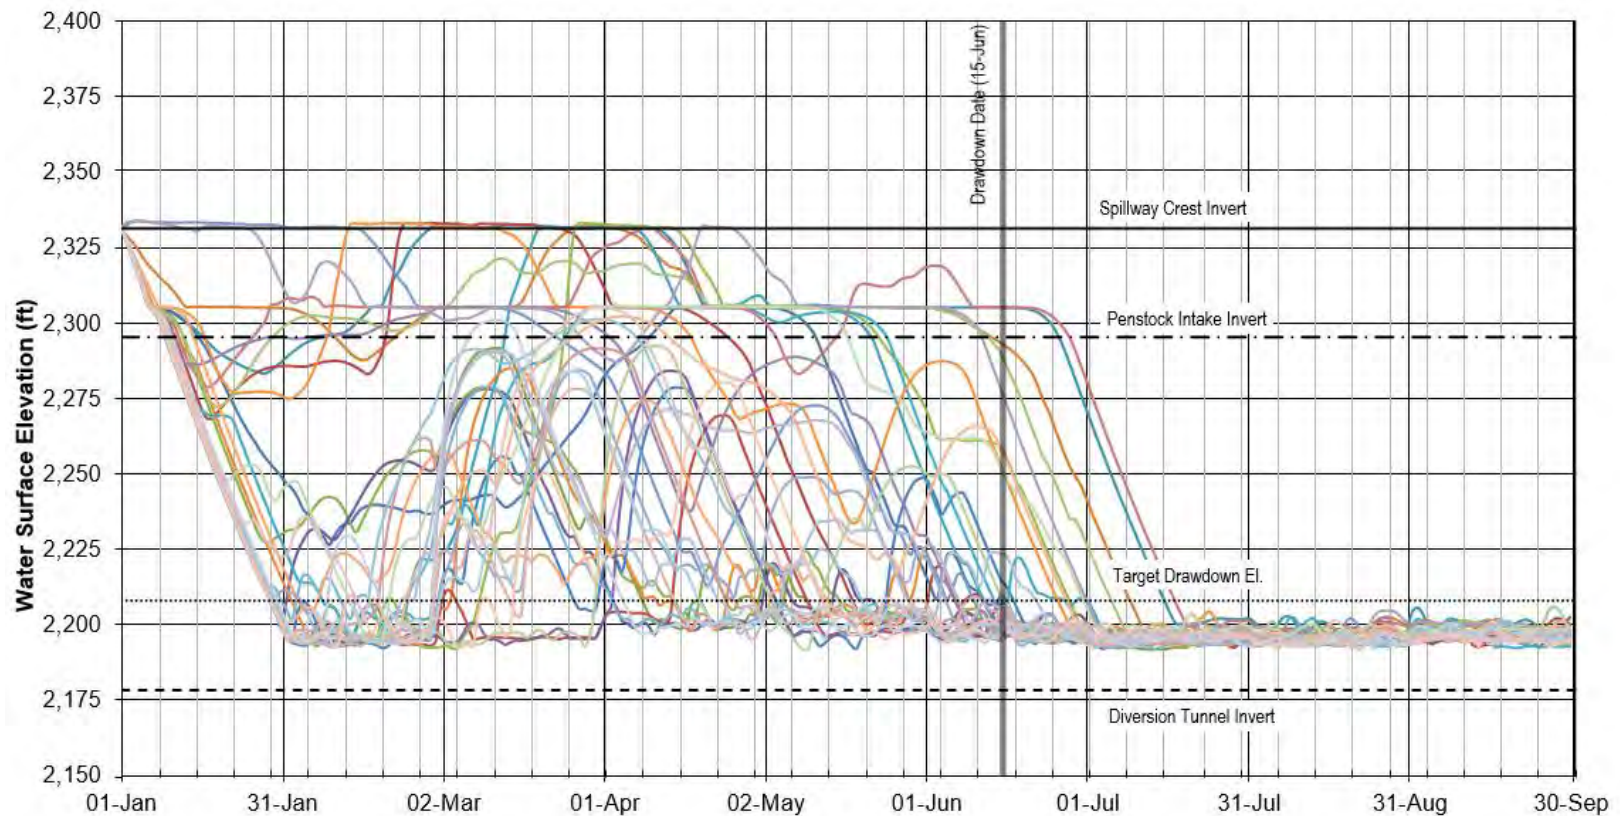
Iron Gate

Preliminary Results – All Model Years WSE

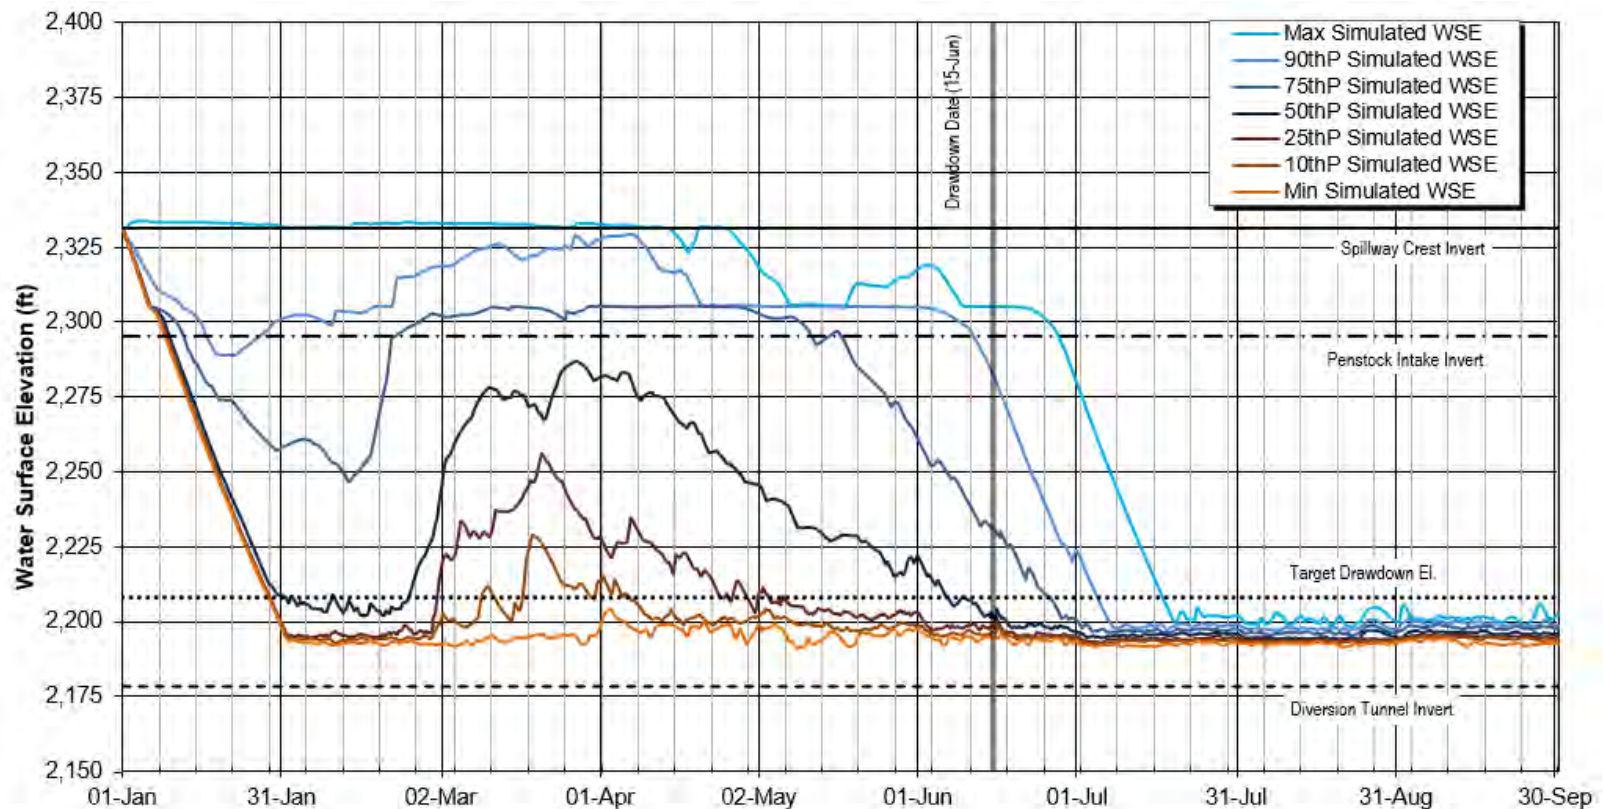
Iron Gate

Preliminary Results – Percentile WSE

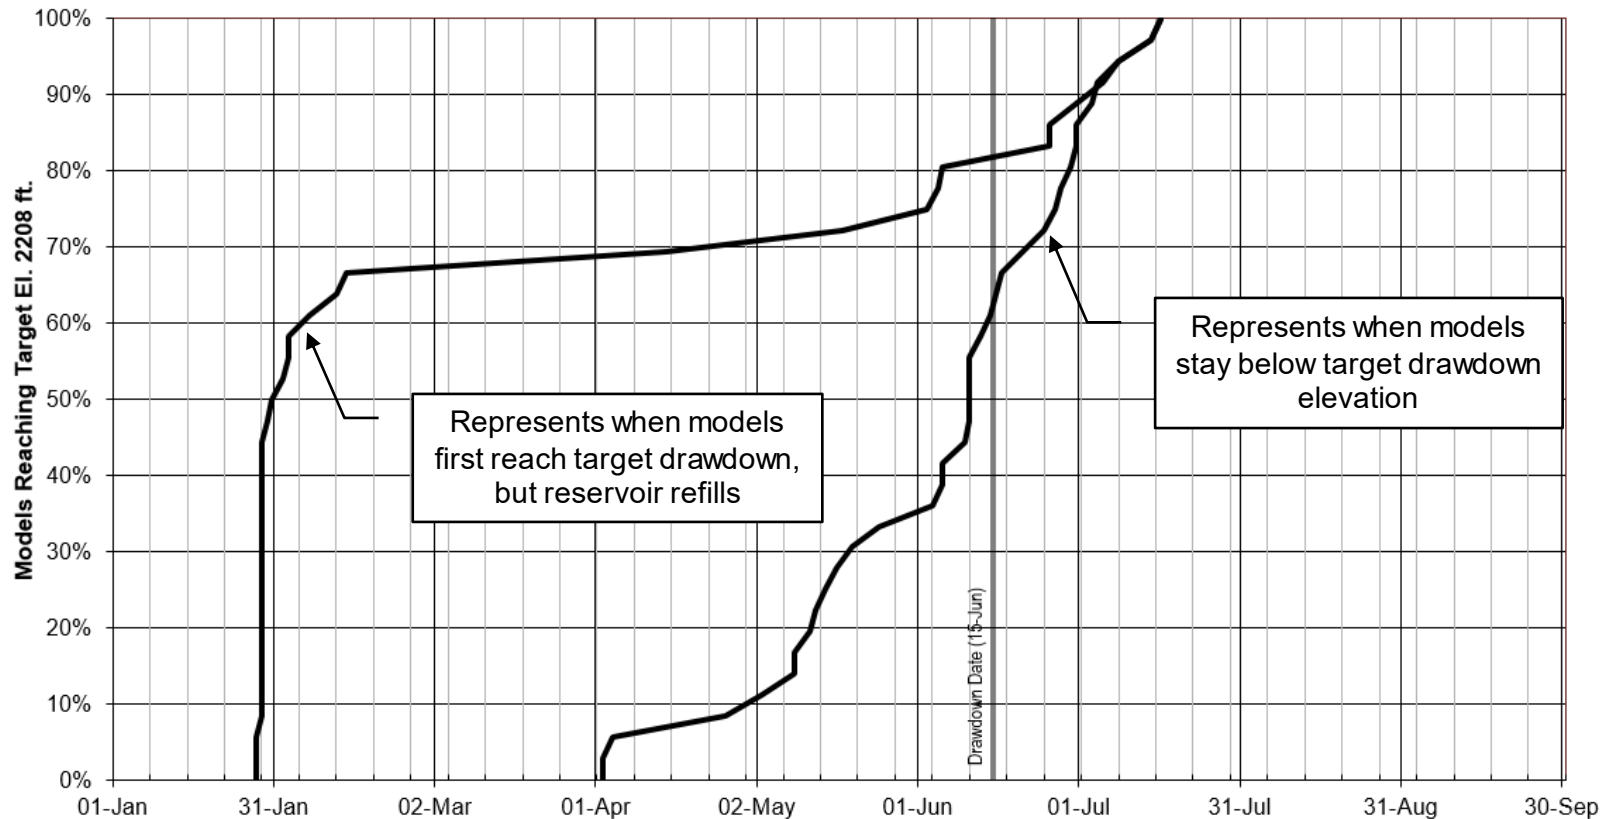
Iron Gate

Preliminary Results – Target Drawdown Dates

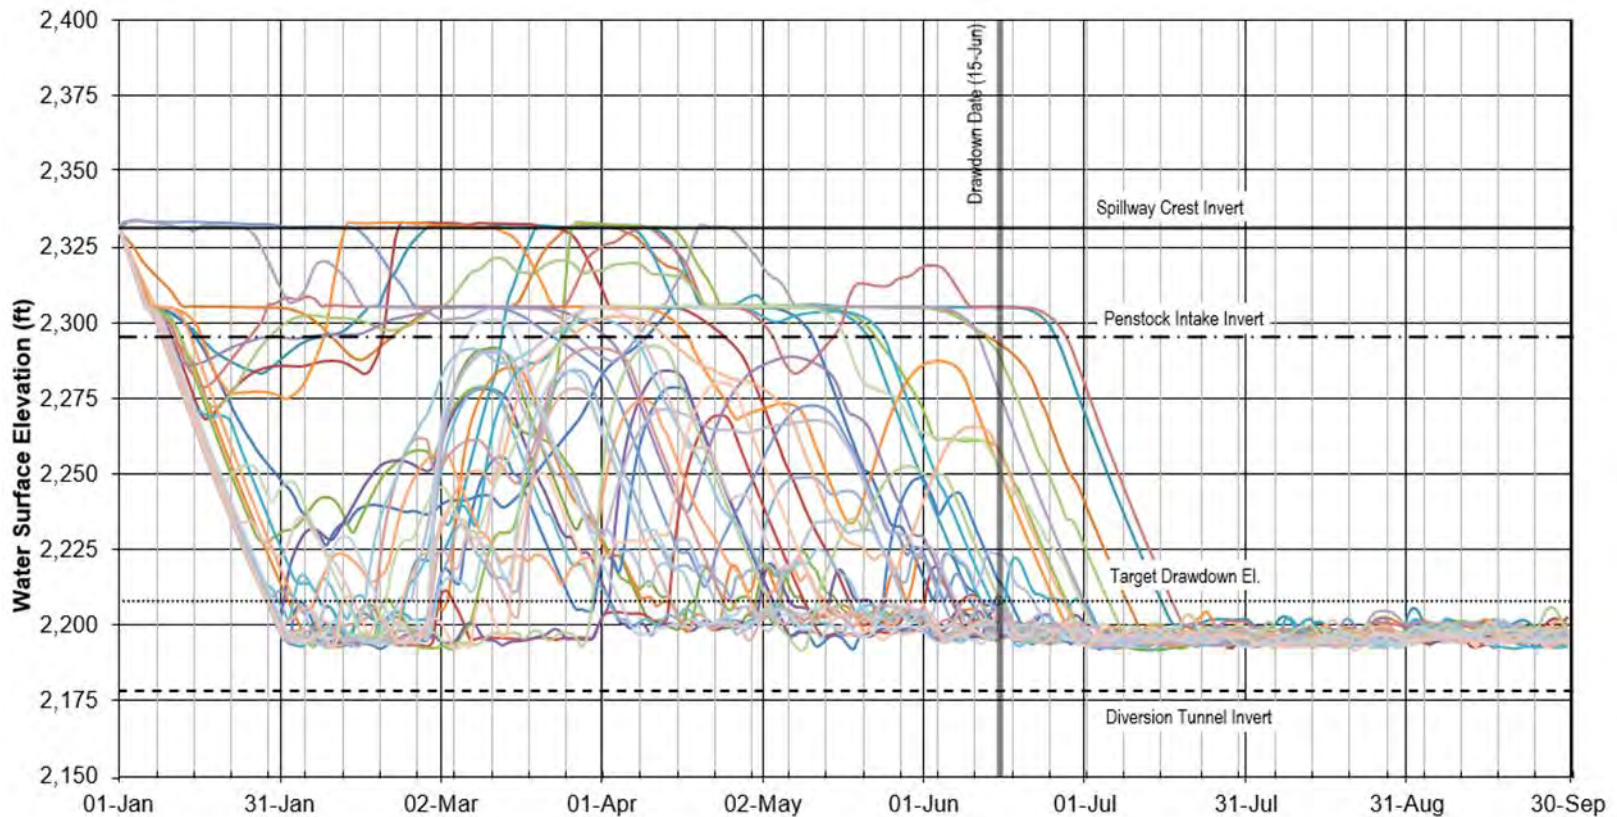
Iron Gate

All Model Years WSE – Jan 1 Initiate Drawdown

- Based on simulations results for 2019 BiOp flows

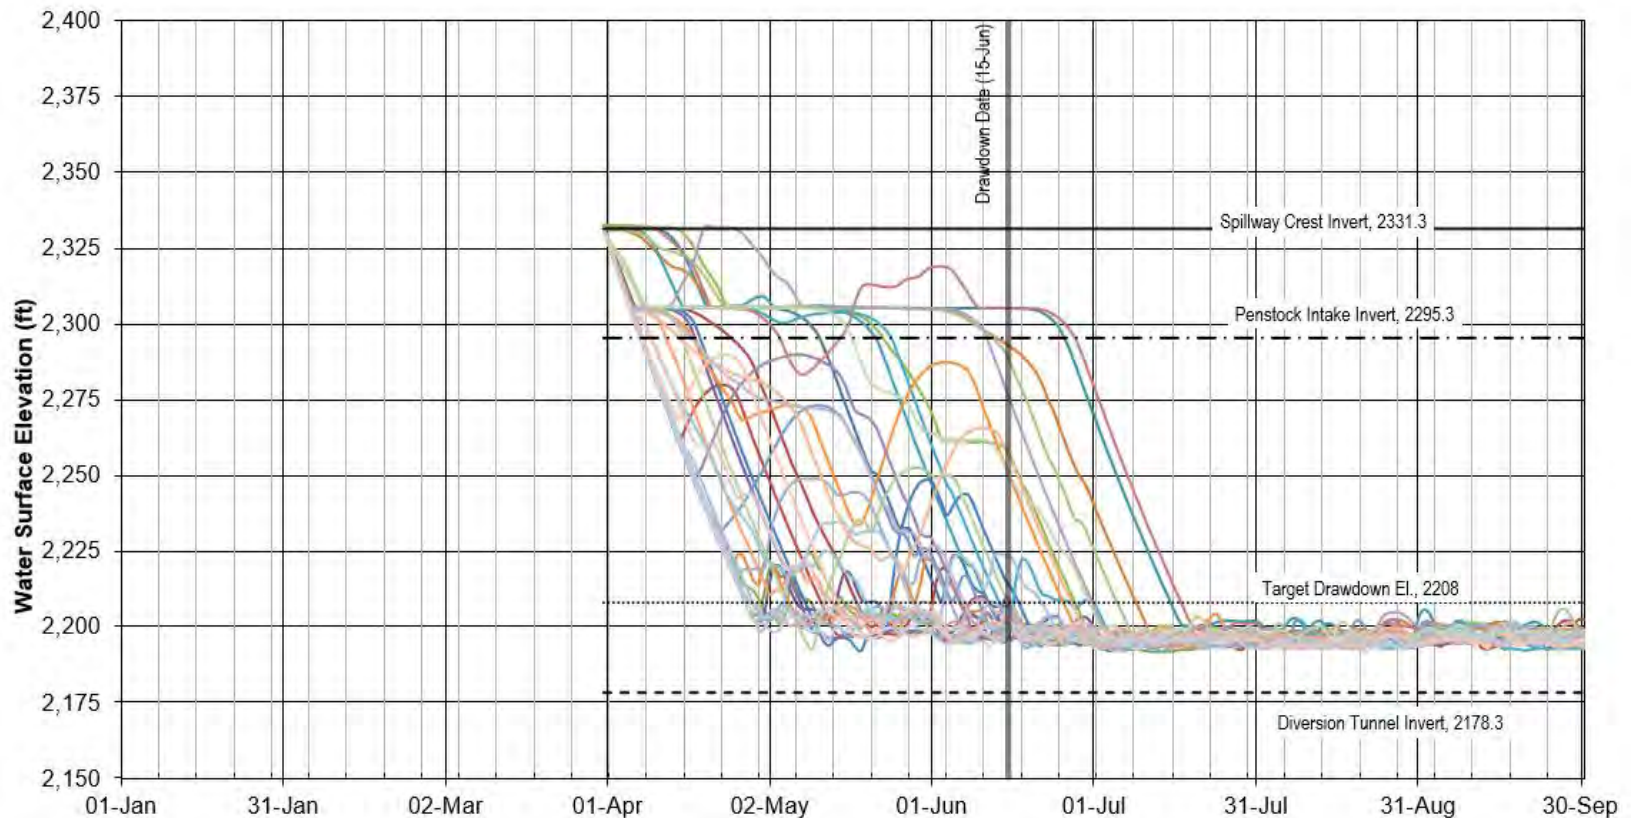
Iron Gate

All Model Years WSE – Apr 1 Initiate Drawdown

- Based on simulations results for 2019 BiOp flows

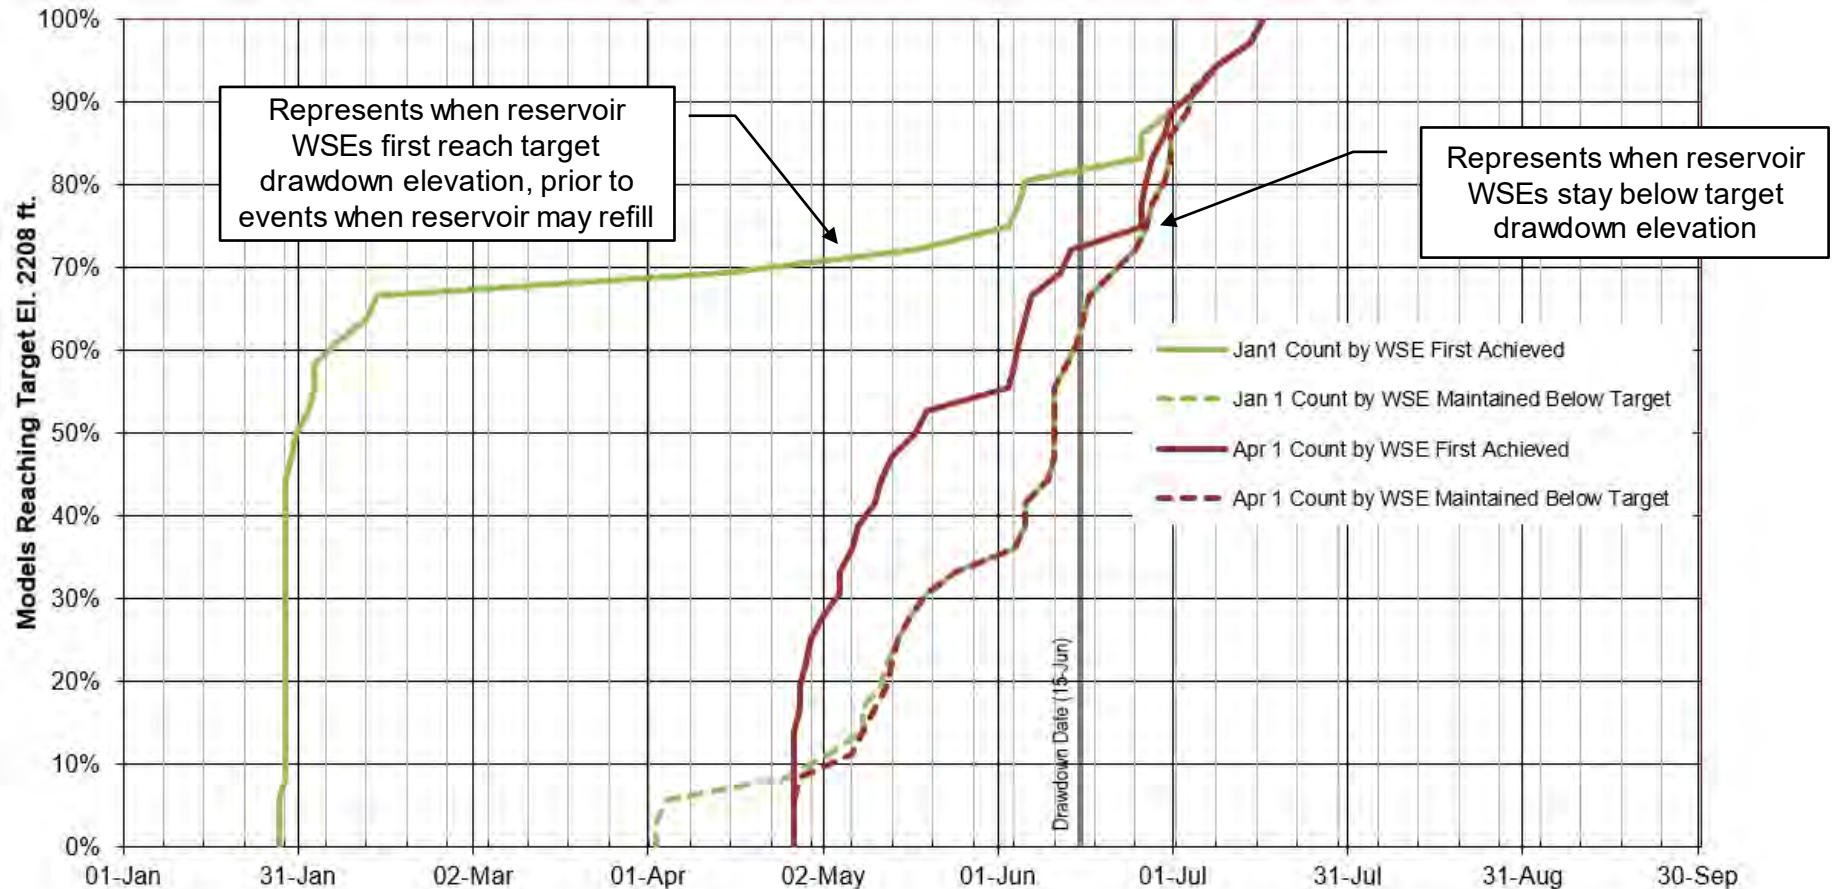
Iron Gate

Target Drawdown Dates

- Based on simulations results for 2019 BiOp flows

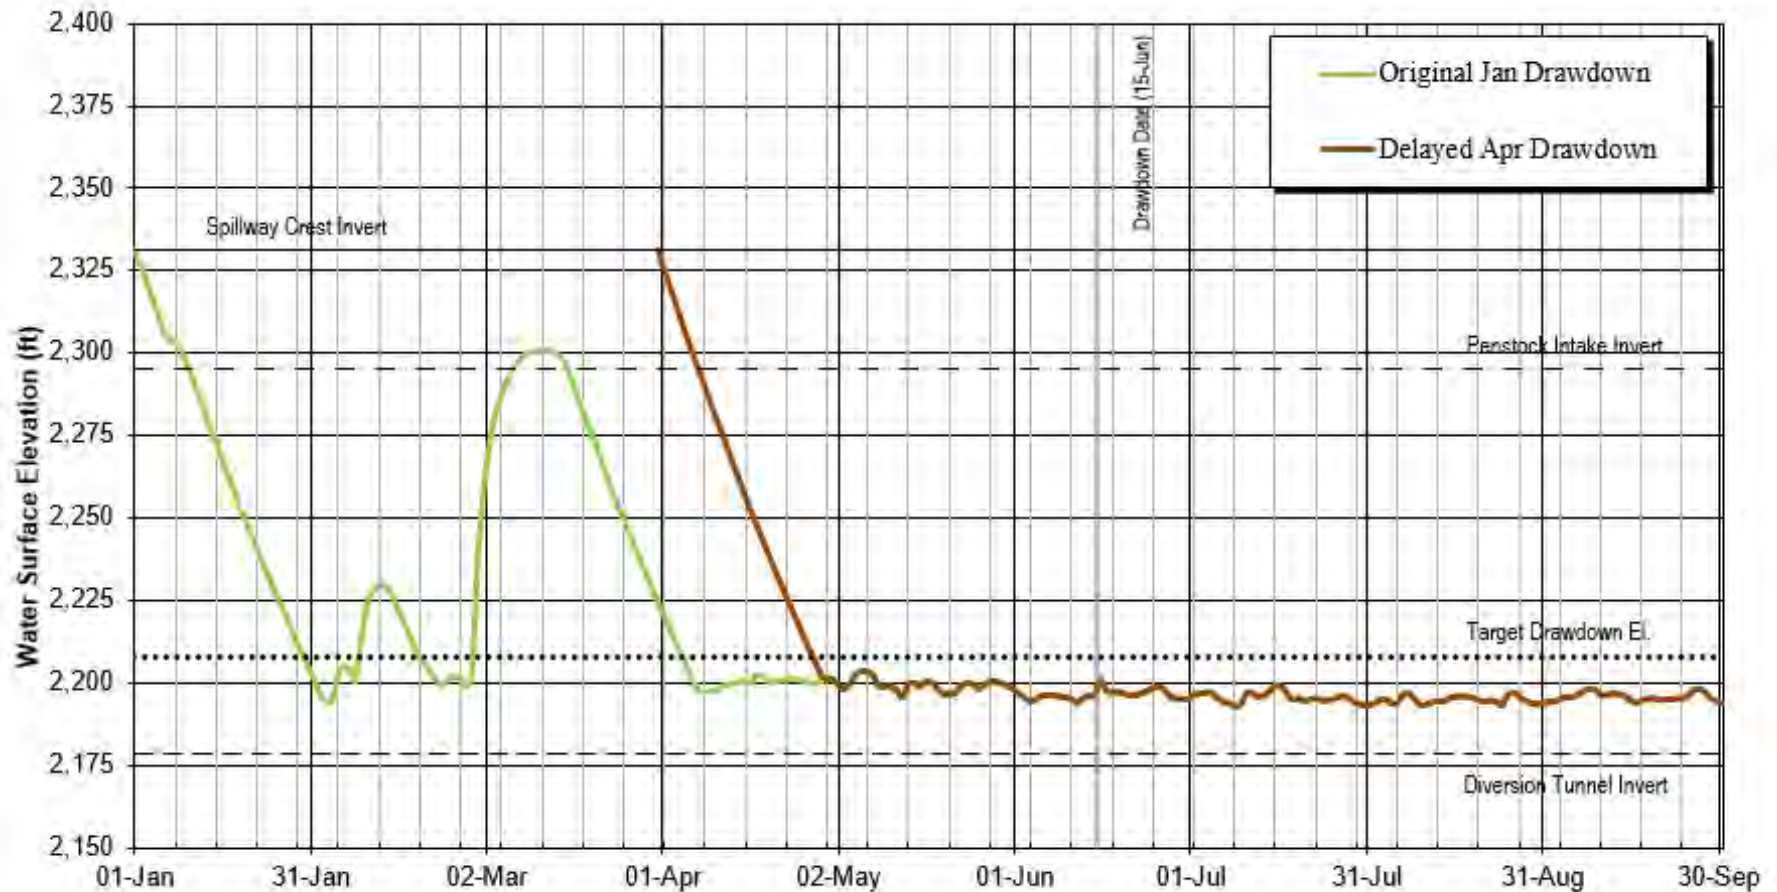
Iron Gate

WY 2015 WSE

- Based on simulations results for 2019 BiOp flows

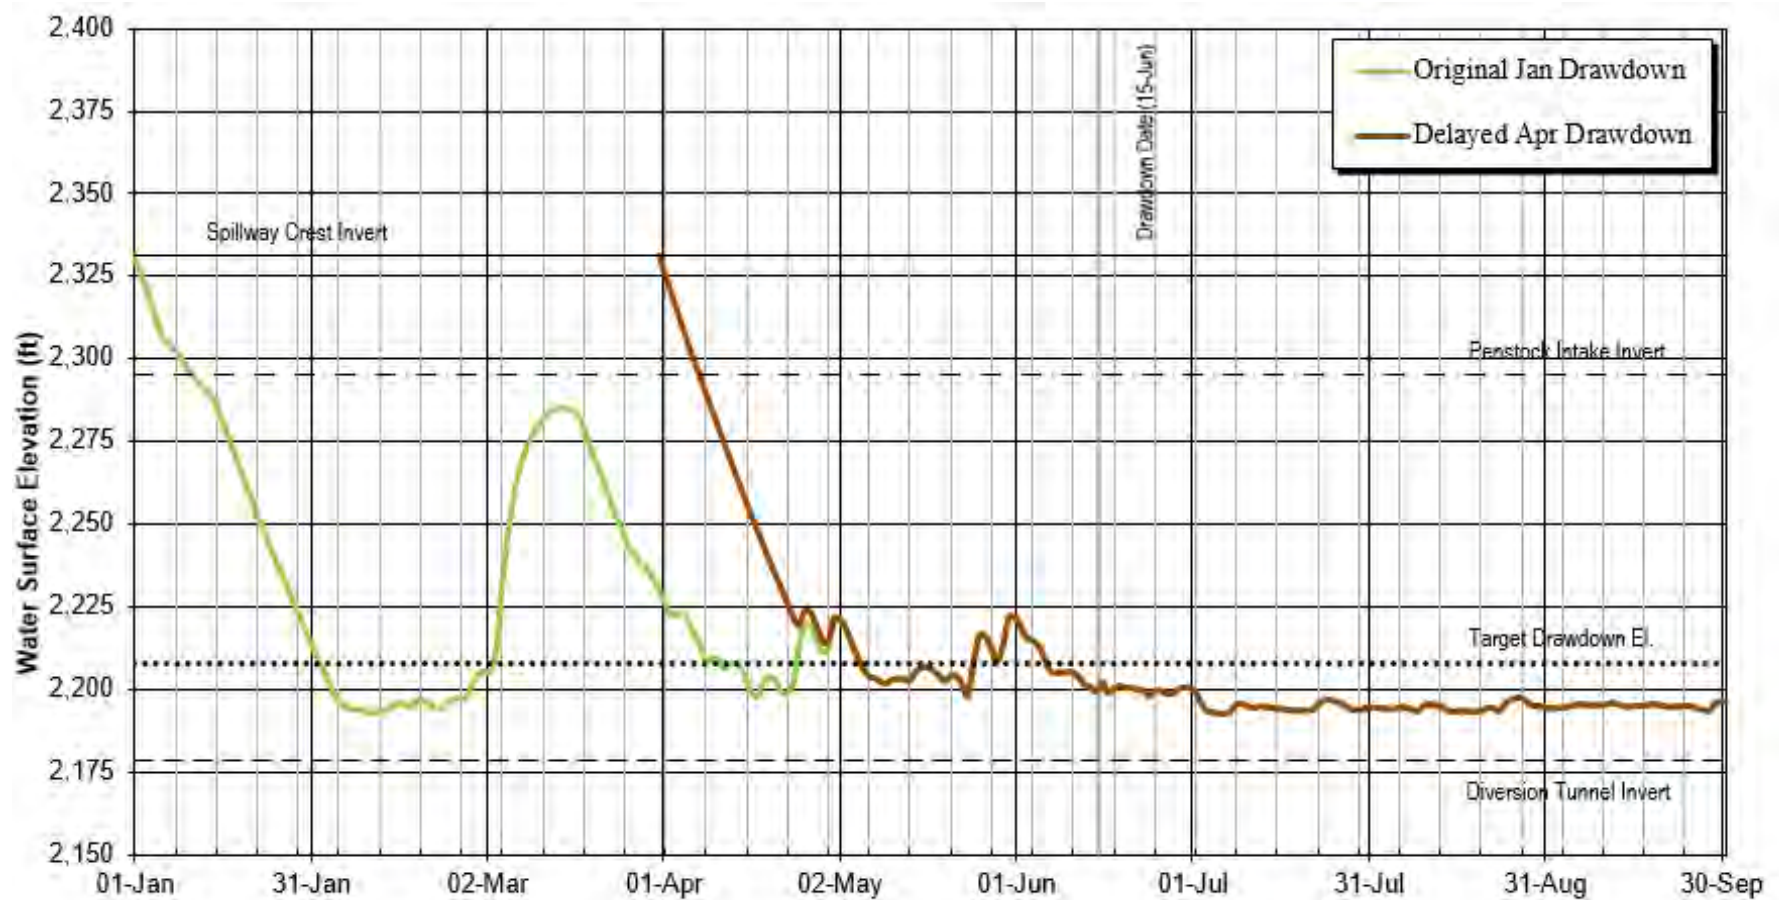
Iron Gate

WY 1990 WSE

- Based on simulations results for 2019 BiOp flows

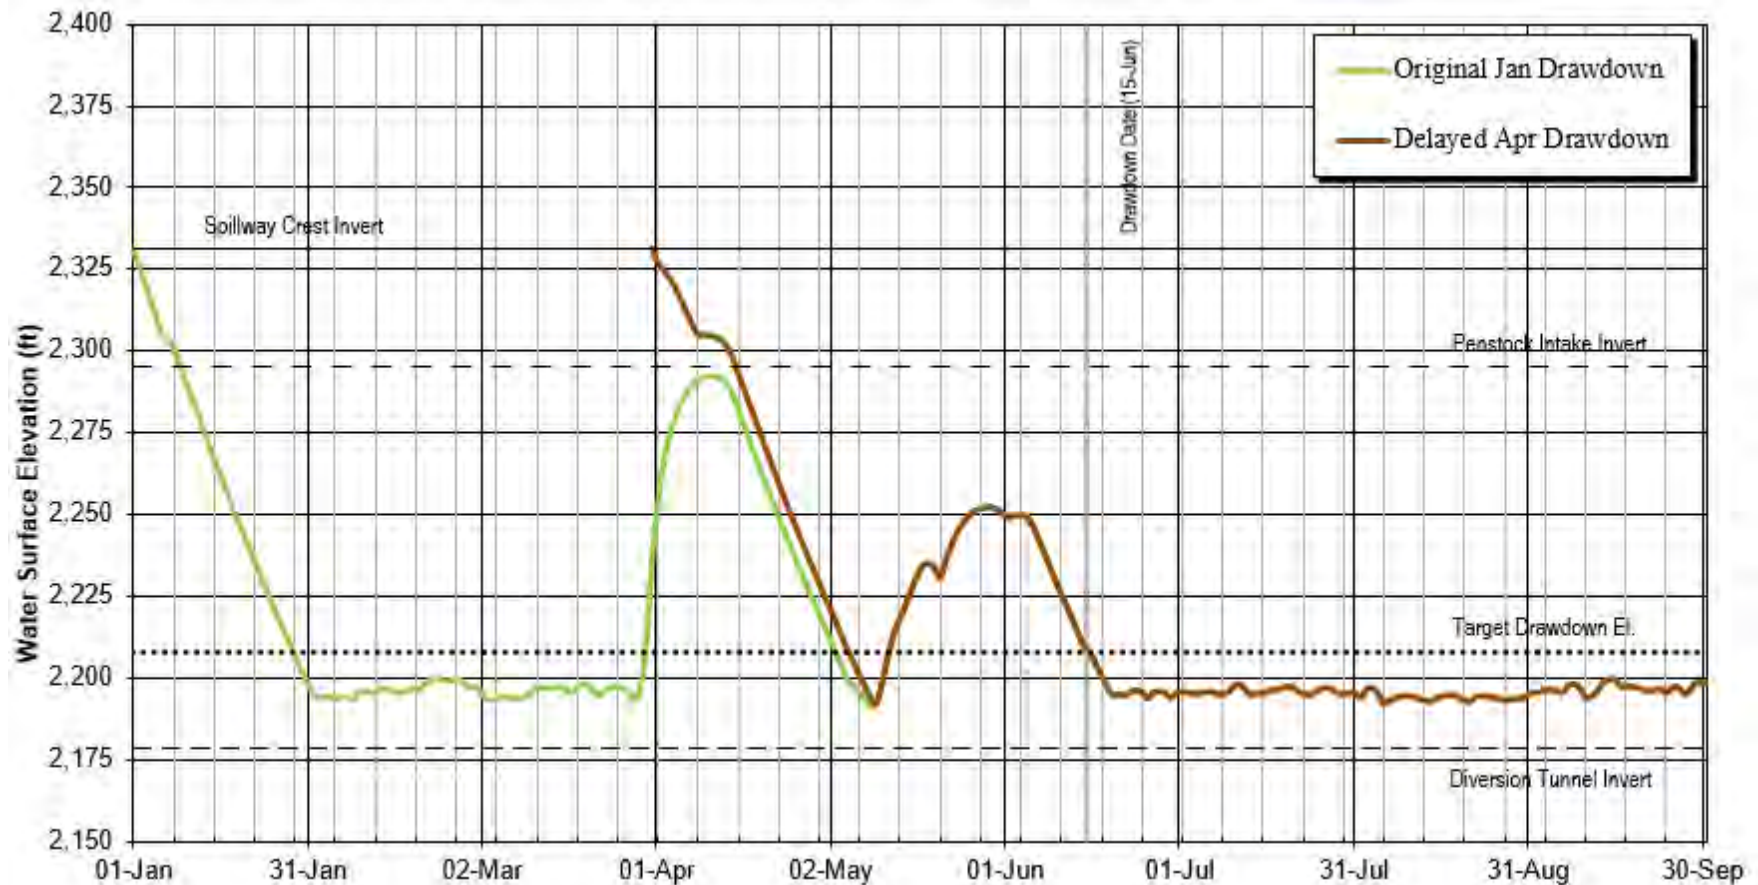
Iron Gate

WY 2005 WSE

- Based on simulations results for 2019 BiOp flows
