RE: KRRP Value Engineering Summary and Advancement to 90% Design

KP was tasked with leading seven VE analyses, which are listed below and described in the following sections of this letter:

VE-1 Submittals: Drawdown Model and Assessment

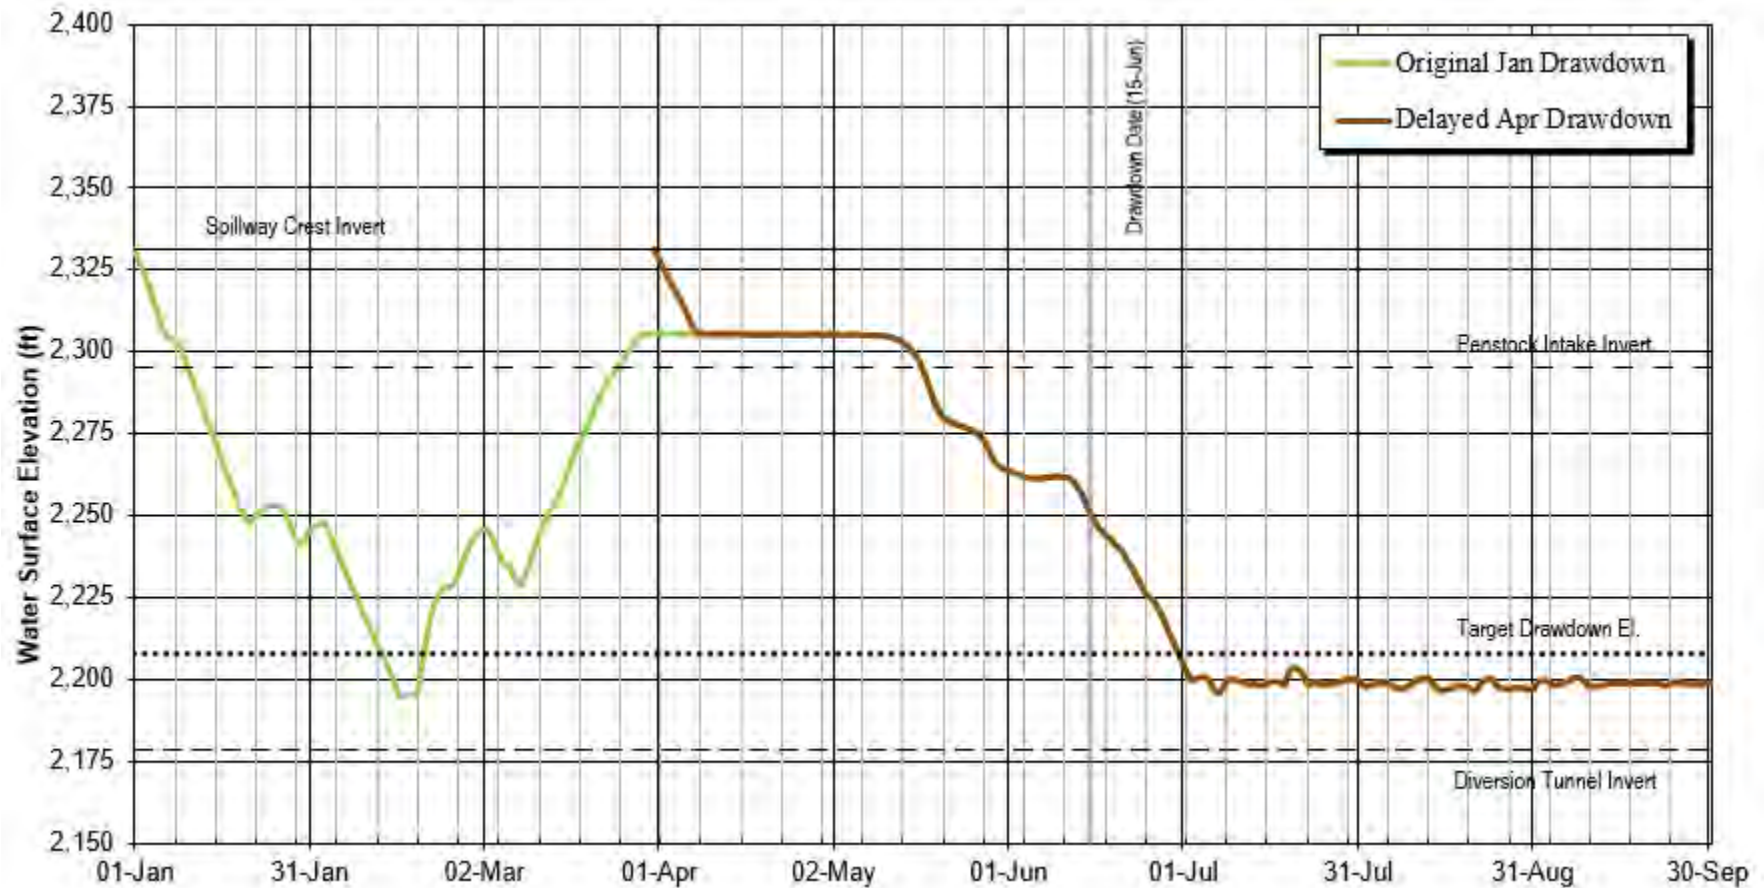
Iron Gate

WY 2011 WSE

- Based on simulations results for 2019 BiOp flows

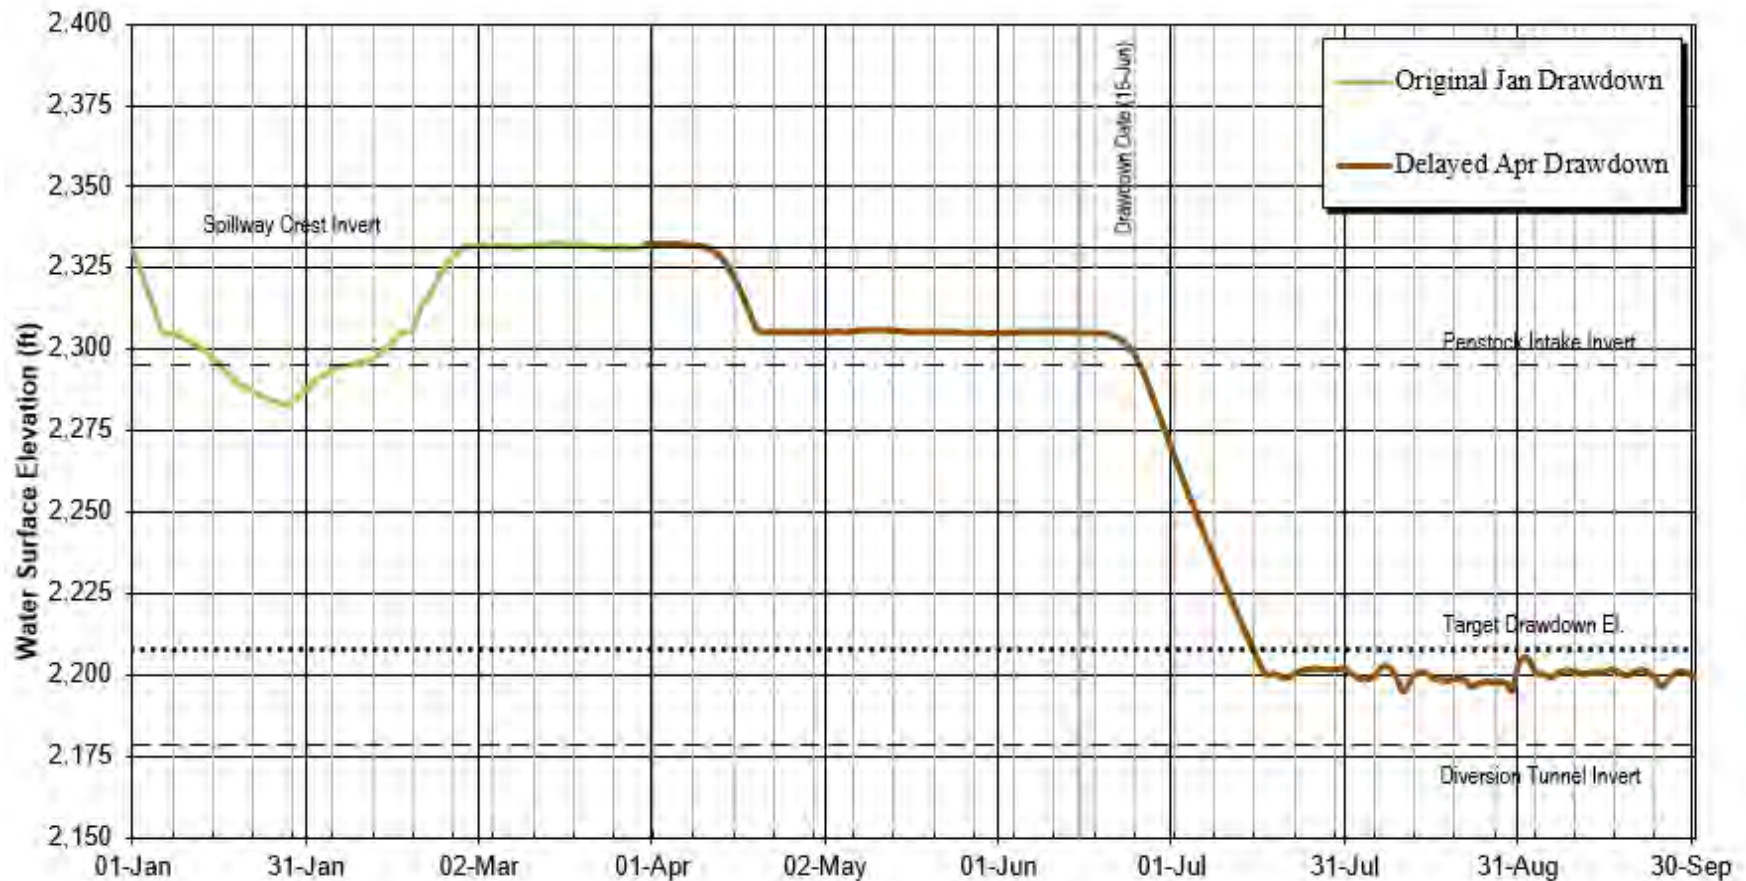
Iron Gate

WY 1983 WSE

- Based on simulations results for 2019 BiOp flows

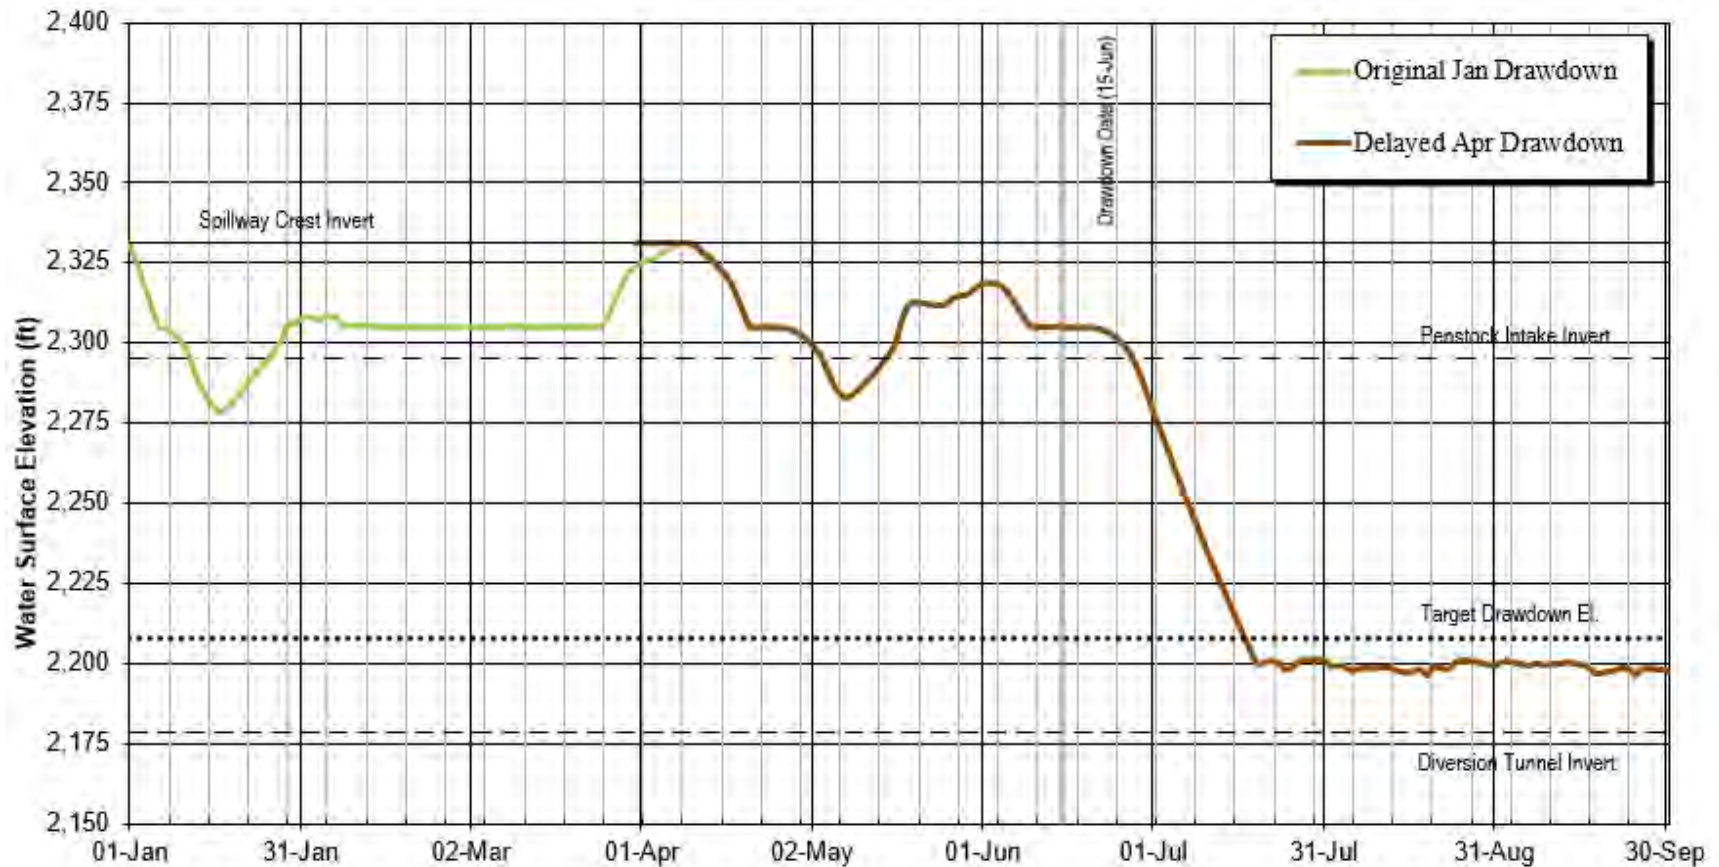
Iron Gate

WY 1998 WSE

- Based on simulations results for 2019 BiOp flows

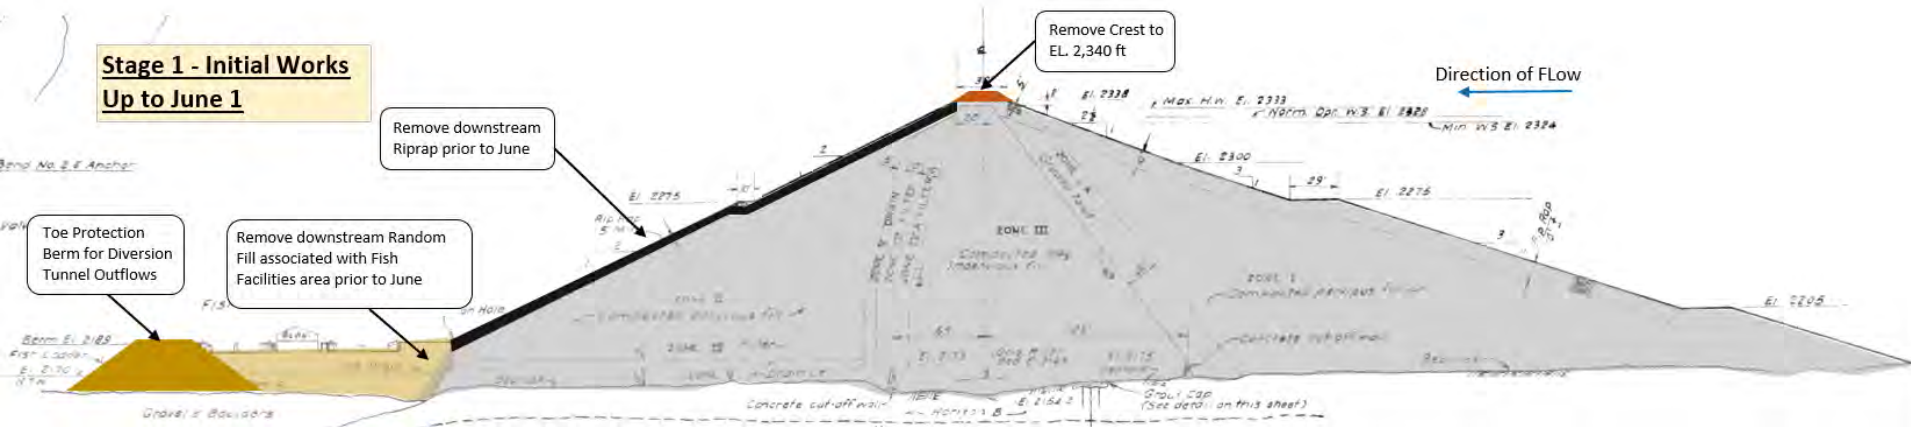
Figure 1: Stage 1 Dam Removal

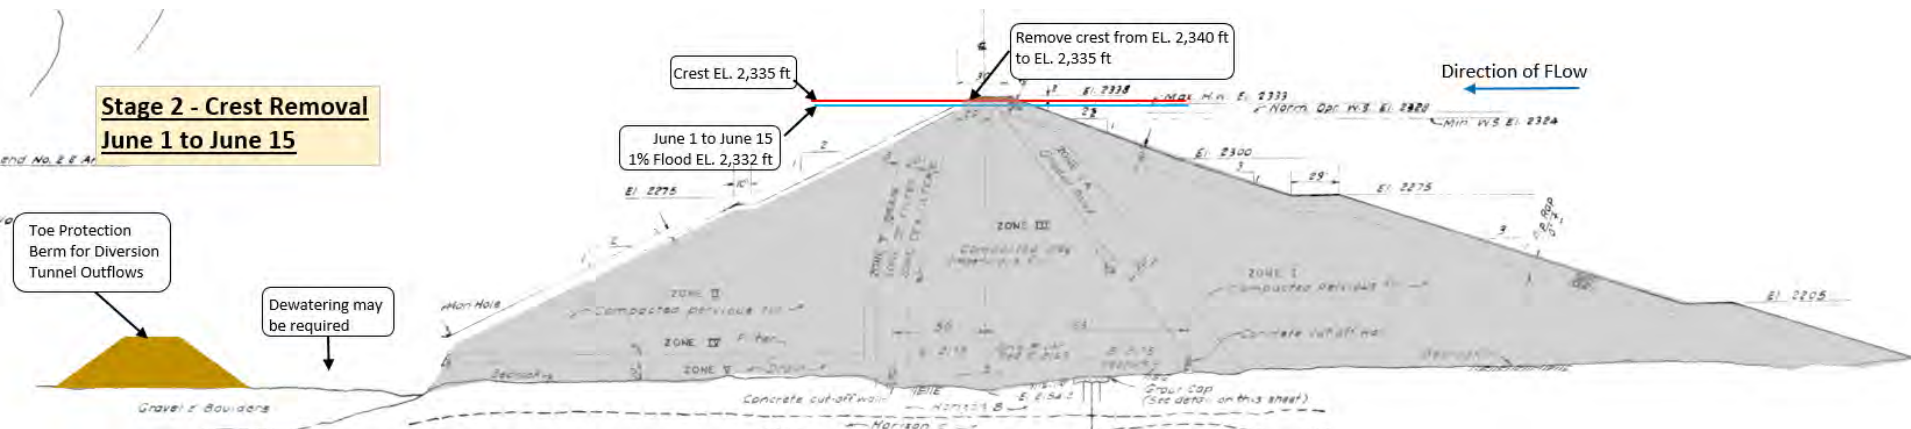
Figure 2: Stage 2 Dam Removal

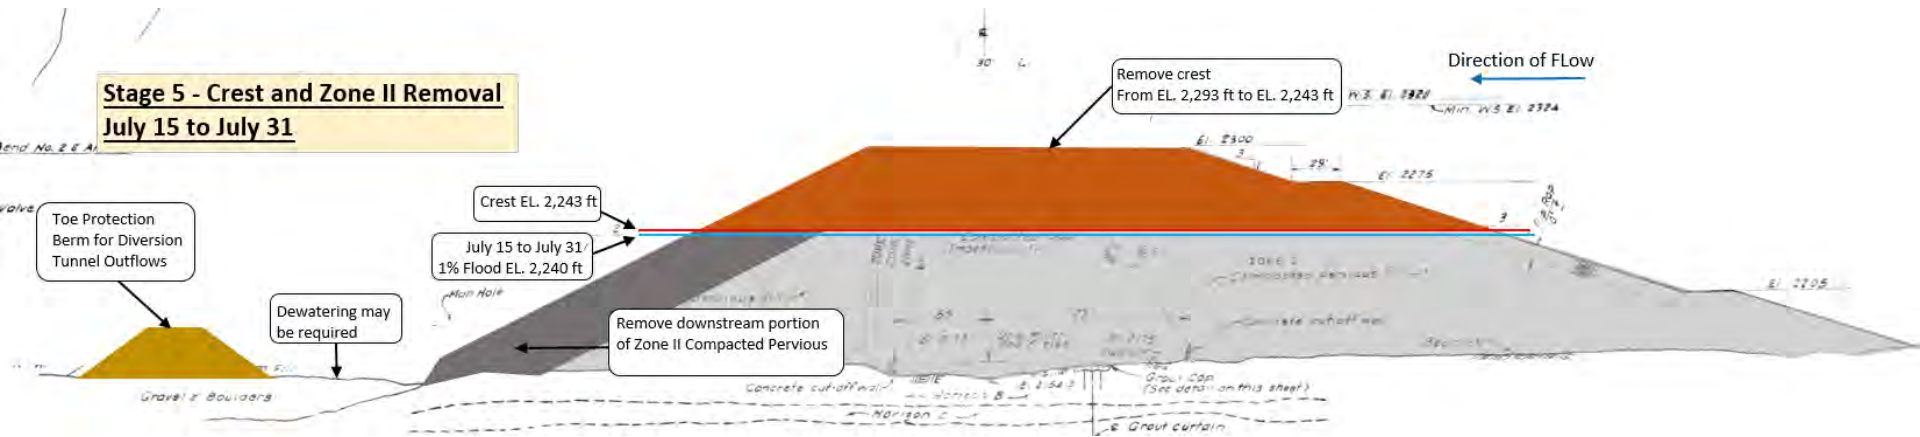
Figure 5: Stage 5 Dam Removal

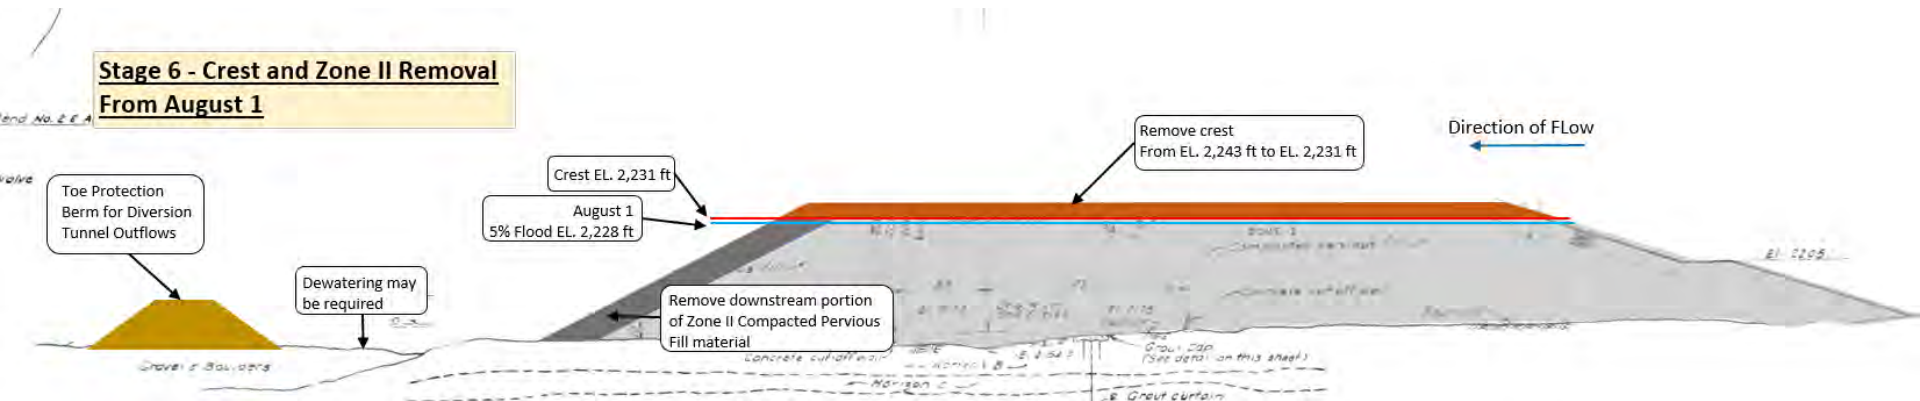
Figure 6: Stage 6 Dam Removal

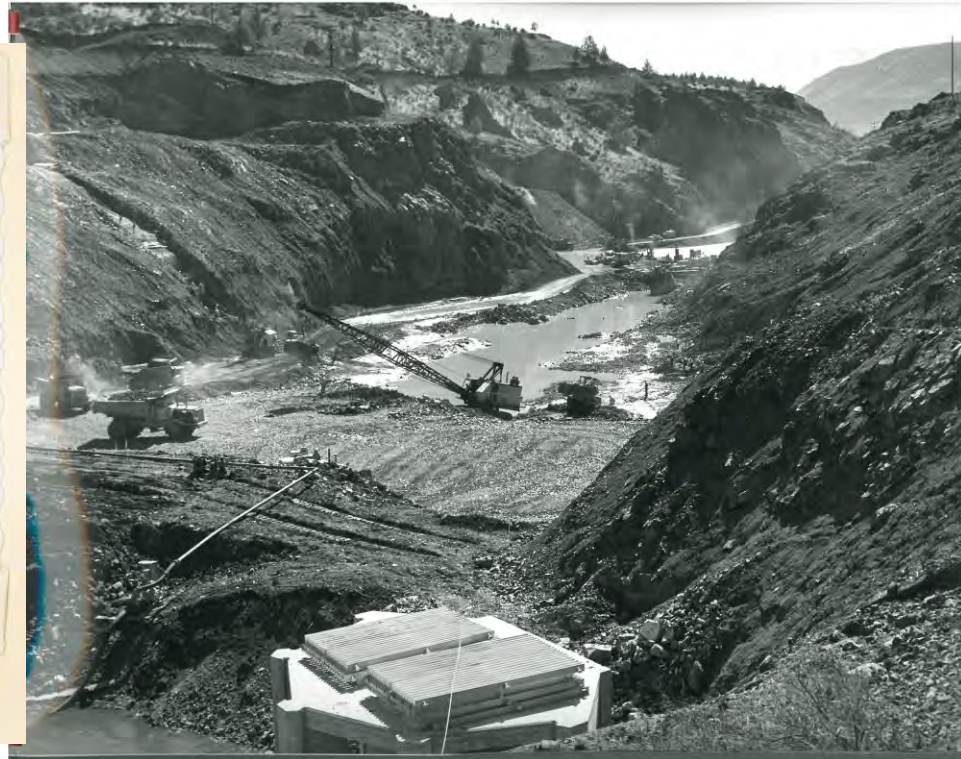
BB 234

Dam. Unwatered foundation.
7/25/57

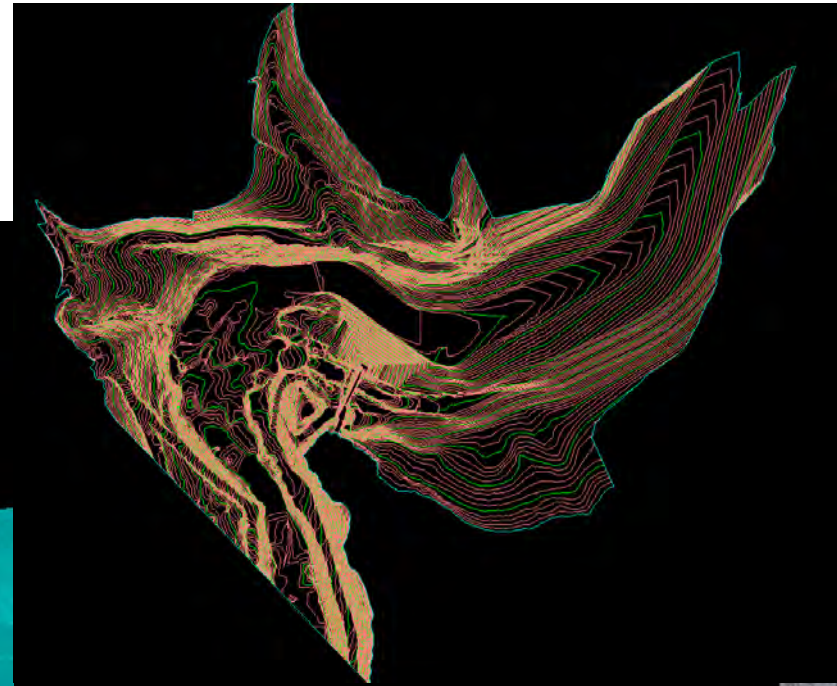
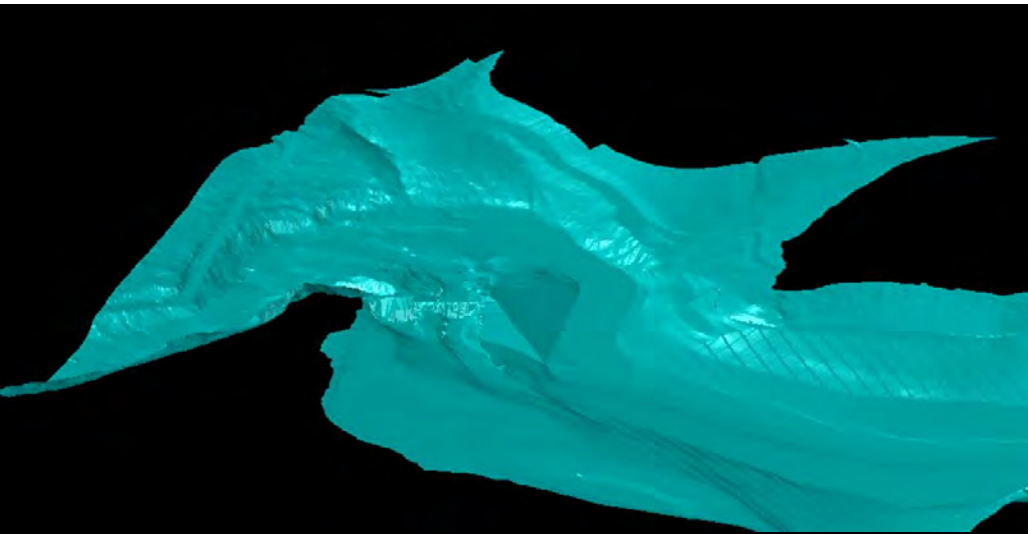
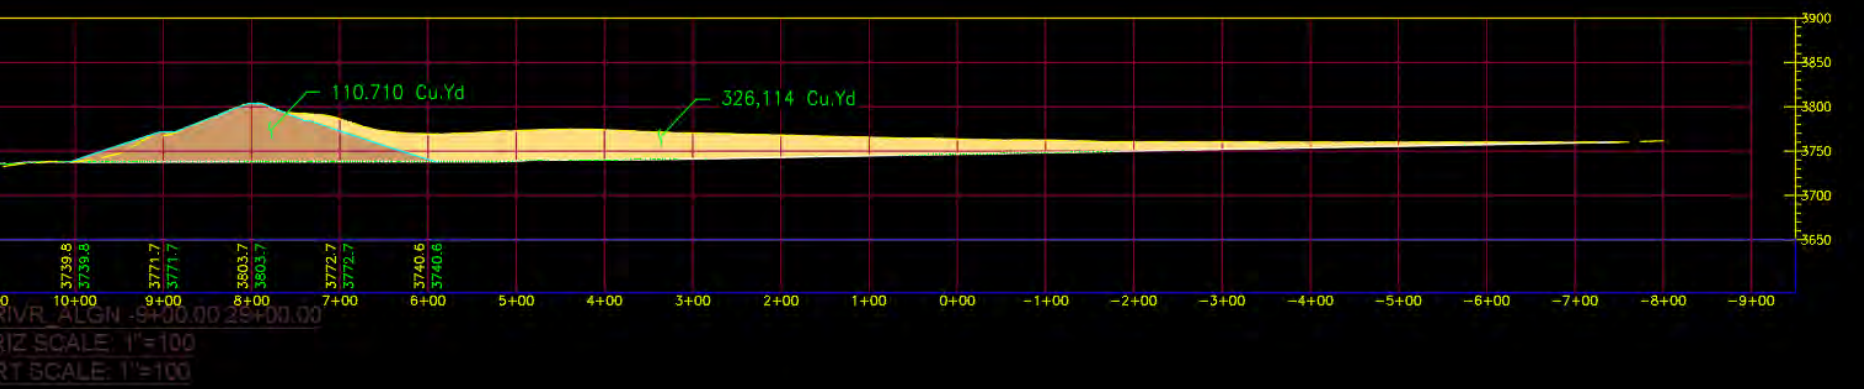
Channel Alignment

JC Boyle

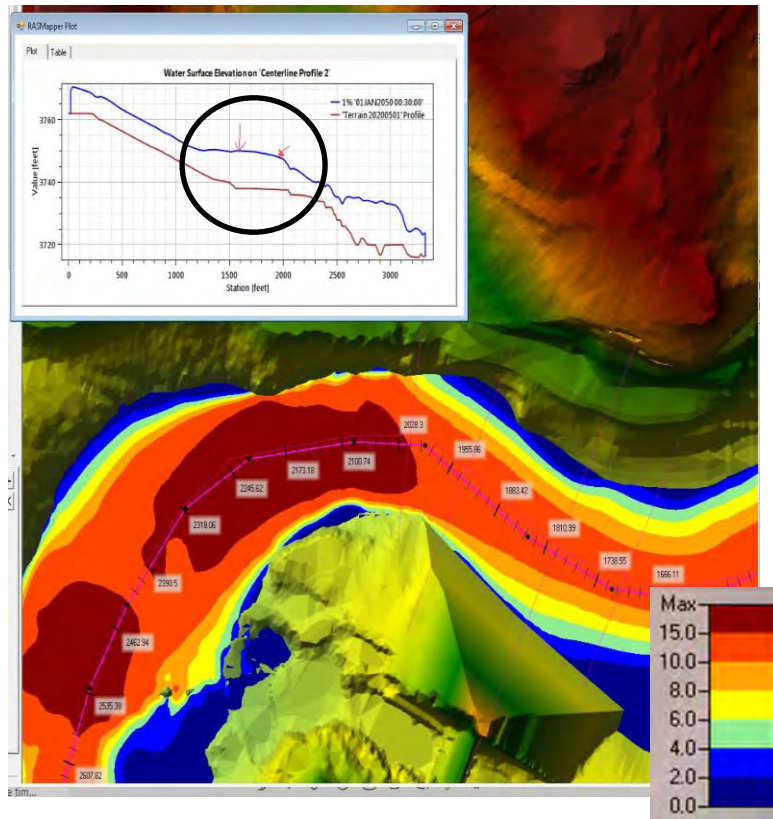
JC Boyle

Terrain and WSE Profile (1% Probable Flood)

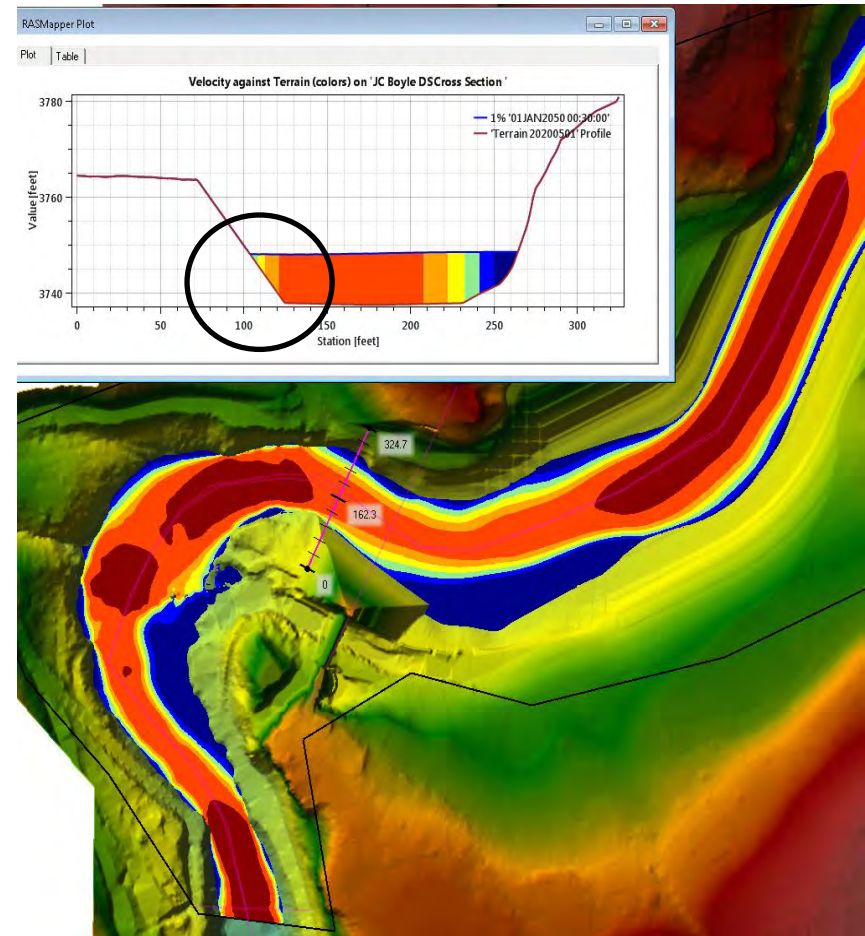
Velocity at 1% Probable Flood (14,200 cfs)

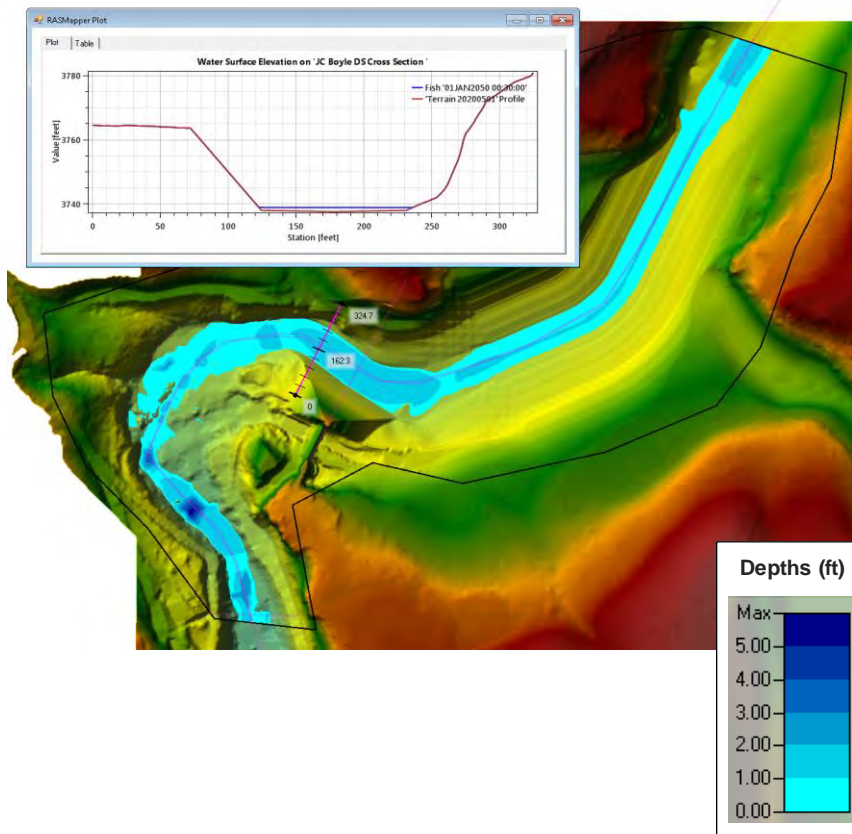
Fish Passage Low Flow (230 cfs) Depth

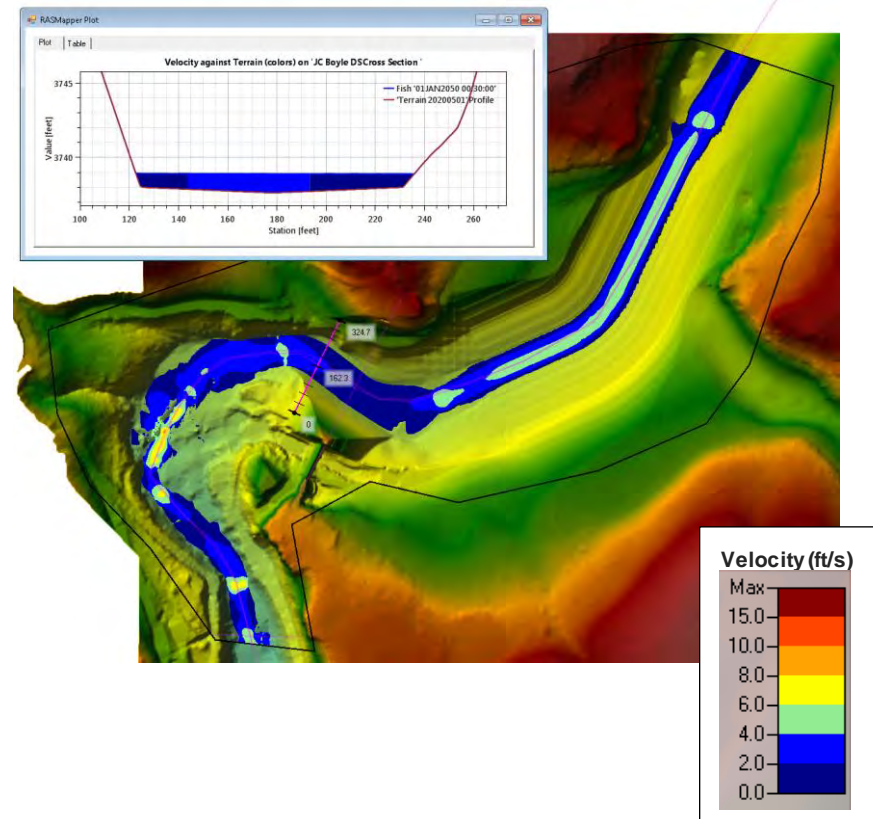
Fish Passage Low Flow (230 cfs) Velocity

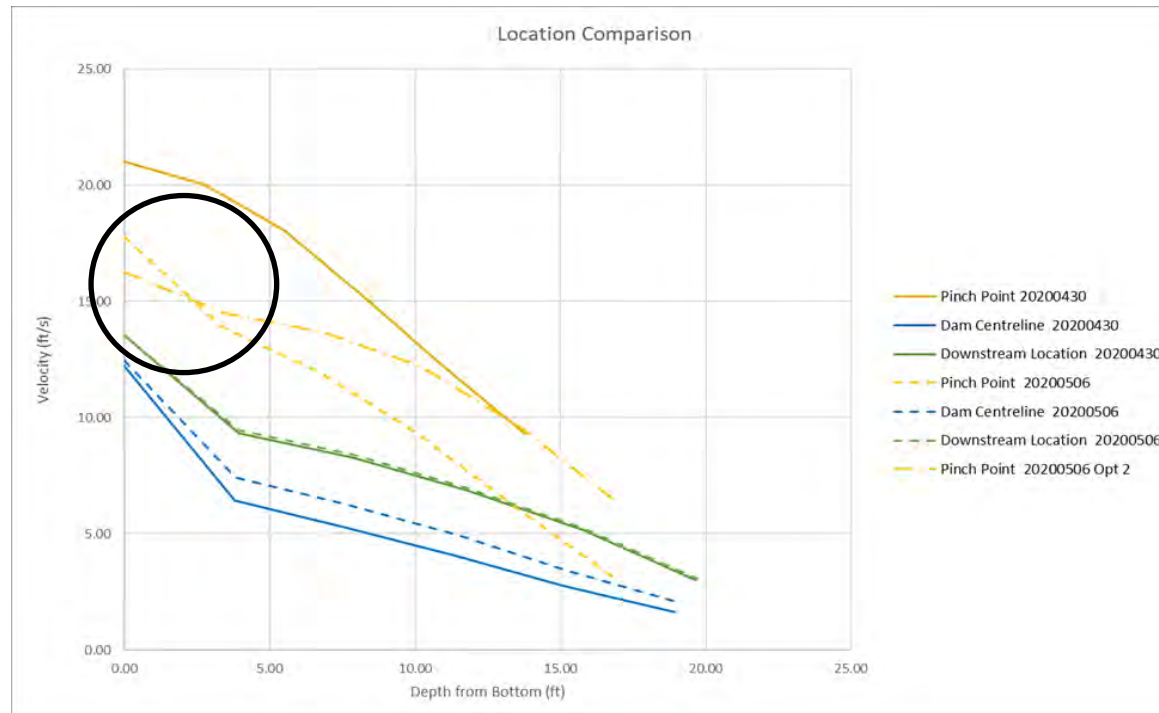
Pinch Point 20200506 = Option 1 – 1% Flow

Pinch Point 20200506 Opt 2 = Option 2 – 1% Flow

Option 1 Chosen – bank velocity from 0-3 ft from bottom is slightly higher, but velocities dissipate rapidly up the right bank slope above approx. 5ft

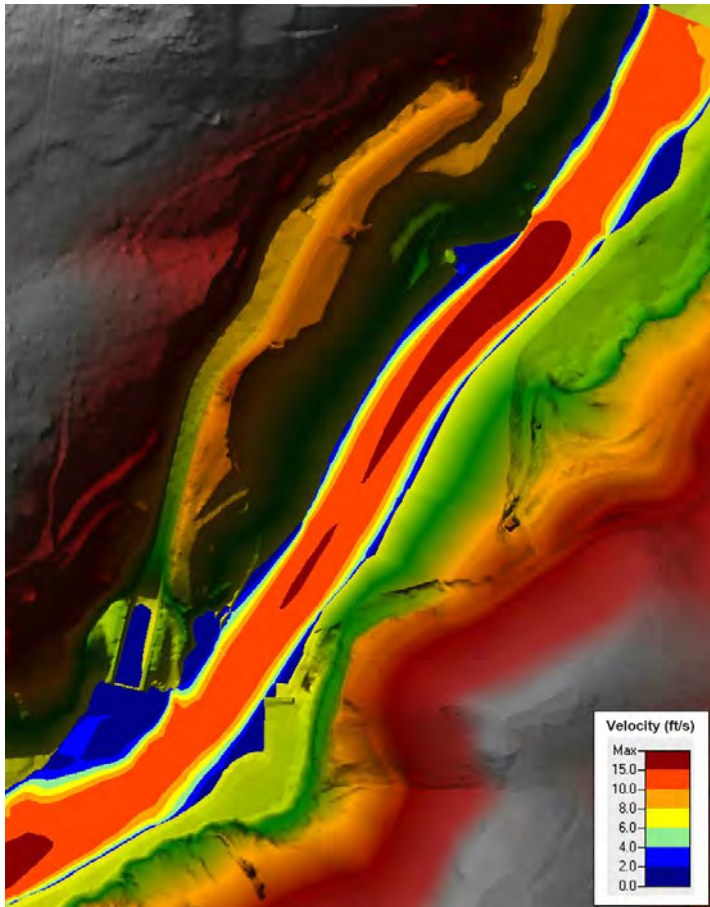
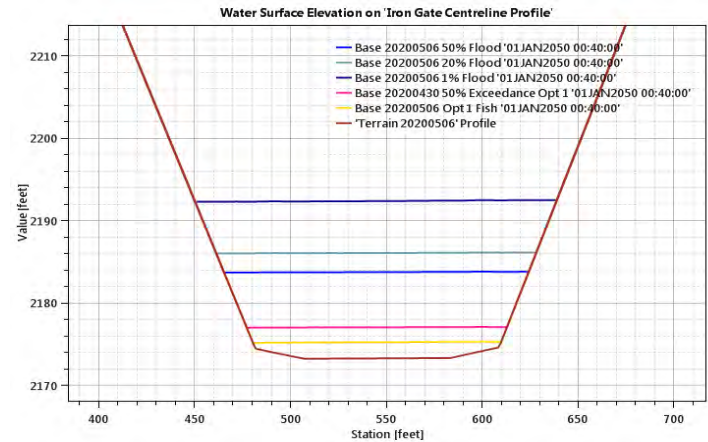
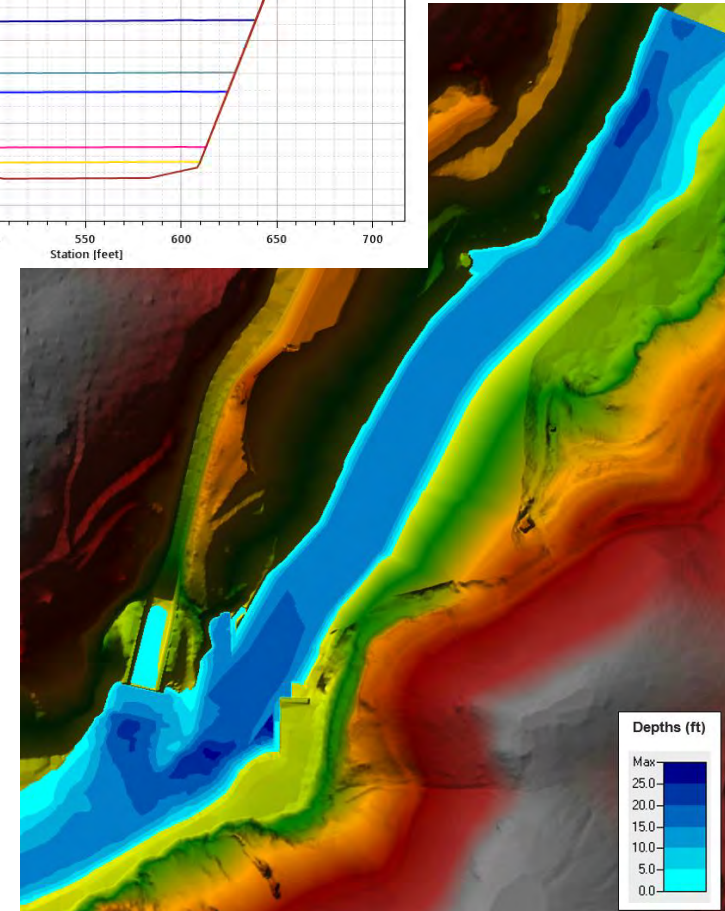
Velocity at 1% Probable Flood (33,700 cfs)

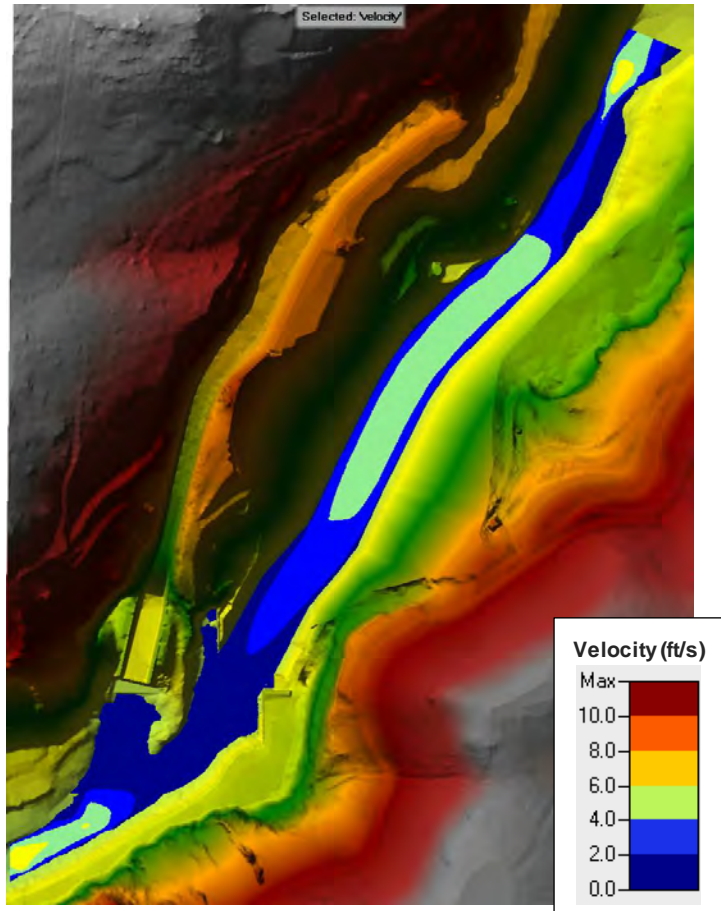
Fish Passage Low Flow (900 cfs) Velocity

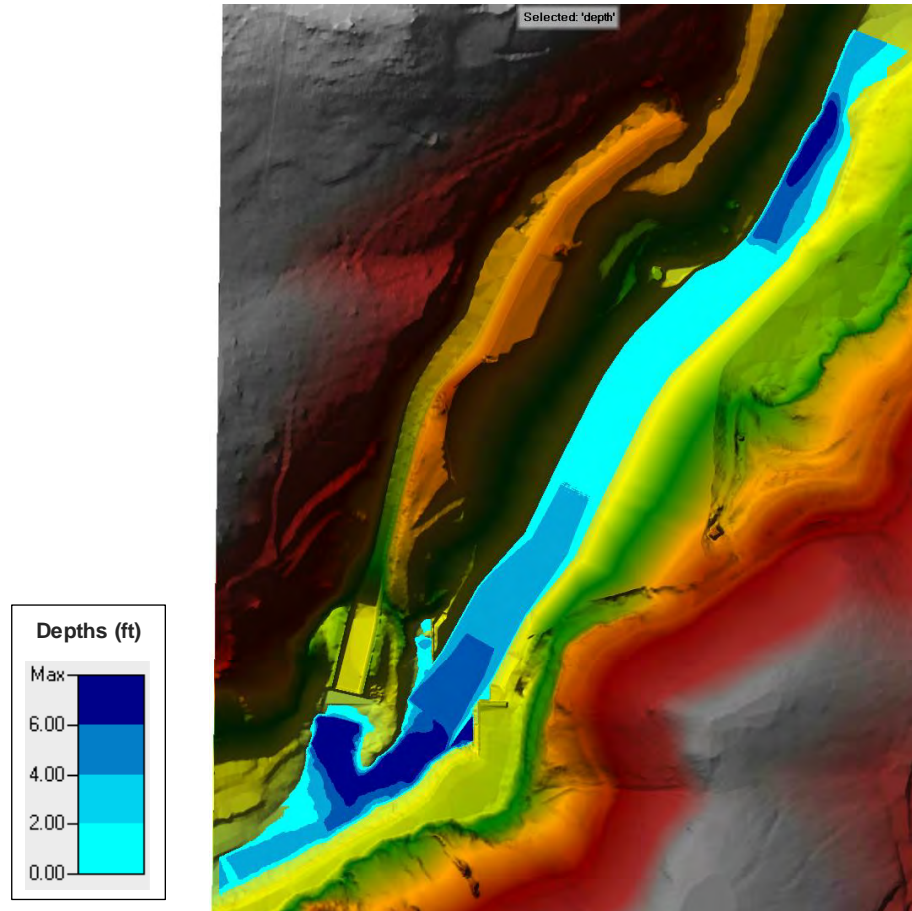
Fish Passage Low Flow (900 cfs) Depth

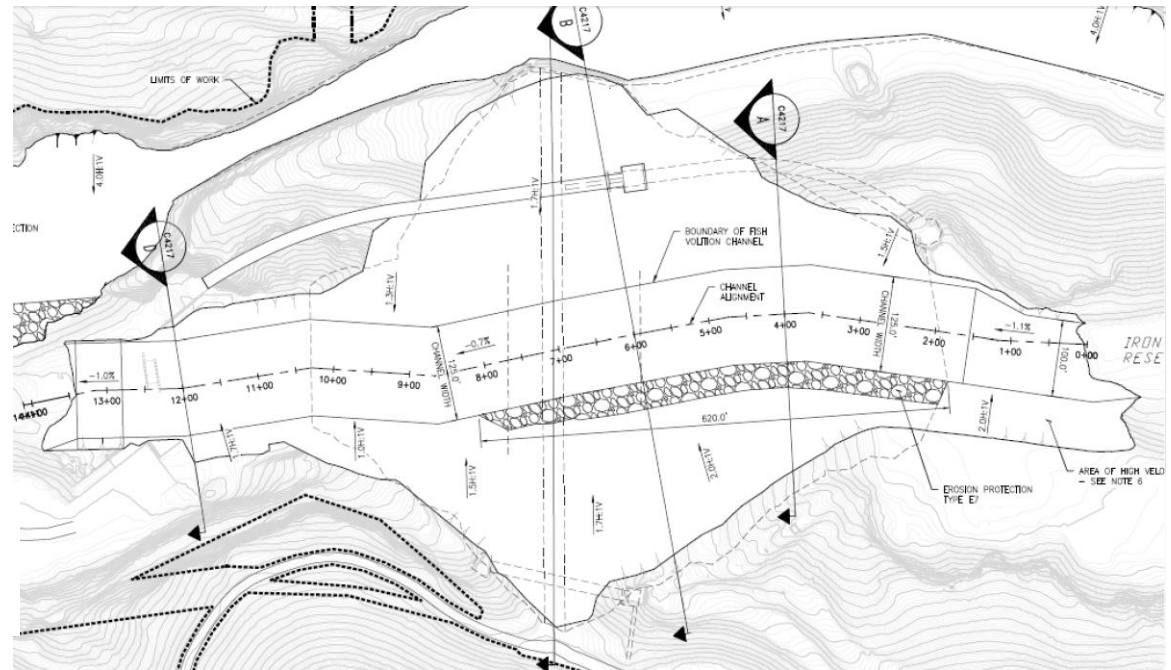
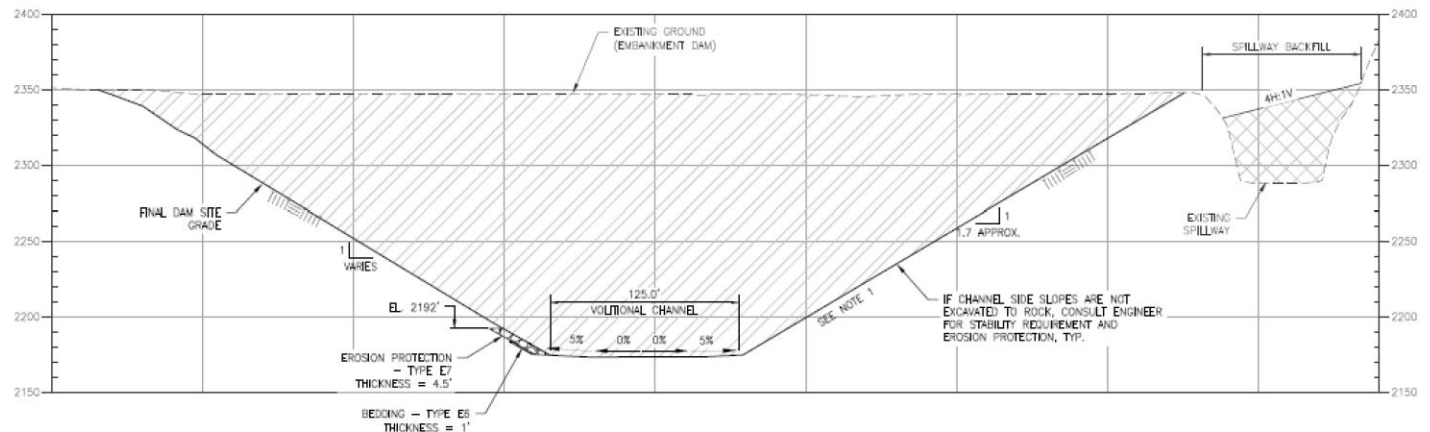
MATERIAL TYPE	D ₅₀ LOWER	D ₅₀ UPPER	VOLUME
EROSION PROTECTION - TYPE E7	2.0 ft	1.0 ft	4900 yd ³
BEDDING - TYPE E6	-	-	500 yd ³

- ALL CUT SLOPES STEEPER THAN 2H:1V ARE ASSUMED TO BE IN AN AREA WHERE EXCAVATION WILL BE BEDROCK.
- ESTIMATED VOLUMES:
 - EMBANKMENT CUT = 935,000 CU. YD.
 - SPILLWAY FILL = 192,612 CU. YD.

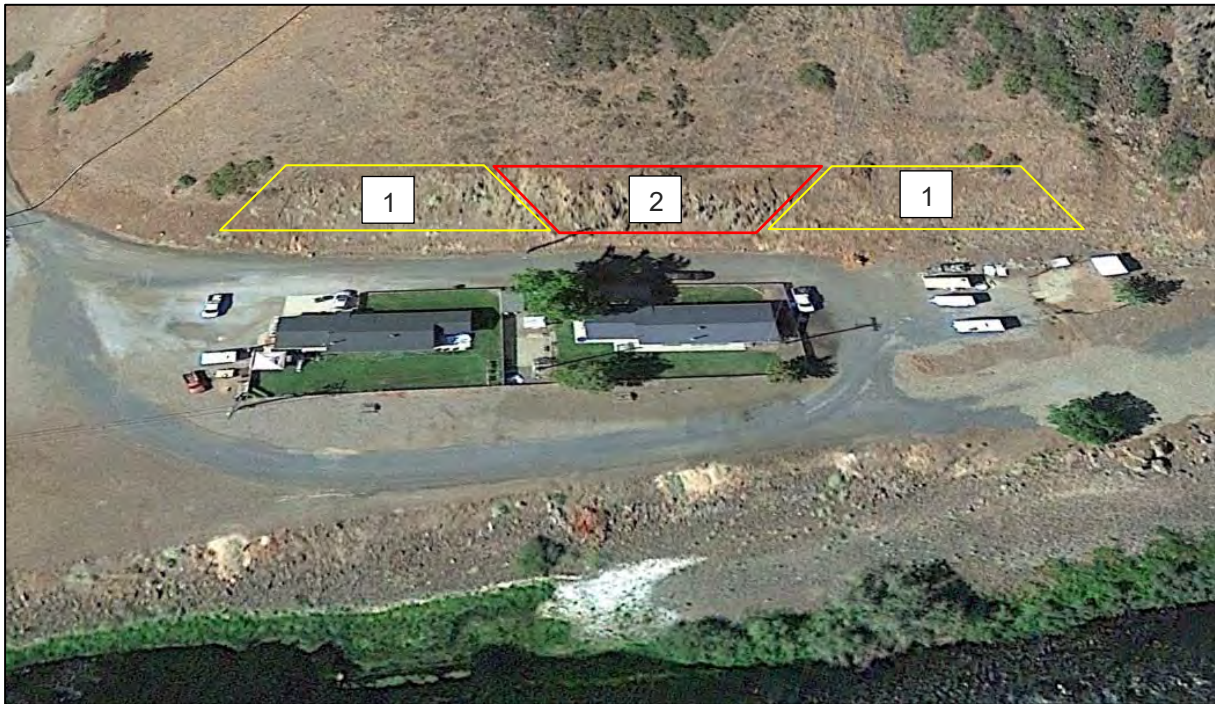
Figure 2.1 Iron Gate Worker's Accommodation Potential Borrow Source

The Iron Gate Worker's Accommodation borrow site is located on the right bank of the Klamath River approximately 1,000 ft downstream the Iron Gate dam. The material on the cut face to the north of the workers accommodation was the primary focus of the investigation, as shown in Figure 2.1, and comprised a potential granular fill potential source, with some limited erosion protection material present adjacent to a rock outcrop.

- Observed gradation of the two Sub-Areas identified:
 - Sub-area 1: ~10% 2-ft minus material, ~35% 1-ft minus material, ~30% 6-inch minus material, ~20% sand, <5% minus No. 200 (plastic fines), approximately 590 yd² based on aerial imaging.

Based on the results of the field assessment, there is potential for Sub-Area 1 to be processed to produce granular fill. The hillside would have to be mined further into the slope to generate larger quantities. There

does not appear to be any surficial infrastructure or property boundary impediments to accomplishing this. This area is not considered an adequate source of erosion protection material.

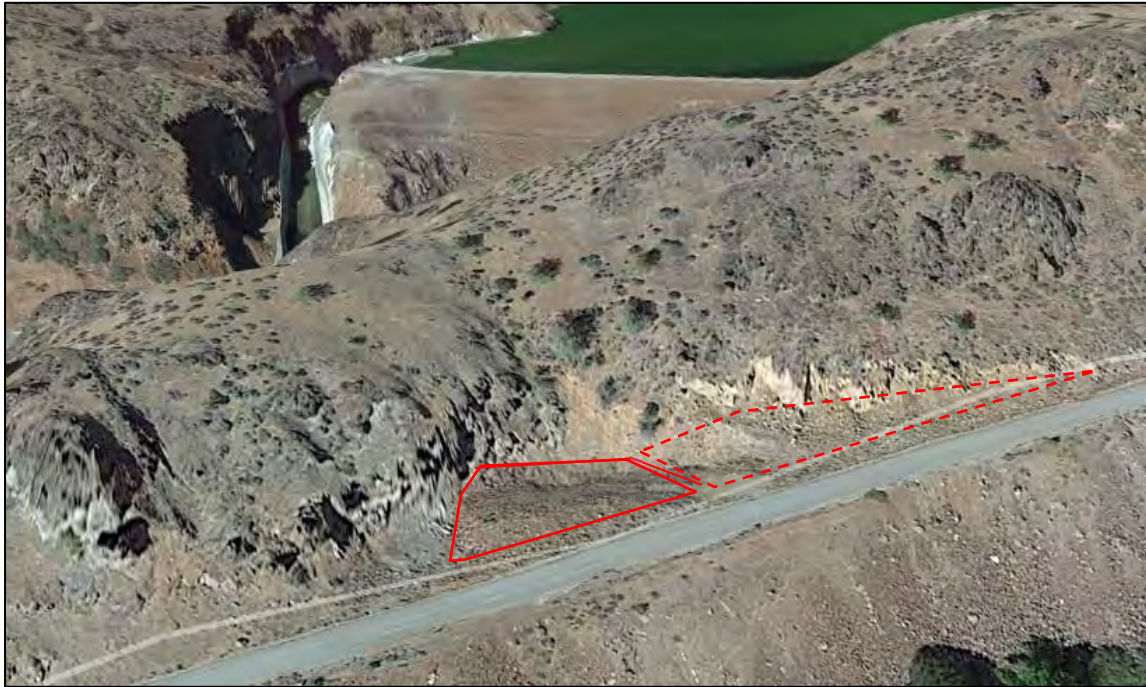
Figure 2.2 Iron Gate Lakeview Road Potential Borrow Source

The Iron Gate Lakeview Road borrow site is located adjacent to Lakeview Road, approximately 1,100 ft east of Daggett Bridge as shown in Figure 2.2. The material primarily comprised smaller class erosion protection, or possibly bedding material.

- Very little organics are apparent, almost zero vegetation is in area.
- Observed Gradation: <1% 4-foot minus material, ~10% 2-ft minus, ~25% 1-ft minus, ~40% 6-inch minus, ~25% 3-inch minus.

Based on the results of the field assessment, the assessed area is appropriate for smaller size erosion protection or bedding material. The dashed area located to the east of the main borrow source may be

suitable for use as granular fill, however a gradation of the material is difficult to estimate from a visual assessment without trenching or probing.

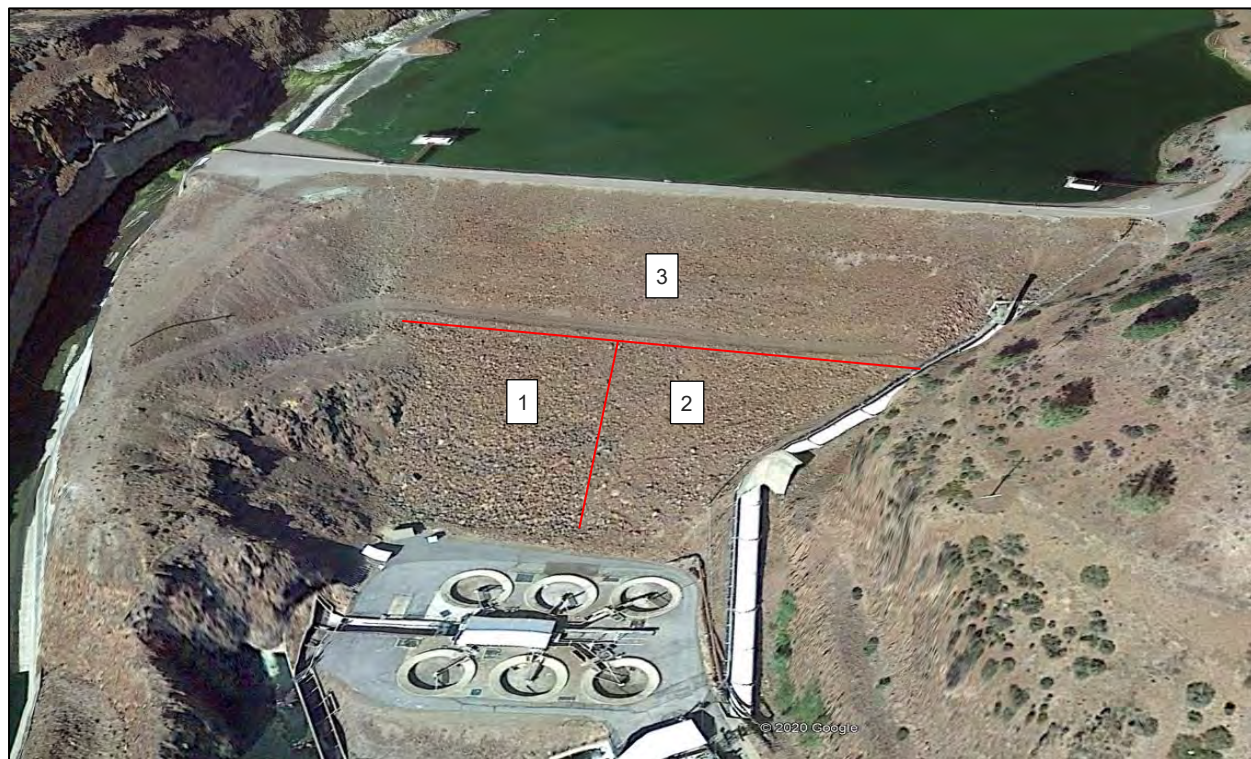
Figure 2.3 Iron Gate Downstream Dam Face

The Iron Gate Dam Downstream Face has existing Erosion Protection placed from the dam crest to the fish hatchery at the dam toe. The dam face was sub-divided into three separate sub-areas based on the apparent surface erosion protection particle size, as shown on Figure 2.3.

- Observed gradation of the three sub-areas assessed on the downstream face:
 - Sub-area 1: $D_{50} = \sim 28"$, $D_{85} = 40"$, approximately 2,980 yd² based on aerial imaging. Split-NET gradation analysis was completed and is presented in C.5. Results indicated a $D_{85} = 36"$, $D_{50} = 18"$ and $D_{15} = 3.4"$.

- Sub-area 2: $D_{50} = \sim 20"$, approximately 1,950 yd² based on aerial imaging. Split-NET gradation analysis was completed and is presented in C.6. Results indicated a $D_{85} = 26"$, $D_{50} = 12"$ and $D_{15} = 1.4"$, which were smaller than the observed average gradation.

- Sub-area 3: $D_{50} = \sim 9"$, $D_{85} = 12"$, $D_{15} = 3"$ approximately 5,900 yd² based on aerial imaging. Split-NET gradation analysis was completed and is presented in C.7. Results indicated a $D_{85} = 10"$, $D_{50} = 3.5"$ and $D_{15} = 0.4"$, which are smaller than the field observed average gradation.

- Erosion Protection sample IGDDS-1 was obtained for durability properties testing across lower half of embankment surface.
- The downstream dam face has a minimum erosion protection thickness of 5 ft, as per historic as-built drawing 5407-A-111.

The observed material quality and durability within all 3 sub-areas of the downstream shell are similar, however the material size varies across each sub-area. Sub-area 1 had the largest material, followed by Sub-areas 2, then Sub-area 3. Based field assessment results, this site can be used as a source for Erosion Protection of varying sizes.

Borrow Source	Approximate Gradation	Surface Area (yd ²) ¹	Assumed Depth (yd)	Expected Volume (CY)
Iron Gate Dam Downstream Face Sub-area 1 Figure 2.3	D ₅₀ = 28" D ₈₅ = 40"	2,980	1.67	4,400 – 4,800
Iron Gate Dam Downstream Face Sub-area 2 Figure 2.3	D ₅₀ = 20"	1,950	1.67	2,900 – 3,200
Iron Gate Dam Downstream Face Sub-area 3 Figure 2.3	D ₁₅ = 3" D ₅₀ = 9" D ₈₅ = 12"	5,900	1.67	9,000 – 9,800
Iron Gate Lakeview Road Figure 2.2	D ₁₅ = 1" D ₅₀ = 6" D ₈₅ = 14"	825	2 – 4	1,600 – 3,200
Copco No. 1 Access Road Sub-area 1 Figure 2.4	D ₁₅ = 3" D ₅₀ = 15" D ₈₅ = 28"	365	0.5 – 2	200 – 700
Copco No. 2 Downstream Right Bank Figure 2.6	D ₁₅ = 36" D ₅₀ = 48" D ₈₅ = 72"	3,000	2 – 5	9,000 – 18,000 ²
Copco No. 2 Downstream Left Bank Figure 2.7	D ₁₅ = 12" D ₅₀ = 40" D ₈₅ = 60"	1,940	1 – 3	2,000 – 6,000 ²
J.C. Boyle Downstream of Dam Sub-area 1 Figure 2.10	D ₁₅ = 1" D ₅₀ = 9" D ₈₅ = 20"	850	0.5 – 2	500 – 1,500
J.C. Boyle Downstream of Dam Sub-area 2 Figure 2.10	D ₁₅ = 8" D ₅₀ = 24" D ₈₅ = 36"	250	0.5 – 1.5	150 - 400
