RE: KRRP Value Engineering Summary and Advancement to 90% Design

KP was tasked with leading seven VE analyses, which are listed below and described in the following sections of this letter:

VE-1 Submittals: Drawdown Model and Assessment

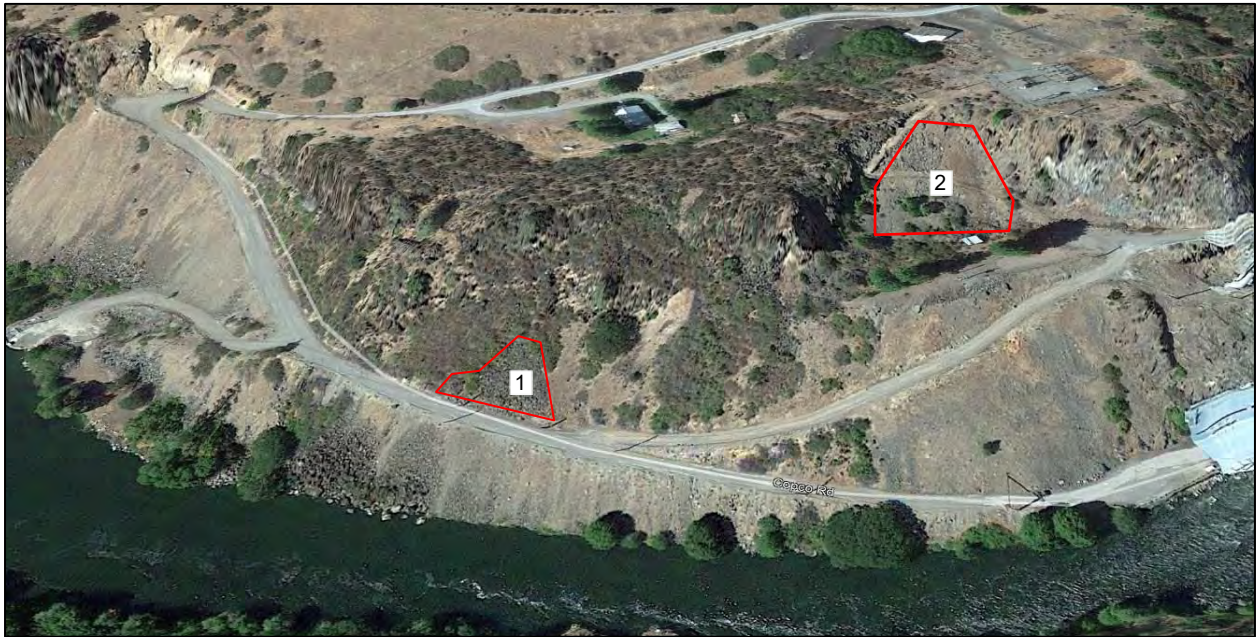
Figure 2.4 Copco No. 1 Access Road Potential Borrow Source

The Copco No. 1 Access Road potential borrow source is located along the existing Copco No. 1 right bank access road and along the proposed future road alignment shown on drawing C2510. The access road construction will produce a surplus material, of which some is expected to be used as source of erosion protection or granular fill. This investigation, however, was limited to surface observations and was unable to ascertain the gradation and material type of the proposed bulk excavation. Two areas that had visible erosion protection material on surface were investigated, as shown on Figure 2.4.

- Fine-grained basalt, some vesicular, angular, lightly weathered, very strong, breaks with hard strikes from rock hammer, Schmidt hammer strength values ranging from 23 to 41 ksi with no apparent sulfide mineralization.
- Observed gradation of two Sub-areas assessed on the Copco No. 1 Access Road:
 - Sub-area 1: $D_{50} = \sim 15"$, $<10\%$ 3-inch minus material, approximately 365 yd² based on aerial imaging.
 - Sub-area 2: Not considered an adequate source. Localized erosion protection material available.

- Two Split-NET gradation analyses were completed in Sub-area 1 and are presented in Appendix C - Figures C.8, and C.9. Results indicated a $D_{85} = 18"$, $D_{50} = 9"$ and $D_{15} = 1.6"$, and a $D_{85} = 15"$, $D_{50} = 7"$ and $D_{15} = 1.8"$, respectively, which are smaller than the field observed average gradation.
- Erosion Protection sample CRBR-1 obtained for durability properties testing in Sub-area 1

Based on the results of the investigation, Sub-area 1 may be an acceptable source of small size Erosion Protection, Riverbed, or Bedding Material. The surface material at Sub-area 2 does not have adequate coverage of large sized rocks to be a reliable borrow source.

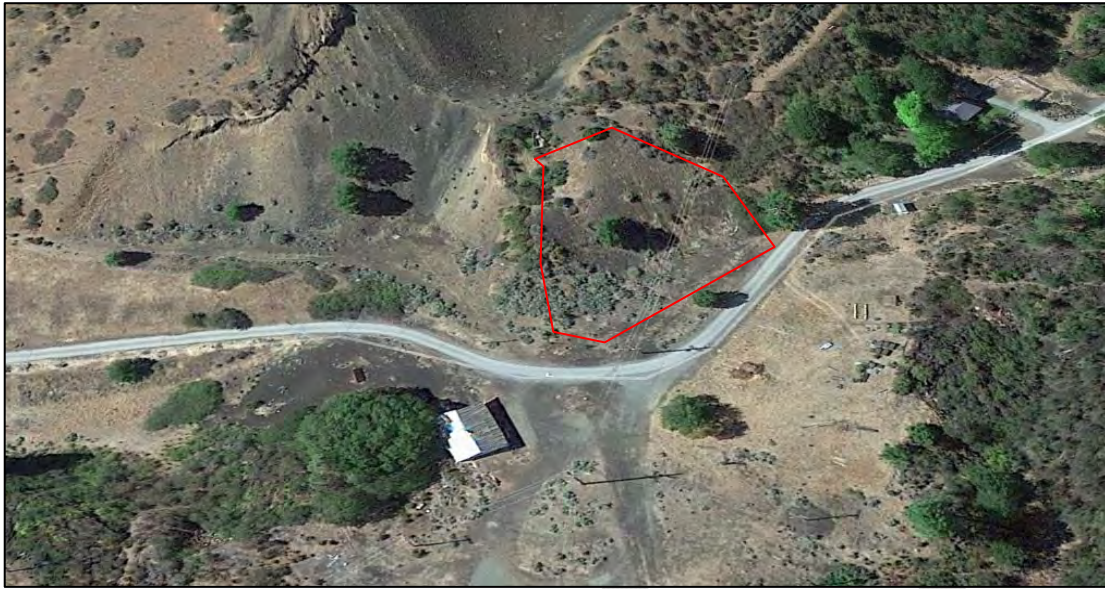
Figure 2.5 Copco No. 1 Village Potential Borrow Source

Copco No. 1 Village potential borrow source is located the north of the Copco No. 1 Dam Right Abutment and lies adjacent to an existing historic borrow source, as shown in Figure 2.5. The material was assessed as a potential source of granular fill.

- USCS, SC, 1 to $\frac{1}{2}"$ minus, clayey sand with gravel. Two Split-NET gradation analyses were completed and are presented in Figures C.10, and C.11 in Appendix C. Results indicated a $D_{85} = 0.9"$, $D_{50} = 0.2"$ and $D_{15} = 0.03"$, and a $D_{85} = 0.6"$, $D_{50} = 0.2"$ and $D_{15} = 0.03"$, respectively.
- Granular Fill sample C1V-1 obtained for sieve analysis and soil classification.
- Approximately 2,070 yd² based on aerial imaging.

Area may be possible source for finer grained granular fill.

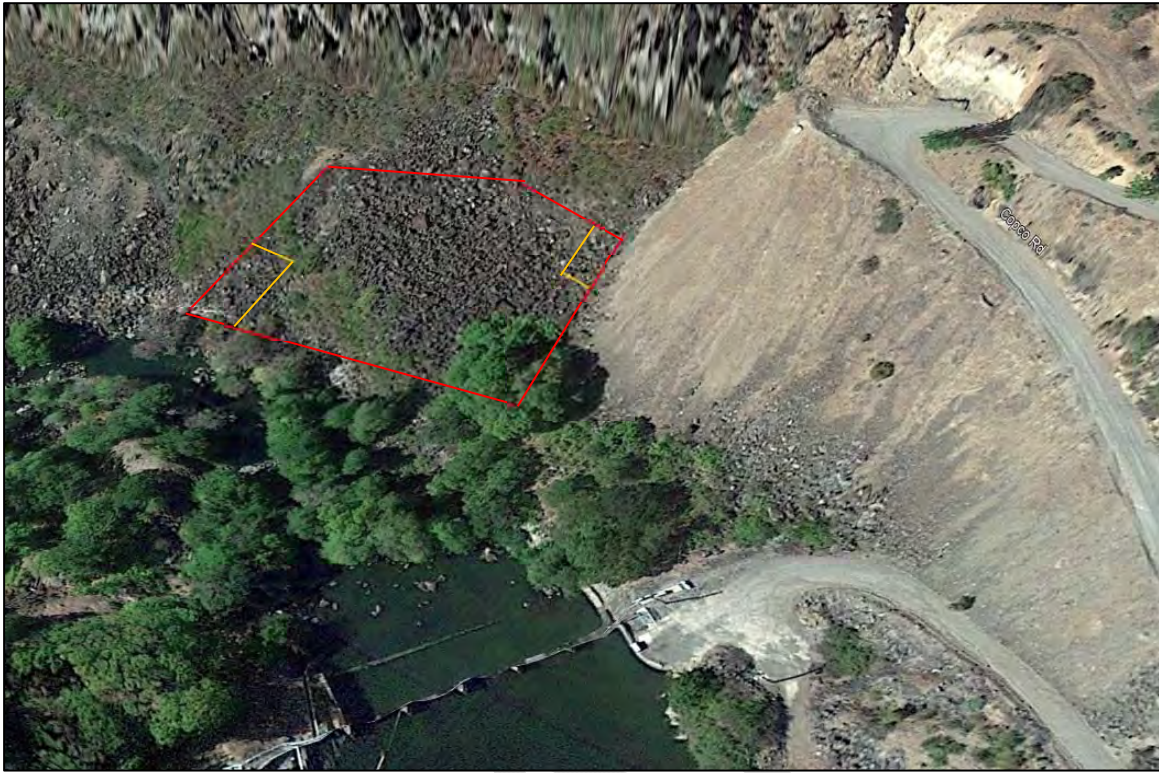
Figure 2.6 Copco No. 2 Downstream Right Bank Potential Borrow Source

The Copco No. 2 downstream right bank potential borrow source is a talus slope located approximately 250 ft downstream of the Copco No. 2 diversion dam, as shown on Figure 2.6. The talus comprises erosion protection material.

- Observed gradation: D_{50} value ~ 48 inches, 20% 7-ft minus, 20% 5-ft minus ft, 50% 4-ft minus, 10% 1-ft minus.
 - In the areas denoted by the orange boundaries in Figure 2.6, the D_{50} was observed to be smaller, approximately 32" to 36".

- Two Split-NET gradation analyses were completed and are presented in Appendix C - Figures C.12, and C.13. Results indicated a $D_{85} = 46"$, $D_{50} = 32"$ and $D_{15} = 14"$, and a $D_{85} = 44"$, $D_{50} = 28"$ and $D_{15} = 5"$, respectively. The results of the analysis are suspected to be smaller than the field observed gradations due to the inability to place both scaling balls in the photograph to account for depth of field.

- Erosion Protection sample C2DSR-1 obtained for durability properties testing.
- No Granular Fill samples obtained at this site.
- Approximately 3,000 yd² based on aerial imaging.

The material found within the right bank talus pile is among the largest onsite sized boulders available and is appropriate for the large erosion protection sizes specified at the Copco No. 1 and No. 2 locations.

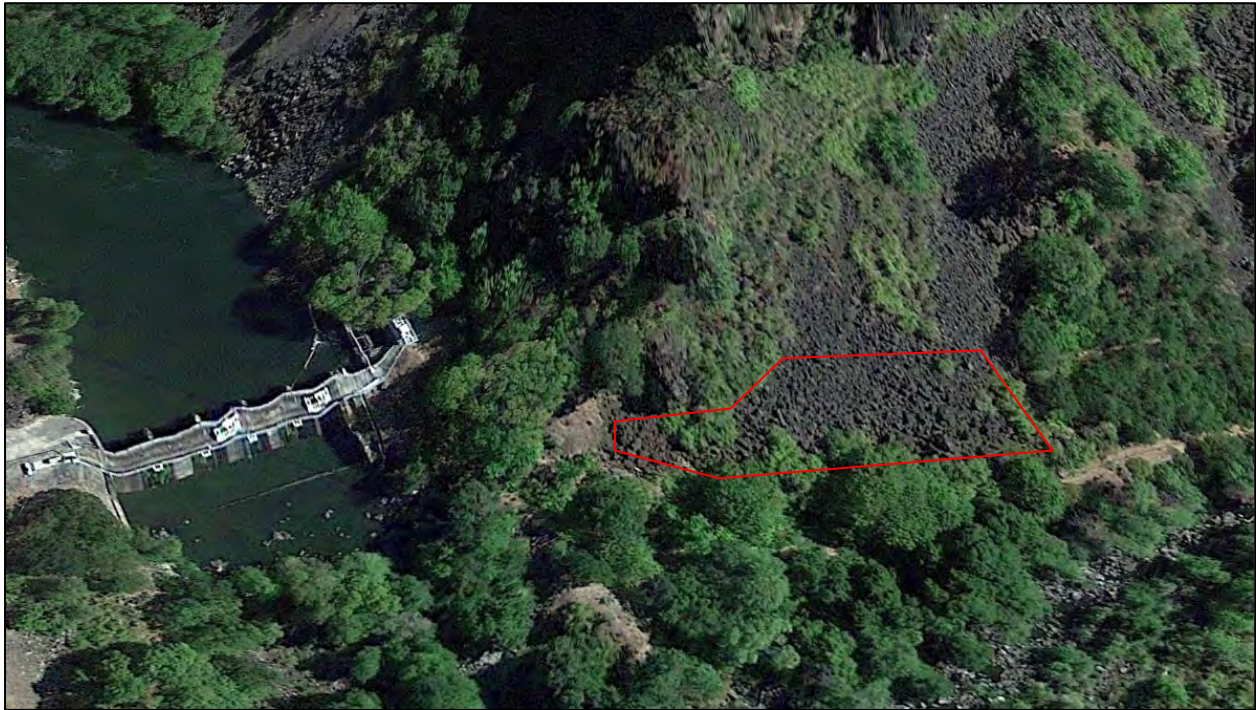
Figure 2.7 Copco No. 2 Downstream Left Bank Potential Borrow Source

The Copco No. 2 downstream left bank potential borrow source is a talus slope located approximately 300 ft downstream of the Copco No. 2 diversion dam, as shown on Figure 2.7. The talus comprises erosion protection material.

- Observed Gradation: $D_{50} = 40"$, general material is 6-ft minus.
- Two Split-NET gradation analyses were completed and are presented in Appendix C -Figure C.14 and C.15. Results indicated a $D_{85} = 44"$, $D_{50} = 28"$, and $D_{15} = 15"$, and a $D_{85} = 60"$, $D_{50} = 33"$, and $D_{15} = 7.5"$, respectively. The two photographs are of the same area but at different setback distances. Figure C.15 photograph was taken further back and the results were closer to the field observed gradation.

- Erosion Protection sample C2LB-1 was obtained for durability properties testing.
- No Granular Fill samples was obtained at this site.
- Approximately 1,940 square yards based on aerial imaging.

The material found within the talus pile on the left bank is among the largest sized boulders available onsite and is appropriate for the large erosion protection classes specified at the Copco No. 2 location.

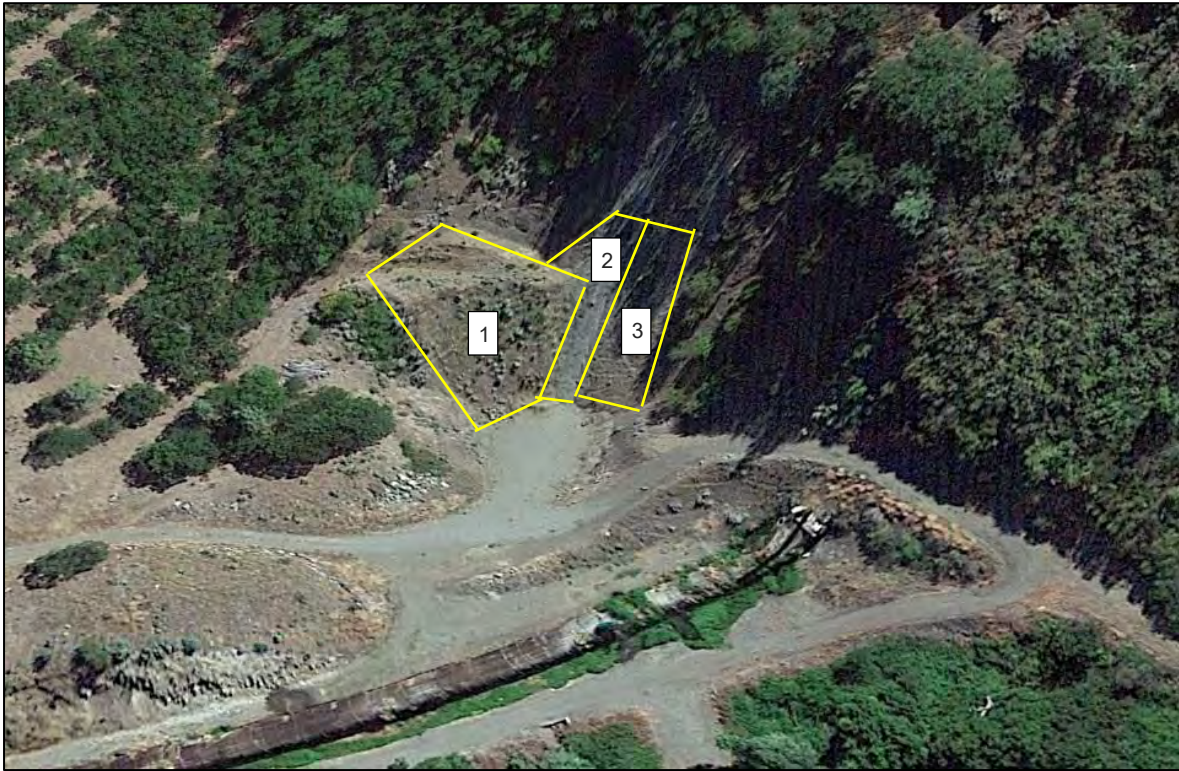
Figure 2.8 Copco No. 2 Wood-Stave Penstock Potential Borrow Source

The Copco No. 2 Wood-Stave Penstock is located to the south of the Wood-Stave Penstock and Tunnel 2 Inlet Portal along the Copco No. 2 Water Conveyance system. The area has possibly been previously used as borrow source or material storage site. The area was divided into three distinct materials, as shown in Figure 2.8.

- Sub-area 2: USCS, GP, grey sandy gravel, approximately 230 yd² based on aerial imaging.
 - Sub-area 3: USCS, GP, 6-inch minus, 75-80% passing 3-inch screen, 50% > 1.5 inches, 20% passing 1-inch screen, approximately 240 yd² based on aerial imaging. A Split-NET gradation analysis of Sub-Area 3 is presented in Appendix C – Figure C.17. Results indicate a $D_{85} = 3.5"$, $D_{50} = 1.2"$ and $D_{15} = 0.14"$.

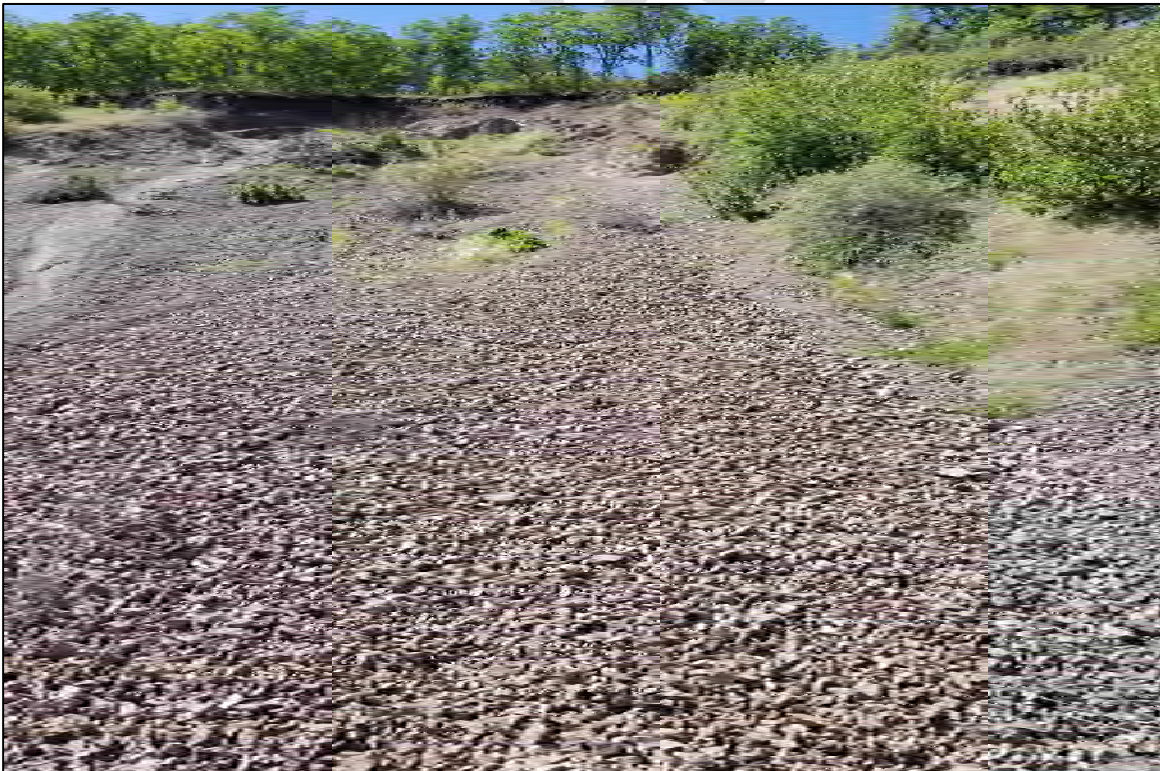
Figure 2.9 Wood-Stave Penstock Sub-Area 3 Coarse Granular Fill

- Granular Fill samples C2WP-1, C2WP-2 AND C2WP-3 was obtained for sieve analysis and soil classification.
- The coarse material in Sub-area 2 and 3, as shown in Figure 2.9, appear to be remnants of processed material that was stockpiled in this area. Without further excavation into the slope the confirmed depth of this coarse material was limited to 2 ft.

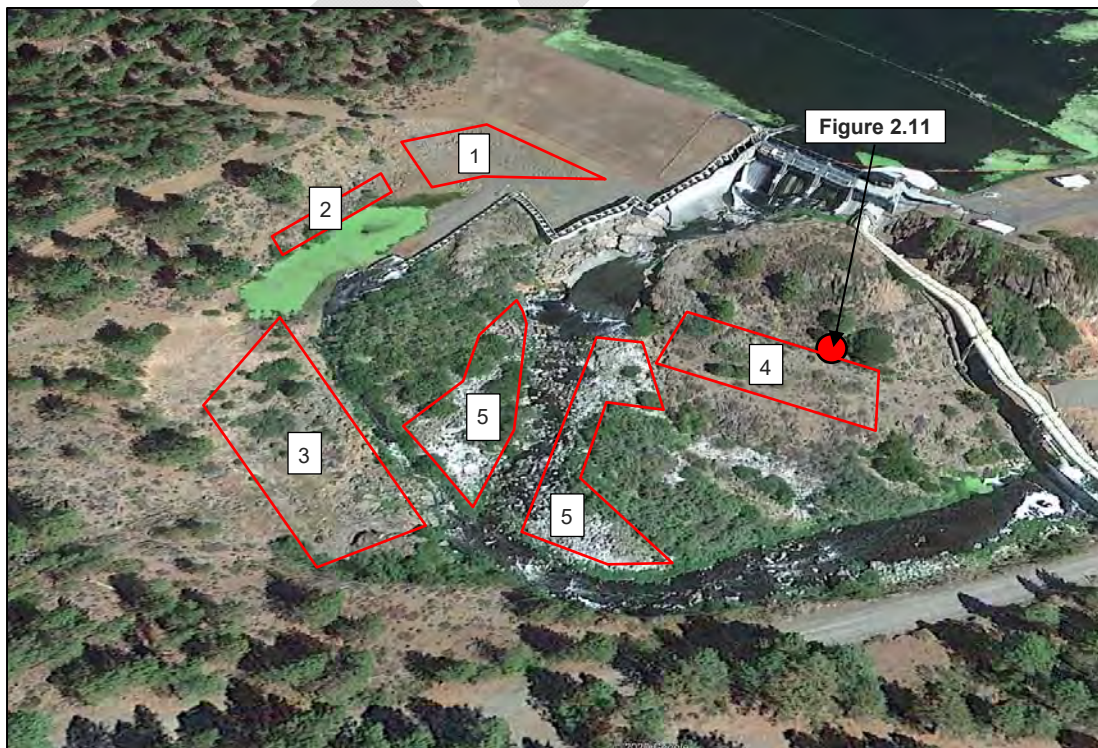
Figure 2.10 J.C. Boyle Downstream of Dam Potential Borrow Source

The area directly downstream of the J.C. Boyle was assessed for possible sources of erosion protection material. Five distinct sub-areas were investigated, as shown in Figure 2.10.

- Observed gradations for the five Sub-areas assessed downstream of the J.C. Boyle dam:
 - Sub-area 1: $D_{50} = \sim 9"$, $D_{max} = \sim 3$ ft, $\sim 35\%$ passing 6" screen, $\sim 20\%$ waste, approximately 850 yd². Two Split-NET gradation analyses were completed and are presented in Appendix C - Figure C.18 and C.19. Results indicated a $D_{85} = 12"$, $D_{50} = 2.4"$ and $D_{15} = 0.03"$, and a $D_{85} = 26"$, $D_{50} = 8.4"$ and $D_{15} = 0.03"$, respectively.

- Sub-area 3: not a significant source of material.
 - Sub-area 4: not a significant source, localized piles of approximately $D_{50} = 36"$ material (see Figure 2.11).

- Sub-area 5: $D_{50} = 24"$, $D_{max} = 48"$, approximately 2,020 yd² based on aerial imaging.
 - Erosion Protection sample JCBEP-1 obtained for durability properties testing.

- No Granular Fill samples obtained at this site.
- The downstream dam face (Sub-area 1) has a minimum erosion protection thickness of 2 ft, as per historic as-built drawing AA 78084.

J.C. Boyle Downstream of Dam Sub-area 5 Figure 2.10	D ₅₀ = 24"	2,020	0.5 – 1.5	1,000 – 1,500

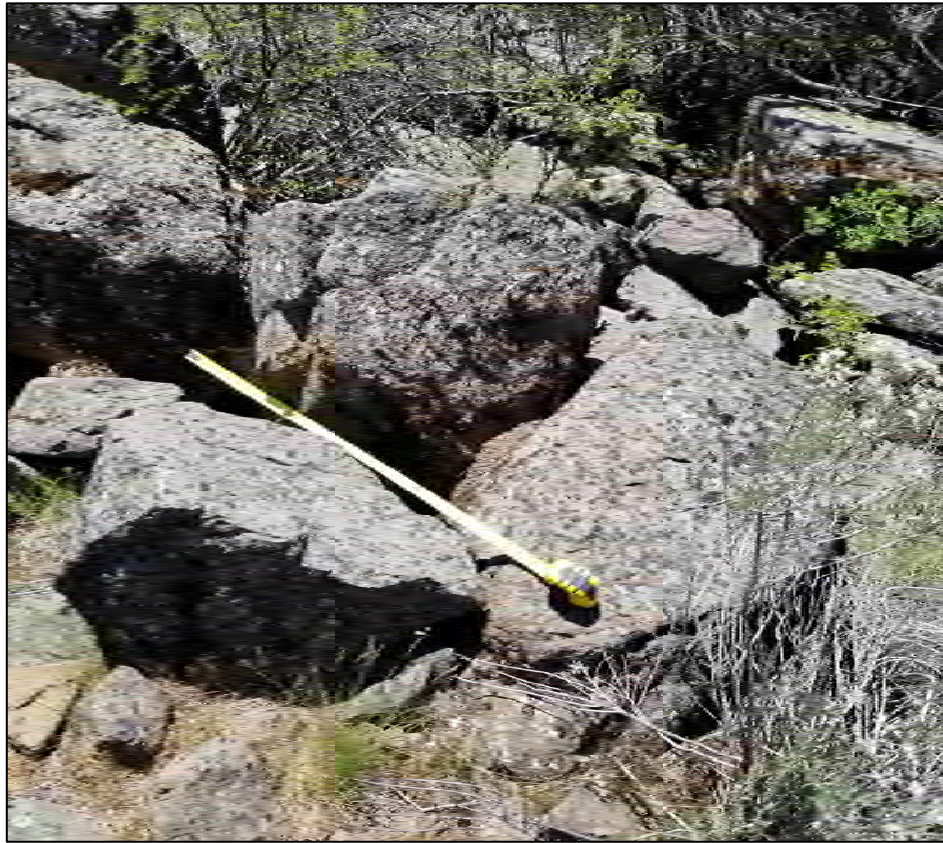
Figure 2.11 Sub-area 4 Downstream, Left Slope coarse particles are scattered and bedded

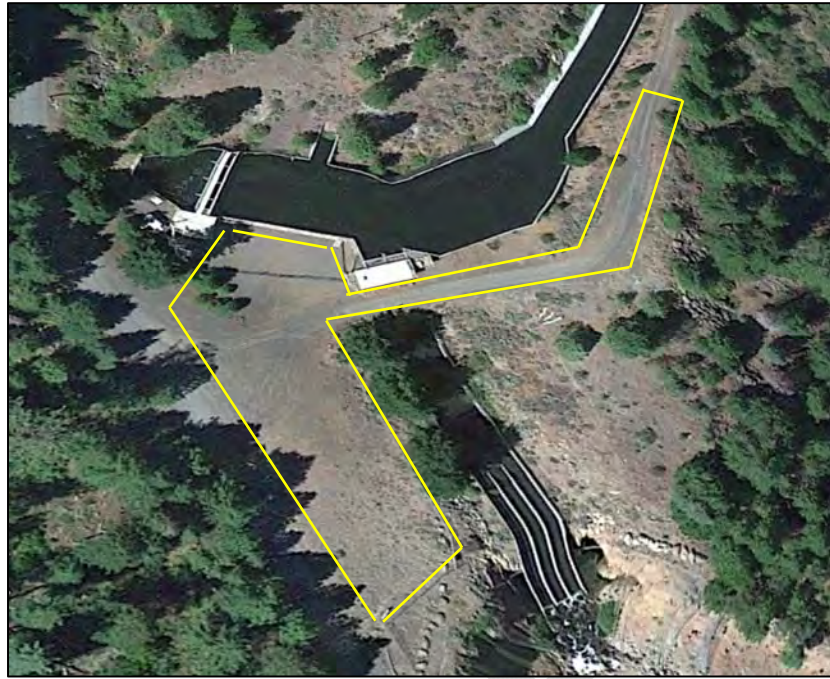
Figure 2.12 J.C. Boyle Forebay Potential Borrow Source

The granular surfacing material at the J.C. Boyle Forebay access road and parking area was identified as a possible granular fill source for the access road realignment. The areas shown in Figure 2.12 were assessed.

- Road course and parking lot generally 1-inch nominal with trace cobbles and boulders, zero to low plasticity, silty sand, and gravel, black in color when moistened. A Split-NET gradation analysis was completed and is presented in Appendix C - Figure C.21. Results indicated a $D_{85} = 0.75"$, $D_{50} = 0.2"$ and $D_{15} = 0.02"$.
- Approximately 0.2 ft in depth within gravel surfacing.
- Material adjacent to road covered areas, gravel with sand, 10-20% cobbles, low to medium plasticity, likely oxidized native material, reddish brown in color when moistened. Material with similar properties exists in access roads below road surfacing gravel (See Figure 2.13).
- Road surfacing area is approximately 2,800 square yards based on aerial imaging, however due to limited thickness of the pavement, there is limited salvageable road coarse material.
- No samples were obtained in this area.

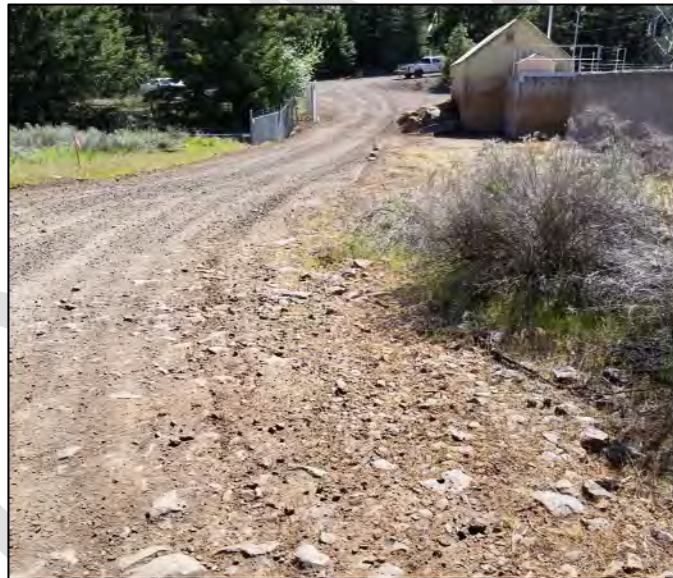
Figure 2.13 Evidence of little to no gravel surfacing along access roads. Coarse fraction in subgrade include cobble to boulder sized particles

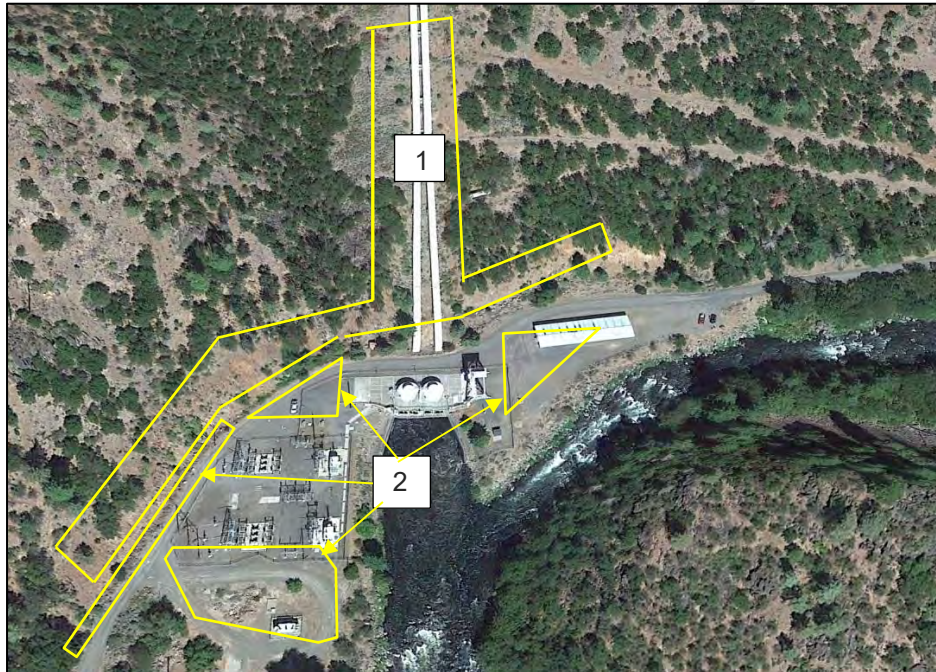
Figure 2.14 J.C. Boyle Powerhouse

The material adjacent to the J.C. Boyle Powerhouse and Penstocks was assessed to determine if any significant volume of areas of possible granular fill or erosion protection materials were present. The area was sub-divided based on material type, as shown in Figure 2.14.

- Sub-area 1: Variable material, typically clayey sand and gravel to clayey gravel with sand, 1-foot minus with boulders and cobbles. Localized concentrated cobble to boulder sized particles present on surface adjacent to road (see JCB Powerhouse Photo 11 in Appendix B). Localized pile was analyzed using Split-NET, as shown in Appendix C - Figure C.22. Results indicated a $D_{85} = 14"$, $D_{50} = 8."$ and $D_{15} = 1.5"$.
- Sub-area 2: Road surfacing gravel nominal size nominal 1-inch; grey sandy gravel; 0.05 to 0.1 ft. in thickness, approximately 3,700 yd², however due to limited thickness of the pavement, there is limited salvageable road coarse material. A Split-NET analysis was complete on the road material, as shown in Appendix C – Figure C.23, however the large cobbles in the top of created unrepresentative results.

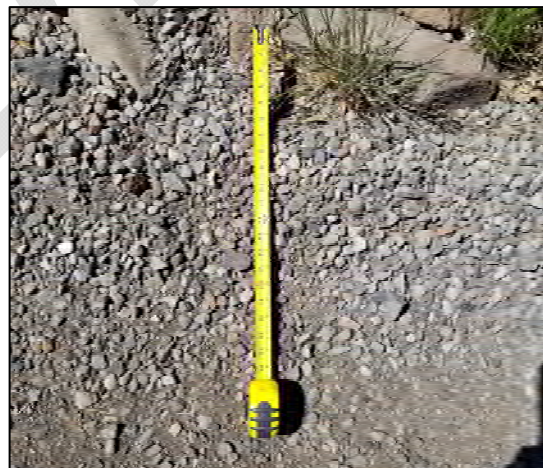
Figure 2.15 J.C Boyle Powerhouse Road Surfacing Material

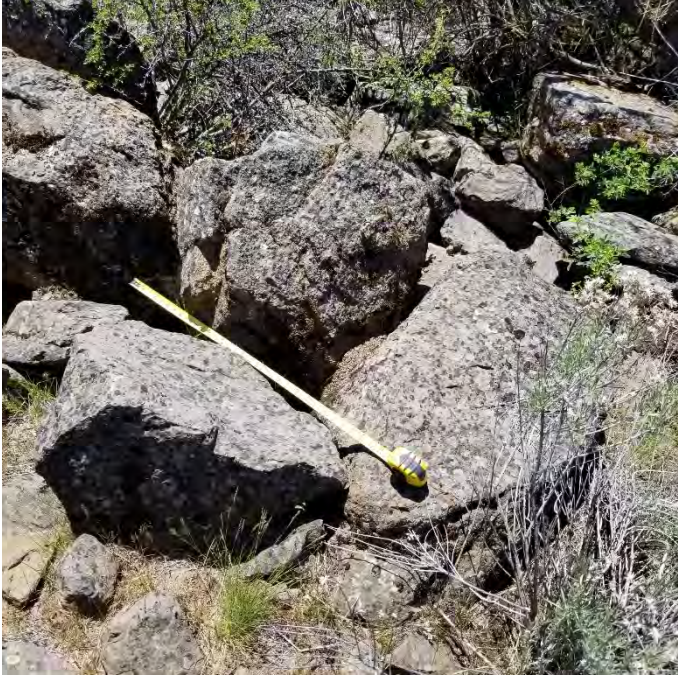
Photo No. 27.

Date: May 6, 2020	
Description: J.C. Boyle Dam – Downstream, tape measure for scale.

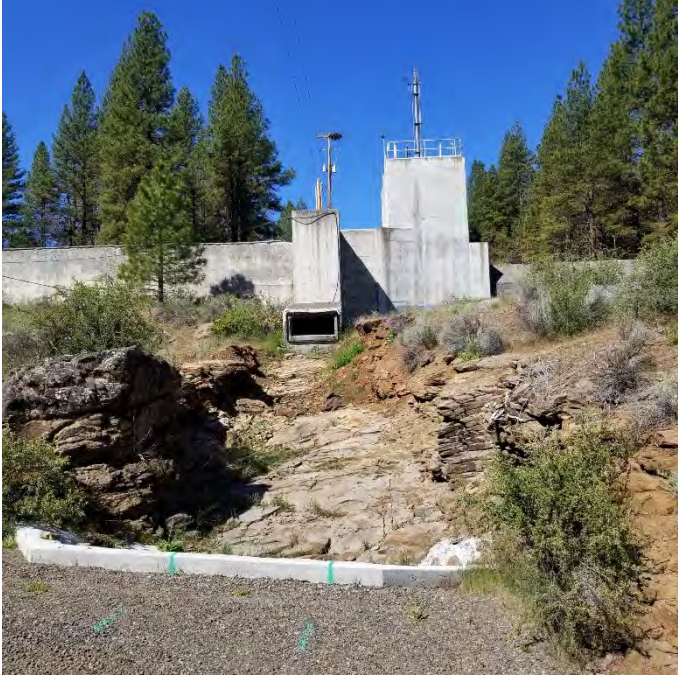
Photo No. 27.

Date: May 6, 2020	
Description: J.C. Boyle Bridge, photo facing west.

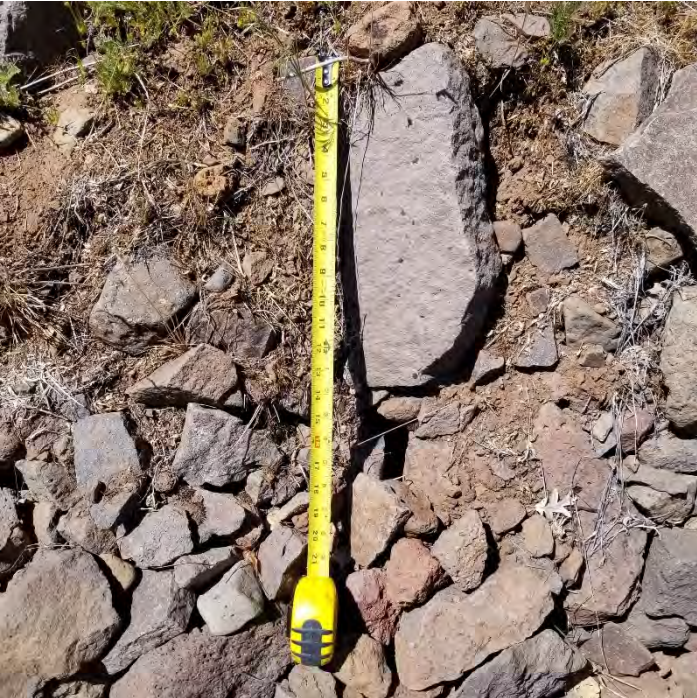
Photo No. 9.

Date: May 6, 2020		
Description: J.C. Boyle Powerhouse, berm at side of road, tape measure for scale.

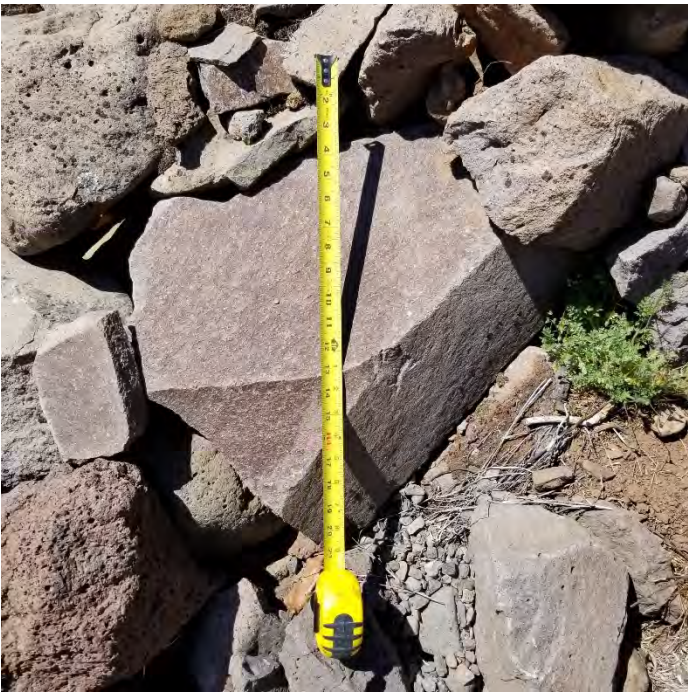
Photo No. 10.

Date: May 6, 2020		
Description: J.C. Boyle Powerhouse, slope north of road, tape measure for scale.

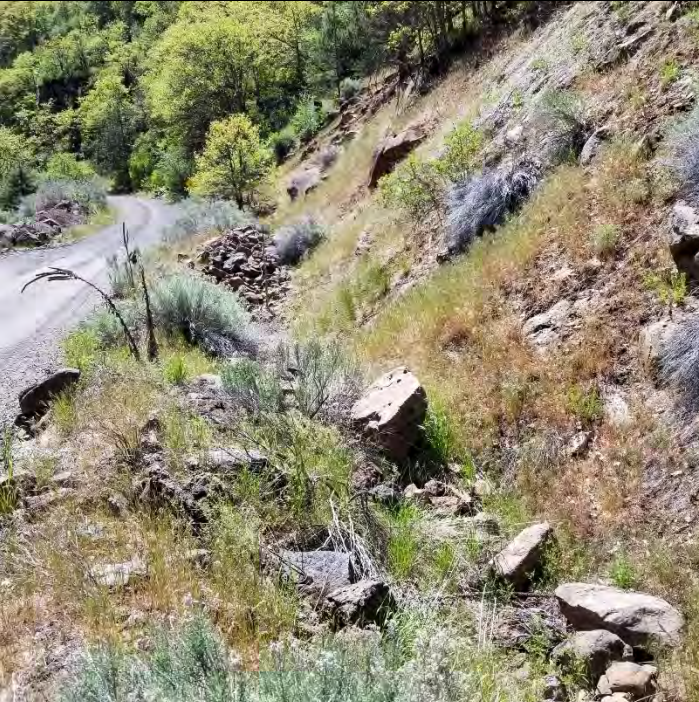
Photo No. 12.

Date: May 6, 2020			
Description: J.C. Boyle Powerhouse, toe of slope north of road, photo facing west.

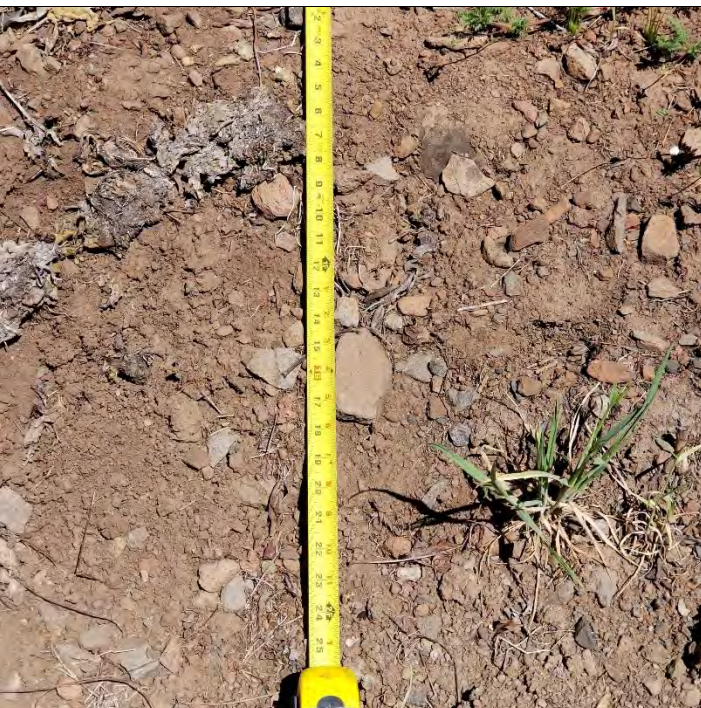
Photo No. 14.

Date: May 6, 2020			
Description: J.C. Boyle Powerhouse, parking area.

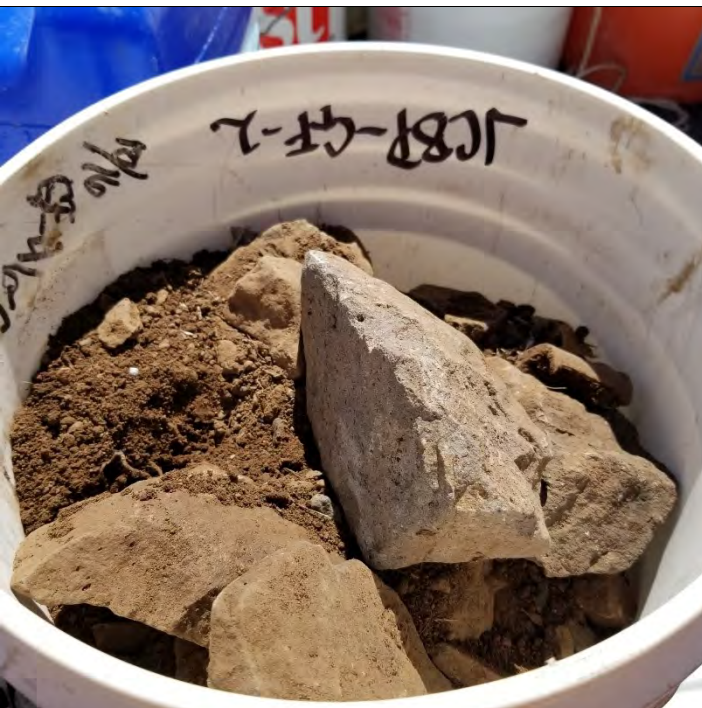
Photo No. 16.

Date: May 6, 2020		
Description: J.C. Boyle Powerhouse, sample of berm north of road.

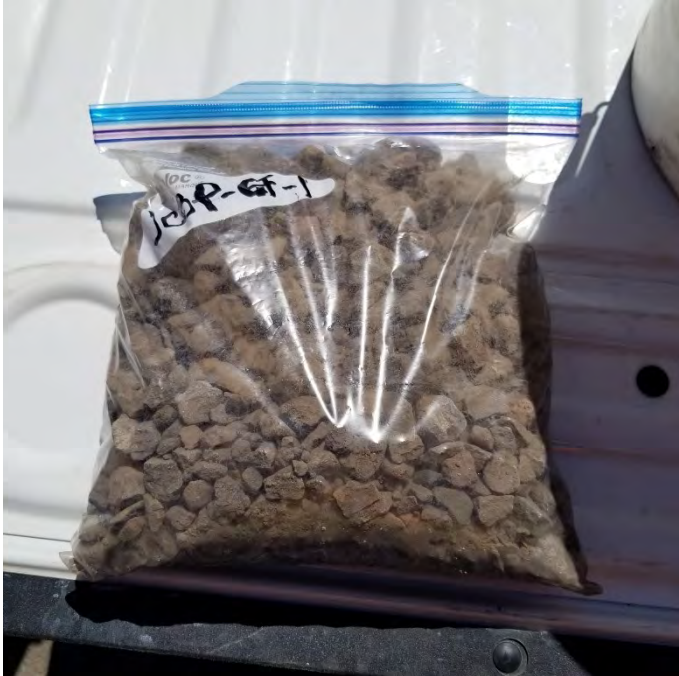
Photo No. 17.	
Date: May 6, 2020	
Description: J.C. Boyle Powerhouse, sample of road wearing course.

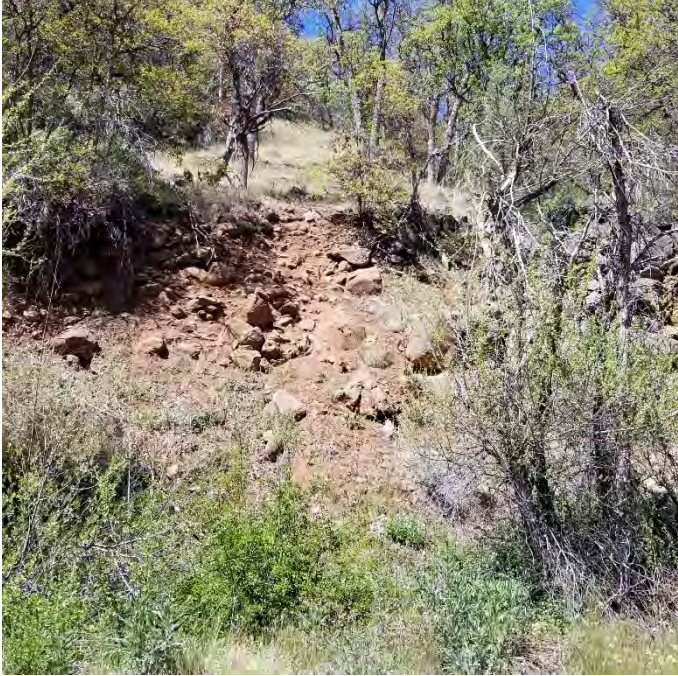
Photo No. 19.

Date: May 6, 2020	
Description: J.C. Boyle Powerhouse, slope north of road.

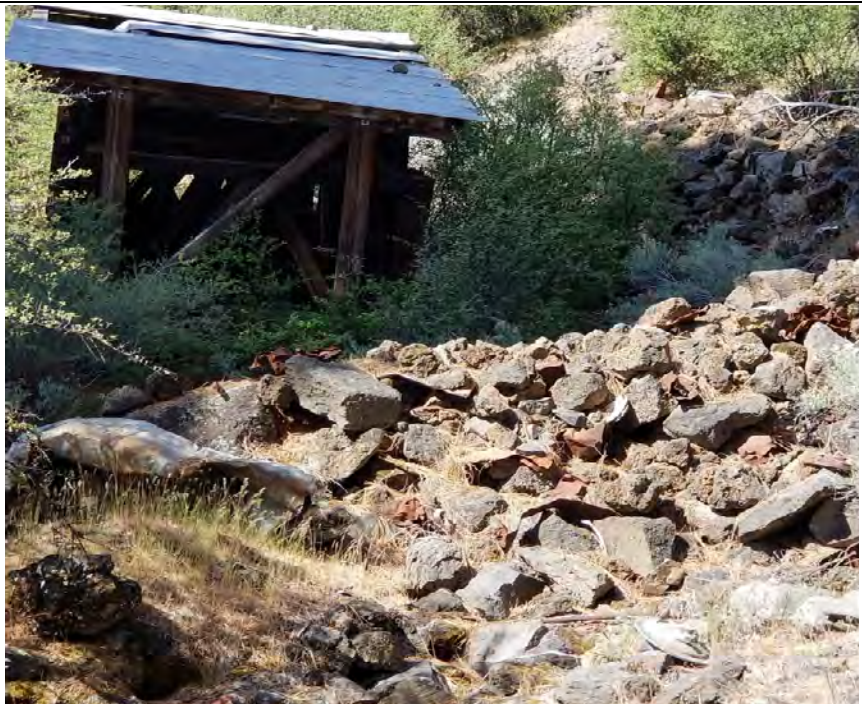
Photo No. 8.

Date: May 5, 2020	
Description: Copco 1 Right Bank road – Zone 2, toe of slope

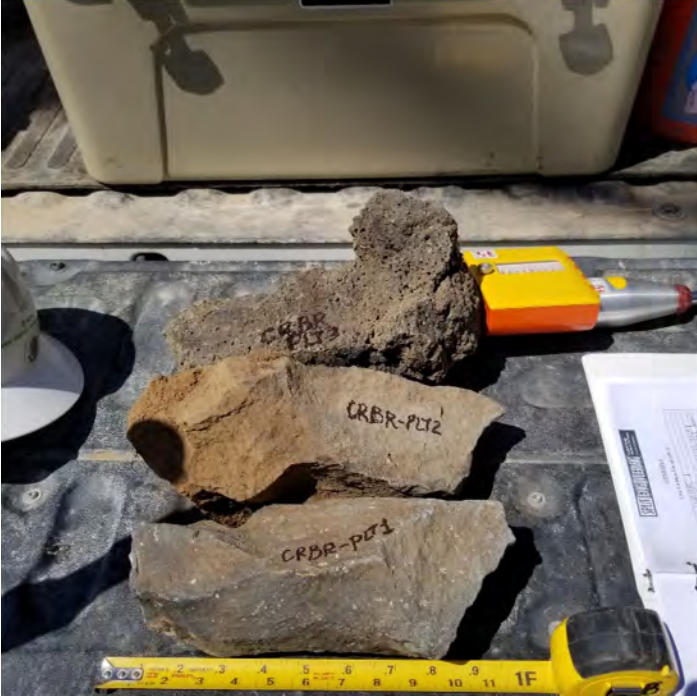
Photo No. 11.

Date: May 5, 2020	
Description: Copco 1 Right Bank road – Schmidt hammer testing

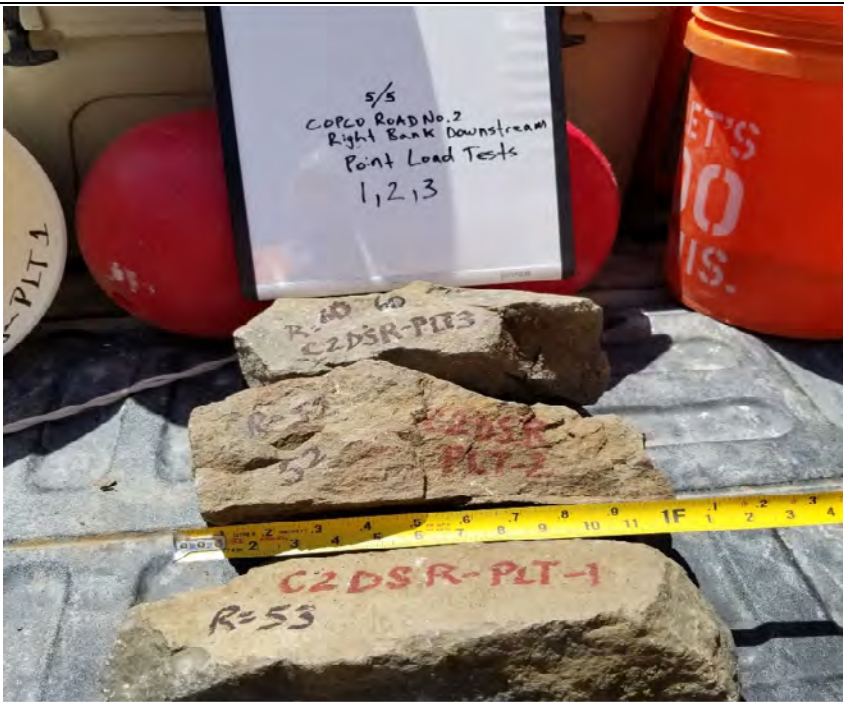
Photo No. 11.

Date: May 5, 2020		
Description: Copco 2, Right Bank Downstream – All 3 PLT samples

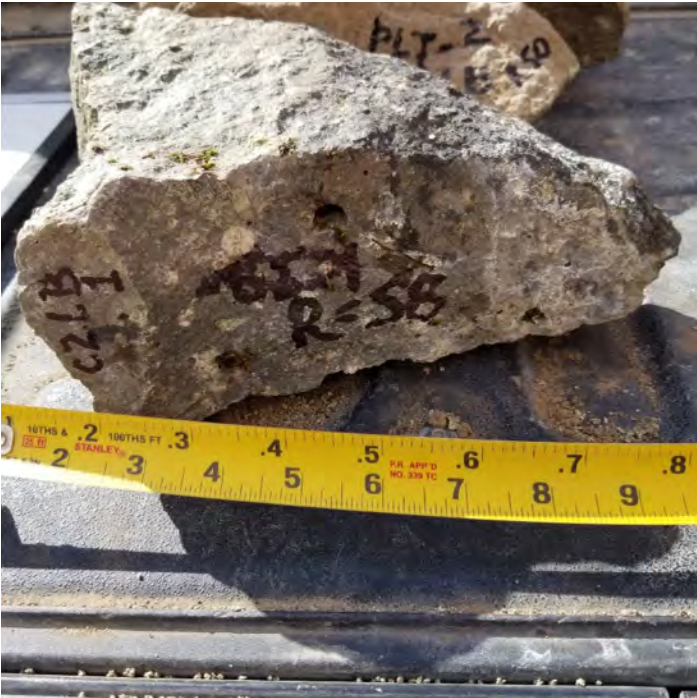
Photo No. 1.

Date: May 5, 2020		
Description: Copco 2, Left Bank Downstream – PLT sample 1

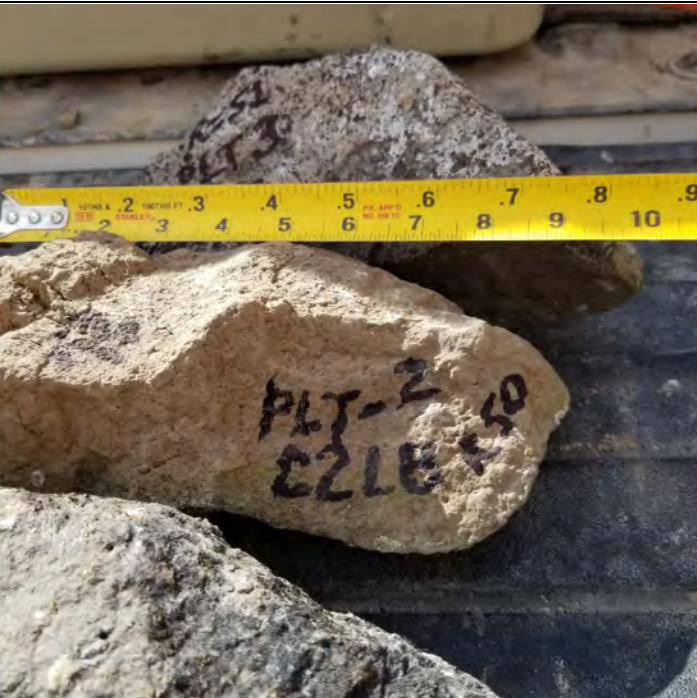
Photo No. 2.

Date: May 5, 2020		
Description: Copco 2, Left Bank Downstream – PLT sample 2

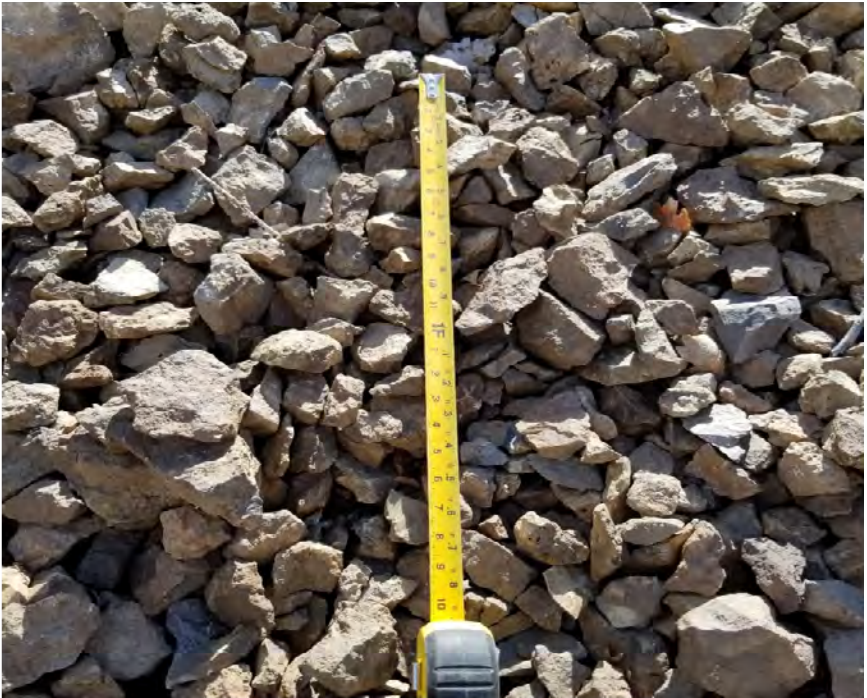
Photo No. 3.

Date: May 5, 2020	
Description: Copco 2 wood-stave Penstock – Zone 3

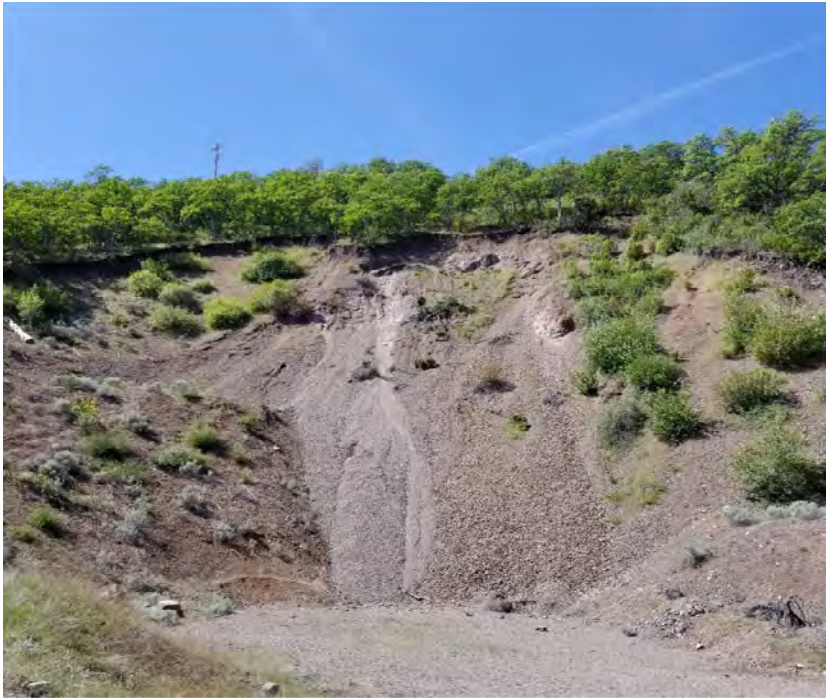
Photo No. 5.

Date: May 7, 2020	
Description: Copco 2 wood-stave Penstock

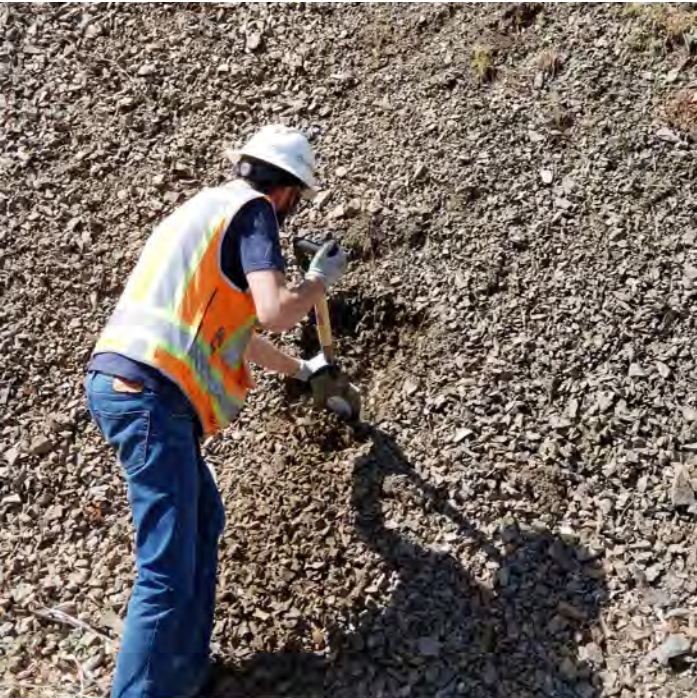
Photo No. 9.

Date: May 7, 2020	
Description: Copco 2 wood-stave Penstock

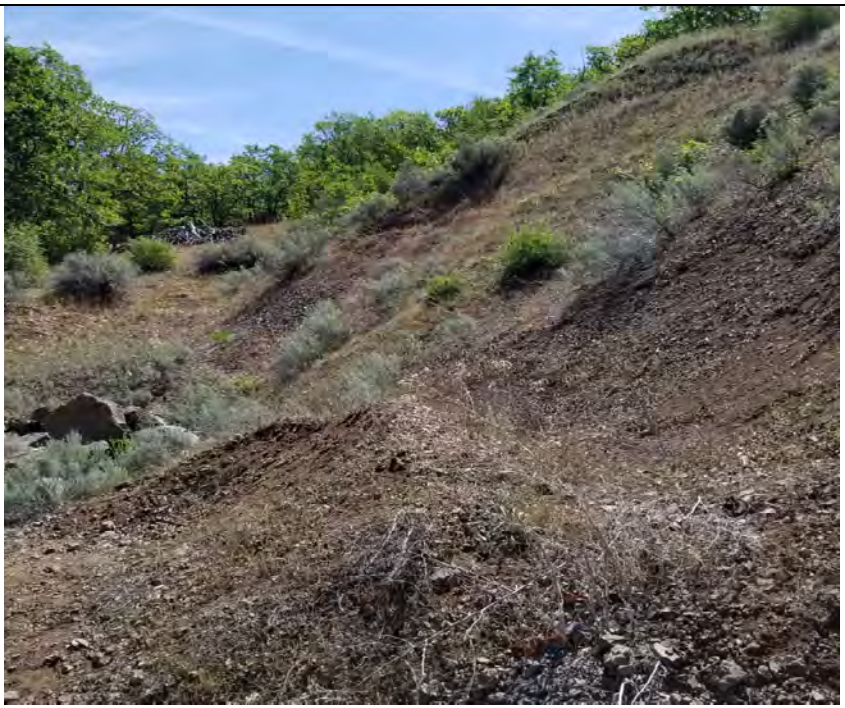
Photo No. 12.

Date: May 7, 2020		
Description: Copco 2 wood-stave Penstock – facing west across upper part of Zone 1

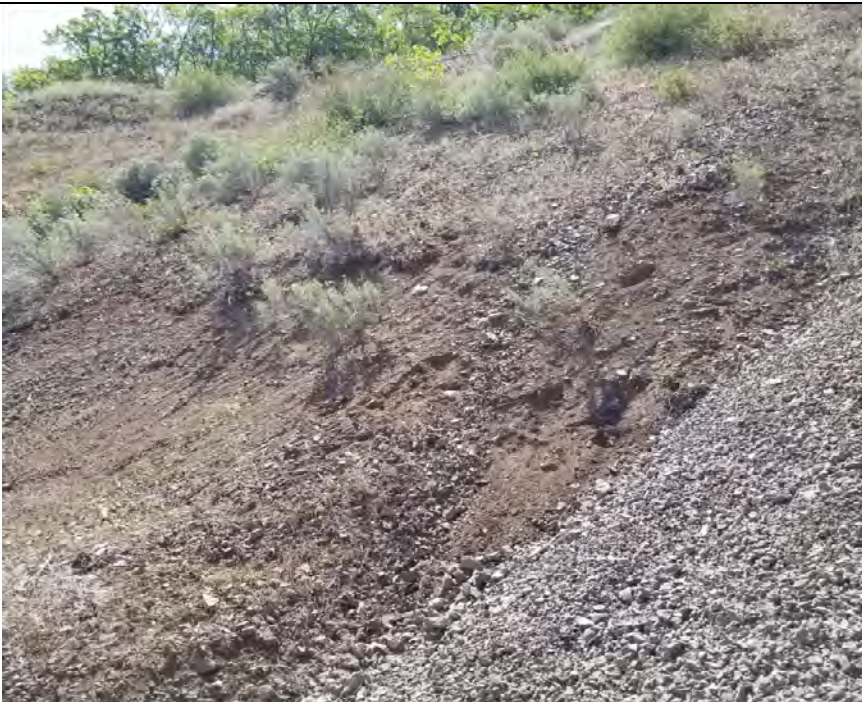
Photo No. 14.

Date: May 7, 2020		
Description: Copco 2 wood-stave Penstock

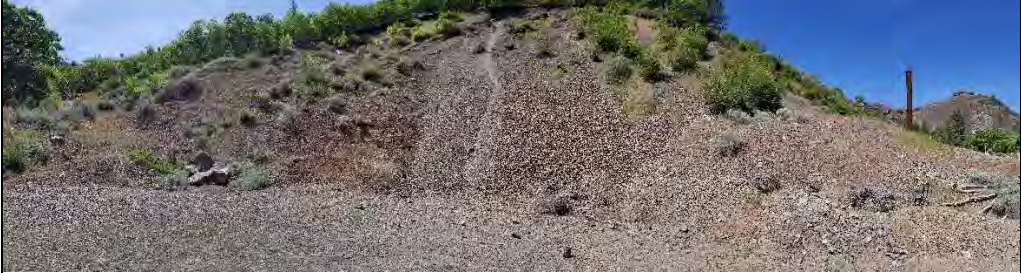
Photo No. 16.

Date: May 7, 2020	
Description: Copco 2 wood-stave Penstock - panorama

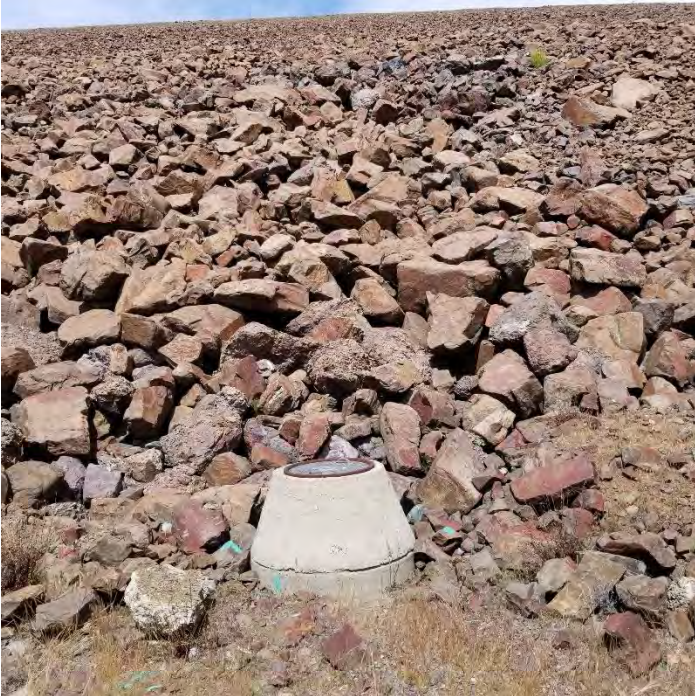
Photo No. 1.

Date: May 4, 2020			
Description: Iron Gate DS Dam Shell – center of embankment
