RE: KRRP Value Engineering Summary and Advancement to 90% Design

KP was tasked with leading seven VE analyses, which are listed below and described in the following sections of this letter:

VE-1 Submittals: Drawdown Model and Assessment

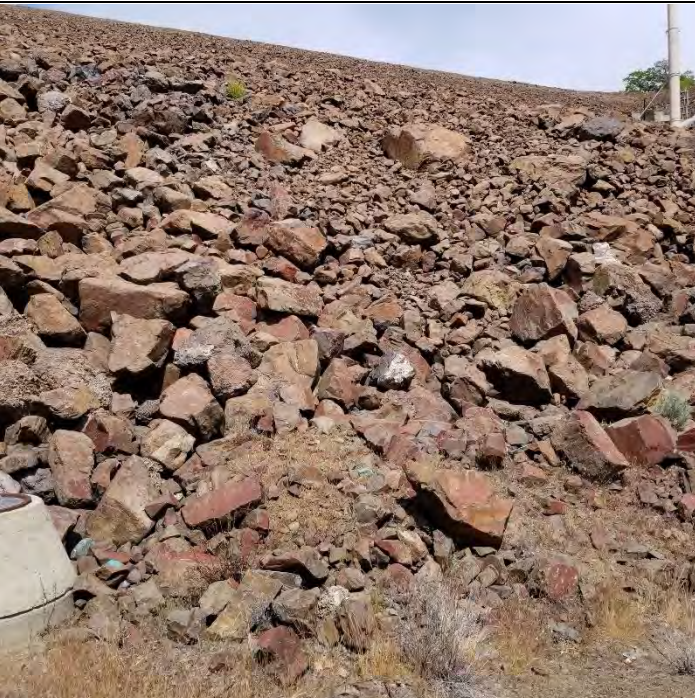
Photo No. 2.

Date: May 4, 2020			
Description: Iron Gate DS Dam Shell

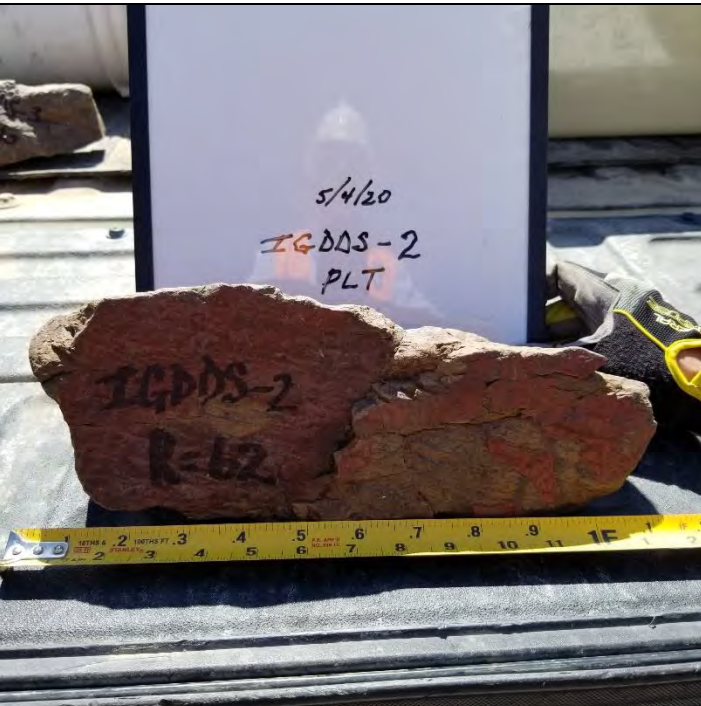
Photo No. 8.

Date: May 4, 2020		
Description: Iron Gate DS Dam Shell – PLT sample

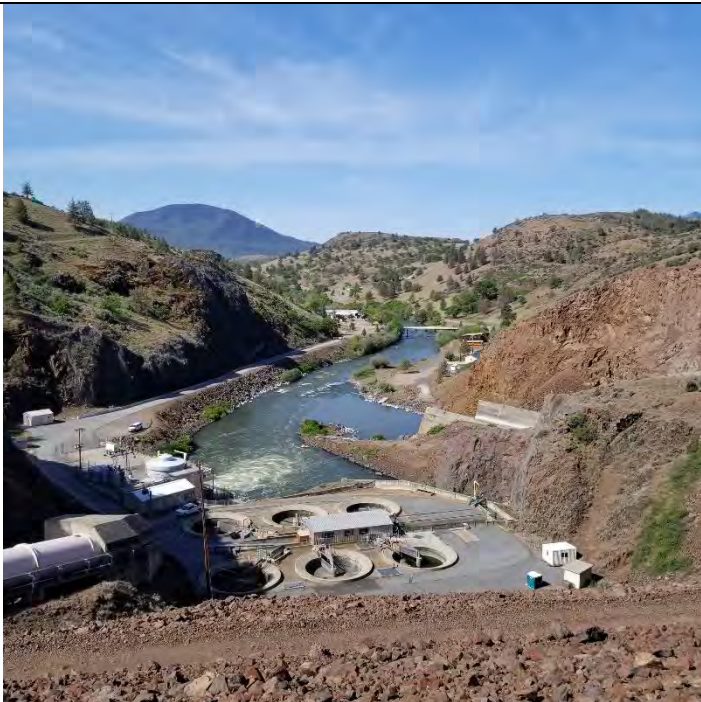
Photo No. 13.

Date: May 7, 2020			
Description: Iron Gate DS Dam Shell – facing downstream

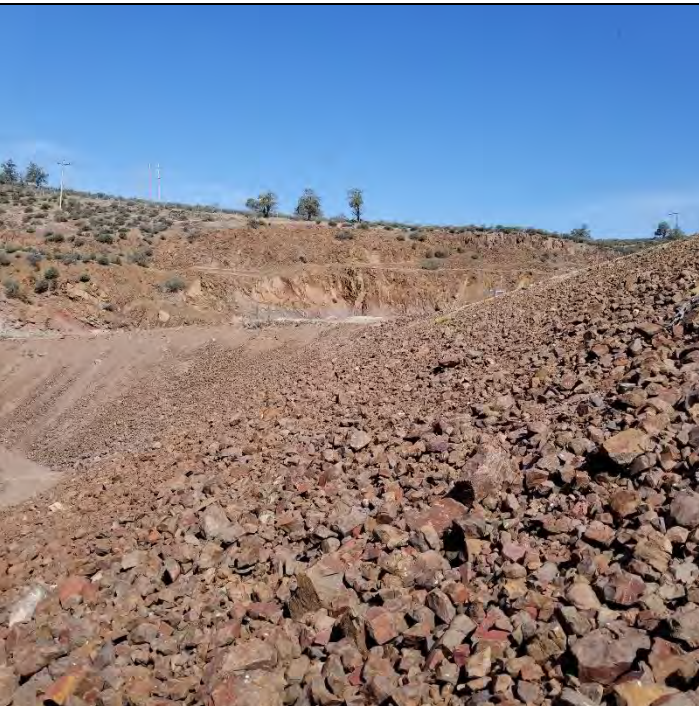
Photo No. 16.

Date: May 7, 2020			
Description: Iron Gate DS Dam Shell

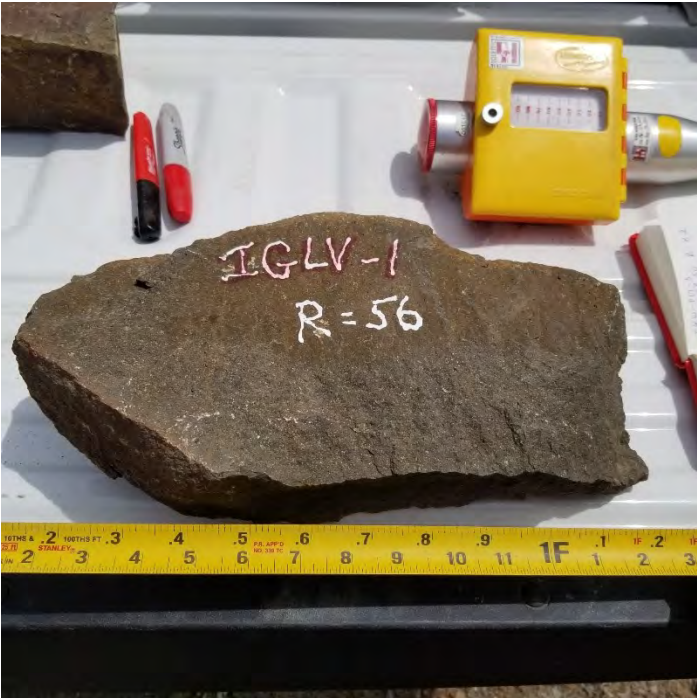
Photo No. 1.

Date: May 4, 2020	
Description: Iron Gate – Lakeview Road PLT sample.

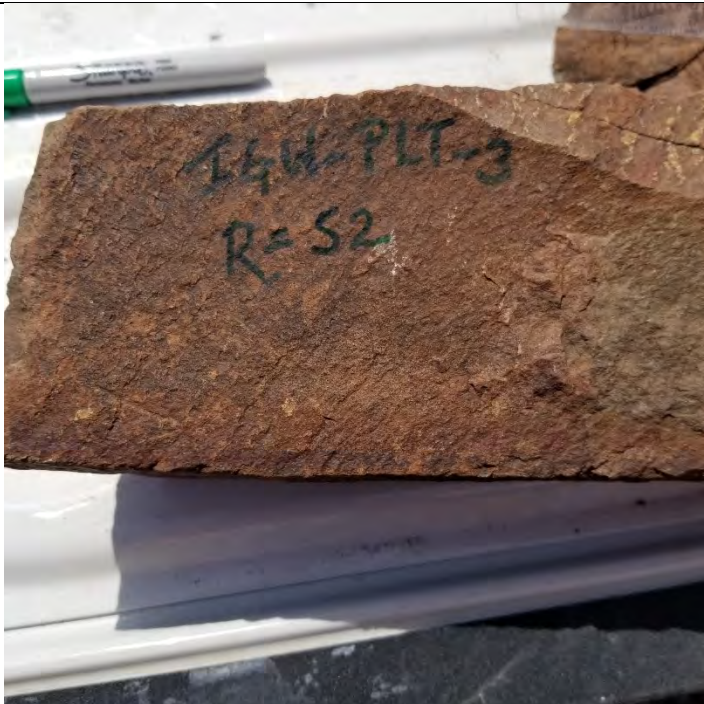
Photo No. 6.

Date: May 4, 2020			
Description: Iron Gate Workers Accommodation Area PLT sample.

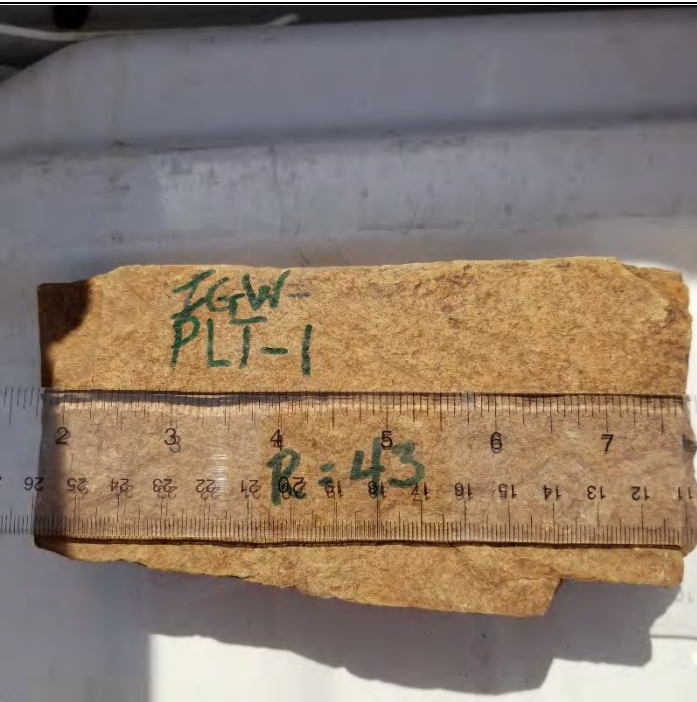
Photo No. 9.

Date: May 4, 2020	
Description: Iron Gate Workers Accommodation Area PLT sample.

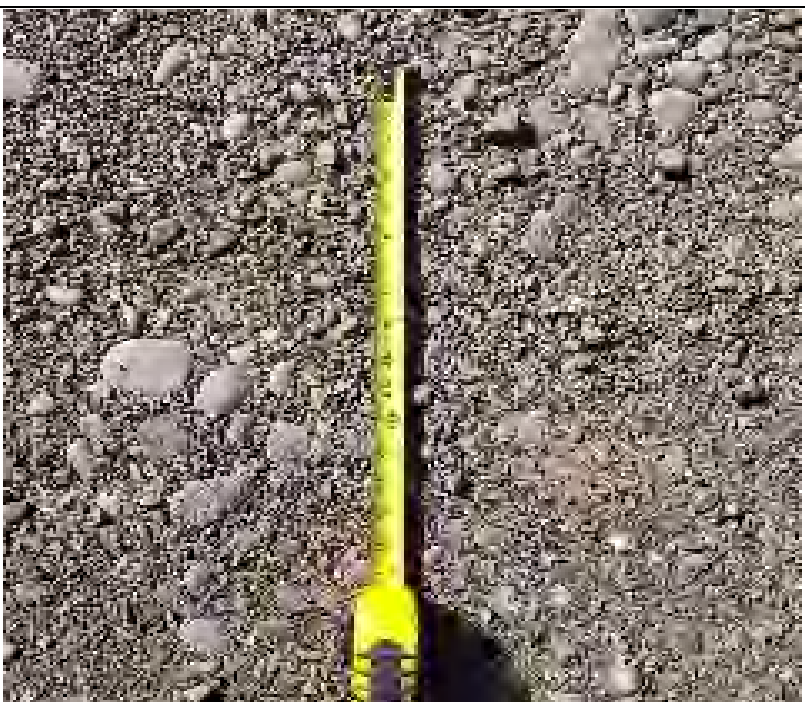
Photo No. 10.

Date: May 7, 2020	
Description: Iron Gate Workers Accommodation Area, road wearing course.

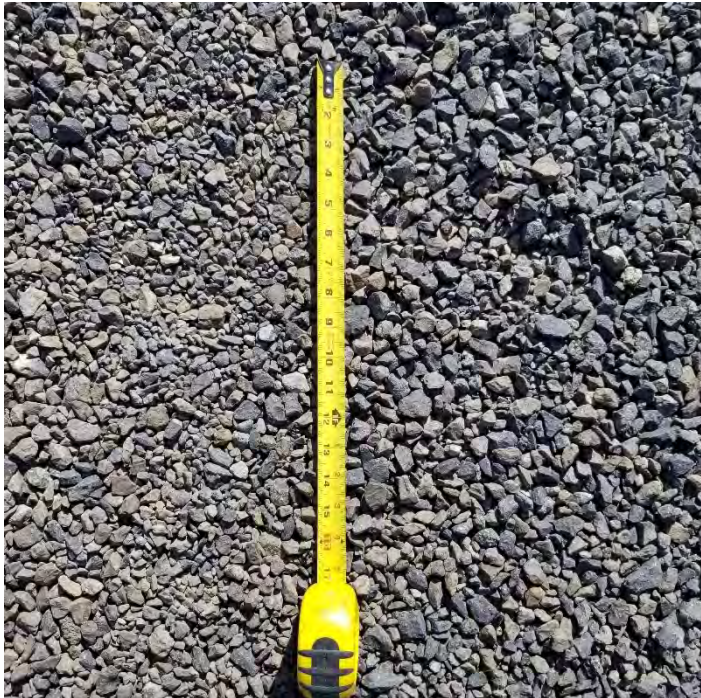
Photo No. 11.

Date: May 7, 2020			
Description: Iron Gate Workers Accommodation Area, road wearing course.

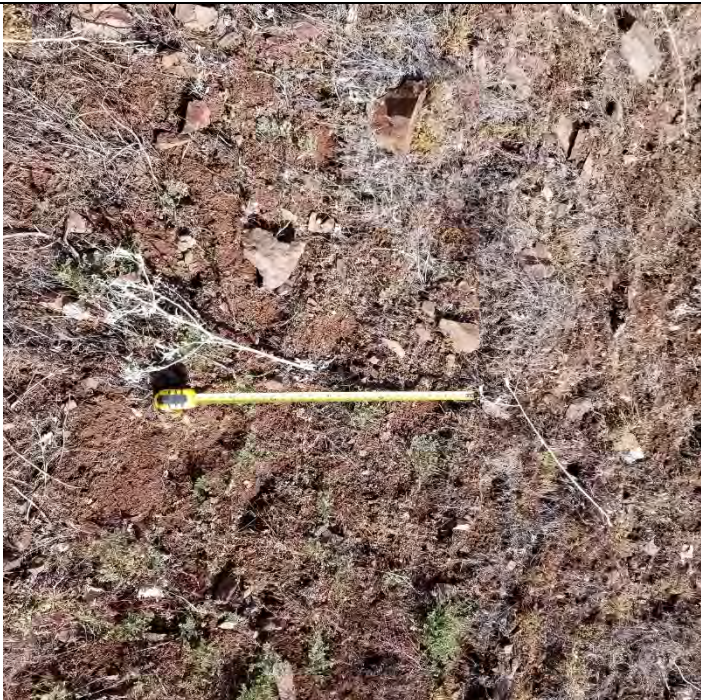
Photo No. 12.

Date: May 7, 2020			
Description: Iron Gate Workers Accommodation Area, face of slope.

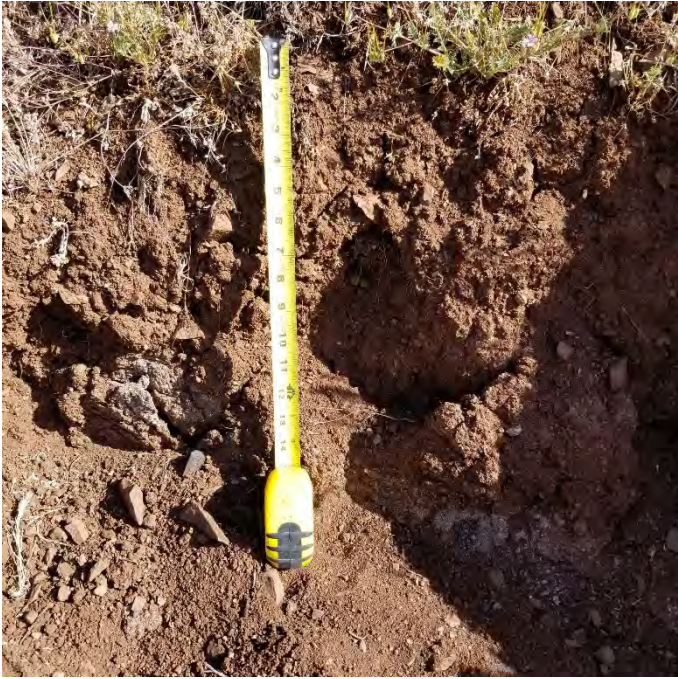
Photo No. 18.

Date: May 7, 2020		
Description: Iron Gate Workers Accommodation Area, face of slope.

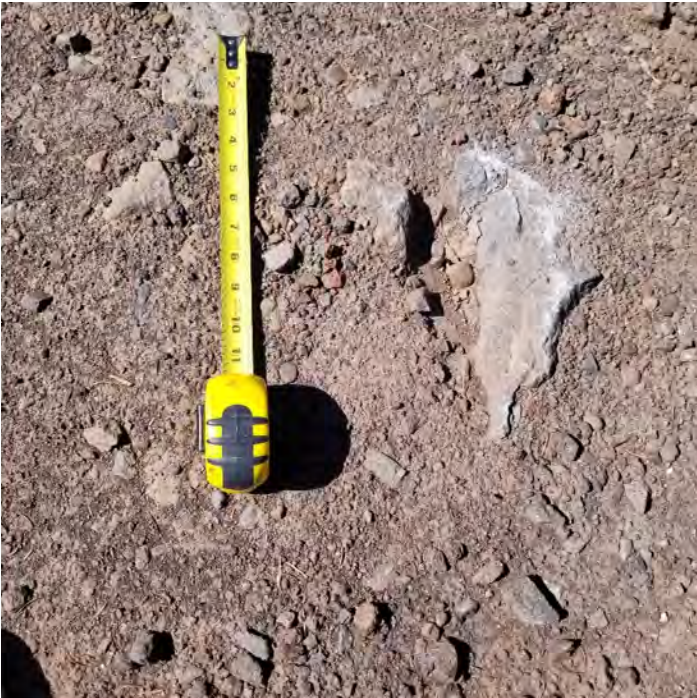
Photo No. 3.

Date: May 6, 2020			
Description: Forebay road surface

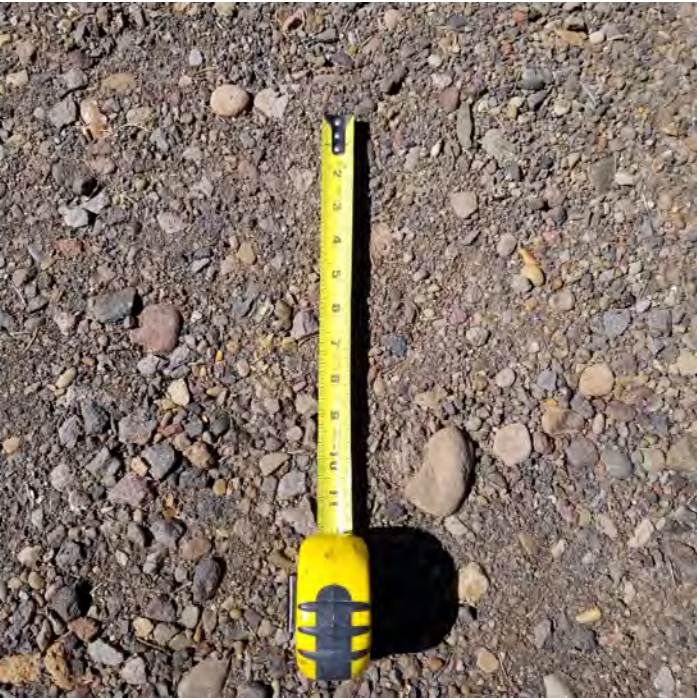
Photo No. 5.

Date: May 6, 2020			
Description: Forebay road surface

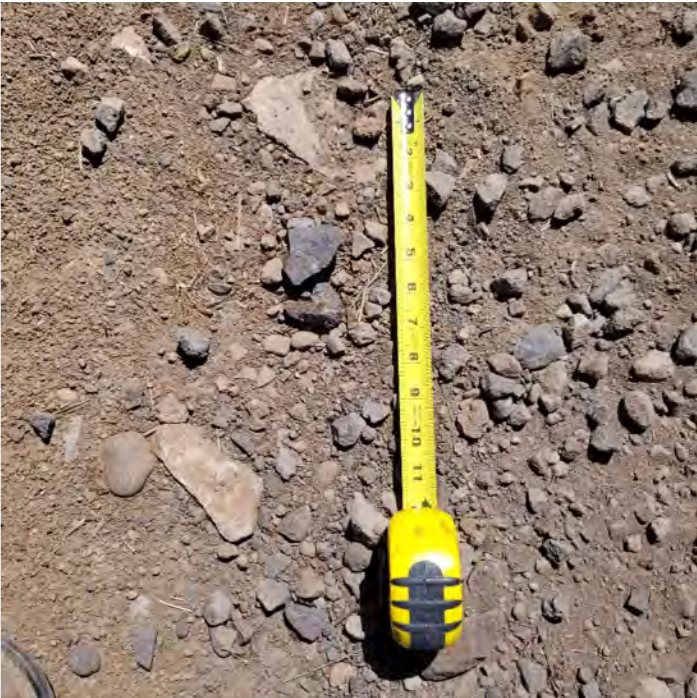
Photo No. 7.

Date: May 7, 2020			
Description: Forebay road surface

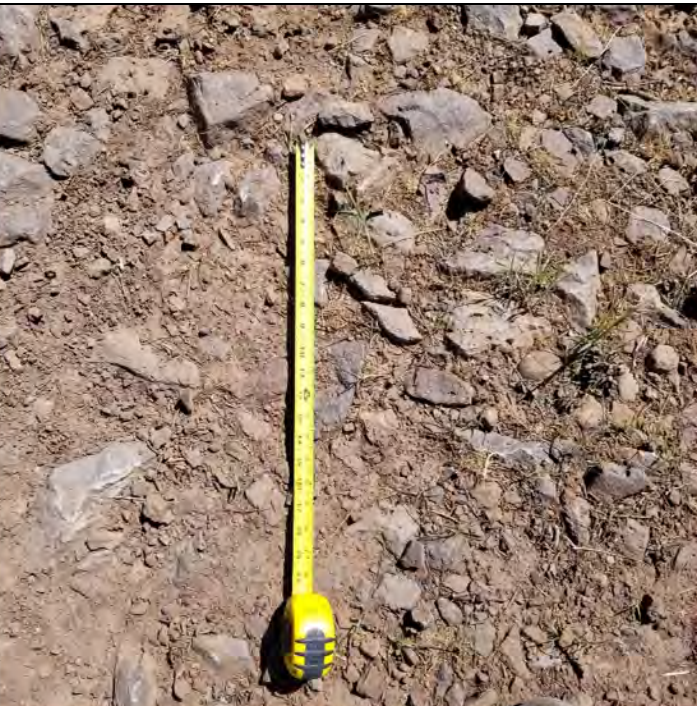
Photo No. 8.

Date: May 6, 2020			
Description: Forebay road surface

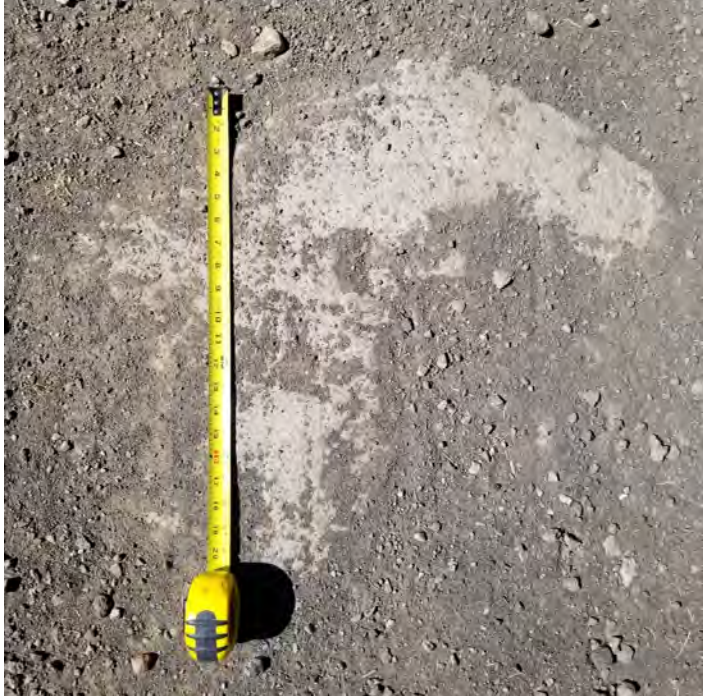
Photo No. 9.

Date: May 6, 2020			
Description: Forebay road surface – Dmax view

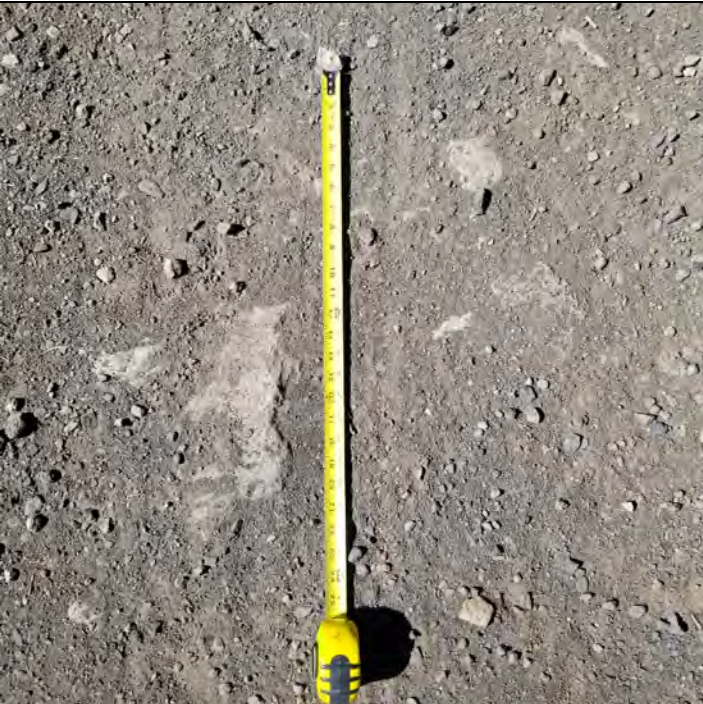
Photo No. 10.

Date: May 6, 2020			
Description: Forebay road surface

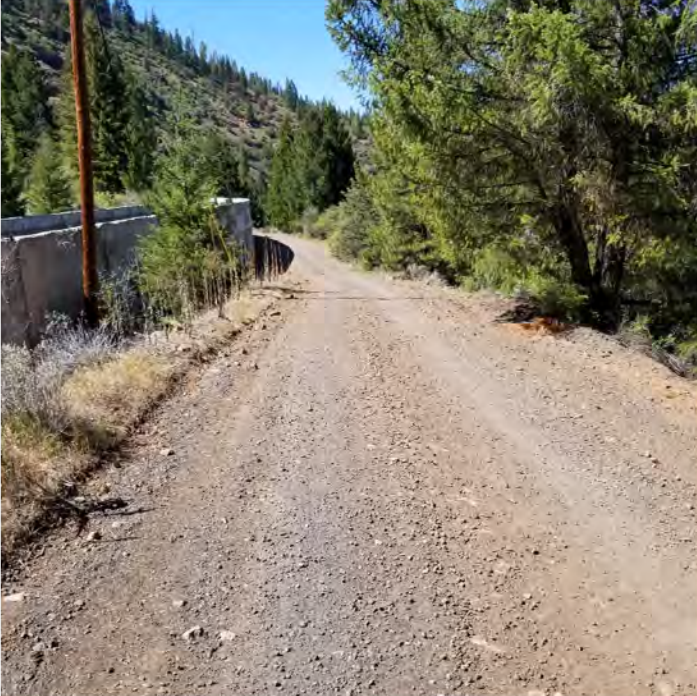
Photo No. 11.

Date: May 6, 2020			
Description: Forebay road surface – Northern portion of site access road

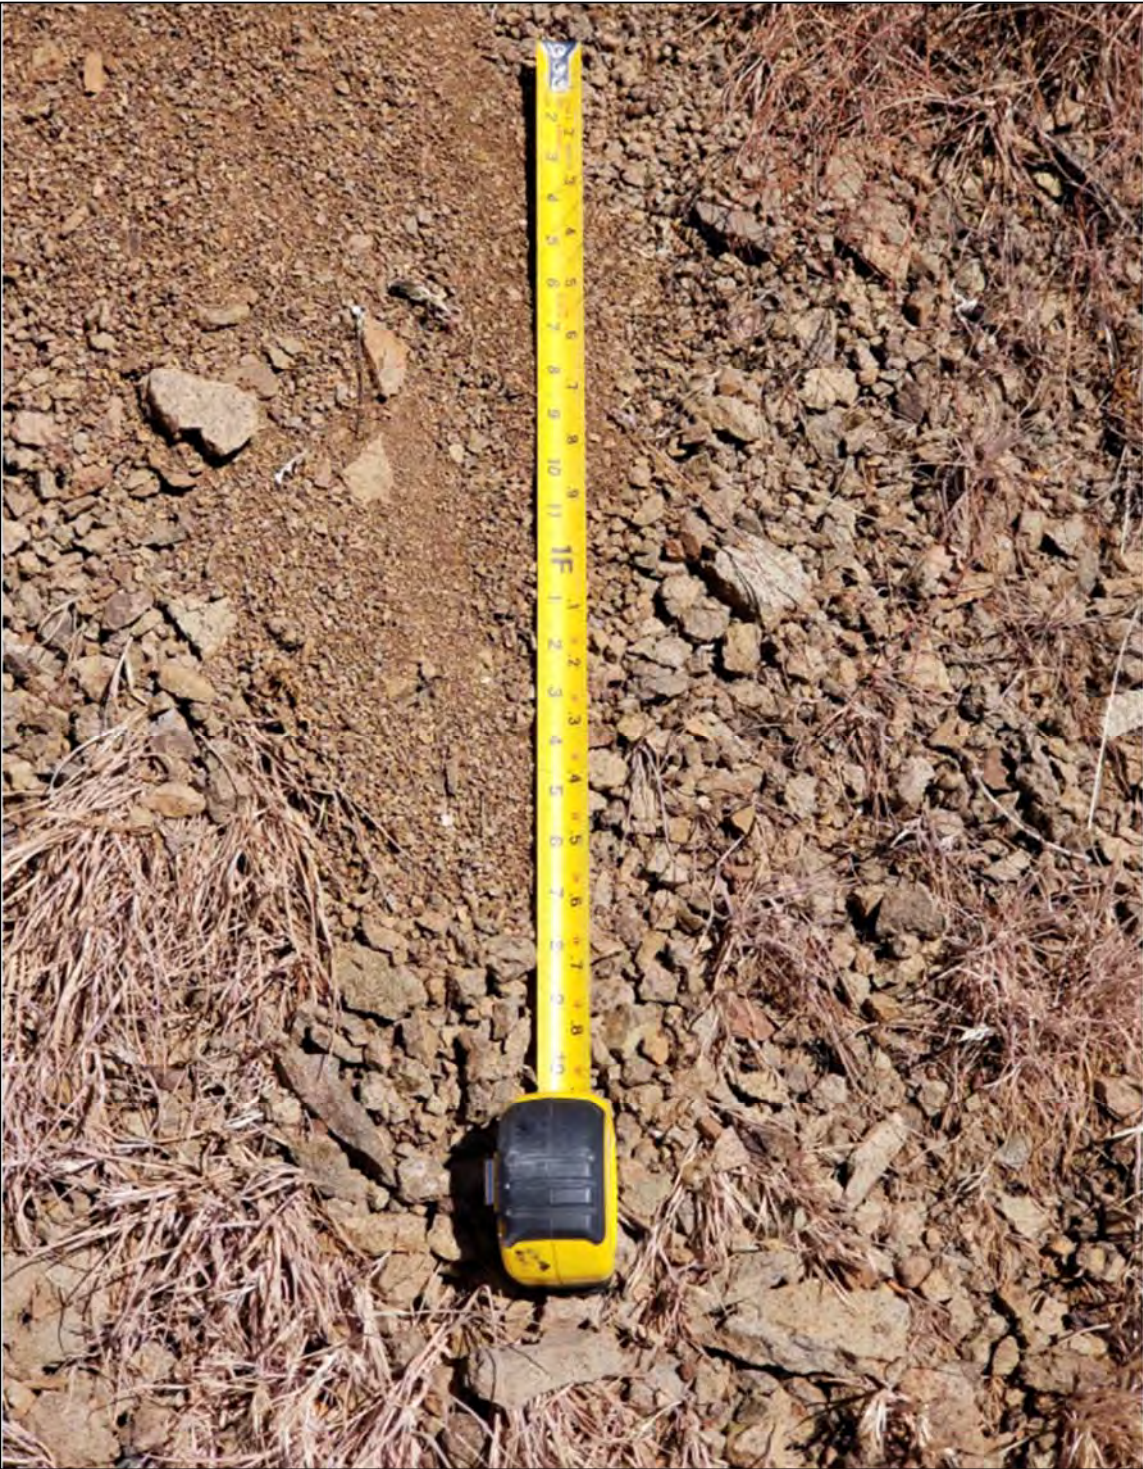
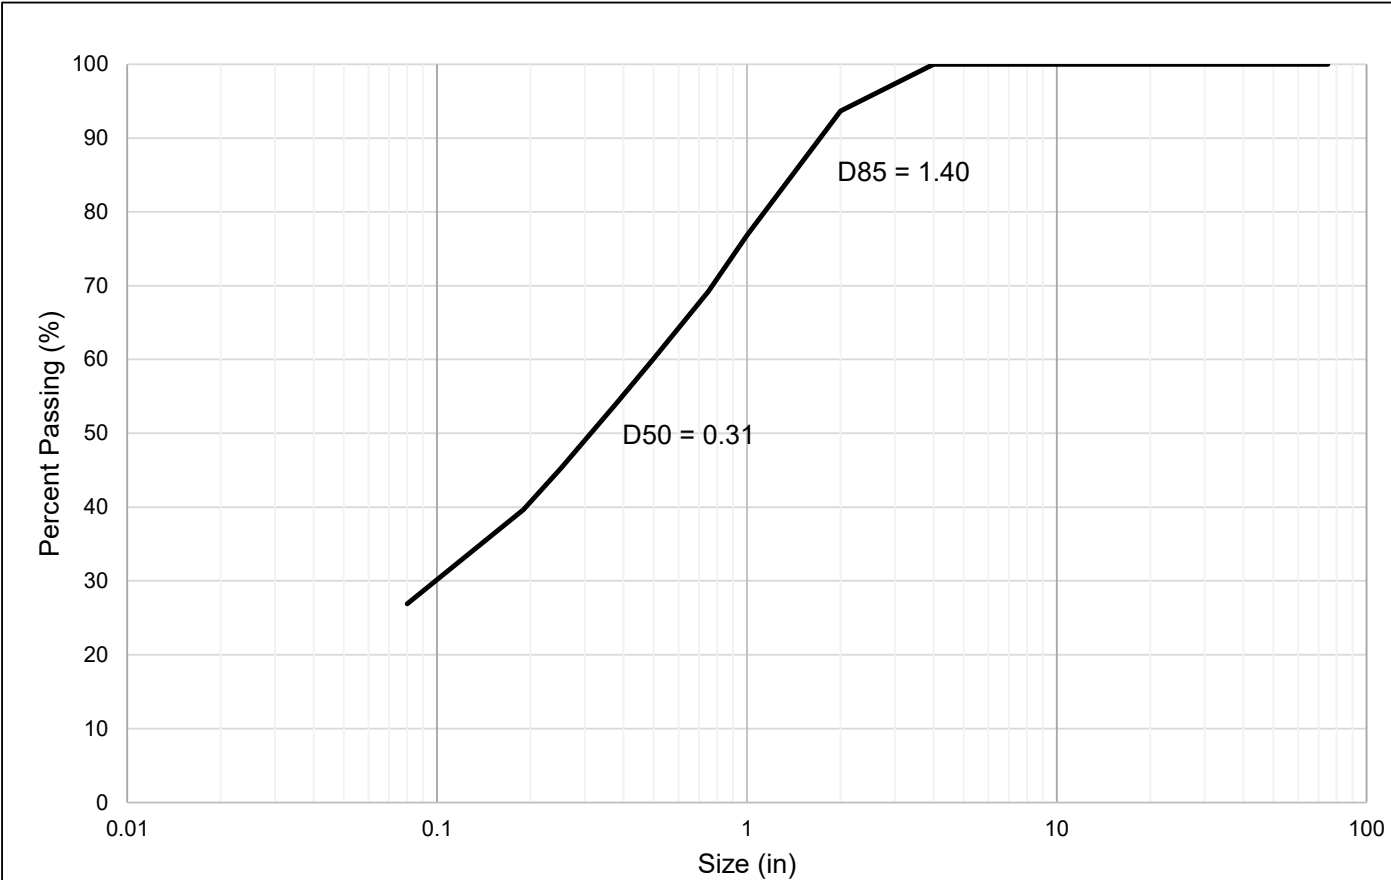
P/A NO. VA103-640/1		REF. NO. VA20-01037
	FIGURE C.1		REV A

Size[in]	% Passing
75	100.00
50	100.00
25	100.00
15	100.00
10	100.00
8	100.00
6	100.00
4	100.00
2	93.67
1	76.83
0.75	69.19
0.5	60.10
0.38	54.11
0.25	45.18
0.19	39.64
0.08	26.91

% Passing	Size[in]
F10	0.01
F20	0.04
F30	0.10
F40	0.19
F50	0.31
F60	0.50
F70	0.77
F80	1.13
F90	1.67
Topsize (99.95%)	3.41

- NOTES:
1. TAPE MEASURE FOR SCALE
 2. ANALYSIS CONDUCTED BY SPLIT ENGINEERING

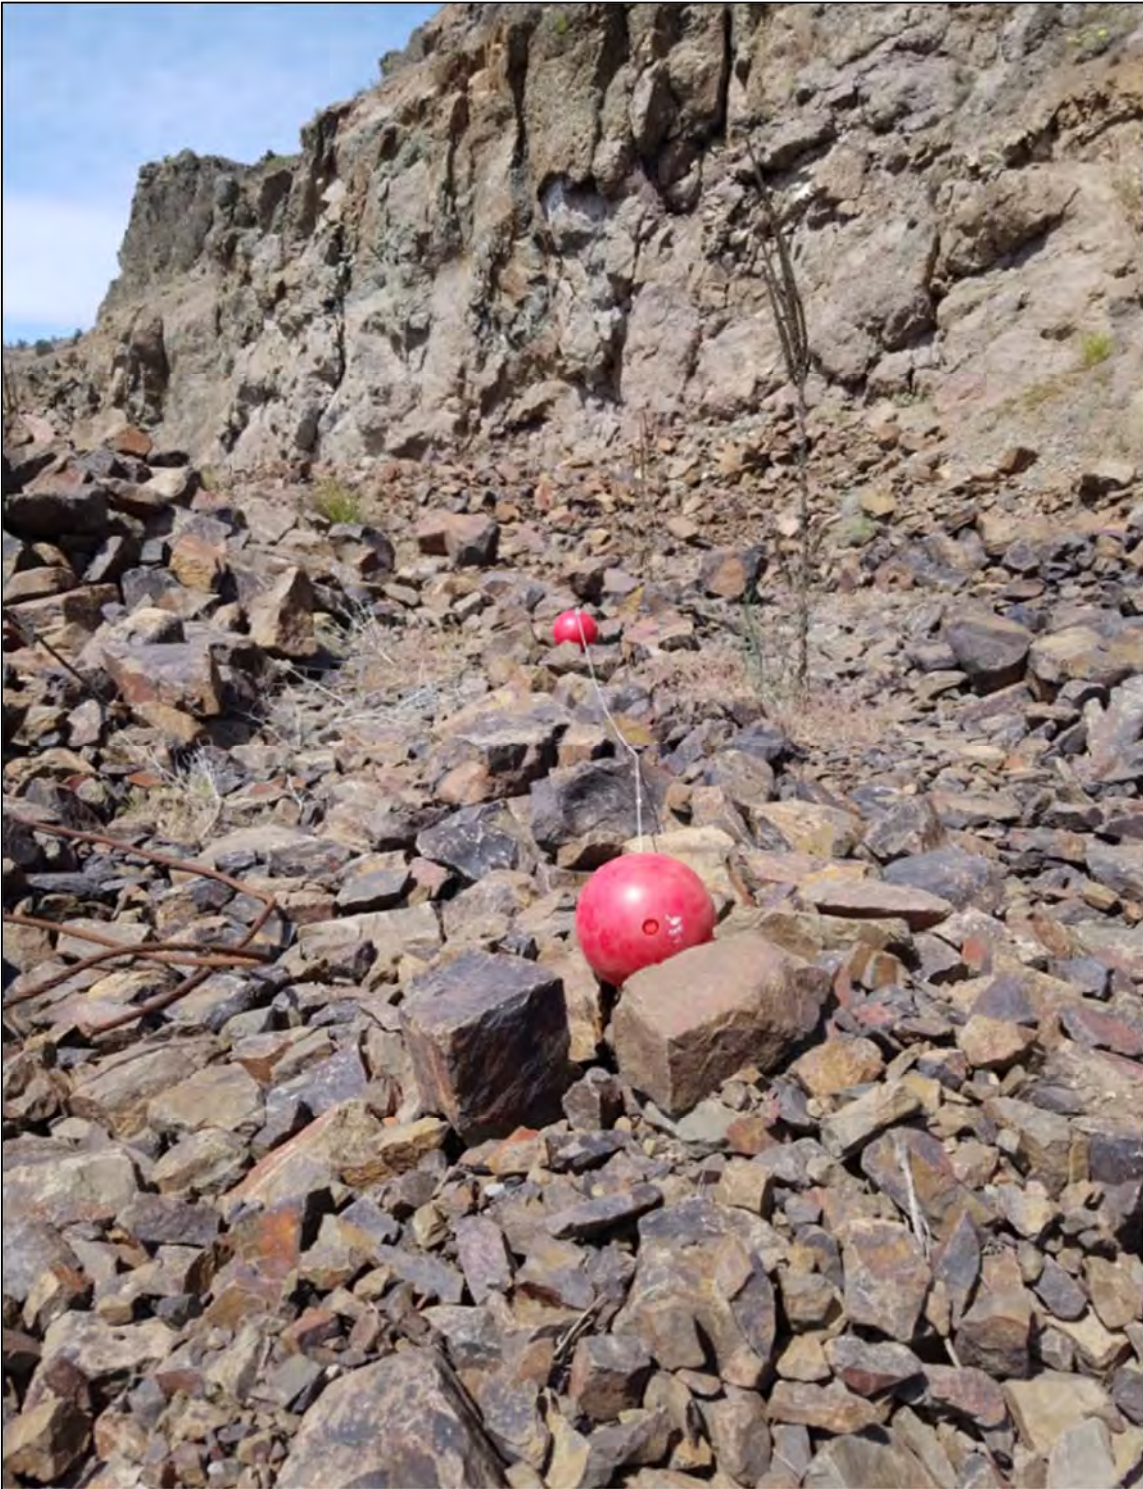
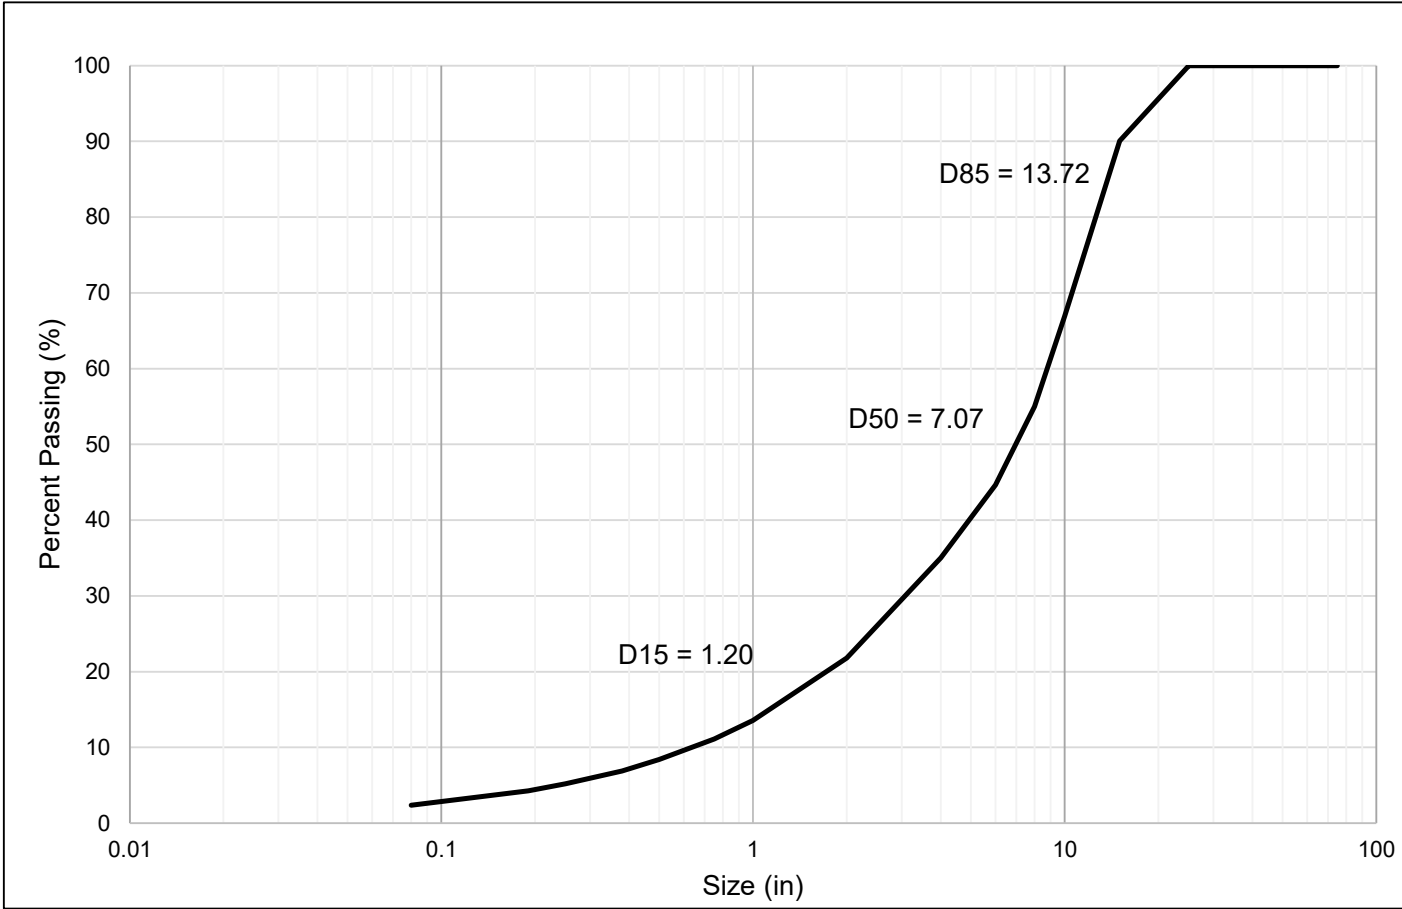
KIEWIT INFRASTRUCTURE WEST CO.		
KLAMATH RIVER RENEWAL PROJECT		
ONSITE BORROW SOURCE SITE INVESTIGATION SPILT-NET PARTICLE SIZE ANALYSIS RESULTS IRON GATE LAKEVIEW ROAD - 1		
	P/A NO. VA103-640/1	REF. NO. VA20-01037
	FIGURE C.2	
		REV A

Size[in]	% Passing
75	100.00
50	100.00
25	100.00
15	90.06
10	66.92
8	55.01
6	44.65
4	35.04
2	21.81
1	13.56
0.75	11.12
0.5	8.41
0.38	6.90
0.25	5.21
0.19	4.26
0.08	2.34

% Passing	Size[in]
F10	0.64
F20	1.76
F30	3.19
F40	4.95
F50	7.07
F60	8.84
F70	10.53
F80	12.46
F90	14.98
Topsize (99.95%)	22.57

- NOTES:**
- 1. SCALE BALL SIZE = 10"
 - 2. ANALYSIS CONDUCTED BY SPLIT ENGINEERING

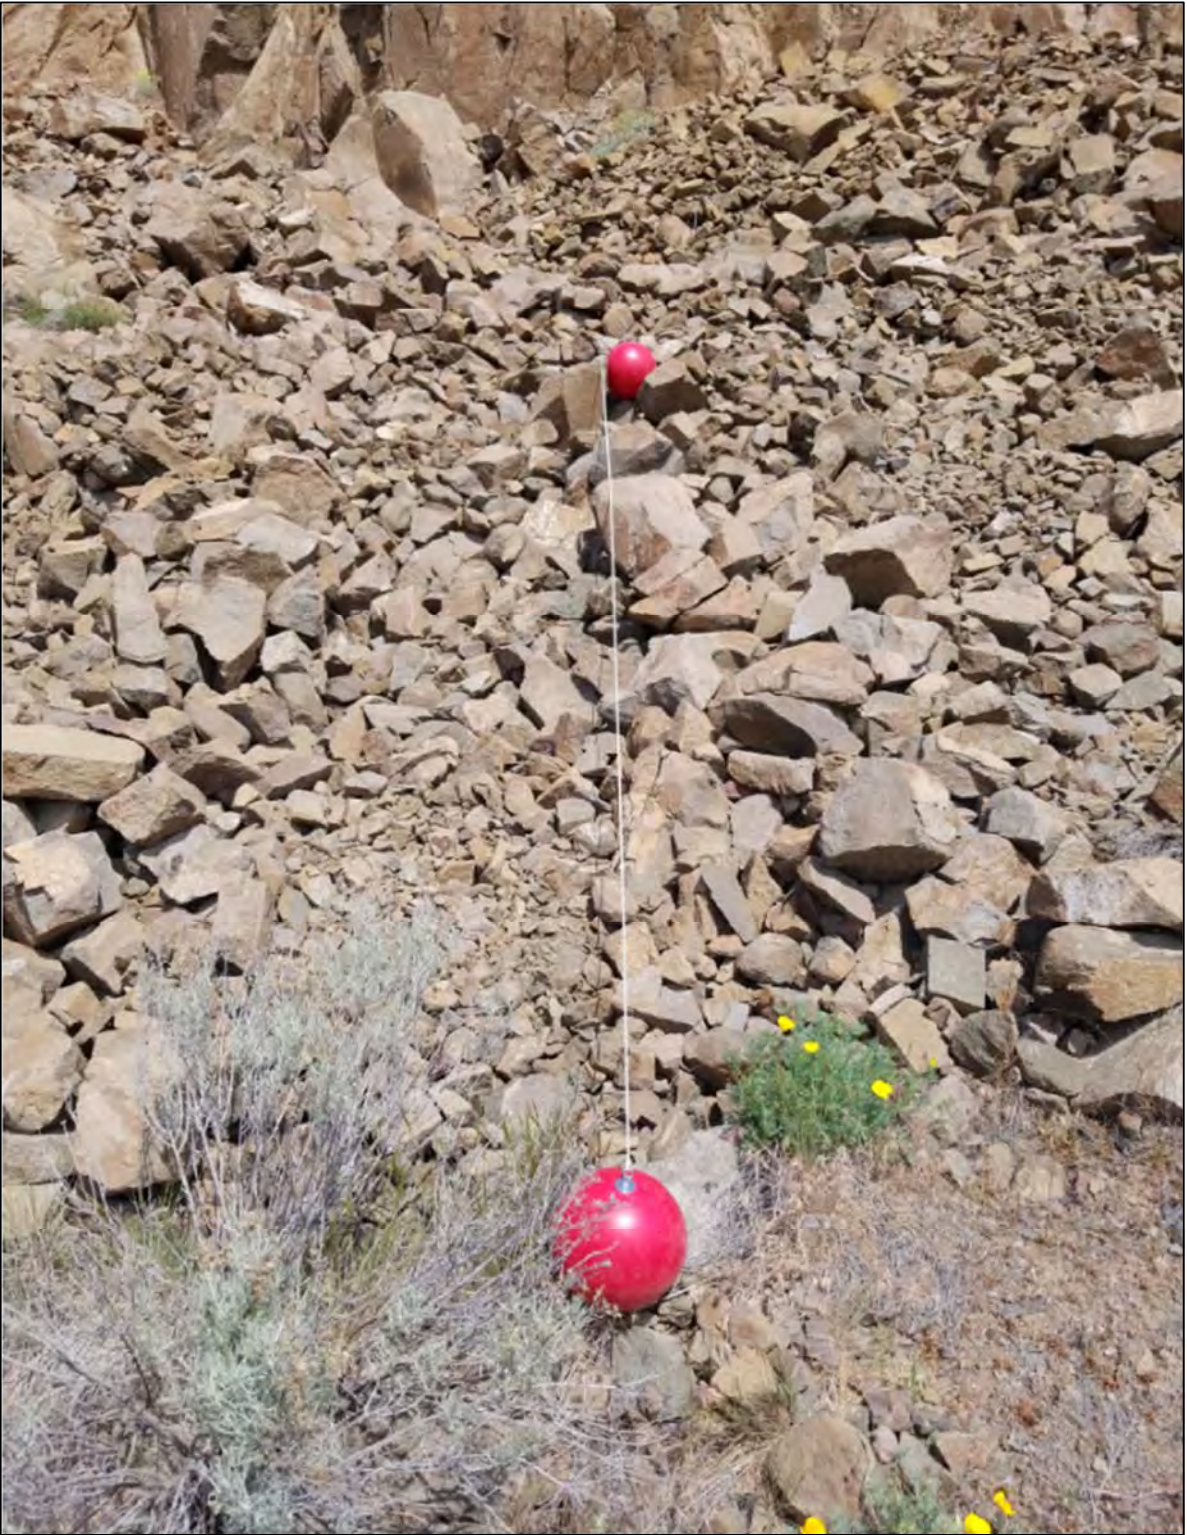
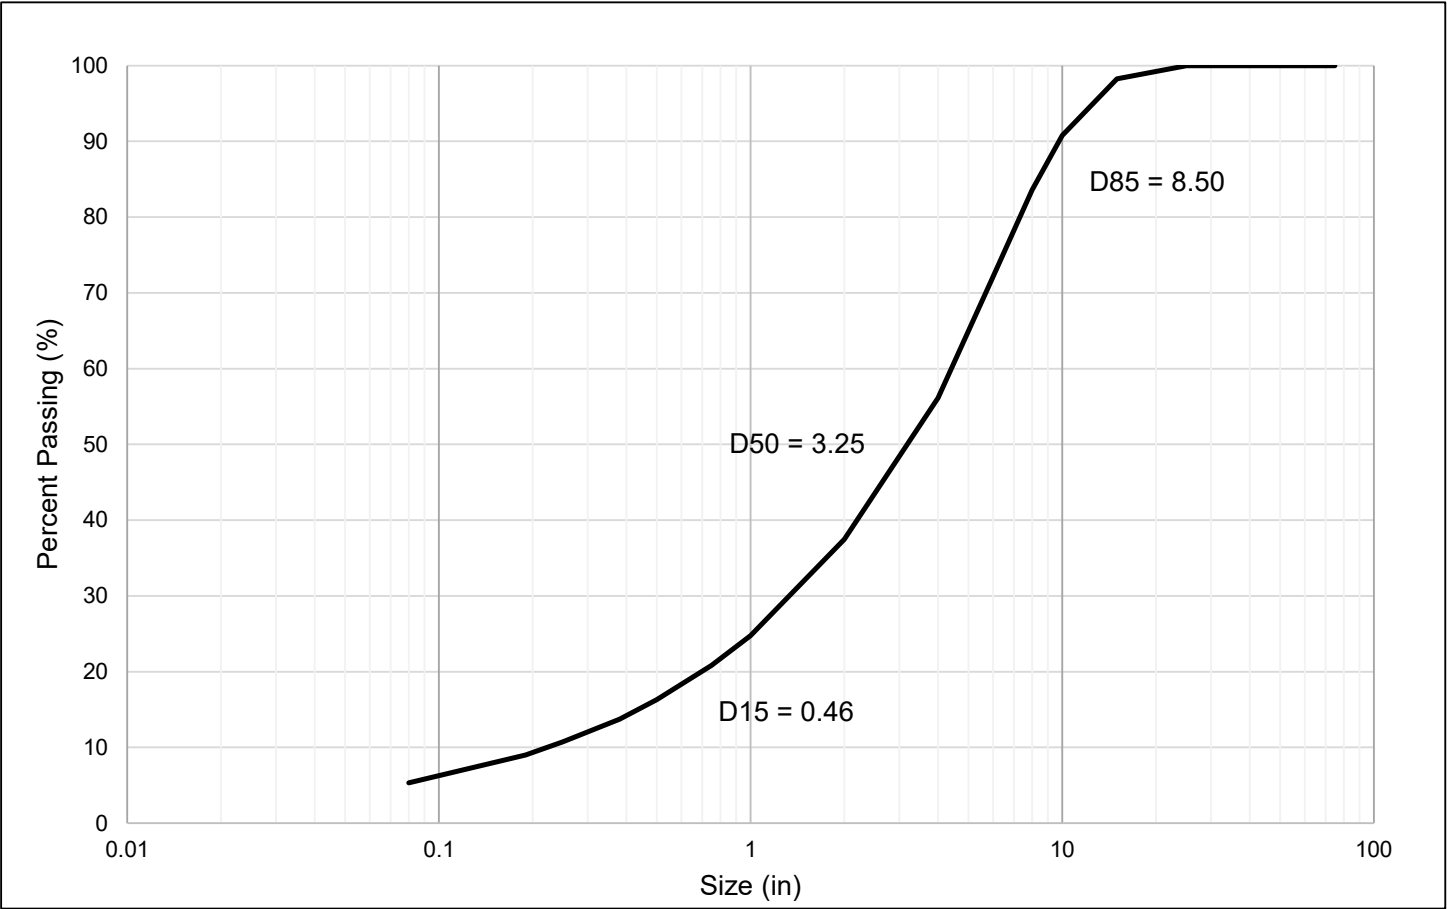
P/A NO. VA103-640/1		REF. NO. VA20-01037
	FIGURE C.3		REV A

Size[in]	% Passing
75	100.00
50	100.00
25	100.00
15	98.25
10	90.77
8	83.61
6	72.16
4	56.15
2	37.46
1	24.75
0.75	20.83
0.5	16.32
0.38	13.72
0.25	10.74
0.19	9.01
0.08	5.33

% Passing	Size[in]
F10	0.22
F20	0.70
F30	1.38
F40	2.23
F50	3.25
F60	4.45
F70	5.70
F80	7.26
F90	9.73
Topsize (99.95%)	19.06

- NOTES:**
- 1. SCALE BALL SIZE = 10"
 - 2. ANALYSIS CONDUCTED BY SPLIT ENGINEERING

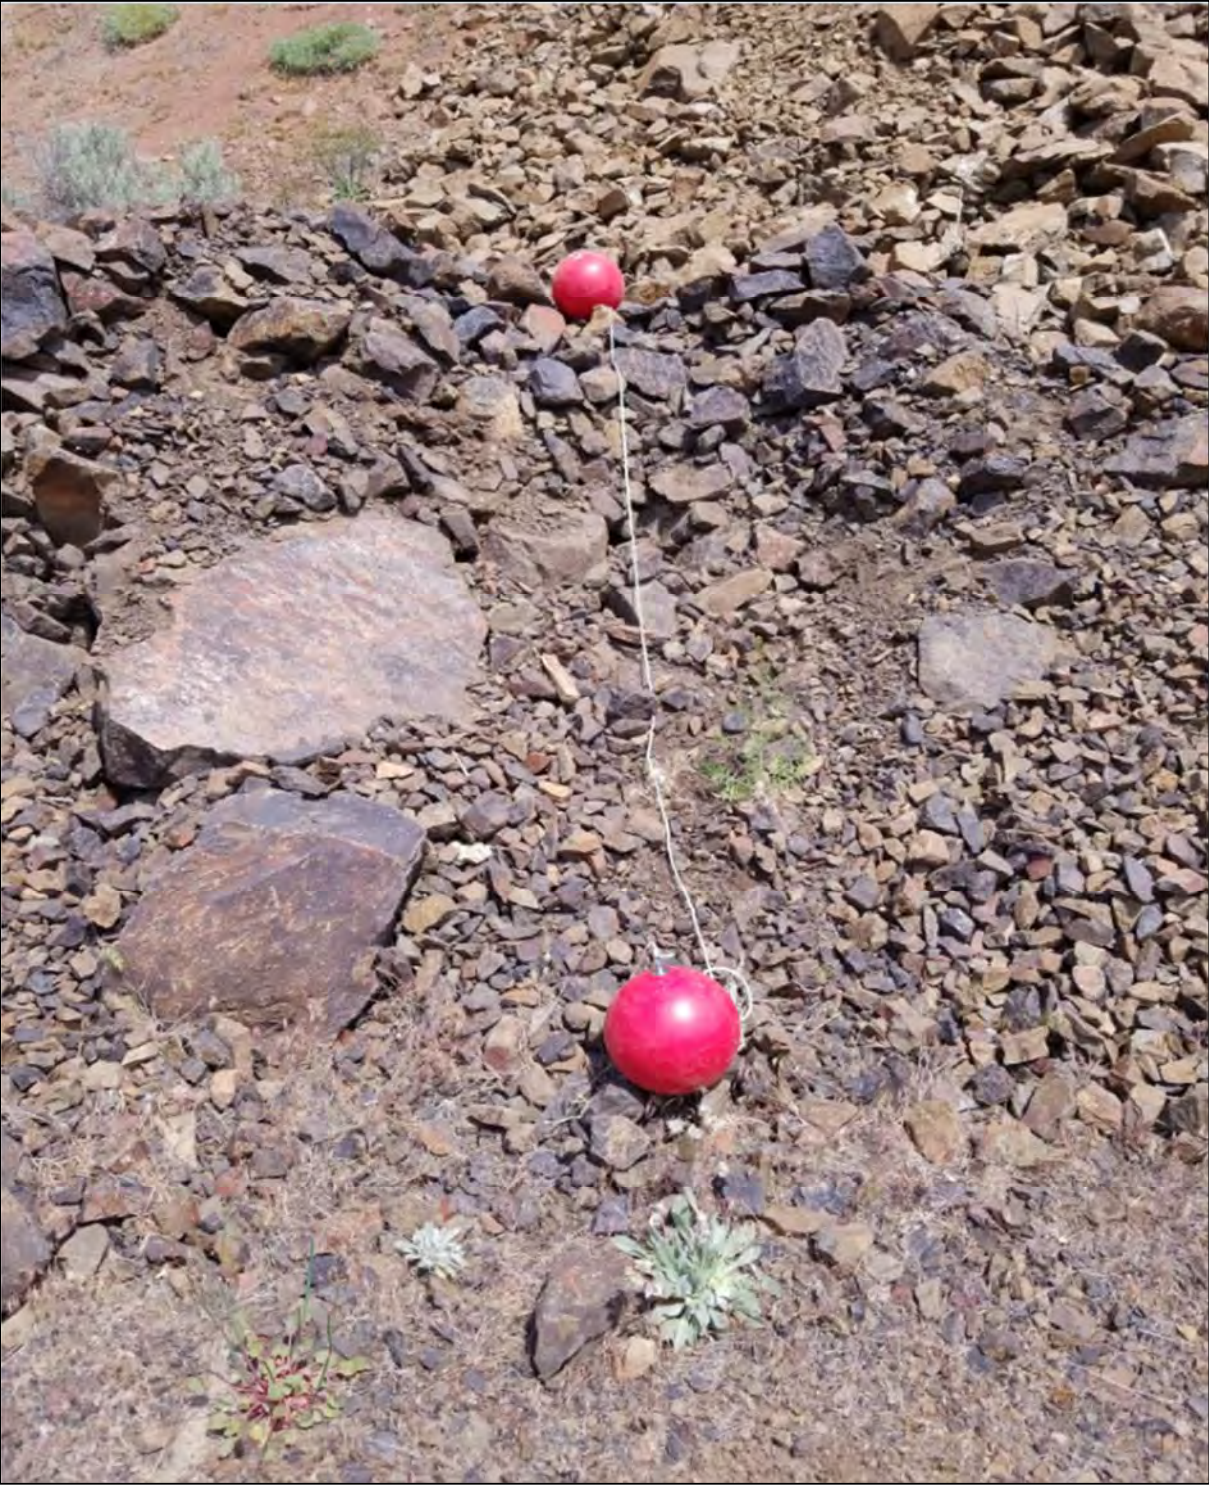
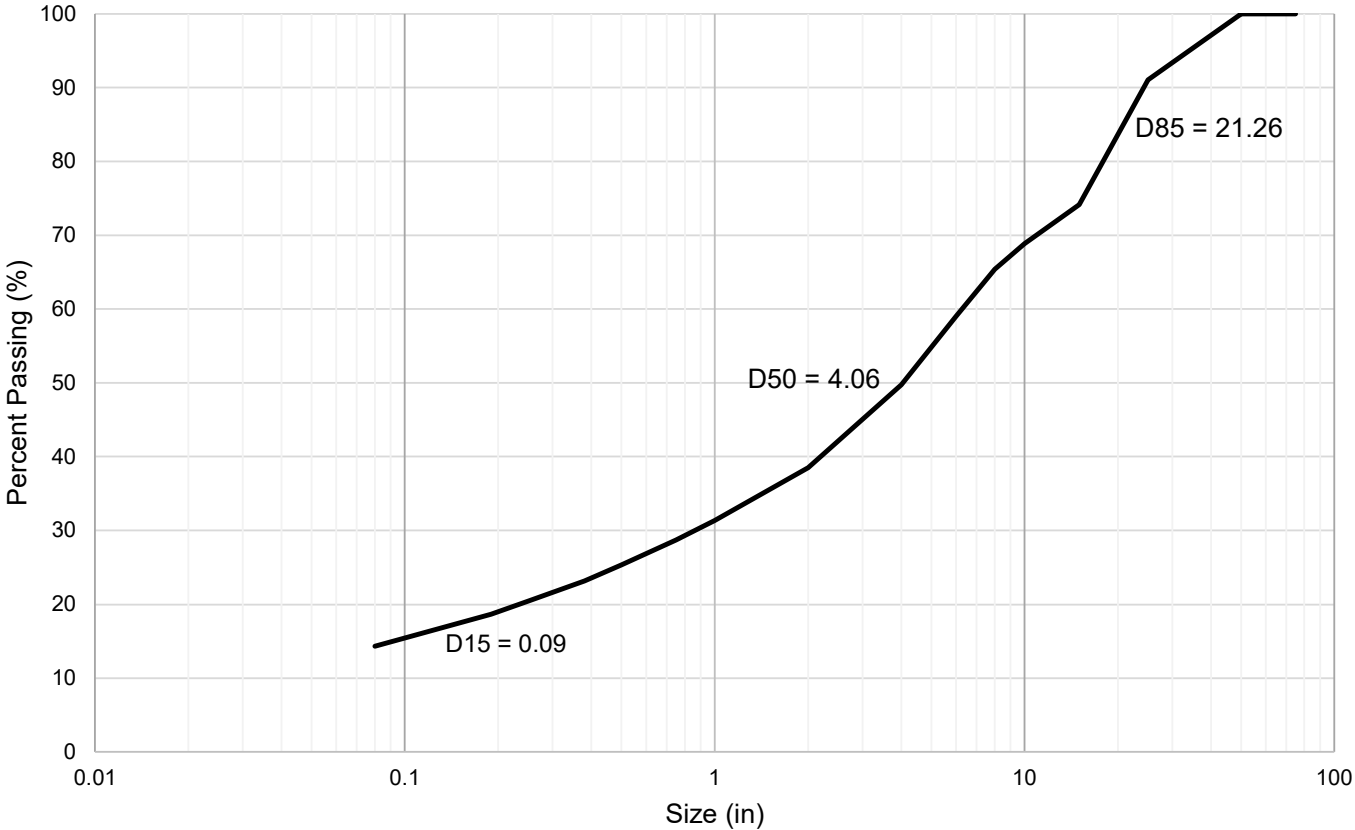
P/A NO. VA103-640/1		REF. NO. VA20-01037
	FIGURE C.4		REV A

Size[in]	% Passing
75	100.00
50	100.00
25	91.05
15	74.14
10	68.87
8	65.37
6	58.99
4	49.71
2	38.49
1	31.36
0.75	28.71
0.5	25.34
0.38	23.19
0.25	20.45
0.19	18.70
0.08	14.33

% Passing	Size[in]
F10	0.02
F15	0.09
F20	0.23
F30	0.87
F40	2.24
F50	4.06
F60	6.25
F70	10.92
F80	18.59
F85	21.26
F90	24.22
Topsize (99.95%)	32.75

- NOTES:
- 1. SCALE BALL SIZE = 10"
 - 2. ANALYSIS CONDUCTED BY SPLIT ENGINEERING
