RE: KRRP Value Engineering Summary and Advancement to 90% Design

KP was tasked with leading seven VE analyses, which are listed below and described in the following sections of this letter:

VE-1 Submittals: Drawdown Model and Assessment

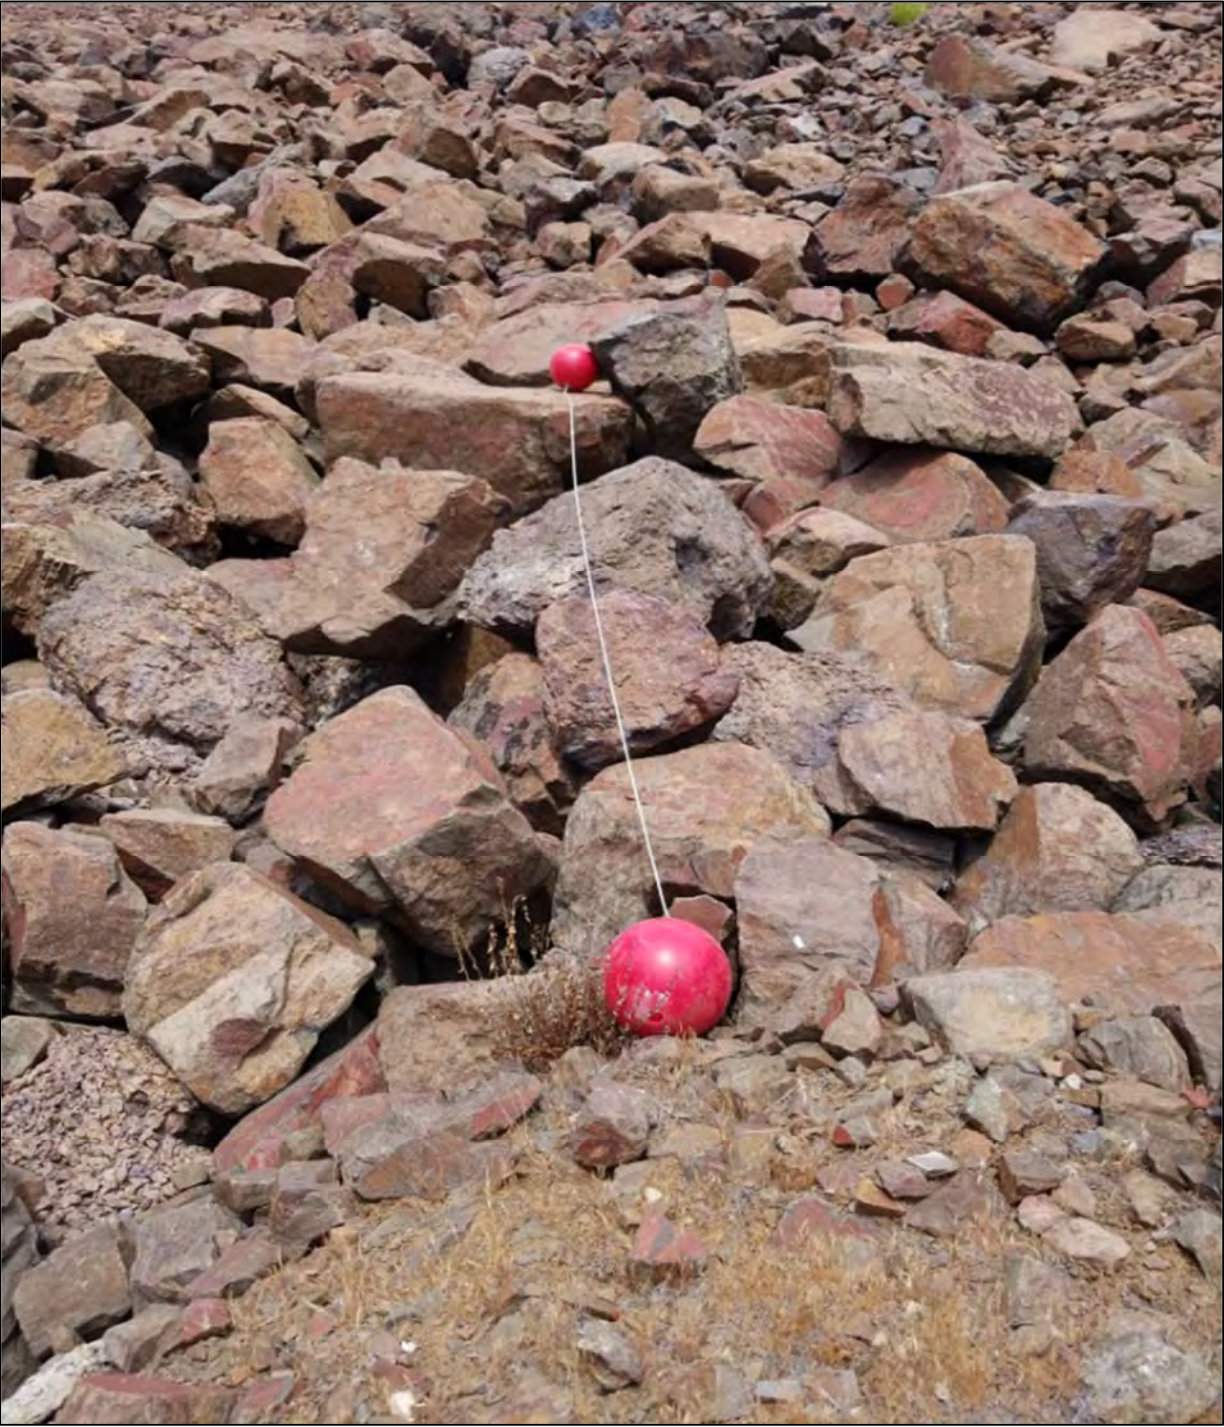
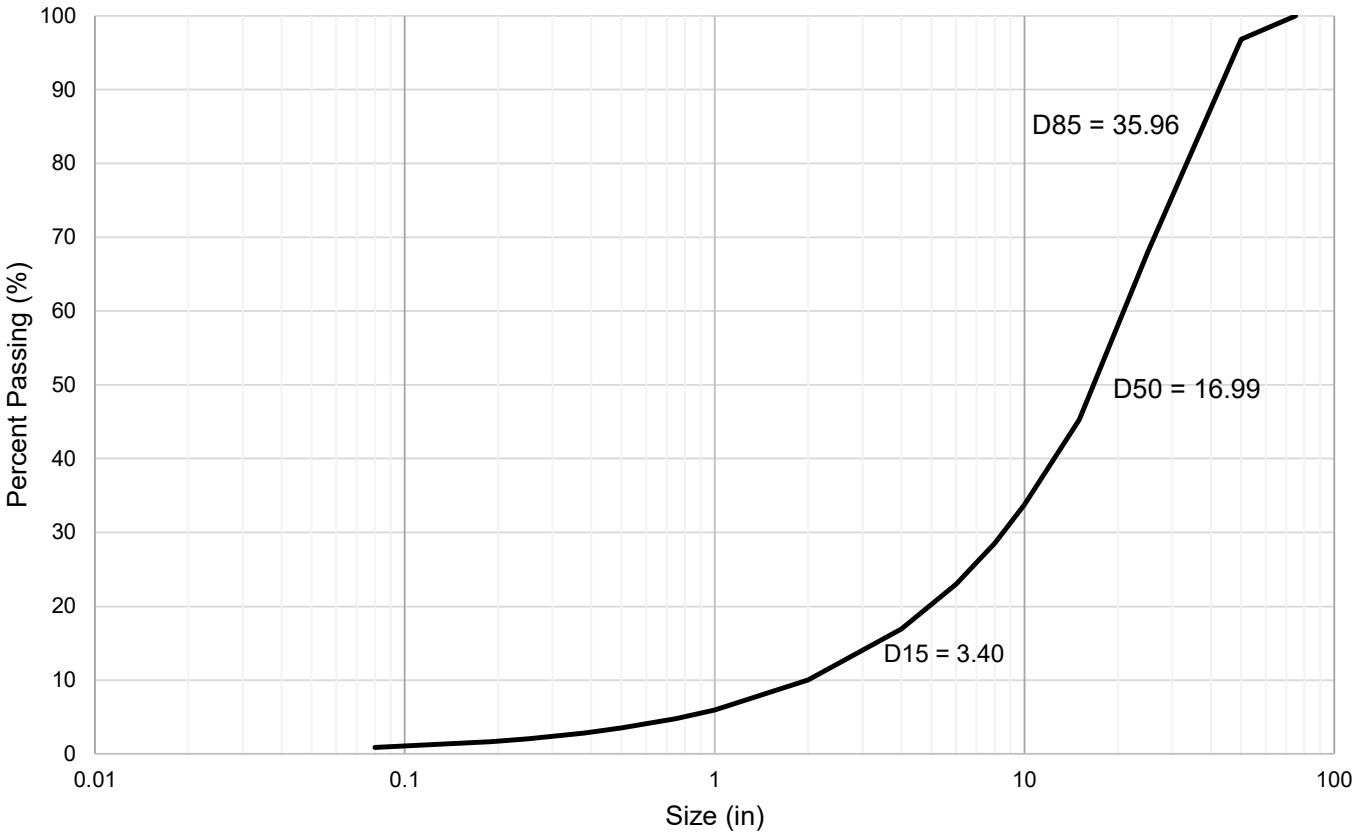
FIGURE C.5

Size[in]	% Passing
75	100.00
50	96.80
25	68.09
15	45.28
10	33.75
8	28.54
6	23.00
4	16.95
2	10.06
1	5.97
0.75	4.80
0.5	3.54
0.38	2.84
0.25	2.09
0.19	1.68
0.08	0.87

% Passing	Size[in]
F10	1.98
F15	3.40
F20	4.98
F30	8.55
F40	12.63
F50	16.99
F60	21.20
F70	25.99
F80	32.05
F85	35.96
F90	40.61
Topsize (99.95%)	65.36

- NOTES:**
- 1. SCALE BALL SIZE = 10"
 - 2. ANALYSIS CONDUCTED BY SPLIT ENGINEERING

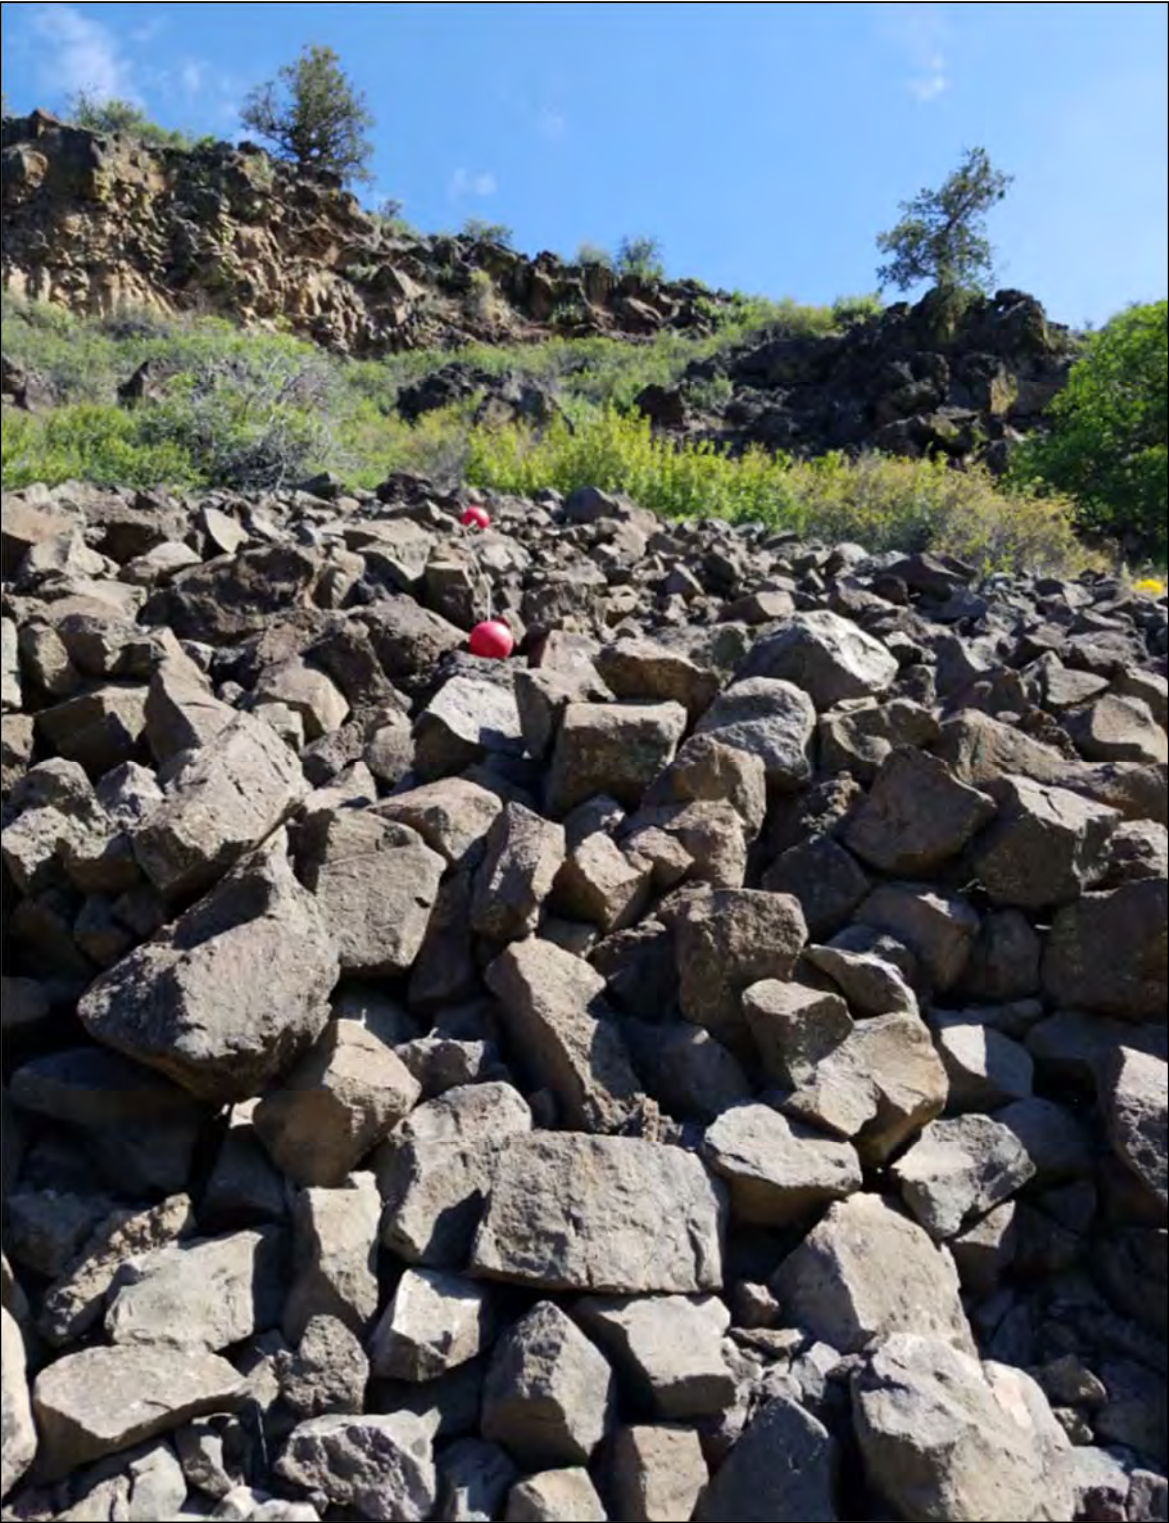
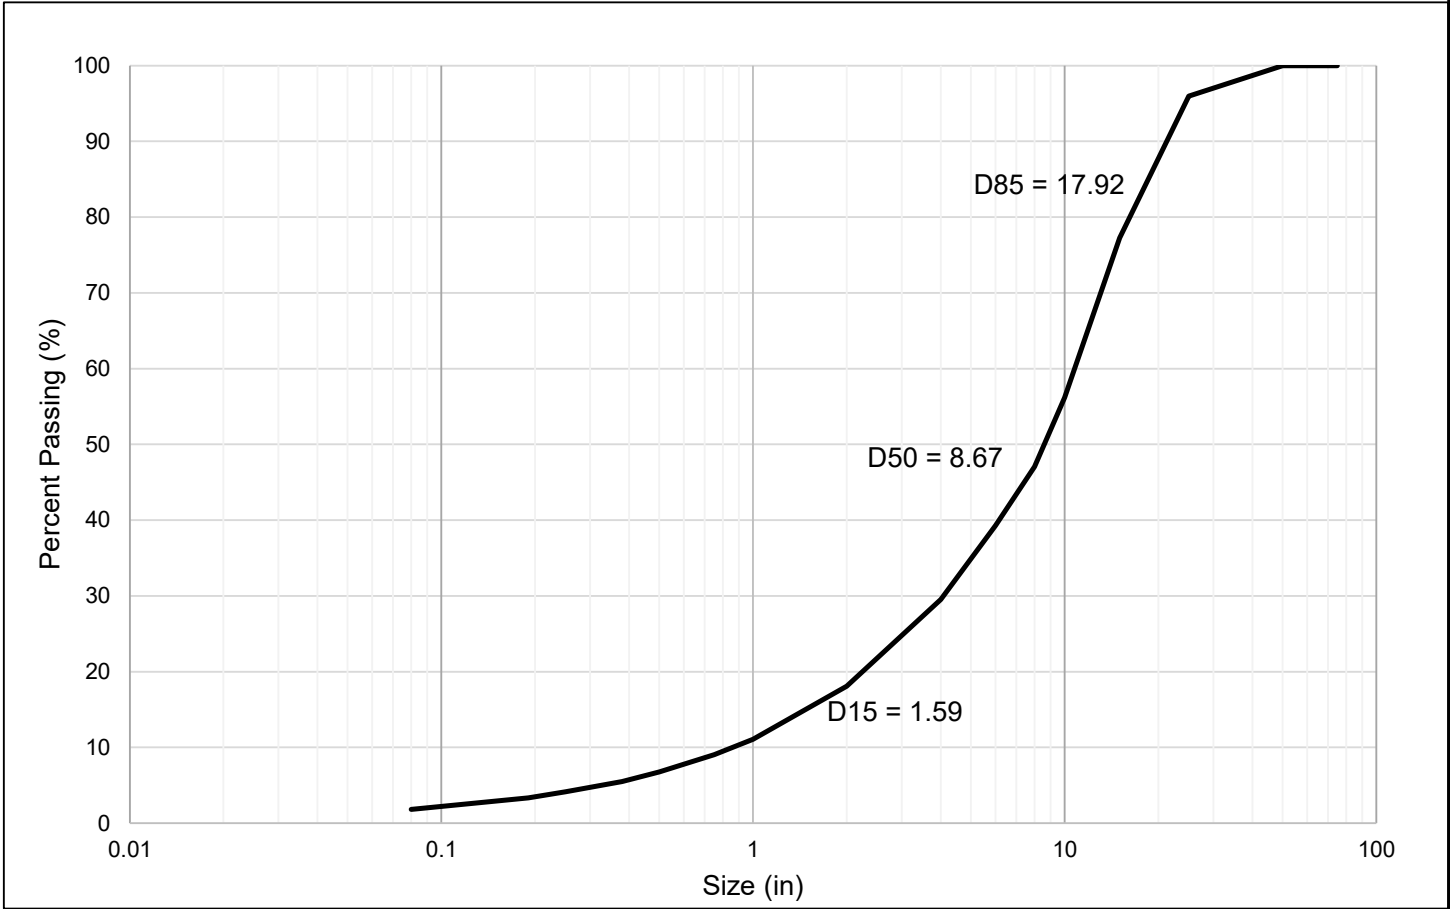
P/A NO. VA103-640/1		REF. NO. VA20-01037
	FIGURE C.8		REV A

- NOTES:**
- 1. SCALE BALL SIZE = 10"
 - 2. ANALYSIS CONDUCTED BY SPLIT ENGINEERING

Size[in]	% Passing
75	100.00
50	100.00
25	95.98
15	77.28
10	56.17
8	47.08
6	39.30
4	29.52
2	18.09
1	11.07
0.75	9.03
0.5	6.77
0.38	5.51
0.25	4.13
0.19	3.35
0.08	1.80

% Passing	Size[in]
F10	0.87
F20	2.31
F30	4.09
F40	6.15
F50	8.67
F60	10.82
F70	13.09
F80	15.81
F90	20.02
Topsized (99.95%)	34.58

KIEWIT INFRASTRUCTURE WEST CO.			
KLAMATH RIVER RENEWAL PROJECT			
ONSITE BORROW SOURCE SITE INVESTIGATION SPILT-NET PARTICLE SIZE ANALYSIS RESULTS COPCO NO. 1 ACCESS ROAD - 1

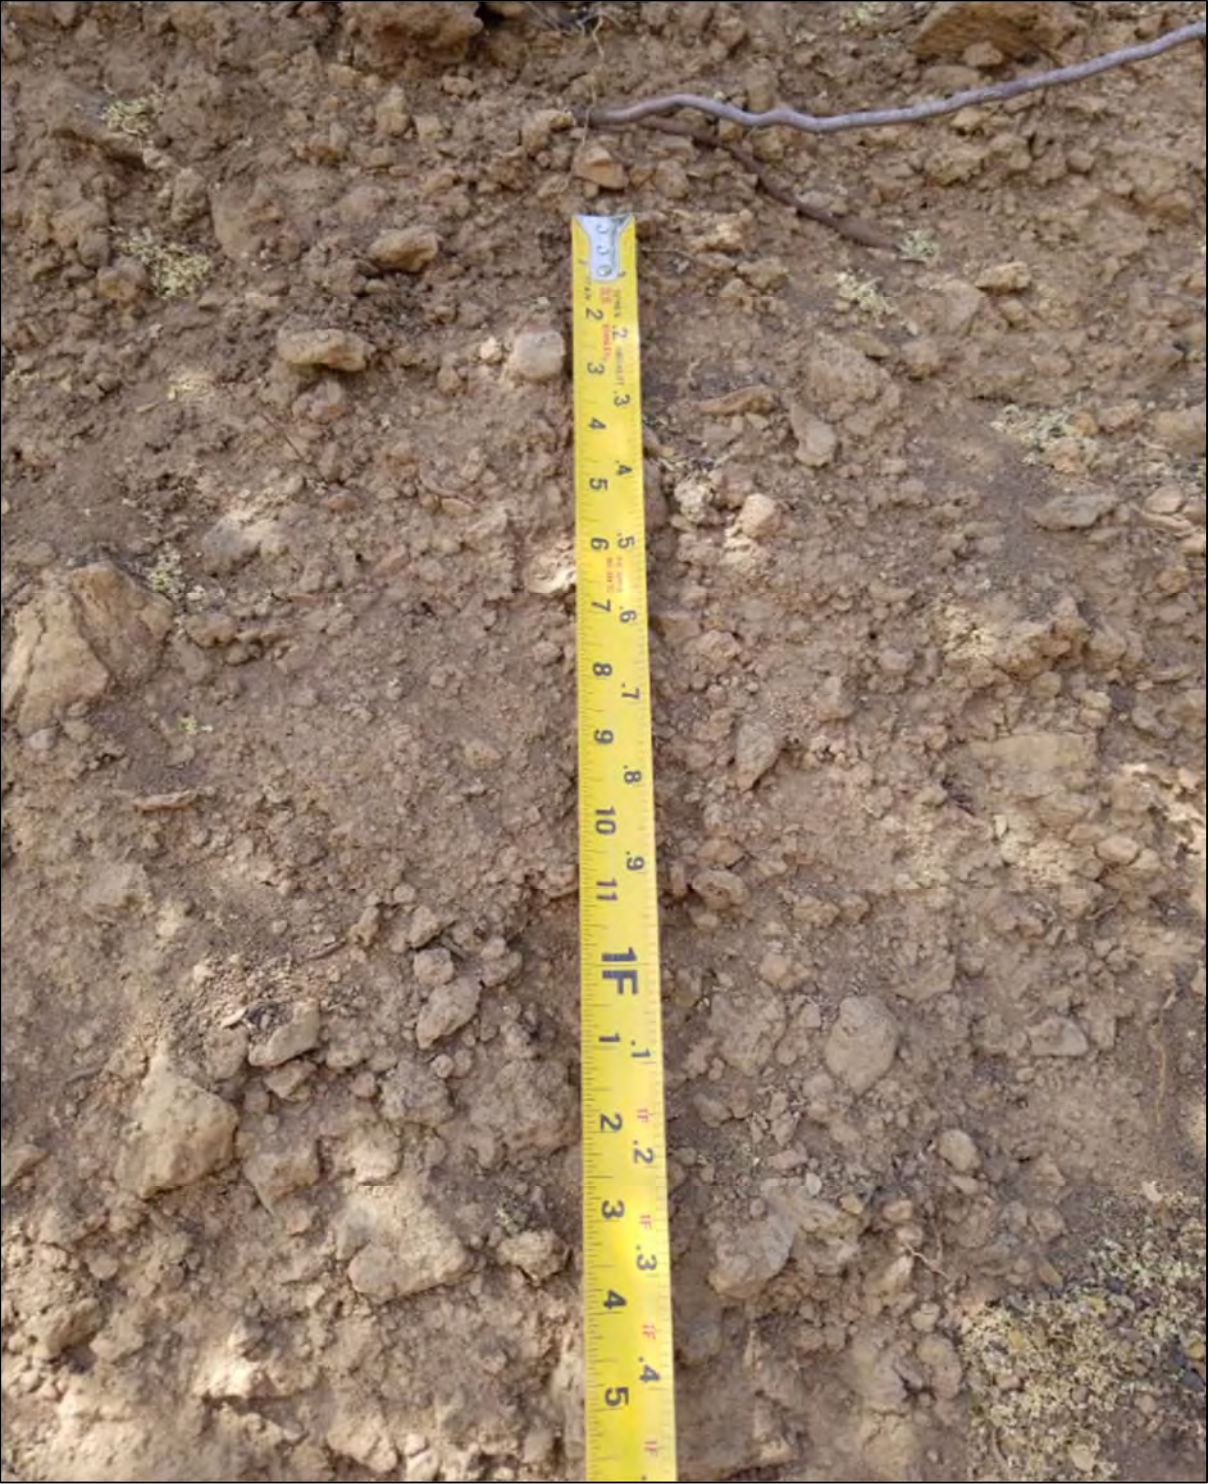
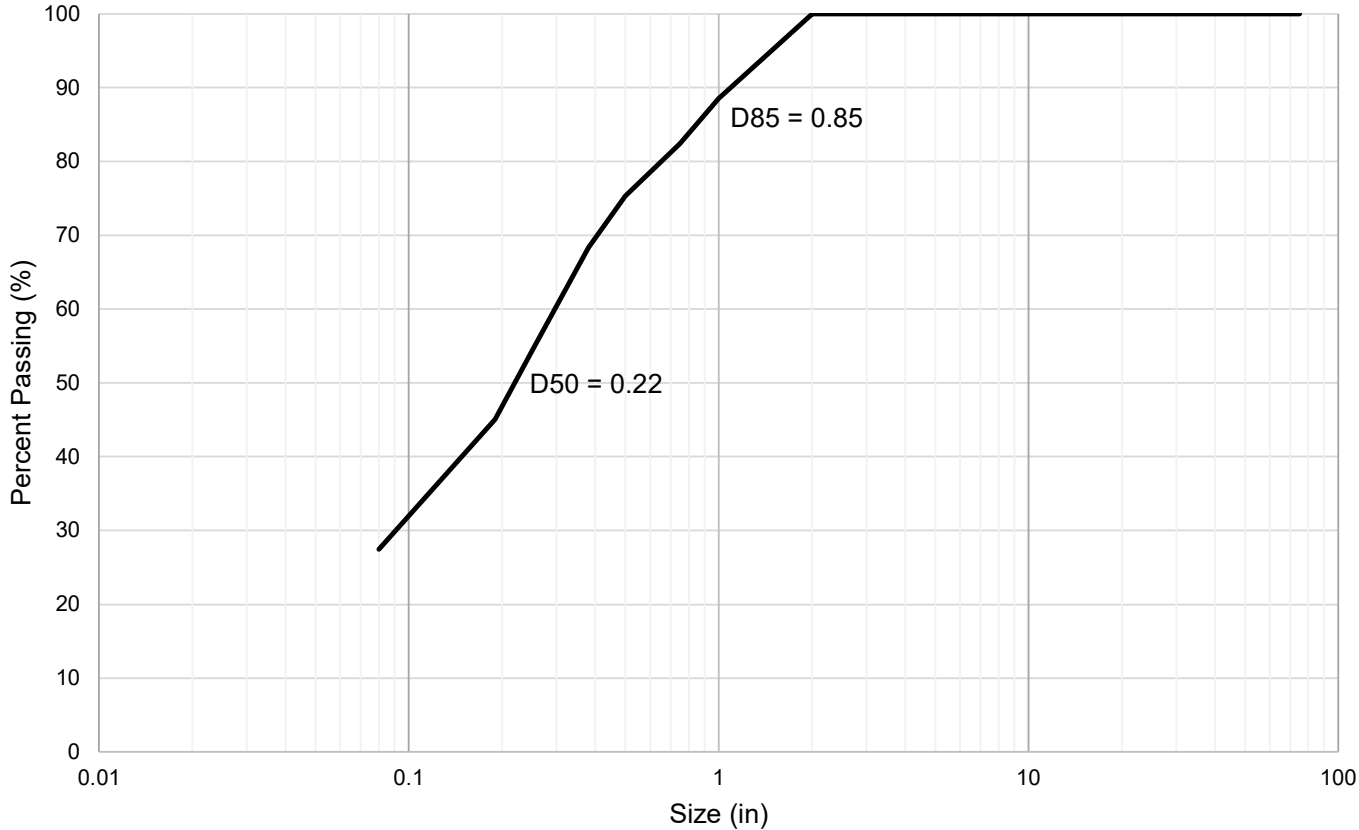
P/A NO. VA103-640/1	REF. NO. VA20-01037
	FIGURE C.10	
		REV A

Size[in]	% Passing
75	100.00
50	100.00
25	100.00
15	100.00
10	100.00
8	100.00
6	100.00
4	100.00
2	99.98
1	88.54
0.75	82.42
0.5	75.30
0.38	68.34
0.25	54.36
0.19	45.06
0.08	27.46

% Passing	Size[in]
F10	0.01
F15	0.03
F20	0.05
F30	0.09
F40	0.15
F50	0.22
F60	0.29
F70	0.40
F80	0.65
F85	0.85
F90	1.07
Topsize (99.95%)	1.98

- NOTES:
- 1. STANDARD TAPE MEASURE FOR SCALE
 - 2. ANALYSIS CONDUCTED BY SPLIT ENGINEERING

KIEWIT INFRASTRUCTURE WEST CO.		
KLAMATH RIVER RENEWAL PROJECT		
ONSITE BORROW SOURCE SITE INVESTIGATION SPILT-NET PARTICLE SIZE ANALYSIS RESULTS COPCO NO. 1 VILLAGE - 1

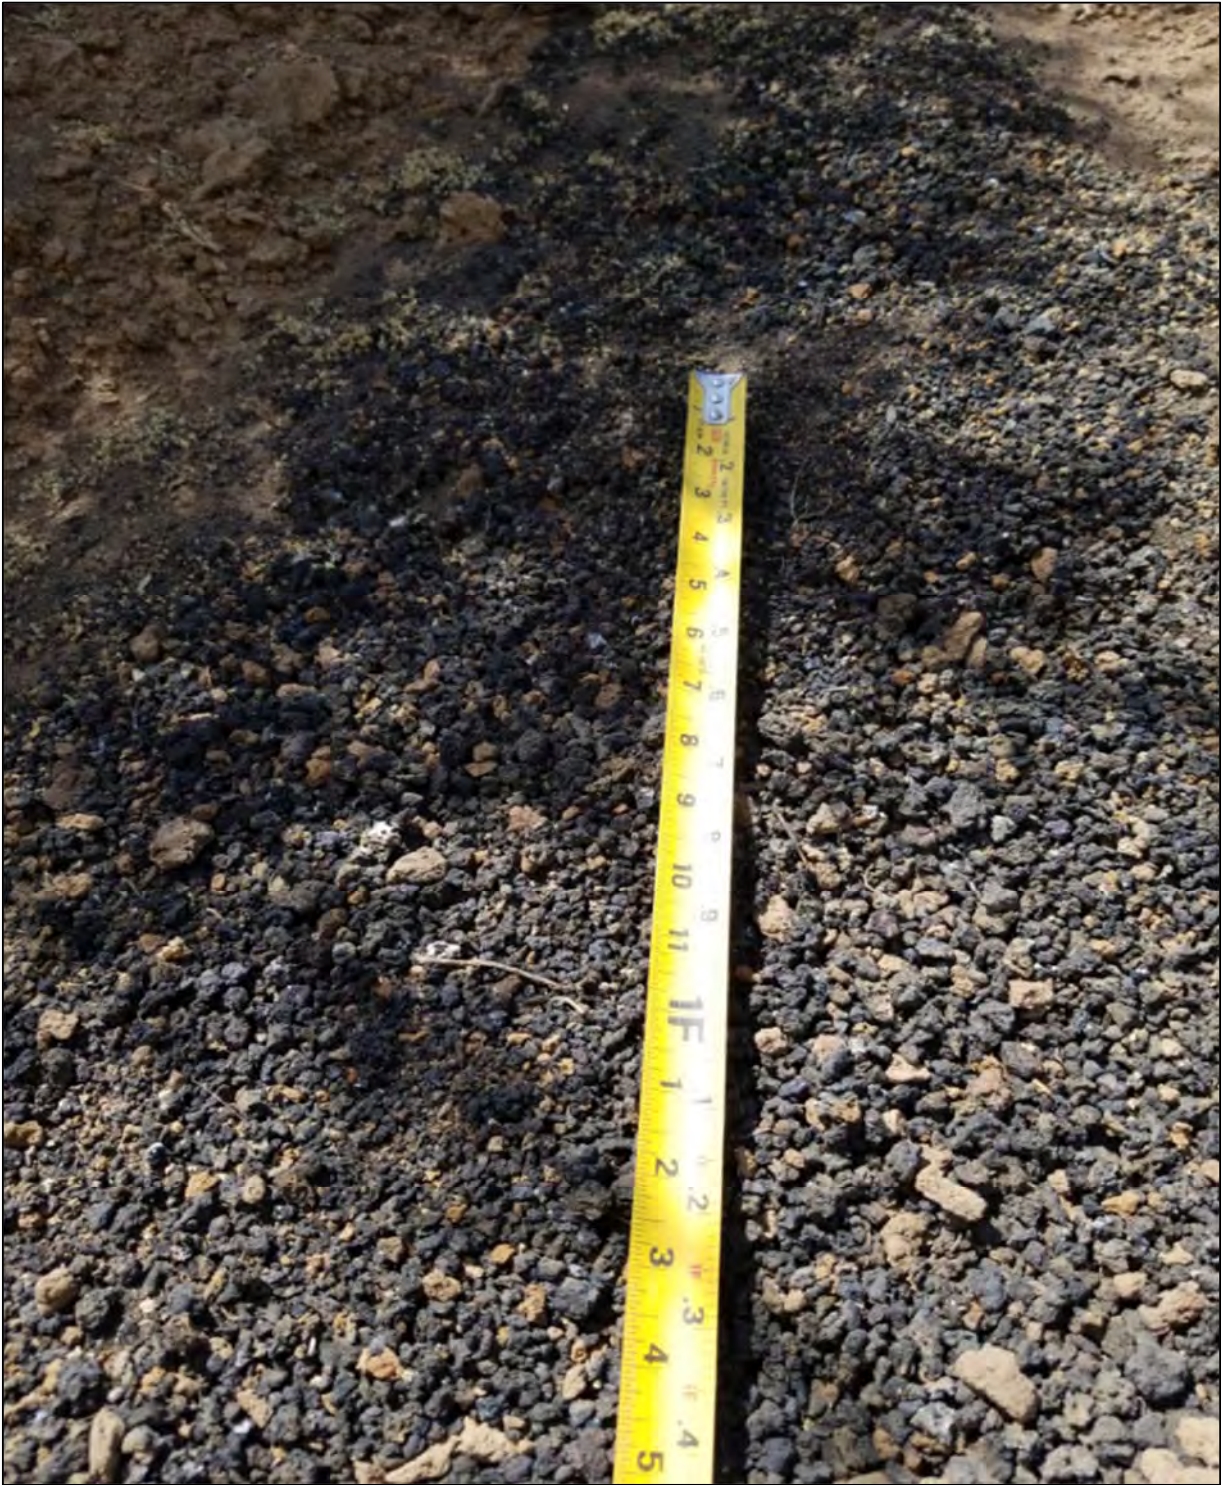
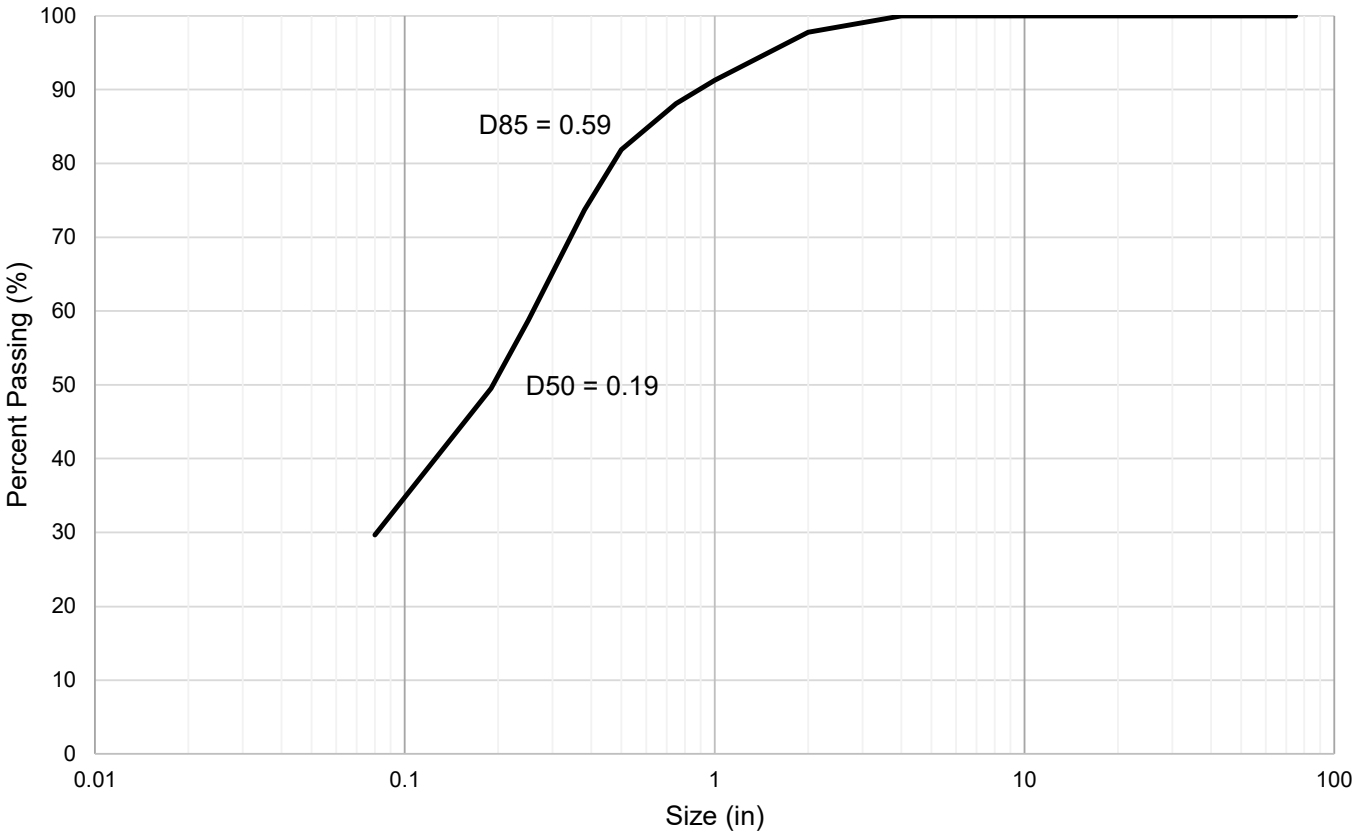
FIGURE C.11

Size[in]	% Passing
75	100.00
50	100.00
25	100.00
15	100.00
10	100.00
8	100.00
6	100.00
4	100.00
2	97.78
1	91.28
0.75	88.12
0.5	81.84
0.38	73.71
0.25	58.69
0.19	49.50
0.08	29.65

% Passing	Size[in]
F10	0.01
F15	0.03
F20	0.04
F30	0.08
F40	0.13
F50	0.19
F60	0.26
F70	0.34
F80	0.46
F85	0.59
F90	0.88
Topsize (99.95%)	2.64

- NOTES:
- 1. STANDARD TAPE MEASURE FOR SCALE
 - 2. ANALYSIS CONDUCTED BY SPLIT ENGINEERING

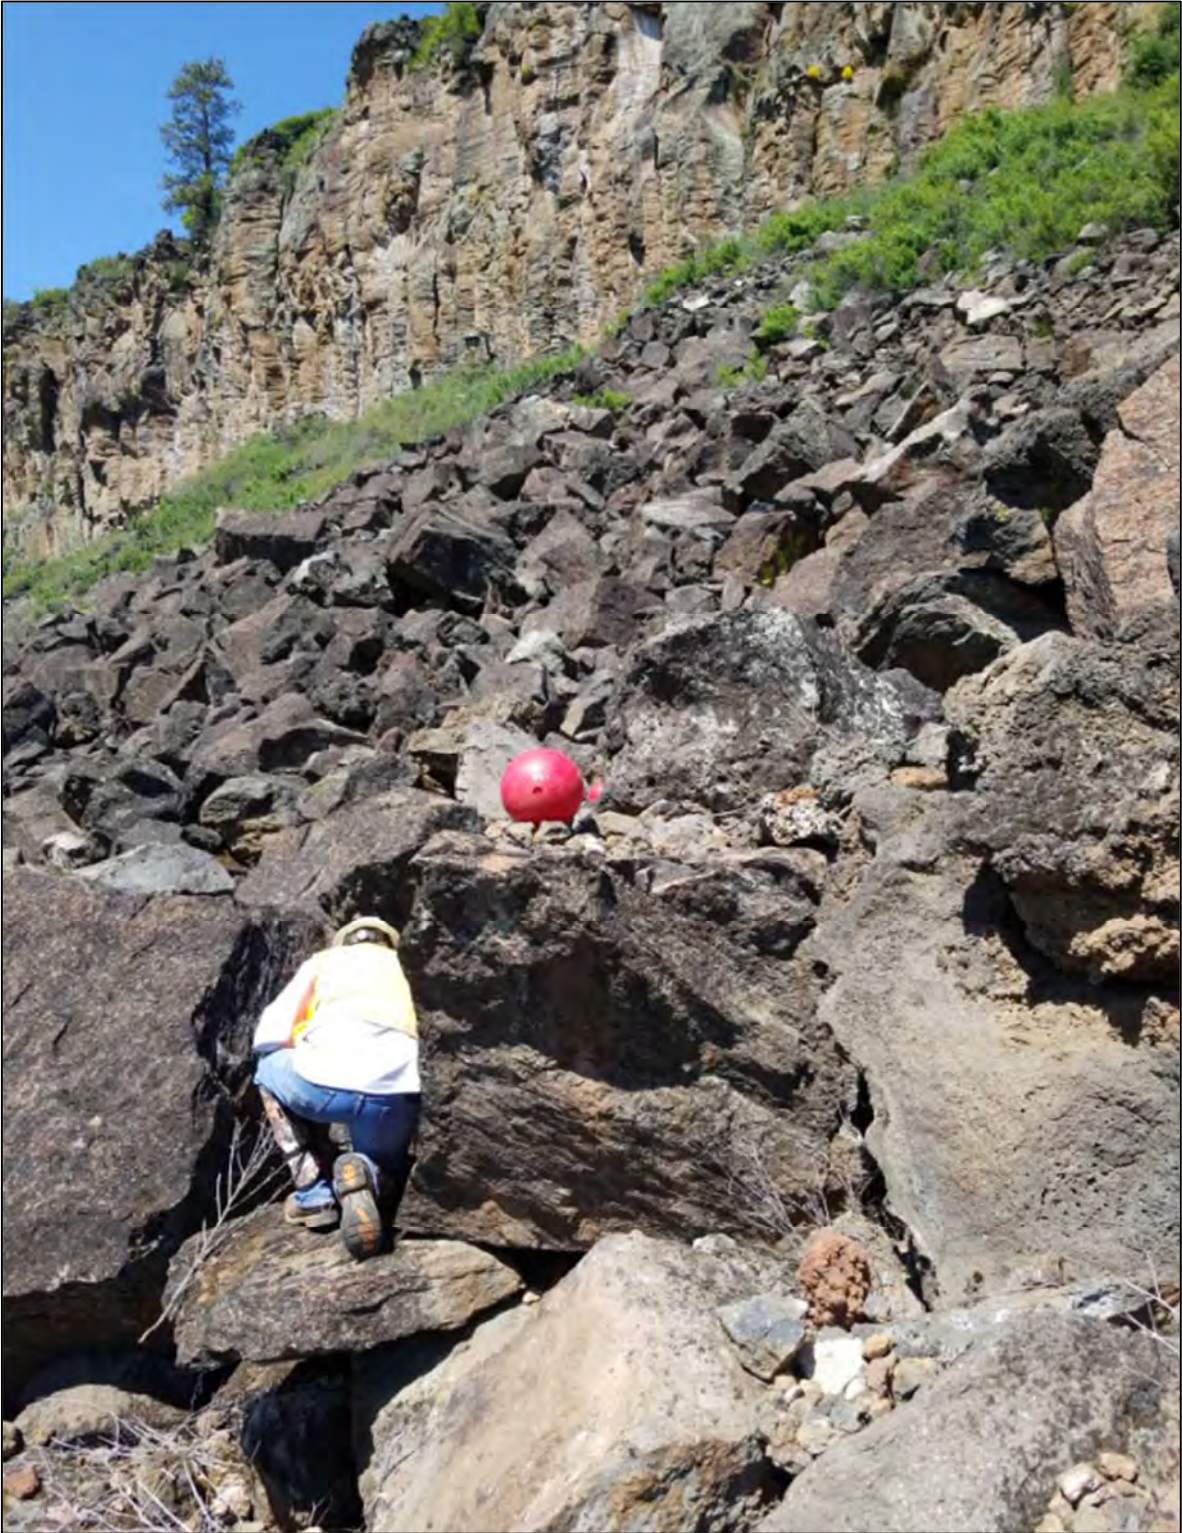
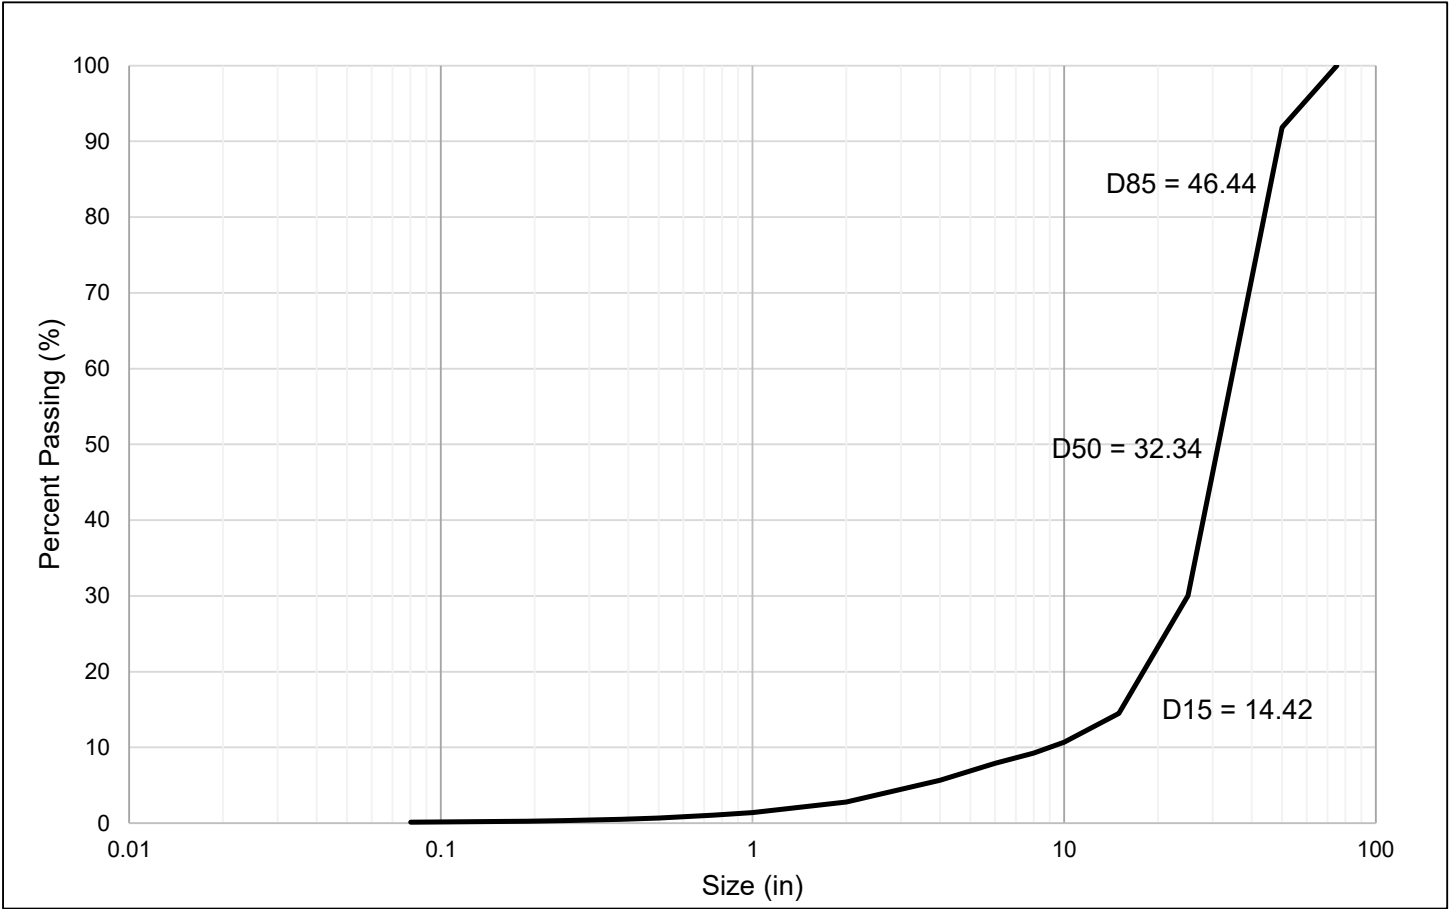
P/A NO. VA103-640/1	REF. NO. VA20-01037
	FIGURE C.12	
		REV A

Size[in]	% Passing
75	100.00
50	91.83
25	30.04
15	14.50
10	10.67
8	9.27
6	7.92
4	5.67
2	2.80
1	1.39
0.75	1.04
0.5	0.69
0.38	0.51
0.25	0.34
0.19	0.25
0.08	0.10

% Passing	Size[in]
F10	9.03
F20	19.81
F30	24.98
F40	28.85
F50	32.34
F60	35.88
F70	39.68
F80	44.02
F90	48.86
Topsize (99.95%)	58.83

- NOTES:**
- 1. SCALE BALL SIZE = 10"
 - 2. ANALYSIS CONDUCTED BY SPLIT ENGINEERING
 - 3. DUE TO THE LARGE PARTICLE SIZES OF THE ROCKS, BOTH SCALING BALLS COULD NOT BE SHOWN IN THE PHOTOGRAPHS SENT FOR ANALYSIS. THE RESULTING ANALYSIS IS THEREFORE EXPECTED TO PRODUCE AN ARTIFICIALLY SMALLER PARTICLE SIZE CURVE DUE TO AN INABILITY TO DETERMINE THE DEPTH OF FIELD.

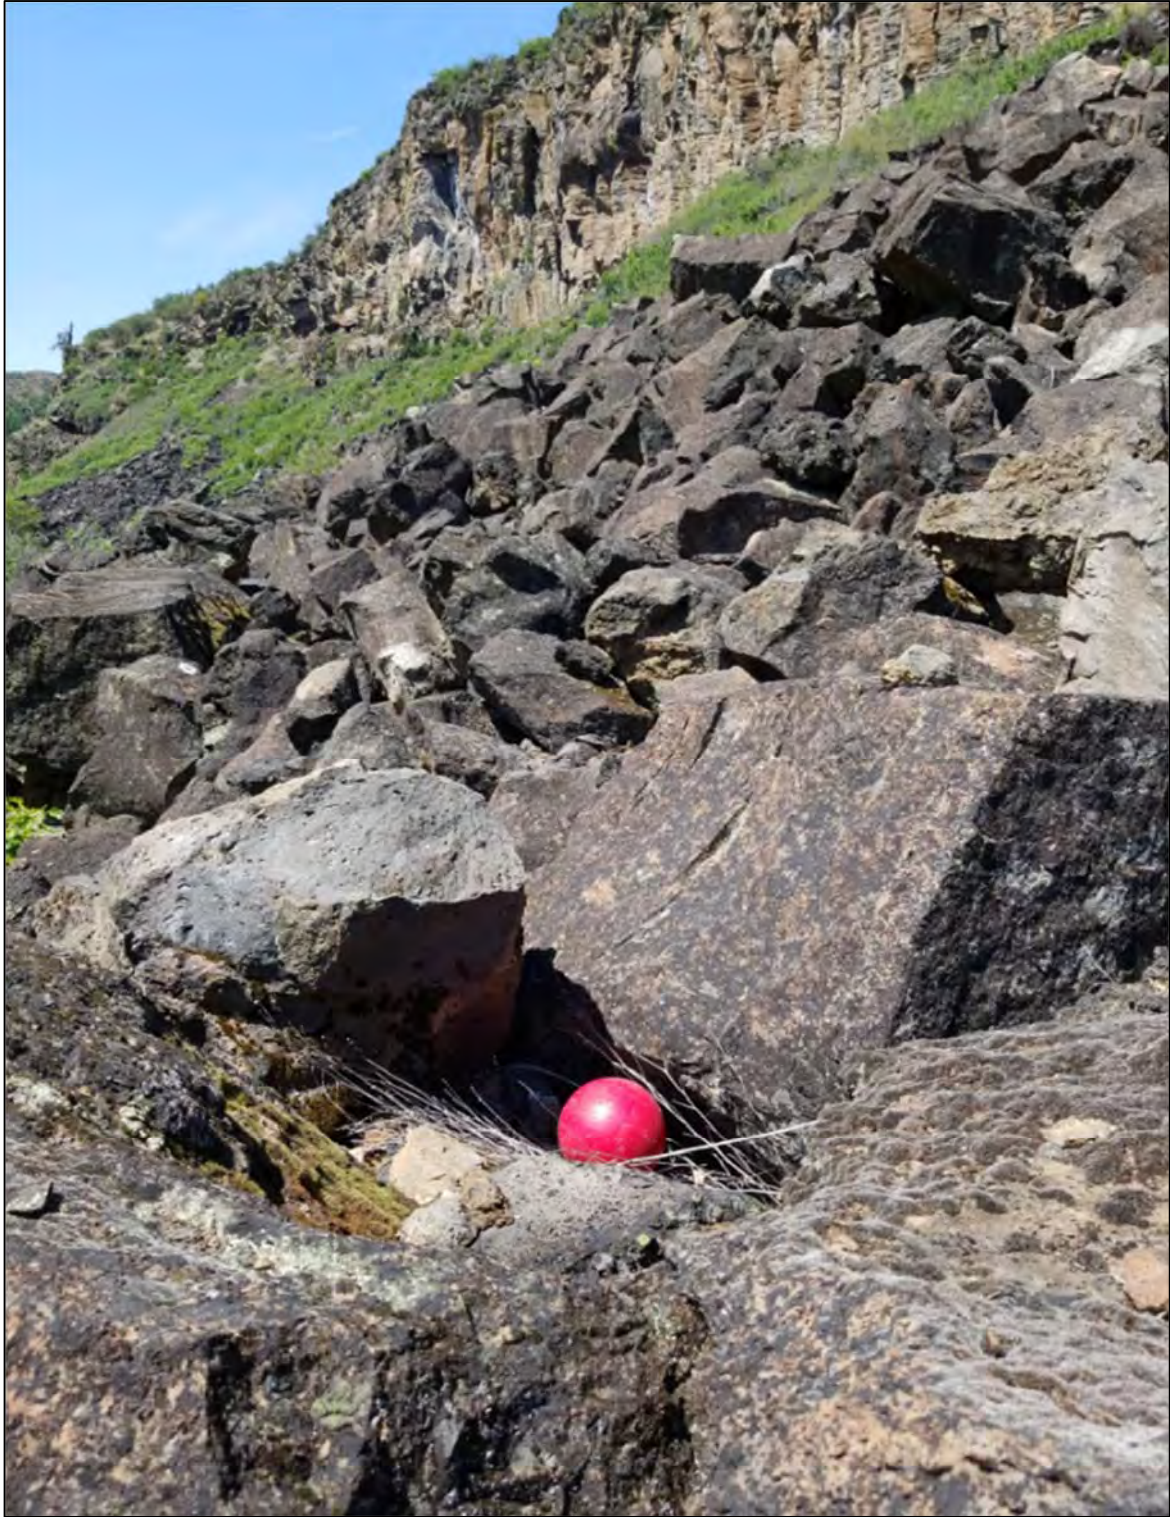
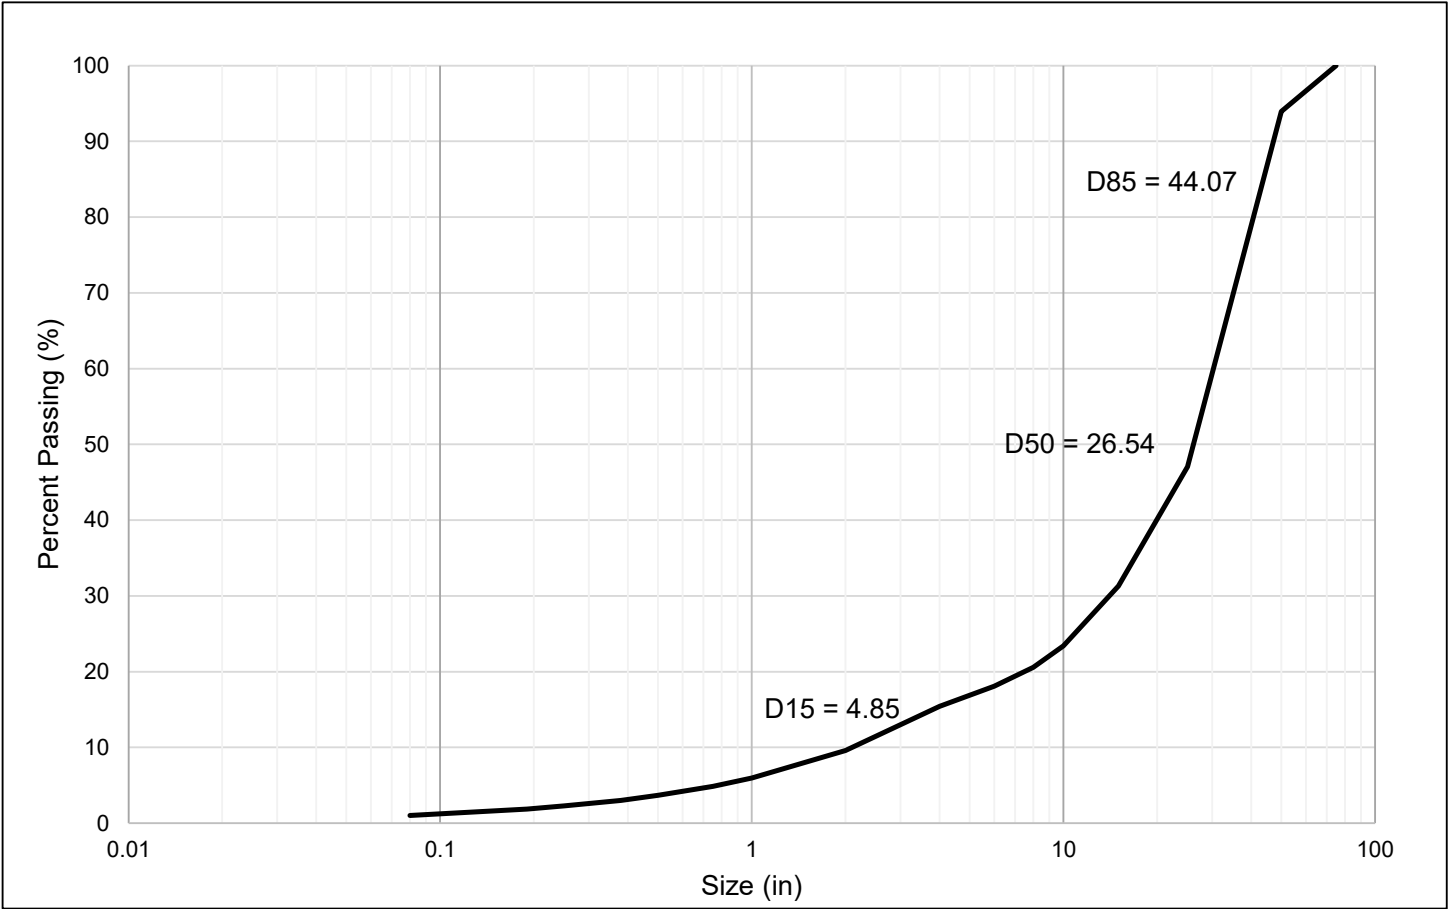
Size[in]	% Passing
75	100.00
50	93.97
25	47.08
15	31.32
10	23.41
8	20.57
6	18.09
4	15.44
2	9.59
1	5.95
0.75	4.88
0.5	3.68
0.38	3.02
0.25	2.28
0.19	1.86
0.08	1.02

% Passing	Size[in]
F10	2.13
F20	7.57
F30	14.17
F40	20.86
F50	26.54
F60	31.36
F70	35.74
F80	40.92
F90	47.21
Topsized (99.95%)	54.73

KIEWIT INFRASTRUCTURE WEST CO.			
KLAMATH RIVER RENEWAL PROJECT			
ONSITE BORROW SOURCE SITE INVESTIGATION SPILT-NET PARTICLE SIZE ANALYSIS RESULTS COPCO NO. 2 DOWNSTREAM RIGHT BANK - 2			
	P/A NO. VA103-640/1		REF. NO. VA20-01037
	FIGURE C.13		REV A

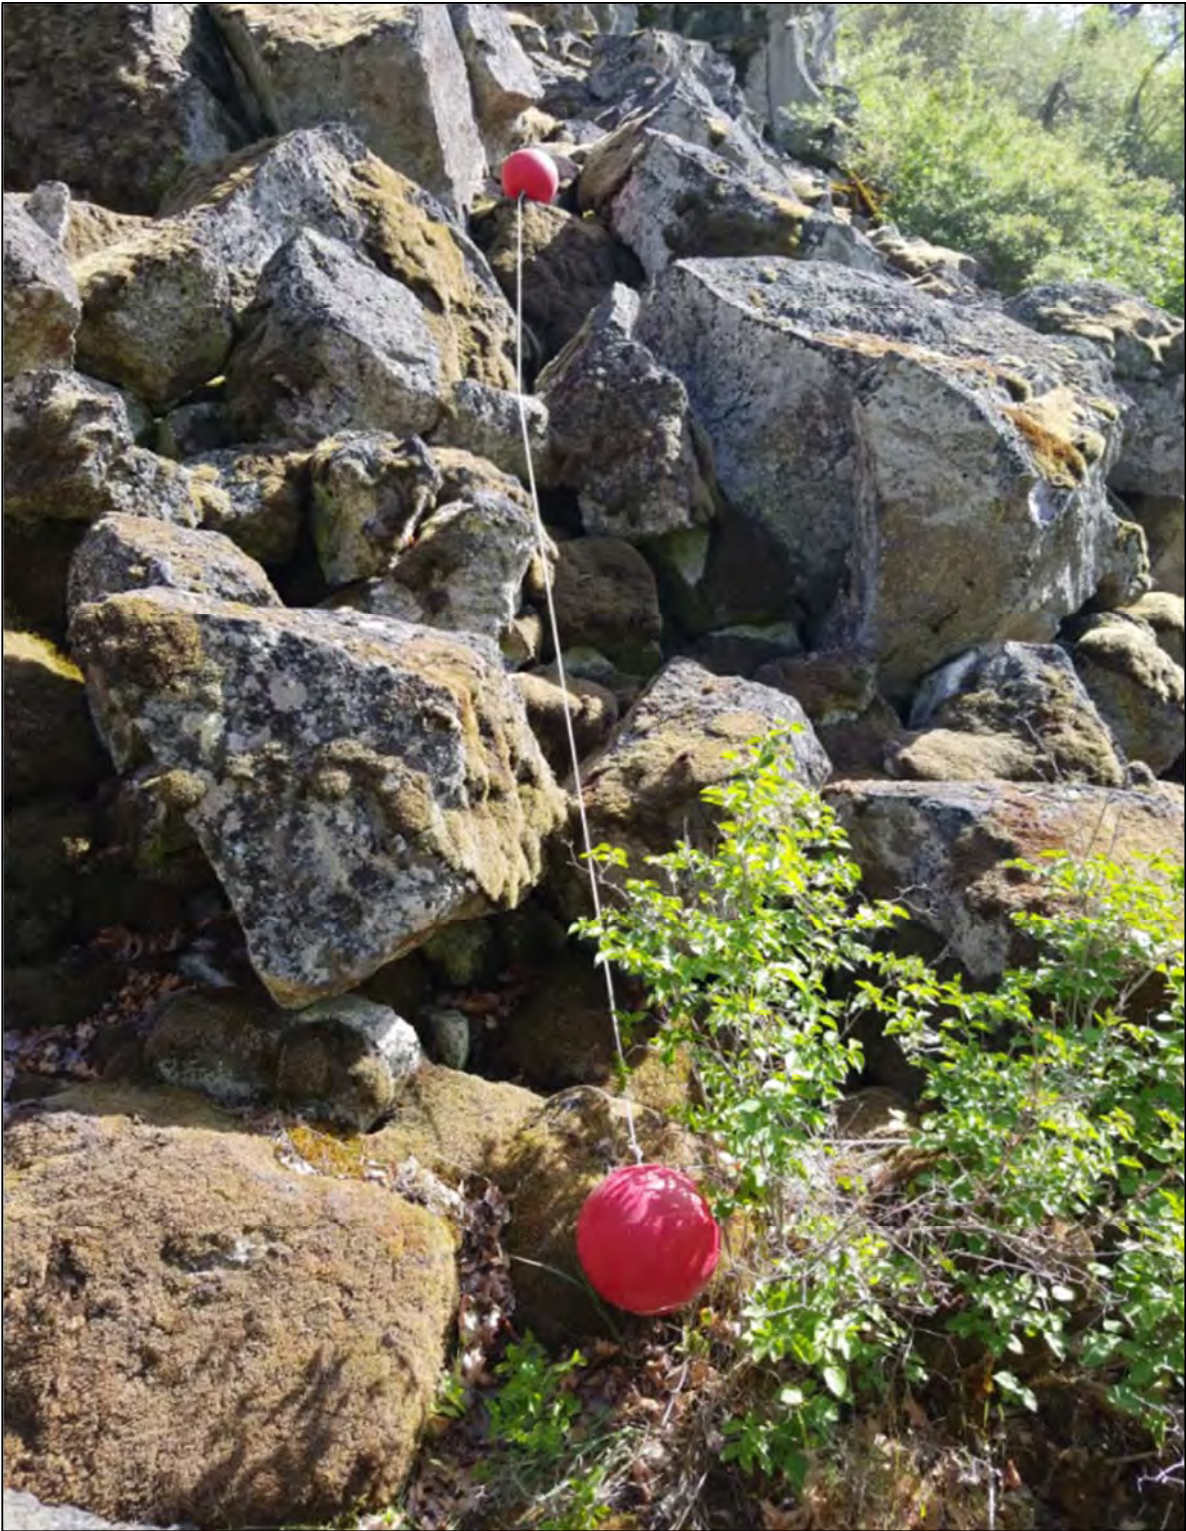
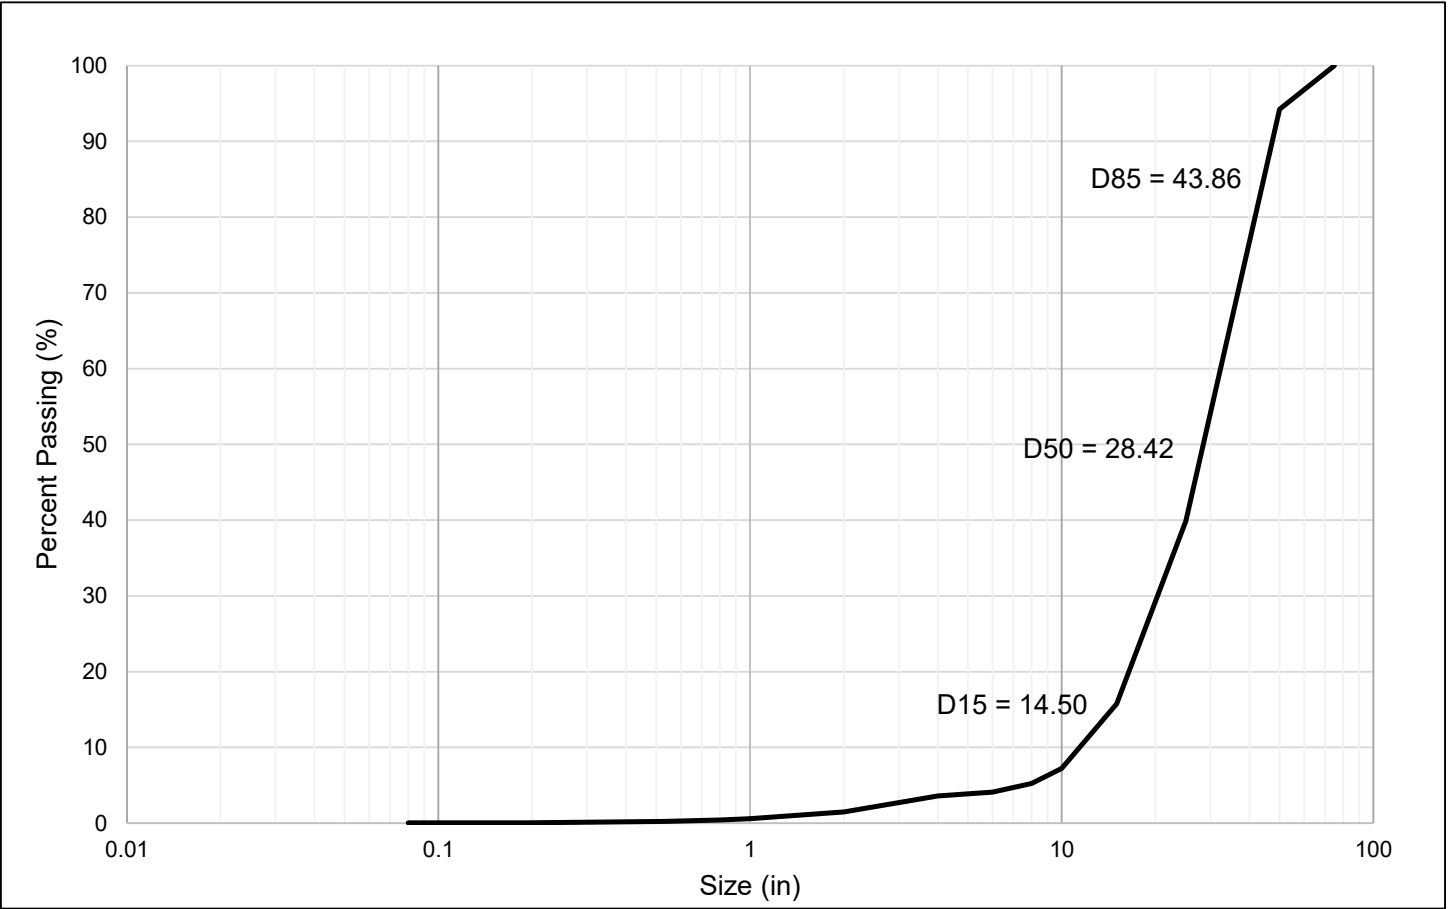
PIA NO. VA103-640/1		REF. NO. VA20-01037
	FIGURE C.14		REV A

Size[in]	% Passing
75	100.00
50	94.25
25	39.87
15	15.75
10	7.22
8	5.23
6	4.12
4	3.58
2	1.46
1	0.58
0.75	0.40
0.5	0.23
0.38	0.16
0.25	0.09
0.19	0.06
0.08	0.02

% Passing	Size[in]
F10	11.96
F20	17.03
F30	21.27
F40	25.05
F50	28.42
F60	32.15
F70	36.23
F80	40.90
F90	46.82
Topsize (99.95%)	59.07

- NOTES:**
- 1. SCALE BALL SIZE = 10"
 - 2. ANALYSIS CONDUCTED BY SPLIT ENGINEERING
