RE: KRRP Value Engineering Summary and Advancement to 90% Design

KP was tasked with leading seven VE analyses, which are listed below and described in the following sections of this letter:

VE-1 Submittals: Drawdown Model and Assessment

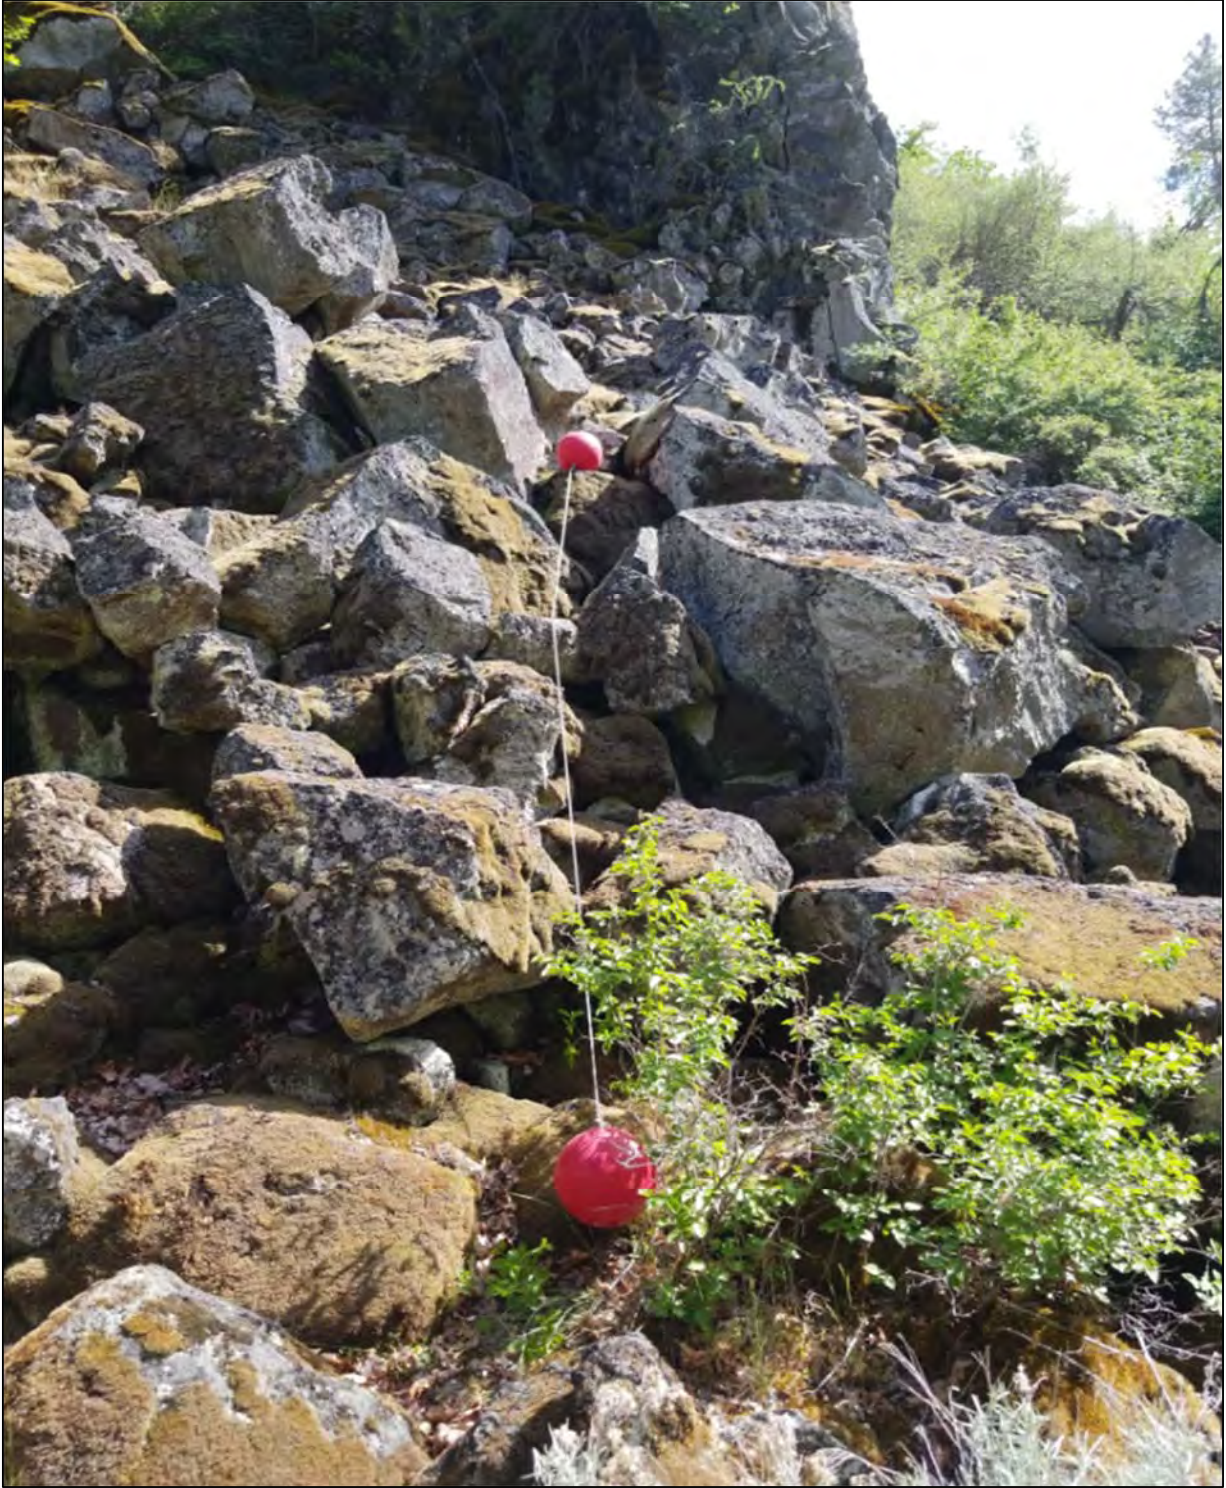
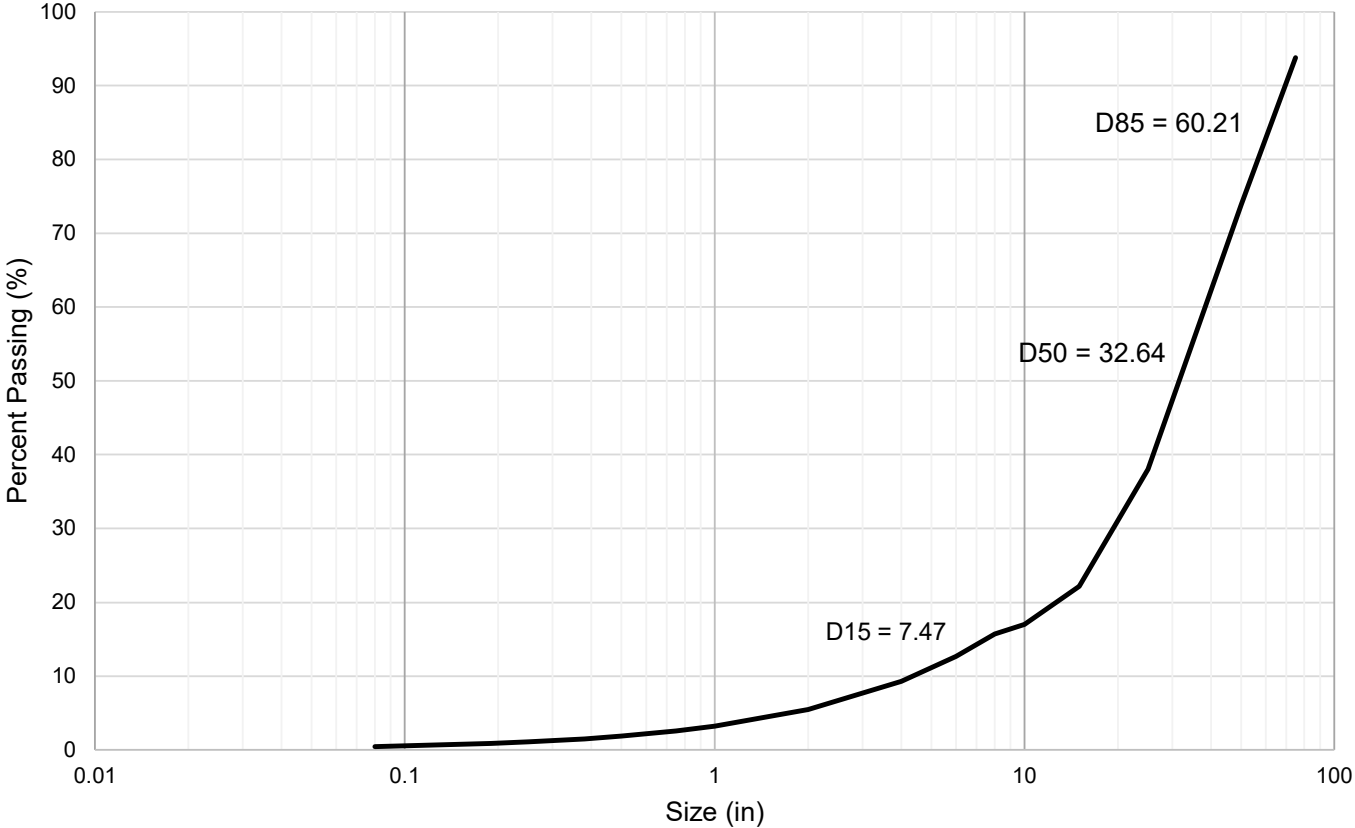
P/A NO. VA103-640/1	REF. NO. VA20-01037	REV A
	FIGURE C.15

Size[in]	% Passing
75	93.79
50	73.82
25	38.04
15	22.20
10	17.01
8	15.71
6	12.68
4	9.31
2	5.48
1	3.23
0.75	2.59
0.5	1.90
0.38	1.52
0.25	1.11
0.19	0.89
0.08	0.46

% Passing	Size[in]
F10	4.39
F15	7.47
F20	13.16
F30	20.16
F40	26.16
F50	32.64
F60	39.26
F70	46.84
F80	55.48
F85	60.21
F90	67.31
Topsize (99.95%)	89.88

- NOTES:
- 1. SCALE BALL SIZE = 10"
 - 2. ANALYSIS CONDUCTED BY SPLIT ENGINEERING

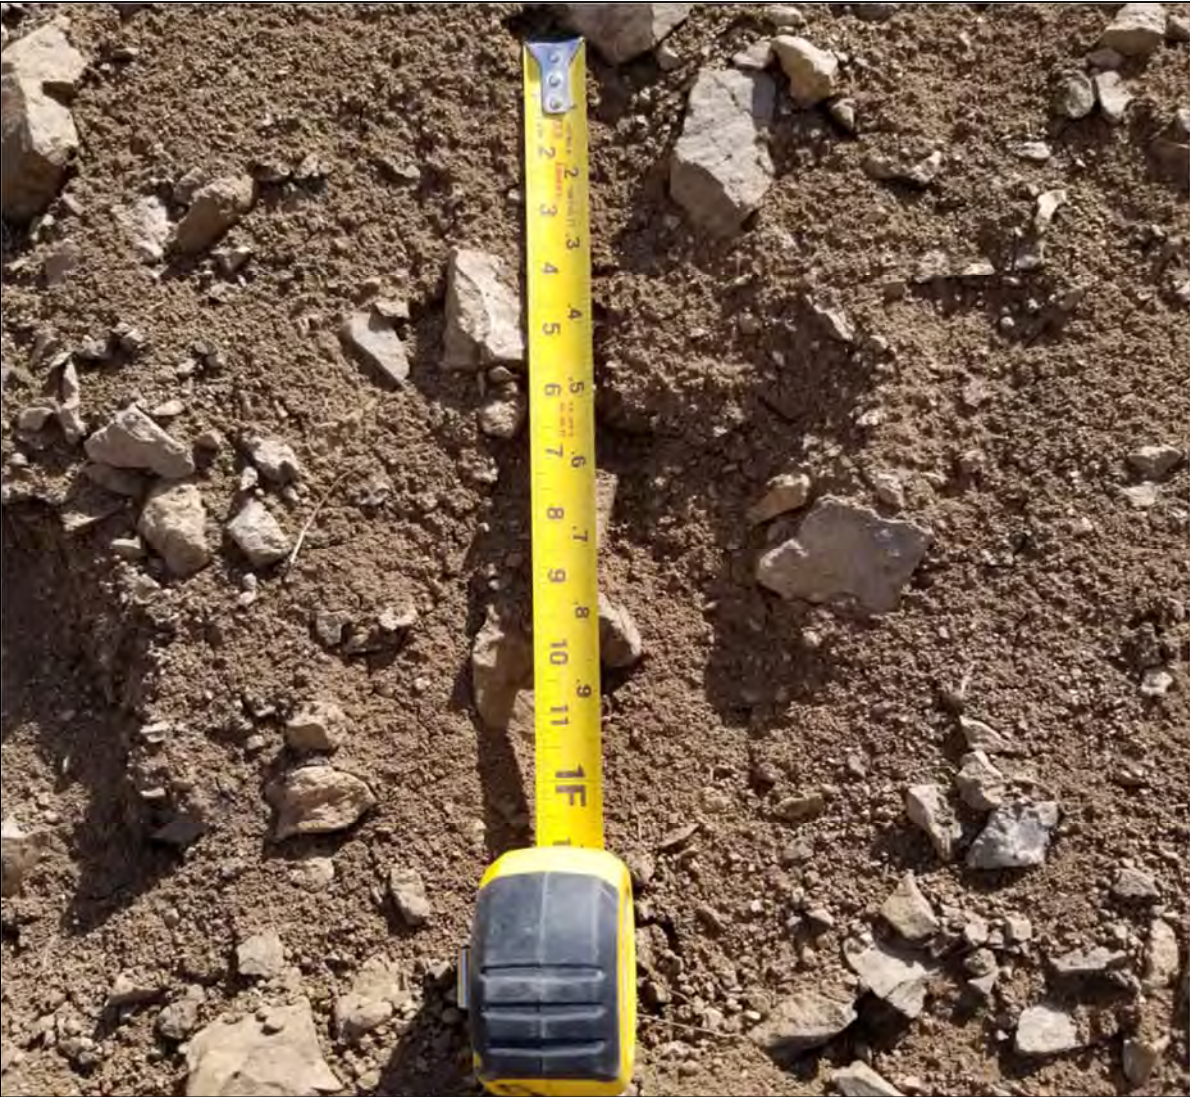
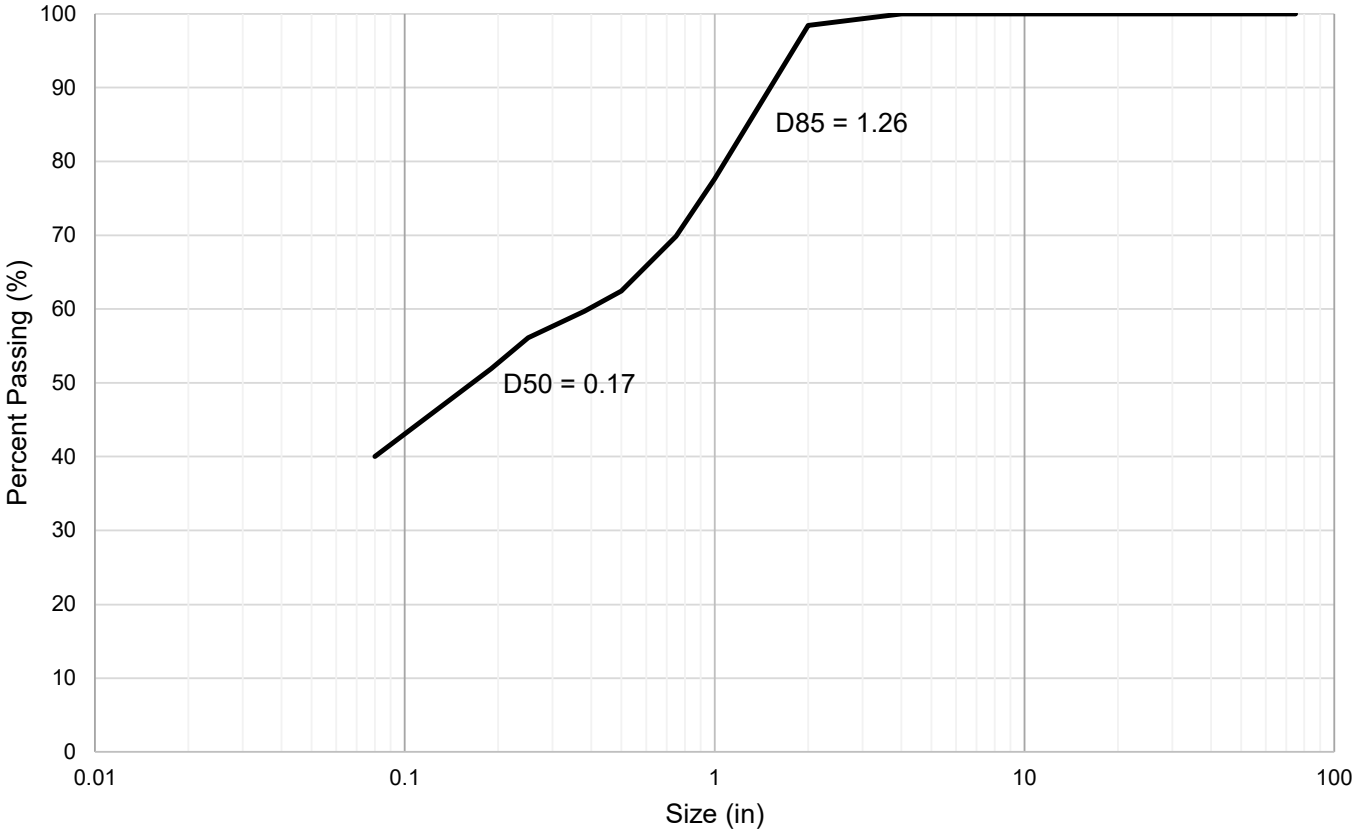
P/A NO. VA103-640/1	REF. NO. VA20-01037	REV A
	FIGURE C.16

Size[in]	% Passing
75	100.00
50	100.00
25	100.00
15	100.00
10	100.00
8	100.00
6	100.00
4	100.00
2	98.41
1	77.66
0.75	69.83
0.5	62.42
0.38	59.72
0.25	56.11
0.19	51.90
0.08	40.02

% Passing	Size[in]
F10	0.00
F15	0.01
F20	0.01
F30	0.03
F40	0.08
F50	0.17
F60	0.39
F70	0.76
F80	1.08
F85	1.26
F90	1.48
Topsize (99.95%)	2.18

- NOTES:**
- 1. STANDARD TAPE MEASURE FOR SCALE
 - 2. ANALYSIS CONDUCTED BY SPLIT ENGINEERING

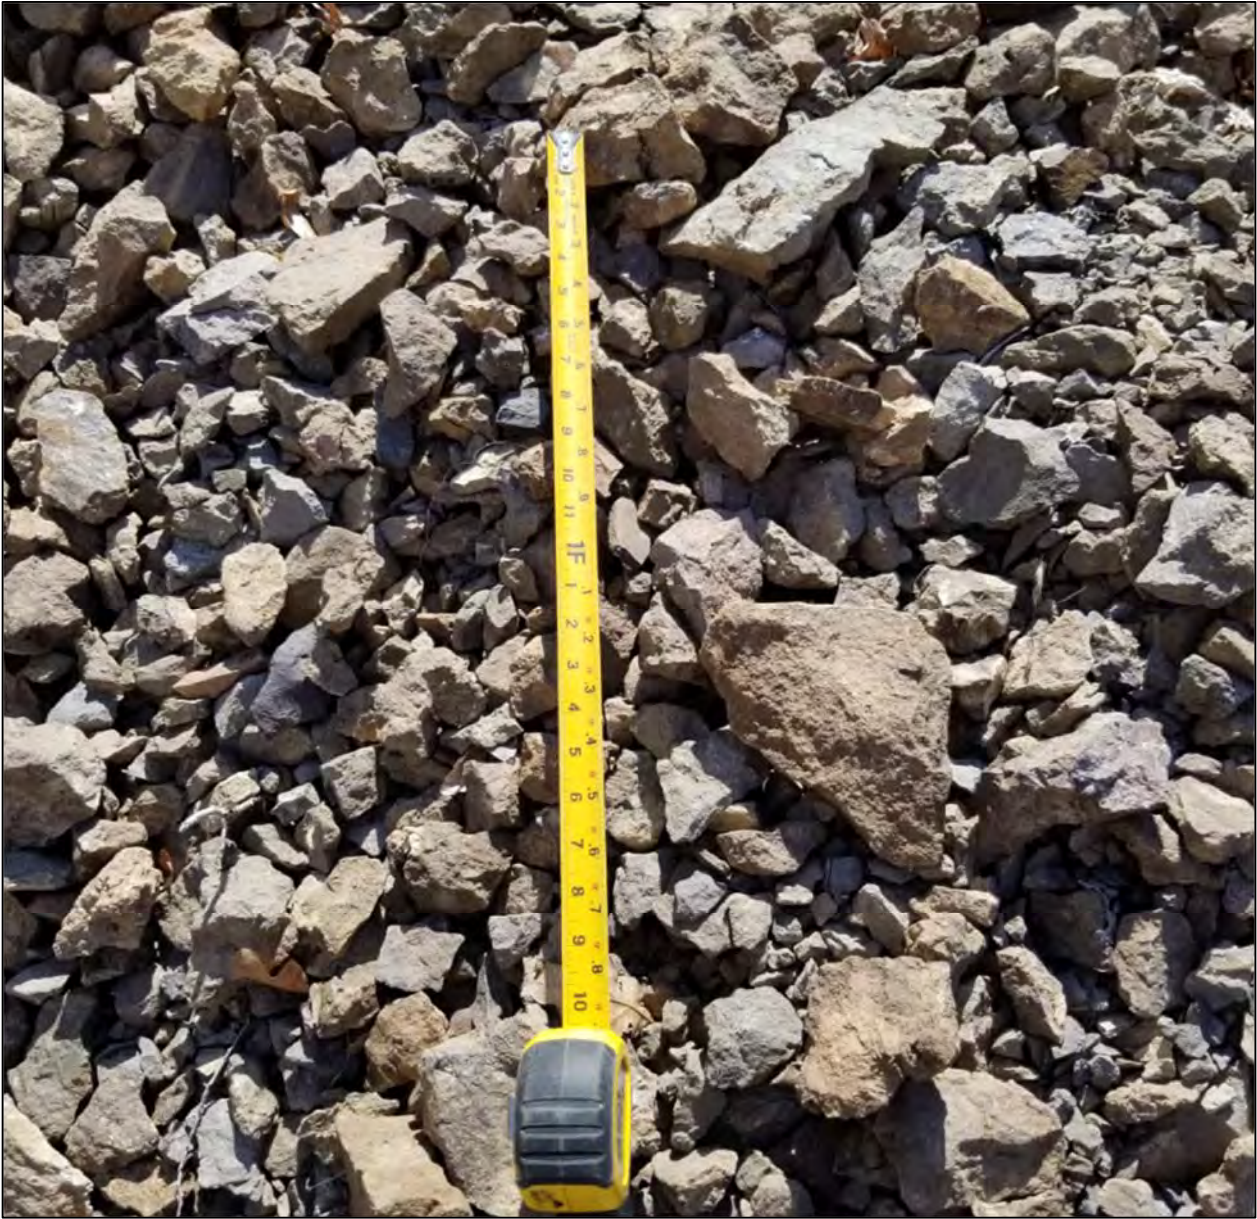
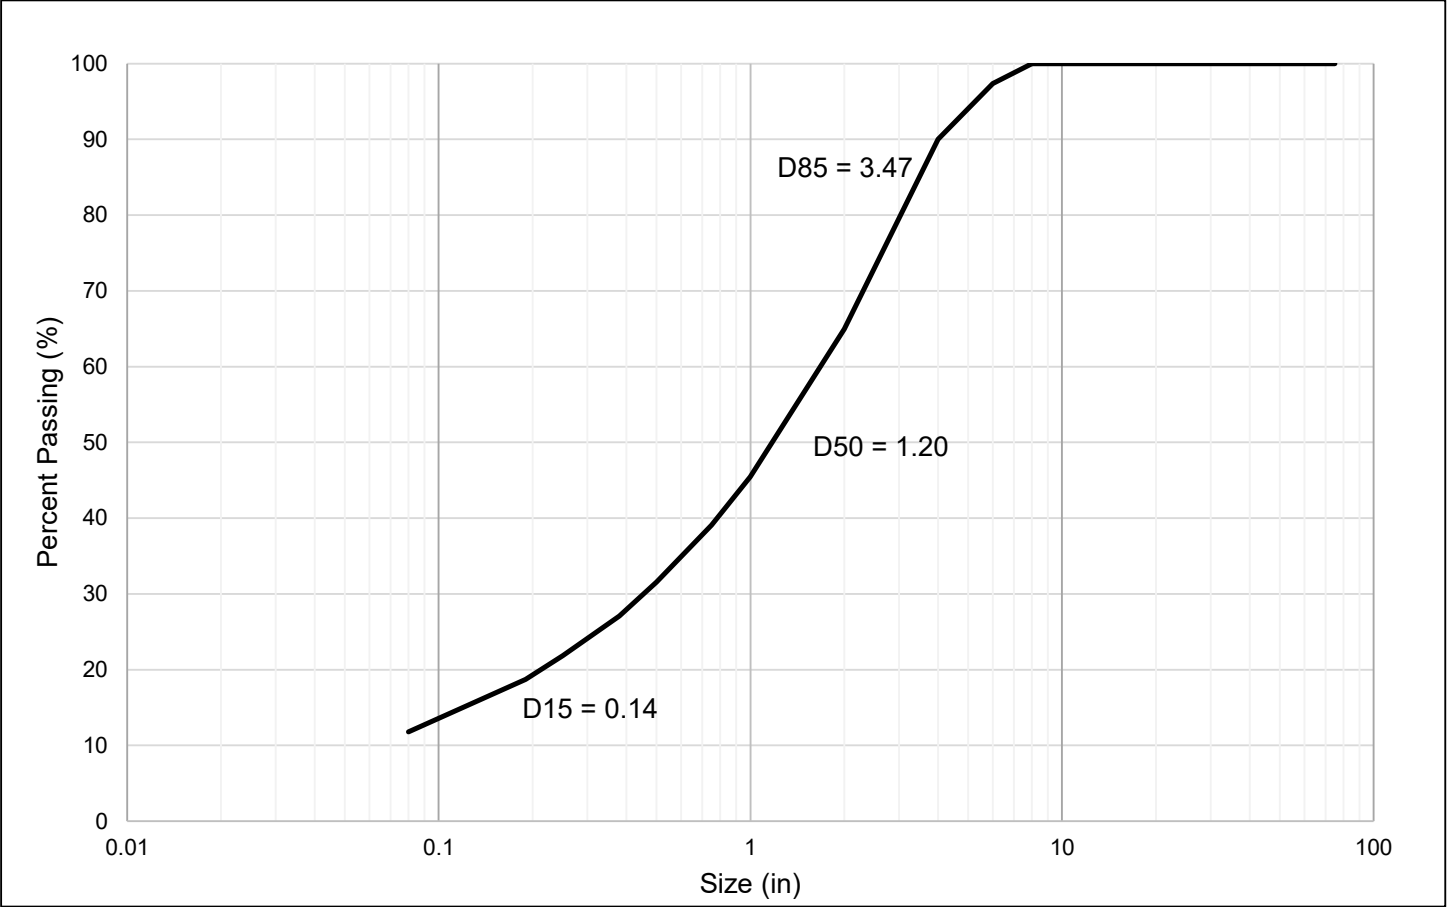
P/A NO. VA103-640/1		REF. NO. VA20-01037
	FIGURE C.17		REV A

Size[in]	% Passing
75	100.00
50	100.00
25	100.00
15	100.00
10	100.00
8	100.00
6	97.36
4	90.02
2	64.97
1	45.46
0.75	39.07
0.5	31.54
0.38	27.08
0.25	21.83
0.19	18.71
0.08	11.80

% Passing	Size[in]
F10	0.06
F20	0.21
F30	0.45
F40	0.78
F50	1.20
F60	1.73
F70	2.29
F80	2.94
F90	4.00
Topsized (99.95%)	7.53

- NOTES:**
- 1. SCALE BALL SIZE = 10"
 - 2. ANALYSIS CONDUCTED BY SPLIT ENGINEERING

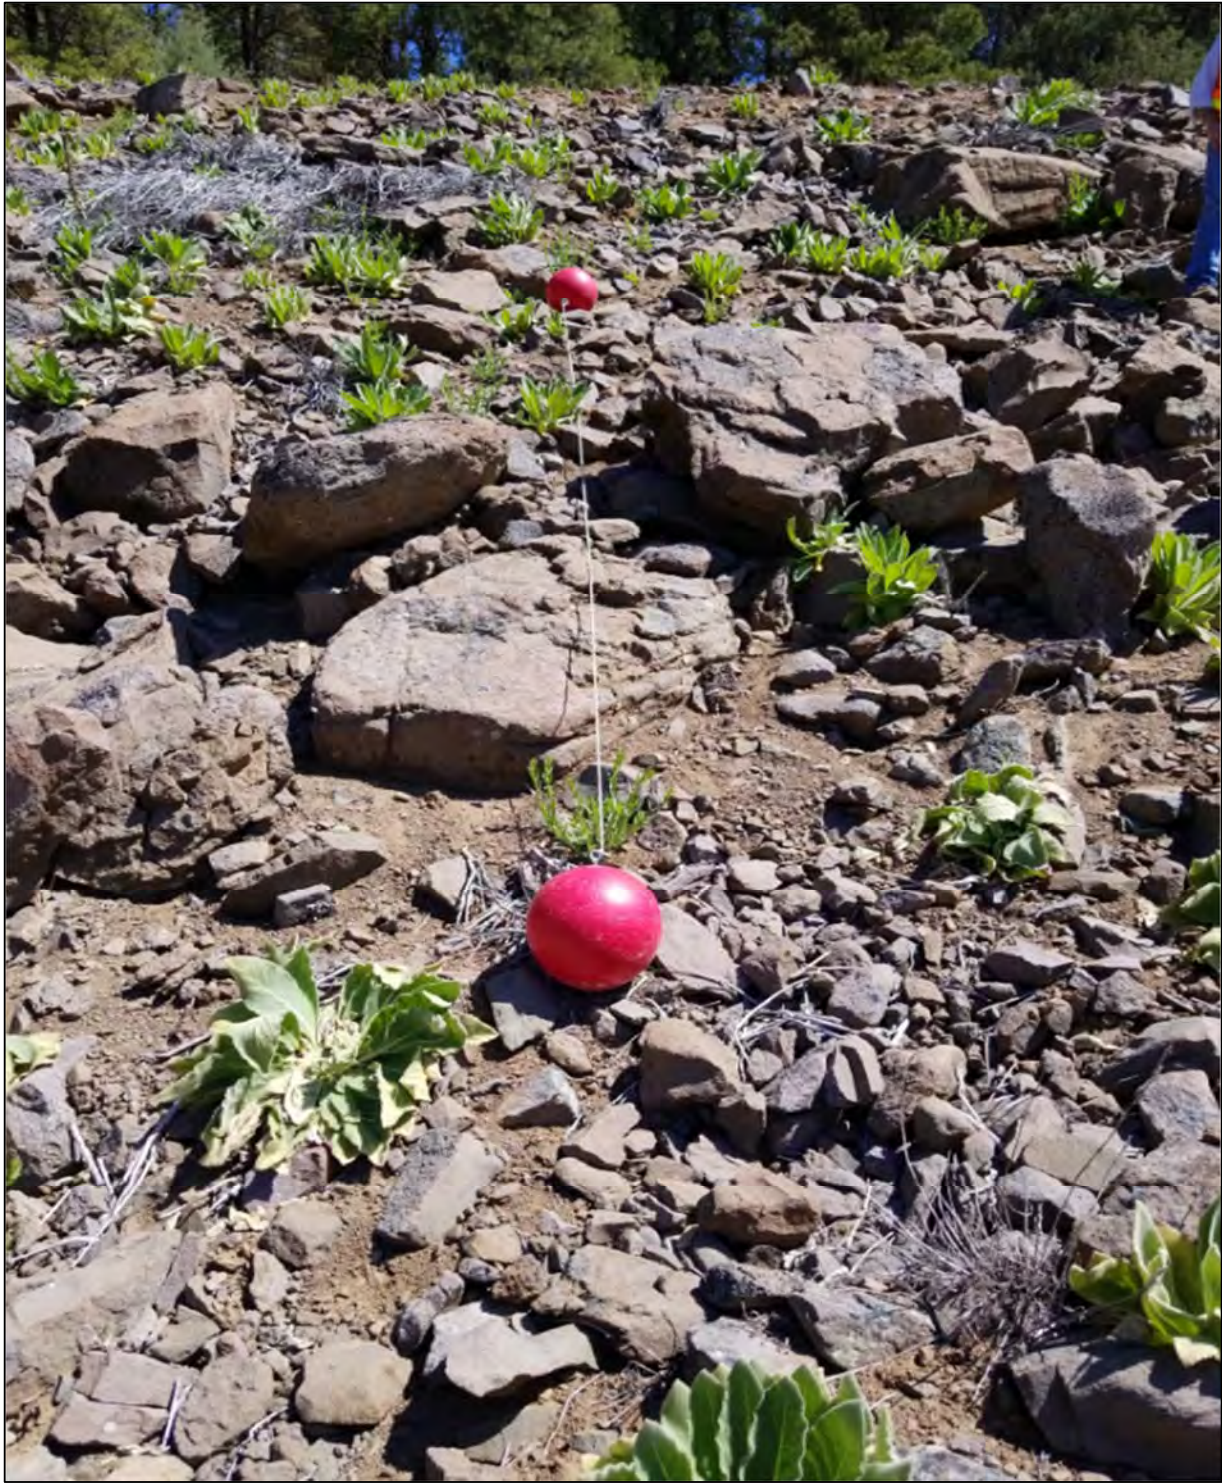
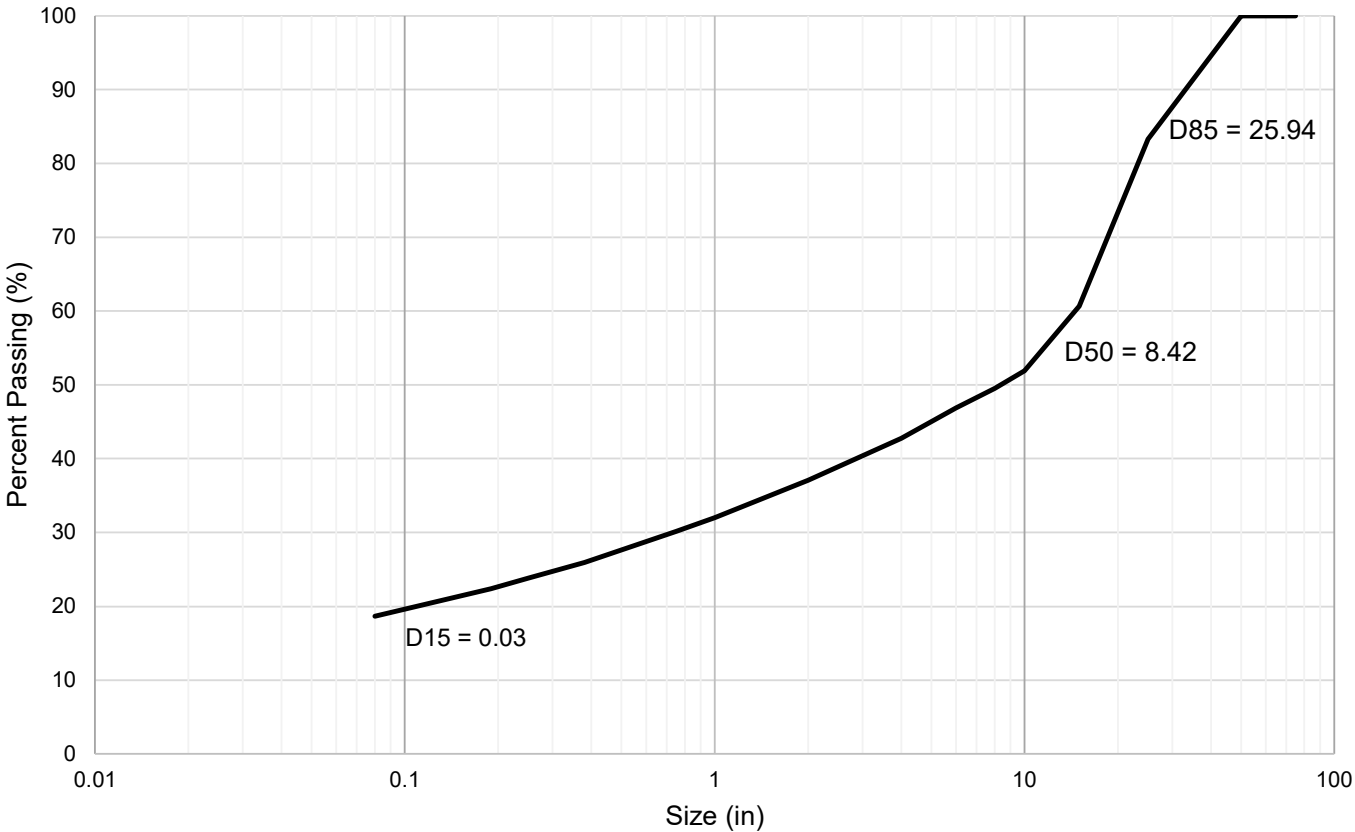
KIEWIT INFRASTRUCTURE WEST CO.			
KLAMATH RIVER RENEWAL PROJECT			
ONSITE BORROW SOURCE SITE INVESTIGATION SPILT-NET PARTICLE SIZE ANALYSIS RESULTS J.C. BOYLE DOWNSTREAM DAM - SUB-AREA 1 - 1			
Knight Piésold CONSULTING	P/A NO. VA103-640/1	REF. NO. VA20-01037	REV A
	FIGURE C.18

Size[in]	% Passing
75	100.00
50	100.00
25	83.27
15	60.67
10	51.91
8	49.51
6	46.88
4	42.74
2	37.07
1	32.01
0.75	30.11
0.5	27.62
0.38	25.98
0.25	23.83
0.19	22.41
0.08	18.67

% Passing	Size[in]
F10	0.01
F15	0.03
F20	0.11
F30	0.74
F40	2.92
F50	8.42
F60	14.68
F70	19.03
F80	23.40
F85	25.94
F90	29.26
Topsize (99.95%)	41.86

- NOTES:**
- 1. SCALE BALL SIZE = 10"
 - 2. ANALYSIS CONDUCTED BY SPLIT ENGINEERING

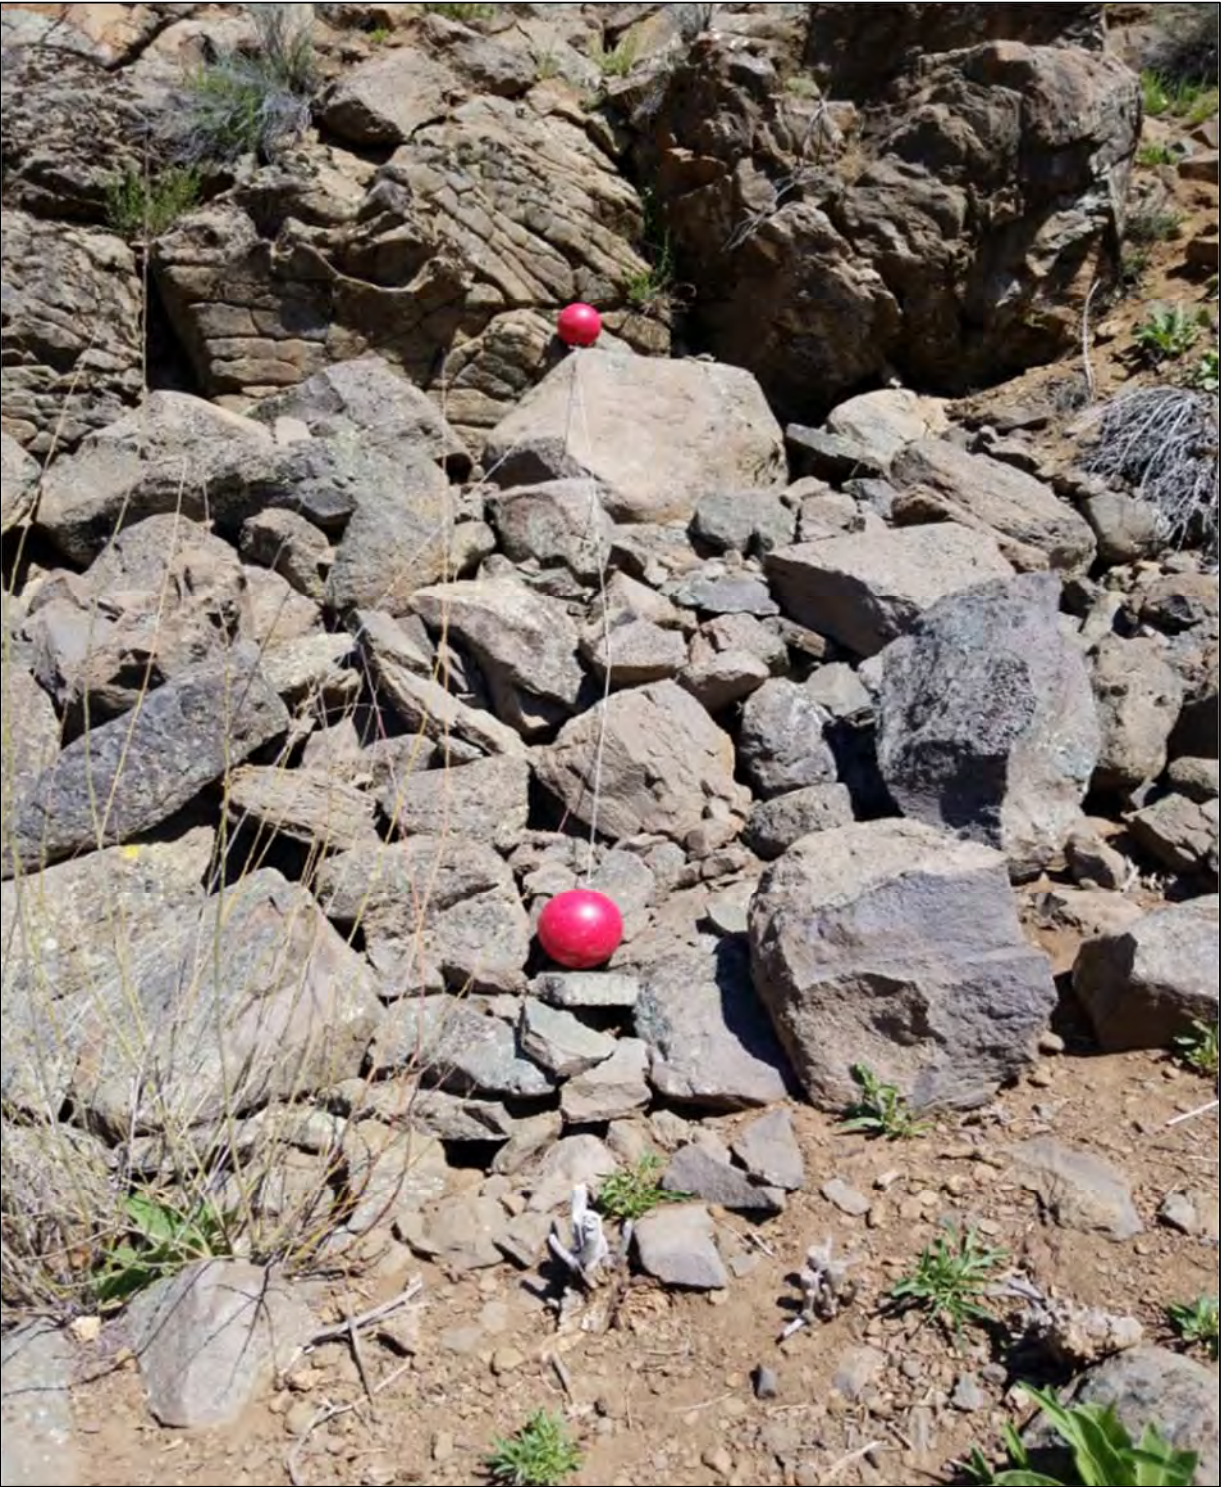
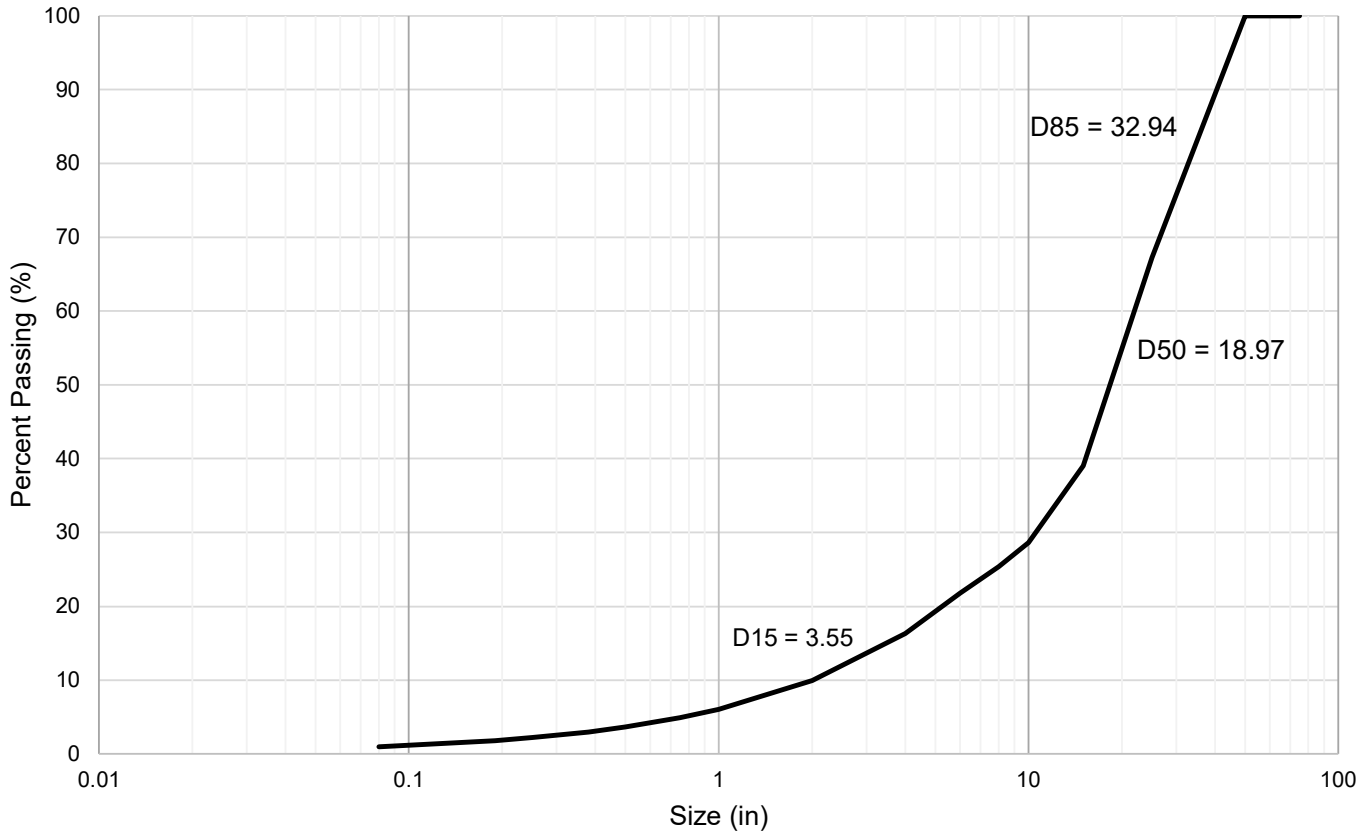
P/A NO. VA103-640/1		REF. NO. VA20-01037
	FIGURE C.19		REV A

Size[in]	% Passing
75	100.00
50	100.00
25	67.26
15	39.01
10	28.62
8	25.42
6	21.81
4	16.33
2	9.95
1	6.06
0.75	4.93
0.5	3.68
0.38	2.99
0.25	2.23
0.19	1.81
0.08	0.97

% Passing	Size[in]
F10	2.01
F15	3.55
F20	5.31
F30	10.78
F40	15.40
F50	18.97
F60	22.40
F70	26.04
F80	30.29
F85	32.94
F90	36.04
Topsize (99.95%)	48.90

- NOTES:**
- 1. SCALE BALL SIZE = 10"
 - 2. ANALYSIS CONDUCTED BY SPLIT ENGINEERING

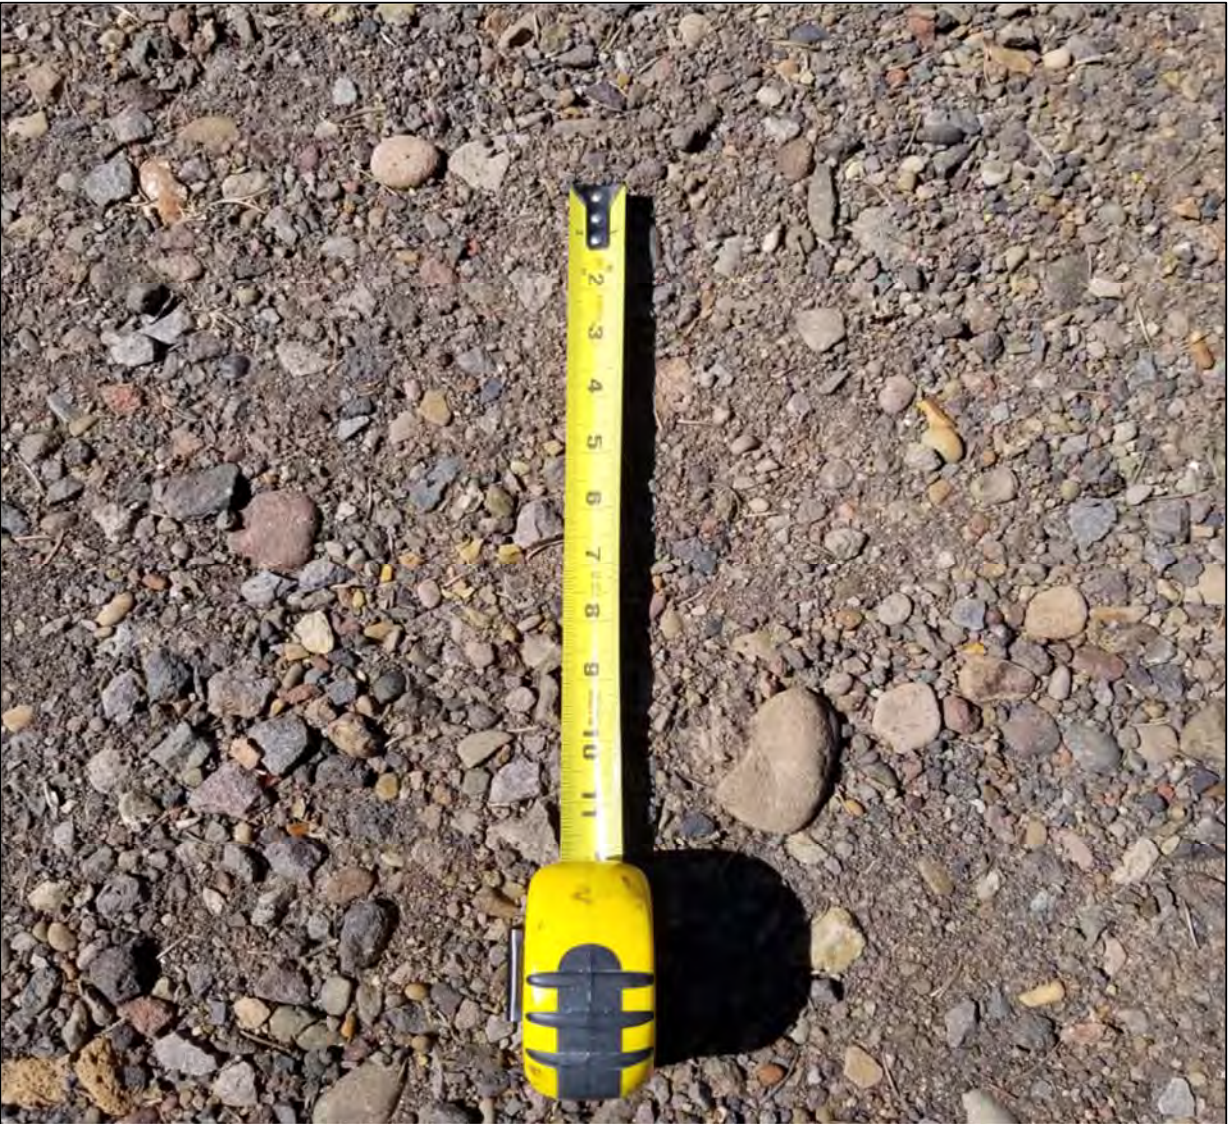
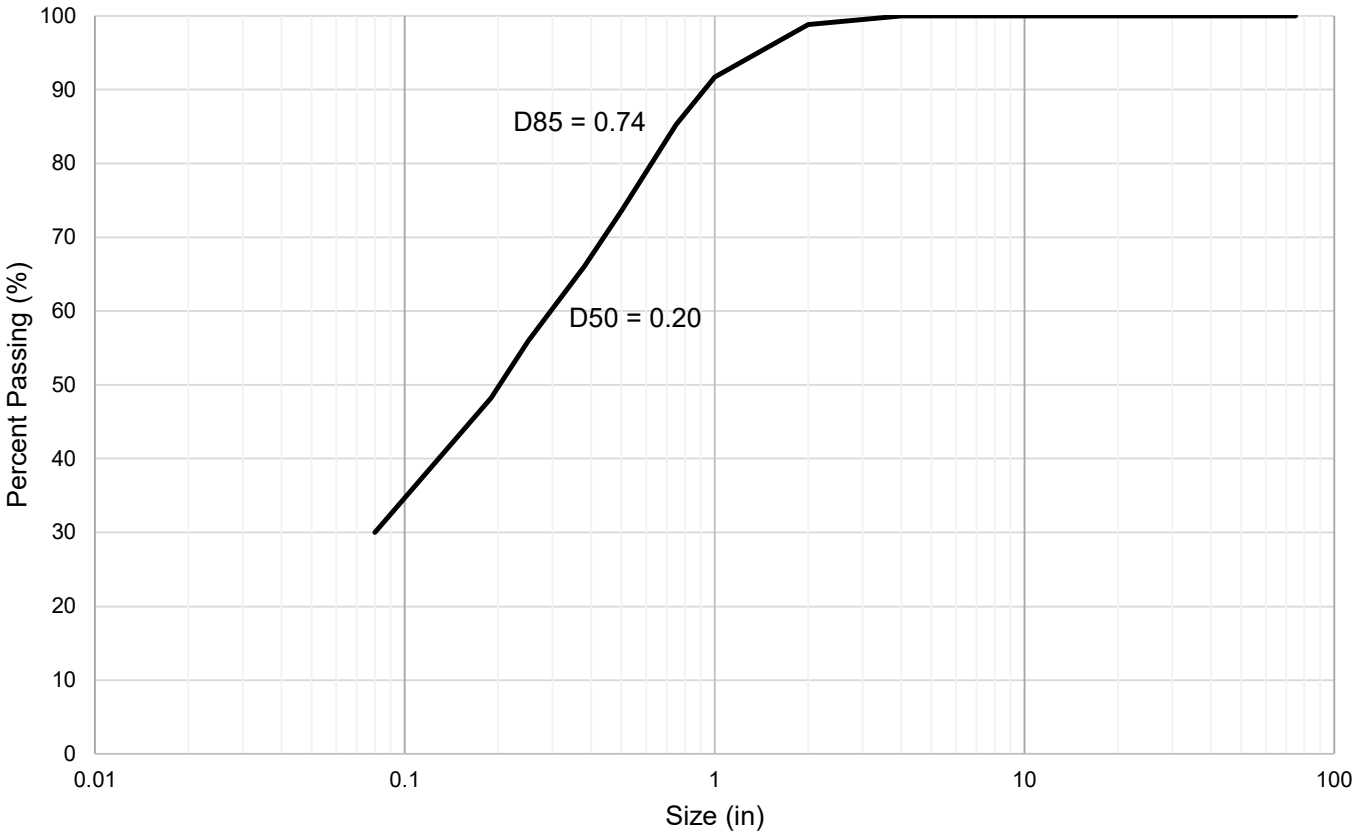
Size[in]	% Passing
75	100.00
50	100.00
25	100.00
15	100.00
10	100.00
8	100.00
6	100.00
4	100.00
2	98.83
1	91.72
0.75	85.23
0.5	73.52
0.38	66.08
0.25	55.91
0.19	48.19
0.08	30.01

% Passing	Size[in]
F10	0.01
F15	0.02
F20	0.04
F30	0.08
F40	0.13
F50	0.20
F60	0.29
F70	0.44
F80	0.62
F85	0.74
F90	0.91
Topsize (99.95%)	2.29

- NOTES:**
- 1. STANDARD TAPE MEASURE FOR SCALE
 - 2. ANALYSIS CONDUCTED BY SPLIT ENGINEERING

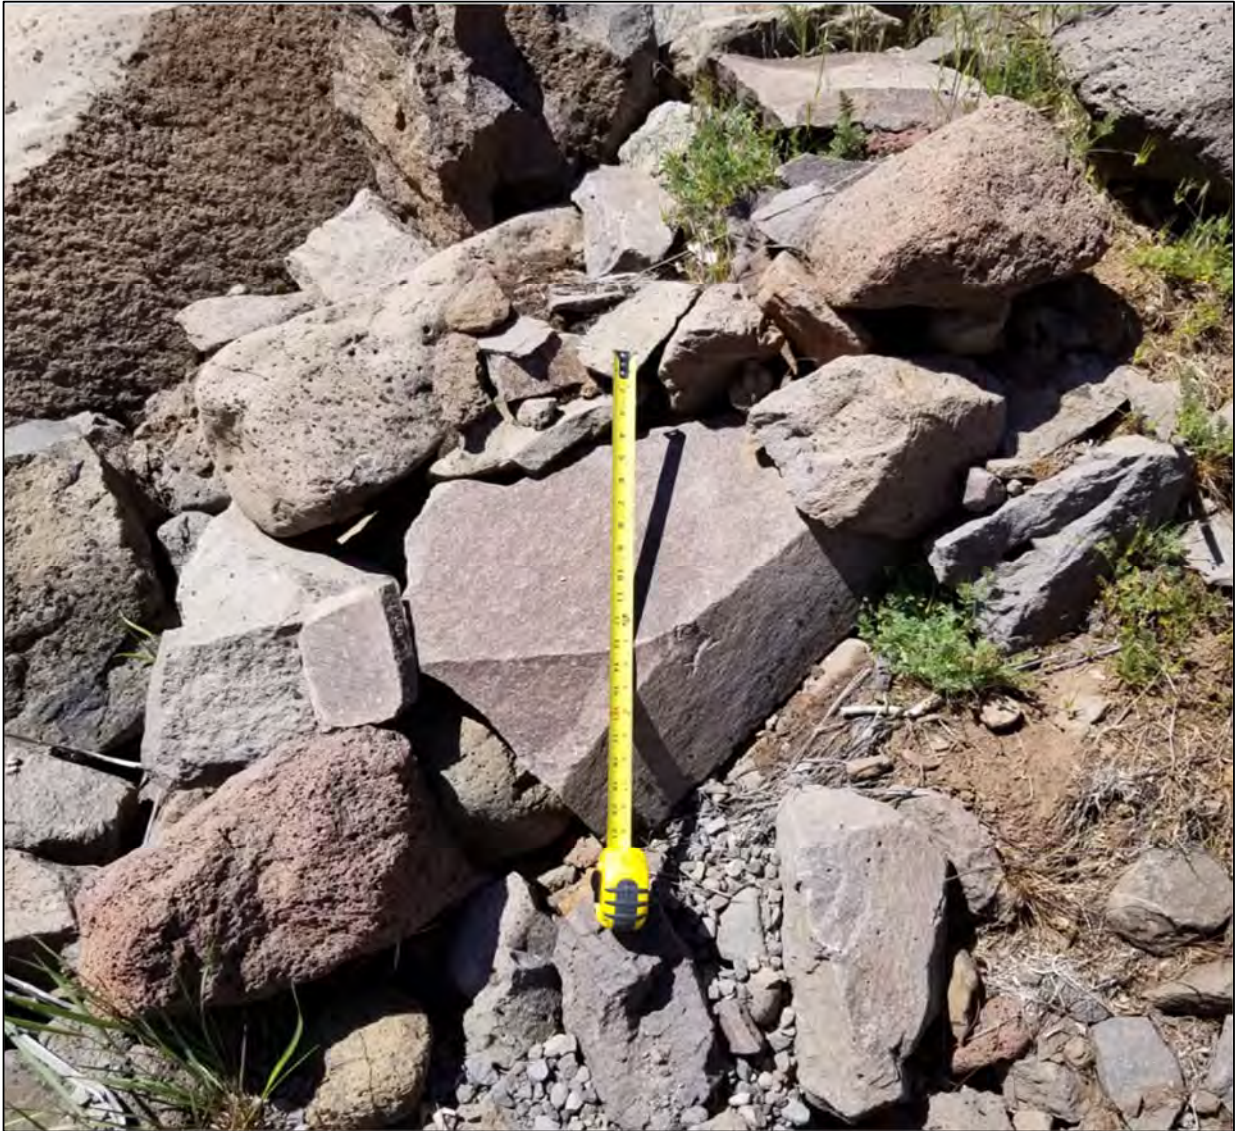
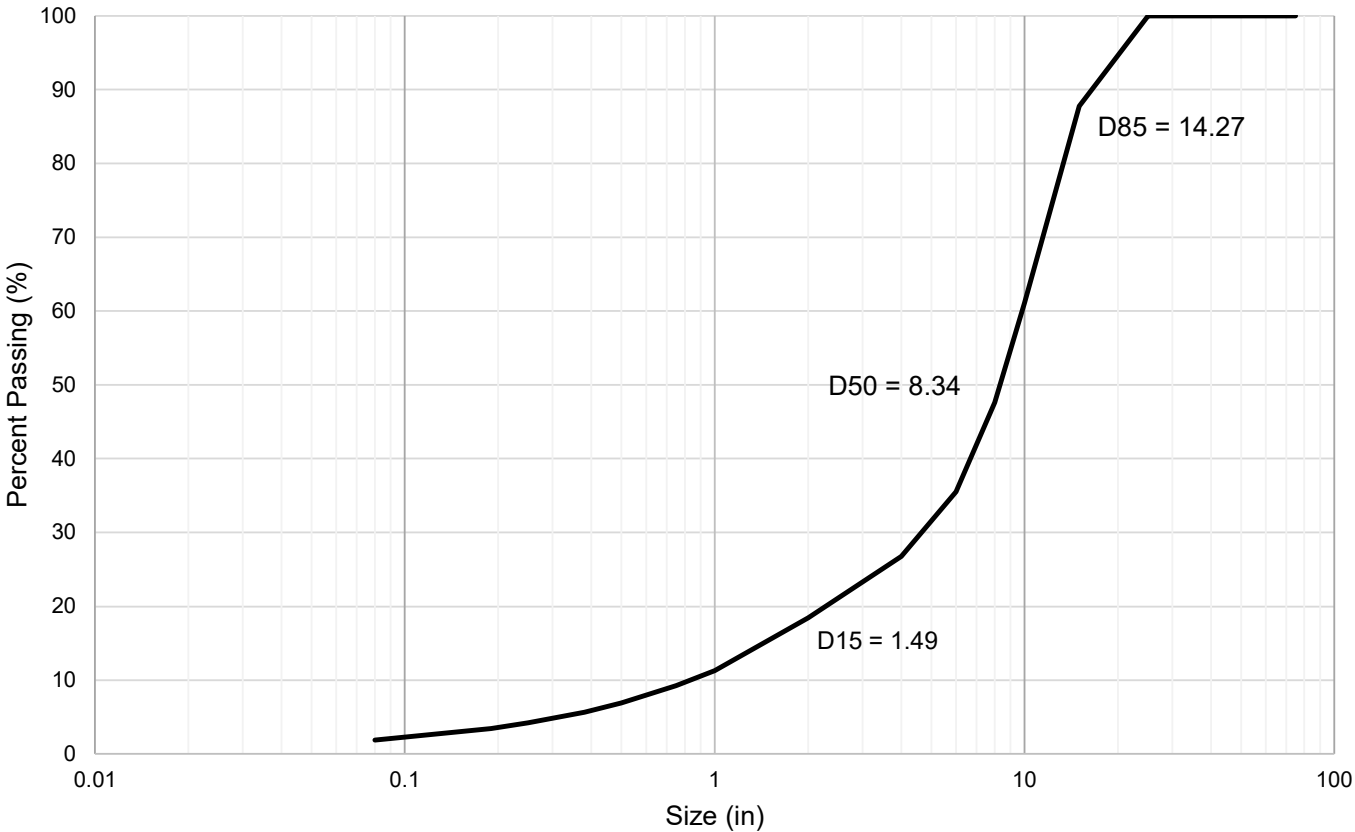
FIGURE C.21

Size[in]	% Passing
75	100.00
50	100.00
25	100.00
15	87.77
10	61.07
8	47.62
6	35.50
4	26.74
2	18.44
1	11.32
0.75	9.25
0.5	6.94
0.38	5.67
0.25	4.25
0.19	3.46
0.08	1.87

% Passing	Size[in]
F10	0.84
F15	1.49
F20	2.25
F30	4.82
F40	6.83
F50	8.34
F60	9.84
F70	11.37
F80	13.17
F85	14.27
F90	15.61
Topsize (99.95%)	19.28

- NOTES:**
- 1. STANDARD TAPE MEASURE FOR SCALE
 - 2. ANALYSIS CONDUCTED BY SPLIT ENGINEERING

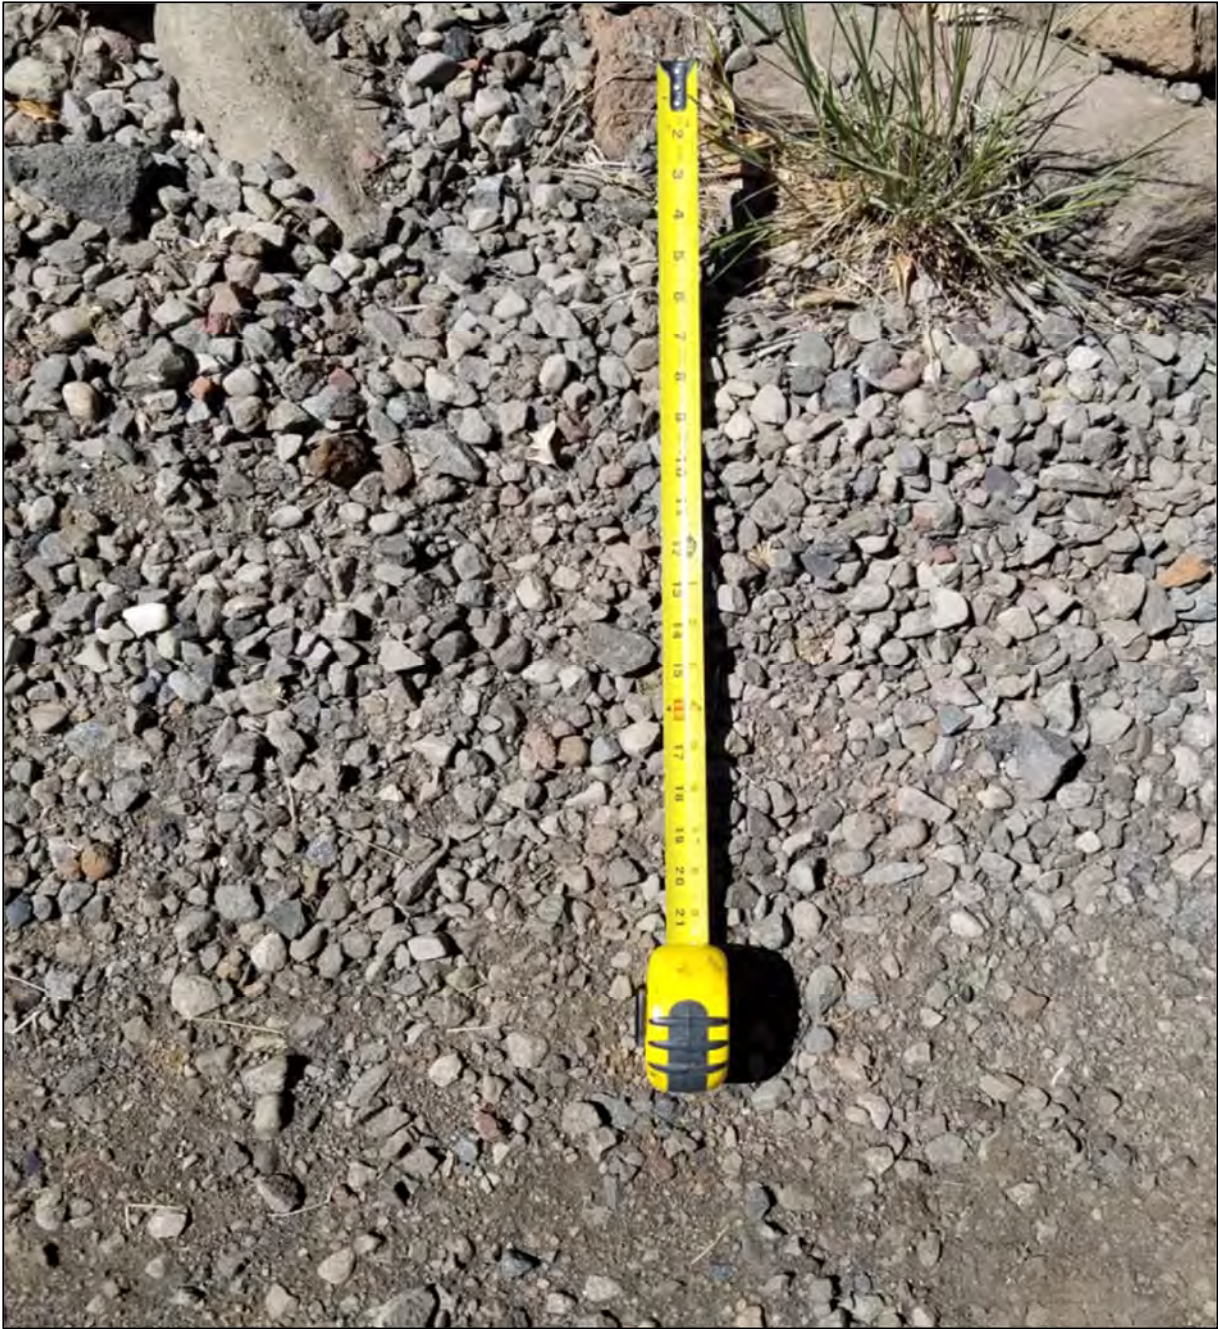
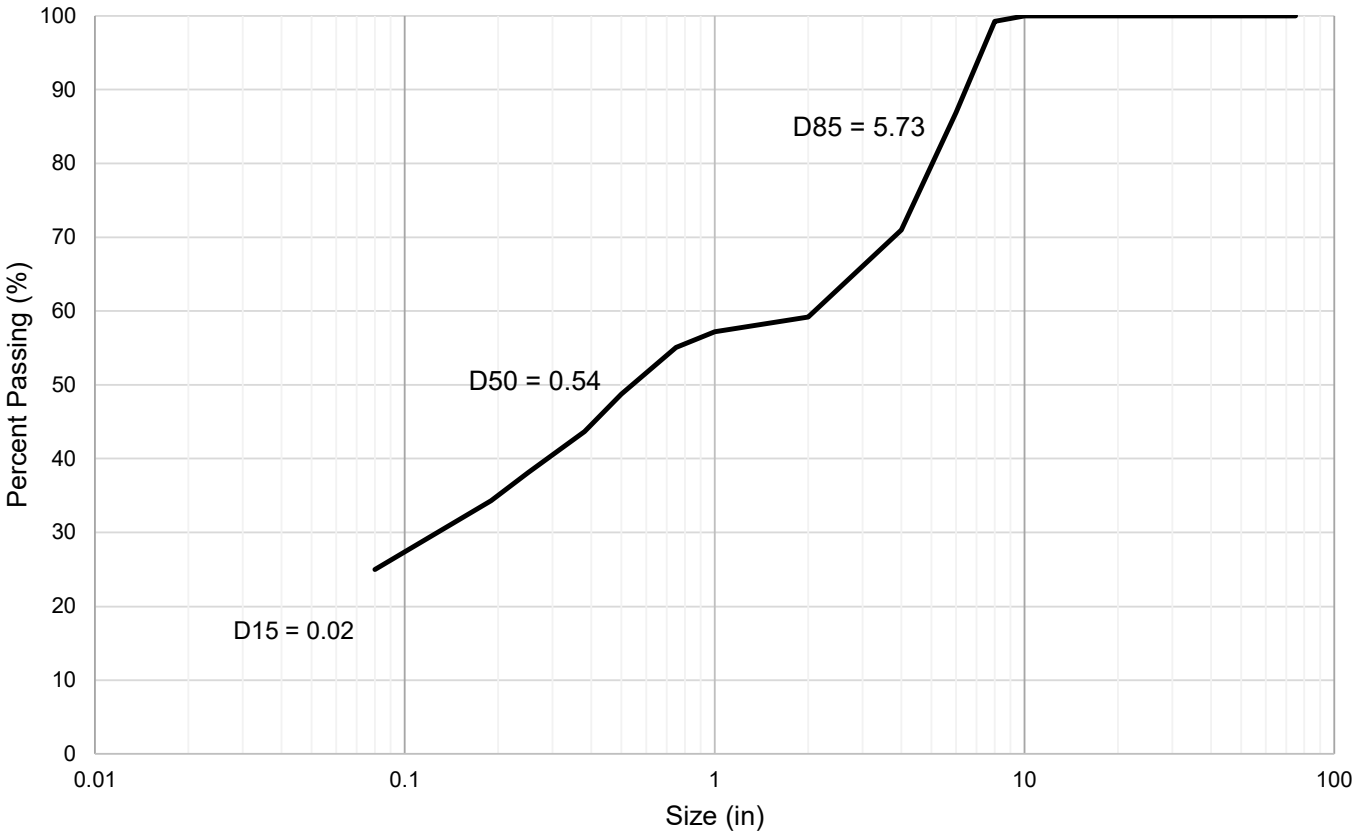
Size[in]	% Passing
75	100.00
50	100.00
25	100.00
15	100.00
10	100.00
8	99.26
6	86.90
4	70.98
2	59.18
1	57.19
0.75	55.04
0.5	48.72
0.38	43.64
0.25	38.11
0.19	34.29
0.08	25.01

% Passing	Size[in]
F10	0.01
F15	0.02
F20	0.04
F30	0.13
F40	0.29
F50	0.54
F60	2.23
F70	3.89
F80	5.03
F85	5.73
F90	6.45
Topsize (99.95%)	8.14

- NOTES:**
- 1. STANDARD TAPE MEASURE FOR SCALE
 - 2. ANALYSIS CONDUCTED BY SPLIT ENGINEERING
