RE: KRRP Value Engineering Summary and Advancement to 90% Design

KP was tasked with leading seven VE analyses, which are listed below and described in the following sections of this letter:

VE-1 Submittals: Drawdown Model and Assessment

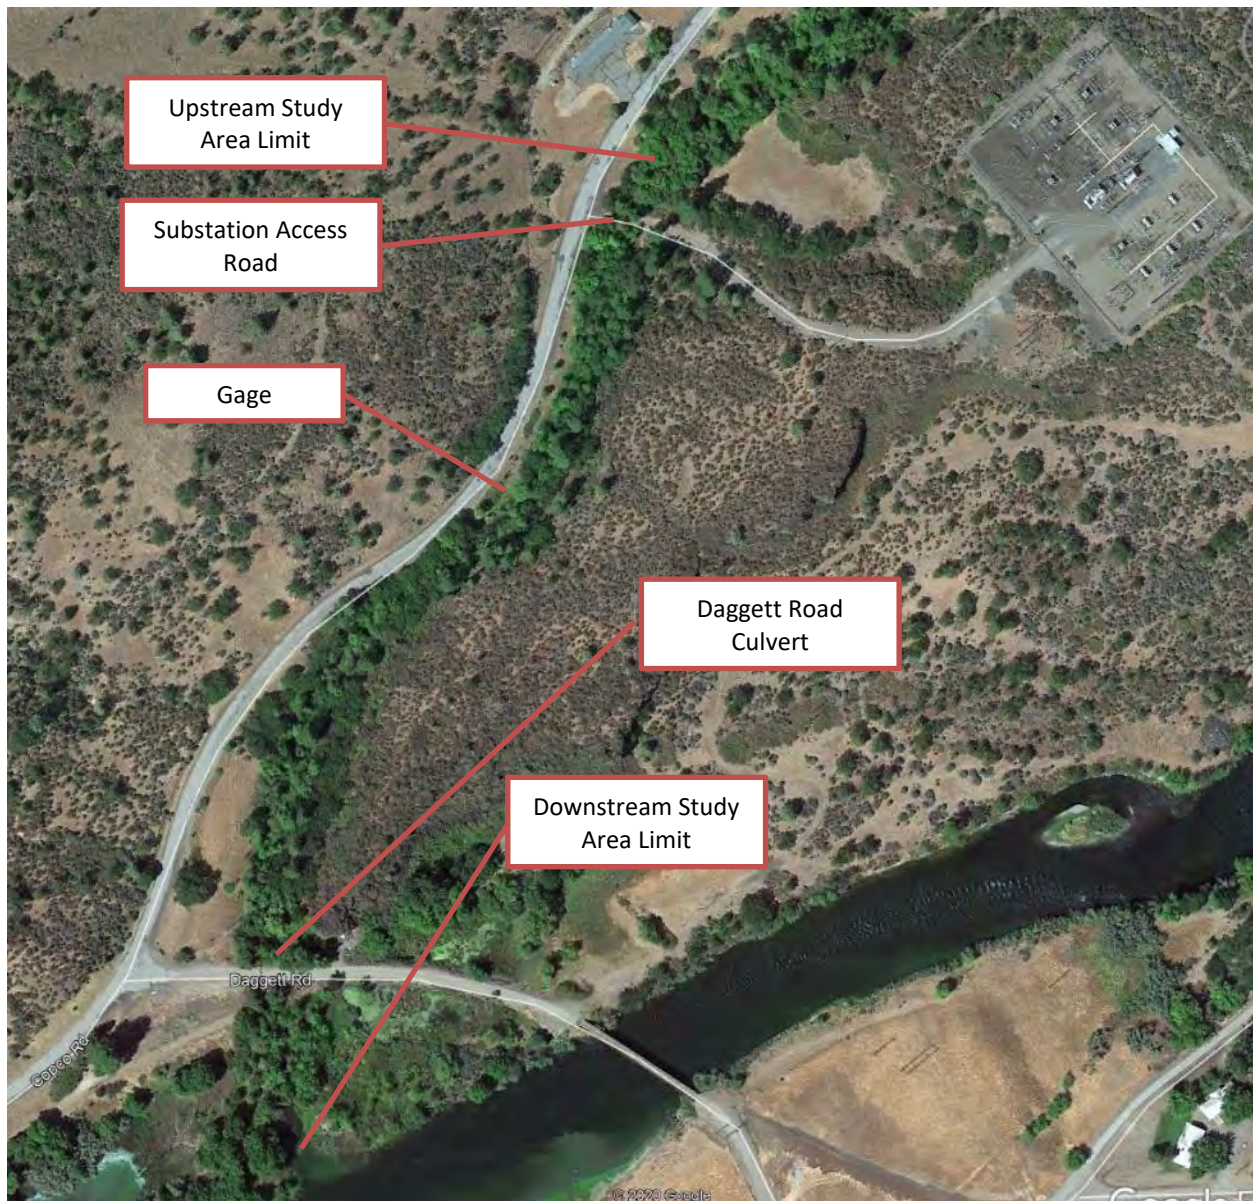
Figure 1. Study Reach

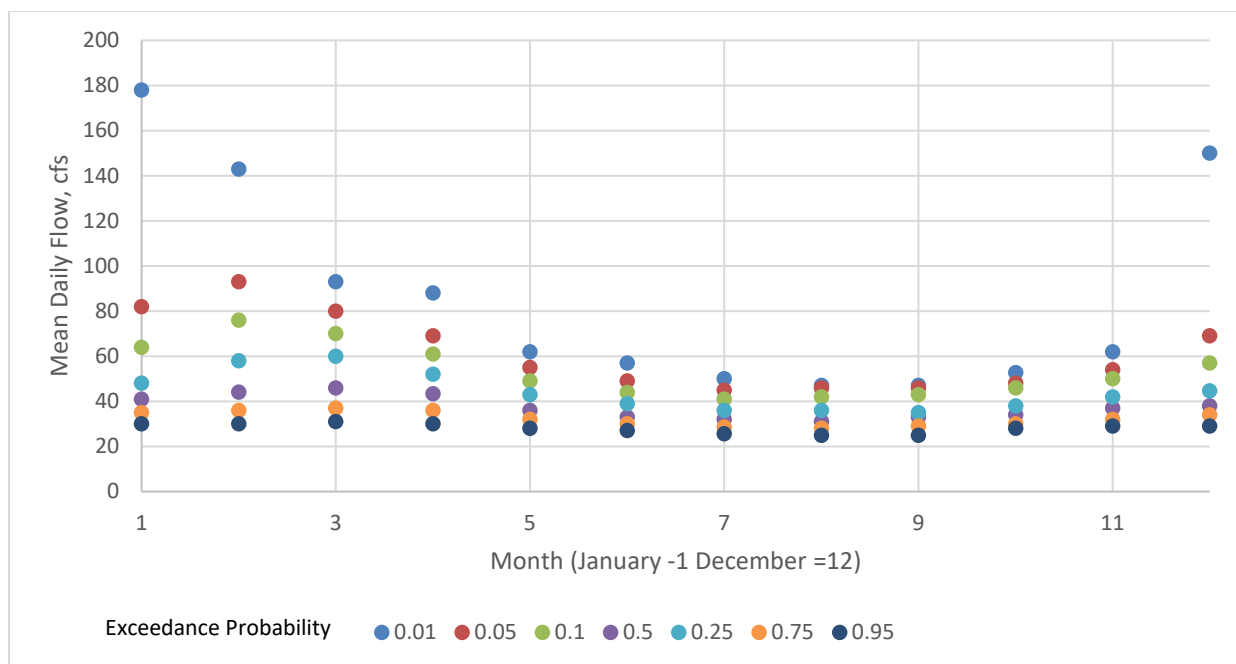
Figure 2. Mean Daily Flow Duration Quantiles for Fall Creek Calculated by Month

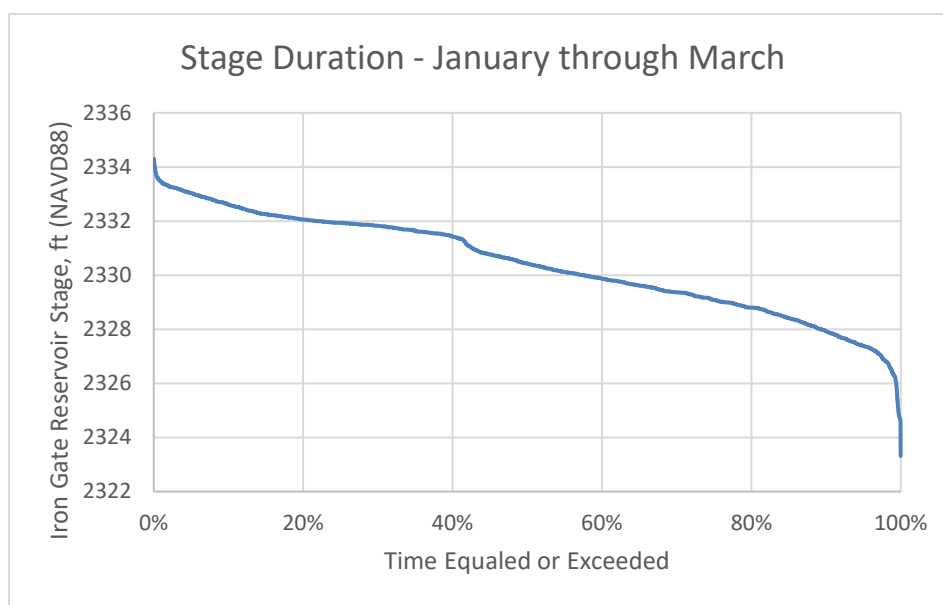
Figure 3. Iron Gate Reservoir Stage Duration Curve

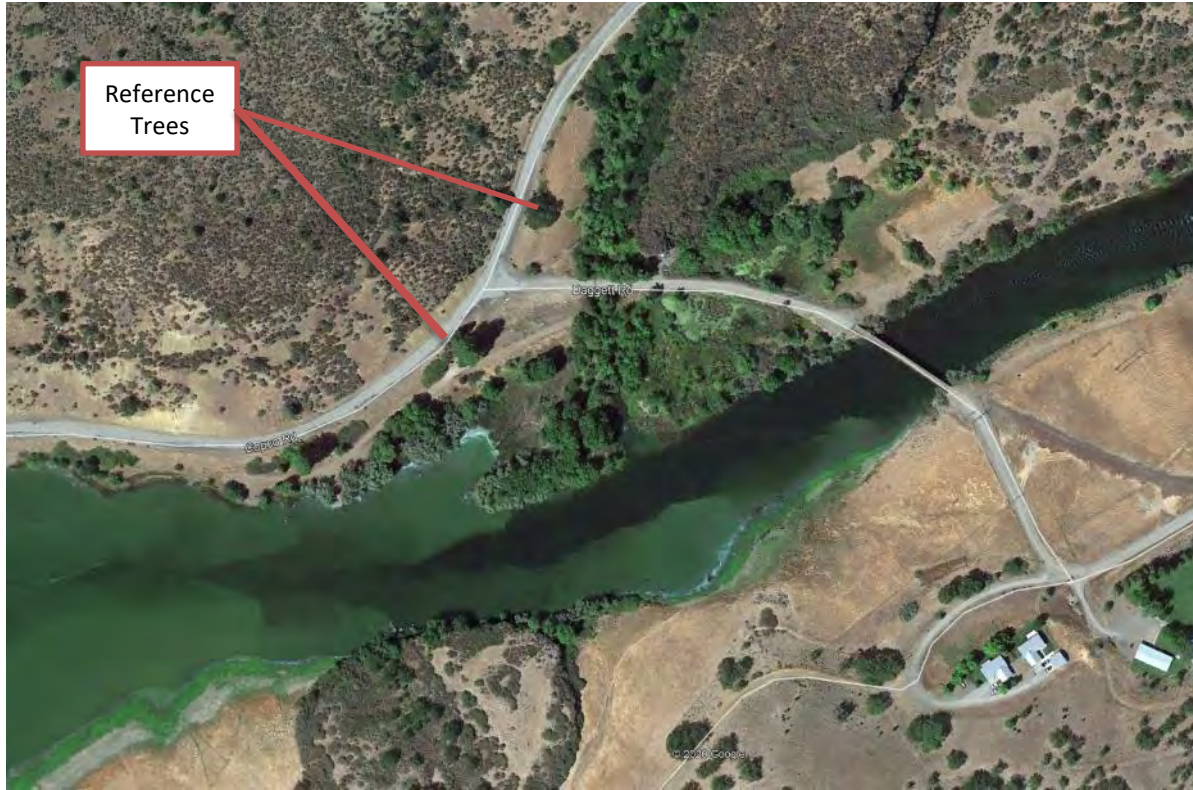
Figure 4. Google Earth Imagery, Date 2019.08.23

Review of field surveyed topographic data shows the average slope from downstream of Daggett Road crossing to upstream of the Substation Access Road crossing is about 0.028 ft/ft. NHC observed local slopes within instream geomorphic units near 8 percent (0.08 ft/ft) within this reach. LiDAR and bathymetric data suggest the average stream slope between the Daggett Road crossing and the post dam confluence elevation with the Klamath River will range from about 0.03 to 0.05 ft/ft. Aerial images are provided of the confluence in 2019 (Figure 4) and in 1955 (Figure 5), prior to dam construction.

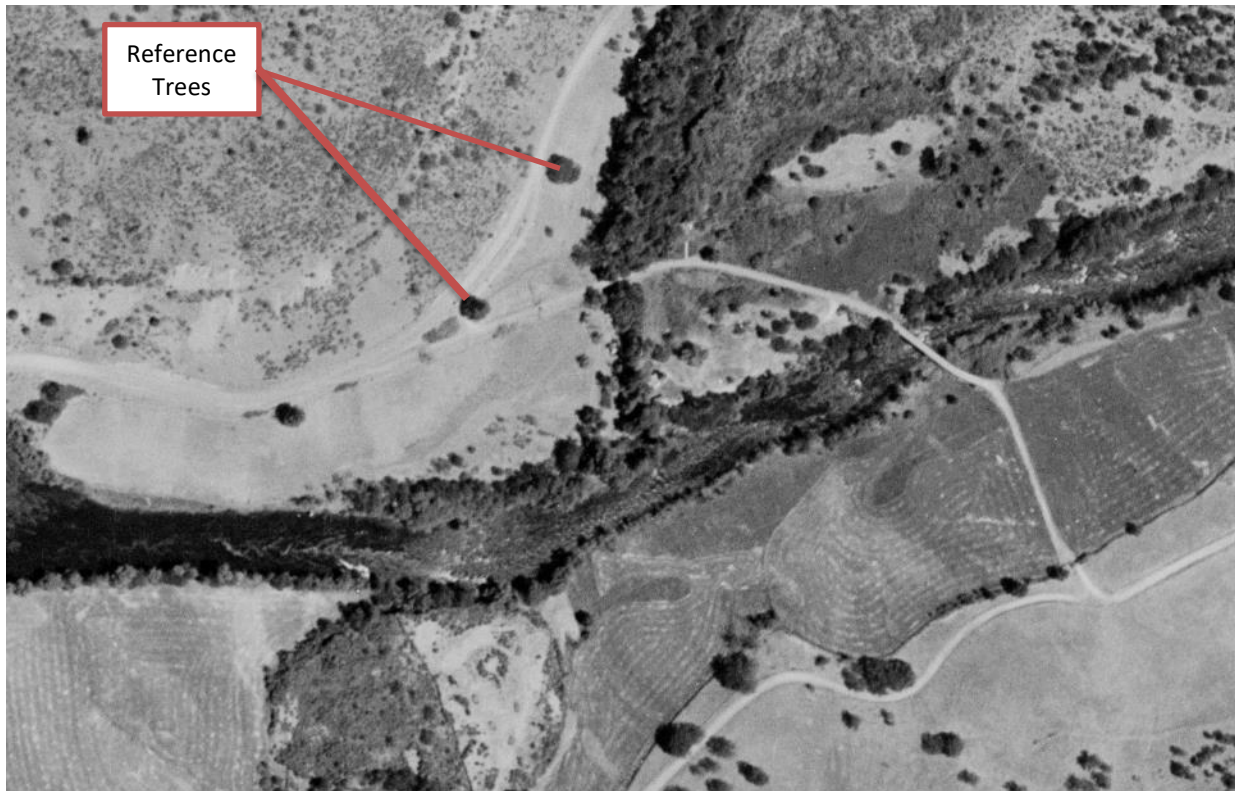
Figure 5. 1955 Pre-Iron Gate Dam

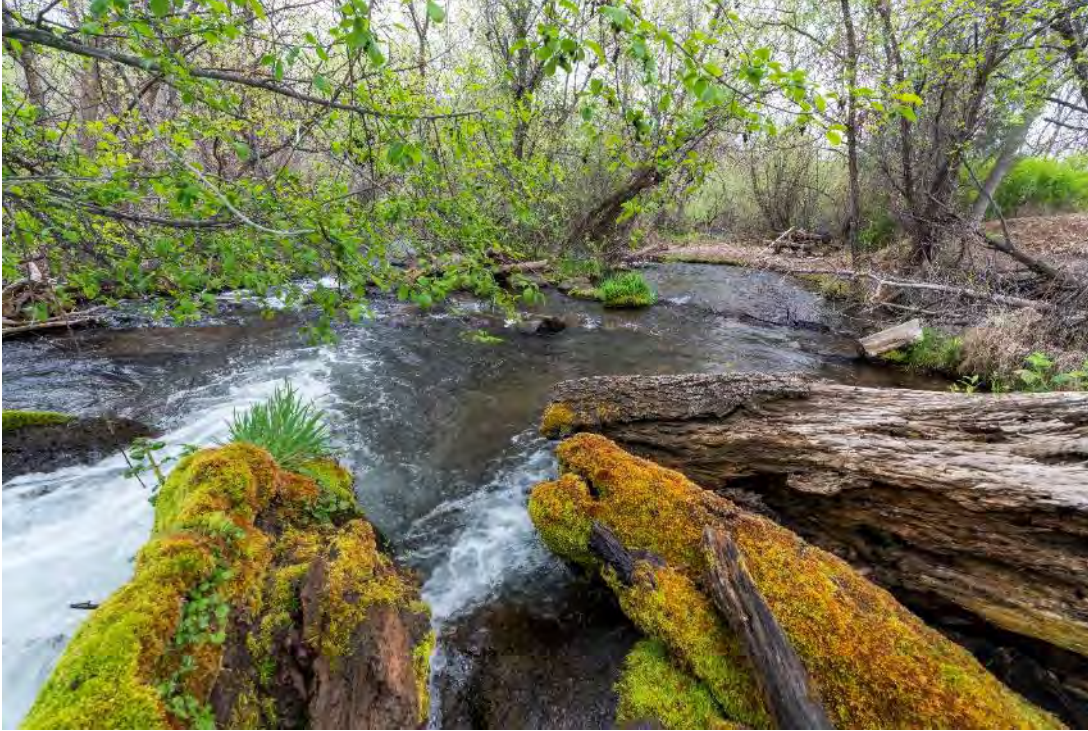
Image 3. Looking downstream of Daggett Culvert

The Daggett Road Culvert slopes at about 4.3 percent (0.043 ft/ft). Flows within the culvert are supercritical and the outlet is perched. During low flows, the hydraulic drop at the culvert outlet is about 18 inches. This drop likely increases during higher flows. These hydraulic/geometric factors could create conditions that are likely to be a complete barrier to juvenile and adult salmonids. Channel conditions near the culvert are shown in Image 3 through Image 7. The active channel width ranges from about 15 to 25 feet near the crossing (Image 8).

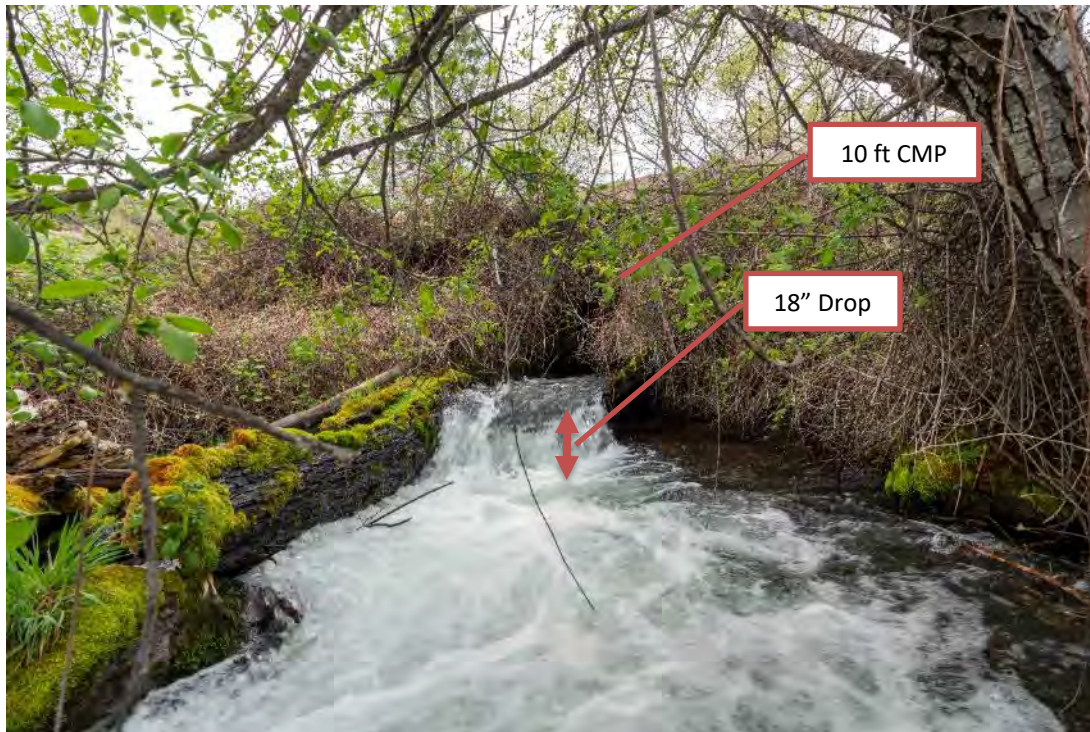
Image 4. Looking upstream at Daggett Culvert outlet

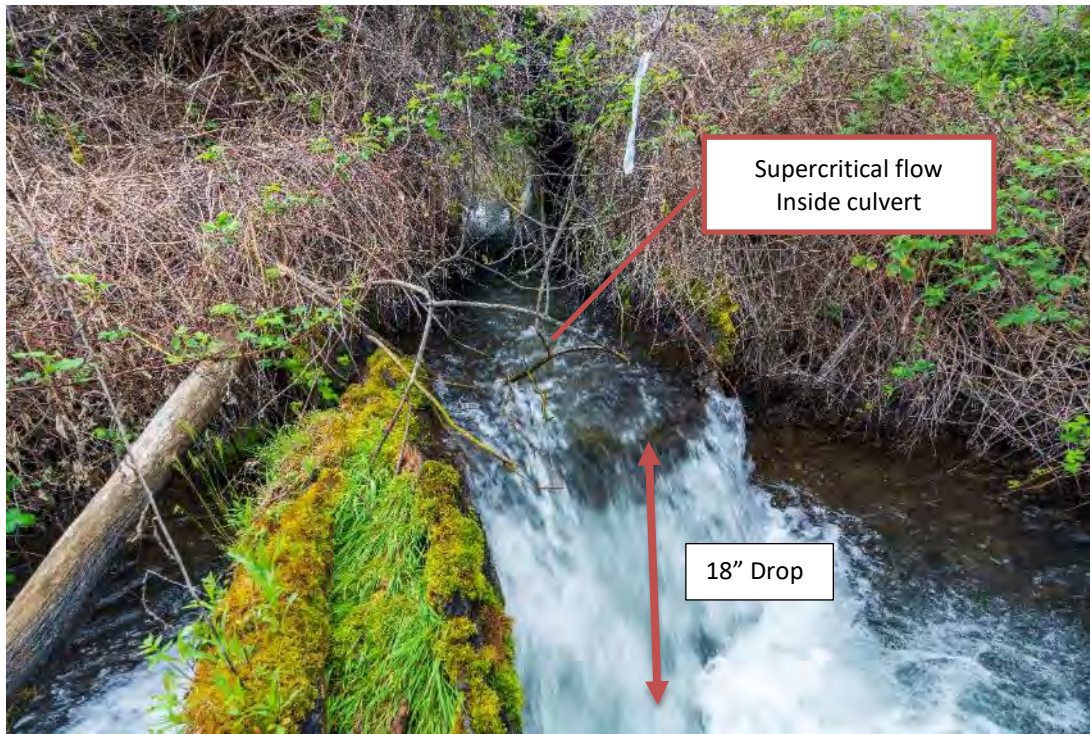
Image 5. Looking upstream at Daggett Road Culvert

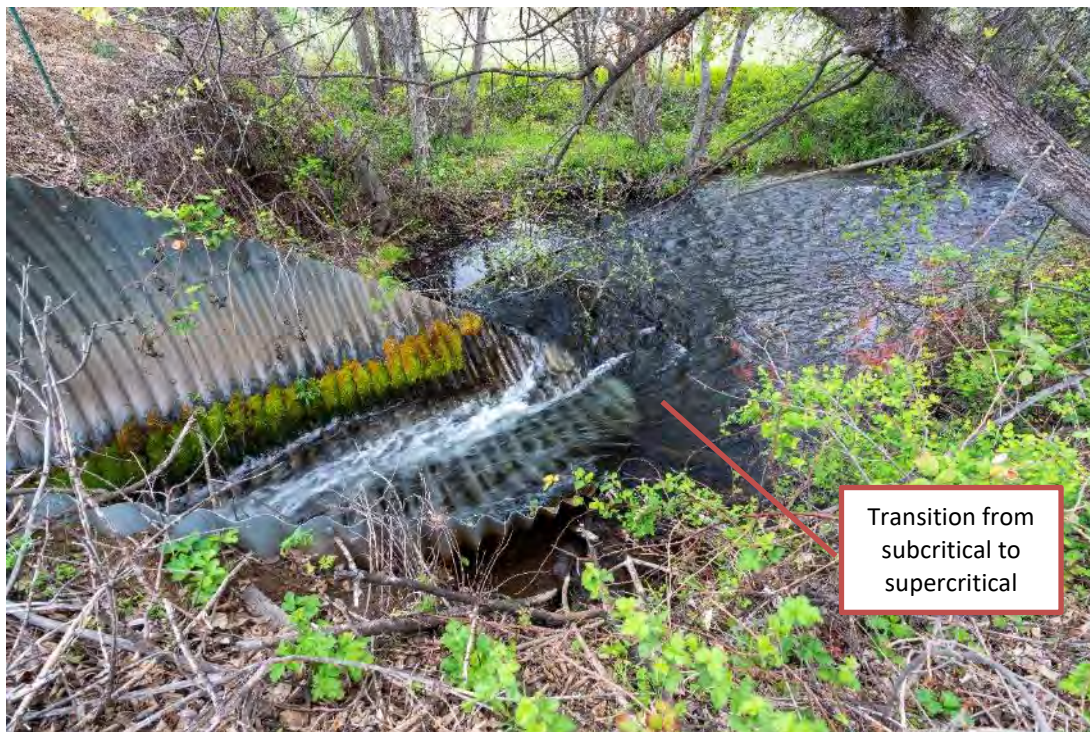
Image 6. Daggett Road Culvert Inlet

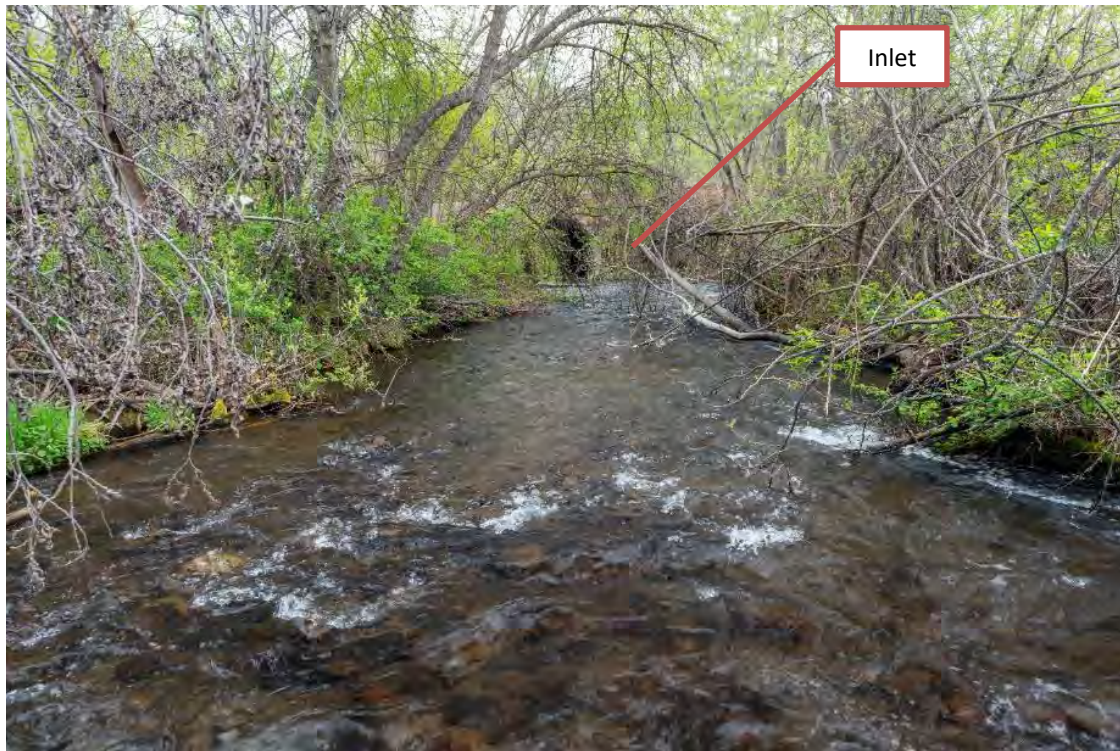
Image 7. View of Daggett Road Culvert Inlet

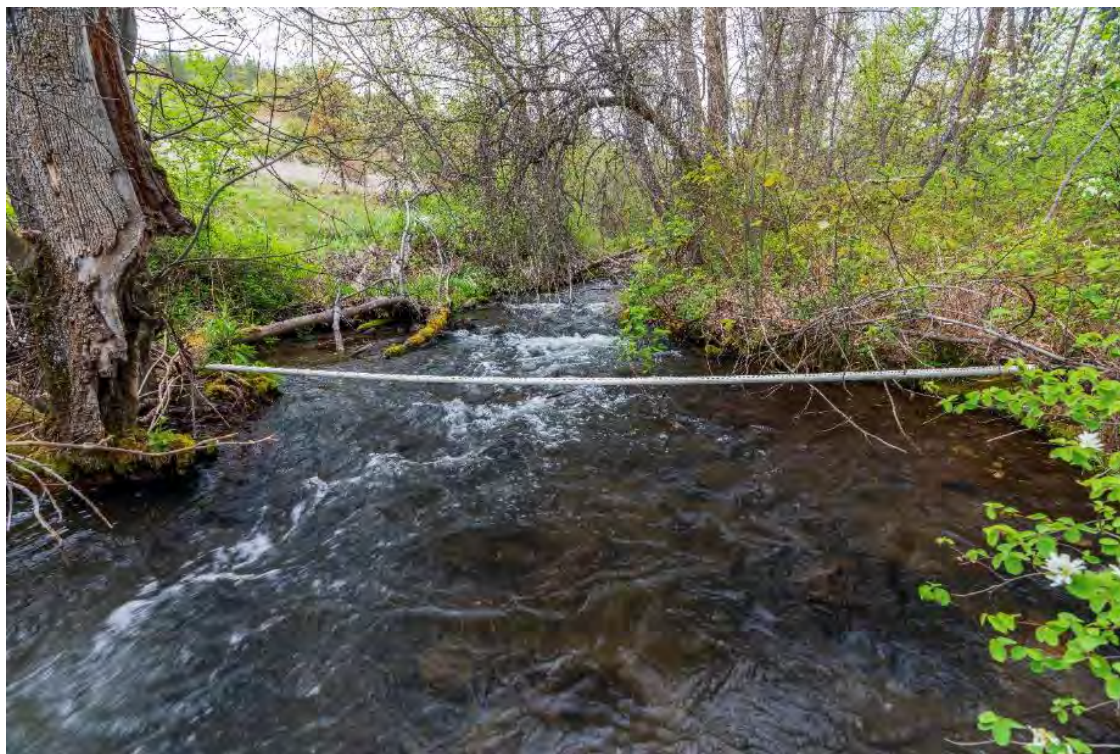
Image 8. Channel Upstream of Daggett Road (Wetted channel about 14 ft wide; Active channel about 18 ft wide)

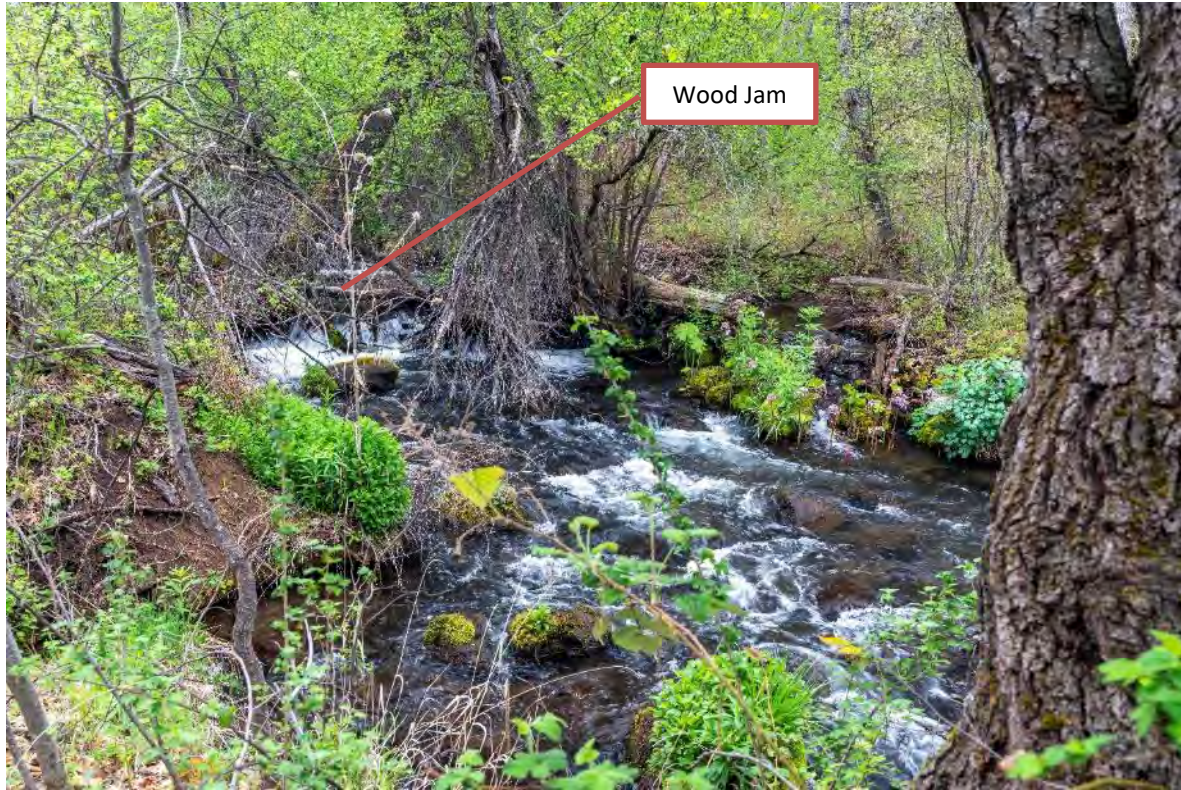
Image 9. Self-formed Wood Jam

The creek becomes confined upstream of Daggett Road as the natural valley slopes converge constricting the channel. Valley bottom confinement increases as road construction further encroaches on the stream corridor. Several wood jams exist within this reach (Image 9). The creek morphology consists of a cascade (Image 10 and Image 11) and a series of step pools (Image 12 and Image 13). Channel widths are highly constrained in this reach (Image 14). However, isolated floodplain pockets consisting of dense vegetation growing on talus and debris exist. These channel units are relatively stable. Adjustment likely only occurs during extreme flood flows or during moderate to high flows shortly after rock slides or boulder detachment from the basalt flow. Bed material ranges from boulder, to cobbles with some gravel.

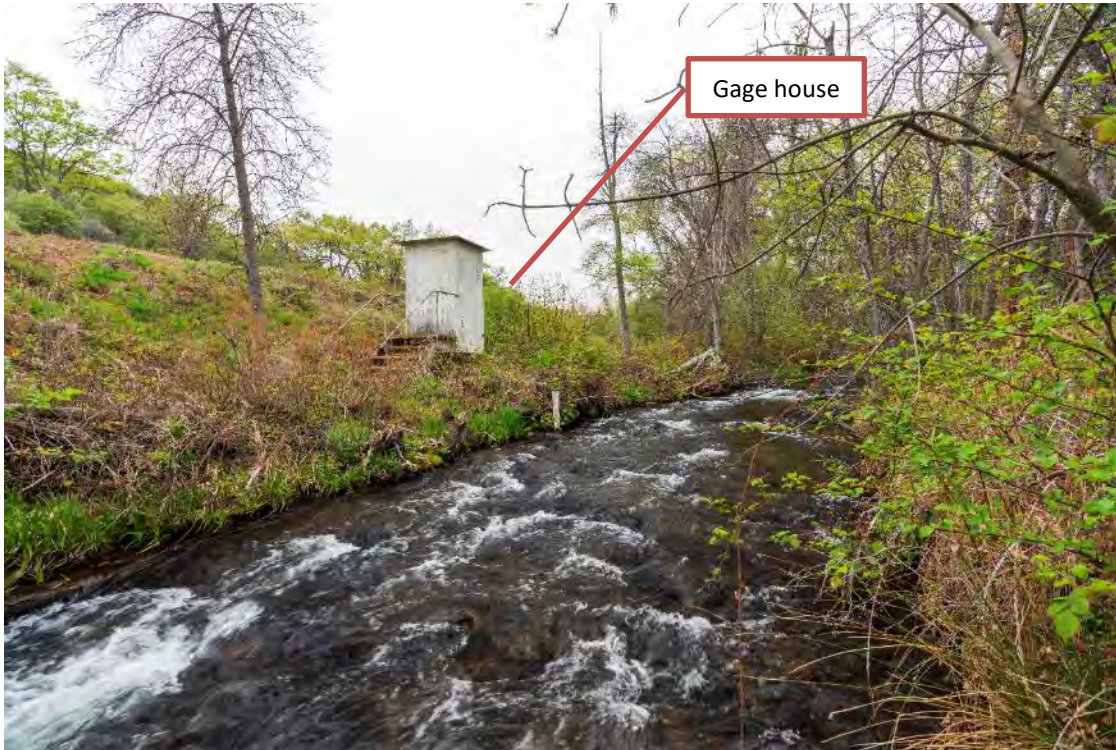
Image 16. Riffle near gage location looking upstream

The creek slope appears to lessen upstream of the gorge from the USGS gage to upstream of the Substation Access Road Bridge (Image 16 and Image 17). Upstream of the USGS gage, the active channel bifurcates forming two channels separated by a vegetated island. Debris jams span both channels near the island head (Image 18). The two channels converge into one, about 100 feet downstream of the bridge. The wetted channel width ranged from 15 to 18 feet and the active channel width appeared to range from about 18 to 22 feet (Image 19, Image 20, and Image 21). The wetted channel width beneath the bridge is about 15 feet and the active channel width is about 20 feet (Image 22). On the east side (river left), an alder tree downstream of the bridge and a cluster of trees upstream of the bridge influence the hydraulics through the bridge. The left channel bank beneath the bridge is comprised of erosion resistant clay. Rock slope protection and tree roots stabilize the right bank beneath the bridge (Image 23). Review of the bank material and vegetation along the banks did not suggest that measurable incision or bank erosion near the bridge has occurred over the last several decades. Active channel widths upstream of the bridge range from about 18 feet to about 25 feet.

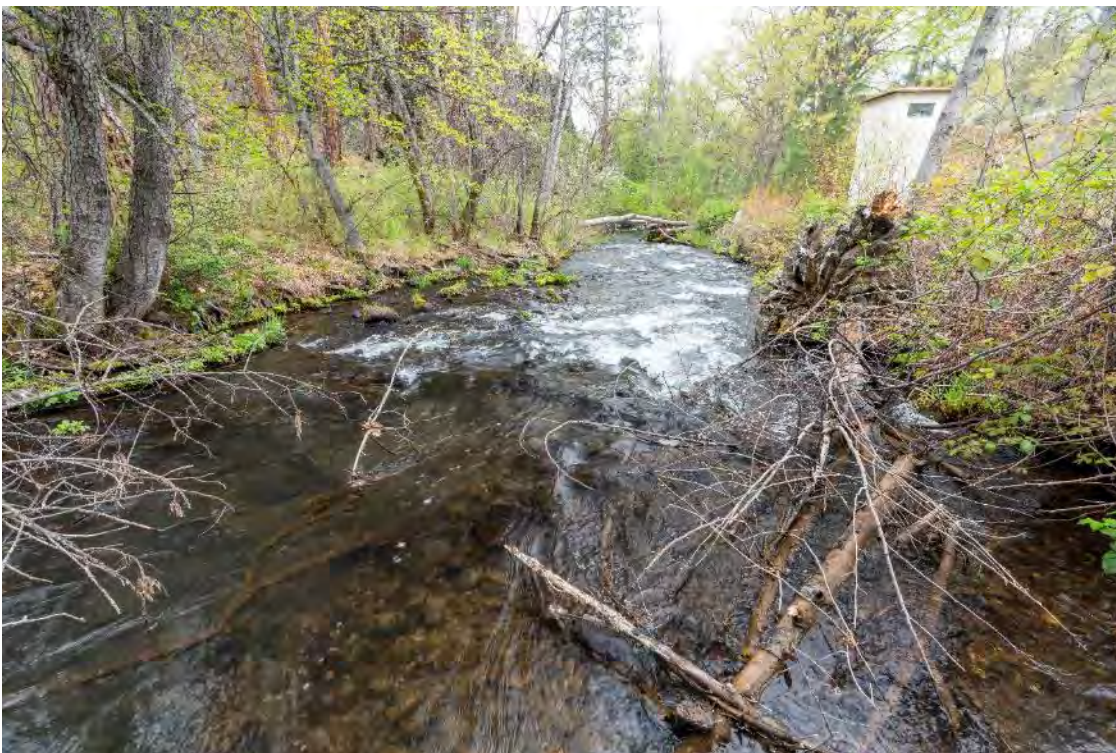
Image 17. Riffle near gage location looking downstream

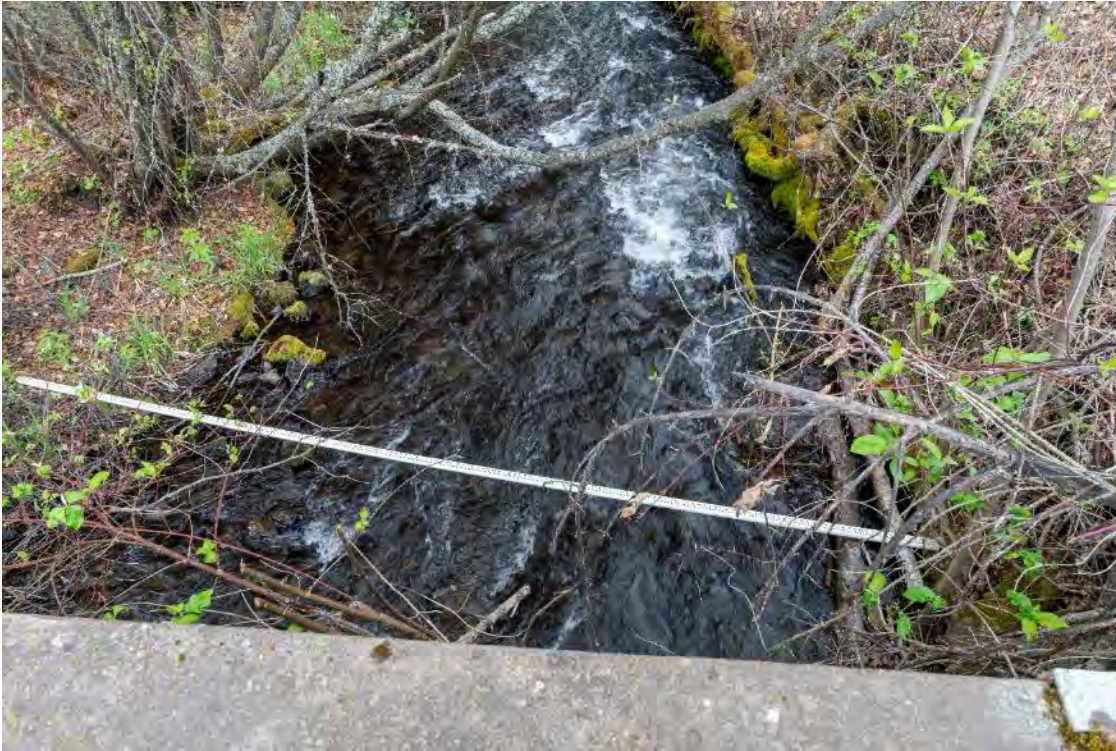
Image 20. Channel Measurement near Downstream End of Substation Access Road Bridge

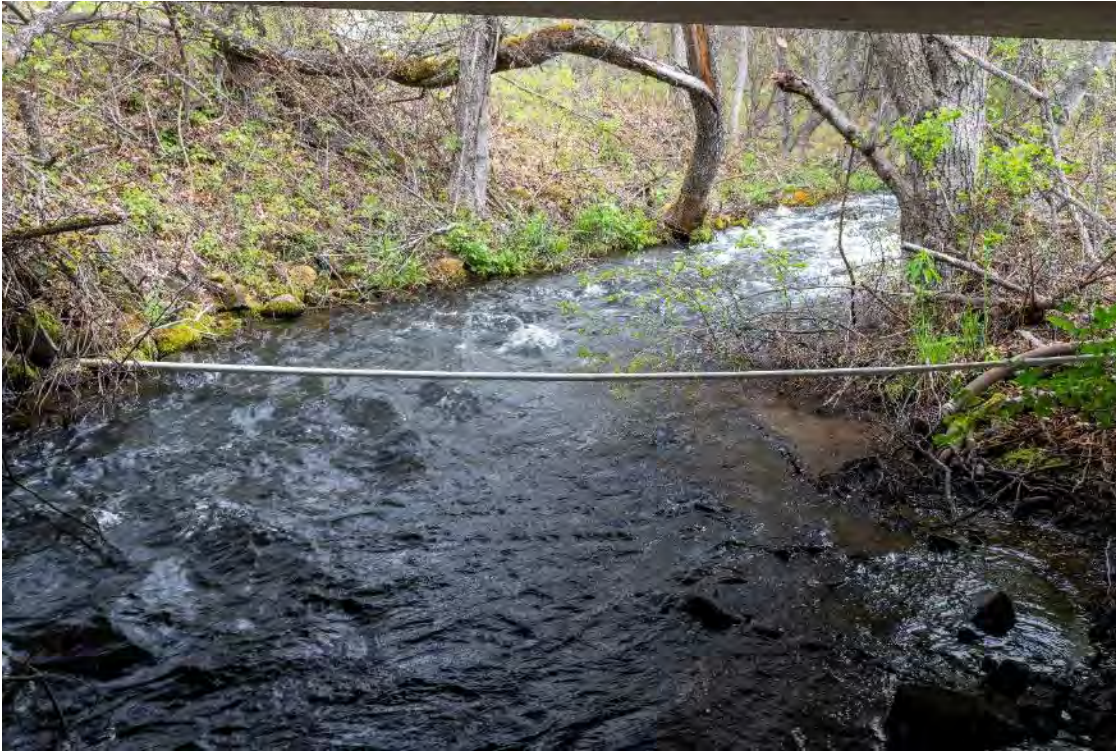
Image 22. Measurement Section Beneath Substation Access Road Bridge

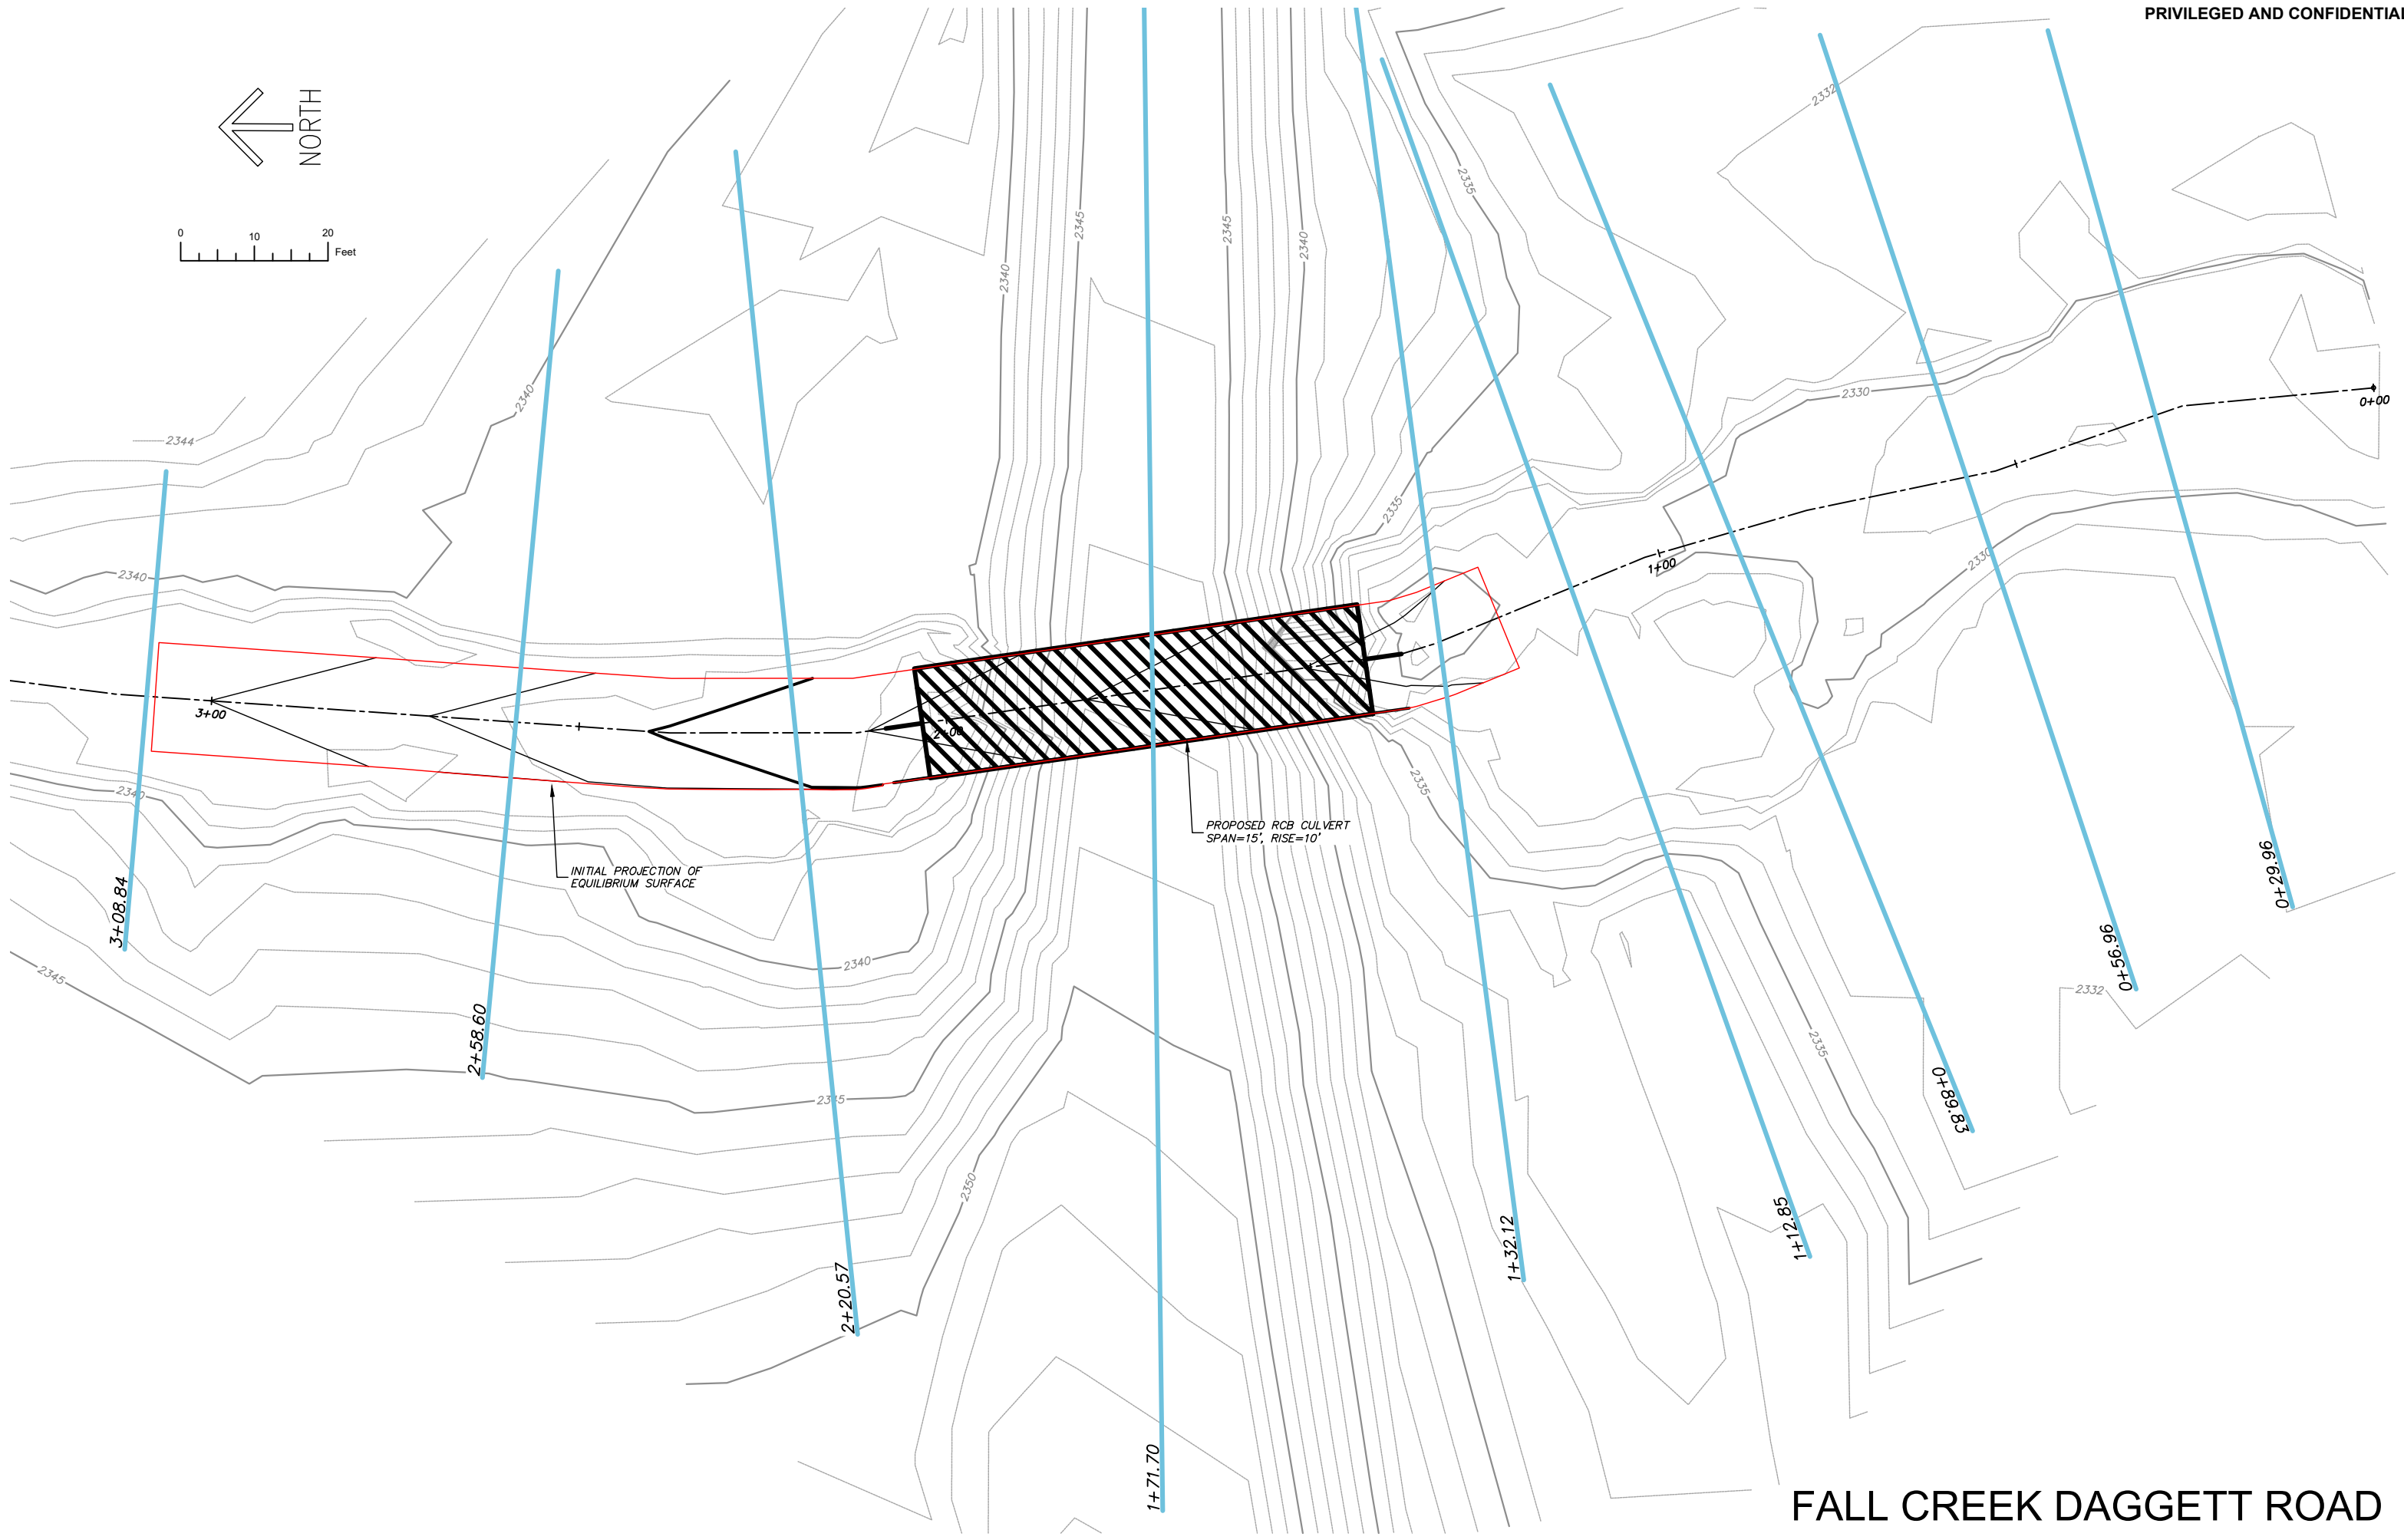
FALL CREEK DAGGETT ROAD

VE-5 Submittals: Fall Creek at Daggett Road – Box Culvert Concept Sketches

The Daggett Road Culvert is a complete barrier to adult and juvenile salmonids. NHC recommends replacing the Daggett Road Culvert using stream simulation or hydraulic design approach to meet fish passage objectives. A stream simulation approach would likely include a 20 to 25-foot-wide clear span

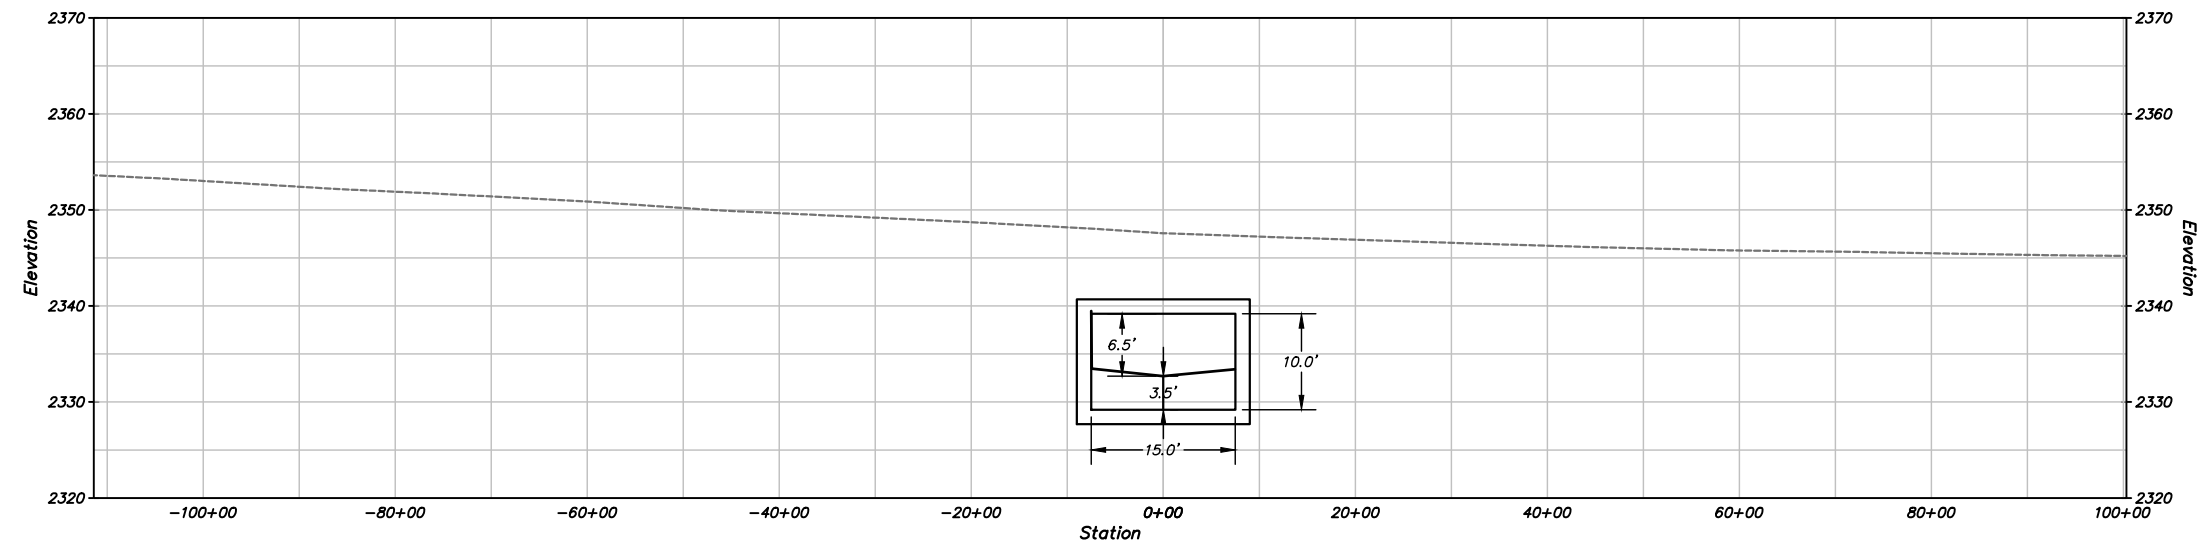
FALL CREEK DAGGETT ROAD

STA. 1+71.70

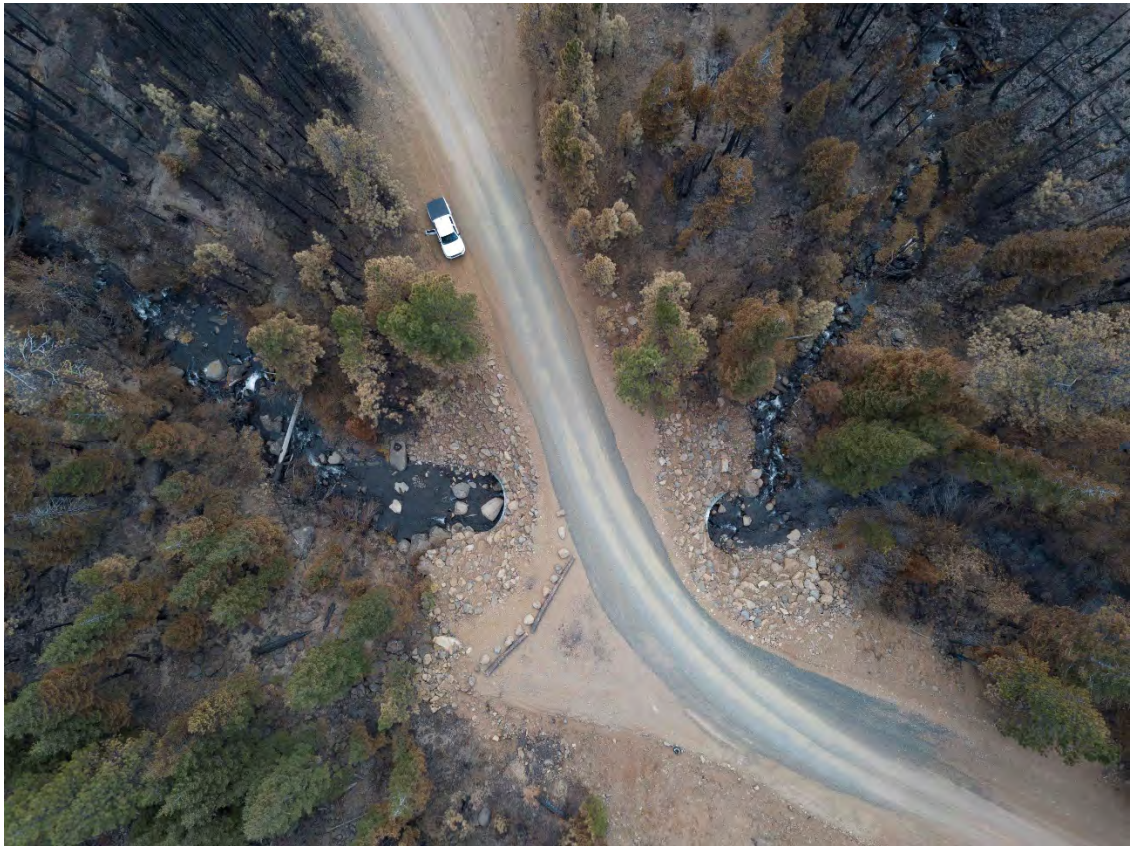
Image 1. Elder Creek Multi-plate sunken culvert 21 ft span, 13 ft rise

- At adult high fish passage design flow, velocities will be less than 6 fps and will meet adult velocity criteria
- Average velocities in culverts will be 2 fps or less, but are unlikely to be 1 fps or less and will likely require a variance. Velocities are unlikely to exceed juvenile coho salmon's swimming ability. Bell (1986) lists sustained speeds (aerobic effort 'used for long periods of travel at low speeds') from 0.5 to 2.1 fps. Swimming abilities have been related to body length and are known to increase with increased body length. Critical swim speeds for steelhead (O. mykiss), which are the stronger salmonid swimmers, have been measured to be about 7.5 body lengths per second. The crossing will be constructed with significant roughness features similar to Image 1 through Image 6. These features will create a complex

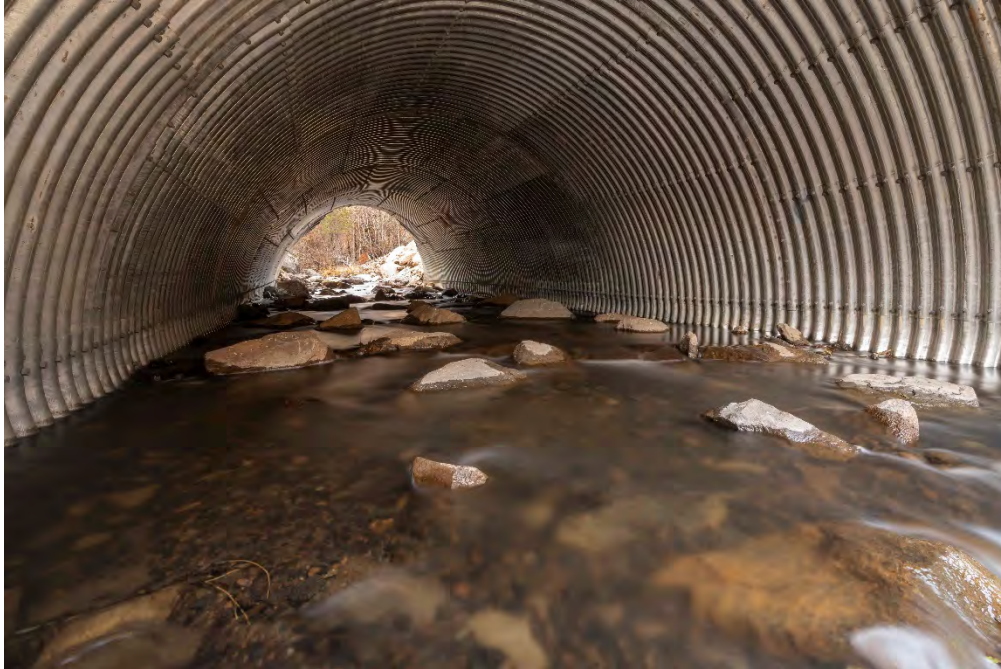
Image 2. Elder Creek Multi-plate sunken culvert 21 ft span, 13 ft rise

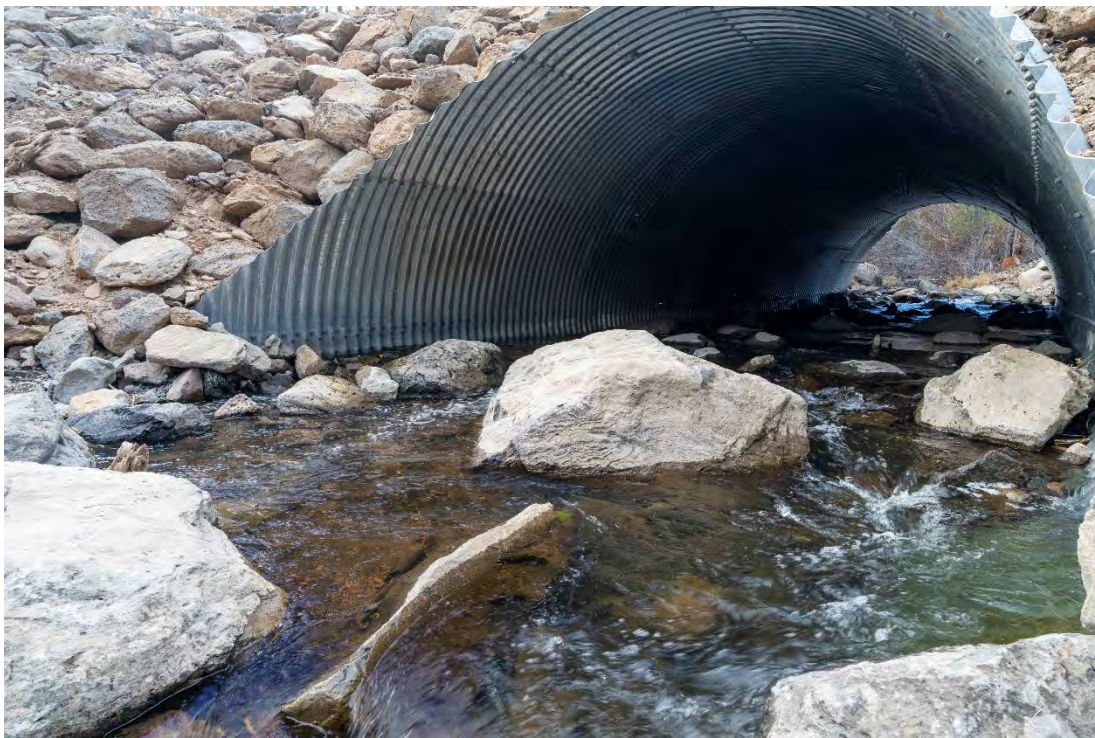
Image 3. Elder Creek Multi-plate sunken culvert (span 21 ft, rise 13 ft)
