RE: KRRP Value Engineering Summary and Advancement to 90% Design

KP was tasked with leading seven VE analyses, which are listed below and described in the following sections of this letter:

VE-1 Submittals: Drawdown Model and Assessment

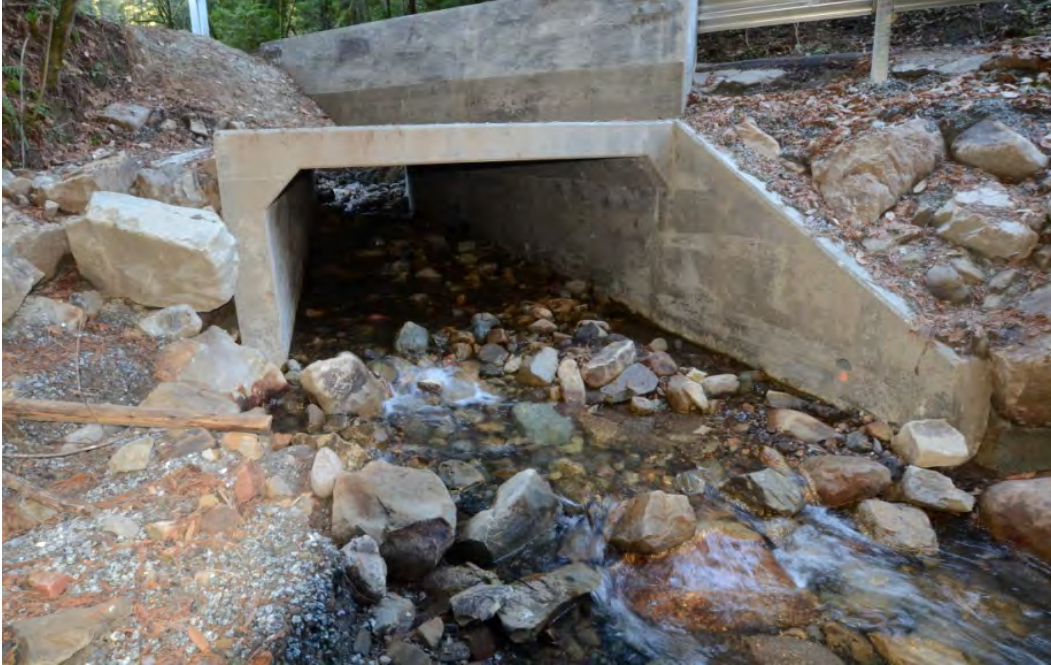
Image 4. Corrolitos Creek Sunken Box Culvert

- At adult high fish passage design flow, velocities will be less than 6 fps and will meet adult velocity criteria
- Average velocities in culverts will be 2 fps or less, but are unlikely to be 1 fps or less and will likely require a variance. Velocities are unlikely to exceed juvenile coho salmon's swimming ability. Bell (1986) lists sustained speeds (aerobic effort 'used for long periods of travel at low speeds') from 0.5 to 2.1 fps. Swimming abilities have been related to body length and are known to increase with increased body length. Critical swim speeds for steelhead (O. mykiss), which are the stronger salmonid swimmers, have been measured to be about 7.5 body lengths per second. The crossing will be constructed with significant roughness features similar to Image 1 through Image 6. These features will create a complex

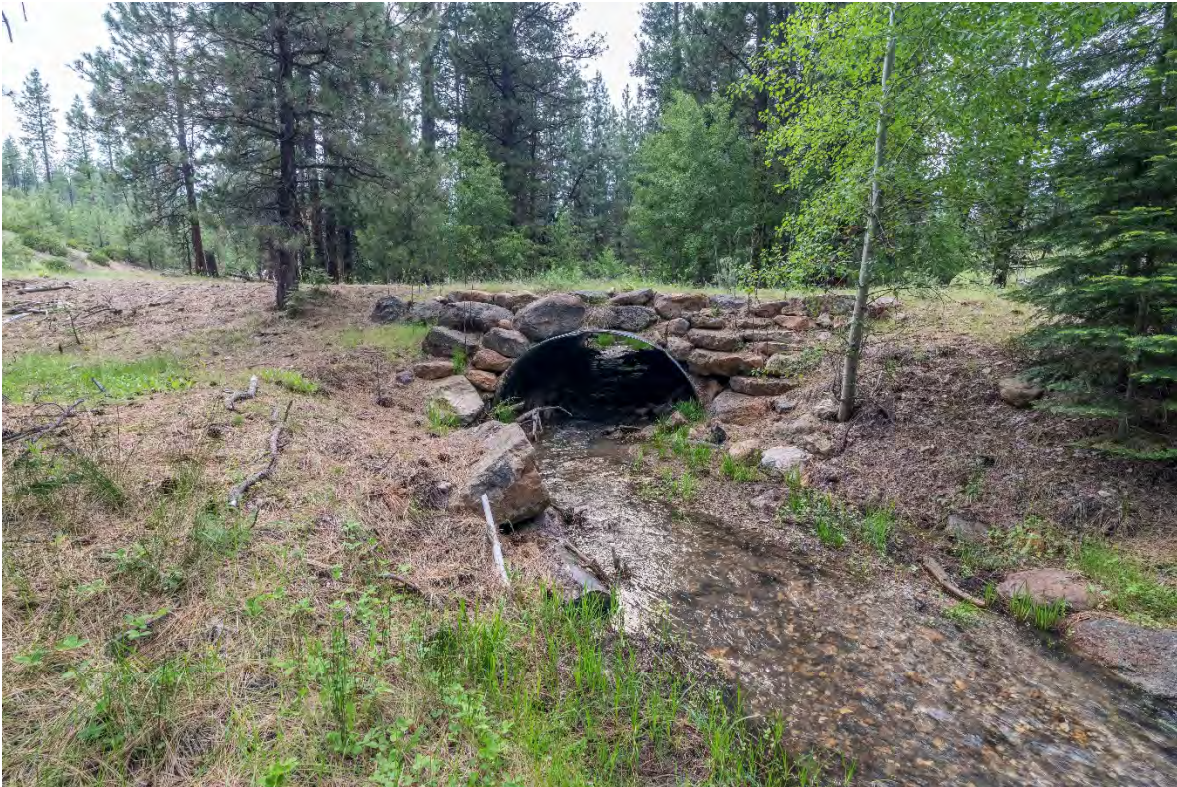
Image 5. Howard Creek Tributary sunken culvert (span 12 ft, 8 ft rise)

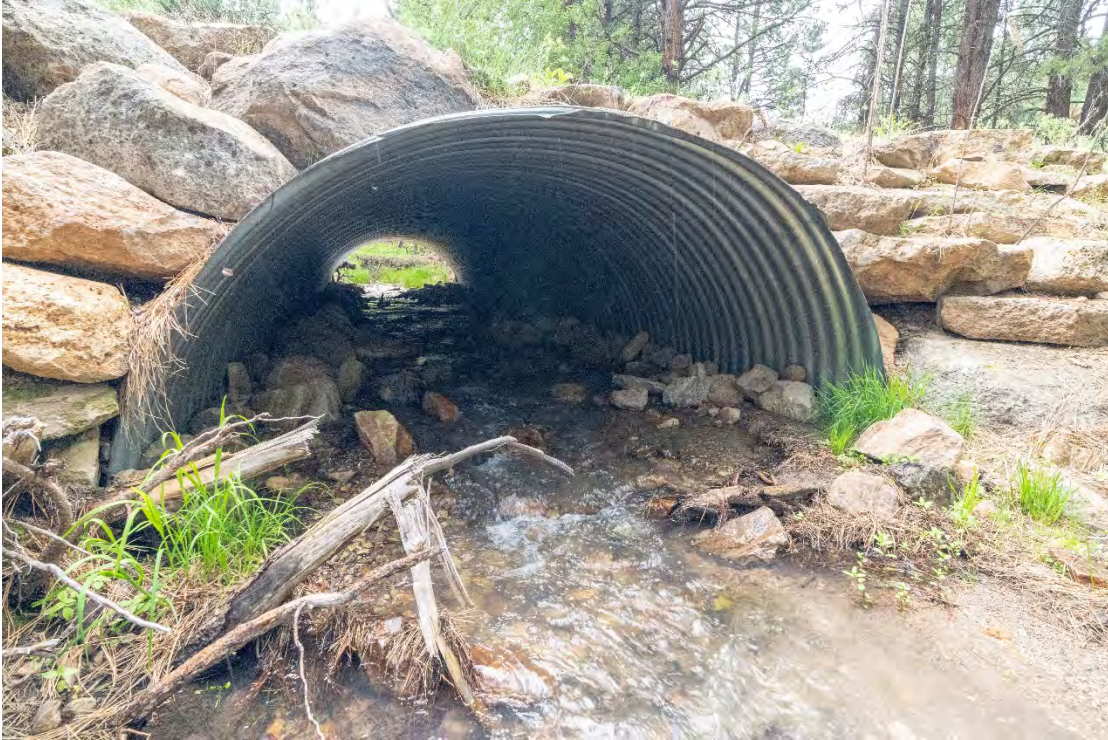
Image 6Howard Creek Tributary sunken culvert (span 12 ft, 8 ft rise)

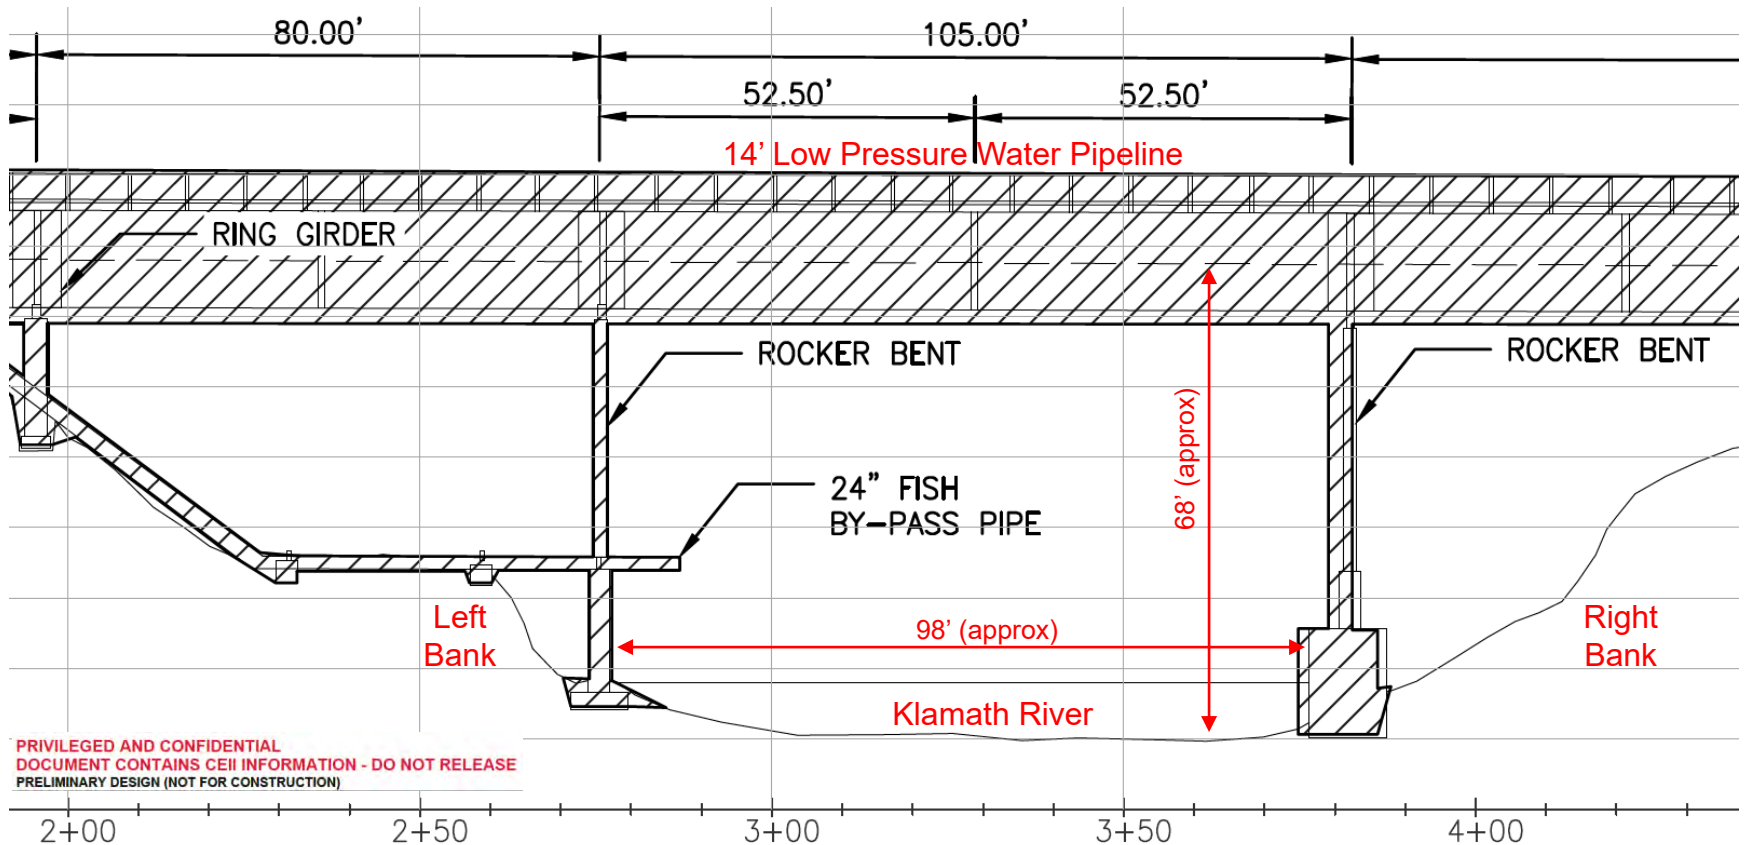
2) J.C. Boyle Timber Bridge – Scour Assessment

Water Pipeline Section - Viewing Downstream Klamath River

Background Information Excerpted from Drawing C1300, Rev. D

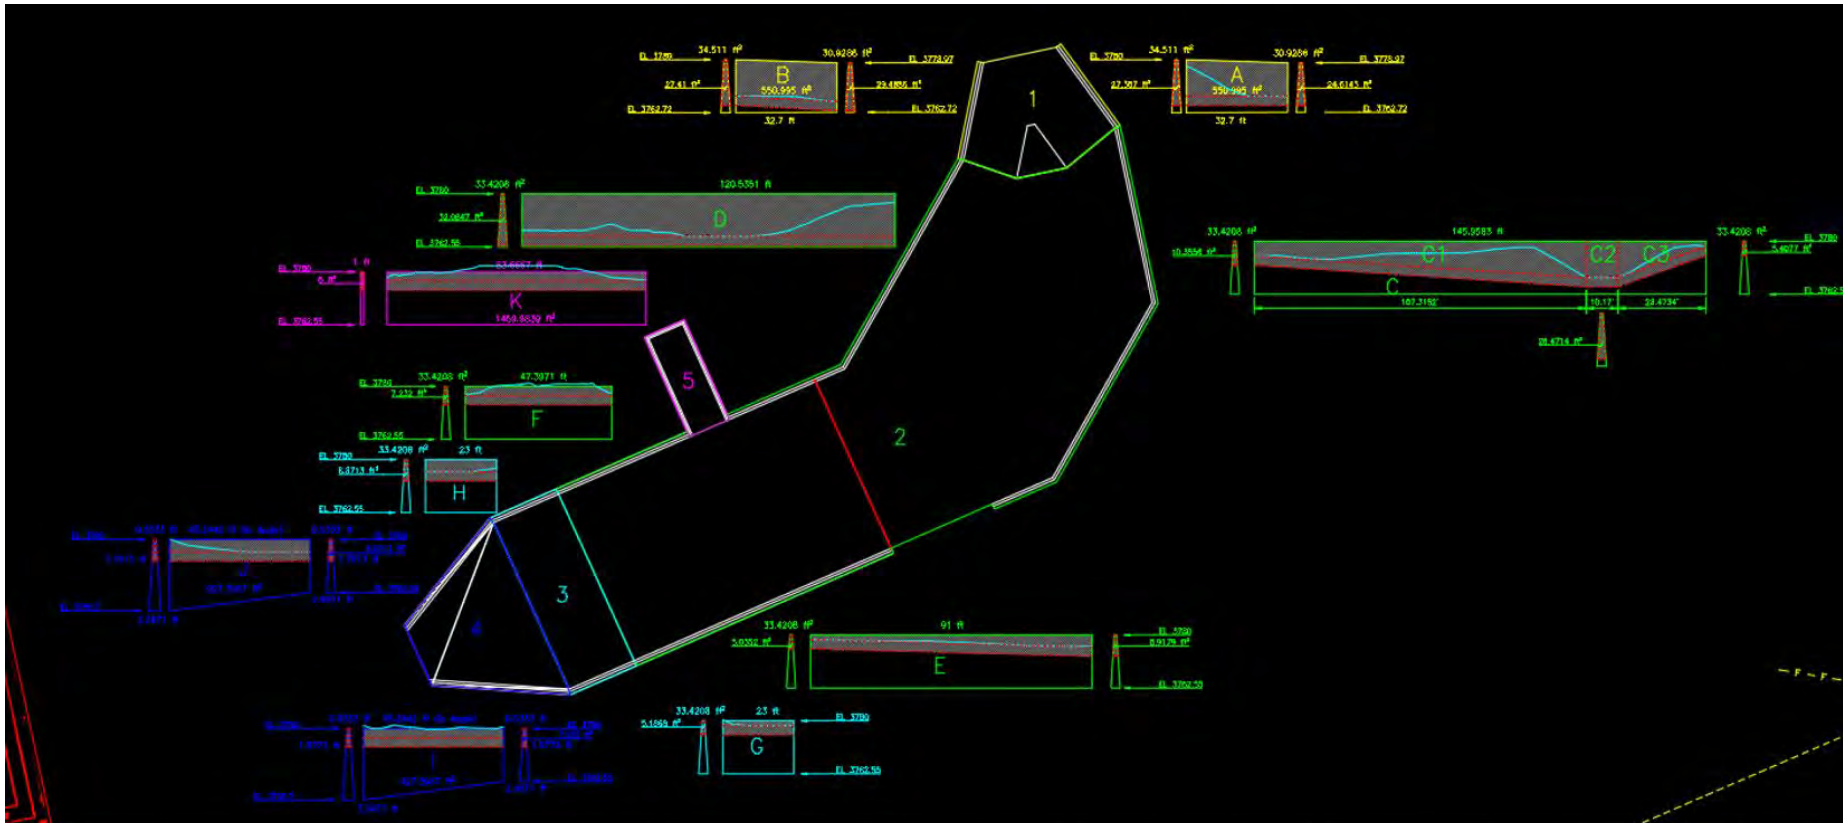
Forebay Grading – Partial Concrete Material Takeoffs

- VE Partial Removal - About 2/3 of concrete volume buried in place
- Top 1/3 of concrete (approx.) removed and placed in scour hole

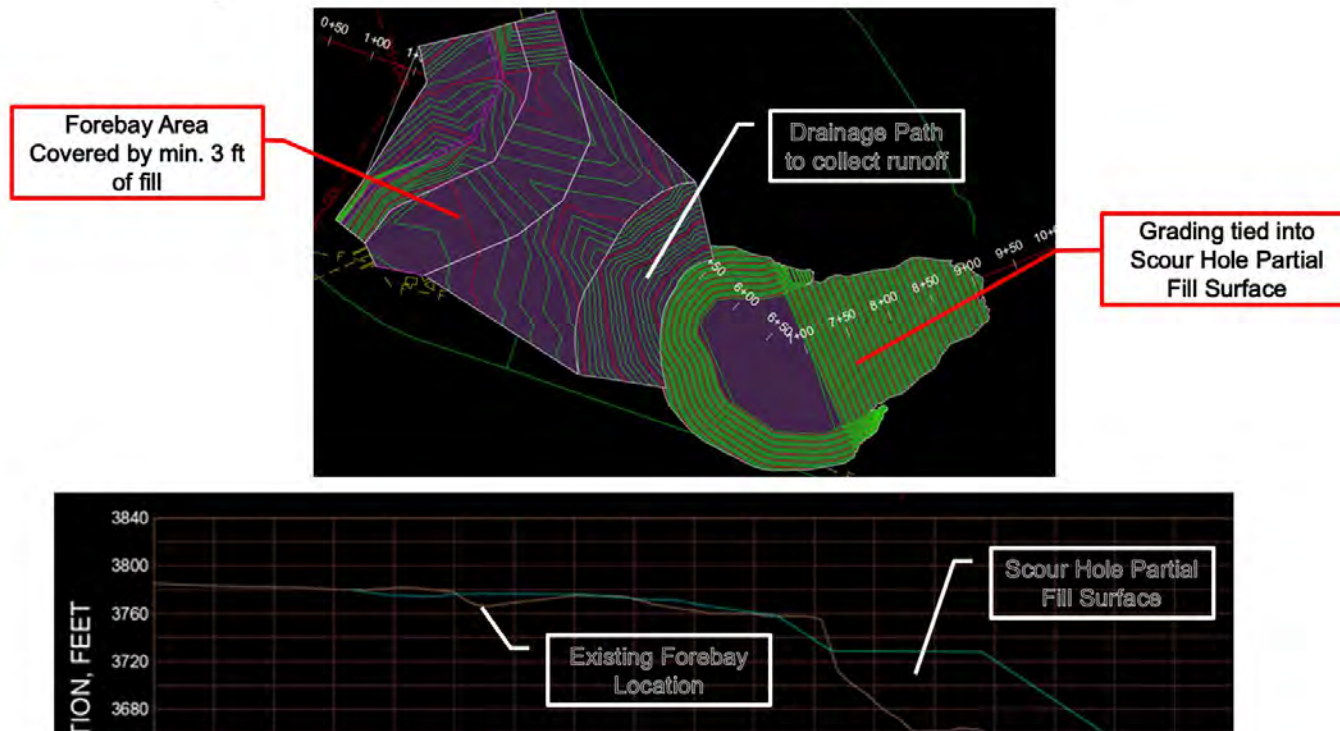
Forebay Grading – Grading Plan and Sections

Summary Info

- Forebay Grading
- Concrete Removal Volume
- Forebay Grading (cut/fill)

~800 yd³
7,200 yd³

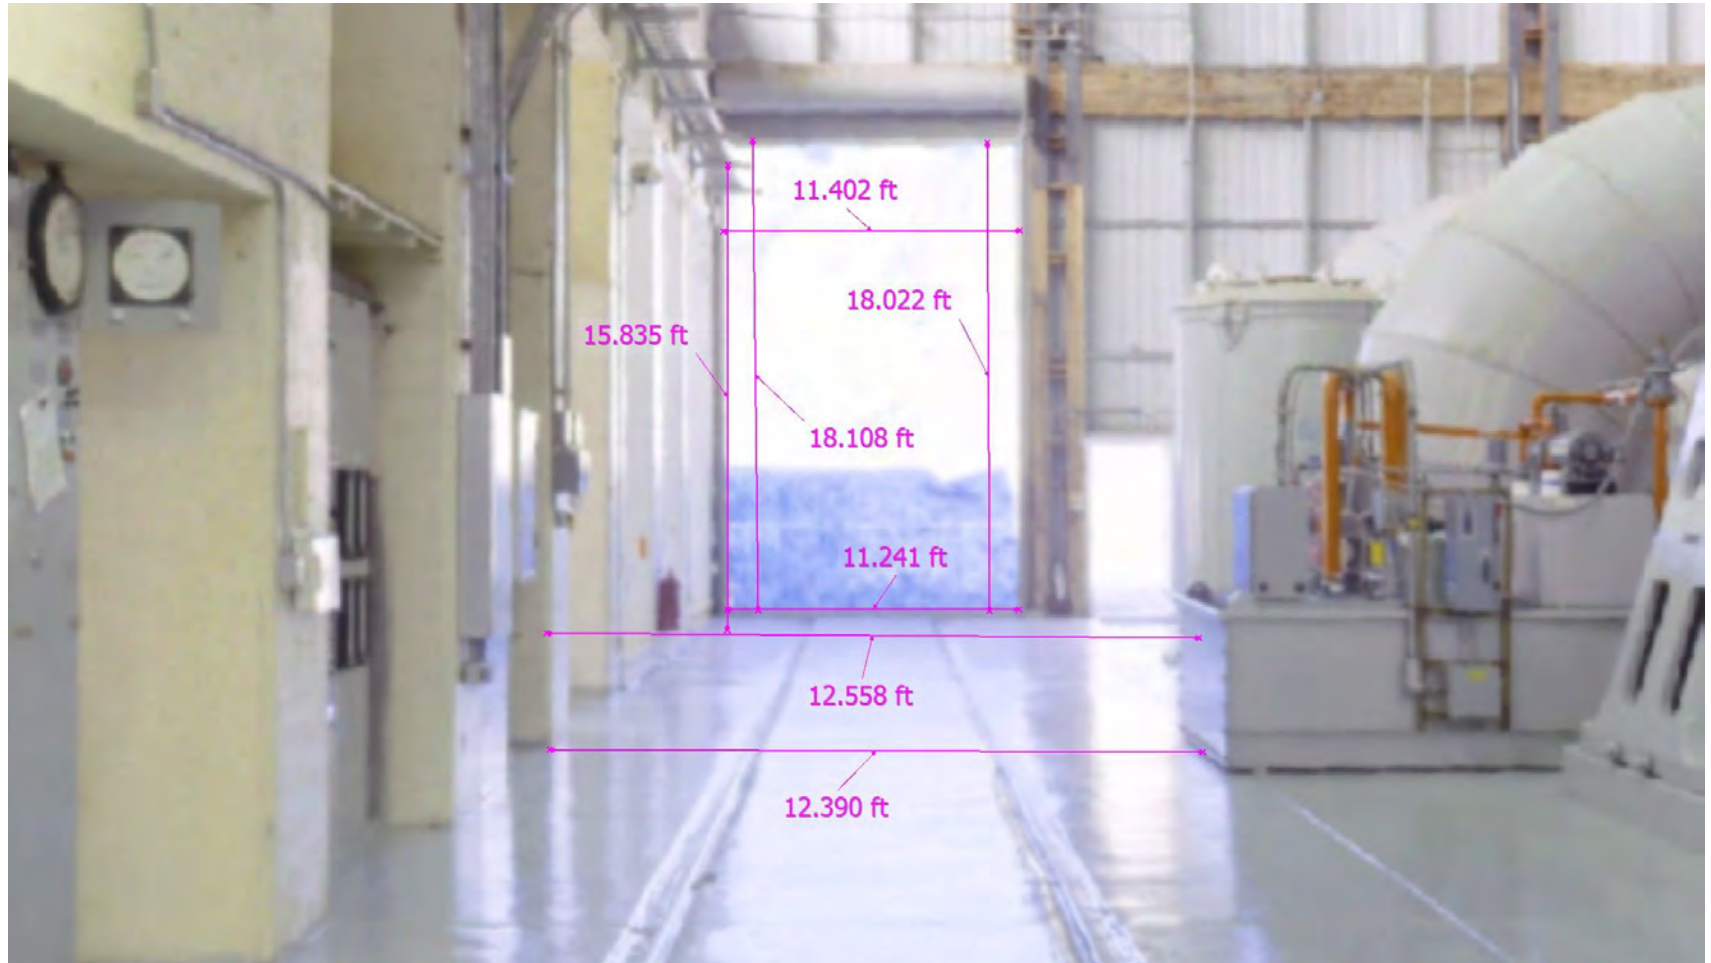
Figure 1: West Wall Entrance, Units 3&4 HPU to Column 4, and Overhead Cable Tray Measurements

- Powerhouse end wall modifications
- Cable tray and pipe support modifications
- Removal of miscellaneous electrical boxes
- Modification of two turbine/generator unit panels

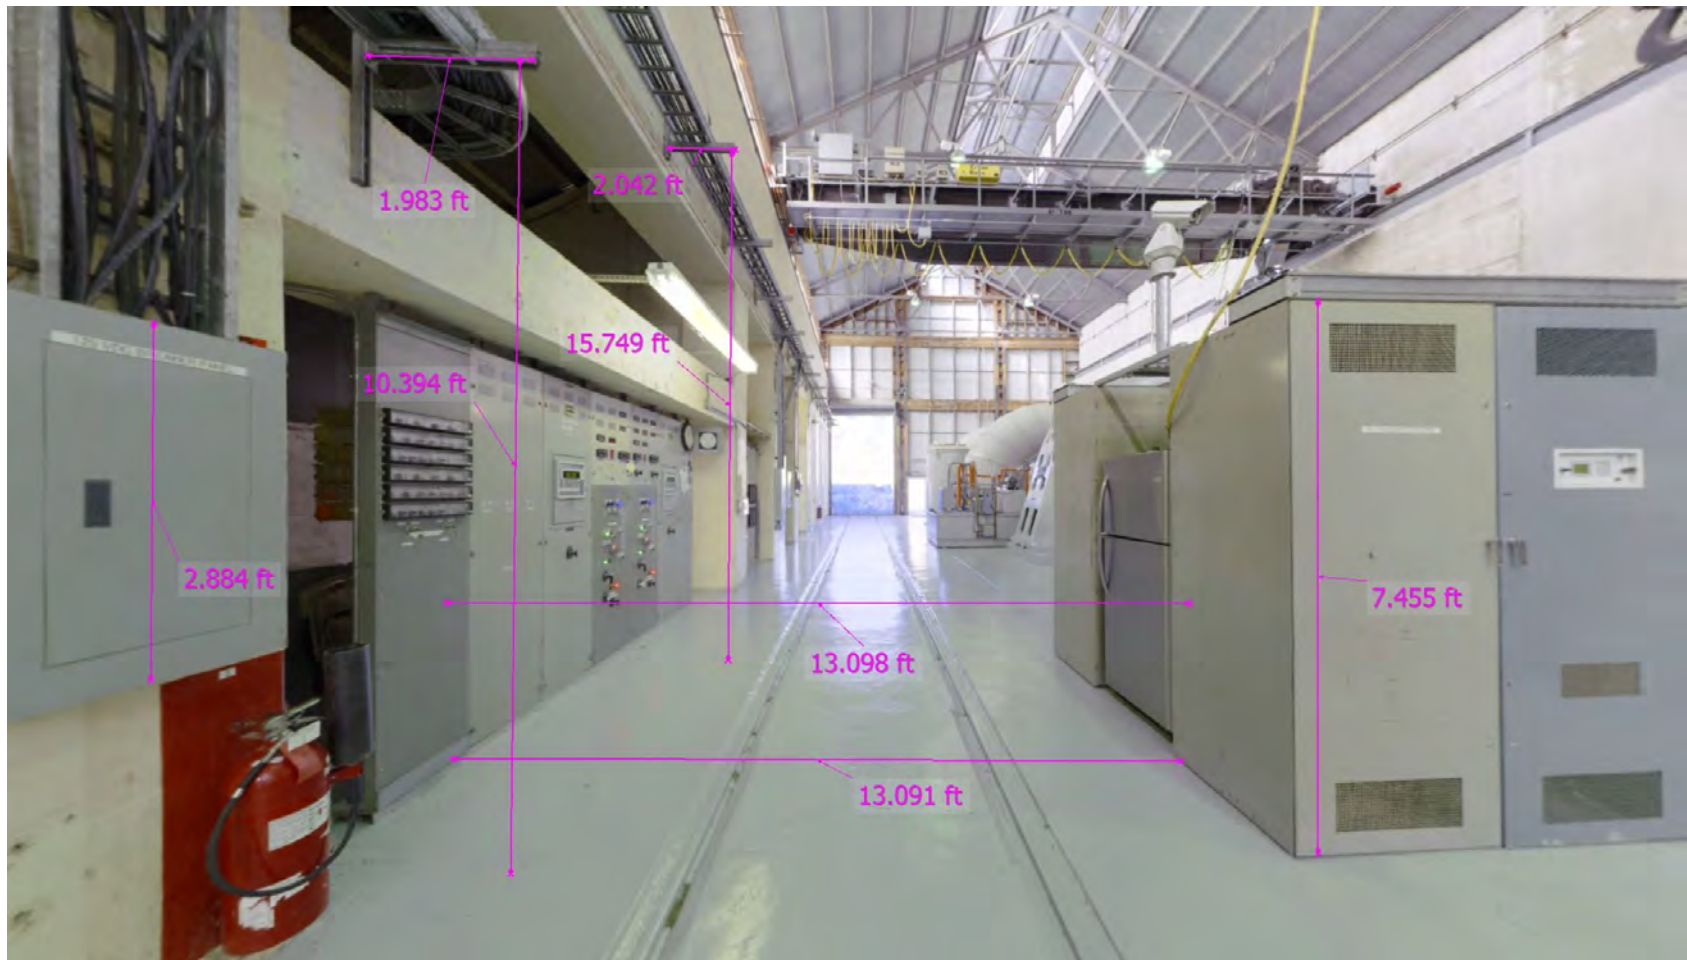
Figure 2. Cable Tray Upper and Lower Measurements, Column 7 to Exciter and Digital Excitation Control System Cabinets

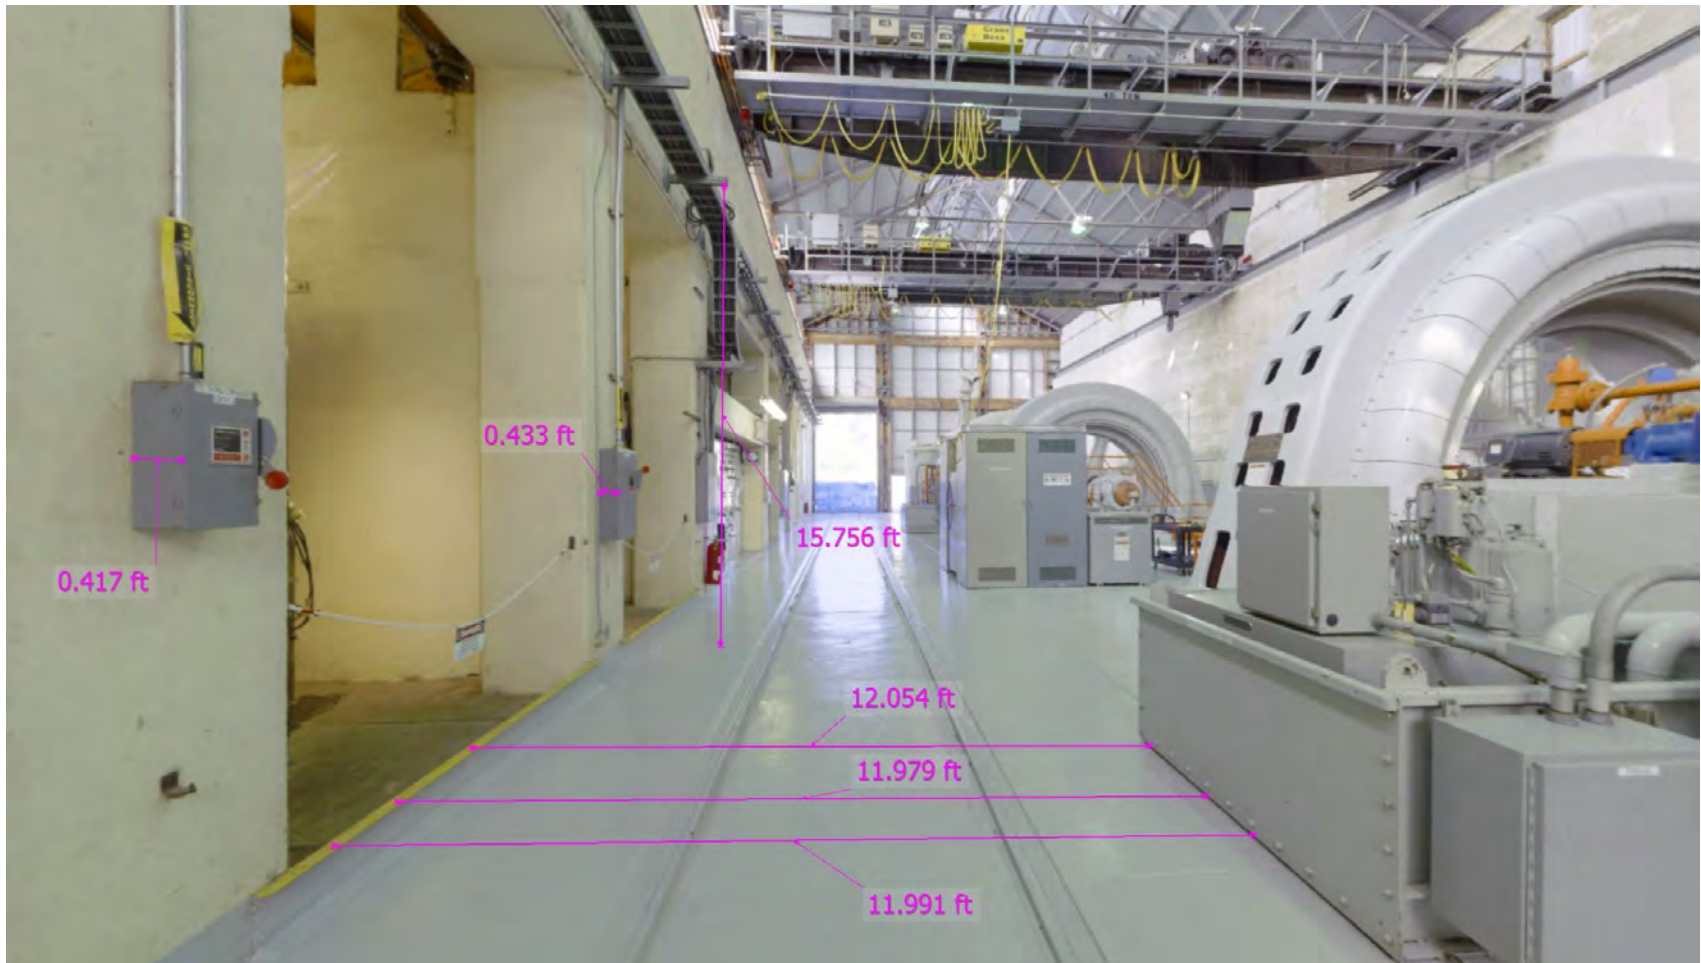
Figure 3: Electrical Switch Box Measurements, Width of corridor between columns 8 & 9 to HPU of Units 1 & 2.

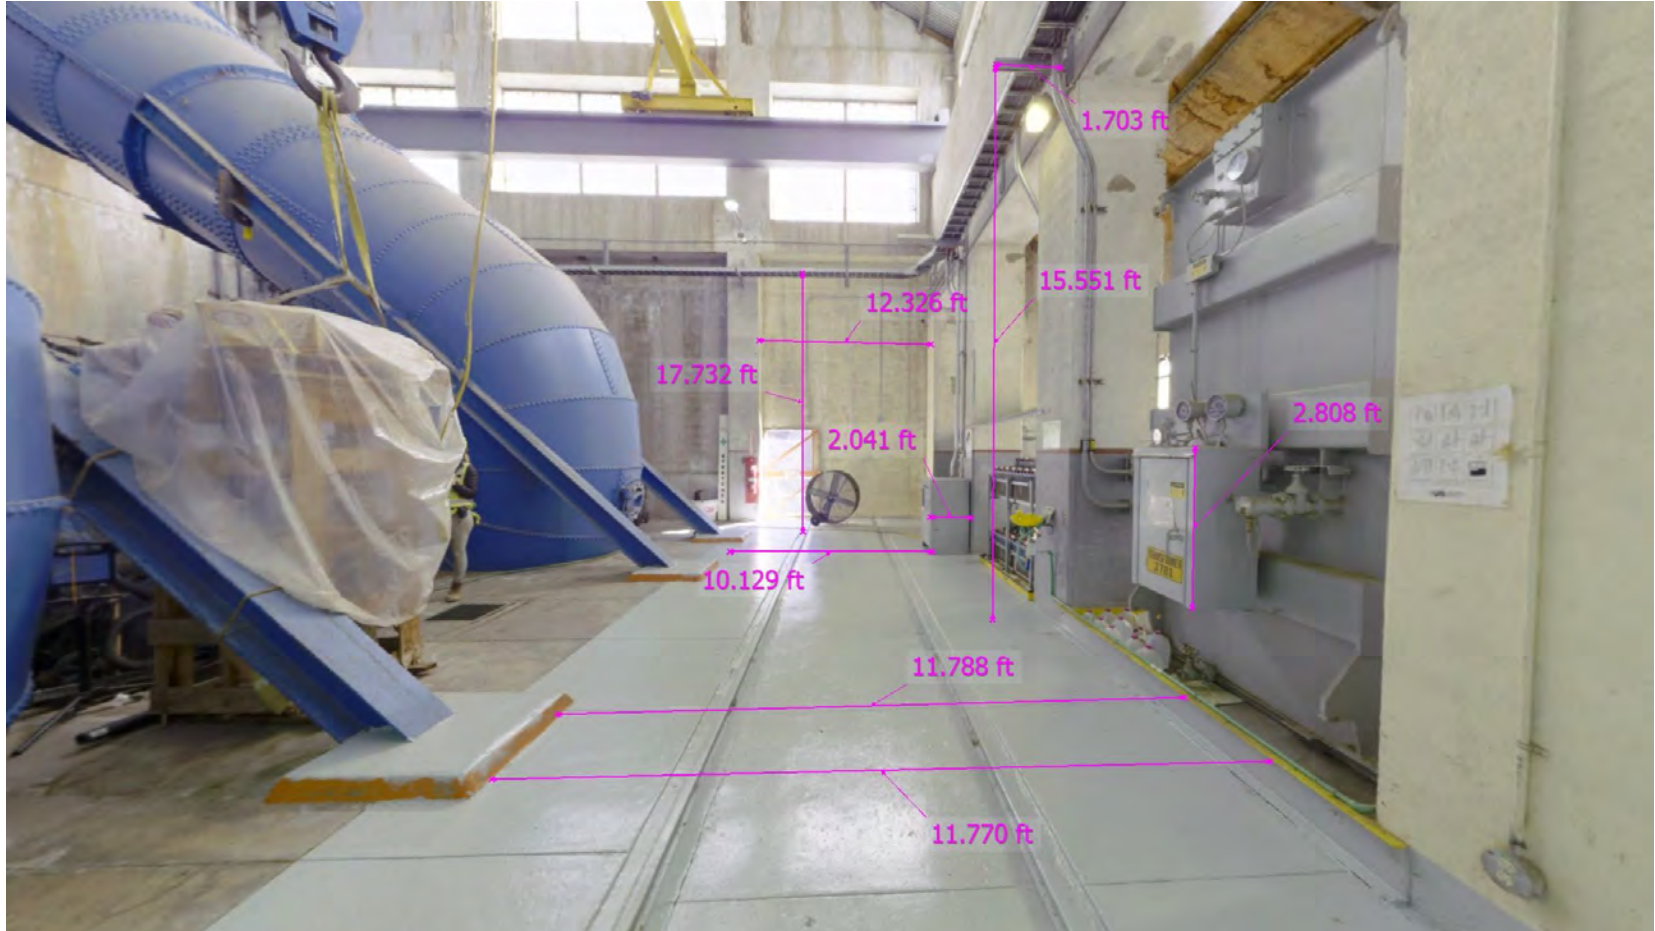
Figure 4: Width of corridor between concrete pedestal to point between columns 10 & 11. Cable Tray Height measurement and support measurement. Corridor width between pedestal and electrical box (Column 12). Electrical Box Width (Column 12). East Wall potential opening measurement

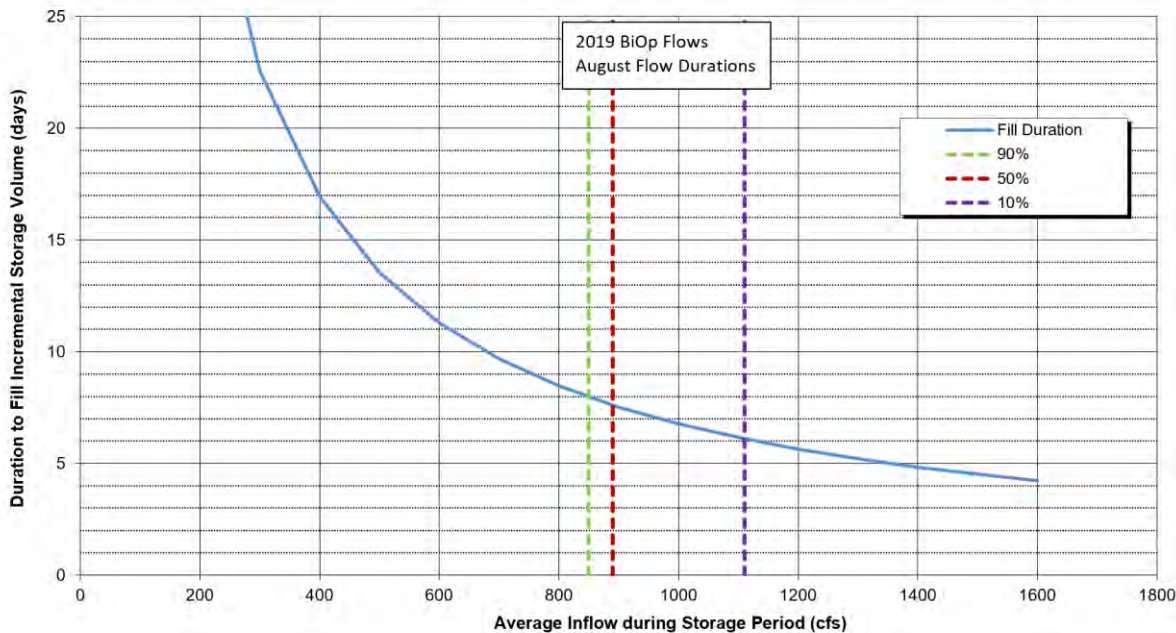
- The chart below shows the duration to fill up from minimum to normal operating level based on average inflow condition during the fill period
- Daily flow duration percentiles for August are shown for context
- Example: At median (50%) August inflow, duration to fill is 7.5 days

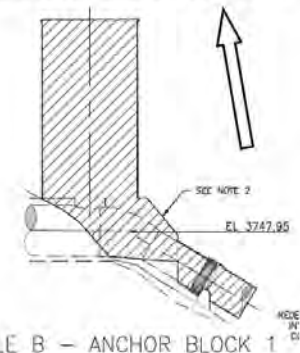
PROFILE B – ANCHOR BLOCK 1

2. REMOVE CONCRETE STRUCTURES TO 'SPRING LINE OF THE PENSTOCK AND BURY USING LOCALLY AVAILABLE SOIL MATERIAL MEETING THE TYPE E9 GENERAL FILL MATERIAL SPECIFICATIONS.

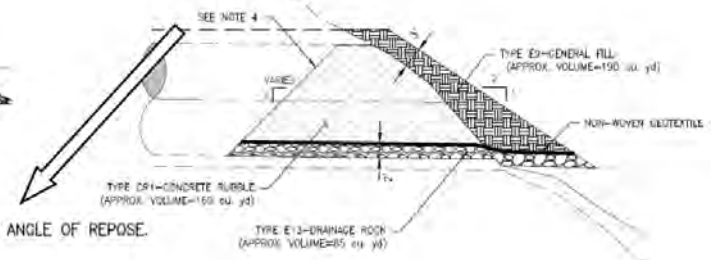
4. CONCRETE RUBBLE PLACED IN TUNNEL AT ANGLE OF REPOSE.

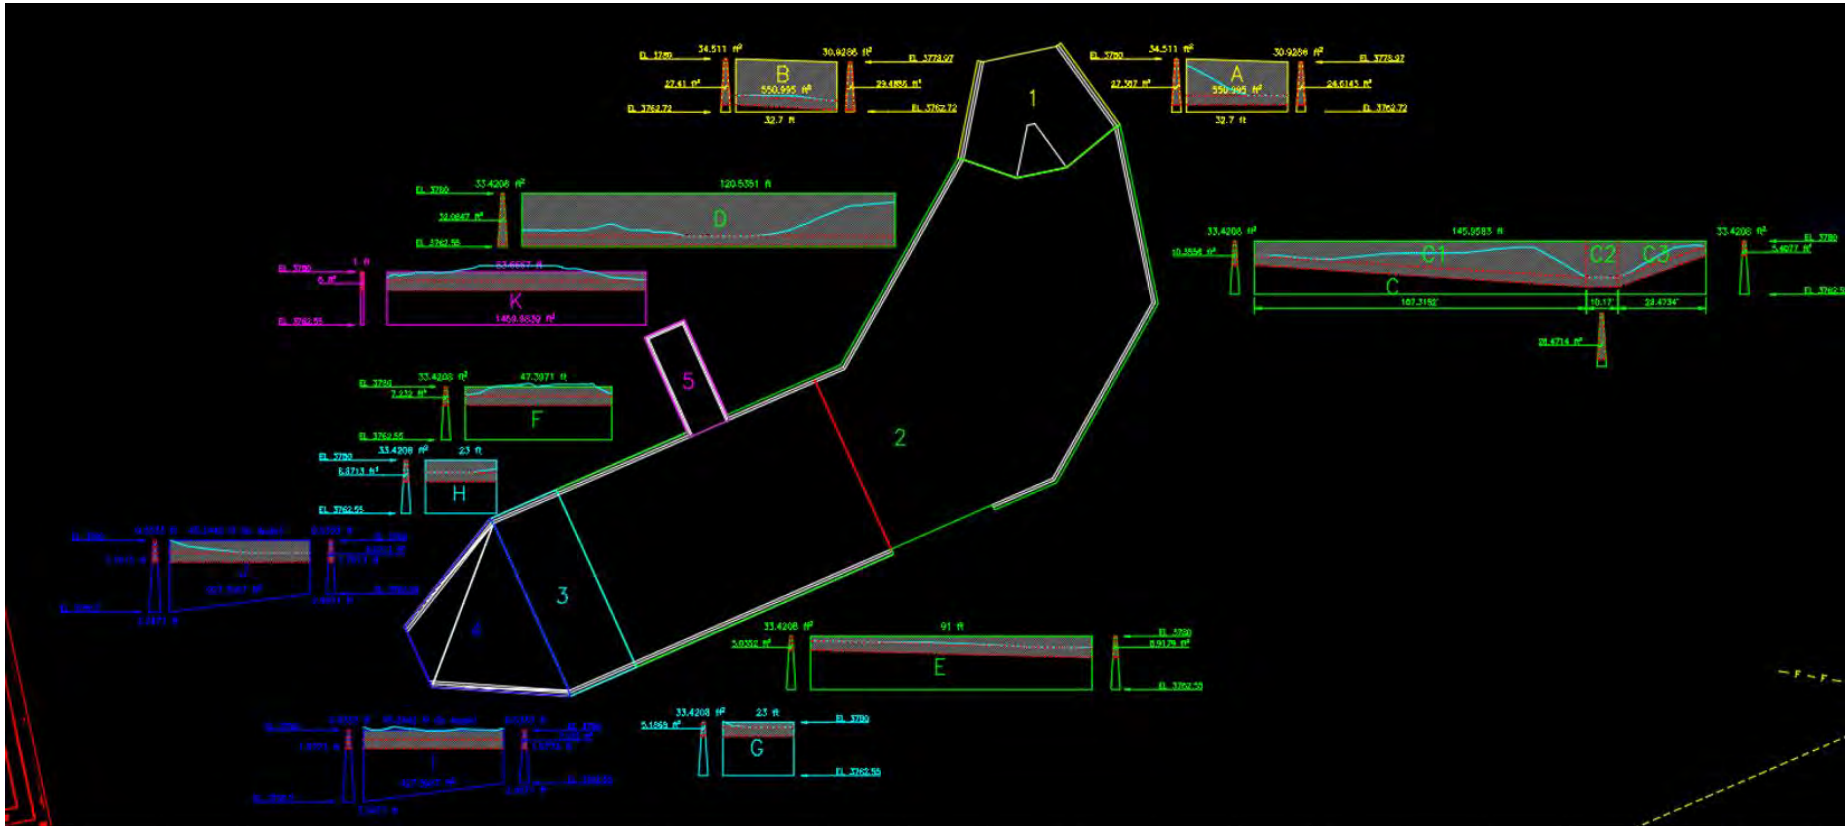
Partial Concrete Material Takeoffs

- VE Partial Removal - About 2/3 of concrete volume buried in place
- Top 1/3 of concrete (approx.) removed and placed in scour hole

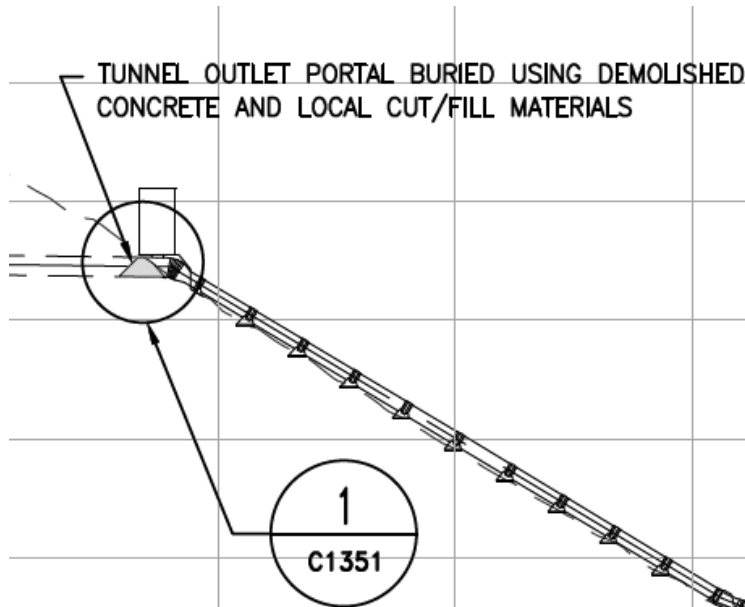
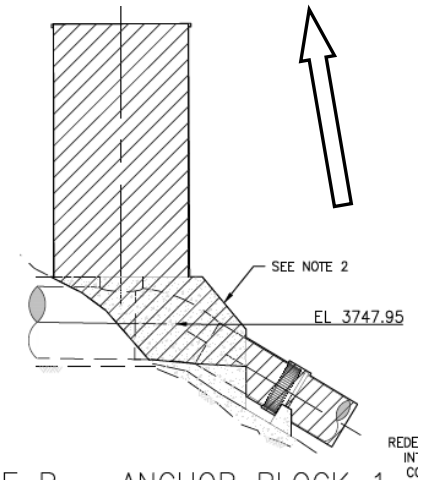
PROFILE B - ANCHOR BLOCK 1

2. REMOVE CONCRETE STRUCTURES TO SPRING LINE OF THE PENSTOCK AND BURY USING LOCALLY AVAILABLE SOIL MATERIAL MEETING THE TYPE E9 GENERAL FILL MATERIAL SPECIFICATIONS.

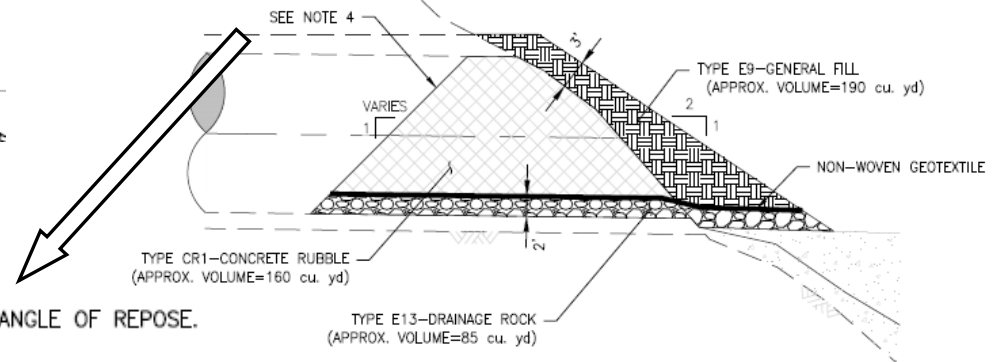
4. CONCRETE RUBBLE PLACED IN TUNNEL AT ANGLE OF REPOSE.

1
C1350
1" = 10'
